# Building and Timber Pest Inspection Report

Inspection Date: Mon, 9 Feb 2026

Property Address: 23 Nurla Ave, Little Bay NSW 2036,  
Australia

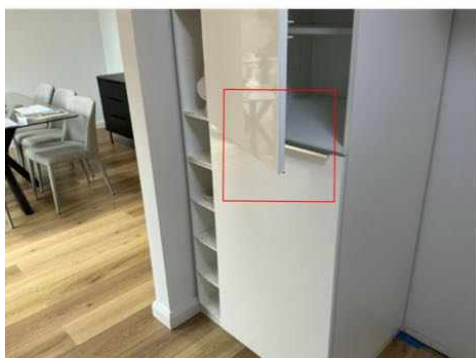
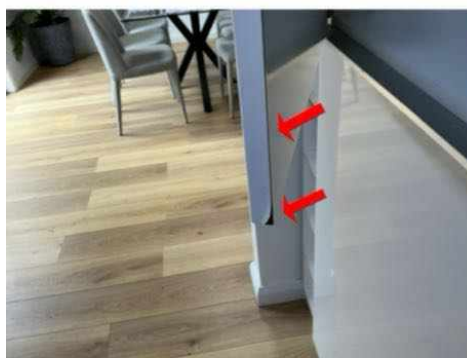
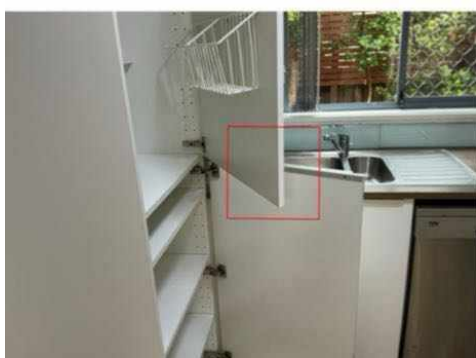
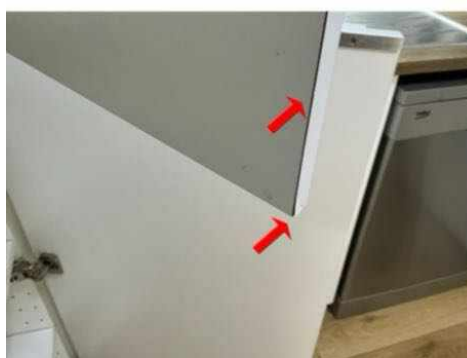
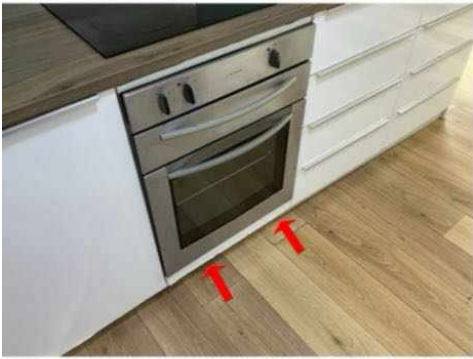
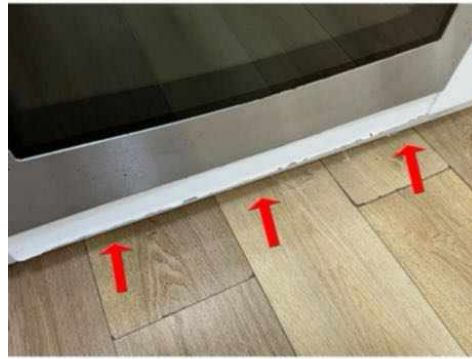
### Finding 3.13

Building:	Main Building
Location:	Kitchen
Finding:	Delamination of timbers
Information:	Delamination is one means by which composite materials (e.g. layered timber composites) may fail over time. In laminated materials, repeated cyclic stresses may lead to the formation of mini-structures of separate layers, with significant loss of mechanical toughness. Water penetration or the presence of excessive moisture also generally contributes to delamination.

Where building materials have become delaminated, they lose their structural strength, and are likely to have a variety of appearance and serviceability defects as a result.

Delamination of timbers may be repaired where the area affected is minor and/or easily accessible, by gluing and screwing layers back together. However, this is an interim repair, and where delamination has occurred, the client should plan for the replacement of affected timbers sooner than would otherwise be expected.

All timber structures affected by delamination should be replaced as soon as possible to avoid any further damage. Repair and replacement estimates should be sought from a registered builder or qualified carpenter.

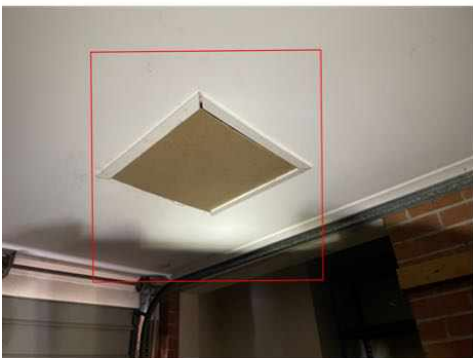
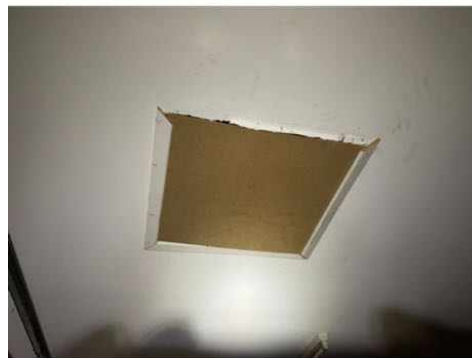
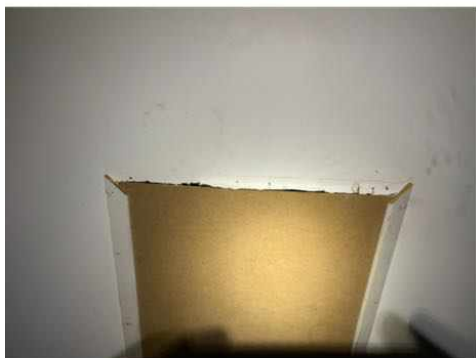
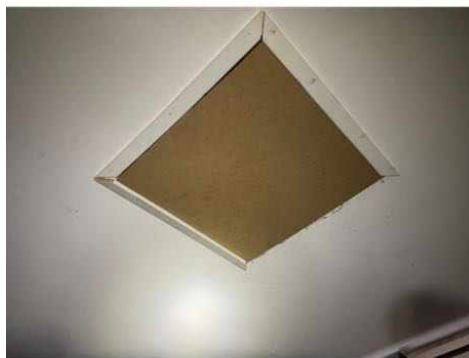
### Finding 3.14

Building:	Main Building
Location:	Garage
Finding:	Building element - Damaged
Information:	Breakage occurs generally when the building materials have either aged and decayed, or as a result of damage (accidental or deliberate).

Repair and/or replacement of broken elements is advised to ensure that additional secondary defects do not arise as a consequence. Such works are necessary, as all building elements play a key role in the operation and function of the overall structure and its performance.

A relevant tradesperson should be appointed to repair or replace the affected building element prior to any subsequent damage being caused.

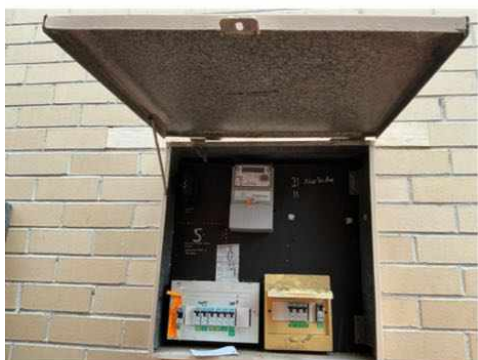
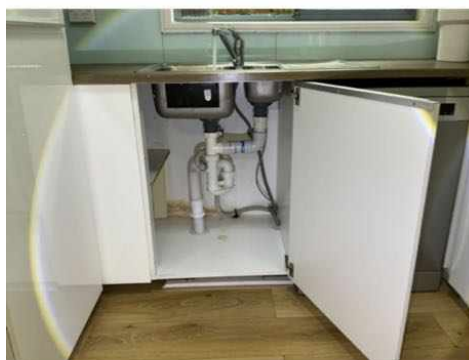
Building:	Main Building
Location:	Meter box, under kitchen sink
Finding:	Termite Management System - no evidence of a chemical installation
Information:	The application of a post-construction chemical termite barrier is highly recommended for all properties, particularly if live termite activity has been found on the site previously. Such barriers are highly effective in preventing termite attack on any timber building elements throughout the property.

A durable notice should be placed in the switchboard unit to indicate current termite barriers. At the time of inspection, it appeared as though no termite management system has been installed, with no evidence to suggest preventative works taking place.

The client may consider gaining further advice from a pest controller as to the costs and procedures involved with this application. It is recommended that obtaining such advice be a short-term priority.

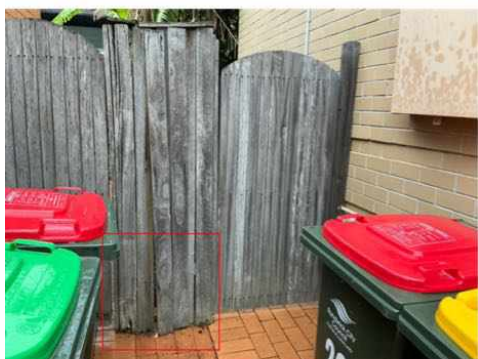
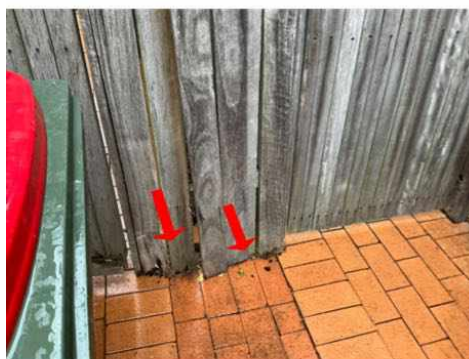
## Finding 6.02

Building:	Main Building
Location:	All rear perimeter fencing
Finding:	Fungal decay - present (localised)
Information:	Fungal decay also known as wood decay or wood rot generally refers to the deterioration of timber elements when in contact with excessive levels of moisture for a prolonged period of time.

The development of fungal decay is accelerated by temperatures in the range of 5degreeC to 40degreeC as well as the presence of oxygen. Generally fungal decay develops on timber elements that are in use in an external environment which are exposed to rain penetration.

In this case although the affected timber element is in a decaying state the extent of any visible damage appears to be localised to a specific area and is yet to spread to other parts of the building element or affect adjoining structures. The fungal decay is therefore likely to be of a relatively superficial nature with minimal impact on the structural integrity or tensile strength of the timber element.

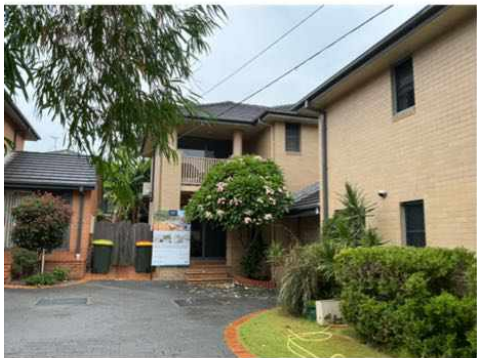
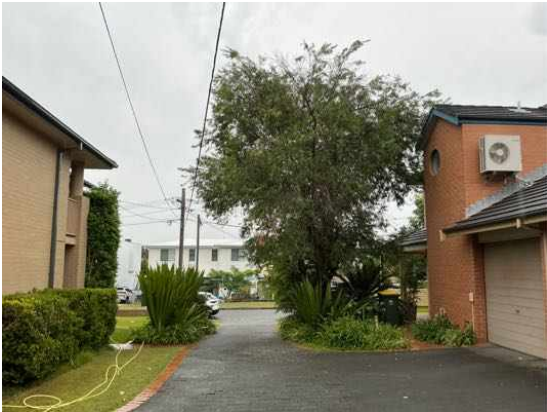
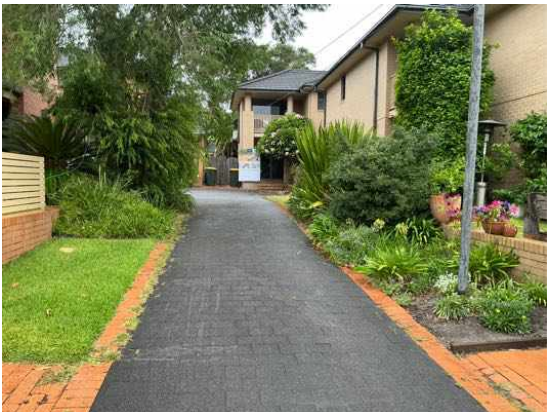
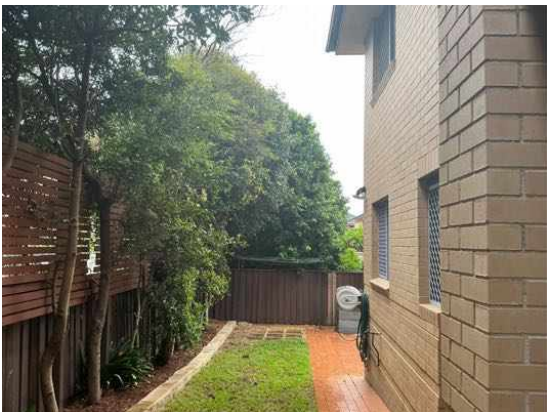
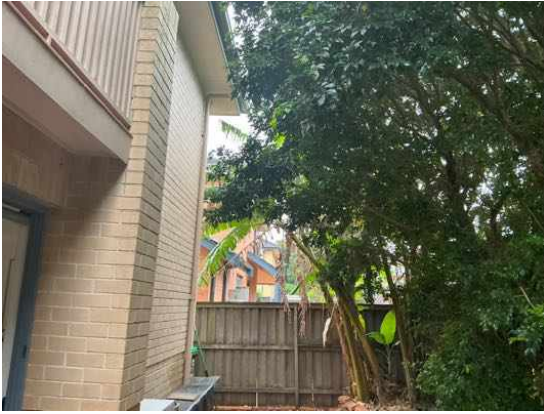
### Finding 6.08

Building: Main Building  
Location: All Areas  
Finding: Trees to be inspected within the property.  
Information: Trees can be conducive to termite activity and nesting. Trees over 100mm on the property, should be drilled and tested for termite activity.

Regular inspections every 6-12 months- or advised by the termite management system installer.

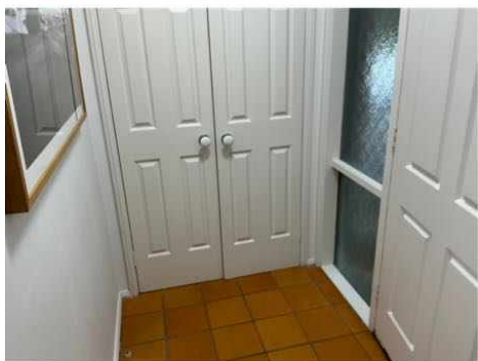
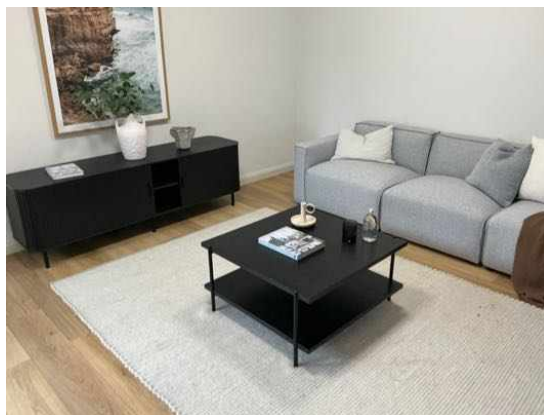
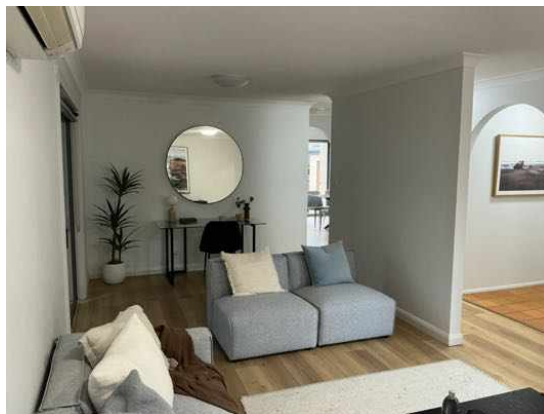
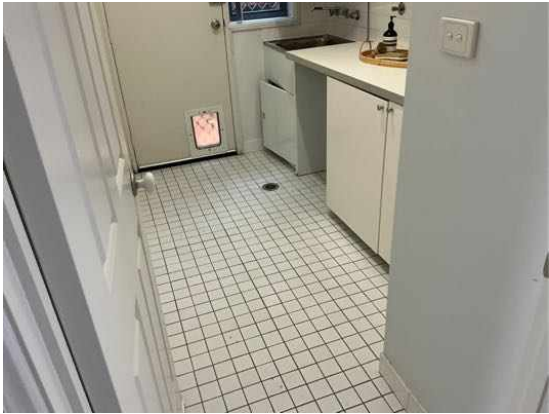
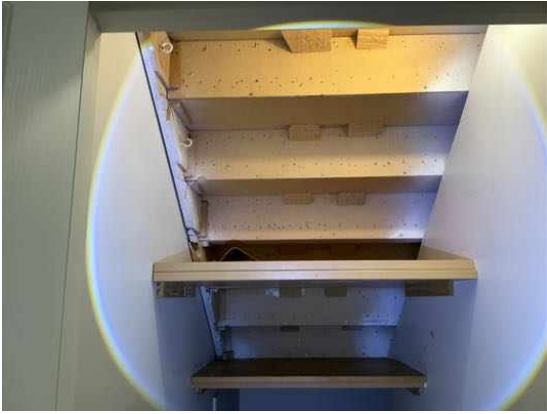
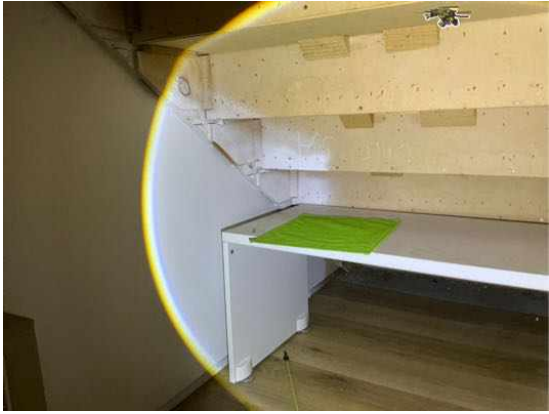
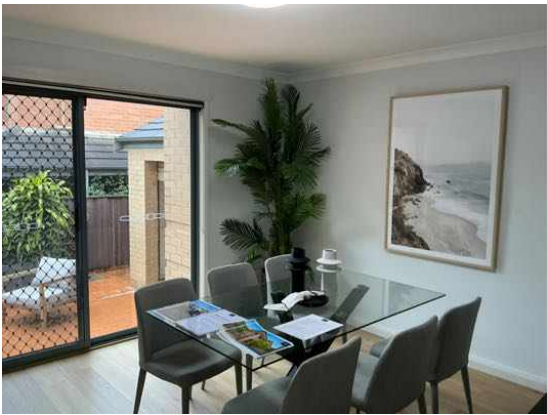
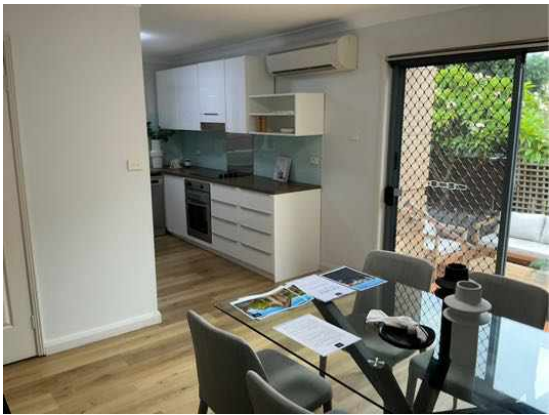
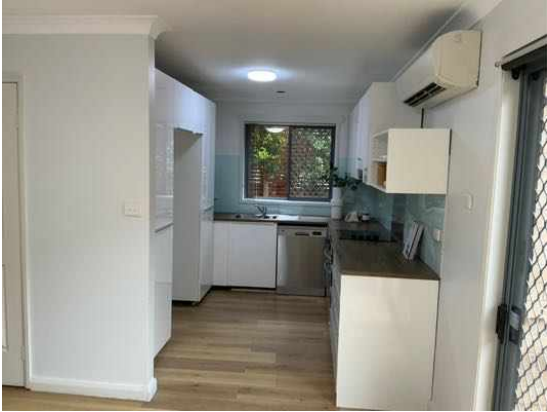
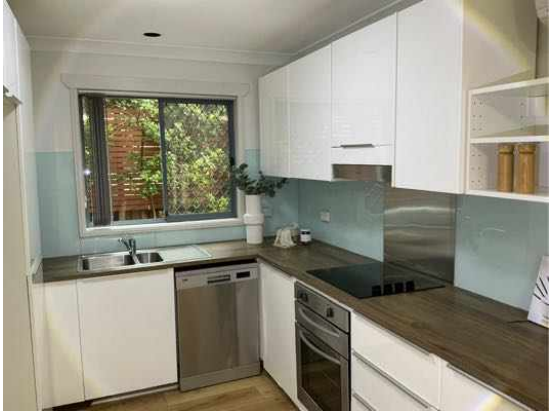
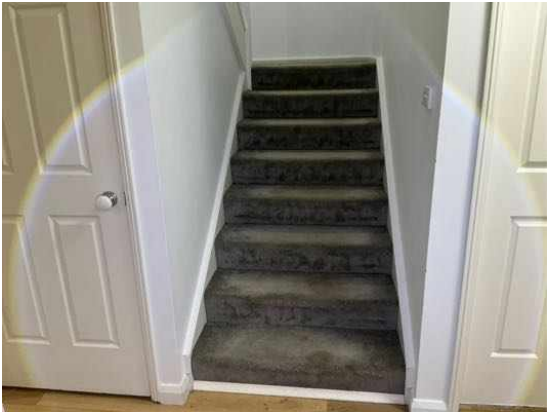
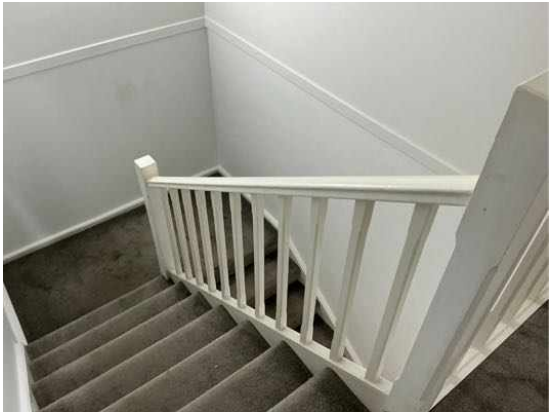
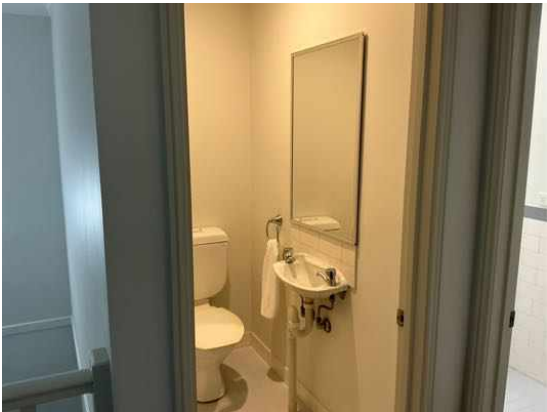
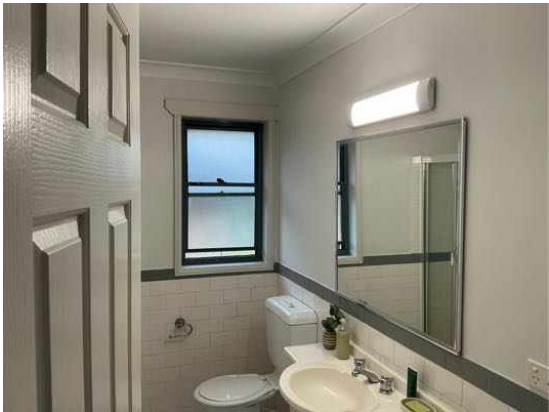
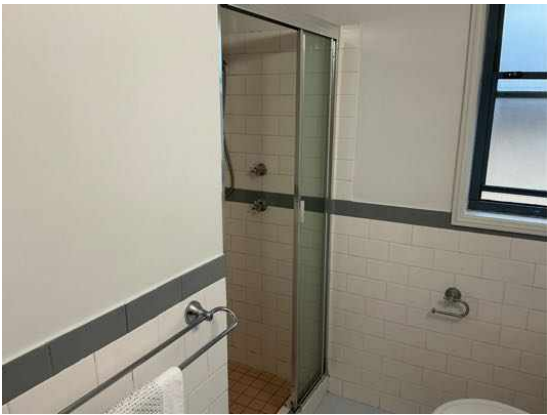
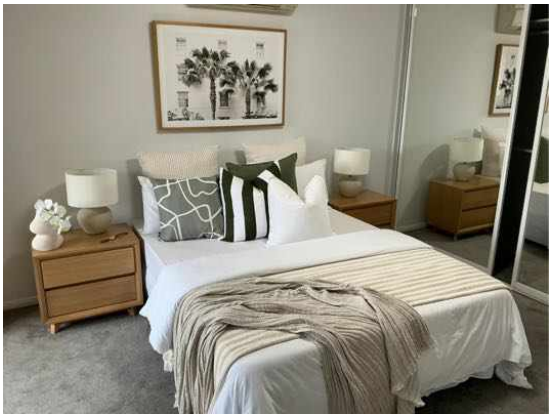
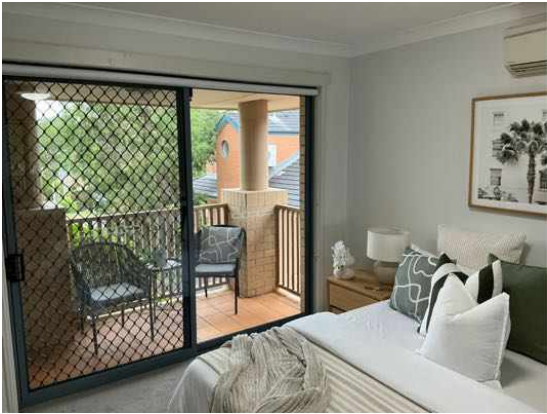
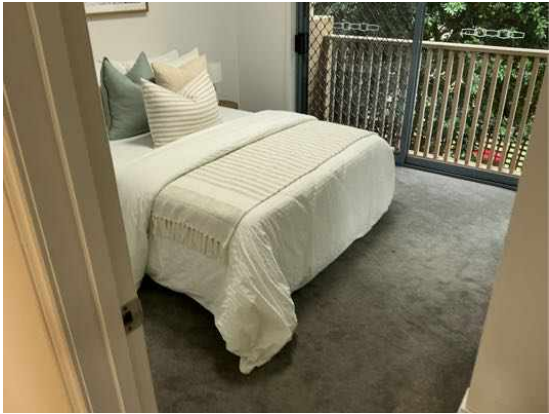
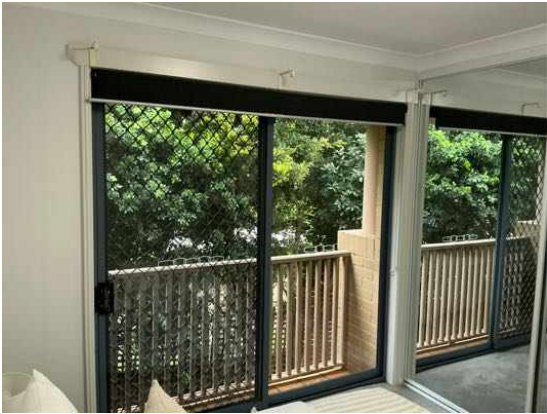
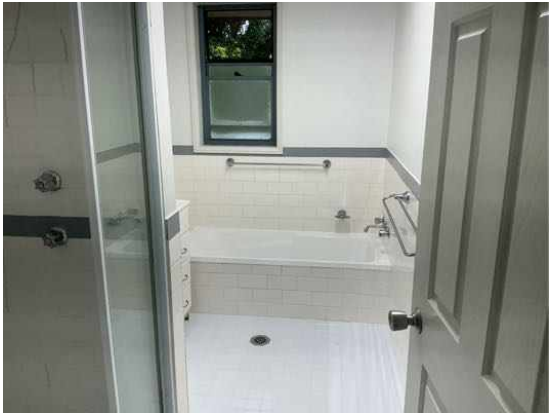
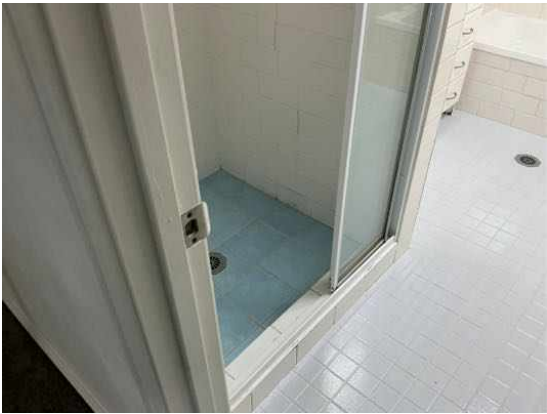
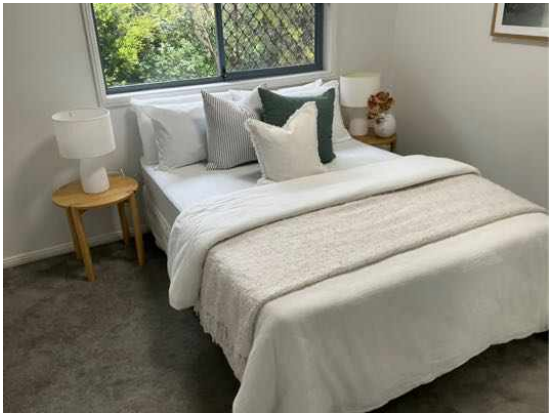
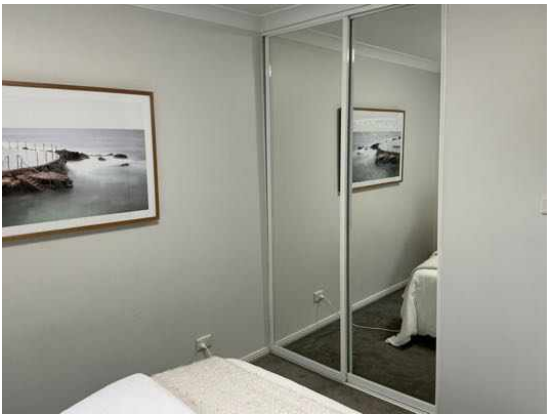
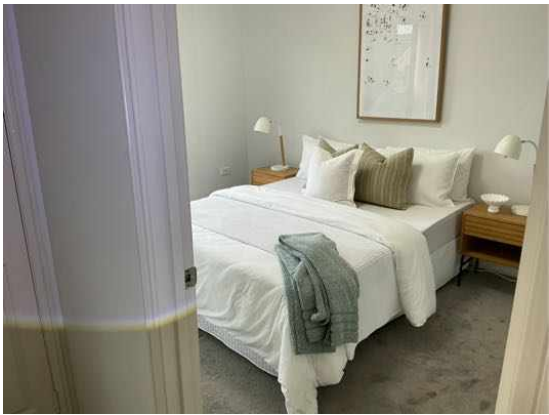
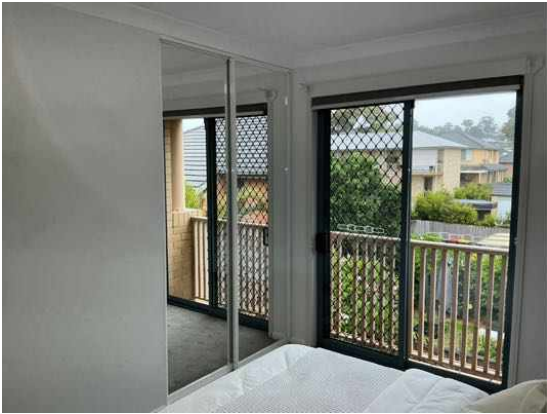
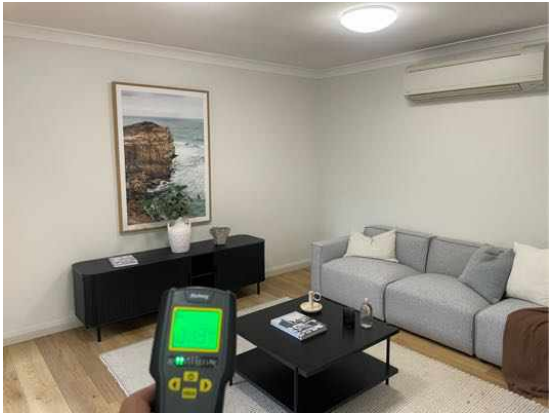
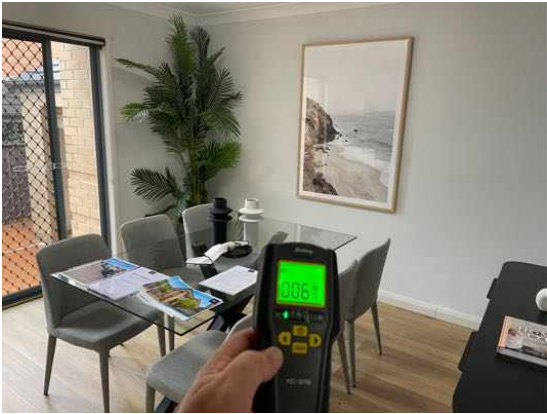
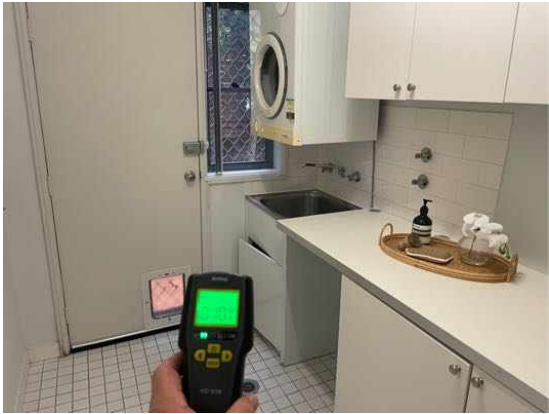
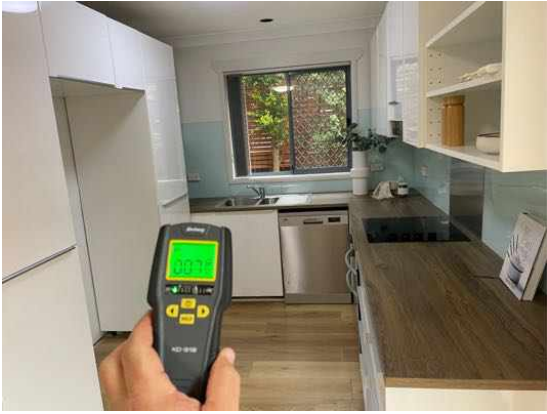
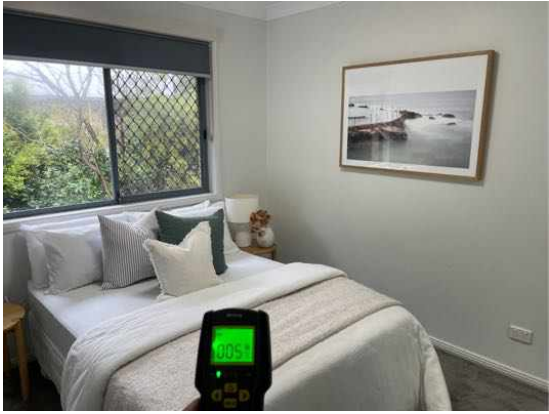
### Noted Item

Building: Main Building  
Location: All Areas- internal  
Finding: Additional Photos - Obstructions and Limitations  
Information: These photographs are an indication of the obstructions and limitations which impeded full inspection of the property at the time of inspection. These obstructions can hide an array of defects and should be removed to allow full inspection to be carried out. A re-inspection is recommended once the areas are made accessible.

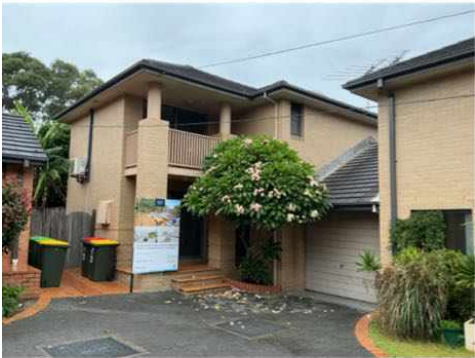
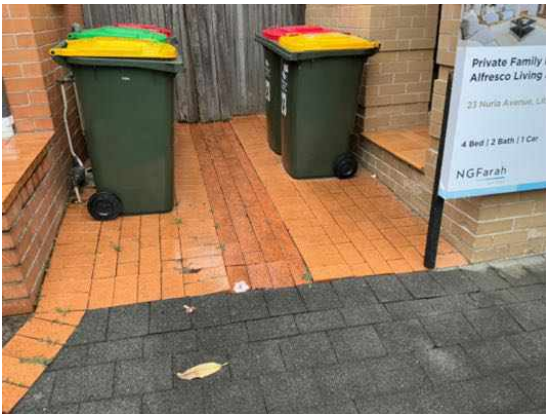
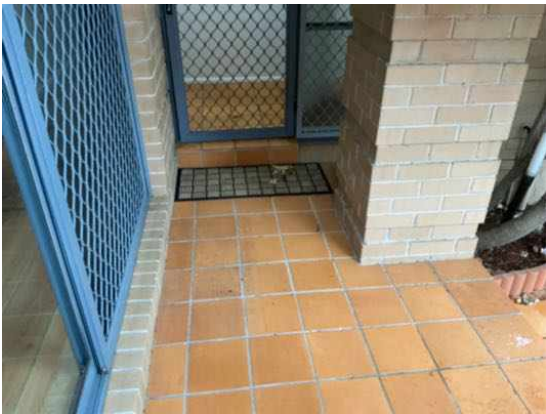
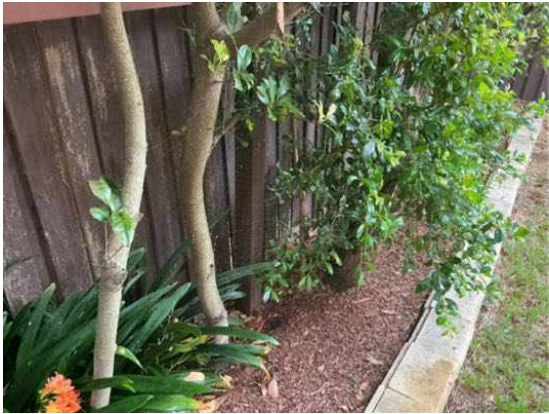
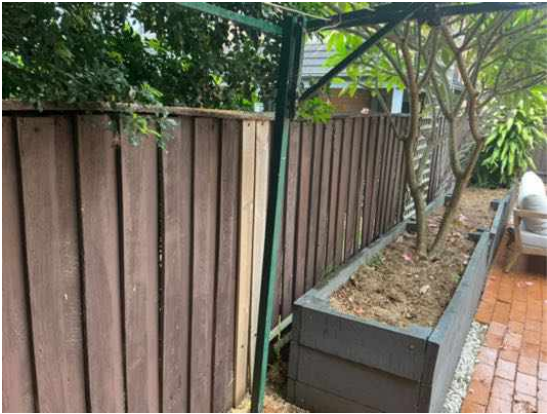
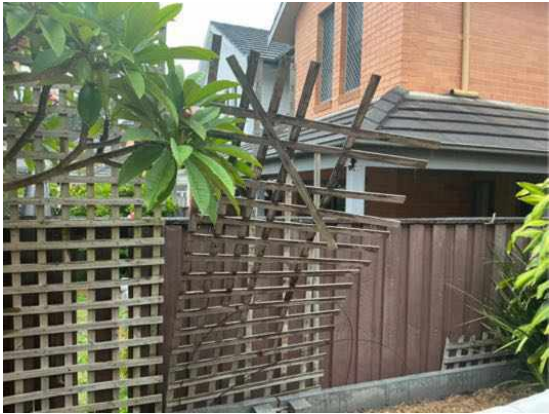
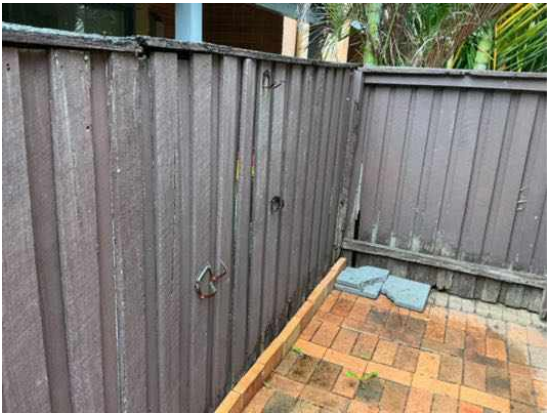
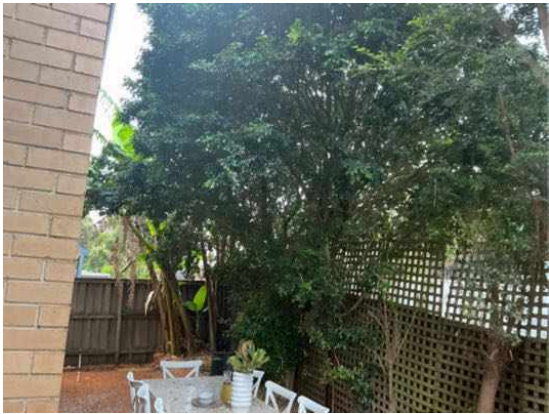
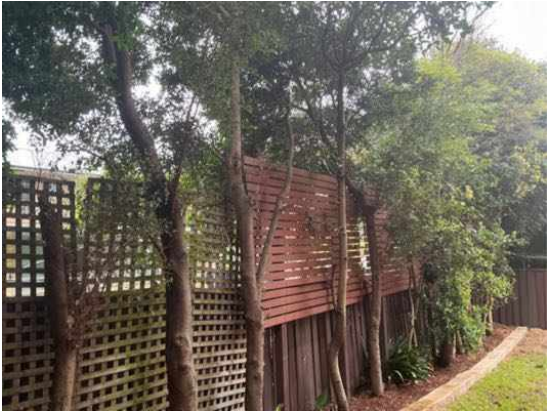
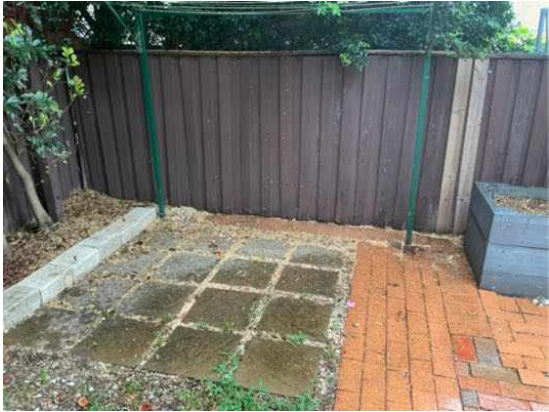
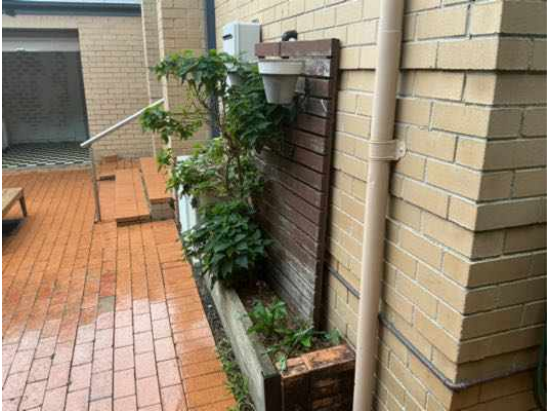
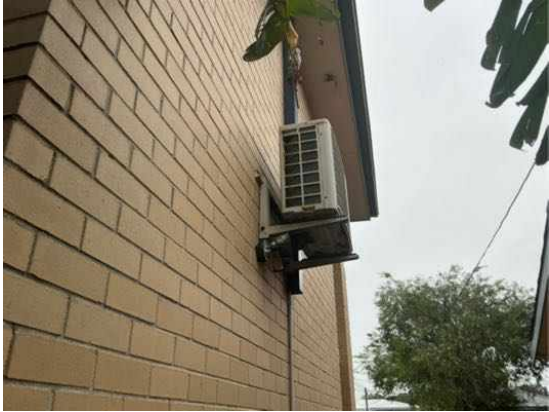
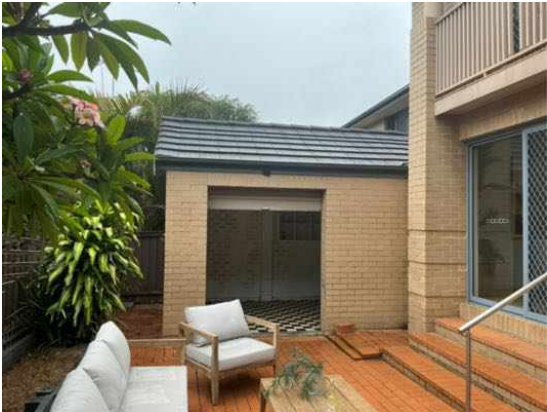
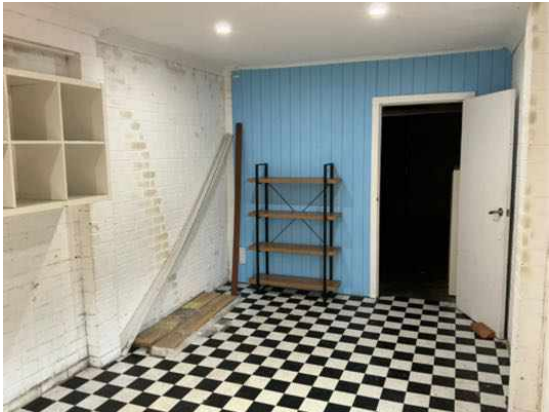
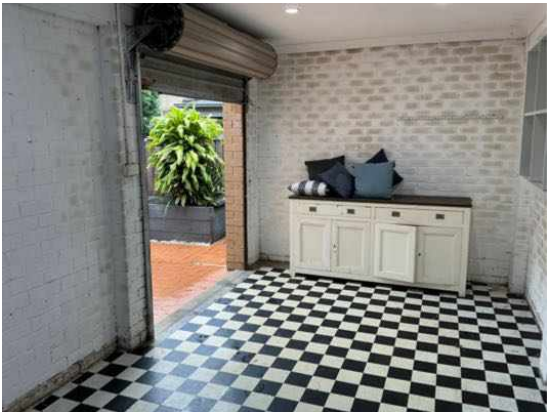
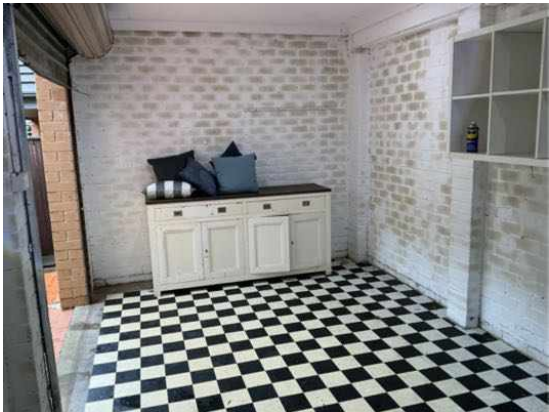
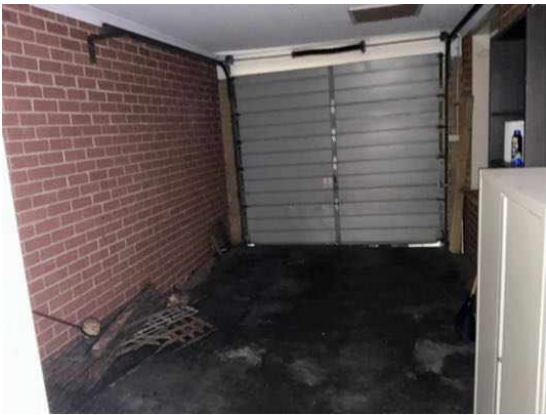
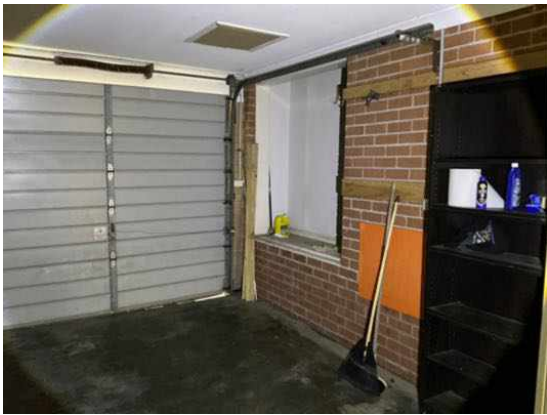
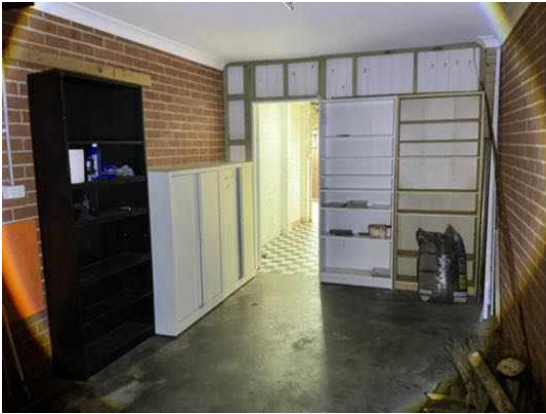
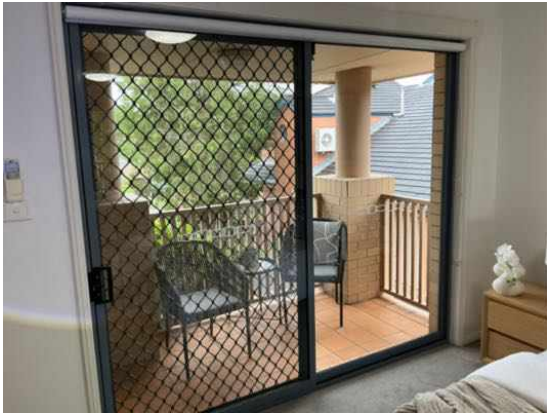
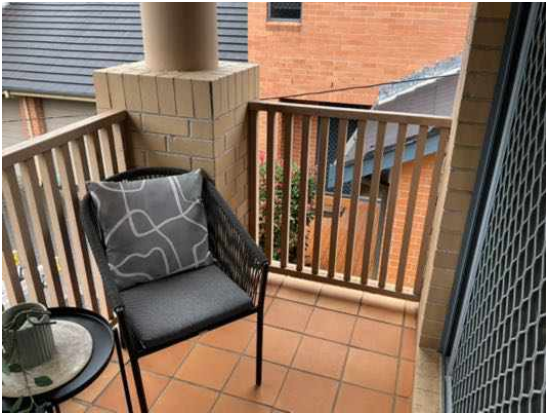
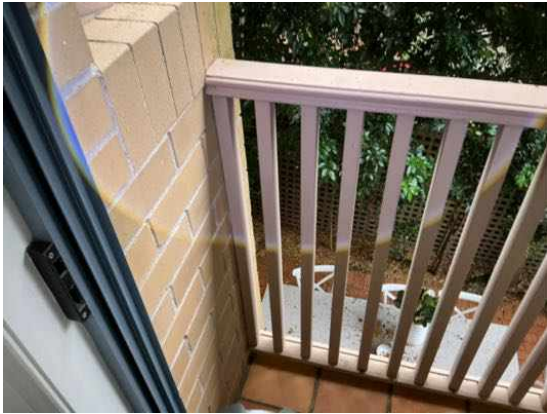
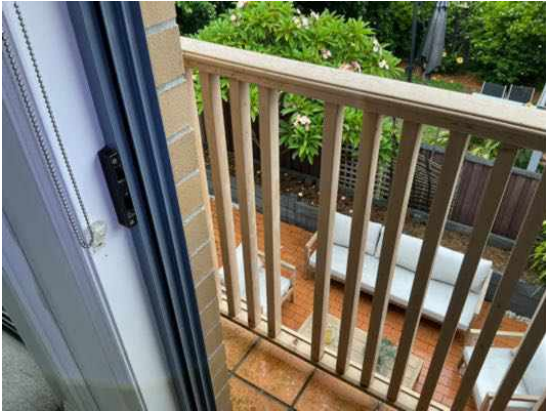
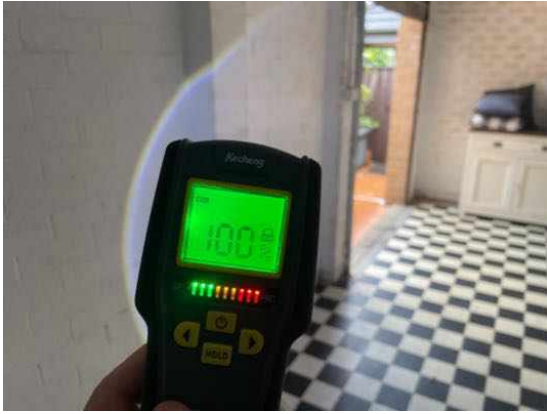
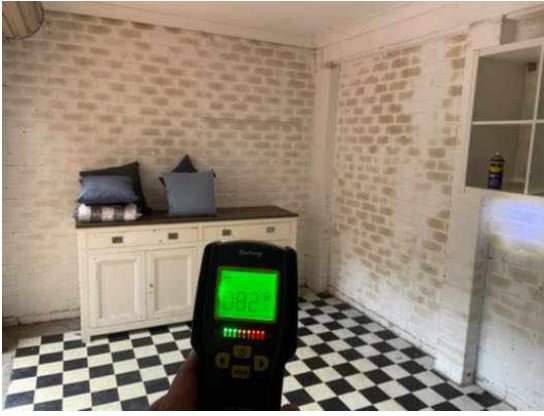
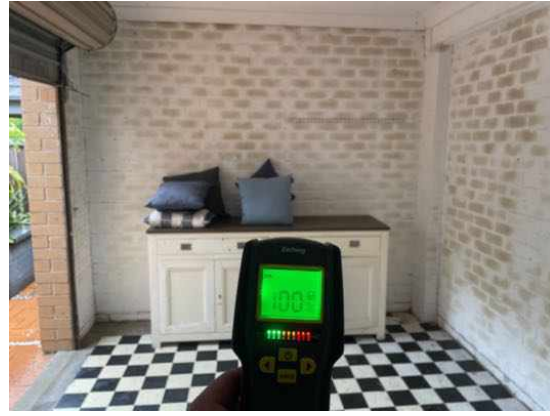
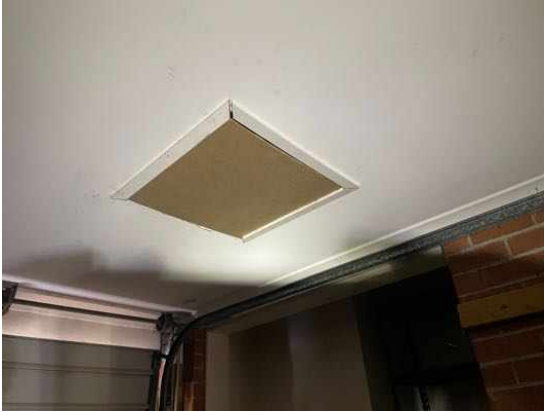
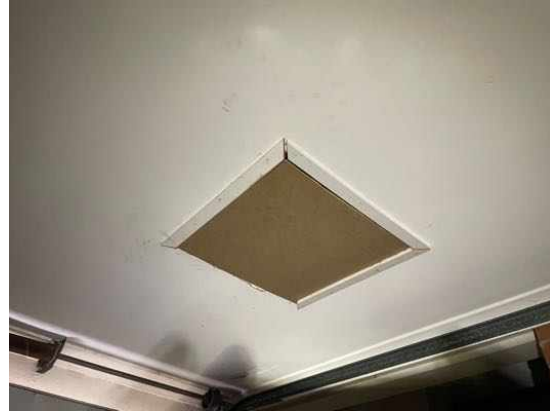
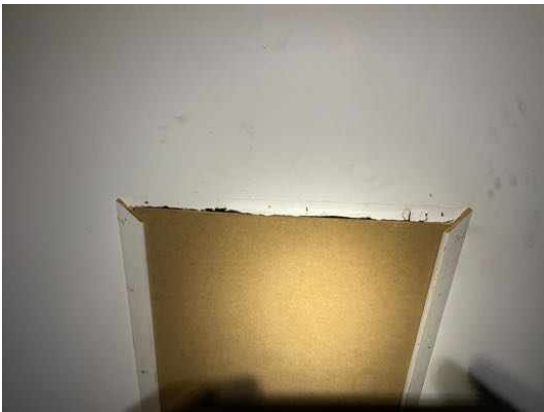
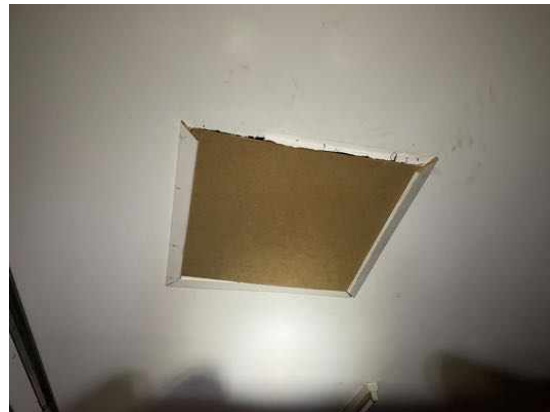
Building: Main Building  
Location: All Areas- external  
Finding: Additional Photos - Obstructions and Limitations  
Information: These photographs are an indication of the obstructions and limitations which impeded full inspection of the property at the time of inspection. These obstructions can hide an array of defects and should be removed to allow full inspection to be carried out. A re-inspection is recommended once the areas are made accessible.

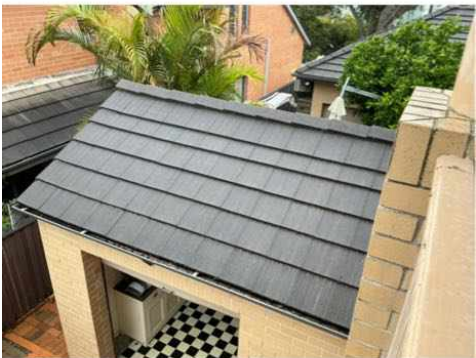
Building: Main Building  
 Location: Roof Exterior  
 Finding: Additional Photos - Obstructions and Limitations  
 Information: These photographs are an indication of the obstructions and limitations which impeded full inspection of the property at the time of inspection. These obstructions can hide an array of defects and should be removed to allow full inspection to be carried out. A re-inspection is recommended once the areas are made accessible.

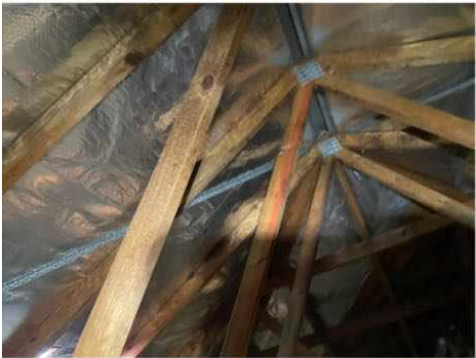
Building: Main Building  
Location: Roof Void  
Finding: Additional Photos - Obstructions and Limitations  
Information: These photographs are an indication of the obstructions and limitations which impeded full inspection of the property at the time of inspection. These obstructions can hide an array of defects and should be removed to allow full inspection to be carried out. A re-inspection is recommended once the areas are made accessible.

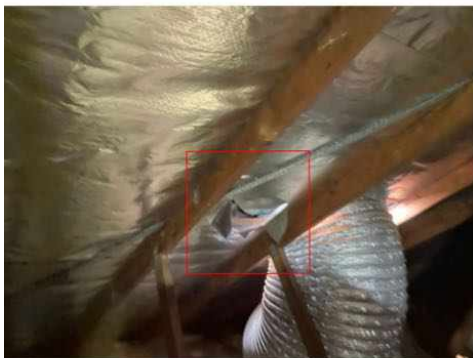
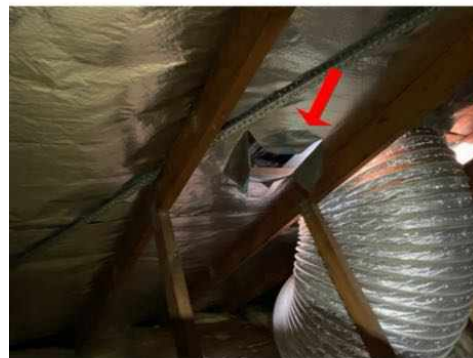
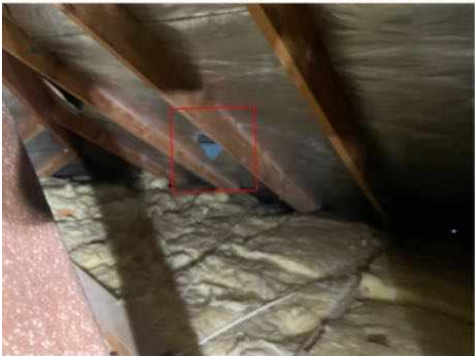
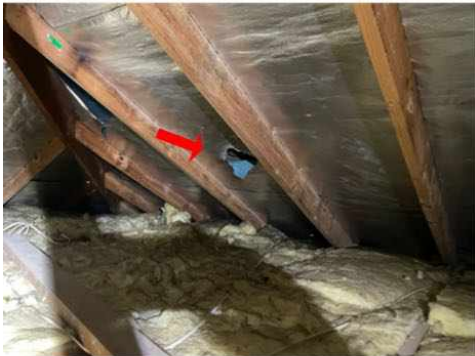
Building:	Main Building
Location:	Roof Void
Finding:	Sarking - Damaged
Information:	Sarking, a laminated aluminium foil applied to the interior of the roof covering, assists in insulating the property and acting as a vapour-barrier to the roof void and, subsequently, to the household.

Where sarking is damaged, both insulation and moisture protection of the property are inhibited. This creates a loss of energy and thus negatively impacts the energy efficiency of the property, allowing potential for moisture ingress from condensation or leaking roof tiles.

It is important to repair any holes or damaged sections of sarking to ensure that the building material is fully functional. A registered builder or qualified carpenter should be consulted to provide further advice on this defect and to perform rectification works at client discretion.
