Building Inspection Report VR

Inspection Date: Fri, 6 Mar 2026

Property Address: 47 Grafton St, Goulburn NSW 2580,
Australia

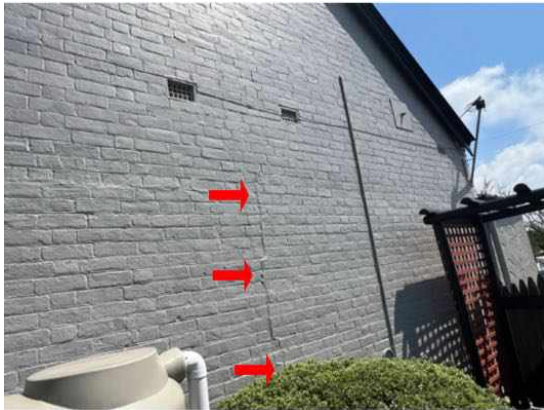
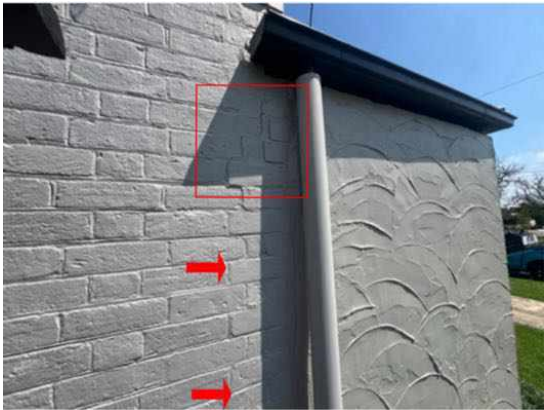
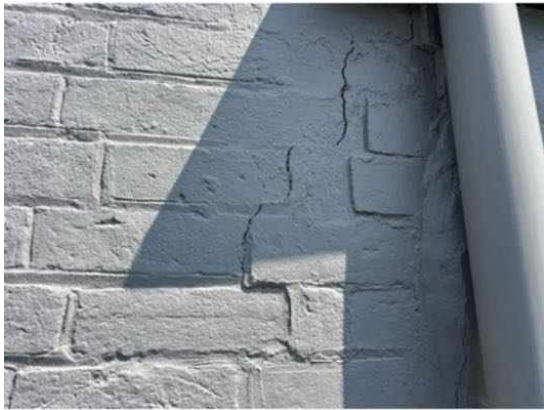
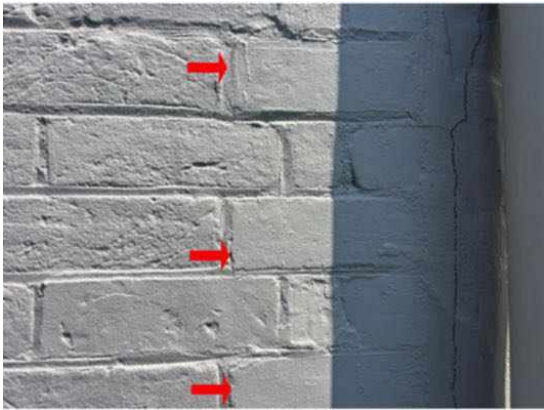
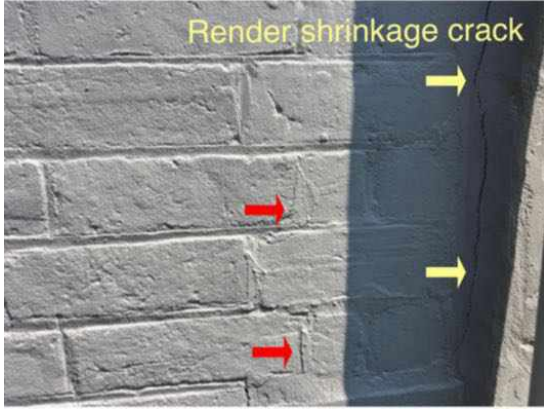
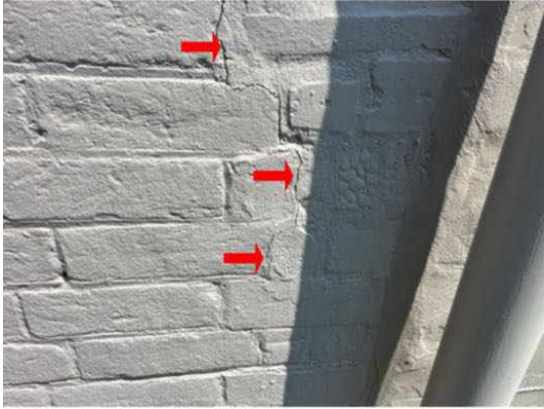
Defects 3.01

Building: Main Building
 Location: Exterior walls - left side
 Finding: Brickwork - Step cracking
 Information: Step cracking was identified to the brickwork in this area at the time of inspection. Step cracking, which is similar to other forms of cracking, has a variety of possible causes. However, the most common is the subsidence of adjacent footings.

Step cracking is a relatively common defect, and is most likely to occur adjacent to windows, doors and other openings. Mortar failure in the gaps between affected bricks indicates the stresses and tensions affecting the wall.

Where step cracking is extensive or severe, the client is advised to consult a structural engineer. Minor step cracking can be used as a warning sign to address factors causing stress to the wall, which can include the effect of surrounding trees, water

leaks, soil erosion, or even the presence of reactive soils in the surrounding area.

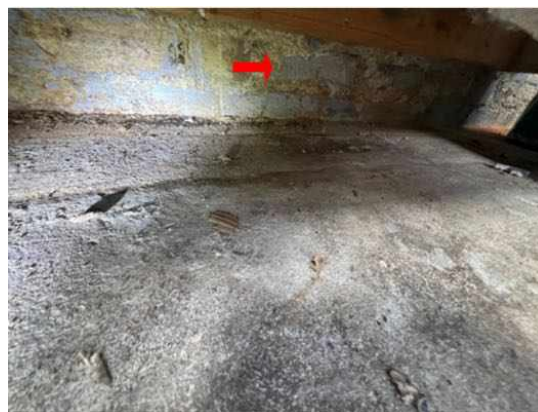
Defects 3.03

Building:	Out Building
Location:	Shed - Brick
Finding:	Damp - Rising
Information:	Rising damp describes the upward movement of water in low sections of building elements (e.g. walls) by capillary action - the movement of water through porous materials such as bricks, sandstone or mortar.

Rising damp is generally managed by the installation of a damp proof course during construction. A Damp Proof Course (DPC) is an impermeable barrier at the base of the wall above ground level. However, many 19th Century buildings have no damp course installed, or the materials have failed. The DPC may have been omitted as a consequence of poor workmanship, or it may have been bridged where materials built up against the side of the house allow moisture ingress above the DPC level.

The first step in addressing rising damp is to diagnose the cause. The identified cause should be addressed first before addressing the appearance and other defects which have resulted from the rising damp. If the original cause is not resolved, further cases of damp are likely to ensue, resulting in secondary defects.

Consultation with a qualified plumber is advised immediately to identify the cause of

the damp and perform remedial works as required.

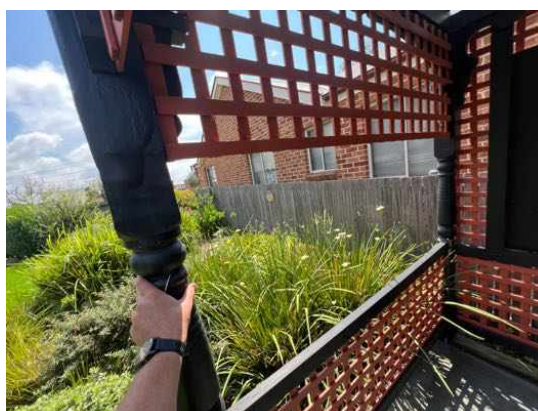
Defects 3.04

Building:	Out Building
Location:	Pergola 2
Finding:	Pergola - Unstable
Information:	A freestanding pergola structure was observed to move and sway when moderate pressure was applied. Structures of this type should generally remain stable and resist noticeable movement under light manual force.

Movement within the posts or framing members may indicate inadequate footing support, loose or deteriorated fixings, or insufficient structural bracing. Continued movement can lead to progressive loosening of connections and may result in further instability over time.

It is recommended that a licensed builder be appointed to inspect the pergola and assess its stability. Further assessment may be required to determine whether remedial works are necessary to ensure the structure remains adequately supported and secure.

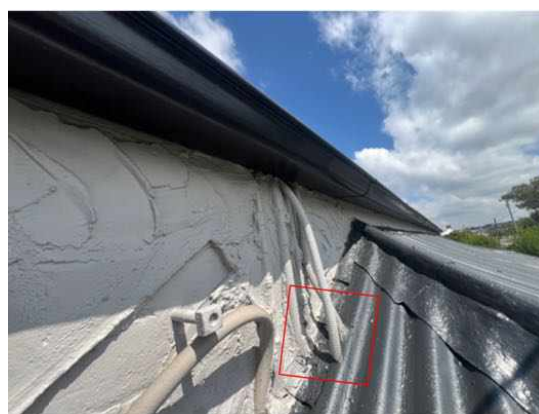
Defects 3.05

Building:	Main Building
Location:	Verandah, Pergola

Finding: Roof Penetrations - Substandard Installation
Information: Various service penetrations through the roof covering, including pipework and electrical conduits, were observed to be substandard in installation. Inadequate flashing, sealing, or general detailing was noted to these penetrations.

Poorly executed roof penetrations may compromise the weatherproofing of the roof system and increase the potential for water ingress around the affected areas. If left unmanaged, moisture may enter the roof space and contribute to deterioration of surrounding building elements.

It is recommended that a licensed roofing contractor be appointed to assess the penetrations and carry out necessary works to ensure the roof covering remains adequately sealed and protected against moisture ingress.

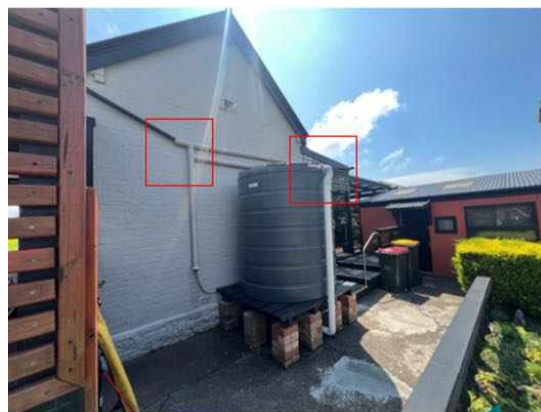
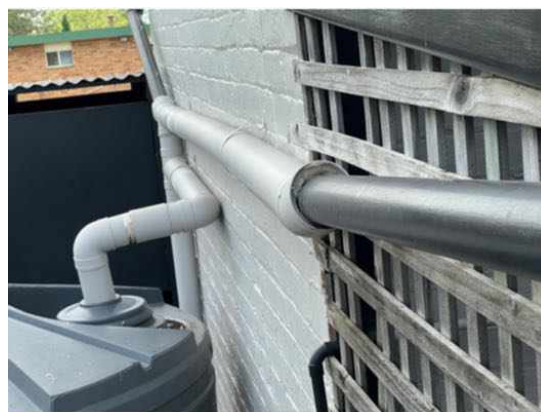
Defects 3.06

Building: Main Building
Location: Exterior walls - front, rear
Finding: Roof plumbing - Insufficient capacity
Information: It is suspected that the roof plumbing to the exterior roof is insufficient in capacity and is not adequately managing the volume of rainwater that it is required to drain. The result is generally that the plumbing overflows during periods of heavy rainfall, creating damp conditions against external surfaces and the base of the building perimeter.

If left unmanaged, the excess moisture in this areas may allow the formation and development of an environment that is conducive to rust, corrosion and rot, creating potential for secondary defects to all associated building elements. Damp conditions are also conducive to termite and pest activity, further exacerbating the risk of the environment.

Appointment of a roofing plumber is recommended to replace any inadequate drainage systems to ensure proper drainage to this area. In the interim, it is important to ensure that all roof plumbing is free of any debris or blockages.

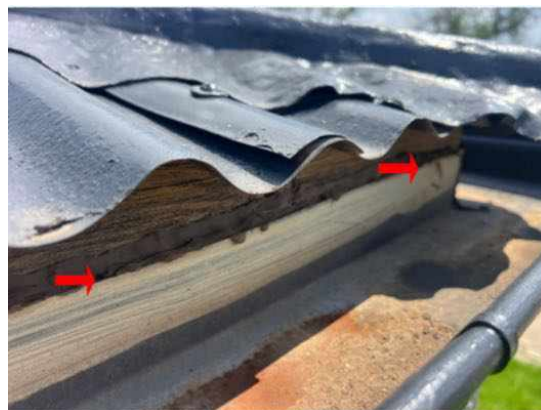
Defects 3.18

Building:	Main Building
Location:	Roof Exterior - Verandah
Finding:	Exterior roof - Inadequate repairs
Information:	It appears that interim roof repairs have previously been undertaken, which have included application of silicone to address roof leakage.

Application of silicone should be viewed as a short-term solution to roof leakage, as it

does not provide adequate long-term protection against weather conditions and other causes of damage and deterioration. Any underlying structures that show signs of damage should be repaired and replaced to ensure the longevity of the roof covering and associated building elements.

Further consultation with a roof restoration company is highly advised. Inadequate roofing repairs are not likely to prevent roof leakage in the long-term future.

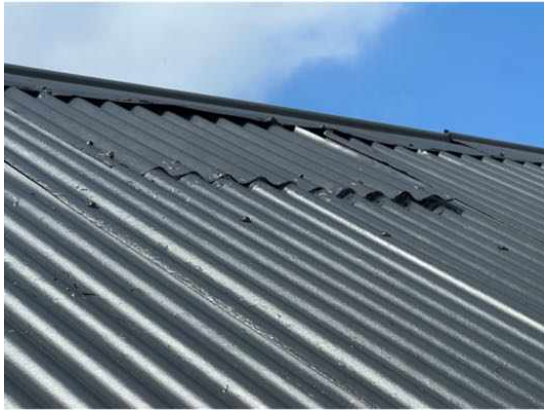
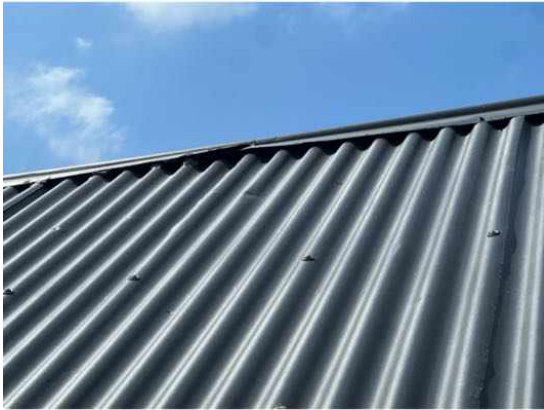
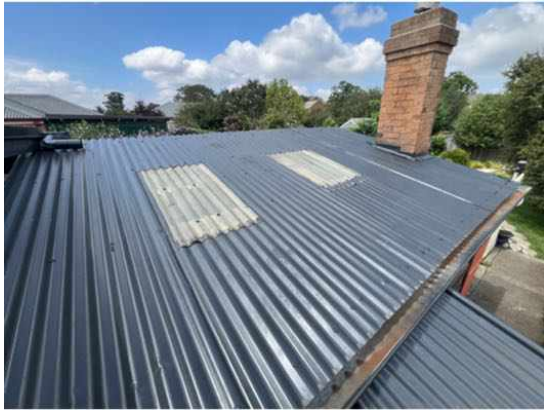
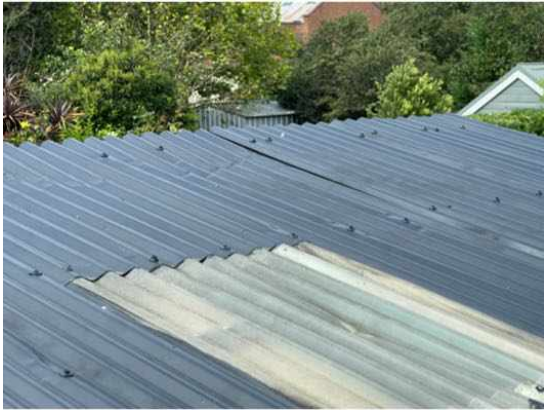
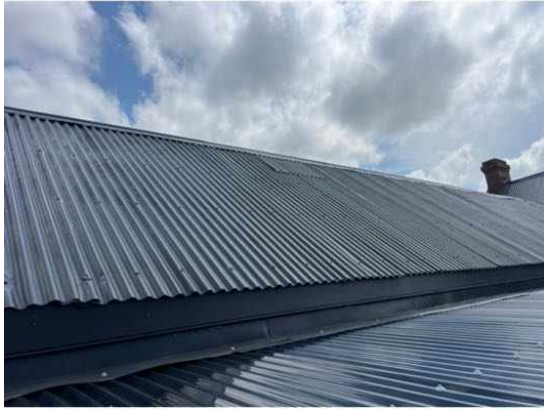
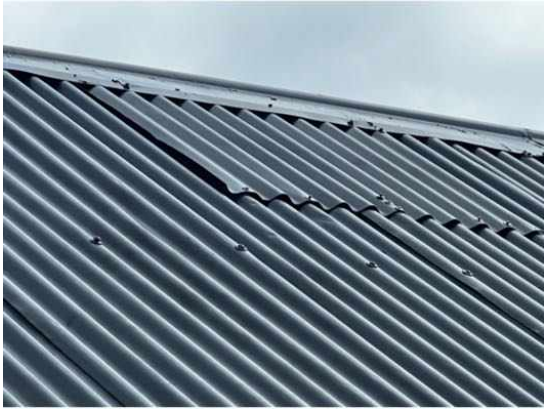
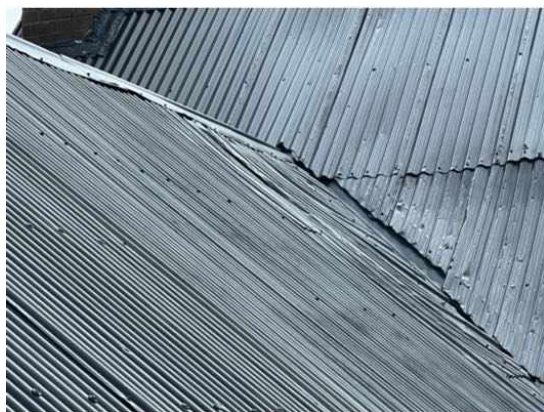
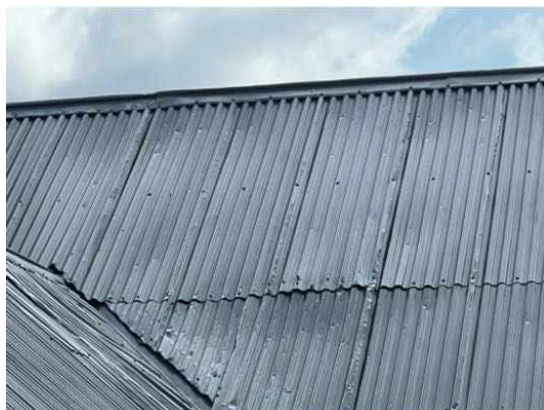
Defects 3.21

Building: Main Building
 Location: Roof Exterior
 Finding: Roof sheets - Deteriorated
 Information:

Upon inspection of the exterior roofing, it was found that the roof sheets show signs of deterioration, with some sheets having come loose from their original fixing. The roofing has sustained an array of issues due to the age of the materials and a lack of general maintenance over time, including loose sheeting, lifting and sagging of sheets, and deterioration of associated building elements.

Loose, deteriorated and damaged roof sheets are susceptible to water penetration, exposing the surrounding associated area to internal roof leaks and water damage.

Re-fixing of all loose roof sheets should be conducted as soon as possible to ensure that no further damage occurs. Depending on the extent of the damage, replacement of sections of roof sheets or associated materials may be required. Engagement of a roofing restoration contractor is highly advised to perform remedial works as necessary.

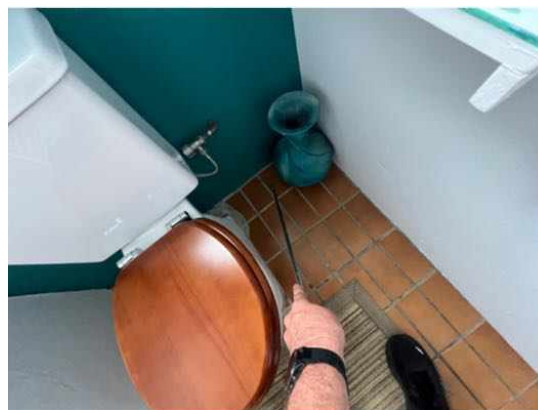
Defects 3.31

Information: Drummy rendered areas were identified at the time of inspection. The term 'drummy' refers to render that has become detached from its fixing, despite it still being solid. Such defects are generally caused by physical or moisture damage to the area. Drummy render may also be a direct result of poor workmanship during the construction process.

Render may swell and shrink with changes in air humidity if the area has sustained moisture damage. Any exposure to moisture is capable of causing rendered areas to become drummy and/or cracked over a prolonged period of time. Drummy render generally requires chipping off and re-rendering or painting.

Specialist trades are available for these types of services. A registered builder may be required to undertake works if damage is extensive, or if secondary building defects have resulted. Immediate action is recommended to ensure that no further damage is sustained in the affected area.

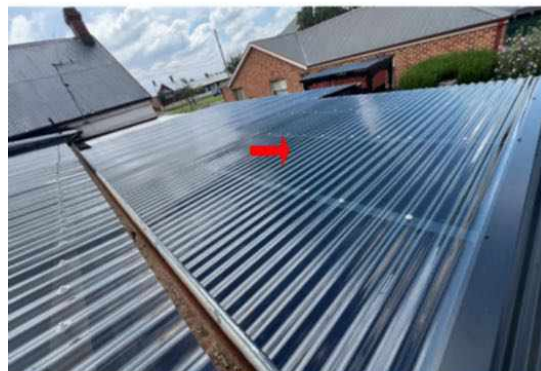
Building:	Main Building
Location:	Pergola
Finding:	Additional structure built without a permit (Suspected) NSW
Information:	The pergola structure on the house is suspected to have been constructed without the necessary council approval. In New South Wales, approval is generally required prior to construction of such structures, either by way of a Complying Development Certificate (CDC) or through the Development Application (DA) process followed by a Construction Certificate.

It is strongly recommended that the purchaser request formal documentation from the vendor confirming whether the pergola structure has been approved. If no approval can be produced, the current owner should be asked to obtain a Building Information Certificate and provide a structural assessment confirming that the structure is safe

and built in accordance with current building standards.

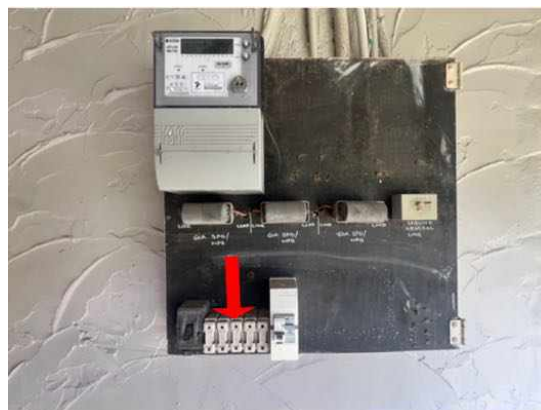
Building:	Main Building
Location:	Exterior walls - front
Finding:	Electrical switchboard - Old ceramic fuses
Information:	The electrical switchboard while appearing to have adequate safety switches installed has old ceramic fuses in place.

While this on its own on is not considered a defect it is noted for the clients consideration that a switchboard upgrade may be required in the short to mid term to improve the functionality of the electrical system. A licensed electrician could be appointed to provide quotation for the works at the client's discretion which may in turn expose other required works to bring the system up to a compliant state.

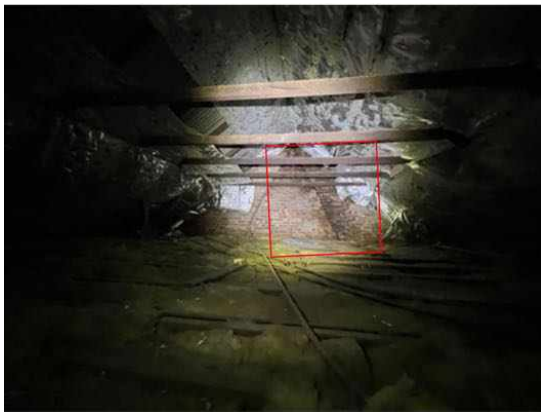
Finding: Brickwork - Evidence of Past Moisture Staining

Information: Sections of the masonry within the roof space exhibited localised staining and discolouration consistent with past moisture exposure. Such staining may occur from historical roof leaks, condensation, or prior moisture migration through masonry.

At the time of inspection, no active moisture, damp insulation, or visible deterioration to adjacent timber framing was identified in the immediate area. Additionally, no corresponding staining or moisture damage was observed to the ceiling lining below the affected location.

While the staining appears historic in nature, the area should be monitored for any future signs of moisture ingress. If staining progresses or moisture becomes evident, further assessment by a licensed roofing contractor may be required to identify the source.

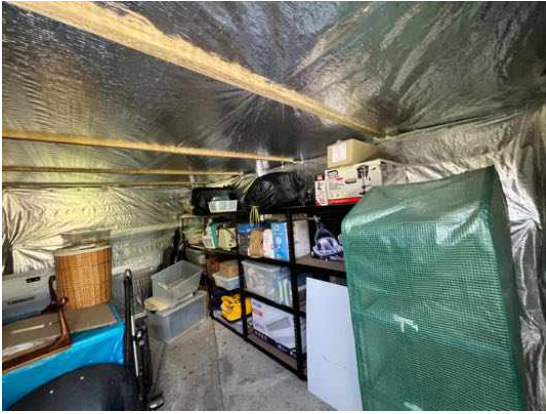
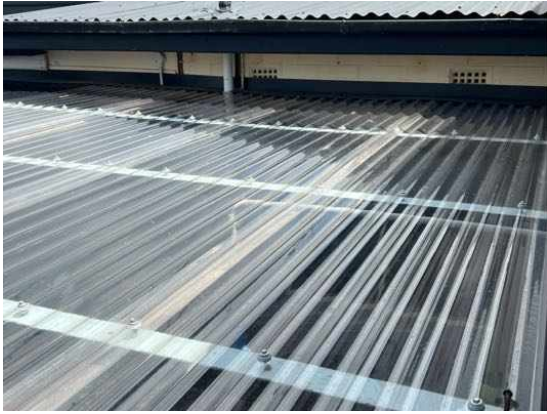
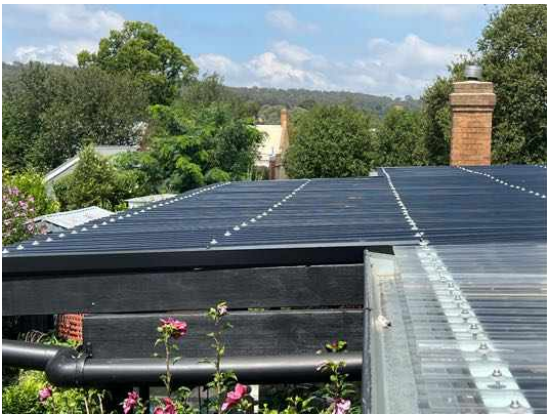
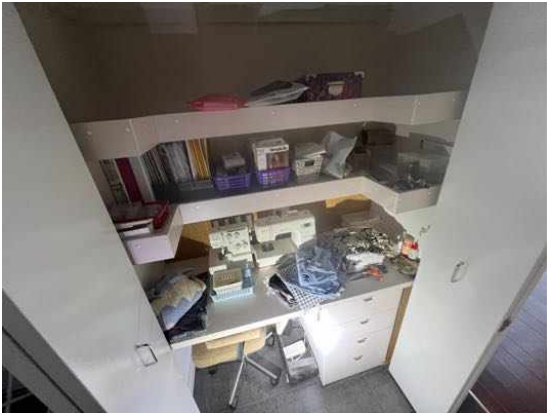
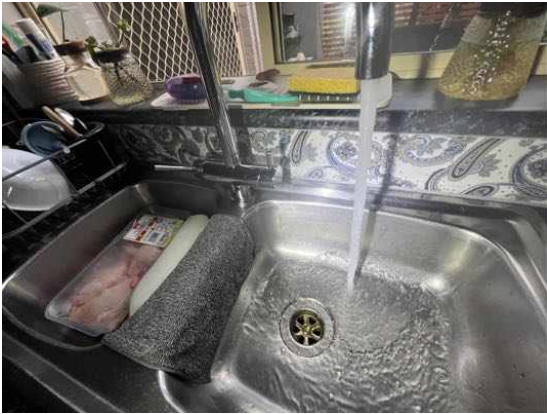
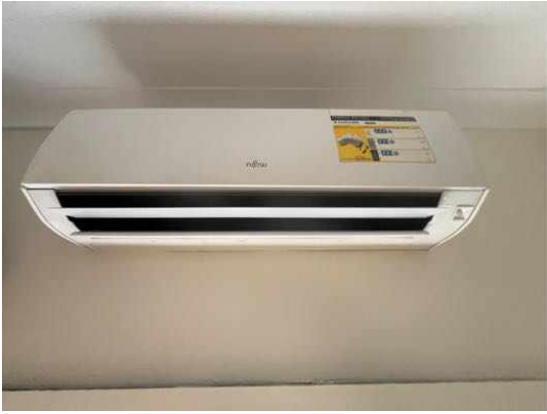
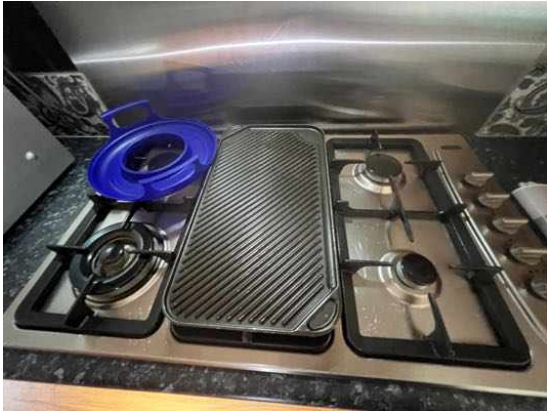
Building: Main Building
Location:
Finding: FYI - Additional Photos
Information: Additional photos are provided for your general reference and may include obstructions, testing of water & windows, moisture readings or minor maintenance items.
