Building and Timber Pest Inspection Report

Inspection Date: Wed, 4 Feb 2026

Property Address: 21A Stafford St, Minto NSW 2566, Australia

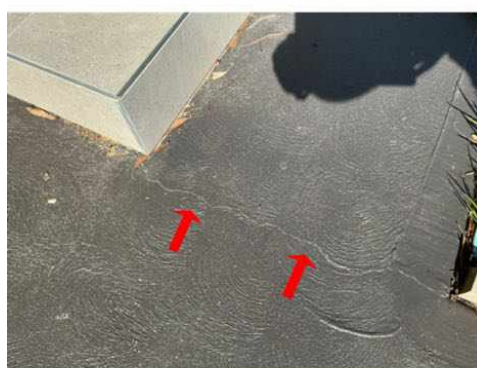
Building: Main Building
 Location: Front entrance
 Finding: Crack in concrete slab - Category 1
 Information: A crack coded as Category 1 was identified in the slab. A Category 1 crack is described as a fine but noticeable crack, with the slab at an otherwise reasonable level.

To be considered Category 1, the approximate width of the crack is less than 1.0mm, or a less than 10mm change in offset when a 3m straight edge is placed over the defect.

Category 1 cracks should be monitored for a period of 12 months. At the end of the monitoring period, identified cracks that are rated greater than Category 2 are considered defects, and require rectification.

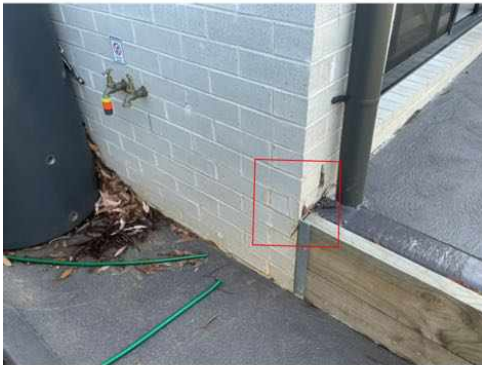
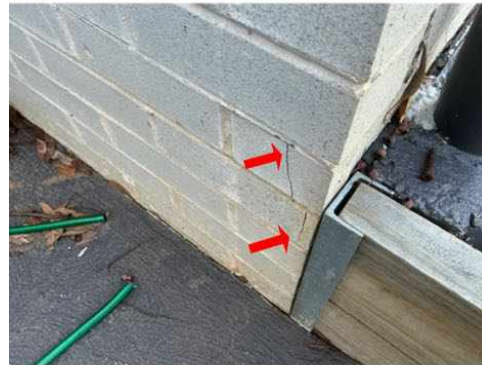
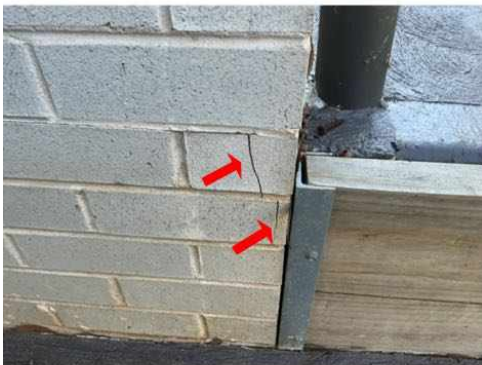
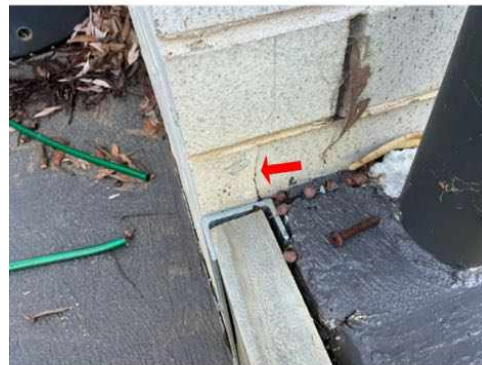
Finding 3.02

Building: Main Building
 Location: Rear back corner (south west)
 Finding: Brickwork - Cracking [Fine]

Information: Although fine cracks are quite noticeable, they are often only considered to be an appearance defect and usually do not indicate any structural damage. Generally, the cause of a fine crack is indicative of a separation between brickwork and mortar throughout the structure, but single bricks may also show cracks of this nature.

Cracking of this nature can generally be repaired with minor filling and should be conducted by a qualified bricklayer.

Always contact a building inspector should cracks widen lengthen or become more numerous.

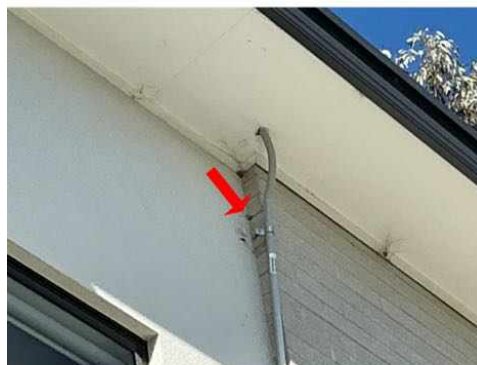
Finding 3.03

Building: Main Building
 Location: Above front entrance
 Finding: Building element - Broken or Damaged, wall bracket displaced.
 Information: Breakage occurs generally when the building materials have either aged and decayed, or as a result of damage (accidental or deliberate).

Repair and/or replacement of broken elements is advised to ensure that additional secondary defects do not arise as a consequence. Such works are necessary, as all building elements play a key role in the operation and function of the overall structure and its performance.

A relevant tradesperson should be appointed to repair or replace the affected building element prior to any subsequent damage being caused.

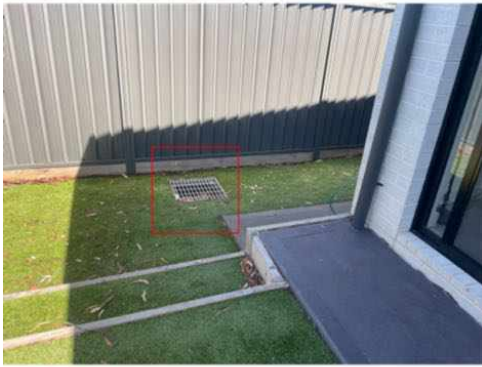
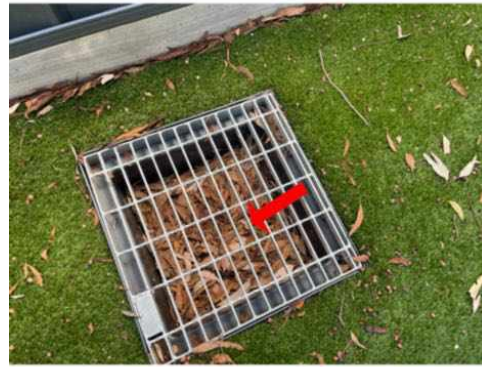
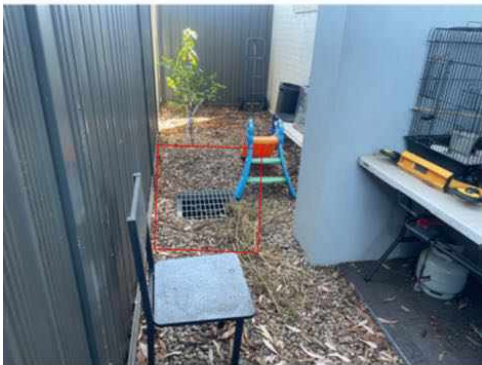
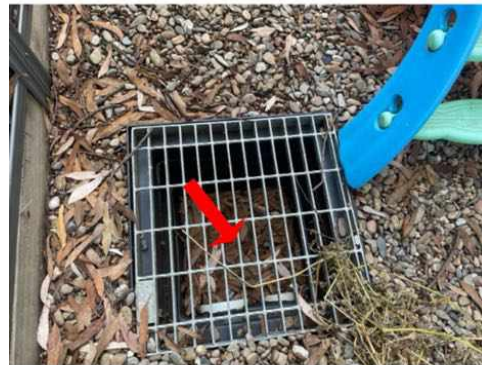
Building:	Main Building
Location:	Back yard and side passage.
Finding:	Drains and Water tank takeup - leaves and twigs built up
Information:	Blockages prevent building elements from operating as intended, detracting from the overall function of the affected building elements. Additionally, the lack of general maintenance may lead to the development of more significant defects, such as damage to surrounding building materials.

Depending on the location of the blockage and the building elements affected, a licensed plumber may be required to perform necessary remedial works.

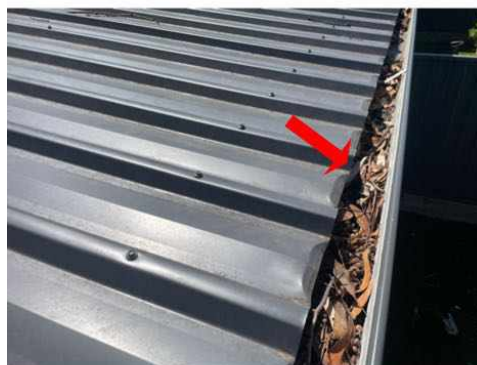
Blocked gutters are likely to lead to high levels of moisture in the affected areas. Such moisture will not only cause rust and decay of the associated building materials, but can also provide conditions that are conducive to termite and timber pest activity. Blockages in gutters should therefore be removed immediately to ensure dry conditions are maintained.

Consult a Licensed Plumber for further specific advice on remedial works that may be required. In the interim, it is highly advised that blocked gutters be removed by the homeowner or a general handyperson as a matter of urgency.

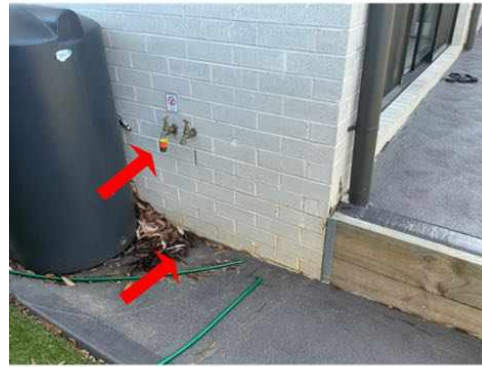
Finding 6.02

Building:	Main Building
Location:	All Areas
Finding:	Overflow - Not plumbed for drainage (Excessive Moisture)
Information:	The overflow is not plumbed or connected to suitable drainage, which has resulted in the surrounding area becoming excessively damp. These damp conditions can lead to secondary defects such as rot, rust or corrosion of associated building elements, the formation of fungal decay, or even the creation of potential slip hazards.

When coupled with poor site drainage, pooling of water may also attract termite activity to this area. It is highly recommended that a qualified plumber be appointed to install adequate drainage to the overflow. These works will ensure that the area remains dry and free of any secondary defects.

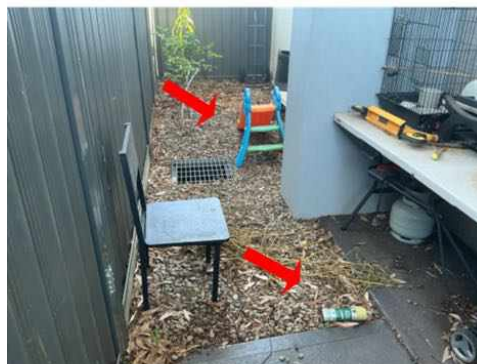
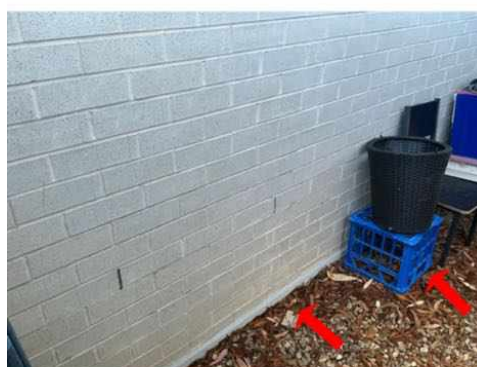
Finding 6.03

Building:	Main Building
Location:	Front garden, side passage
Finding:	Untreated or non-durable timbers in a hazardous environment (Timbers in ground contact)
Information:	To reduce the risk of timber pest attack it is essential that timber used in a hazardous environment (e.g. in direct contact with the ground or frequently exposed to damp conditions) is of sufficient durability and/or is adequately preservative treated.

If untreated or non-durable timbers are found to be in a hazardous environment it is highly advised that replacement of these building elements be performed as soon as possible to aid the protection of the property against termite / timber pest attack.

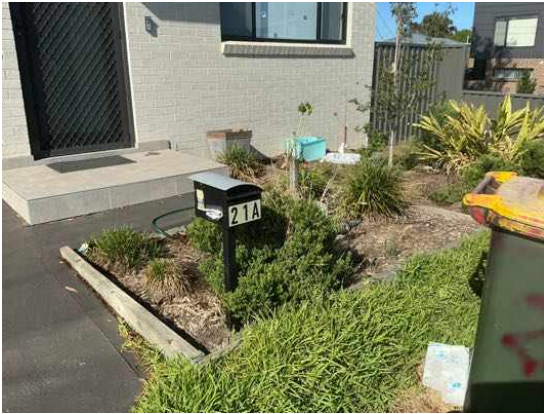
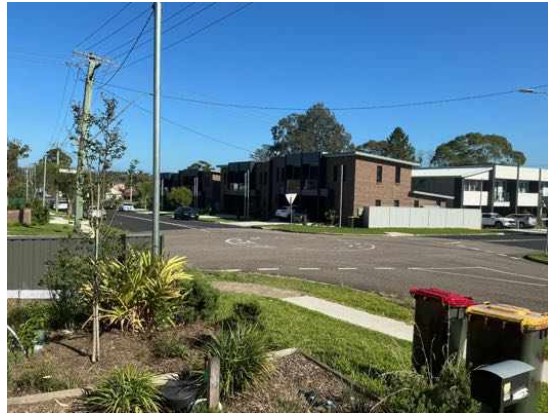
Building: Main Building
 Location: All Areas
 Finding: Trees to be inspected within the property.
 Information: Trees can be conducive to termite activity and nesting. Trees over 100mm on the property, should be drilled and tested for termite activity.
 Regular inspections every 6-12 months- or advised by the termite management system installer.

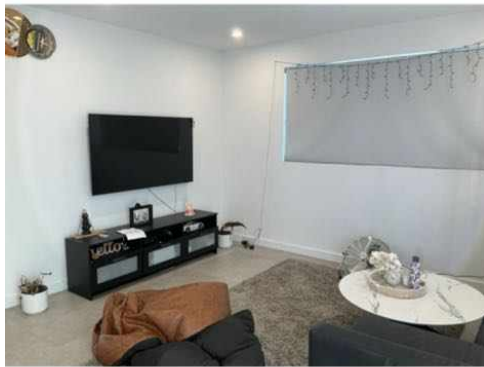
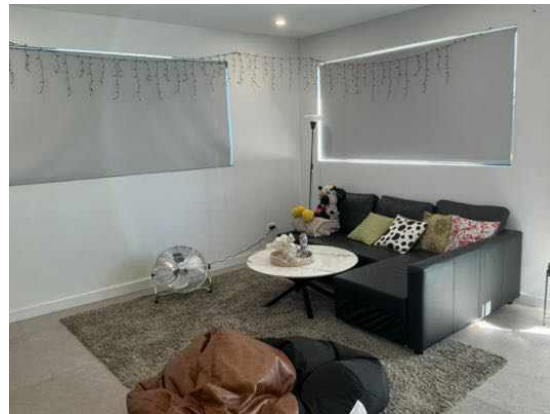
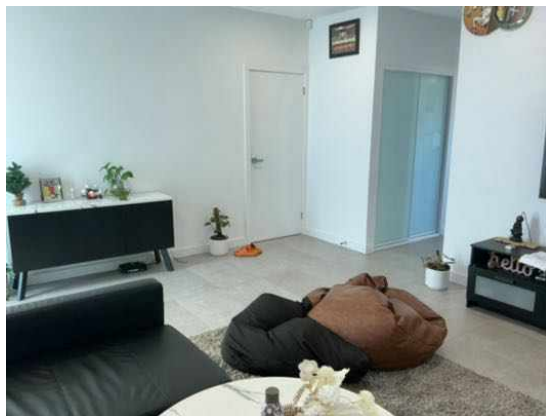
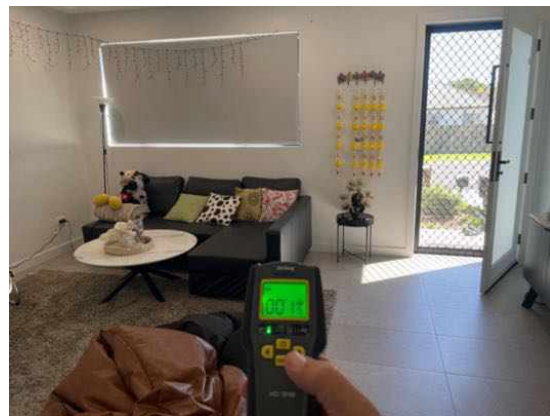
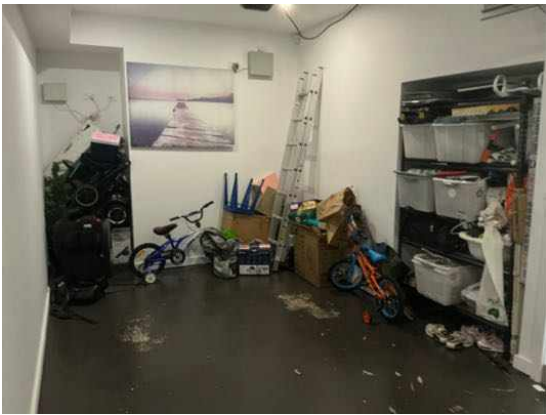
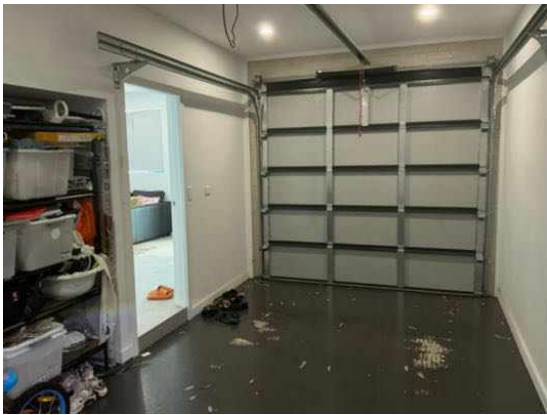
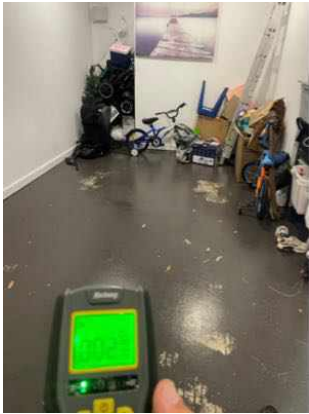
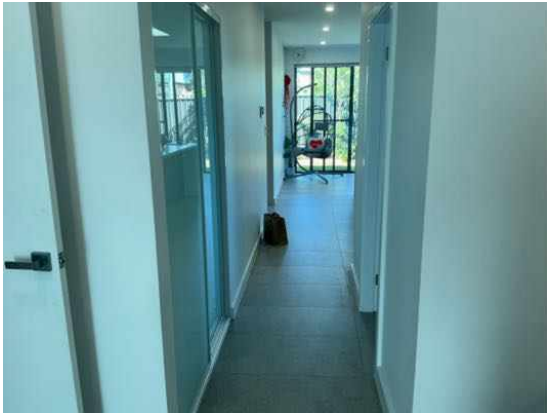
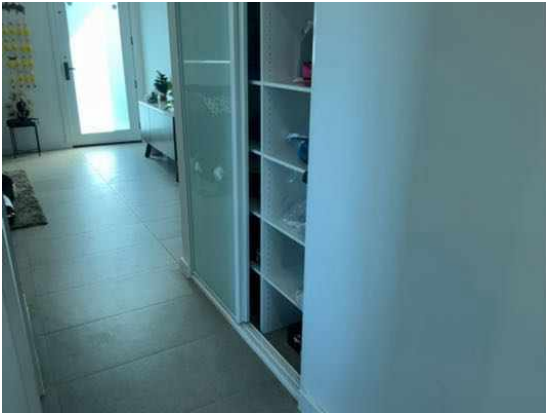
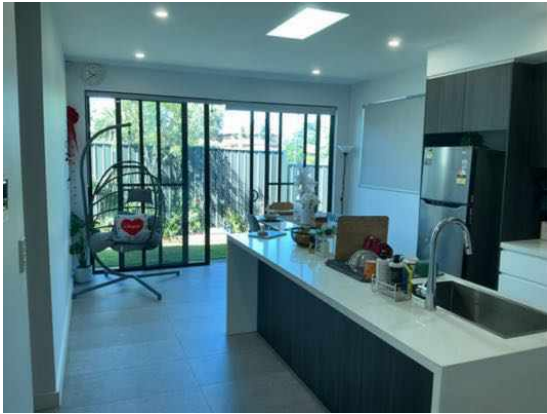
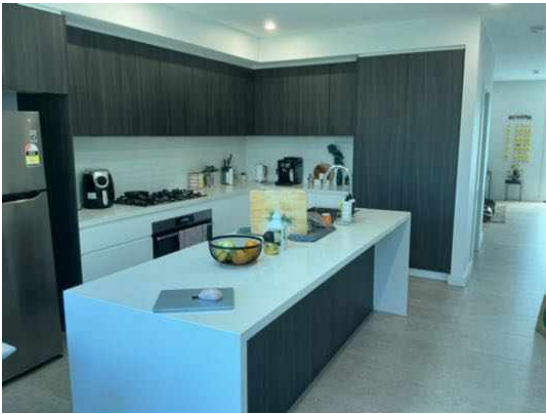
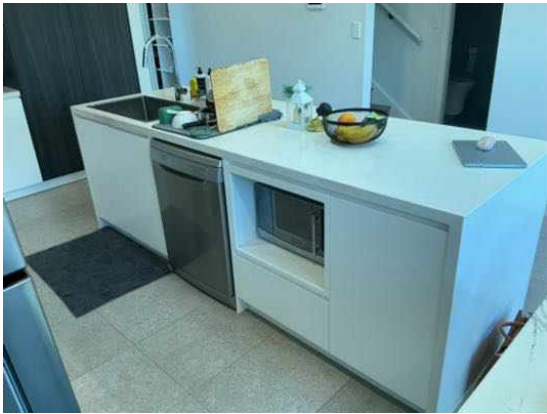
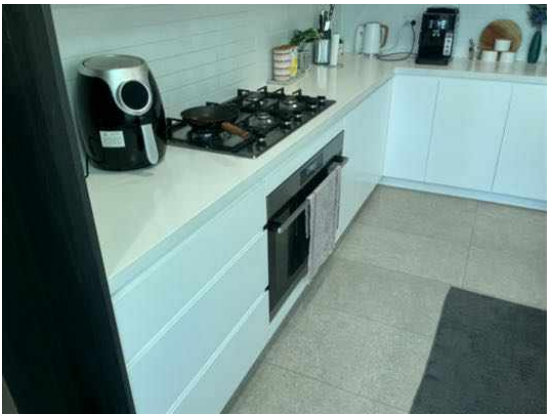
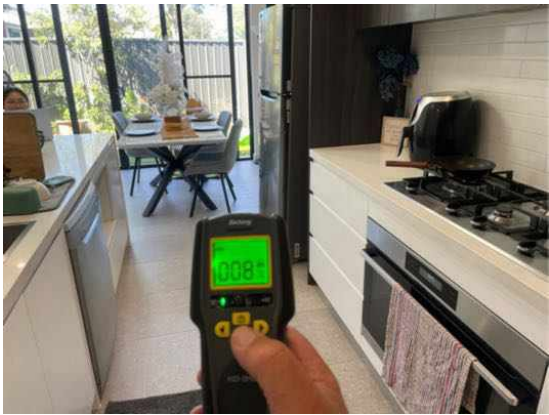
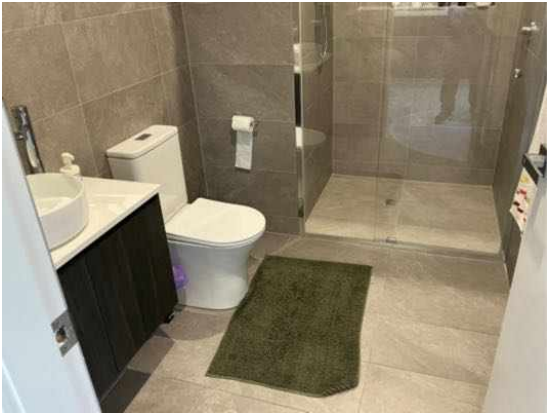
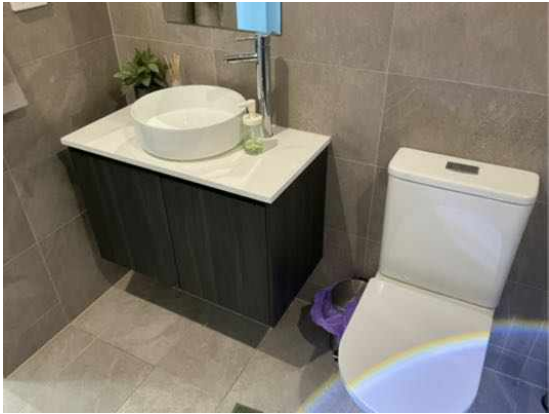
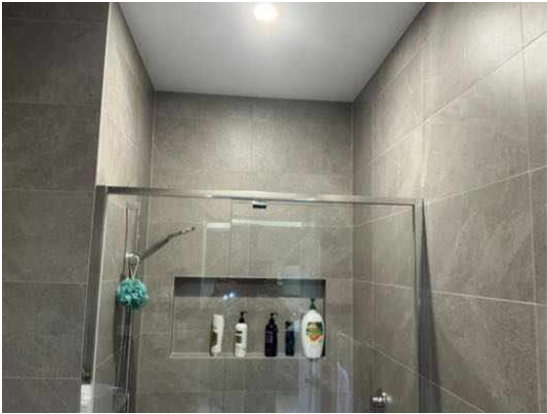
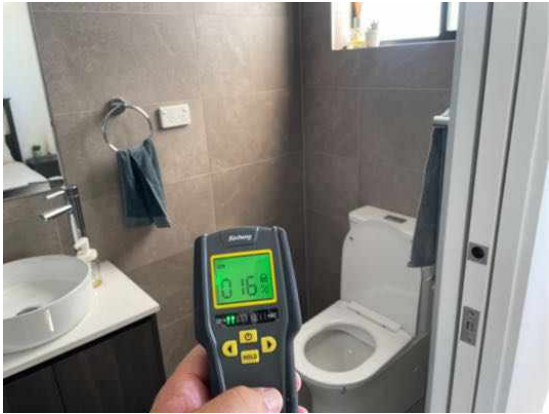
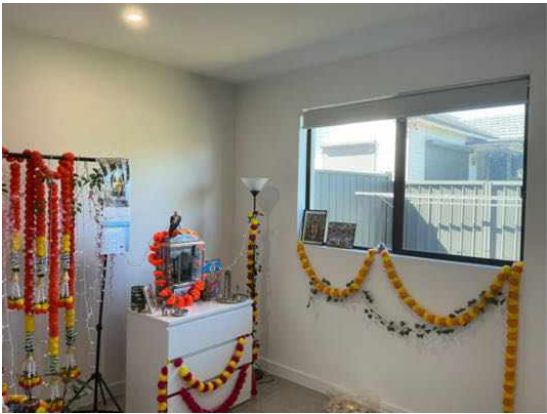
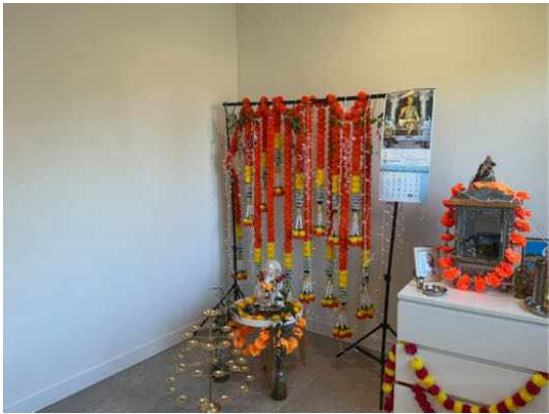
Noted Item

Building: Main Building
Location: All Areas- Interior
Finding: Additional Photos - Obstructions and Limitations
Information: These photographs are an indication of the obstructions and limitations which impeded full inspection of the property at the time of inspection. These obstructions can hide an array of defects and should be removed to allow full inspection to be carried out. A re-inspection is recommended once the areas are made accessible.

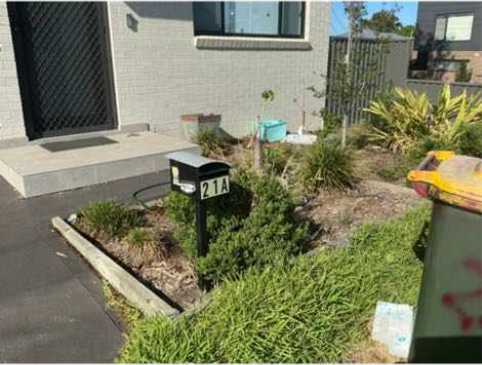
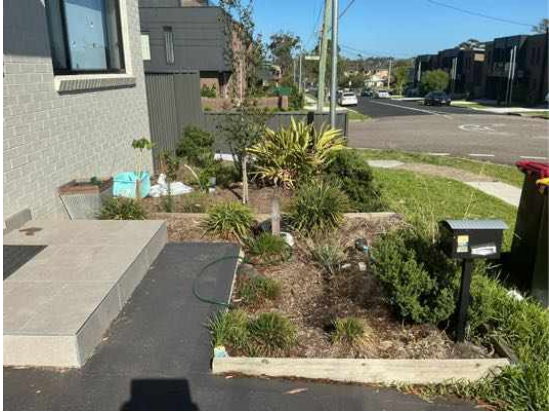
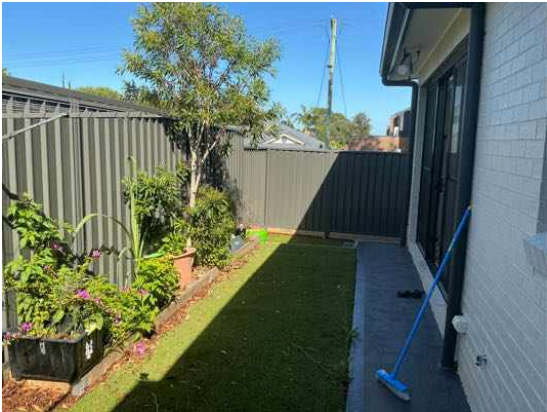
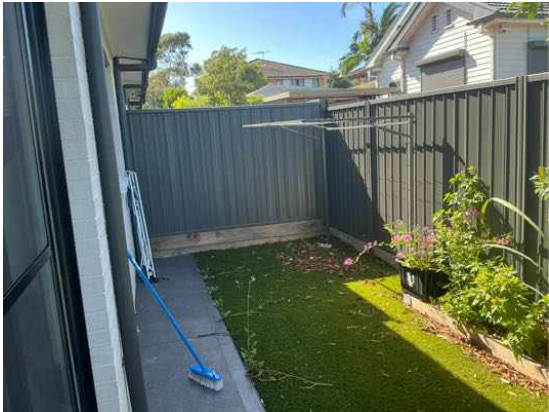
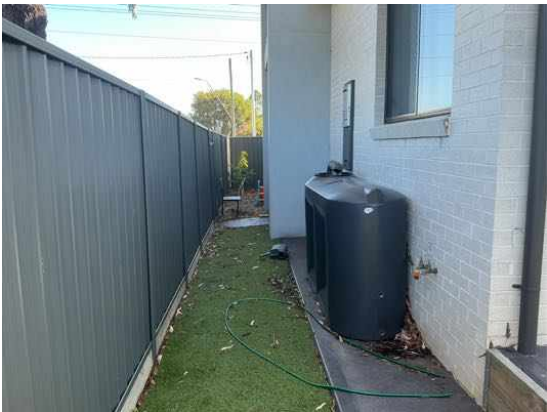
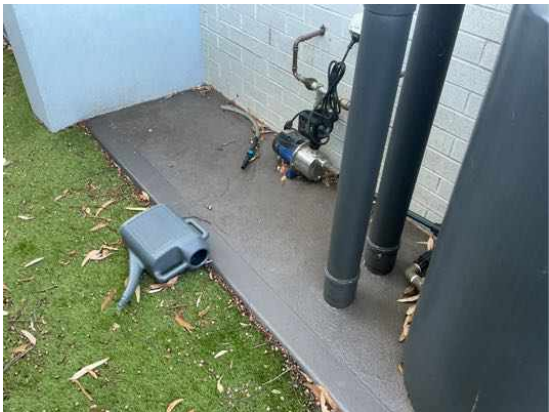
Building: Main Building
Location: All Areas- exterior
Finding: Additional Photos - Obstructions and Limitations
Information: These photographs are an indication of the obstructions and limitations which impeded full inspection of the property at the time of inspection. These obstructions can hide an array of defects and should be removed to allow full inspection to be carried out. A re-inspection is recommended once the areas are made accessible.

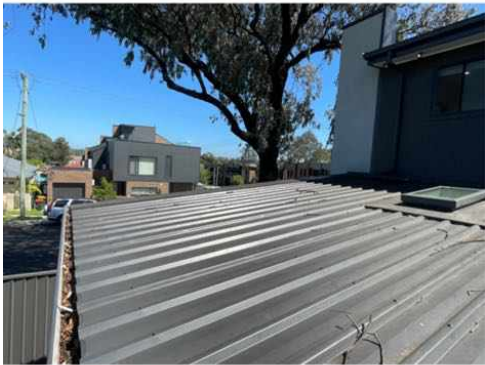
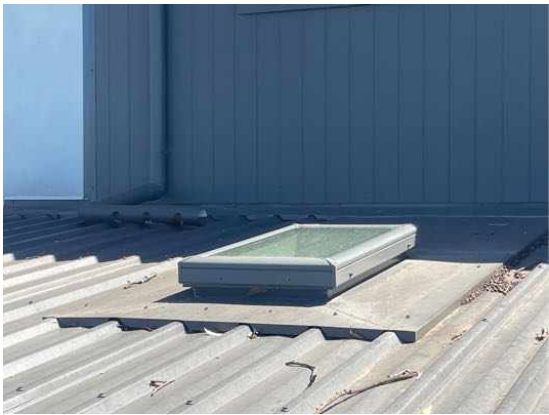
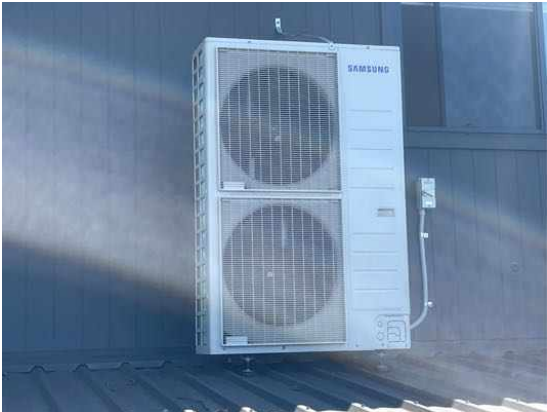
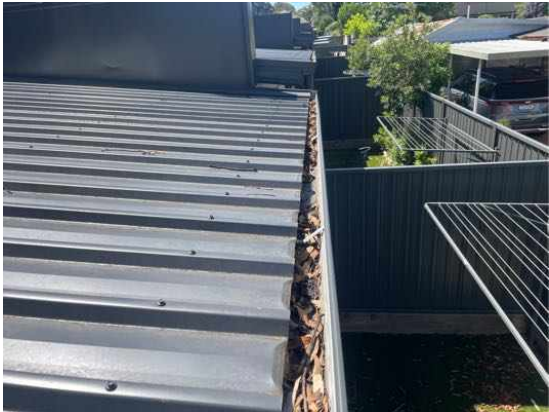
Building: Main Building
 Location: Roof Exterior
 Finding: Additional Photos - Obstructions and Limitations
 Information: These photographs are an indication of the obstructions and limitations which impeded full inspection of the property at the time of inspection. These obstructions can hide an array of defects and should be removed to allow full inspection to be carried out. A re-inspection is recommended once the areas are made accessible.

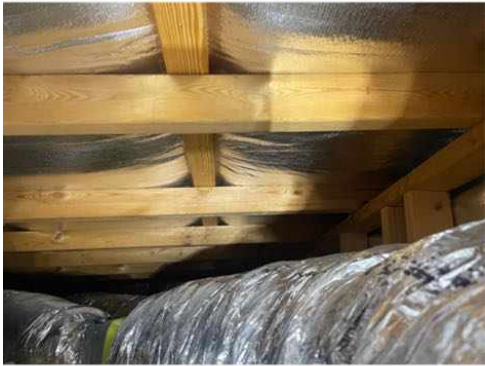
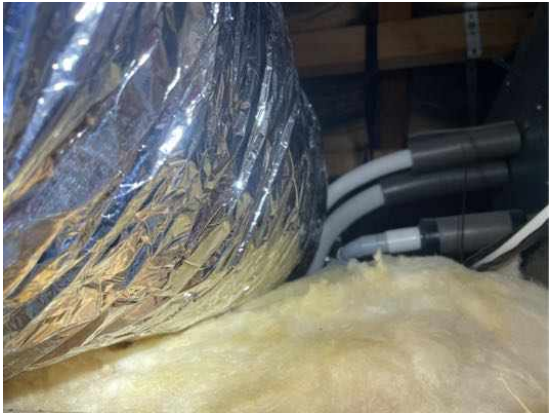
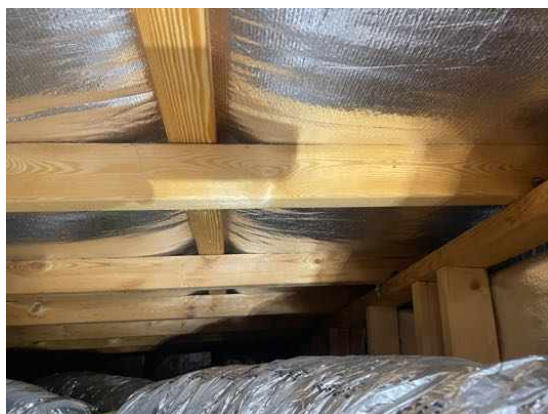
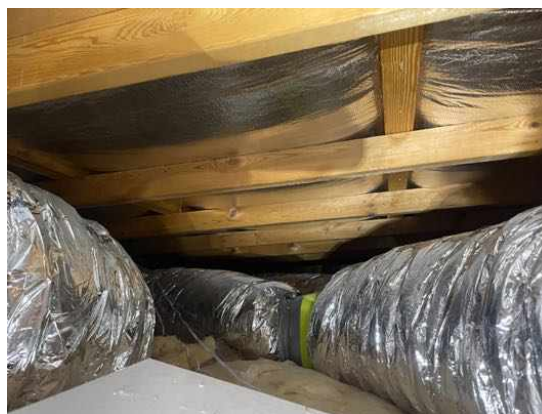
Building: Main Building
Location: Roof Void
Finding: Additional Photos - Obstructions and Limitations
Information: These photographs are an indication of the obstructions and limitations which impeded full inspection of the property at the time of inspection. These obstructions can hide an array of defects and should be removed to allow full inspection to be carried out. A re-inspection is recommended once the areas are made accessible.

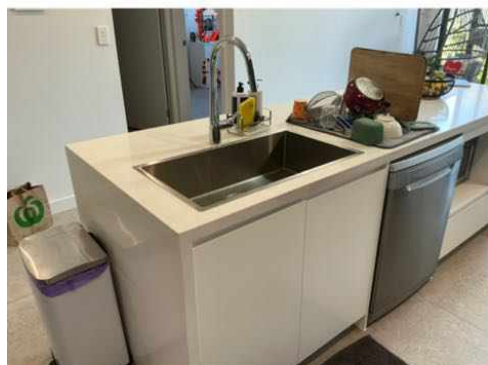
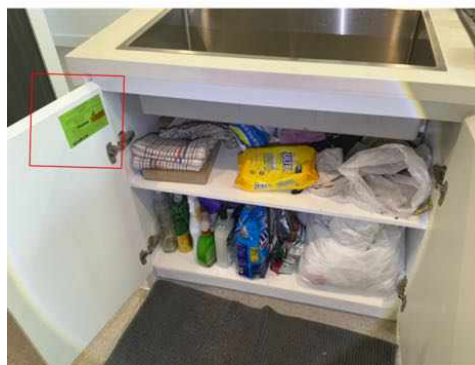
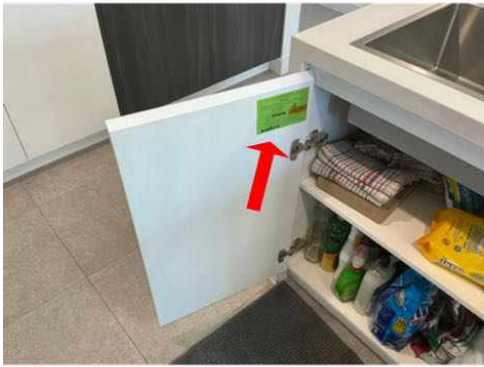
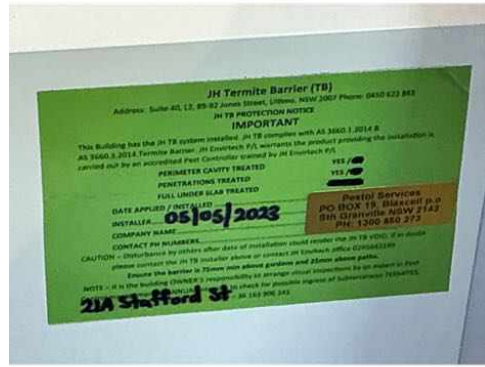
Where a Termite Management System has been identified you should refer to the type of barrier date of installation warranty conditions and any documentation provided by a builder or past owner. Consult the company who installed the barrier to confirm whether the system is still under warranty.

Most chemical termite management systems expire and require replenishment and all physical systems are primarily designed to prevent concealed entry.
