Building Inspection Report

Inspection Date: Mon, 19 Jan 2026

Property Address: 398 Liverpool Rd, Strathfield South NSW
2136, Australia

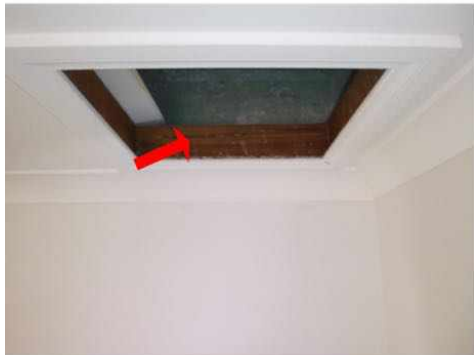
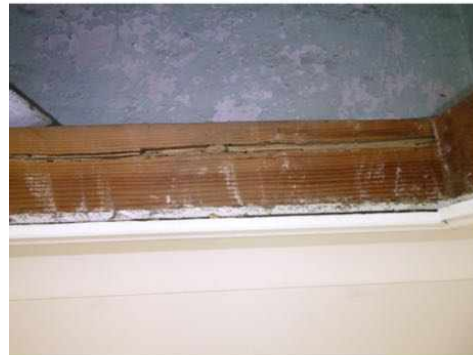
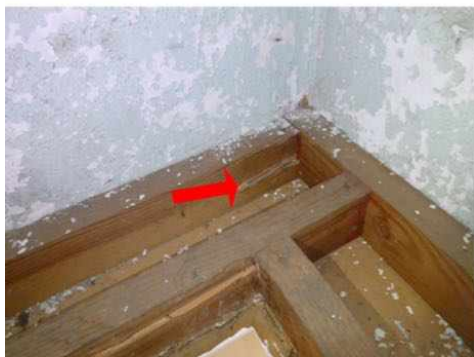
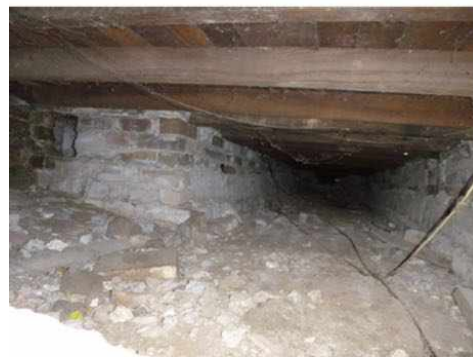
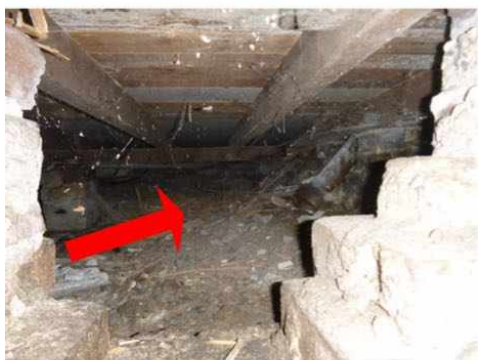
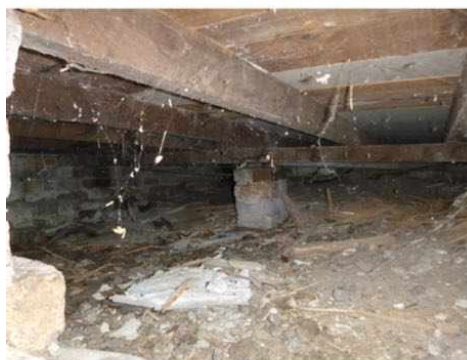
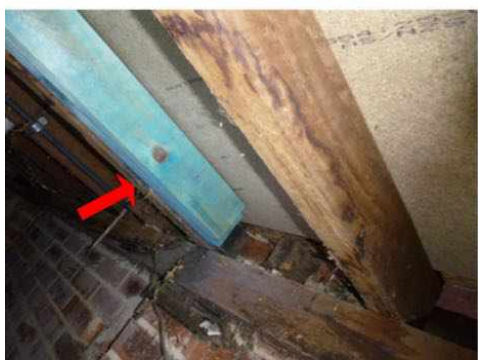
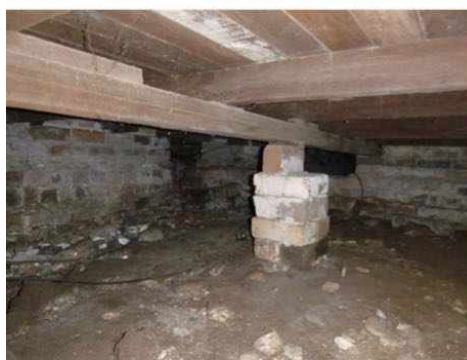
Defects 2.01

Building: Main Building
Location: Subfloor Ceiling void
Finding: Suspected Previous termite activity identified
Information: Although no evidence of live termite activity was found at the time of inspection it is suspected that a termite colony is present on the property. Further inspection of external and internal areas is required in order to correctly identify the presence of termite activity and may include works of an intrusive nature.

It is strongly recommended that further inspection be conducted as soon as possible in order to prevent any further damage that may ensue.

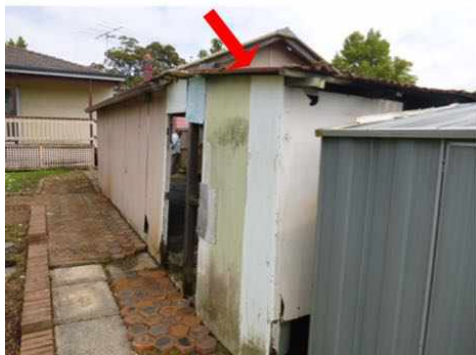
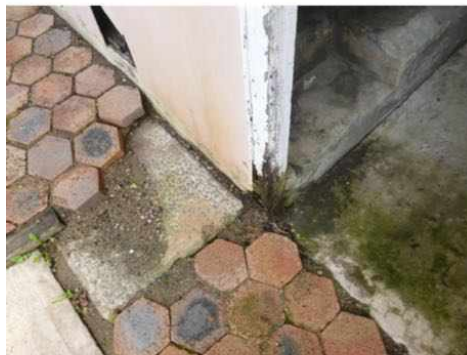
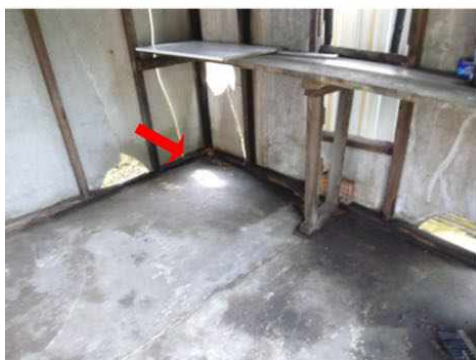
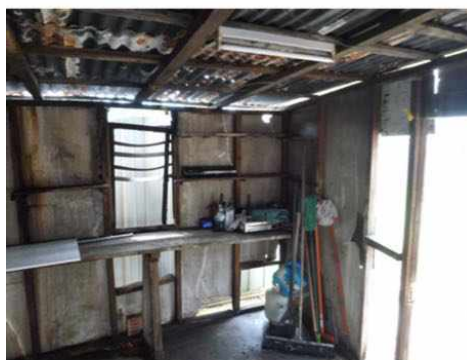
Defects 2.02

Building:	Main Building
Location:	Garage
Finding:	Garage structure - Unstable & wood rot
Information:	This building element shows evidence of wood rot. Wood rot, also known as Fungal Decay, occurs when timbers and other cellulose building materials are exposed to damp conditions on an ongoing basis. This could be the result of exposure to weathering over a prolonged period of time, or the attraction of excessive moisture from other abutting building materials.

Movement was evident in the carport structure, indicating that it may not be structurally sound or compliant with current building regulations. While some degree of movement is expected of structures of this design, it is suspected that strong winds or forceful impact may cause the stability of the carport to further decline.

further, potentially creating an environment which is unsafe.

Early intervention and regular maintenance, particularly of exterior timbers, will prolong the useful life of these building elements. Prior to any works being performed, the cause of the moisture that has created the visible wood rot should be identified and addressed in a suitable manner. Replacement of affected timbers may then be a necessary step in protecting surrounding building elements from such deterioration.

Additional bracing of the carport is required immediately to ensure its safety and structural integrity. If left unmanaged, the carport structure is likely to deteriorate

A registered builder with the assistance of trades, e.g. qualified carpenter, should be appointed to perform remedial works as a matter of urgency.

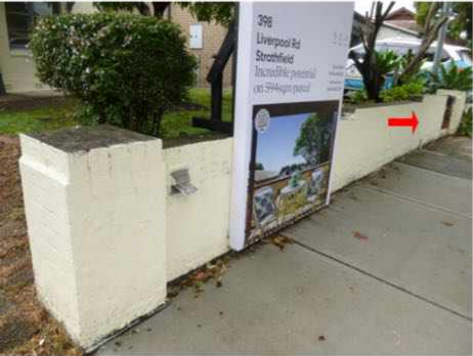
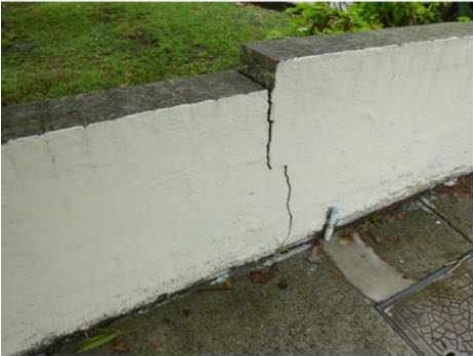
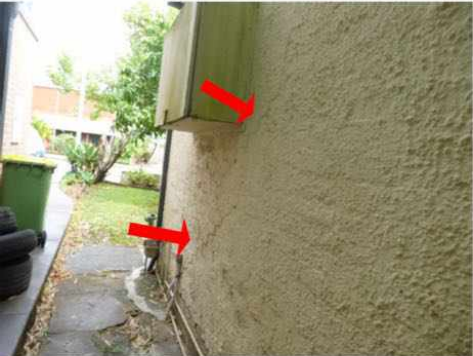
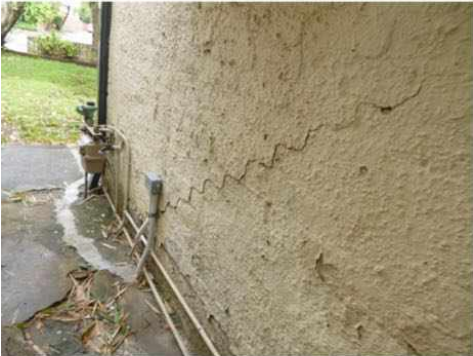
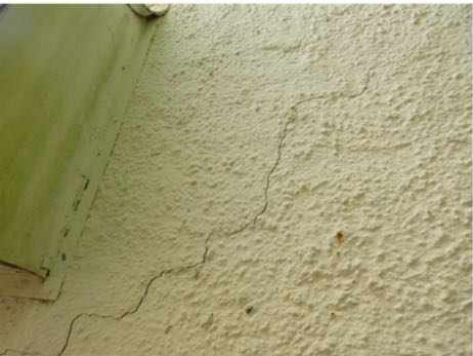
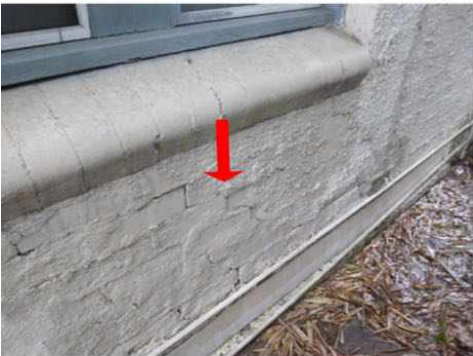
Defects 3.01

Building:	Main Building
Location:	Garage
Finding:	Cracking - External Concrete Paving Damage Category 4 - Gaps in Slab (4mm - 10mm +)
Information:	Gaps in the slab were identified in external concrete paving. Gaps in the slab are significant and are likely to lead to the development of safety hazards and secondary defects if left unmanaged, such as the creation of a trip hazard.

General age and expected deterioration of the paved areas is a common cause of this type of cracking. However, expansion and contraction of the slab may also have occurred due to environmental factors. Such factors include variable moisture and weather conditions, the presence of trees and their roots having a settling or lifting affect on the soil, or the effect of load bearing, e.g. heavy vehicles over a sustained

Cracking to this degree may also be due to poor original installation of the concrete. Factors such as poor compaction of the sub surface and/or inadequate reinforcing of the slab may create cracking and other secondary defects. Gaps in the concrete paving may also have a more significant structural cause, such as subsidence of soils.

Where gaps in the concrete paving are adjacent to structural elements of the building, the advice of a Structural Engineer is advisable before undertaking repairs. Significant repair and likely replacement of the concrete paving is probable.

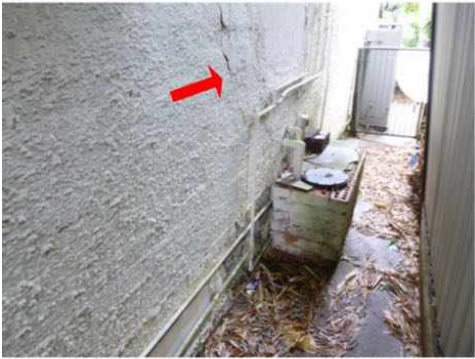
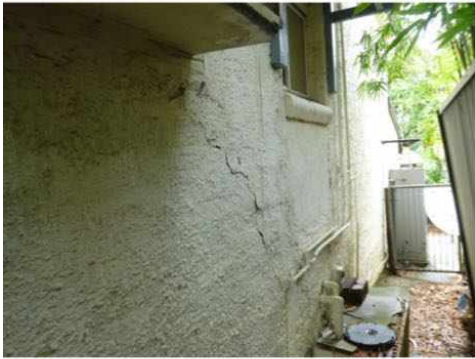
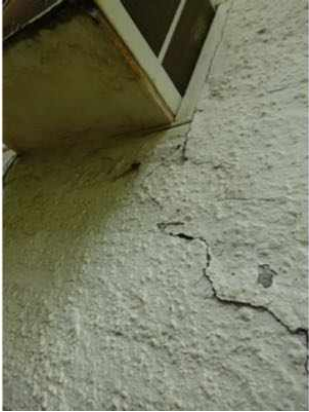
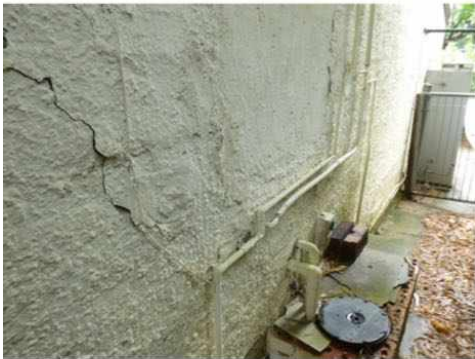
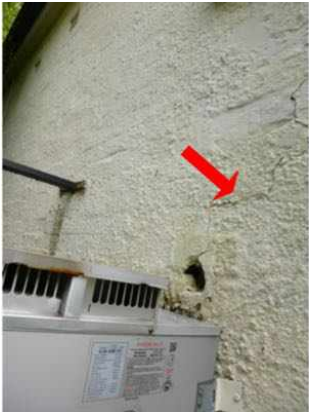
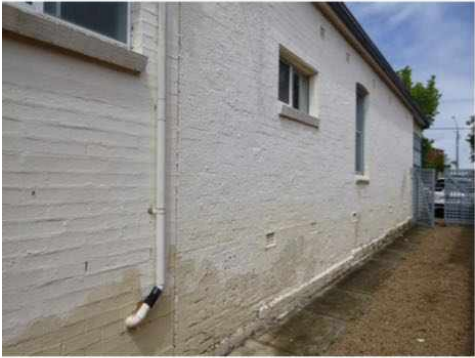
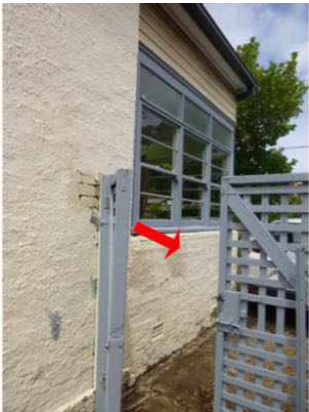
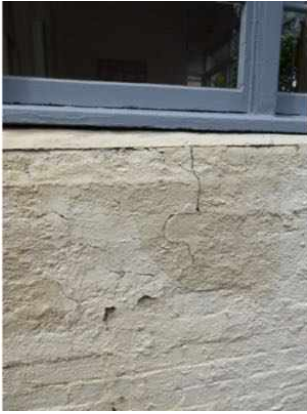
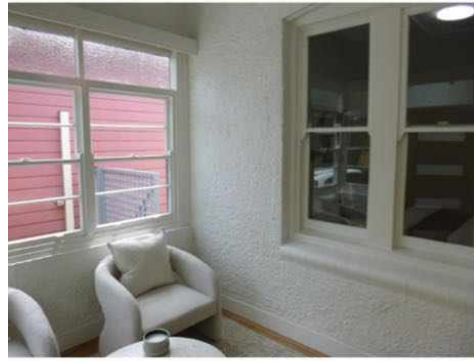
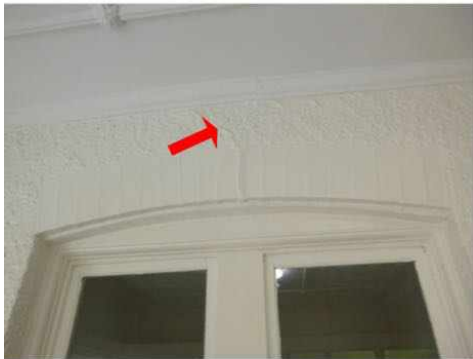
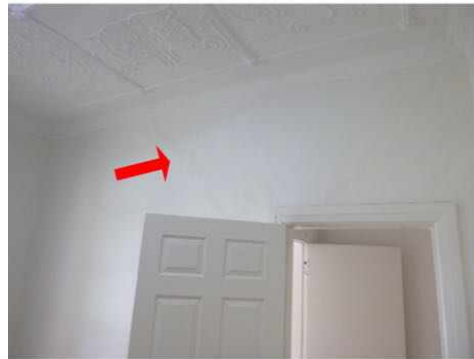
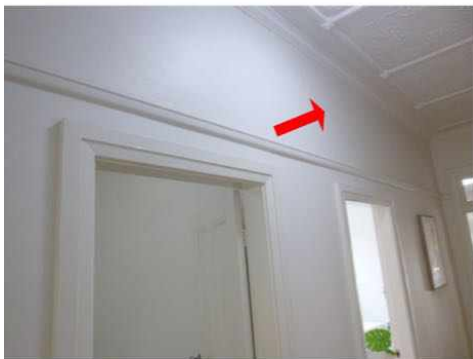
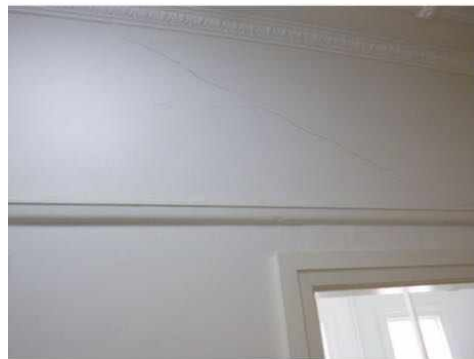
Defects 3.02

Building:	Main Building
Location:	Exterior walls
Finding:	Brickwork - Cracking noticeable
Information:	There were several cracks and or crack repairs evident to external brickwork.

Noticeable cracks are a common occurrence in external brickwork and are a likely result of age expected building movement, general expansion, and/or contraction of building materials in different weather conditions. Noticeable cracks in brickwork may develop if left unattended, with potential for necessitating major remedial works or replacement of the brickwork. Step cracking was identified to the brickwork in this area at the time of inspection. Step cracking, which is similar to other forms of cracking, has a variety of possible causes. However, the most common is the subsidence of adjacent footings.

Step cracking is a relatively common defect, and is most likely to occur adjacent to windows, doors and other openings. Mortar failure in the gaps between affected bricks indicates the stresses and tensions affecting the wall.

It is highly advised that a qualified bricklayer be appointed to provide necessary works to cracked brickwork to prevent any further damage. Such works should be conducted as soon as possible.

Always monitor these cracks and contact a building inspector should cracks widen, lengthen, or become more numerous.

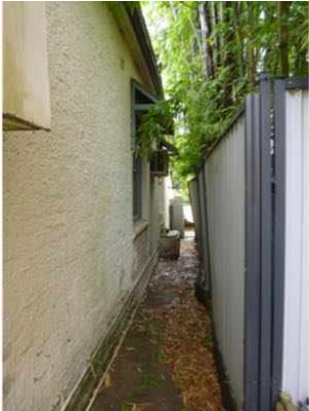
Defects 3.03

Building: Main Building
 Location: Fencing
 Finding: Fencing - Deteriorated
 Information:

A licensed fencing contractor should be appointed to provide further advice and perform rectification works as necessary.

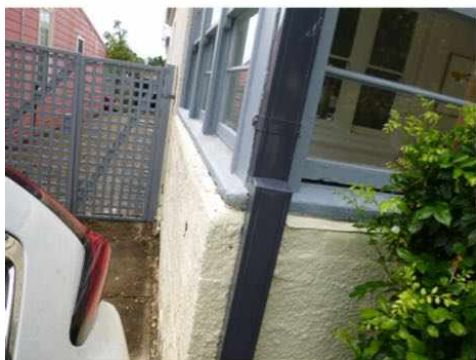
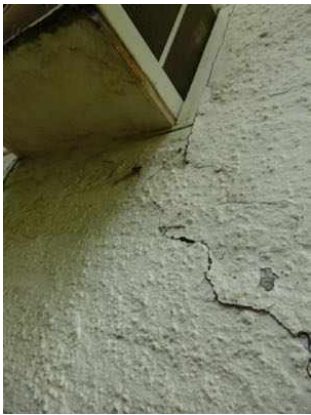
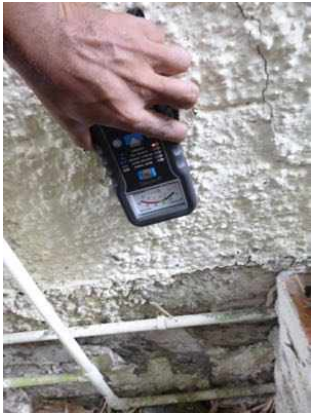
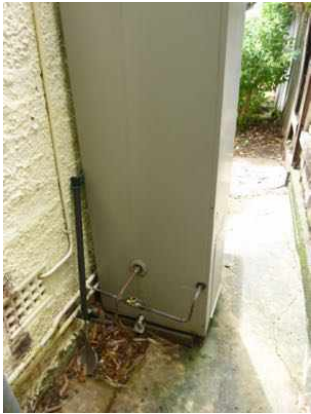
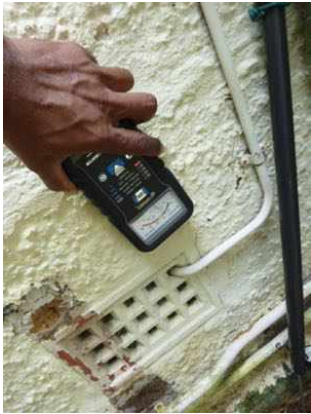
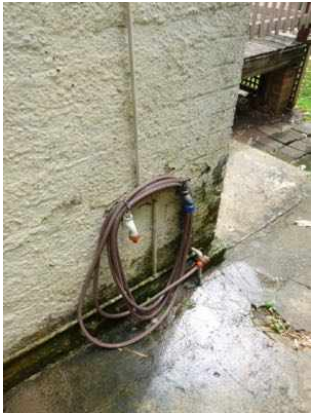
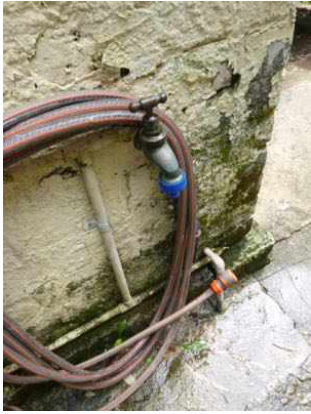
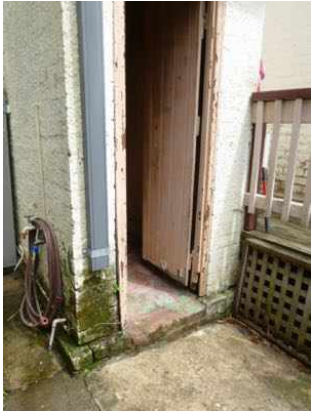
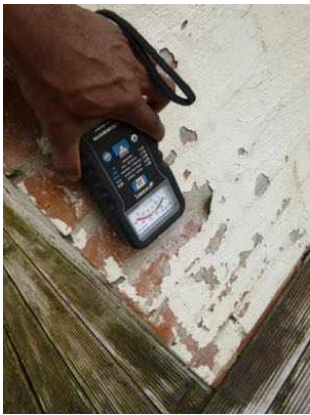
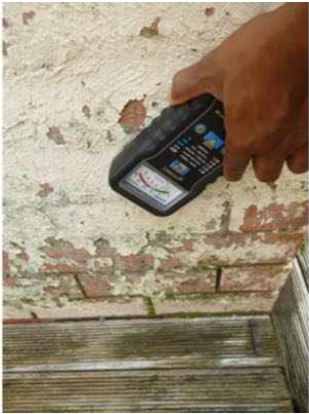
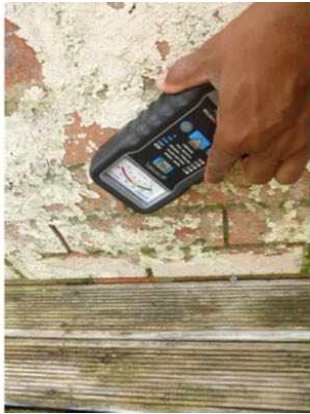
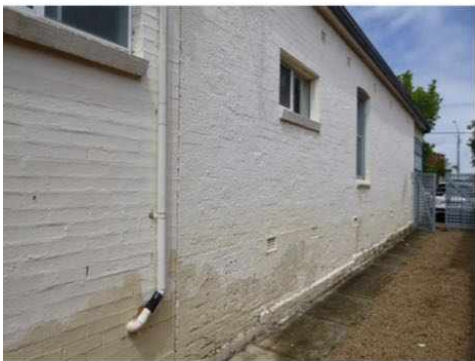
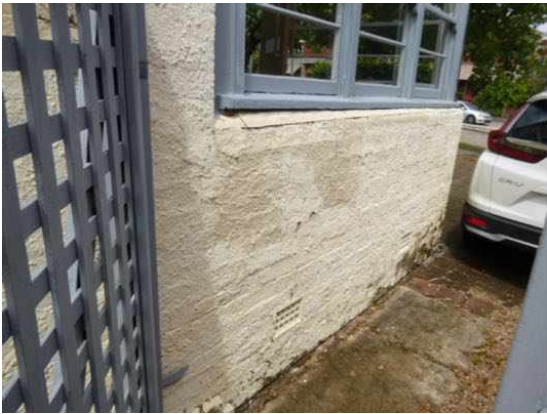
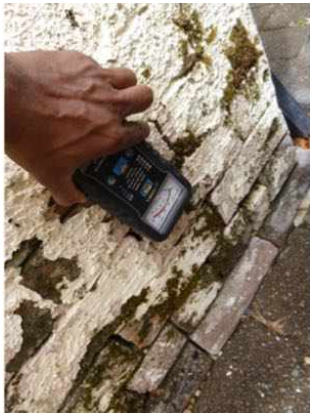
Defects 3.05

Information: Lateral penetrating damp refers to the sideways movement of moisture, predominantly from the surrounding ground, which tends to affect basement walls and other earth-retaining walls. The implications of unmanaged damp range from mould fungi growth, wood rot and decaying building materials, to finishes including lifting, bubbling, peeling and staining of paint, plaster and wallpaper.

It is important to address damp conditions as the World Health Organisation notes that excess moisture leads - on almost all indoor materials - to the growth of microbes such as moulds, fungi and bacteria, which subsequently emit spores and other matter into the indoor air. Exposure to these contaminants is associated with a wide range of respiratory and other health-related problems. Additionally, the development of damp in timber building elements also provides an environment that is conducive to termite / timber pest attack.

Structural waterproofing barriers or tanking barriers are often used to protect internal surfaces against the effects of lateral penetrating dampness. These types of work are generally undertaken where the source of the penetrating damp cannot be prevented.

Immediate consultation with a licensed plumber is advised to address the cause of the damp and to perform remedial works as necessary.

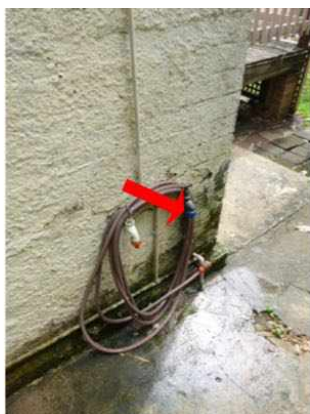
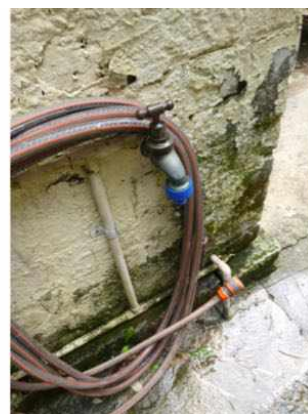
Defects 3.06

Building:	Main Building
Location:	Yard - Back
Finding:	Tap - Leaking
Information:	The tap in this area was found to be leaking at the time of inspection. This is a common defect that is consistent with general ageing of the building element. However, it may be indicative of substandard plumbing workmanship if the tap is relatively new.

While this defect only seems minor, if left unmanaged, it is likely to result in the development of rust, water damage and/or extensive water usage.

It is advised that a handyman or licensed plumber be appointed to perform remedial works on the affected tap. Such works should be performed prior to the development of secondary defects to ensure adequate functionality of all associated building elements.

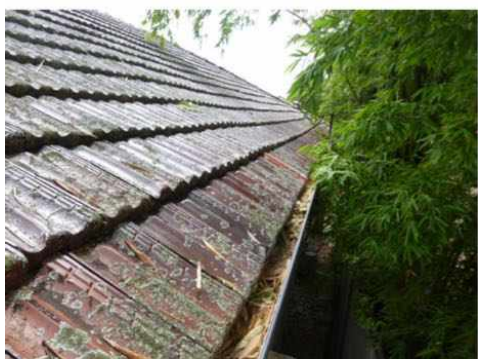
Defects 3.07

Building:	Main Building
Location:	Gutters Roof valley
Finding:	Gutters - Blocked
Information:	Roof plumbing structures, such as guttering and downpipes, should be free of all debris to prevent blockages. Blockages of the guttering and downpipes will lead to pooling and accumulated water overflows, which is likely to subsequently flood eaves and exterior walls.

Blocked gutters are likely to lead to high levels of moisture in the affected areas. Such moisture will not only cause rust and decay of the associated building materials, but can also provide conditions that are conducive to termite and timber pest activity. Blockages in gutters should therefore be removed immediately to ensure dry conditions are maintained.

Consult a Licensed Plumber for further specific advice on remedial works that may be required. In the interim, it is highly advised that blocked gutters be removed by the homeowner or a general handyperson as a matter of urgency.

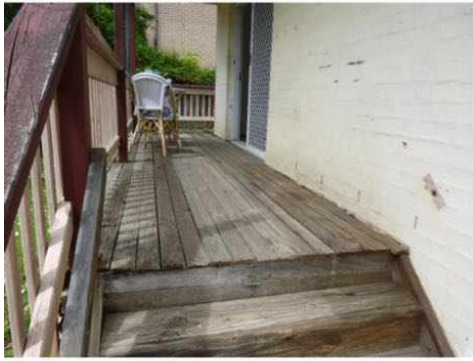
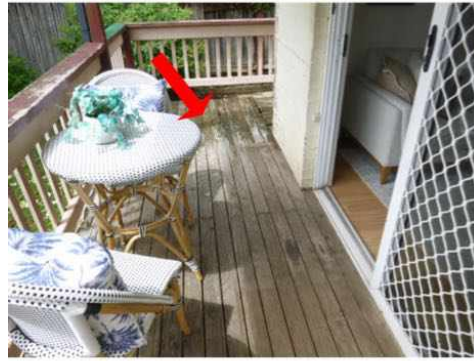
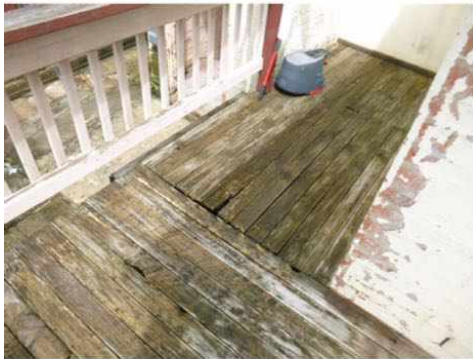
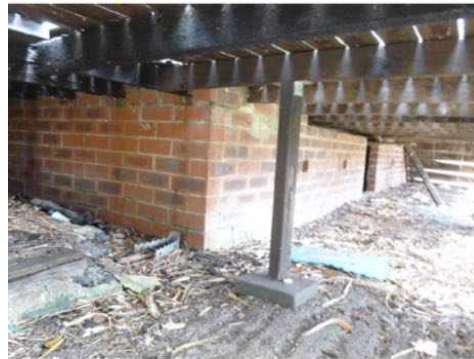
Defects 3.08

Building:	Main Building
Location:	Yard - Back
Finding:	External Timber Balcony or Deck - Structural Stability
Information:	The load capacity of the external balcony or deck could not be verified during the inspection.

External timber structures are also constantly exposed to weather elements and can deteriorate in an accelerated manner, ongoing assessments are required.

It is highly recommended that a Structural Engineer further assess the external timber balcony or deck to inform the client of its load capacity. Regular maintenance inspections by competent practitioners is needed.

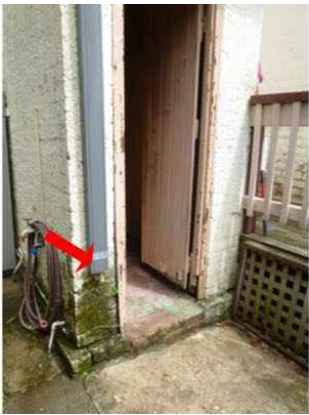
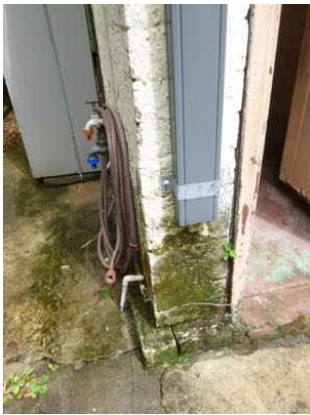
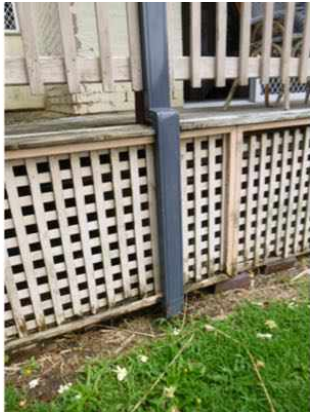
Defects 3.09

Building:	Main Building
Location:	Yard - Back
Finding:	Stormwater drain - Not connected
Information:	The roof plumbing is not adequately connected to stormwater drainage on the site. This disconnection negatively impacts the functional capacity of the roof plumbing.

Where roof plumbing doesn't drain adequately, the area at the base perimeter can become excessively damp, potentially creating an environment that is susceptible to rust and corrosion of surrounding building elements, as well as attracting termites and other pests.

It is highly recommended that a plumber be appointed to further inspect the area and to install adequate drainage equipment where necessary.

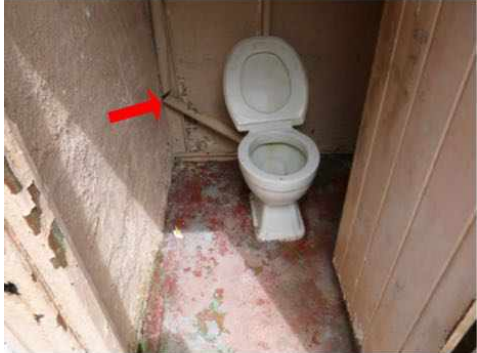
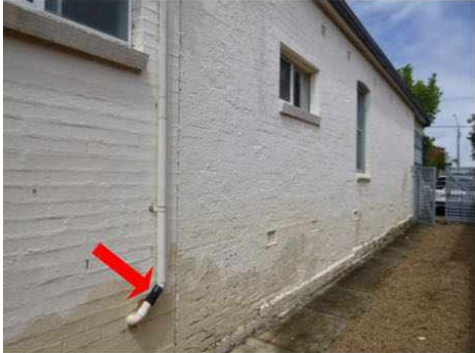
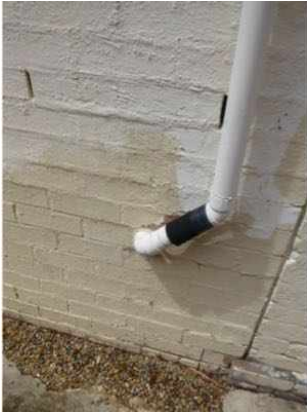
Defects 3.10

Building: Main Building
 Location: Toilet (WC)- Out door
 Finding: Air vent pipe - Damaged
 Information: It was noted at the time of inspection that air vent in this area has damaged/deteriorated. This damage is suspected to have been caused by deliberately. Air vent pipe is to regulate pressure in the drainage system. Repair or replacement of the air vent pipe is advised to ensure the protection and longevity drainage system. Such works may be performed by a general handyperson or qualified plumber.

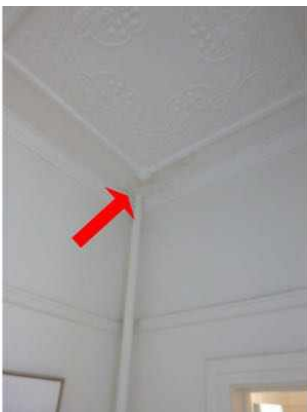
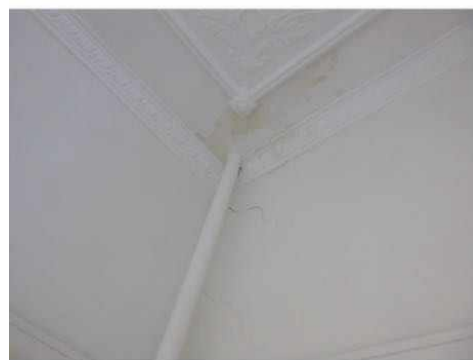
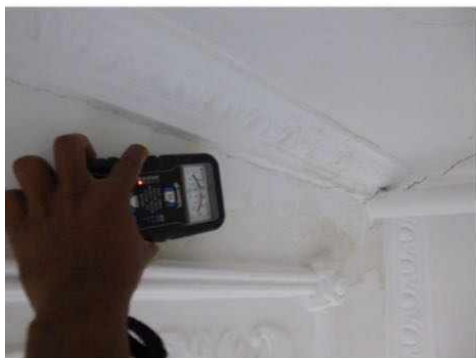
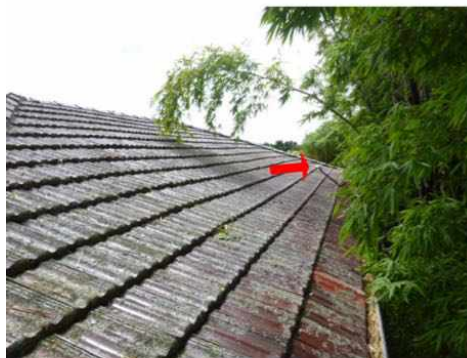
Defects 3.11

Finding: Ceiling - Water stained/ leaking

Information: Water staining to ceiling linings in this area was evident at the time of inspection. Water staining indicates that surfaces have been exposed to excessive moisture over time. The minerals and other elements in the water lead to staining, which may graduate to corrosion and deterioration if left unmanaged.

While mostly an appearance defect, water staining can be indicative of more serious defects, which may be currently concealed by interior ceilings.

Where water staining is active, a licensed plumber must be consulted to identify the cause of the staining and to provide advice on any reparation works that may be required. Replacement of any damaged structures is advised.

Conversely, where water staining is old and inactive, affected building materials may be repaired or replaced at client discretion.

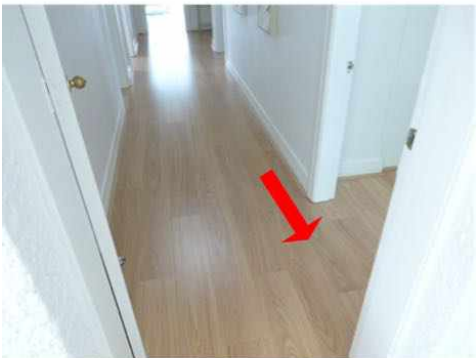
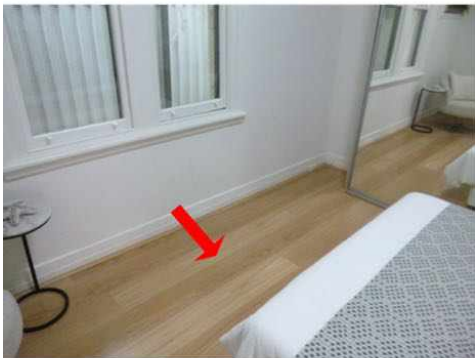
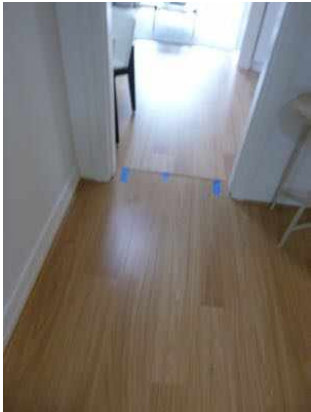
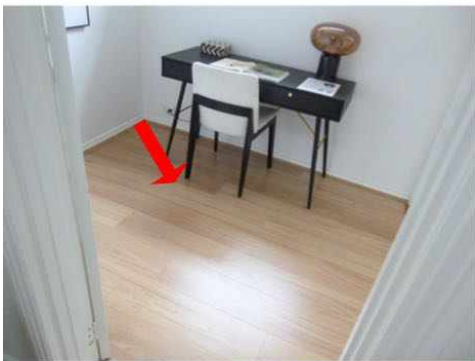
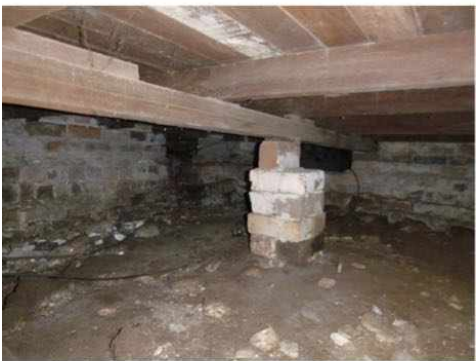
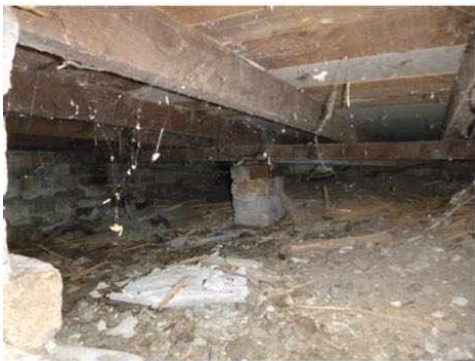
Defects 3.12

Building:	Main Building
Location:	Hallway Bed rooms
Finding:	Floors - bouncy & uneven
Information:	The internal flooring in this area was identified as being bouncy and uneven at the time of inspection. A bouncy floor surface generally presents as a discernible change in level as they are walked across, in noisy or creaking flooring, or in consequent movement of surrounding furniture and fixtures. Uneven flooring is likely to indicate minor defects such as expected movement of the foundations of the property, but may also indicate subsidence of the associated subfloor stumps.

Bouncy floors generally indicate that the floorboards or the subfloor structures are coming loose from the joists that they are installed on. Bouncy flooring may also be the result of gaps between flooring and stumps or joist structures, which require packing.

It is advised that the flooring be closely monitored to identify any further movement. Where flooring remains relatively unchanged for an extended period of time (i.e. several months), it is likely that this defect has been caused by expected movement of the foundations of the property.

However, where flooring is uneven further, potentially invasive inspection of the subfloor structures and stumps in this area is required. In this case, works to repair are likely to be required, and would be carried out by a registered builder specialising in re-stumping.

The client is advised to seek quotations for required repairs from a Registered Builder specialising in re-stumping. The potential resolution may range from packing gaps in subfloor structures through to replacement of subfloors stumps and refixing of flooring.

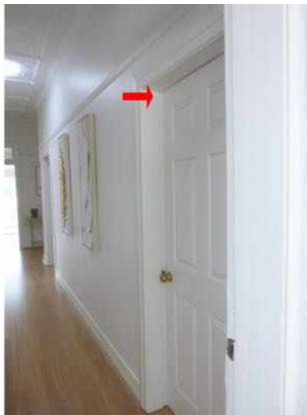
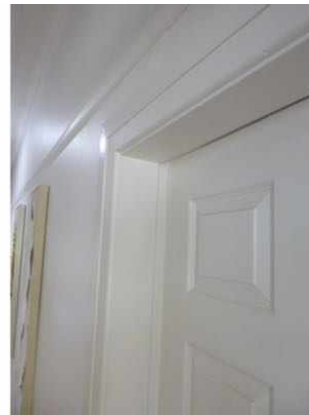
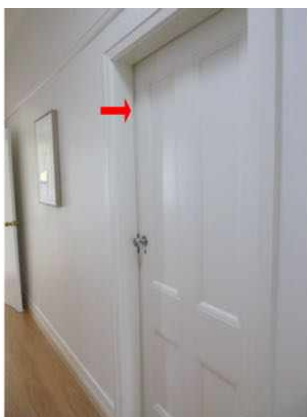
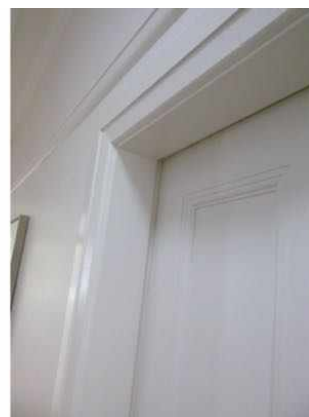
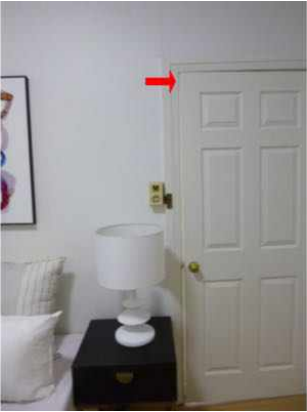
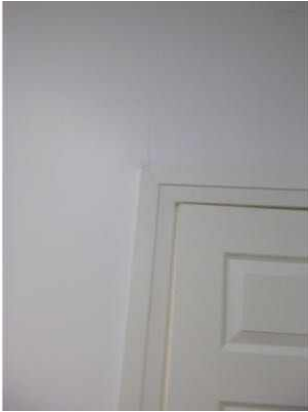
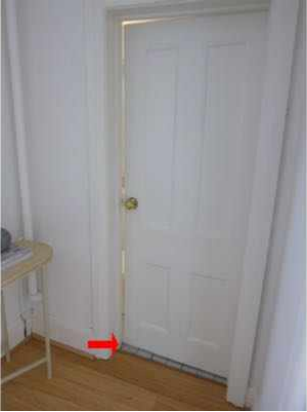
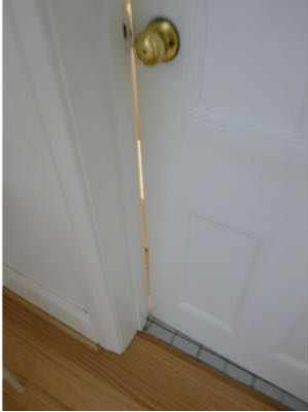
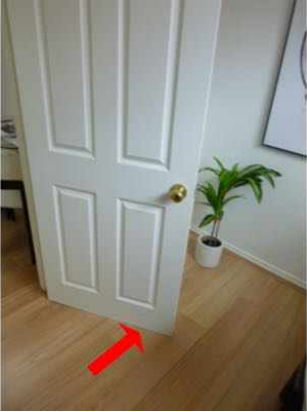
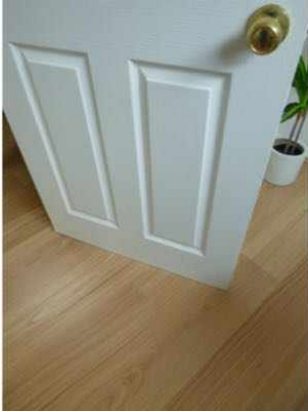
Defects 3.13

Building: Main Building
Location: Bedroom Doors
Finding: Door - Binding/jamming
Information: Binding and/or jamming of this door is evident during standard operation. This defect inhibits the functionality of the affected door as well as creating potential for secondary defects to associated building elements, such as damage to the floor covering.

A door that binds to flooring or to the associated door frame may have several causes, ranging from minor defects, such as poor installation of the door or deteriorated hinges, through to major structural issues, such as damage to subfloor structures.

Where door binding/jamming appears to indicate major structural issues, a registered builder specialising in re-stumping should be appointed to provide an estimate on the cost of rectification.

For minor causes, a qualified carpenter or general handyman should be appointed to perform minor rectification works at client discretion.

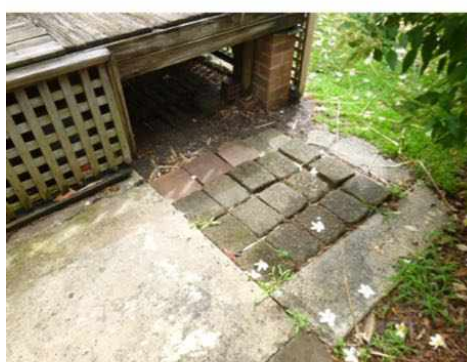
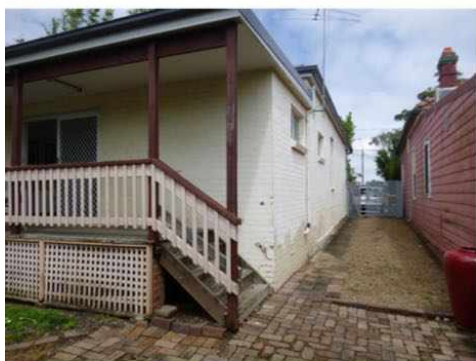
Building:	Main Building
Location:	Yard - Front
Finding:	Paving - Uneven
Information:	Sections of the external paved area are uneven, creating a potential trip hazard. It appears as though the area has been subject to rough installation, or that paving sections have lifted due to movements in the foundation of the property.

Where paving creates a trip hazard, personal injury may ensue if due caution is not taken by all persons within this area.

Re-paving of the area is required as soon as possible to remedy this situation. Further consultation with a specialist concreter is advised.

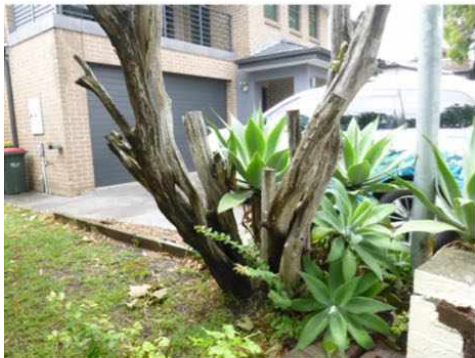
Building:	Main Building
Location:	All Areas
Finding:	Landscaping & stored timbre
Information:	Any timbers in direct ground contact provide opportunity for concealed termite entry and are likely to be subject to premature rot and decay as the soil retains moisture or damp conditions against the timbers. Remove untreated timber that is in direct contact with external grounds. If there is old tree stumps present frequent pest inspections are advised to readily identify any termite activity in these areas.

The storing of timbers in the subfloor space or around the external property increases the risk of termite activity being present. As they are likely to come into contact with weather conditions or excessive moisture wood rot is likely to develop on timbers that are not treated. It is highly recommended that any stored timbers be immediately removed from areas in which they may attract any termite / timber pest attack. Minimisation of risk / prevention of termite attack is far more adequate than dealing with the presence of termite activity.

Monitor treated landscape timbers within the garden area, as treated pine breaks down and rots over a period of time causing conducive conditions for termite activity.

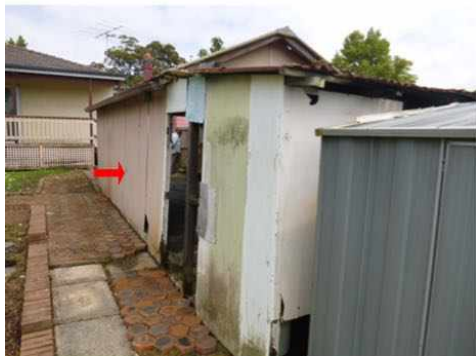
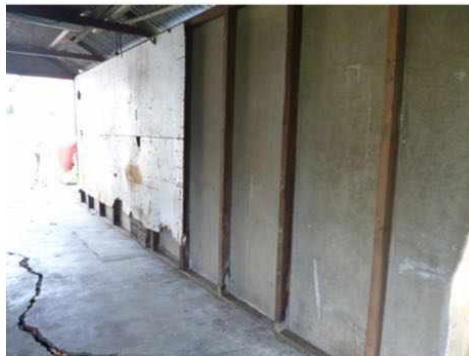
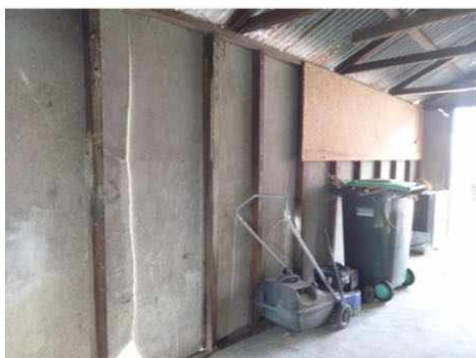
Building: Main Building
 Location: Garage
 Finding: Asbestos - Suspected ACM Identified on Site
 Information: Reporting on Asbestos is outside the Scope of this Report. This suspected defect is highlighted as a caution only. We suspect, based on our experience in the building industry, that there is a higher risk of the identified building element containing asbestos.

As Asbestos Reporting is outside the scope of this report, we advise that you consider a separate Asbestos Inspection and Condition Audit, which can include the taking of samples for definitive confirmation of the presence of Asbestos.

In the interim, the client is advised to act with caution, especially when considering any damage to building materials general wear and tear renovations extensions demolition and general maintenance activities due to the suspected presence of Asbestos.

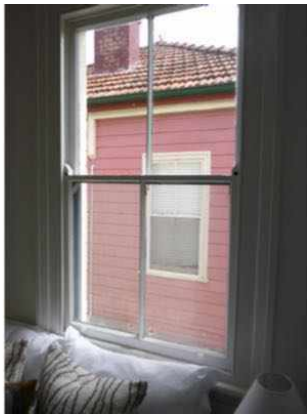
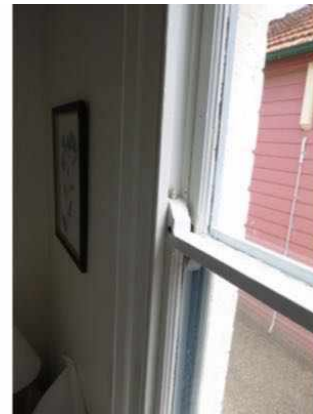
Building: Main Building
 Location: Bedroom windows
 Finding: Windows - Sash painted shut & Sash cords missing
 Information: Where window sashes have been painted shut, it is generally indicative of poor, rushed workmanship. Sashes are the moveable panes of windows that primarily slide vertically over each other to expose one half of the window area. Each sash is provided with springs balances and/or compression weather-stripping, which act to hold the window in place in one position.

To facilitate this operation the weight of the glazed panel is usually balanced by steel weights or counterbalances. The sash weight is connected by a cord or chain that runs over a pulley at the top of the frame. These cords are prone to degradation over time and replacement is required.

Where windows have been painted shut the seal of the paint needs to be broken. This is generally done by breaking the seal of the paint and then maintaining the sash tracks clearing and lubricating them with silicone. Remedial paint work will likely be required and can be completed along with the rest of the remedial works necessary by a general handyman. Repairing or replacing sash cords involves some work and is often best completed by an experienced carpenter or specialist window restorer. It is advised that such works be completed to improve the operational state of the affected window.

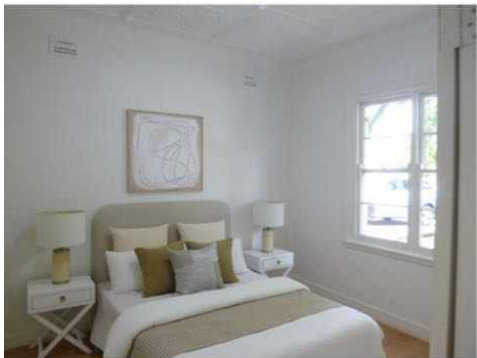
Building:	Main Building
Location:	All Areas
Finding:	Additional Photos - Obstructions and Limitations
Information:	These photographs are an indication of the obstructions and limitations which impeded full inspection of the property at the time of inspection. These obstructions can hide an array of defects and should be removed to allow full inspection to be carried out.

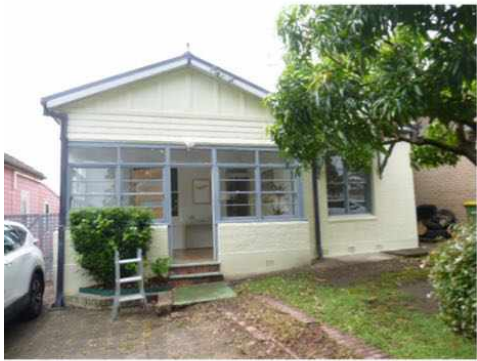
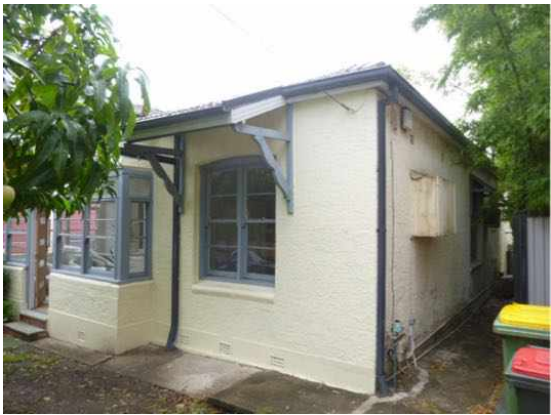
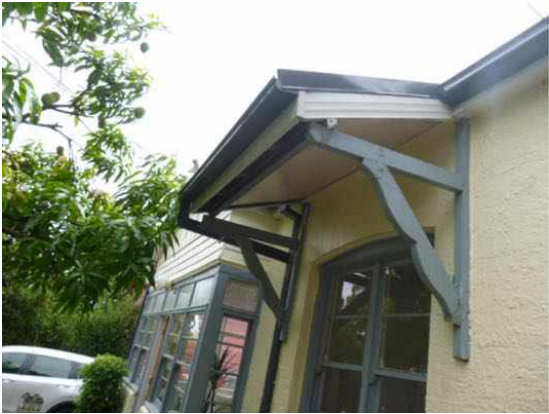
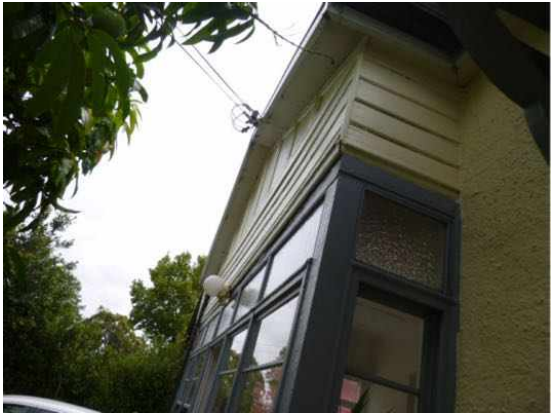
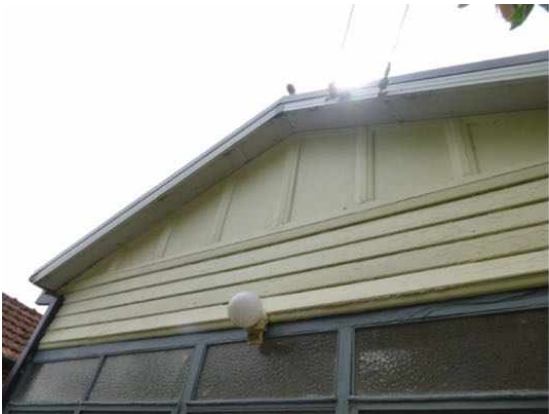
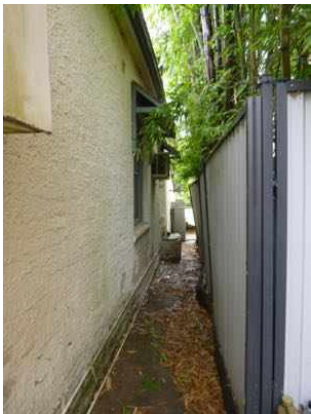
Building: Main Building
Location: All Areas
Finding: Additional Photos
Information: Additional photos are provided for your general reference. Arrows have been included to highlight areas of importance. Please discuss these photos with your building consultant for clarification.

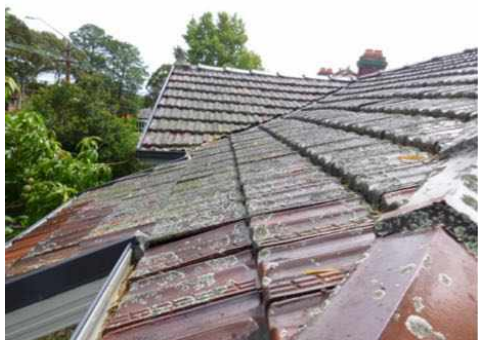
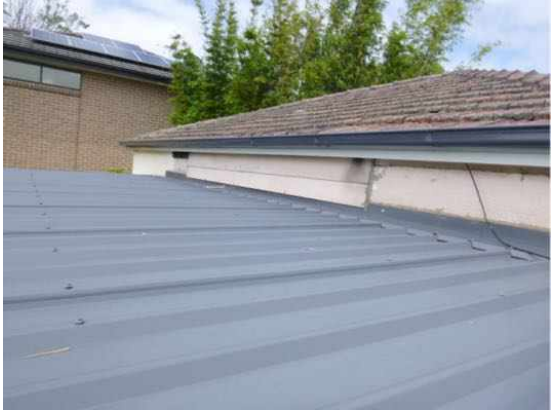
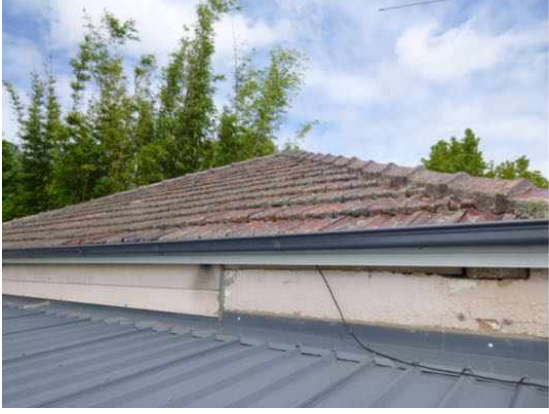
Building:	Main Building
Location:	Roof exterior
Finding:	Roof tiles - Weathered
Information:	Upon inspection of the exterior roofing, the majority of roof tiles were considered to be in a fair condition. While weathering of the tiles is consistent with the age of the property, maintenance works are required.

Isolated areas of mortar have come loose in the valleys and minor cracking is also present. Re-pointing and re-sealing the may be considered as an interim solution by the client to help preserve and extend the life span of the tiles.

Where left unmanaged, deteriorating roof tiles are likely to lead to a number of secondary defects, including minor water leaks and weather exposure to internal roofing structures.

Consultation with a roofing contractor is highly advised to gain advice on cost of remedial works that may be required in the short to medium term. Remedial works are likely to increase the longevity of the exterior roofing structure.
