Building and Timber Pest Inspection Report

Inspection Date: Thu, 5 Feb 2026

Property Address: 159 Leicester St, Fitzroy VIC 3065, Australia

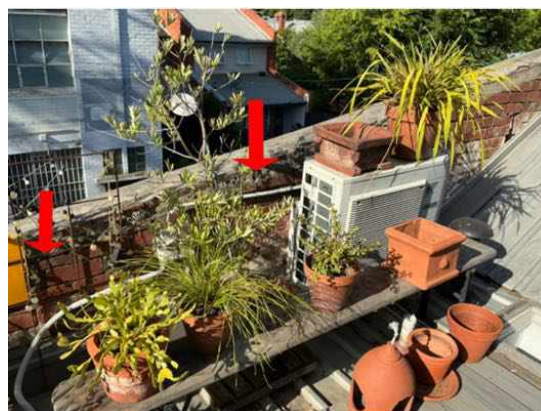
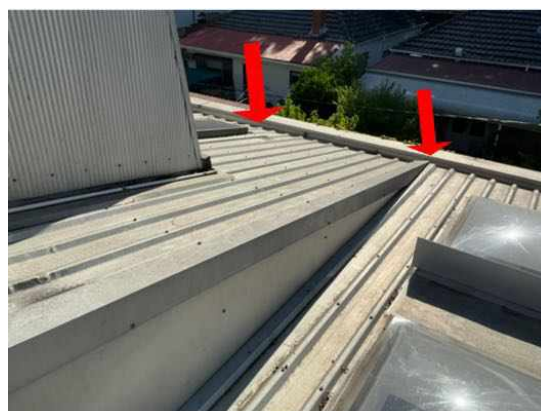
Building: Main Building
 Location: Study/Outside
 Finding: Fall Hazard/ Study/ Outside
 Information: During the inspection, it was observed that guardrails are installed on the perimeter of the building. This poses a significant risk of individuals falling from a height exceeding three metres.

The construction of the guardrails must be carried out by a Registered Builder or Carpenter.

It is strongly recommended that this matter be addressed as expeditiously as possible.

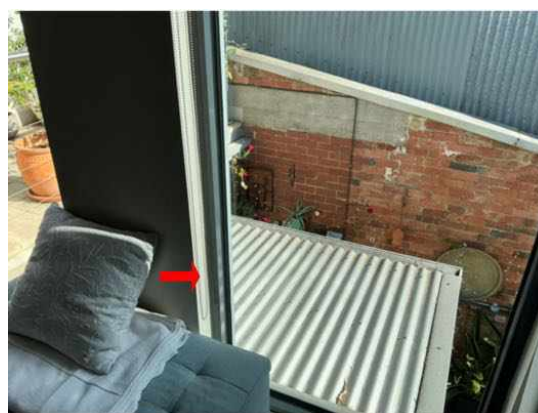
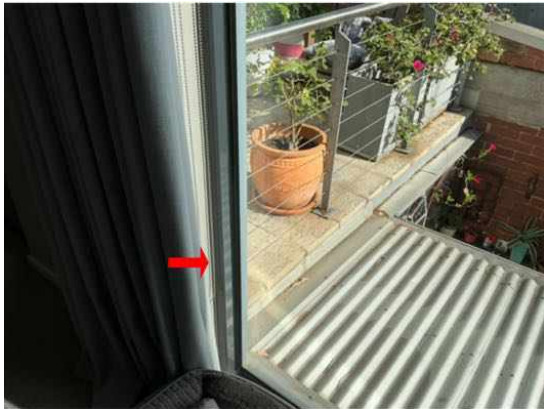
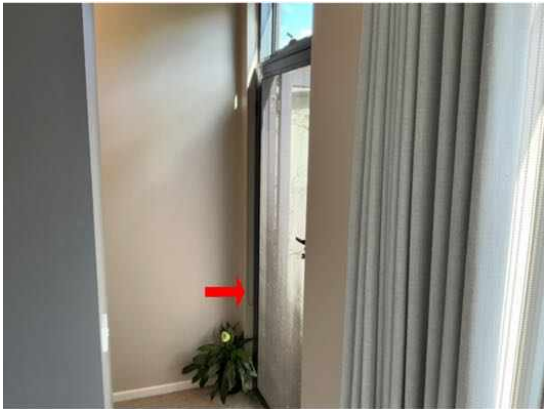
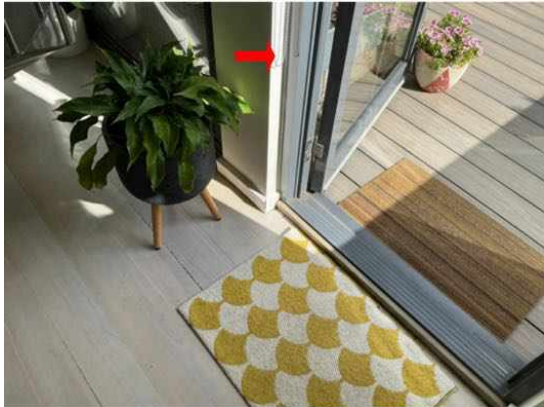
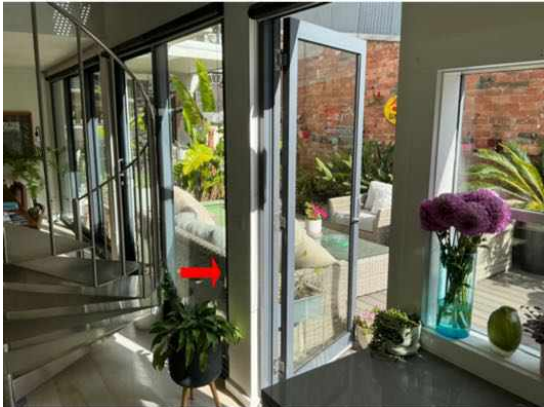
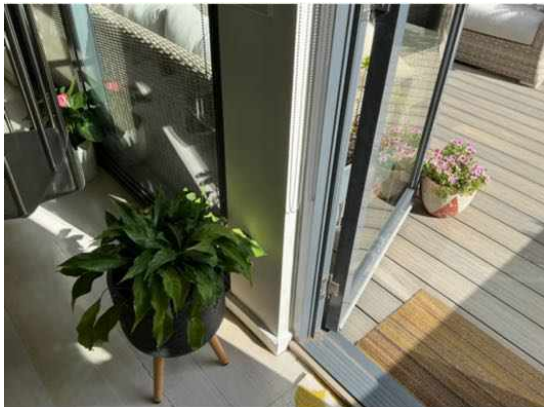
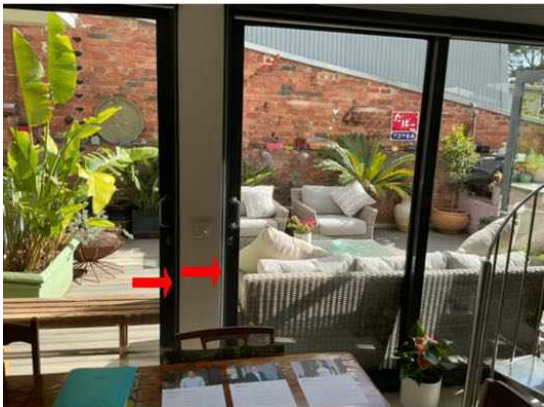
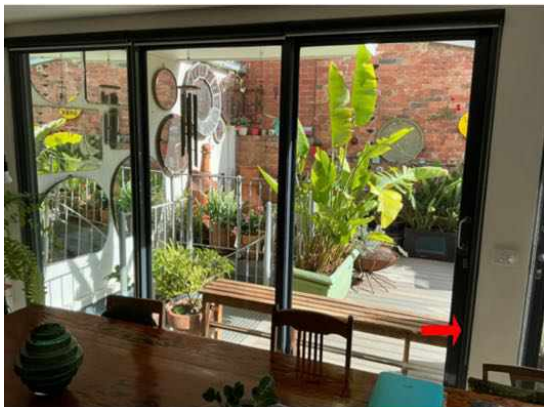
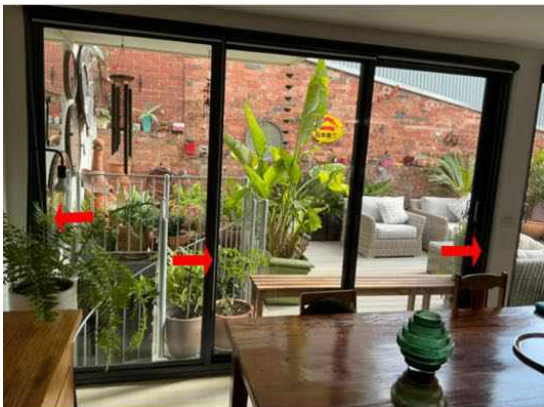
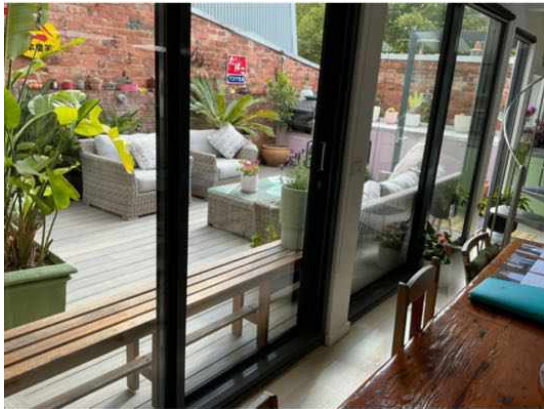
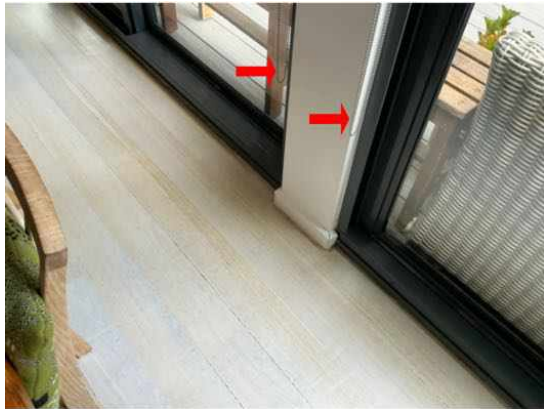
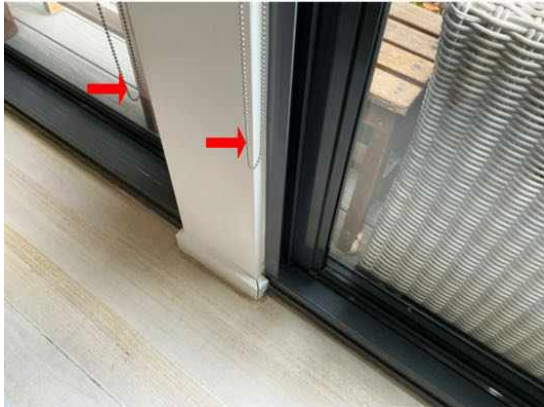
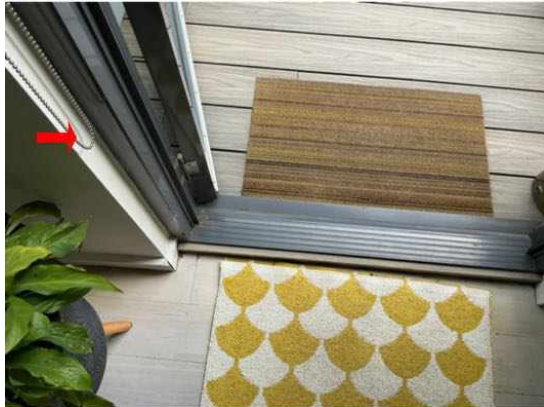
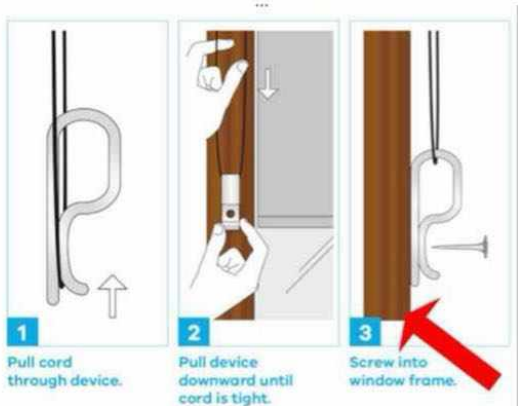
Finding 1.02

Building: Main Building
 Location: All Areas

Information: Looped curtain and blind cords pose a significant strangulation hazard for children as they can place the loop over their head and/or get tangled in the loose cords.

Check all the rooms in your house for any blinds or curtains with long cords that are either loose or looped. This includes any cords that are within children's reach at floor level or near furniture they can climb on.

Secure any loose or looped cords with cleats or tension devices – these can be purchased from your local curtain and blind retailer or hardware store. Do not put furniture such as cots, beds, highchairs, playpens, couches, chairs, tables or bookshelves near a window where children can reach the blind or curtain cord.

It is recommended that this defect be resolved immediately to avoid harm to occupants.

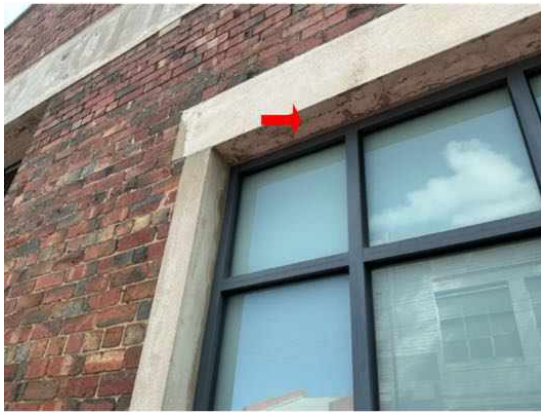
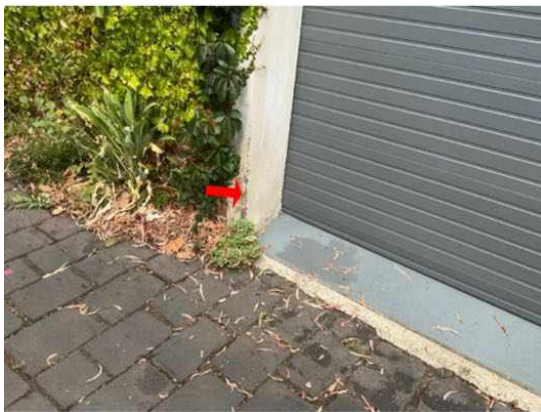
Building: Main Building
Location: All Areas
Finding: Cracks to external render - Category 1

Information: It has been observed that cracking to the external rendered surfaces has occurred. The degree of damage falls within Category 1, described as fine cracks that do not need repair and which are less than 1.0mm in width limit.

Although fine cracks are quite noticeable, they are often only considered to be an appearance defect, and usually do not indicate any structural damage. Generally, the cause of a fine crack is indicative of a separation between building materials and finishes (e.g. paint, plaster, render etc.) along joins.

Cracking of this nature can generally be repaired with filling or rendering. Such works should be performed by a qualified Renderer or a general Handyman.

Monitoring of all cracking should be conducted frequently. Always contact a Building Inspector should cracks widen, lengthen, or become more numerous.

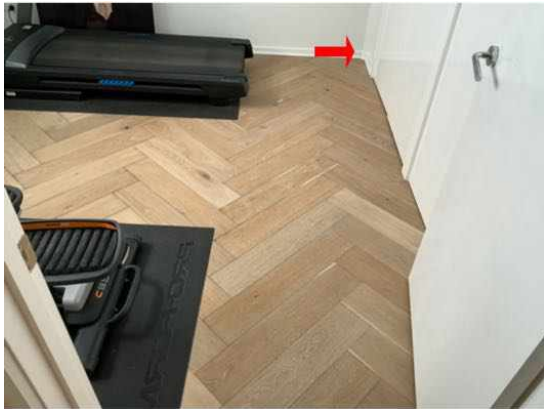
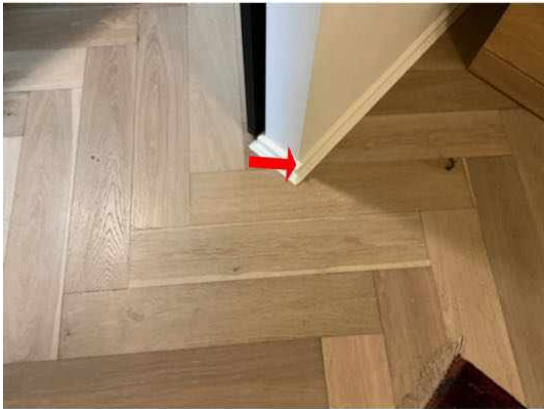
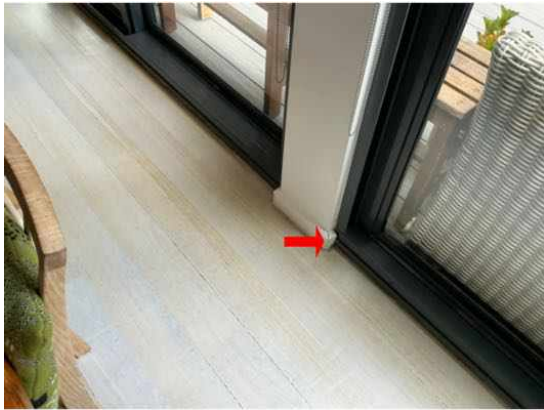
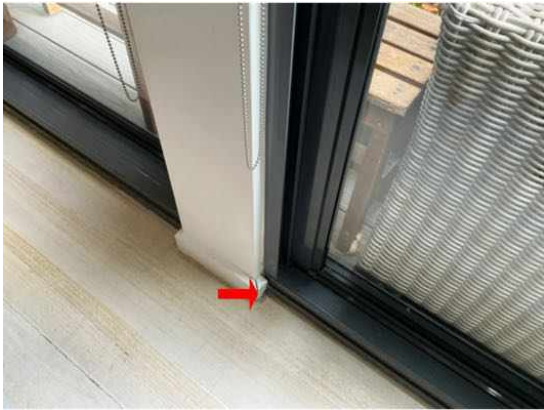
Finding 3.02

Building:	Main Building
Location:	All Areas
Finding:	Cracking - Damage Category 1 - Fine (up to 1mm)
Information:	Although fine cracks are quite noticeable, they are often only considered to be an appearance defect, and usually do not indicate any structural damage. Generally, the cause of a fine crack is indicative of a separation between building materials and finishes (e.g. paint, plaster, etc.) along joins.

In this instance client have indicate that these cracks become visible after roof leaks. However the leaks have been repaired, and hence no change in terms of sizes.

Cracking of this nature can generally be repaired with minor sanding, filling and/or repainting. Such works should be performed by a qualified Painter or a general Handyman.

Monitoring of all cracking should be conducted frequently. Always contact a Building Inspector should cracks widen, lengthen, or become more numerous.

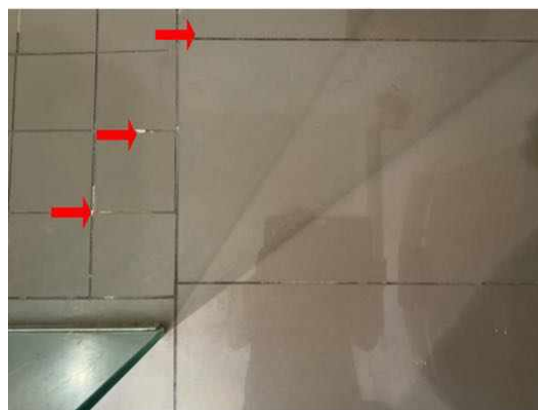
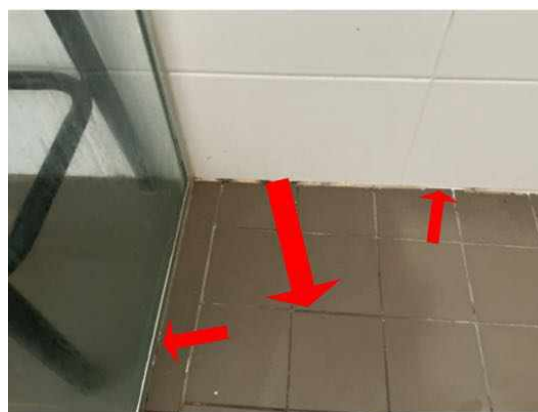
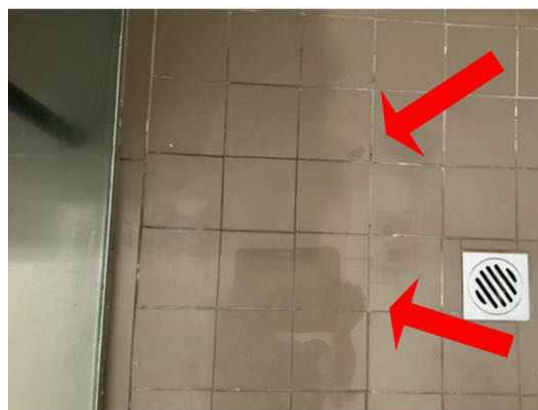
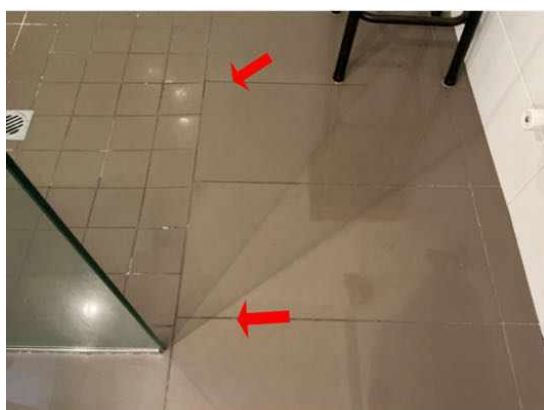
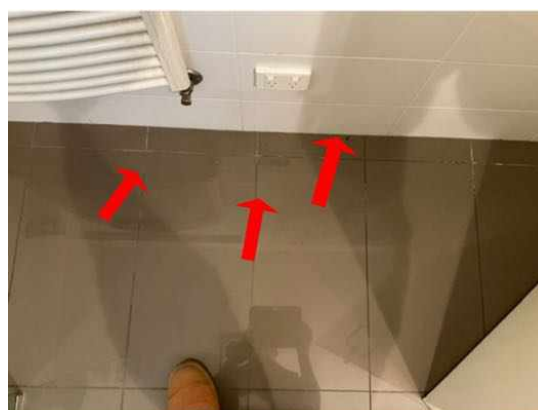
Finding 3.03

Building:	Main Building
Location:	Bathroom 2
Finding:	Sealant and grouting - Missing or damaged
Information:	It was noted on inspection that sealant or grout is degraded to the tiled shower alcove and or other areas of the bathroom . A flexible sealant is required to allow for expected expansion and contraction, while keeping the joint water tight and protective of all associated building materials.

The lack of sealant between tiles can cause water damp to the wall behind it.

Regular maintenance and replacement of damage or missing or damaged sealant and grout is highly recommended to the wet areas, as this is a regular wear and tear defect. Sealant and grouting in areas that come into regular contact with water should be maintained for the long term care of your property.

Consultation with a sealant specialist is advised immediately to perform remedial works as required.

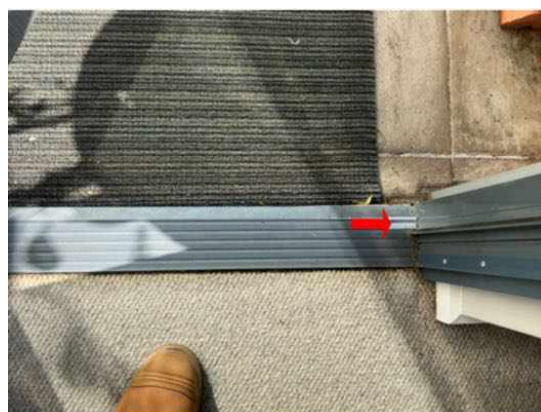
Finding 3.04

Building: Main Building
 Location: Bedroom - Master
 Finding: Door - Binding/jamming
 Information: Binding and/or jamming of this door is evident during standard operation. This defect inhibits the functionality of the affected door as well as creating potential for secondary defects to associated building elements, such as damage to the door frame.

A door that binds to the associated door frame may have several causes, ranging from minor defects, such as poor installation of the door or deteriorated hinges.

A registered Builder specialising in re-stumping should be appointed to provide an

estimate on the cost of rectification.

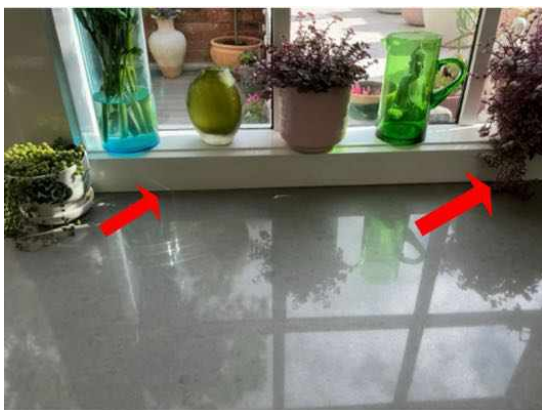
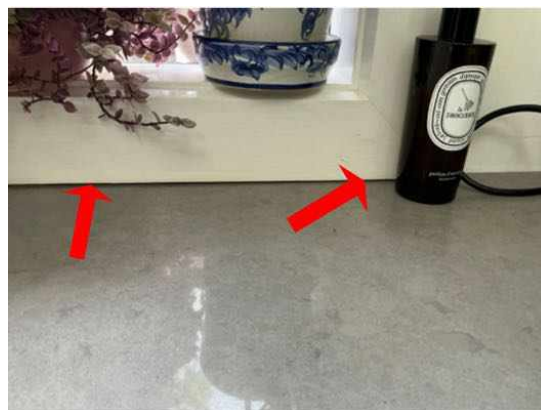
Finding 3.05

Building:	Main Building
Location:	Kitchen
Finding:	Sealant- Missing
Information:	The lack of sealant between wall and bench top can cause water damp to the wall behind it.

Consultation with a sealant specialist is advised immediately to perform remedial works as required.

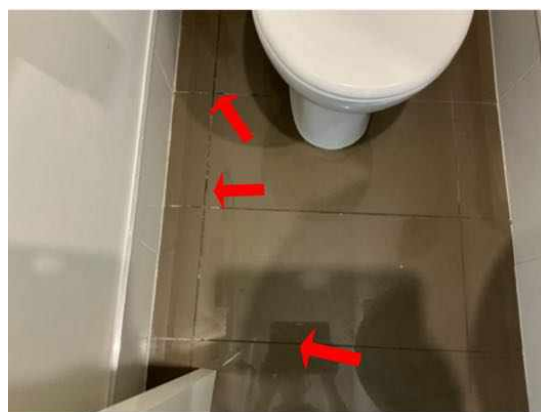
Finding 3.06

Building:	Main Building
Location:	Toilet (WC)
Finding:	Sealant and grouting -WC- Missing or damaged
Information:	During inspection, it was observed that sealant or grout is absent from the water cistern.

To prevent any potential water damage, flexible and mould-resistant materials should be applied to the affected areas. Regular maintenance and replacement of damaged or missing sealant and grout are strongly recommended for wet areas, as this is a common wear-and-tear issue. Sealant and grouting in areas frequently exposed to water should be maintained to ensure the long-term maintenance of your property.

It is advisable to appoint a sealant specialist or tiling contractor to complete these repairs as soon as possible.

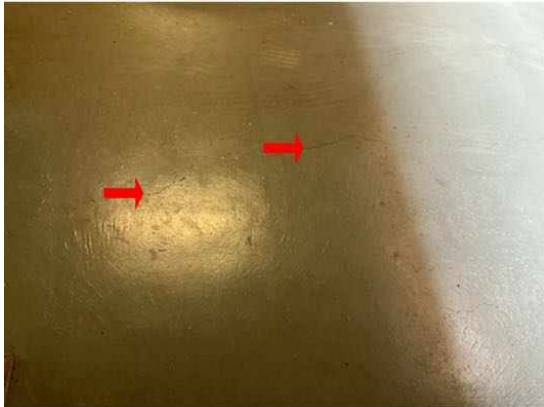
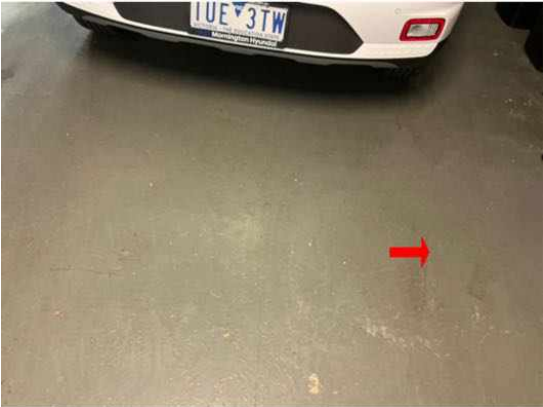
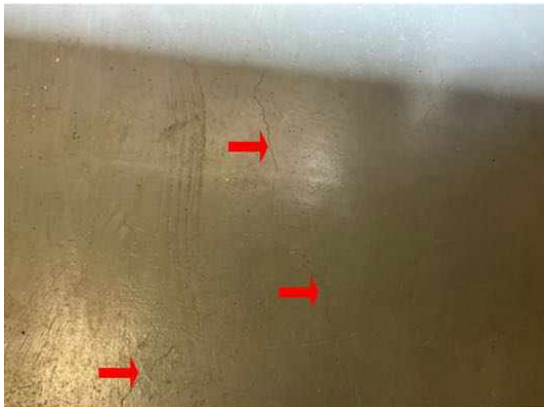
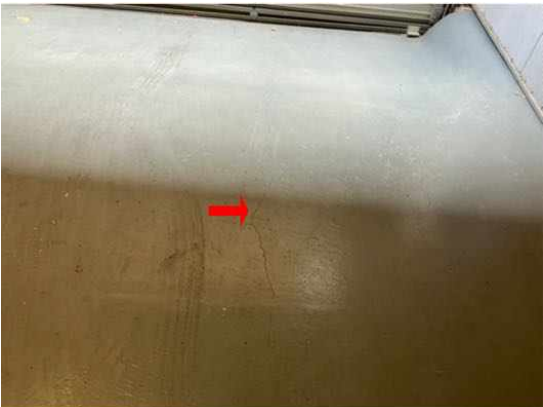
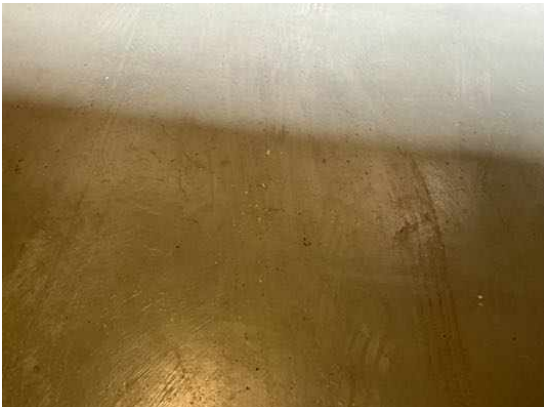
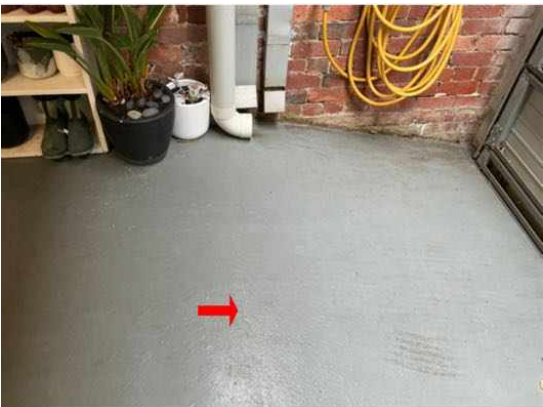
Finding 3.07

Building:	Main Building
Location:	Garage
Finding:	Crack in concrete slab - Category 1
Information:	A crack coded as Category 1 was identified in the slab. A Category 1 crack is

To be considered Category 1, the approximate width of the crack is less than 1.0mm, or a less than 10mm change in offset when a 3m straight edge is placed over the defect.

Category 1 cracks should be monitored for a period of 12 months. At the end of the monitoring period, identified cracks that are rated greater than Category 2 are considered defects, and require rectification.

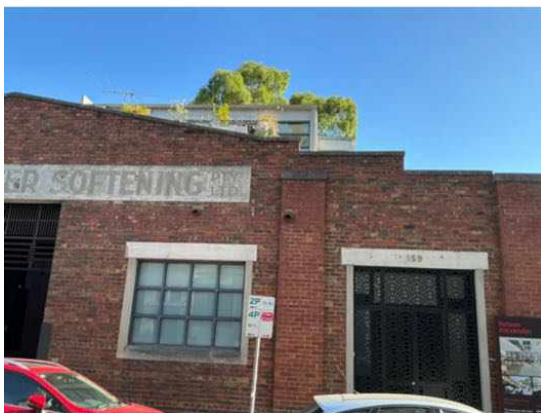
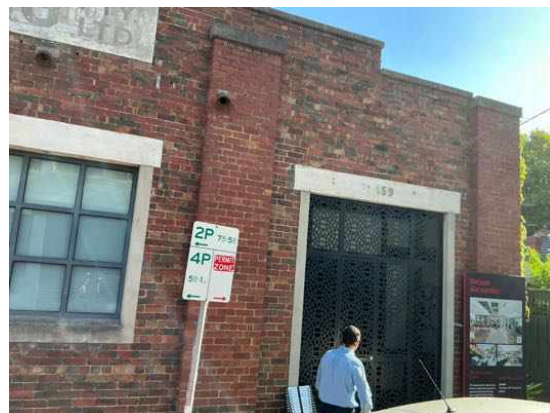
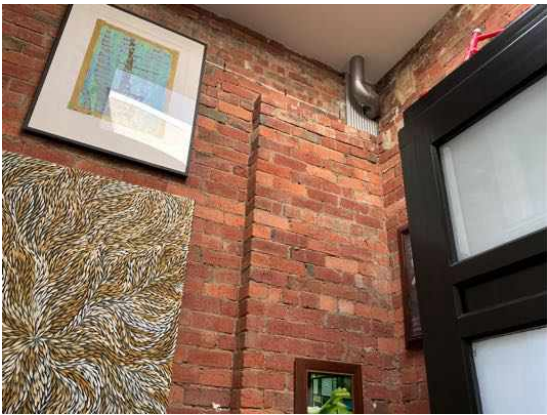
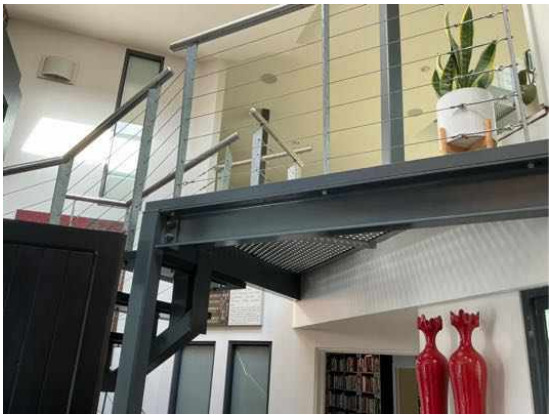
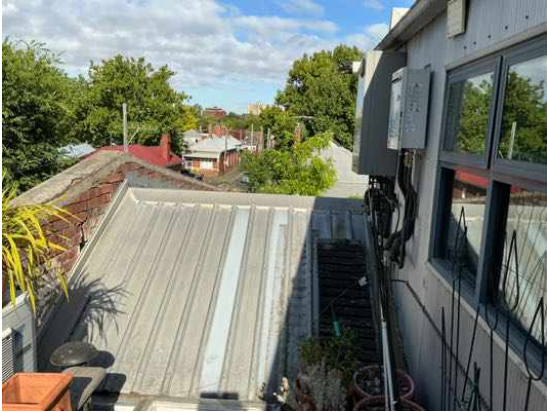
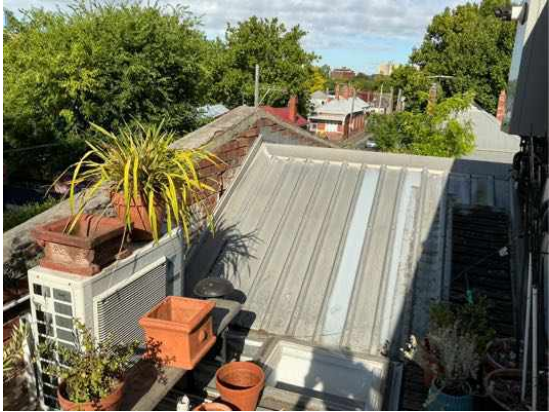
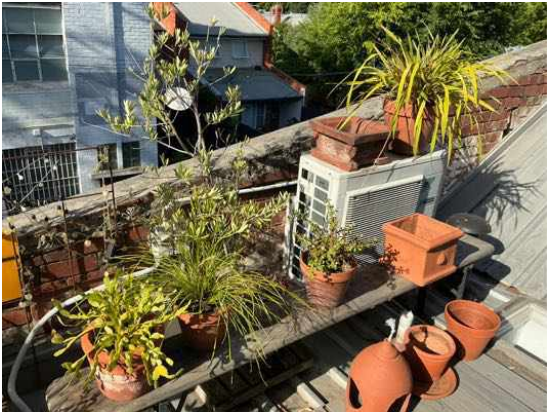
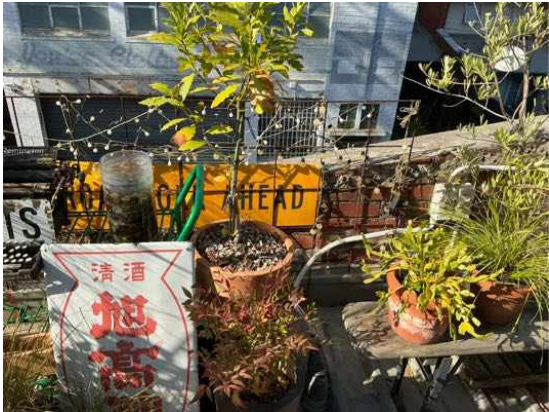
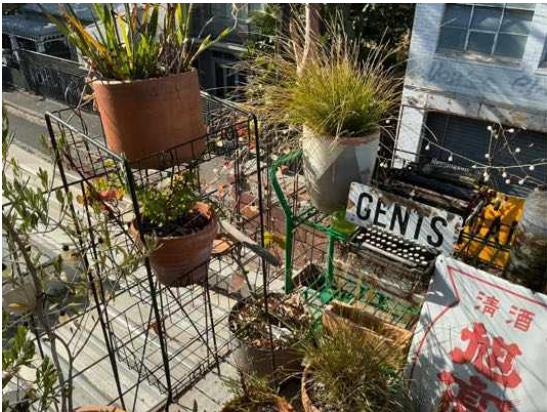
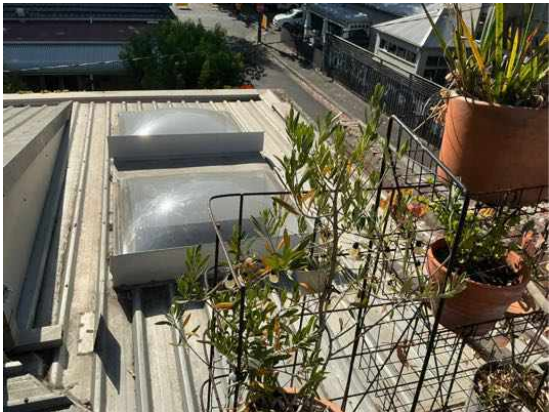
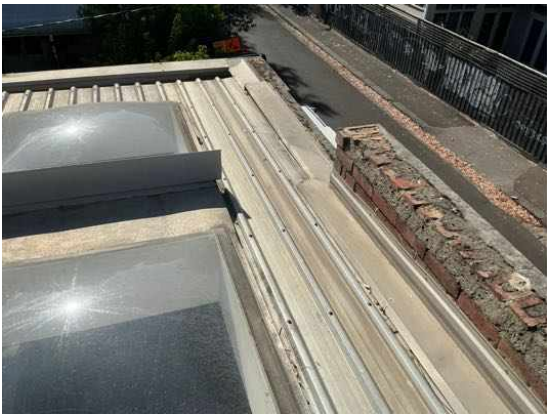
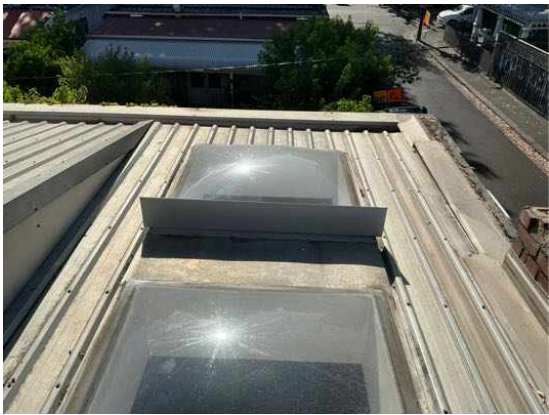
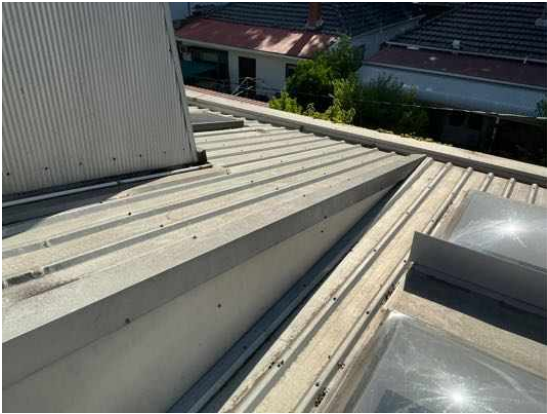
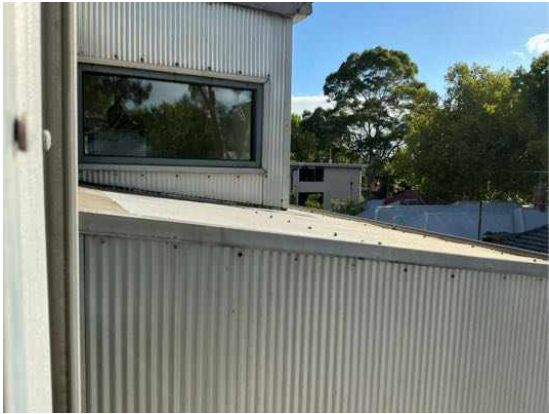
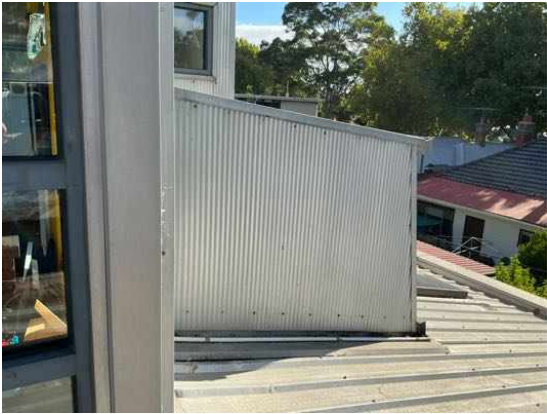
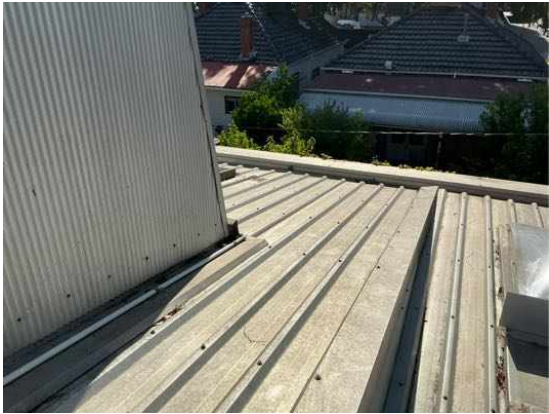
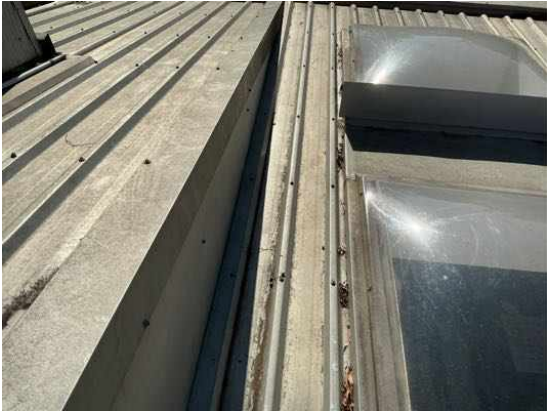
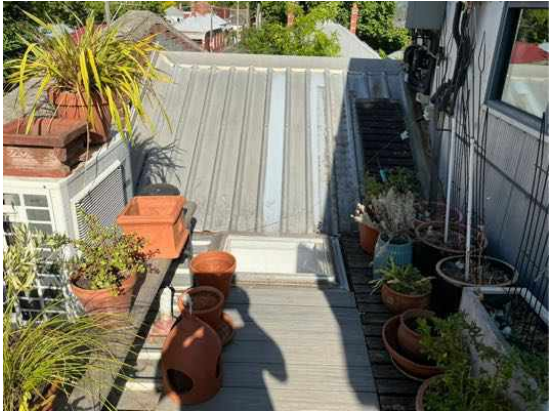
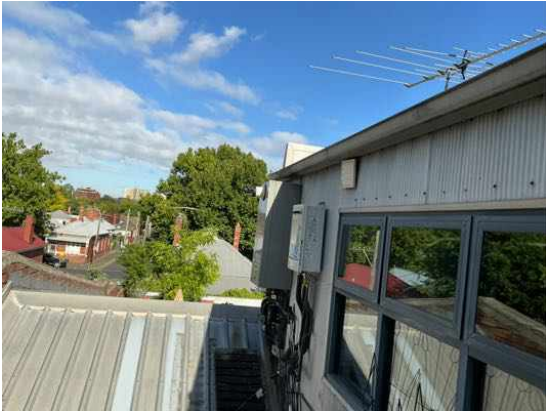
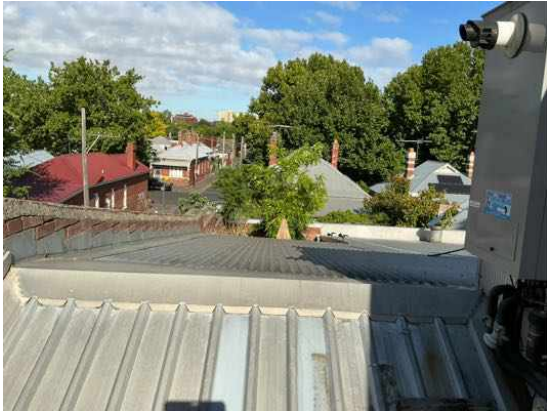
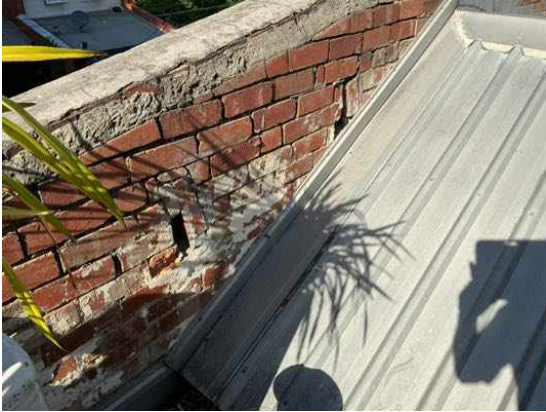
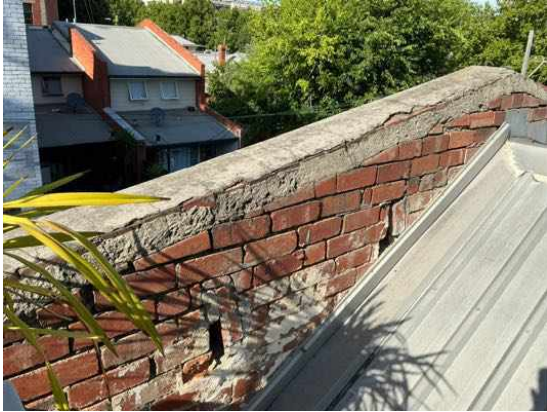
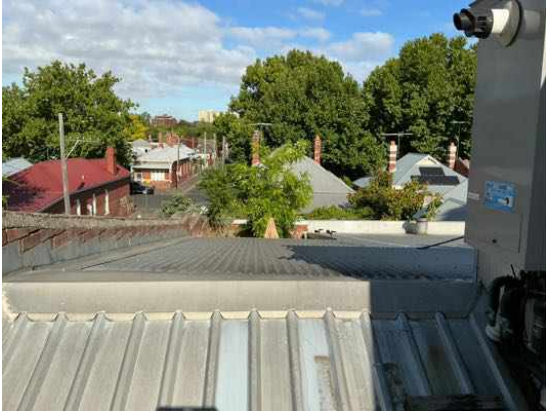
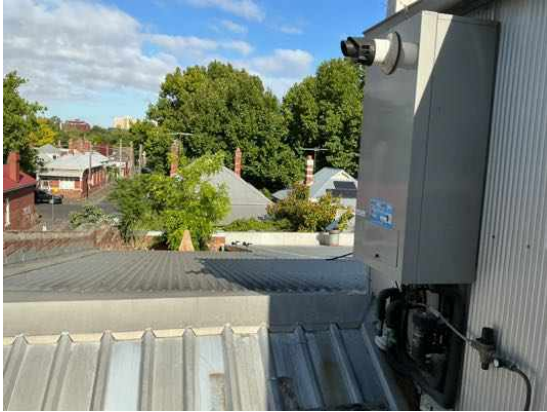
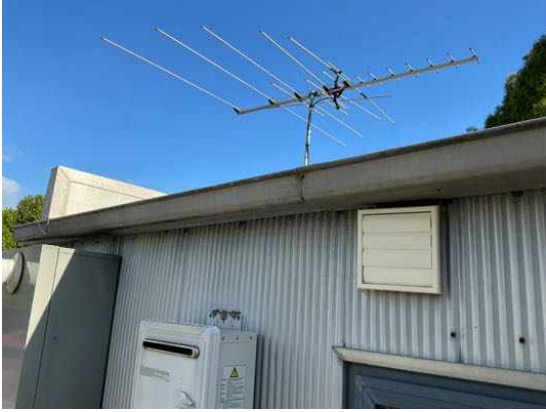
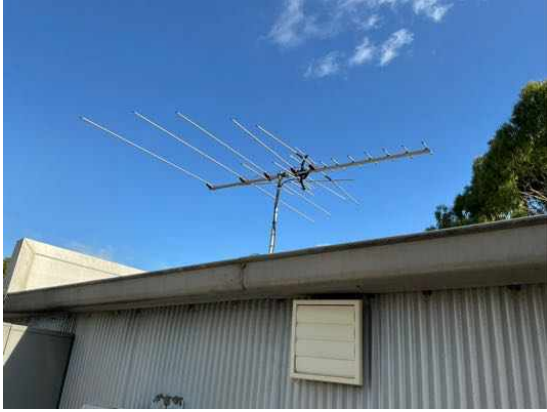
Noted Item

Building:	Main Building
Location:	All Areas
Finding:	Additional Photos - Obstructions and Limitations
Information:	These photographs are an indication of the obstructions and limitations which impeded full inspection of the property at the time of inspection. These obstructions can hide an array of defects and should be removed to allow full inspection to be carried out. A re-inspection is recommended once the areas are made accessible.
