Building and Timber Pest Inspection Report

Inspection Date: Thu, 5 Feb 2026

Property Address: 159 Leicester St, Fitzroy VIC 3065, Australia

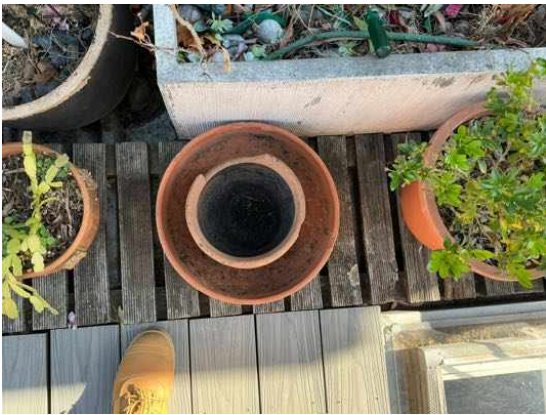
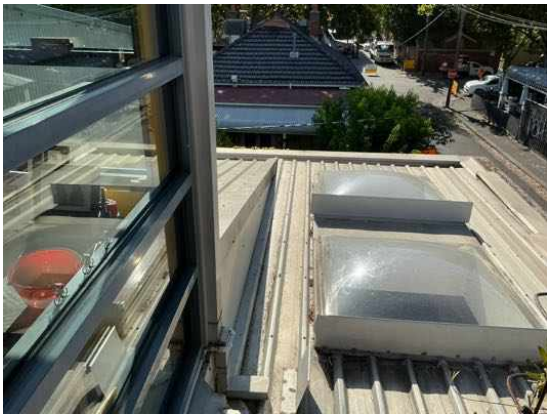
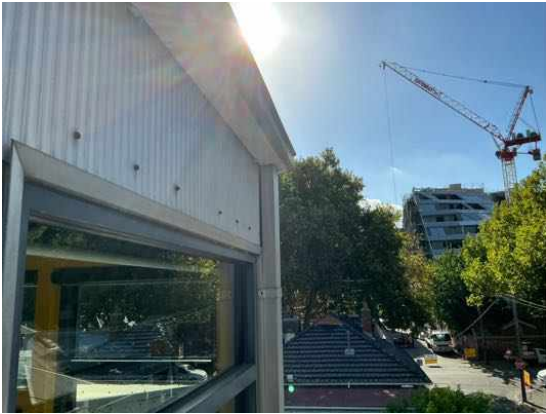
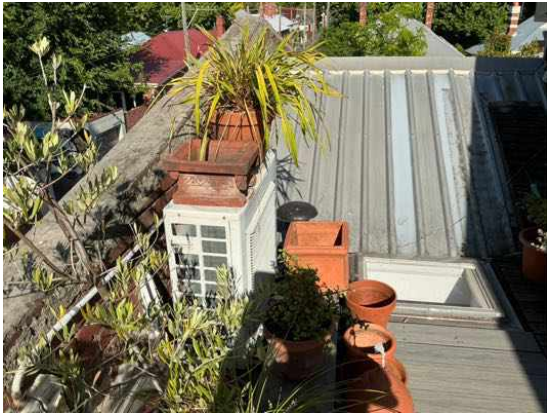
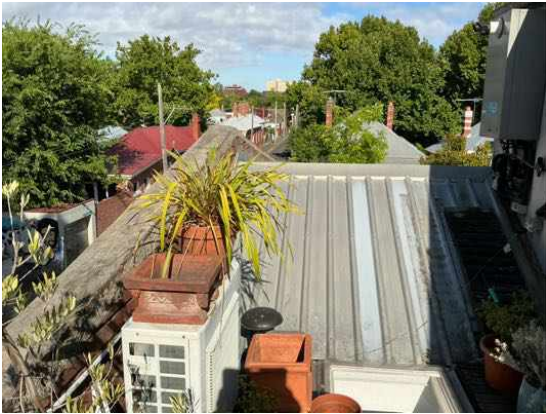
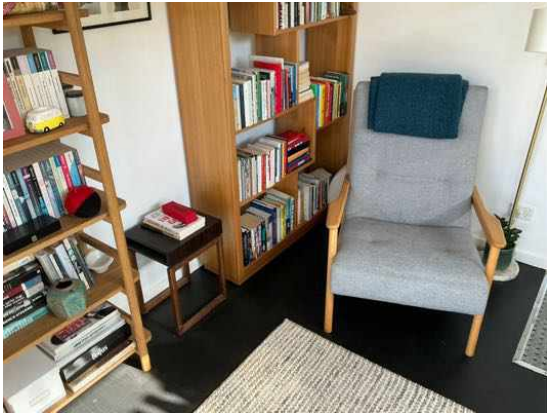
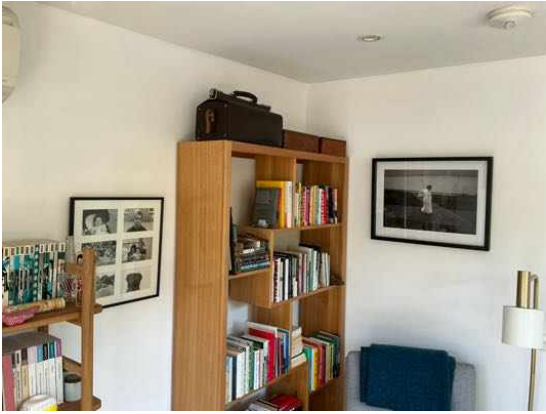
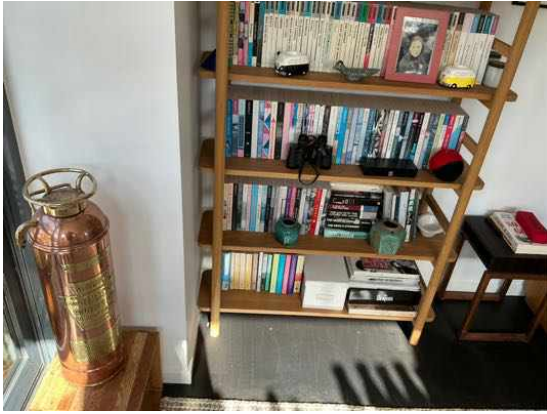
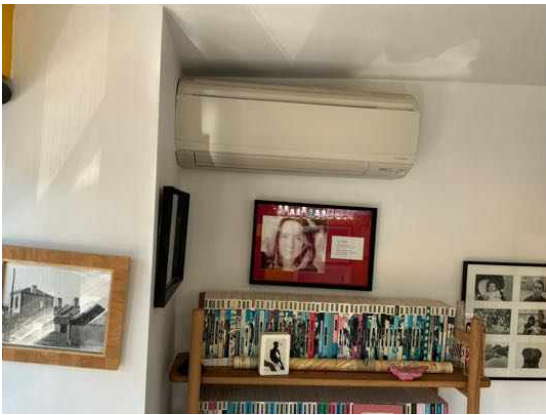
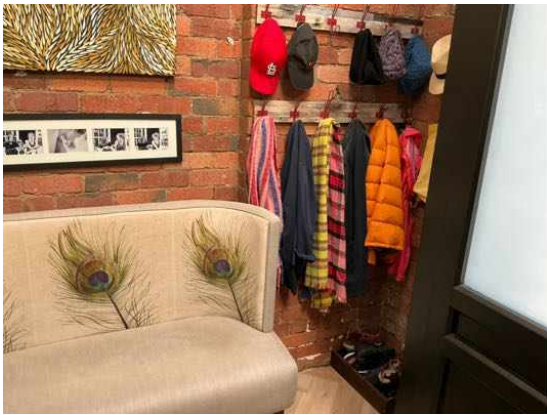
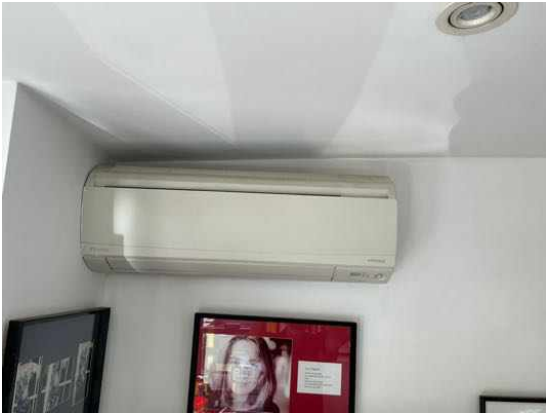
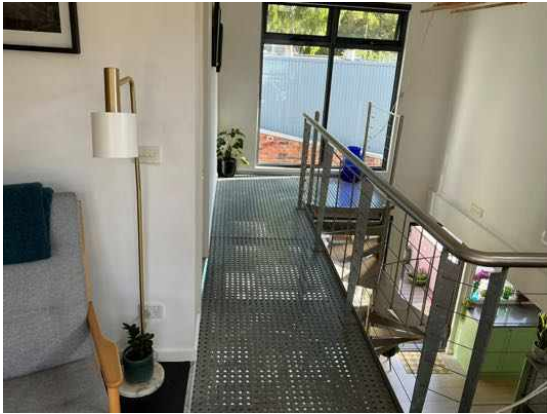
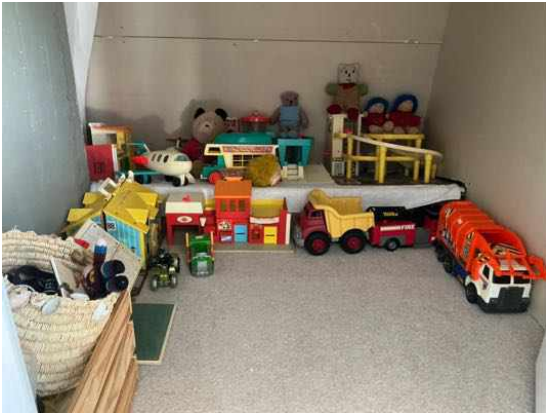
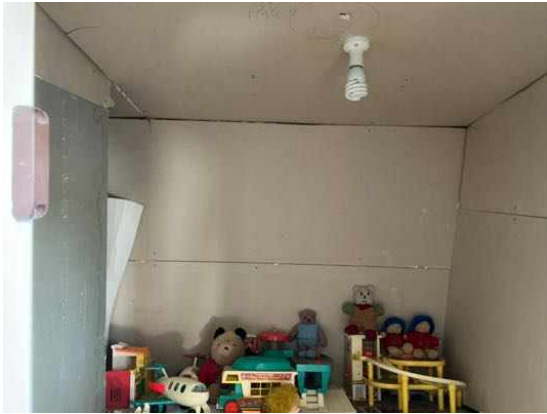
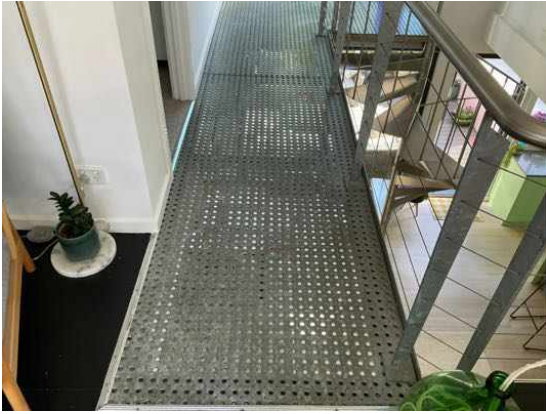
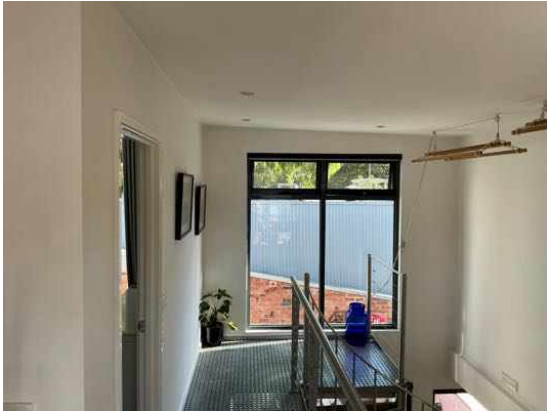
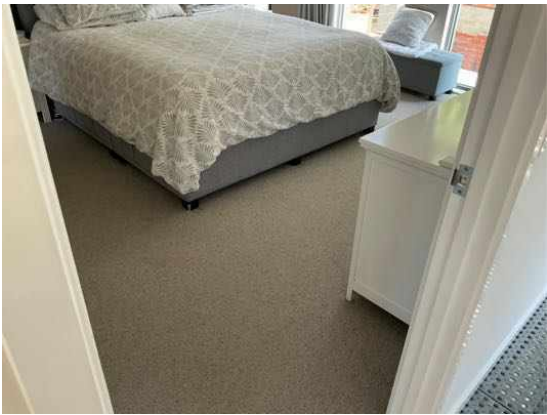
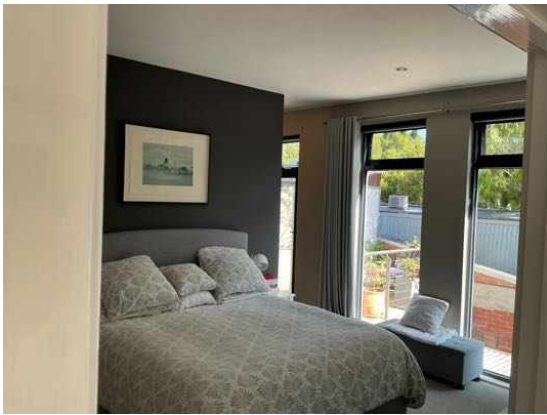
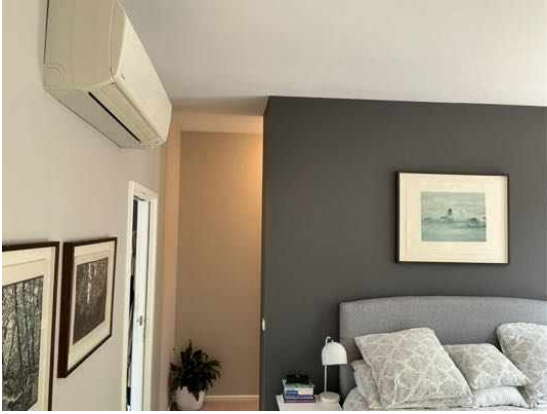
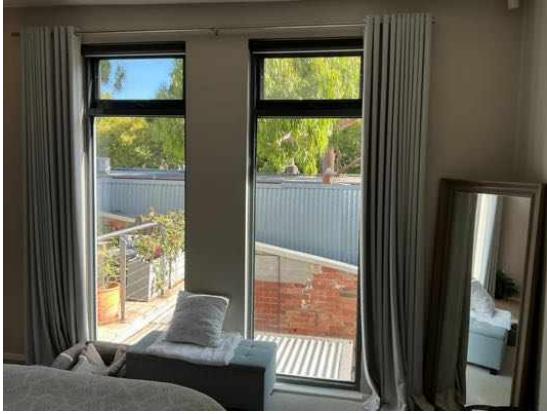
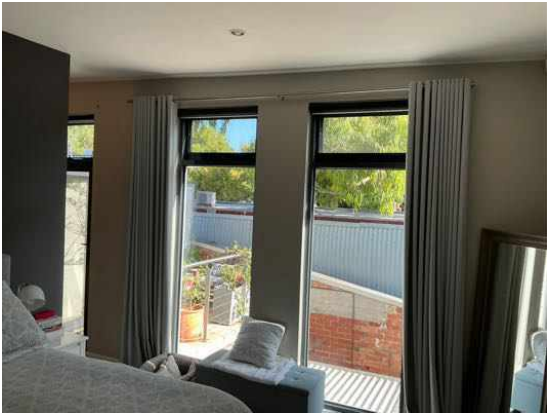
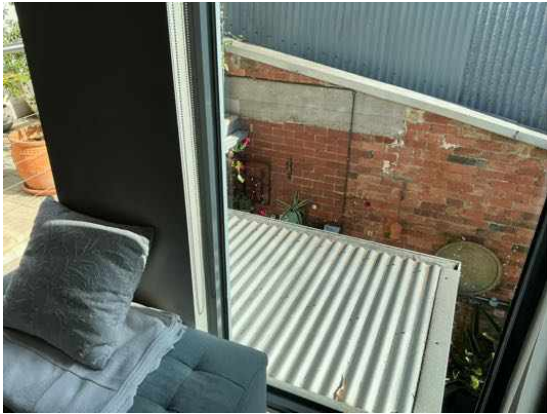
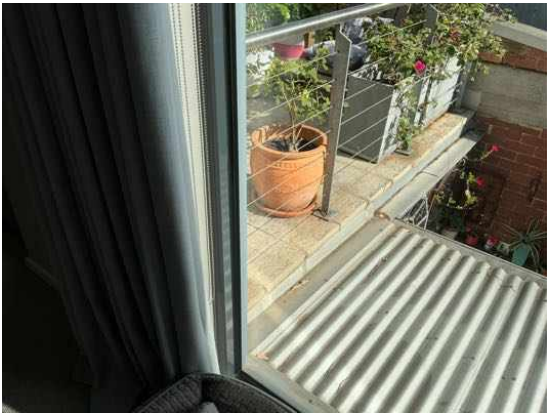
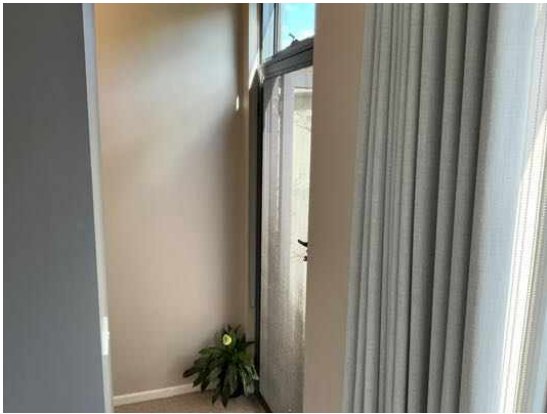
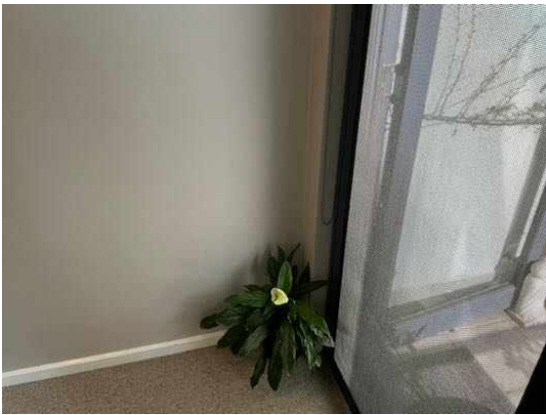
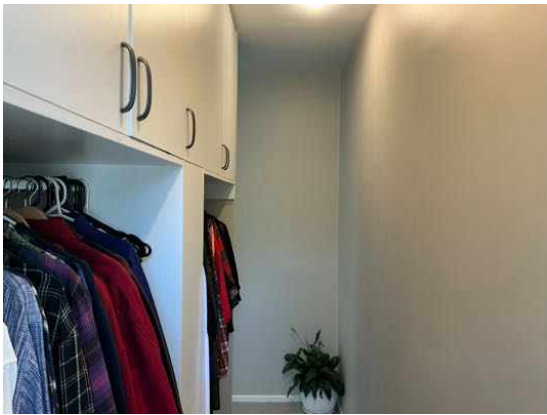
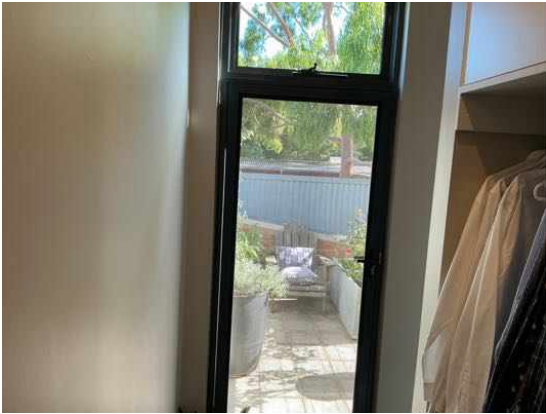
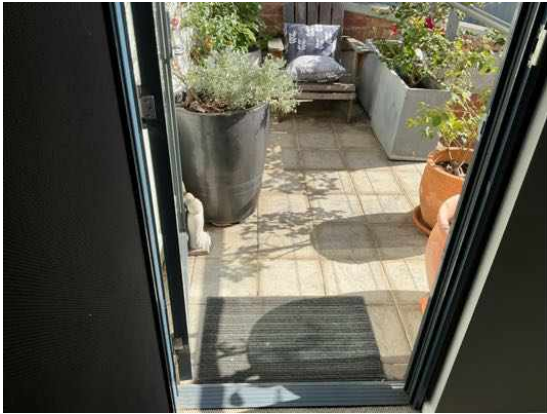
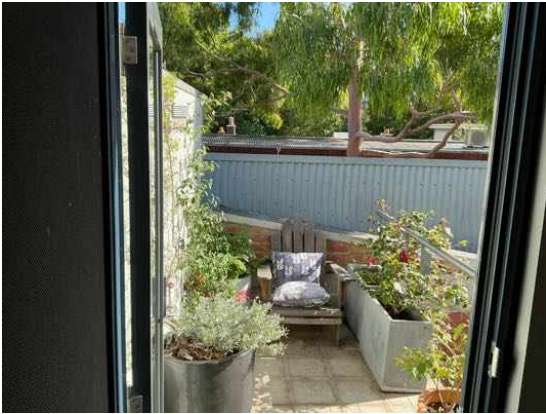
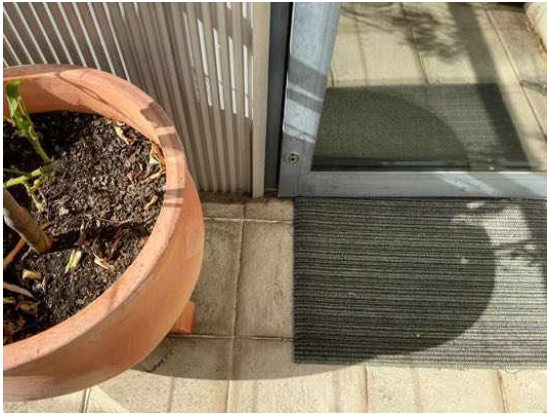
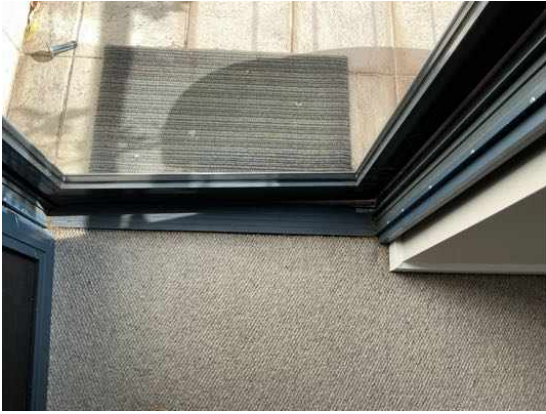
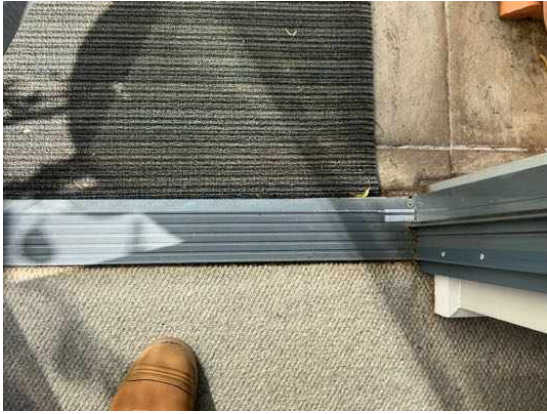
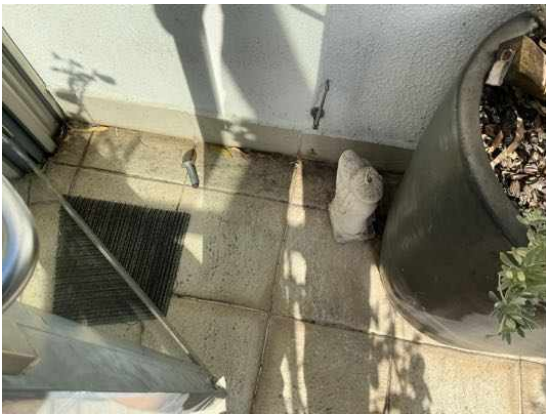
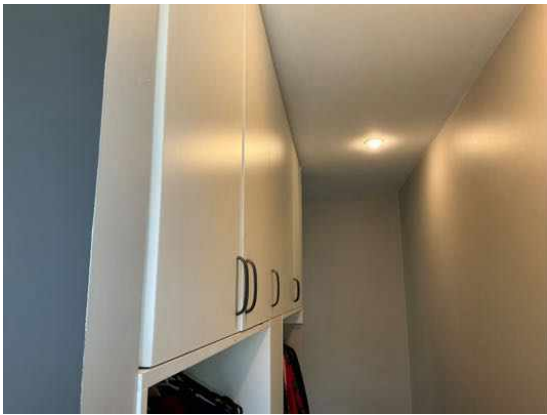
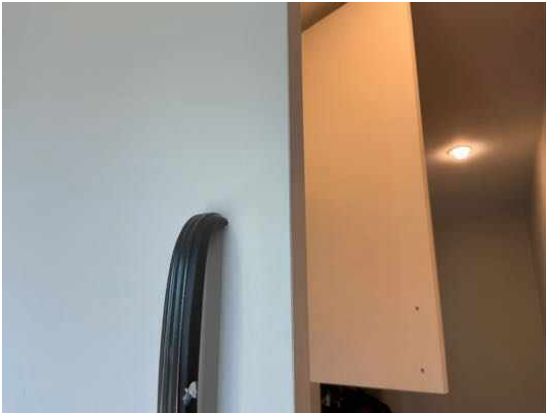
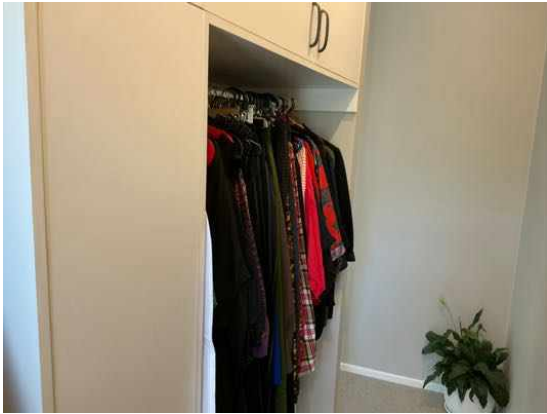
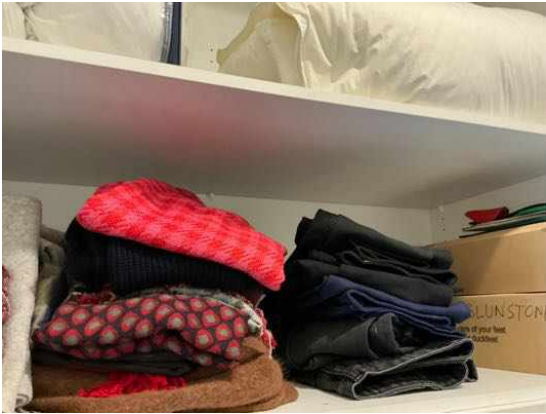
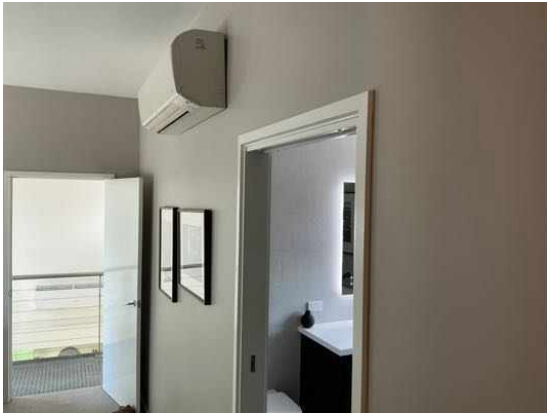
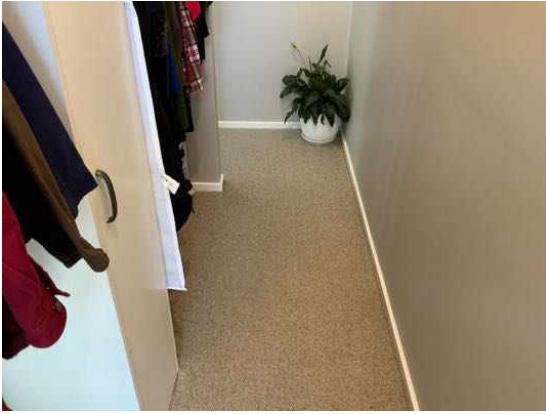
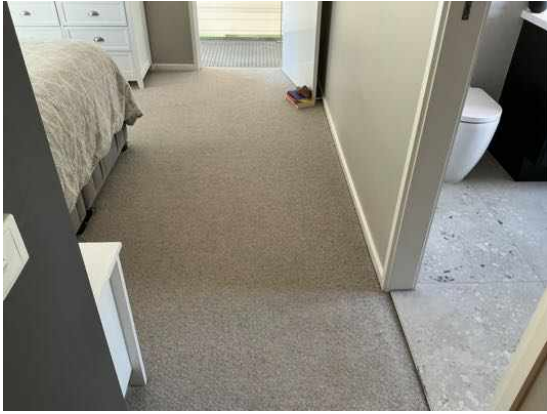
Building:	Main Building
Location:	All Areas
Finding:	Additional Photos - Obstructions and Limitations
Information:	These photographs are an indication of the obstructions and limitations which impeded full inspection of the property at the time of inspection. These obstructions can hide an array of defects and should be removed to allow full inspection to be carried out. A re-inspection is recommended once the areas are made accessible.

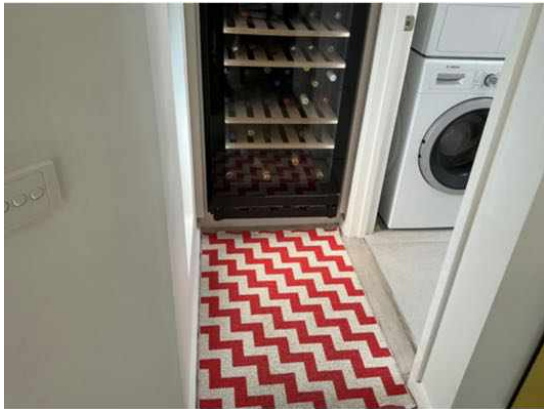
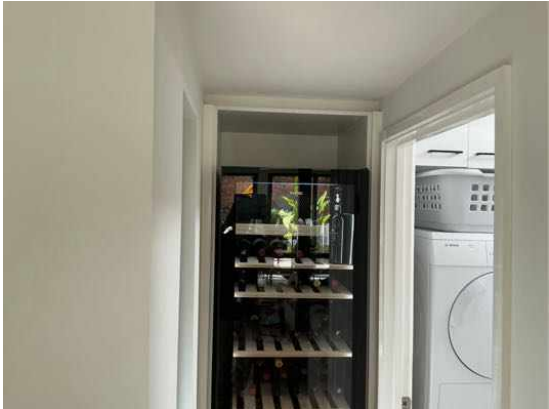
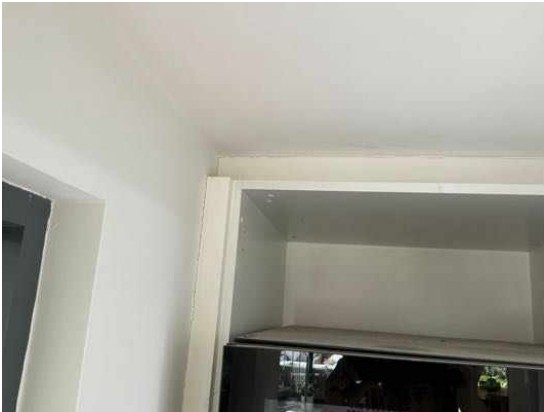
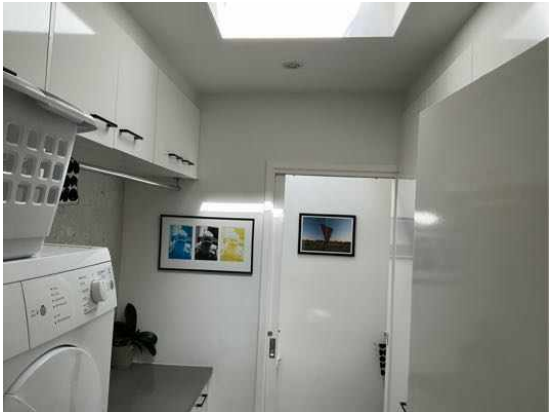
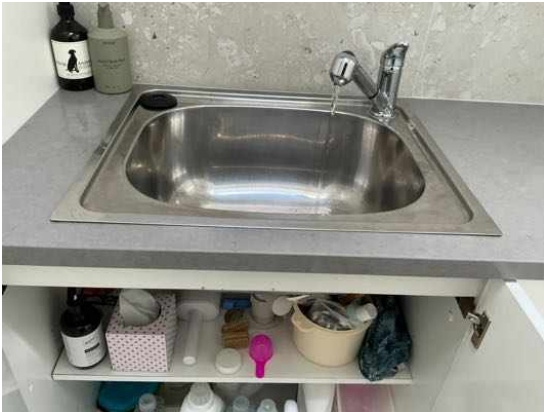
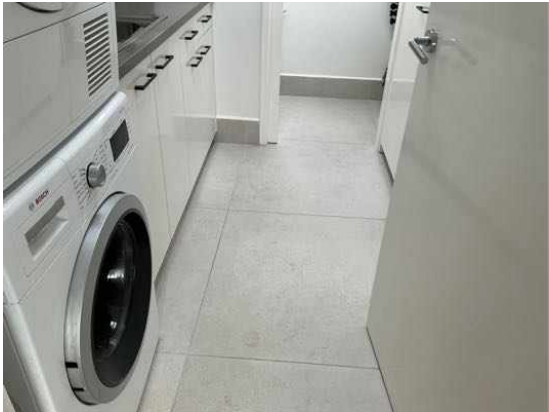
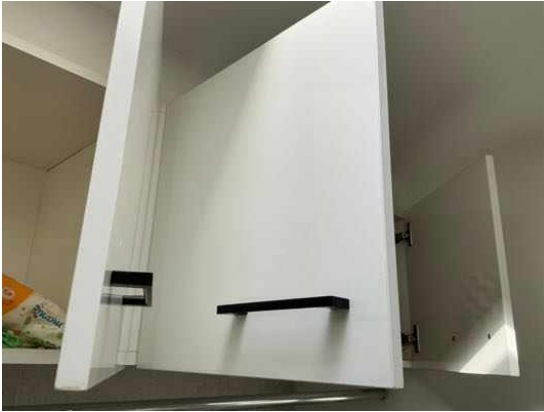
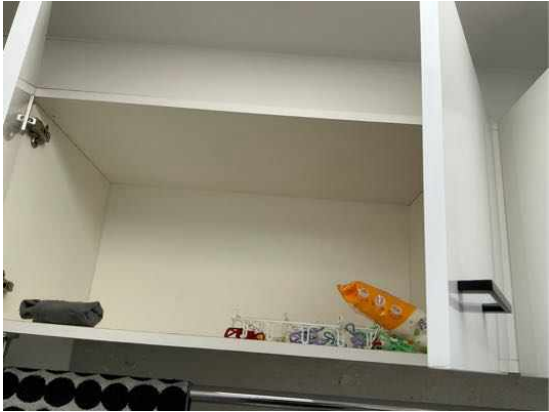
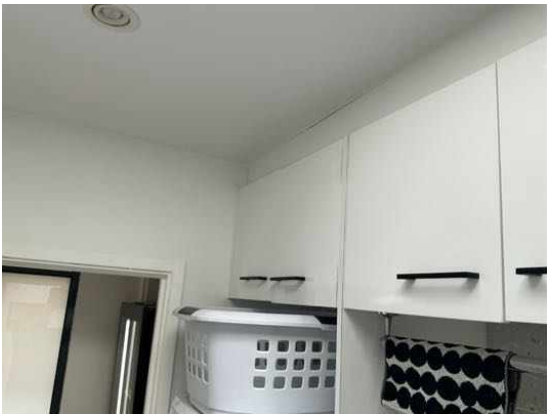
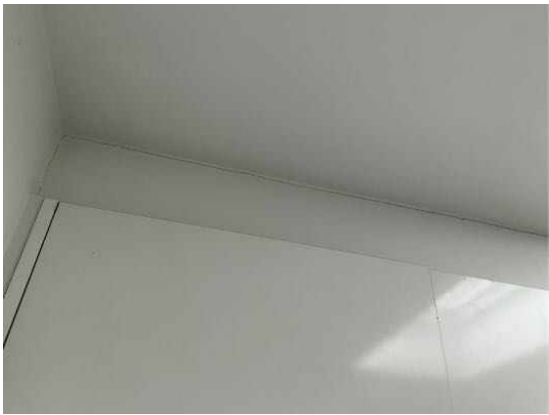
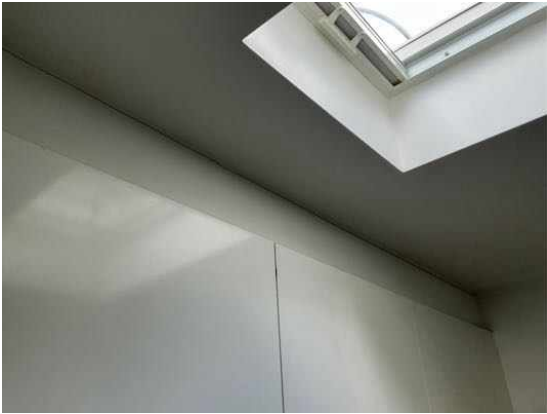
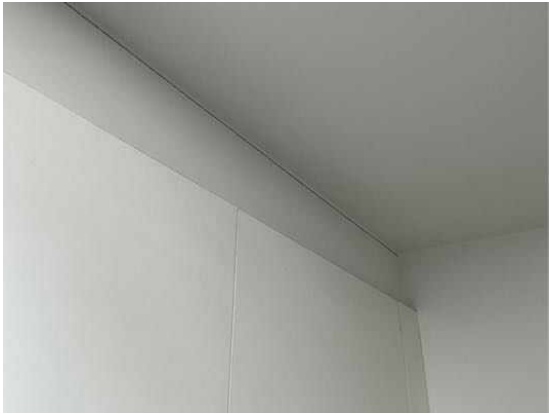
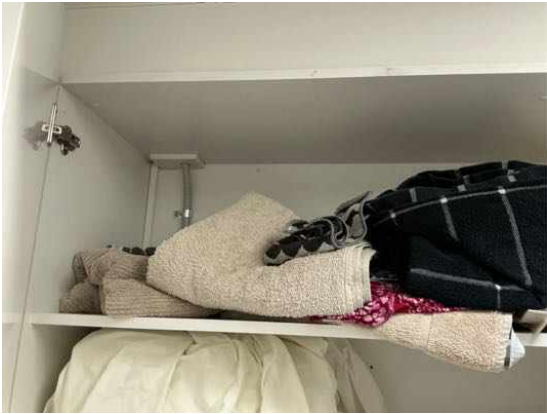
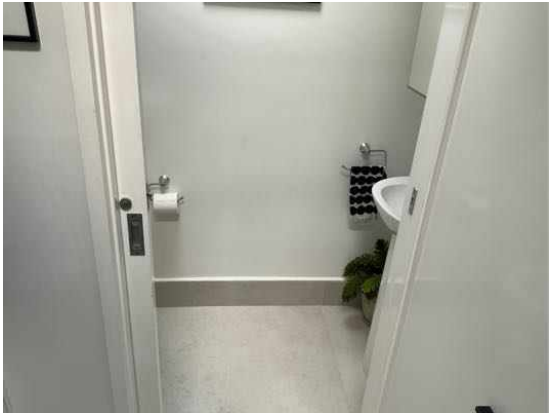
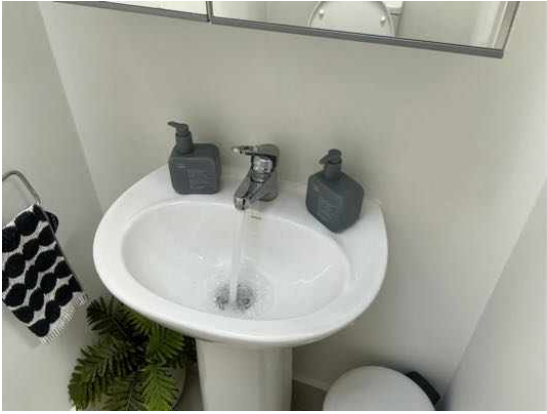
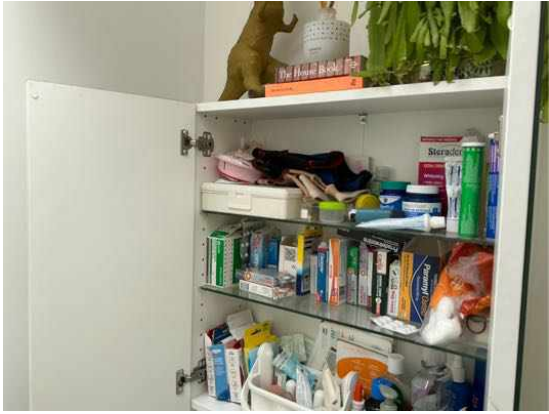
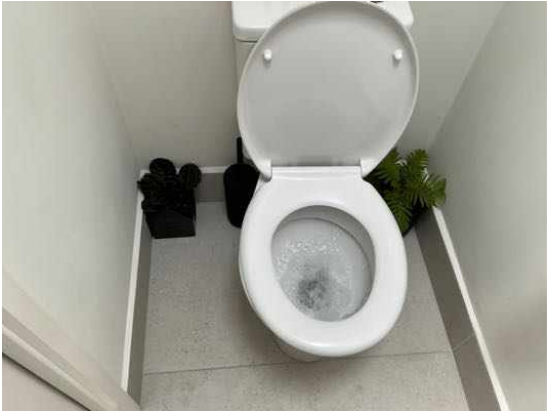
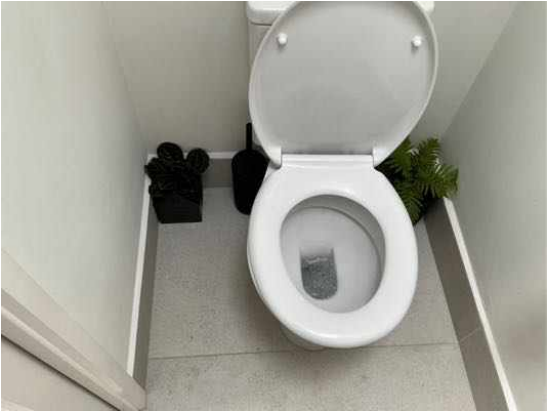
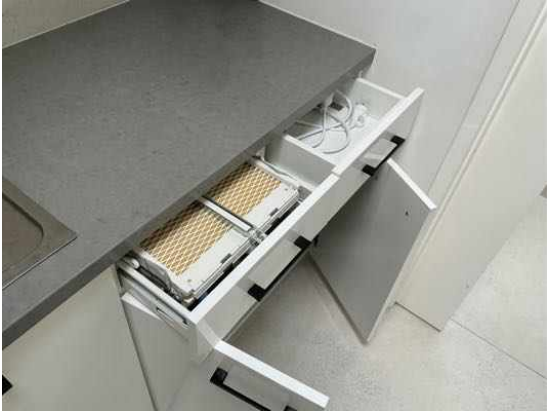
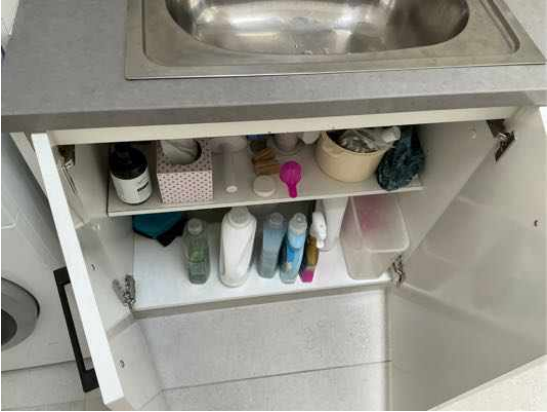
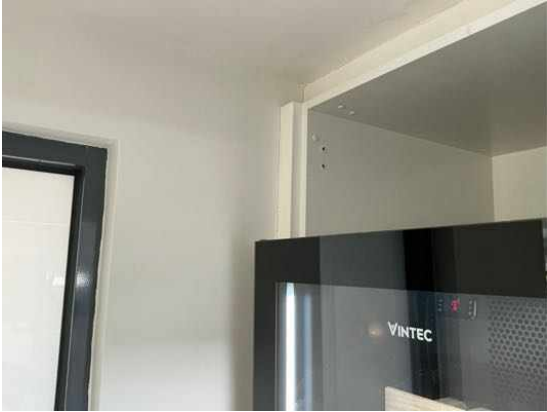
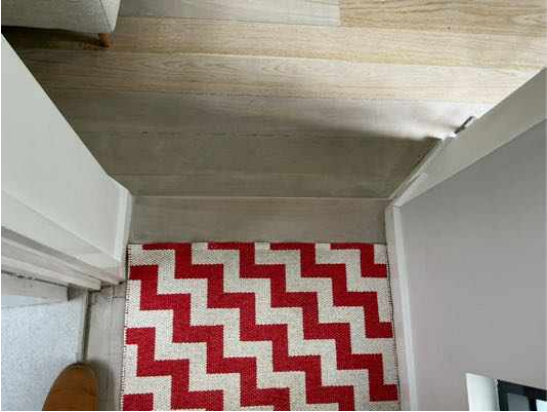
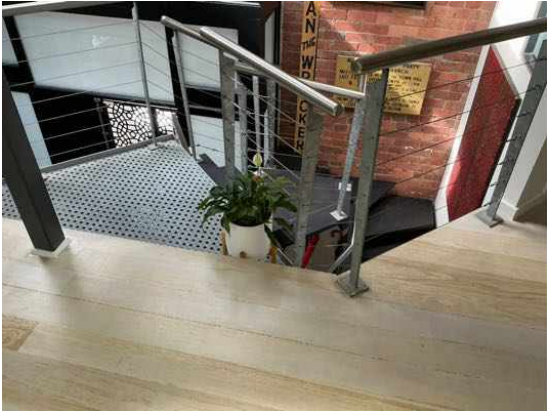
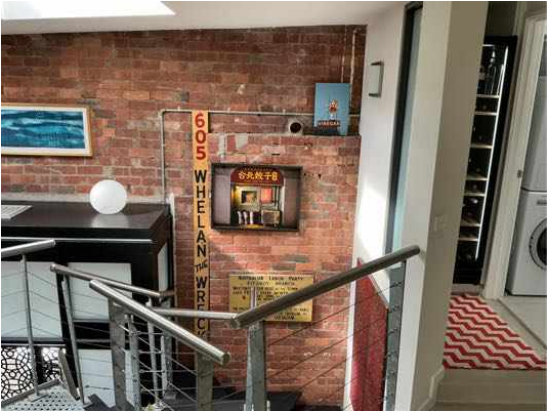
Building:	Main Building
Location:	All Areas
Finding:	Additional Photos - Obstructions and Limitations
Information:	These photographs are an indication of the obstructions and limitations which impeded full inspection of the property at the time of inspection. These obstructions can hide an array of defects and should be removed to allow full inspection to be carried out. A re-inspection is recommended once the areas are made accessible.
