Building and Timber Pest Inspection Report

Inspection Date: Mon, 30 Mar 2026

Property Address: 16 Latona St, Pymble NSW 2073, Australia

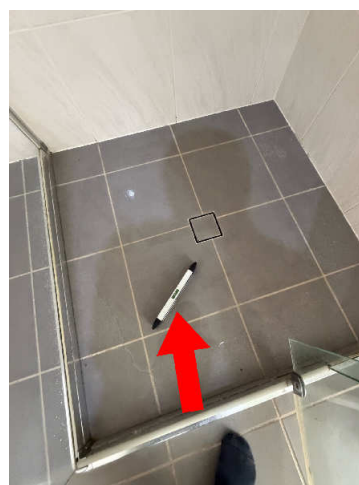
Information: Evidence of water pooling around the floor waste in the shower recess was noticed at the time of inspection. It is suspected that this excessive moisture is attributed to insufficient fall in the shower floor tiles.

Pooling water around floor wastes can create a slip hazard in extreme cases and create conditions that are conducive to mould growth over time. Where left unmanaged, the degradation of sealant and grouting is also likely to occur, possibly necessitating further repair works.

Remedial works may involve some sections of tiling and flooring repair and replacement.

A tiling contractor or bathroom specialist should be appointed to provide further advice on reparation options and to perform works as necessary.

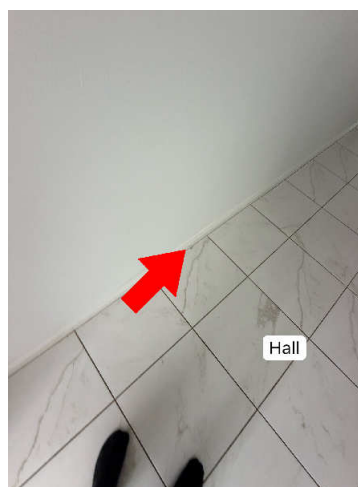
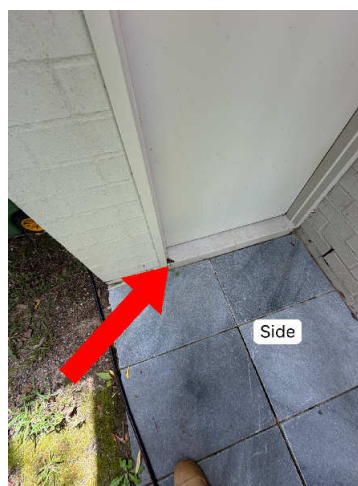
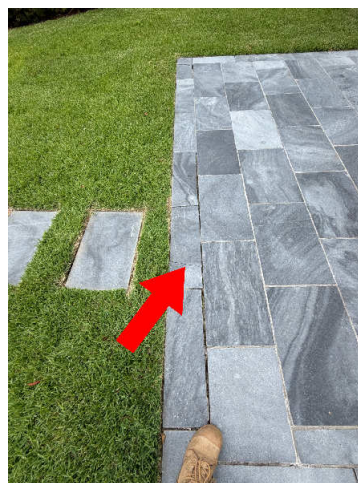
Finding 3.03

Finding: Cracking - Damage Category 2 - Noticeable (up to 5mm)

Information: Noticeable cracks are a common occurrence as a result of many primary defects. Such causes may include age, general wear and tear, expected building movement, general expansion/contraction of building materials in different weather conditions, and/or minor failings in the installation or application of building materials.

Noticeable cracks may result in minor sticking or jamming of associated doors and windows, which require easement. However, noticeable cracks are easily filled and repaired.

A plasterer can be consulted to install an expansion joint at this point to allow for this movement during different weather conditions.

Monitoring of all cracking should be conducted frequently. Always contact a building inspector should cracks widen, lengthen, or become more numerous. Additionally, your building inspector should also be contacted if associated building elements such as doors and windows become more difficult to operate over time.

Relevant tradespeople, such as carpenters, painters and plasterers, should be appointed to perform remedial works, as deemed necessary.

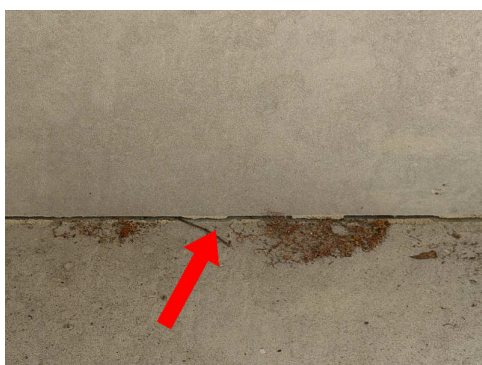
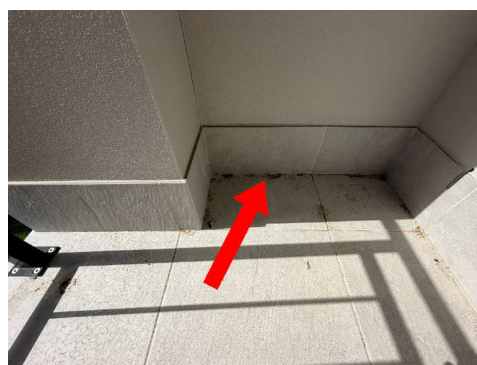
Building:	Main Building
Location:	Balcony
Finding:	Sealant and grouting - Missing or damaged
Information:	It was noted on inspection that sealant or grout is degraded in this area.

Different materials and floor areas move at different rates, generally causing cracking to grout or sealant at this point.

Flexible and mould resistant materials should be applied to affected areas to prevent any subsequent water damage that is likely to occur. Regular maintenance and replacement of damage or missing or damaged sealant and grout is highly recommended to the wet areas, as this is a regular wear and tear defect.

Sealant and grouting in areas that come into regular contact with water should be maintained for the long term care of your property.

A sealant specialist or tiling contractor should be appointed to complete these works as soon as possible

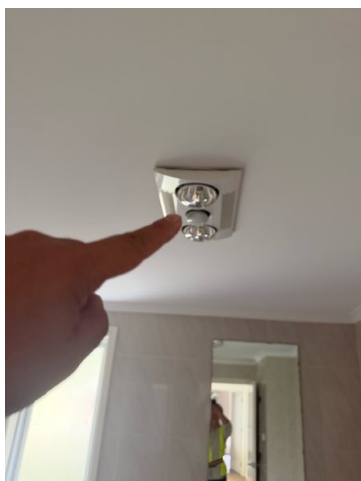
Finding: Bulb - Missing/Not Working

Information: The bulbs in this area were noted not working at the time of the inspection.

Licensed electrician should appointed to replace the bulbs.

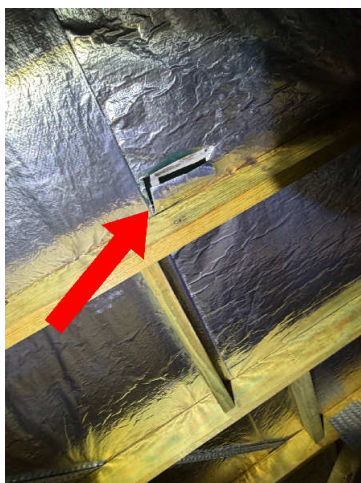
Finding 3.09

Finding: Sarking - Damaged

Where sarking is damaged, both insulation and moisture protection of the property are inhibited.

This creates a loss of energy and thus negatively impacts the energy efficiency of the property, allowing potential for moisture ingress from condensation or leaking roof tiles.

It is important to repair any holes or damaged sections of sarking to ensure that the building material is fully functional. A registered builder or qualified carpenter should be consulted to provide further advice on this defect and to perform rectification works at client discretion.

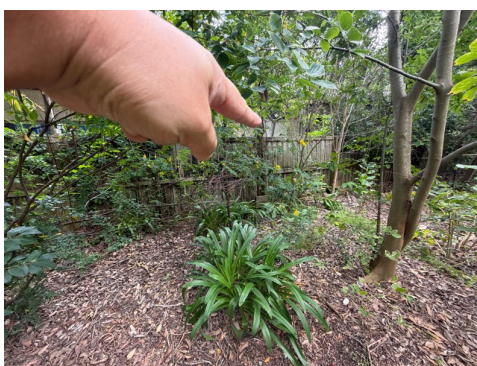
Finding 3.10

Finding: Fencing - Deteriorated

Information: It was noted at the time of inspection that sections of the fencing throughout the property have deteriorated. Typically fencing deteriorates due to age and or wear, rot and or rust which is generally expected for a structure of this age, due to prolonged exposure to weather conditions. Sometimes inadequate installation or maintenance can be to blame.

If left unattended, it is likely that further damage will occur. It is suspected that repair of several elements of the fencing may be required however replacement may be a consideration of the client also.

A licensed fencing contractor should be appointed to provide further advice and perform rectification works as necessary.

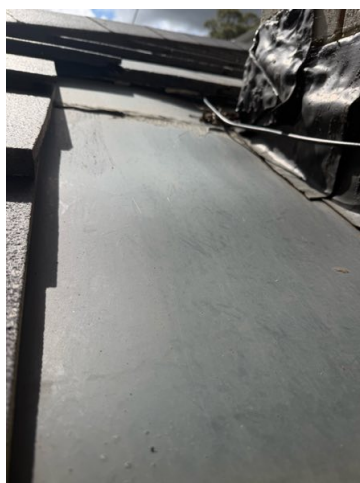
Finding 3.11

Finding: Roof tiles - Missing

Information: A section of roof tiles is missing; however, the area has been covered with metal (sheet/flashings). The absence of this roof tile constitutes a defect that requires attention and rectification.

The absence of a tile leaves an exposed area, which can potentially lead to several issues, including Water Infiltration, Structural Integrity and Energy Efficiency.

They will be able to provide expert advice and ensure that the replacement tile is installed correctly, adhering to the manufacturer's specifications and local building codes.

Addressing this defect in a timely manner is crucial to prevent any further damage to the property and maintain the roof's longevity and effectiveness in protecting the structure.

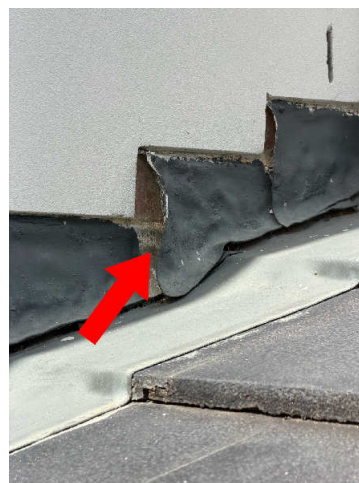
Finding 3.12

Premature ageing and secondary building defects are imminent where roof plumbing is missing or inadequately installed. Additionally, water pooling also creates an environment that is susceptible to termite and pest infestation.

A roofing plumber should be appointed as soon as possible to install relevant roof plumbing materials, ensuring that no further damage is sustained.

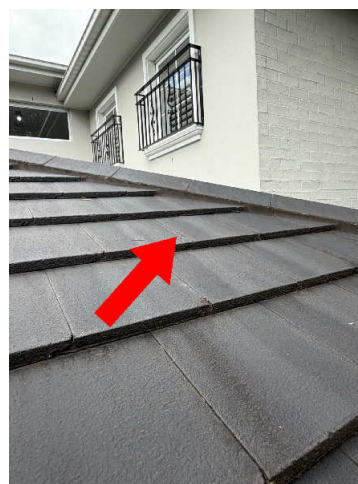
Finding 3.13

Broken roof tiles are also likely to detract from the effectiveness of the roof drainage system, creating potential for secondary damage to the exterior roof covering and roof plumbing.

Replacement of broken tiles is required and should be performed by a roofing contractor as soon as possible.

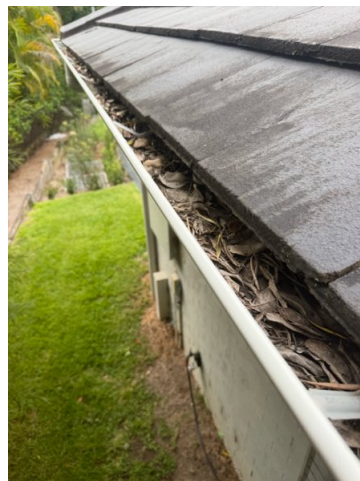
Finding 3.14

Information: Rubbish was found in the gutter during the time of inspection.

Remove rubbish in order to prevent blockage of the gutter and down pipes.

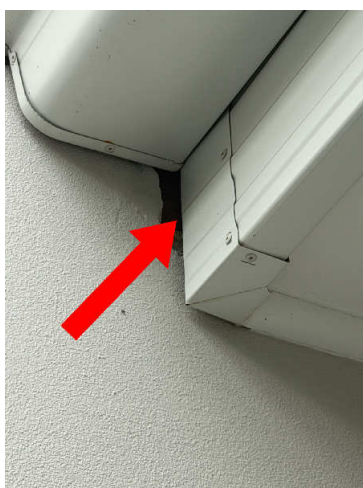
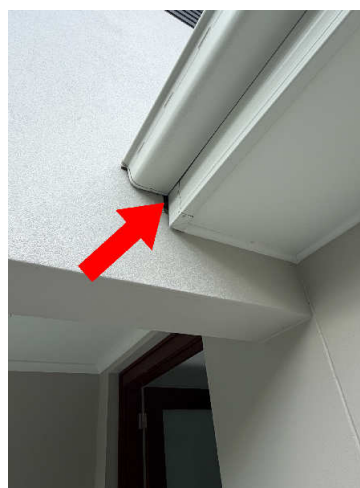
Finding 3.15

Information: A gap is present at the junction between the eaves/soffit lining and the adjacent wall/beam. The corner detailing is incomplete, with visible separation and an unsealed opening.

Seal the gap using appropriate external-grade sealant or trim to fully close the opening. Ensure the soffit lining is properly fitted and all junctions are finished to a weather-tight standard.

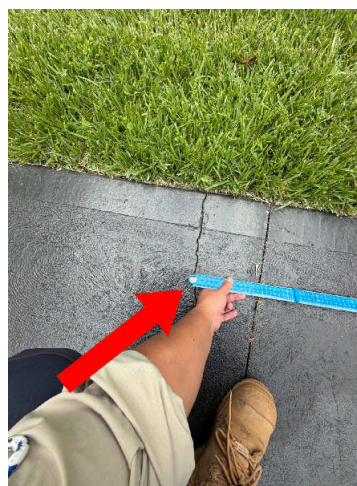
Finding 3.16

Wide cracks may also have a more significant structural cause, such as subsidence of soils.

Where the crack is located adjacent to structural elements of the building, the advice of a Structural Engineer is advisable before undertaking repairs. Significant repair and likely replacement of the concrete paving is probable.

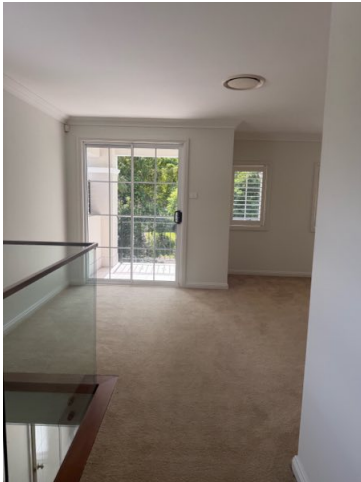
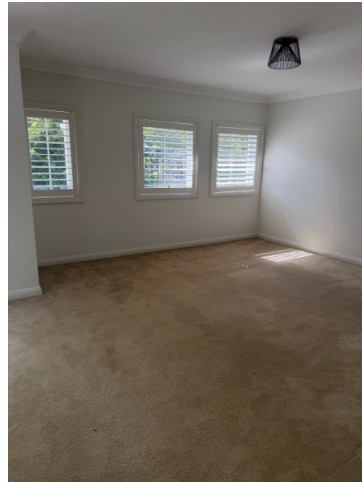
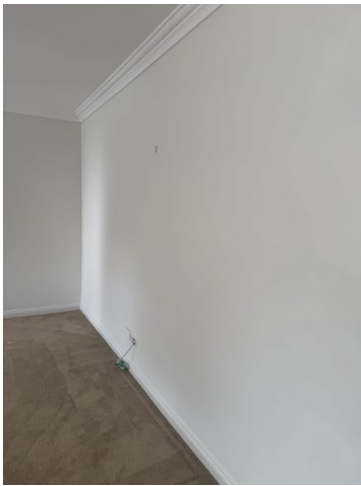
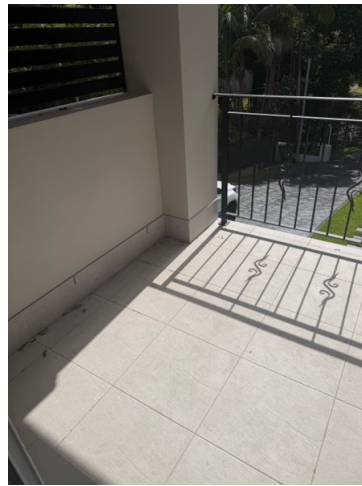
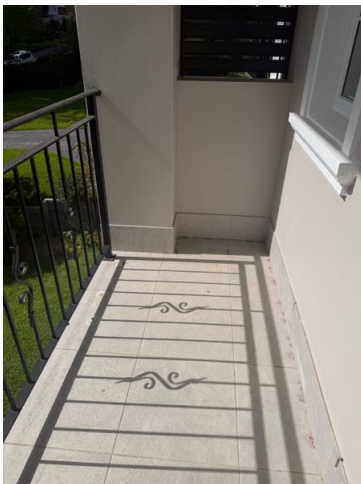
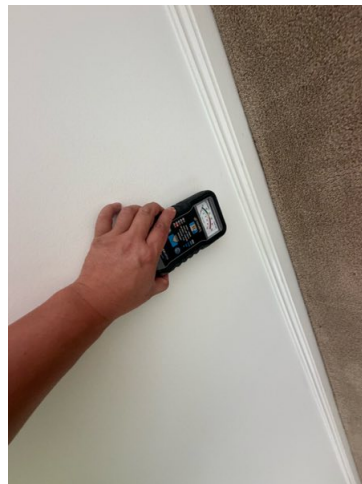
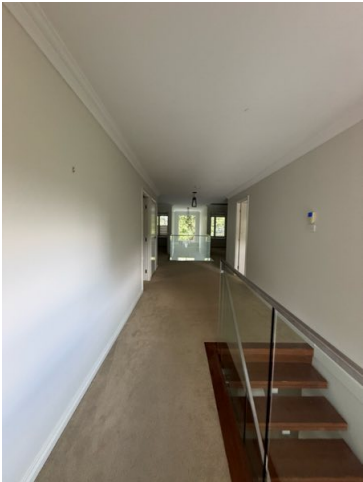
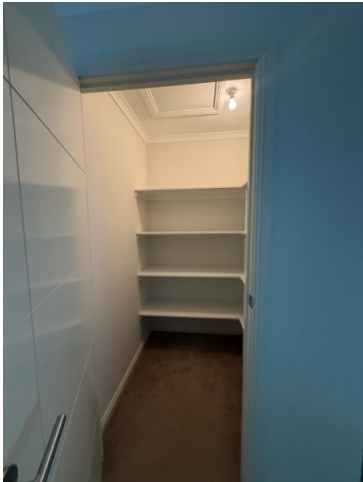
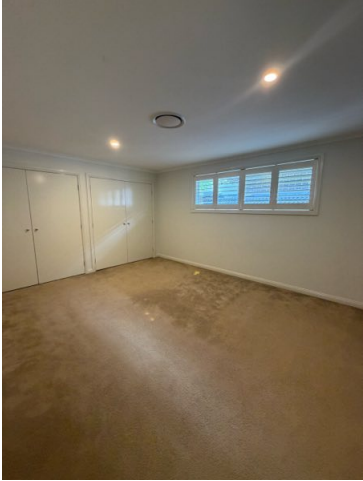
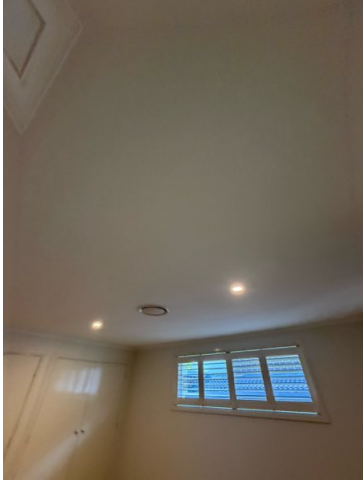
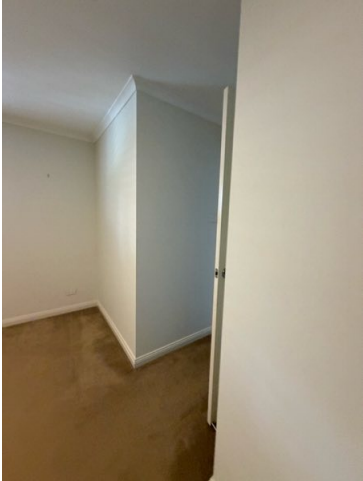
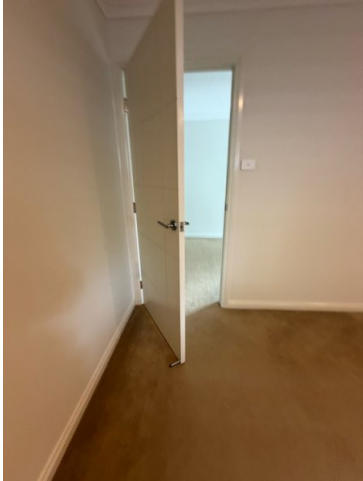
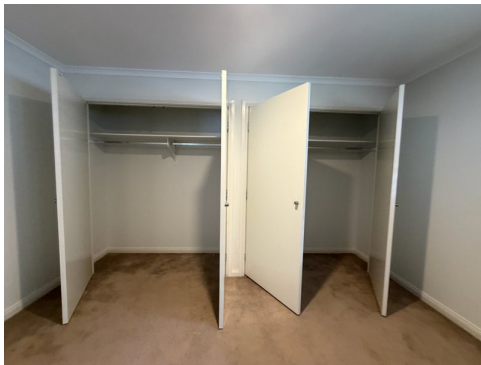
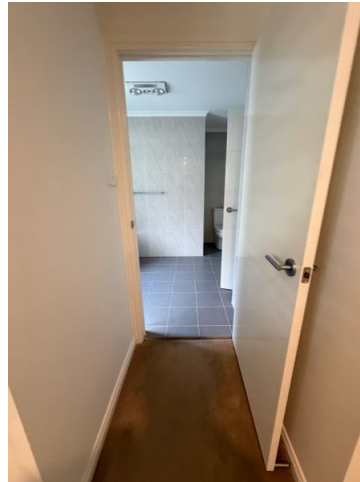
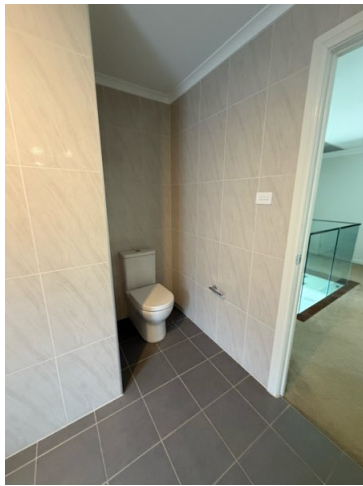
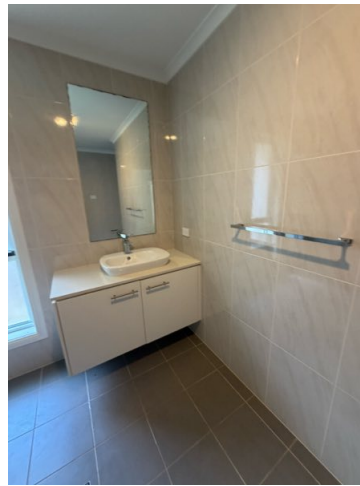
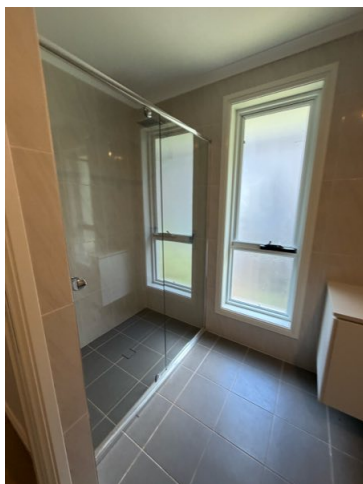
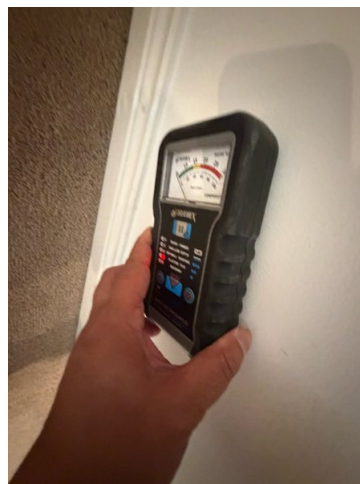
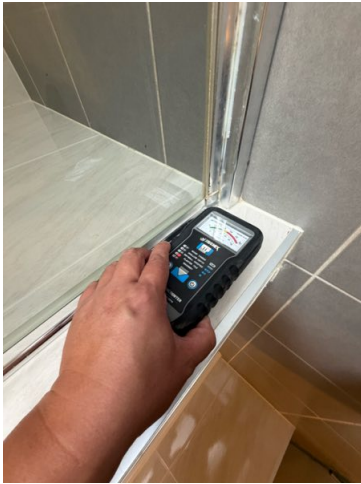
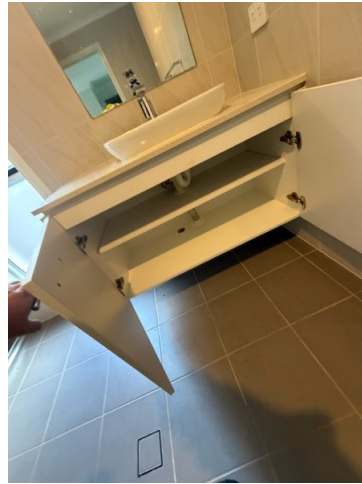
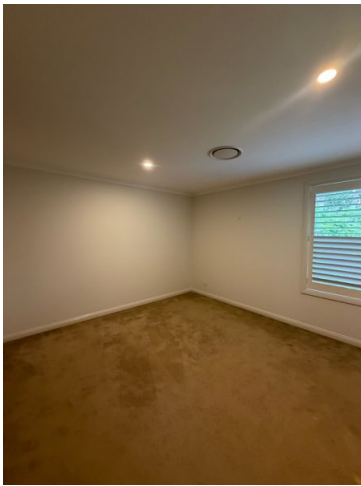
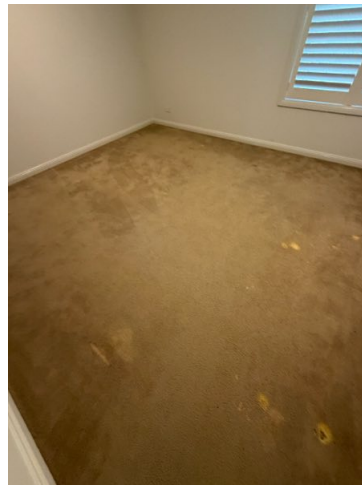
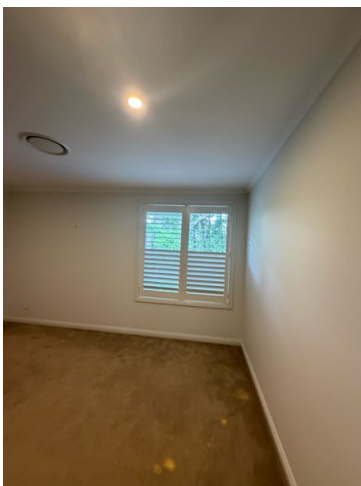
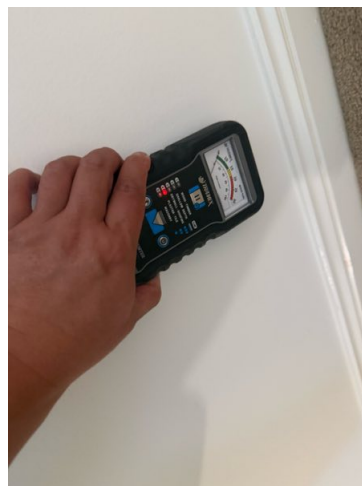
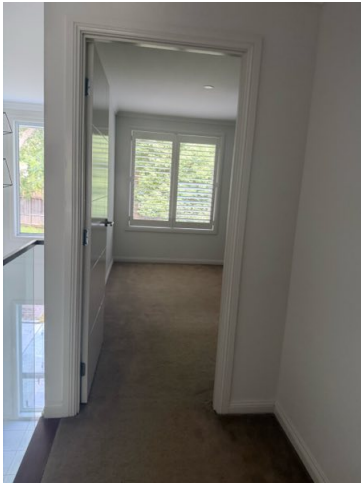
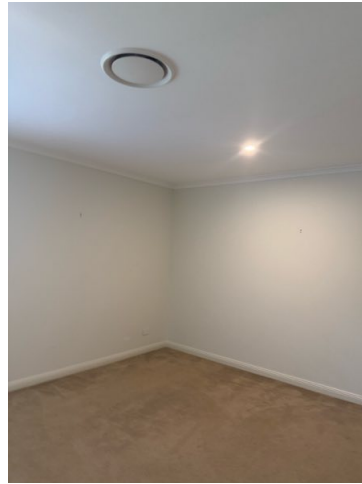
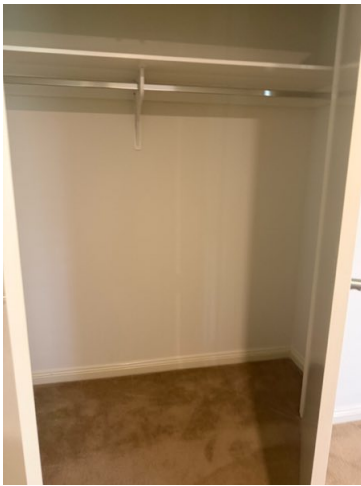
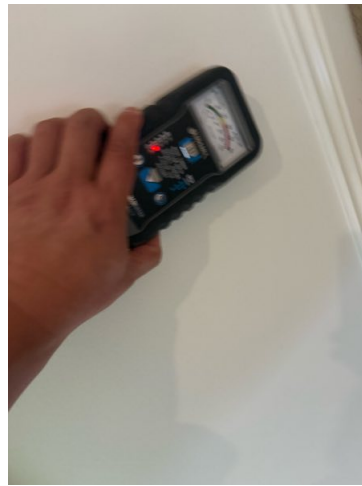
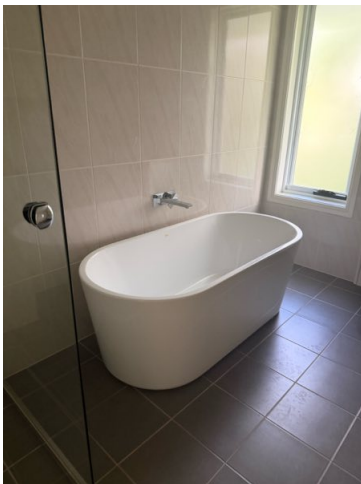
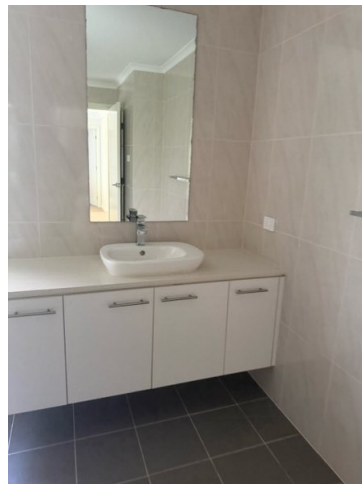
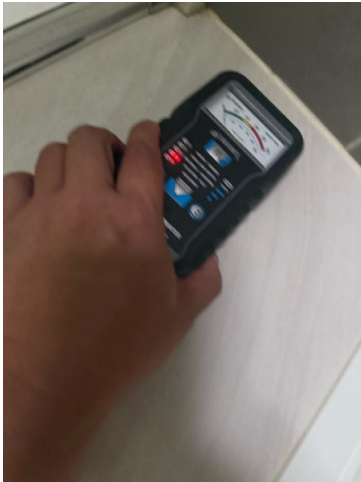
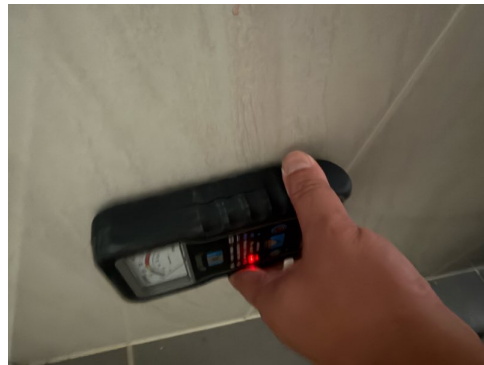
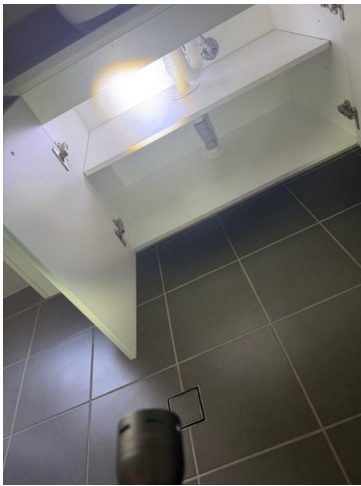
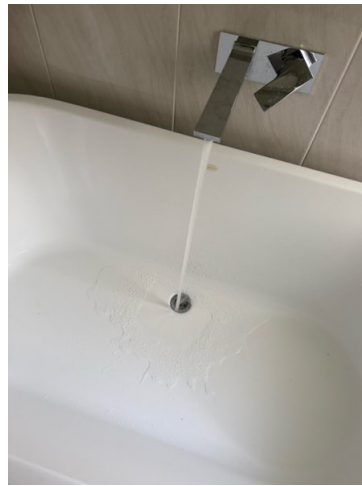
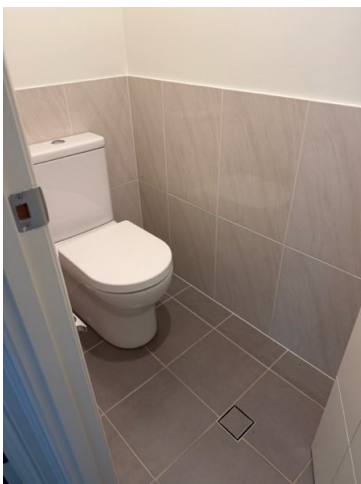
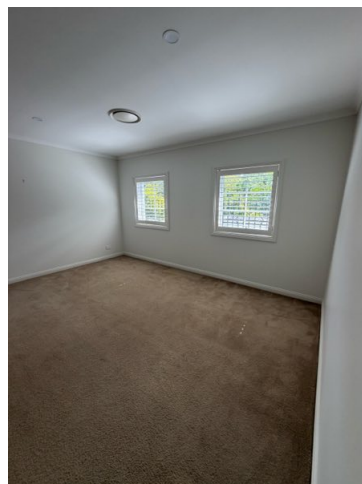
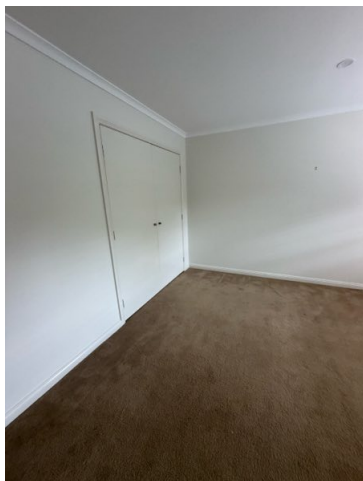
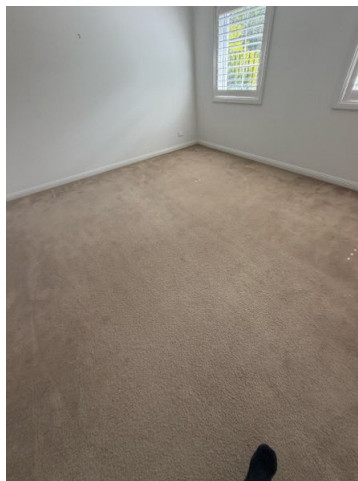
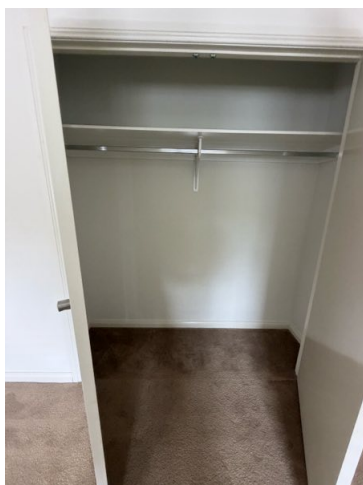
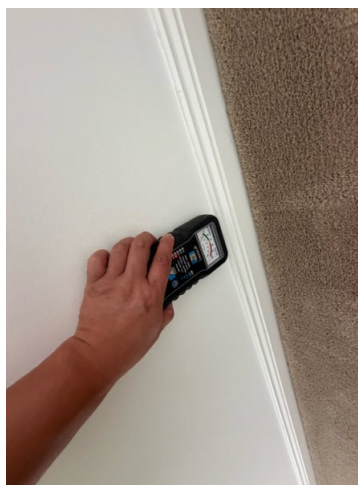
Information: Additional photos are provided for your general reference and may include obstructions, limitations, testing of water, moisture readings or minor maintenance items.

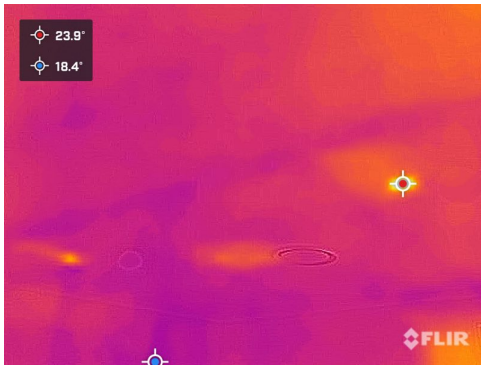
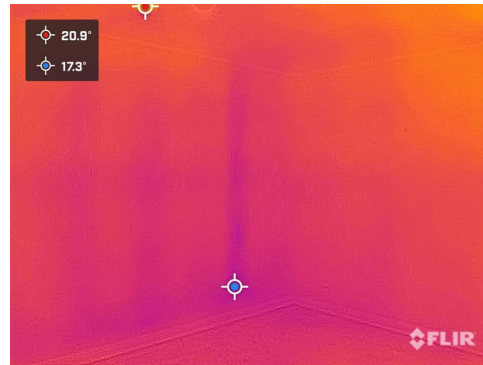
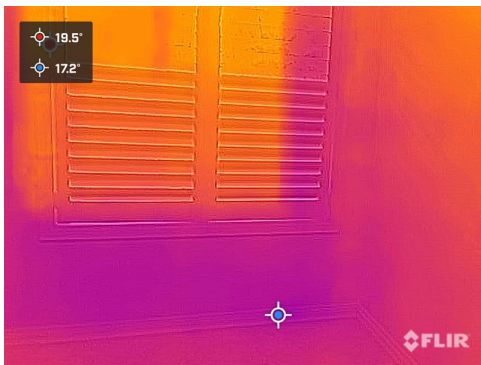
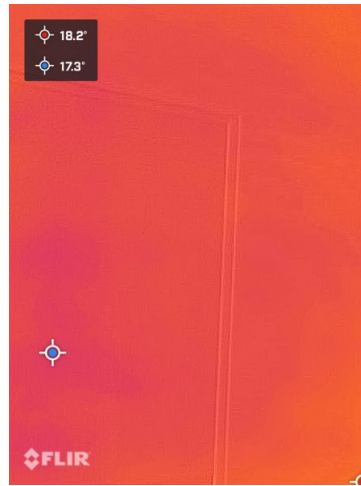
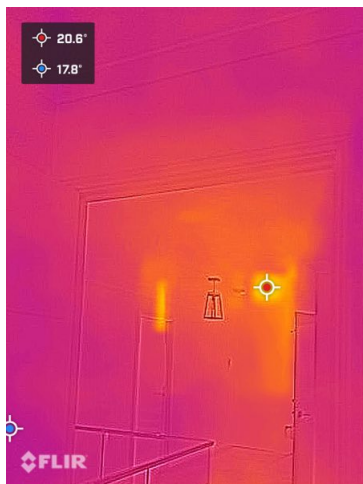
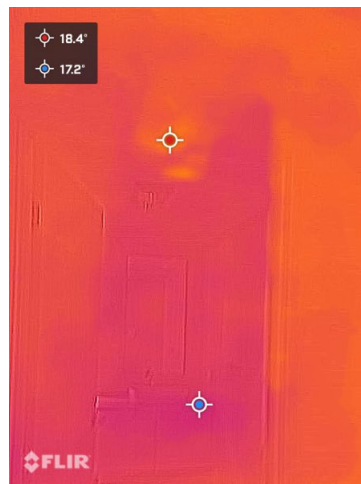
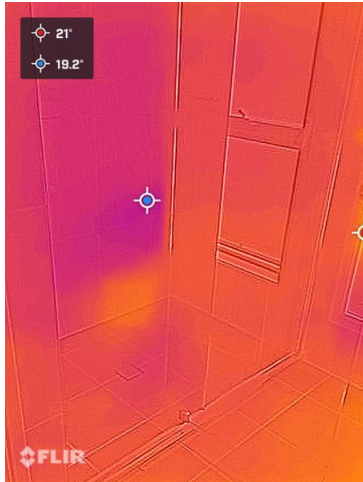
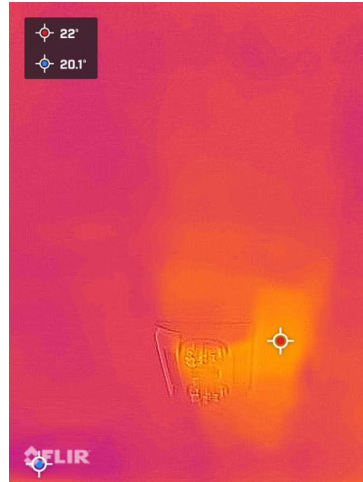
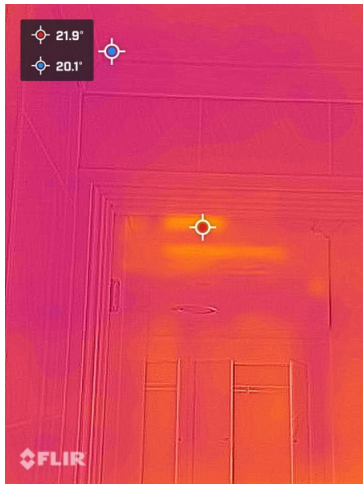
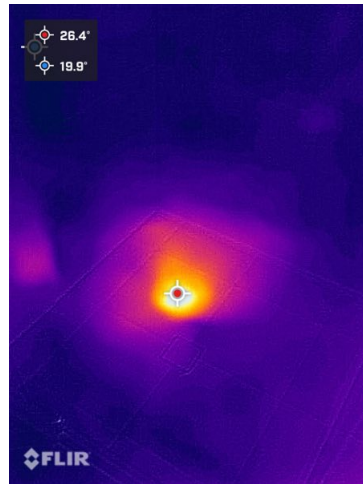
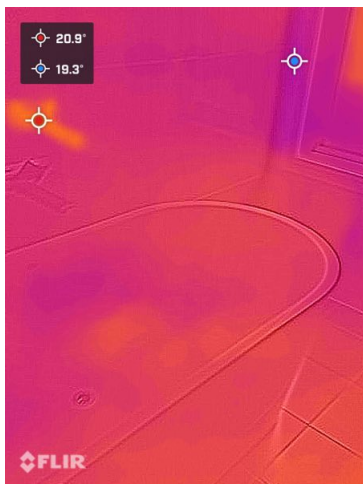
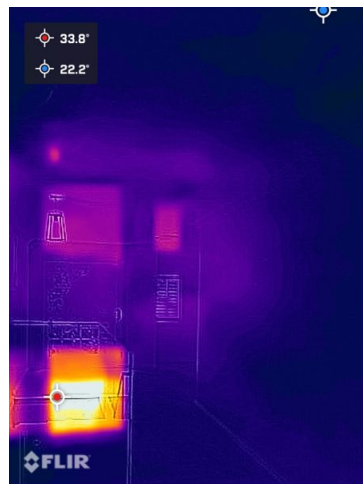
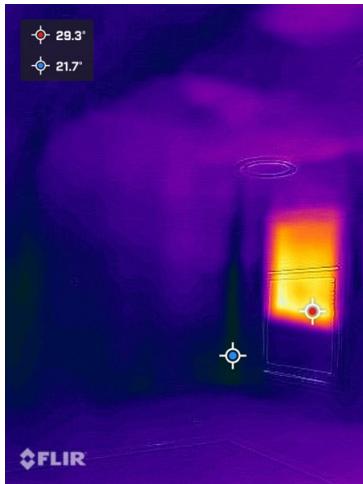
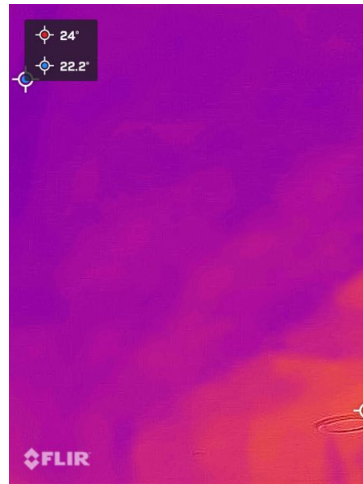
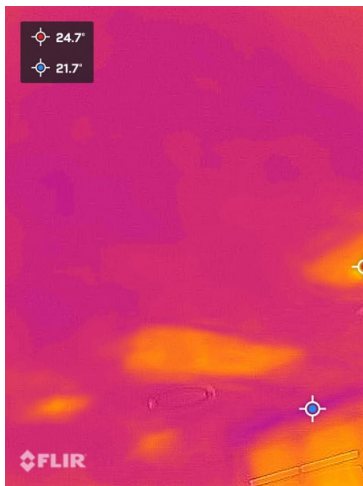
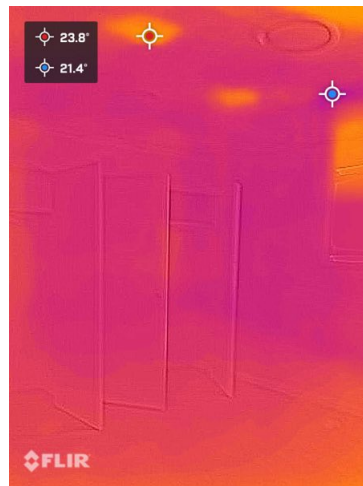
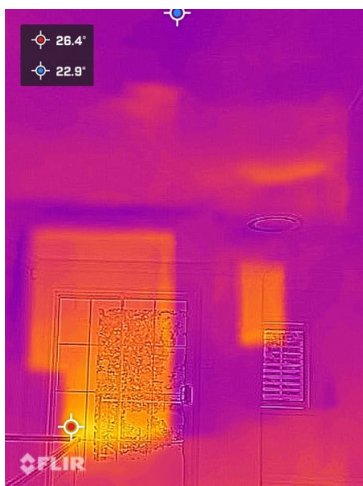
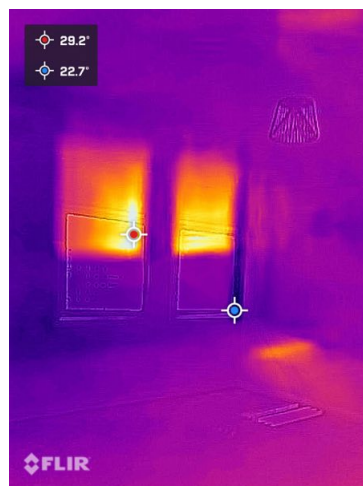
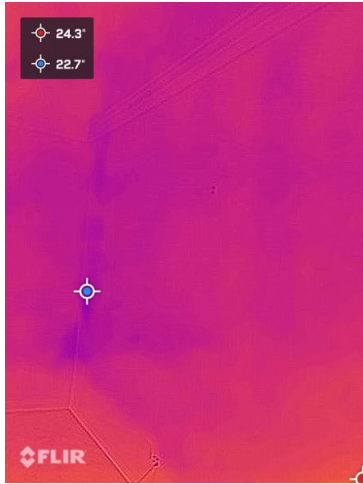
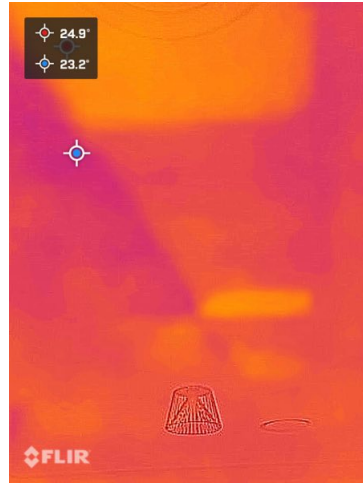
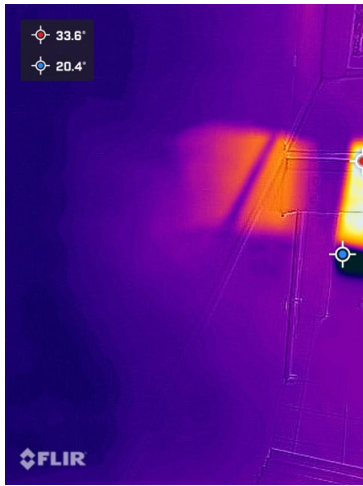
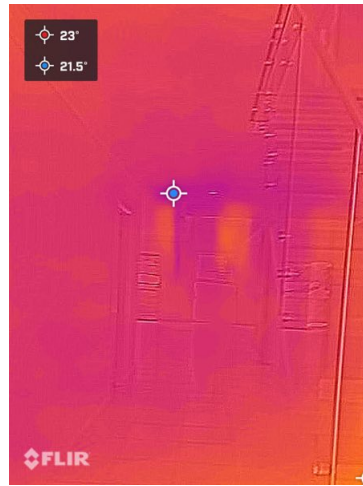
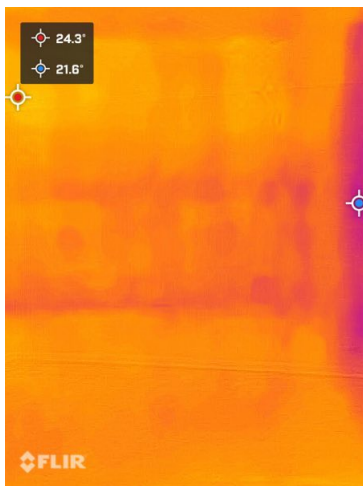
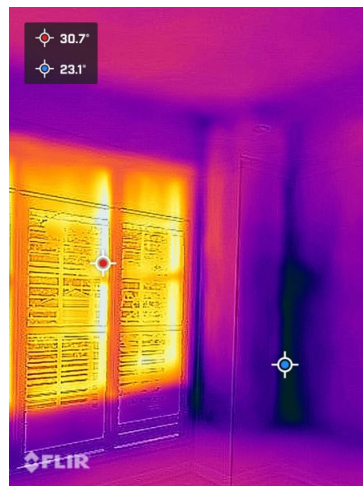
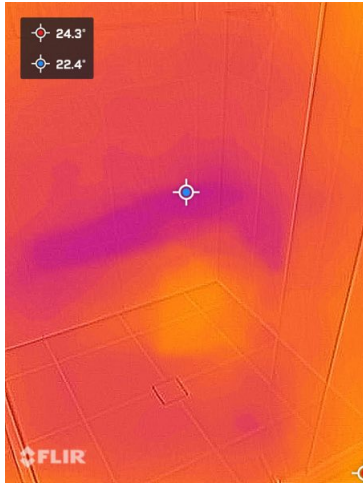
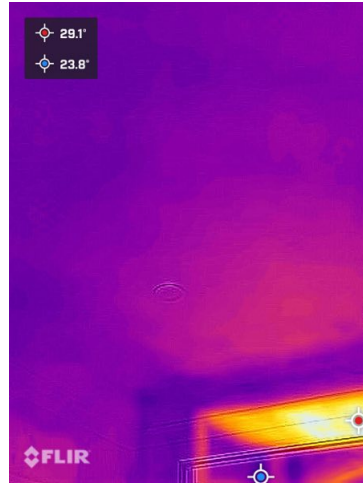
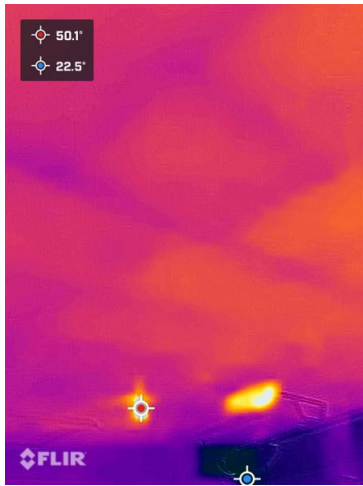
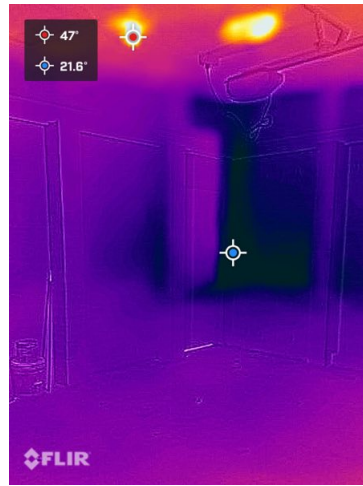
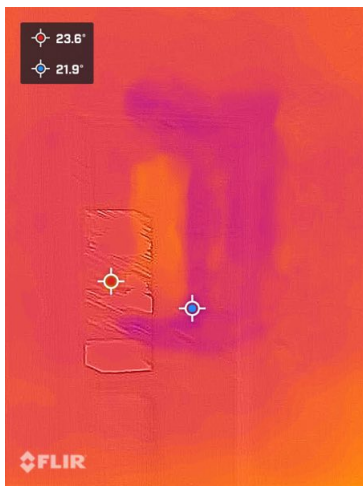
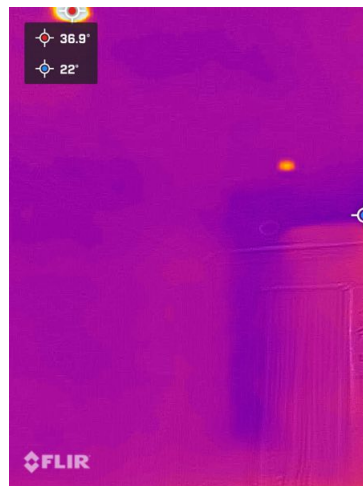
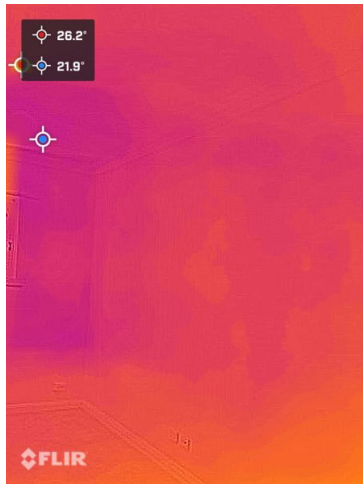
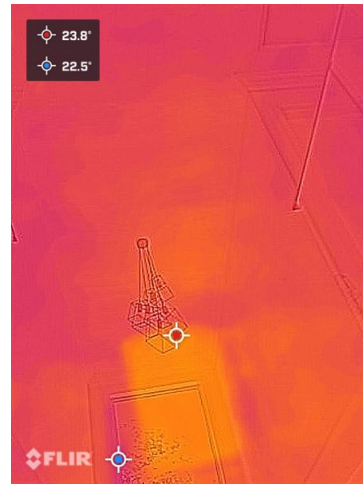
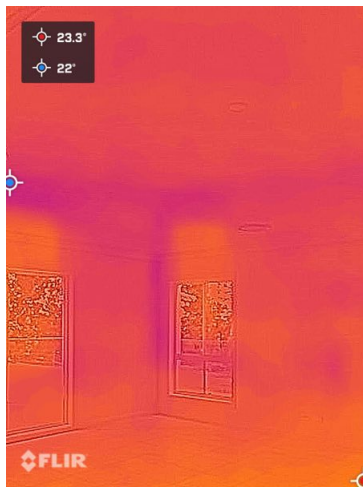
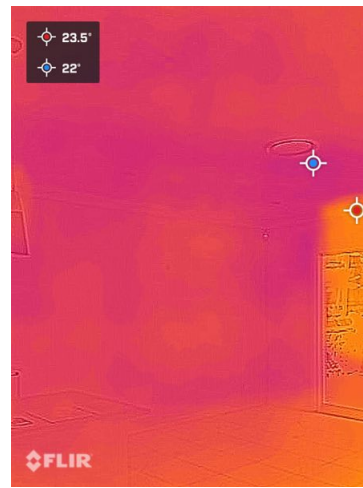
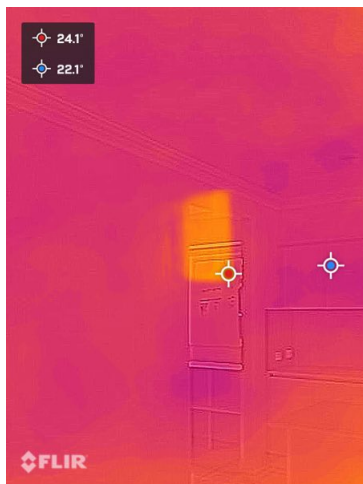
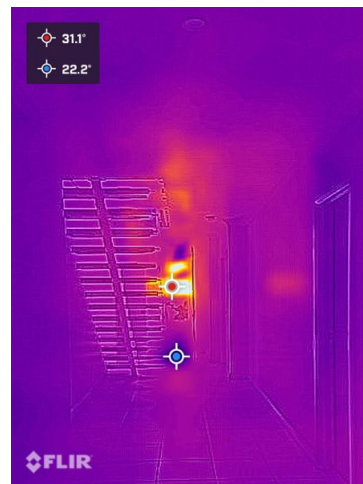
Finding: Additional Thermal Image Photos - Interior Area

Information: These Thermal Image photographs are an indication of the interior area at the time of inspection.

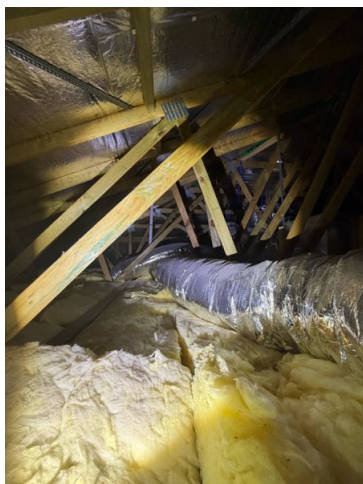
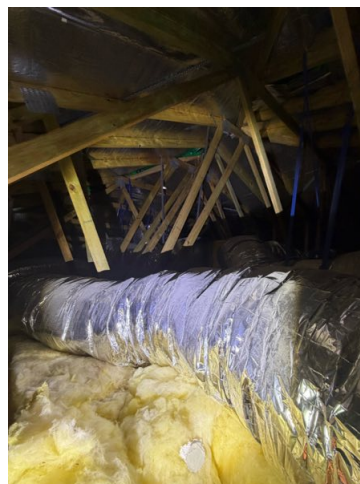
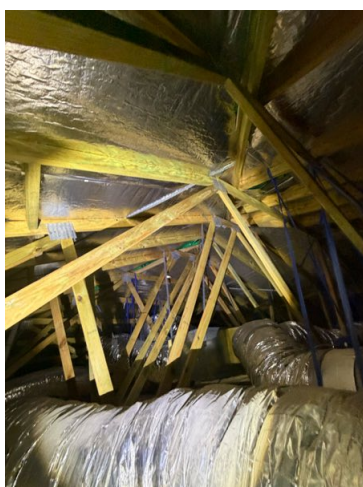
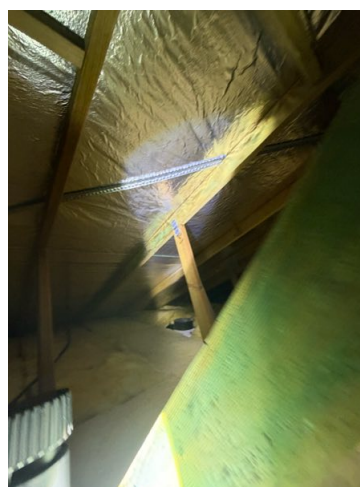
Finding: Additional Photos - Obstructions and Limitations—roof space area

Information: These photographs are an indication of the obstructions and limitations which impeded full inspection of the roof space area at the time of inspection. These obstructions can hide an array of defects and should be removed to allow full inspection to be carried out. A re-inspection is recommended once the areas are made accessible.
