Building and Timber Pest Inspection Report

Inspection Date: Mon, 30 Mar 2026

Property Address: 16 Latona St, Pymble NSW 2073, Australia

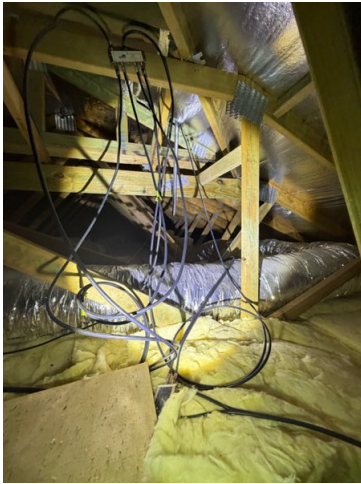
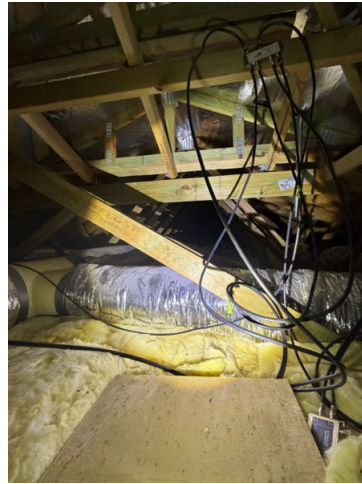
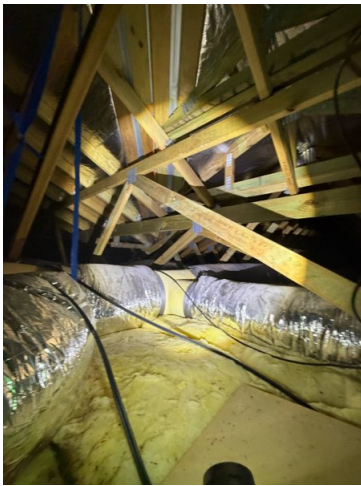
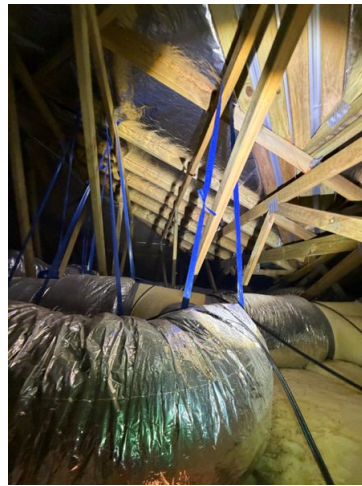
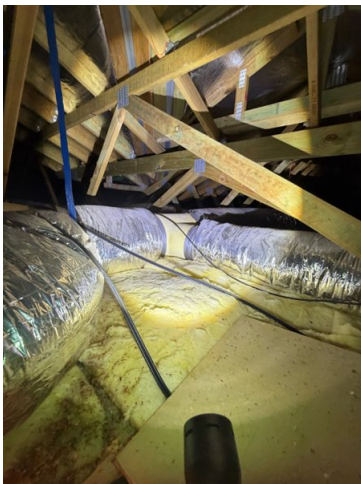
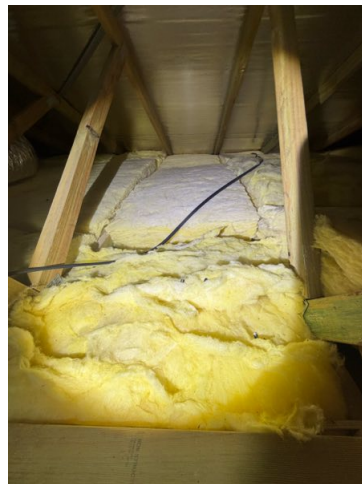
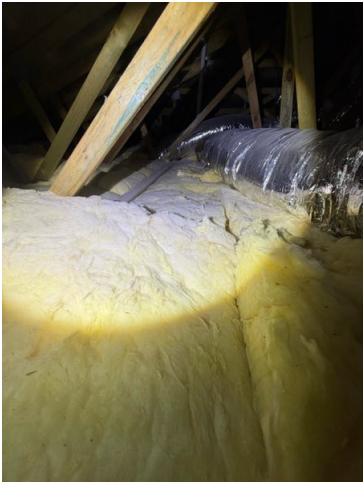
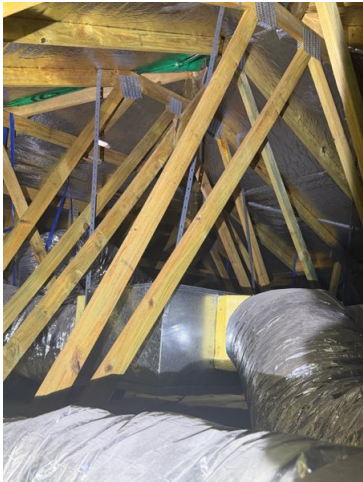
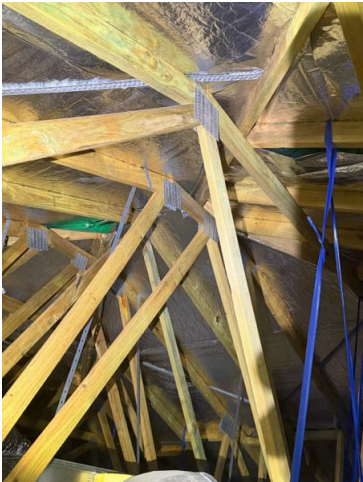
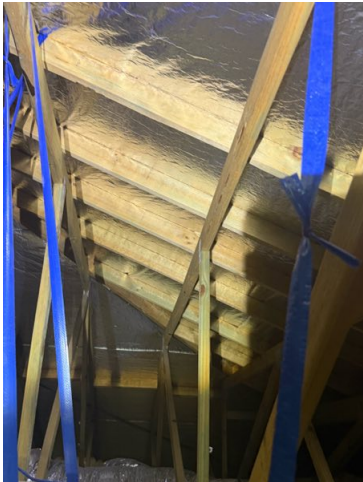
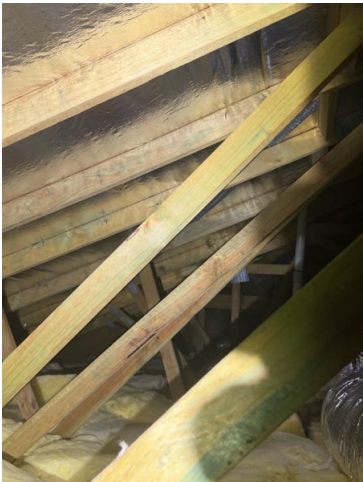
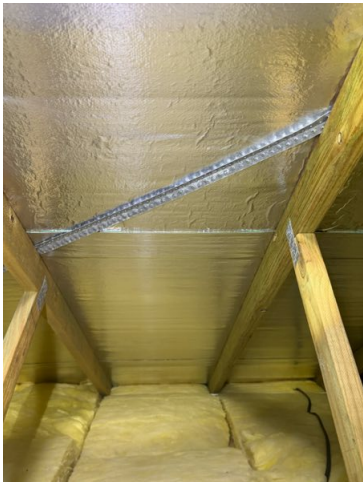
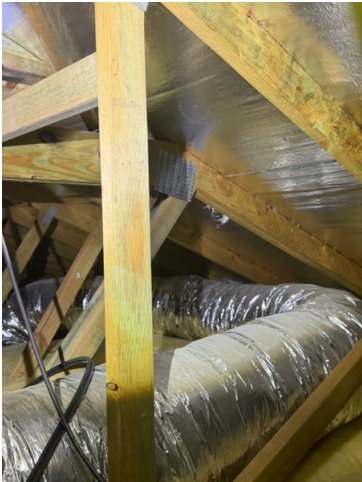
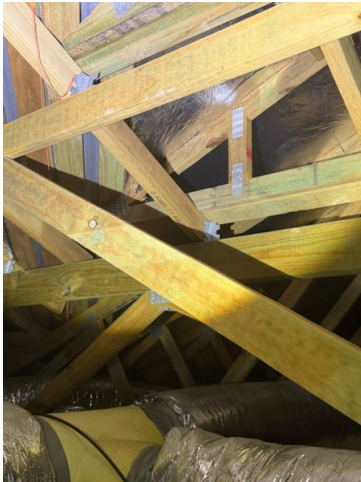
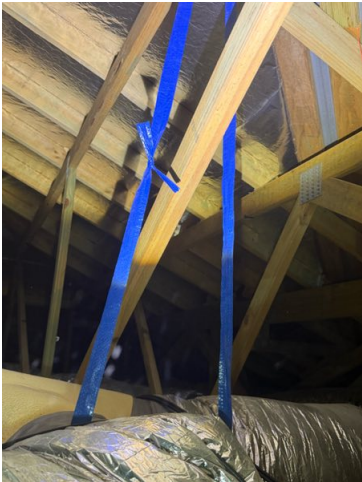
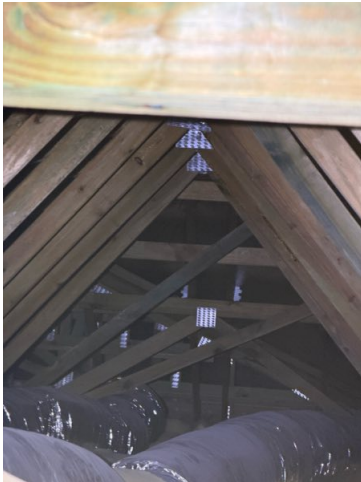
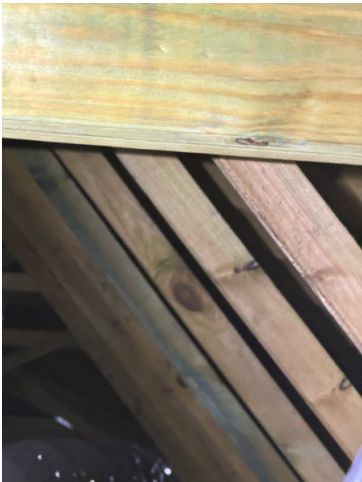
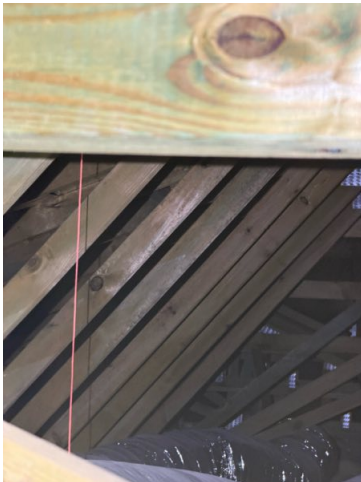
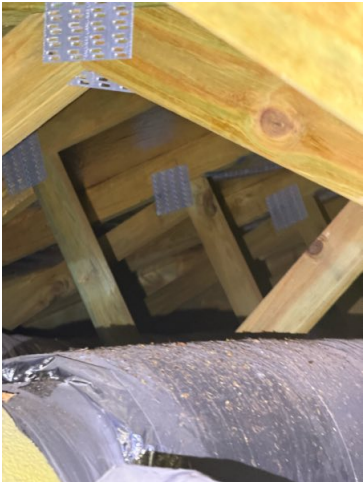
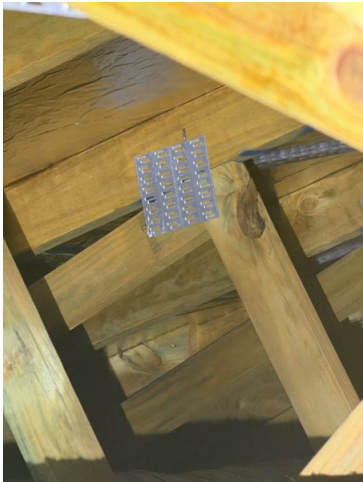
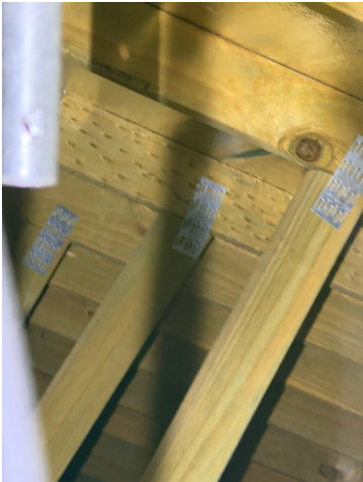
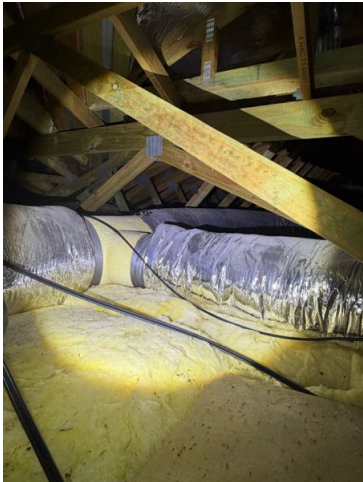
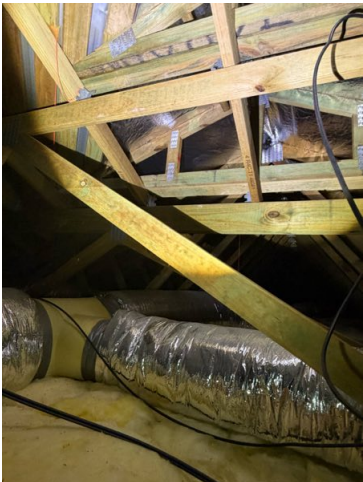
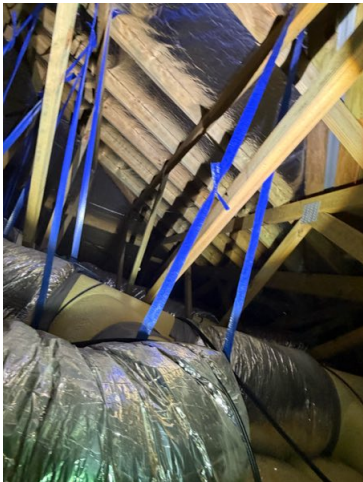
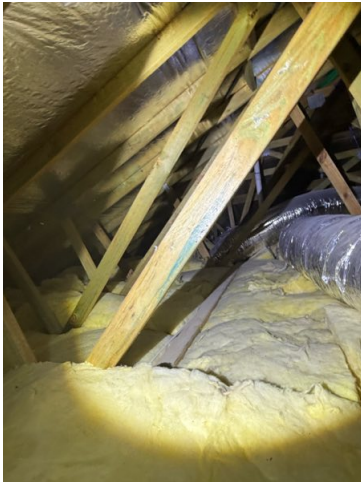
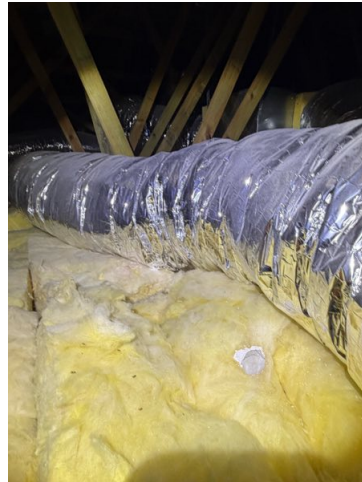
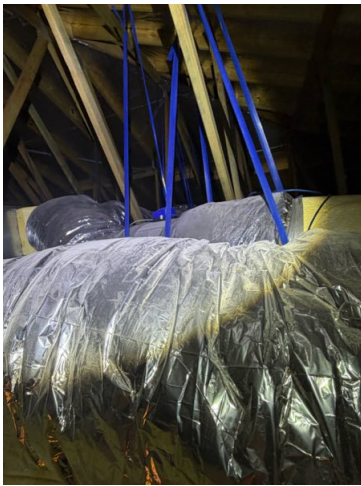
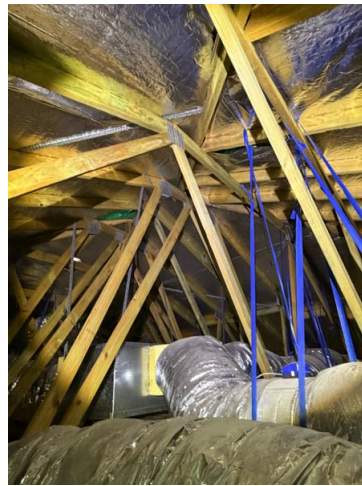
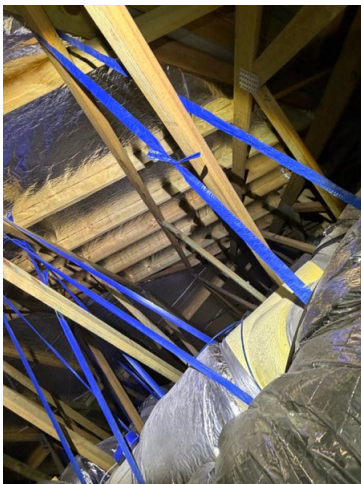
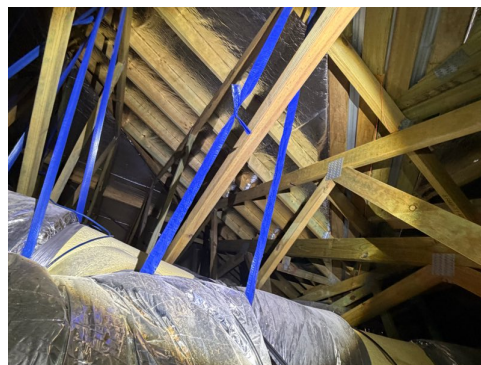
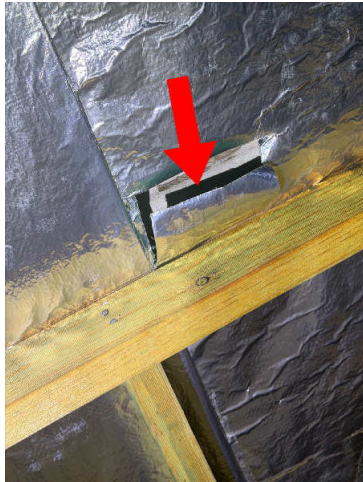
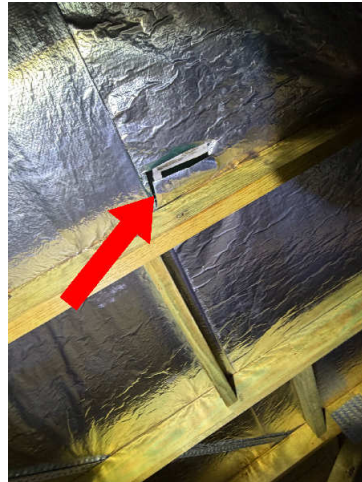
Noted Item

Information: These photographs are an indication of the obstructions and limitations which impeded full inspection of the roof space area at the time of inspection. These obstructions can hide an array of defects and should be removed to allow full inspection to be carried out. A re-inspection is recommended once the areas are made accessible.

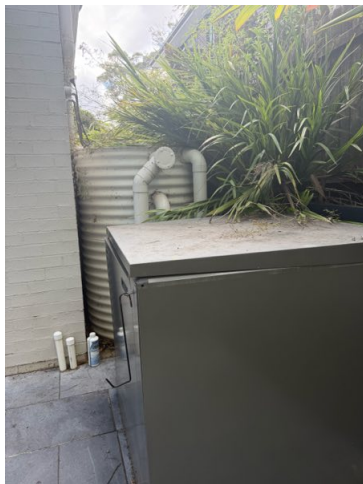
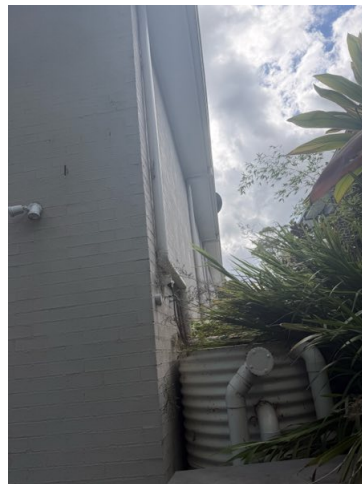
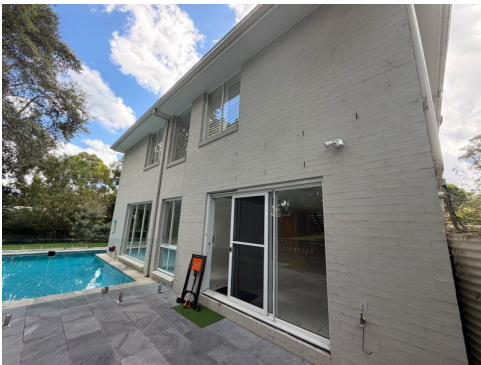
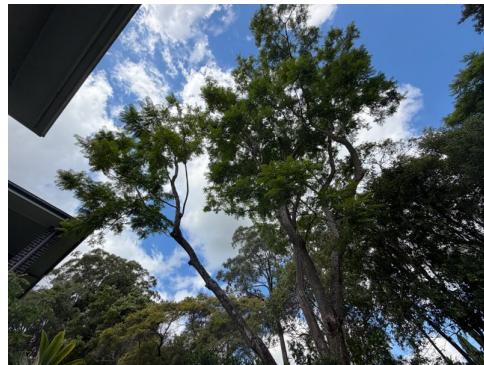
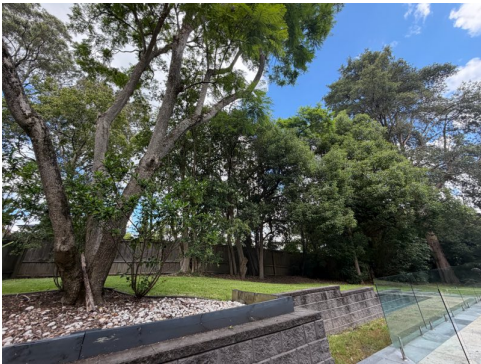
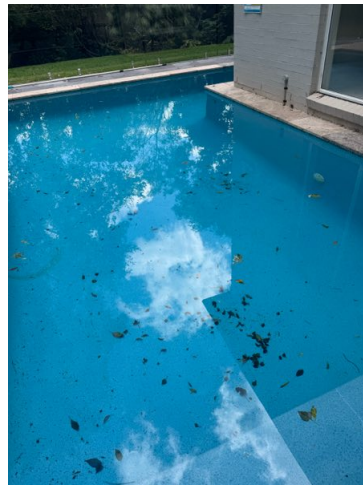
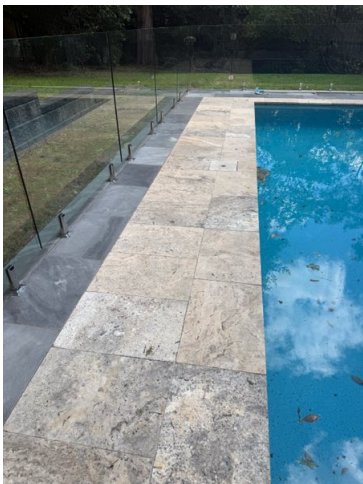
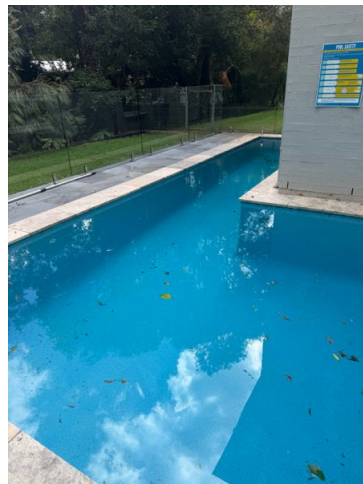
Noted Item

Finding: Additional Photos - Exterior Area

Information: Additional photos are provided for your general reference and may include obstructions, limitations or minor maintenance items.

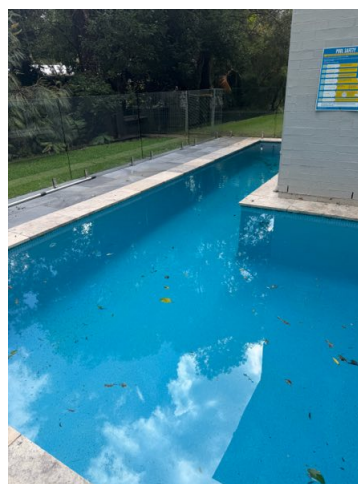
Location:	All External Areas
Finding:	Pool fencing - Inspection required
Information:	Please note that this inspection does not cover pool fencing and other pool fittings and fixtures. It is highly advised that a specialist be appointed to inspect the pool and surrounding area and provide advice on rectification works that may be required.

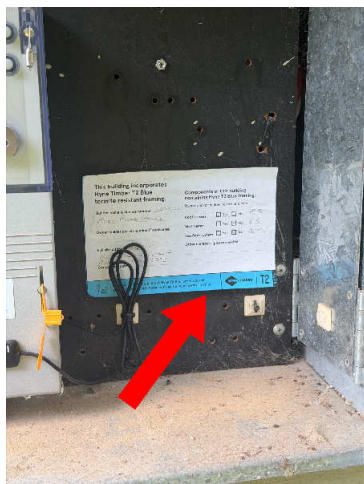
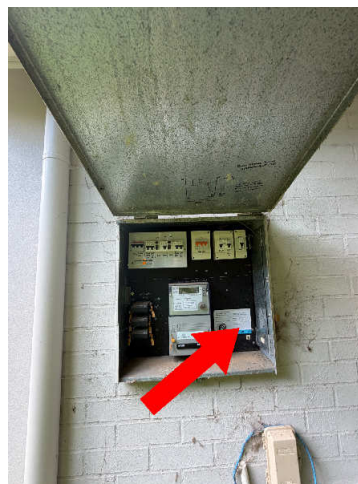
The following items were noted as -Evidence of a previous termite management program

Where a Termite Management System has been identified you should refer to the type of barrier date of installation warranty conditions and any documentation provided by a builder or past owner.

Consult the company who installed the barrier to confirm whether the system is still under warranty.
