Building and Timber Pest Inspection Report

Inspection Date: Wed, 25 Feb 2026

Property Address: 16 Burdekin Dr, Albion Park NSW 2527,
Australia

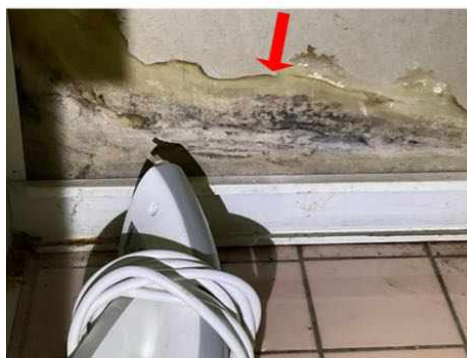
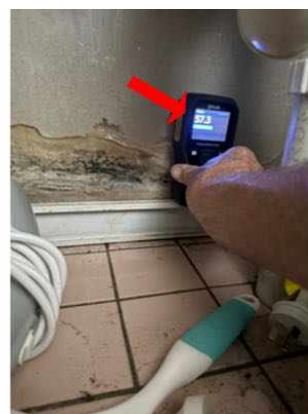
Building: Building 1
Location: Laundry
Finding: Mould present and excessive moisture
Information: Where evidence of mould growth and high moisture was noted under the laundry tub, there may be environmental, biological or health issues associated with the report. A specialist inspection by a suitably qualified environmental health inspector is warranted, where mould is extensive or where any queries regarding air quality spores or other related issues apply.

The reason for this mould is suspected to be the lack of fall to the laundry tiles under the tub. Any water leaked or spilled here will pool against the rear wall and not reach the floor waste. It is also possible a leak may also be within this wall in the laundry plumbing. A moderately high moisture reading of 57.3 was recorded in this area of mould with no other significant readings found in the house and all nearby laundry areas recording zero.

Any mould found during the inspection should be cleaned immediately by a cleaning contractor or the homeowner as applicable.

A qualified plumbers inspection is recommended to determine the reason for this leak. The external brick wall was tested behind this area and most water reached the rear left external strip drain.

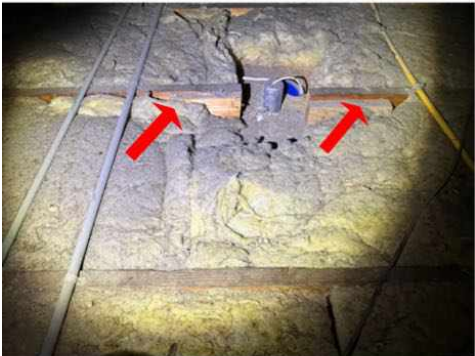
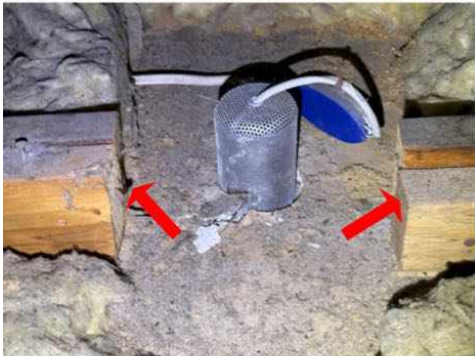
Building: Building 1
 Location: Roof Cavity - kitchen/ hall area
 Finding: Roof truss - Lack of support
 Information: The roofing structure was found to lack support due to an electrician cutting a truss bottom chord at the time of inspection. This truss need another piece of timber laminated on to support the ceiling in this area to stop sagging and creating a strain on associated building elements..

It is advised that a licensed builder be engaged to resupported this area to ensure the longevity and structural integrity of the roof and ceiling.

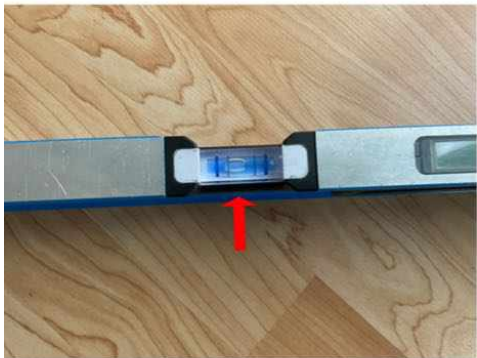
Building: Building 1
Location: Pictured areas
Finding: Incomplete or substandard works
Information: The works to some flooring appears to have been completed to a substandard level. Some floating flooring has gaps and minor movement evident.

No evidence of slab damage was found except some uneven areas mainly at the internal entry.

It is highly recommended that a carpenter or flooring installer be appointed to complete these works and ensure the safety of the area and the longevity of all associated building elements.

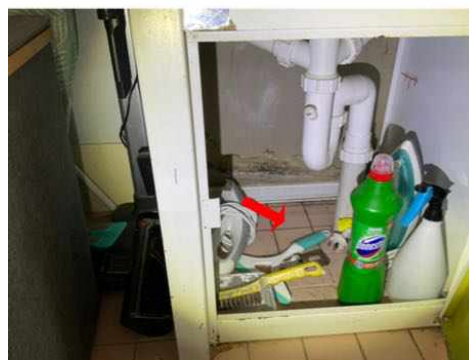
Building:	Building 1
Location:	Laundry & kitchen
Finding:	Building elements - Damaged
Information:	Evidence of minor missing or damaged areas was identified at the time of the inspection. These include -

1. The laundry tub door needs repair.
2. The laundry floor under the tub falls back to the wall and not to the drain.
3. There is minor moisture damage in kitchen sink cupboard with no leaks found.

A carpenter would be the trade responsible for rectification of these areas when convenient.

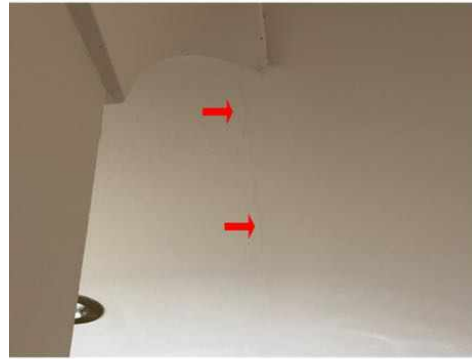
Finding: Cracking - Damage Category 1 - Fine (up to 1mm)

Information: Although fine cracks are quite noticeable, they are often only considered to be an appearance defect, and usually do not indicate any structural damage. Generally, the cause of a fine crack is indicative of a separation between building materials and finishes (e.g. paint, plaster, etc.) along joints.

Cracking of this nature can generally be repaired with minor sanding, filling and/or repainting. Such works should be performed by a qualified painter or a general handyman.

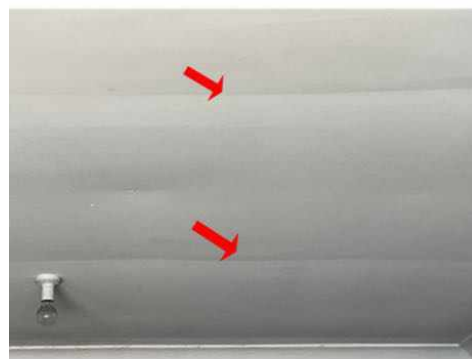
Building:	Building 1
Location:	Garage
Finding:	Ceiling - Sagging and nails popping
Information:	Sections of the garage ceiling were found to be sagging at the time of inspection. Sagging to the fixed ceiling structure generally indicates that the building materials have swollen, due to contact with water, or that fixings (e.g. nails or glue) have become loose and require reattachment.

The appropriate action should be taken by the client as soon as possible to ensure that any potential further damage is limited. As no moisture was evident, renailing / screwing this ceiling up is required to support it in the long term.

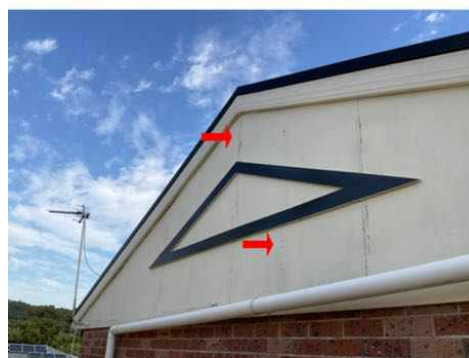
Building:	Building 1
Location:	Roof Exterior
Finding:	Roof tiles - Weathered
Information:	Upon inspection of the exterior roofing, the majority of roof tiles were considered to be in a good condition. While weathering of the tiles is consistent with the age of the property, maintenance works are required.

Consultation with a roofing contractor is highly advised to gain advice on cost of remedial works that may be required in the short to medium term. Remedial works are likely to increase the longevity of the exterior roofing structure.

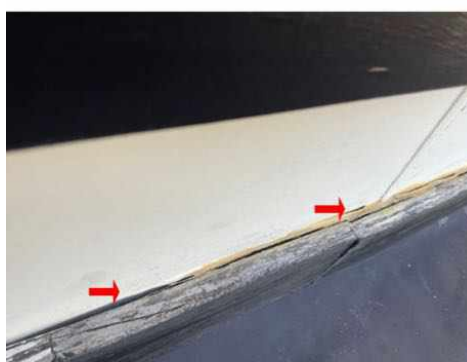
Location: Exterior roof walls
 Finding: Sealant (external) - missing and paint degraded
 Information: It was noted on inspection that areas of external sealant and paint were missing to small areas.

Flexible sealants should be applied to these affected areas to prevent any subsequent water damage that is likely to occur.

A sealant specialist or skilled handy person should be appointed to complete these works as soon as possible

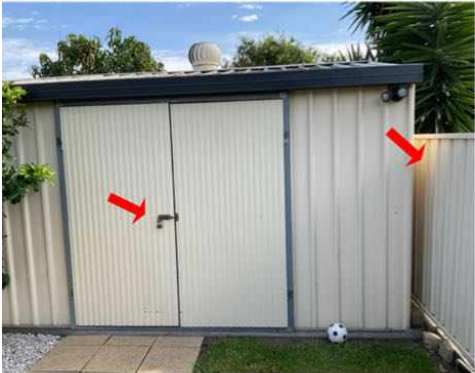
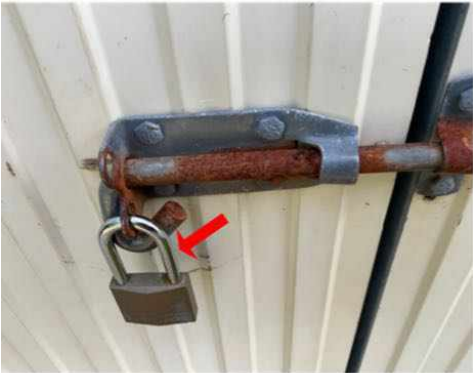
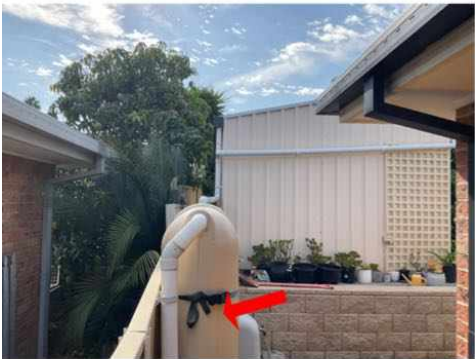
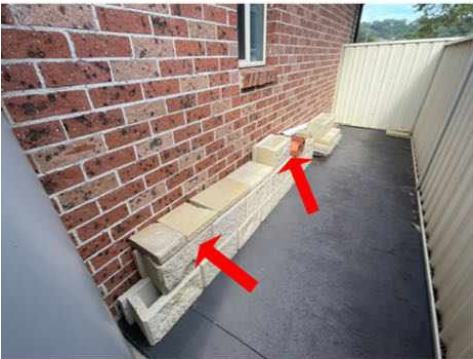
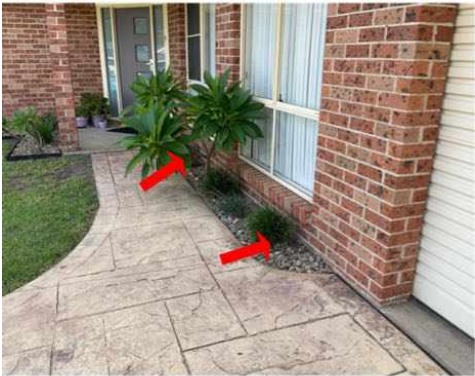
Building: Building 1
 Location: All External Areas
 Finding: Additional Photos - Obstructions and Limitations of EXTERNAL AREAS
 Information: These photographs are an indication of the obstructions and limitations which impeded full inspection of external areas at the time of inspection. These obstructions can hide an array of defects and should be removed to allow full inspection to be carried out. A re-inspection is recommended once the areas are made accessible.

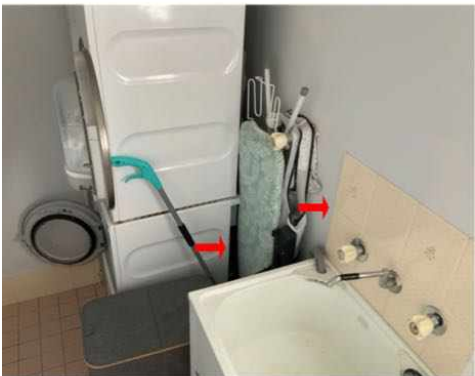
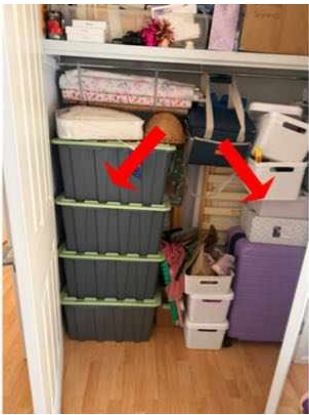
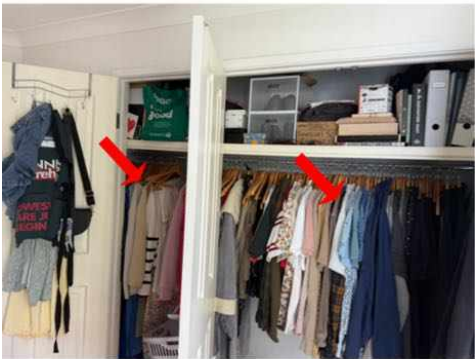
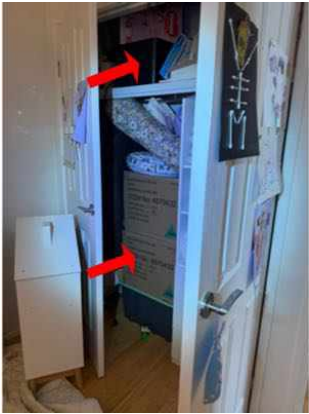
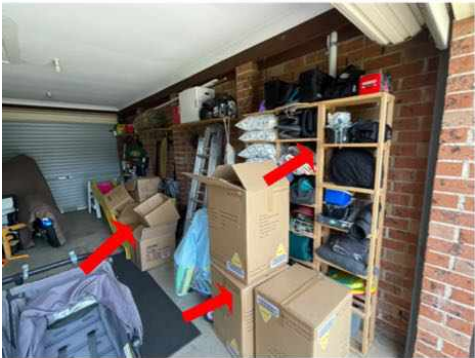
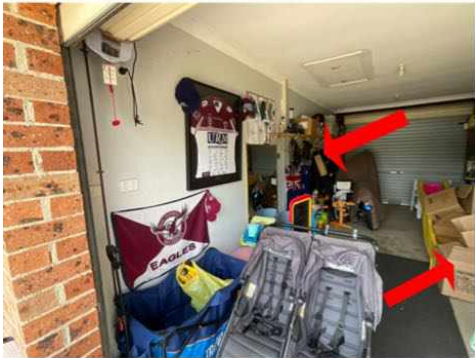
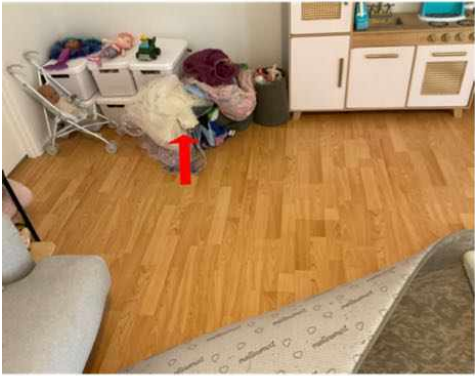
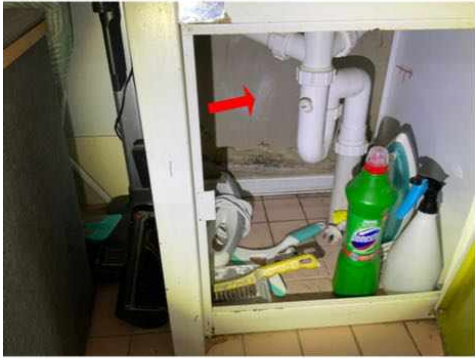
Building: Building 1
Location: All Internal Areas
Finding: Additional Photos - Obstructions and Limitations of INTERNAL AREAS
Information: These photographs are an indication of the obstructions and limitations which impeded full inspection of Internal areas at the time of inspection. These obstructions can hide an array of defects and should be removed to allow full inspection to be carried out. A re-inspection is recommended once the areas are made accessible.

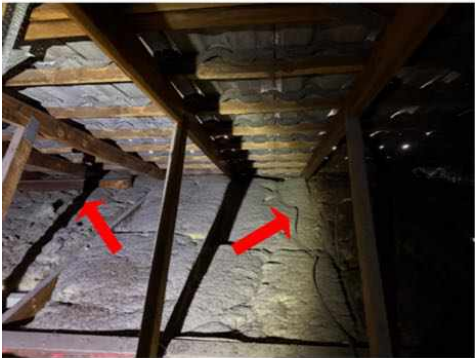
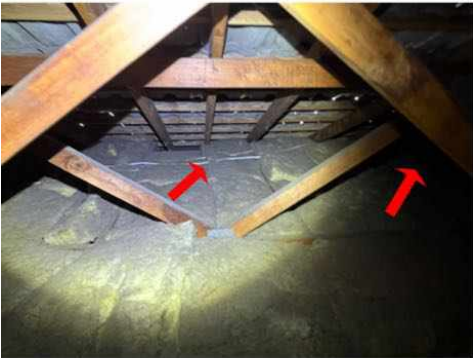
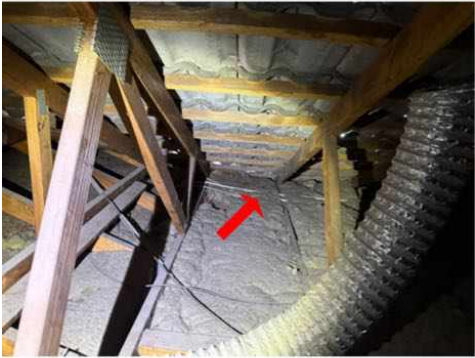
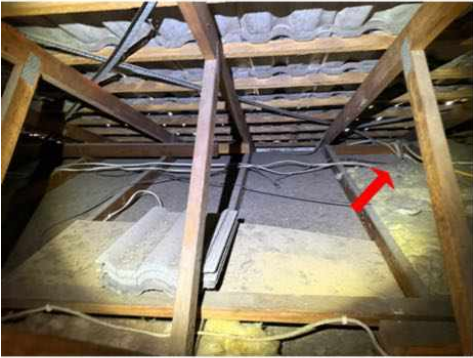
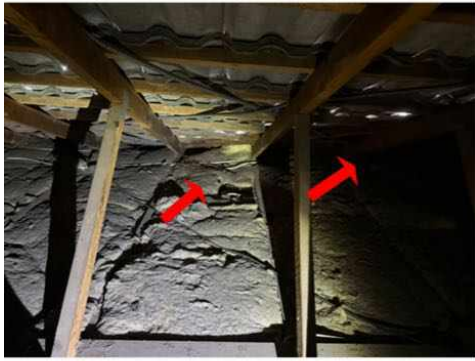
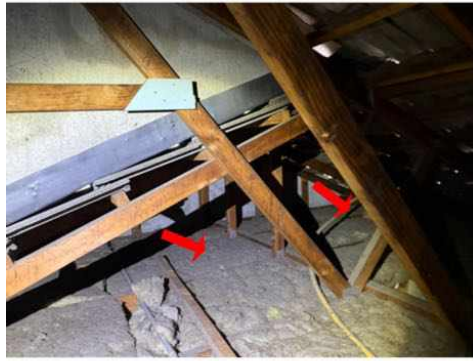
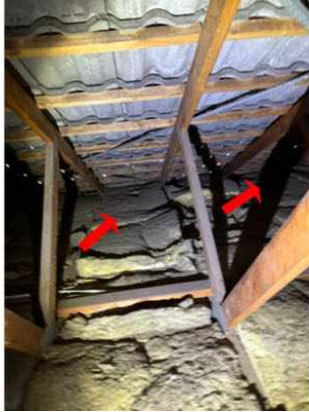
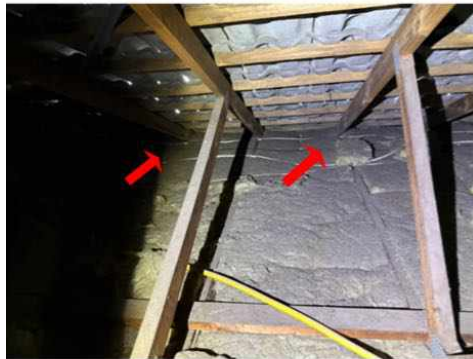
Building: Building 1
Location: All Roof cavity areas
Finding: Additional Photos - Obstructions and Limitations of the ROOF CAVITY
Information: These photographs are an indication of the obstructions and limitations which impeded full inspection of roof cavity areas at the time of inspection. These obstructions can hide an array of defects and should be removed to allow full inspection to be carried out if applicable. A re-inspection is recommended once the areas are made accessible.

The inspection was also limited to areas with an allowable crawl space of 600mm x 600mm, in particular towards the external walls where the roof line diminishes, these areas were not accessible.

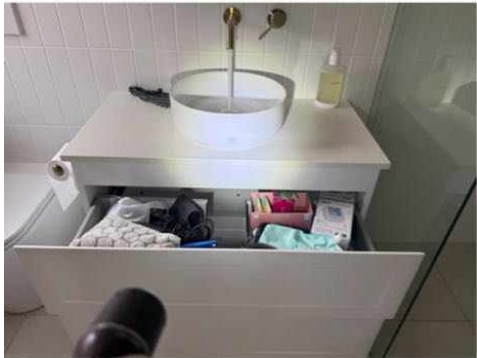
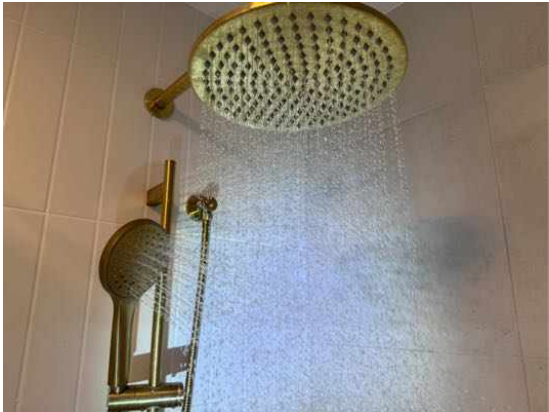
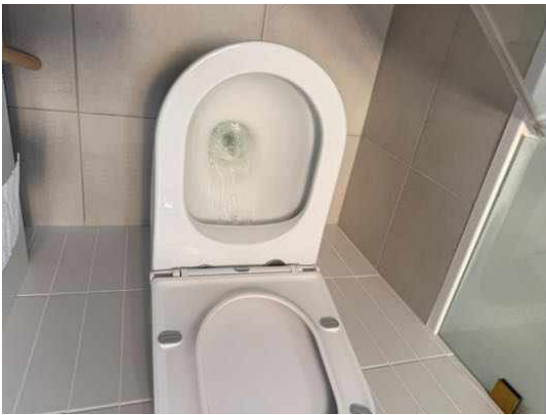
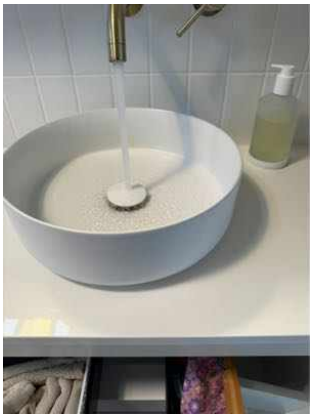
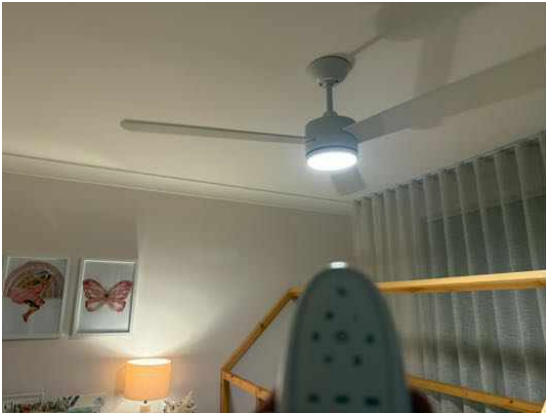
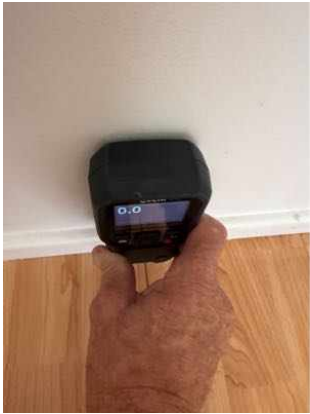
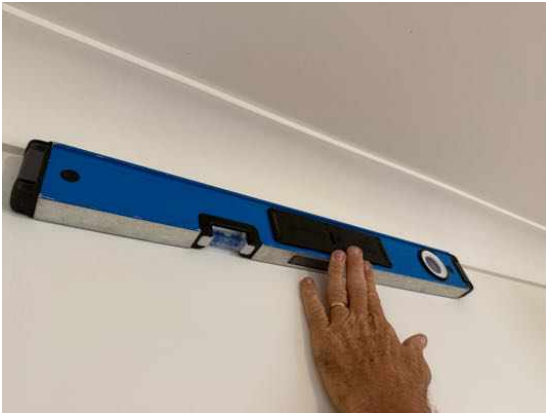
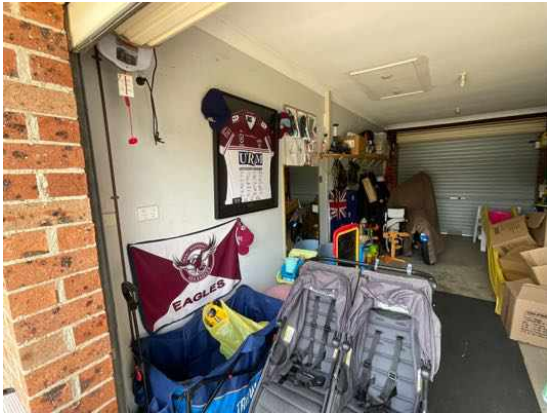
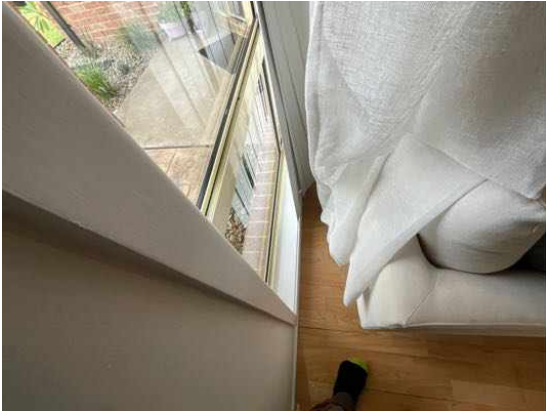
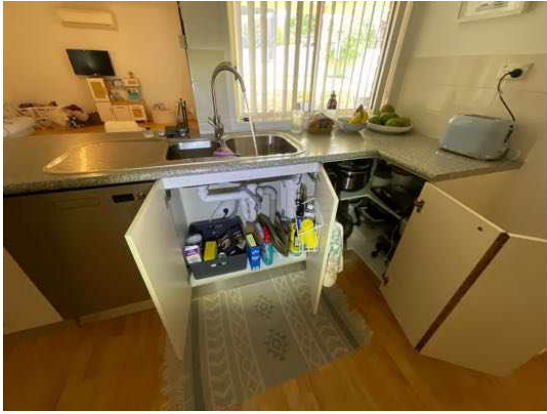
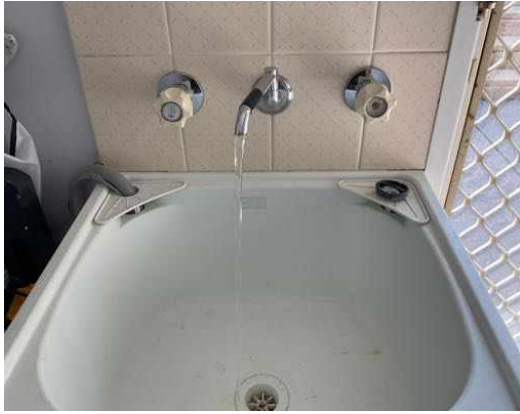
Building: Building 1
Location: All Internal Areas
Finding: Additional Photos
Information: Additional photos are provided for your general reference

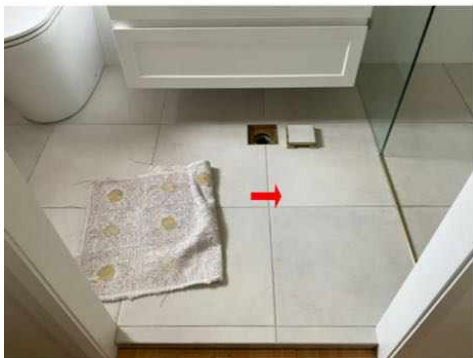
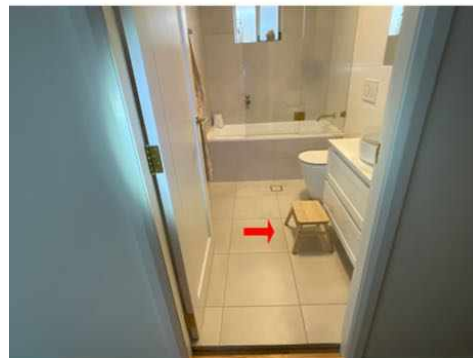
Building: Building 1
 Location: Bathrooms and laundry
 Finding: Waterproofing membranes - Information Only
 Information: Internal Water Proofing Membranes, are crucial in preventing water ingress into the property is important to know that the Membrane System used is to Australian Standards and has been installed correctly.

With older property's where this information is unavailable all wet areas should be monitored. If any leaks, water staining, peeling or bubbling of the paint become evident to any adjacent walls or ceilings below a licensed builder or waterproofing specialist is recommended to investigate further.
