Building and Timber Pest Inspection Report

Inspection Date: Sat, 24 Jan 2026

Property Address: 14/27 Mangerton Rd, Wollongong NSW
2500, Australia

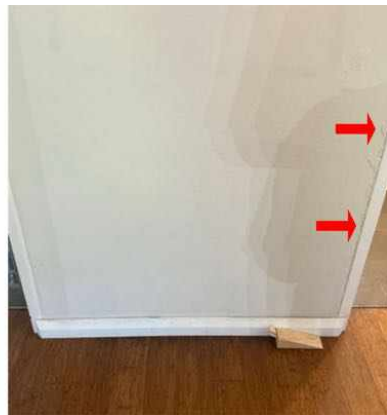
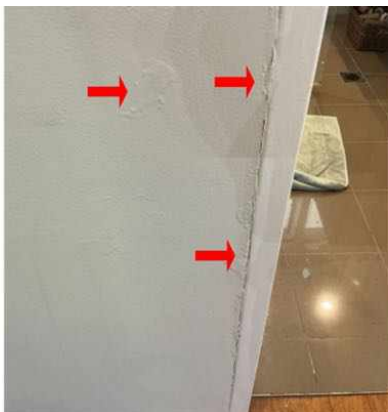
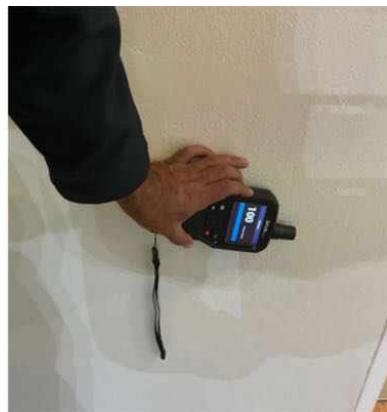
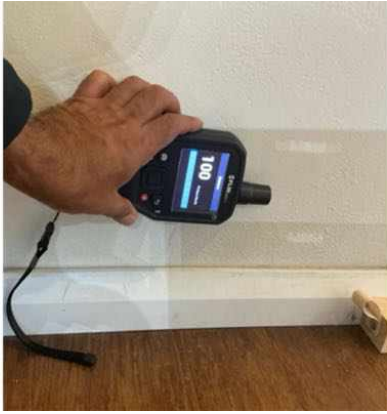
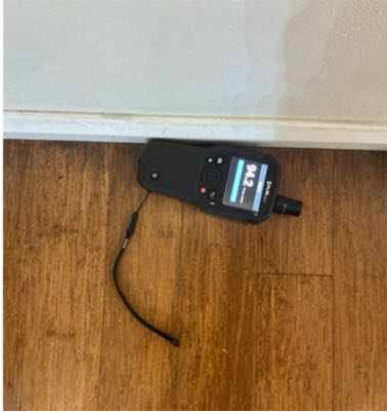
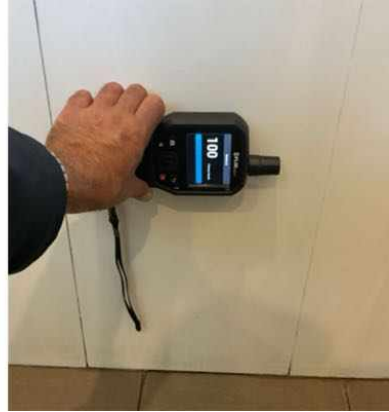
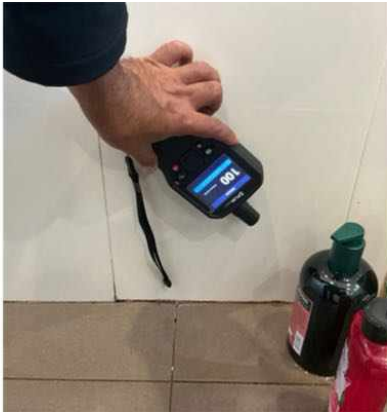
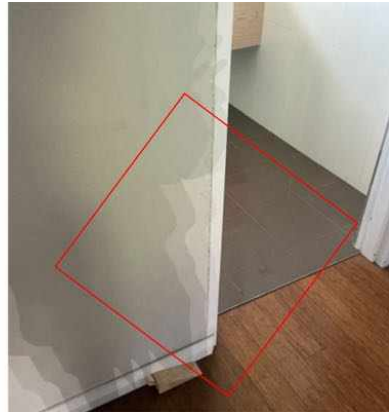
Finding 2.01

Building: Main Building
Location: Bathroom
Finding: Elevated Moisture Bathroom & Back of shower
Information: Elevated moisture levels were detected to tiled surfaces in bathroom/shower areas. This may be due to porous or missing grout, cracked tiles or recent use, however the possibility of waterproofing membrane failure or plumbing leaks cannot be excluded. Persistent moisture ingress can lead to concealed damage, including timber rot and mould growth. Further investigation by a licensed plumber and/or waterproofing contractor is recommended as soon as possible. The back of shower area also showed elevated moisture but no visible deterioration was evident at the time of inspection.

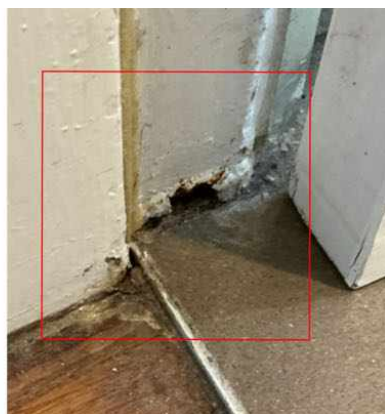
Finding 3.01

Building:	Main Building
Location:	All Internal Areas
Finding:	Wet-Area Door Jambs – Moisture Staining / Decay
Information:	Minor moisture staining and early signs of deterioration were observed at the base of the wet-area door jamb and architraves. This is commonly due to water splashing or moisture tracking from the bathroom floor into adjacent joinery.

It is recommended that the door junctions be resealed with a suitable moisture-resistant sealant and that ventilation and drainage within the bathroom be maintained to reduce further dampness. Where timber swelling or decay has progressed, localised repair or replacement using moisture-resistant materials (H3-treated or equivalent) should be undertaken.

For information only — further inspection by a licensed carpenter or waterproofing contractor is recommended to confirm the extent of deterioration and verify whether remedial sealing or minor replacement works are warranted.

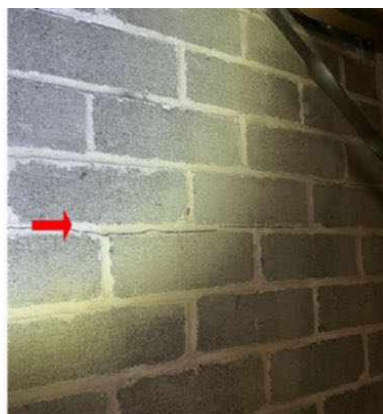
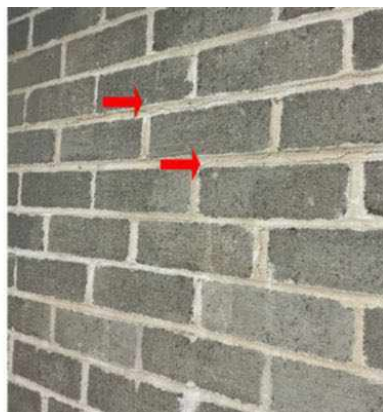
Finding 3.02

Building:	Main Building
Location:	Store Room
Finding:	Brickwork - Cracking noticeable
Information:	Noticeable cracks are a common occurrence in external brickwork and are a likely result of age expected building movement, general expansion, and/or contraction of building materials in different weather conditions. Noticeable cracks in brickwork may develop if left unattended, with potential for necessitating major remedial works or replacement of the brickwork.

It is highly advised that a qualified bricklayer be appointed to provide necessary works to cracked brickwork to prevent any further damage.

Always monitor these cracks and contact a building inspector should cracks widen, lengthen, or become more numerous.

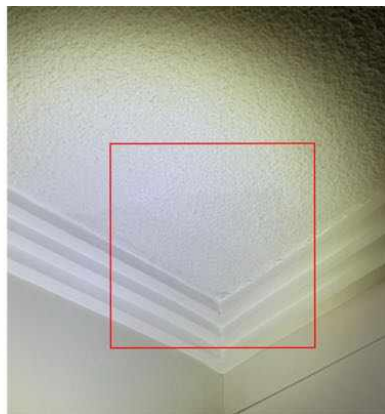
Finding 3.03

Finding: Water staining

Information: Water staining was evident in this area at the time of inspection. Water staining indicates that surfaces have been exposed to excessive moisture over time. The minerals and other elements in the water lead to staining, which may graduate to corrosion and deterioration if left unmanaged.

While mostly an appearance defect, water staining can be indicative of more serious defects, which may be currently concealed by other building elements.

Where water staining is active, a licensed plumber must be consulted to identify the cause of the staining and to provide advice on any reparation works that may be required. Replacement of any broken or damaged structures is advised.

Conversely, where water staining is old and inactive, affected building materials may be repaired or replaced at client discretion. A qualified carpenter or registered builder may be appointed to perform these works.

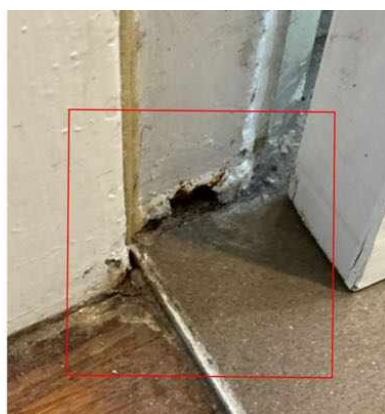
Finding 3.04

Building:	Main Building
Location:	All Internal Areas - Bathroom door frame
Finding:	Building element - Rusted or corroded
Information:	This building element shows evidence of rusting and corrosion, which is likely to have developed as a result of excessive exposure to moisture and or inadequate coatings.

As surface rust provides no protection to the underlying iron, the deteriorating condition is likely to worsen if not addressed in the short-term future.

Where possible, the use of galvanized (treated) metals or aluminium coated metals aid in rust prevention, as does regular general maintenance. Rust formation can be controlled with coatings, such as paint, that isolate the iron from the environment.

Rusting and corrosion should be managed by ideally removing or limiting the affected surface from exposure to moisture. A registered builder may be appointed to replace any building elements that have been severely affected by rust or water damage.

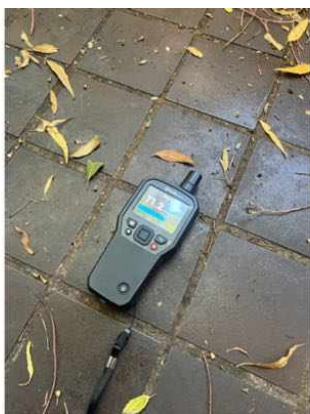
Finding 3.05

Building:	Main Building
Location:	Balcony
Finding:	Balcony Elevated Moisture - Strata

Information: Elevated moisture was recorded in balcony tiles. While no internal damage was visible at the time of inspection, balconies in multi-unit dwellings are high-risk areas for waterproofing failure, which can lead to leaks into adjoining units and significant rectification costs. Further investigation by a licensed waterproofing contractor is strongly recommended.

Depending on the strata plan, this area may form part of the common property, in which case remedial responsibility may rest with the owners corporation (strata). Purchasers should seek clarification from the strata manager and legal adviser prior to purchase.

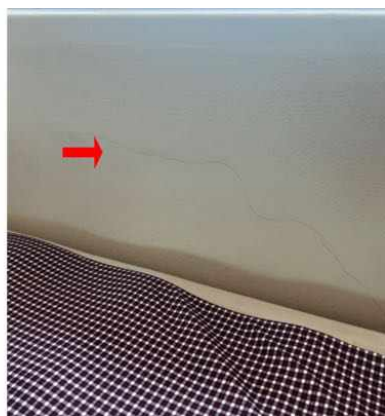
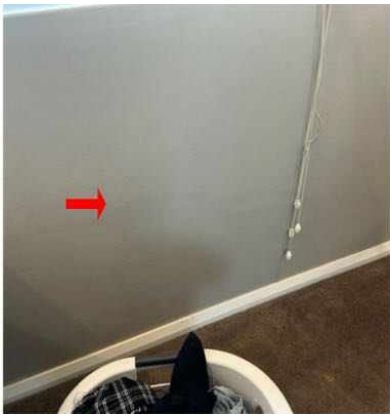
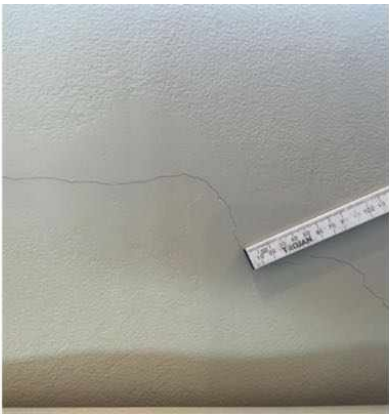
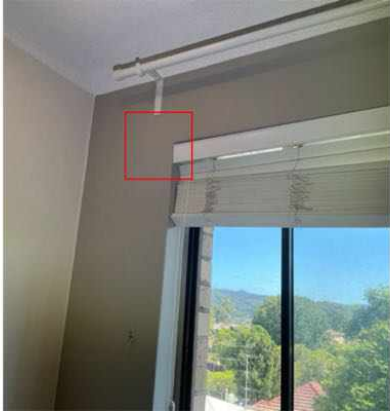
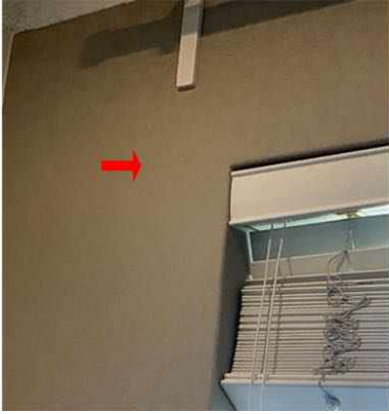
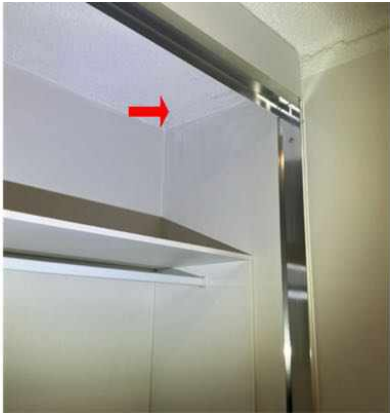
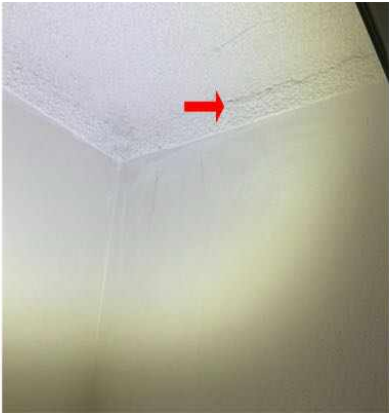
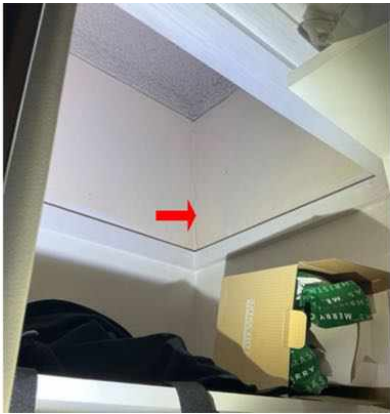
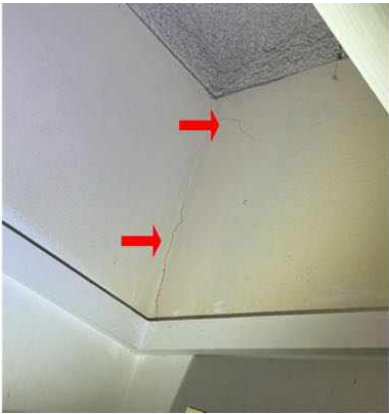
Finding 3.06

Building: Main Building
 Location: All Internal Areas - Bedroom 2 Right
 Finding: Cracks to internal render - Category 1
 Information: It has been observed that cracking to internal rendered surfaces has occurred. The degree of damage falls within Category 1, described as fine cracks that do not need repair and which are less than 1.0mm in width limit.

Damage of this category is not considered a defect for rectification. Always contact your building inspector should cracks widen, lengthen, or become more numerous.

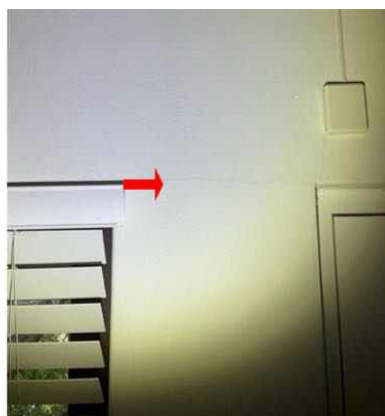
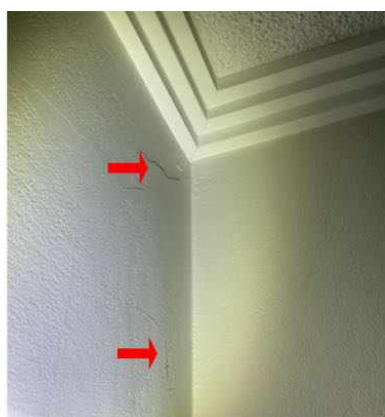
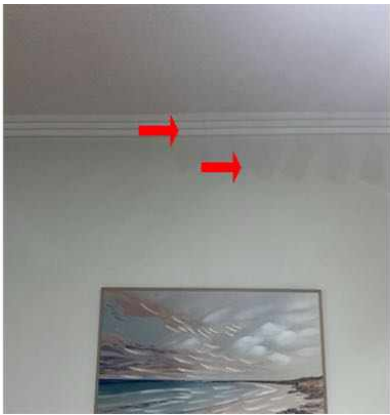
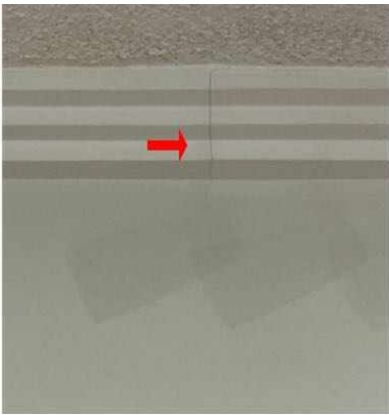
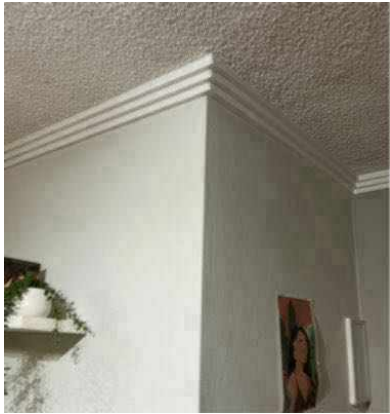
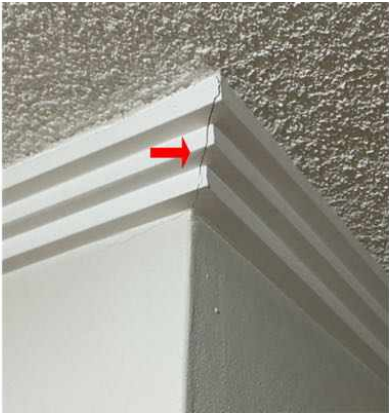
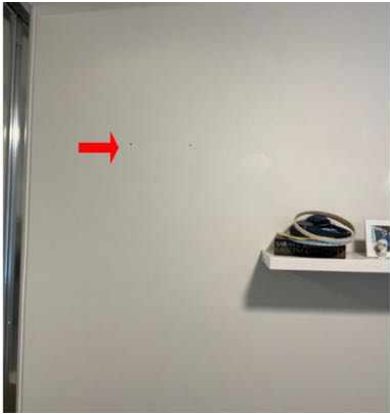
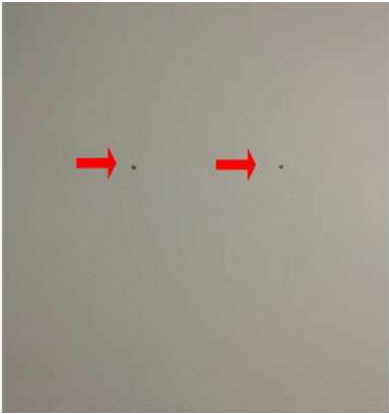
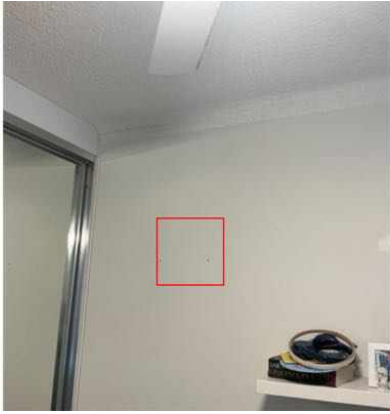
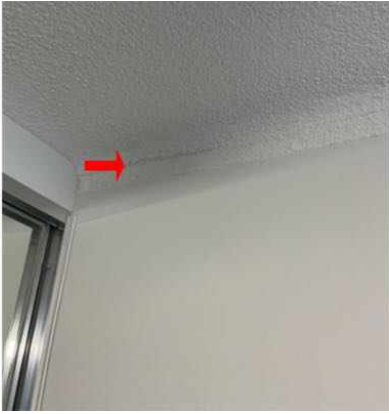
Finding 3.07

Building:	Main Building
Location:	All Internal Areas
Finding:	Paint finish and hairline cracking
Information:	The paint finish in this area was identified as being incomplete at the time of inspection including some hairline minor cracking.

Whilst incomplete or missing paint finish is generally an appearance defect, it can also lead to the development of secondary building defects over time. Incomplete areas of paint finish expose the area to moisture, potentially accelerating the deterioration of underlying building materials.

Incomplete paint finishes should be sanded back, filled, leveled and painted, as applicable. Where inadequate or missing paint protection has led to the deterioration of the associated building element, repair and/or replacement of this building element may be required.

A painting contractor should be appointed as soon as possible to perform necessary works to aid the appearance of the affected area and to ensure the area is protected against further deterioration. Alternatively, the homeowner following manufacturer instructions may perform these works.

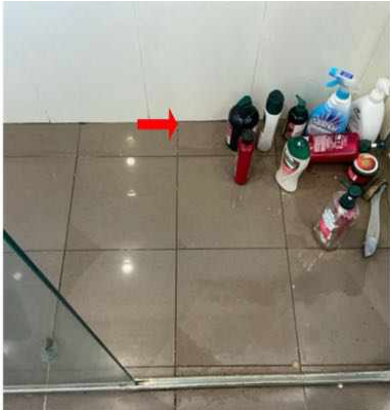
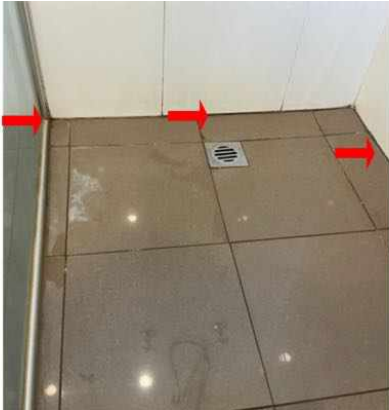
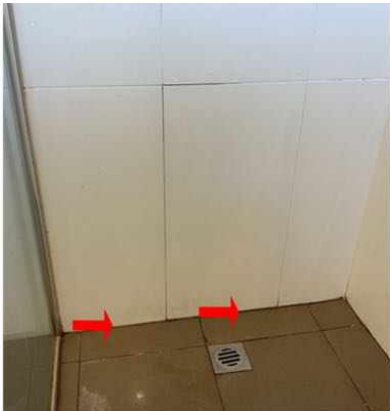
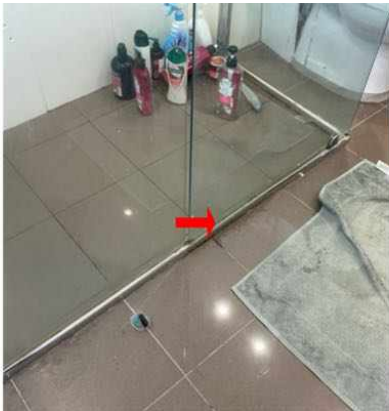
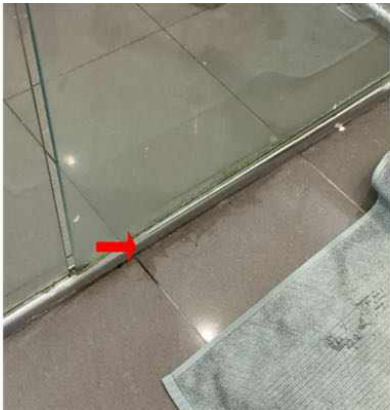
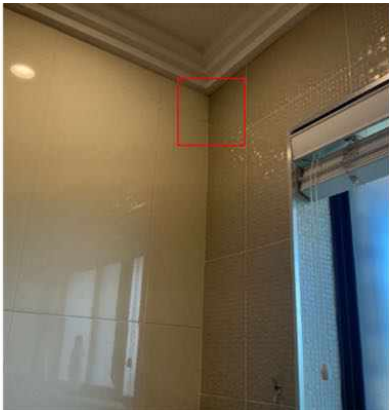
Finding 3.08

Building:	Main Building
Location:	All Internal Areas
Finding:	Sealant and grouting - Missing or degraded
Information:	It was noted on inspection that sealant or grout is degraded. There is also evidence of poor workmanship and excessive use of sealant. Silicone should never be used as a first line of defence against waterproofing. Further inspection by a licensed waterproofing contractor is highly recommend

Different materials and floor areas move at different rates, generally causing cracking to grout or sealant at this point. A flexible sealant is required to allow for expected expansion and contraction, while keeping the joint water tight and protective of all associated building materials.

There appears to be excessive mould to the sealant and grout which will likely require scraping out and replacement.

Flexible and mould resistant materials should be applied to affected areas to prevent any subsequent water damage that is likely to occur. Regular maintenance and replacement of damage or missing or damaged sealant and grout is highly recommended to the wet areas, as this is a regular wear and tear defect. Sealant and grouting in areas that come into regular contact with water should be maintained for the long term care of your property.

A sealant specialist or tiling contractor should be appointed to complete these works as soon as possible

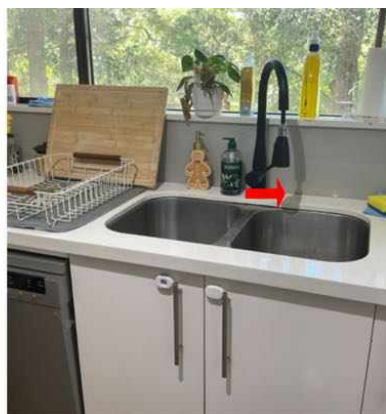
Finding 3.09

Building:	Main Building
Location:	All Internal Areas - Kitchen
Finding:	Building element - Damaged - Stone top chipped
Information:	Breakage occurs generally when the building materials have either aged and decayed, or as a result of damage (accidental or deliberate).

Repair and/or replacement of broken elements is advised to ensure that additional secondary defects do not arise as a consequence. Such works are necessary, as all building elements play a key role in the operation and function of the overall structure and its performance.

A relevant tradesperson should be appointed to repair or replace the affected building element prior to any subsequent damage being caused.

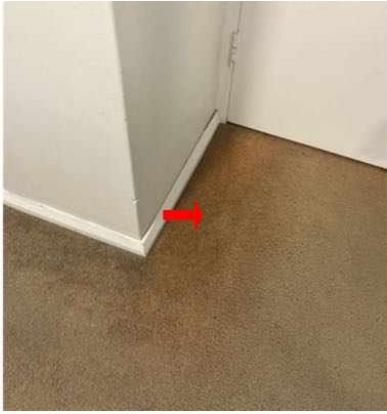
Building: Main Building
Location: All Internal Areas
Finding: Carpet Wear and Shading
Information: Carpet throughout shows pile flattening/shading,/staining/lifting and/or visible traffic patterns.

Condition is consistent with normal wear and tear. Professional steam cleaning is recommended to improve appearance.

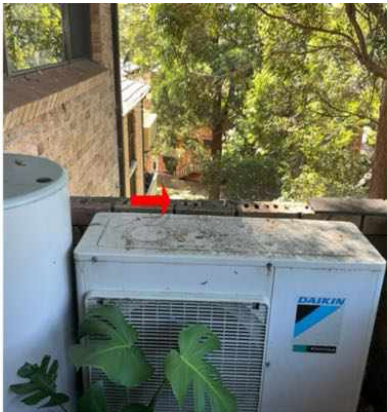
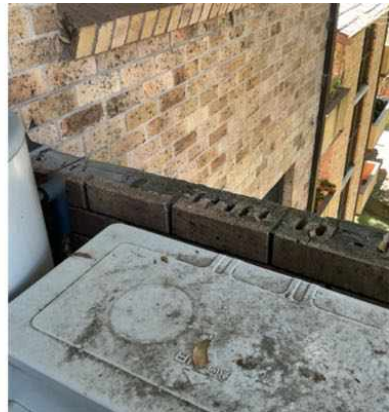
Finding 3.11

Finding: Building element - Missing - Tiles missing

Replacement of any missing building element should be conducted as soon as possible to ensure that no damage or functional issues occur to associated building materials.

The appropriate tradesperson should be appointed as soon as possible to replace the missing building element.

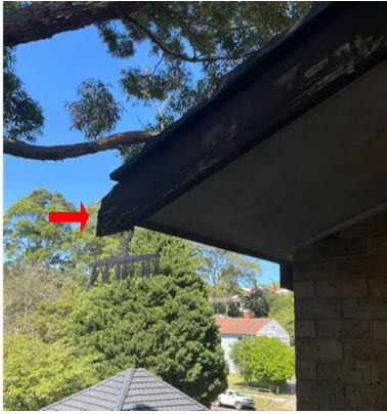
Finding 3.12

Building:	Main Building
Location:	Balcony
Finding:	Fascias - Wood rot
Information:	Wood rot was found to be affecting fascias and barges in this area, evidenced by the presence of mould on the surface in some areas. Wood rot, also known as Fungal Decay, occurs when timbers and other cellulose building materials are exposed to damp conditions on an ongoing basis.

It is likely that this wood rot has developed as a result of faults in the roof plumbing, creating excessive moisture in this areas. Frequent exposure to rain and other weather conditions also make fascias and barges susceptible to accelerated deterioration.

Early intervention and regular maintenance will prolong the useful life of these building elements. Prior to any works being performed, the cause of the moisture that has created the visible wood rot should be identified and addressed in a suitable manner.

It is advised that a roof plumber be appointed to inspect all roof plumbing and subsequently identify the cause of the wood rot. Replacement of affected fascias and barges may then be a necessary step in protecting surrounding building elements from such deterioration.

A qualified plumber may be appointed to assess the cause of excessive moisture and to provide advice on any remedial works as required. A qualified carpenter or registered builder may also be required to replace affected building materials.

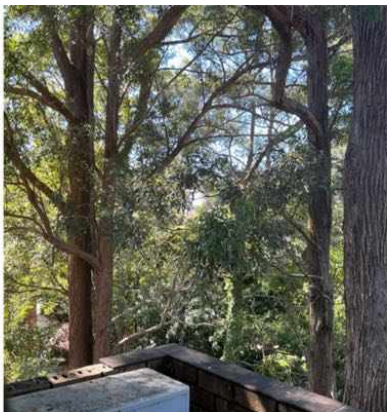
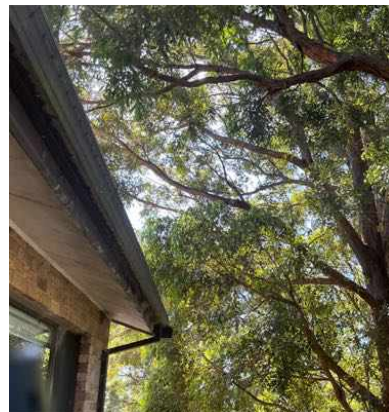
Finding 6.01

Building:	Main Building
Location:	All External Areas
Finding:	Trees within 50m
Information:	Trees within 50m of the property can be conducive to termite activity. It is recommended an invasive inspection of all trees with 50m to the property be carried out by a qualified pest control expert.

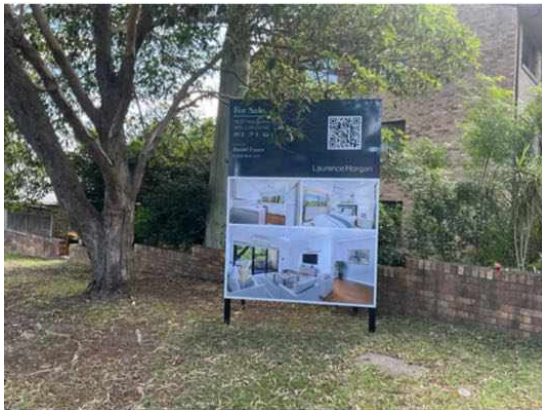
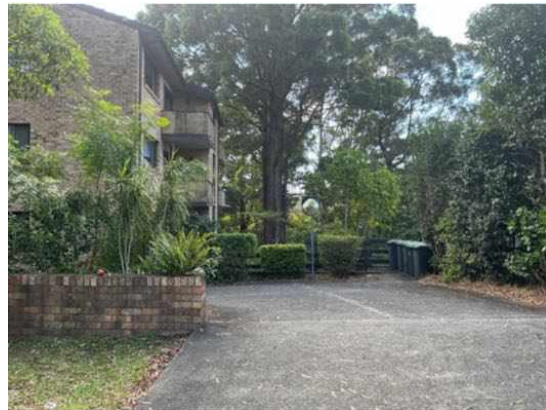
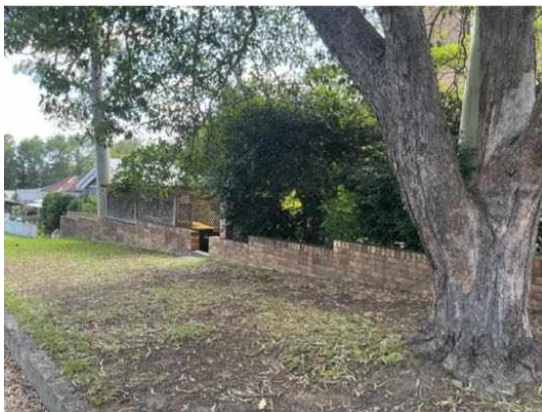
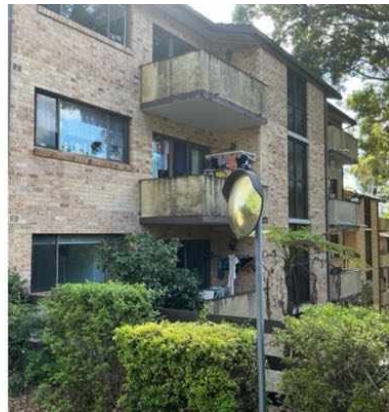
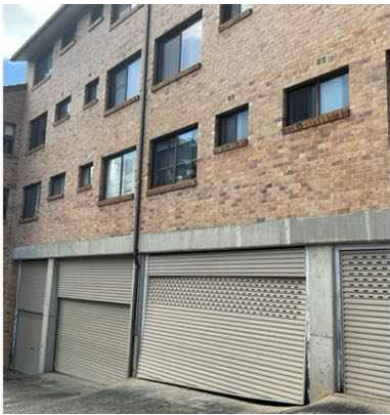
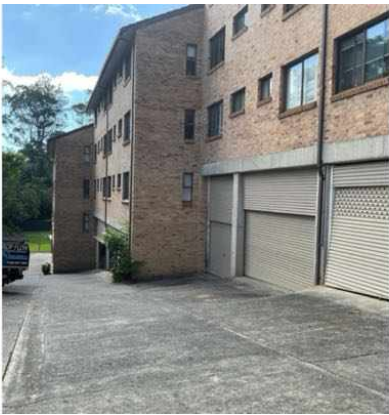
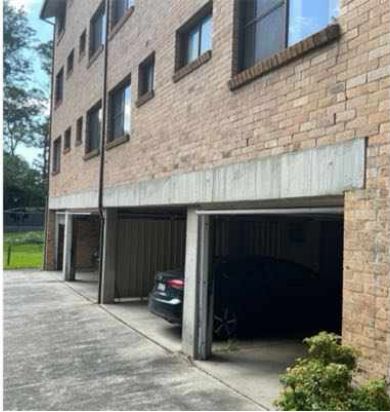
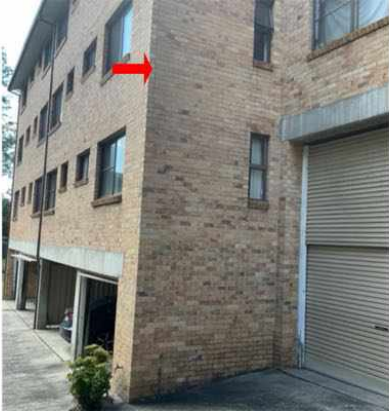
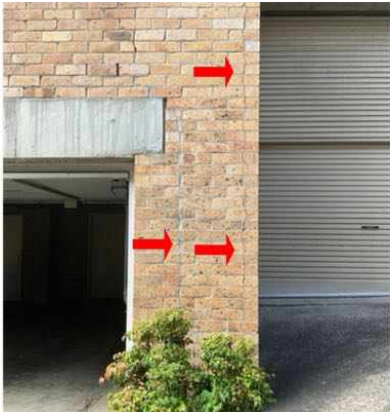
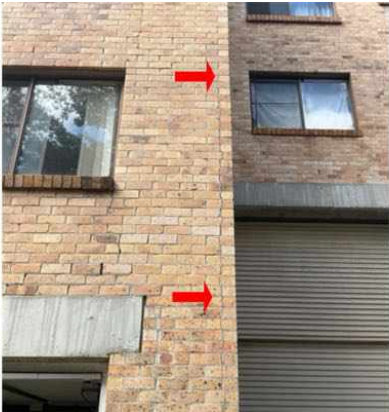
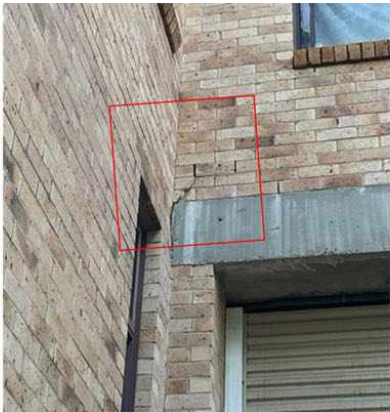
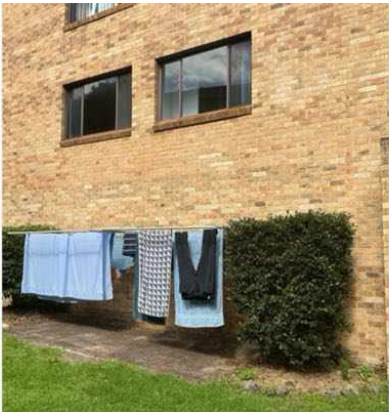
Noted Item

Building: Main Building
Location: All External Areas
Finding: Additional Photos - Obstructions and Limitations
Information: These photographs are an indication of the obstructions and limitations which impeded full inspection of the property at the time of inspection. These obstructions can hide an array of defects and should be removed to allow full inspection to be carried out. A re-inspection is recommended once the areas are made accessible.

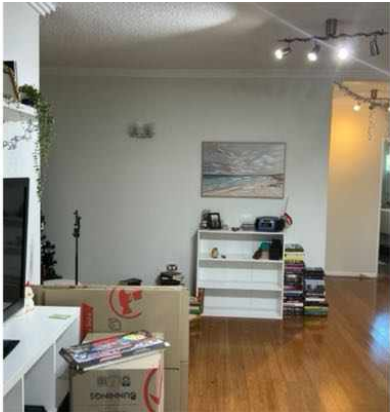
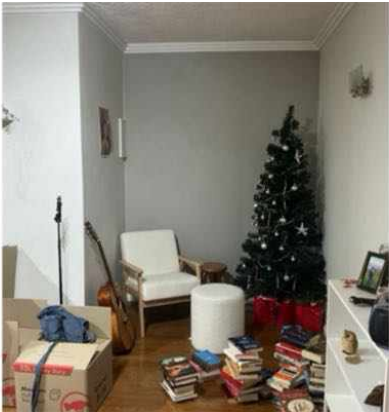
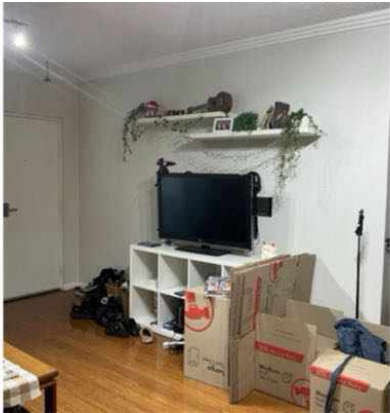
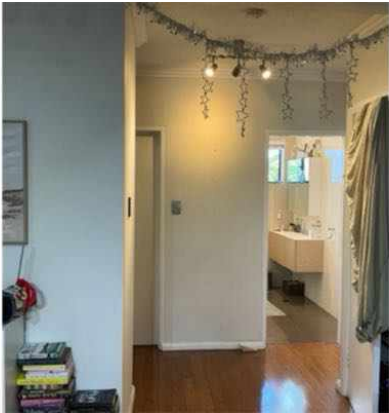
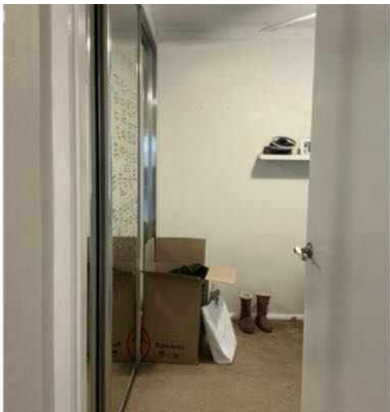
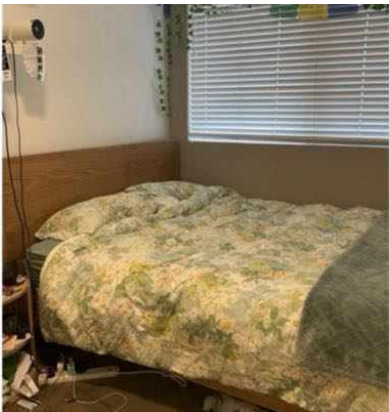
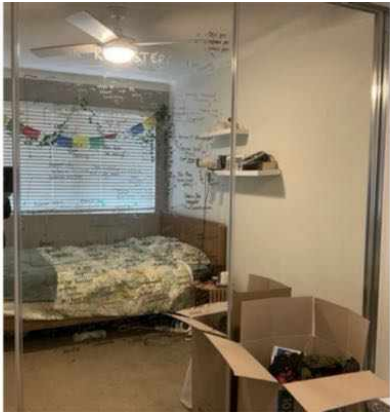
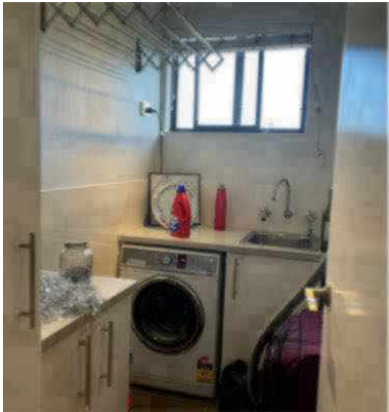
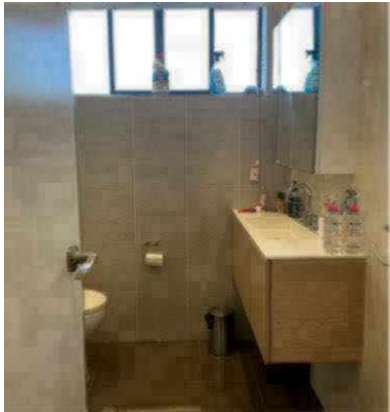
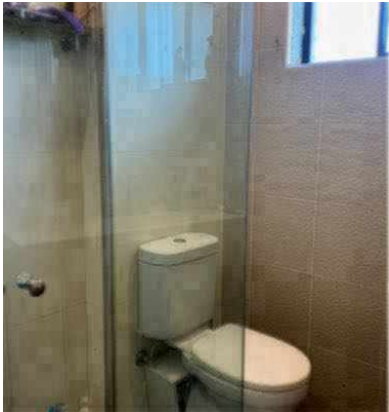
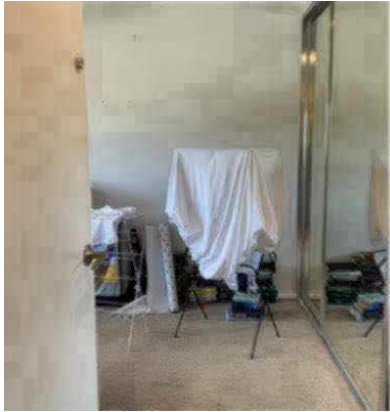
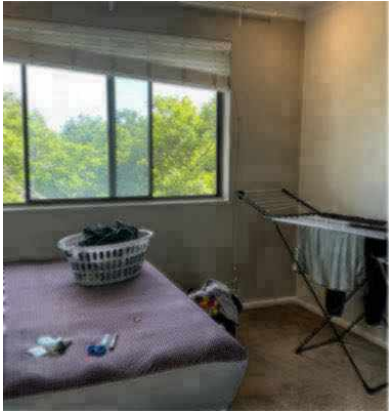
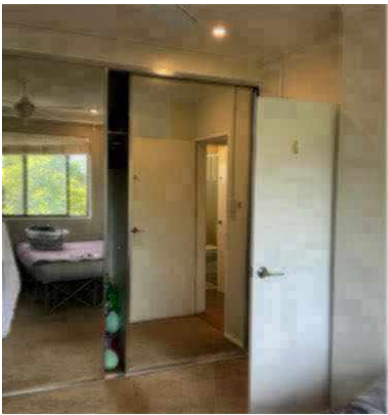
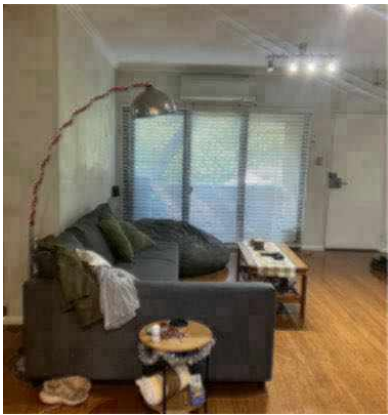
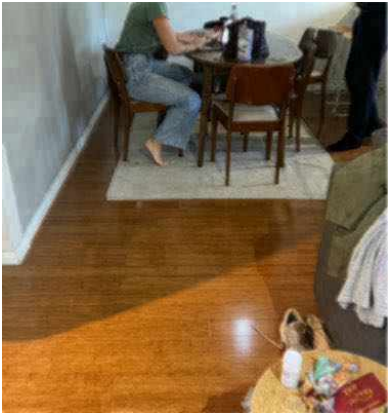
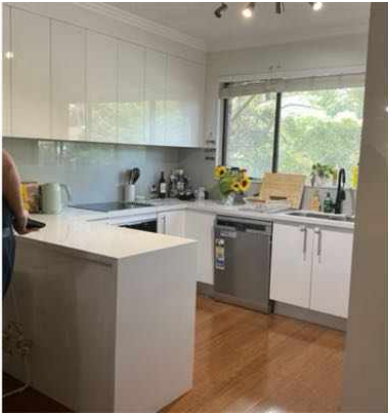
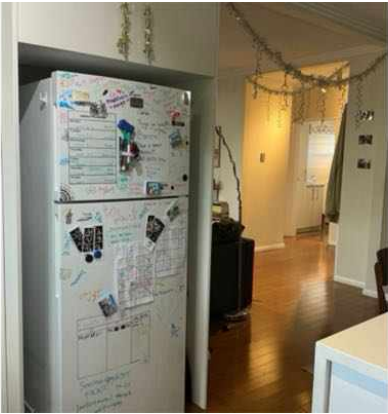
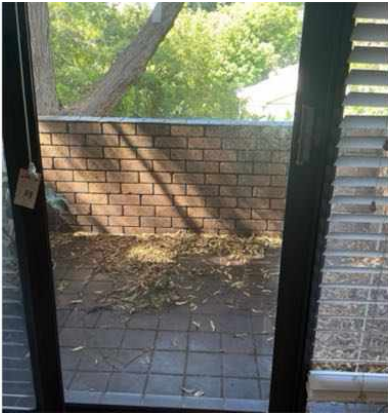
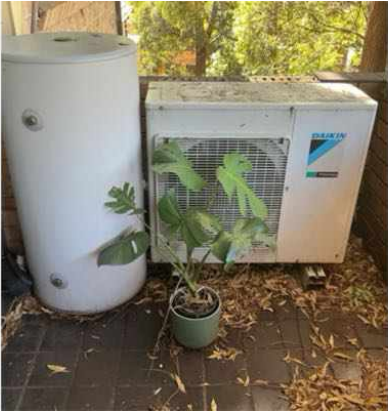
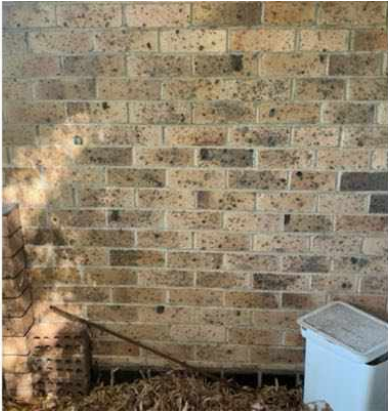
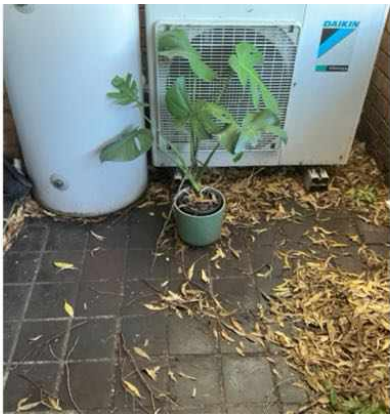
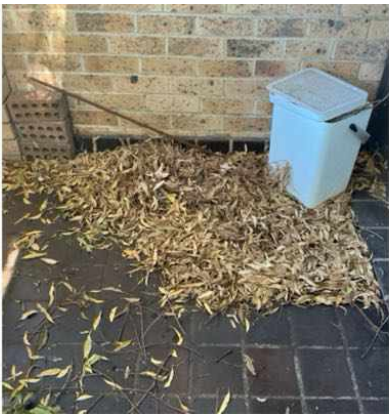
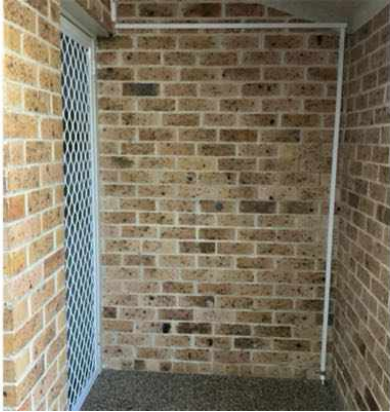
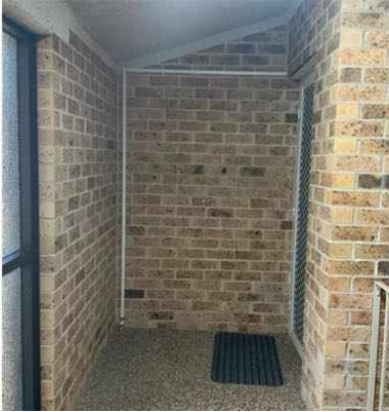
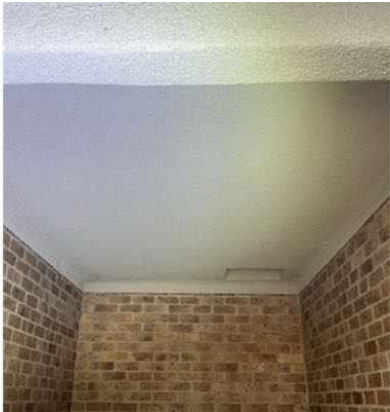
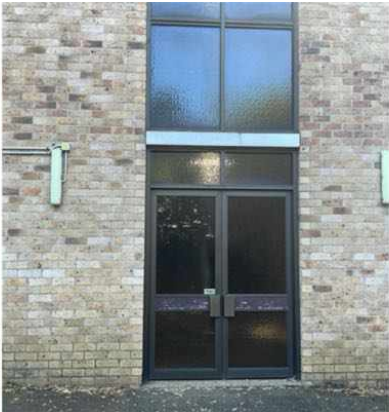
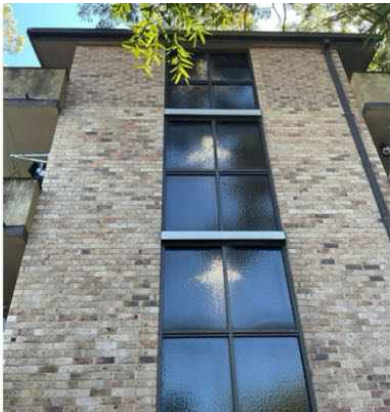
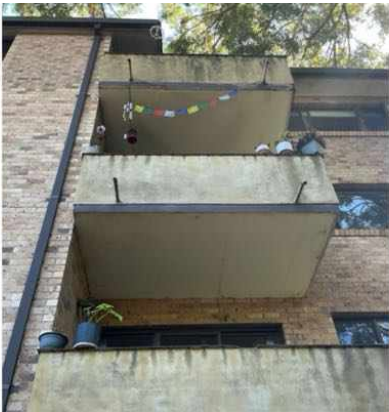
Building: Main Building
Location: All Areas - Interior and exterior
Finding: Additional Photos - Obstructions and Limitations
Information: These photographs are an indication of the obstructions and limitations which impeded full inspection of the property at the time of inspection. These obstructions can hide an array of defects and should be removed to allow full inspection to be carried out. A re-inspection is recommended once the areas are made accessible.

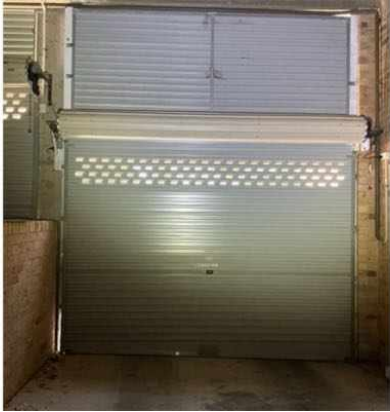
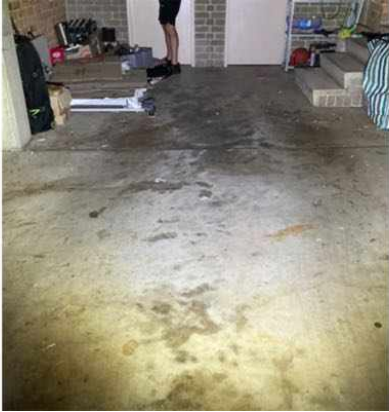
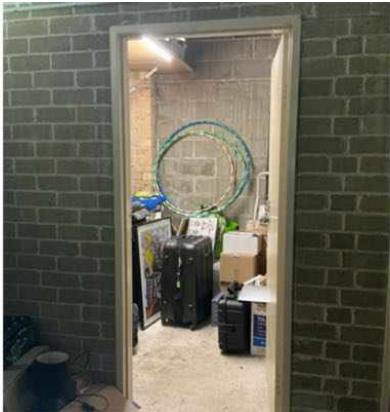
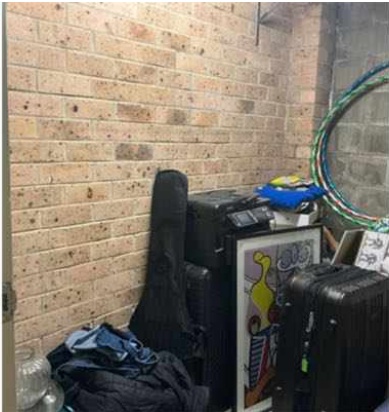
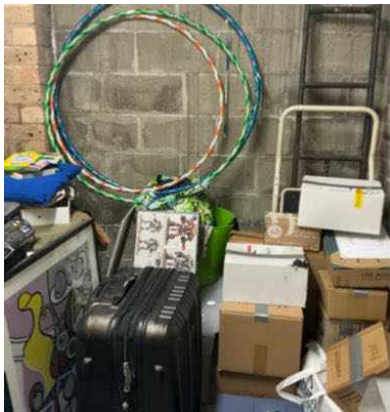
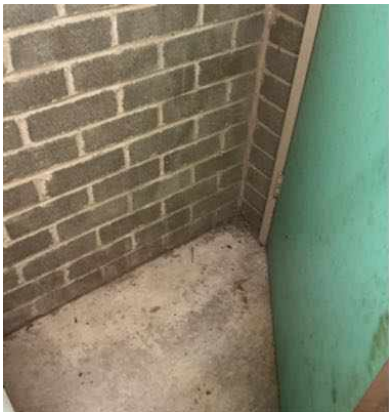
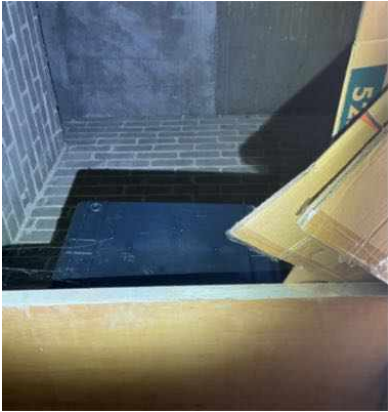
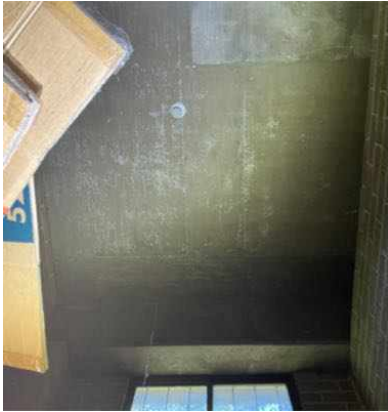
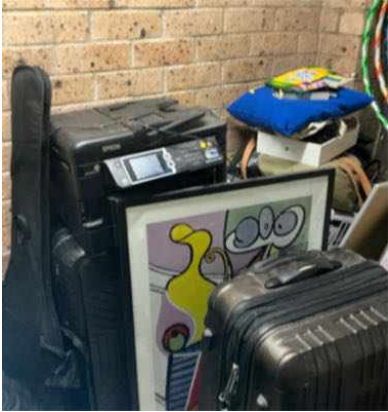
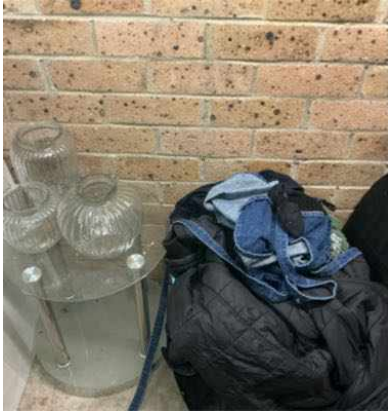
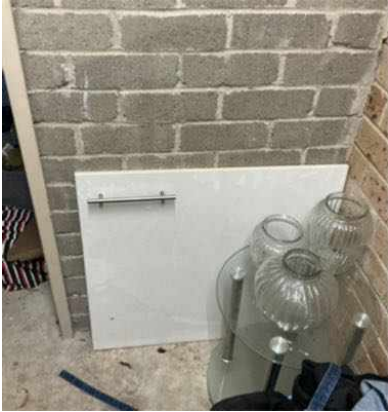
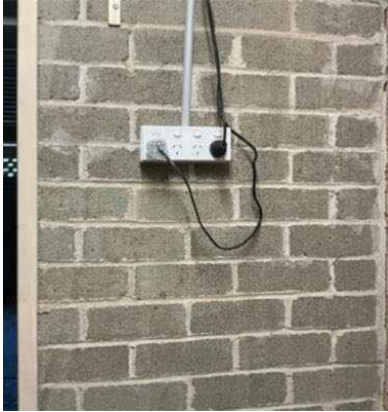
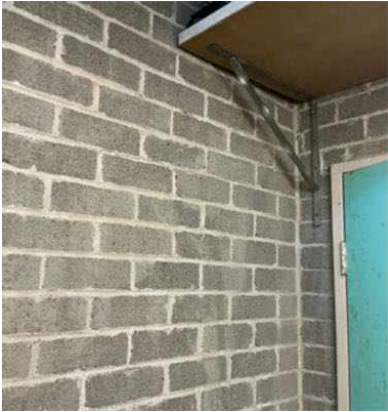
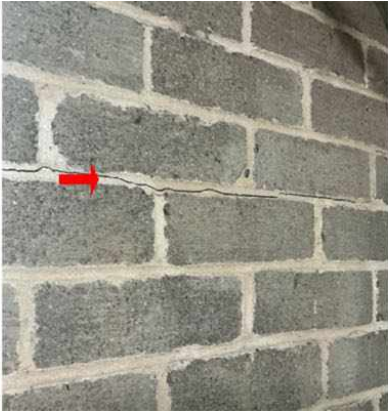
Building: Main Building
Location: Garage
Finding: Additional Photos - Obstructions and Limitations
Information: These photographs are an indication of the obstructions and limitations which impeded full inspection of the property at the time of inspection. These obstructions can hide an array of defects and should be removed to allow full inspection to be carried out. A re-inspection is recommended once the areas are made accessible.

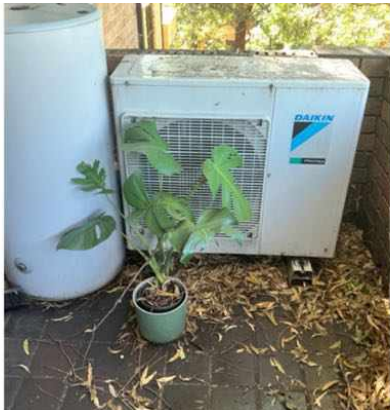
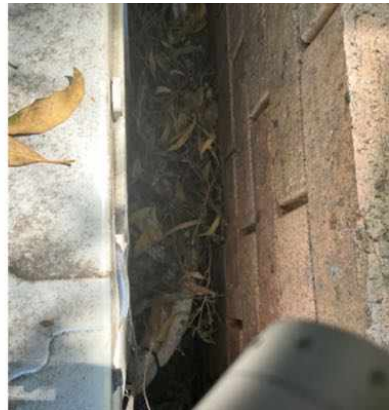
Finding: Debris

Information: The balcony area shows accumulated leaf litter and organic debris, restricted drainage gaps at the slab-to-wall junction, and close proximity of combustible material to the building fabric. These conditions collectively increase the risk of moisture retention, which may contribute to surface deterioration, mould growth, and reduced durability of adjoining materials over time, as well as a low-to-moderate fire risk due to the presence of dry combustible debris, particularly during hot or dry conditions.
