Building and Timber Pest Inspection Report

Inspection Date: Mon, 30 Mar 2026

Property Address: 8 Cross St, Raceview QLD 4305, Australia

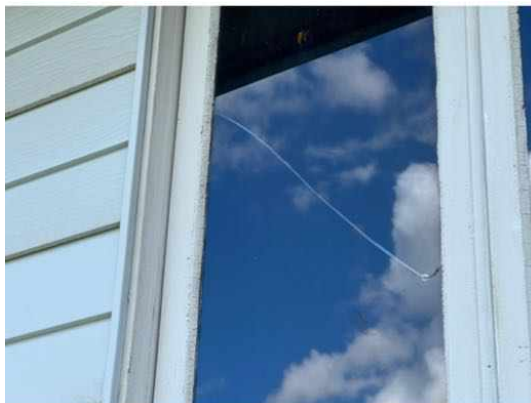
Building:	Main Building
Location:	Front & Rear Elevations
Finding:	Windows - Cracked
Information:	At the time of inspection cracking in a number of windows located at both the front and rear of the building was identified.

Cracking in windows is generally the result of impact damage, and is likely to develop further when left unmanaged.

The likelihood of this windowpane further cracking and shattering is increased exponentially, providing a safety hazard in the area. The cracked window also impairs the weather tightness of the building, creating potential for minor water leaks.

A qualified glazier is required to repair the window as soon as possible. Depending on the extent of the cracking, replacement of the window may be required.

Please be advised that any persons coming into contact with the cracked window should do so with due caution to avoid any personal injury that may ensue.

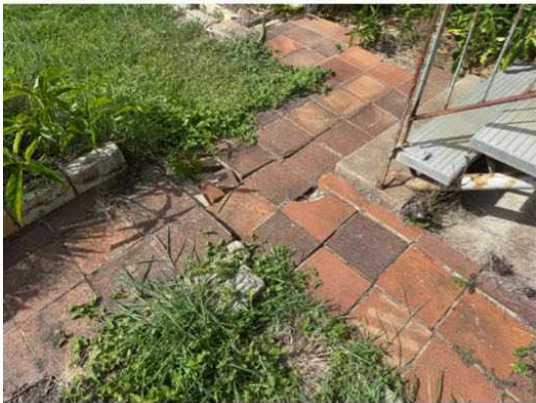
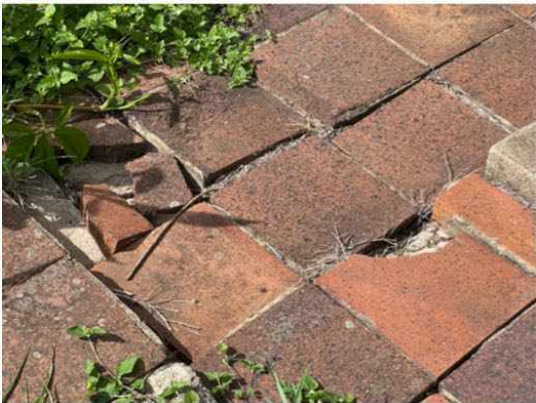
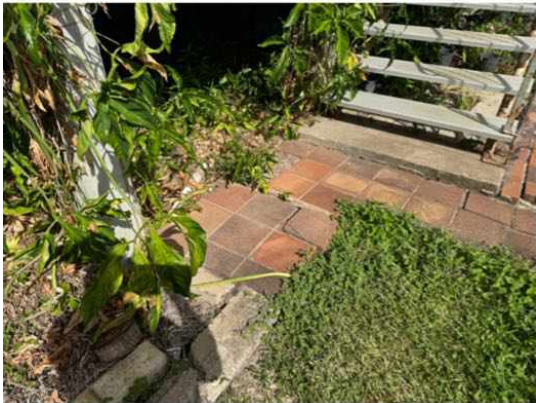
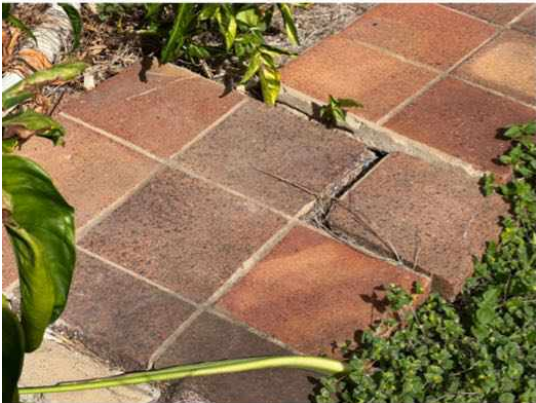
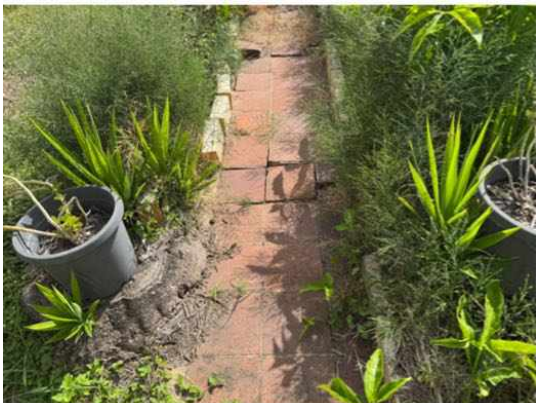
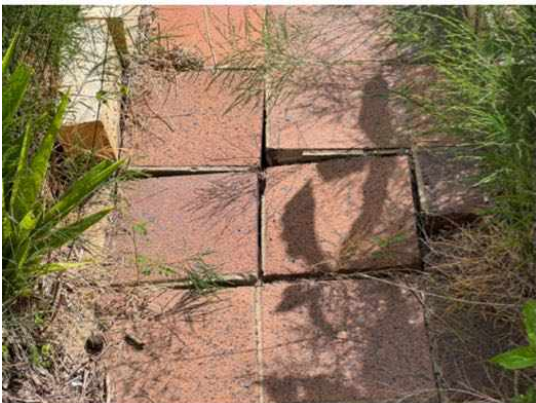
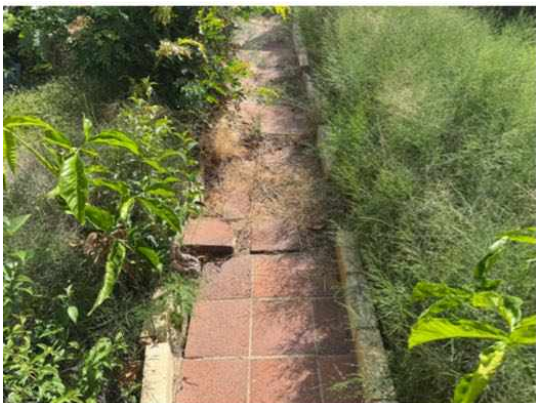
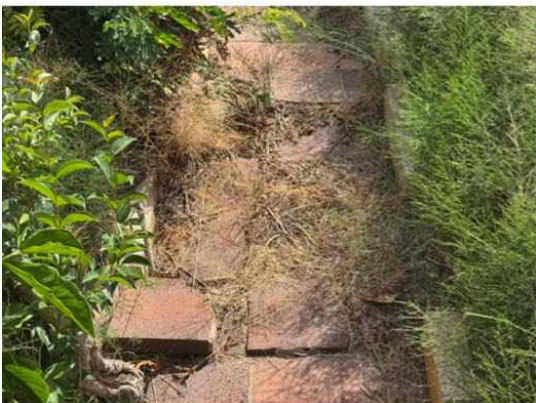
Finding 1.02

Building: Yard
Location: Yard - Front
Finding: Paving - Uneven
Information: Sections of the external paving located in the front of the property are uneven, creating a potential trip hazard.

It appears as though the area has been subject to rough installation, or that paving sections have lifted due to movements in the foundations.

Where paving creates a trip hazard, personal injury may ensue if due caution is not taken by all persons within this area.

Re-paving of the area is required as soon as possible to remedy this situation. Further consultation with a specialist concreter is advised.

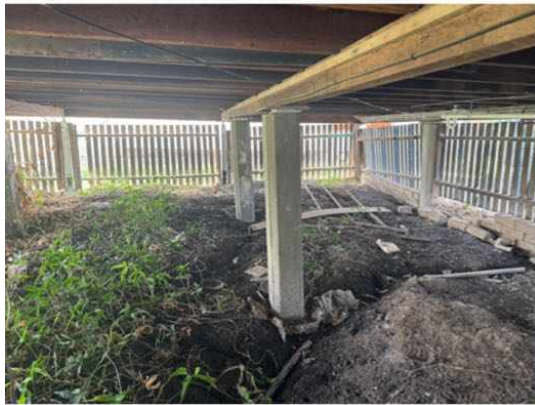
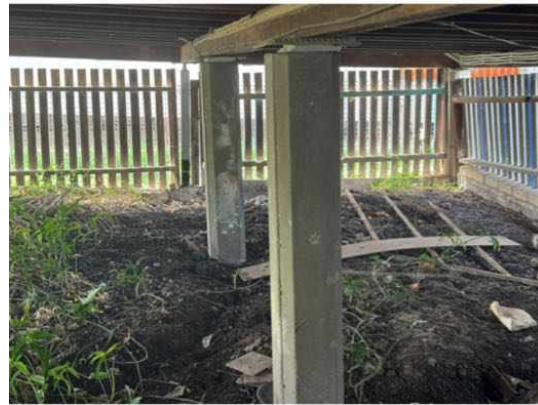
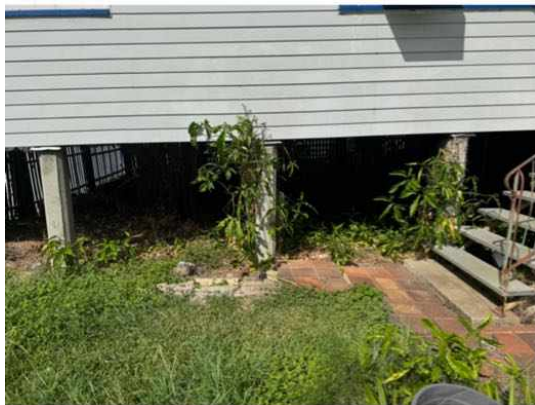
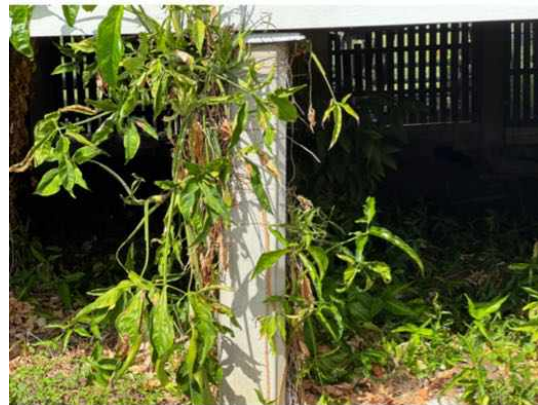
The client should be prepared that in purchasing a property with leaning piers, the need to restump the property in the short- to medium-term future is highly likely, which involves expensive works.

A structural engineer may be appointed to provide advice on the structural integrity of the piers.

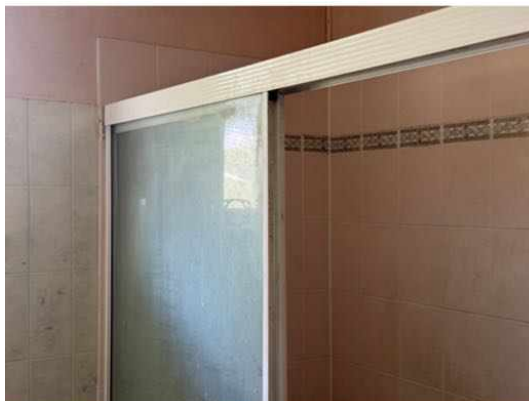
Replacement of shower screen hardware or frame may be required, as well as minor repairs and cleaning.

A contractor specialising in shower screen installations should be engaged to perform repair works.

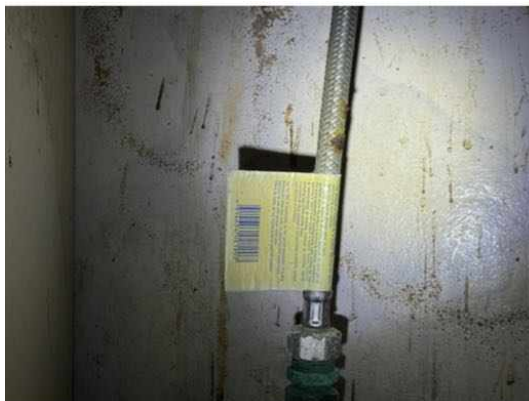
Rusting and corrosion should be managed by ideally removing or limiting the affected surface from exposure to moisture.

A registered plumber should be appointed to replace these elements as soon as possible.

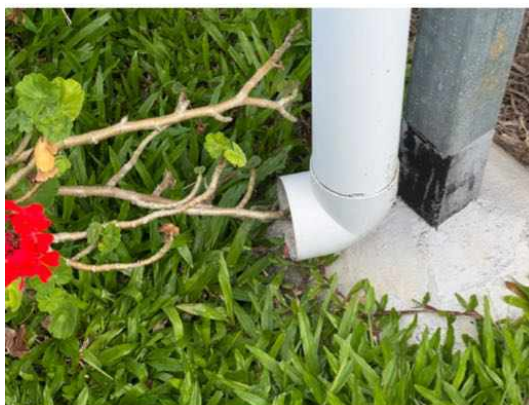
It is important that water does not lie against the base of walls. Surrounding paths and ground levels should be sloped to drain water away from the building.

It is highly recommended that a plumber be appointed to further inspect the area and to install adequate drainage equipment where necessary.
