Building and Timber Pest Inspection Report

Inspection Date: Fri, 30 Jan 2026

Property Address: 3 Brockamin Dr, South Penrith NSW 2750, Australia

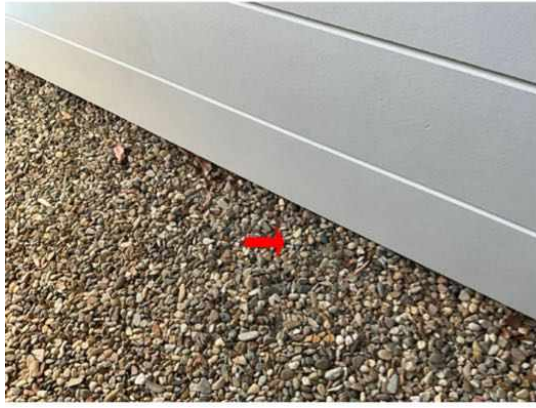
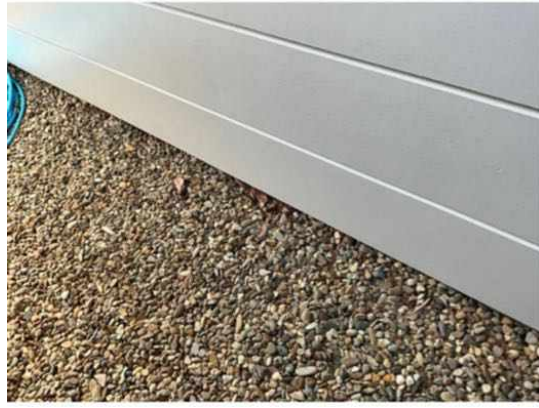
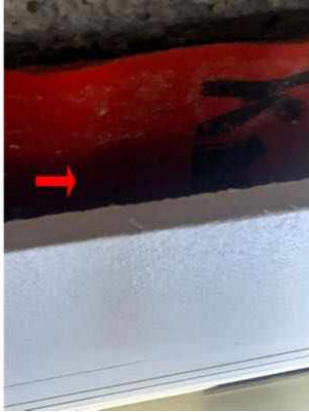
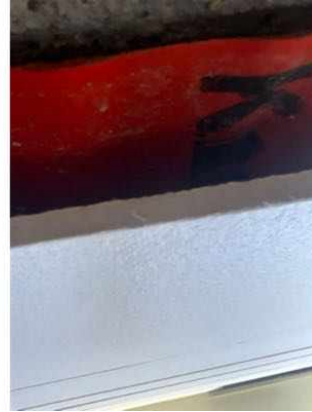
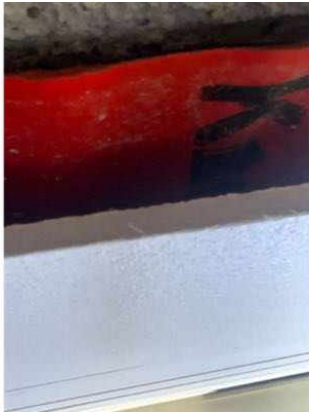
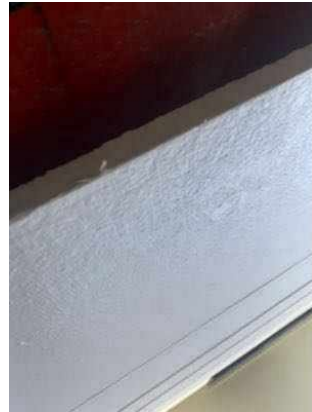
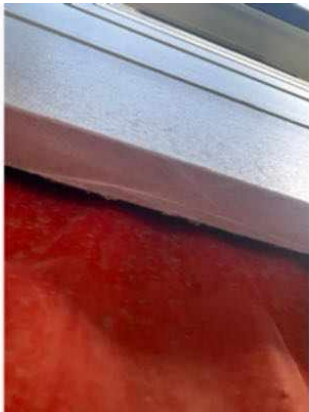
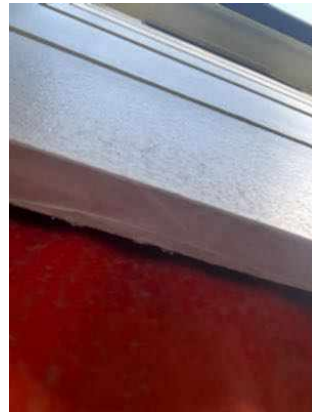
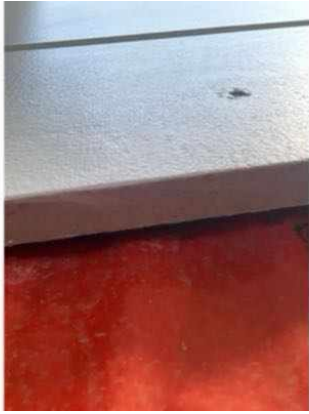
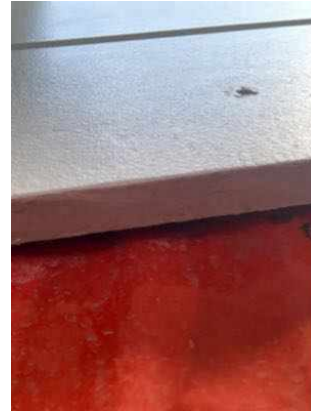
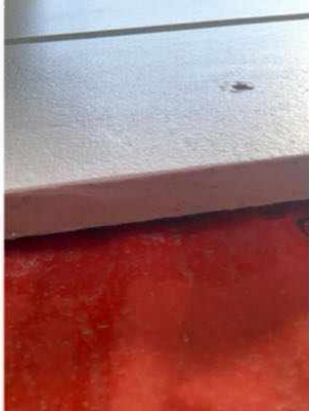
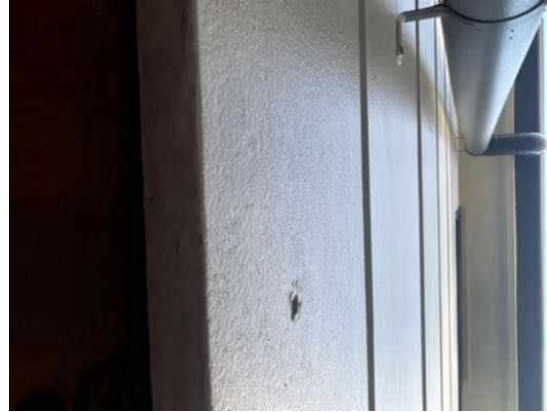
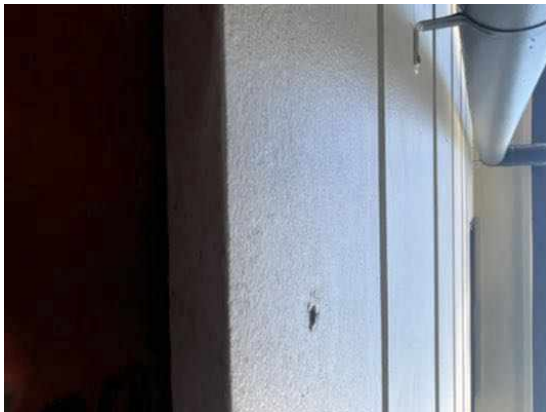
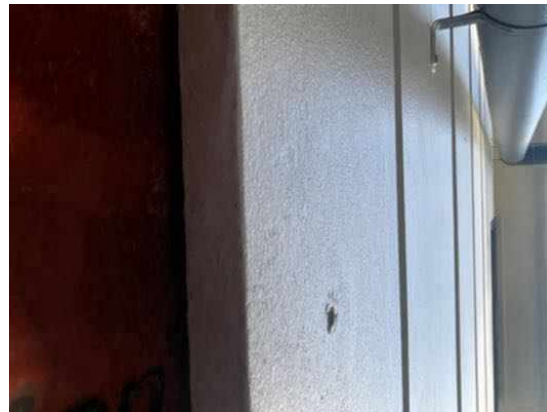
Building: Main Building
Location: Exterior walls - rear
Finding: External Cladding – Missing Bottom/starter Trims
Information: The bottom trims / starter trims to the external wall cladding were observed to be missing in areas inspected. This has resulted in exposed lower edges of the cladding and gaps at the base.

- Increased risk of moisture ingress behind the cladding, potentially leading to deterioration of framing and wall components.
- Potential pest entry (including insects and vermin) through exposed gaps.
- Reduced durability of cladding due to exposure of cut edges.
- Possible non-compliance with manufacturer installation requirements and building standards.

The missing bottom trims should be installed to adequately seal and protect the lower edge of the cladding system.

A licensed builder or qualified cladding installer should be engaged to supply and install appropriate bottom trims in accordance with the cladding manufacturer's specifications and relevant Australian Standards.

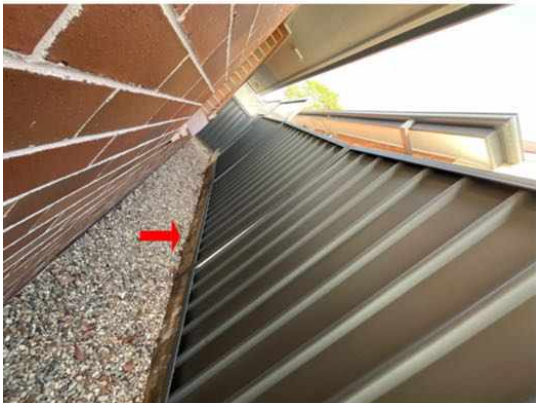
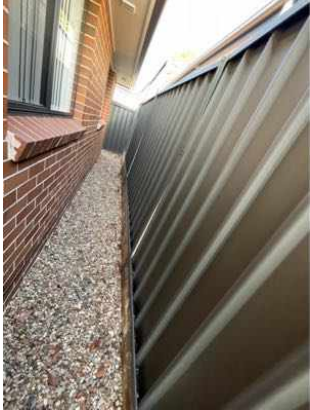
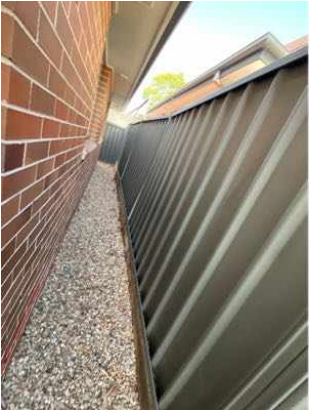
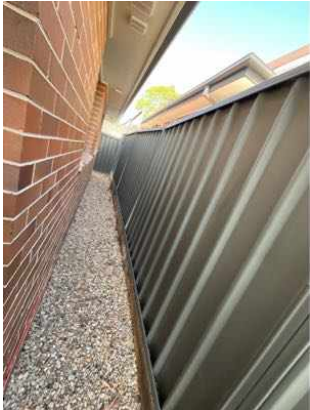
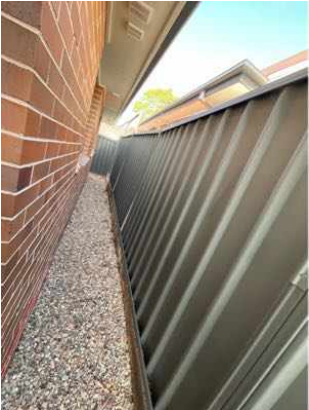
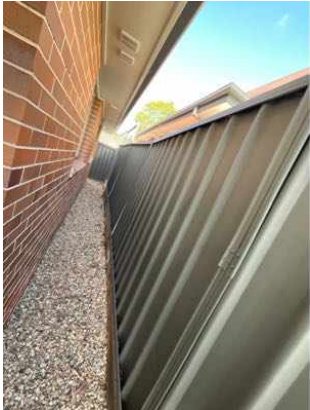
Finding 3.02

Building: Main Building
 Location: Yard - Back
 Finding: Leaning fence
 Information: The fence is leaning, deviating from its vertical position, compromising its stability and aesthetic appeal.

The leaning fence poses a risk of collapse, potential property damage, and a security breach, diminishing its effectiveness as a barrier.

A skilled fencing contractor or handyman is needed to assess and rectify the leaning fence. Timely repair is crucial to restore the fence's stability and prevent further

damage or safety hazards.

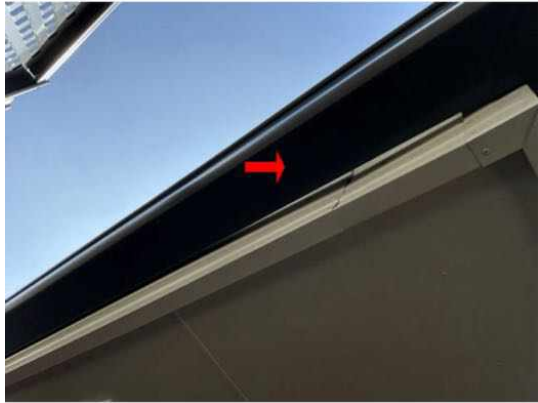
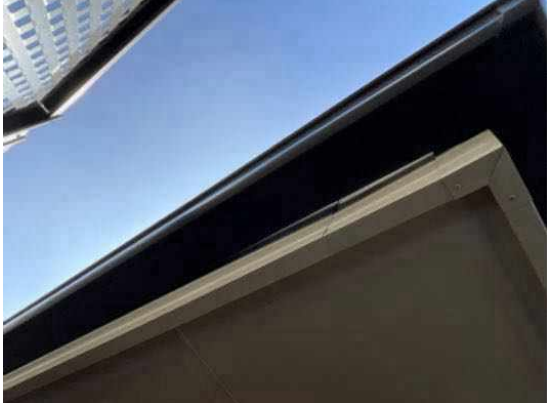
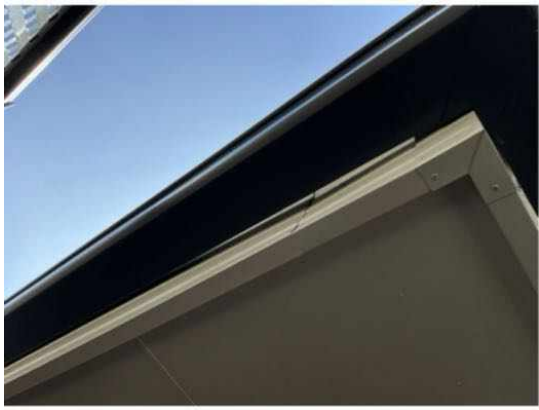
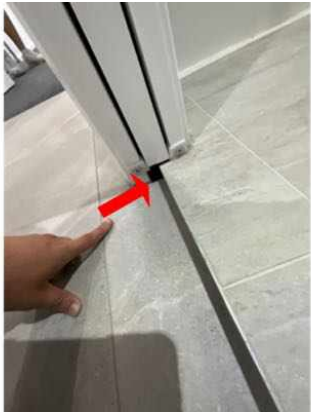
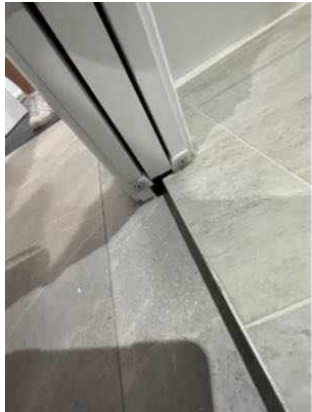
Finding 3.03

Building: Main Building
Location: Rear Elevation
Finding: Poor workmanship
Information: The structure exhibits signs of poor workmanship, evident in various aspects of construction and finishing.

Risk: Poor workmanship poses a range of risks, including compromised structural integrity, potential safety hazards, and a decreased lifespan of the structure. It may

also lead to aesthetic and functional issues.

Resolution: A qualified contractor or construction professional should be consulted to assess and address the poor workmanship. They can implement corrective measures to ensure structural soundness, safety, and overall quality of the construction.

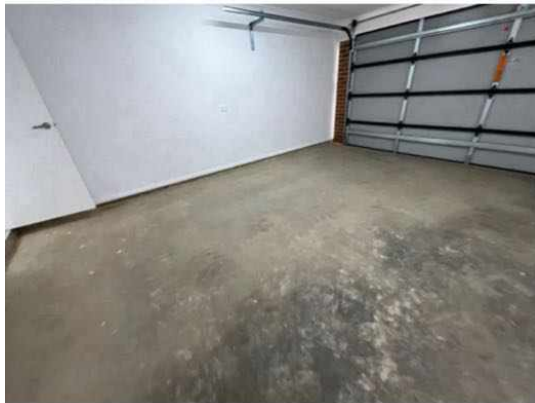
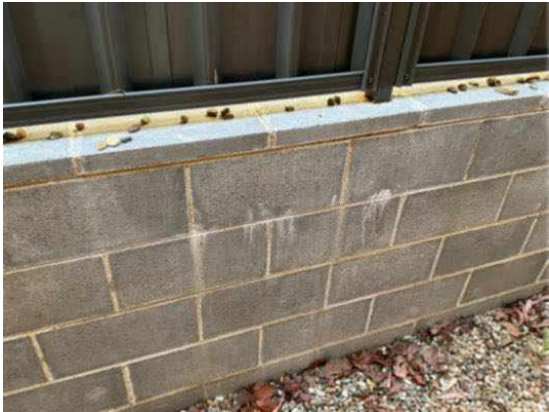
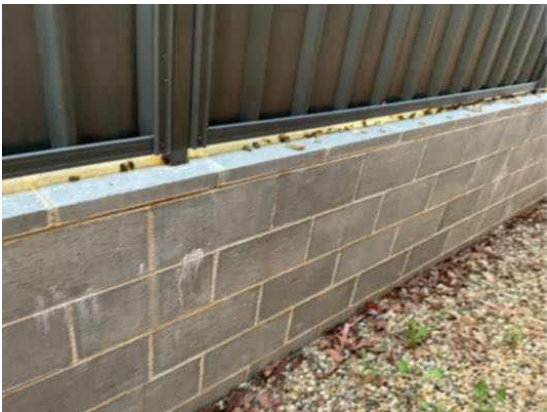
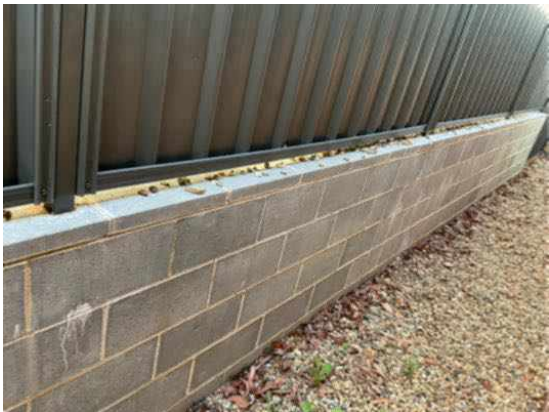
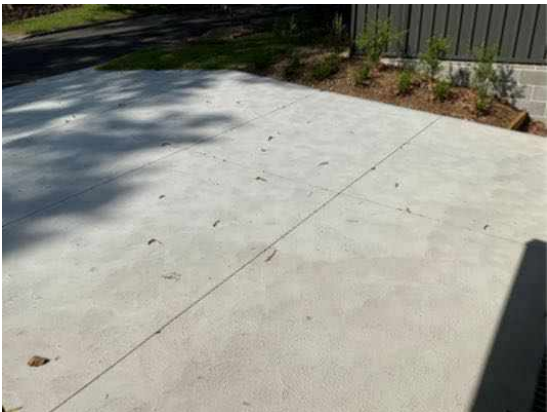
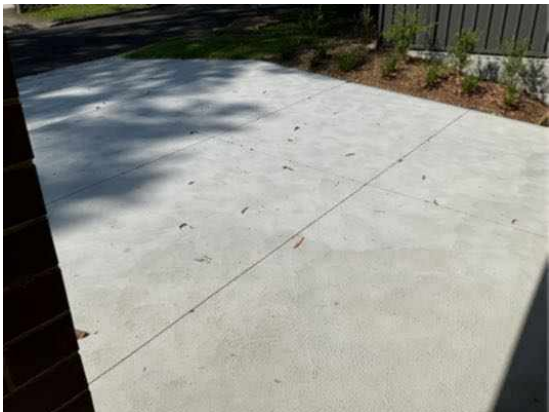
Finding 3.04

Building: Main Building
Location: All Areas
Finding: Cleaning required
Information: It was observed that the house requires cleaning.

Works are defective where windows are not clean, floors are not swept, mopped or vacuumed as appropriate, tiles, sinks, basins, baths, windows or any other area throughout the property are not cleaned, and shelving, drawers and cupboards are not ready for use not cleaned and ready for use at handover.

Building sites are defective if they are not clear of building debris.

This is to be addressed prior to handover.

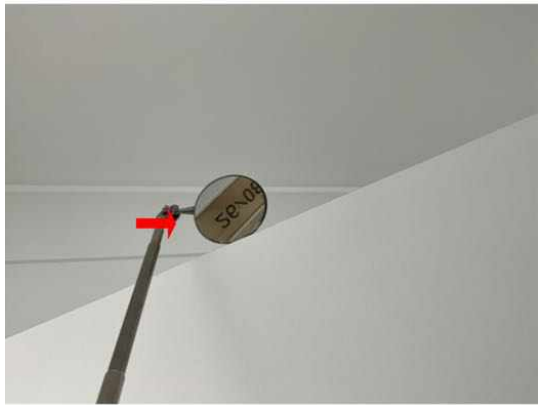
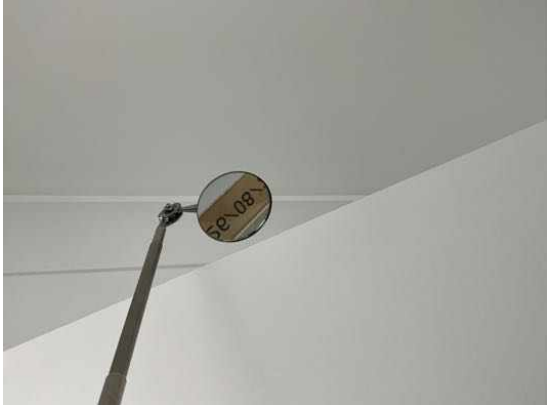
Finding 3.05

Building:	Main Building
Location:	All Areas
Finding:	Incomplete Painting of Doors
Information:	The paintwork on the doors throughout the building is incomplete, failing to meet the requirements specified by Australian Guides and Tolerances.

- ****Coverage:**** Incomplete paint coverage on the doors, with visible areas left unpainted or thinly coated.
- ****Edges and Corners:**** Edges and corners of the doors are inadequately painted, showing bare or poorly covered areas.

- Reduced durability and protection of the door surfaces against wear and environmental factors.
- Compromised aesthetic quality and overall visual appeal of the building.
- Increased maintenance costs due to the need for early repainting or repairs.

- Ensuring complete and consistent paint coverage on all surfaces of the doors.
- Achieving a smooth and even finish without visible defects such as brush marks, drips, or streaks.
- Proper surface preparation to ensure good paint adhesion and prevent peeling or flaking.
- Thoroughly painting edges and corners to achieve a uniform appearance.

A detailed inspection should be conducted post-repainting to confirm compliance with the required standards.

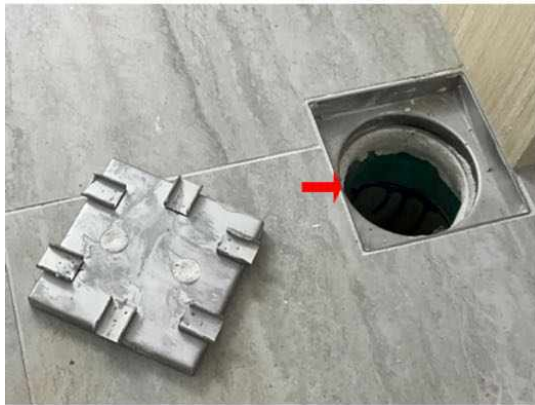
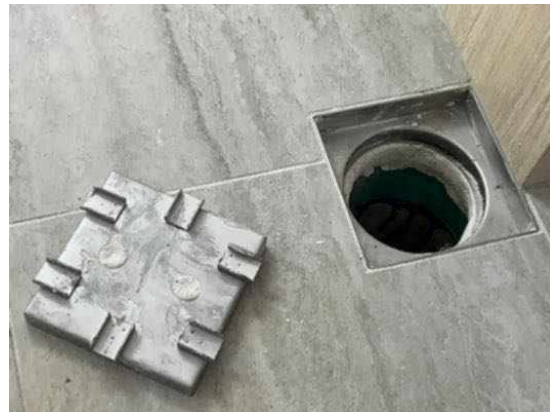
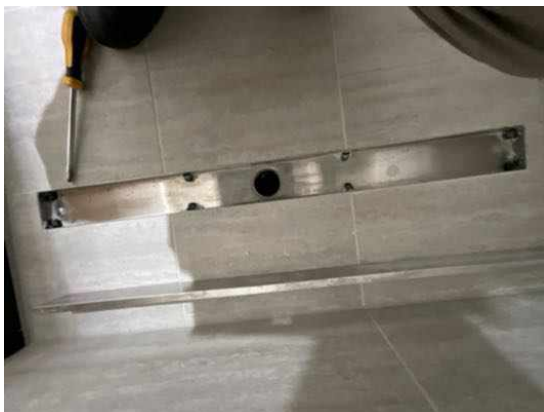
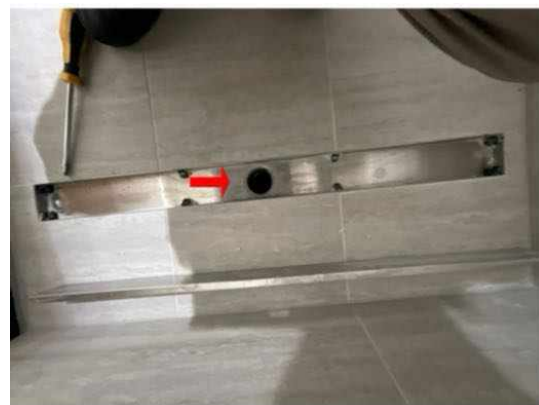
Finding 3.06

Building: Main Building
Location: All Areas
Finding: Floor waste- missing internal grill component (strainer or insert)
Information: The drain cover in the tiled floor area is missing its internal grill component (strainer or insert), exposing a direct opening into the drain pipe. This is considered a non-compliant installation as the drain cover is incomplete.

- AS/NZS 3500.2:2021 – Plumbing and Drainage – Sanitary plumbing and drainage requires that all plumbing fittings and fixtures must be installed in a manner that prevents debris from entering the drainage system and ensures the safe operation of the drain.
- The Guide to Standards and Tolerances 2017, Section 13 (Plumbing and Drainage), notes that drainage systems should be installed in accordance with relevant standards, including correct fitting of drain covers and grates to ensure hygiene, safety, and protection from blockages.

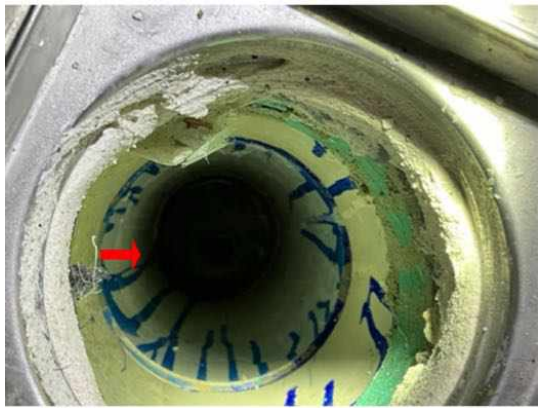
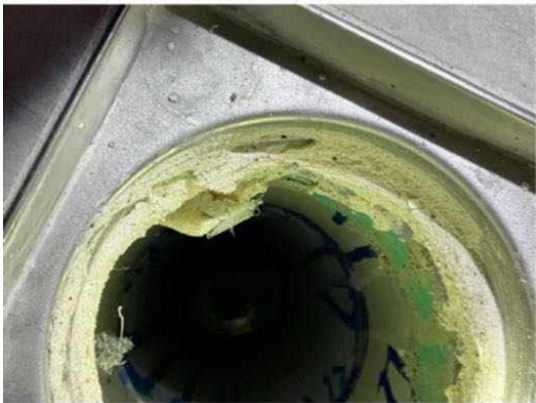
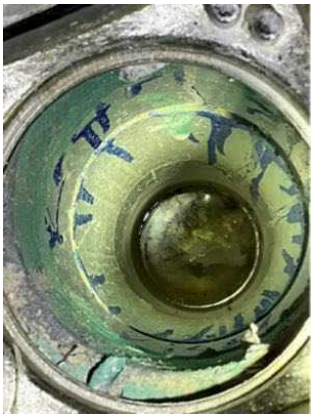
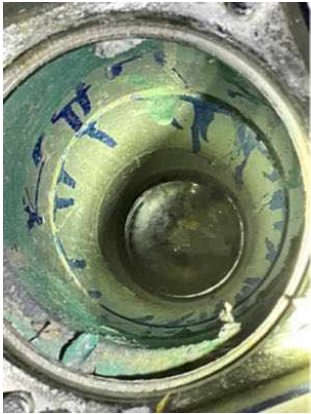
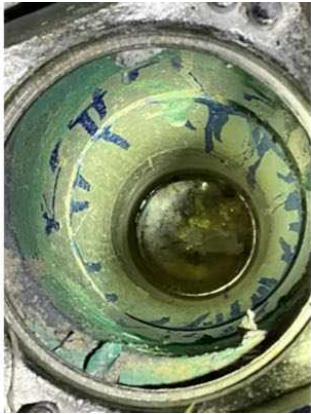
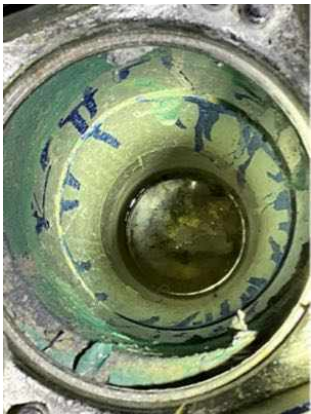
Finding 3.07

Building: Main Building
Location: All Areas
Finding: Floor waste Debris
Information: It was noted that there is builder debris in the floor waste drainage. Debris in the plumbing system may lead to blockages in the future.

This is referenced against the Australian Standards and Tolerances clause 19.8 Cleaning - Owners are entitled to expect that the building site and works are clean and tidy on completion.

Building sites are defective if they are not clear of building debris. All floor wastes need to be checked and cleared prior to handover.

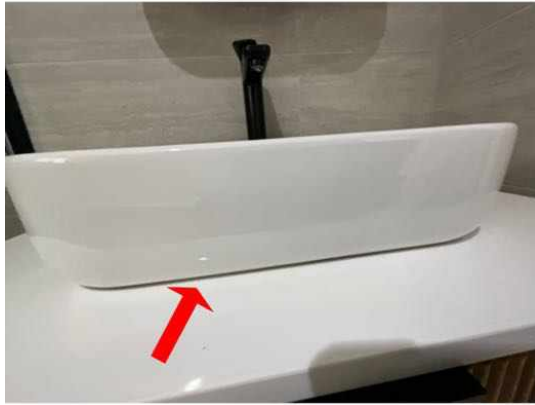
Finding 3.08

Building: Main Building
Location: All Areas
Finding: Silicone- Missing Sealant Around Basin
Information: No silicone sealant was observed around the perimeter of the vessel basin where it meets the benchtop surface. This is considered non-compliant with good building practice and may allow moisture ingress, leading to potential swelling, mould growth, and damage to cabinetry and surrounding finishes.

In accordance with the NCC and the Guide to Standards and Tolerances 2017, joints between sanitary fixtures (such as basins) and adjoining surfaces must be properly sealed with a flexible waterproof sealant to ensure water resistance and durability.

It is recommended that a qualified tradesperson apply a continuous bead of mould-resistant, sanitary-grade silicone sealant to all exposed joints to prevent future water damage and ensure compliance with standards.

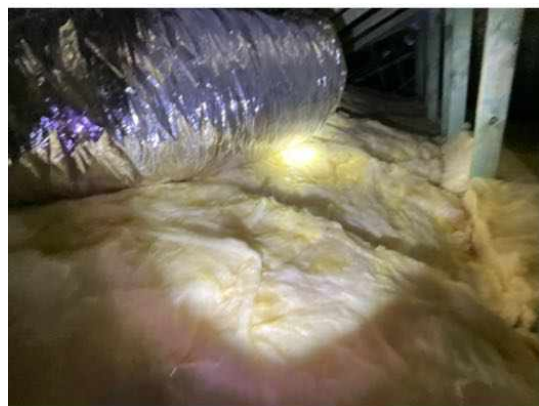
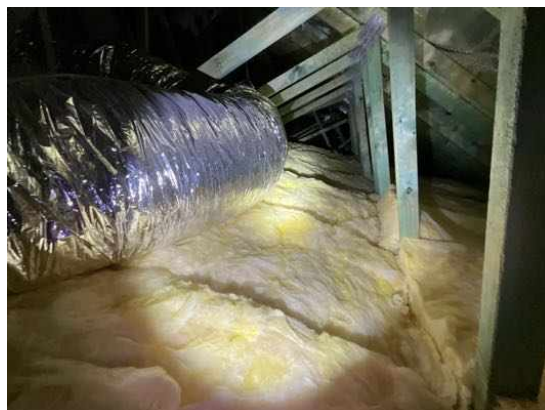
Finding 3.09

Building:	Main Building
Location:	Roof Void
Finding:	Insulation - Covering downlights
Information:	Sections of insulation in the roof void have been poorly installed or moved from their original position and are covering down light fittings. While the down lights have been

fitted with appropriate protective covers, the presence of this insulation creates a potential fire hazard.

Any insulation within the vicinity of down light fixtures should be moved and re-applied to more appropriate sections of the roof void, thus ensuring the area is fire-safe. An insulation contractor should be appointed as soon as possible to perform any necessary works as required.

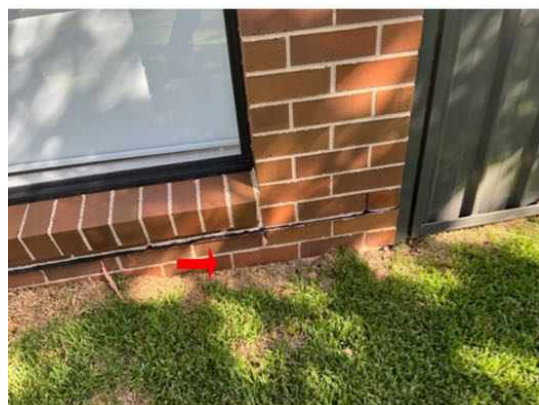
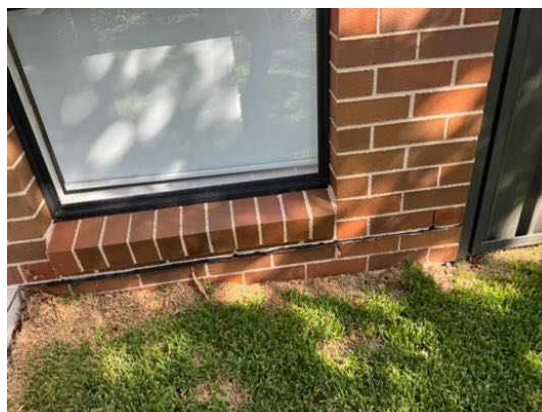
If the slab edge is not properly exposed there is a high risk of termite attack. Sometimes, in order to determine the type of slab, a suitably qualified person such as an architect or builder may be required to consult the construction plans.

Where the slab edge cannot be properly inspected, it is highly recommended that termite or timber pest inspections be carried out every 6-12 months to aid protection of the property against infestation.

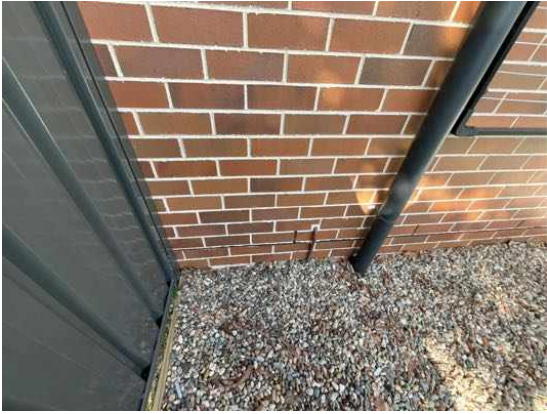
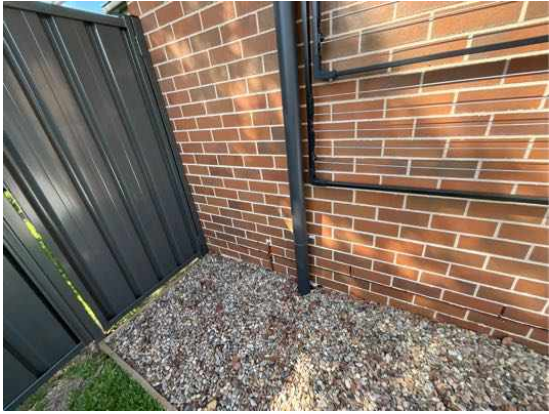
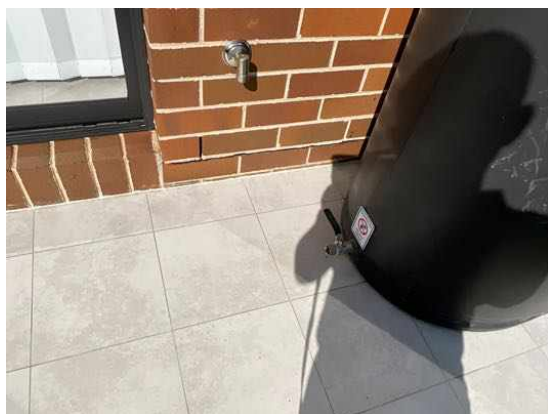
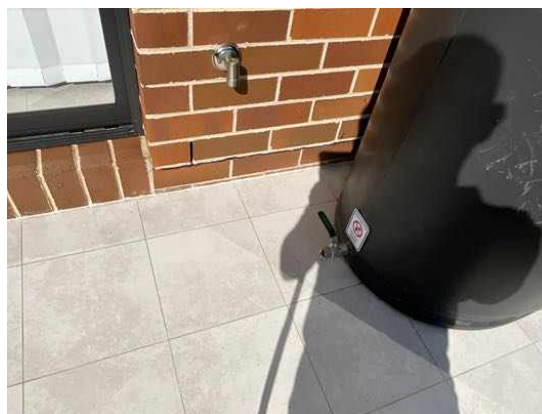
Finding 6.02

Building:	Main Building
Location:	All Areas
Finding:	No Drain under tap
Information:	There is no drain installed under the tap, leading to water accumulation and creating conducive conditions for timber pests. This defect needs immediate attention to prevent potential damage and pest infestation.

1. Water Accumulation: Without proper drainage, water can accumulate around the base of the tap, leading to persistent dampness in the surrounding area.
2. Timber Pest Infestation: The damp environment created by standing water is highly conducive to timber pests, such as termites and wood borers, which thrive in moist conditions and can cause significant damage to wooden structures.
3. Structural Damage: Prolonged exposure to moisture can lead to wood rot and deterioration of structural timber, compromising the integrity of the building.
4. Health Hazards: Persistent dampness can also promote mold and mildew growth, posing health risks to occupants.
5. Aesthetic Damage: Water stains and damage to finishes and materials around the tap area can detract from the appearance of the building and lead to costly repairs.

A licensed plumber or a qualified building contractor can address this defect by:

3. Repair and Prevention: Inspecting and repairing any existing water damage and implementing measures to prevent future water accumulation and pest infestations.

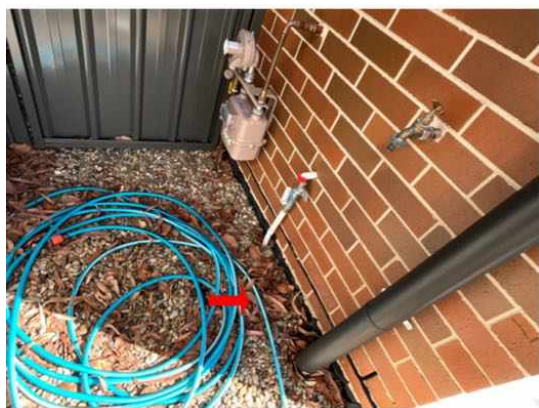
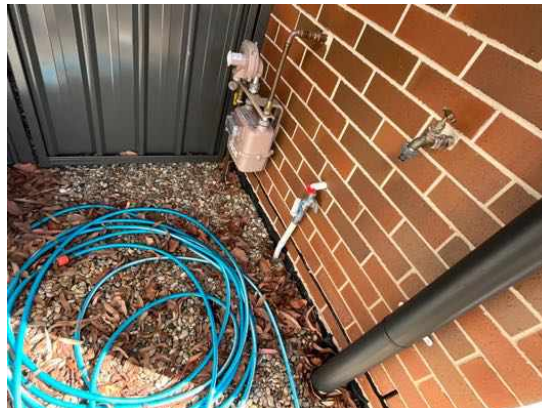
Finding 6.03

Building:	Main Building
Location:	All Areas
Finding:	Bridging or Obstruction Conducive environment for Termites
Information:	Bridging of termite barriers occurs when termites bridge (usually by building a mud tunnel) a termite barrier or inspection inspection zone or where termites have a passage, allowing them to bridge the barrier.

Recommended moving obstructions away from the external walls for further and future inspections.

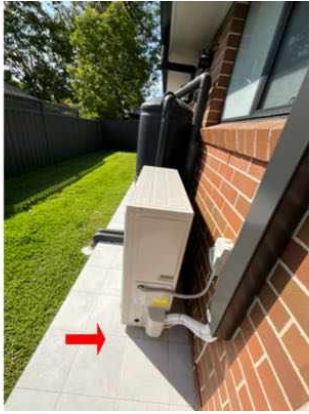
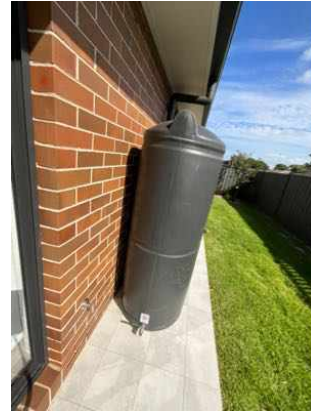
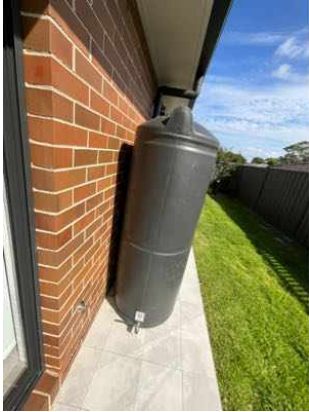
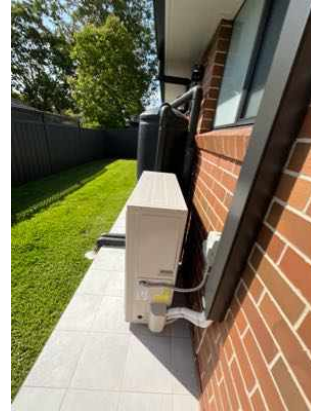
Where bridging has occurred full inspection is prevented and termites may enter a property in a concealed or undetected manner.

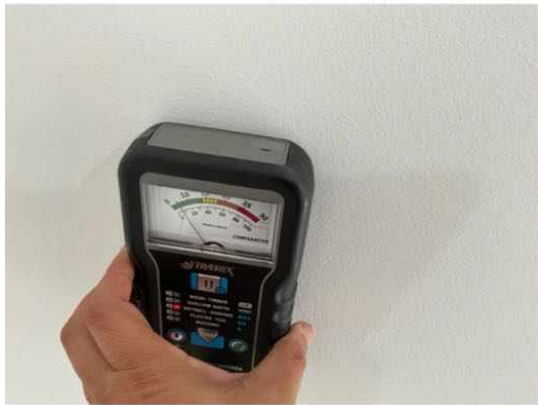
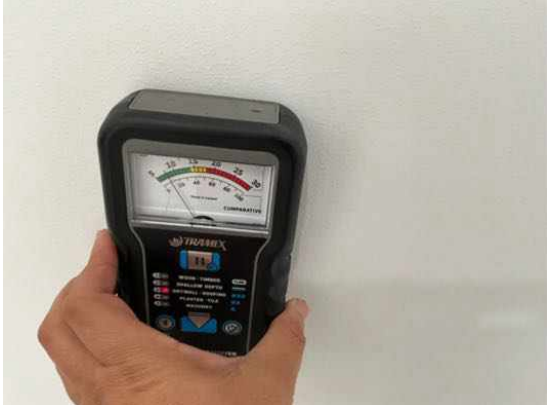
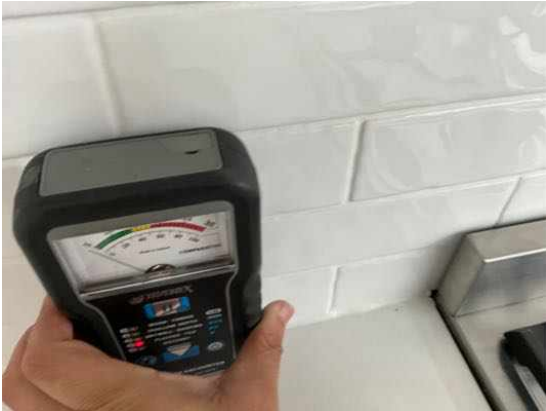
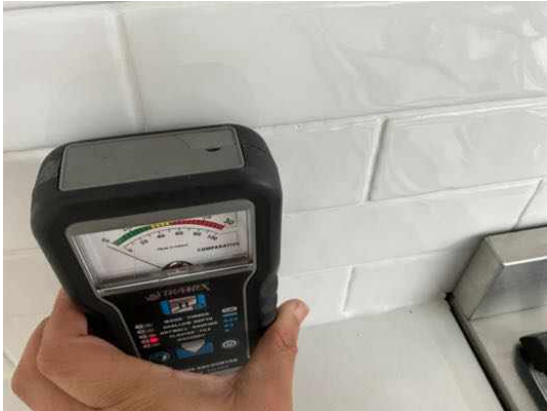
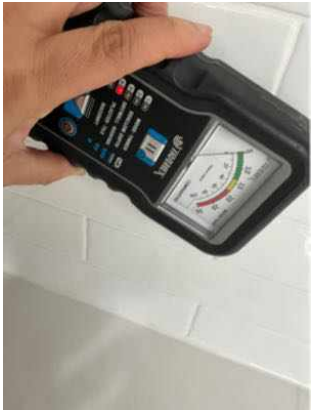
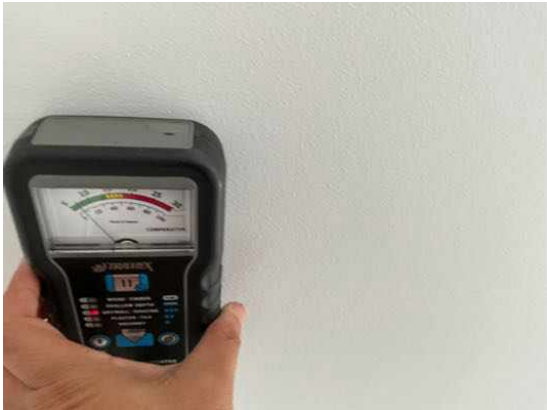
Building: Main Building
Location: All Areas
Finding: Additional Photos
Information: Additional photos are provided for your general reference

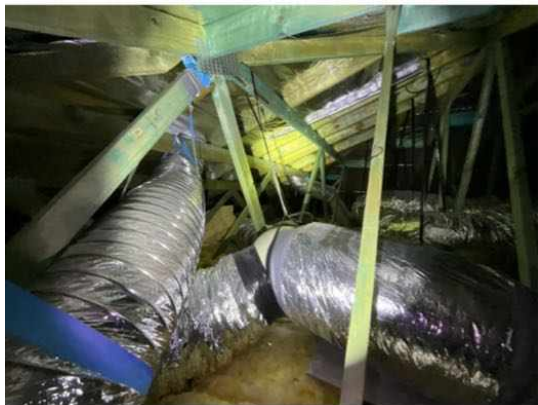
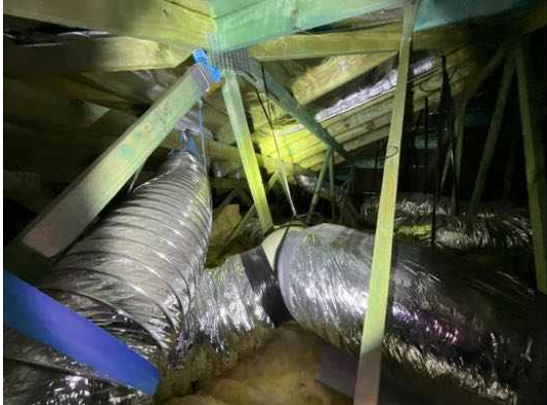
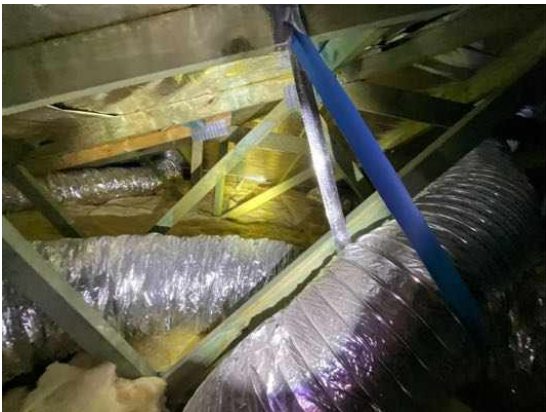
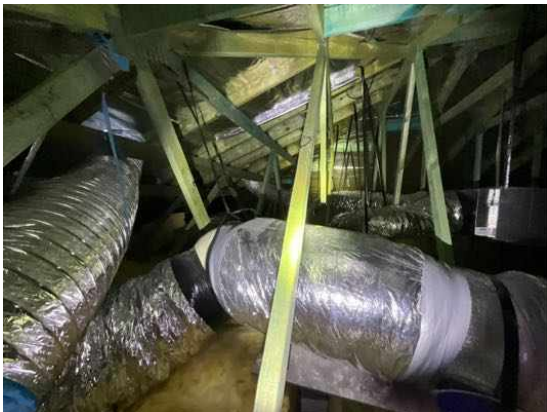
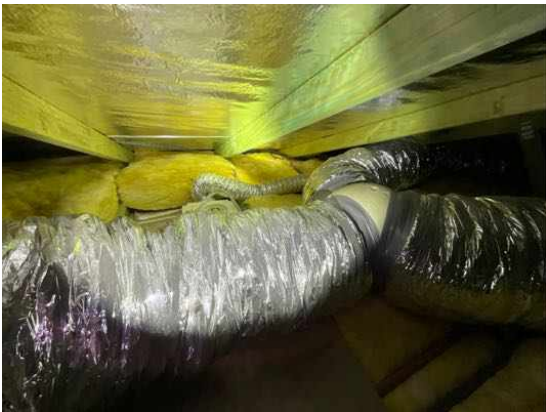
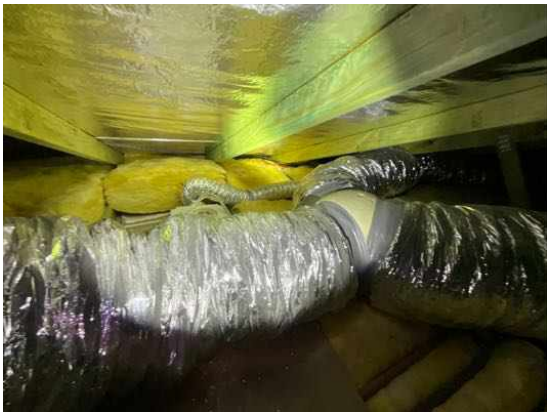
Building: Main Building
Location: All Areas
Finding: Additional Photos - Obstructions and Limitations
Information: These photographs are an indication of the obstructions and limitations which impeded full inspection of the property at the time of inspection. These obstructions can hide an array of defects and should be removed to allow full inspection to be carried out. A re-inspection is recommended once the areas are made accessible.

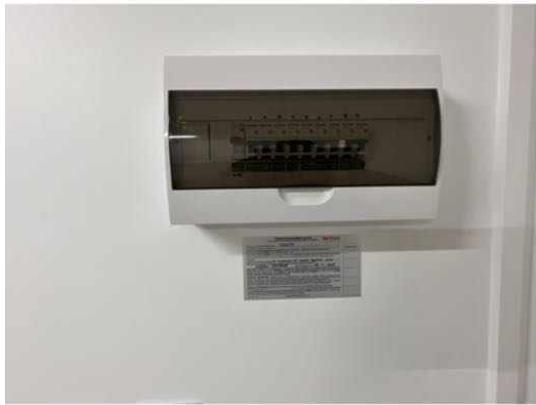
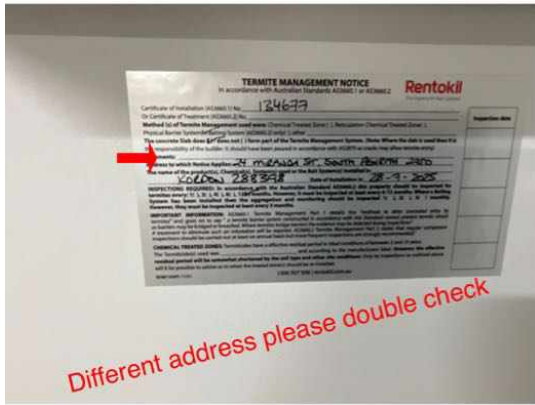
Building:	Main Building
Location:	Garage
Finding:	Evidence of Termite Management System - Durable notice / Legible Sticker
Information:	The application of a pre & post-construction chemical termite barrier is highly recommended for all properties. Such barriers are highly effective in preventing termite attack on any timber building elements throughout the property.

A durable notice placed in the switchboard unit to indicate current termite barriers is legible at the time of inspection.

Client may seek further information from the vendor or real estate agent if the conditions of termite management systems were maintained as per the label or seek advise from licensed pest controller.
