# Building and Timber Pest Inspection Report

Inspection Date: Fri, 06 Mar 2026

Property Address: 28A Vale Rd, Thornleigh NSW 2120,  
Australia

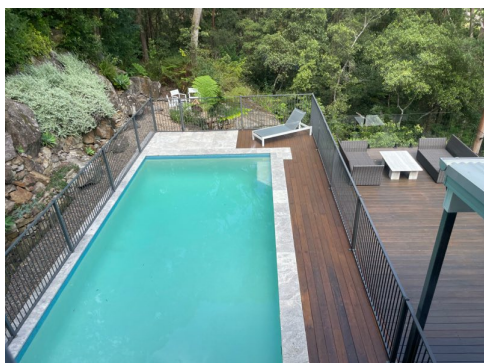
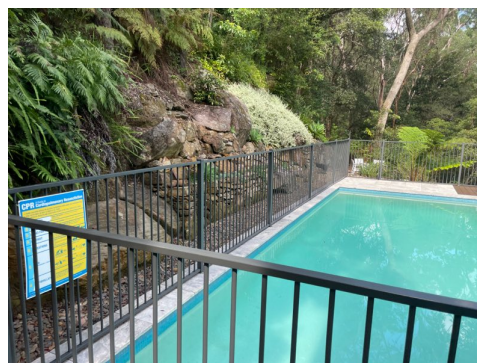
Building:	Main Building
Location:	Swimming Pool
Finding:	Pool fencing/area
Information:	This inspection specifically excludes any inspection of the pool, associated pool equipment and pool surrounds. An inspection should be made by a specialist pool inspector to determine the condition of the pool, pool equipment and surrounds. A pool safety inspection is not included as part of a standard building inspection and must be commissioned separately as a specialist report.
