Building and Timber Pest Inspection Report

Inspection Date: Fri, 6 Feb 2026

Property Address: 25 Leith Rd, Pennant Hills NSW 2120, Australia

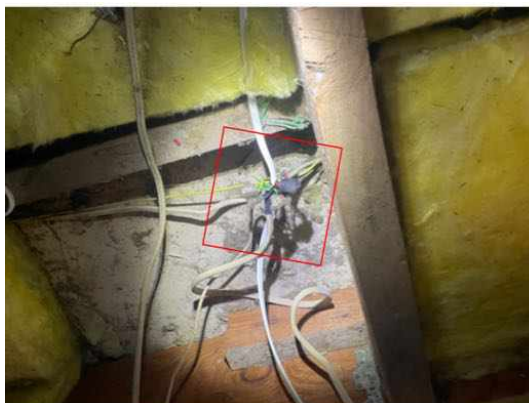
Building:	Main Building
Location:	Roof Void
Finding:	Electrical junction box - Missing
Information:	Several wiring joins in the roof space are not adequately protected by a junction box. Junction boxes provide a second insulation barrier to adequately seal off and protect the wires, increasing the safety of the immediate environment and ensuring that the wiring is not damaged.

The absence of junction boxes in the roof space poses as an electrical safety hazard, providing risk of electrocution. It appears as though wiring in this area has been completed to a substandard level of workmanship, evidenced by the lack of adequate

wiring protection.

Appointment of a licensed electrician is highly advised to provide additional information on the risks of unprotected wiring and to install junction boxes and any other elements as required. Such works should be carried out as a matter of urgency; until this time, any persons within the roof space should exercise a high level of caution.

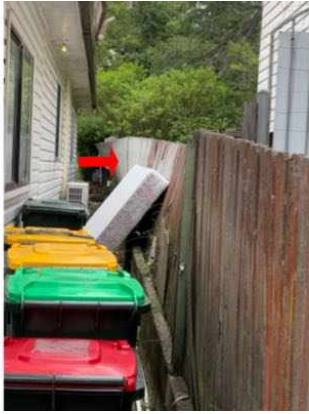
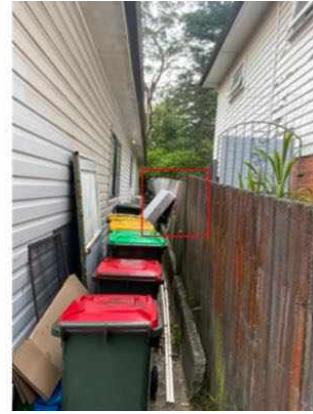
Finding 2.01

Building: Main Building
 Location: Exterior walls - right side
 Finding: Fencing - Deteriorated
 Information: It was noted at the time of inspection that sections of the fencing throughout the property have deteriorated. Typically fencing deteriorates due to age and or wear, rot and or rust which is generally expected for a structure of this age, due to prolonged exposure to weather conditions. Sometimes inadequate installation or maintenance can be to blame.

If left unattended, it is likely that further damage will occur. It is suspected that repair of several elements of the fencing may be required however replacement may be a consideration of the client also.

A licensed fencing contractor should be appointed to provide further advice and perform rectification works as necessary.

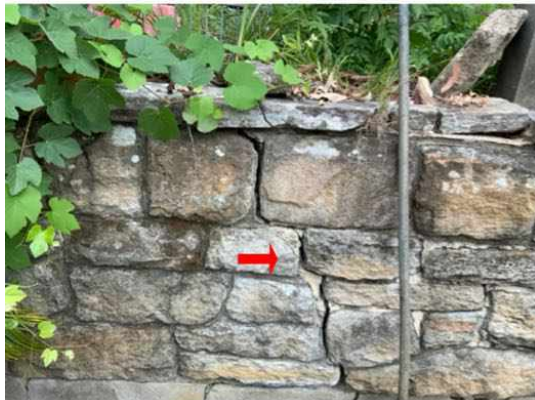
Finding 2.02

Building: Main Building
 Location: Exterior walls - rear
 Finding: Retaining wall - Defective
 Information:

The retaining wall in this area was found to be defective at the time of inspection. Generally, defective retaining walls are caused by poor original design or material use. However, deteriorated retaining walls may also be a result of substandard construction, poor site drainage or unmanaged stormwater flows.

If left unmanaged, the retaining wall may become a safety hazard if it continues to destabilise.

Significant repair and replacement should be expected. Where retaining walls are considered structural walls, a structural engineer / surveyor should be consulted regarding required remedial works. Otherwise, a landscaper or retaining wall installer may be appointed to repair or replace the wall, at the discretion of the client.

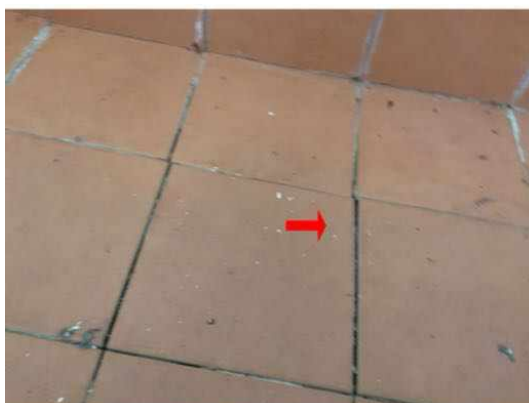
Finding 2.03

Building:	Main Building
Location:	Toilet (WC)
Finding:	Tiles - loose and grout missing
Information:	Loose tiled areas were identified at the time of inspection. The term loose refers to tiles that have become detached from their fixing, despite otherwise being in relatively good condition. Such defects are generally caused by physical or moisture damage to the area. Loose tiled areas may also be a direct result of poor workmanship during the construction process.

Tiled areas may swell and shrink with changes in air humidity if the area has sustained moisture damage. Any exposure to moisture is capable of causing tiled areas to become drummy and/or cracked over a prolonged period of time. Drummy tiled areas generally require removal and replacement of affected tiles, with adequate sealant and grouting.

Specialist trades are available for these types of services. A registered builder may be required to undertake works if damage is extensive or if secondary building defects have resulted. Otherwise, it is advised that a tiling contractor be appointed to perform works as necessary. Immediate action is recommended to ensure that no further damage is sustained in the affected area.

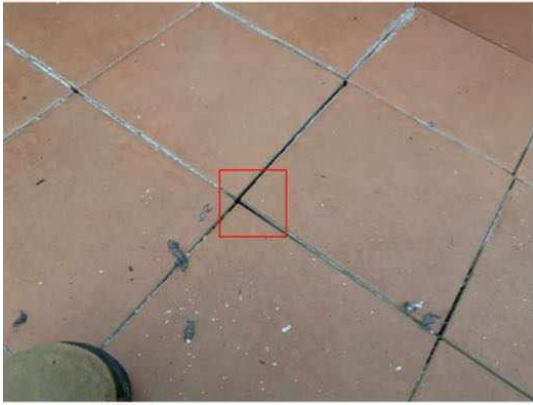
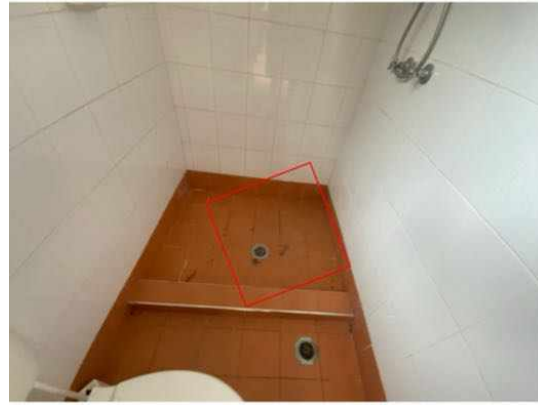
Finding 2.04

Finding: Tiles - Cracked or damaged

Information: Cracking was evident to the tiling in this area at the time of inspection. While the cracking appears to be minor, this area is frequently exposed to water, allowing potential for water penetration into adjoining sections of walls or flooring.

If left unmanaged, water penetration to these areas may lead to subsequent water damage, which is likely necessitate repair work to affected building elements.

A tiling contractor should be appointed to ensure that no further water damage occurs. The re-application of silicone and grouting throughout remaining tile work is also advised, to further protect the area against water penetration.

Where water penetration has led to water damage, appointment of a relevant tradesperson may be required to repair damaged building elements.

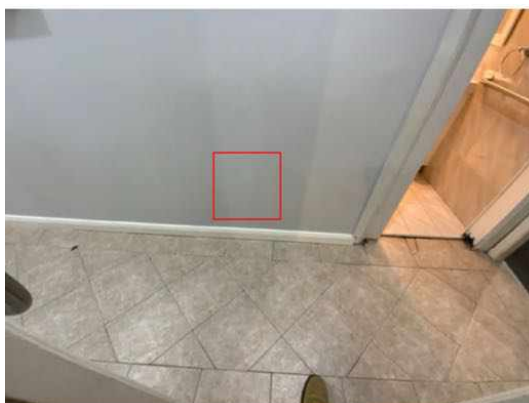
Building:	Main Building
Location:	Bathroom
Finding:	Shower - Leaking
Information:	High Moisture was evident to the shower base at the time of inspection. It is suspected that the leaking has occurred as a result of general ageing of the building elements.

Leaking from the shower base, where left unattended, is likely to lead to water damage to adjoining flooring and walls. Such damage can lead to water damage and necessitate extensive remedial works being required. Active water leaks may also create an environment that is susceptible to the formation and development of mould.

Appointment of a tiling contractor is required to repair or replace the shower base. Such works should be performed as soon as possible to ensure that no further damage occurs.

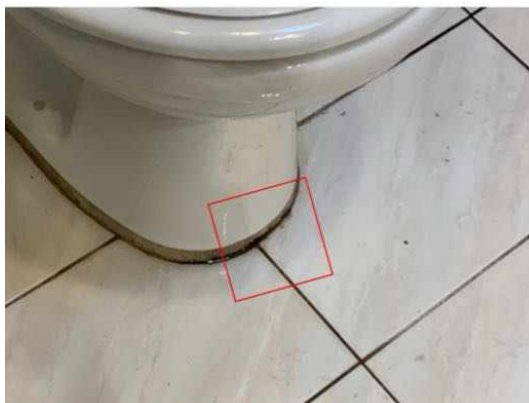
Finding 2.06

Building:	Main Building
Location:	Bathroom
Finding:	Toilet - Leaking

Information: At the time of inspection, the toilet showed evidence of leaking during operation.

Although common, internal water leaks can be detrimental to surrounding building elements. Rust, corrosion, decay and water damage are all potential outcomes of a water leak that is left unattended, which are then likely to develop into more serious defects and may necessitate major repair works. Additionally, internal water leaks may significantly increase the water usage within the property.

It is highly advised that internal water leak be addressed by a licensed plumber as soon as possible. Use of the leaking toilet should be minimised until such time.

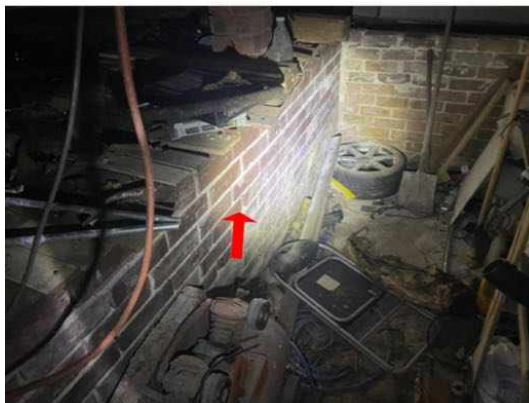
Finding 2.07

Finding: Retaining wall - Defective

Information: The retaining wall in this area was found to be defective at the time of inspection. Generally, defective retaining walls are caused by poor original design or material use. However, deteriorated retaining walls may also be a result of substandard construction, poor site drainage or unmanaged stormwater flows.

If left unmanaged, the retaining wall may become a safety hazard if it continues to destabilise.

Significant repair and replacement should be expected. Where retaining walls are considered structural walls, a structural engineer / surveyor should be consulted regarding required remedial works. Otherwise, a landscaper or retaining wall installer may be appointed to repair or replace the wall, at the discretion of the client.

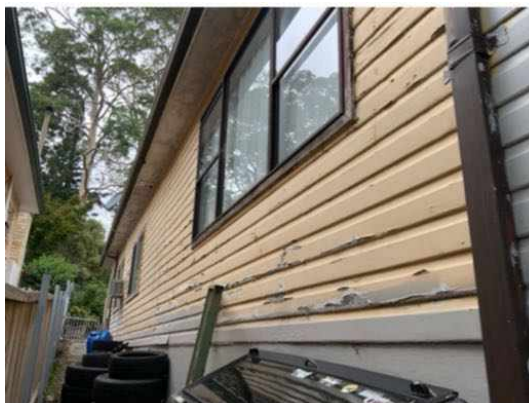
Building:	Main Building
Location:	All Areas
Finding:	External painting deteriorated
Information:	Much of the external paintwork including but not limited to windows, fascias, guttering, veranda and other external fitments have been neglected and require attention to prepare and re-paint.

Whilst incomplete or missing paint finish is generally an appearance defect, it can also lead to the development of secondary building defects over time. Incomplete areas of paint finish expose the area to moisture, potentially accelerating the deterioration of underlying building materials.

Degraded paint finishes should be sanded back, filled, leveled and painted, as applicable. Where inadequate or missing paint protection has led to the deterioration of the associated building element, repair and/or replacement of this building element may be required.

A painting contractor should be appointed as soon as possible to perform necessary works to aid the appearance of the affected area and to ensure the area is protected against further deterioration. Alternatively, the homeowner following manufacturer instructions may perform these works.

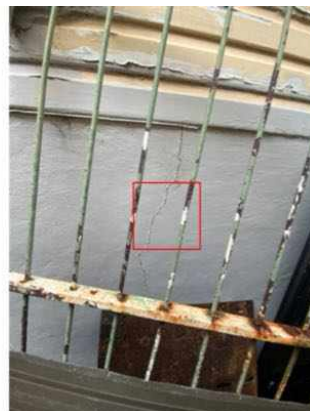
Finding 3.03

Building:	Main Building
Location:	Exterior walls - left side
Finding:	Subsidence Monitor
Information:	It appears that the wall structure has been affected by movement of the foundations, often referred to as sinking or subsidence. A degree of movement is expected in subfloors over time, especially as environmental conditions change and buildings settle after construction.

The apparent subsidence is evidenced by some gaps and cracks to brickwork, usually adjacent to windows or openings, excessive footpath movement and undulation of floors.

General subsidence is usually initiated by changes in soil moisture content. The most critical factor is identifying the specific causes, and identifying if this is a recurring or ongoing problem, or one that has been resolved by previous works in the past.

Subsidence can have complex and varying causes, which will influence the required remedial works. If movement continues It is advised to consult a structural engineer to determine if repair works are warranted. Works may include some form of underpinning, as well as addressing the underlying cause. Consultation with a geotechnical engineer may also be necessary where changes to soil moisture content is apparent.

A Registered Builder would then generally carry out works as advised by an Engineer.

At this point it is recommended to contain storm water flows, ensure pavements flow away from the building to lessen any excessive wetting and drying effects.

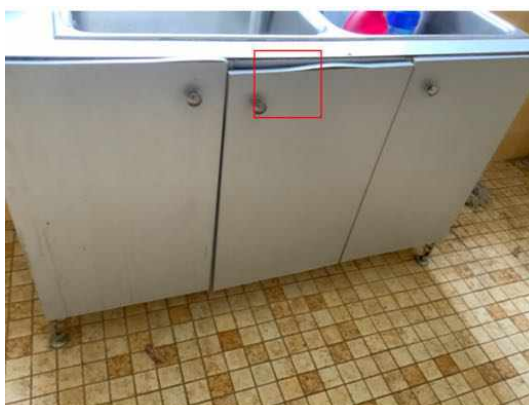
Building: Main Building
 Location: Laundry
 Finding: Laundry cupboard/deteriorated
 Information: At the time of inspection it was noted that the laundry cupboard were delaminating due to age and exposure to water or moisture ,also could be due to low quality doors or the misuse by the occupants or the lack of ventilation.

A qualified cabinets maker should be contacted to make good at the client discretion.

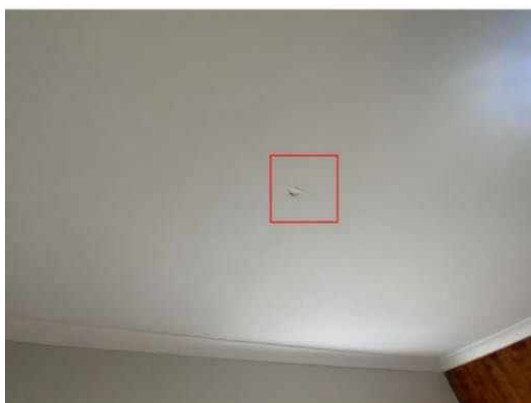
Finding 3.08

Building: Main Building
 Location: Bedroom
 Finding: Ceiling - Water damaged
 Information: Water damage to the ceiling lining is generally an indication of excessive moisture being present in the roof void, usually via a leak to the roof covering.

Where water damage is evident to the ceiling, the primary requirement is to identify and rectify the source of the leak. A roofing plumber should be appointed as soon as possible to identify the leak and perform rectification works as necessary, ensuring the water damage is restricted.

Once the leak is repaired, consultation with relevant tradespeople, including plasterers and painters, is advised. Rectification works may include replacement of ceiling lining or minor repainting, depending on the extent of the damage.

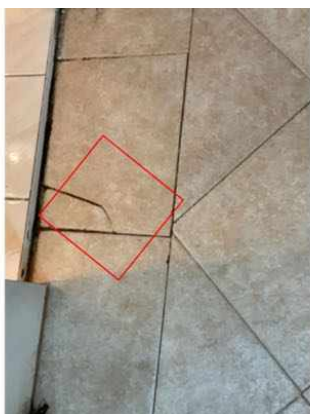
Finding 3.10

Building:	Main Building
Location:	Hallway
Finding:	Floor tiles - Cracked
Information:	Cracking in the floor tiles was evident in this area at the time of inspection. It is suspected that this cracking has occurred as a result of the floor being uneven and lacking a solid or suitable foundation for the tiles to be laid on. Settlement in the floor foundations may also have caused movement and resulted in the cracking of tiles in this area.

Cracked tiles throughout the household detract from the overall appearance of the affected areas, as well as creating potential for water penetration to adjoining building elements. If left unmanaged, water damage may occur as a result of constant water penetration over a prolonged period of time.

While not considered a matter of urgency, replacement of cracked floor tiles is advised as a solution. A tiling contractor or general handyperson may be appointed to perform these works at client discretion. Where cracks become more numerous, consultation with a registered builder specialising in re-stumping may be required.

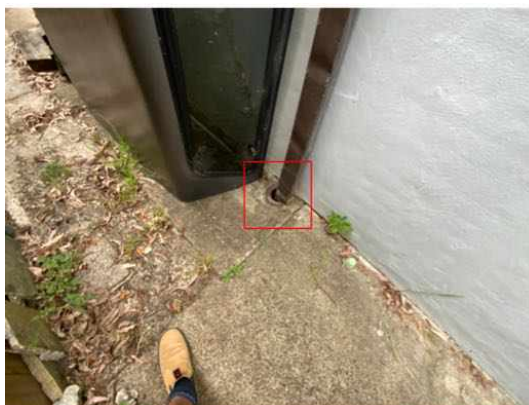
Where roof plumbing doesn't drain adequately, the area at the base perimeter can become excessively damp, potentially creating an environment that is susceptible to rust and corrosion of surrounding building elements, as well as attracting termites and other pests.

It is highly recommended that a plumber be appointed to further inspect the area and to install adequate drainage equipment where necessary.

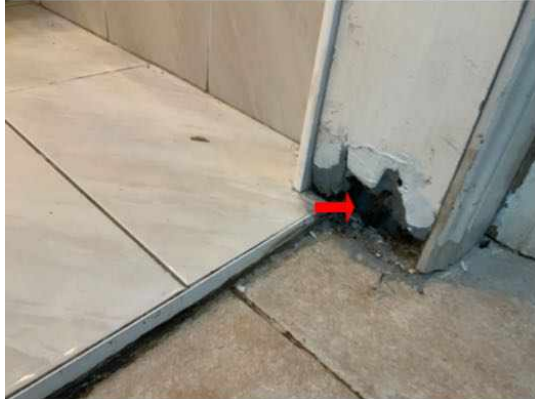
Finding 7.03

Building:	Main Building
Location:	Bathroom
Finding:	Wood rot
Information:	This door jamb shows evidence of wood rot. Wood rot, also known as Fungal Decay, occurs when timbers and other cellulose building materials are exposed to damp conditions on an ongoing basis. This could be the result of exposure to weathering over a prolonged period of time, or the attraction of excessive moisture from other abutting building materials. Contributing factors also include poor air ventilation in the area.

addressed in a suitable manner. Replacement of affected timbers may then be a necessary step in protecting surrounding building elements from such deterioration.

A qualified carpenter or registered builder may also be required to replace affected building materials.

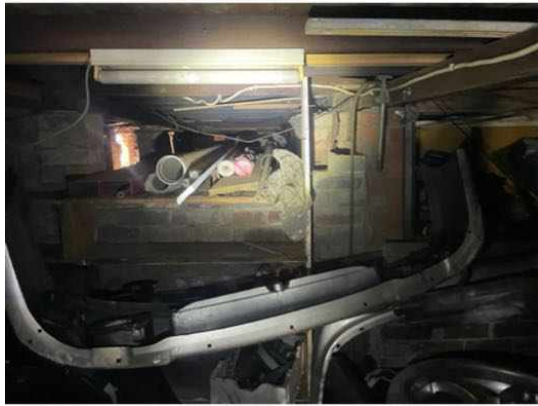
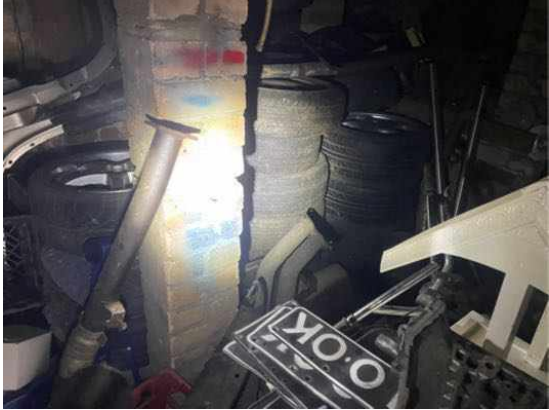
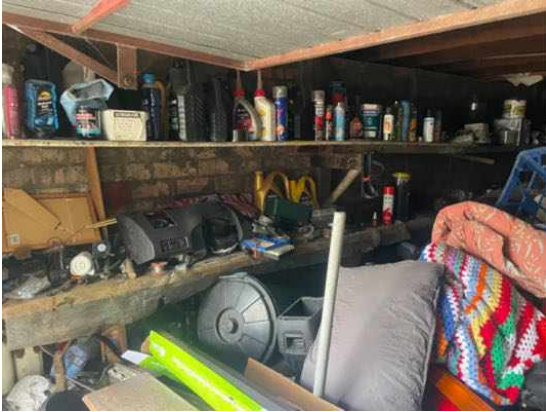
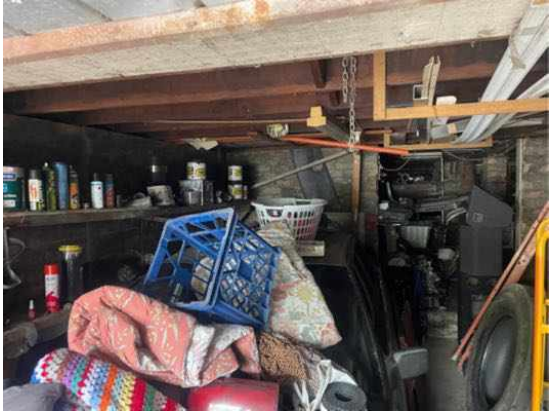
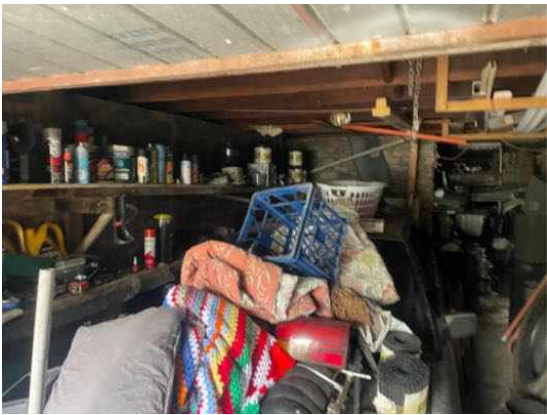
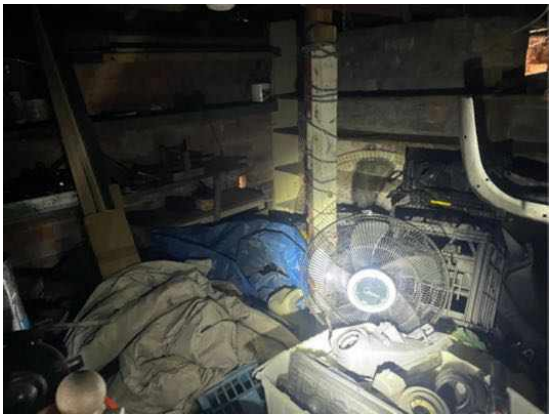
Building: Main Building
Location: All Areas
Finding: Additional Photos - Obstructions and Limitations
Information: These photographs are an indication of the obstructions and limitations which impeded full inspection of the property at the time of inspection. These obstructions can hide an array of defects and should be removed to allow full inspection to be carried out. A re-inspection is recommended once the areas are made accessible.

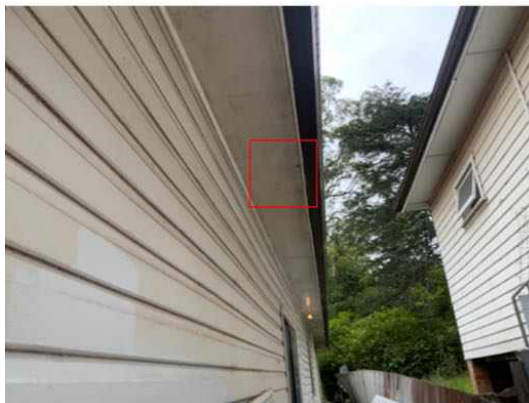
Building:	Main Building
Location:	All Areas
Finding:	Asbestos - Suspected ACM Identified on Site
Information:	Reporting on Asbestos is outside the Scope of this Report. This suspected defect is highlighted as a caution only. We suspect, based on our experience in the building industry, that there is a higher risk of the identified building element containing asbestos.

As Asbestos Reporting is outside the scope of this report, we advise that you consider a separate Asbestos Inspection and Condition Audit, which can include the taking of samples for definitive confirmation of the presence of Asbestos.

In the interim, the client is advised to act with caution, especially when considering any damage to building materials general wear and tear renovations extensions demolition and general maintenance activities due to the suspected presence of Asbestos.

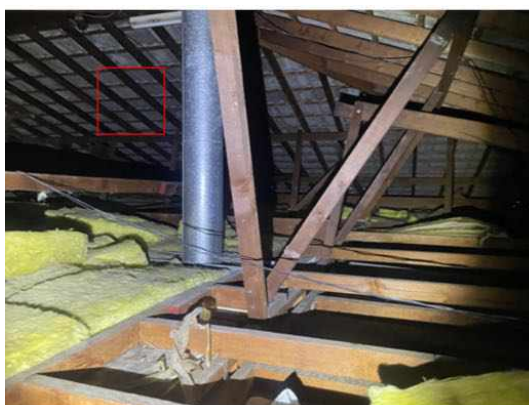
Building: Main Building
 Location: Roof Void
 Finding: Sarking - Missing
 Information: Sarking is missing under the roof sheeting. Sarking acts as an insulator that helps with noise reduction and protects against water penetration. Sarking plays a key role in the operation and function of the overall roofing structure and its performance.

Although not a requirement at the time of construction, replacement of any missing building element is advisable (although this can be quite expensive to do after the time of construction). Where sarking is missing, regular inspections of the roof tiles for cracking and potential moisture penetration is required.

Sarking may be retrospectively fitted by a registered builder at the discretion of the client.
