Building and Timber Pest Inspection Report

Inspection Date: Thu, 26 Mar 2026

Property Address: 44 La Fontaine Ave, Lavington NSW 2641,
Australia

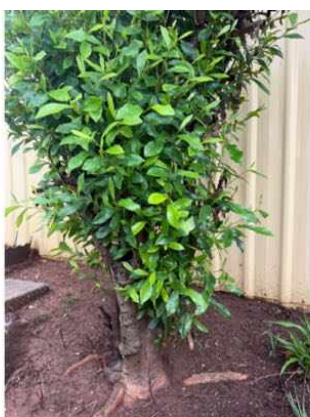
Where feasible, any timbers in direct contact with the ground should be removed and any trees in close proximity to the building should be removed or test drilled

(inspected) at least annually to reduce the risk of termite infestation & detect any early signs of termite activity.

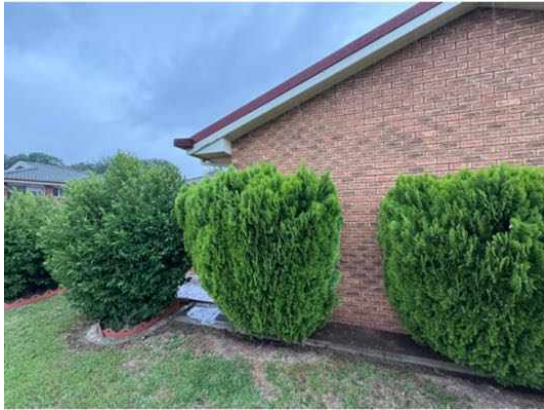
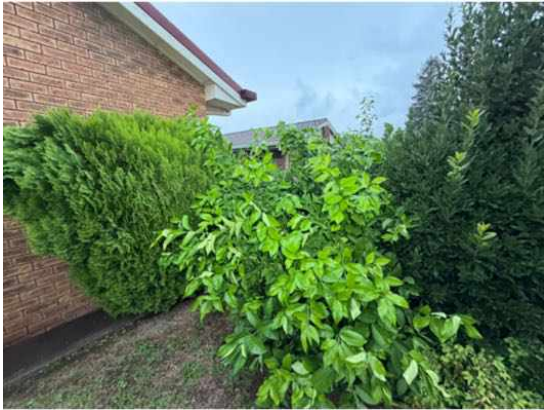
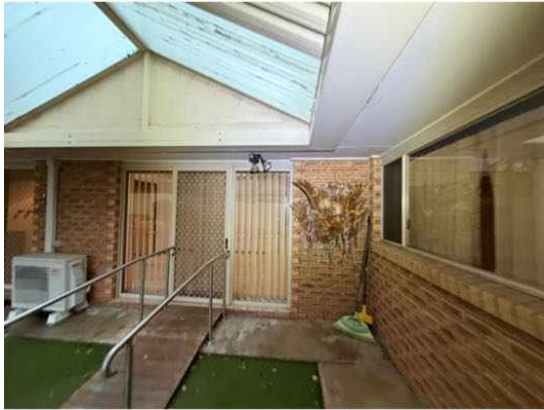
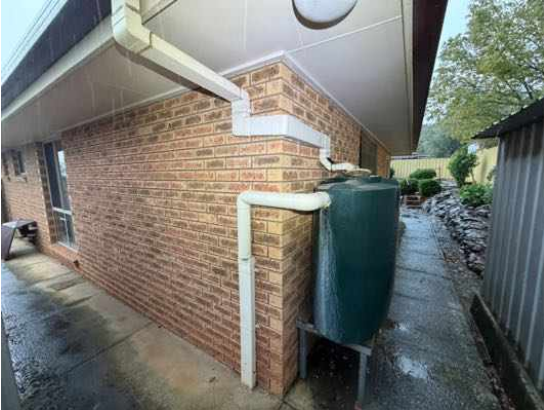
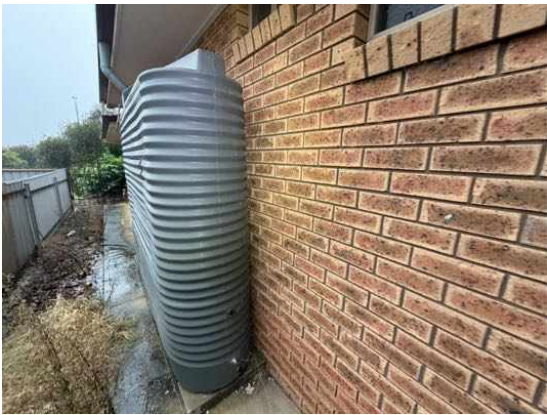
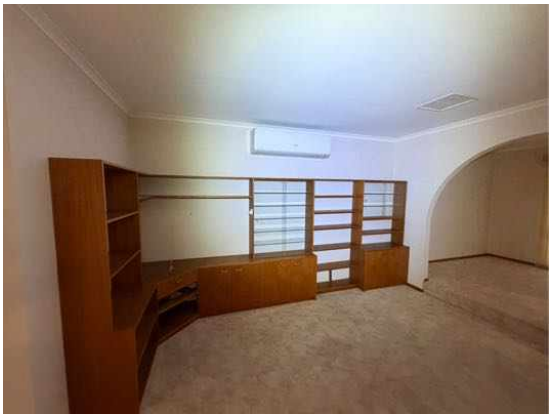
Building: Main Building
Location: All Areas
Finding: Additional Photos - Obstructions and Limitations
Information: These photographs are an indication of the obstructions and limitations which impeded full inspection of the property at the time of inspection. These obstructions can hide an array of defects and should be removed to allow full inspection to be carried out. A re-inspection is recommended once the areas are made accessible.

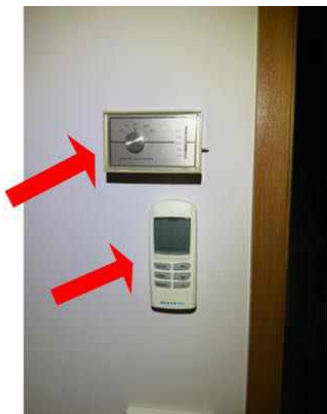
Building: Main Building
 Location: Roof Void
 Finding: HVAC Systems - Not Operating
 Information: It appears that the evaporative system and ducted heating system were not operating at the time of inspection. The client can engage a HVAC specialist at their discretion to provide further advice regarding the systems.

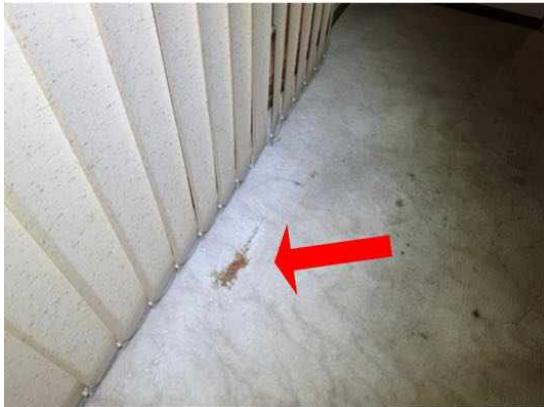
Building: Main Building
Location: Internal Areas
Finding: Carpet - Deteriorated / Weathered
Information: It is noted for the clients information that areas of the carpet were found to be weathered and deteriorated. Although this is mostly visual defect, the client can engage a flooring contractor at their discretion, to provide remedial works where necessary
