Building Inspection Report

Inspection Date: Tue, 17 Mar 2026

Property Address: 119 Richmond Rd,CAMBRIDGE
PARK,NSW,2747,Australia

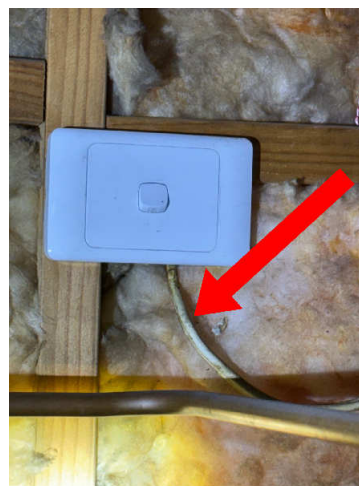
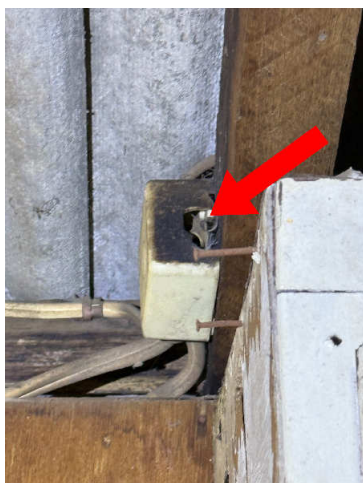
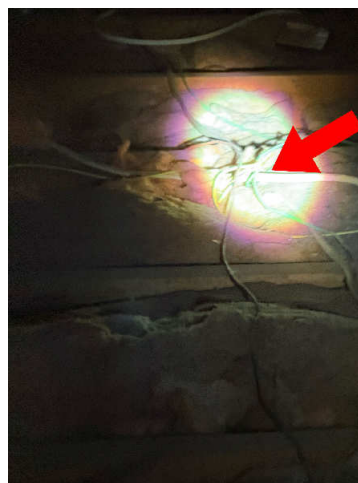
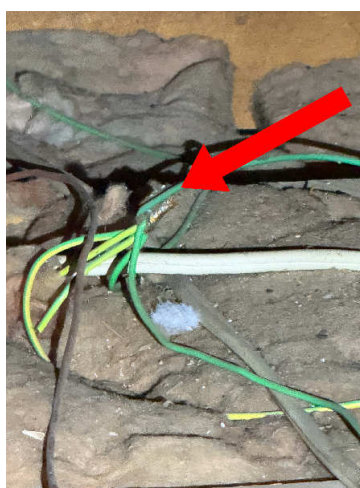
Defects 1.01

Finding: Exposed wiring

Information: During the inspection, exposed electrical wires were noted. This condition poses a significant safety hazard, as it increases the risk of electrical shock, short circuits, and potential fire. It is imperative that a qualified electrician addresses this issue immediately by properly insulating the exposed wires and ensuring all electrical connections comply with safety standards. Prompt action will mitigate the risks associated with exposed wiring and maintain the safety and integrity of the property's electrical system.

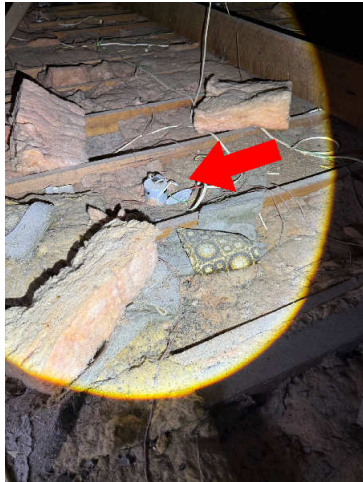
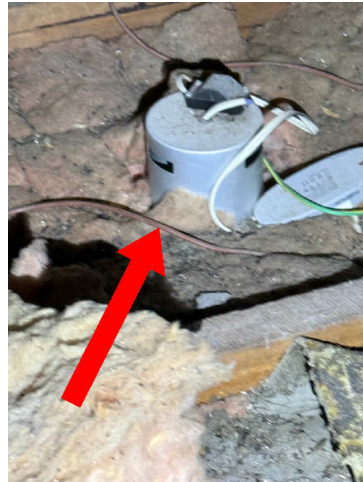
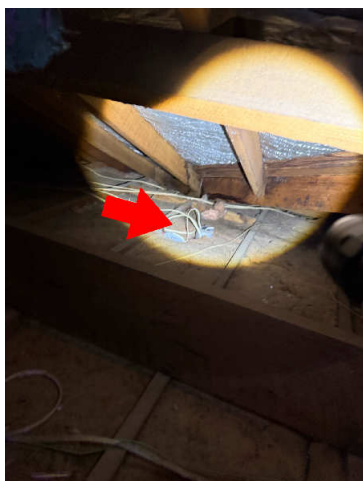
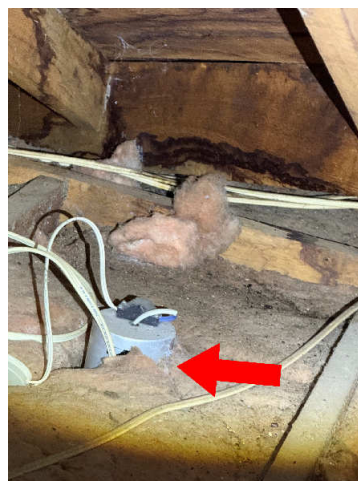
Defects 1.02

Information: Sections of insulation in the roof void have been poorly installed or moved from their original position and are covering down light fittings. While the down lights have been fitted with appropriate protective covers, the presence of this insulation creates a potential fire hazard.

Any insulation within the vicinity of down light fixtures should be moved and re-applied to more appropriate sections of the roof void, thus ensuring the area is fire-safe.

An insulation contractor should be appointed as soon as possible to perform any necessary works as required.

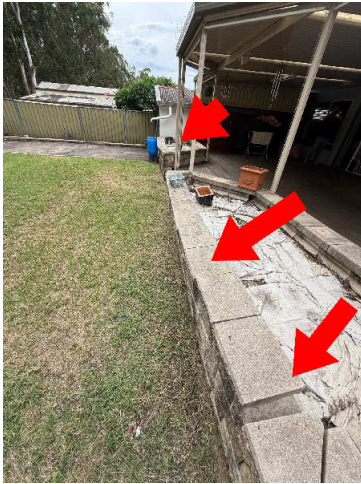
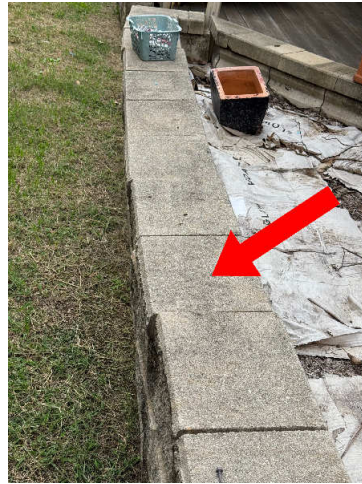
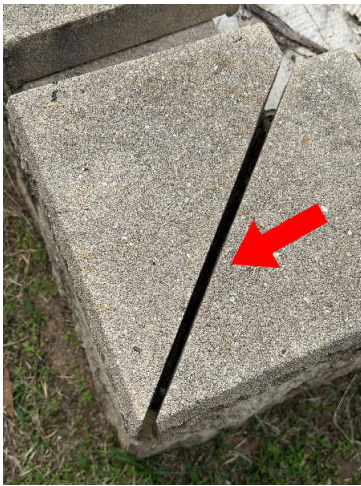
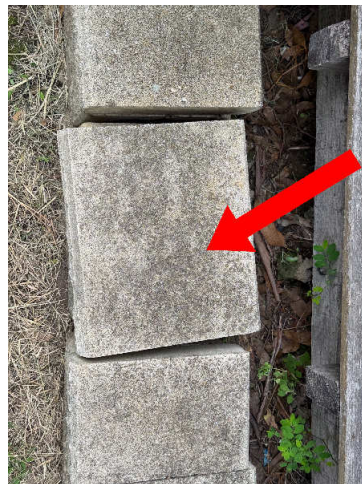
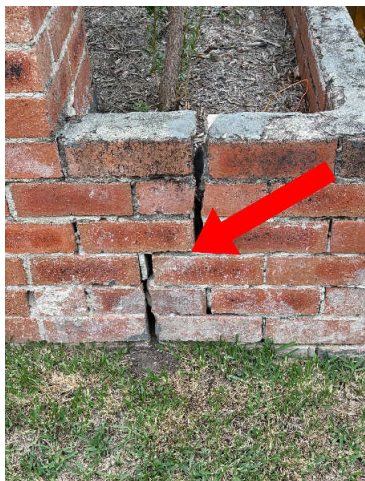
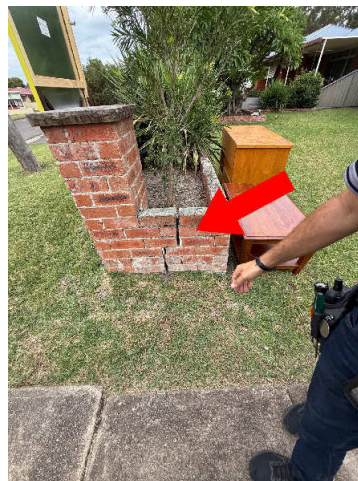
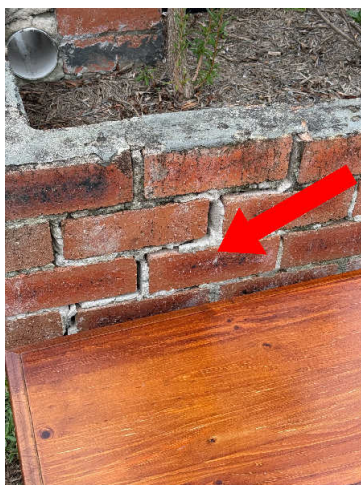
Defects 2.01

Information: The external planter box constructed of brick and concrete masonry blocks is observed to be leaning outward, with evidence of structural movement and separation between masonry units. Several capping units are displaced, misaligned, and uneven, with visible gaps and cracking in mortar joints. These conditions indicate loss of structural integrity, likely due to ground movement, inadequate footing support, soil pressure from retained fill, and/or ineffective drainage behind the planter wall.

The observed displacement and leaning represent a structural defect and pose a risk of progressive movement, collapse, and potential injury.

The condition may also allow water ingress, accelerate deterioration of masonry, and cause further instability over time.

This condition is considered a major defect as the planter box is no longer performing its intended structural function and may present a safety hazard

It is strongly recommended that a licensed builder, structural engineer, or qualified landscaper experienced in retaining structures be engaged to further assess the planter box and too rectify as needed

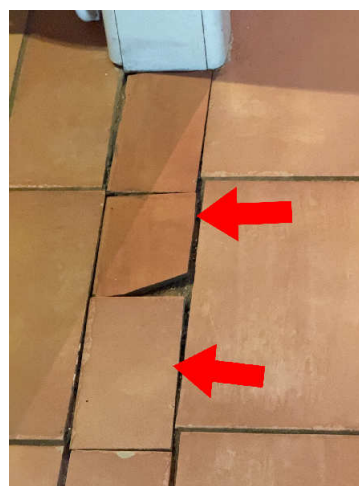
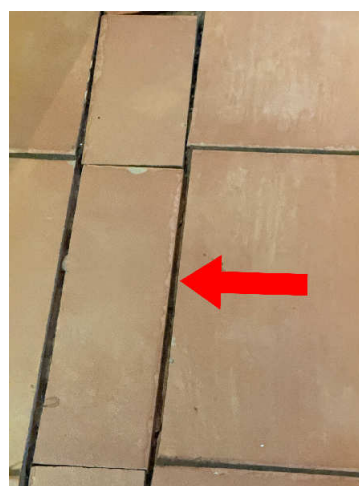
Defects 2.02

Finding: Loose floor tiles

Information: At the time of the inspection, it was observed that several ceramic floor tiles within the dining area were found to be loose, debonded, and uneven, with missing or degraded adhesive and open grout joints visible. Some tiles exhibit vertical and lateral movement when walked on, indicating inadequate bonding to the substrate. Localised cracking and separation between tiles were also observed.

Loose tiles present a trip hazard and may worsen with continued use.

The condition suggests adhesive failure, substrate movement, moisture ingress, or age-related deterioration. If left unrectified, further tile loosening and damage to surrounding tiles can be expected.

Putting this as a major defect because it is causing safety hazard also.

It is recommended that a qualified tiler or builder be engaged as soon as possible to further investigate the cause of tile failure. Rectification may involve lifting and re-laying affected tiles, repairing the substrate, and re-grouting, or replacing sections of flooring where necessary.

Any repairs should be carried out in accordance with current standards and good building practice.

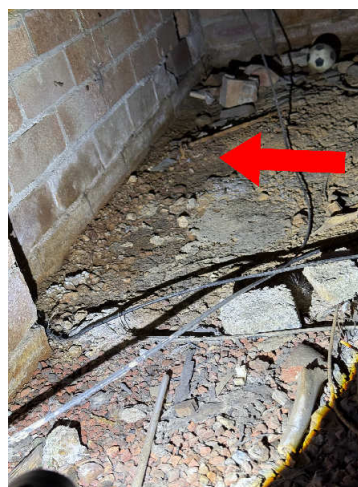
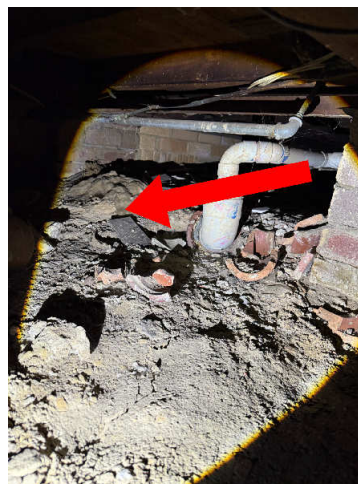
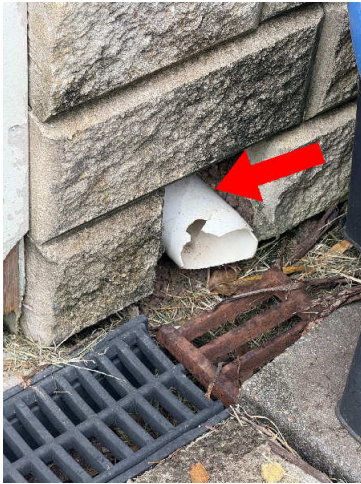
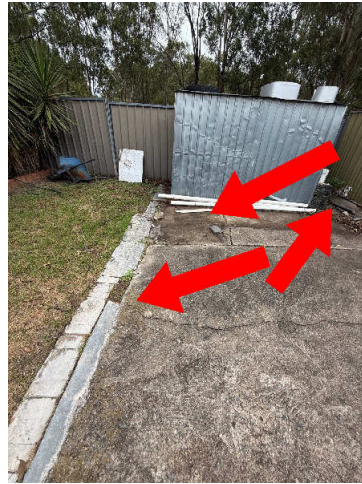
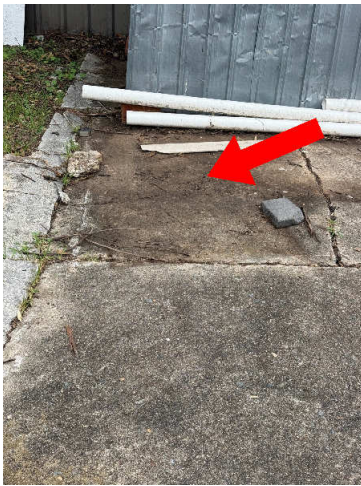
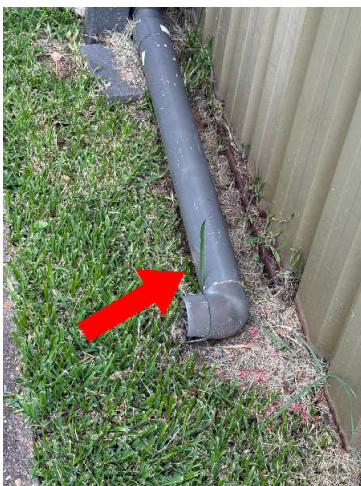
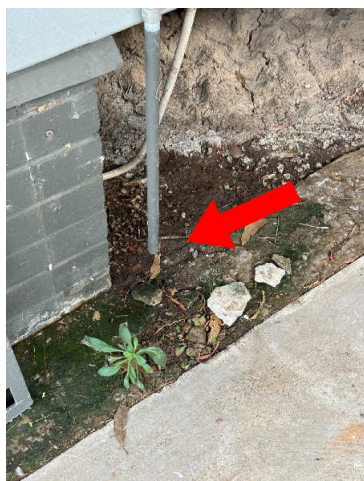
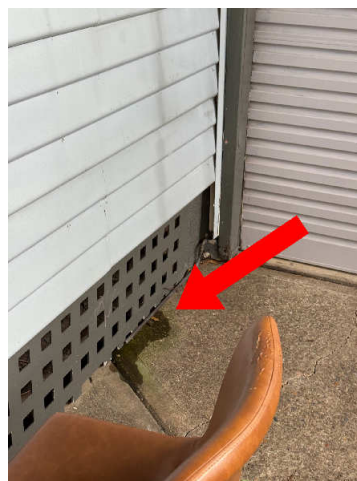
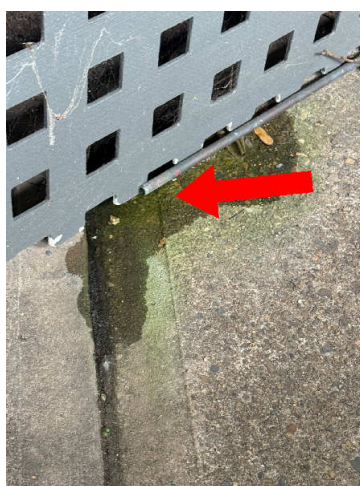
Defects 2.03

Building:	Main Building
Location:	The Site
Finding:	Site drainage - Inadequate

The site drainage in this area was found to be inadequate at the time of inspection, creating potential for subsequent water damage to associated building elements.

It is important that water does not lie against the base of walls; surrounding paths and ground levels should be sloped to drain water away from walls. Downpipes should not disgorge stormwater onto lower walls or plinths. Stormwater should be carried away by large, regularly cleaned drains. Ground levels may need to be lowered to expose a buried DPC.

Where site drainage is inadequate, installation of an Agricultural (Aggie) Drain may be required. A qualified plumber should be appointed to further inspect the property and perform any remedial works as necessary. Water damage and secondary defects are likely to occur if left unmanaged.

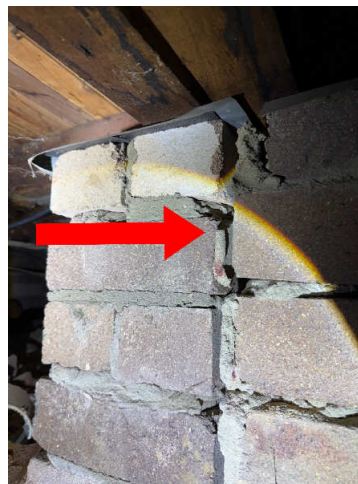
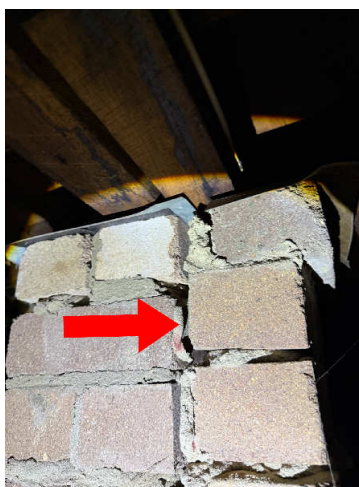
Defects 2.04

Finding: Subfloor brick piers - Unstable or deteriorated

At the time of the inspection, it was observed that the brick pier supporting the subfloor structure is observed to be splitting and cracked, with displaced bricks and deteriorated mortar joints. Cracking appears to extend through multiple courses, and there is evidence of separation along the vertical mortar joints.

This condition indicates a loss of structural integrity of the pier and may be associated with foundation movement, overloading, or inadequate original construction.

The condition of the brick pier may compromise its ability to adequately support the loads above. Continued movement or deterioration could result in further cracking, uneven floors, or localised structural instability.

This defect is considered structural in nature
It is strongly recommended that this brick pier be urgently assessed by a qualified structural engineer to determine the cause of the cracking and confirm the adequacy of support. Repairs may involve rebuilding, underpinning, or replacement of the pier in accordance with the engineer's recommendations. All rectification work should be carried out by a suitably licensed contractor.

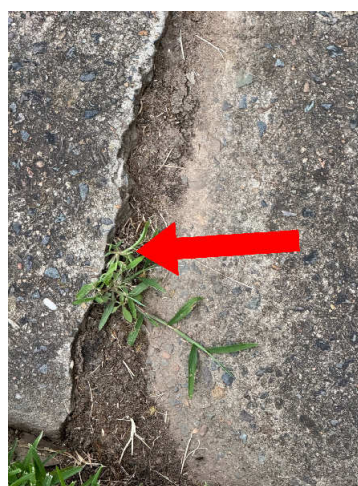
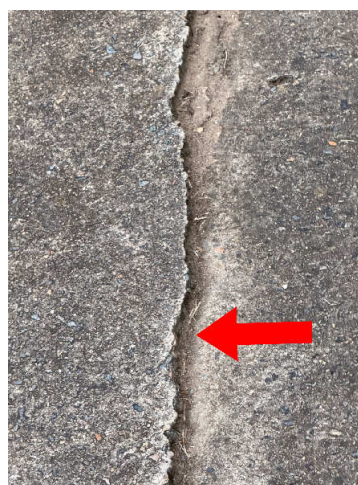
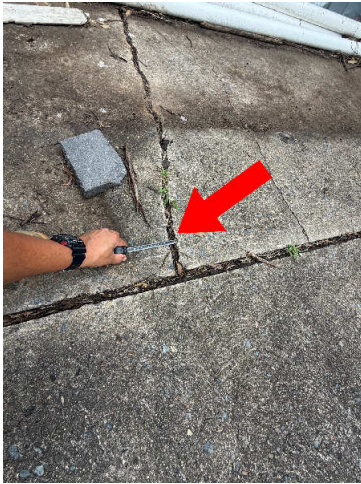
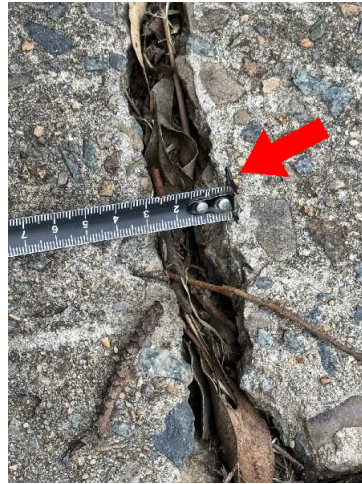
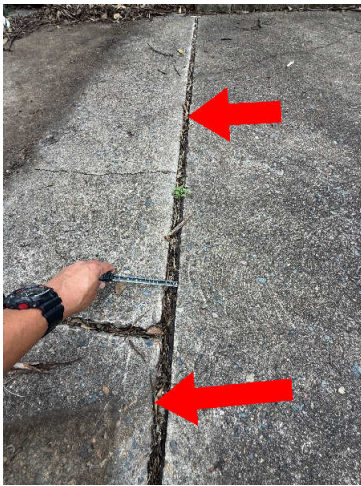
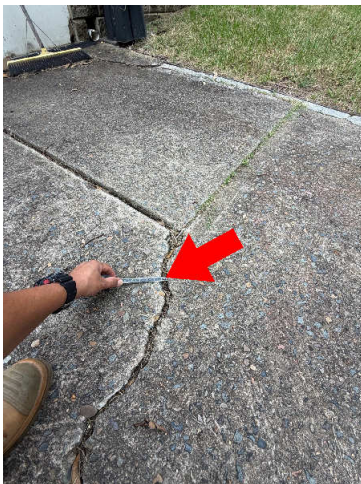
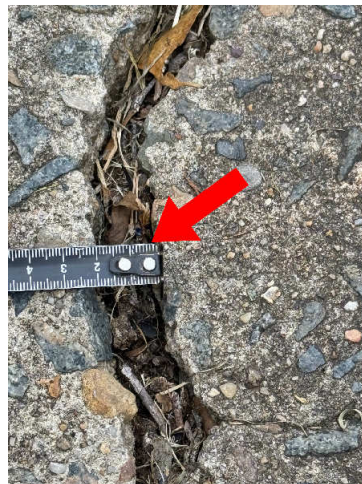
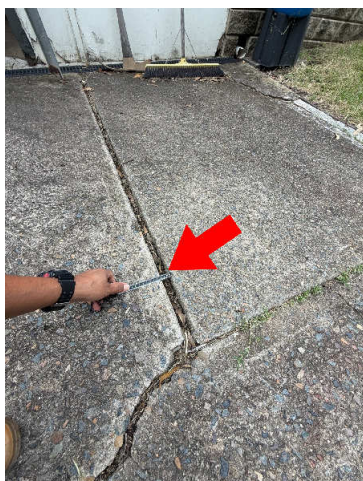
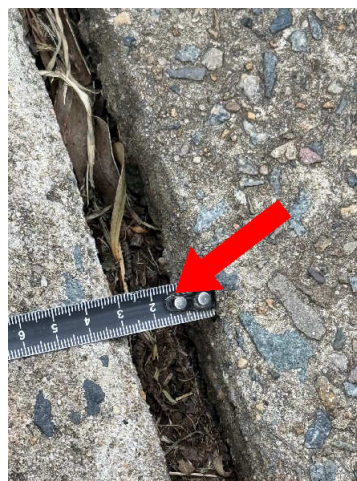
Defects 3.01

Building:	Main Building
Location:	Driveway
Finding:	Crack in concrete slab - Category 3
Information:	A crack coded as Category 3 was identified in the slab.

A Category 3 crack is described as a wide crack with obvious curvature or change in level, affecting the slab.

The approximate width of the crack to be considered Category 3 is greater than 2.0mm, or a change in offset of 15-25mm when a 3m straight edge is placed over the defect.

Category 3 cracks to slabs exceed allowable Standards and Tolerances, and are considered defects requiring rectification.

Inadequate control joints or joint failure

Age-related deterioration

Moisture variation in subgrade soils

If not rectified, the open gaps may continue to widen, create trip hazards, allow water ingress and vegetation growth, and contribute to further deterioration of the concrete and supporting subgrade.

It is highly recommended that suitable contractor is engaged as soon as possible to assess the concrete slab condition and carry out rectification

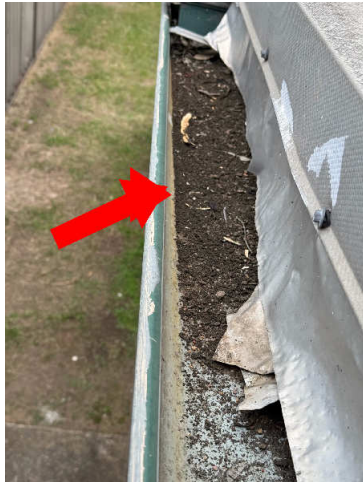
Defects 3.02

Information: At the time of inspection, it was observed that the roof gutters are blocked and were full of leaves and debris.

Blocked gutters are likely to lead to high levels of moisture in the affected areas.

Consult a Licensed Plumber for further specific advice on remedial works that may be required.

In the interim, it is highly advised that blocked gutters be cleaned by the homeowner or a general handyperson as a matter of urgency.

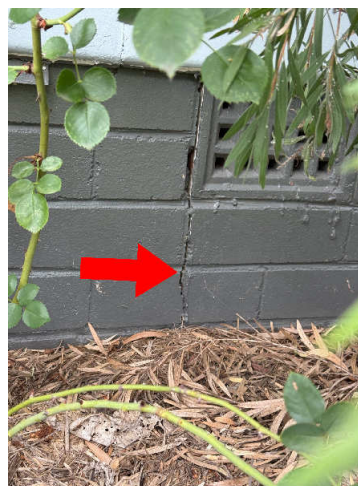
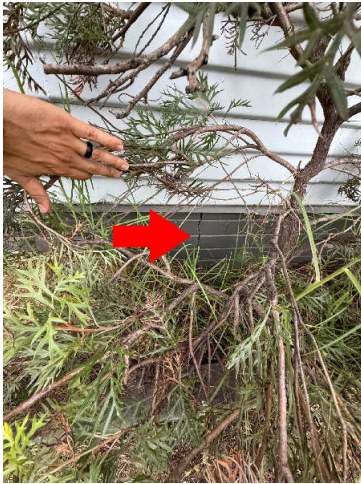
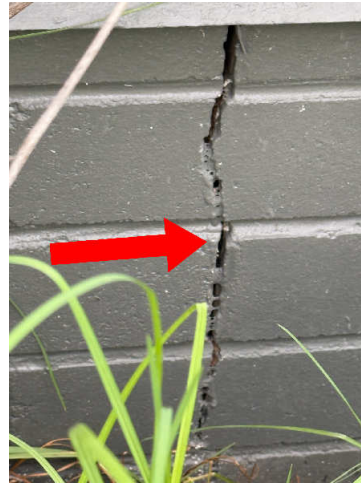
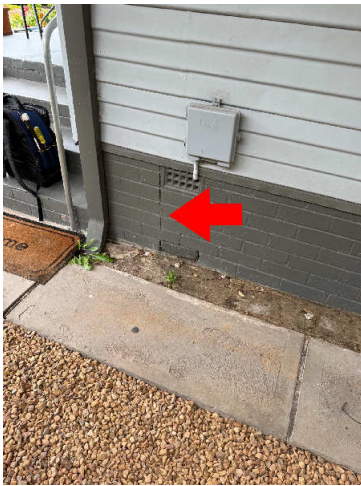
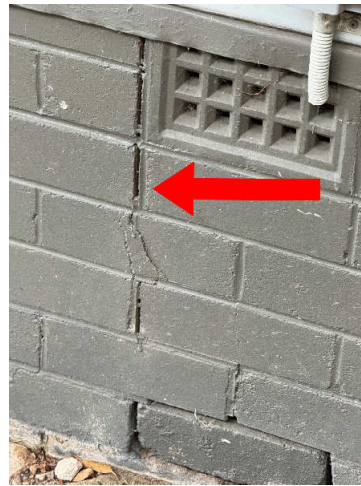
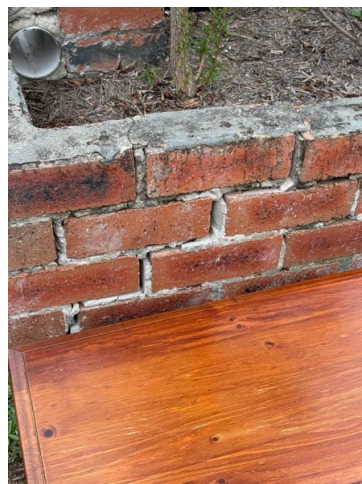
Defects 3.03

Finding: Brickwork - Cracking [Repair required]

Information: Significant vertical and stepped cracking was observed to the external masonry wall, extending through multiple courses of brickwork and mortar joints. The cracks show clear separation between masonry units and are of a width and nature greater than typical shrinkage or thermal cracking. This type of cracking is indicative of structural movement and exceeds what would be considered a minor or maintenance-related defect. In accordance with AS 4349.1 – Inspection of Buildings, cracks of this extent and pattern are assessed as a major defect due to their potential to affect the structural performance, serviceability, and durability of the building.

Foundation or footing movement

Ground subsidence or reactive soil conditions

Implications: If left unaddressed, further movement may occur, resulting in widening of cracks, loss of structural integrity, increased moisture ingress, and potential deterioration of the masonry wall.

Recommendation: It is strongly recommended that a qualified structural engineer be engaged to carry out a detailed assessment of the affected areas.

The engineer should determine the cause, extent, and significance of the movement and provide appropriate rectification and monitoring recommendations. Structural repairs may be required.

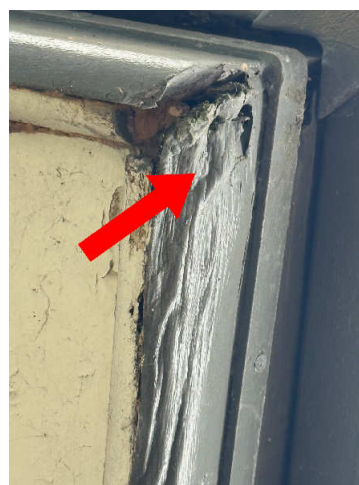
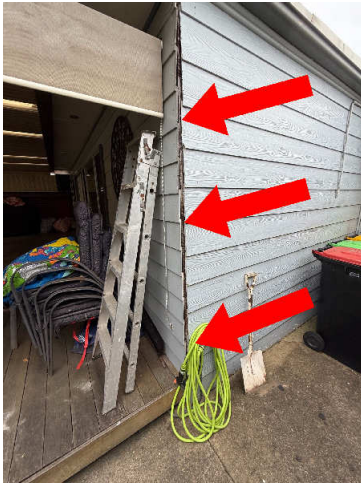
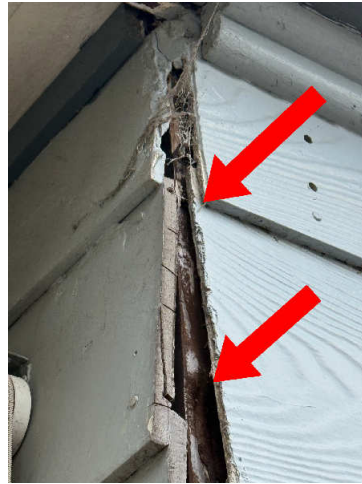
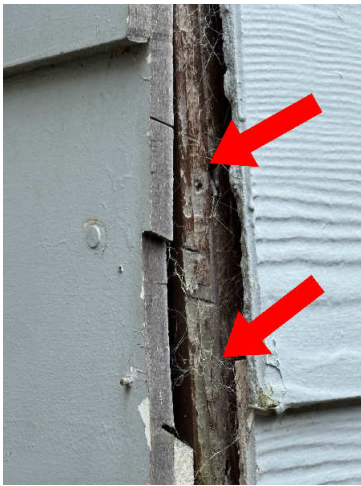
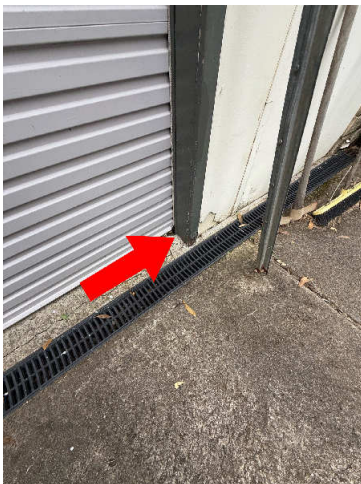
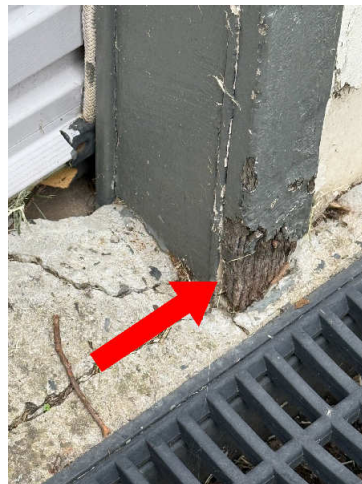
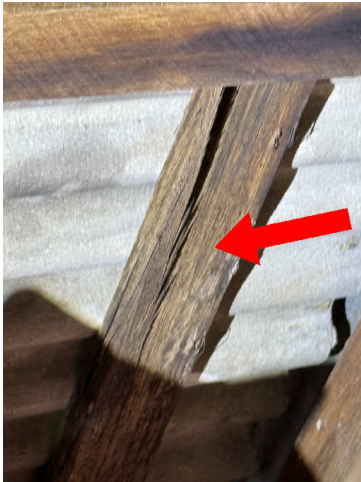
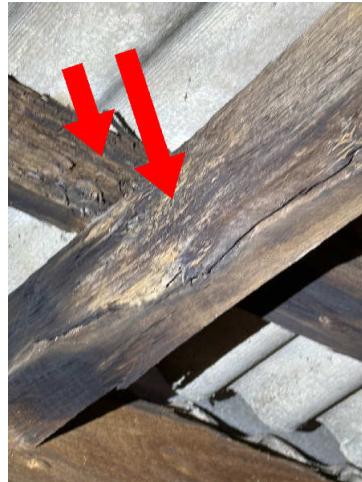
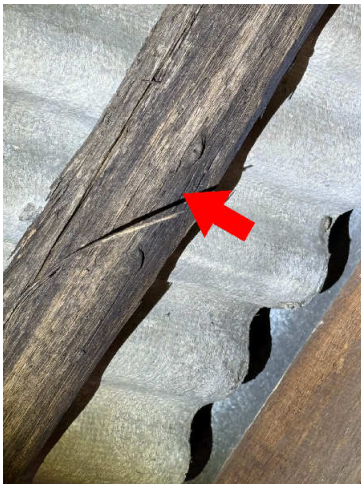
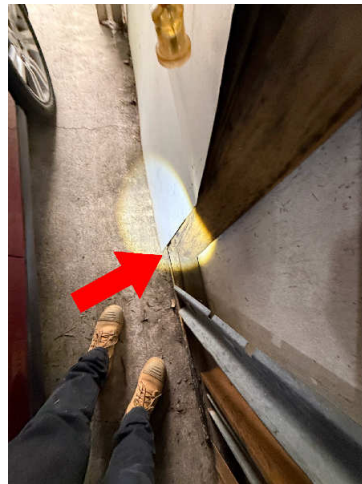
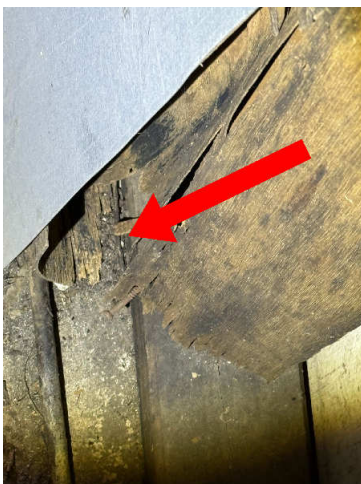
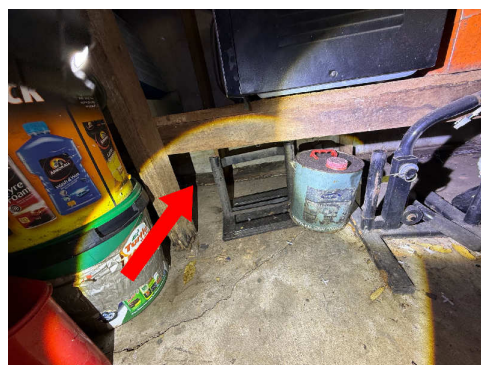
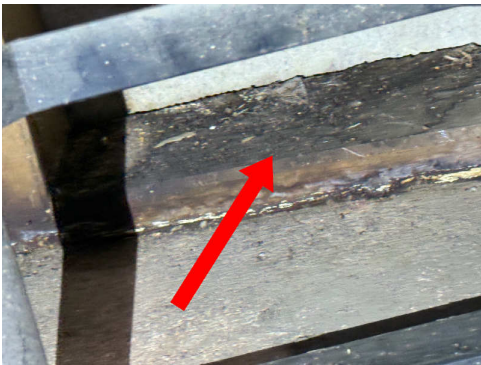
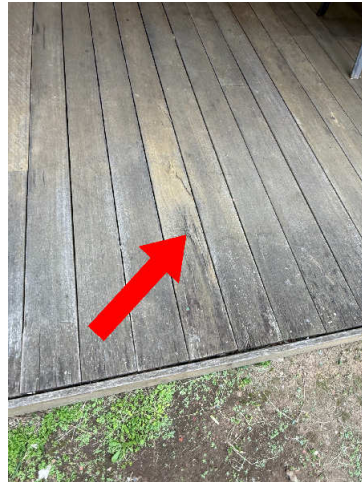
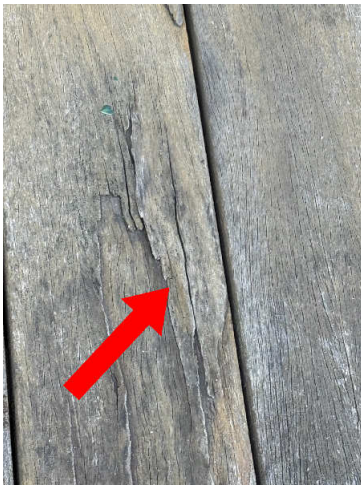
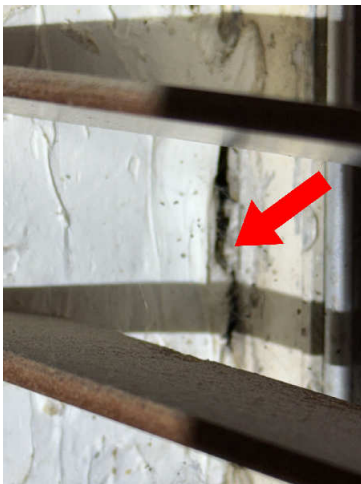
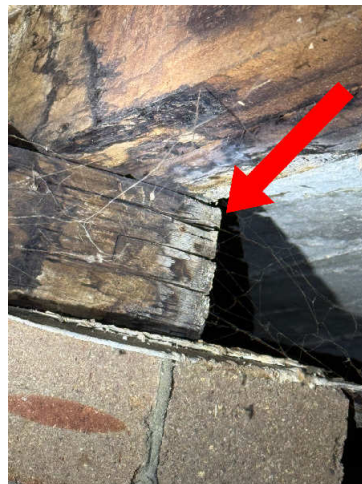
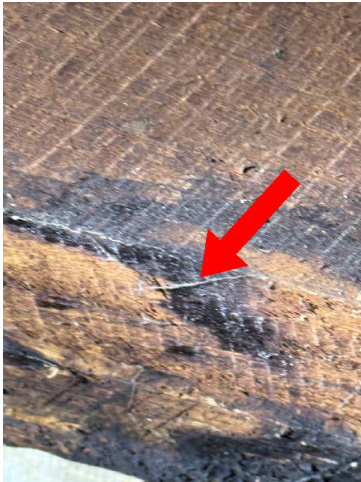
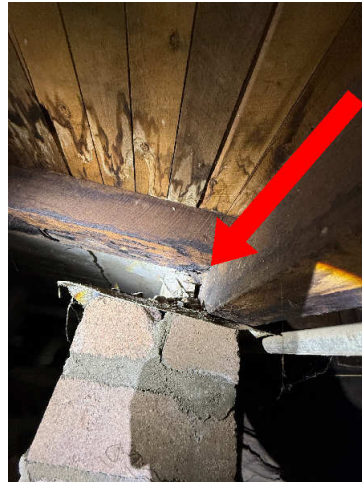
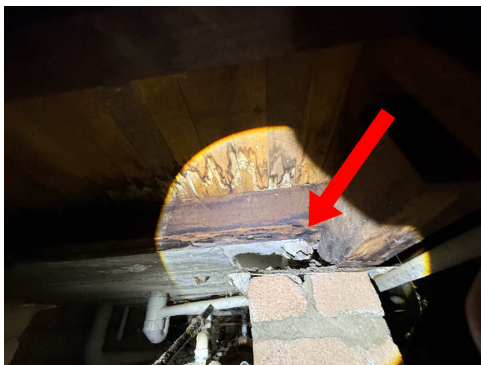
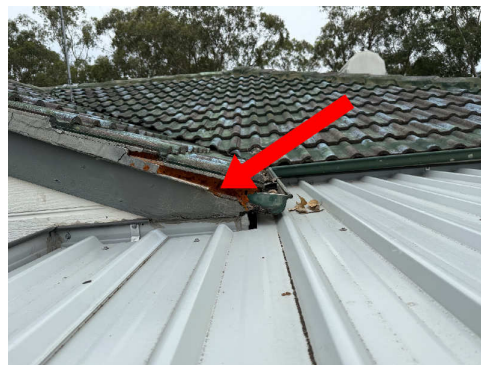
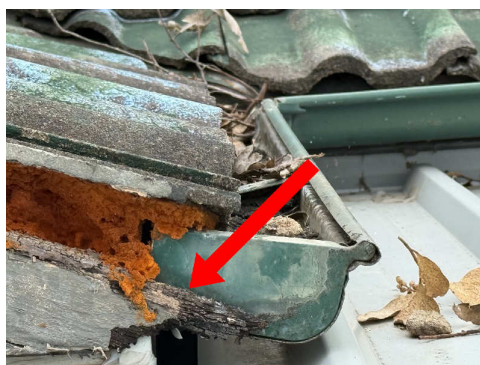
Defects 3.04

Finding: Wood rot (fascia, decking, timber in ground, window)

Information: This building element shows evidence of wood rot. Wood rot, also known as Fungal Decay, occurs when timbers and other cellulose building materials are exposed to damp conditions on an ongoing basis. This could be the result of exposure to weathering over a prolonged period of time, or the attraction of excessive moisture from other abutting building materials. Contributing factors also include poor air ventilation in the area.

Wood rot is often associated with general damp problems and is evidenced by a 'musty' smell or mould and mildew occurring on surfaces. If left unmanaged, damp conditions can lead to further health problems and the decay of timbers will continue.

Prior to any works being performed, the cause of the moisture that has created the visible wood rot should be identified and addressed in a suitable manner. Replacement of affected timbers may then be a necessary step in protecting surrounding building elements from such deterioration.

A qualified plumber may be appointed to assess the cause of excessive moisture and to provide advice on any remedial works as required.

A qualified carpenter or registered builder may also be required to replace affected building materials.

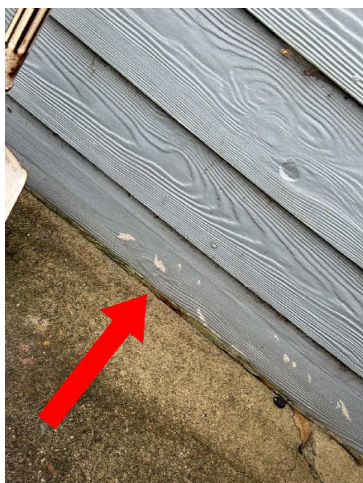
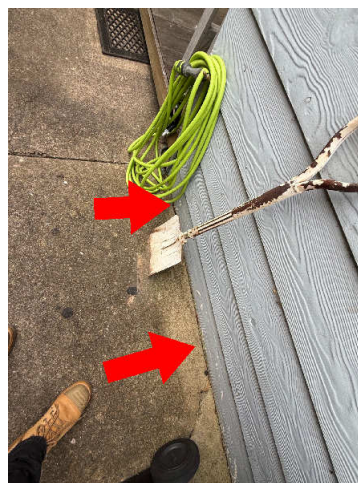
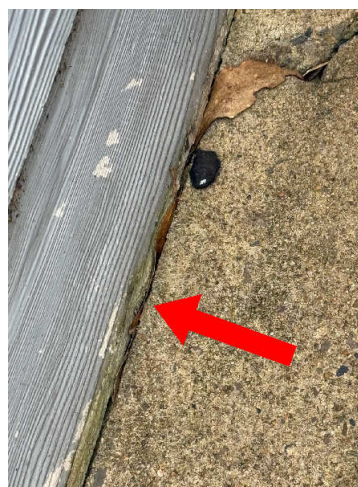
Defects 3.05

Evidence of moisture staining and deterioration at the lower edge of the cladding was observed.

Cladding installed in direct contact with concrete paving is susceptible to moisture wicking, premature deterioration, and concealed decay of wall components. This condition also restricts drainage and drying, increasing the risk of water ingress, mould growth, and pest activity.

The lack of clearance is not consistent with good building practice.

It is recommended that a licensed builder be engaged to assess this condition. Rectification may involve lowering the pavement level, introducing an appropriate clearance gap, installing a termination flashing or trim, or replacing affected cladding where deterioration has occurred. Any repairs should be carried out in accordance with current standards, manufacturer requirements, and good building practice.

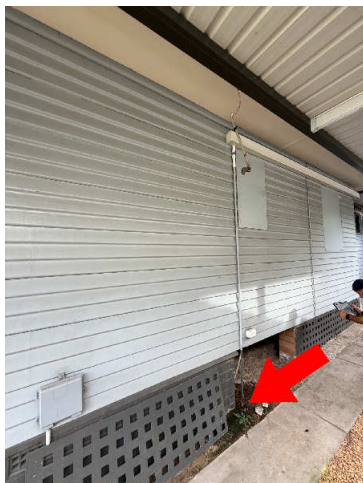
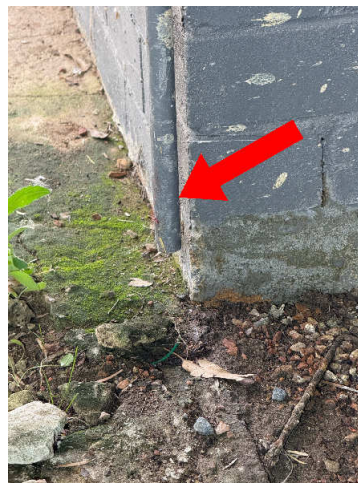
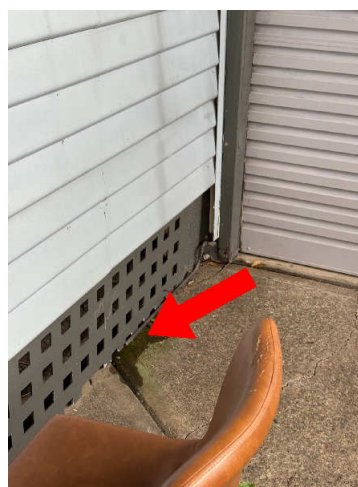
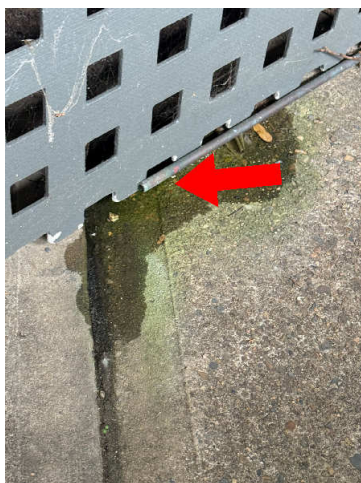
Defects 3.06

Information: The Hot Water System (HWS) overflow and AC drain were found to be disconnected from storm water drainage and is creating excessive moisture in the surrounding area.

These damp conditions can lead to secondary defects such as rot, rust or corrosion of associated building elements, the formation of fungal decay, or even the creation of potential slip hazards.

When coupled with poor site drainage, pooling of water may also attract termite activity to this area.

It is highly recommended that a licensed plumber be appointed to connect the HWS overflow in order to prevent such an environment from being created. These minor works should be carried out as soon as possible.

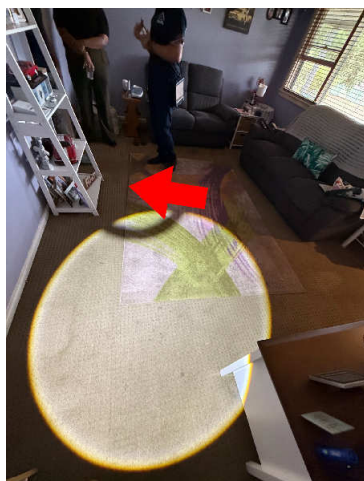
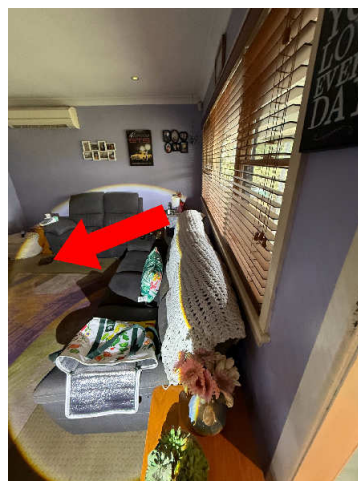
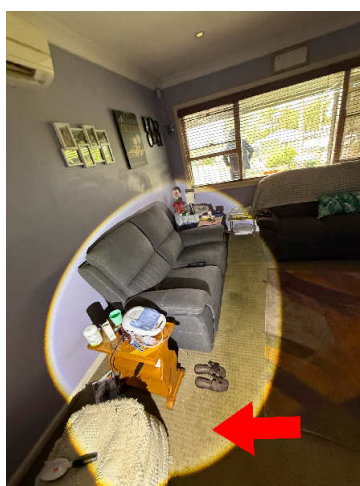
Defects 3.07

During the inspection, sections of the internal flooring beneath the carpet were observed to exhibit a noticeable springy or “jumping” movement when walked on. This movement indicates that the floor structure is not firm or stable in these areas.

Given the age of the dwelling, this condition may be associated with factors such as subfloor settlement, deteriorated or loose bearers and joists, inadequate support, moisture-related deterioration, or historical movement.

While some degree of floor movement can be common in older houses, excessive or noticeable jumping is not considered normal wear and tear and may indicate underlying structural issues.

Continued movement may worsen over time and could result in further floor damage, cracking of finishes, or costly repairs if left unaddressed.

It is strongly recommended that a licensed builder or structural professional carry out a further invasive assessment, including inspection of the subfloor where accessible, to determine the cause and extent of movement and to advise on any necessary repairs.

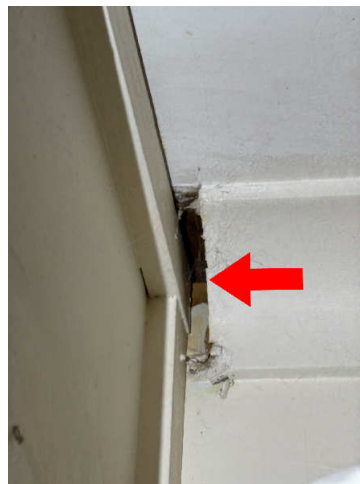
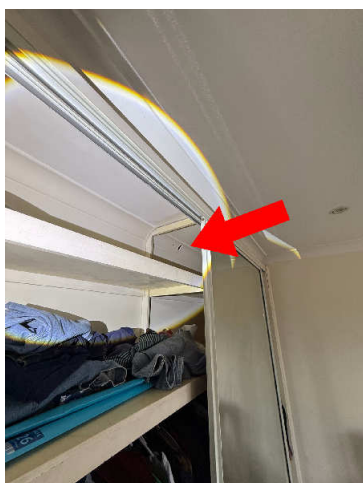
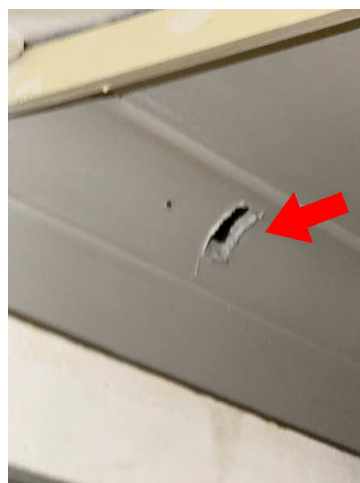
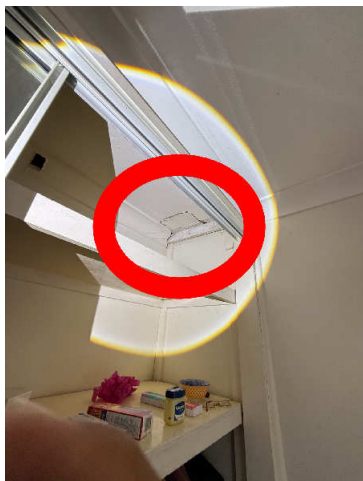
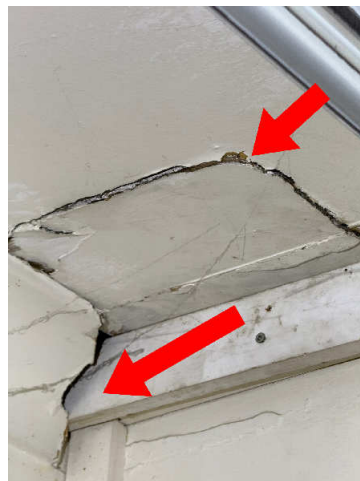
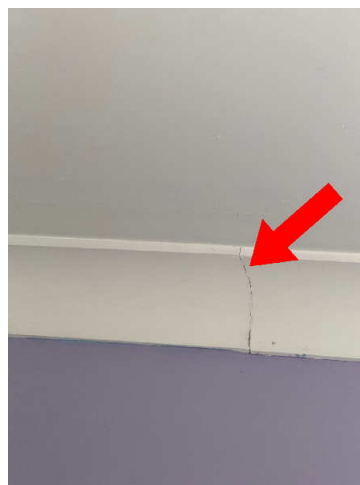
The extent of deterioration could not be fully determined without invasive inspection.

It is recommended that a licensed builder or qualified tradesperson be engaged to further investigate the cause of the ceiling damage and carry out appropriate repairs or replacement. Where moisture damage is suspected, the source should be identified and rectified before cosmetic repairs are undertaken.

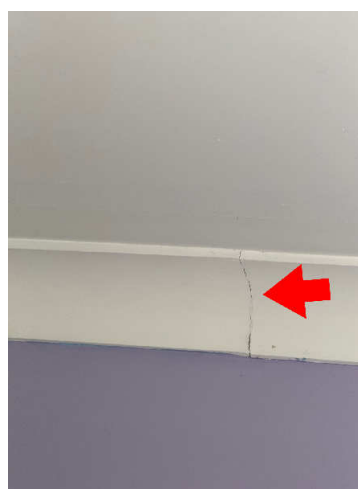
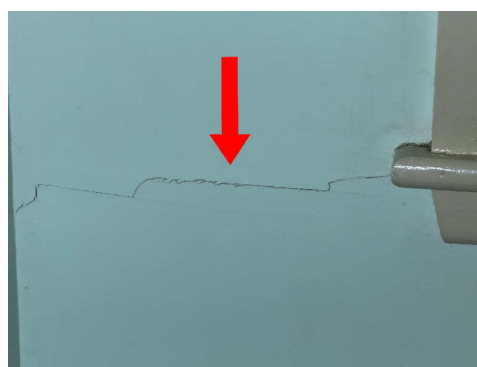
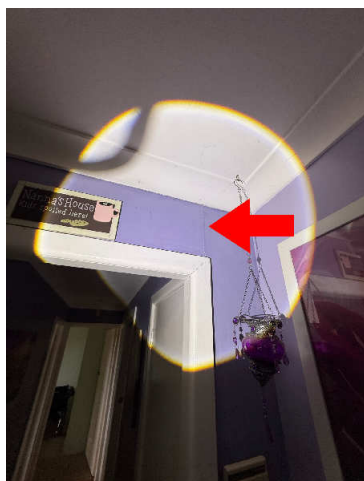
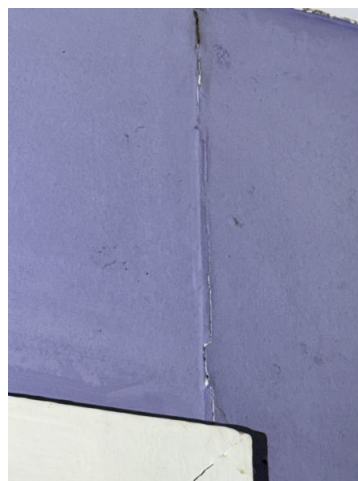
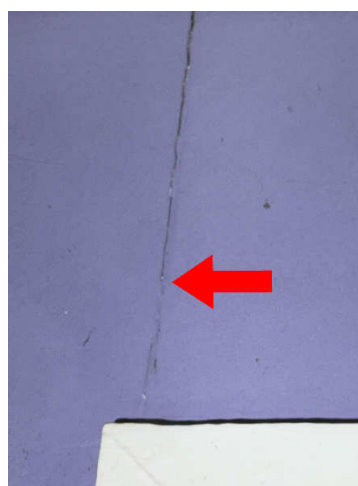
Defects 3.09

Finding: Settlement Cracks in Gyprock

Information: There are fine cracks and gaps visible through out the house. Over time, settlement cracks have appeared in the gyprock walls. These defects are typically caused by natural building movement, foundation settlement, or thermal expansion and contraction.

While common in new constructions during the settling period, they affect the aesthetic finish and may require repair to prevent further deterioration.

- Natural foundation settlement over time.
- Thermal expansion and contraction of building materials.
- Inadequate joint treatment or sealing during construction.

The severity is primarily aesthetic, but requires monitoring for structural concerns.

It is recommended to hire a professional painter to seal cracks and gaps and paint the surfaces at the client's discretion.

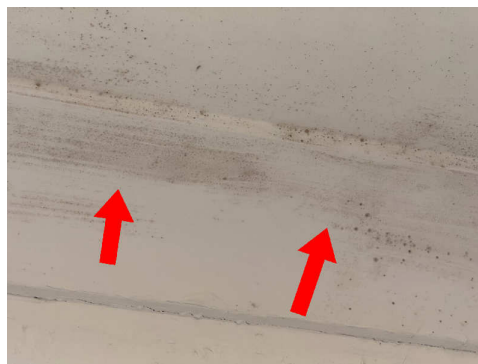
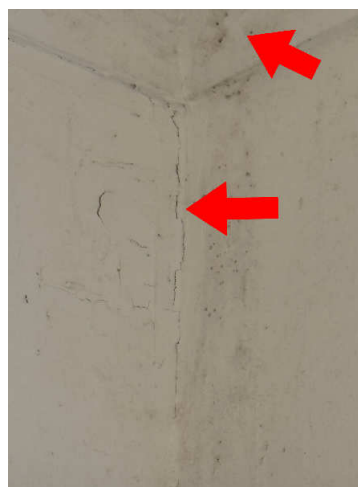
Defects 3.10

Information: Visible mould growth was observed on the bathroom ceiling and wall surfaces, particularly along junctions, corners, and high-moisture zones. The mould appears as dark spotting and staining, consistent with prolonged moisture and inadequate ventilation. Associated cracking and deteriorated paint finishes were also noted in affected areas.

Mould growth indicates persistent elevated moisture levels and may be associated with poor ventilation, ineffective exhaust systems, excessive condensation, or possible water leaks.

If left unaddressed, mould may continue to spread and can contribute to deterioration of finishes and potential health concerns, particularly for occupants with respiratory sensitivities.

The presence of mould may indicate underlying moisture issues that were not fully identifiable at the time of inspection.

It is recommended that a qualified tradesperson be engaged on urgent basis to clean and treat the affected surfaces using appropriate mould remediation methods. In addition, the source of excess moisture should be identified and rectified, which may include improving ventilation (e.g. exhaust fan performance), repairing waterproofing or leaks if present, and reinstating damaged finishes.

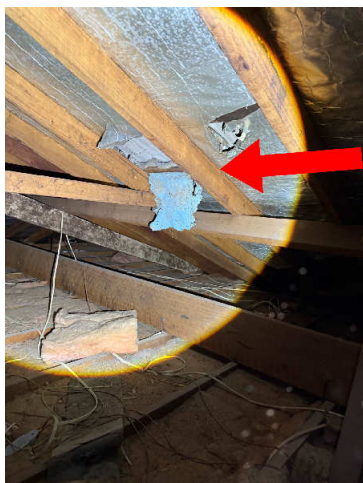
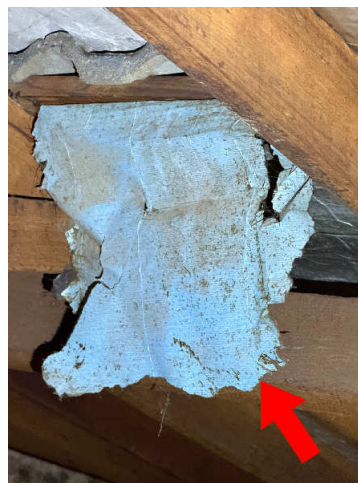
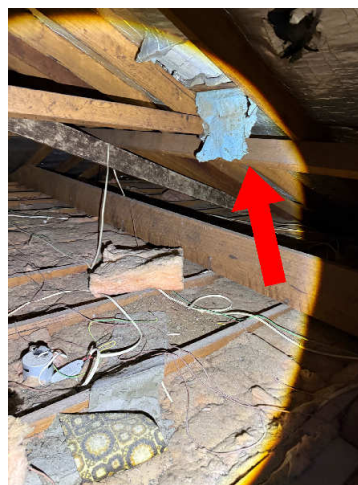
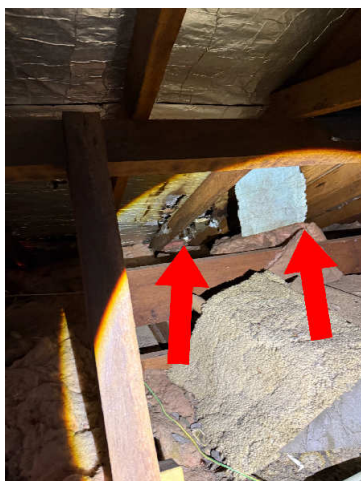
Defects 3.11

Building:	Main Building
Location:	Roof Void
Finding:	Sarking - Damaged

During inspection, it was observed that roof sarking was damaged (Deteriorated) at many places in the roof void.

Where sarking is damaged, both insulation and moisture protection of the property are inhibited.

This creates a loss of energy and thus negatively impacts the energy efficiency of the property, allowing potential for moisture ingress from condensation or leaking roof tiles.

It is important to repair any holes or damaged sections of sarking to ensure that the building material is fully functional. A registered builder or qualified carpenter, roof installer should be consulted as soon as possible to provide further advice on this defect and to perform rectification works

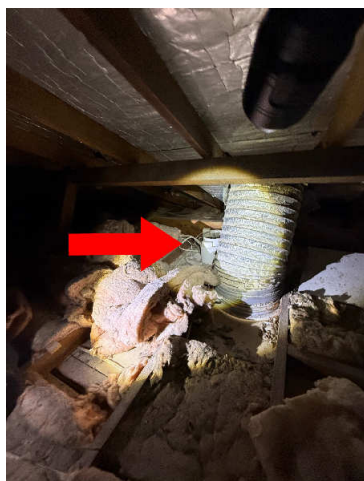
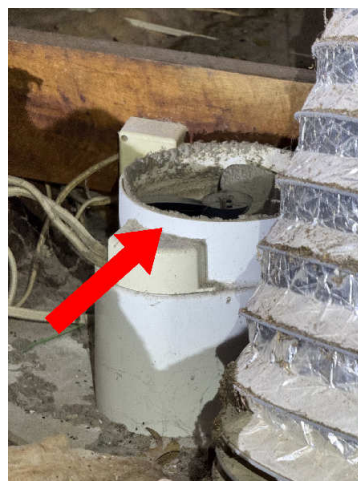
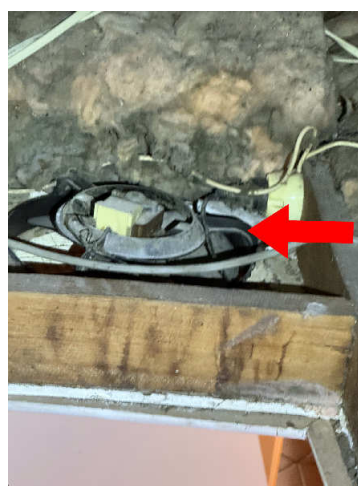
Defects 3.12

Information: At the time of inspection, the bathroom exhaust fan was found to be venting directly into the roof space, rather than being ducted to discharge to the external atmosphere.

Where exhaust fans discharge into the roof space, there is an increased risk of moisture accumulation, particularly if roof sarking is installed, as this can restrict natural ventilation through roof tile gaps.

Prolonged moisture buildup within the roof cavity may contribute to condensation issues, mould growth and deterioration of roof timbers, insulation, and other building elements

It is recommended that the client engage a licensed electrician as soon as possible to upgrade the bathroom exhaust fan system so that it vents directly to the external atmosphere, in order to reduce the risk of moisture buildup and associated damage

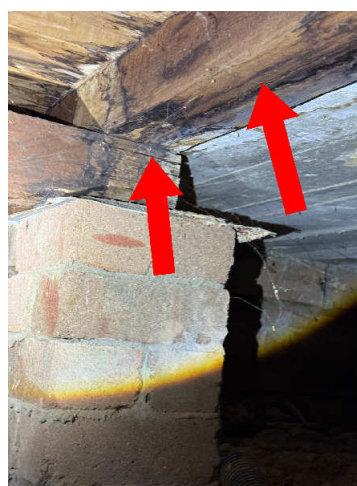
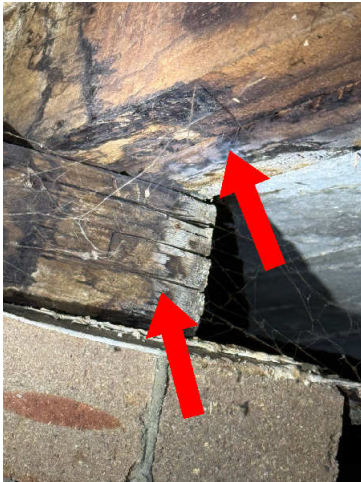
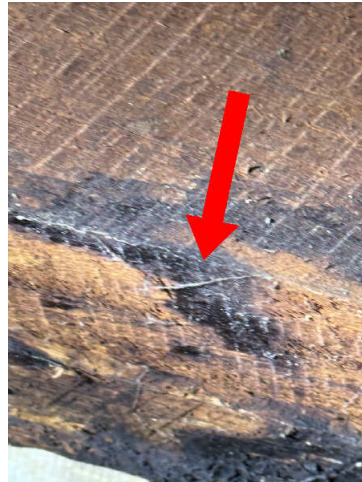
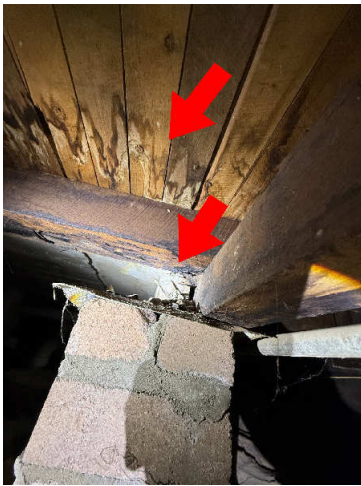
Defects 3.13

Finding: Water staining to timber joist, bearers and floor boards

Information: Evidence of water staining and moisture damage was observed on timber floorboards, joists, and bearers within the subfloor. The affected timbers display dark staining and discoloration consistent with past or ongoing moisture exposure. These conditions may be associated with inadequate subfloor drainage, plumbing leaks, poor ventilation, or external water ingress.

Prolonged or repeated moisture exposure can lead to timber deterioration, fungal decay, reduced structural capacity, and may create conditions conducive to termite or pest activity.

While active decay or excessive moisture was not confirmed at the time of inspection, the presence of water staining indicates an elevated risk that warrants further assessment.

It is recommended that

The source of moisture be identified and rectified (e.g. plumbing leaks, drainage issues, or inadequate subfloor ventilation).

A licensed plumber or qualified contractor be engaged to investigate potential leaks or water ingress.

A licensed pest controller assess the area, as damp conditions may attract timber pests.

Ongoing monitoring of the affected timbers is undertaken, and repairs or replacement carried out where deterioration is confirmed.
