Building Inspection Report

Inspection Date: Tue, 17 Mar 2026

Property Address: 119 Richmond Rd,CAMBRIDGE
PARK,NSW,2747,Australia

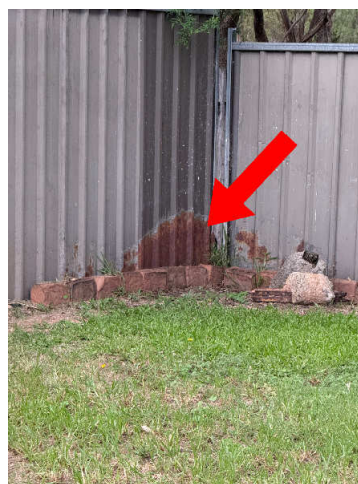
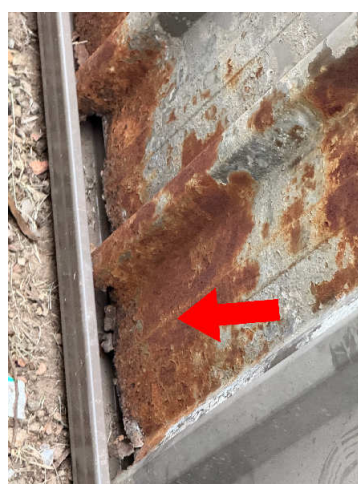
Defects 3.14

Finding: Rusted Metal fence

Information: The metal boundary fence panels exhibit significant corrosion, particularly along the lower sections where the metal is in close contact with soil and moisture. Visible rusting and surface deterioration are evident, indicating breakdown of the protective coating and ongoing metal degradation. Continued corrosion may lead to loss of structural integrity, reduced service life, and eventual failure of fence panels. Corroded metal can also result in sharp edges, presenting a safety hazard. The condition suggests prolonged moisture exposure and inadequate corrosion protection at ground level. It is recommended that:
A qualified contractor assess the extent of corrosion.
Affected fence sections be treated, repaired, or replaced as necessary.
Protective coatings be restored or upgraded, and ground contact reduced where possible to limit further deterioration.
Ongoing monitoring and maintenance be undertaken to prevent recurrence.

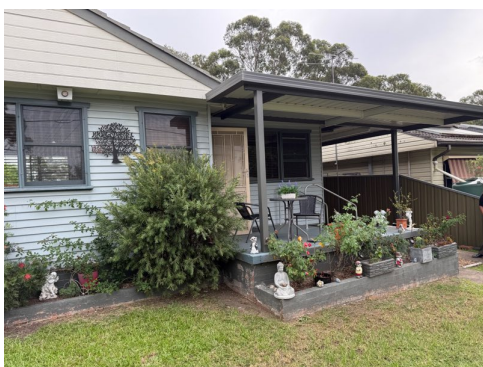
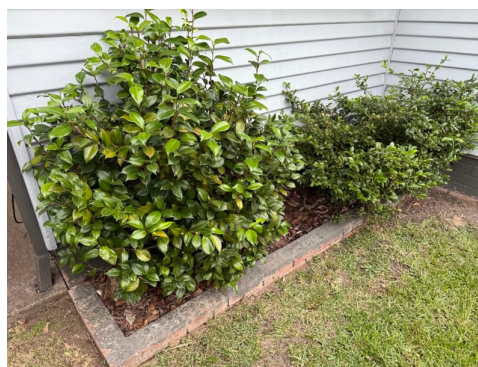
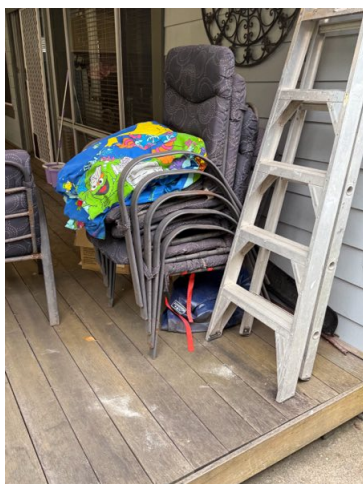
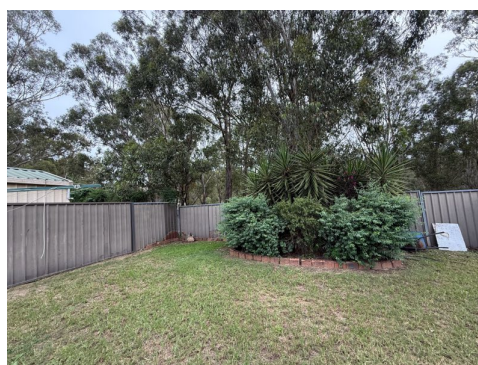
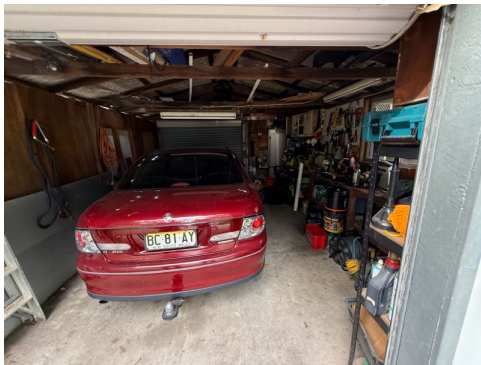
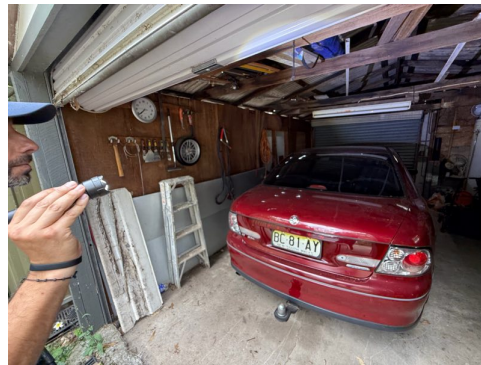
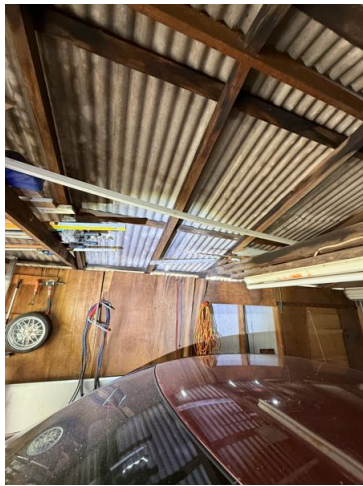
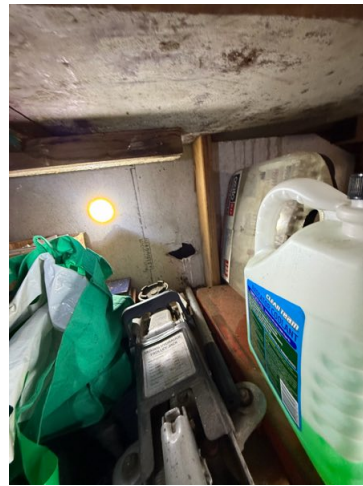
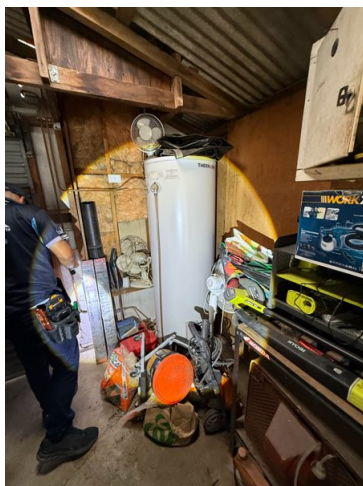
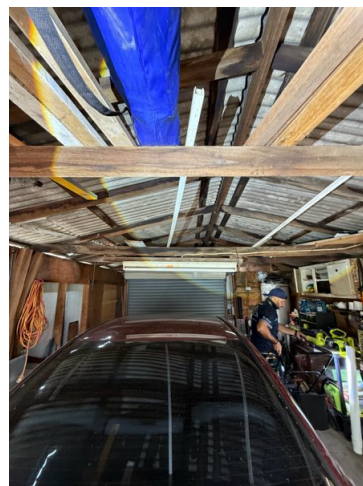
Finding: Additional Photos - Obstructions and Limitations

Information: These photographs are an indication of the obstructions and limitations which impeded full inspection of the property at the time of inspection. These obstructions can hide an array of defects and should be removed to allow full inspection to be carried out. A re-inspection is recommended once the areas are made accessible.

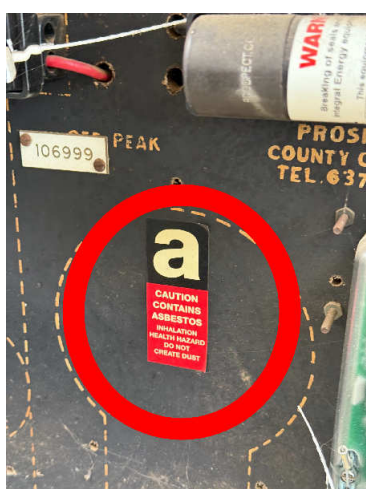
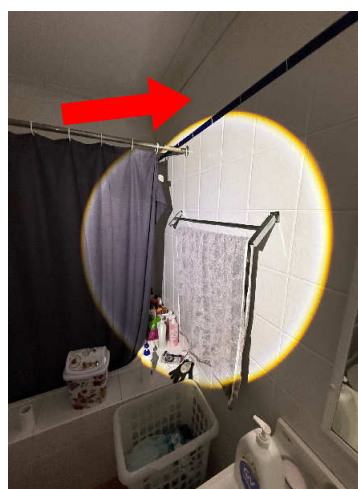
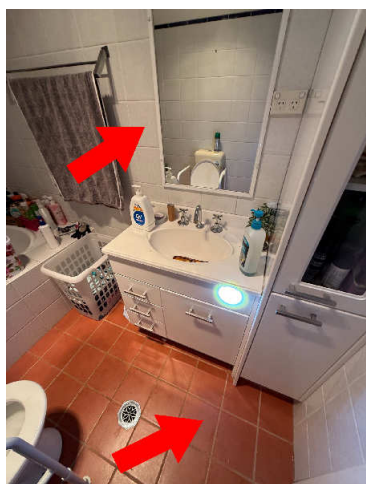
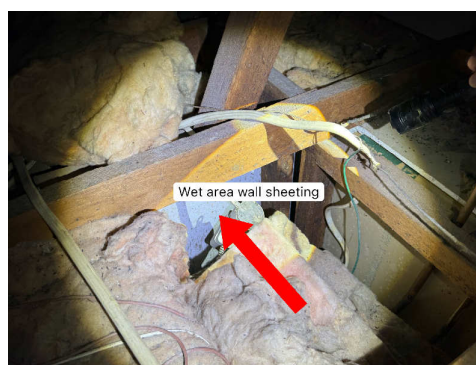
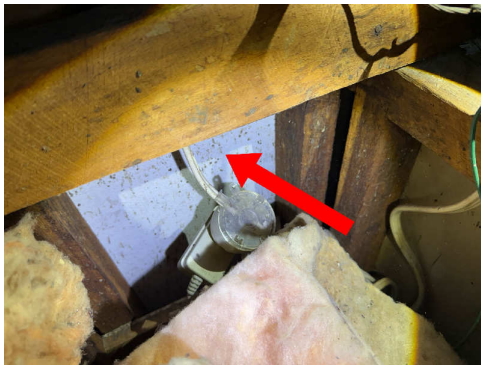
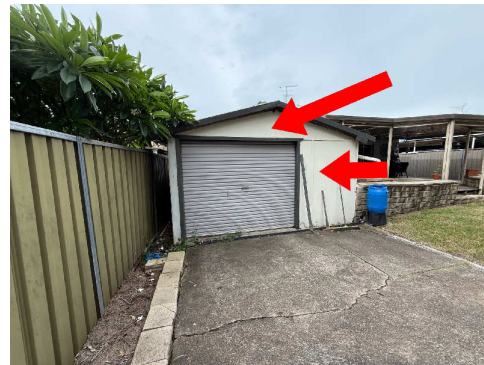
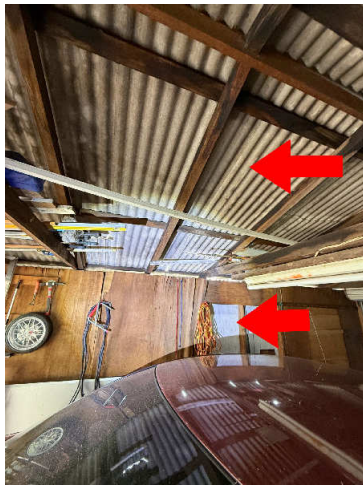
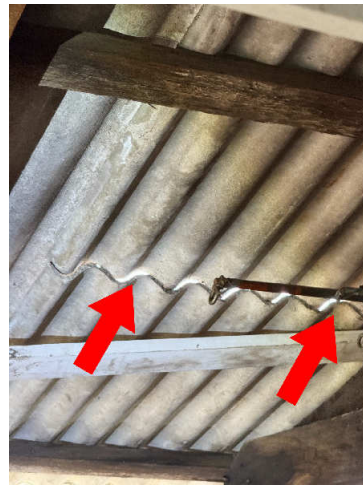
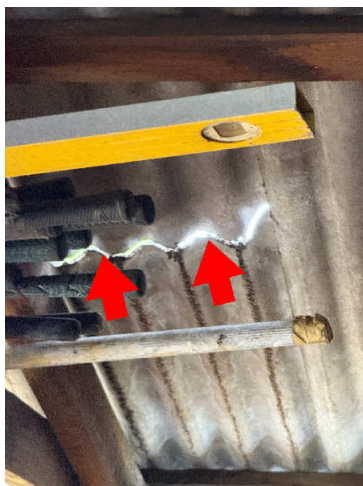
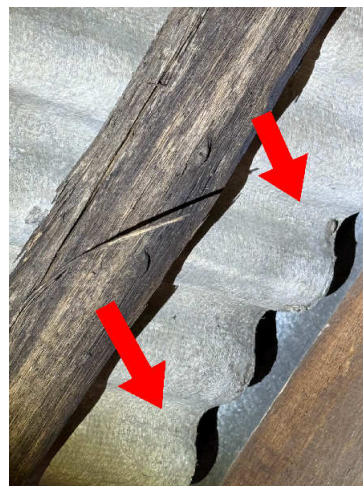
Information: The sheet construction material behind the ceramic tiles in bathroom, exterior cladding and substrate, garage shed and garage roof area is suspected to be an asbestos containing material (ACM). This material is generally found in bathrooms, kitchen and external facade and roofing material in this construction context in buildings pre-1985.

The observable areas of sheeting appear to be bonded, undamaged and free of deterioration in wall cladding. But damaged in garage shed and garage roof.

Damaged and deteriorated ACM's have a higher probability of releasing airborne asbestos fibres, creating a significant health and safety risk.

The area should be avoided and no works should be undertaken on the area until lab analysis results are available.

Should Asbestos be confirmed, the client should arrange for removal by a Licensed Asbestos Removal firm.

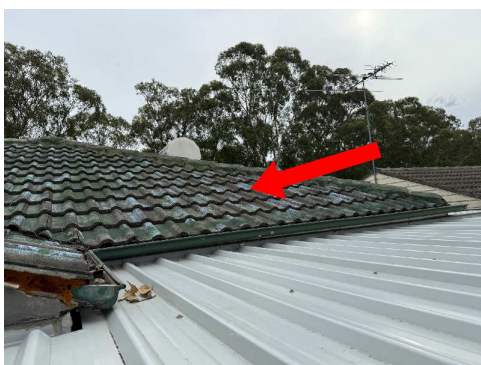
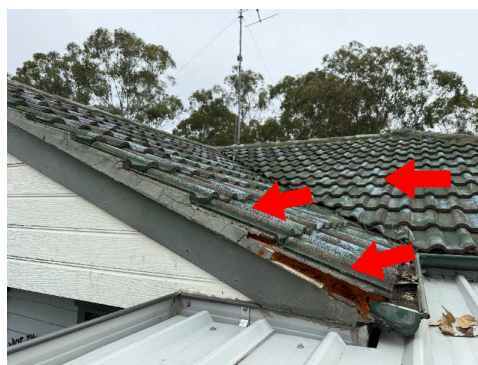
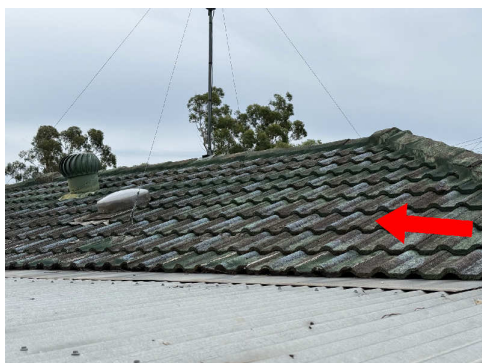
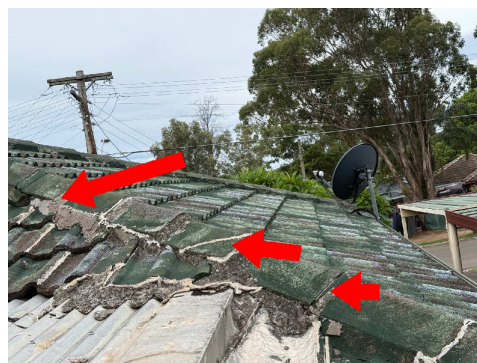
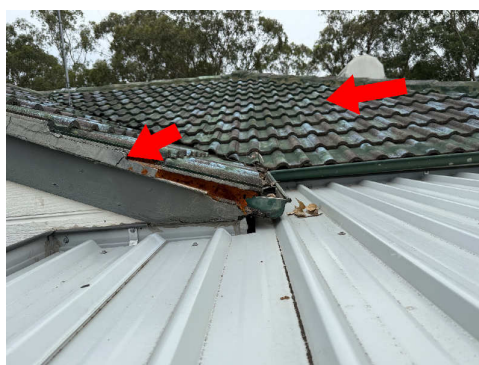
Information: Upon inspection of the exterior roofing, the majority of roof tiles were considered to be in a fair condition. While weathering of the tiles is consistent with the age of the property, maintenance works are required.

Isolated areas of mortar have come loose in the valleys and minor cracking is also present.

Where left unmanaged, deteriorating roof tiles are likely to lead to a number of secondary defects, including minor water leaks and weather exposure to internal roofing structures.

Consultation with a roofing contractor is highly advised to gain advice on cost of remedial works that may be required in the short to medium term.

Remedial works are likely to increase the longevity of the exterior roofing structure.

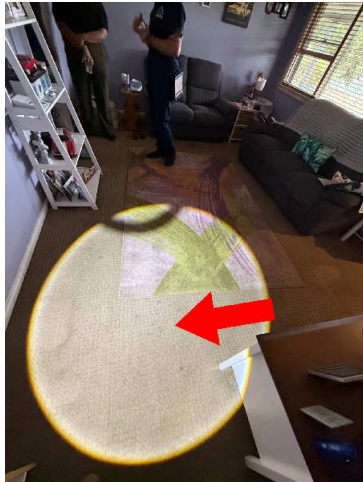
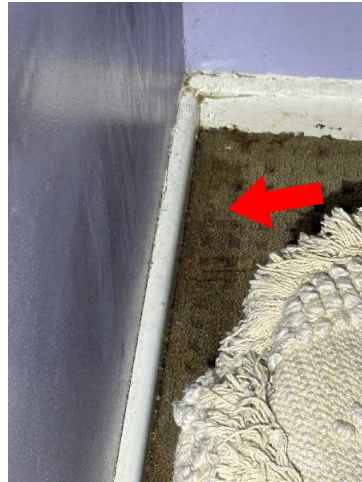
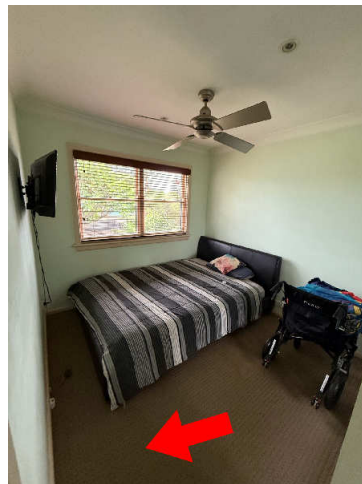
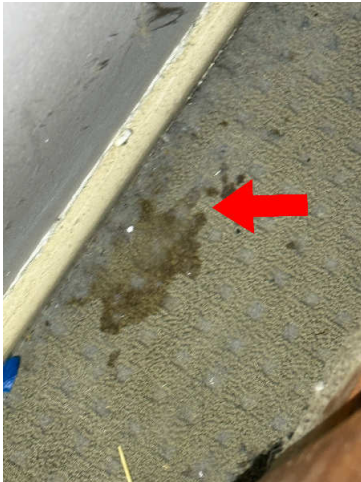
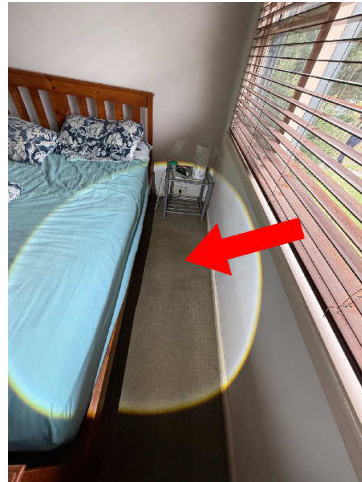
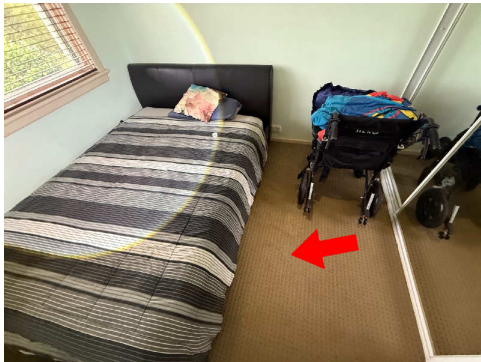
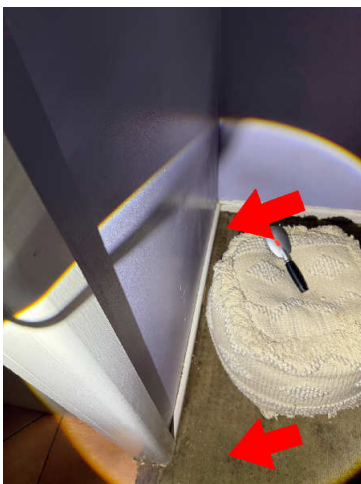
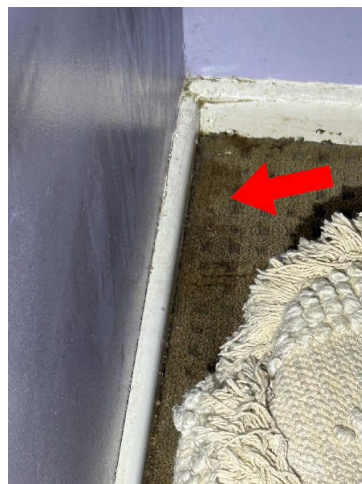
Finding: Carpet condition

Information: Given the age of the dwelling, the existing carpets are significantly worn, dated, and not suitable for continued use. The carpets show signs consistent with long-term wear and ageing and are considered beyond their practical service life. While not a structural defect, the condition of the carpets may affect comfort, hygiene, and presentation of the home.

Prospective purchasers should allow for removal and replacement of all carpets as part of post-purchase refurbishment, particularly if intending to occupy the property immediately.

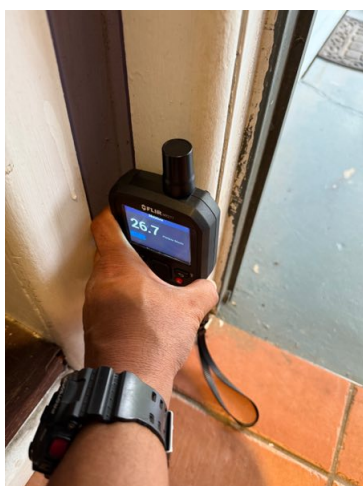
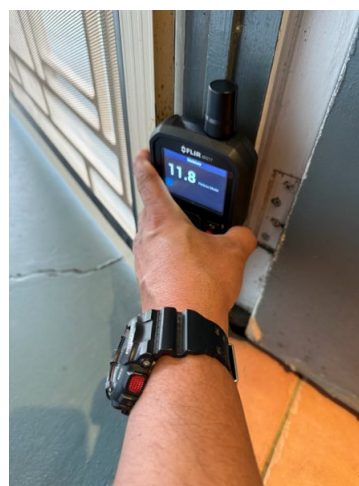
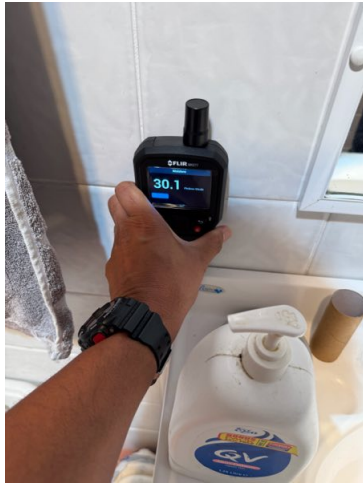
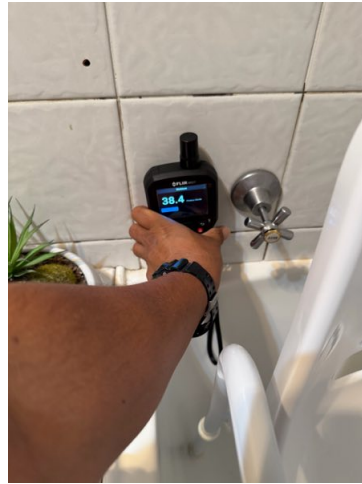
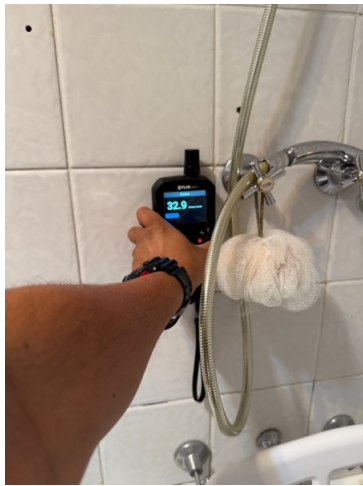
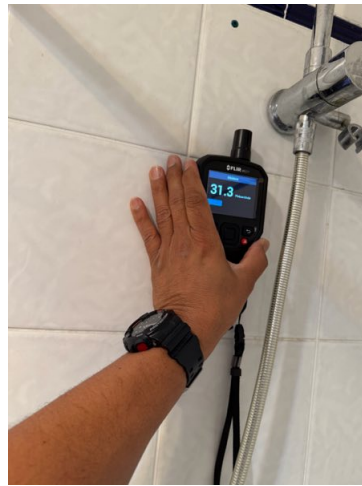
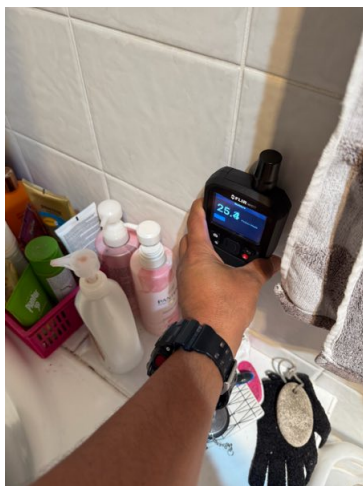
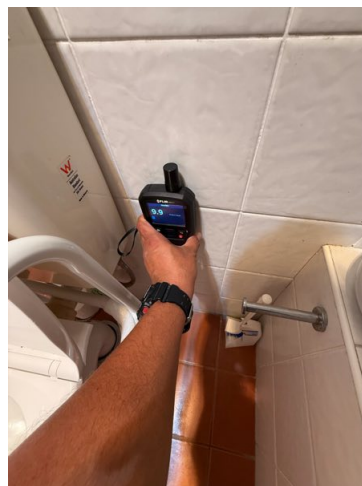
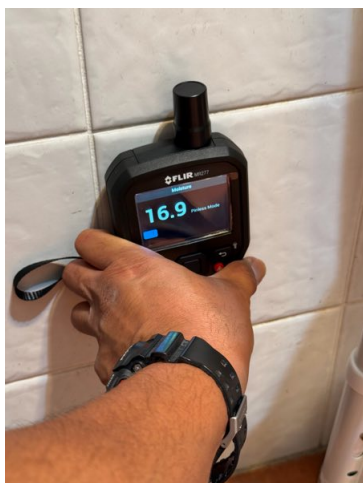
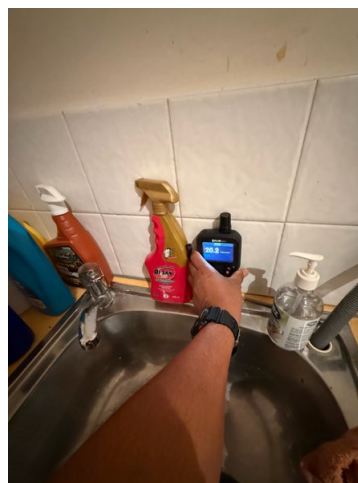
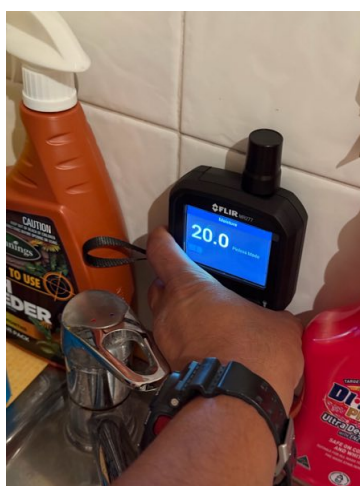
Location:	Wet areas
Finding:	Additional photos(Moisture reading)
Information:	Additional moisture meter reading photos have been provided for the property to offer further clarity on areas tested during the inspection.

These photos are intended to give a visual reference for the specific locations where moisture levels were measured.

While the readings reflect the property's moisture levels during the inspection, they may not represent future conditions, and increased moisture could lead to issues such as dampness, mould growth, or deterioration of building materials if left unmonitored.

Regular monitoring of moisture-prone areas is recommended to ensure any emerging concerns are addressed promptly, particularly during wetter seasons or in high-humidity conditions.
