# Building and Timber Pest Inspection Report

Inspection Date: Wed, 4 Feb 2026

Property Address: 8 Devlin Rd, North Epping NSW 2121,  
Australia

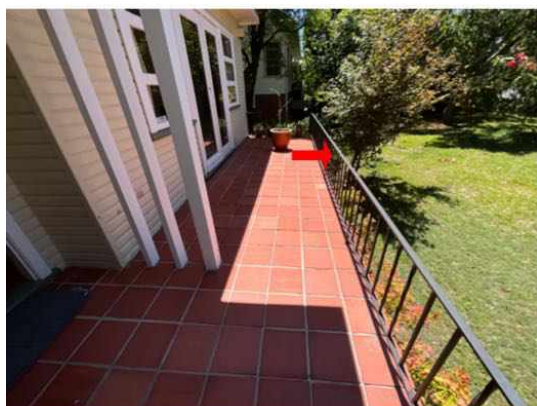
This issue is covered off in section 3.9.2 of the National Construction Code, Barriers and Handrails which generally states any area with more than 1m off must have an approved barrier.

A licensed builder could be appointed to provide necessary works to the balcony.

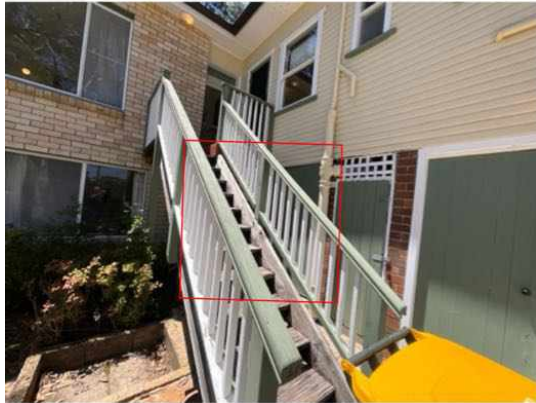
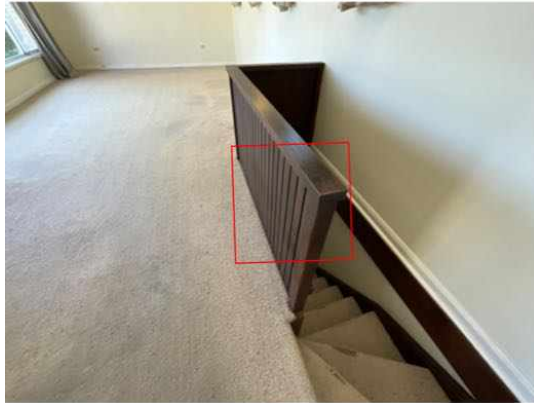
#### Finding 1.02

Building:	Main Building
Location:	Multiple areas
Finding:	Loose handrail — Fall from heights
Information:	The handrail was lacking appropriate support and fixing to the adjacent wall or floor at the time of inspection.

The handrail was further loose and moving upon minimal force applied with hand.

These handrails pose a risk and persons coming in contact may fall from heights if these handrails fail, thus causing severe injury.

A licensed builder must be appointed as soon as possible to rectify any non-compliance.

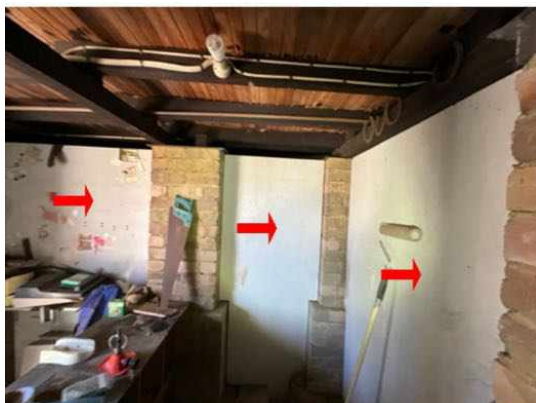
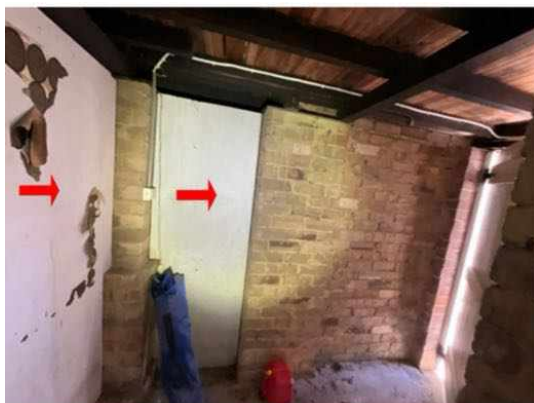
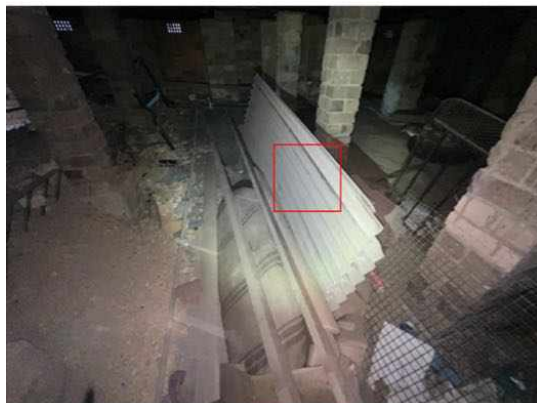
### Finding 1.03

Information: Reporting on Asbestos is outside the Scope of this Report. This suspected defect is highlighted as a caution only. We suspect, based on our experience in the building industry, that there is a higher risk of the identified building element containing asbestos.

As Asbestos Reporting is outside the scope of this report, we advise that you consider a separate Asbestos Inspection and Condition Audit, which can include the taking of samples for definitive confirmation of the presence of Asbestos.

In the interim, the client is advised to act with caution, especially when considering any damage to building materials general wear and tear renovations extensions demolition and general maintenance activities due to the suspected presence of Asbestos.

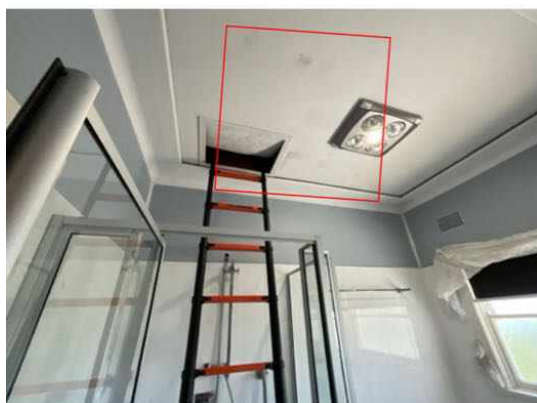
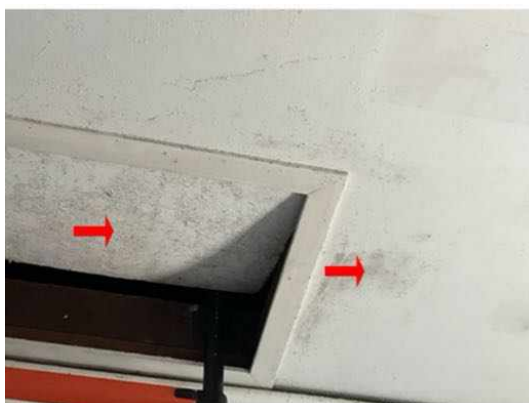
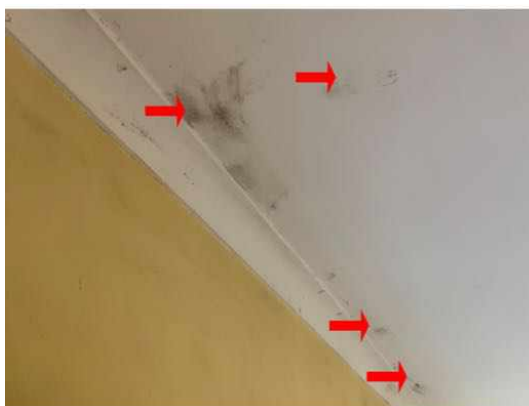
### Finding 1.04

Building:	Main Building
Location:	Multiple areas
Finding:	Mould - Present
Information:	Where evidence of mould growth was noted, there may be environmental, biological or health issues associated with the report. A specialist inspection by a suitably qualified environmental health inspector is warranted, where mould is extensive or where any queries regarding air quality spores or other related issues apply.

Generally, the client is advised to ensure that the general environment is free of moisture and humidity to aid in the prevention of mould formation and development. Any mould found during the inspection should be cleaned immediately by a cleaning contractor or the homeowner as applicable.

Please note that severely affected building elements may require replacement by a registered builder or qualified carpenter.

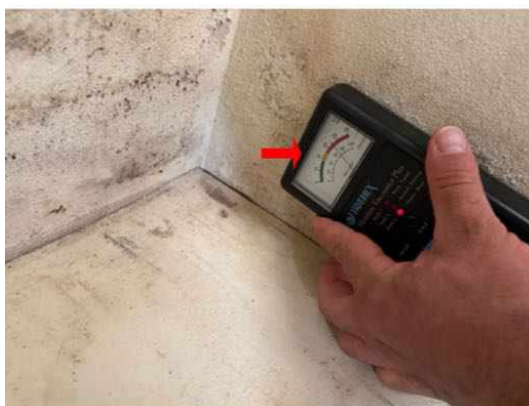
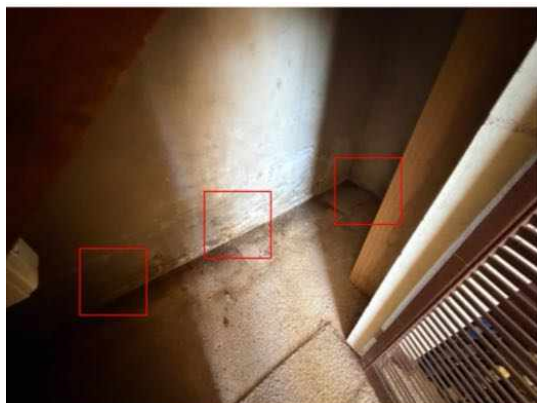
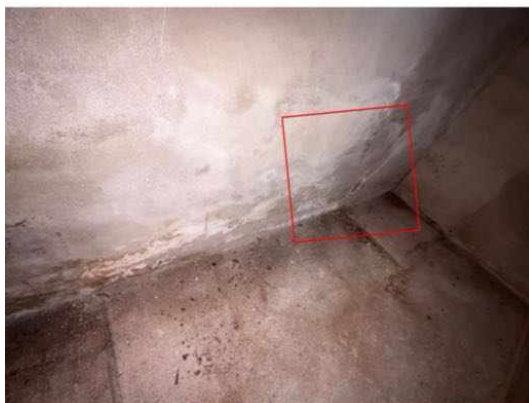
### Finding 2.01

Building:	Main Building
Location:	Extension downstairs
Finding:	Exterior walls - Lateral damp
Information:	Lateral penetrating damp refers to the sideways movement of moisture, predominantly from the surrounding ground, which tends to affect basement walls and other earth-retaining walls. The implications of unmanaged damp range from mould fungi growth, wood rot and decaying building materials, to finishes including lifting, bubbling, peeling and staining of paint, plaster and wallpaper.

It is important to address damp conditions as the World Health Organisation notes that excess moisture leads - on almost all indoor materials - to the growth of microbes such as moulds, fungi and bacteria, which subsequently emit spores and other matter into the indoor air. Exposure to these contaminants is associated with a wide range of respiratory and other health-related problems. Additionally, the development of damp in timber building elements also provides an environment that is conducive to termite / timber pest attack.

Structural waterproofing barriers or tanking barriers are often used to protect internal surfaces against the effects of lateral penetrating dampness. These types of work are generally undertaken where the source of the penetrating damp cannot be prevented.

Immediate consultation with a licensed builder and plumber is advised to address the cause of the damp and to perform remedial works as necessary.

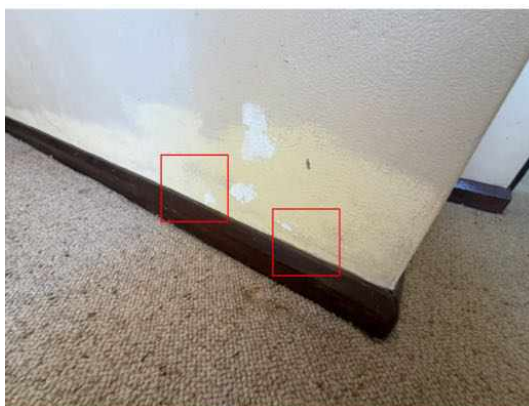
### Finding 2.02

Building:	Main Building
Location:	Extension bathroom
Finding:	Water leak - Internal
Information:	A water leak was found in this area at the time of inspection. Internal water leaks can be detrimental to surrounding building elements; their potential causes include damage to plumbing fittings and fixtures, through to water damage and deterioration of associated building elements.

Rust, corrosion, decay and water damage are potential outcomes where a minor water leak is left unattended. More serious defects may also result, such as electrical hazards, or water damage to structural building elements.

In extreme cases, structural damage may develop due to a prolonged water leak. It is highly advised that internal water leaks be addressed by a licensed plumber as a matter of relative urgency.

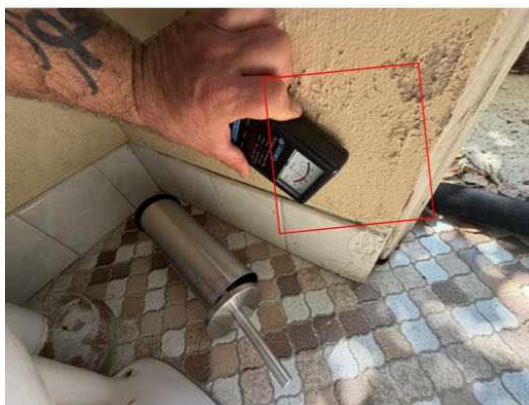
### Finding 2.03

Building:	Main Building
Location:	Extension bathroom
Finding:	Evidence of excessive moisture was present at the time of inspection
Information:	Excessive moisture can attract termites and produce conditions that promote termite attack, fungal growth and wood decay. Excessive moisture is generally caused by deteriorated, inadequate or missing roof drainage, leaking plumbing pipes or fixtures, poorly plumbed HWS overflows or condenser units and poor site drainage. It is highly recommended that all plumbing and drainage fixtures and fittings be maintained regularly in order to prevent excessive moisture being present in the external / internal property.

A licensed plumber must be appointed urgently for assessment and repairs.

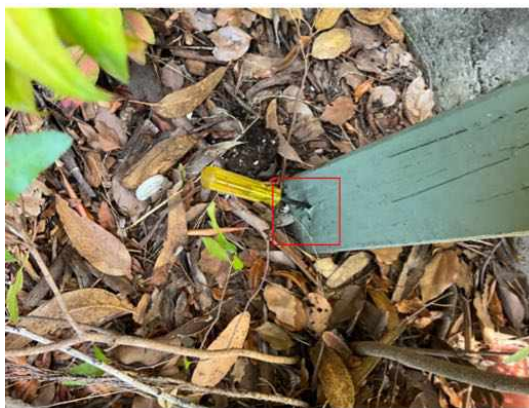
### Finding 2.04

Building:	Main Building
Location:	Rear staircase
Finding:	Wood rot/decay
Information:	This building element shows evidence of severe wood rot. Wood rot, also known as Fungal Decay, occurs when timbers and other cellulose building materials are exposed to damp conditions on an ongoing basis. If left unmanaged, damp conditions can lead

to further health problems and the decay of timbers will continue, causing the complete failure of the staircase.

Replacement of affected timbers is a necessary step in protecting surrounding building elements from such deterioration.

A licensed carpenter is required to replace affected building materials.

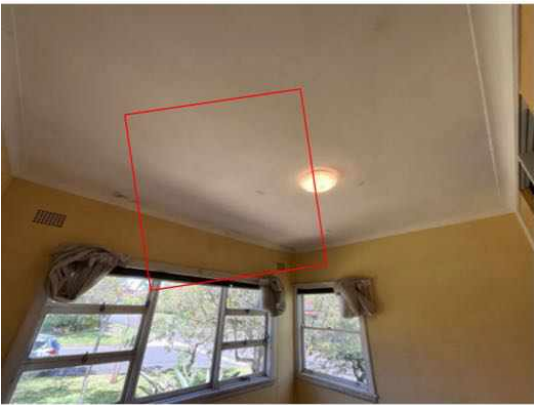
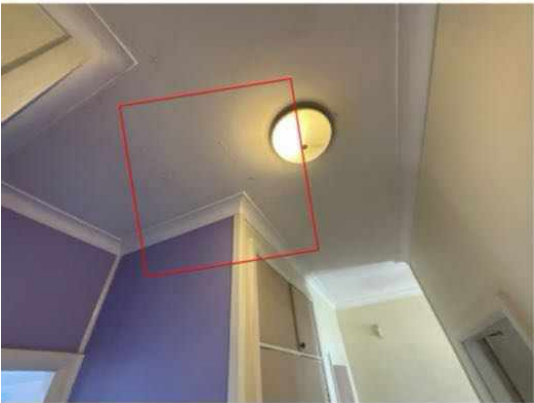
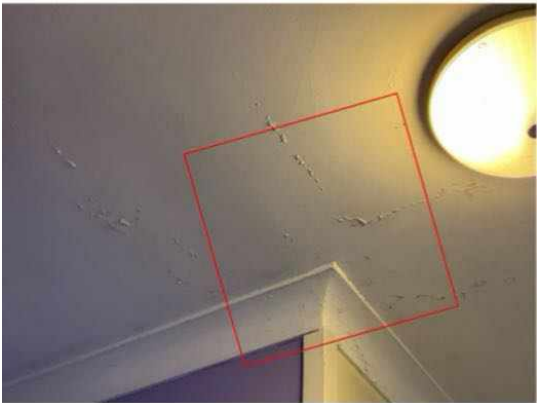
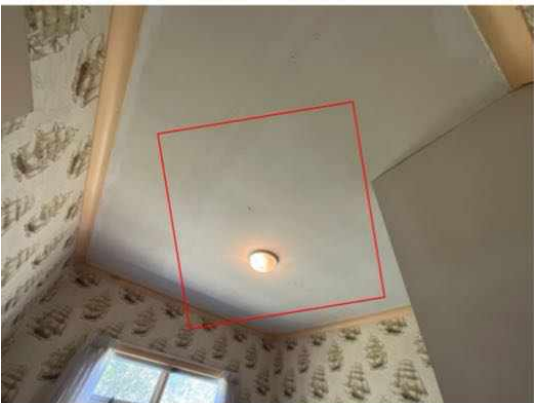
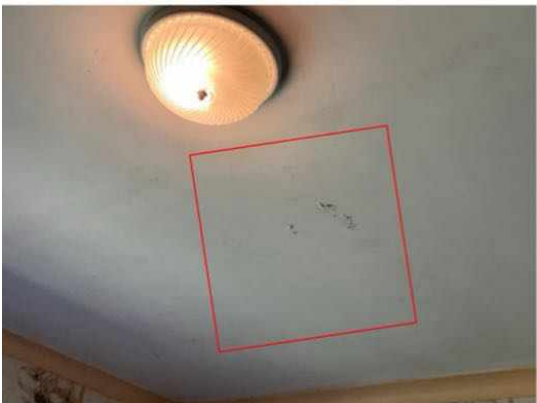
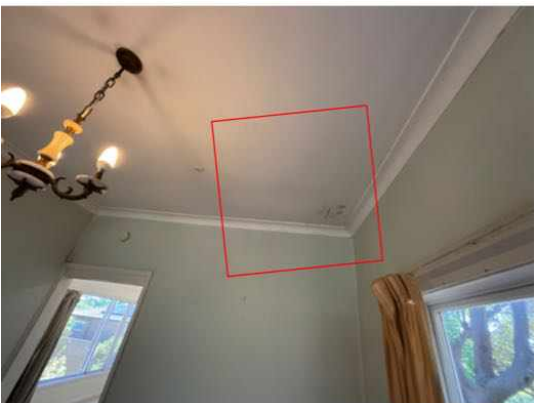
## Finding 2.05

Building:	Main Building
Location:	Multiple areas
Finding:	Ceiling - Water damaged
Information:	Water damage to the ceiling lining is generally an indication of excessive moisture being present in the roof void, usually via a leak to the roof covering.

Where water damage is evident to the ceiling, the primary requirement is to identify and rectify the source of the leak. A roofing plumber should be appointed as soon as possible to identify the leak and perform rectification works as necessary, ensuring the water damage is restricted.

Once the leak is repaired, consultation with relevant tradespeople, including plasterers and painters, is advised. Rectification works may include replacement of ceiling lining or minor repainting, depending on the extent of the damage.

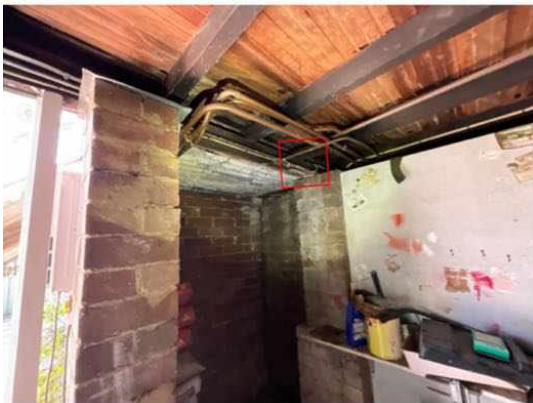
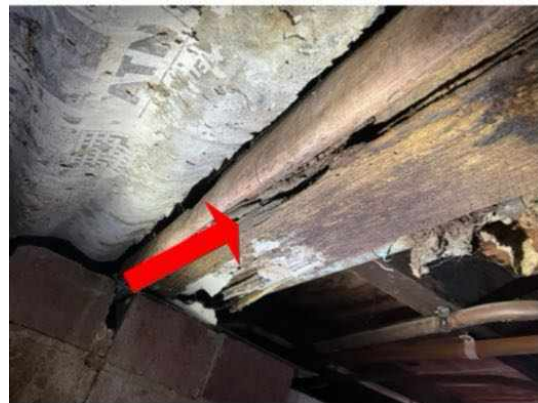
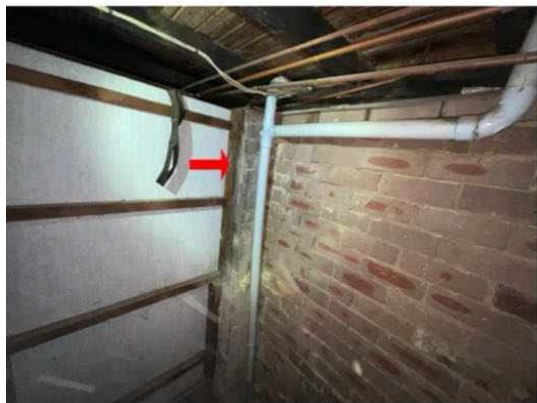
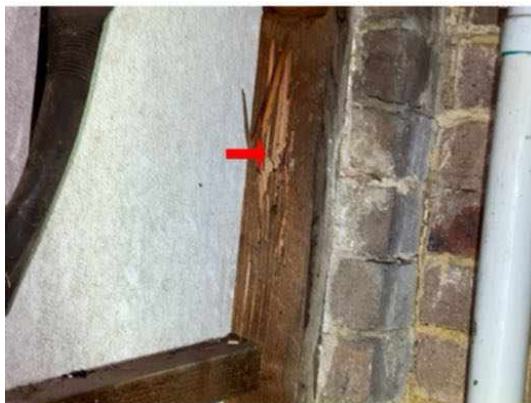
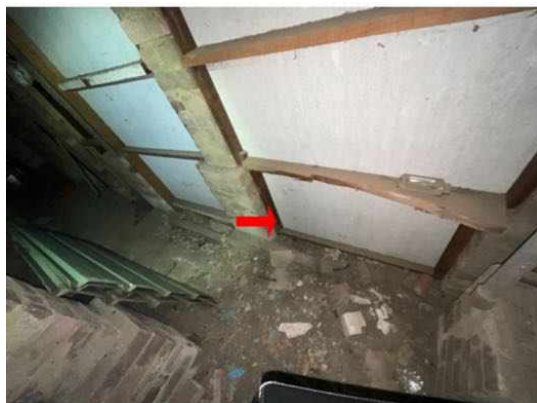
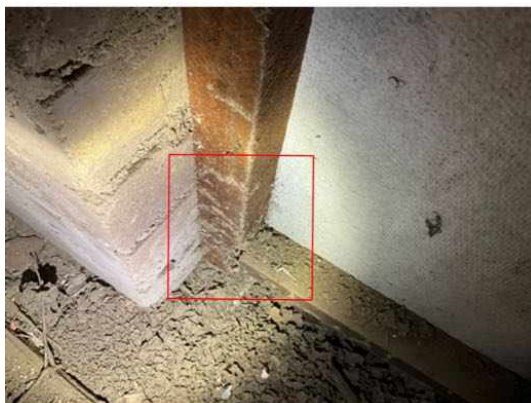
### Finding 2.06

Finding: Evidence of termite damage

Information: Despite no live termite or timber pest activity being indicated, previous termite damage was found to have affected this area or otherwise termite workings were identified at the time of inspection. This damage is considered to be inactive, however structural in nature.

Left unmanaged, further deterioration is possible which can affect the overall integrity of the property.

A licensed termite specialist should be appointed for an invasive inspection to determine the extent of damages and also to install a chemical barrier.

A licensed builder should then be appointed to replace any affected timber elements.

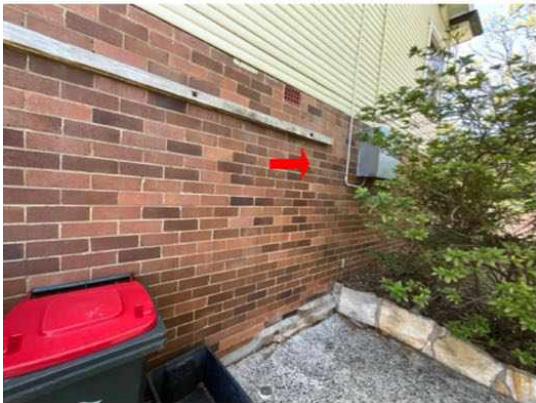
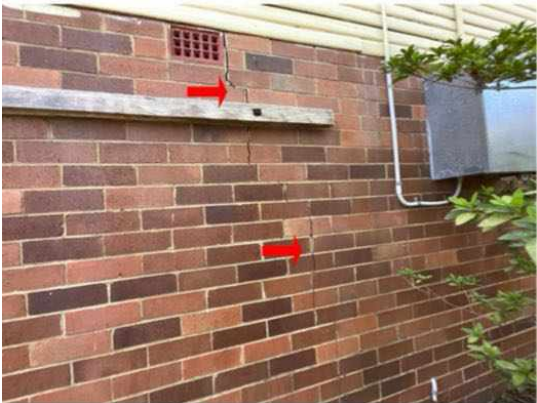
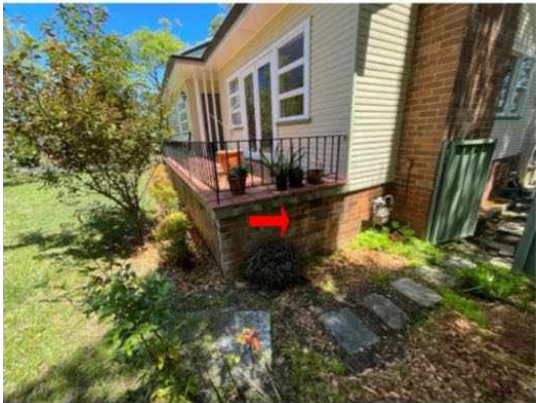
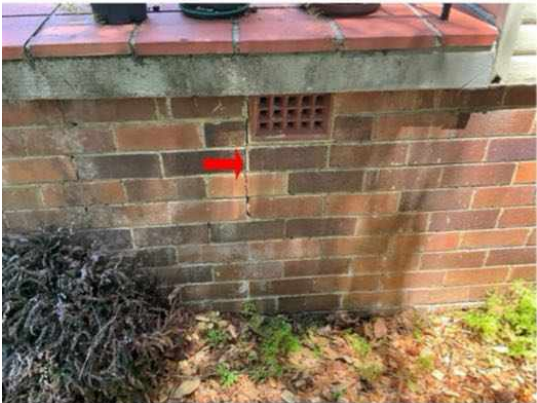
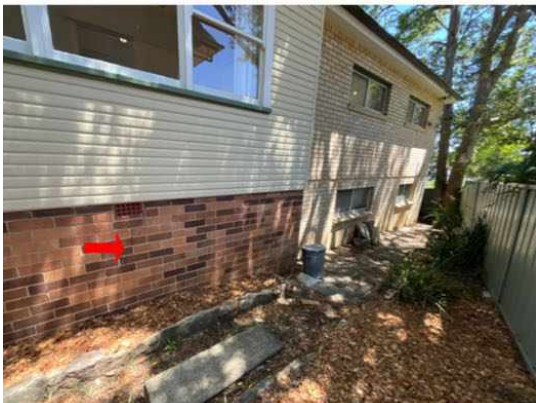
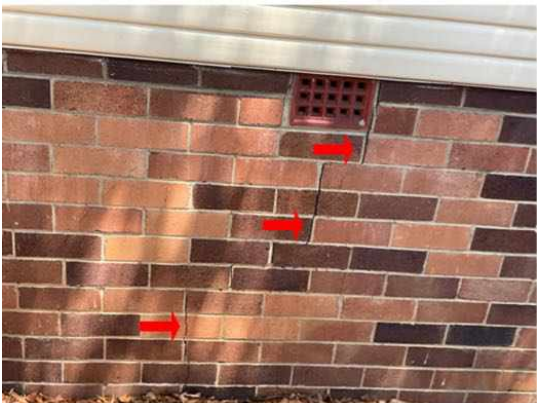
### Finding 3.01

Building:	Main Building
Location:	Walls
Finding:	Damage to Masonry Walls (Cracks)- Category 2
Information:	It has been observed that damage to masonry walls caused by movement of slabs, footings, or other causes, has occurred. The degree of damage falls within Category 2, described as noticeable cracks which are easily filled. Such cracking may cause doors and/or windows to stick slightly, and are generally less than 5mm in width.

Damage of this category is required to be monitored for a period of 12 months, after which time a crack rated at Category 2 or above is considered a defect requiring rectification, such as minor repairs and repointing. Always contact your building inspector should cracks widen, lengthen, or grow more numerous.

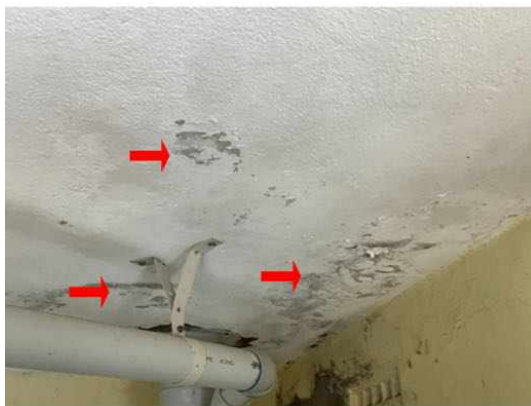
**Finding 3.02**

Building: Main Building  
Location: Laundry  
Finding: Water Damage  
Information: Water damage is generally an indication of excessive moisture being present, usually via a leak.

Where water damage is evident, the primary requirement is to identify and rectify the source of the leak. A roofing plumber should be appointed as soon as possible to identify the leak and perform rectification works as necessary, ensuring the water damage is restricted.

Once the leak is repaired, consultation with relevant tradespeople, including carpenters, plasterers and painters, is advised.

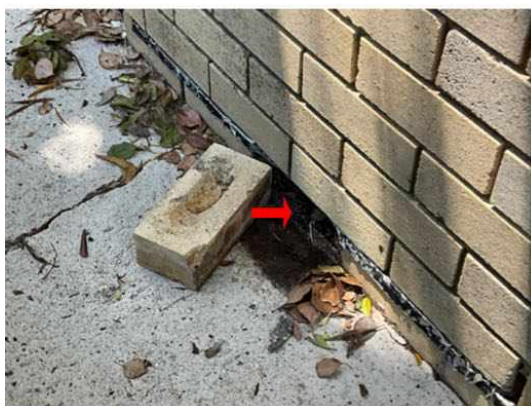
### Finding 3.03

Building:	Main Building
Location:	Rear Elevation
Finding:	Unconventional handyman work
Information:	This handyman work appears to have been completed to a substandard level and does not comply with regular building practices. Where handyman work is not completed satisfactorily, accelerated deterioration of the associated building elements is likely to occur and secondary defects to surrounding structures may develop.

It is highly recommended that the substandard work be rectified by professional services. Works to improve this area are likely to increase the safety and the operation of the associated building elements.

The client should exercise care when coming into the immediate vicinity of the substandard works. Rectification works are advised as soon as possible by the appropriate trades.

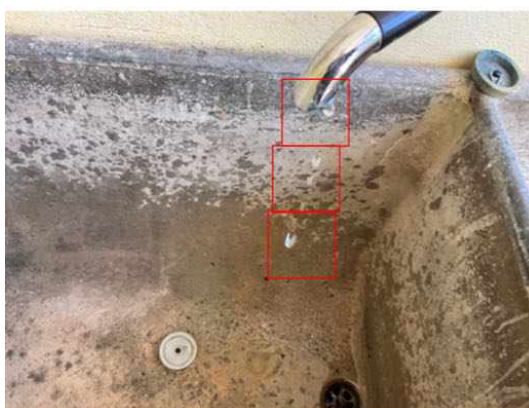
### Finding 3.04

Building: Main Building  
 Location: Laundry  
 Finding: Washers - Degraded  
 Information: The washers on the taps in this area appear to have degraded as a result of general ageing. Degraded washers generally result in slow, persistent leakage from taps and plumbing hardware.

Replacement of washers will ensure that water wastage does not occur and that the persistent water leak does not result in secondary damage to surrounding structures. Such damage may range from rust and corrosion to damage of surfaces, e.g. bench tops, etc.

A qualified plumber should be appointed to replace degraded washers and to further inspect associated plumbing fixtures and fittings. Where water damage has occurred, a carpenter or cabinet maker may be appointed to replace affected building elements.

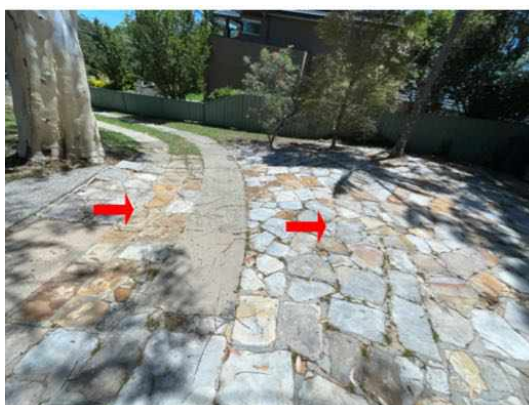
Sections of the external paved area are uneven, which may develop into a trip hazard. It appears as though the area has been subject to rough installation, or that paving sections have lifted due to movements in the foundation.

Left unmanaged, the May develop into a safety hazard due to trip and fall.

Re-paving of the area is required to remedy this situation. Further consultation with a specialist concreter is advised.

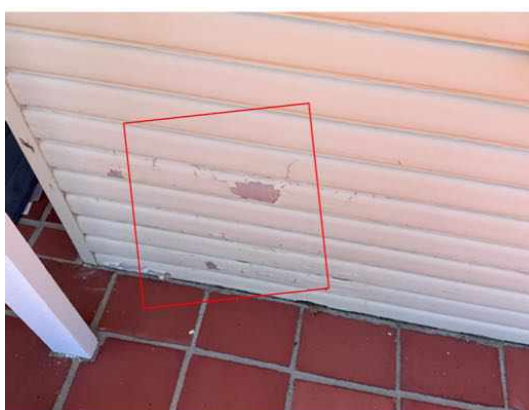
### Finding 3.07

Building: Main Building  
 Location: Porch  
 Finding: Paint cracking and peeling  
 Information:

Cracking and ultimately flaking of paint can occur for a variety of reasons. Often these failures are due to the fact that the paint has inadequate adhesion and flexibility, both common problems with lower quality exterior flat paints.

When timber is involved, moisture intrusion results in swelling of the wood surface followed by contraction as the wood dries. The expansion and contraction cycles, can result in cracking and subsequent paint failure by flaking and peeling.

Cracking and flaking can also result when paint is applied too thinly due to overspreading (higher-than-recommended spread rate) or excessive thinning. These practices tend to diminish the paint's final film thickness, so that it is more vulnerable to cracking and flaking.

Inadequate surface preparation can also cause these failures, especially when paint is applied to bare wood or a very porous surface without first applying a primer.

A qualified painter should be appointed to rectify the problem.

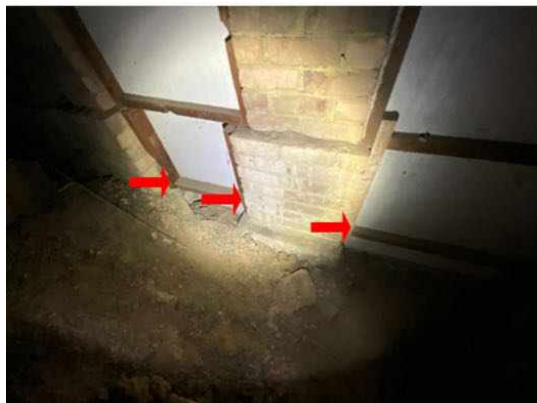
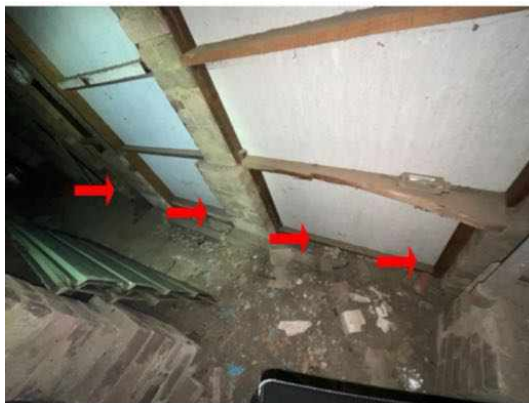
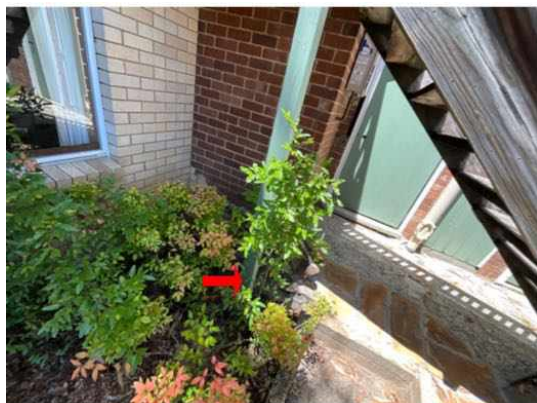
### Finding 3.08

Building:	Main Building
Location:	Yard
Finding:	Untreated or non-durable timbers in a hazardous environment
Information:	To reduce the risk of timber pest attack it is essential that timber used in a hazardous environment (e.g. in direct contact with the ground or frequently exposed to damp conditions) is of sufficient durability and/or is adequately preservative treated.

Untreated timbers in direct contact with the ground are likely to develop severe wood rot and/or fungal decay if left unattended creating attraction for subterranean termites to infest the timbers from surrounding areas.

If untreated or non-durable timbers are found to be in a hazardous environment it is highly advised that replacement of these building elements be performed as soon as possible to aid the protection of the property against termite / timber pest attack.

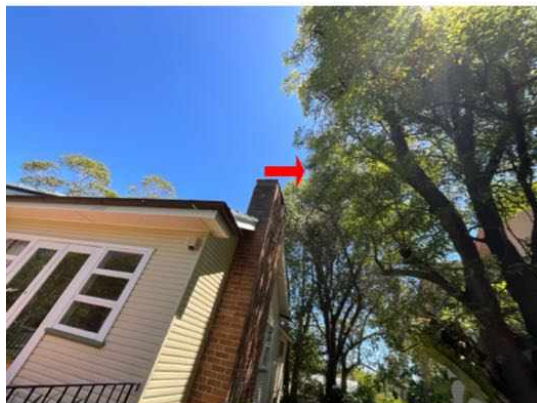
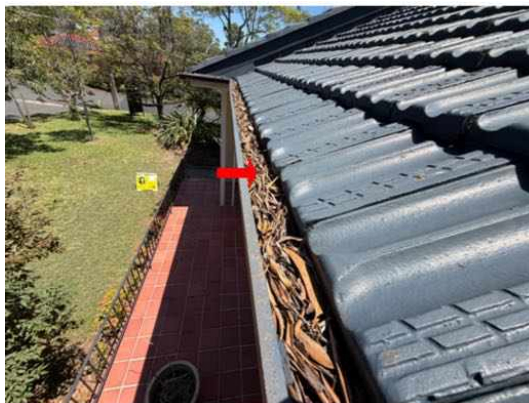
### Finding 3.09

Building:	Main Building
Location:	Roof Exterior
Finding:	Trees - Overhanging and filling gutters
Information:	Overhanging trees often result in excessive amounts of leaf debris accumulating in gutters.

Gutters are a critical part of the building's management of storm water and rain. It is therefore important that they be kept clear to prevent secondary damage to associated building elements, including exterior and interior walls, ceiling linings and any adjoining building elements. Where gutters are blocked, pooling of rainwater is likely to occur, fast-tracking rust and corrosion of the roof plumbing elements.

It is highly advised that all overhanging tree branches be removed as soon as possible to prevent any further damage. Repair and/or replacement of sections of damaged guttering may also be required where the extent of the damage necessitates.

Such works should be performed by the homeowner; however, appointment of a landscape contractor or an arborist may be required. Consultation with a licensed roof plumber is required where guttering has been damaged.

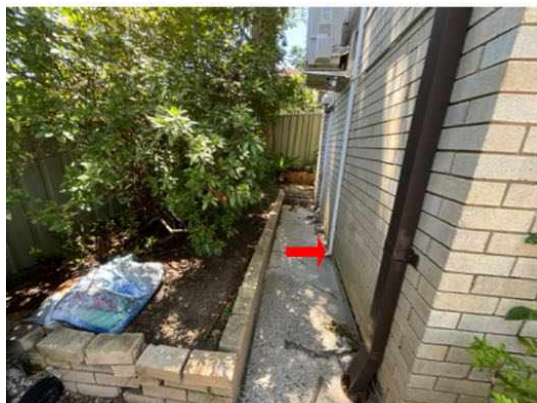
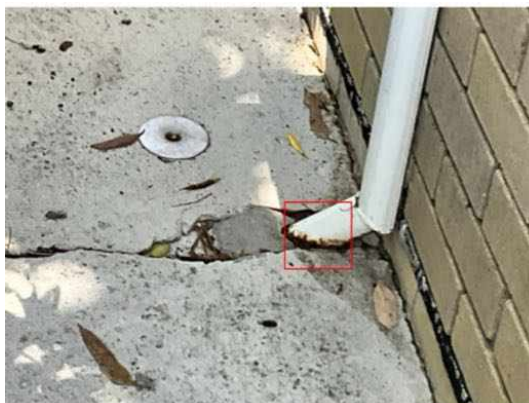
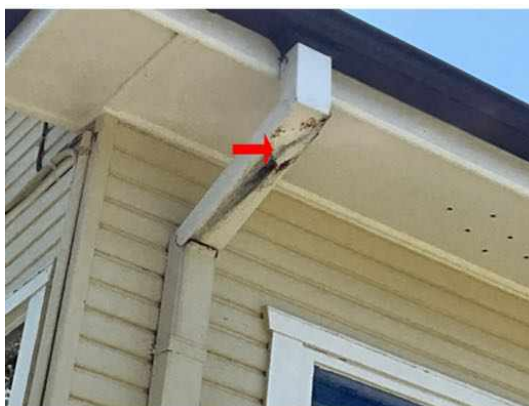
### Finding 3.10

Building:	Main Building
Location:	Roof plumbing
Finding:	Roof plumbing - Rusted or corroded
Information:	The roof plumbing has areas of rust and corrosion. It is suspected that this has been caused by blockages, resulting in pooling or standing water, that have prematurely rusted elements of the roof plumbing.

Rusted roof plumbing will generally develop holes and leaks that can affect other building elements with poor drainage of storm water. Poorly drained roof areas will also lead to damp conditions surrounding the base perimeter of the building which, if left unmanaged, can lead to a range of secondary building defects.

Repair and/or replacement of rusted roof plumbing is highly required in order to reinstate the roof drainage system to a fully operational level. To further maintain these areas, gutters should be cleaned frequently, allowing the avoidance of any partial blockages.

A licensed plumber or specialist roof restoration company should be appointed to undertake these works. It is advised that such works be completed as soon as possible to prevent any further damage and deterioration.

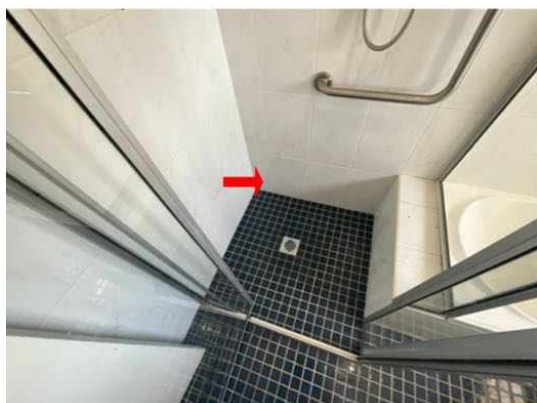
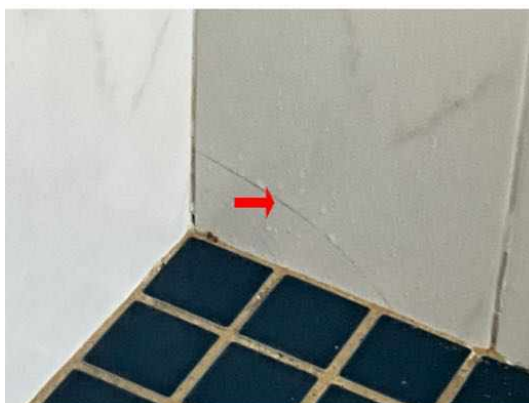
### Finding 3.11

Building:	Main Building
Location:	Bathroom
Finding:	Wet area tiles - Cracked or damaged
Information:	Cracking was evident to the tiling in this area at the time of inspection. While the cracking appears to be minor, this area is frequently exposed to water, allowing potential for water penetration into adjoining sections of walls or flooring.

If left unmanaged, water penetration to these areas may lead to subsequent water damage, which is likely necessitate repair work to affected building elements.

A bathroom specialist should be appointed to determine the integrity of the bathroom waterproofing membrane. If the membrane was found to be intact then relatively minor works to replace the cracked tiles should be carried out to ensure no further damage occurs. The re-application of silicone and grouting throughout remaining tile work is also advised, to further protect the area against water penetration.

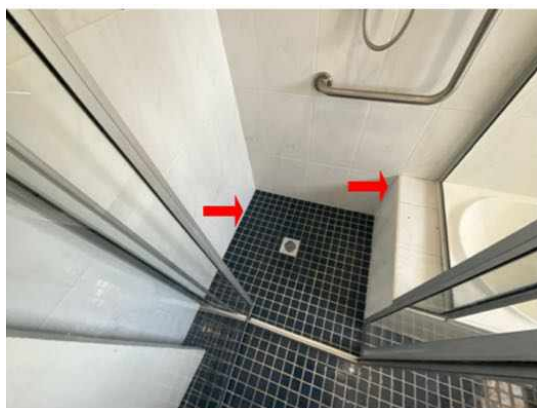
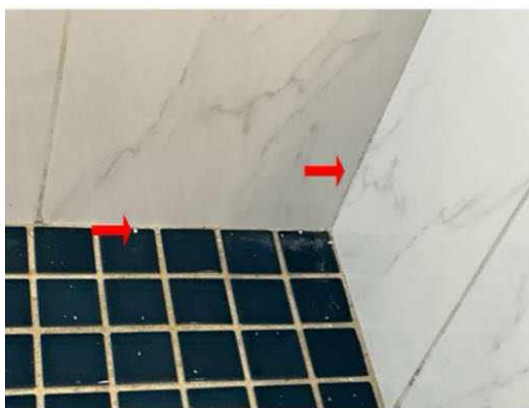
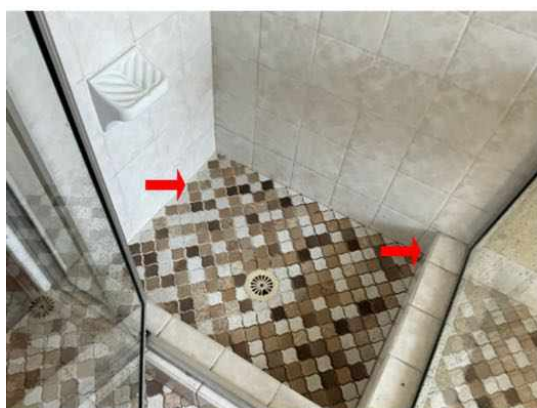
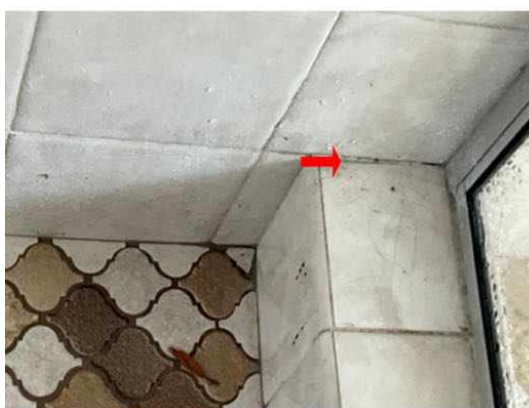
### Finding 3.12

Building:	Main Building
Location:	All Wet Areas
Finding:	Sealant and grouting - Missing or damaged

Information: It was noted on inspection that sealant or grout is degraded to this area.

Different materials and floor areas move at different rates, generally causing cracking to grout or sealant at this point. A flexible sealant is required to allow for expected expansion and contraction, while keeping the joint water tight and protective of all associated building materials.

Flexible and mould resistant materials should be applied to affected areas to prevent any subsequent water damage that is likely to occur. Regular maintenance and replacement of damage or missing or damaged sealant and grout is highly recommended to the wet areas, as this is a regular wear and tear defect. Sealant and grouting in areas that come into regular contact with water should be maintained for the long term care of your property.

A sealant specialist should be appointed to complete these works as soon as possible.

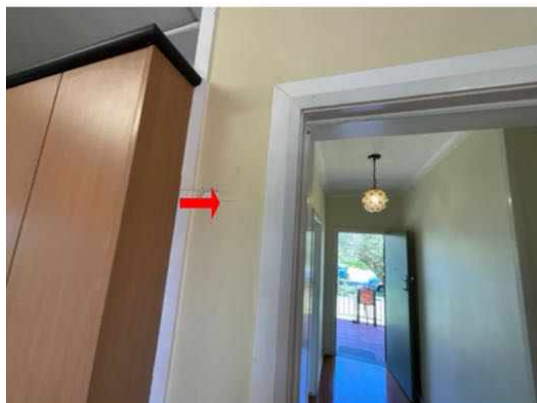
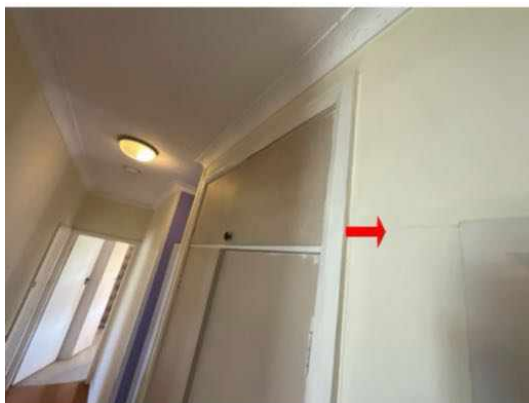
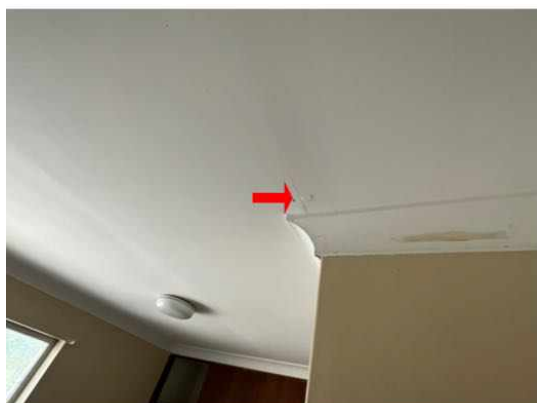
### Finding 3.13

Building: Main Building  
 Location: Multiple areas  
 Finding: Cracking - Damage Category 1 - Fine (up to 1mm)  
 Information: Although fine cracks are quite noticeable, they are often only considered to be an

appearance defect, and usually do not indicate any structural damage. Generally, the cause of a fine crack is indicative of a separation between building materials and finishes (e.g. paint, plaster, etc.) along joins.

Cracking of this nature can generally be repaired with minor sanding, filling and/or repainting. Such works should be performed by a qualified painter or a general handyman.

Monitoring of all cracking should be conducted frequently. Always contact a building inspector should cracks widen, lengthen, or become more numerous.

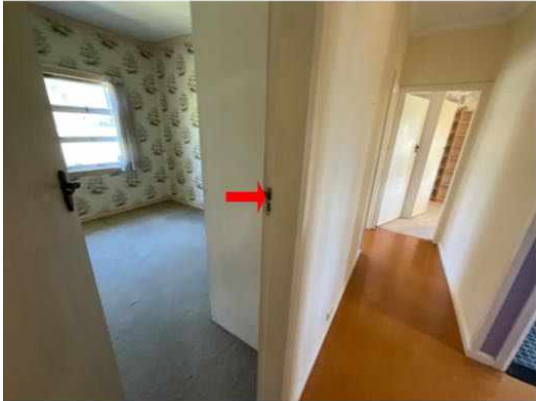
### Finding 3.14

Building:	Main Building
Location:	Multiple areas
Finding:	Door - Striker plate misaligned
Information:	The striker plate to this door appears to have become misaligned and has consequently resulted in the door's operation being compromised.

This is a common defect and is expected in a property of this age, whether being due to substandard installation or general deterioration of the door hardware.

Readjustment of the striker plate is recommended at client discretion. Works such as these can be completed by a general handyman or qualified carpenter.

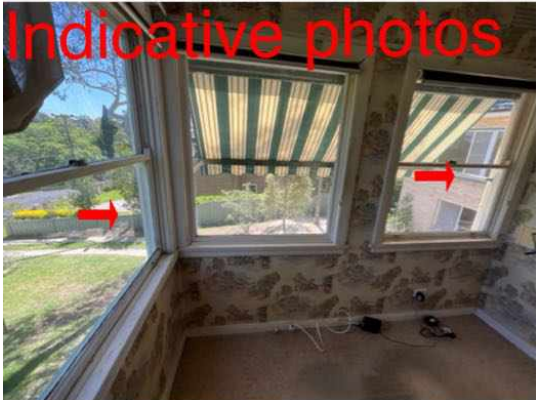
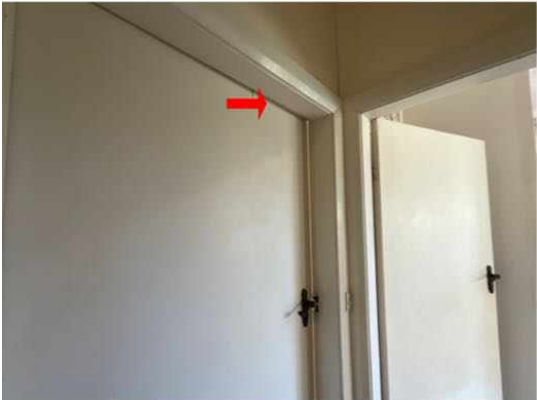
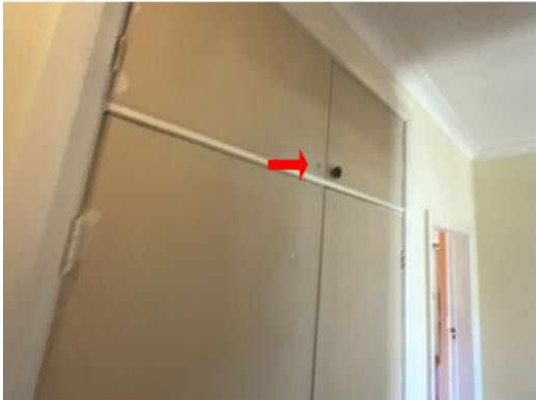
**Finding 3.15**

Building: Main Building  
Location: Multiple areas  
Finding: Window and Door Service - Required  
Information: With reference to the Guide to Standards and Tolerances 2017 Section 9.7 Operation of windows and doors it states that the installation of doors and windows is defective if, within three months of completion, they: a. bind or jam as a result of the builder’s workmanship b. do not operate as intended by the manufacturer.

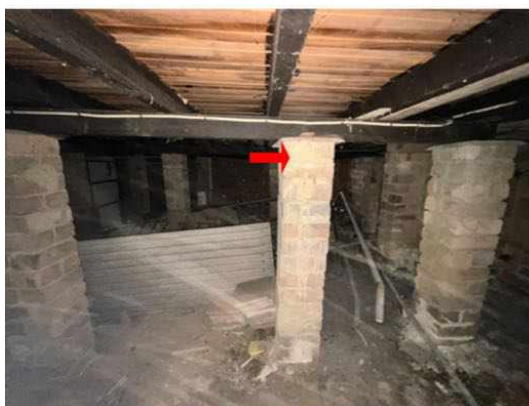
Building:	Main Building
Location:	Subfloor
Finding:	Piers - Leaning
Information:	Pier to the subfloor structure is leaning, indicating that its structural integrity may have been affected. The cause of this instability is likely to be caused by movement / minor subsidence of the pier due to moisture.

Although only minor the pier should be monitored to avoid potential structural damage, which is likely to lead to a range of major and minor defects. Improving site drainage is recommended to avoid further movement / subsidence of the affected pier.

If further movement is evident appointment of a structural engineer is advised to assess the condition of the piers and provide advice on remedial works that may be required.

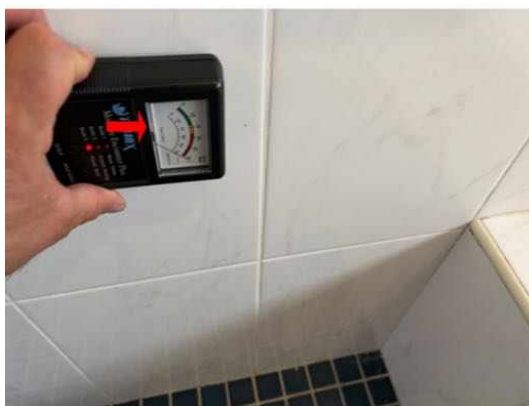
### Finding 3.18

Building:	Main Building
Location:	Bathroom
Finding:	Shower damp - Sealant and grout
Information:	Damp is evident to the lower 400mm of wall to the shower alcove. This defect is quite common, and is suspected to have been caused by moisture permeating or leaching through the grouting and sealant in this area, which shows evidence of deterioration. Leaking pipes within the wall is also a possible cause however this seems unlikely in this instance as there is no moisture build up around the taps or transferring to the other side of the wall. There appears to be no sealant around the tap spindles which may be a small contributing factor.

Damp (or structural damp) refers to the presence of unwanted moisture in the structure of a building, either as the result of intrusion from outside, or condensation from within the structure. In the shower area, internal water leaks, degraded materials or other sources of excessive moisture are generally the cause of damp.

Unmanaged damp in the shower recess is likely to facilitate the formation and development of mould and fungi growth, decaying associated building materials and compromising their structural integrity of associated elements. It is important to address damp conditions, as the World Health Organisation notes that excess moisture leads - on almost all indoor materials - to growth of microbes such as moulds, fungi and bacteria, which subsequently emit spores and other matter into the indoor air. Exposure to these contaminants is associated with a wide range of respiratory and other health-related problems. Damp conditions also create a conducive environment for termite infestation.

Consultation with a bathroom sealant specialist is advised immediately to identify the cause of damp and to perform remedial works as required.

Always ensure that sealant and grout is in good condition to prevent any moisture issues occurring in the future.

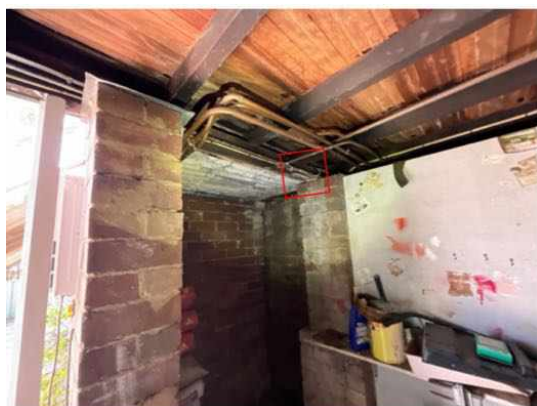
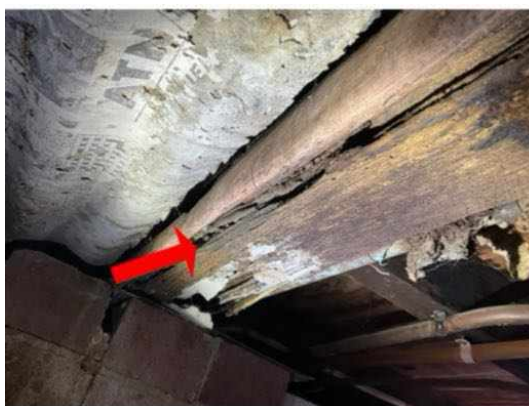
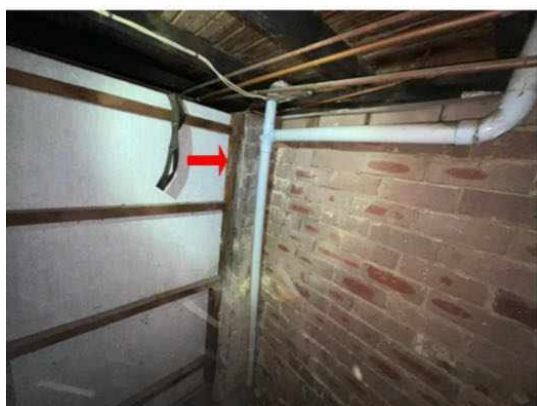
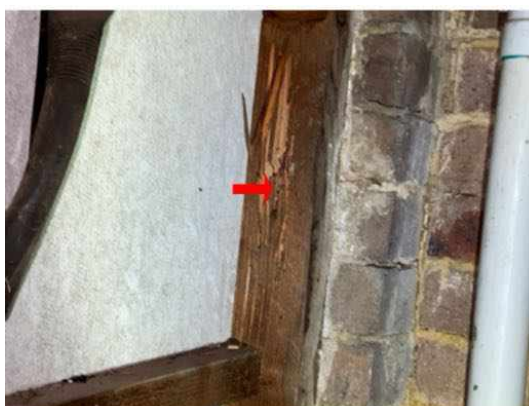
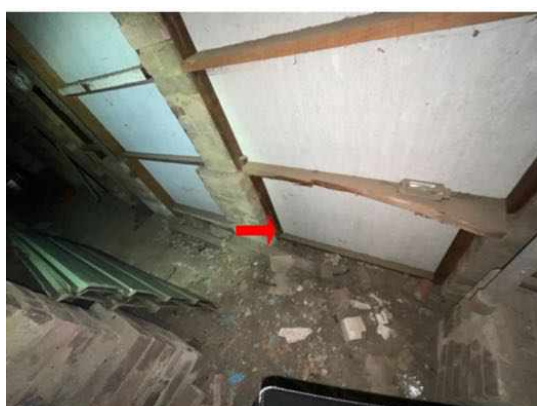
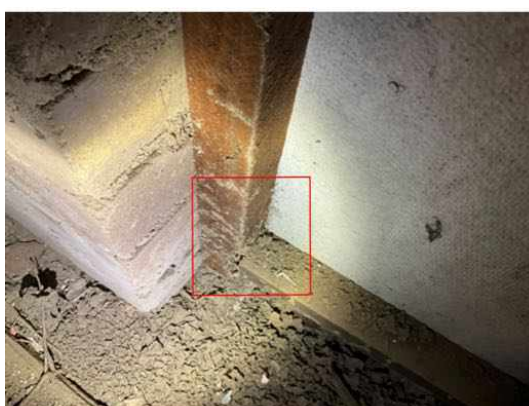
Building: Main Building  
 Location: Kitchen  
 Finding: Evidence of termite damage  
 Information: Despite no live termite or timber pest activity being indicated, previous termite damage was found to have affected this area or otherwise termite workings were identified at the time of inspection. This damage is considered to be inactive, however structural in nature.

Left unmanaged, further deterioration is possible which can affect the overall integrity of the property.

A licensed termite specialist should be appointed for an invasive inspection to determine the extent of damages and also to install a chemical barrier.

A licensed builder should then be appointed to replace any affected timber elements.

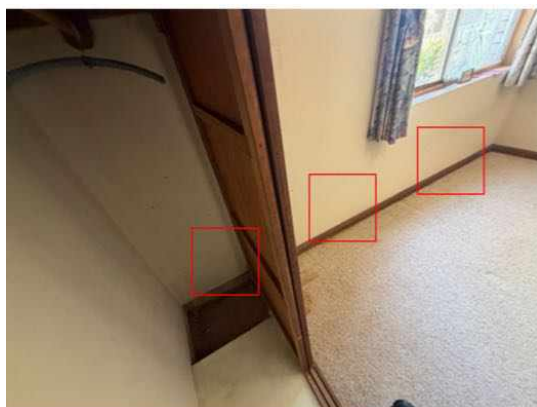
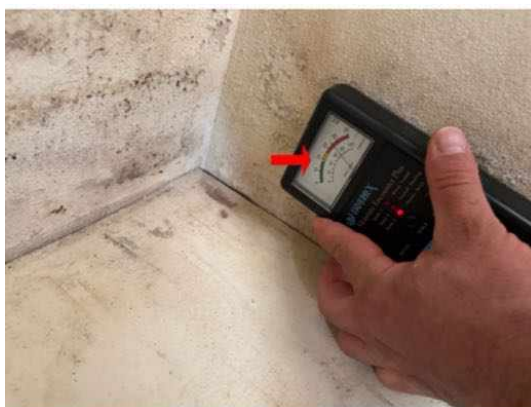
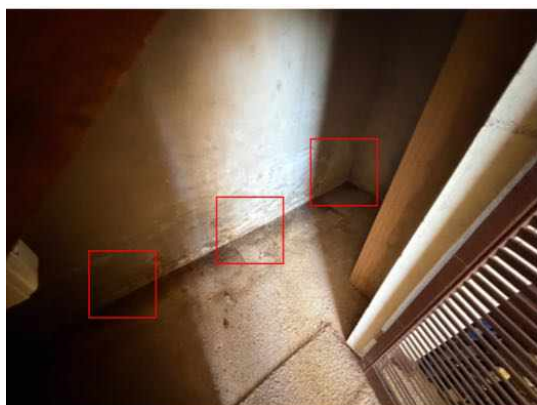
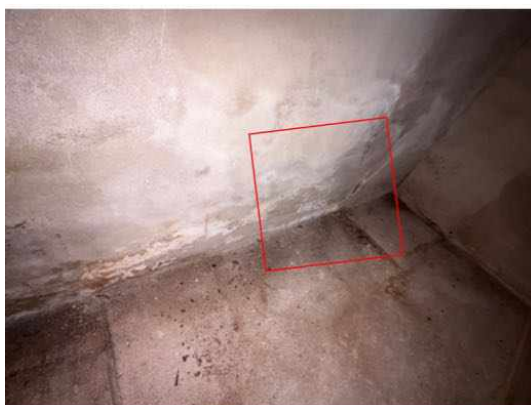
### Finding 6.01

Building:	Main Building
Location:	Extension downstairs
Finding:	Exterior walls - Lateral damp
Information:	Lateral penetrating damp refers to the sideways movement of moisture, predominantly from the surrounding ground, which tends to affect basement walls and other earth-retaining walls. The implications of unmanaged damp range from mould fungi growth, wood rot and decaying building materials, to finishes including lifting,

bubbling, peeling and staining of paint, plaster and wallpaper.

It is important to address damp conditions as the World Health Organisation notes that excess moisture leads - on almost all indoor materials - to the growth of microbes such as moulds, fungi and bacteria, which subsequently emit spores and other matter into the indoor air. Exposure to these contaminants is associated with a wide range of respiratory and other health-related problems. Additionally, the development of damp in timber building elements also provides an environment that is conducive to termite / timber pest attack.

Structural waterproofing barriers or tanking barriers are often used to protect internal surfaces against the effects of lateral penetrating dampness. These types of work are generally undertaken where the source of the penetrating damp cannot be prevented.

Immediate consultation with a licensed builder and plumber is advised to address the cause of the damp and to perform remedial works as necessary.
