# Building and Timber Pest Inspection Report

Inspection Date: Wed, 4 Feb 2026

Property Address: 8 Devlin Rd, North Epping NSW 2121,  
Australia

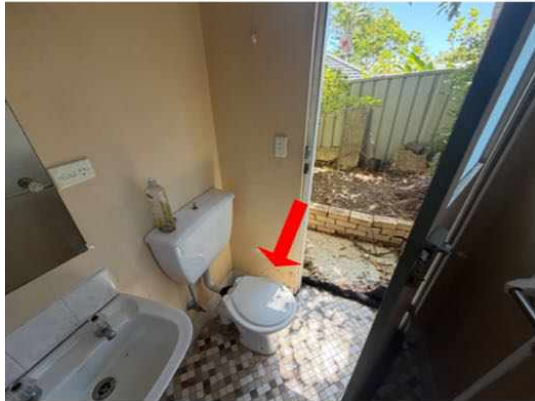
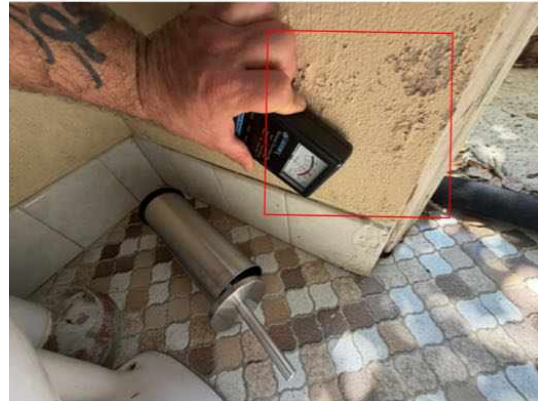
### Finding 6.02

Building:	Main Building
Location:	Extension bathroom
Finding:	Evidence of excessive moisture was present at the time of inspection
Information:	Excessive moisture can attract termites and produce conditions that promote termite attack, fungal growth and wood decay. Excessive moisture is generally caused by

deteriorated, inadequate or missing roof drainage, leaking plumbing pipes or fixtures, poorly plumbed HWS overflows or condenser units and poor site drainage. It is highly recommended that all plumbing and drainage fixtures and fittings be maintained regularly in order to prevent excessive moisture being present in the external / internal property.

A licensed plumber must be appointed urgently for assessment and repairs.

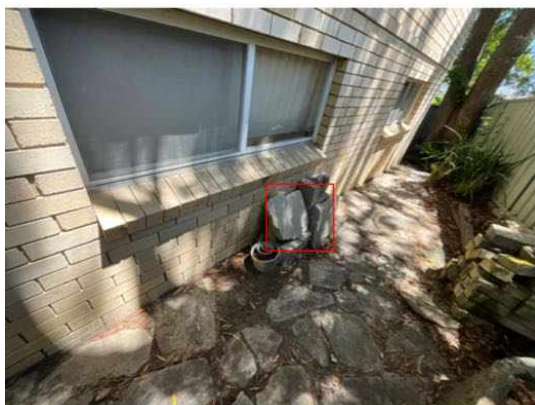
### Finding 6.03

Building:	Main Building
Location:	Exterior walls - left side
Finding:	Bridging of termite barrier
Information:	Bridging of termite barriers occurs when termites bridge (usually by building a mud tunnel) a termite barrier or inspection zone or where termites have a passage allowing them to bridge the barrier.

Generally this takes the form of finished ground levels external paving or concrete being retrospectively installed above the damp course level the adjacent internal floor level or weep and ventilation holes.

Where bridging has occurred full inspection is prevented and termites may enter a property in a concealed or undetectable manner.

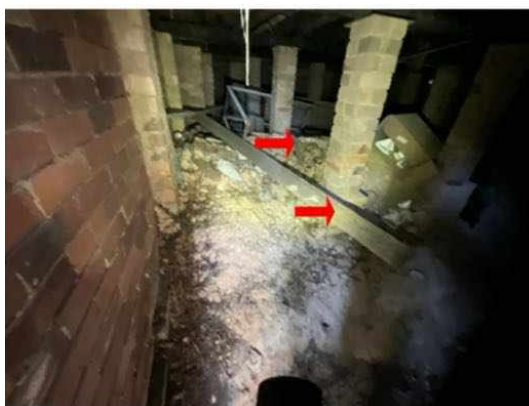
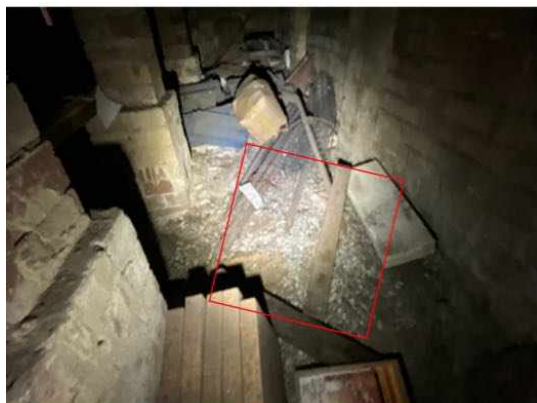
Building:	Main Building
Location:	Yard, subfloor
Finding:	Stored timbers - subfloor space or external area
Information:	The storing of timbers in the subfloor space or around the external property increases the risk of termite activity being present. As they are likely to come into contact with weather conditions or excessive moisture wood rot is likely to develop on timbers that are not treated.

It is highly recommended that any stored timbers be immediately removed from areas in which they may attract any termite / timber pest attack. Minimisation of risk / prevention of termite attack is far more adequate than dealing with the presence of termite activity.

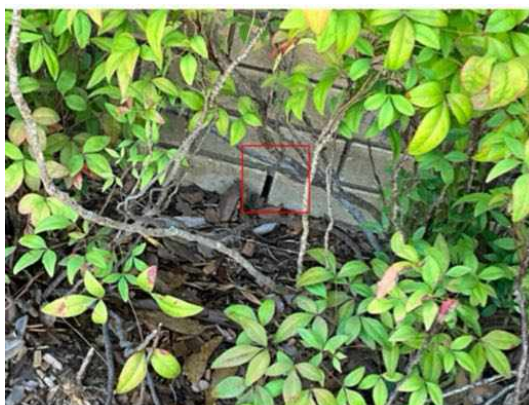
Weep holes in the exterior brickwork of the property are designed to allow condensation that may build up between the brickwork and subsequent timber framework to drain from within the wall hence preventing any deterioration of the timber building elements.

Additionally build-up of moisture is likely to occur if weep holes are covered further attracting termite activity to these areas.

It is highly recommended that weep holes are left exposed in all areas throughout the

external property. Therefore if any termite activity leading into weep holes becomes easily detectable during frequent pest inspections.

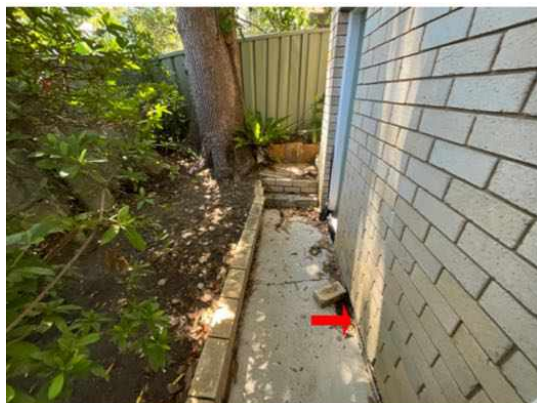
### Finding 6.08

Building:	Main Building
Location:	Extension
Finding:	Service penetrations
Information:	Services into home can allow for concealed termite entry without additional or adequate termite protection.

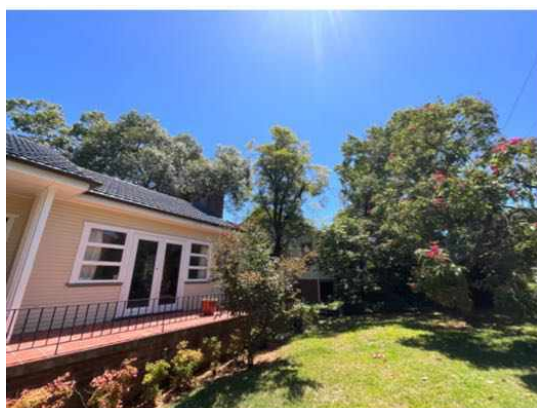
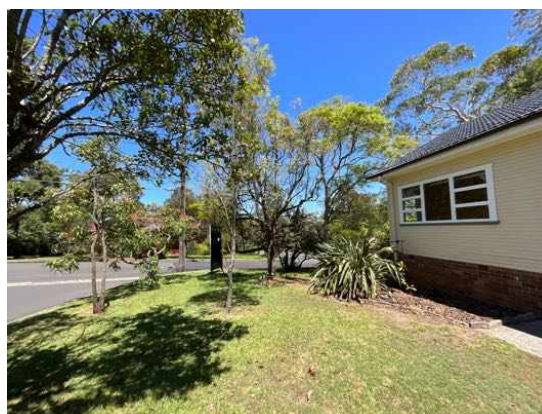
### Finding 6.10

Building:	Main Building
Location:	Vegetation
Finding:	Vegetation - Abutting property
Information:	Vegetation against external wall may have an invasive root system. If there are weak points in the brick work or concrete slab, it is possible for the roots to gain entry into these areas. Once the roots have gained entry, it is possible for termites to gain concealed entry via these roots. It is recommended to remove the vegetation and root system where possible.

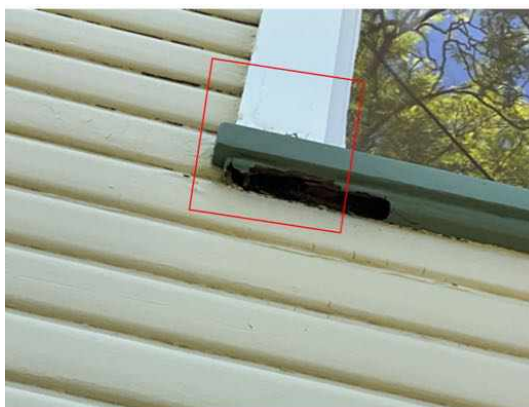
### Finding 7.04

Building:	Main Building
Location:	Exterior walls - right side
Finding:	Weatherboards - Rotting
Information:	The external weatherboards show signs of fungal decay (wood rot) in several sections. This wood rot is suspected to have developed over a prolonged period of time due to frequent weather exposure, which is expected in a property of this age and condition

Weatherboards are sealed and protected by paint and other sealants. When these sealants deteriorate over time, they allow water penetration to the weatherboards, causing wood rot. If left unmanaged, the wood rot is likely to develop further, possibly necessitating major repair or replacement works in the long-term future.

To maintain the condition of the external wall cladding, any severely affected weatherboards should be substituted as soon as possible with pre-treated replacements. Where weatherboards have rotted due to excessive moisture other than rain penetration, the cause of the moisture should be identified immediately by a licensed plumber. A qualified carpenter should be appointed to repair and replace rotting weatherboards.

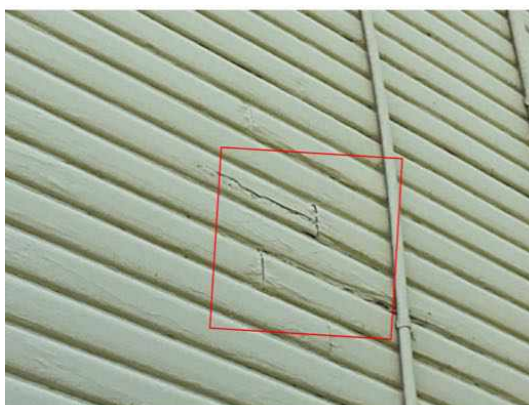
### Finding 8.01

Building:	Main Building
Location:	Trees
Finding:	Evidence of wood borer activity identified
Information:	Wood borers small beetles that colonise in exposed timber elements are a common timber pest that are regularly mistaken for termites. Although wood borer activity is generally not detrimental to the affected timber they may lead to serious damage and necessitate replacement of certain building elements if left unattended.

The other commonly known borer the Anobium borer is more likely to attack floorboards and may cause severe structural damage to flooring areas.

As no live wood borer activity was identified treatment is not required at this time. Replacement of affected timbers may be considered by the client for superficial reasons.

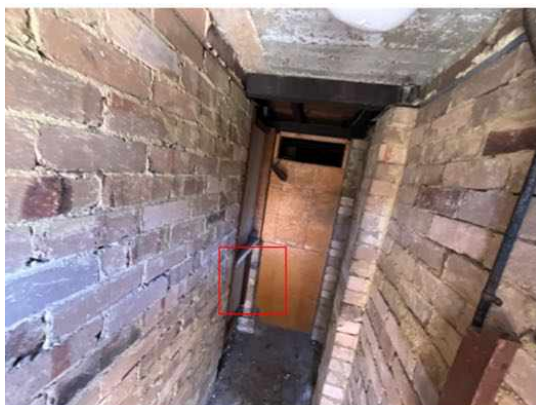
Information: Wood borers small beetles that colonise in exposed timber elements are a common timber pest that are regularly mistaken for termites. Although wood borer activity is generally not detrimental to the affected timber they may lead to serious damage and necessitate replacement of certain building elements if left unattended.

The other commonly known borer the Anobium borer is more likely to attack floorboards and may cause severe structural damage to flooring areas.

As no live wood borer activity was identified treatment is not required at this time. Replacement of affected timbers may be considered by the client.

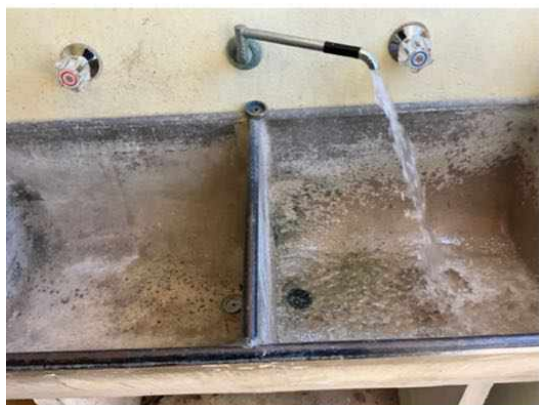
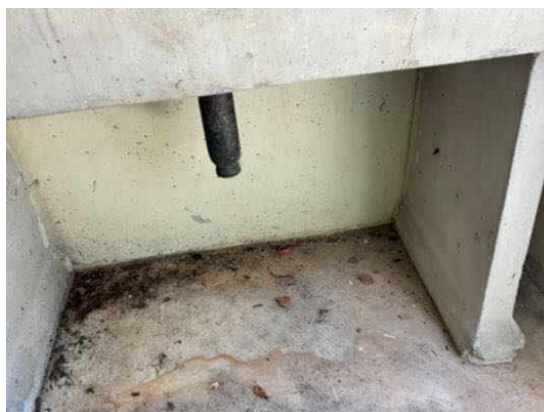
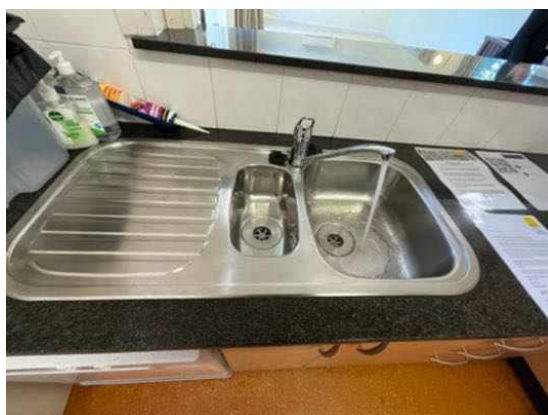
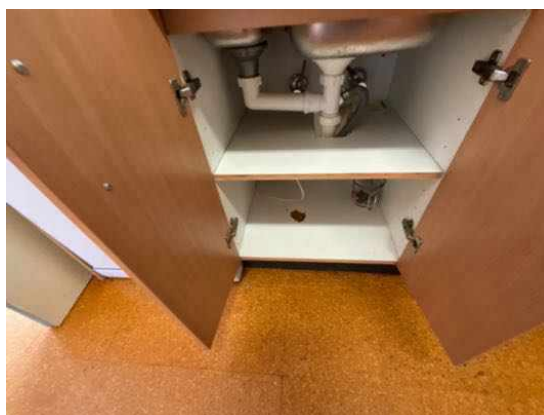
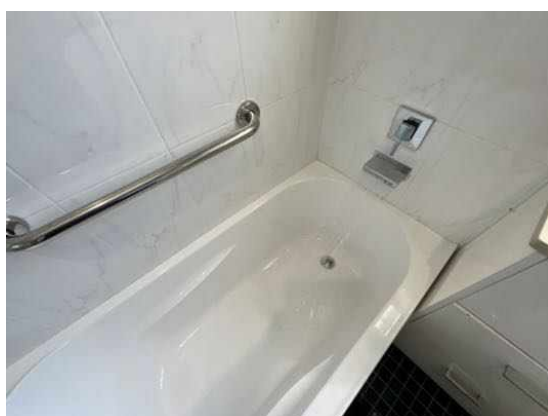
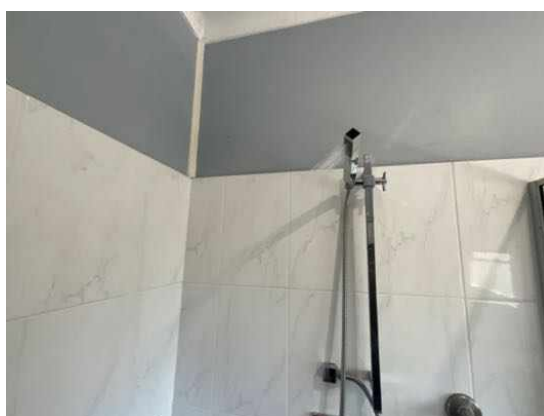
### Noted Item

Building: Main Building  
 Location: All Wet Areas  
 Finding: Waterproofing  
 Information:

All taps, mixers and toilets were tested for operation, except for those obstructed. The waterproofing to the shower recess was assessed by checking the walls in and around the shower recess for varying moisture content. There were no significant variations across the tested areas. No sign of recent water damage was evident upon a visual inspection of the surrounding walls, where the visual nature of the inspection was possible.

Consequently, there is no conclusive evidence of any current shower recess leakage other than those which may have already been mentioned earlier in this report. It is reasonable to assume the shower waterproofing is sound. Note that if the shower is not used, or has not been used for some time, moisture readings would not vary significantly and this can lead to erroneous results. It is not possible under the visual inspection criteria (under which a prepurchase inspection is carried out) to categorically determine if there are leaks. If a more accurate assessment is required, a special purpose inspection should be requested. Alternatively, the assumption should be made that the shower may leak.

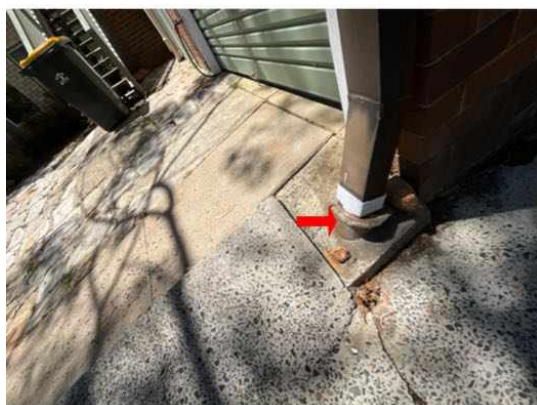
Building:	Main Building
Location:	
Finding:	Pipework - Old urban wear pipes
Information:	Old urban wear pipes were identified at the time of inspection.

Consultation with a licensed plumber is advised. CCTV inspection on pipes may be required.

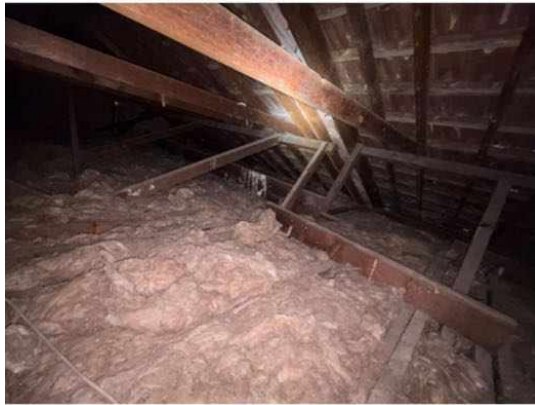
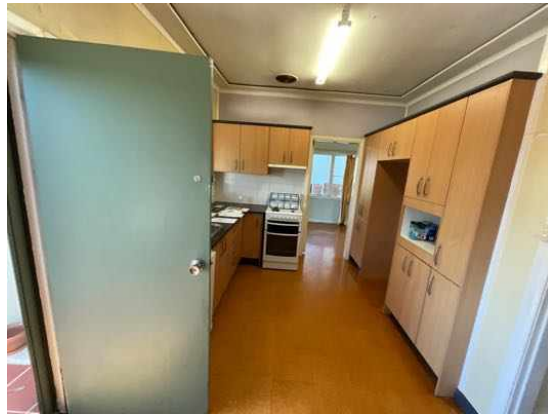
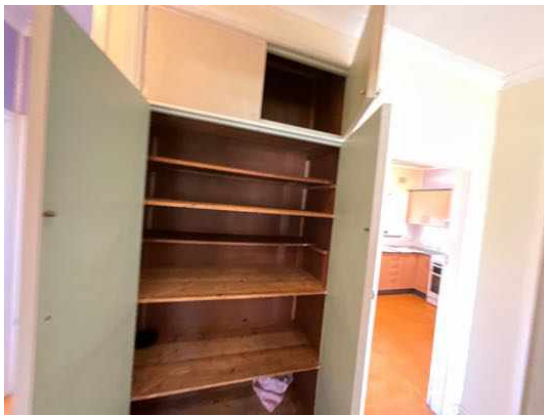
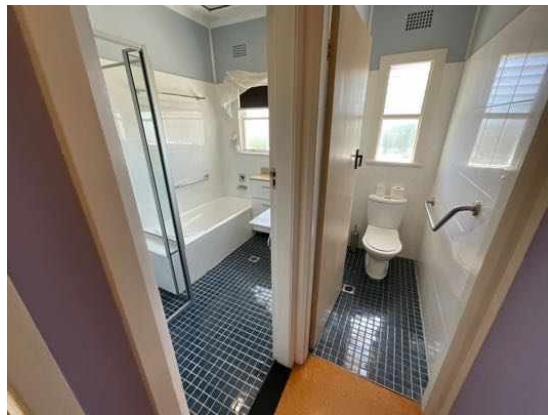
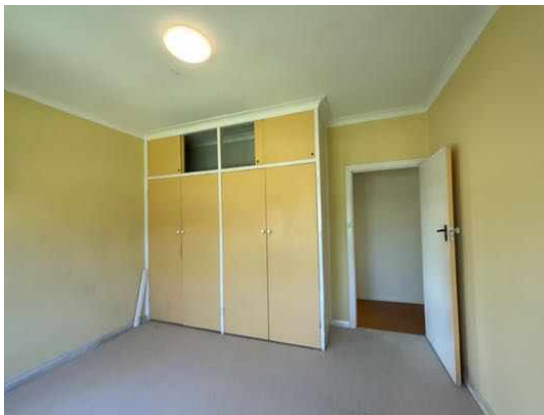
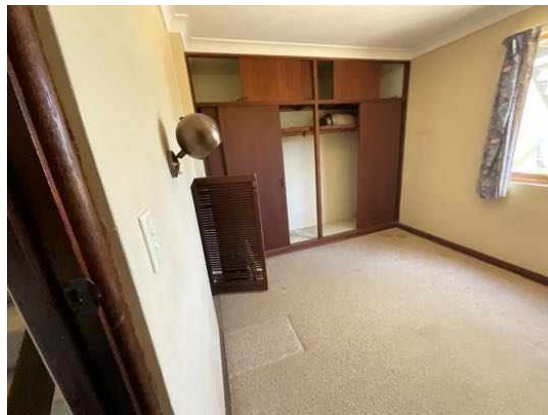
Building:	Main Building
Location:	All Areas
Finding:	Additional Photos - Obstructions and Limitations
Information:

These photographs are an indication of the obstructions and limitations which impeded full inspection of the property at the time of inspection. These obstructions can hide an array of defects and should be removed to allow full inspection to be

carried out. A re-inspection is recommended once the areas are made accessible.

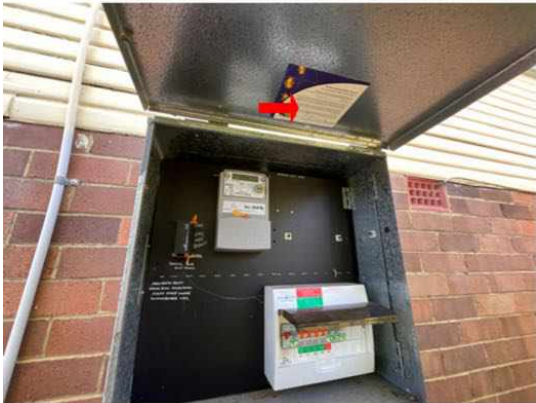
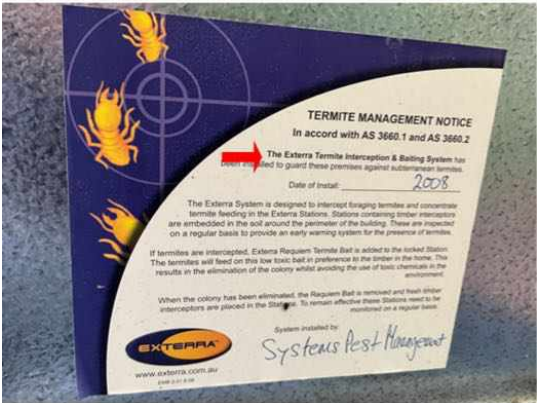
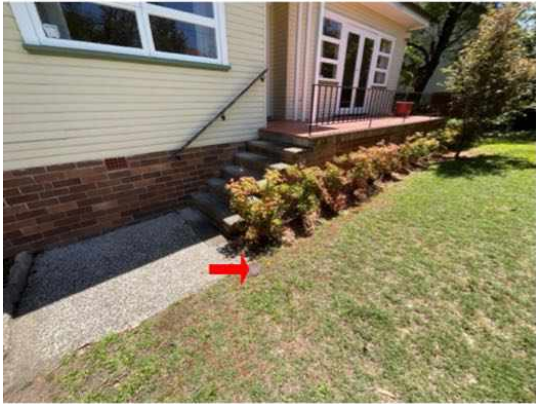
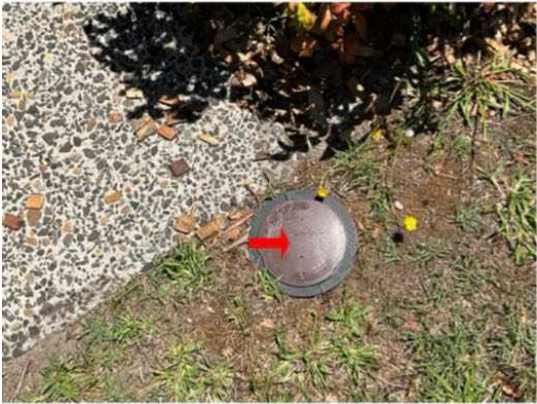
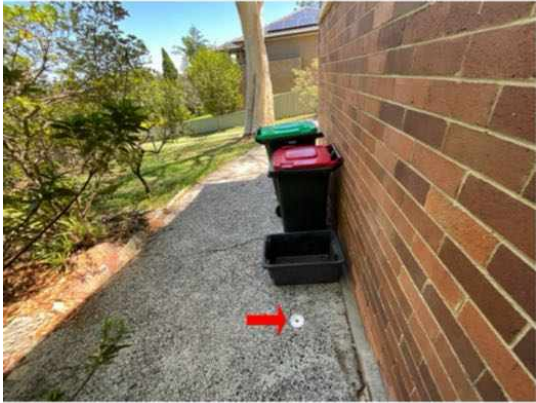
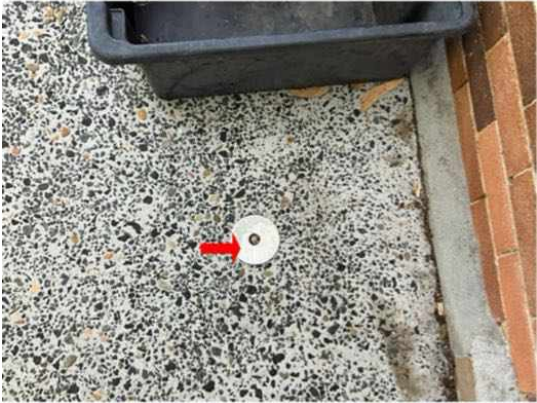
Where a Termite Management System has been identified you should refer to the type of barrier date of installation warranty conditions and any documentation provided by a builder or past owner. Consult the company who installed the barrier to confirm whether the system is still under warranty.

Most chemical termite management systems expire and require replenishment and all physical systems are primarily designed to prevent concealed entry.
