Building and Timber Pest Inspection Report VR

Inspection Date: Fri, 13 Feb 2026

Property Address: 4 Cornelius Place, Regentville NSW 2745

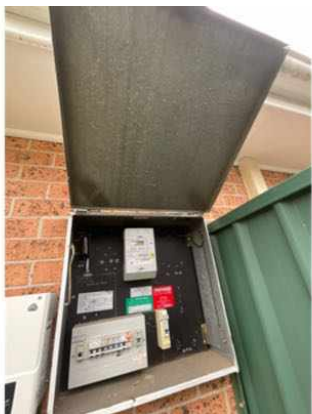
Proper maintenance and documentation are essential to ensure continued protection. Without a visible durable notice, there is no clear indication of what system (if any) is in place, which may limit the effectiveness of future termite inspections and hinder warranty claims.

Building:	Main Building
Location:	All Areas
Finding:	Proposal for Termite Risk Management – AS 3660.2 Compliance..
Information:	Recommendation:

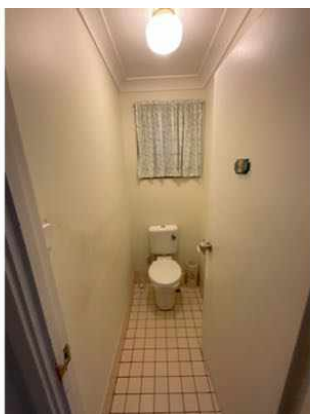
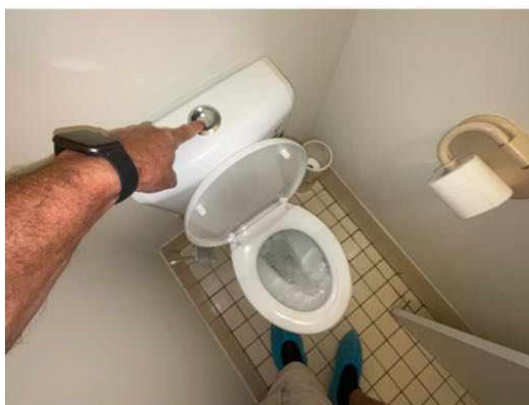
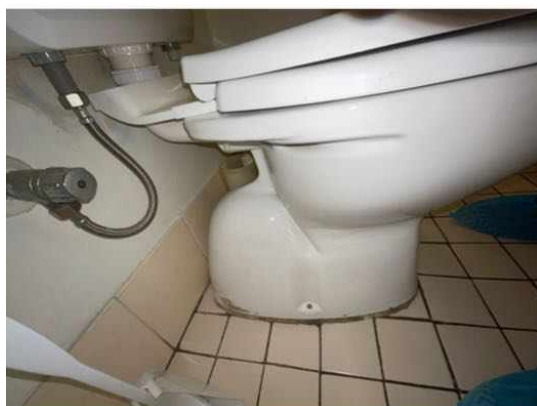
Building: Main Building
 Location: All Areas
 Finding: Water Pressure – Observation Only.
 Information: During the inspection, water pressure appeared to be within a normal operating range based on a basic functional check. However, this observation was made without the use of pressure testing equipment and does not constitute an assessment by a licensed plumber.
