Building and Timber Pest Inspection Report

Inspection Date: Mon, 16 Mar 2026

Property Address: 24 Rose St, Liverpool NSW 2170, Australia

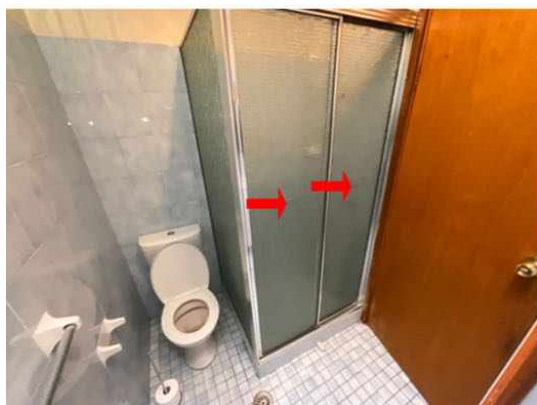
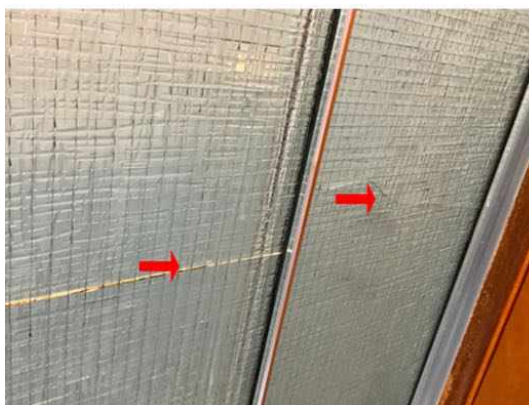
Building:	Main Building
Location:	Granny flat bathroom
Finding:	Shower screen - Cracked
Information:	Cracking was evident to the shower screen at the time of inspection, which is suspected to be due to accidental impact damage.

While the cracking appears to be minor, any further impact may lead to additional cracking and or shattering of the shower screen, creating a potential safety hazard in the area. Further damage would almost certainly necessitate replacement of the entire shower screen.

A qualified glazier is required to repair the shower screen as soon as possible. Please be advised that any persons coming into contact with the cracked shower screen should do so with due caution to avoid any personal injury that may ensue.

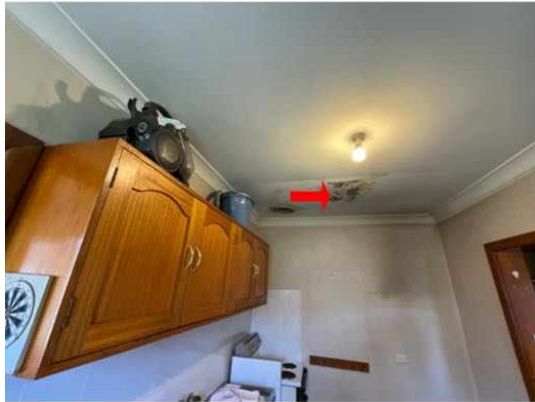
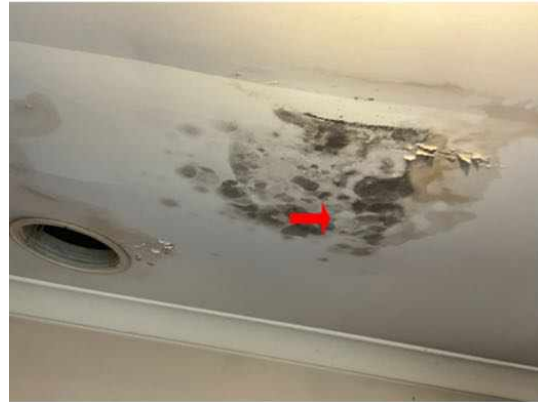
Finding 1.02

Building:	Main Building
Location:	Granny flat kitchen
Finding:	Mould - Present
Information:	Where evidence of mould growth was noted, there may be environmental, biological or health issues associated with the report. A specialist inspection by a suitably qualified environmental health inspector is warranted, where mould is extensive or where any queries regarding air quality spores or other related issues apply.

Generally, the client is advised to ensure that the general environment is free of moisture and humidity to aid in the prevention of mould formation and development. Any mould found during the inspection should be cleaned immediately by a cleaning

contractor or the homeowner as applicable.

Please note that severely affected building elements may require replacement by a licensed builder.

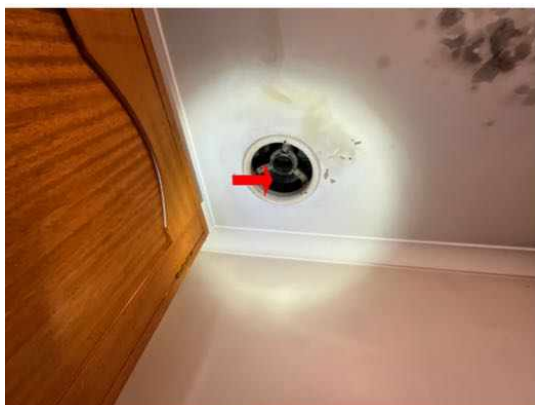
Finding 1.03

Building:	Main Building
Location:	Granny flat kitchen
Finding:	Exhaust fan - Missing
Information:	An exhaust fan has not been installed in this area. Missing exhaust fans may lead to the development of more significant defects such as moisture damage to surrounding building materials from inadequate ventilation. Inadequate ventilation in internal areas creates an environment that is conducive to the formation and development of mould and other respiratory hazards. It is highly advised that a licensed electrician be appointed to retrospectively install an exhaust fan. Failure to perform works to aid the ventilation of the area may lead to the development of these secondary defects.

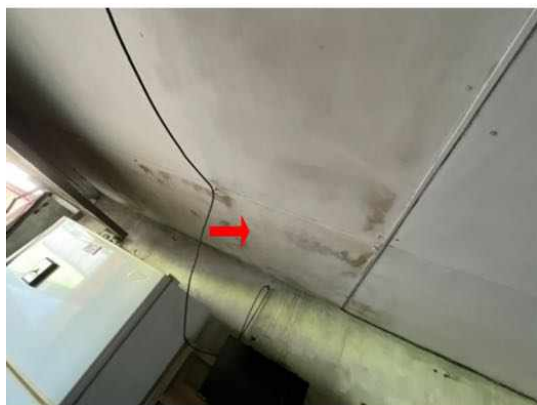
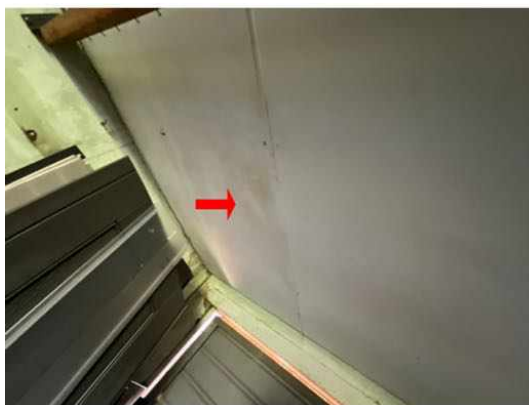
Finding 2.01

Building:	Main Building
Location:	Garage
Finding:	Ceiling - Water damaged
Information:	Water damage to the ceiling lining is generally an indication of excessive moisture being present in the roof void, usually via a leak to the roof covering.

Where water damage is evident to the ceiling, the primary requirement is to identify and rectify the source of the leak. A roof restoration specialist should be appointed as soon as possible to identify the leak and perform rectification works as necessary, ensuring the water damage is restricted.

Once the leak is repaired, consultation with relevant tradespeople, including plasterers and painters, is advised. Rectification works may include replacement of ceiling lining or minor repainting, depending on the extent of the damage.

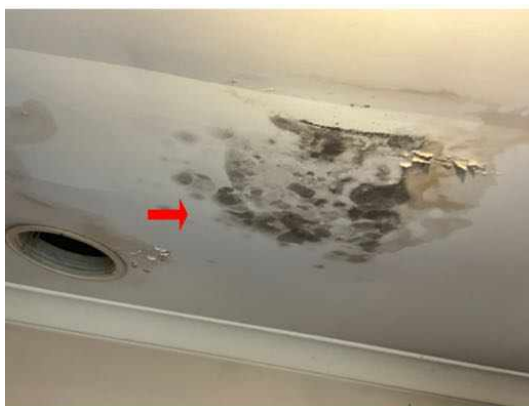
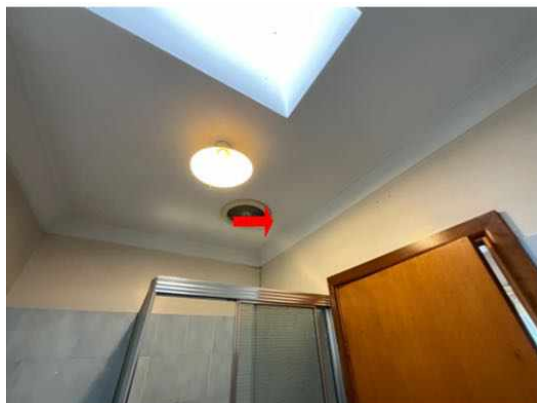
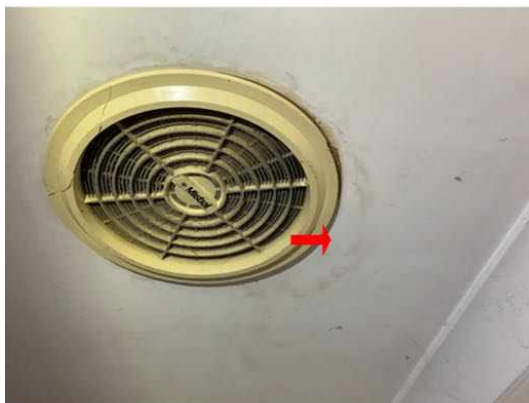
Finding 2.02

Building:	Main Building
Location:	Granny flat
Finding:	Ceiling - Water damaged
Information:	Water damage to the ceiling lining is generally an indication of excessive moisture being present in the roof void, usually via a leak to the roof covering.

Where water damage is evident to the ceiling, the primary requirement is to identify and rectify the source of the leak. A roof restoration specialist should be appointed as soon as possible to identify the leak and perform rectification works as necessary, ensuring the water damage is restricted.

Once the leak is repaired, consultation with relevant tradespeople, including plasterers and painters, is advised. Rectification works may include replacement of ceiling lining or minor repainting, depending on the extent of the damage.

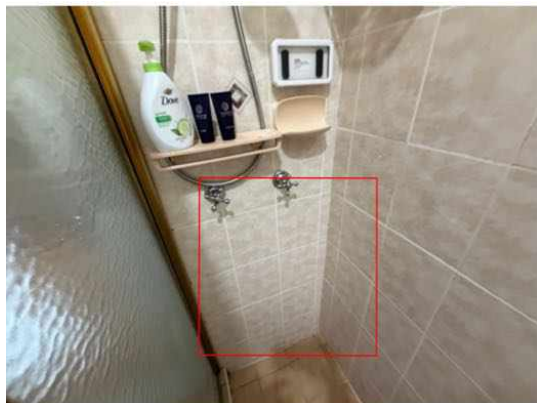
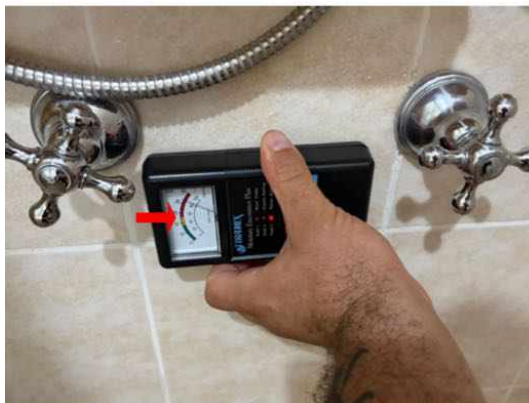
Finding 2.03

Building:	Main Building
Location:	Bathroom
Finding:	Water leak - Suspected
Information:	A water leak is suspected in this area as excessive moisture was detected at the time of inspection. Another potential cause maybe moisture ingress behind the tiles from around the wall fittings and penetrations.

Internal water leaks can be detrimental to surrounding building elements; their potential causes include damage to plumbing fittings and fixtures, through to water damage and deterioration of associated building elements.

Attracting termites, corrosion, mould, decay and water damage are potential outcomes where a minor water leak is left unattended. More serious defects may also result, such as electrical hazards, or water damage to structural building elements.

In extreme cases, structural damage may develop due to a prolonged water leak. It is highly advised that internal water leaks be addressed by a licensed plumber as a matter of relative urgency.

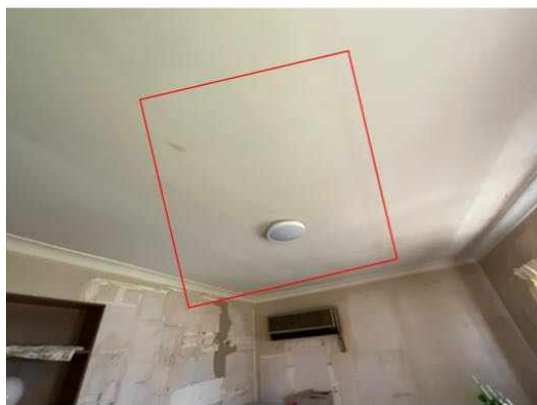
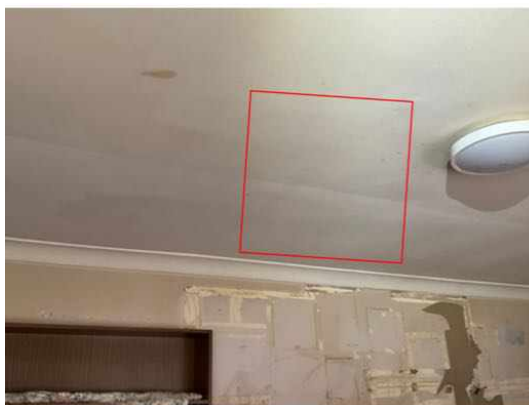
Finding 3.01

Building:	Main Building
Location:	Granny flat lounge
Finding:	Ceiling - Sagging
Information:	Sections of the ceiling were found to be sagging at the time of inspection. Sagging to the fixed ceiling structure generally indicates that the building materials have swollen, due to contact with water, or that fixings (e.g. nails or glue) have become loose and require reattachment.

Where minor sagging is evident, comparatively minor works, such as re-gluing of ceiling sheets, may be required. Such works may be performed by relevant tradespeople, such as plasterers and painters. Where excessive moisture has caused the roofing structure to swell and sag, the source of the water leak should primarily be identified prior to any remedial works being performed.

The appropriate action should be taken by the client as soon as possible to ensure that any potential further damage is limited.

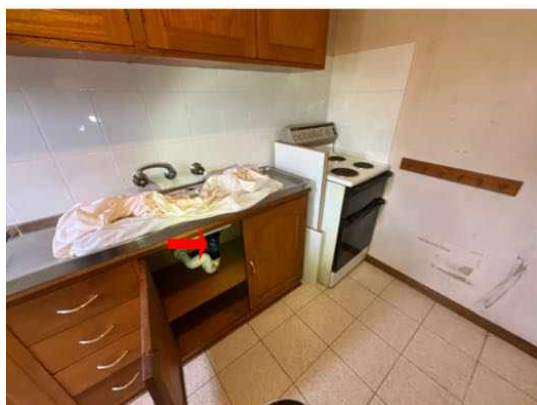
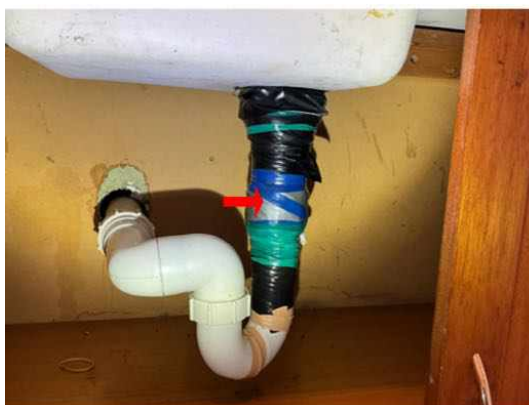
Finding 3.02

Building:	Main Building
Location:	Granny flat kitchen
Finding:	Unconventional handyman work
Information:	This handyman work appears to have been completed to a substandard level and does not comply with regular building practices. Where handyman work is not completed satisfactorily, accelerated deterioration of the associated building elements is likely to occur and secondary defects to surrounding structures may develop.

It is highly recommended that the substandard work be rectified by professional services. Works to improve this area are likely to increase the safety and the operation of the associated building elements.

The client should exercise care when coming into the immediate vicinity of the substandard works. Rectification works are advised as soon as possible by a licensed plumber.

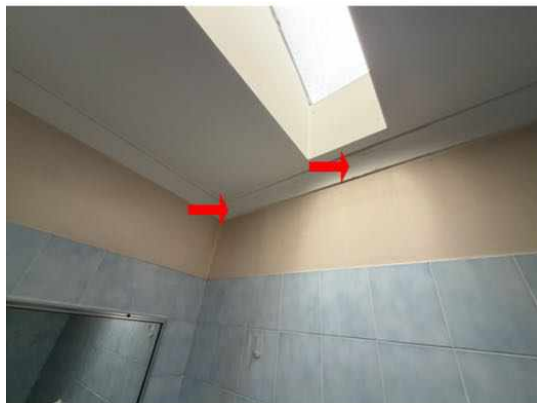
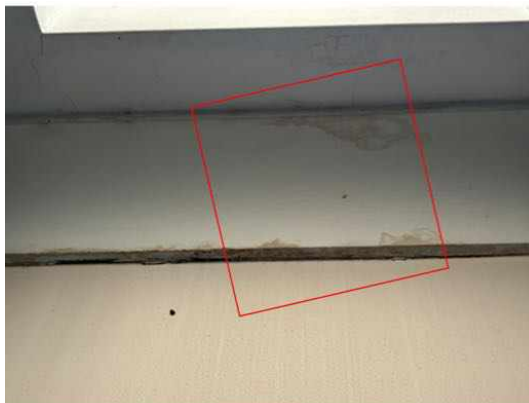
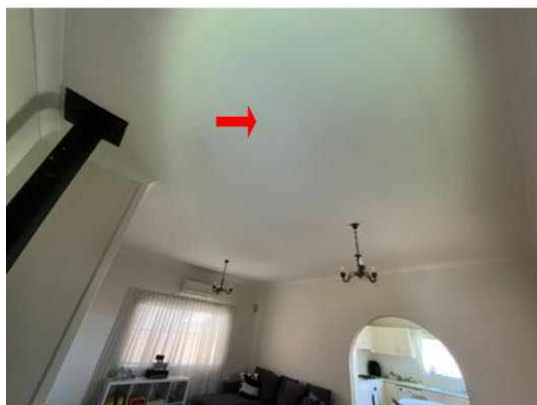
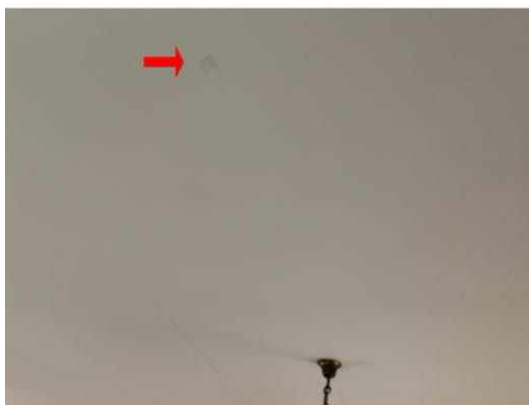
Finding 3.03

Building:	Main Building
Location:	Granny Bathroom, Main house Loungeroom
Finding:	Ceiling - Water stained
Information:	Water staining to ceiling linings in this area was evident at the time of inspection. Water staining indicates that surfaces have been exposed to excessive moisture over time. The minerals and other elements in the water lead to staining, which may graduate to corrosion and deterioration if left unmanaged.

While mostly an appearance defect, water staining can be indicative of more serious defects, which may be currently concealed by interior ceilings.

Where water staining is active, a licensed plumber must be consulted to identify the cause of the staining and to provide advice on any reparation works that may be required. Replacement of any damaged structures is advised.

Conversely, where water staining is old and inactive, affected building materials may be repaired or replaced at client discretion.

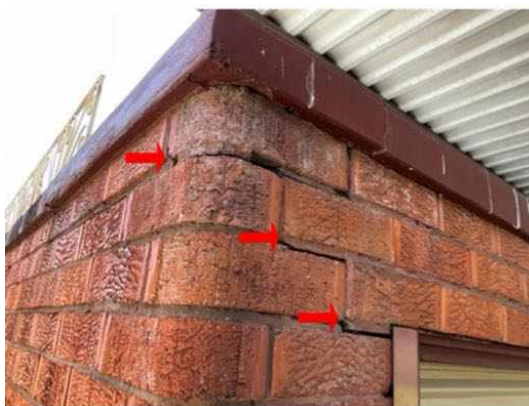
Finding 3.04

Building:	Main Building
Location:	Carport
Finding:	Brickwork - Step cracking
Information:	Step cracking was identified to the brickwork in this area at the time of inspection. Step cracking, which is similar to other forms of cracking, has a variety of possible causes. However, the most common is the subsidence of adjacent footings.

Step cracking is a relatively common defect, and is most likely to occur adjacent to windows, doors and other openings. Mortar failure in the gaps between affected bricks indicates the stresses and tensions affecting the wall.

Minor step cracking can be used as a warning sign to address factors causing stress to the wall, which can include the effect of surrounding trees, water leaks, soil erosion, or even the presence of reactive soils in the surrounding area. Damage of this category is required to be monitored for a period of 12 months, after which time a crack rated at Category 2 or above is considered a defect requiring rectification, such as minor repairs and repointing. Always contact your building inspector should cracks widen, lengthen, or grow more numerous.

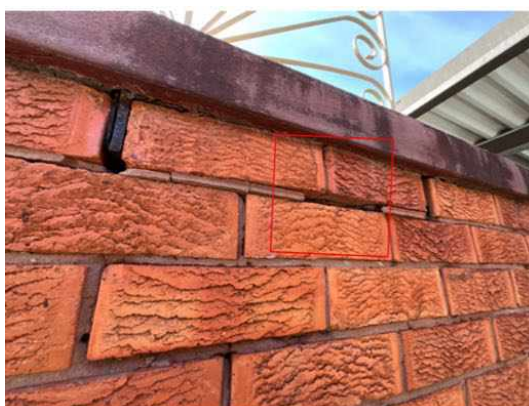
Finding 3.05

Building:	Main Building
Location:	Carport
Finding:	Mortar - Deteriorated (Erosion)
Information:	The mortar in this area was found to be deteriorated. Mortar, or 'bedding', is the material which fills joints and intersections between bricks in masonry walls and structures.

Commonly referred to as corrosion or erosion, the bricks and mortar are aged and likely to have been affected by a variety of factors, including moisture, salt-based deterioration, and more.

Mortar and brickwork should be replaced to ensure the structure remains in their intended location and to prevent gaps, which would allow water or moisture ingress and secondary damage as a result.

This can be addressed by a licensed bricklayer.

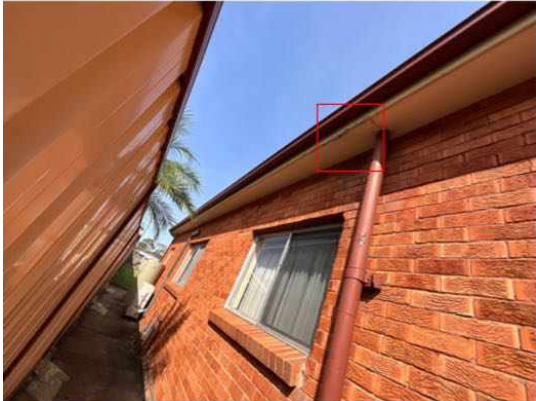
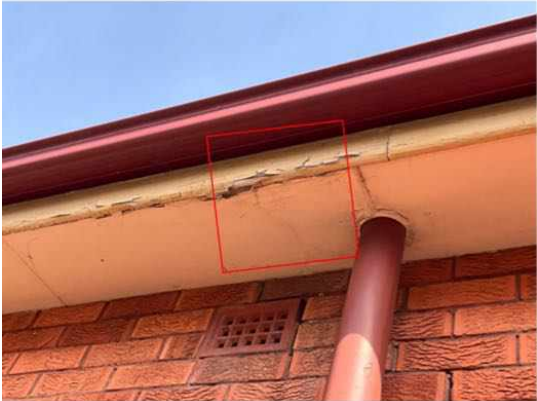
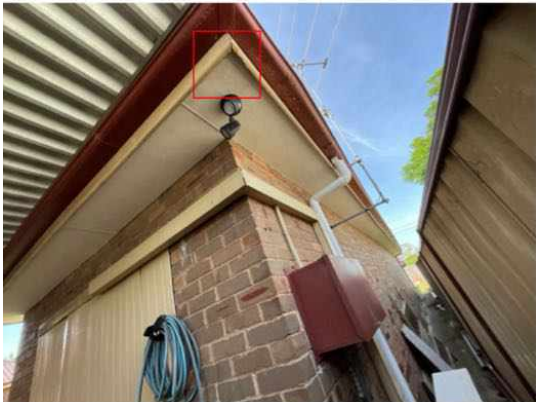
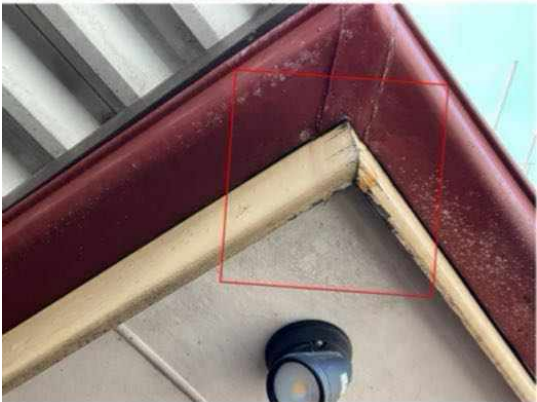
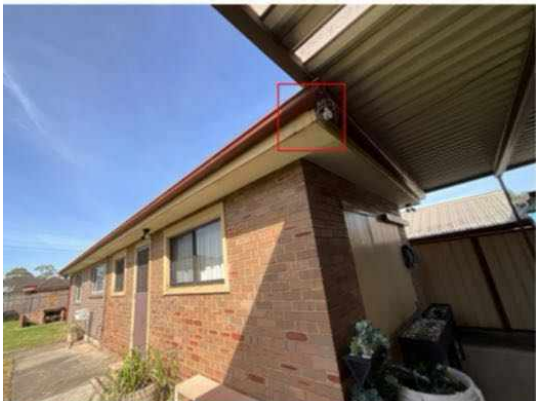
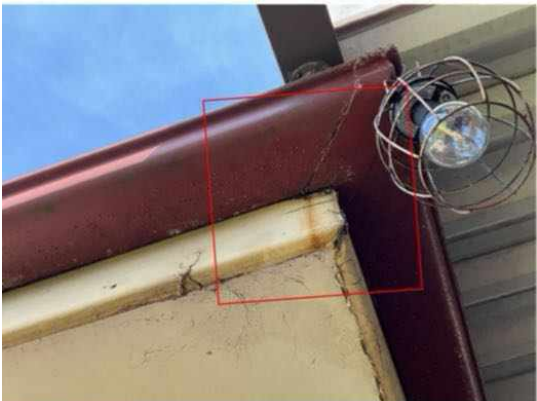
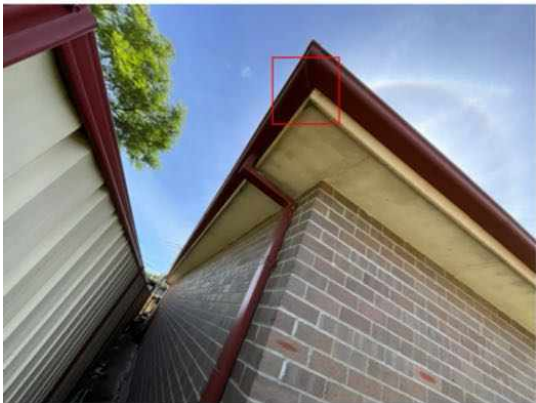
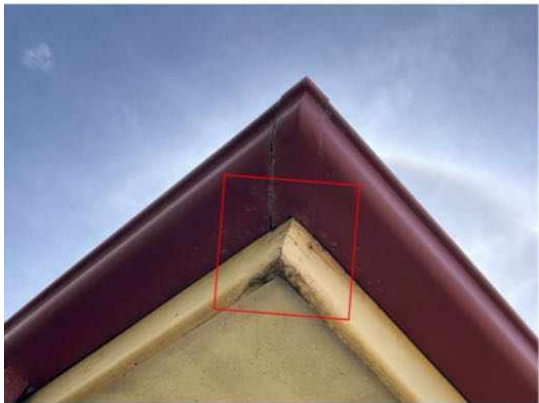
Finding 3.06

Building:	Main Building
Location:	Multiple areas
Finding:	Eaves/Roof plumbing -- water damages

Information: Water damage is generally an indication of excessive moisture being present, usually via a leak. It is suspected that gutter blockages causing stormwater to backflow into the eaves causing water damages. This is additionally conducive to termite activity due to the damp conditions.

Where water damage is evident, the primary requirement is to identify and rectify the source of the leak. Gutters must be kept clear of any blockages moving forward. A roofing plumber should be appointed for further assessment if the problem persists.

Once the leak is repaired, consultation with relevant tradespeople, including carpenters, plasterers and painters, is advised.

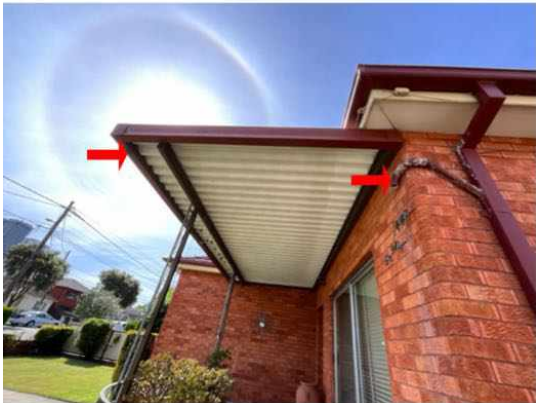
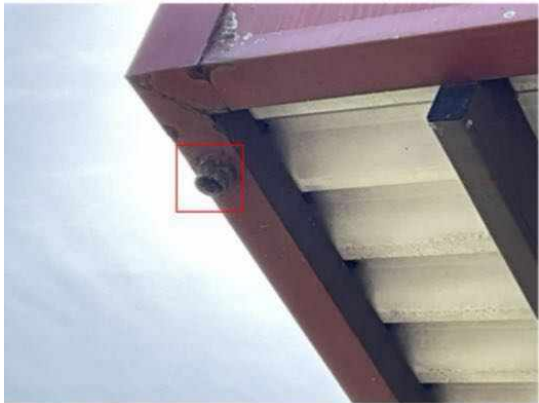
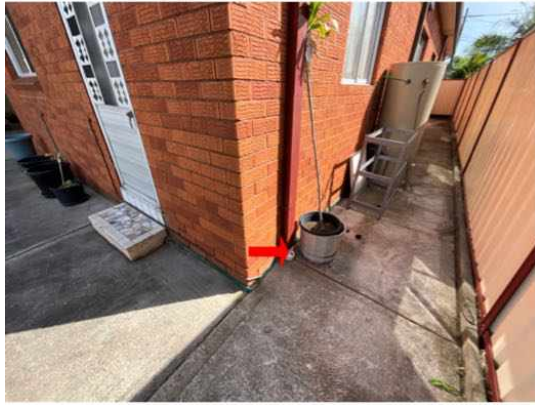
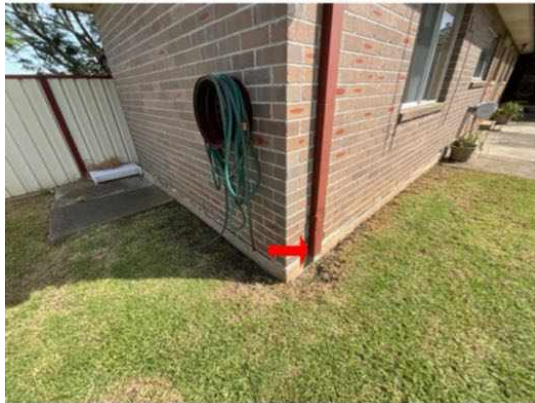
Finding 3.07

Building: Main Building
Location: Multiple areas
Finding: Stormwater drain - Not connected/Damaged
Information: The roof plumbing is not adequately connected to stormwater drainage on the site. This disconnection negatively impacts the functional capacity of the roof plumbing.

Where roof plumbing doesn't drain adequately, the area at the base perimeter can become excessively damp, potentially creating an environment that is susceptible to rust and corrosion of surrounding building elements, as well as attracting termites and other pests.

It is highly recommended that a plumber be appointed to further inspect the area and to install adequate drainage equipment where necessary.

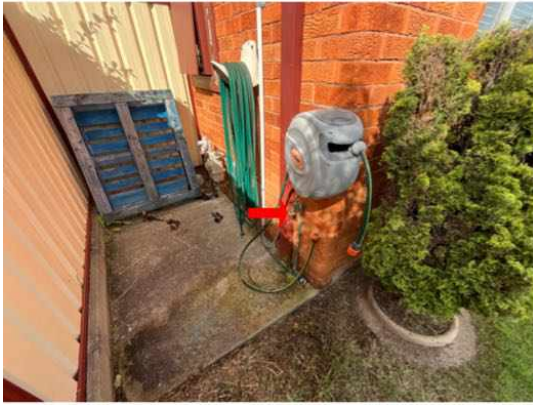
Finding 3.08

Building:	Main Building
Location:	Front right corner
Finding:	Washers - Degraded
Information:	The washers on the taps in this area appear to have degraded as a result of general ageing. Degraded washers generally result in slow, persistent leakage from taps and plumbing hardware.

Replacement of washers will ensure that water wastage does not occur and that the persistent water leak does not result in secondary damage to surrounding structures. Such damage may range from rust and corrosion to damage of surfaces, e.g. bench tops, etc.

A qualified plumber should be appointed to replace degraded washers and to further inspect associated plumbing fixtures and fittings. Where water damage has occurred, a carpenter or cabinet maker may be appointed to replace affected building elements.

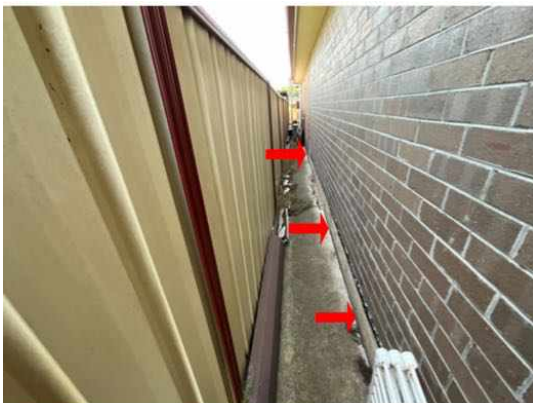
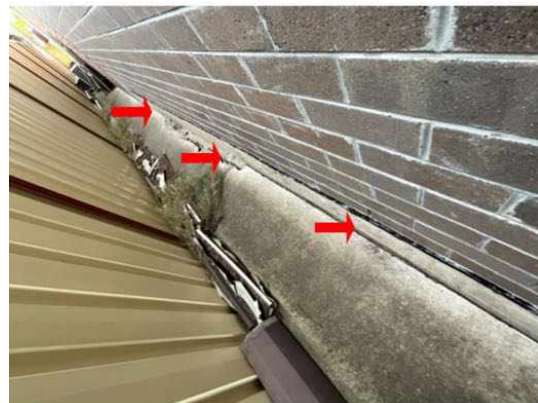
Finding 3.09

Information: Gaps in the external concrete paving were identified at the time of inspection. Gaps in the slab are significant and are likely to lead to the development of secondary defects if left unmanaged, such as the creation of a trip hazard and water entry points.

With reactive clay soils, it is extremely important to ensure that all stormwater flows including roof and ground flows, contained and continually maintained. High moisture also creates an environment that is conducive to termite attack.

A licensed Plumber should be appointed immediately to ensure that the stormwater pipework is intact and adequate, and all gaps to concrete, driveways and paths should be sealed by a licensed builder or a general handy person to keep moisture from entering.

A licensed concretor may be required to replace pavements that are beyond repair.

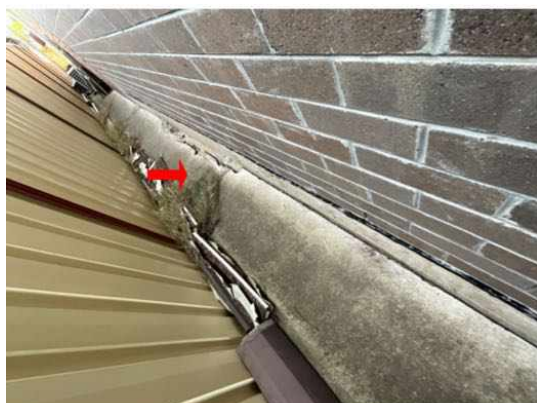
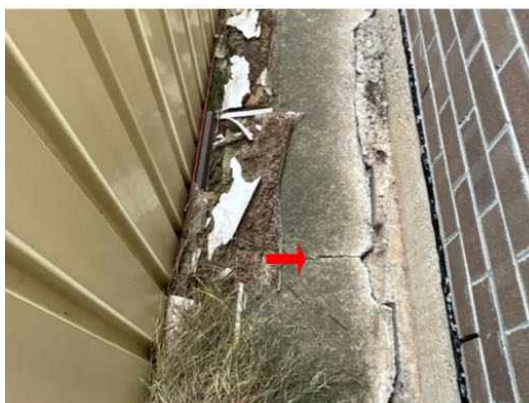
Building:	Main Building
Location:	Granny flat
Finding:	Cracking - External Concrete Paving Damage Category 1 - Fine (less than 2mm)
Information:	Fine cracks were identified in external concrete paving. Although fine cracks are quite noticeable, they are often only considered to be an appearance defect, and usually do not indicate any structural damage. To be considered a Category 1 or fine crack, the crack is found to be less than 2mm in width.

Generally the cause of a hairline crack in existing concrete paving such as driveways and pathways is indicative of the expansion and contraction of the concrete. Such causes are generally due to environmental factors, such as moisture levels, weather conditions, root systems of nearby trees or the soil types on which they are laid.

Fine cracks may also be due to poor original installation of the concrete. Factors such as poor compaction of the sub surface and/or inadequate reinforcing of the slab may create cracking and other secondary defects.

Monitoring of all cracking should be conducted frequently. Always contact a building inspector should cracks widen, lengthen, or become more numerous.

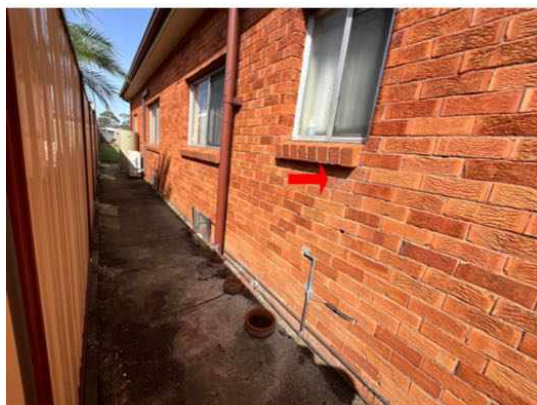
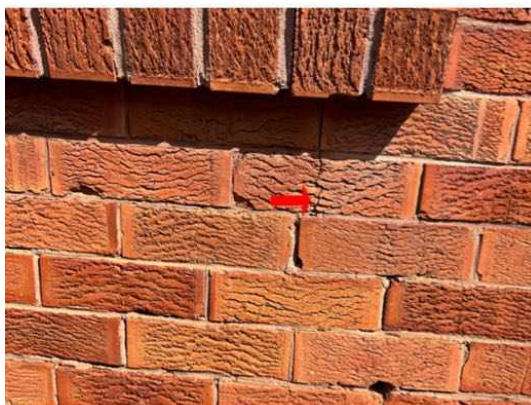
Finding 3.11

Building:	Main Building
Location:	Exterior walls - right side
Finding:	Brickwork - Cracking [Fine]
Information:	Although fine cracks are quite noticeable, they are often only considered to be an appearance defect and usually do not indicate any structural damage. Generally, the cause of a fine crack is indicative of a separation between brickwork and mortar throughout the structure, but single bricks may also show cracks of this nature.

Cracking of this nature can generally be repaired with minor filling and should be conducted by a qualified bricklayer.

Always contact a building inspector should cracks widen lengthen or become more

numerous.

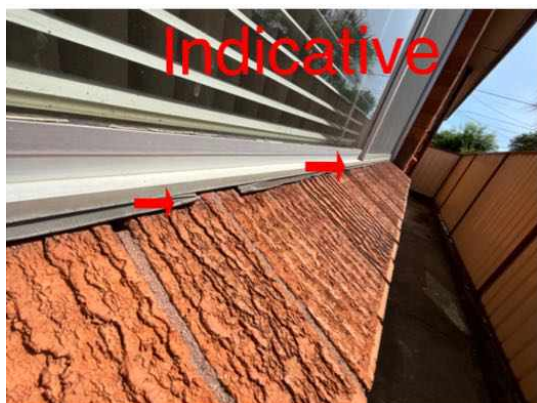
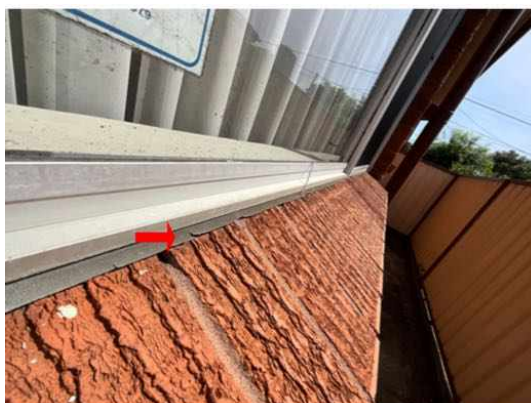
Finding 3.12

Building:	Main Building
Location:	Multiple Windows
Finding:	Window rubber seals - Inadequate
Information:	Some window seals are in a generally poor condition. It is suspected they have been cut short during the initial construction phase of the building. The window is no longer weather-tight; rain penetration and subsequent water damage is therefore likely to ensue. Insulation of the area against external weather conditions will also be compromised. It is highly recommended these seals be repaired or replaced by a sealant expert to prevent any further damage and to restore the window to a fully functional level.

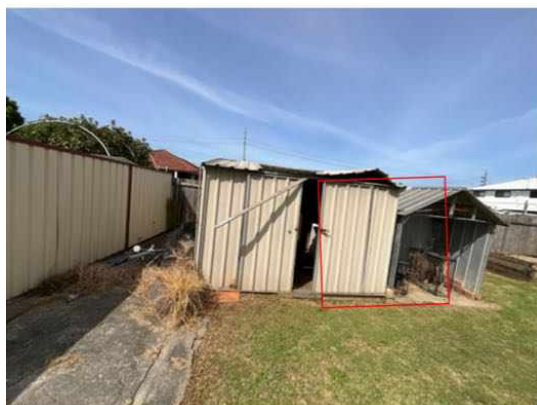
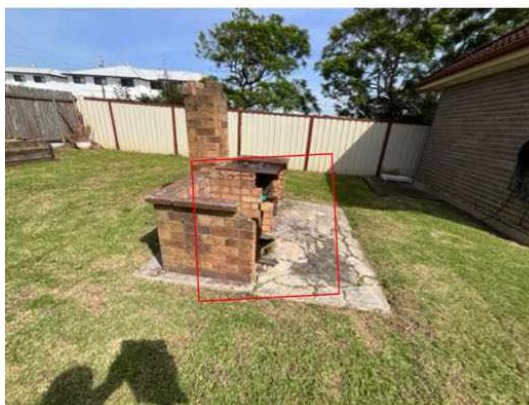
Finding 3.13

Building:	Main Building
Location:	Outboundings
Finding:	Deteriorated components
Information:	It was identified that some elements around the exterior of the home have suffered from environmental effects with replacement required.

Secondary defects are likely if the issue is not addressed. A licensed carpenter should be appointed for repairs immediately.

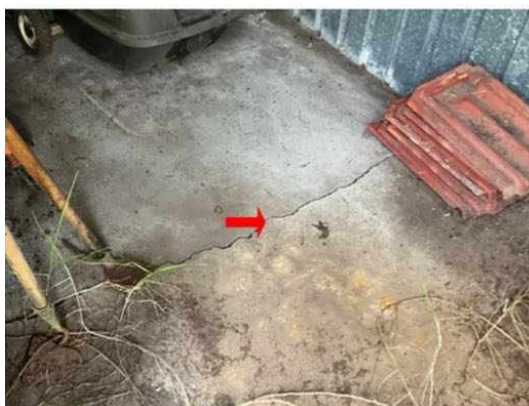
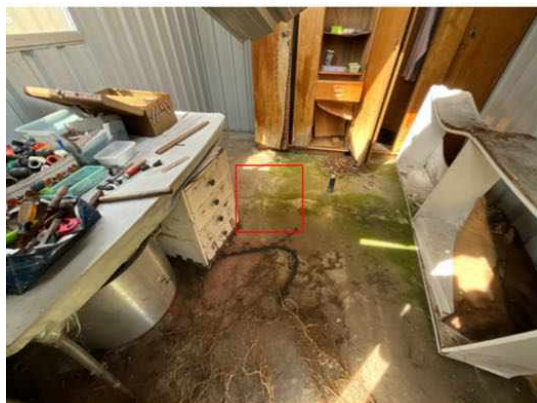
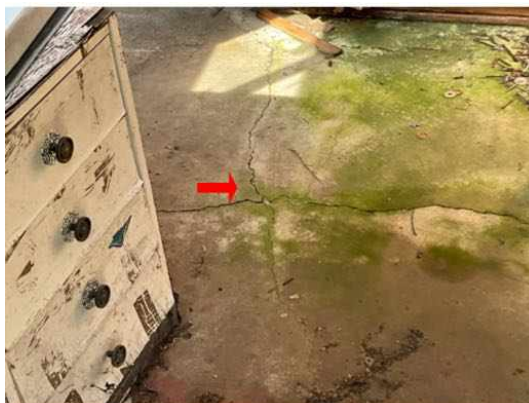
Finding 3.14

Building:	Main Building
Location:	Sheds
Finding:	Crack in concrete slab - Category 3
Information:	A crack coded as Category 3 was identified in the slab. A Category 3 crack is described as a wide crack with obvious curvature or change in level, affecting the slab.

The approximate width of the crack to be considered Category 3 is greater than 2.0mm, or a change in offset of 15-25mm when a 3m straight edge is placed over the defect.

Category 3 cracks to slabs exceed allowable Standards and Tolerances, and are considered defects requiring rectification.

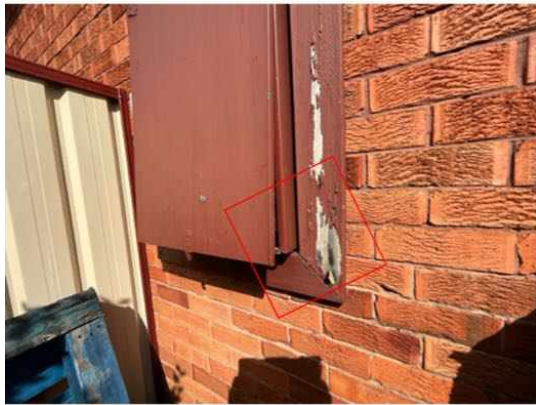
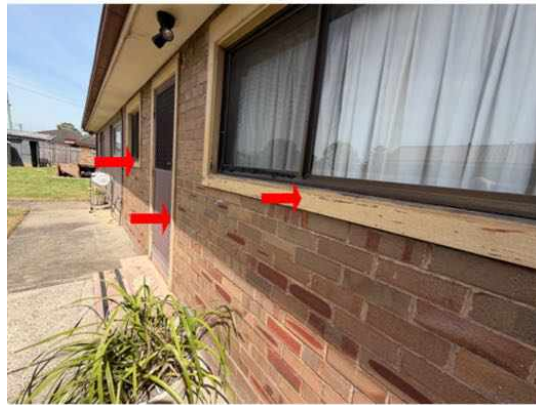
Finding 3.15

Building:	Main Building
Location:	Multiple areas
Finding:	External painting deteriorated
Information:	The external paintwork to multiple areas have been neglected and require attention to prepare and re-paint.

Whilst incomplete or missing paint finish is generally an appearance defect, it can also lead to the development of secondary building defects over time. Incomplete areas of paint finish expose the area to moisture, potentially accelerating the deterioration of underlying building materials.

Degraded paint finishes should be sanded back, filled, leveled and painted, as applicable. Where inadequate or missing paint protection has led to the deterioration of the associated building element, repair and/or replacement of this building element may be required.

A painting contractor should be appointed as soon as possible to perform necessary works to aid the appearance of the affected area and to ensure the area is protected against further deterioration. Alternatively, the homeowner following manufacturer instructions may perform these works.

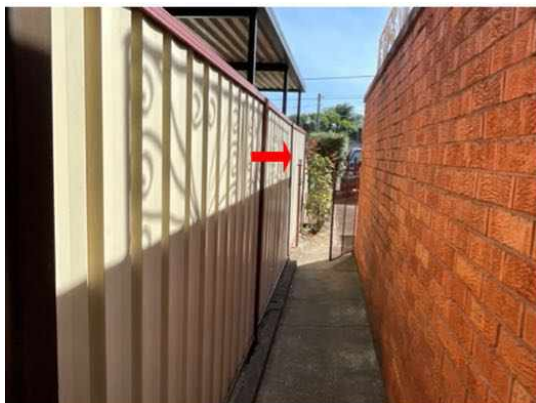
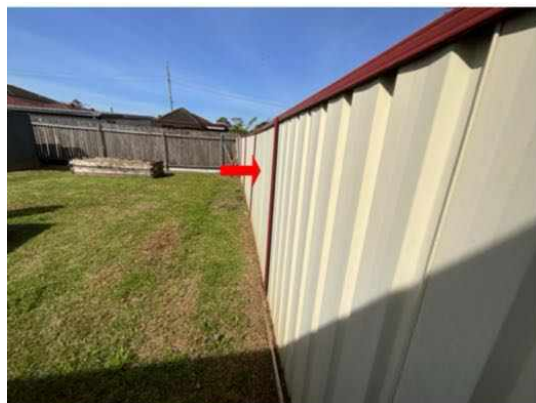
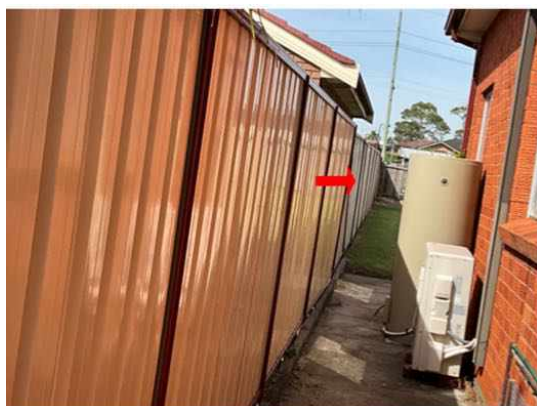
Finding 3.16

Finding: Fencing - Deteriorated

Information: It was noted at the time of inspection that sections of the fencing in this area has deteriorated. Typically fencing deteriorates due to age and or wear, rot and or rust which is generally expected for a structure of this age, due to prolonged exposure to weather conditions. Sometimes inadequate installation or maintenance can be to blame.

If left unattended, it is likely that further damage will occur. It is suspected that repair of several elements of the fencing may be required however replacement may be a consideration of the client also.

A licensed fencing contractor should be appointed to provide further advice and perform rectification works as necessary.

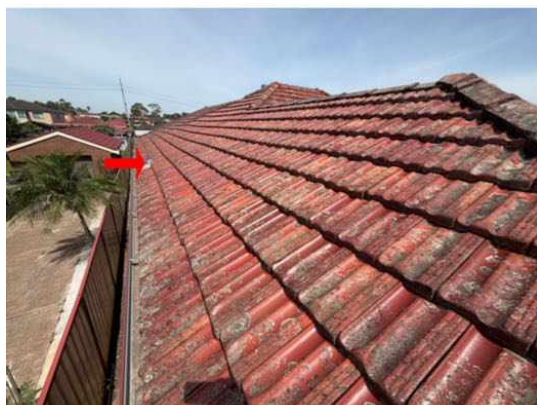
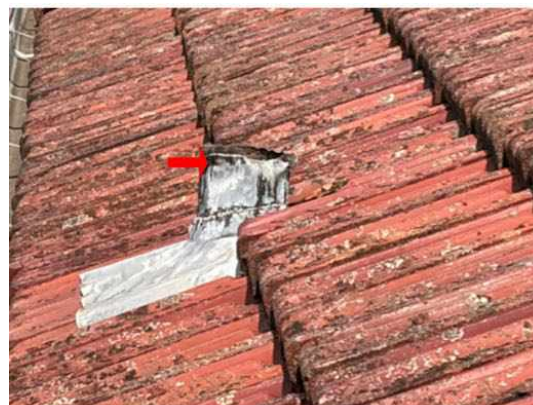
Finding 3.17

Building:	Main Building
Location:	Roof Exterior
Finding:	Pipe vent cowl - Missing
Information:	The pipe vent cowl on the roof was found to be missing at the time of inspection.

This may allow moisture, debris and pest ingress to the pipe, causing blockage and other secondary defects.

A general handyman should be appointed to install the top flue ensuring further damages are prevented.

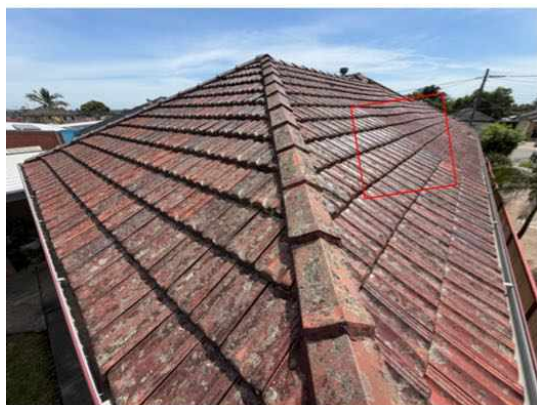
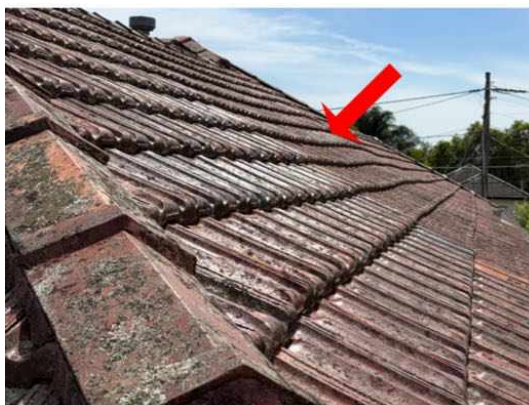
Finding 3.18

Building:	Main Building
Location:	Roof Exterior
Finding:	Roof structure - Hipped roof sagging
Information:	The hipped roofing structure was found to be sagging in sections at the time of inspection. Generally, sagging in a hipped roof occurs due to the ceiling joists and rafters being unparallel; this causes the joists and rafters to not connect adequately, providing insufficient support.

creating potential for secondary damage. The roof is also unlikely to have sufficient support, which will lead to further sagging if left unmanaged.

It is highly advised that a roofing contractor be appointed as soon as possible to provide further advice on repair options. Remedial works should be performed as a matter of urgency to ensure any further damage is avoided.

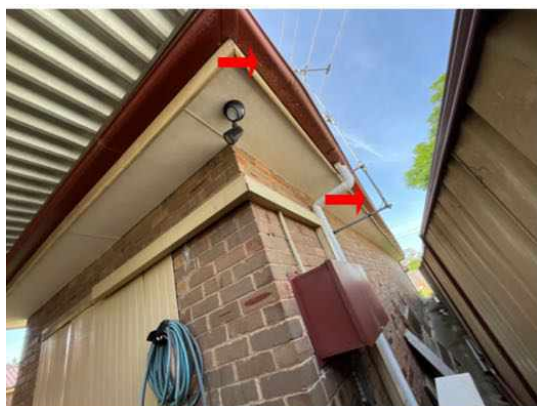
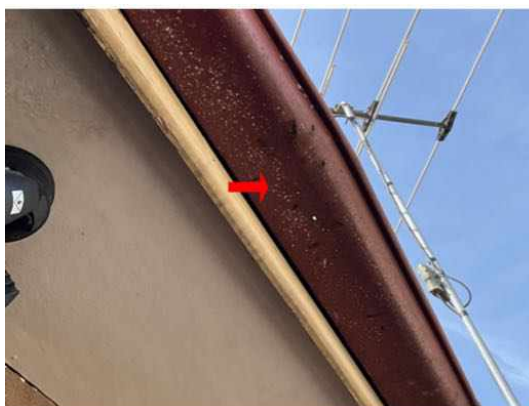
Finding 3.19

Building:	Main Building
Location:	Gutters
Finding:	Roof plumbing - Rusted or corroded
Information:	The roof plumbing has areas of rust and corrosion. It is suspected that this has been caused by blockages, resulting in pooling or standing water, that have prematurely rusted elements of the roof plumbing.

Rusted roof plumbing will generally develop holes and leaks that can affect other building elements with poor drainage of storm water. Poorly drained roof areas will also lead to damp conditions surrounding the base perimeter of the building which, if left unmanaged, can lead to a range of secondary building defects.

Repair and/or replacement of rusted roof plumbing is highly required in order to reinstate the roof drainage system to a fully operational level. To further maintain these areas, gutters should be cleaned frequently, allowing the avoidance of any partial blockages.

A licensed plumber or specialist roof restoration company should be appointed to undertake these works. It is advised that such works be completed as soon as possible to prevent any further damage and deterioration.

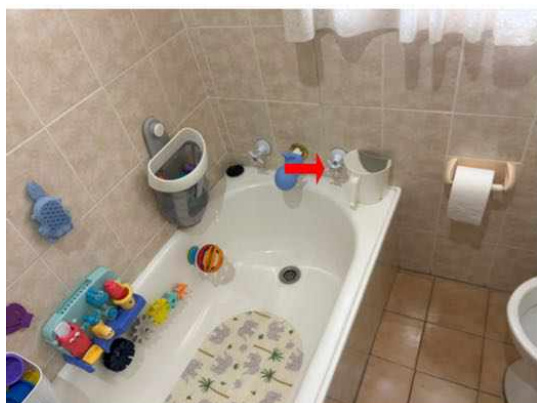
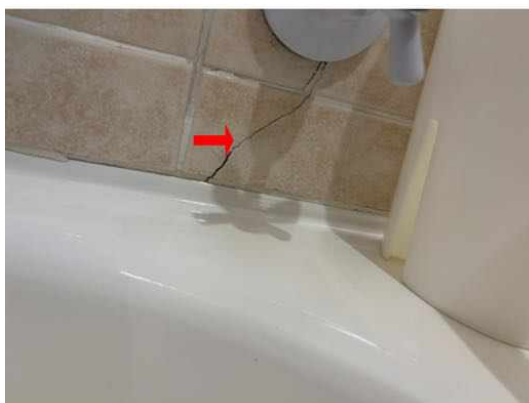
Finding 3.20

Finding: Wet area tiles - Cracked or damaged

Information: Cracking was evident to the tiling in this area at the time of inspection. While the cracking appears to be minor, this area is frequently exposed to water, allowing potential for water penetration into adjoining sections of walls or flooring.

If left unmanaged, water penetration to these areas may lead to subsequent water damage, which is likely necessitate repair work to affected building elements.

A bathroom specialist should be appointed to determine the integrity of the bathroom waterproofing membrane. If the membrane was found to be intact then relatively minor works to replace the cracked tiles should be carried out to ensure no further damage occurs. The re-application of silicone and grouting throughout remaining tile work is also advised, to further protect the area against water penetration.

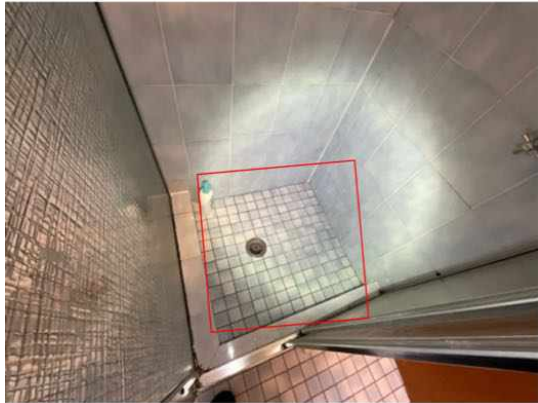
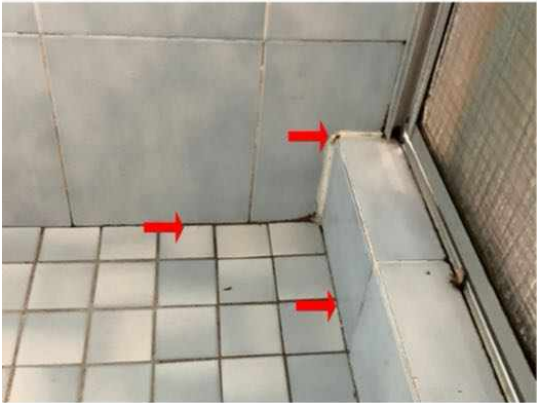
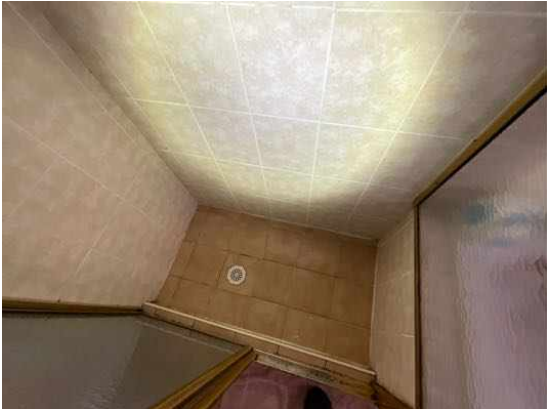
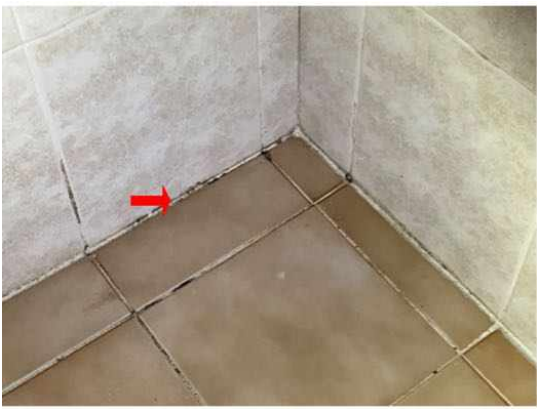
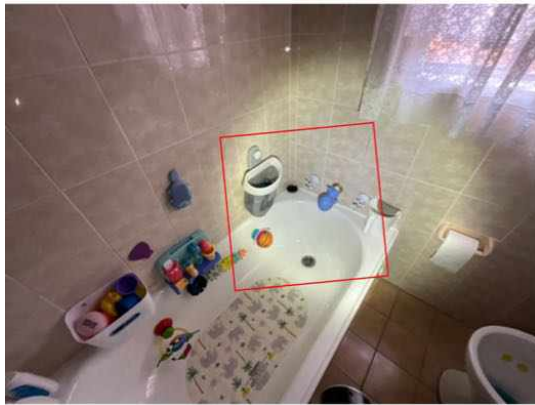
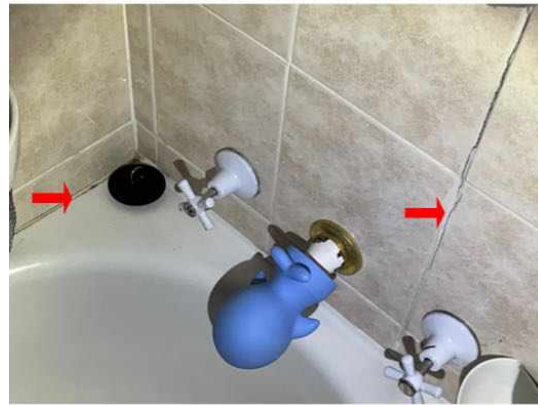
Finding 3.21

Finding: Sealant and grouting - Missing or damaged

Information: It was noted on inspection that sealant or grout is degraded to this area.

Different materials and floor areas move at different rates, generally causing cracking to grout or sealant at this point. A flexible sealant is required to allow for expected expansion and contraction, while keeping the joint water tight and protective of all associated building materials.

Flexible and mould resistant materials should be applied to affected areas to prevent any subsequent water damage that is likely to occur. Regular maintenance and replacement of damage or missing or damaged sealant and grout is highly recommended to the wet areas, as this is a regular wear and tear defect. Sealant and grouting in areas that come into regular contact with water should be maintained for the long term care of your property.

A sealant specialist should be appointed to complete these works as soon as possible.

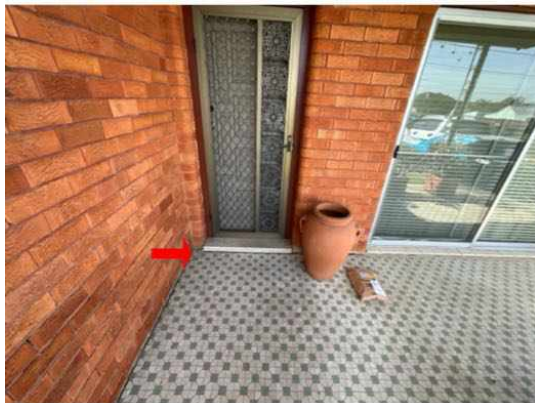
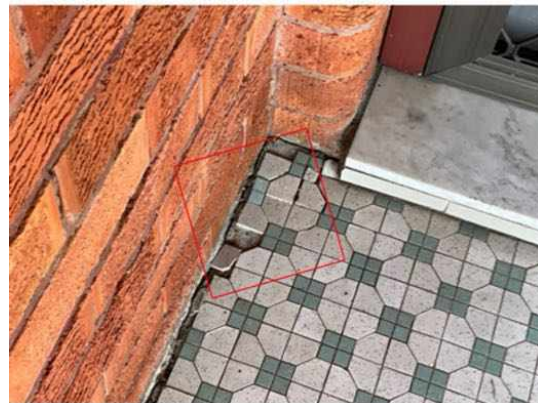
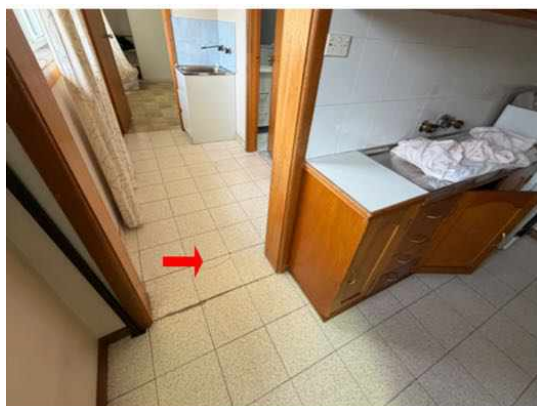
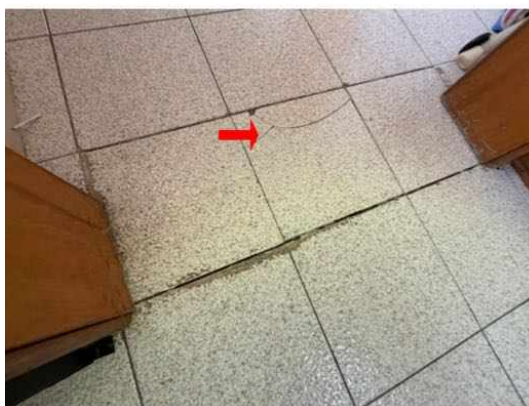
Finding 3.22

Building: Main Building
 Location: Multiple areas
 Finding: Cracked floor tiles
 Information:

Cracking in the floor tiles was evident in this area at the time of inspection. It is suspected that this cracking has occurred as a result of minor settlement or shrinkage.

Cracked tiles throughout the household detract from the overall appearance of the affected areas however it is unlikely to create or lead to any secondary defects.

While not considered a matter of urgency, replacement of cracked floor tiles is recommended at the clients discretion. A licensed tiling contractor may be appointed to perform these works. Where cracks become more numerous, contact a licensed building inspector for further investigation.

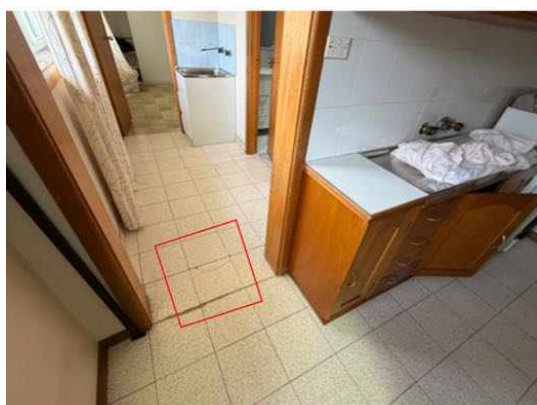
Finding 3.23

Building:	Main Building
Location:	Granny flat
Finding:	Tiles - Drummy
Information:	Drummy tiled areas were identified at the time of inspection. The term 'drummy' refers to tiles that have become detached from their fixing, despite otherwise being in relatively good condition. Such defects are generally caused by physical or moisture damage to the area. Drummy tiled areas may also be a direct result of poor workmanship during the construction process.

Tiled areas may swell and shrink with changes in air humidity if the area has sustained moisture damage. Any exposure to moisture is capable of causing tiled areas to become drummy and/or cracked over a prolonged period of time. Drummy tiled areas generally require removal and replacement of affected tiles, with adequate sealant and grouting.

Specialist trades are available for these types of services. A licensed tiling contractor may be appointed to perform works as necessary.
