Building and Timber Pest Inspection Report

Inspection Date: Mon, 16 Mar 2026

Property Address: 24 Rose St, Liverpool NSW 2170, Australia

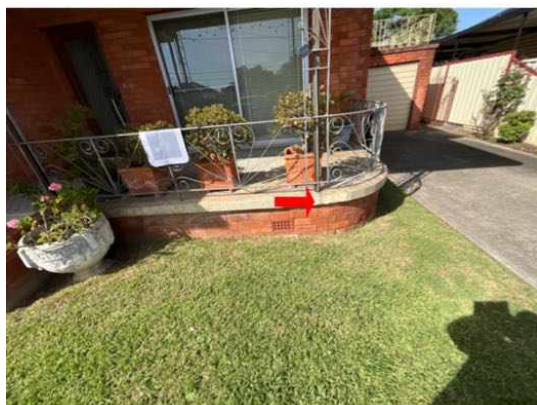
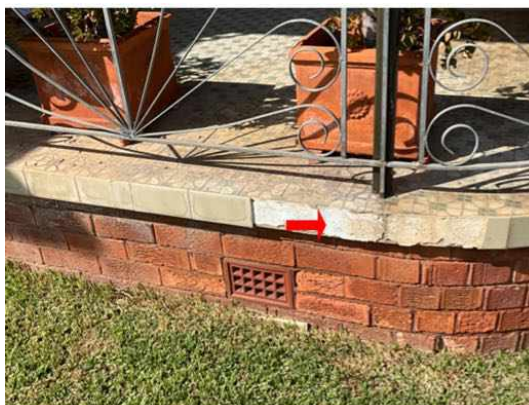
Finding 3.24

Location: Porch
 Finding: Tiles - Missing
 Information: Tiles were found to be missing in this tiled area. It appears as though broken tiles have been removed and not replaced, or have come loose from their original fixing through general deterioration.

Where tiles are missing, water penetration is likely to occur to exposed walls and flooring, creating potential for subsequent water damage.

Any tiles that are missing should be replaced immediately by a tiling contractor or general handyman. If left unmanaged over a prolonged period of time, water damage is likely to necessitate repair works to surrounding building elements.

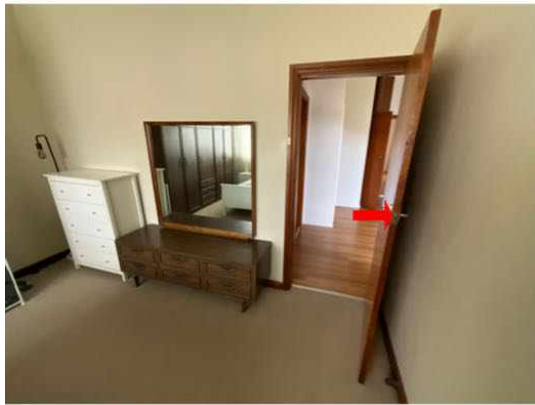
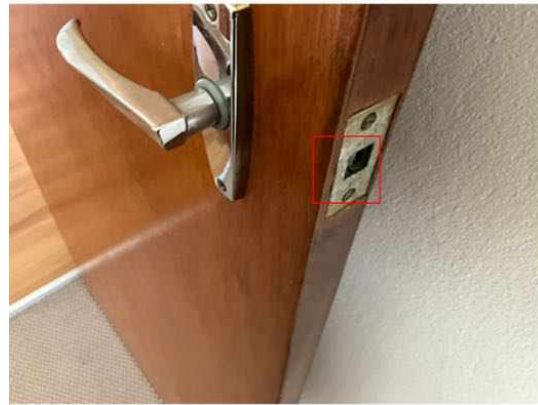
Finding 3.25

Building: Main Building
 Location: Bedroom - Master
 Finding: Building element - Damaged
 Information: Breakage occurs generally when the building materials have either aged and decayed, or as a result of damage (accidental or deliberate).

Repair and/or replacement of broken elements is advised to ensure that additional secondary defects do not arise as a consequence. Such works are necessary, as all building elements play a key role in the operation and function of the overall structure and its performance.

A relevant tradesperson should be appointed to repair or replace the affected building element prior to any subsequent damage being caused.

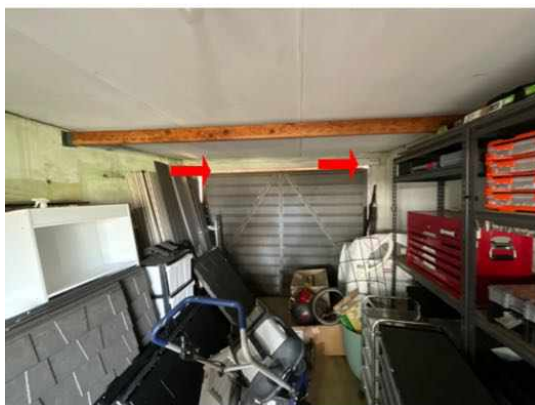
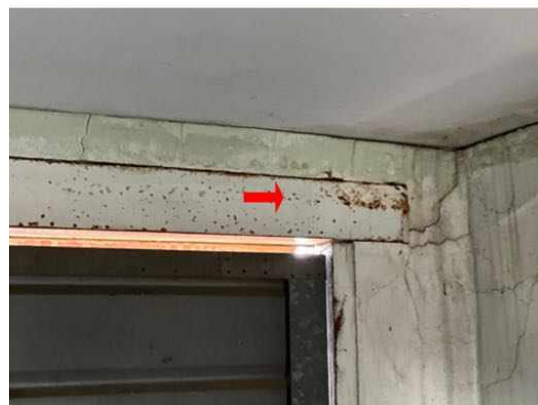
Building:	Main Building
Location:	Garage
Finding:	Building element - Rusted or corroded
Information:	This building element shows evidence of rusting and corrosion, which is likely to have developed as a result of excessive exposure to moisture and or inadequate coatings.

As surface rust provides no protection to the underlying iron, the deteriorating condition is likely to worsen if not addressed in the short-term future.

Where possible, the use of galvanized (treated) metals or aluminium coated metals aid in rust prevention, as does regular general maintenance. Rust formation can be controlled with coatings, such as paint, that isolate the iron from the environment.

Rusting and corrosion should be managed by ideally removing or limiting the affected surface from exposure to moisture. A licensed builder may be appointed to replace any building elements that have been severely affected by rust or water damage.

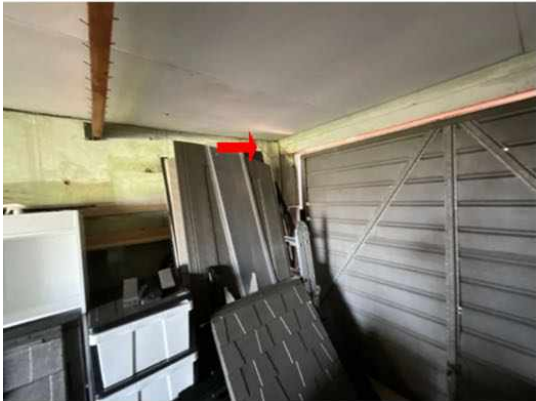
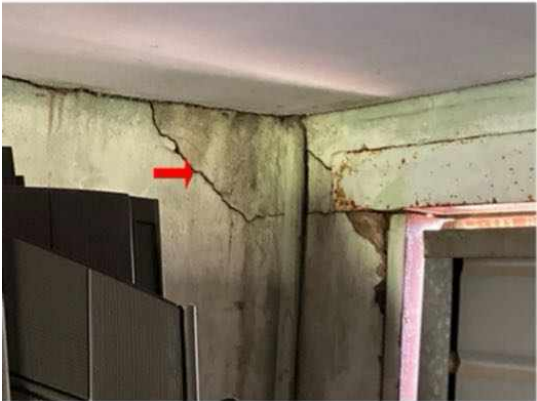
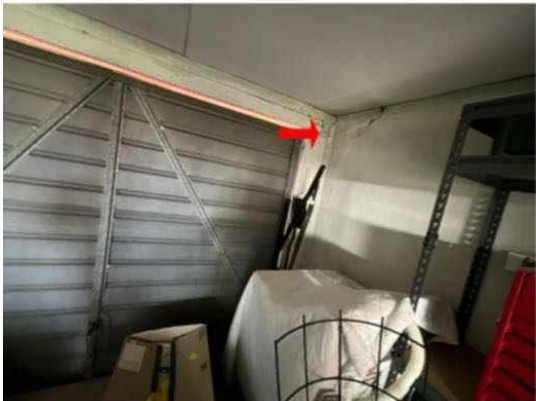
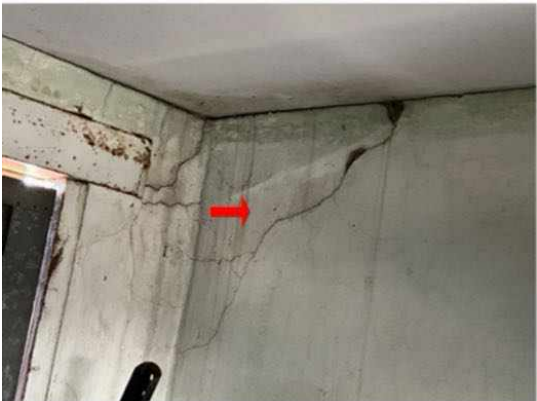
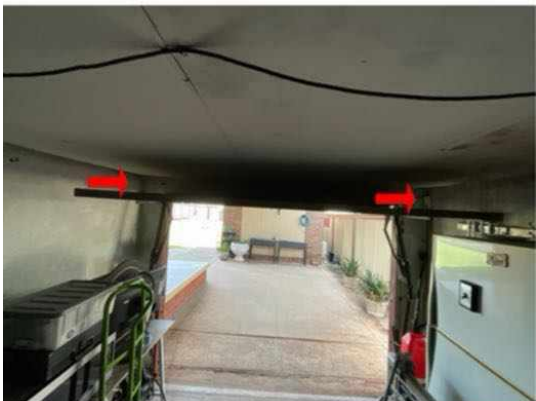
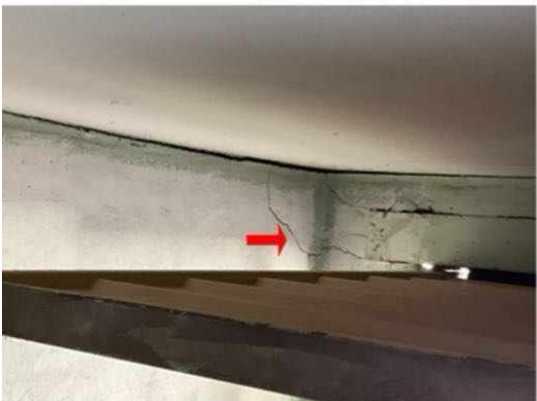
Finding 3.27

Building:	Main Building
Location:	Multiple areas
Finding:	Cracks to internal render - Category 1

Information: It has been observed that cracking to internal rendered surfaces has occurred. The degree of damage falls within Category 1, described as fine cracks that do not need repair and which are less than 1.0mm in width limit.

Damage of this category is not considered a defect for rectification. Always contact your building inspector should cracks widen, lengthen, or become more numerous.

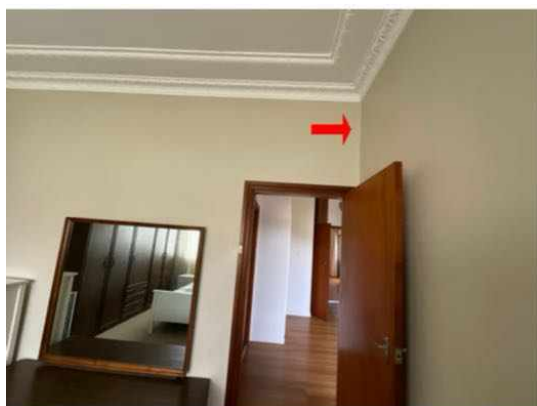
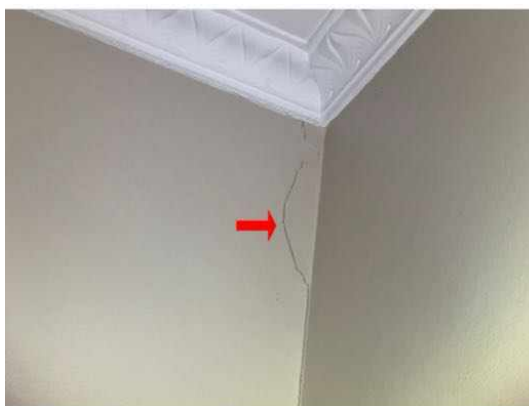
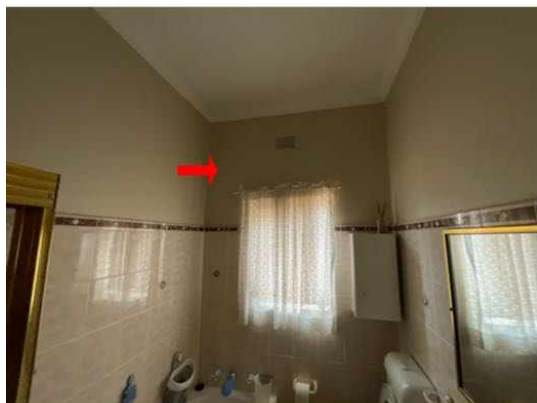
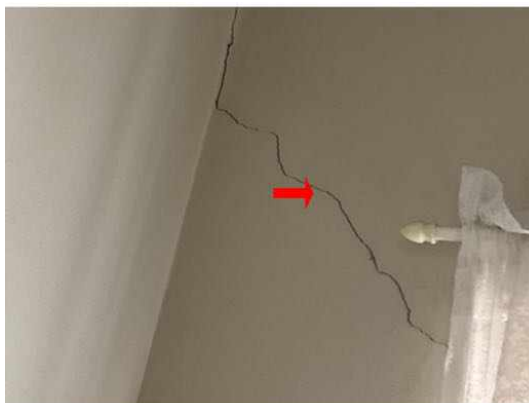
Finding 3.28

Building:	Main Building
Location:	Multiple areas
Finding:	Cracking - Damage Category 1 - Fine (up to 1mm)
Information:	Although fine cracks are quite noticeable, they are often only considered to be an appearance defect, and usually do not indicate any structural damage. Generally, the cause of a fine crack is indicative of a separation between building materials and finishes (e.g. paint, plaster, etc.) along joins.

Cracking of this nature can generally be repaired with minor sanding, filling and/or repainting. Such works should be performed by a qualified painter or a general handyman.

Monitoring of all cracking should be conducted frequently. Always contact a building inspector should cracks widen, lengthen, or become more numerous.

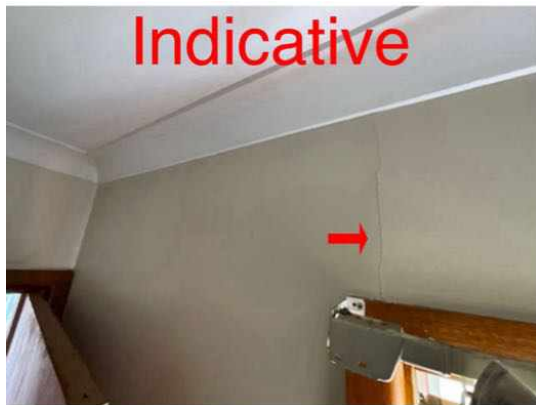
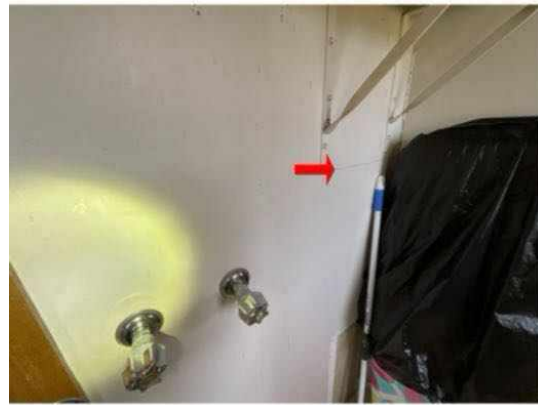
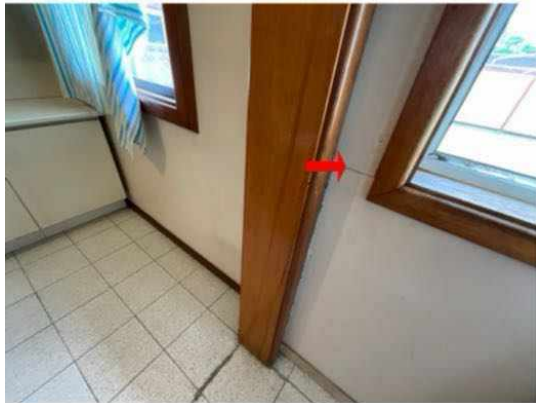
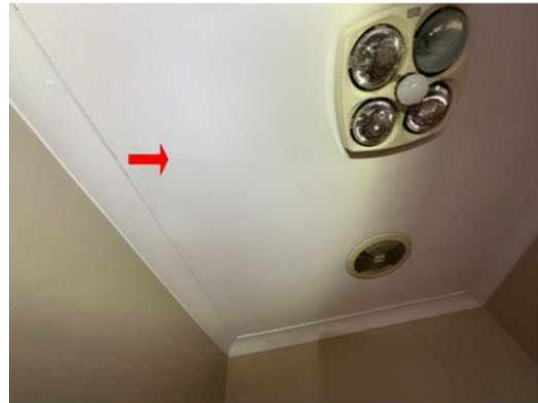
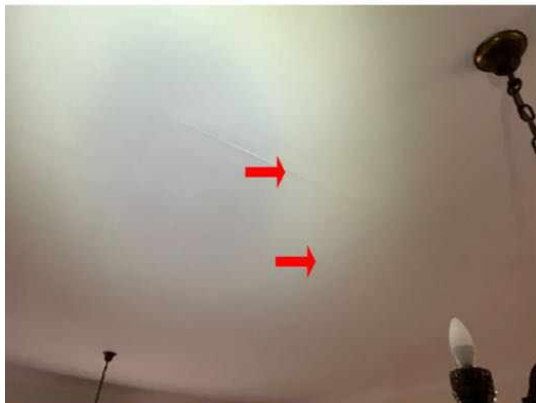
Finding 3.29

Information: Although detracting from the overall appearance, marked or stained surfaces do not indicate any operational or structural damage. This degree of surface damage is consistent with general wear and tear and is expected of a property of this age and condition.

Marked surfaces may be left as is at client discretion, as no repairs or replacement are necessarily required for this appearance defect. However, the client may wish to seek quotations for the cost to refurbish or replace the identified building element.

A painting or cleaning contractor may be appointed to rectify marked surfaces at the discretion of the client.

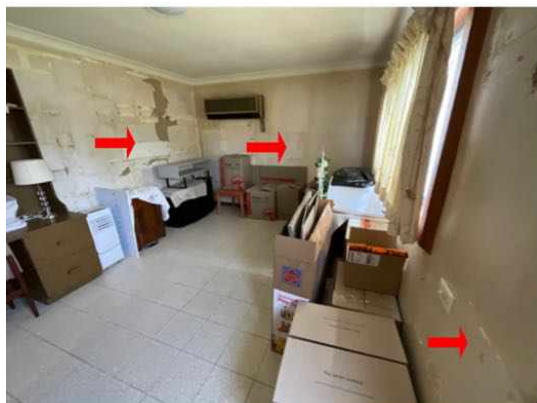
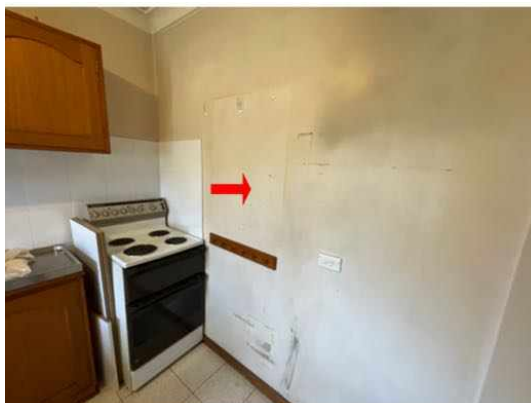
Finding 3.30

Building:	Main Building
Location:	Granny flat
Finding:	Incomplete or substandard works
Information:	The works to this area appear to be incomplete or have been completed to a substandard level.

Works that have not been completed to a satisfactory level create potential for the development of building defects and may impede on the safety and integrity of the overall structure.

It is highly recommended that the relevant trades be appointed to complete these works and ensure the safety of the area and the longevity of all associated building elements.

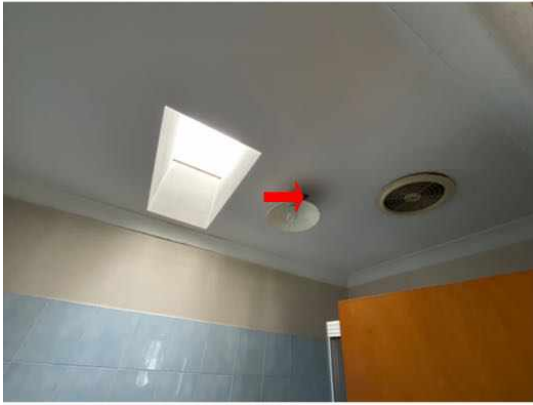
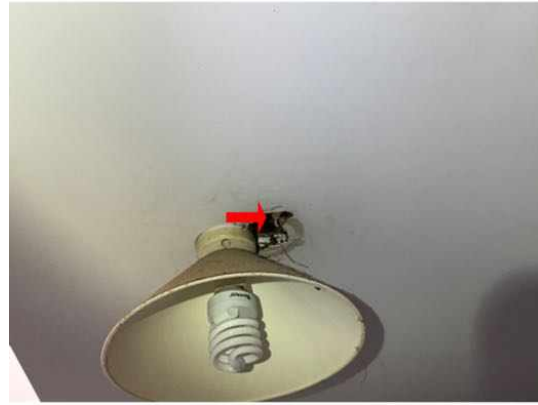
Finding 3.31

Building:	Main Building
Location:	Granny flat
Finding:	Surface - Holes
Information:	Holes in surfaces are generally indicative of impact damage, whether accidental or deliberate, or a failing of the surface material.

Where holes are apparent in the surface of a building material, the surface is no longer sealed against water penetration or further impact damage, which may lead to additional damage to the surrounding surface.

Repair or replacement of the affected building element is recommended as soon as possible to ensure that any secondary defects are minimised. A qualified carpenter or general handyperson should be appointed to perform these works.

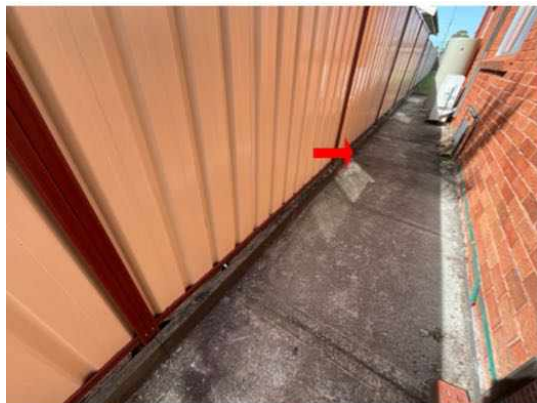
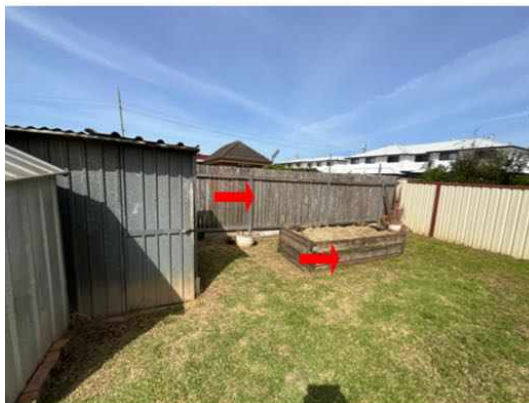
Finding 6.06

Information: The storing of timbers in the subfloor space or around the external property increases the risk of termite activity being present. As they are likely to come into contact with weather conditions or excessive moisture wood rot is likely to develop on timbers that are not treated.

It is highly recommended that any stored timbers be immediately removed from areas in which they may attract any termite / timber pest attack. Minimisation of risk / prevention of termite attack is far more adequate than dealing with the presence of termite activity.

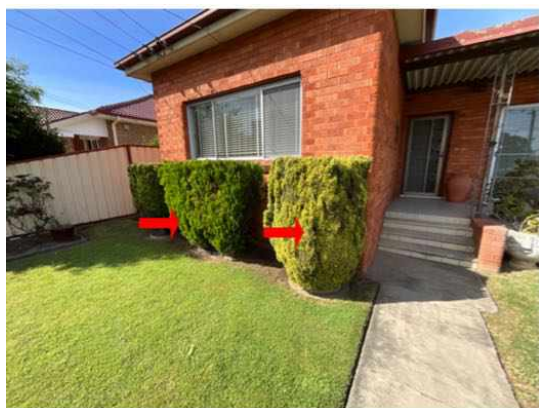
Finding 6.08

Building:	Main Building
Location:	Vegetation
Finding:	Vegetation - Abutting property
Information:	Vegetation against external wall may have an invasive root system. If there are weak points in the brick work or concrete slab, it is possible for the roots to gain entry into these areas. Once the roots have gained entry, it is possible for termites to gain concealed entry via these roots. It is recommended to remove the vegetation and root system where possible.

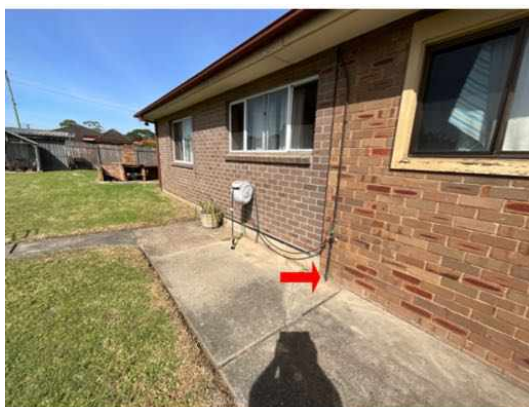
Finding 6.09

Building:	Main Building
Location:	External tap
Finding:	Tap - No drain
Information:	The external tap in this area was noted to have no drain at the time of inspection.

This keeps the surrounding surfaces damp while using the tap, which becomes conducive to termite activity.

A licensed plumber must be appointed to ensure an appropriate drain is installed.

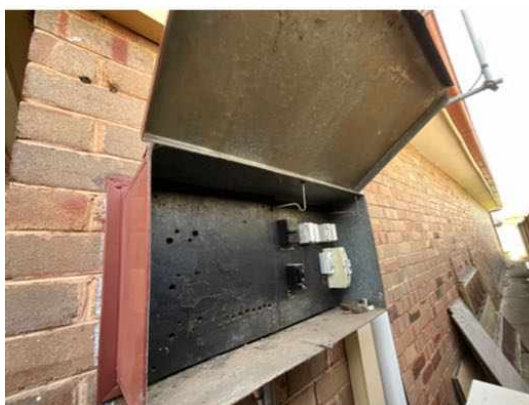
The electrical switchboard while appearing to have adequate safety switches installed has old ceramic fuses in place.

While this on its own on is not considered a defect it is noted for the clients consideration that a switchboard upgrade may be required in the short to mid term to improve the functionality of the electrical system. A licensed electrician could be appointed to provide quotation for the works at the client's discretion which may in turn expose other required works to bring the system up to a compliant state.

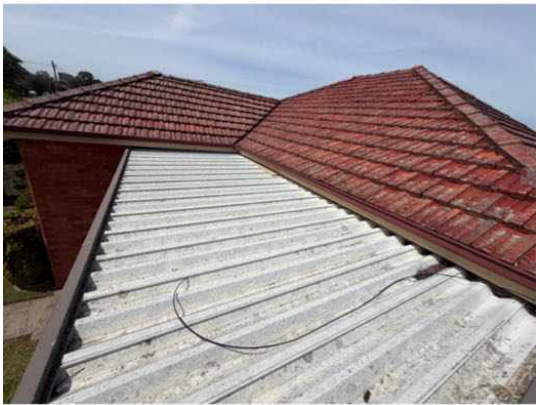
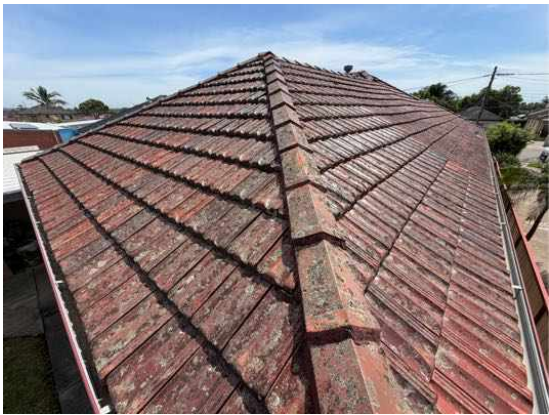
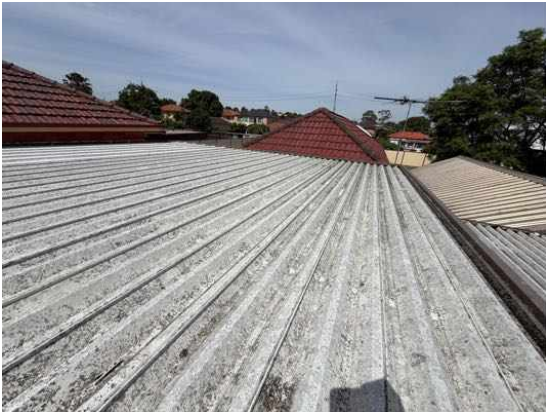
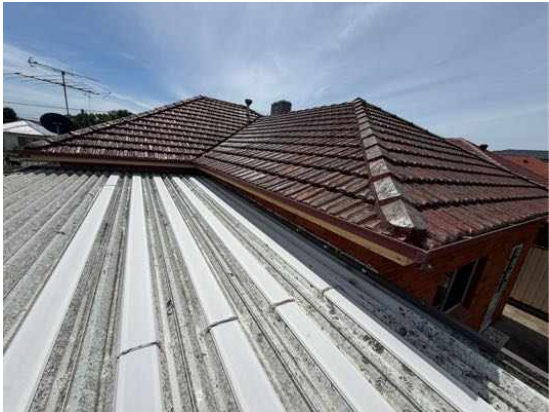
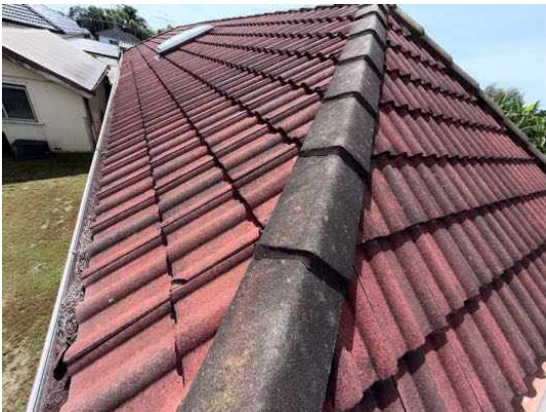
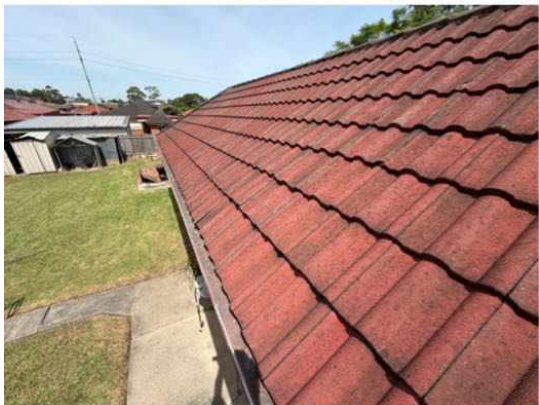
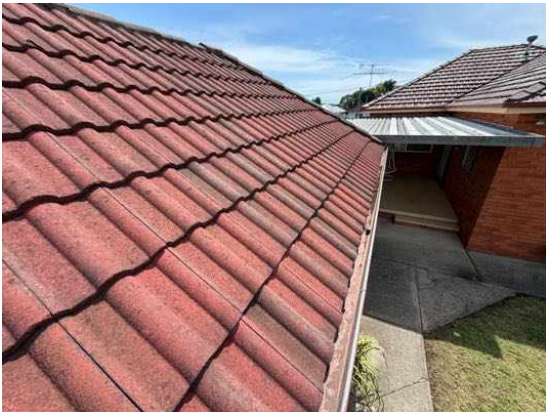
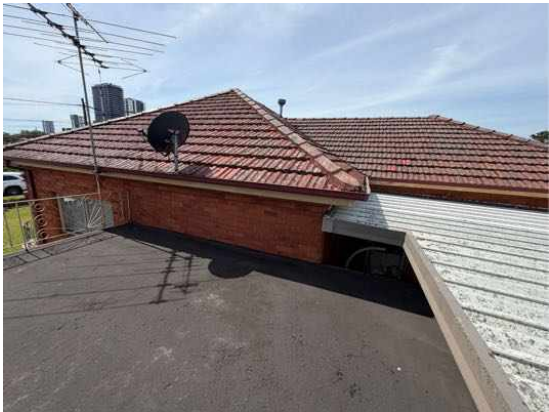
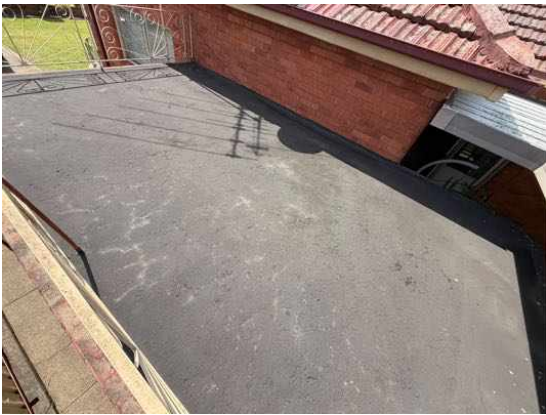
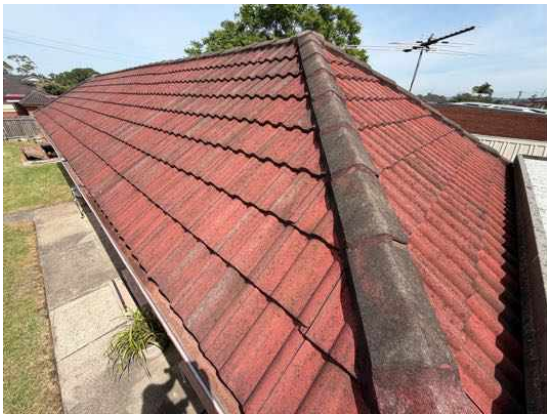
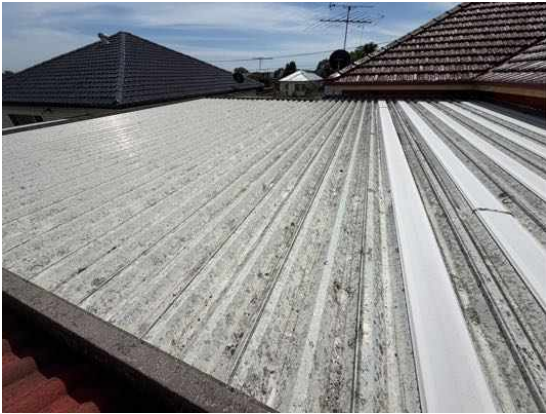
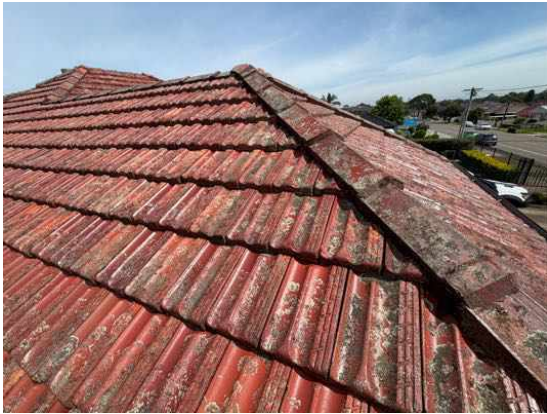
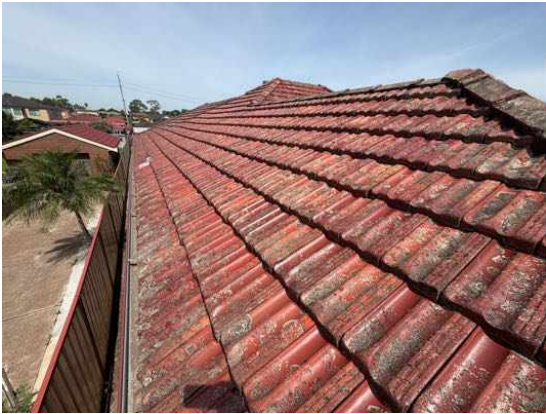
Building: Main Building
Location: Roof Exterior
Finding: Additional Photos
Information:

Additional photos are provided for your general reference.

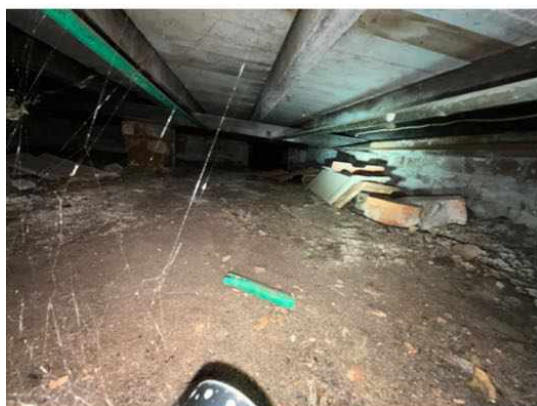
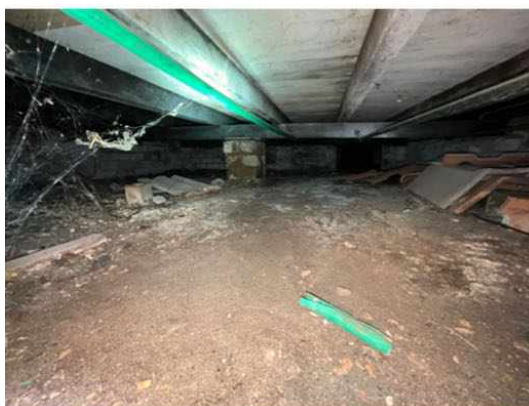
Building: Main Building
Location: Subfloor
Finding: Additional Photos
Information: Additional photos are provided for your general reference.

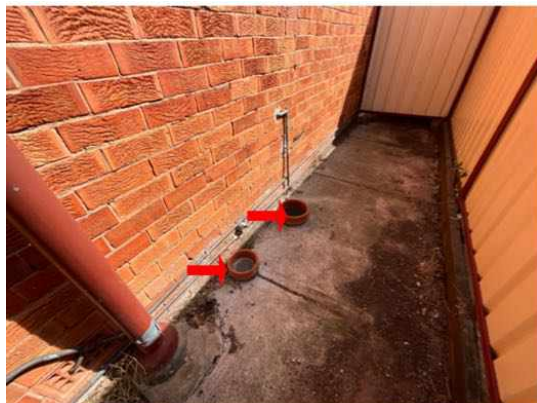
Building: Main Building
Location:
Finding: Pipework - Old urban wear pipes
Information: Old urban wear pipes were identified at the time of inspection.

Consultation with a licensed plumber is advised. CCTV inspection on pipes may be required.

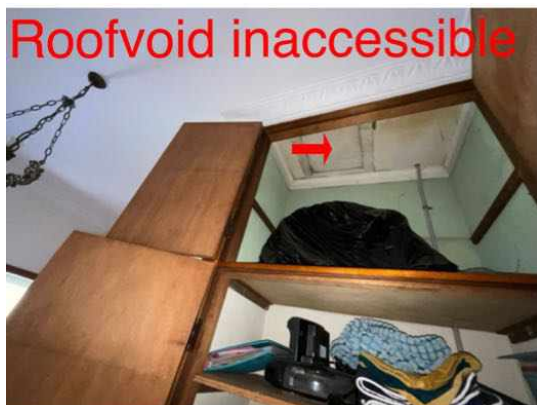
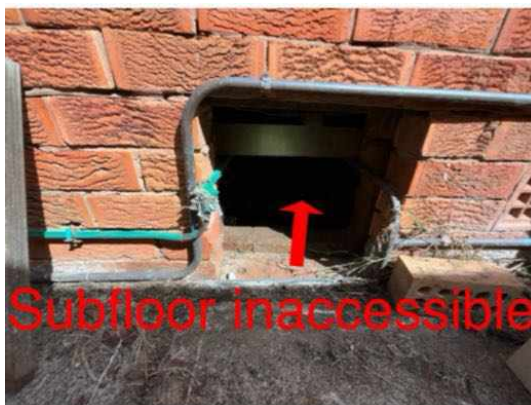
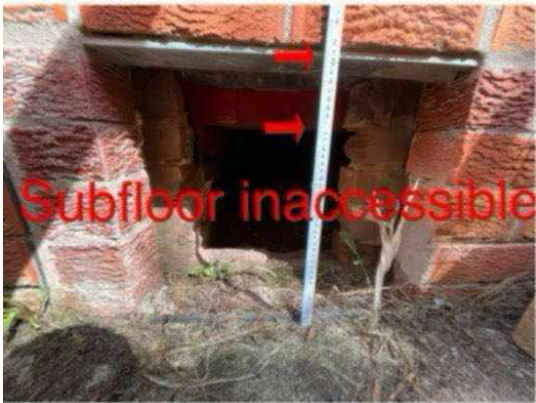
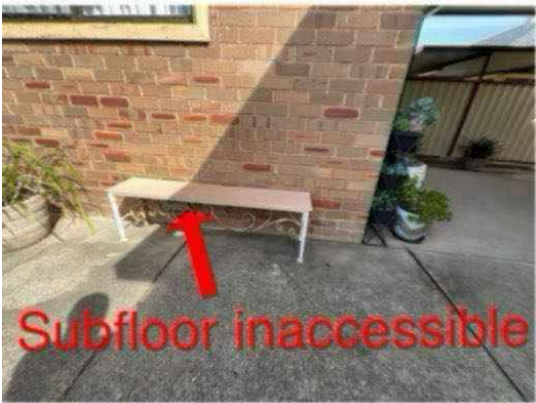
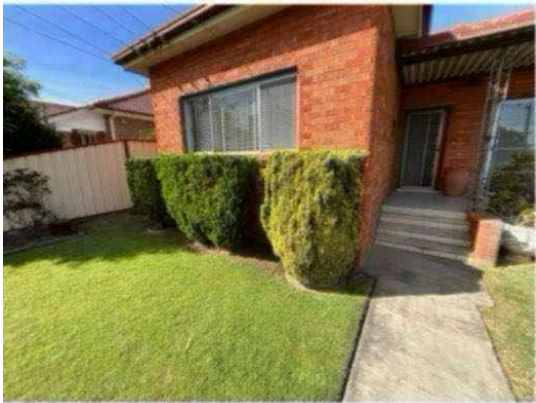
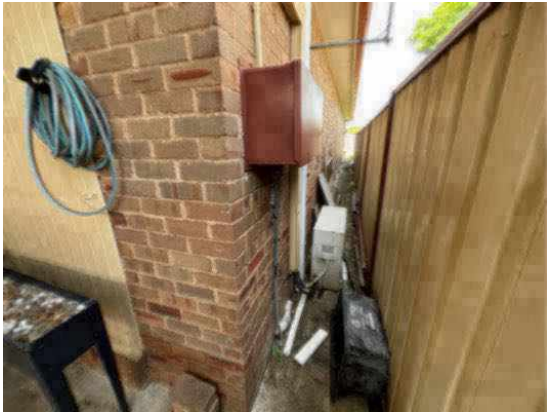
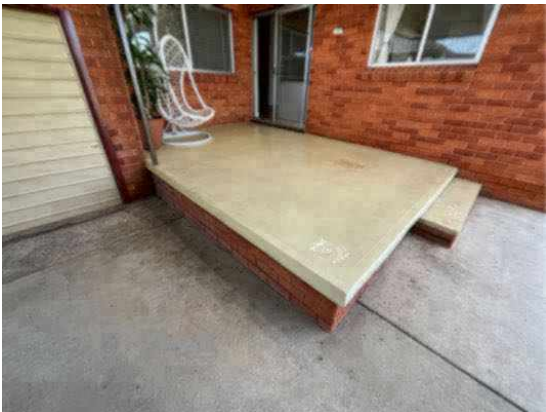
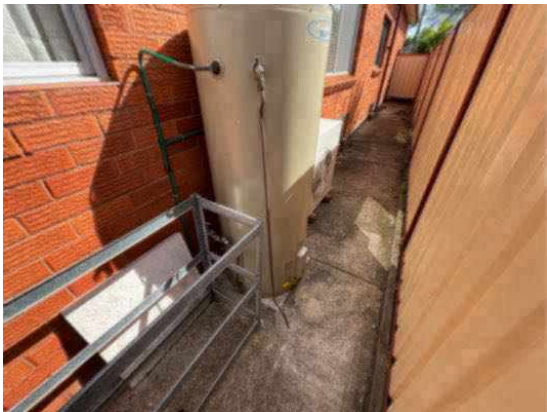
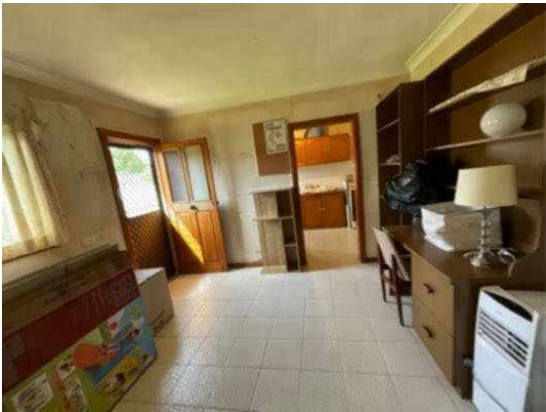
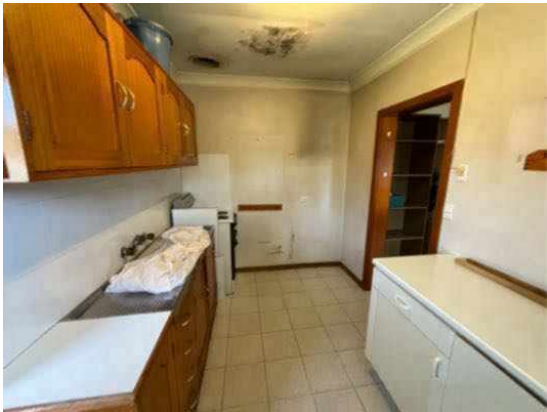
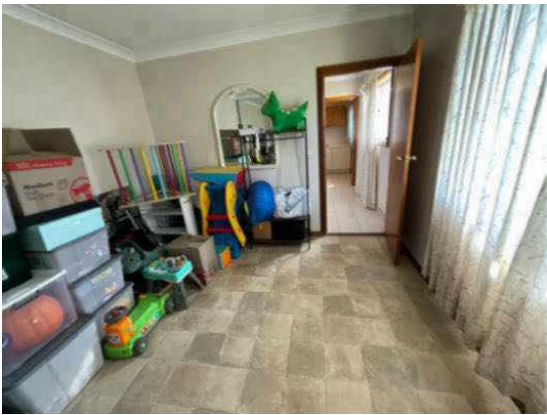
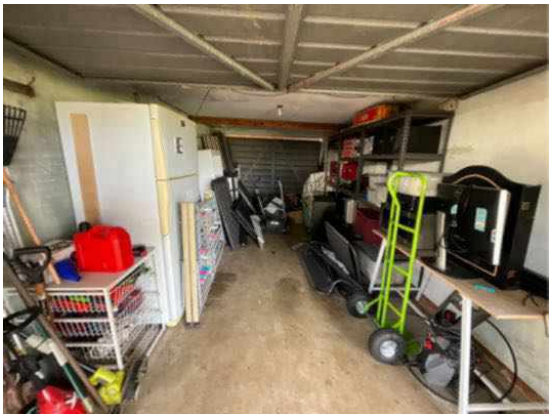
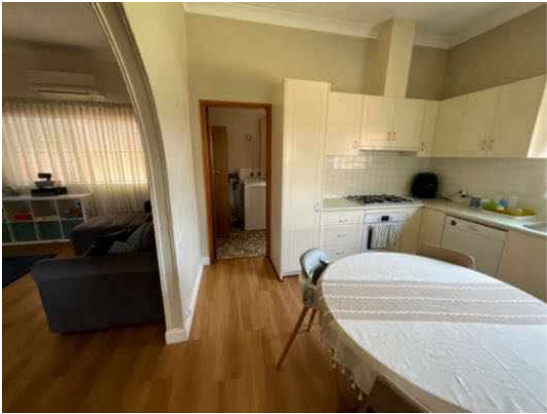
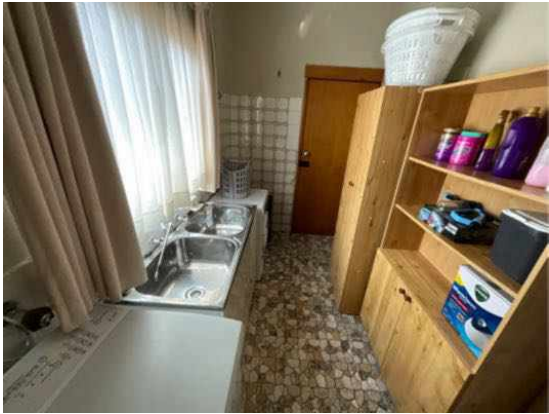
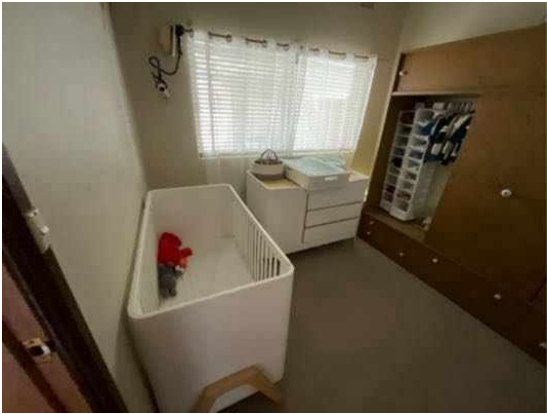
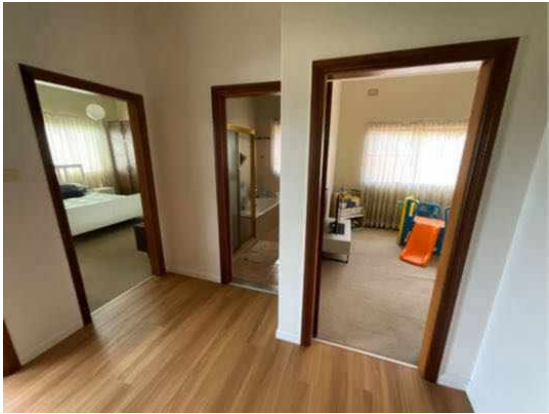
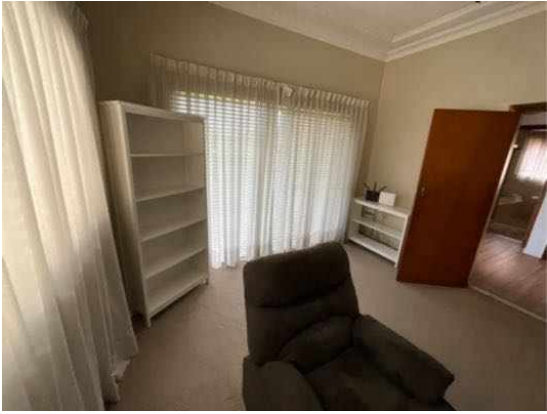
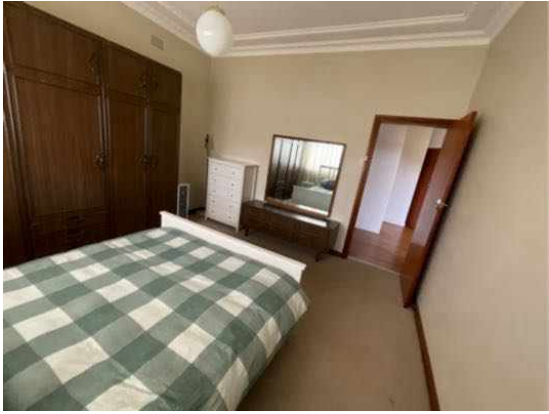
Building: Main Building
Location: All Areas
Finding: Additional Photos - Obstructions and Limitations
Information:

These photographs are an indication of the obstructions and limitations which impeded full inspection of the property at the time of inspection. These obstructions can hide an array of defects and should be removed to allow full inspection to be carried out. A re-inspection is recommended once the areas are made accessible.
