Building and Timber Pest Inspection Report

Inspection Date: Sat, 28 Mar 2026

Property Address: 8 Lone Pine Ave, Chatswood NSW 2067,
Australia

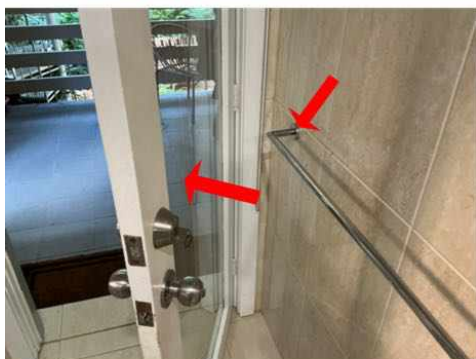
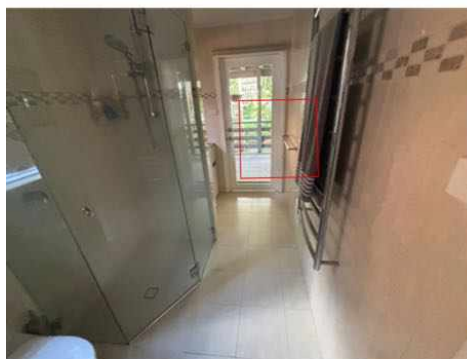
Building:	Main Building
Location:	Laundry
Finding:	Door Stopper (Glass) - Missing
Information:	At the time of inspection, no door stopper was installed behind the door in this area. As a result, the door has the potential to swing open and come into contact with the adjacent towel holder. This presents a safety hazard, particularly due to the presence of glass, which may crack or shatter upon impact.

The client is advised to exercise caution when operating the door to avoid accidental contact. It is recommended that a qualified handyman be engaged to install an appropriate door stopper to prevent overextension of the door and reduce the risk of damage or injury.

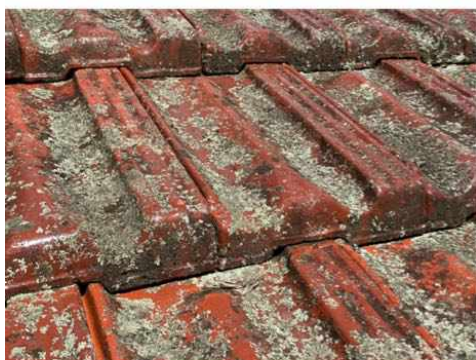
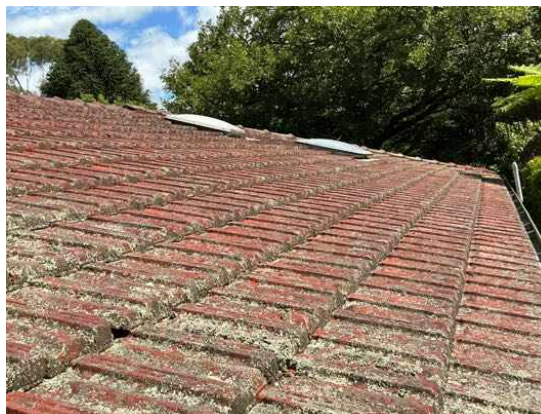
Building:	Main Building
Location:	All Areas
Finding:	Roof Tiles Weathered - Lichen Build Up
Information:	Upon inspection of the exterior roofing, the majority of roof tiles were considered to be in a fair condition. While weathering of the tiles is consistent with the age of the property, maintenance works are required.

Concrete roof tiles are typically cleaned to have the visible moss and lichen removed. Concrete tiles are made from a product which is a naturally moist material. Moss and lichen is attracted to the roof tiles surface, and if left will continue to grow and most likely restrict the flow of rain water over the tiles surface, into the roofs gutters. An application of an environmentally friendly anti-fungal solution should be applied to all moss and lichen, prior to undertaking the roof cleaning process.

A roof restoration company can be contacted for further advice at the clients discretion.

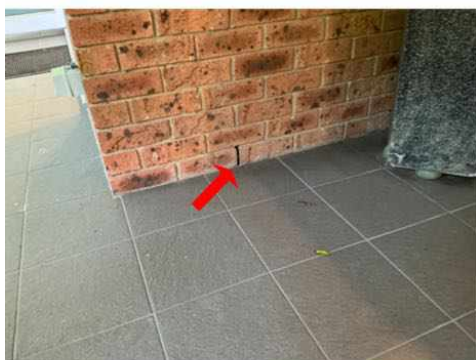
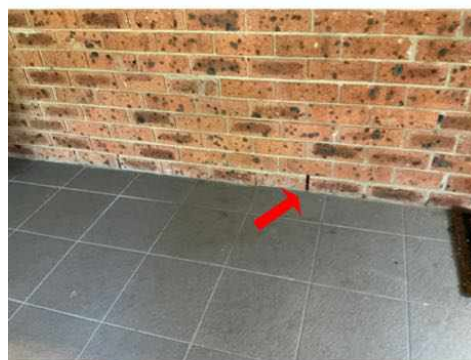
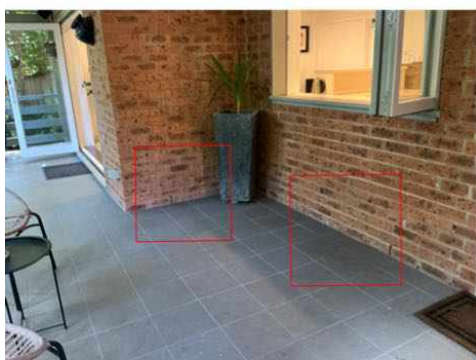
Finding 3.02

Building:	Main Building
Location:	Exterior walls - rear
Finding:	Weep Holes - At Ground Level
Information:	It was noted at the time of inspection, the weep holes have been identified at ground level, which constitutes a defect.

According to building standards, weep holes should be positioned above the finished ground level to ensure proper drainage and to prevent water ingress into the wall cavity. Weep holes located at ground level can lead to water entering the structure, causing potential damage to the masonry, insulation, and internal finishes. This placement fails to provide the necessary protection against moisture and does not comply with standard building practices.

The relevant tradesperson must address this issue by ensuring that weep holes are correctly positioned above ground level to meet the required standards and to maintain the integrity of the building.

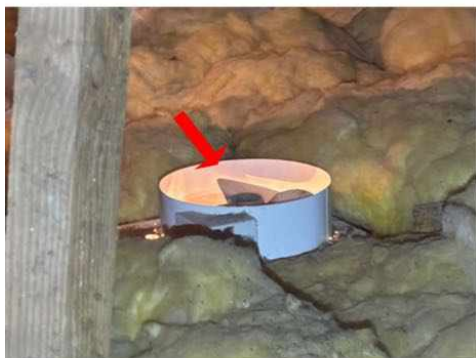
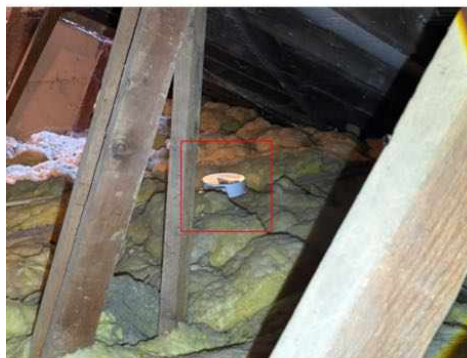
Finding 3.03

Building:	Main Building
Location:	Roof Void
Finding:	Vent - Extracted into Roof Space
Information:	During the inspection, it was noted that the exhaust vent has been improperly terminated into the roof space instead of being ducted to the exterior of the property.

This configuration is a defect as it allows moist air to accumulate within the roof cavity, increasing the risk of condensation, mould growth, and deterioration of insulation or timber framing. Proper ventilation is essential to maintain a healthy indoor environment and protect the structural integrity of the building. It is recommended that the vent be appropriately re-routed to discharge externally in compliance with relevant building standards.

A licensed mechanical ventilation contractor/electrician should be appointed as soon as possible to provide further consultation on the scope of these works and to provide quotations for any necessary works.

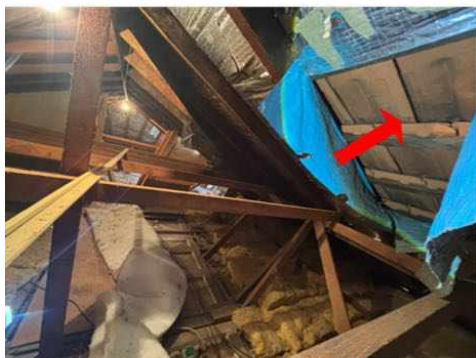
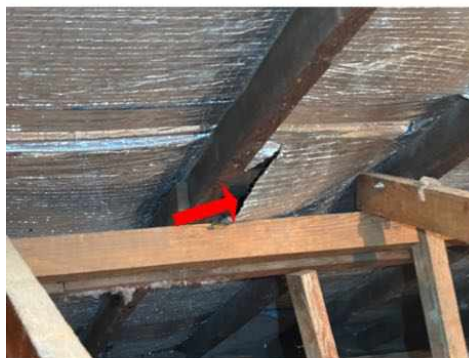
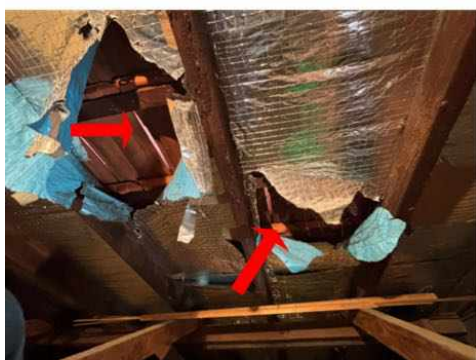
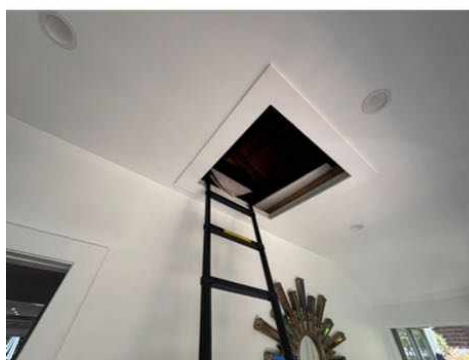
Finding 3.04

Building:	Main Building
Location:	Roof Void
Finding:	Sarking - Damaged
Information:	Sarking, a laminated aluminium foil applied to the interior of the roof covering, assists in insulating the property and acting as a vapour-barrier to the roof void and, subsequently, to the household.

Where sarking is damaged, both insulation and moisture protection of the property are inhibited. This creates a loss of energy and thus negatively impacts the energy efficiency of the property, allowing potential for moisture ingress from condensation or leaking roof tiles.

It is important to repair any holes or damaged sections of sarking to ensure that the building material is fully functional. A registered builder or qualified carpenter should be consulted to provide further advice on this defect and to perform rectification works at client discretion.

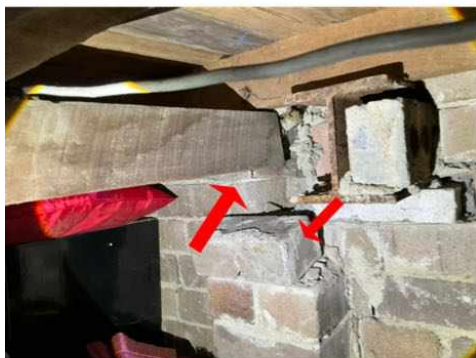
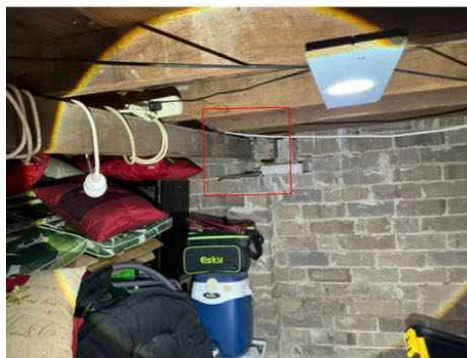
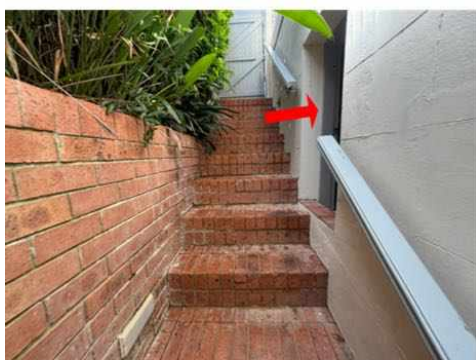
Finding 3.05

Building:	Main Building
Location:	Under House Storage
Finding:	Inadequate Support to Subfloor Bearer
Information:	At the time of inspection, the subfloor bearer was observed to have inadequate support, with missing and displaced bricks noted beneath the bearer. This condition may result in uneven load distribution and movement within the structure over time.

If left unaddressed, this may lead to further structural instability and potential damage to the flooring above.

It is recommended that the client engage the services of a qualified builder as soon as possible to reinstate proper support to the bearer, including installation of appropriate footings or supports, to ensure the structural stability of the subfloor.

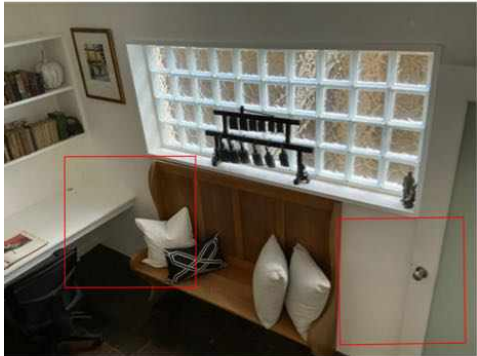
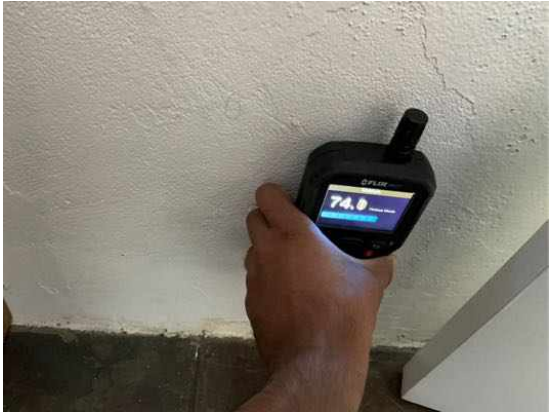
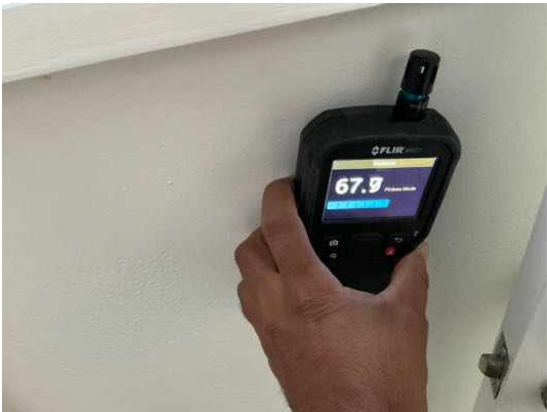
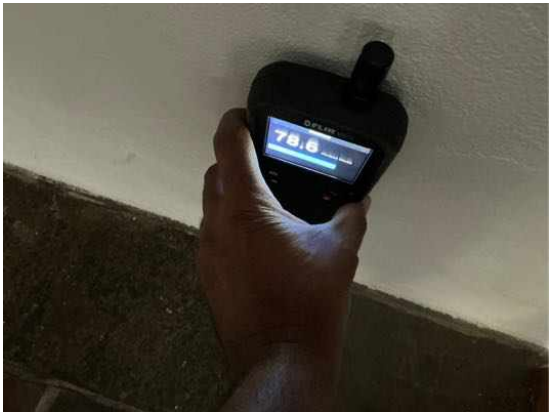
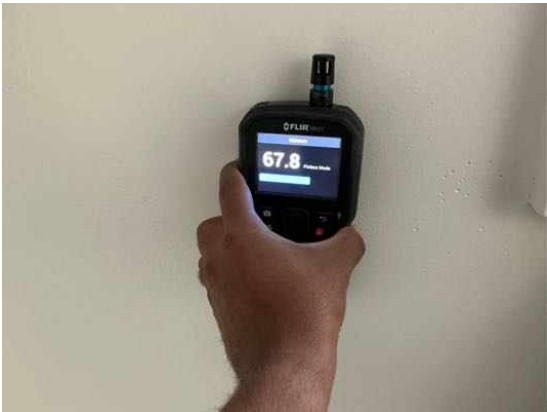
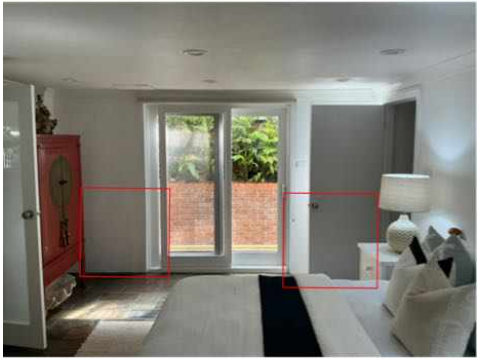
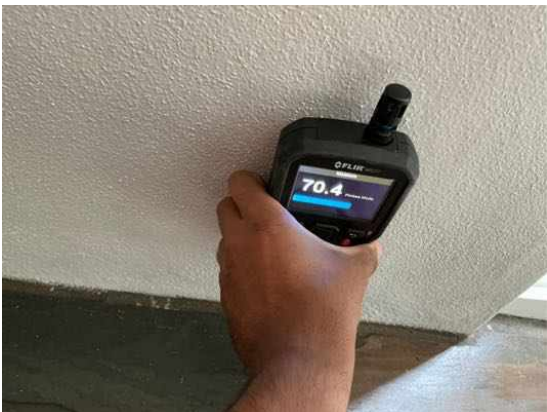
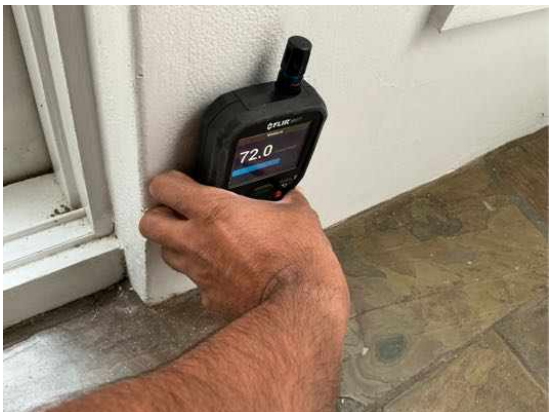
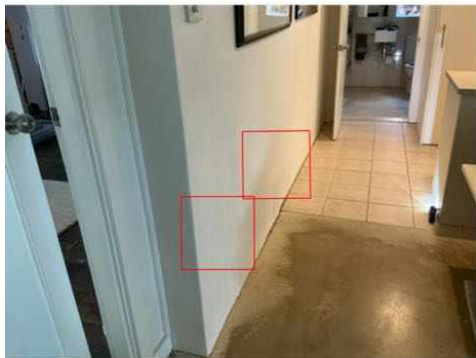
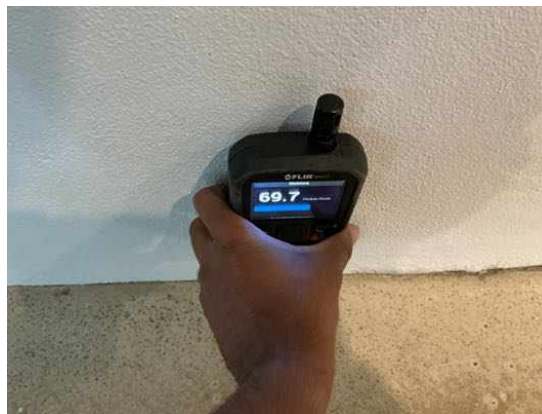
Finding 3.06

Building:	Main Building
Location:	Bedroom 4, Study, Lower Level Lounge
Finding:	Damp - Rising
Information:	At the time of inspection, rising damp was identified within the property. This condition results from the upward movement of moisture through porous building materials, such as bricks, sandstone, or mortar, via capillary action. A damp-proof course (DPC), an impermeable barrier installed at the base of walls above ground level during construction, is typically used to prevent rising damp. However, the absence, deterioration, or bridging of the DPC can compromise its effectiveness, specially in older buildings, leading to moisture ingress. Inadequate site drainage, which allows water to accumulate around the foundation, is a common contributing factor to this issue.

If left unaddressed, rising damp can pose significant health risks due to mould growth and cause extensive damage to building elements, including wall finishes such as paint and plasterwork. The current condition should be monitored over a 12-month period to assess its progression.

It is strongly recommended that the client engage a qualified damp-proofing specialist for remedial actions. Additionally, consulting a qualified plumber or drainage specialist to assess and improve site drainage is advised to mitigate further risks. Monitoring the condition for 12 months is essential to evaluate its status and prevent potential

recurrence or further damage.

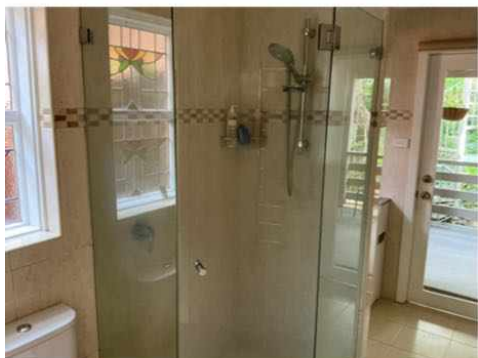
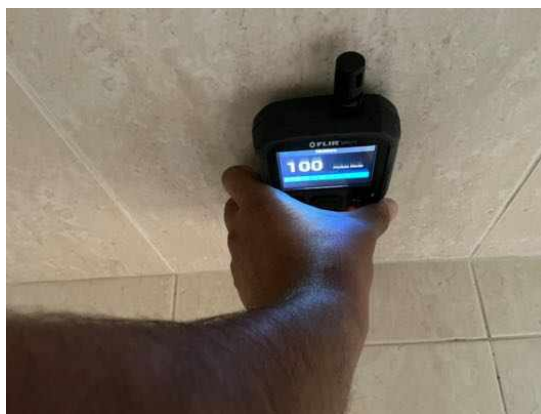
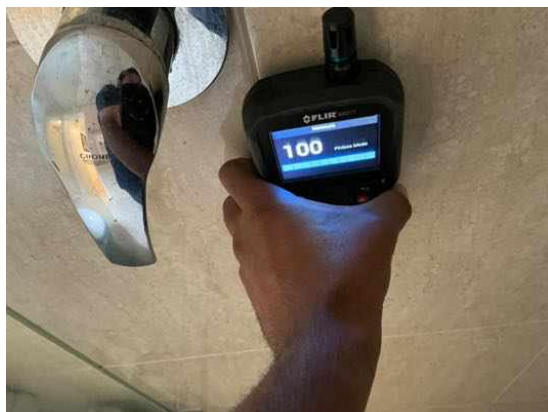
Finding 3.07

Building:	Main Building
Location:	Lower Level Bathroom
Finding:	Excessive Moisture - Shower Damp
Information:	At the time of inspection, excessive moisture was noted within the shower area, which is a common issue in wet areas due to the continual exposure to water. This condition is typically caused by moisture seeping through grout lines and settling behind tiles, resulting in localised high-moisture zones. Provided there is no evidence of water staining or elevated moisture readings on the opposite side of the wall, this is considered a minor defect.

However, persistently damp conditions may act as conducive conditions for termite activity, as termites are strongly attracted to moisture-rich environments. It is recommended that the client ensures regular use of the exhaust fan and maintains adequate ventilation after shower use to promote drying and reduce long-term moisture build-up, thereby also reducing the risk of attracting termites.

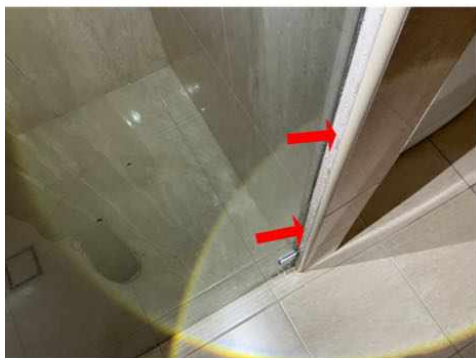
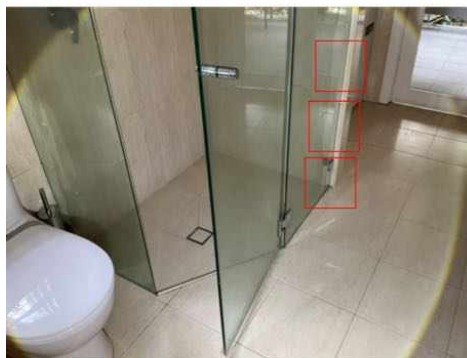
Finding 3.08

Building:	Main Building
Location:	Lower Level Bathroom
Finding:	Shower Screen - Leaking (Sides)
Information:	The shower screen was noted as leaking through sides at the time of inspection.

The shower enclosure in the bathroom exhibits a defect characterized by moisture buildup and potential leakage at the base where the shower door meets the wall and floor tiles. Visible signs include deteriorated caulking, indicating that the waterproof seal has been compromised. This issue not only affects the aesthetic appeal of the bathroom but also poses a risk of water damage to adjacent structures and surfaces.

Immediate attention is required to re-caulk and seal the affected areas to prevent further moisture penetration and to maintain the integrity of the shower enclosure.

The client is advised to engage the services of a professional plumber to rectify the issue.

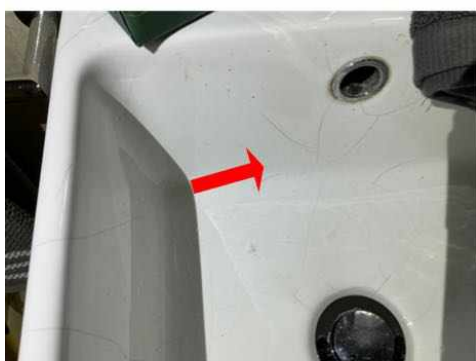
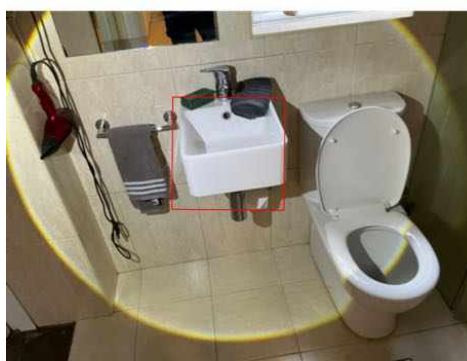
Finding 3.09

Building:	Main Building
Location:	Lower Level Bathroom
Finding:	Sink - Cracked
Information:	At the time of inspection, a visible crack was noted on the surface of the bathroom sink basin. While the crack appears minor, it may worsen over time due to regular use and moisture exposure. It is recommended to engage a licensed plumber to assess and replace the basin to prevent potential water damage to the underlying vanity unit and maintain the integrity of the bathroom fixture.

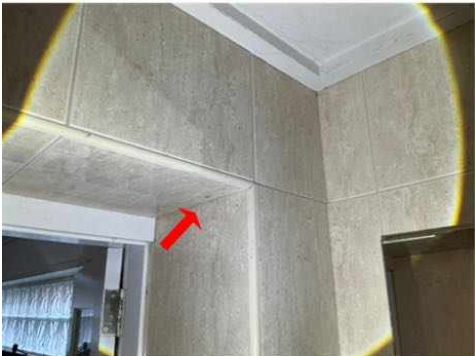
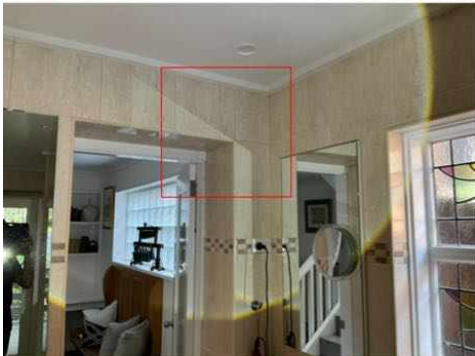
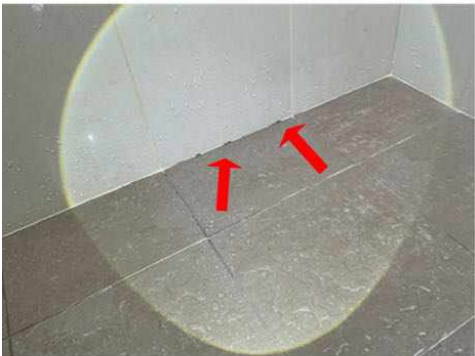
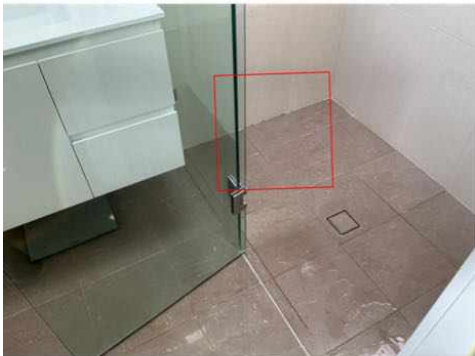
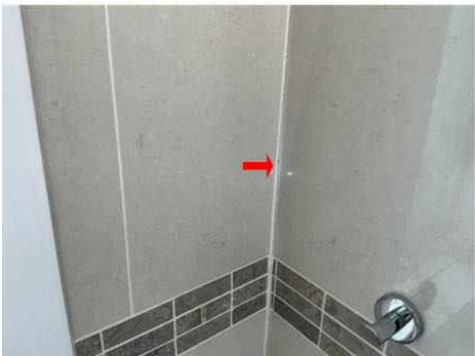
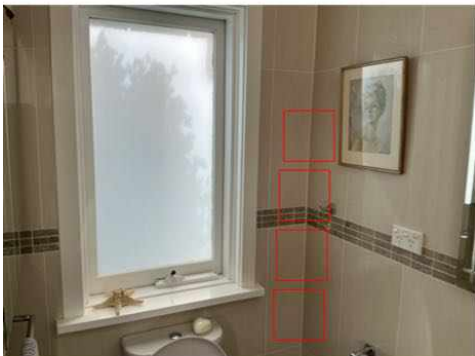
Building:	Main Building
Location:	All Bathrooms
Finding:	Sealant/Grouting - Missing or Damaged
Information:	At the time of inspection, areas of missing and/or deteriorated sealant and grout were noted in this area. This condition can allow water to penetrate behind finishes, which may lead to moisture ingress, deterioration of waterproofing membranes, mould growth, and potential leaks into adjoining areas over time. If left unaddressed, this may result in costly repairs and hidden water damage.

It is recommended that a licensed plumber (or suitably qualified tradesperson

experienced in wet area sealing) be engaged to assess the affected areas and reinstate compliant waterproof sealant and grout as required, ensuring all junctions are properly sealed to prevent further water ingress.

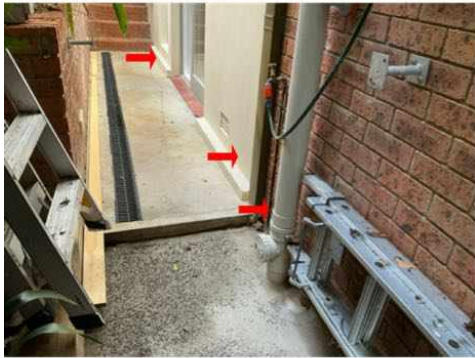
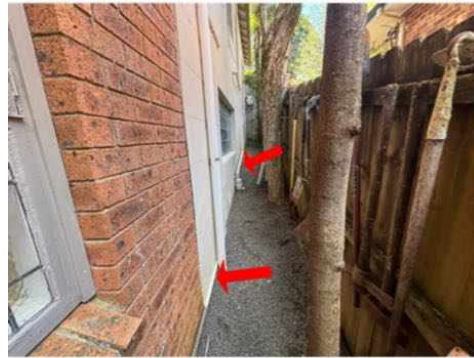
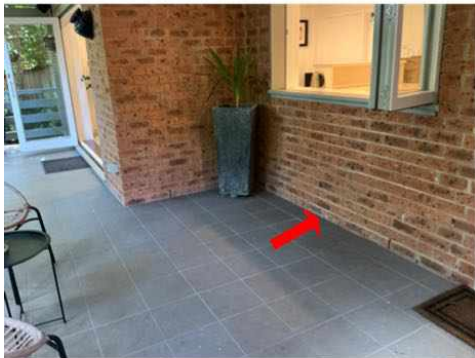
Finding 6.02

Building:	Main Building
Location:	All Areas
Finding:	Bridging or Breaching of Termite Barriers - Adjacent Internal Flooring
Information:	Bridging is the spanning of a termite barrier or inspection zone so that subterranean termites are provided with passage over or around that barrier.

It is important for internal flooring to be raised above adjacent external ground levels. Where external ground levels are above or same level as internal flooring, water pooling and subsequent internal flooding is likely to occur which may attract termite activity to the internal area.

It is highly advised that a landscaper or relevant tradesperson be appointed to lower external grounds that are raised above or same as adjacent internal flooring. Alternatively if external grounds and internal flooring is level installation of a raised door sill may be appropriate in preventing any water pooling in the area. If the client wishes not to make any changes, then a qualified pest controller is recommended for termite treatment around the perimeter of the house and subfloor (if any) as soon as possible.

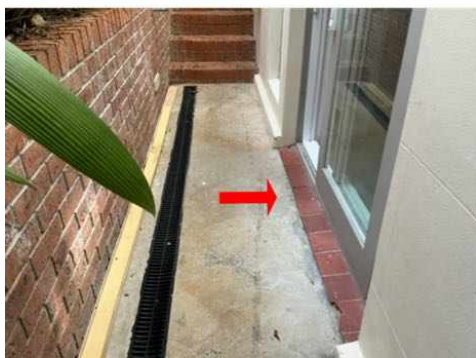
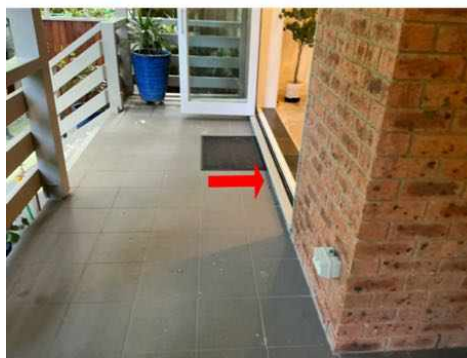
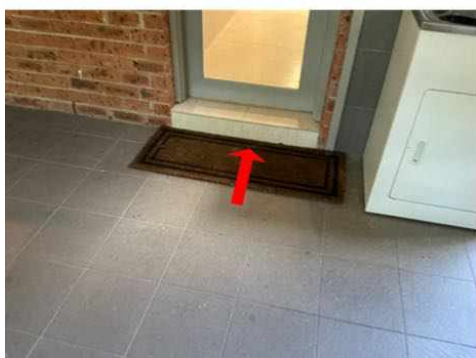
Finding 6.03

Building:	Main Building
Location:	Entry
Finding:	Bridging of physical termite barriers - Concrete Porch
Information:	Bridging is the spanning of a physical termite barrier or inspection zone so that subterranean termites are provided with an entry point over or around that barrier.

The concrete porch abutting was providing a concealed entry point at the time of the inspection. Where the location of the porch is retrospectively installed against an external wall, this provides a concealed entry point for termites.

The client should consider gaining further advice from a timber pest technician as to treatments required in this area. It is recommended that obtaining such advice be a short-term priority.

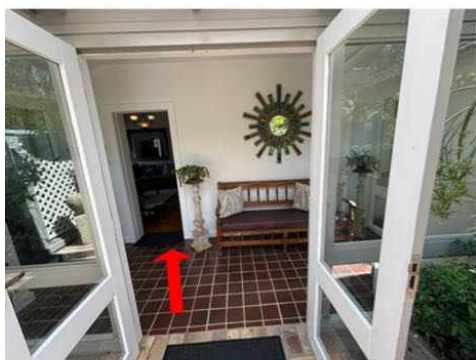
Finding 6.04

Building:	Yard
Location:	All Areas
Finding:	Building Materials in Direct Ground Contact - Conducive to Termites
Information:	Timber elements that are in direct contact with the ground and exposed to moisture or damp conditions are highly conducive to termite activity. This susceptibility arises because timber, when in contact with soil and dampness, creates an environment that is particularly attractive to termites, encouraging infestation and potential structural compromise. Whether the timber is used as a part of the building's construction or incorporated into fencing, its presence near or on the ground can become a pathway for termites to access and damage the property.

When exposed to excessive moisture, timber begins to deteriorate, developing conditions such as wood decay and rot. These compromised areas of timber are even more appealing to termites, as they are easier to infest and consume. This is especially true for untreated or non-durable timber, which lacks the protective treatments that can deter or withstand termite attacks. Termites can use these weakened, moisture-laden elements as a bridge into other parts of the structure, creating an entry point for potential infestations that can spread and cause extensive damage if left unchecked.

For any timber in direct contact with the external ground, special attention is required. The combination of moisture, untreated wood, and direct ground contact not only accelerates the decay process but also provides subterranean termites with a straightforward means of ingress into the structure. This entry can lead to termites moving undetected into other vulnerable areas, resulting in potentially significant structural issues and costly repairs.

To mitigate the risk of termite activity, it is imperative that any such materials or timber elements be appropriately treated or removed as soon as possible. Timbers that are necessary for use should be made durable through appropriate treatments and maintained to ensure they do not create conditions conducive to termites. Additionally, the client is advised to schedule regular termite treatments to maintain an effective barrier against infestations and ensure ongoing protection.

The client is strongly advised to assess the property for any timber elements that may be in direct contact with the ground and ensure prompt action is taken to remove or treat them effectively. Regular inspections, proactive maintenance, and consistent termite treatment are essential steps in minimising the risk of termite attack and protecting the structural integrity of the property. Taking these preventive measures is crucial for maintaining a termite-free environment and avoiding potentially costly damage and future repairs.

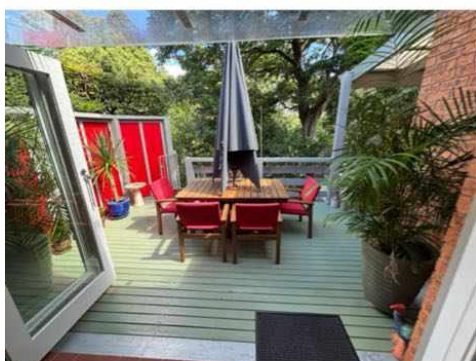
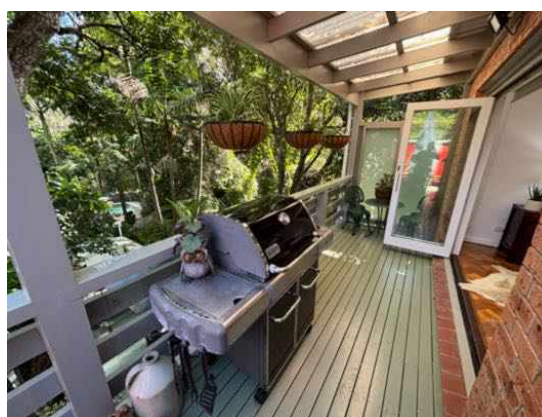
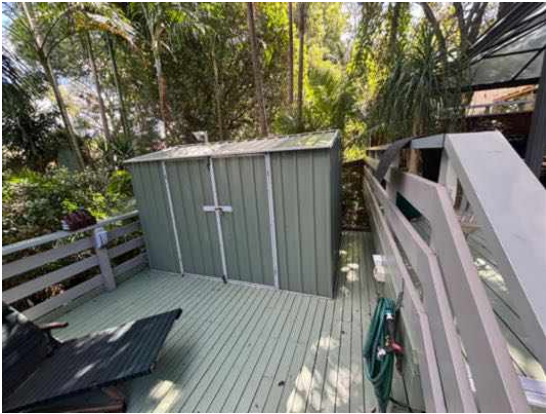
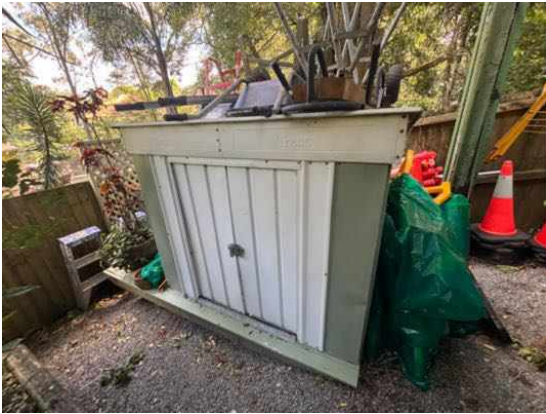
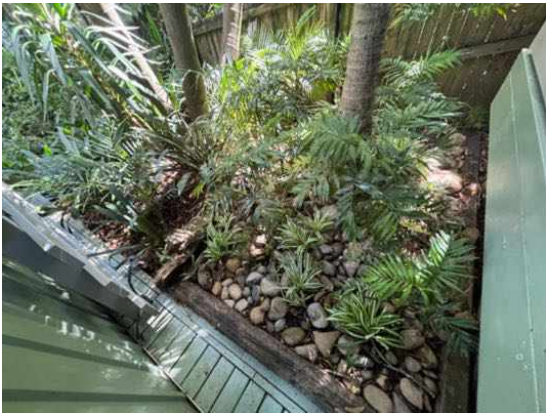
Noted Item

Building: Main Building
Location: All External Areas
Finding: Obstructions and Limitations - External Areas
Information: The attached photographs provide a visual representation of the obstructions and limitations that impeded a full inspection of the external areas of the property at the time of assessment. These obstructions, which may include vegetation, stored items, debris, or other physical barriers, can obscure potential defects and prevent a thorough evaluation of the property's condition. Obstructions of this nature can conceal a wide range of issues, such as structural damage, water ingress, pest infestations, or deteriorating building materials, which may not be visible during the initial inspection.

It is essential that these obstructions be cleared to allow for a comprehensive inspection of the external areas. Removing these barriers will enable a more accurate assessment of the property's condition and allow any hidden defects to be identified and addressed promptly. Failure to do so could result in undetected issues worsening over time, potentially leading to more costly repairs in the future.

Therefore, it is strongly recommended that the obstructions be removed and a re-inspection be scheduled once the affected areas are made fully accessible. This will ensure a complete evaluation of the property's exterior and provide the client with a clear understanding of any potential issues that may have been concealed during the initial inspection.

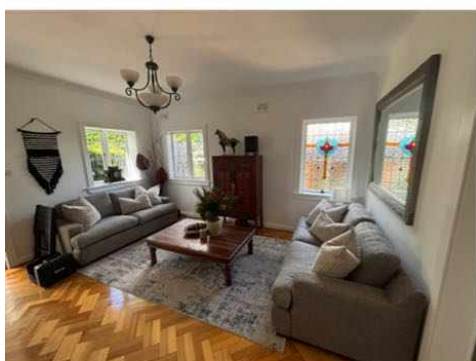
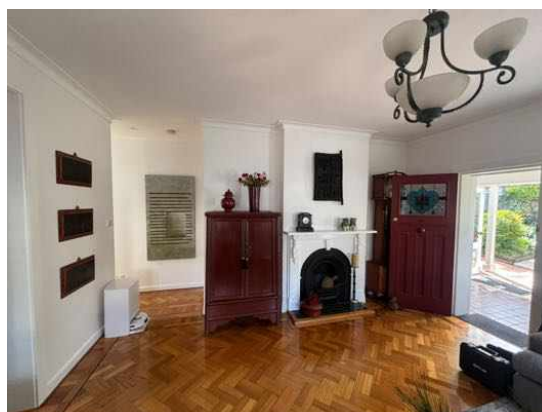
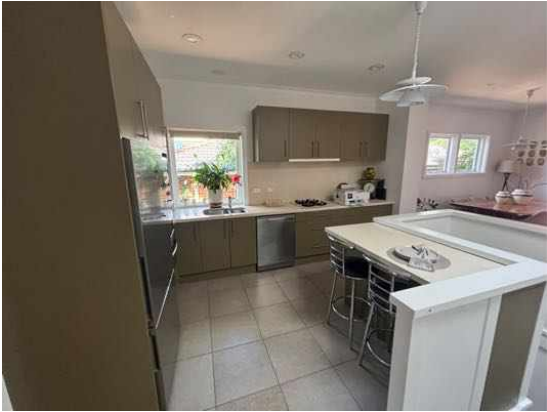
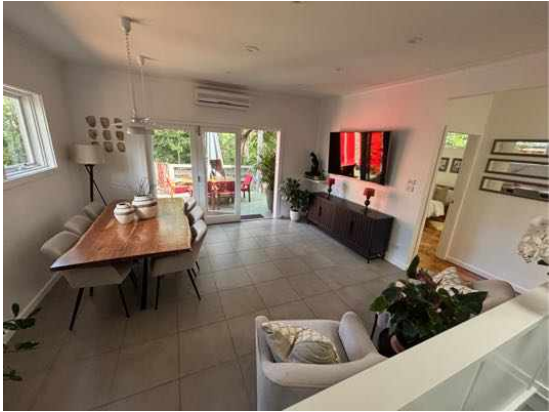
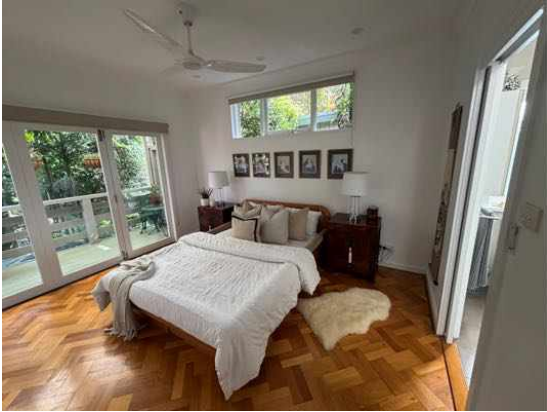
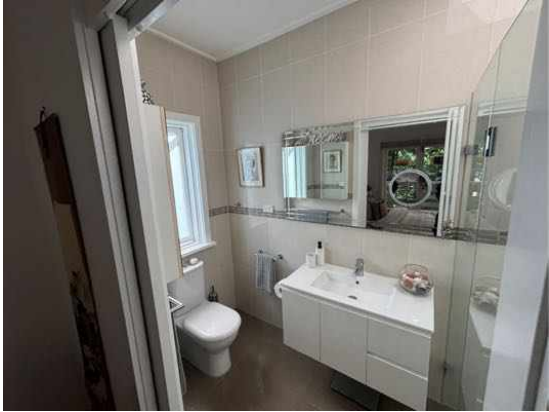
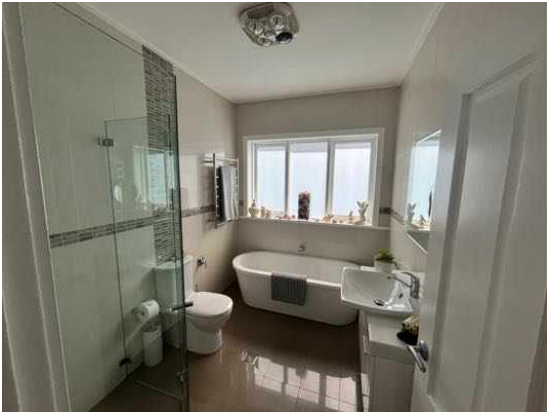
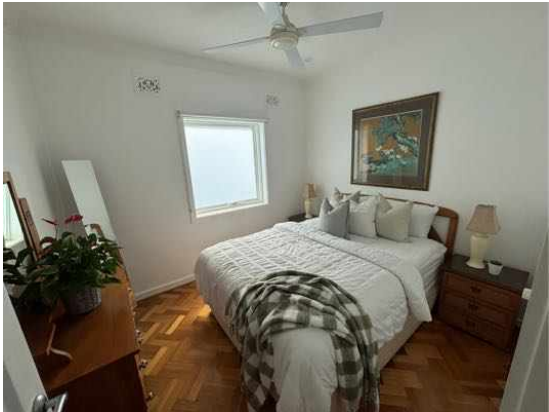
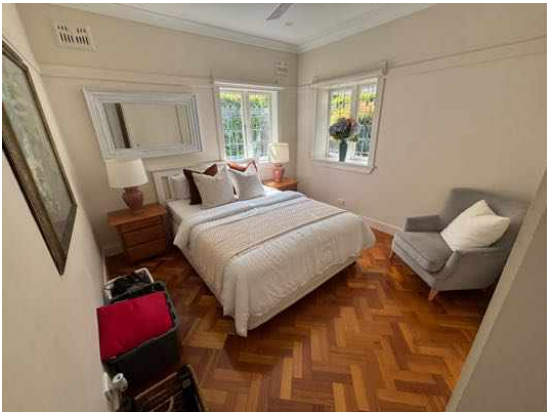
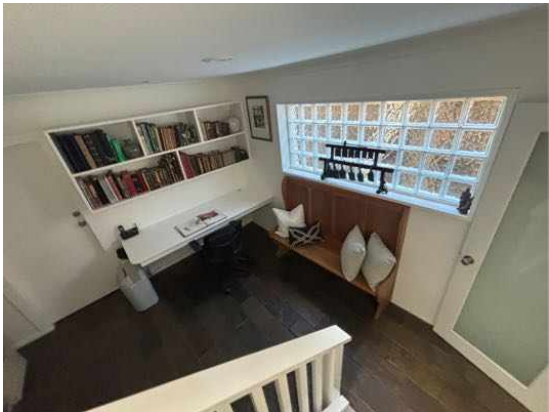
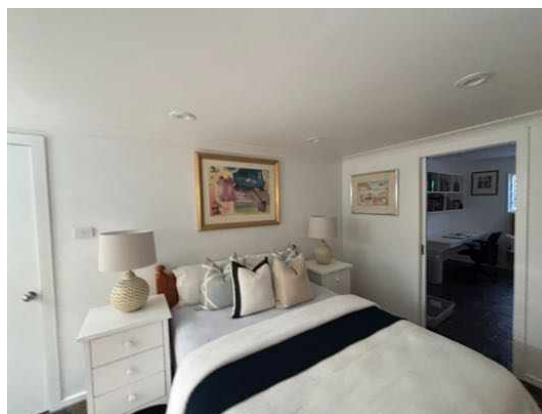
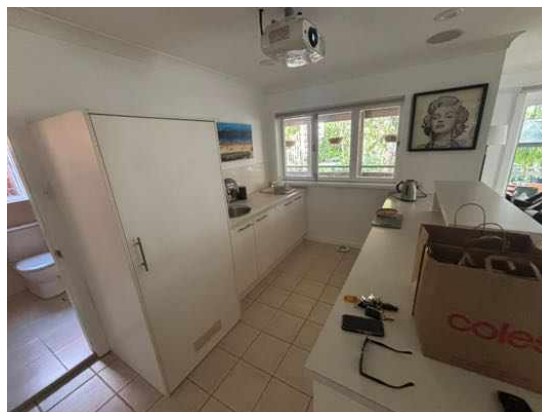
Noted Item

The presence of these impediments means that critical areas of the property were not accessible, and therefore, any underlying defects that may affect the integrity and safety of the property could remain undetected. These hidden defects, if left unaddressed, could worsen over time and may result in costly repairs or pose potential safety hazards to the occupants.

It is highly recommended that all obstructions be cleared to facilitate a complete and thorough inspection of the internal areas. Once the obstructions have been removed and full access is available, a re-inspection should be carried out to ensure that any previously concealed issues can be properly identified and rectified. This follow-up inspection will provide a more accurate assessment of the property's internal condition and help the client make informed decisions about any necessary repairs or maintenance.

In summary, the limitations encountered during the inspection highlight the importance of ensuring full access to all areas of the property to accurately assess its overall condition. A re-inspection is strongly advised once these areas are made accessible.

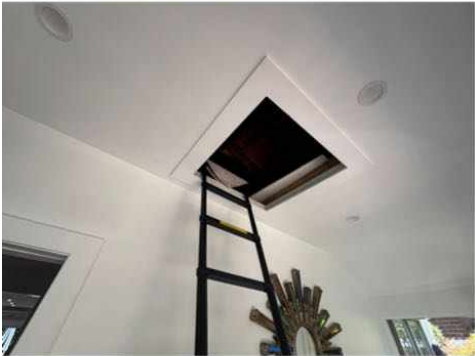
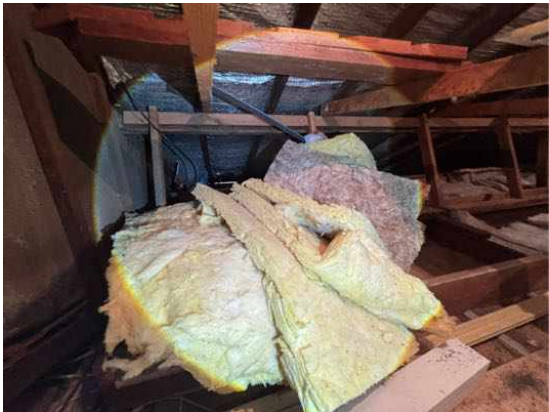
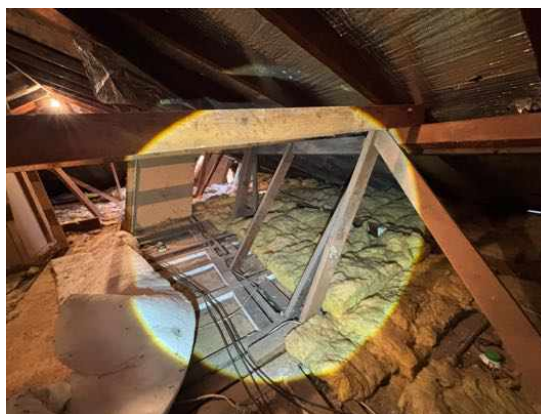
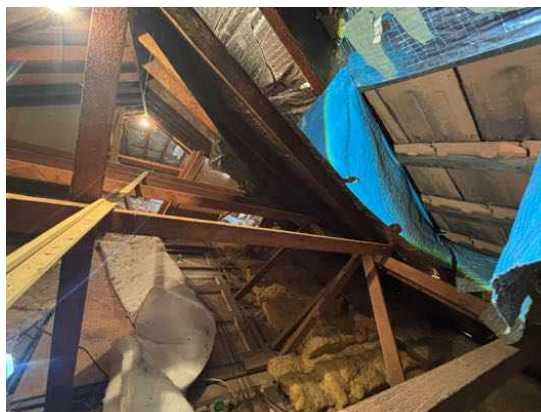
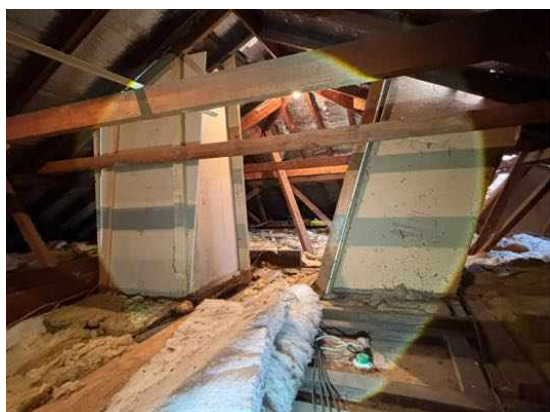
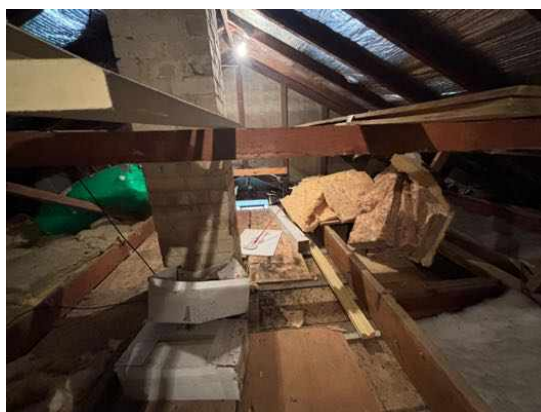
Noted Item

Finding: Obstructions, Limitations, and General Roof Space Condition

Information: The photographs provided document both the general condition and the obstructions and limitations that were present in the roof cavity of the main building at the time of inspection. These obstructions—such as insulation materials, stored items, structural elements, or electrical wiring—restricted safe and adequate access to key areas within the roof space. As a result, a comprehensive inspection of all components could not be completed.

Obstructions of this nature may conceal a variety of potential defects, including

damaged framing, compromised insulation, evidence of moisture ingress, pest activity, or electrical hazards. While no major issues were observed in the visible areas, the presence of these limitations means that some defects may remain undetected.

It is recommended that these barriers be removed or repositioned to facilitate full and safe access to the roof space. Once clear, a follow-up inspection should be conducted to allow for a thorough assessment of all concealed areas. This will help ensure that the condition of the roof cavity is accurately evaluated and any hidden issues are appropriately identified and addressed.

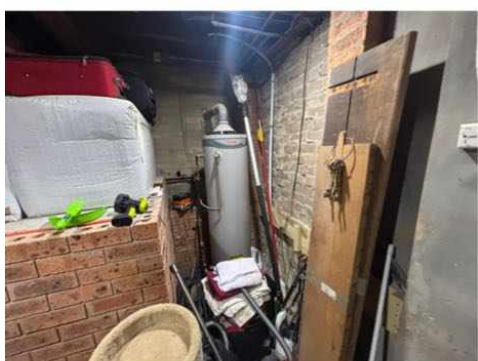
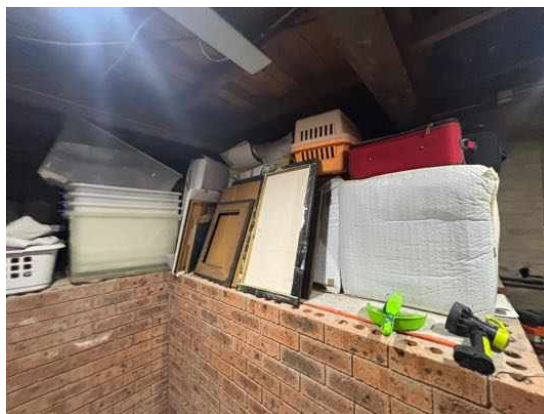
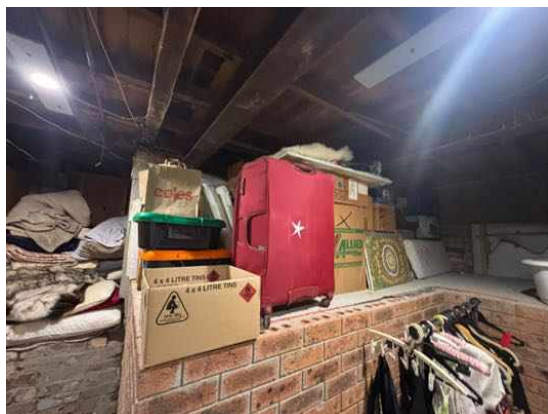
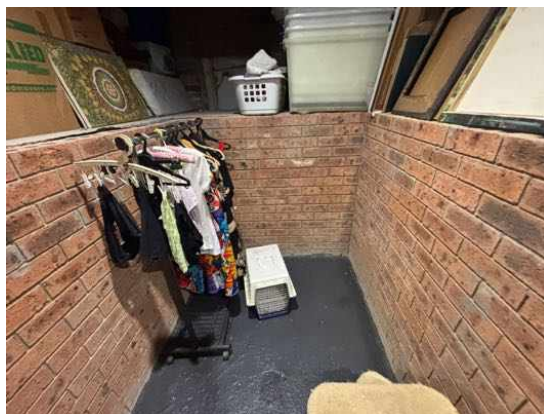
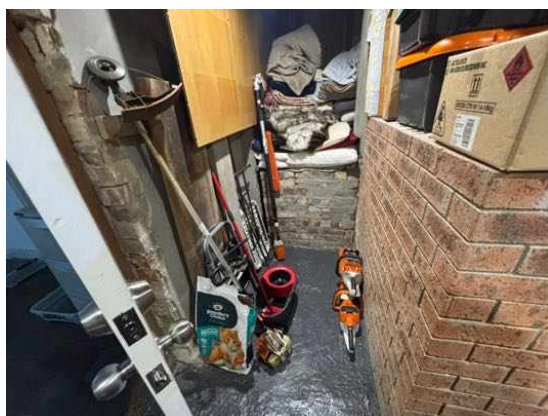
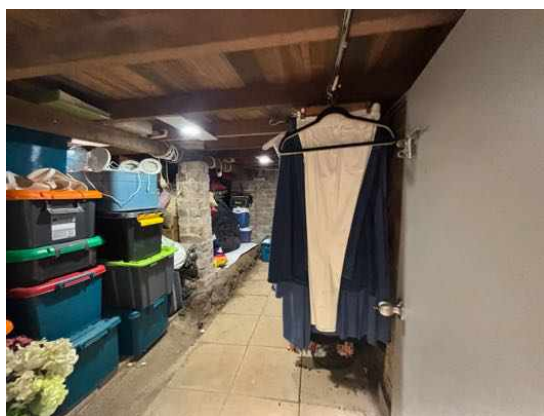
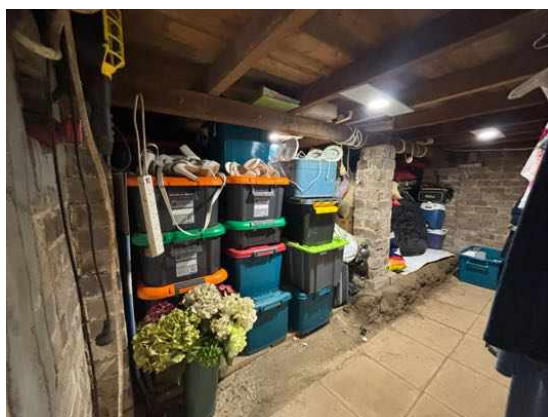
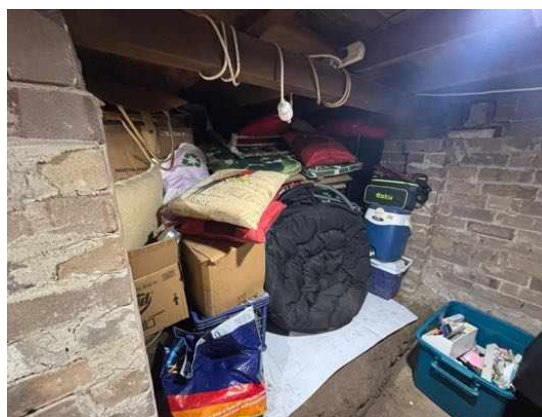
Noted Item

Finding: Obstructions, Limitations, and General Subfloor Condition

important elements such as floor joists, bearers, stumps, drainage, subfloor ventilation, and signs of moisture or pest activity. These obstructions may also conceal defects such as timber decay, water ingress, termite damage, inadequate support, or ventilation issues that are not immediately visible during a limited inspection.

While no major concerns were identified in the accessible areas, a full and unobstructed inspection is necessary to properly assess the overall condition of the subfloor. It is recommended that obstructions be removed and access improved where possible. Once adequate clearance is provided, a re-inspection should be arranged to ensure that any concealed defects can be identified and addressed accordingly. This will assist in providing a more comprehensive understanding of the subfloor's condition and reduce the risk of unforeseen issues.
