Building and Timber Pest Inspection Report

Inspection Date: Sat, 28 Mar 2026

Property Address: 8 Lone Pine Ave, Chatswood NSW 2067,
Australia

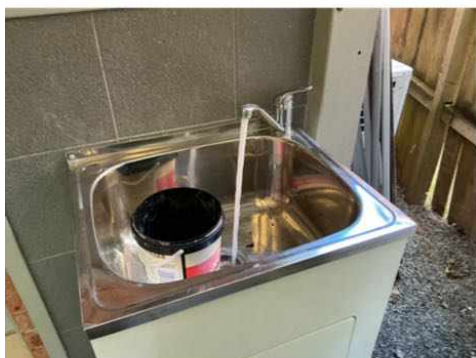
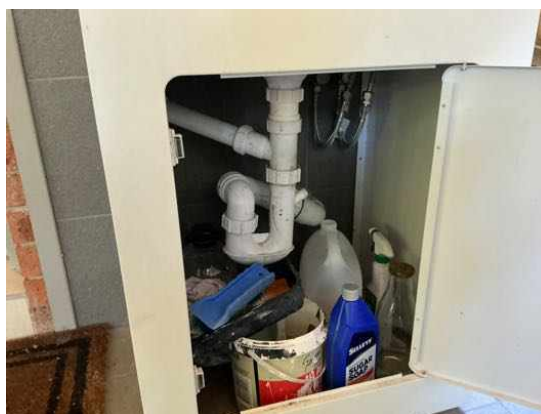
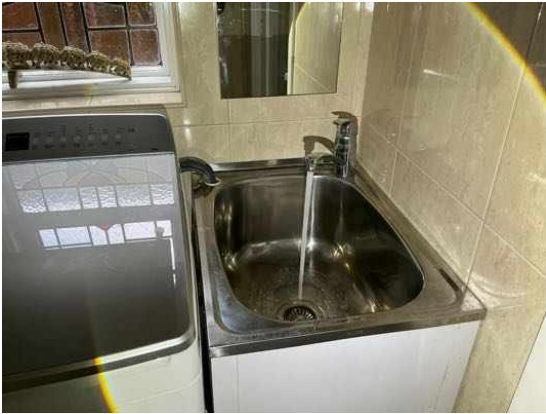
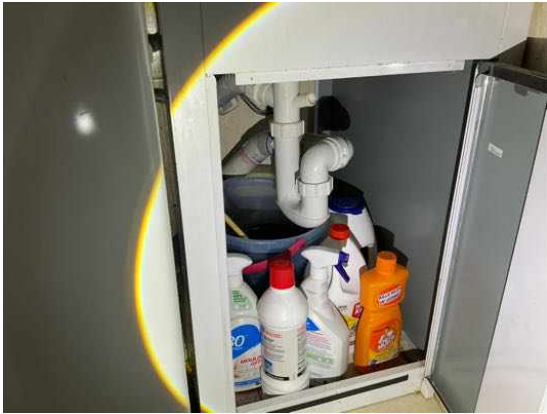
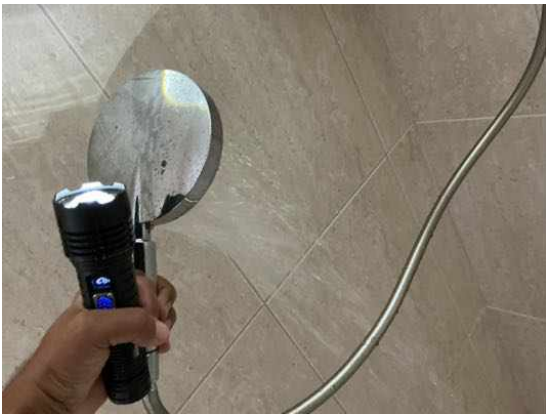
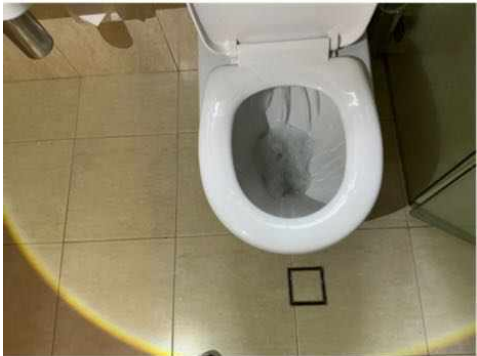
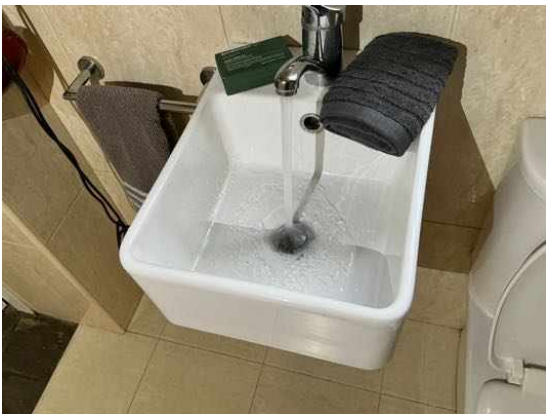
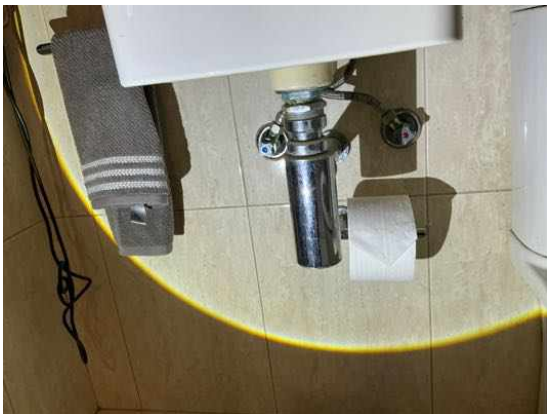
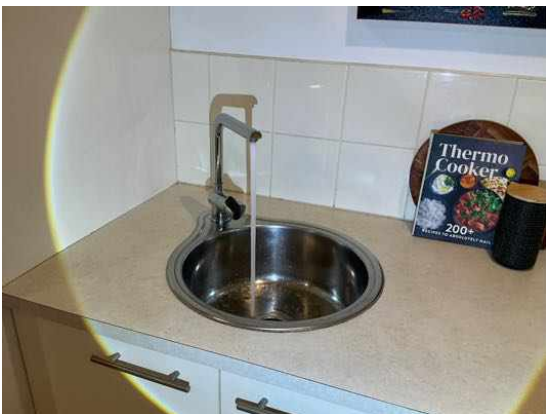
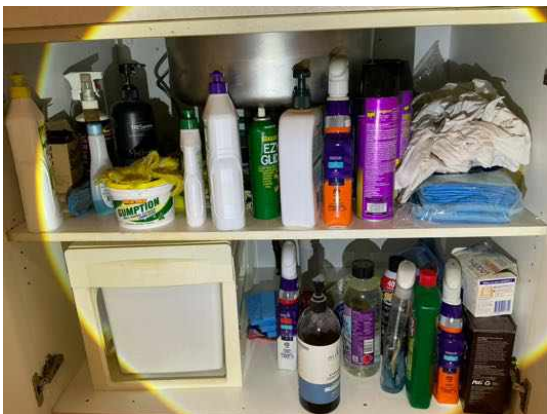
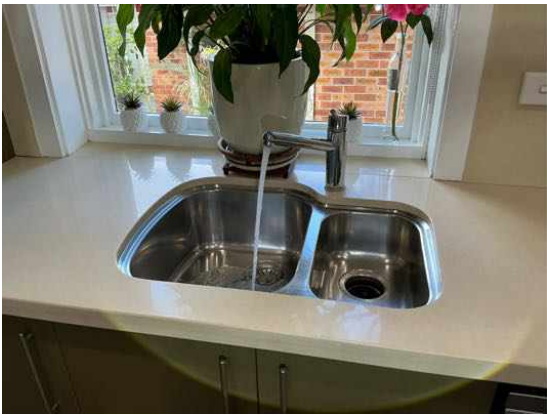
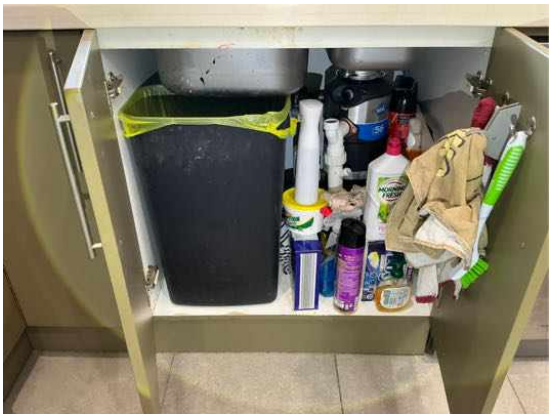
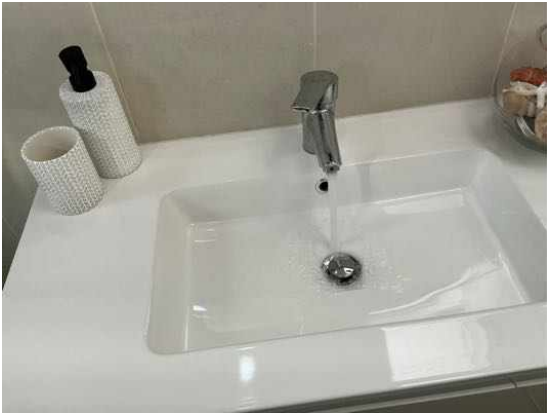
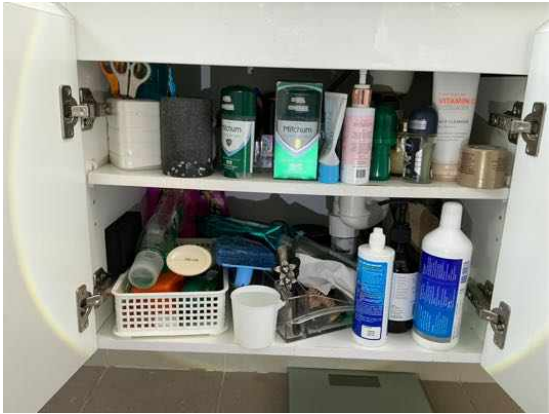
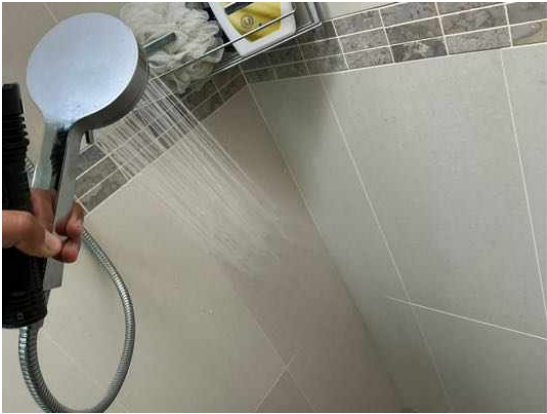
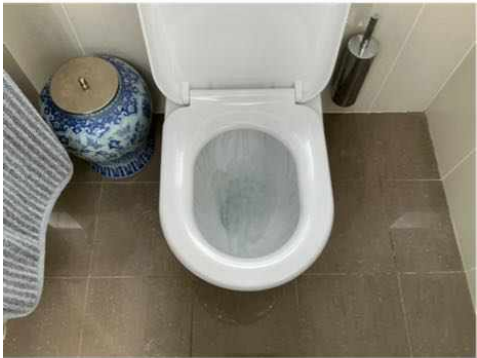
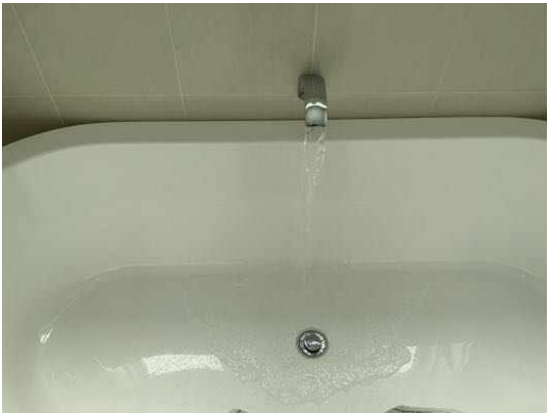
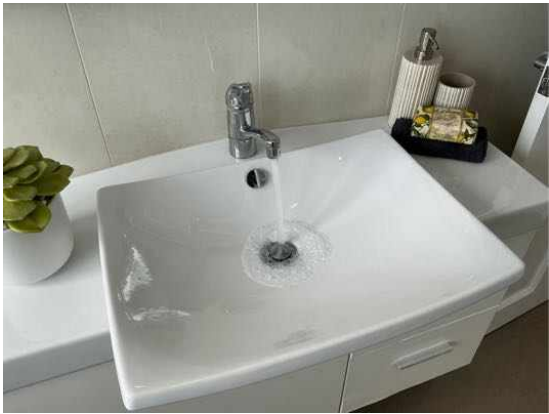
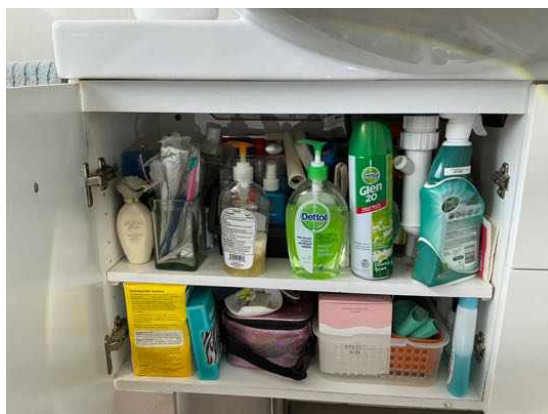
Building:	Main Building
Location:	All Areas
Finding:	FYI - Taps, Drainage & Toilets Tested and Cabinetry Obstructions
Information:	During the inspection, all accessible taps, drainage systems, and toilets were tested for water flow and drainage efficiency, and checked for any visible signs of leakage. At the time of the inspection, no issues were noted in these areas. Unless highlighted in a separate defect statement, no immediate remedial work appears necessary. Supporting images may be found in the additional photos section for reference.

It is important to note that while a visual inspection of cupboards and cabinetry beneath sinks and vanities was undertaken, stored personal items and fixtures presented obstructions that limited full visibility of the internal areas. As per standard inspection practices, inspectors are not permitted to move or disturb personal belongings during the inspection process. Therefore, only visible and accessible sections were inspected, and concealed water damage or plumbing defects may not have been detected.

Given this, a re-inspection is recommended after all obstructions have been cleared to allow for a comprehensive assessment of these areas. Regular maintenance and monitoring of plumbing and drainage systems is also advised to ensure ongoing functionality and early detection of potential issues.

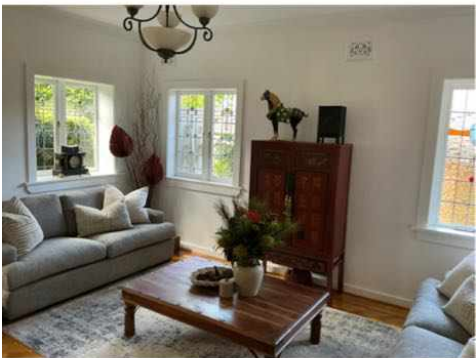
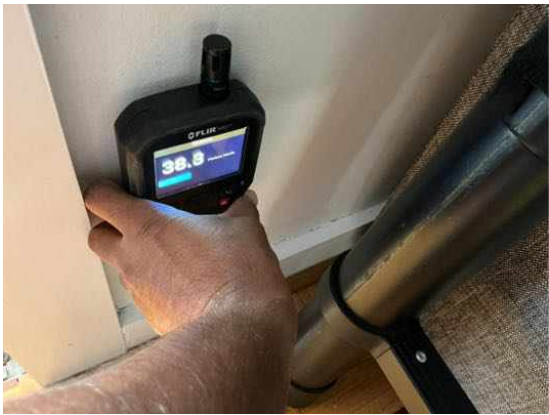
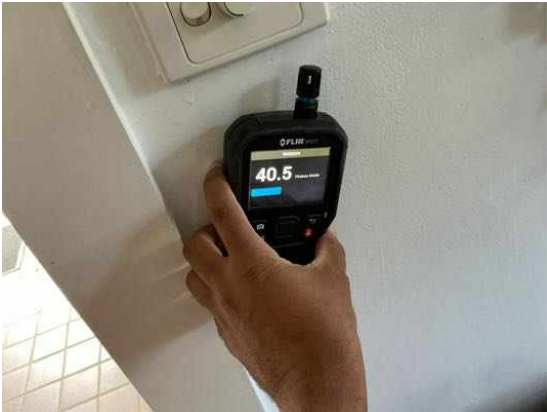
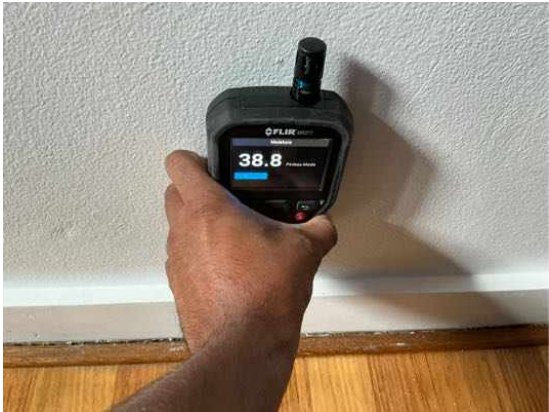
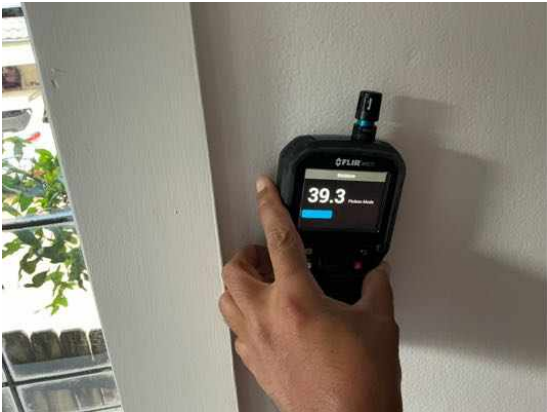
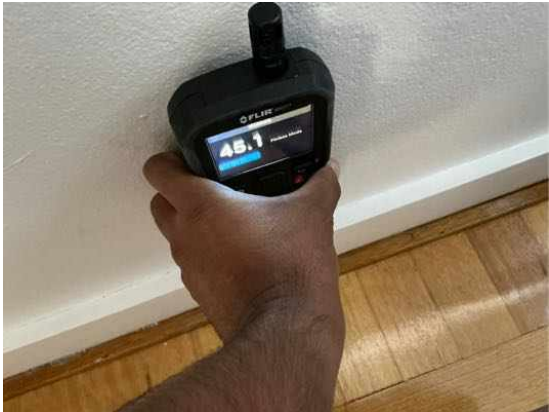
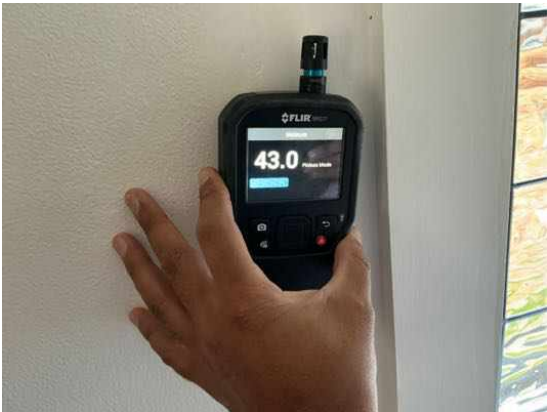
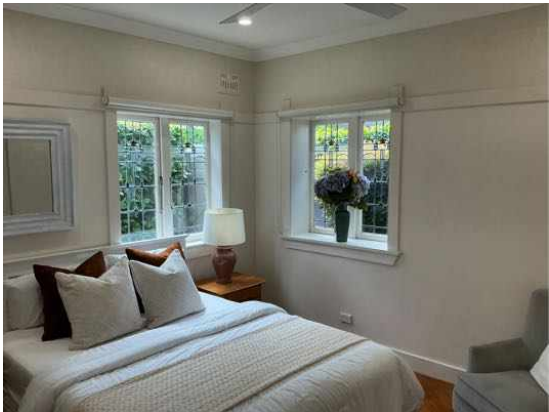
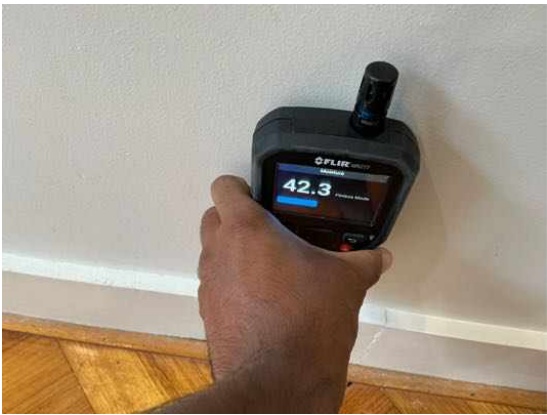
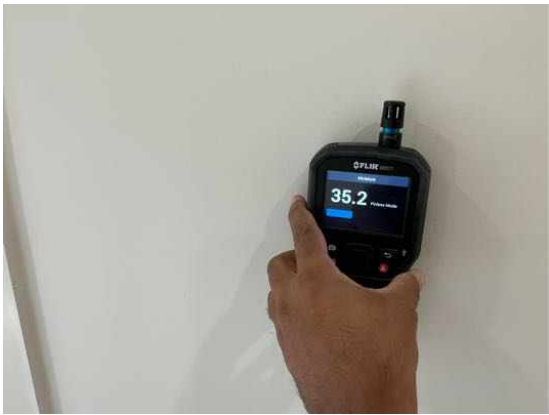
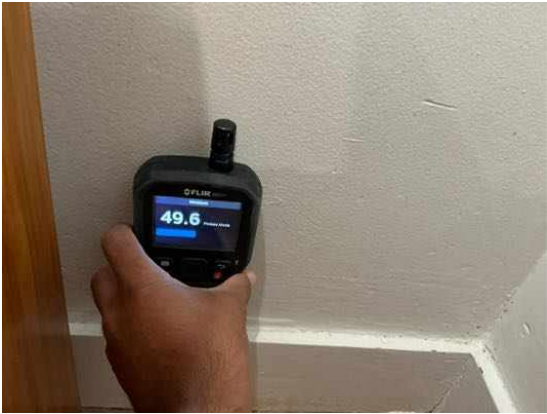
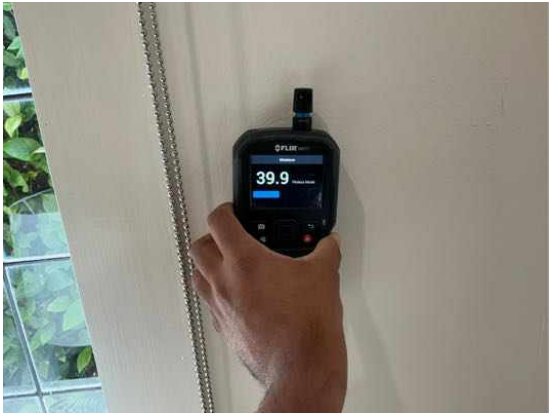
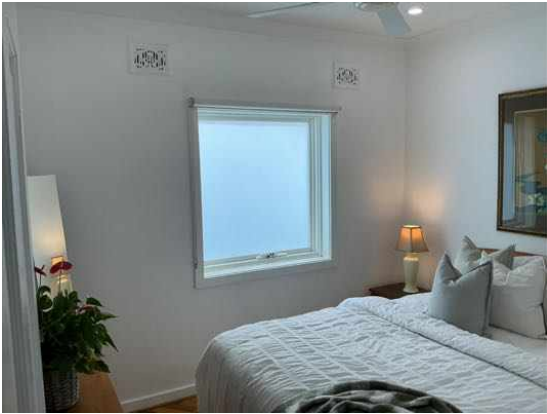
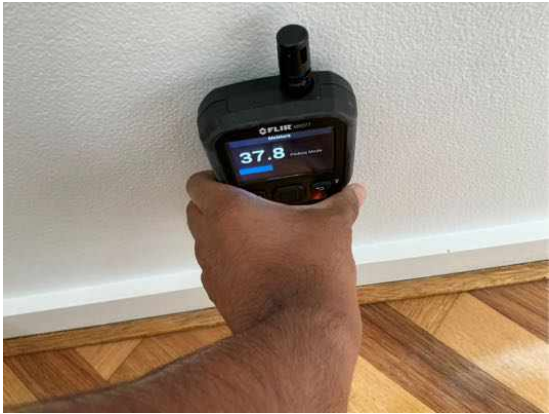
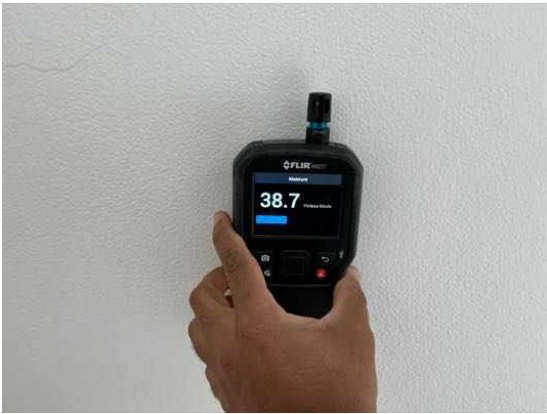
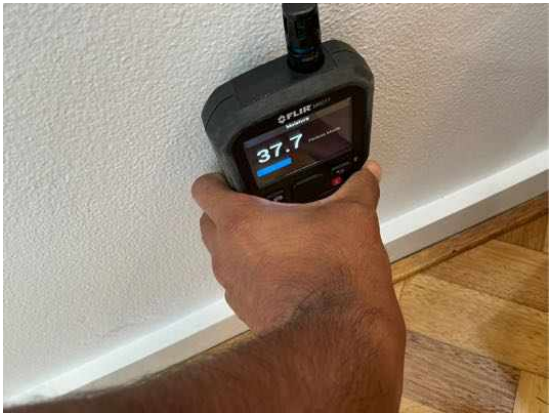
Finding: Additional Photos - Moisture Meter Readings

Information: Additional moisture meter reading photos have been provided for the property to offer further clarity on areas tested during the inspection. These photos are intended to give a visual reference for the specific locations where moisture levels were measured. These readings were taken at the time of the inspection to assess any potential moisture-related issues within the property. Any defects related to moisture that were identified during the inspection have been separately mentioned in the defect statements within the report.

For further clarification or additional information regarding the moisture readings, the client is encouraged to contact the building inspector directly. Regular monitoring of moisture-prone areas is recommended to ensure any emerging concerns are addressed promptly, particularly during wetter seasons or in high-humidity conditions.

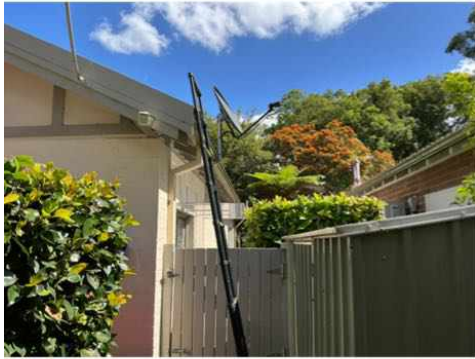
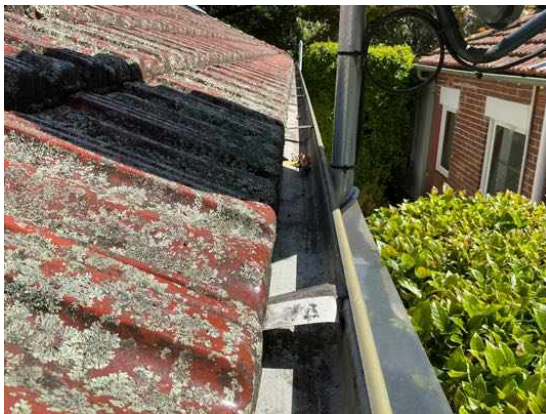
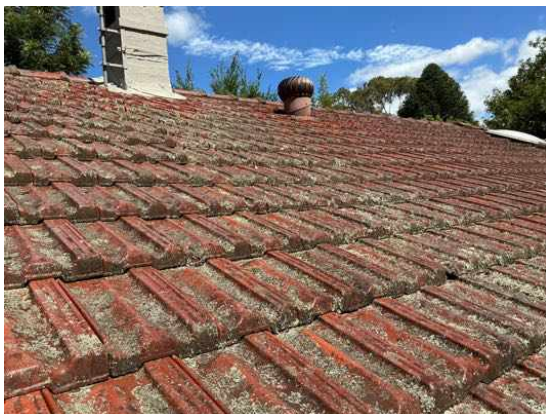
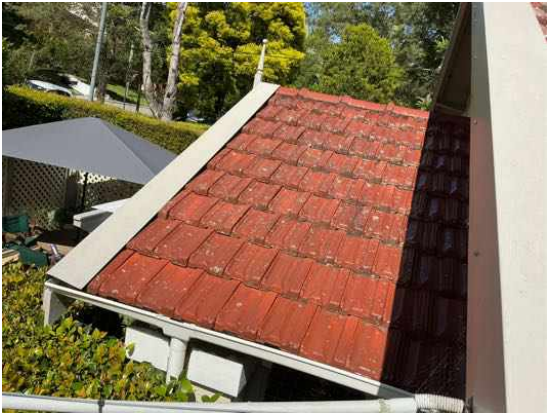
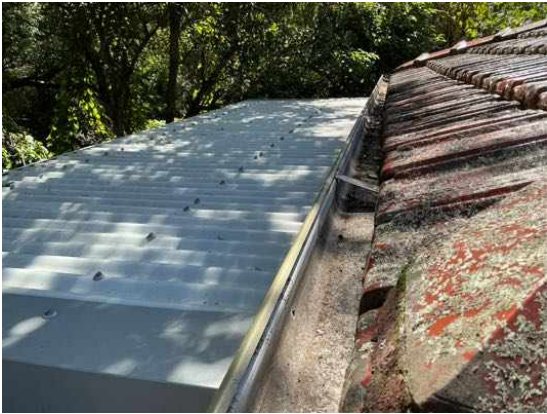
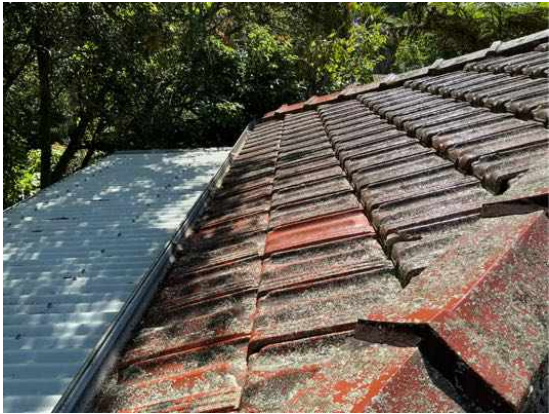
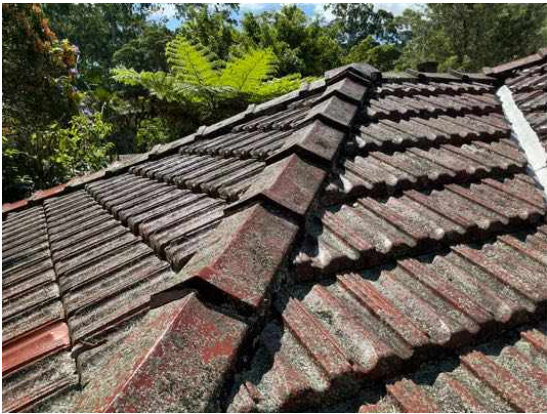
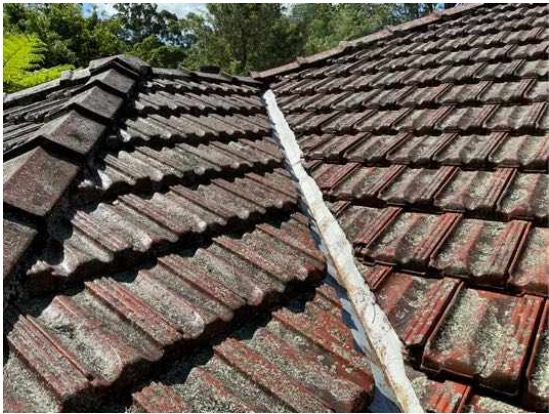
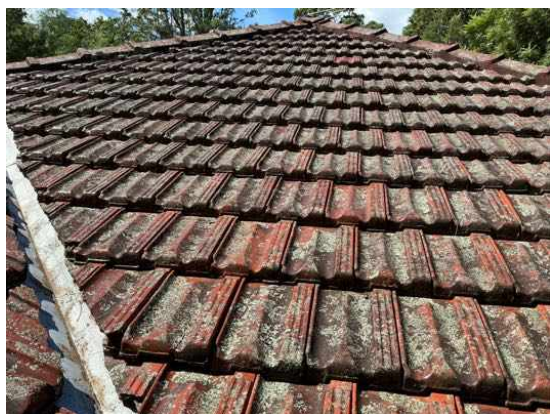
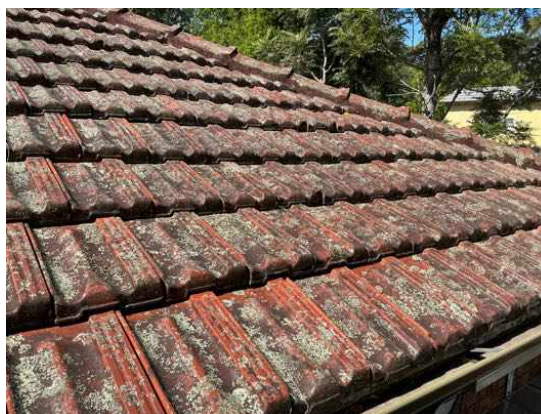
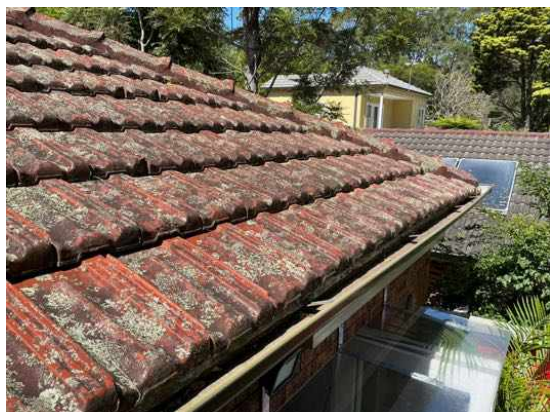
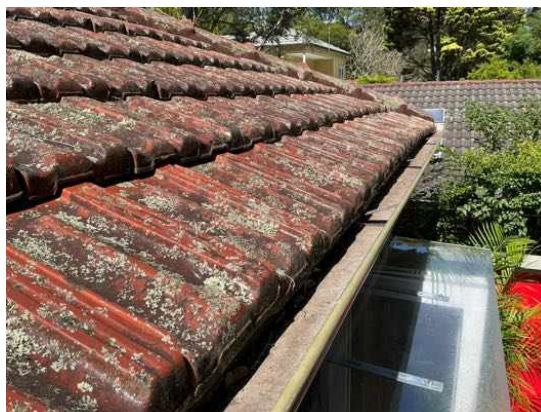
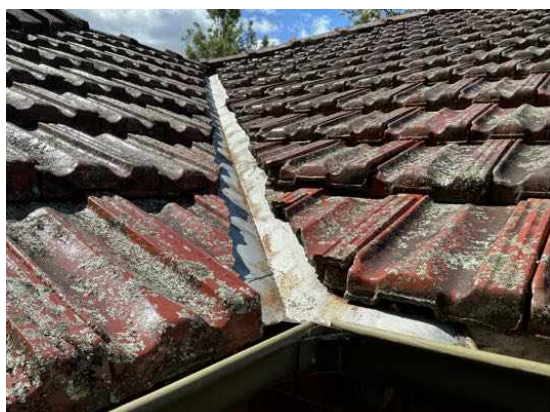
Building: Main Building
Location: Roof Exterior
Finding: Additional Roof Photos
Information: As part of the information provided, please note that the attached roof photos represent the condition of the roof at the time of inspection. These photos are for visual reference only and do not constitute a detailed roofing assessment. Any defects or issues identified with the roof are mentioned separately in the defect statements. It is strongly recommended that the client engage a qualified roofer to conduct a thorough inspection of the roof, ensuring that any potential issues, such as leaks, structural integrity, or wear and tear, are properly identified and addressed.

Additionally, the condition of the roof may change over time due to weather, natural wear, or other unforeseen factors. Regular maintenance and inspections by a licensed professional are advised to ensure the roof remains in good condition and to avoid costly repairs in the future. The information provided in these photos should be considered a snapshot of the roof's condition during the time of inspection and not a guarantee of its future performance.

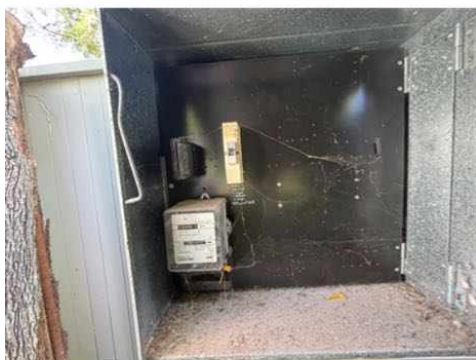
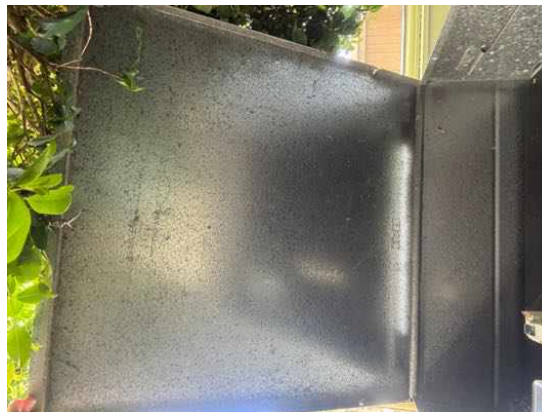
Building: Main Building
 Location: Meter Box
 Finding: Termite Management Recommendation – No Evidence of Chemical Installation
 Information: At the time of inspection, there was no visible evidence of a chemical termite management system installed around the property. Chemical barriers are a key component of termite protection and are particularly important in preventing concealed termite entry into timber elements of the structure.

In accordance with standard requirements, a durable notice should be located within the electrical switchboard to detail any termite protection systems applied, including chemical treatments. No such notice was observed during the inspection.

It is recommended that the client engage a licensed pest controller to assess the suitability of installing a chemical barrier, and to provide advice on associated costs and procedures. This should be considered a short-term priority, particularly if the property has any history of termite activity or is located in a high-risk area.

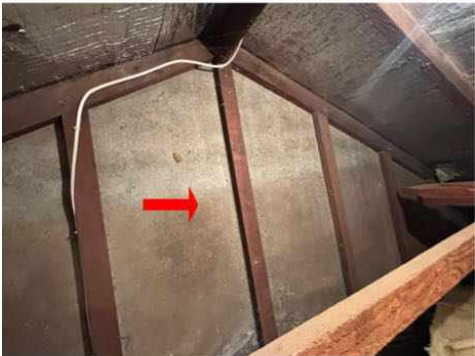
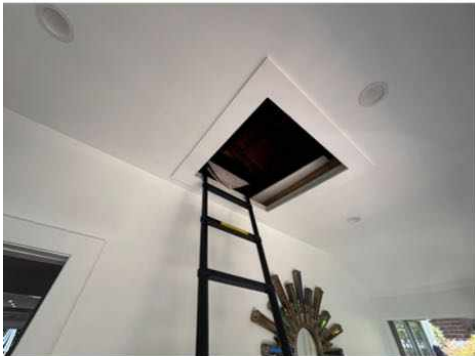
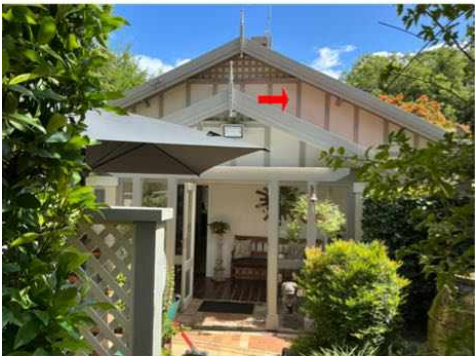
Building:	Main Building
Location:	Roof Void
Finding:	Asbestos - Suspected ACM Identified on Site
Information:	Reporting on Asbestos is outside the Scope of this Report. This suspected defect is highlighted as a caution only. We suspect, based on our experience in the building industry, that there is a higher risk of the identified building element containing asbestos.

As Asbestos Reporting is outside the scope of this report, we advise that you consider a separate Asbestos Inspection and Condition Audit, which can include the taking of samples for definitive confirmation of the presence of Asbestos.

In the interim, the client is advised to act with caution, especially when considering any damage to building materials general wear and tear renovations extensions demolition and general maintenance activities due to the suspected presence of Asbestos.
