Building and Timber Pest Inspection Report

Inspection Date: Tue, 17 Feb 2026

Property Address: 8/8 Galloway St, North Parramatta NSW
2151, Australia

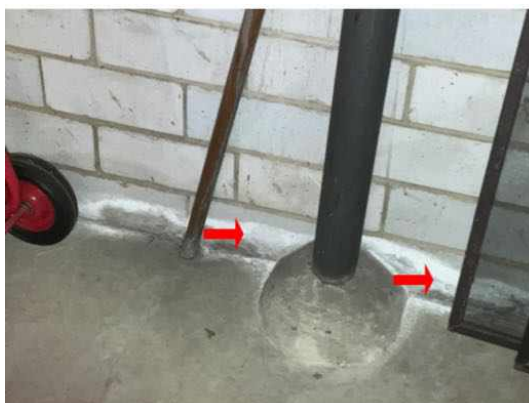
Building:	Main Building
Location:	Garage
Finding:	Exterior walls - Lateral damp
Information:	Lateral penetrating damp refers to the sideways movement of moisture, predominantly from the surrounding ground, which tends to affect basement walls and other earth-retaining walls. The implications of unmanaged damp range from mould fungi growth, wood rot and decaying building materials, to finishes including lifting, bubbling, peeling and staining of paint, plaster and wallpaper.

It is important to address damp conditions as the World Health Organisation notes that excess moisture leads - on almost all indoor materials - to the growth of microbes such as moulds, fungi and bacteria, which subsequently emit spores and other matter into the indoor air. Exposure to these contaminants is associated with a wide range of respiratory and other health-related problems. Additionally, the development of damp in timber building elements also provides an environment that is conducive to termite / timber pest attack.

Structural waterproofing barriers or tanking barriers are often used to protect internal surfaces against the effects of lateral penetrating dampness. These types of work are generally undertaken where the source of the penetrating damp cannot be prevented.

Immediate consultation with a licensed builder is advised to address the cause of the damp and to perform remedial works as necessary. A landscaper must be appointed immediately to lower the external ground levels.

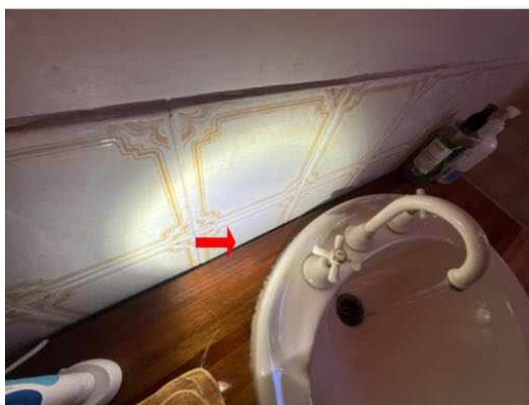
It was noted on inspection that sealant or grout is degraded to this area.

Flexible and mould resistant materials should be applied to affected areas to prevent any subsequent water damage that is likely to occur. Regular maintenance and replacement of damage or missing or damaged sealant and grout is highly recommended to the wet areas, as this is a regular wear and tear defect. Sealant and grouting in areas that come into regular contact with water should be maintained for the long term care of your property.

A sealant specialist should be appointed to complete these works as soon as possible.

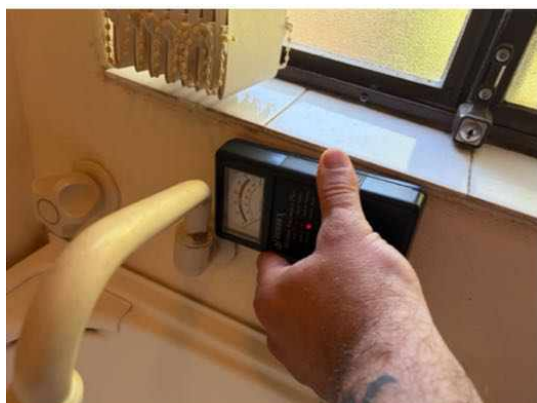
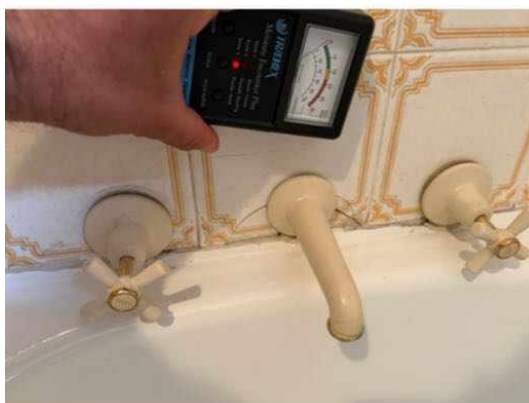
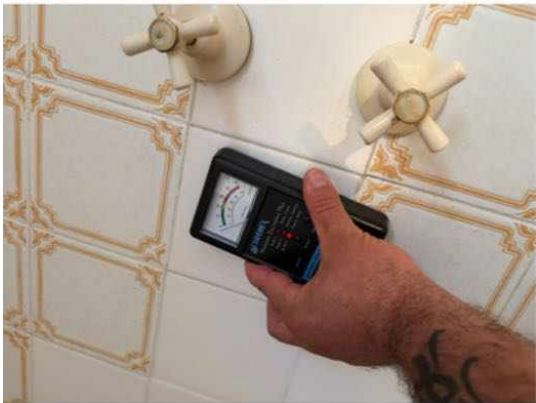
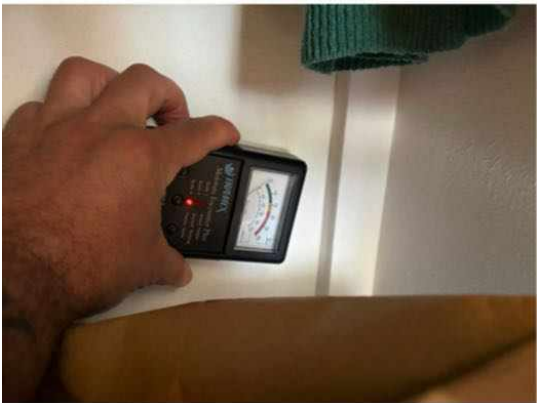
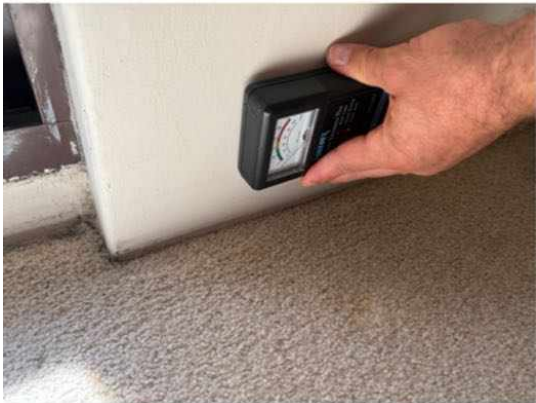
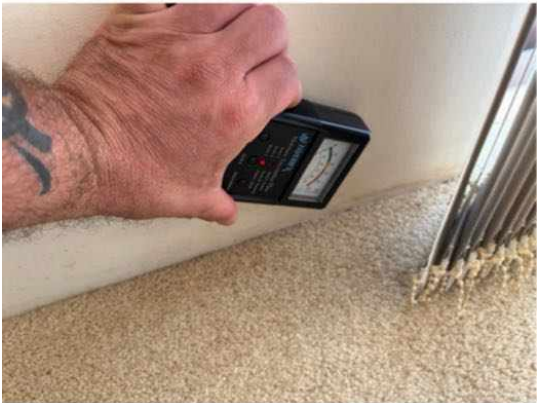
Building: Main Building
 Location: All Areas
 Finding: Moisture metre
 Information: During the inspection the property was checked for moisture using a moisture metre.

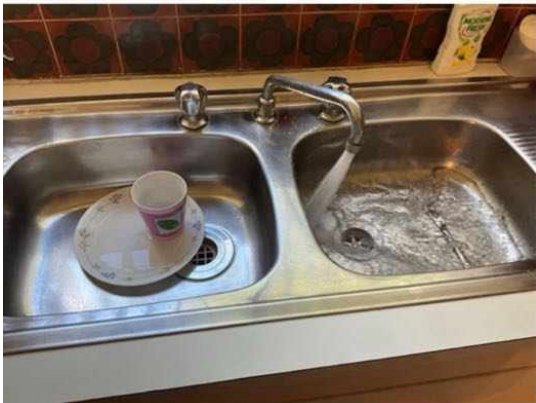
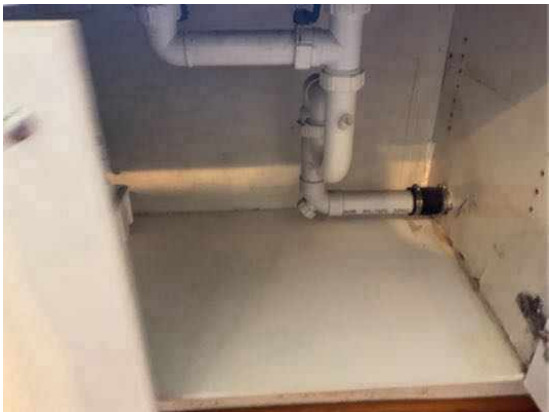
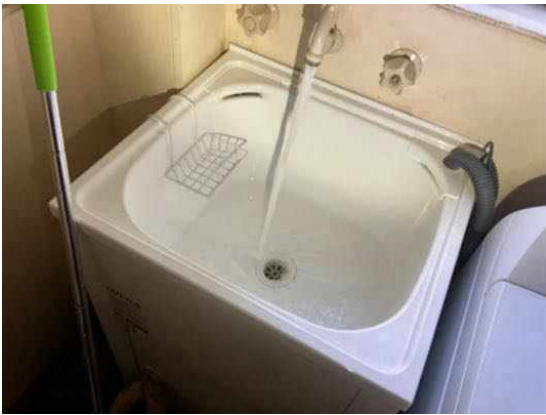
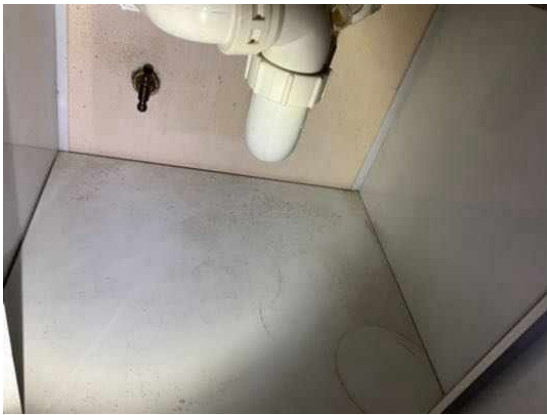
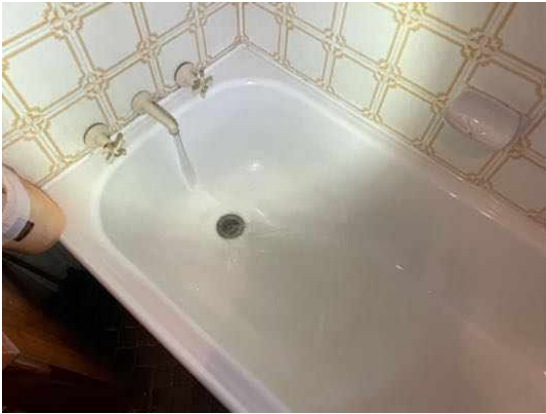
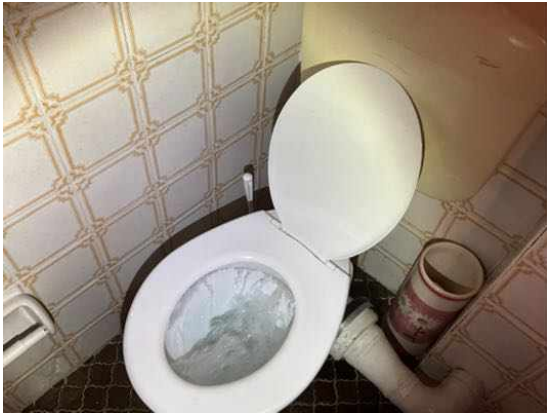
Building: Main Building
Location: All Wet Areas
Finding: Additional Photos
Information:

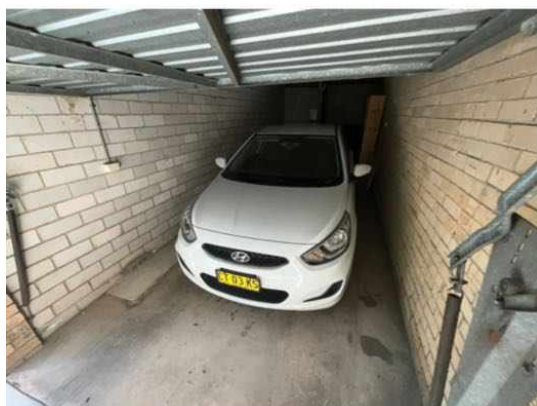
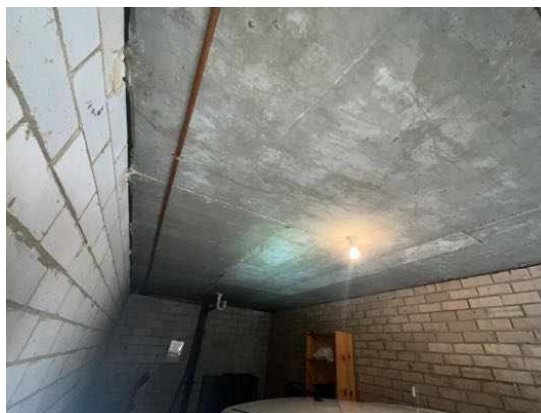
Building:	Main Building
Location:	Garage
Finding:	Additional Photos- Garage
Information:	Additional photos are provided for your general reference. Arrows may have been included to highlight areas of importance. Please discuss these photos with your building consultant for clarification.

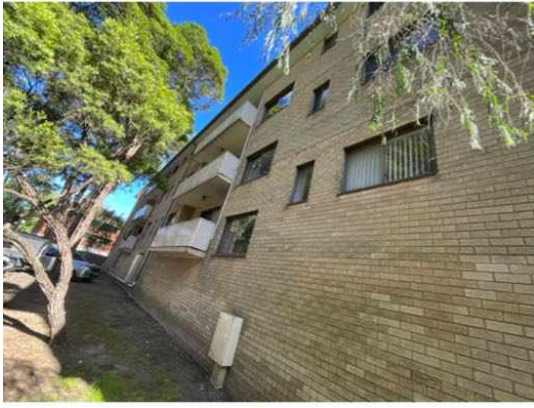
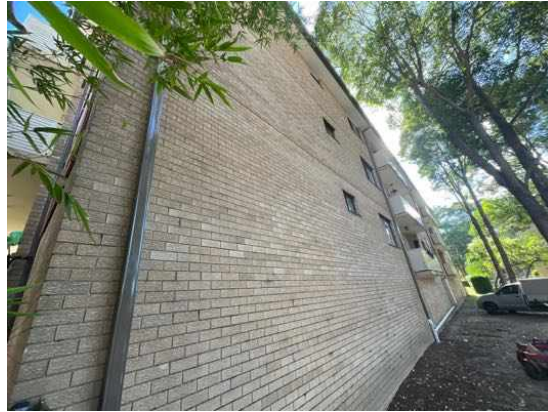
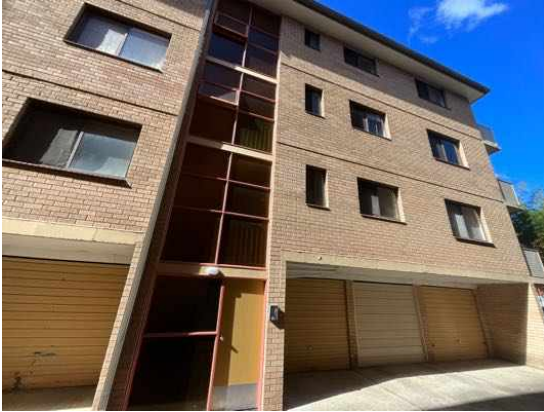
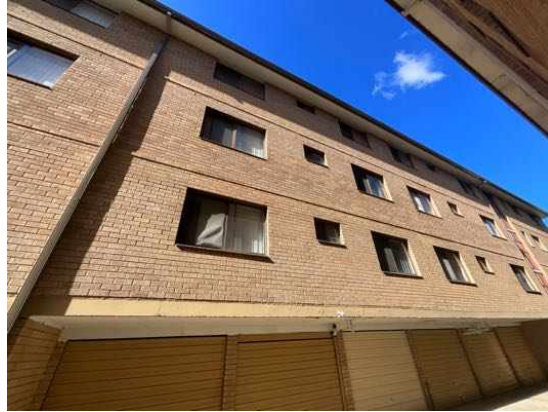
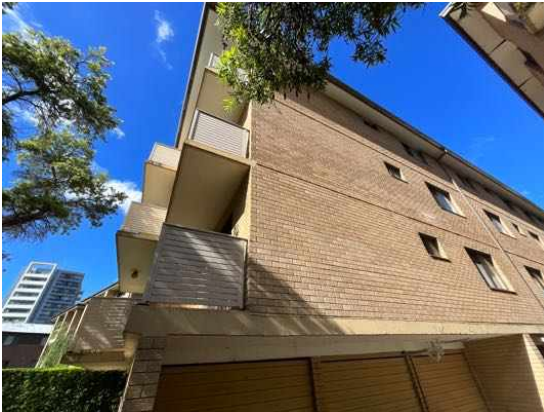
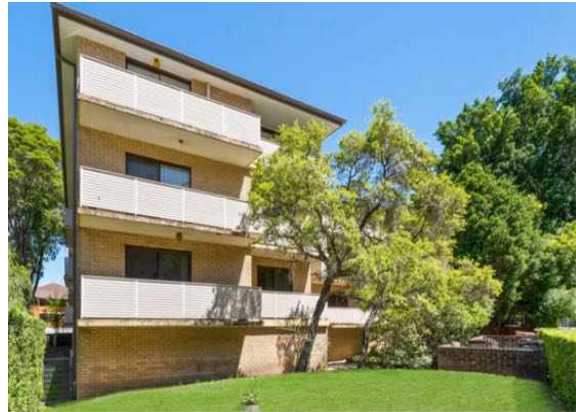
Building:	Main Building
Location:	Exterior
Finding:	Additional Photos
Information:	Additional photos are provided for your general reference.

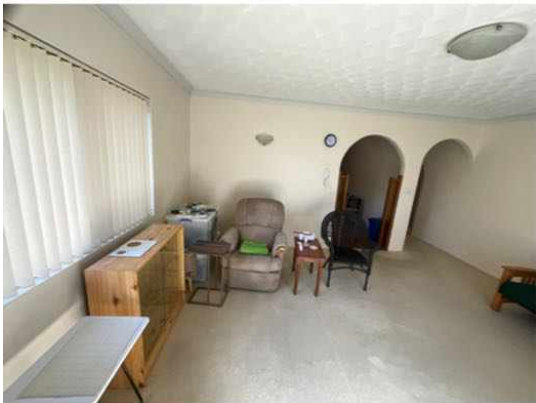
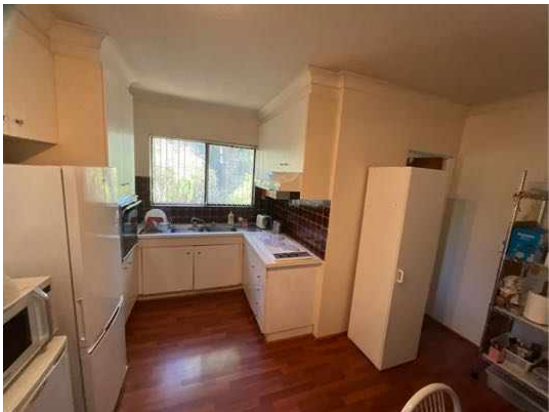
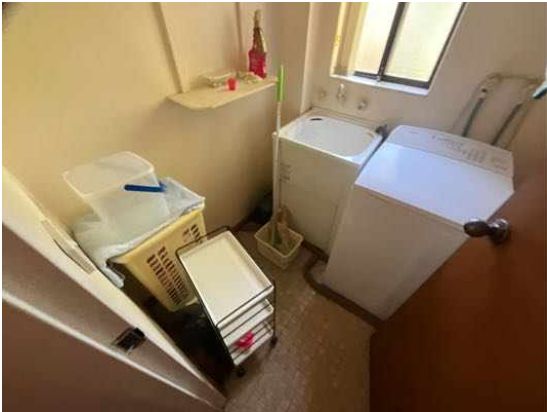
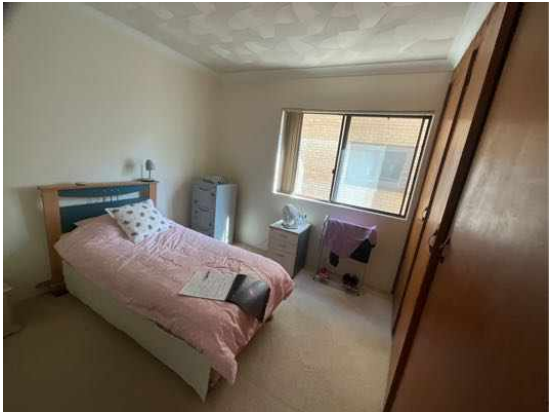
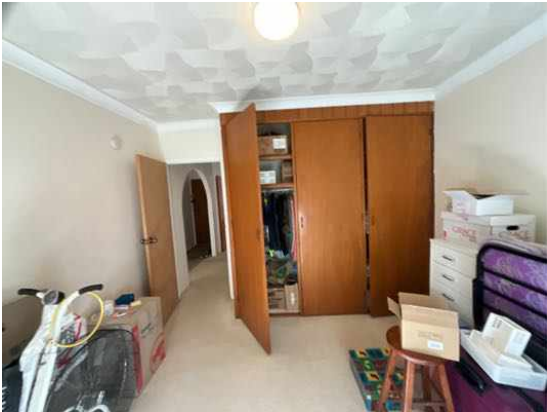
Building: Main Building
 Location: All Areas
 Finding: Additional Photos - Obstructions and Limitations
 Information:

These photographs are an indication of the obstructions and limitations which impeded full inspection of the property at the time of inspection. These obstructions can hide an array of defects and should be removed to allow full inspection to be carried out. A re-inspection is recommended once the areas are made accessible.
