Building and Timber Pest Inspection Report

Inspection Date: Tue, 10 Mar 2026

Property Address: 6 Beatrice St, Preston VIC 3072, Australia

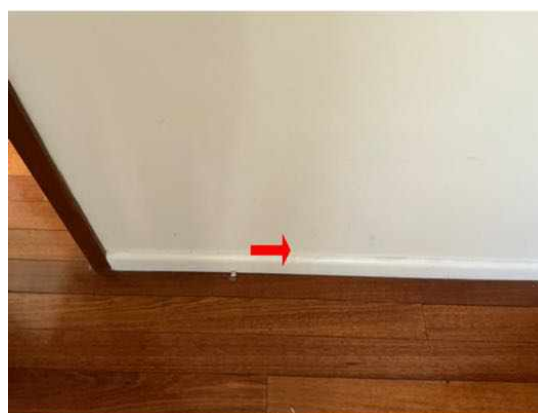
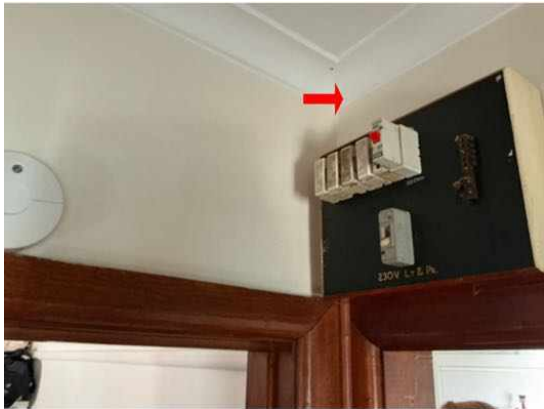
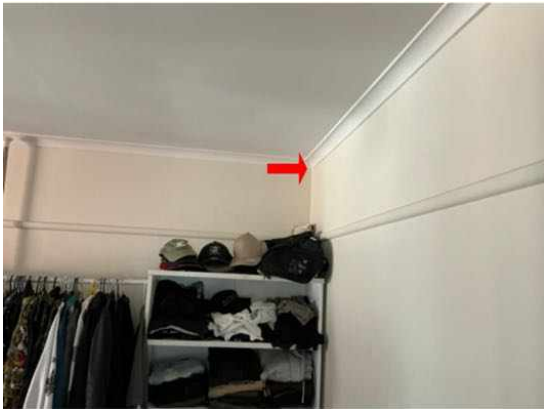
Building:	Main Building
Location:	All Areas
Finding:	Cracking - Damage Category 1 - Fine (up to 1mm)
Information:	Although fine cracks are quite noticeable, they are often only considered to be an appearance defect, and usually do not indicate any structural damage. Generally, the cause of a fine crack is indicative of a separation between building materials and finishes (e.g. paint, plaster, etc.) along joins.

In this instance client have indicate that these cracks become visible after roof leaks. However the leaks have been repaired, and hence no change in terms of sizes.

Cracking of this nature can generally be repaired with minor sanding, filling and/or repainting. Such works should be performed by a qualified Painter or a general Handyman.

Monitoring of all cracking should be conducted frequently. Always contact a Building Inspector should cracks widen, lengthen, or become more numerous.

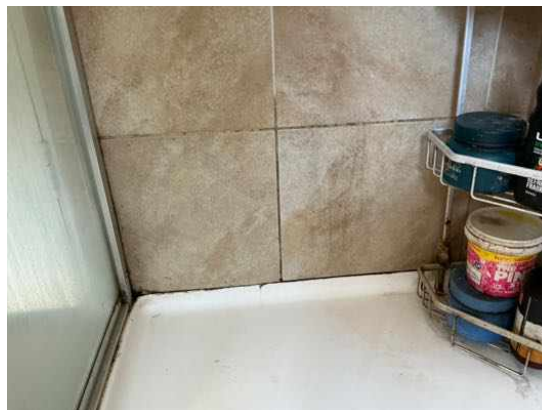
Finding 3.02

Building:	Main Building
Location:	Bathroom
Finding:	Sealant and grouting - Missing or damaged
Information:	During inspection, it was observed that the sealant or grout has degraded to the tiled shower wall. A flexible sealant is necessary to accommodate the anticipated expansion and contraction while maintaining the joint water-tight and protective of all associated building materials.

The absence of sealant between tiles can cause water to seep into the wall behind it.

Regular maintenance and replacement of damaged, missing, or damaged sealant and grout are highly recommended for wet areas, as this is a regular wear-and-tear defect. Sealant and grouting in areas that come into regular contact with water should be maintained for the long-term care of your property.

Consultation with a sealant specialist is advised immediately to perform remedial works as necessary. Epoxy grout is highly recommended

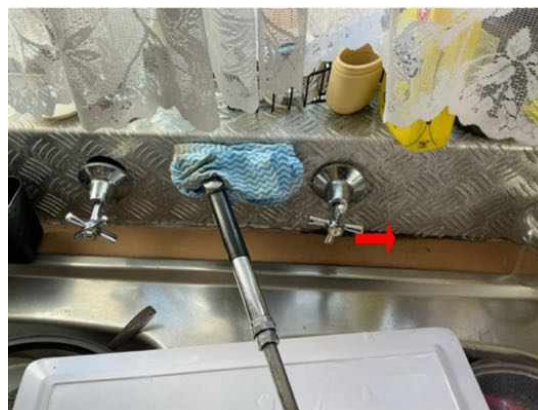
Finding 3.03

Building:	Main Building
Location:	Kitchen
Finding:	Sealant- Missing
Information:	The lack of sealant between splash back and sink can cause water damp to the wall behind it.

Consultation with a sealant specialist is advised immediately to perform remedial works as required.

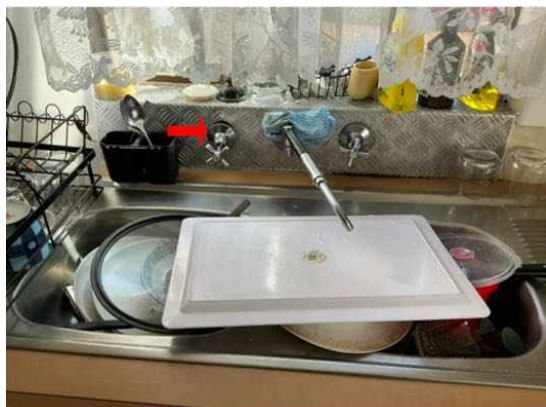
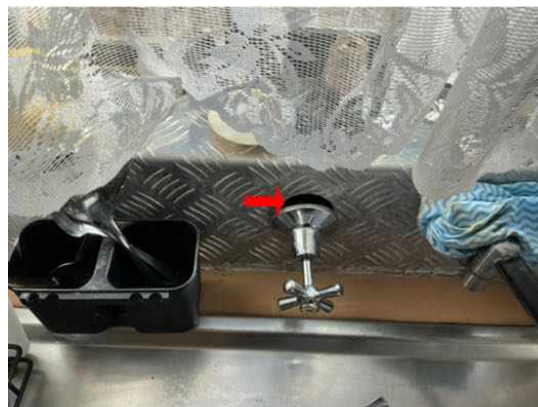
Finding 3.04

Finding: Tap - Loose

Information: The tap in the kitchen sink has not been installed correctly, and is consequently loose. This tap being loose creates potential for water leaks and subsequent water damage to the surrounding area.

Where taps or spouts are loose, a qualified plumber should be appointed to re-fix the plumbing fitting as soon as possible .

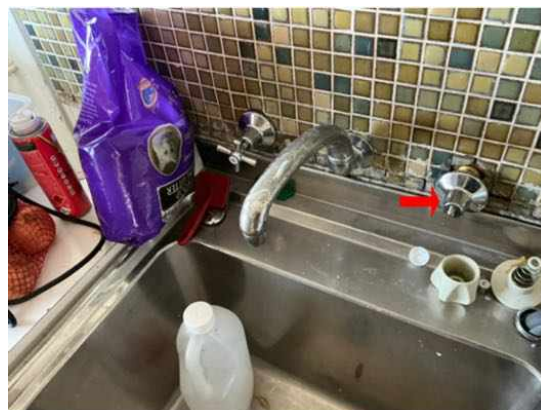
Finding 3.05

Finding: Tap handle- Broken

Information: The tap handle of the laundry trough has not been broken. This tap handle being broken creates potential for water leaks and subsequent water damage to the surrounding area.

Where taps or spouts are broken , a qualified plumber should be appointed to re-fix the plumbing fitting as soon as possible .

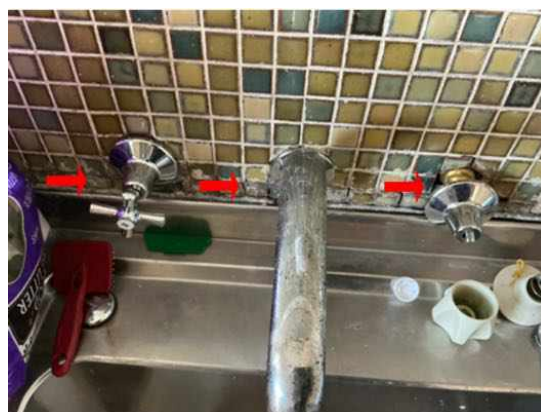
Finding 3.06

Building:	Main Building
Location:	Laundry
Finding:	Sealant and grouting - Missing or damaged
Information:	During inspection, it was observed that the sealant or grout has degraded to the tiled splashback and bench top in the kitchen. A flexible sealant is necessary to accommodate the anticipated expansion and contraction while maintaining the joint water-tight and protective of all associated building materials.

The absence of sealant between tiles can cause water to seep into the wall behind it.

Regular maintenance and replacement of damaged, missing, or damaged sealant and grout are highly recommended for wet areas, as this is a regular wear-and-tear defect. Sealant and grouting in areas that come into regular contact with water should be maintained for the long-term care of your property.

Consultation with a sealant specialist is advised immediately to perform remedial works as necessary.

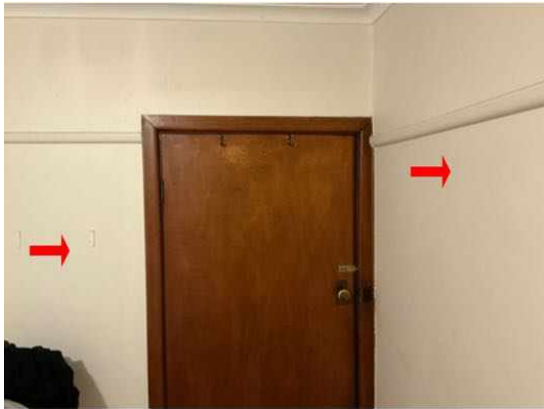
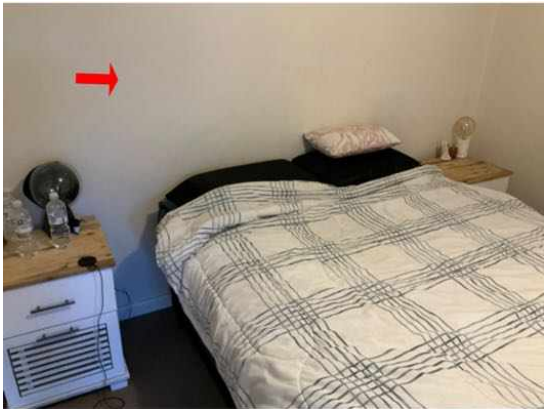
Finding 3.07

Building:	Main Building
Location:	All Internal Areas
Finding:	Internal Painting Deteriorated
Information:	Much of the internal paintwork including but not limited to ceiling, walls, doors and windows have been neglected and require attention to prepare and re-paint.

Whilst incomplete or missing paint finish is generally an appearance defect, it can also lead to the development of secondary building defects over time. Incomplete areas of paint finish expose the area to moisture, potentially accelerating the deterioration of underlying building materials.

Degraded paint finishes should be sanded back, filled, leveled and painted, as applicable. Where inadequate or missing paint protection has led to the deterioration of the associated building element, repair and/or replacement of this building element may be required.

A Painting contractor should be appointed as soon as possible to perform necessary works to aid the appearance of the affected area and to ensure the area is protected against further deterioration. Alternatively, the Homeowner following manufacturer instructions may perform these works.

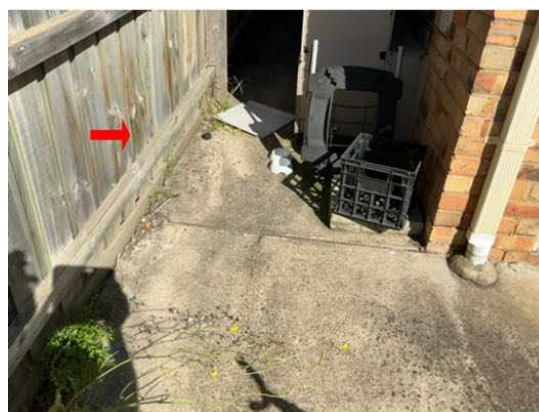
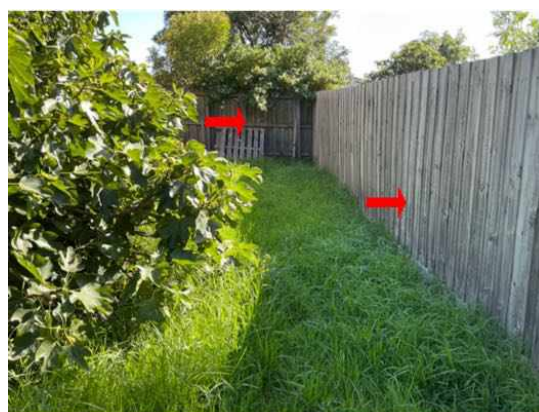
Building: Main Building
 Location: Fencing
 Finding: Fencing - Deteriorated
 Information: It was noted at the time of inspection that sections of the fencing throughout the property have deteriorated. Typically fencing deteriorates due to age and or wear, rot and or rust which is generally expected for a structure of this age, due to prolonged exposure to weather conditions. Sometimes inadequate installation or maintenance can be to blame.

If left unattended, it is likely that further damage will occur. It is suspected that repair of several elements of the fencing may be required however replacement may be a consideration of the client also.

A licensed fencing contractor should be appointed to provide further advice and perform rectification works as necessary.

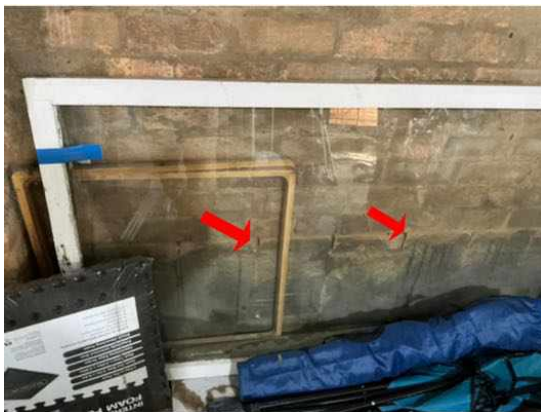
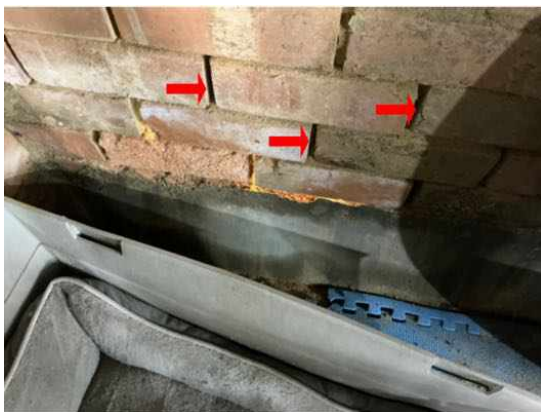
Finding 3.11

Building: Main Building
 Location: Garage
 Finding: Brickwork - Deteriorated mortar throughout the wall
 Information: Mortar, or 'bedding', is the material which fills joints and intersections between bricks in masonry walls and structures. Sections of mortar in this brickwork were identified as

having deteriorated, which is generally expected for a property of this age and condition.

Mortar may deteriorate as a result of age of building materials, minor movement of bricks, or frequent exposure to weathering. Mortar should be replaced to ensure that bricks remain in their intended location and to prevent gaps, which would allow water or moisture ingress and secondary damage as a result.

Mortar deterioration can be addressed by a Bricklayer where areas of deterioration are localised and easily accessible. Alternatively, appointment of a registered Builder is advised, to repoint large areas of decaying mortar. Where secondary structural defects have become evident, consultation with a Structural Engineer may be required.

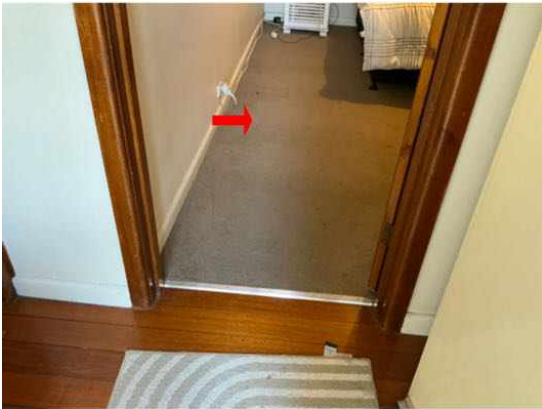
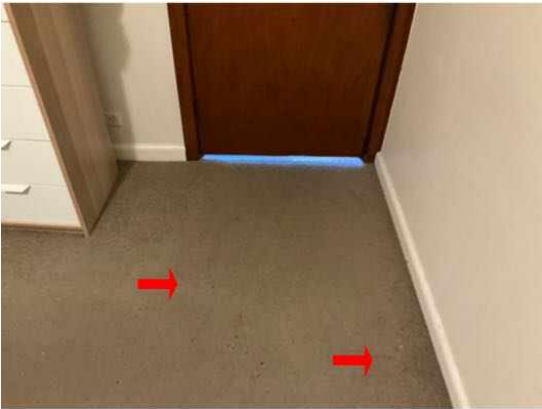
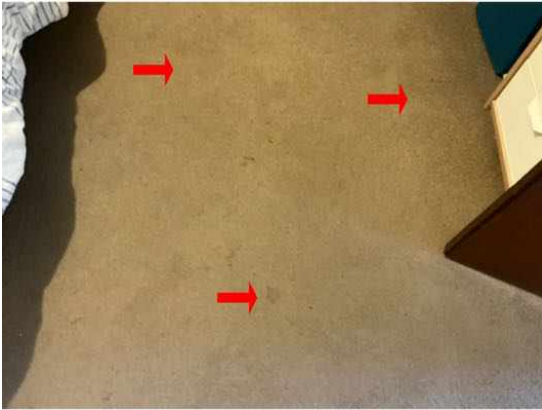
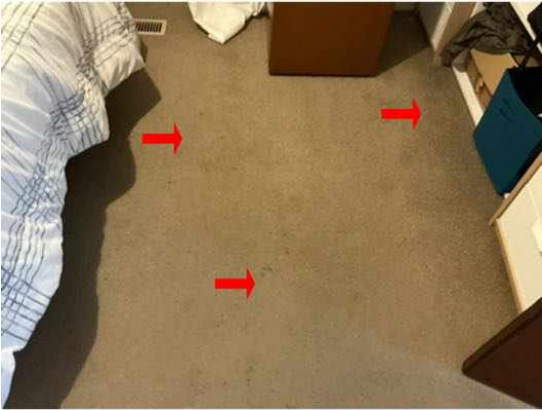
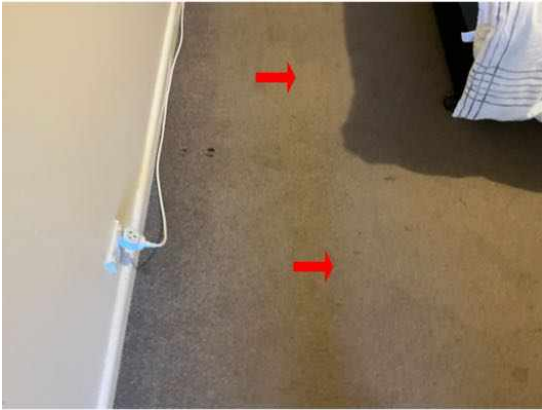
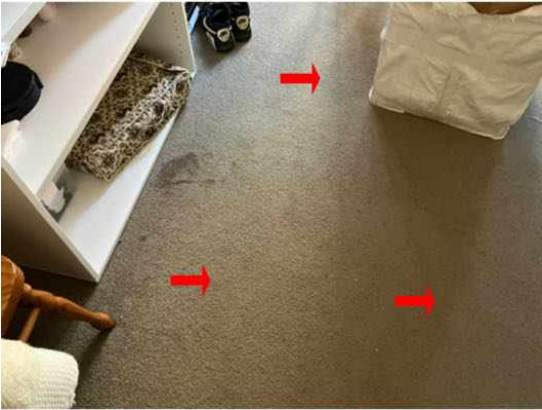
Finding 3.12

Building:	Main Building
Location:	All Areas
Finding:	Carpet - Deteriorated
Information:	Sections of the carpet floor covering in this area exhibited signs of deterioration, likely attributed to ageing.

Replacement of the affected carpet is recommended at the client's discretion.

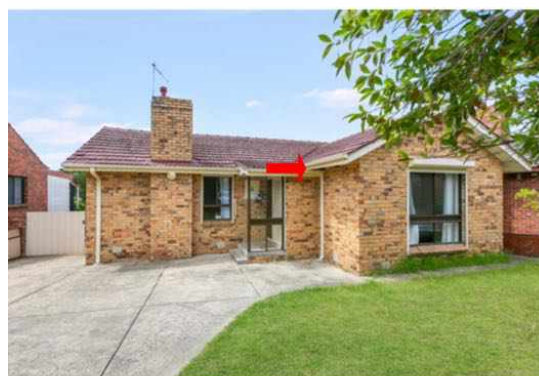
Blocked gutters are likely to lead to high levels of moisture in the affected areas. Such moisture will not only cause rust and decay of the associated building materials, but can also provide conditions that are conducive to termite and timber pest activity. Blockages in gutters should therefore be removed immediately to ensure dry conditions are maintained.

Consult a Licensed Plumber for further specific advice on remedial works that may be required. In the interim, it is highly advised that blocked gutters be removed by the homeowner or a general handyperson as a matter of urgency.

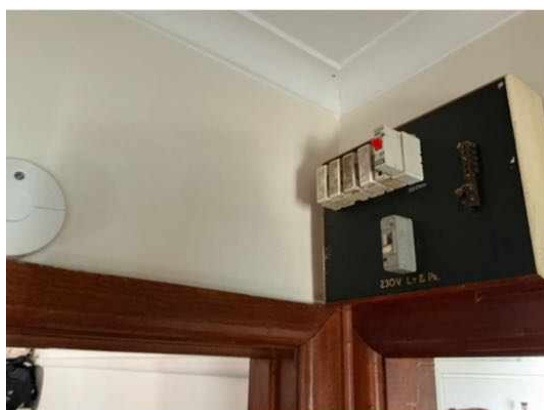
Finding 6.02

Building:	Main Building
Location:	Electrical switchboard
Finding:	Termite Management System - no evidence of installation
Information:	The application of a post-construction chemical termite barrier is highly recommended for all properties, particularly if live termite activity has been found on the site previously. Such barriers are highly effective in preventing termite attack on any timber building elements throughout the property.

A durable notice should be placed in the switchboard unit to indicate current termite barriers. At the time of inspection, it appeared as though no termite management system has been installed, with no evidence to suggest preventative works taking place.

The client may consider gaining further advice from a pest controller as to the costs and procedures involved with this application. It is recommended that obtaining such advice be a short-term priority.

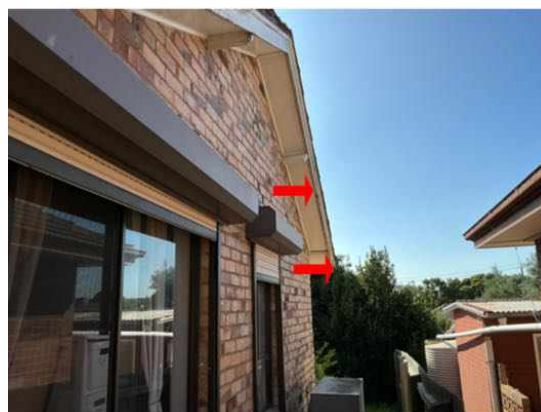
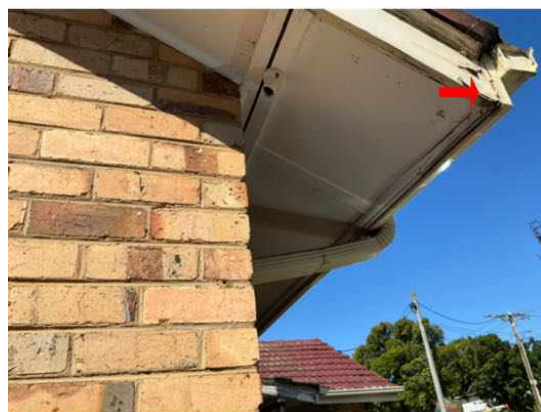
Finding 7.01

Building:	Main Building
Location:	All External Areas
Finding:	Fascias - Wood rot
Information:	Wood rot was found to be affecting fascias and barges in this area, evidenced by the presence of mould on the surface in some areas. Wood rot, also known as Fungal Decay, occurs when timbers and other cellulose building materials are exposed to damp conditions on an ongoing basis.

It is likely that this wood rot has developed as a result of faults in the roof plumbing, creating excessive moisture in this areas. Frequent exposure to rain and other weather

conditions also make fascias and barges susceptible to accelerated deterioration.

Early intervention and regular maintenance will prolong the useful life of these building elements. Prior to any works being performed, the cause of the moisture that has created the visible wood rot should be identified and addressed in a suitable manner.

It is advised that a roof plumber be appointed to inspect all roof plumbing and subsequently identify the cause of the wood rot. Replacement of affected fascias and barges may then be a necessary step in protecting surrounding building elements from such deterioration.

A qualified plumber may be appointed to assess the cause of excessive moisture and to provide advice on any remedial works as required. A qualified carpenter or registered builder may also be required to replace affected building materials.

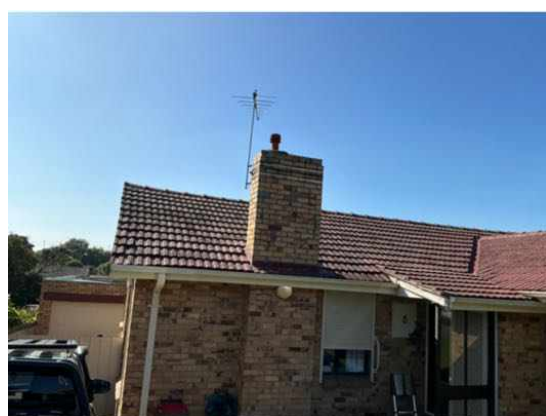
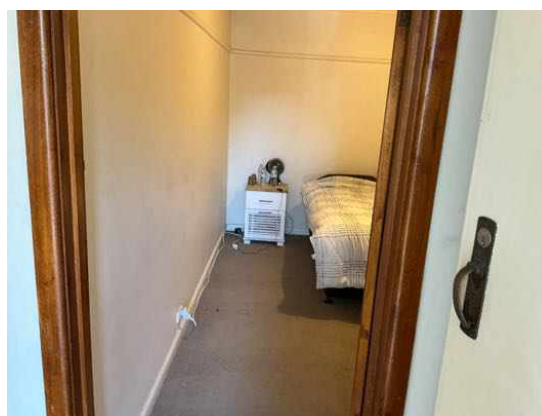
Noted Item

Building:	Main Building
Location:	All Areas
Finding:	Additional Photos - Obstructions and Limitations
Information:	These photographs are an indication of the obstructions and limitations which impeded full inspection of the property at the time of inspection. These obstructions can hide an array of defects and should be removed to allow full inspection to be carried out. A re-inspection is recommended once the areas are made accessible.

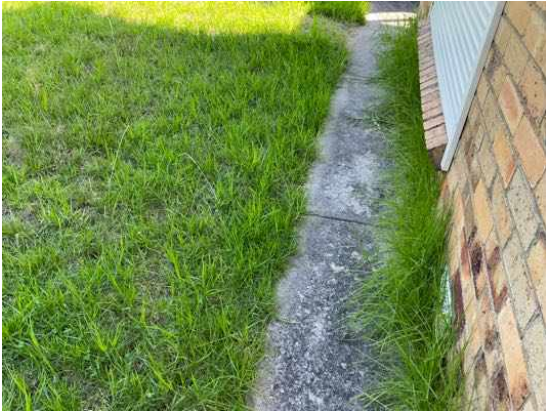
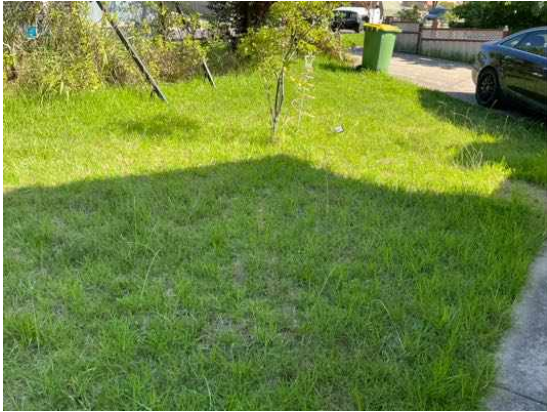
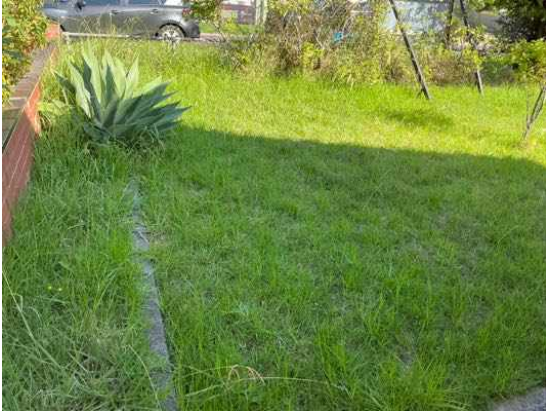
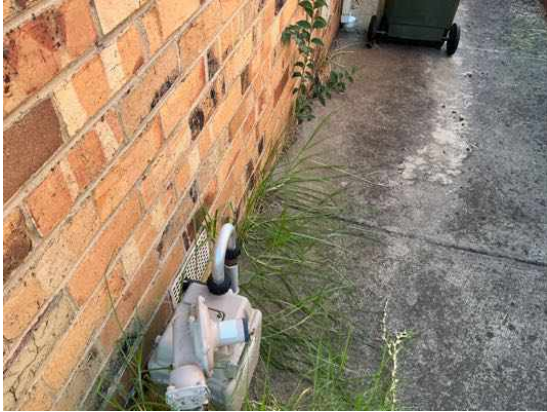
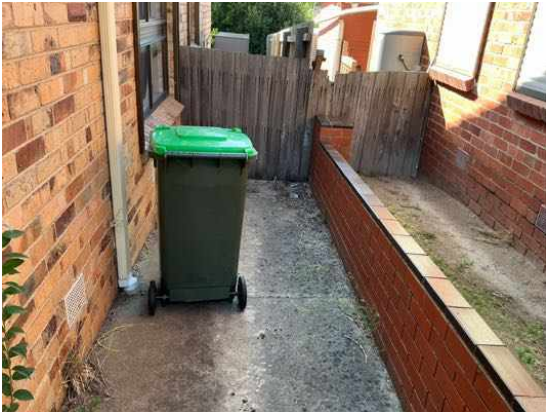
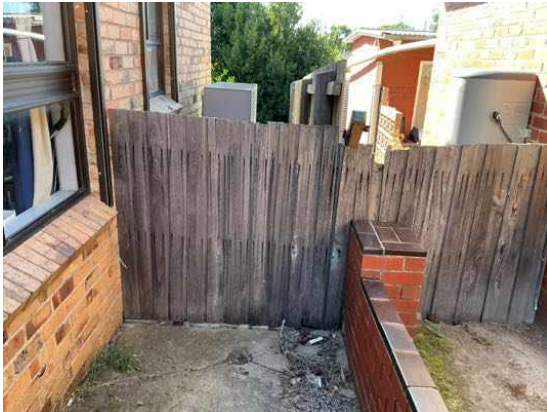
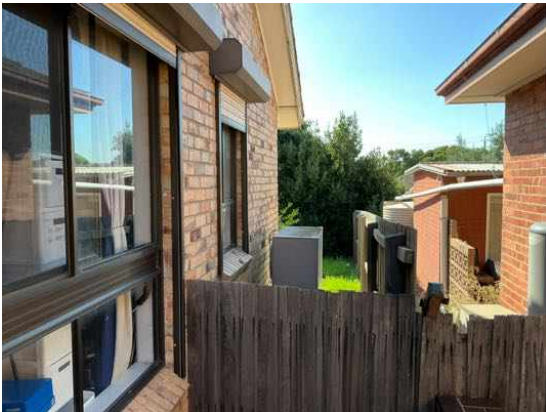
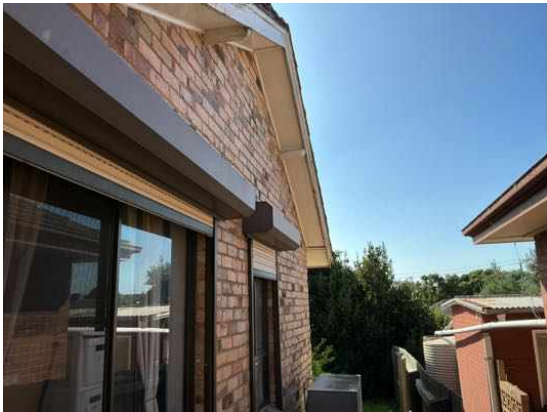
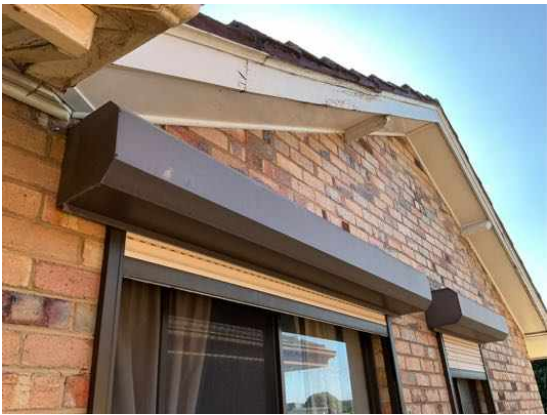
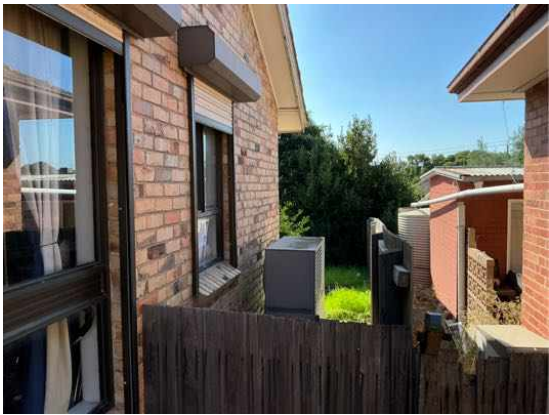
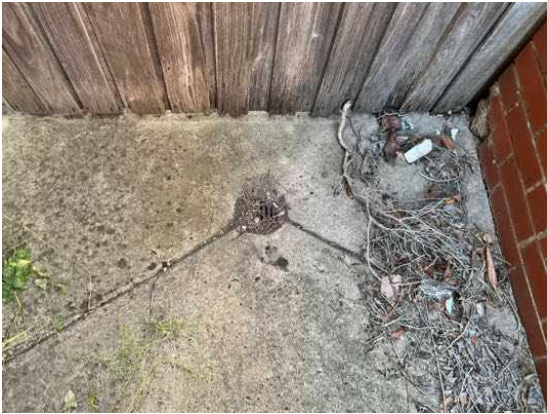
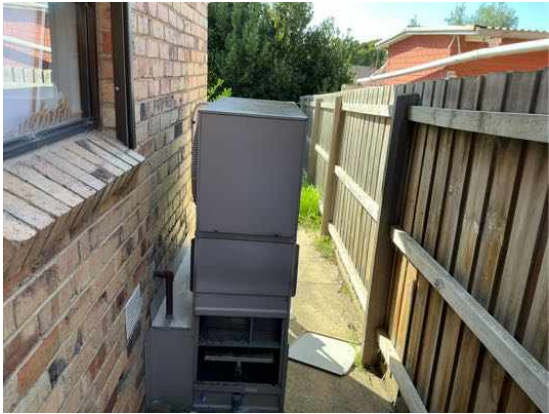
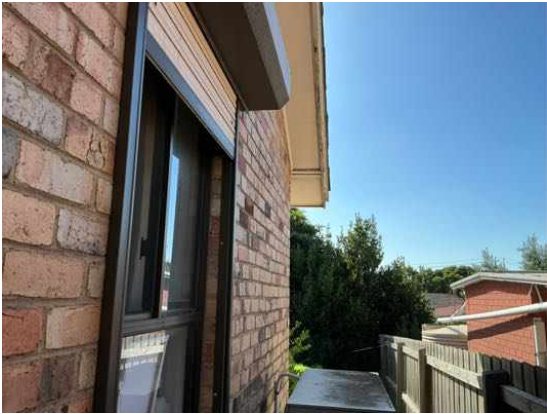
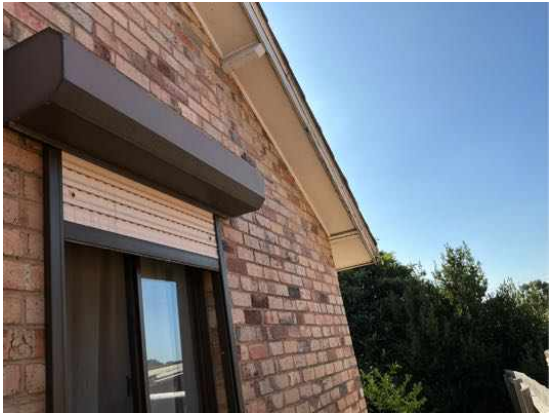
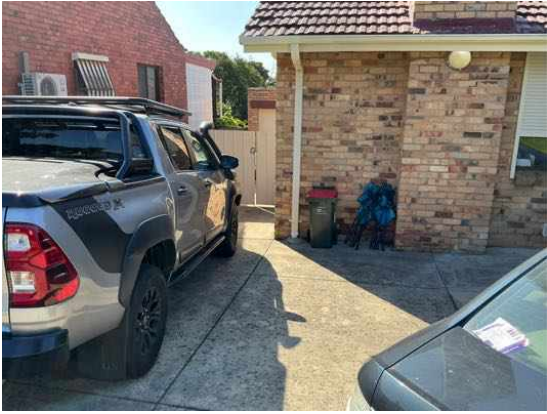
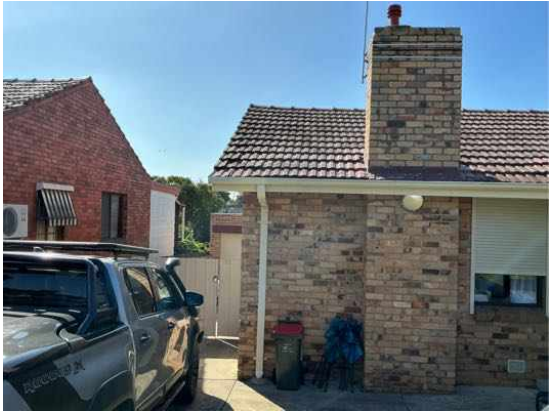
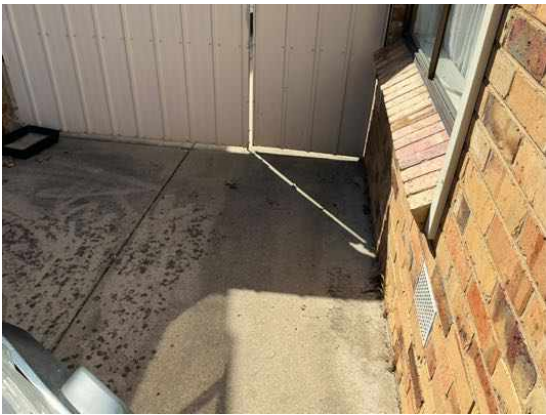
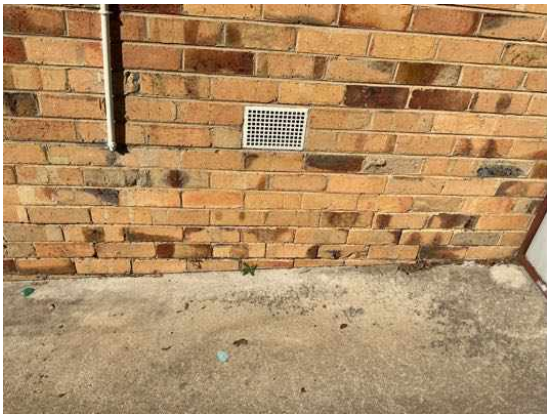
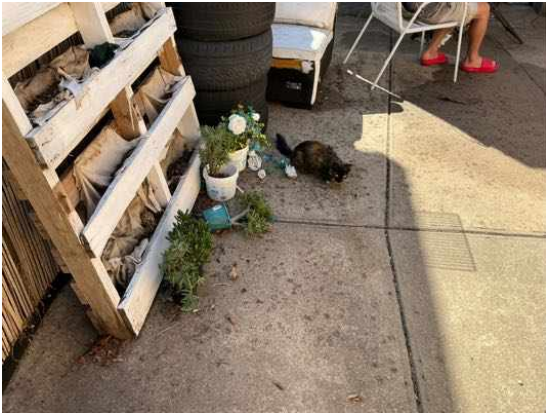
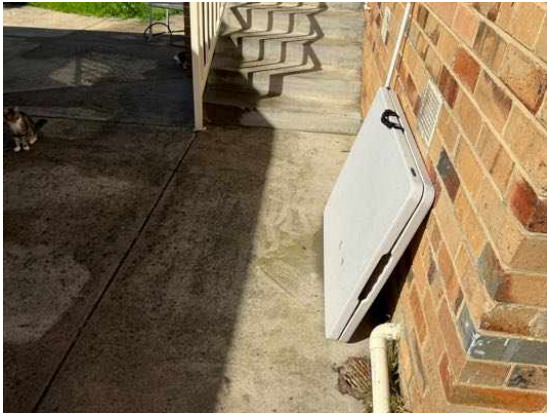
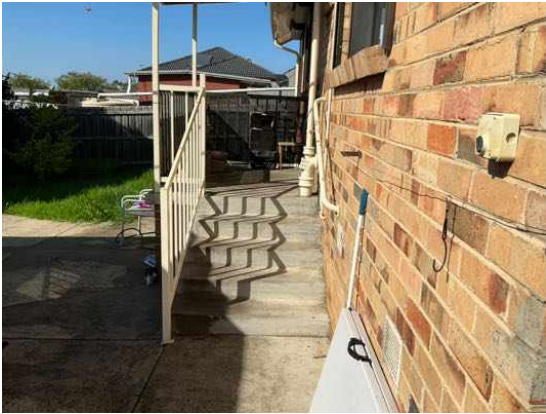
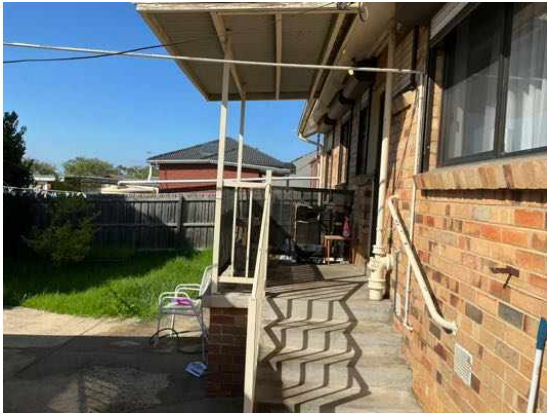
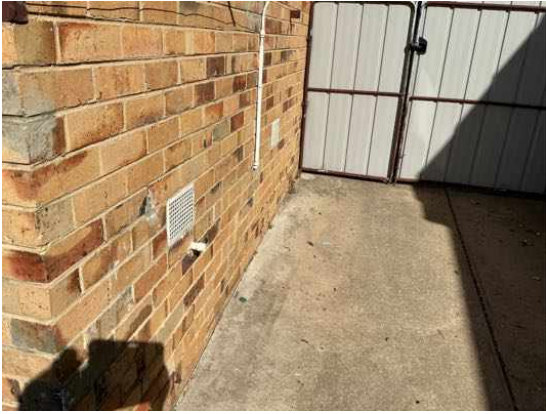
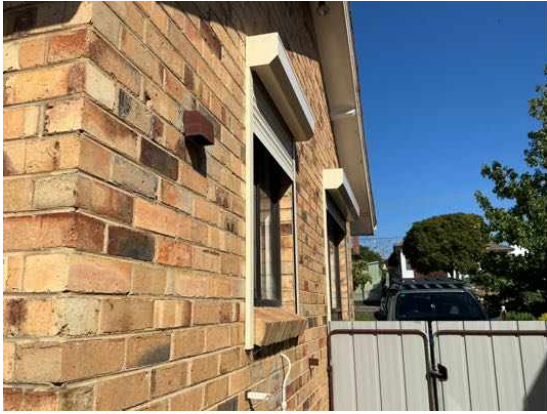
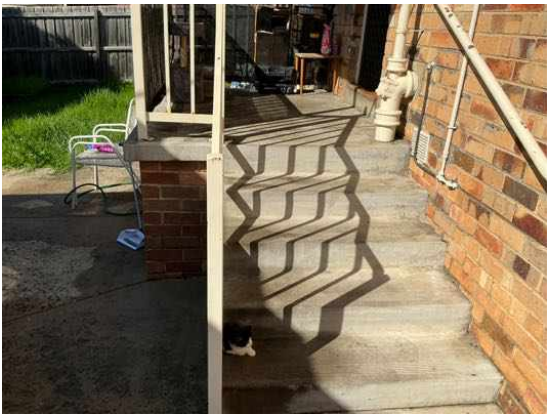
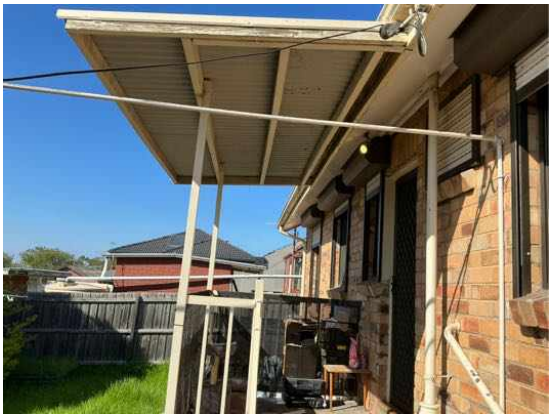
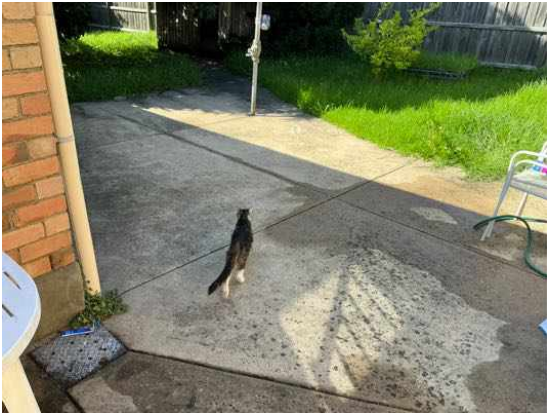
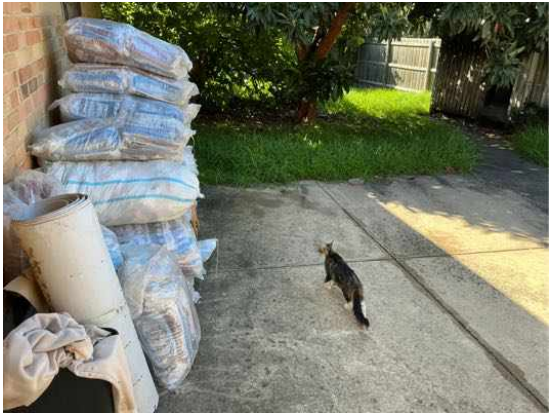
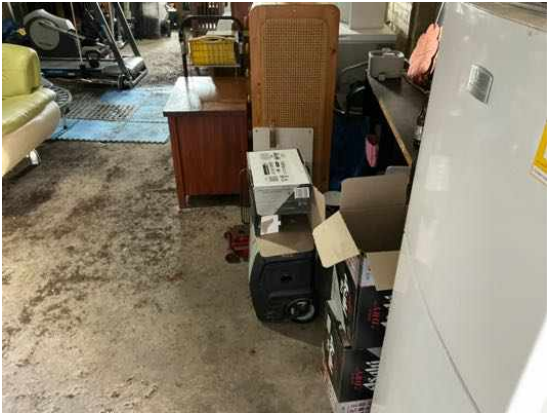
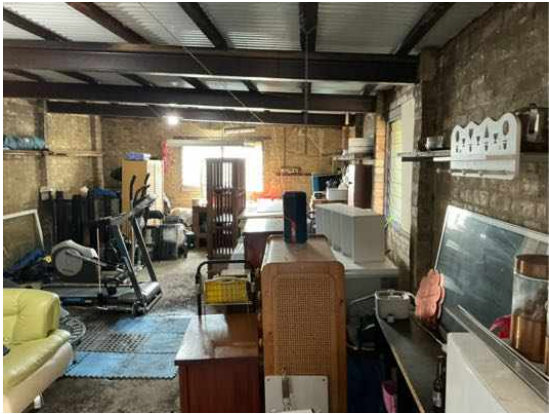
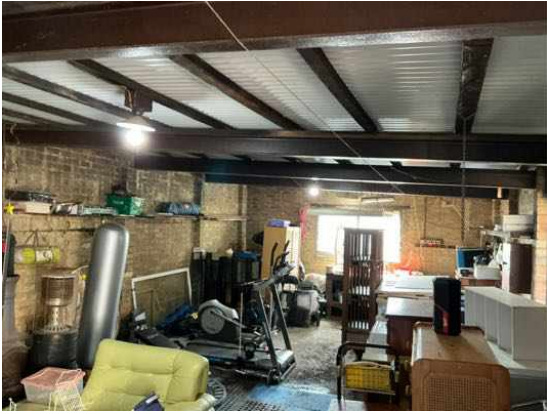
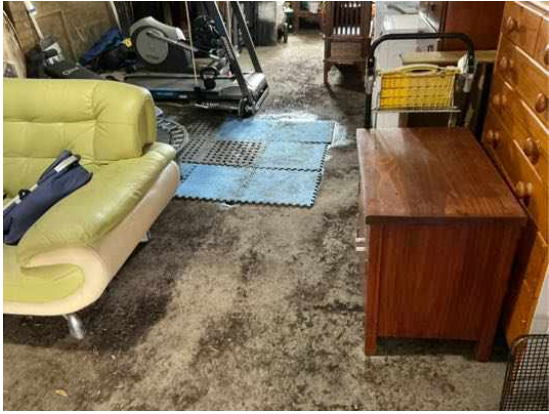
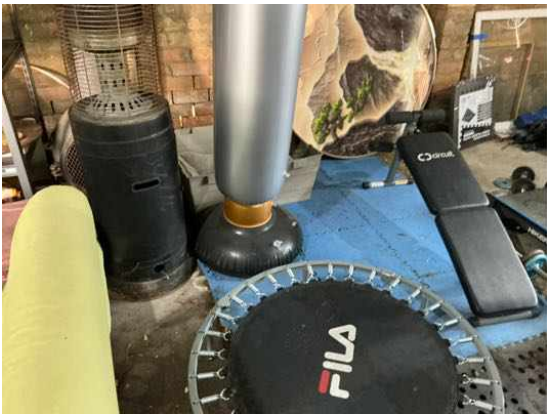
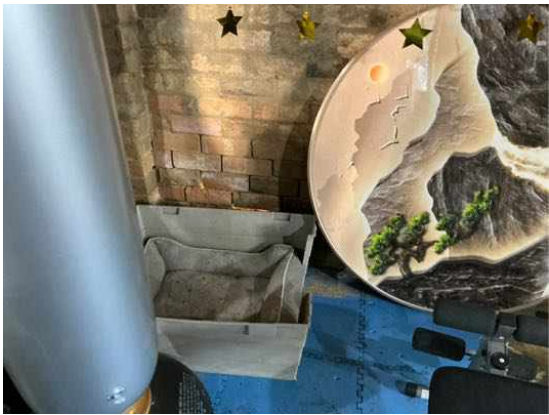
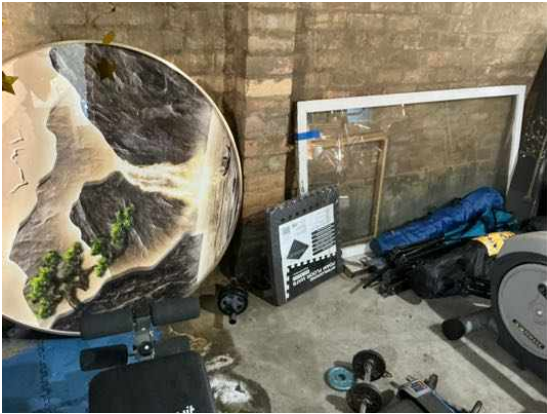
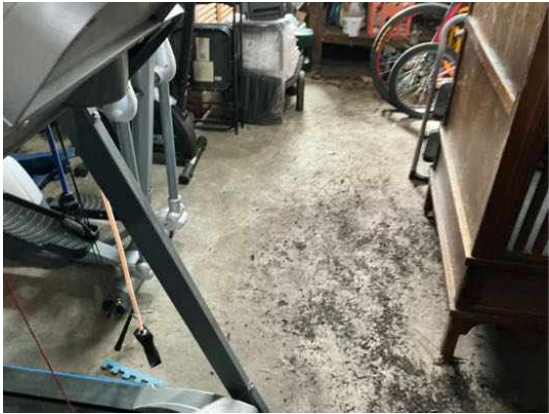
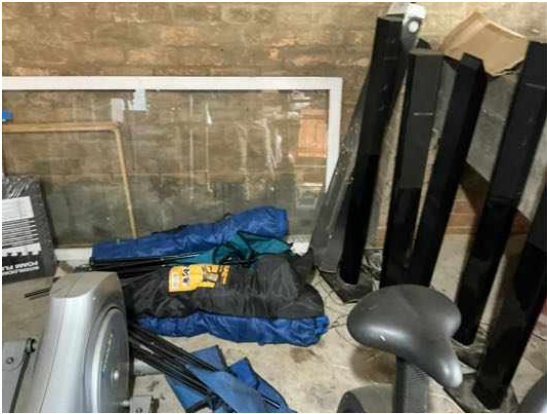
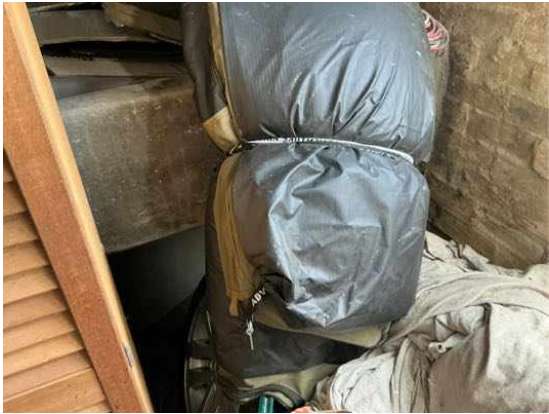
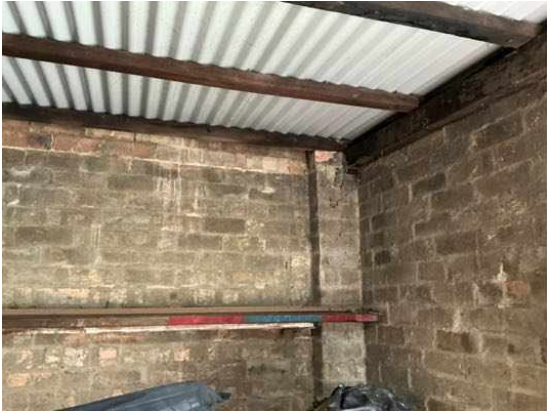
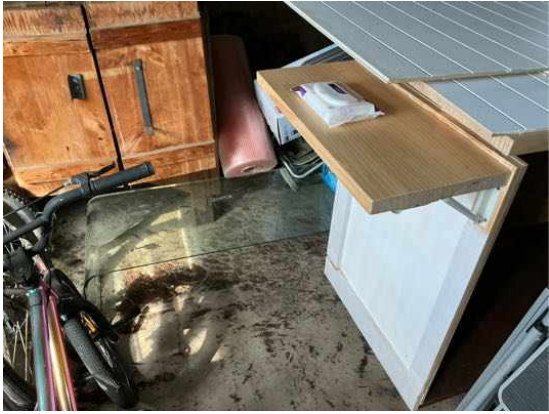
Building: Main Building
 Location: All Areas
 Finding: Additional Photos - Obstructions and Limitations
 Information: These photographs are an indication of the obstructions and limitations which impeded full inspection of the property at the time of inspection. These obstructions can hide an array of defects and should be removed to allow full inspection to be carried out. A re-inspection is recommended once the areas are made accessible.
