Building and Timber Pest Inspection Report

Inspection Date: Tue, 10 Mar 2026

Property Address: 6 Beatrice St, Preston VIC 3072, Australia

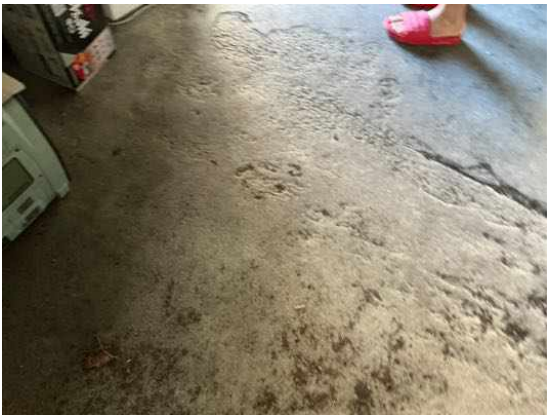
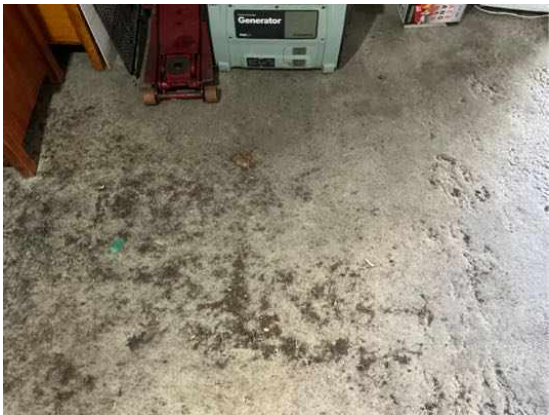
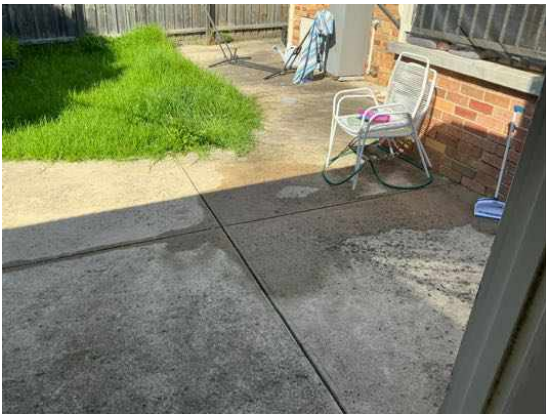
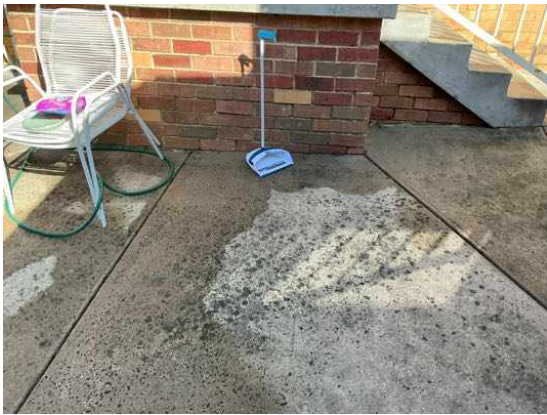
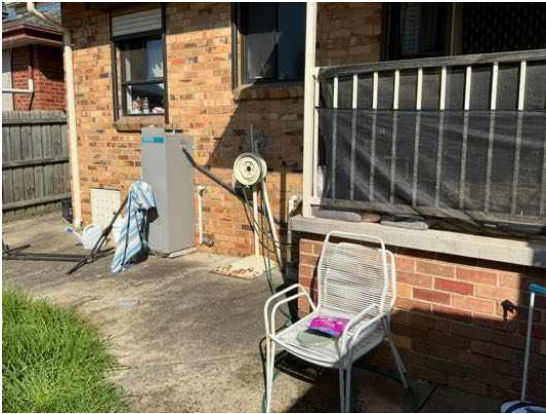
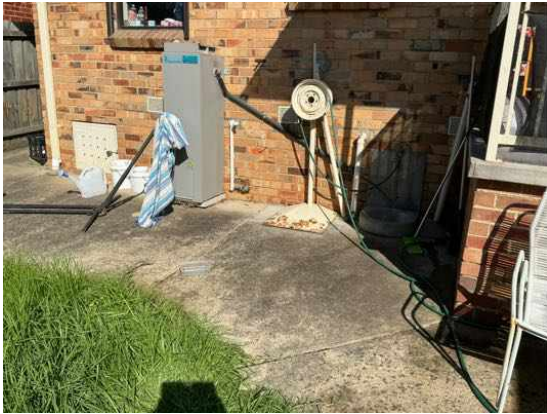
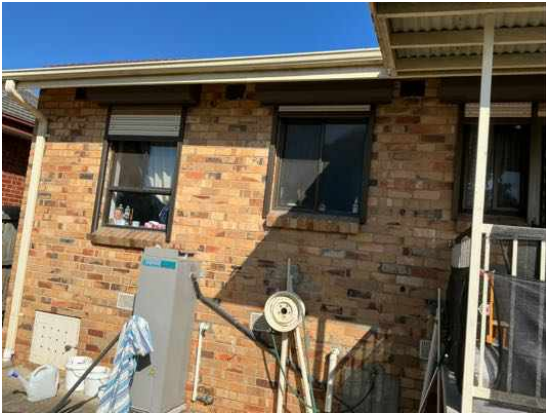
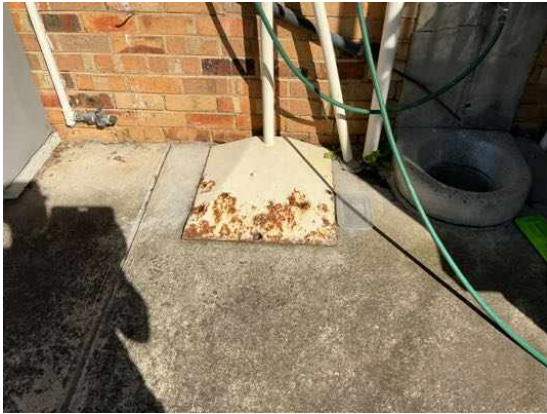
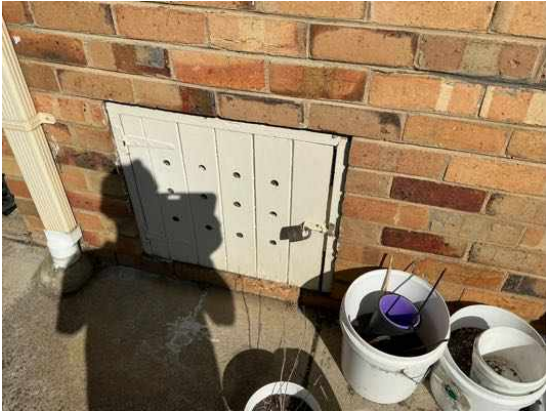
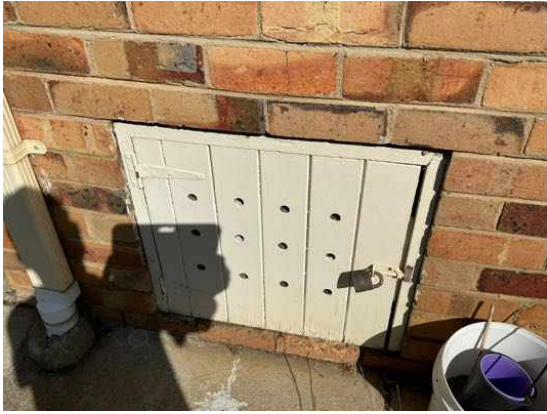
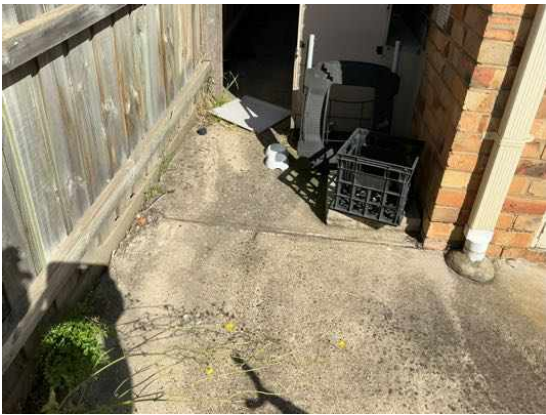
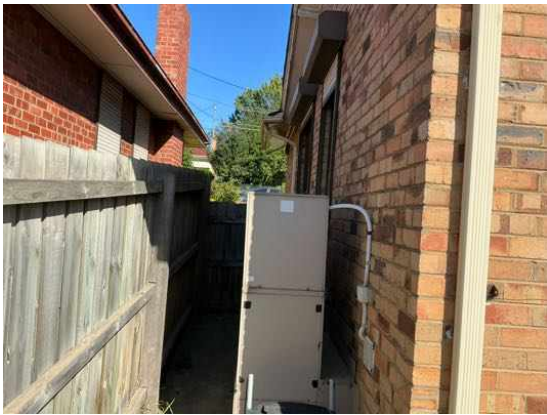
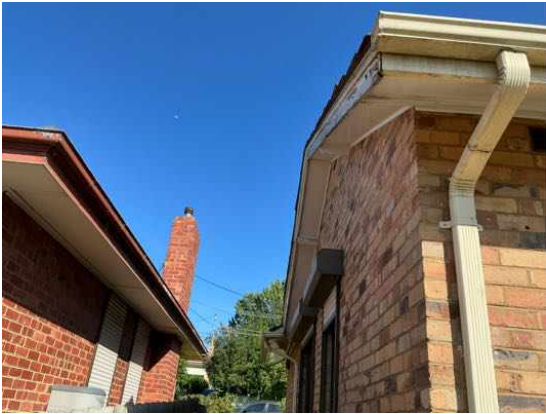
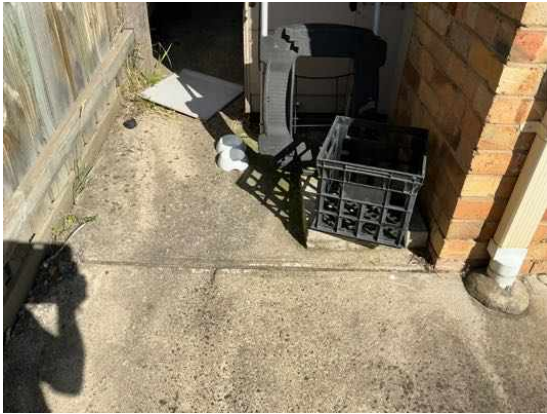
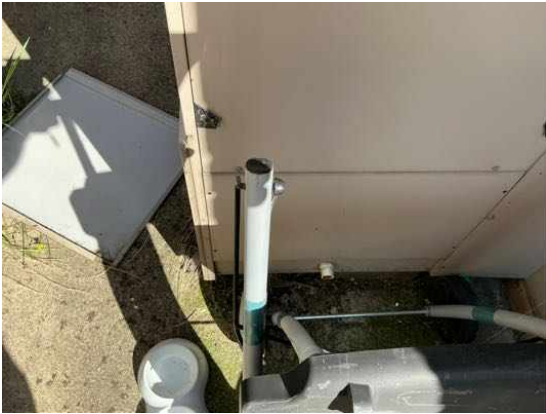
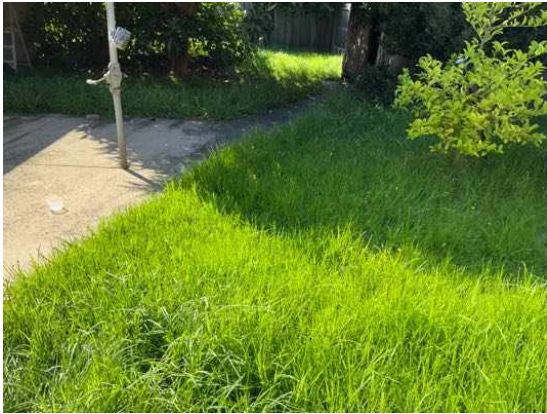
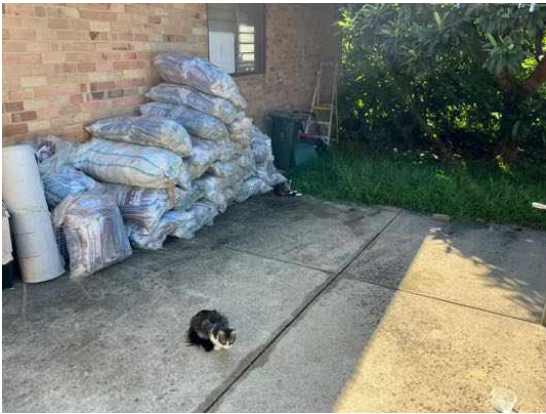
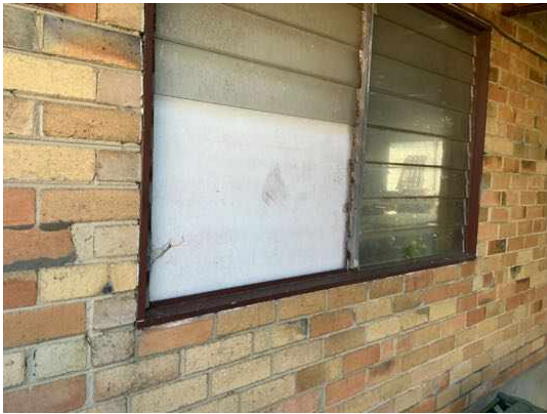
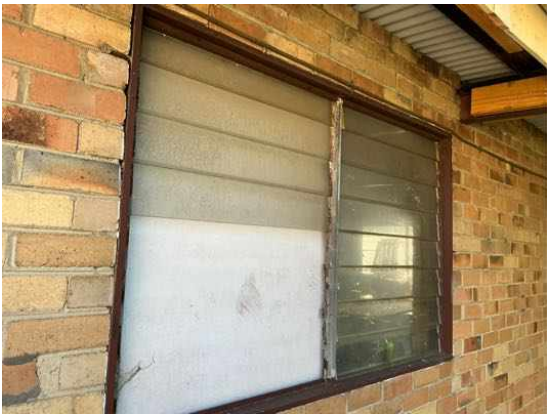
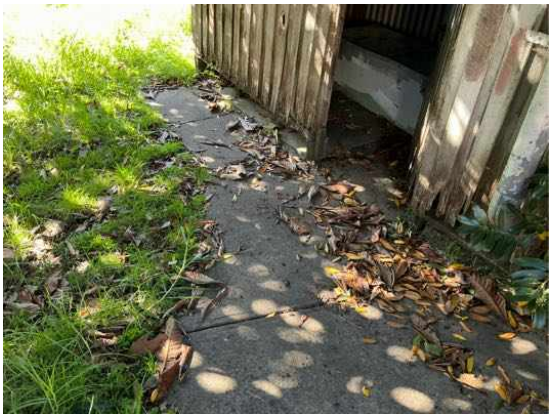
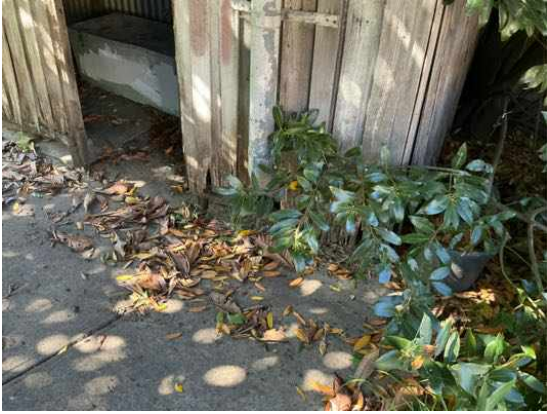
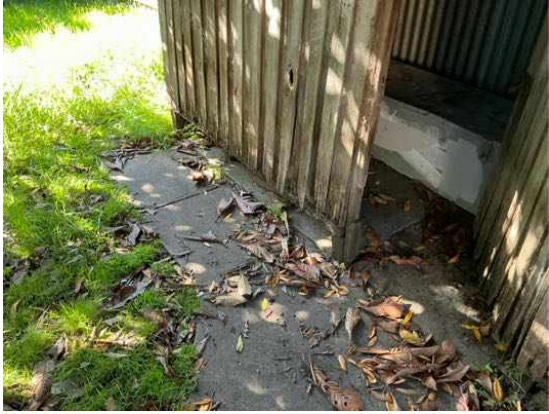
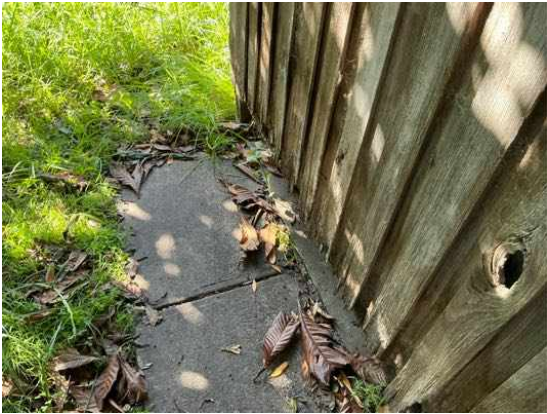
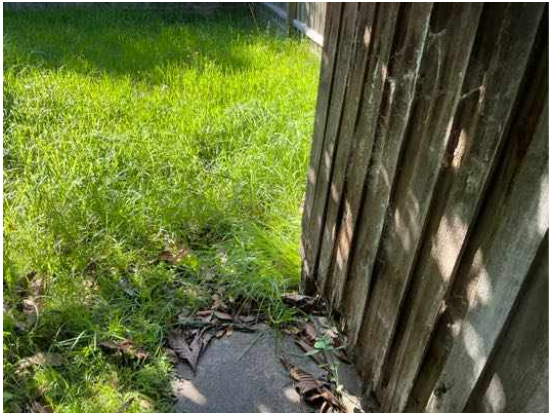
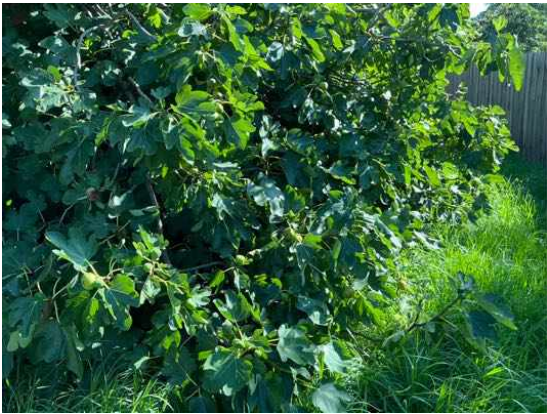
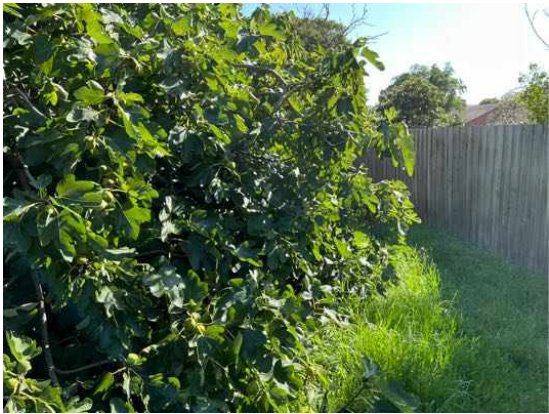
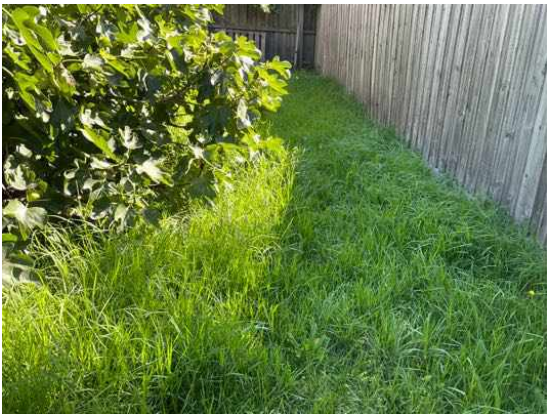
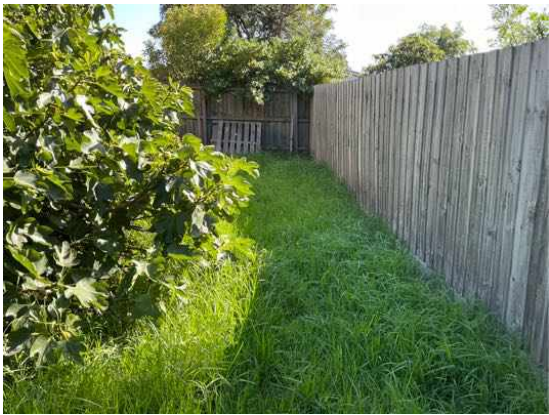
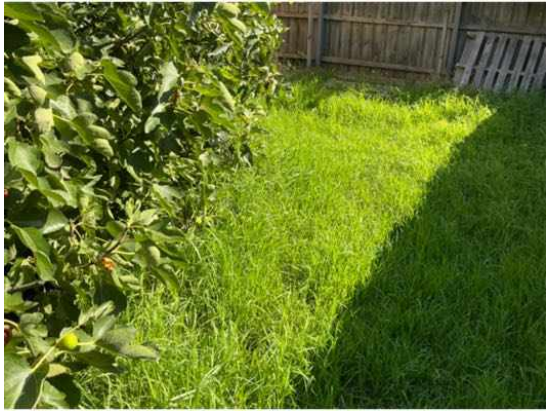
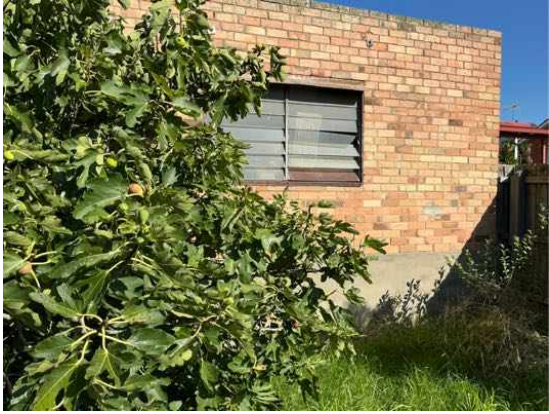
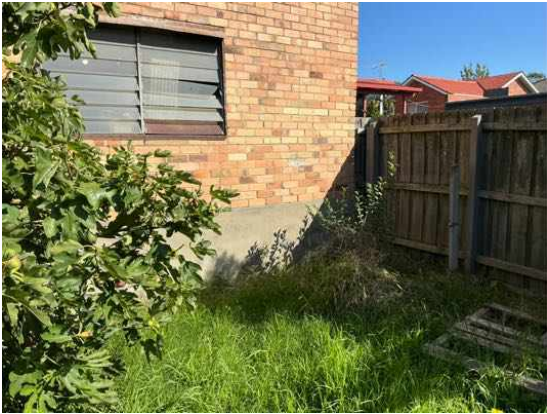
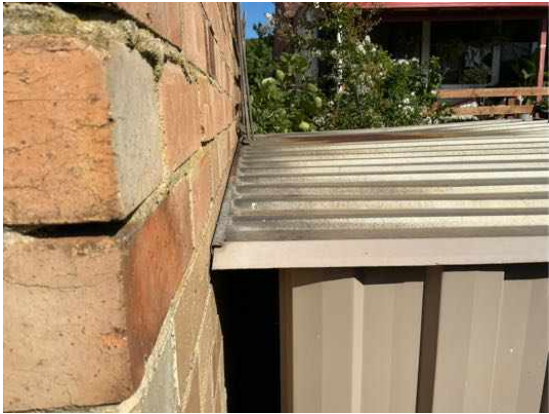
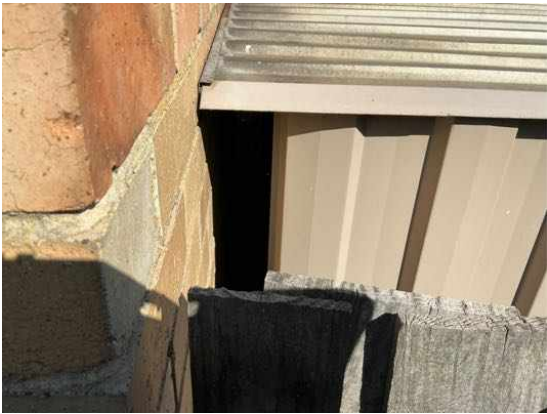
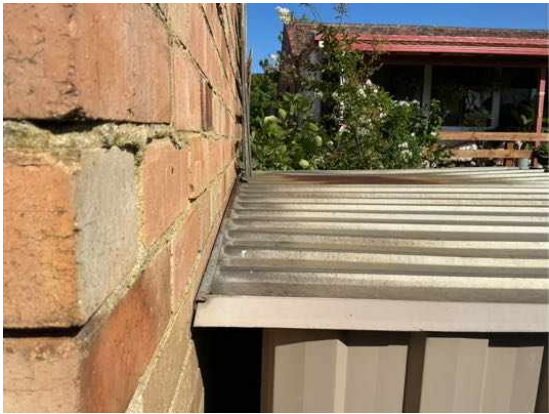
Building: Main Building
 Location: All Areas
 Finding: Additional Photos - Obstructions and Limitations
 Information: These photographs are an indication of the obstructions and limitations which impeded full inspection of the property at the time of inspection. These obstructions can hide an array of defects and should be removed to allow full inspection to be carried out. A re-inspection is recommended once the areas are made accessible.
