Building and Timber Pest Inspection Report

Inspection Date: Wed, 5 Nov 2025

Property Address: 7 Courtenay Rd, Rose Bay NSW 2029,
Australia

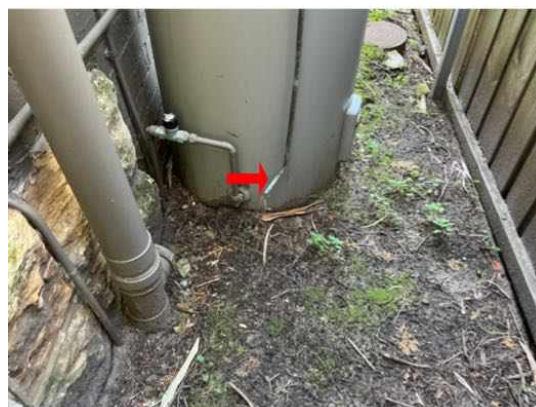
Building:	Main Building
Location:	Exterior walls - right side
Finding:	HWS Overflow - Not Connected
Information:	The Hot Water System (HWS) overflow was found to be disconnected from storm water drainage and is creating excessive moisture in the surrounding area.

These damp conditions can lead to secondary defects such as rot, rust or corrosion of associated building elements, the formation of fungal decay, or even the creation of potential slip hazards. When coupled with poor site drainage, pooling of water may also attract termite activity to this area.

It is highly recommended that a licensed plumber be appointed to connect the HWS overflow in order to prevent such an environment from being created. These minor works should be carried out as soon as possible.

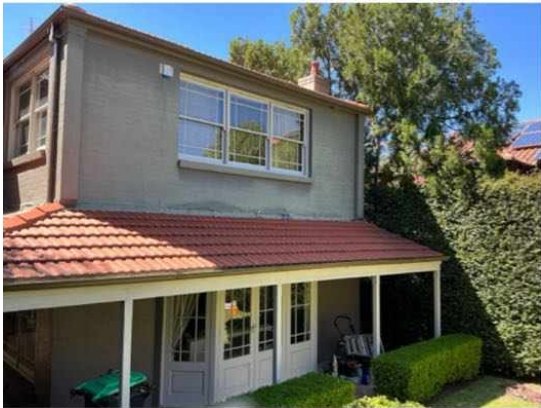
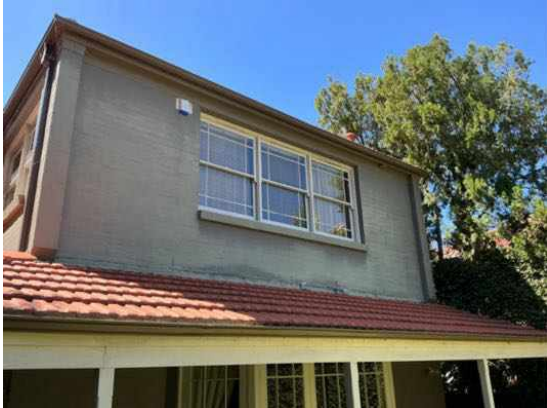
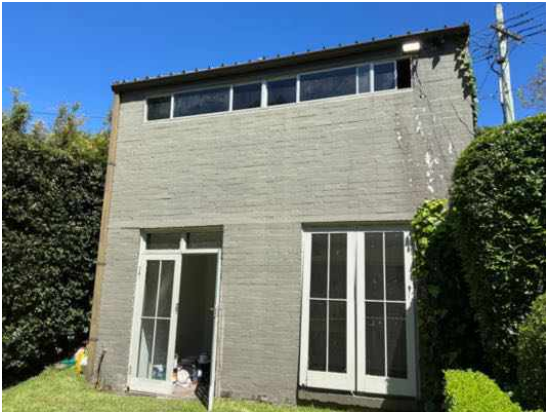
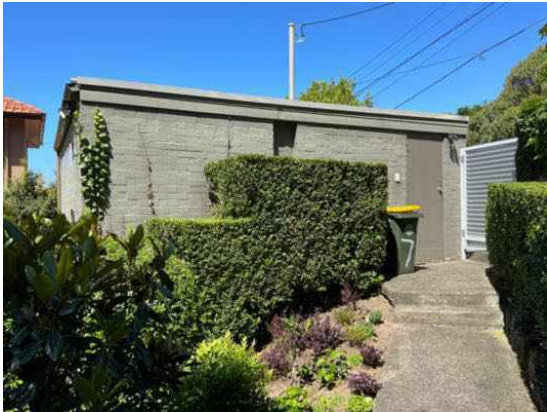
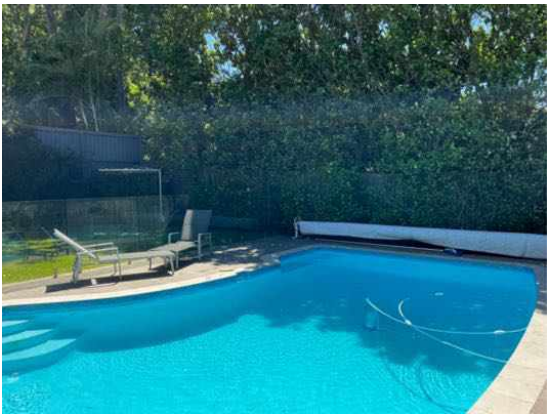
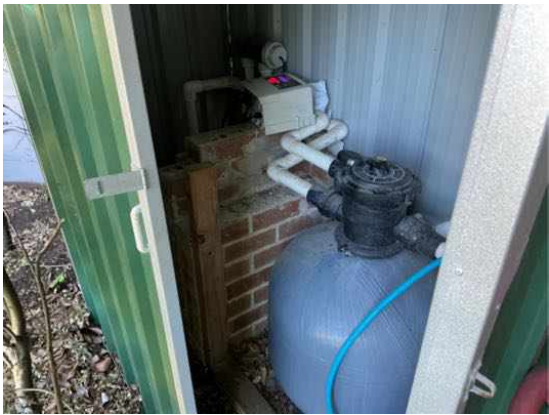
Building: Main Building
Location: All Areas
Finding: Additional Photos - Obstructions and Limitations
Information: These photographs are an indication of the obstructions and limitations which impeded full inspection of the property at the time of inspection. These obstructions can hide an array of defects and should be removed to allow full inspection to be carried out. A re-inspection is recommended once the areas are made accessible.

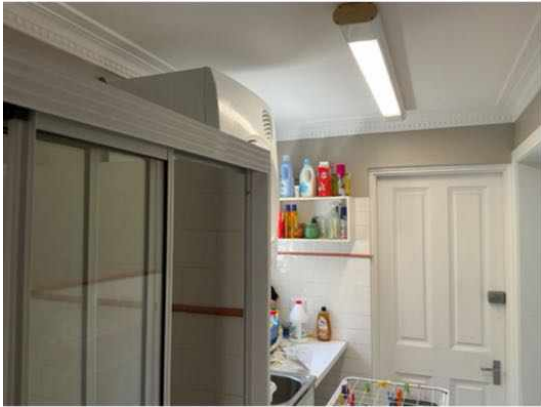
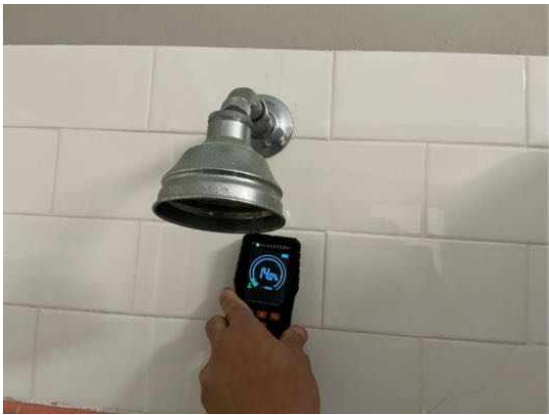
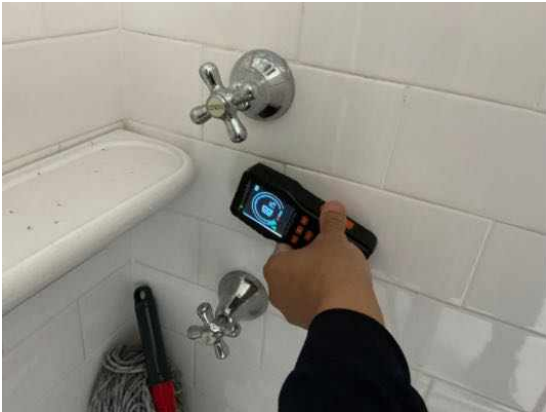
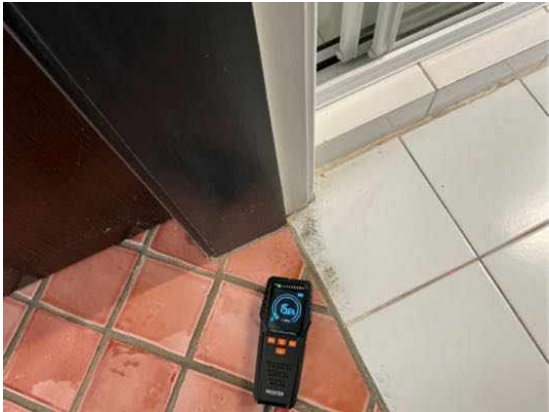
Building:	Main Building
Location:	Laundry
Finding:	No high moisture reading found
Information:	During the home inspection, These areas were checked using a moisture meter, and no high moisture readings were detected.

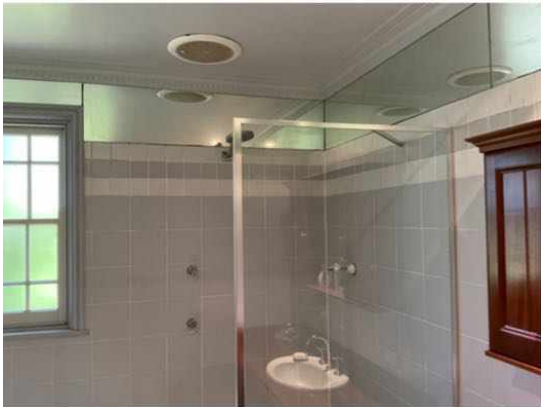
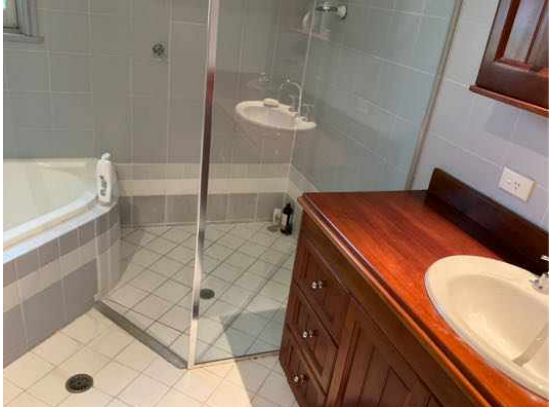
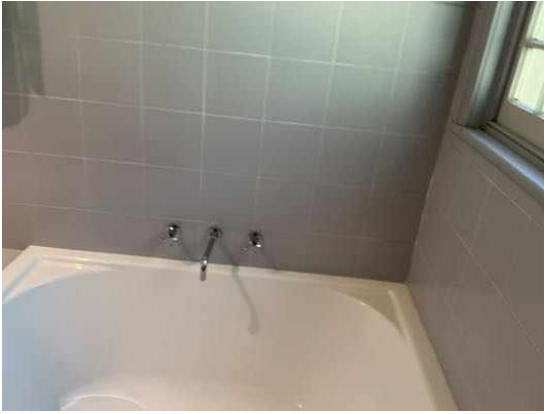
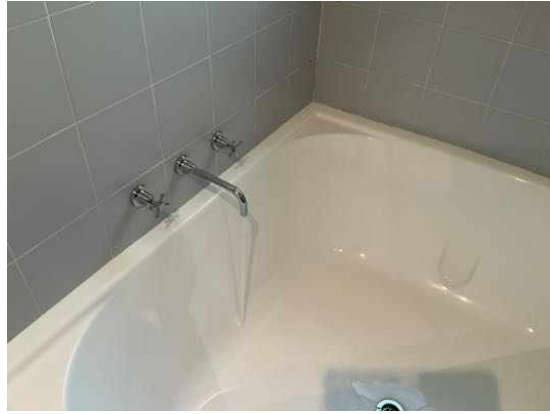
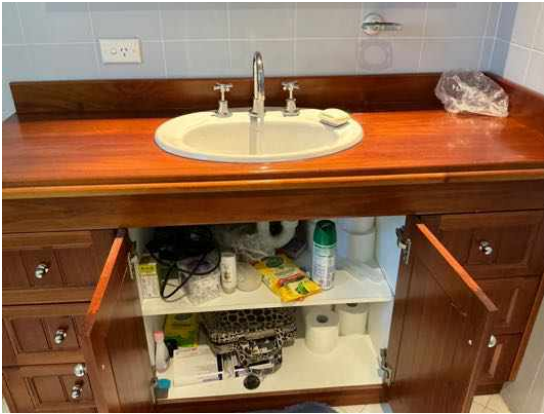
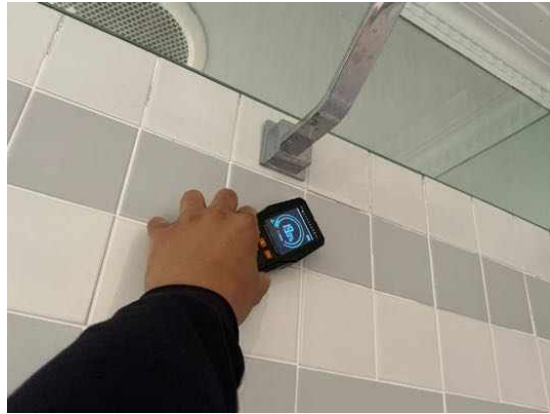
Building: Main Building
Location: Ensuite - Master
Finding: No high moisture reading found
Information: During the home inspection, These areas were checked using a moisture meter, and no high moisture readings were detected.

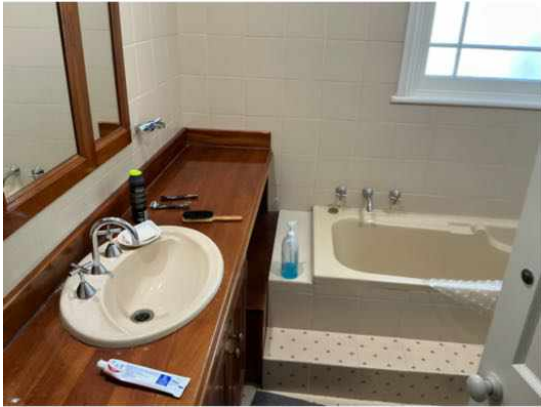
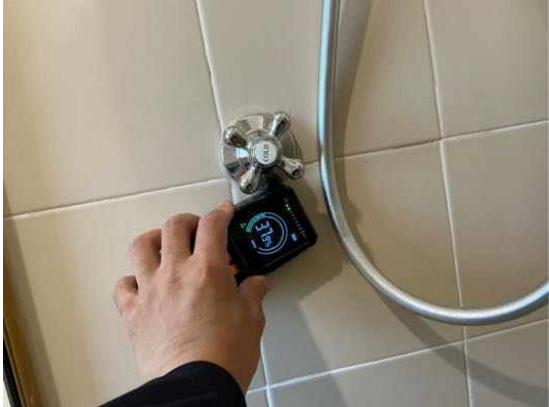
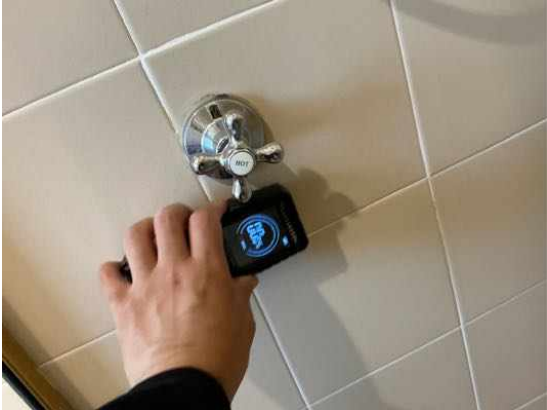
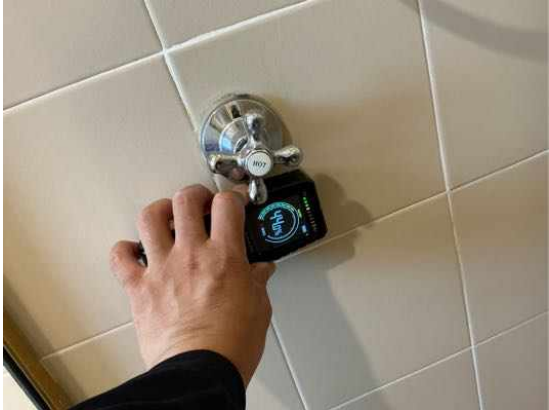
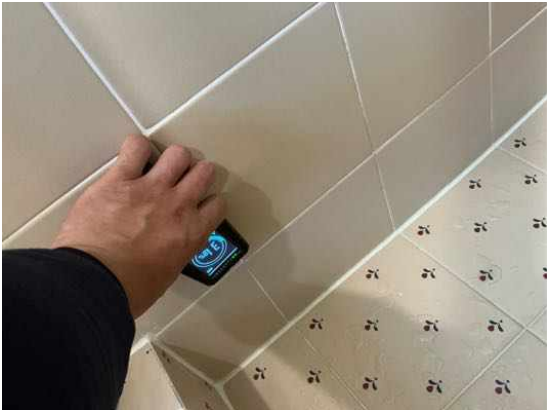
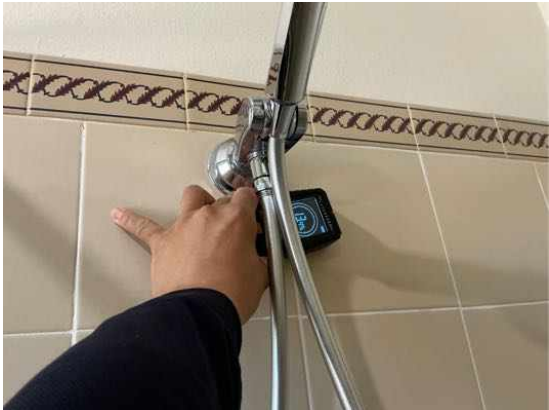
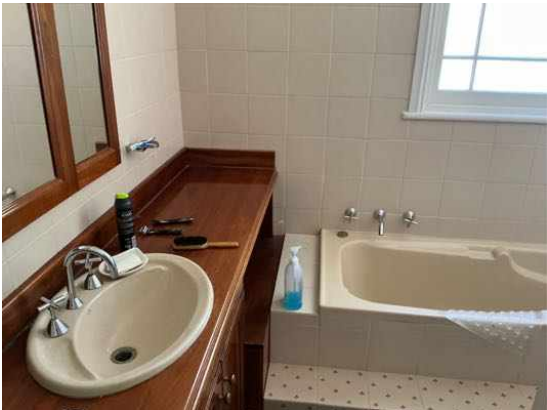
Noted Item

Building: Main Building
Location: Bathroom
Finding: No high moisture reading found
Information: During the home inspection, These areas were checked using a moisture meter, and no high moisture readings were detected.

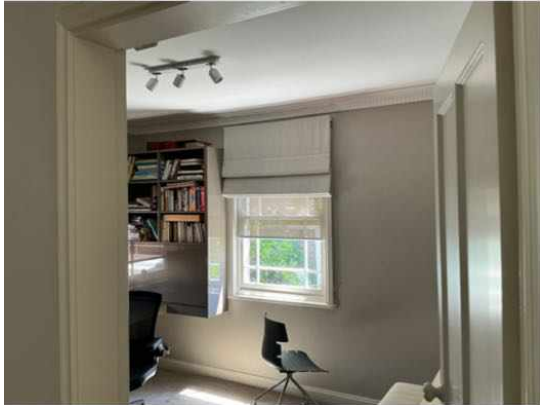
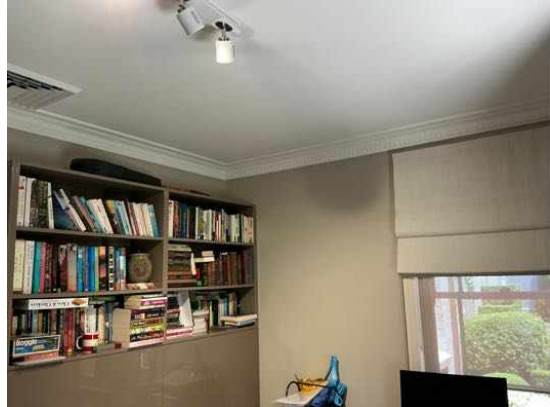
Noted Item

Building: Main Building
Location: Study
Finding: No Visible Defects
Information: Additional photos are provided for your general reference

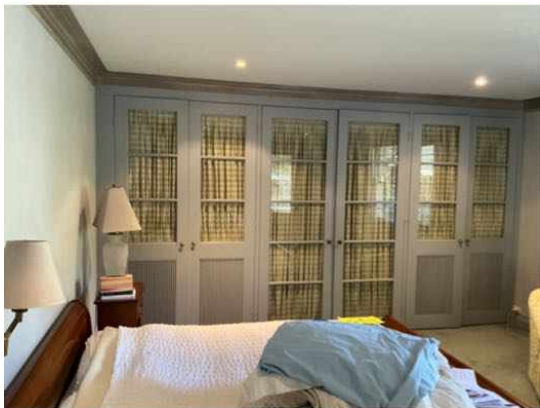
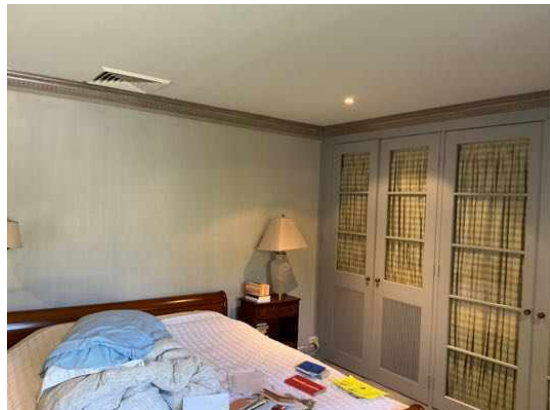
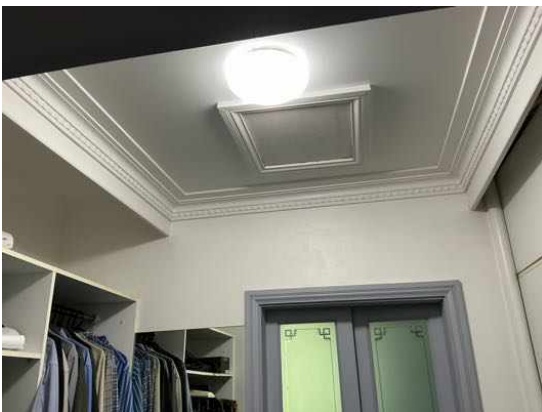
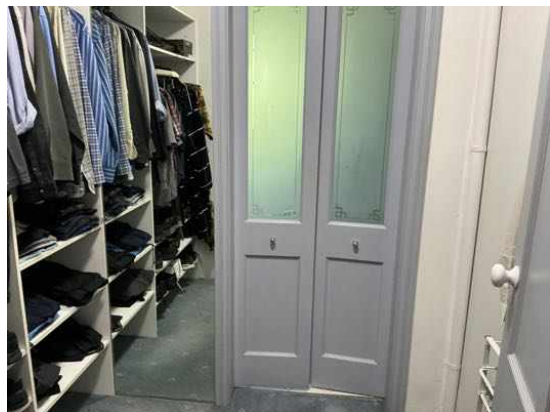
Noted Item

Building: Main Building
Location: Bedroom - Master
Finding: No Visible Defects
Information: Additional photos are provided for your general reference
