Building and Timber Pest Inspection Report

Inspection Date: Thu, 26 Feb 2026

Property Address: 201A Wellington Rd, CHESTER HILL, NSW,
2162, Australia

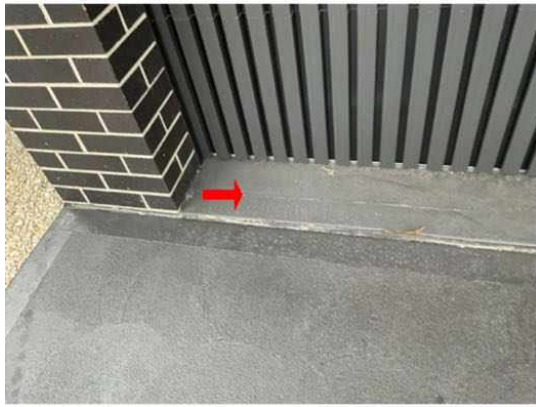
| Information: | It was observed that the house requires cleaning. |

Works are defective where windows are not clean, floors are not swept, mopped or vacuumed as appropriate, tiles, sinks, basins, baths, windows or any other area throughout the property are not cleaned, and shelving, drawers and cupboards are not ready for use not cleaned and ready for use at handover.

Building sites are defective if they are not clear of building debris.

This is to be addressed prior to handover.

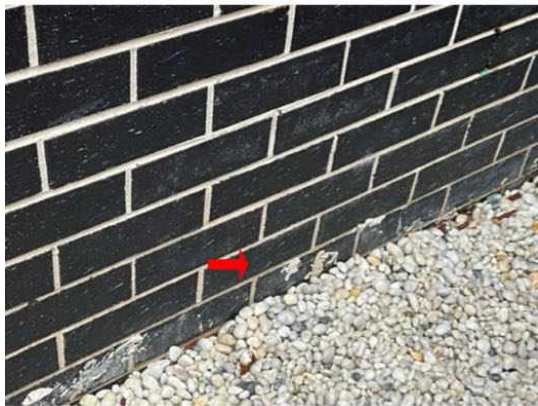
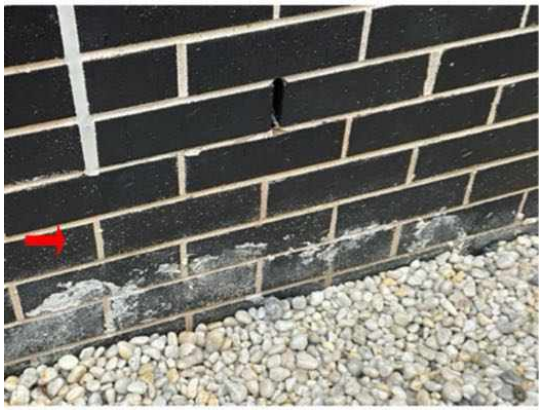
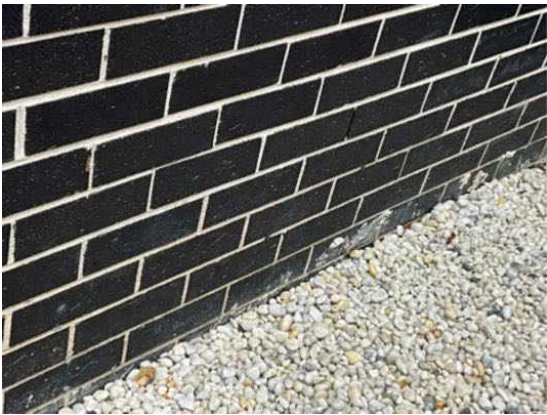
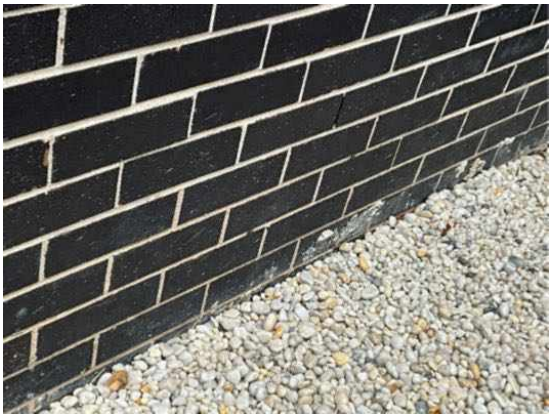
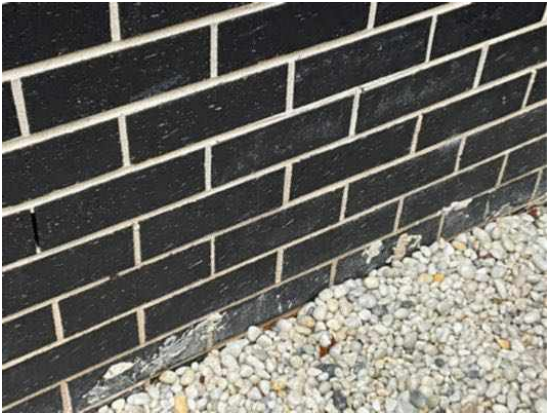
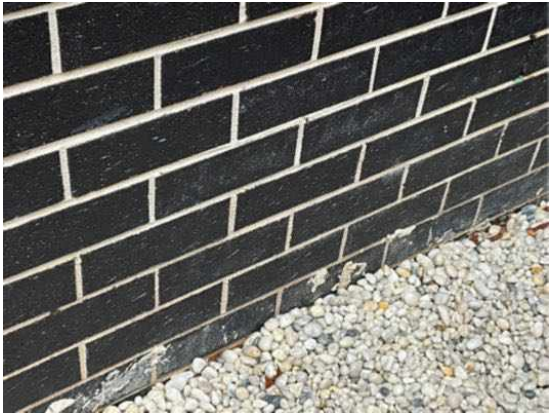
Building: Main Building
Location: All Areas
Finding: Brickwork - Excessive mortar (AS4455)
Information: It was observed at the time of inspection that several bricks in this area of brickwork require cleaning to remove excessive mortar. While not likely to cause secondary defects, excessive mortar detracts from the overall appearance of the area and should therefore be removed.

At the time of inspection, this area does not meet contractual requirements regarding acceptable finishes. The responsible contractor should be appointed to complete these works in order to comply with standards and regulations. Such works should be completed prior to final handover.

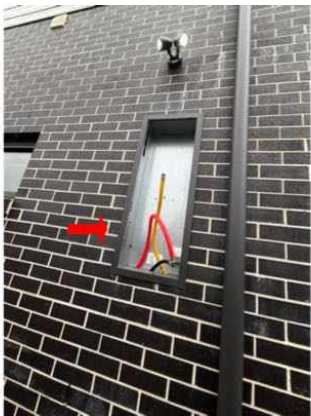
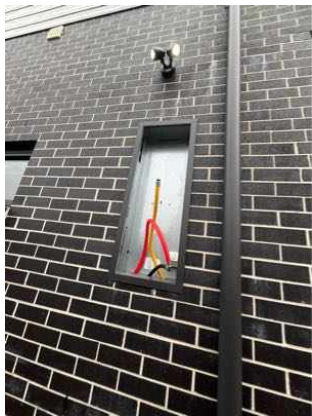
Finding 3.03

Building: Main Building
Location: Exterior walls - left side
Finding: Hot water unit - gap/ not plumb
Information: A gap between the hot water unit and the wall, the box is not plumb. The hot water unit box has not been installed correctly. This is to be rectified prior to handover.

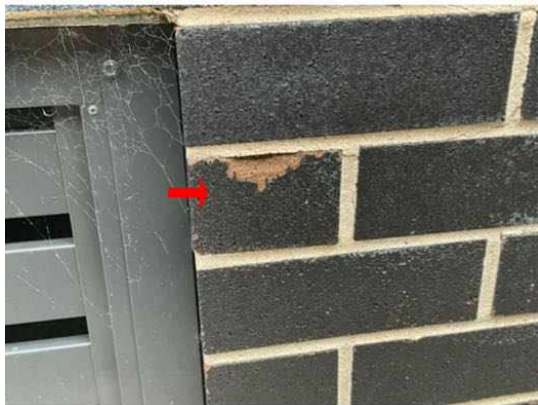
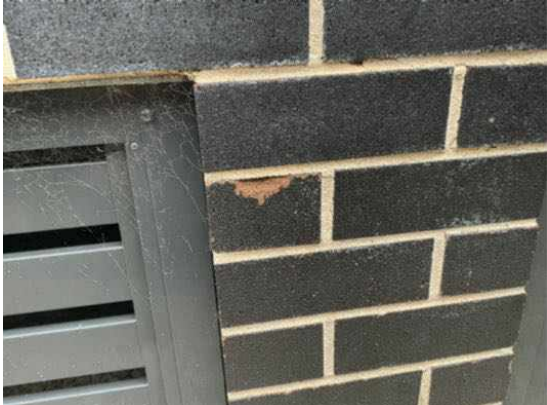
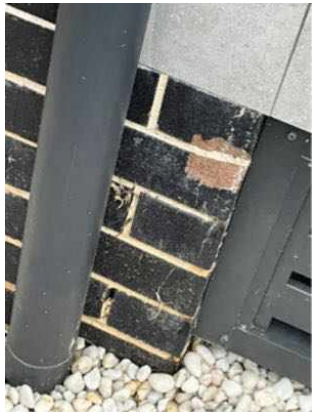
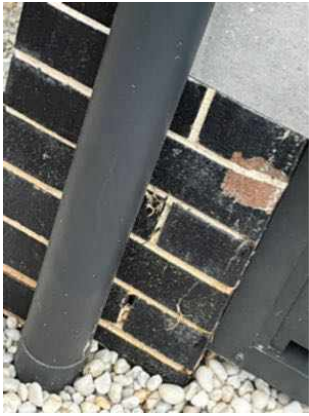
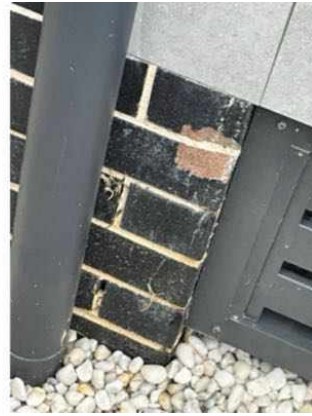
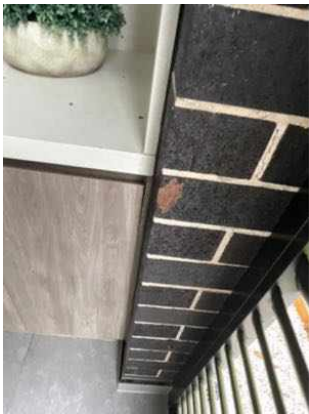
Finding 3.04

Finding: Masonry Facing Defective
Information: Instances of holes in the mortar to the external brickwork have been identified. Masonry faces are required to be free of damage with reference to Guide To Standards & Tolerances 2017.

Voids and holes in mortar in masonry walls, with the exception of weepholes and vents, are defective if they are visible from normal viewing position, which is 1.5 meters.

All known defects must be rectified prior to handover.

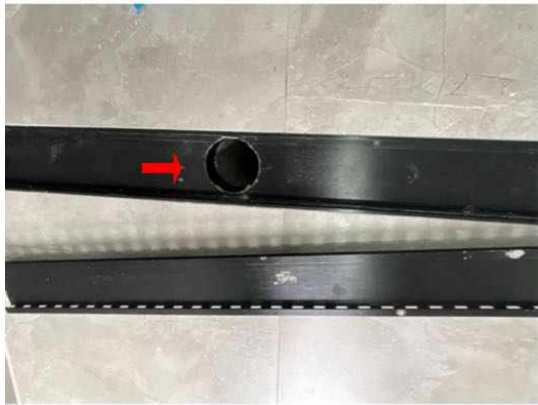
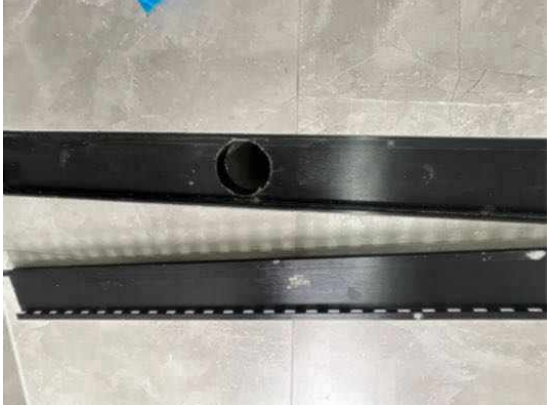
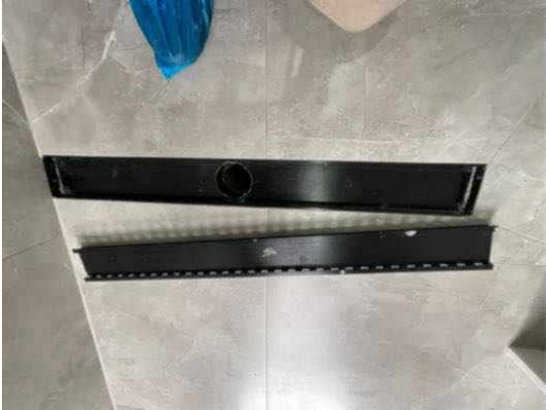
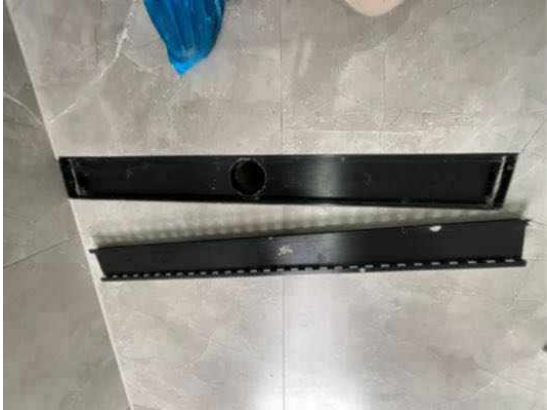
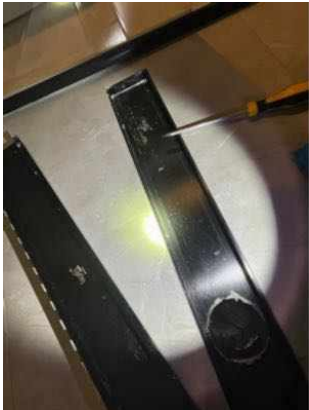
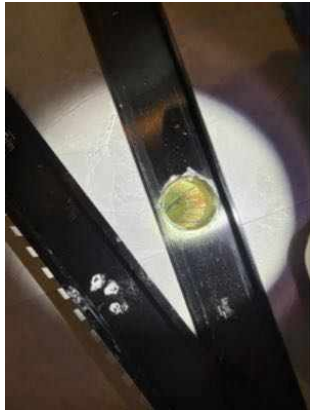
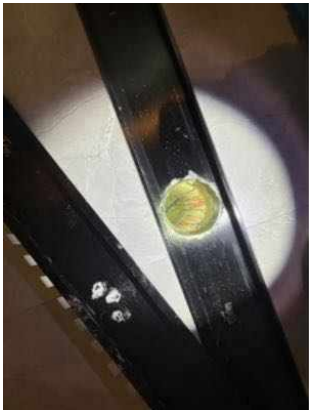
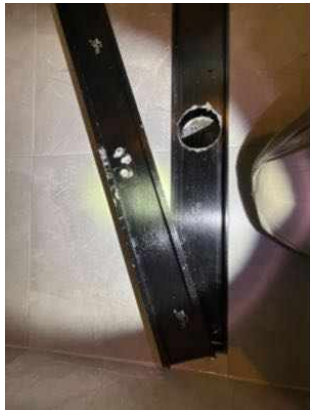
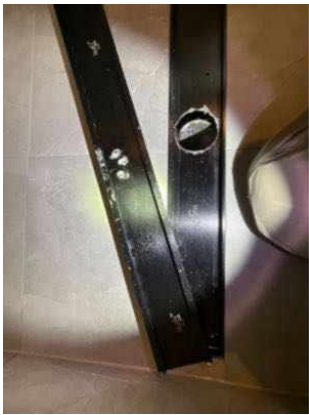
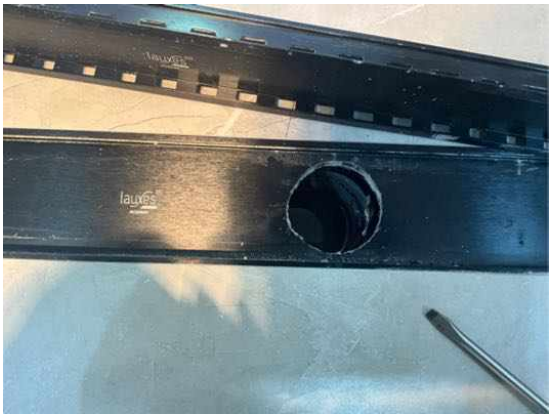
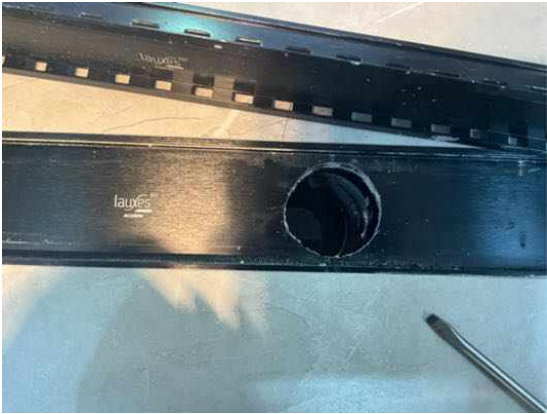
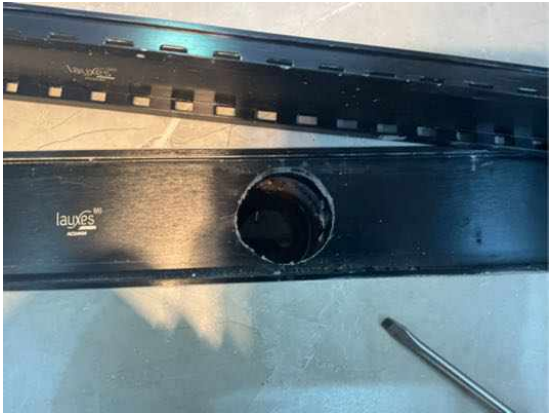
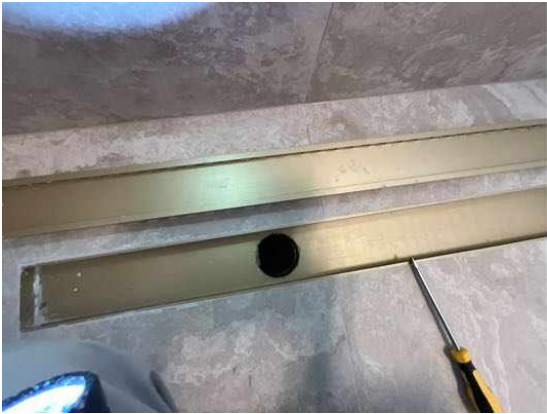
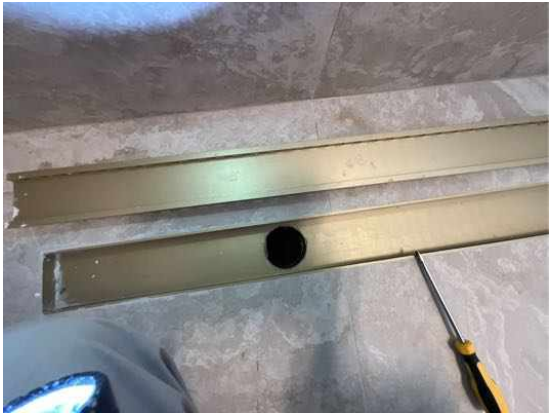
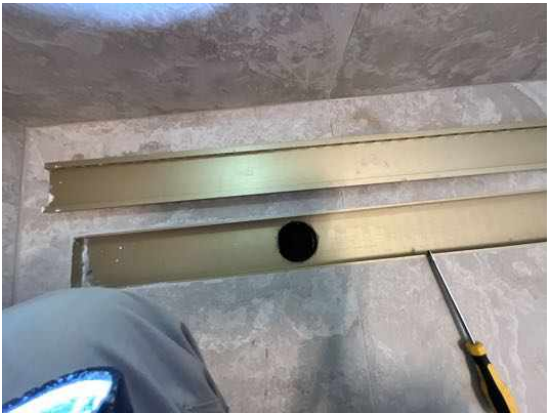
Finding 3.07

| Finding: | Floor waste- missing internal grill component (strainer or insert) |
| Information: | The drain cover in the tiled floor area is missing its internal grill component (strainer or insert), exposing a direct opening into the drain pipe. This is considered a non-compliant installation as the drain cover is incomplete. |

- AS/NZS 3500.2:2021 – Plumbing and Drainage – Sanitary plumbing and drainage requires that all plumbing fittings and fixtures must be installed in a manner that prevents debris from entering the drainage system and ensures the safe operation of the drain.
- The Guide to Standards and Tolerances 2017, Section 13 (Plumbing and Drainage), notes that drainage systems should be installed in accordance with relevant standards, including correct fitting of drain covers and grates to ensure hygiene, safety, and protection from blockages.

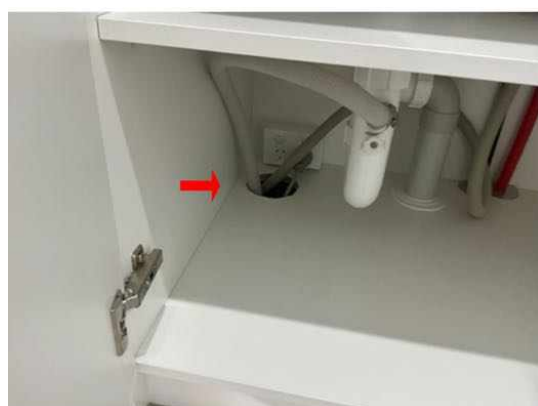
Finding 3.08

Building: Main Building
 Location: Kitchen
 Finding: Pipe Penetrations not capped
 Information: There is an open hole around the pipes under the cabinetry that hasn't been sealed or capped.

- Pests like mice or cockroaches can enter through the gap.
- Water can get in and cause mould or damage to the cabinet.
- It looks untidy and is hard to keep clean.

A plumber or handyman can seal the hole using a cover plate, grommet, or suitable sealant.

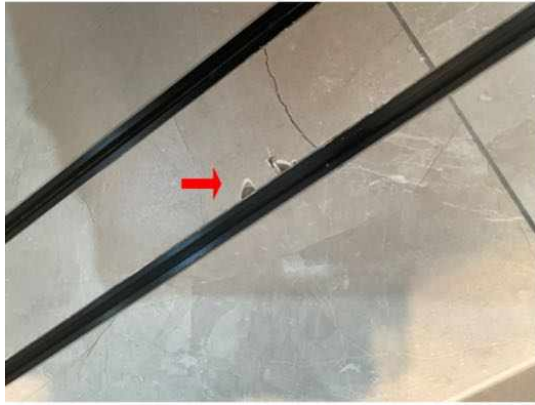
Finding 3.09

Building: Main Building
 Location: Bathroom
 Finding: Tiles - Chipped
 Information: Cracked, pitted, chipped, scratched or loose tiles

Tiles are defective if they are cracked, pitted, chipped, scratched or loose at handover.

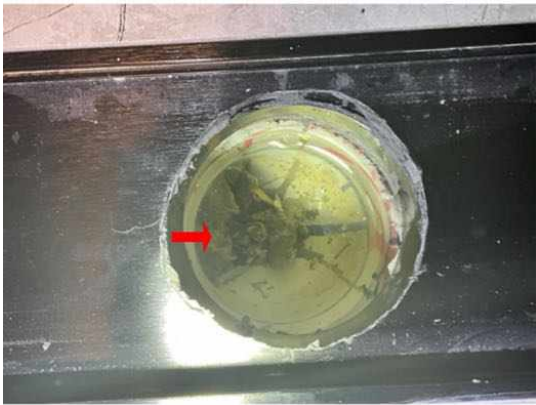
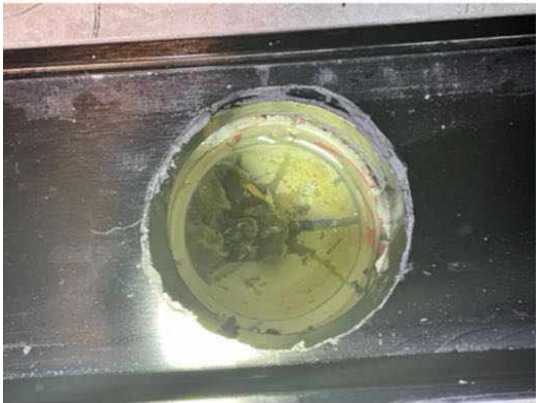
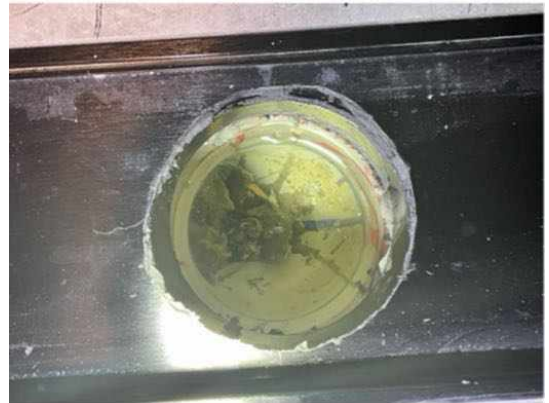
Finding 3.10

| Information: | It was noted that there is builder debris in the floor waste drainage. Debris in the plumbing system may lead to blockages in the future. |

This is referenced against the Australian Standards and Tolerances clause 19.8 Cleaning - Owners are entitled to expect that the building site and works are clean and tidy on completion.

Building sites are defective if they are not clear of building debris. All floor wastes need to be checked and cleared prior to handover.

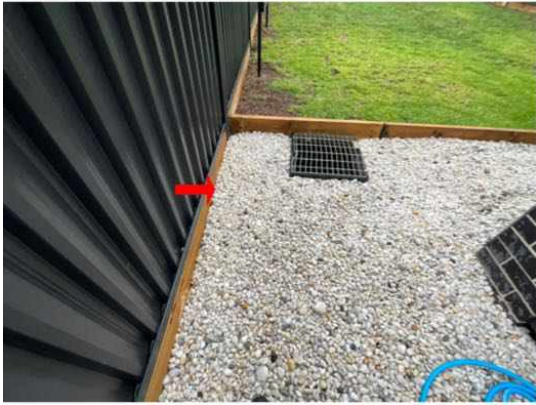
Building: Main Building
Location: All Areas
Finding: Timber on ground / conducive conditions to termite damage
Information: Timber on the ground is indeed conducive to termite damage. Termites are known to thrive in moist environments, and wood in contact with soil or moisture is more susceptible to infestation.

To prevent this, it's important to keep timber elevated and away from direct ground contact. Regular inspections and proper termite control measures are also essential to protect your wooden structures from termite damage.

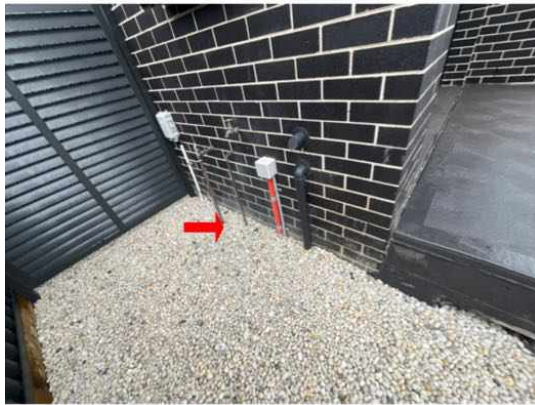
Finding 6.02

| Information: | There is no drain installed under the tap, leading to water accumulation and creating conducive conditions for timber pests. This defect needs immediate attention to prevent potential damage and pest infestation. |

1. Water Accumulation: Without proper drainage, water can accumulate around the base of the tap, leading to persistent dampness in the surrounding area.
2. Timber Pest Infestation: The damp environment created by standing water is highly conducive to timber pests, such as termites and wood borers, which thrive in moist conditions and can cause significant damage to wooden structures.
3. Structural Damage: Prolonged exposure to moisture can lead to wood rot and deterioration of structural timber, compromising the integrity of the building.
4. Health Hazards: Persistent dampness can also promote mold and mildew growth, posing health risks to occupants.
5. Aesthetic Damage: Water stains and damage to finishes and materials around the tap area can detract from the appearance of the building and lead to costly repairs.

A licensed plumber or a qualified building contractor can address this defect by:

3. Repair and Prevention: Inspecting and repairing any existing water damage and implementing measures to prevent future water accumulation and pest infestations.

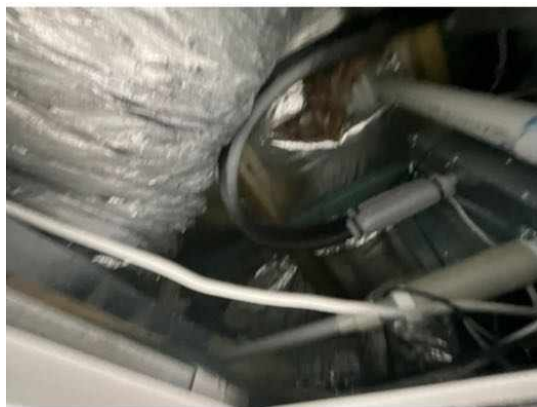
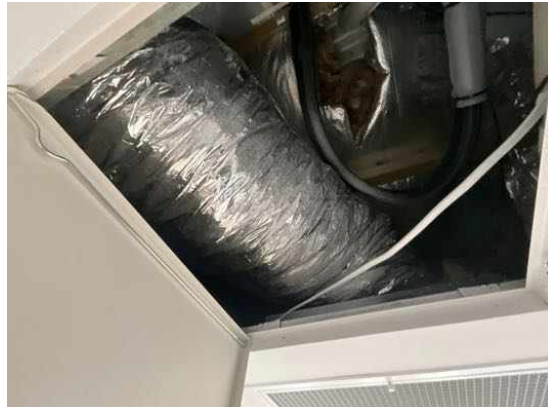
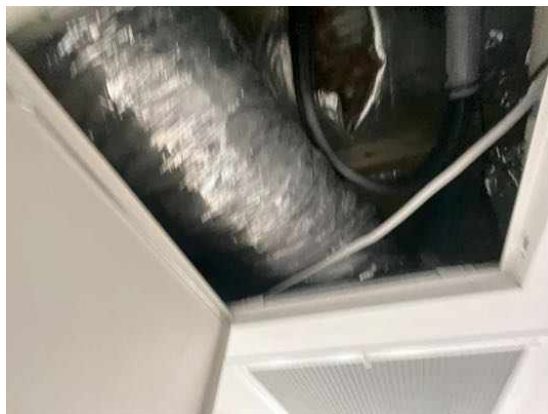
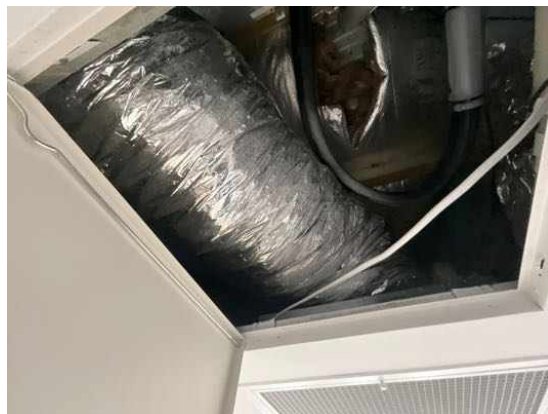
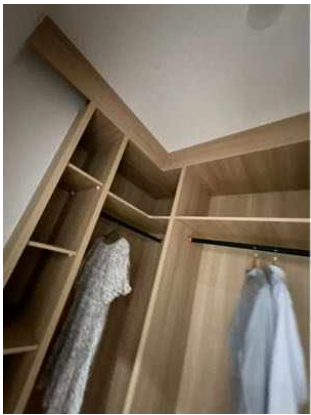
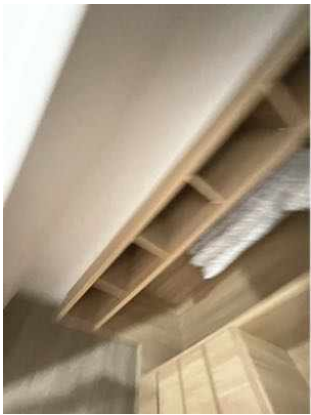
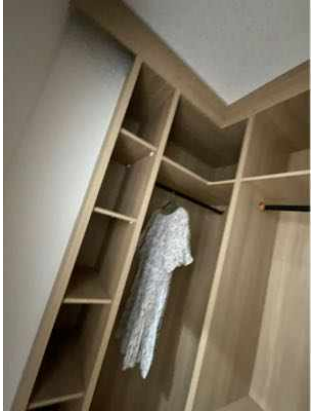
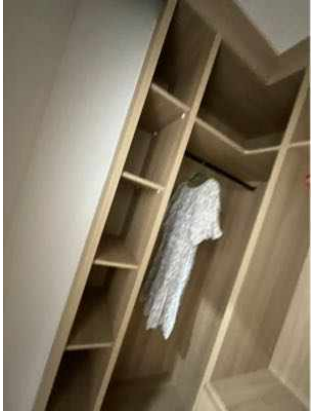
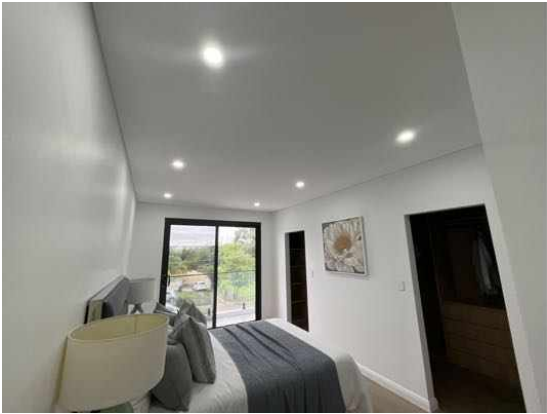
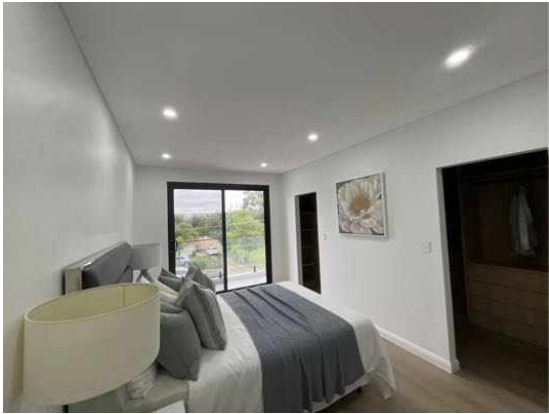
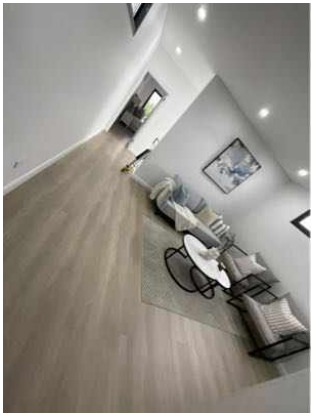
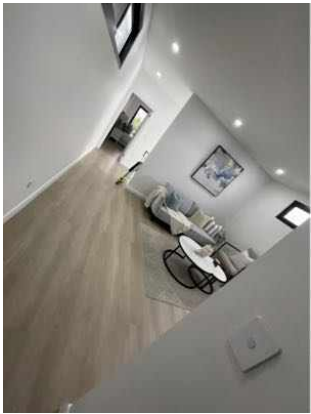
Finding: Additional Photos - Obstructions and Limitations

Information: These photographs are an indication of the obstructions and limitations which impeded full inspection of the property at the time of inspection. These obstructions can hide an array of defects and should be removed to allow full inspection to be carried out. A re-inspection is recommended once the areas are made accessible.

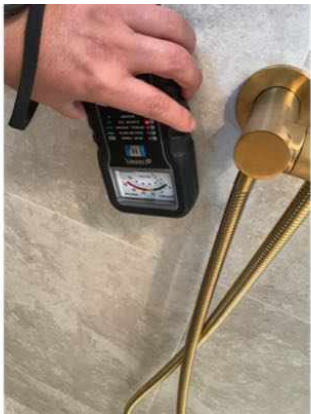
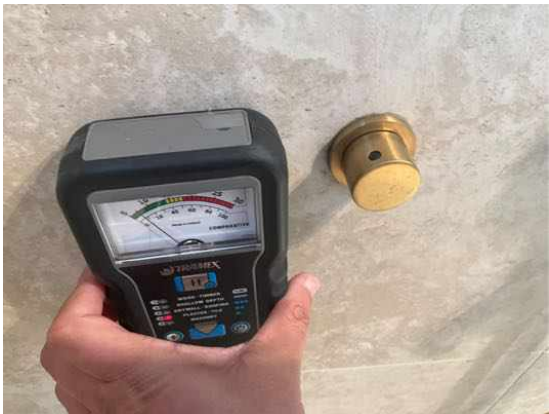
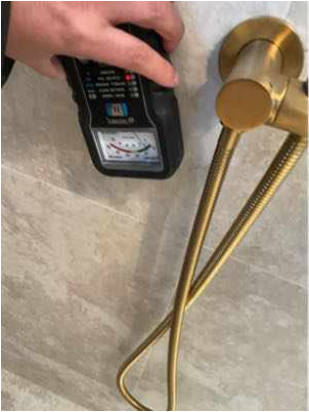
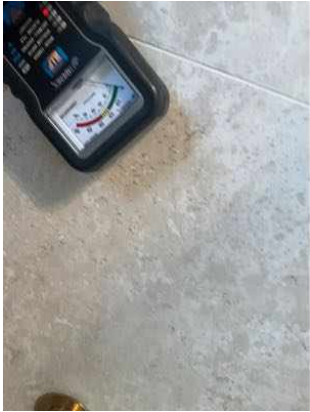
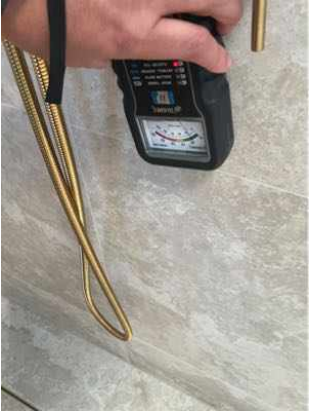
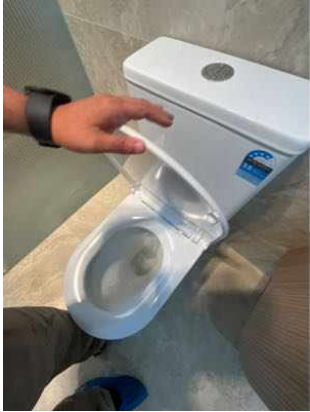
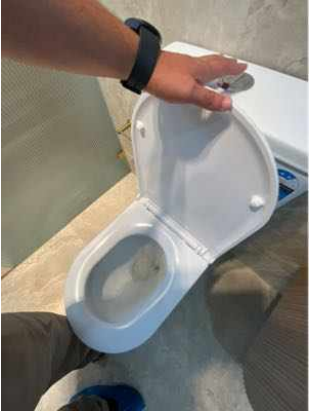
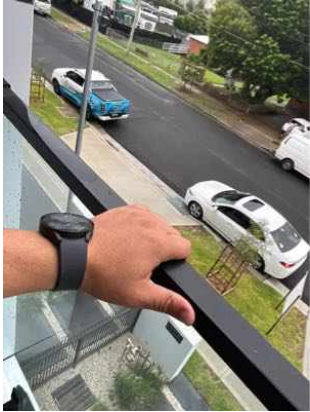
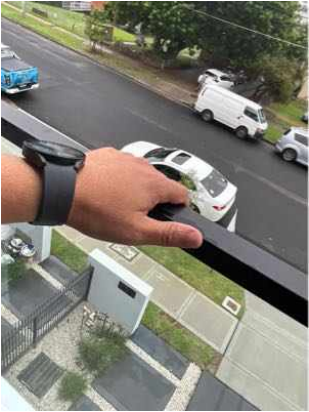
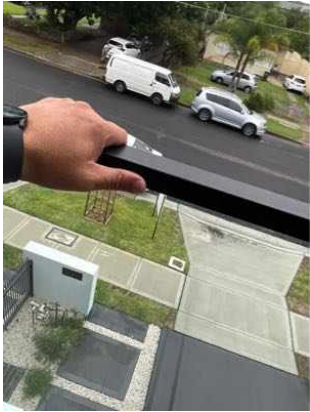
Building: Main Building
Location: All Areas
Finding: Additional Photos
Information: Additional photos are provided for your general reference

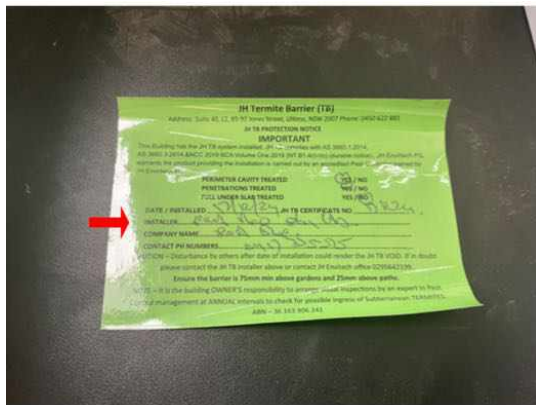
A durable notice placed in the switchboard unit to indicate termite barriers at the time of inspection.

Client must seek further information from the vendor or real estate agent if the conditions of termite management systems were maintained as per the label or seek advise from licensed pest controller.
