# Building and Timber Pest Inspection Report

Inspection Date: Tue, 10 Mar 2026

Property Address: 1/15B Barrenjoey Close, Woodbine

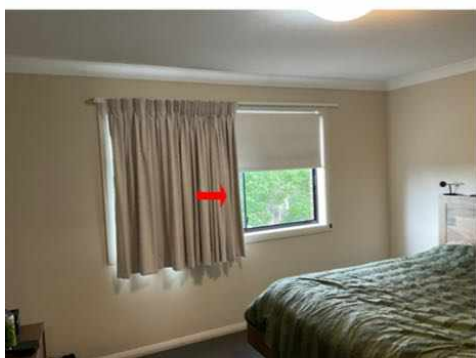
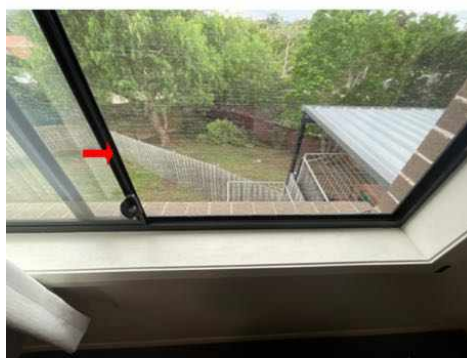
Building:	Building 1
Location:	Bedroom
Finding:	Window opening restrictors missing.
Information:	The Building Code of Australia rules require all openable windows (where the internal floor is more than 2m above the ground outside) in residential rooms to be fitted with a suitable screen or restrictor. Windows located 1.7m above the floor level do not require protection.

Window restrictors are required where people who are vulnerable to the risk of falling have access to windows. This means all windows above ground level which do not have another fall prevention safety measure in place, such as a balcony or balustrade should have a restrictor.

These need to be added urgently for the safety of all persons.

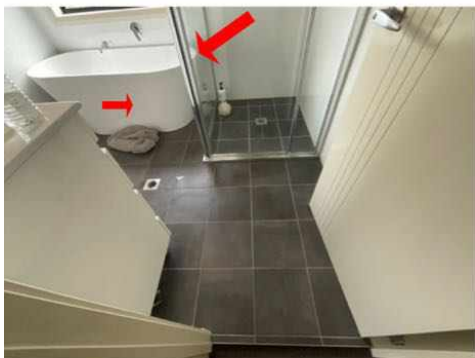
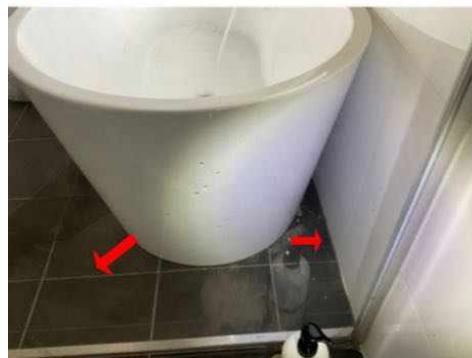
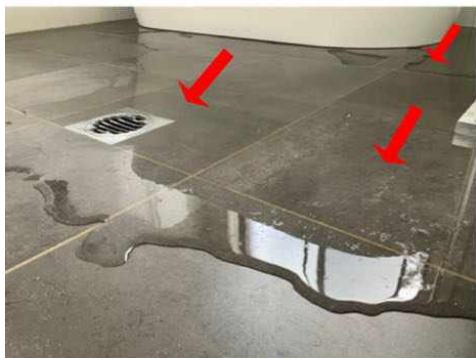
Finding: Bath - Leaking

Information: The bath was turned on for 30 seconds and water poured out from behind it flooding the rear bathroom at the time of inspection. If left unmanaged, this is likely to result in the development of water damage to many other areas of the house leading to a loss of utility and further deterioration of the property

It is advised that a licensed plumber be appointed to perform remedial works on the bath immediately.

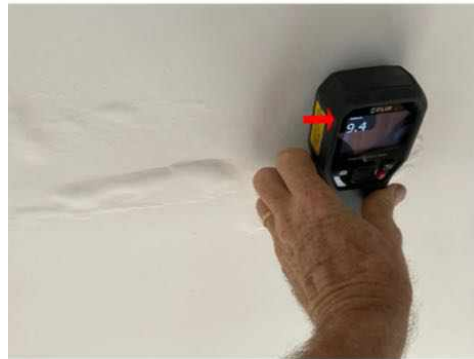
### Finding 3.01

Building:	Building 1
Location:	Dining Room
Finding:	Ceiling and wall - Water stained and sagging
Information:	Water staining to ceiling and wall linings and plaster damage in this dining room areas was evident at the time of inspection. Water staining indicates that surfaces have been exposed to excessive moisture over time. The minerals and other elements in the water lead to staining, which may graduate to corrosion and deterioration if left unmanaged.

A low moisture reading of 9.4 in the middle of the ceiling under the bathroom shows moisture is present. The rear wall showed a low reading of 5.3. All surrounding areas to these damaged plaster areas recorded a zero reading for reference. The external rear eave behind the rear wall showed minor mould but no moisture evident.

Water staining can be indicative of more serious defects, which may be currently concealed by interior ceilings.

Where water staining is active here, a licensed plumber must be consulted to identify the cause of the staining and to provide advice on any reparation works that may be required. Replacement of any damaged structures is advised.

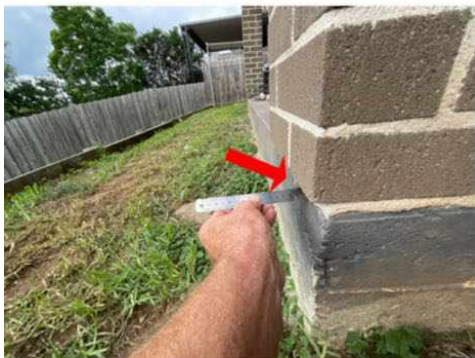
### Finding 3.02

Building: Building 1  
 Location: Walls  
 Finding: Masonry overhanging concrete slabs  
 Information: The rear lower verandah wall brickwork and pillars overhang the slab by up to 26mm.

‘ A masonry course is defective if it is laid on a concrete slab or strip footing so as to project over the edge of the slab or footing by more than 15mm ‘.

These areas should be restrengthened by a concreter or licensed builder to prevent possible step cracking in the above brickwork.

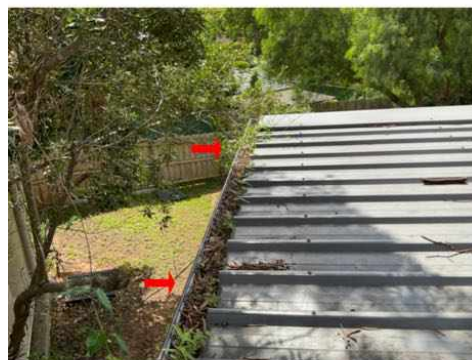
Building:	Building 1
Location:	Roof exterior
Finding:	Gutters - Full and blocked
Information:	The guttering on around the roof was found to be blocked at the time of the inspection. Roof plumbing structures, such as guttering and downpipes, should be free of all debris to prevent blockages. Blockages of the guttering and downpipes will lead to pooling and accumulated water overflows, which is likely to subsequently flood eaves and exterior walls.

Blocked gutters are likely to lead to high levels of moisture in the affected areas which can cause rust and decay of the gutters and downpipes and wood rot to adjoining timber areas. Blockages in gutters should therefore be removed immediately to ensure dry conditions are maintained.

It is highly advised that gutters be cleaned by the homeowner or a general handyperson as a matter of urgency.

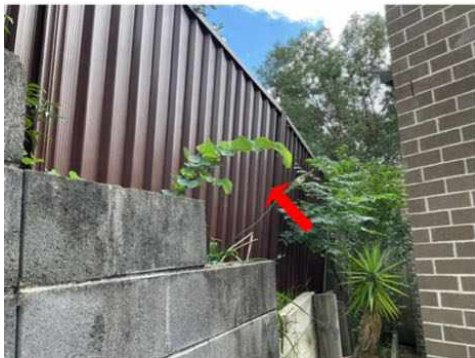
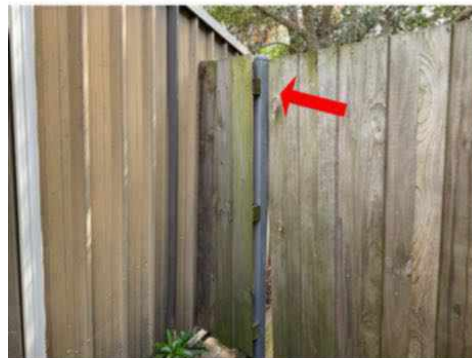
### Finding 3.06

Building:	Building 1
Location:	Pictured fences
Finding:	Fence and one area of rear retaining wall leaning
Information:	Evidence of damage to the pictured left fence and part of the rear left yard wall was identified at the time of the inspection. The likely cause of this fence and wall leaning is not enough concrete used in the post footings. If left unmanaged these areas may deteriorate further. This has meant the left gate binds on the fence and cannot be closed fully.

It is suggest a fencing contractor be engaged for rectification when convenient.

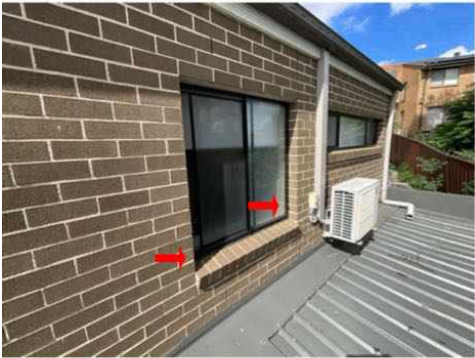
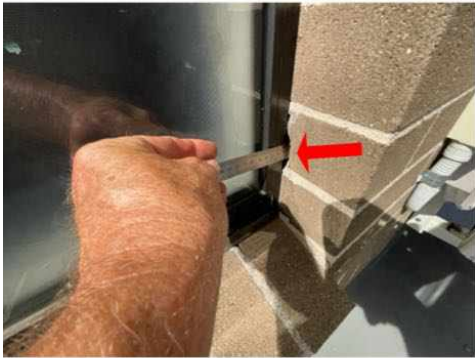
Building: Building 1  
Location: Pictured Areas  
Finding: Sealant (external) - Missing.  
Information: It was noted on inspection that areas of external sealant was missing to small areas of the external walls.

Flexible sealants should be applied to these affected areas to prevent any subsequent water damage that is likely to occur.

A sealant specialist or skilled handy person should be appointed to complete these works as soon as possible

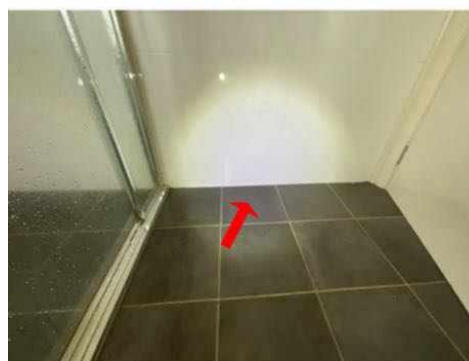
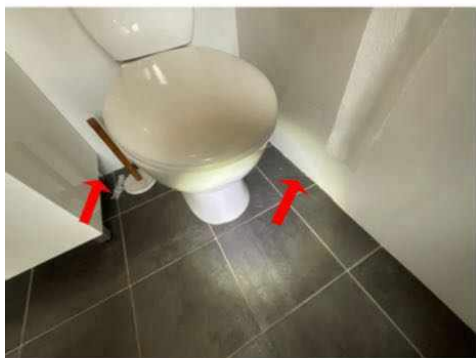
### Finding 3.09

Building:	Building 1
Location:	Bathroom
Finding:	Sealant and grouting - Missing or damaged
Information:	It was noted on inspection that sealant or grout is degraded to these pictured wet areas.

Different materials and floor areas move at different rates, generally causing cracking to grout or sealant at this point. A flexible sealant is required to allow for expected expansion and contraction, while keeping the joint water tight and protective of all associated building materials.

Flexible and mould resistant materials should be applied to affected areas to prevent any subsequent water damage that is likely to occur. Regular maintenance and replacement of damage or missing or damaged sealant and grout is highly recommended to the wet areas, as this is a regular wear and tear defect. Sealant and grouting in areas that come into regular contact with water should be maintained for the long term care of your property.

A sealant specialist or tiling contractor should be appointed to complete these works as soon as possible

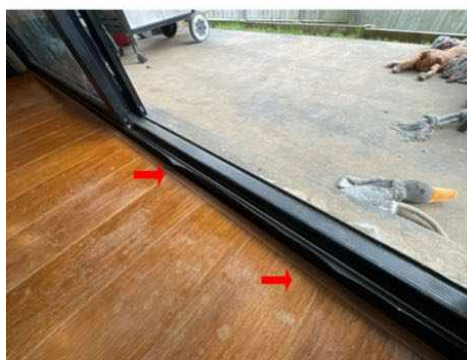
Location: Pictured areas  
 Finding: Building elements - Damaged  
 Information: Evidence of damaged areas was identified at the time of the inspection. These include -

1. The rear sliding door track is bent not affecting its operation.
2. The laundry tub has rusted.

A carpenter would be the trade responsible for rectification of these areas when convenient.

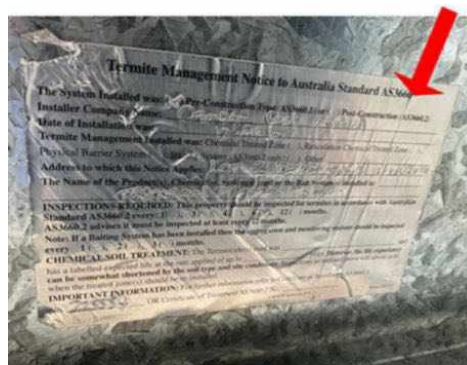
Information: The application of a post-construction chemical termite barrier is highly recommended for all properties. Such barriers are highly effective in preventing termite attack on any timber building elements throughout the property.

A durable notice should be placed in the switchboard unit to indicate current termite barriers. At the time of inspection, the durable notice was evident and it appeared as though no chemical termite management system has been installed, with no evidence to suggest preventative works taking place since the property was built.

The client may consider gaining further advice from a pest controller as to the costs and procedures involved with a 'chemical' application. It is recommended that obtaining such advice be a short-term priority.

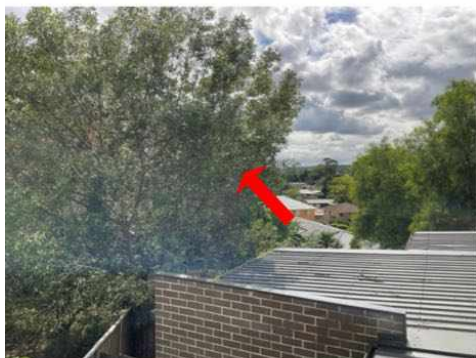
## Finding 6.02

Building: Building 1  
 Location: Roof areas  
 Finding: Trees - Overhanging and filling gutters  
 Information: Overhanging trees often result in excessive amounts of leaf debris accumulating in gutters.

Gutters are a critical part of the building's management of storm water and rain. It is therefore important that they be kept clear to prevent secondary damage to associated building elements, including exterior and interior walls, ceiling linings and any adjoining building elements. Where gutters are blocked, pooling of rainwater is likely to occur, fast-tracking rust and corrosion of the roof plumbing elements.

It is highly advised that all overhanging tree branches be removed as soon as possible to prevent any further damage. Such works should be performed by the homeowner; however, appointment of a landscape contractor or an arborist may be required.

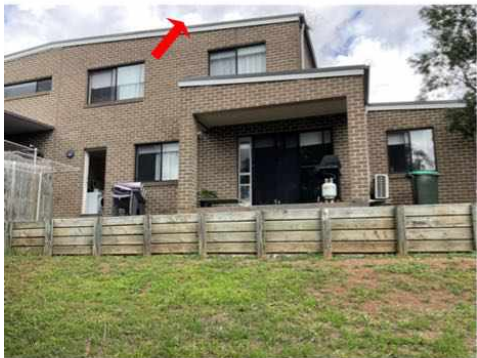
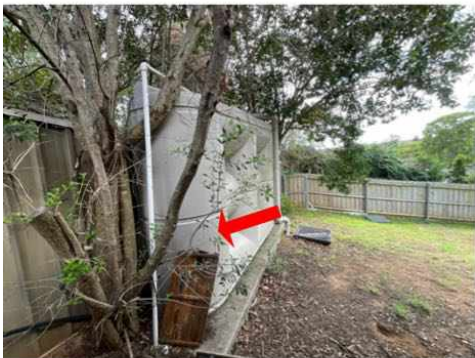
Building: Building 1  
 Location: All External Areas  
 Finding: Additional Photos - Obstructions and Limitations of EXTERNAL AREAS  
 Information: These photographs are an indication of the obstructions and limitations which impeded full inspection of external areas at the time of inspection. These obstructions can hide an array of defects and should be removed to allow full inspection to be carried out. A re-inspection is recommended once the areas are made accessible.

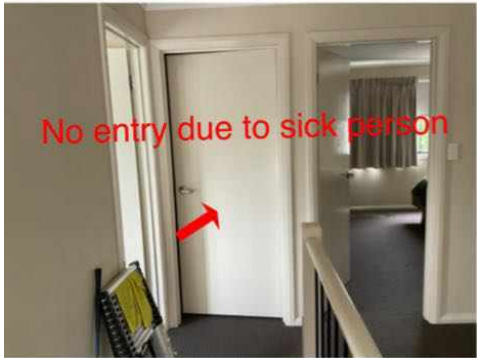
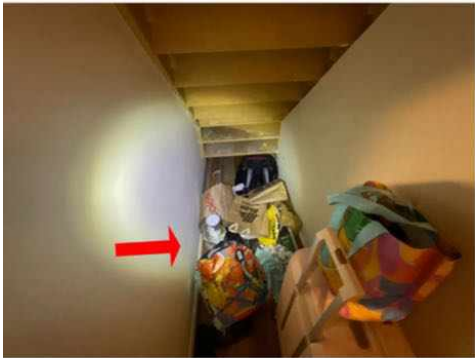
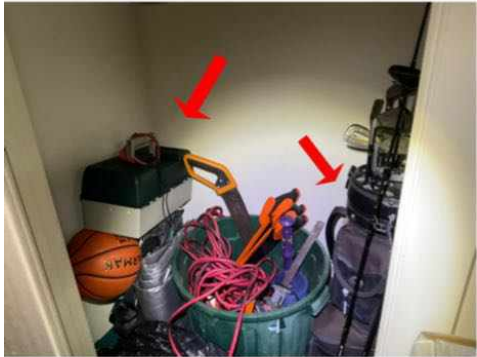
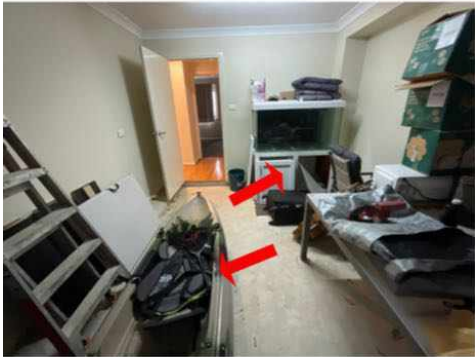
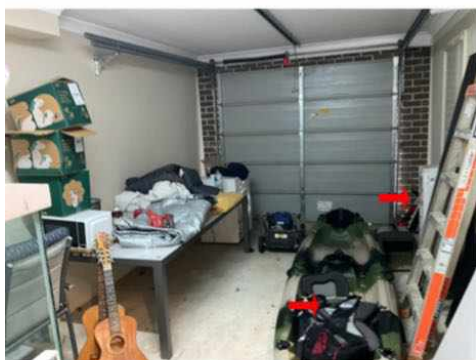
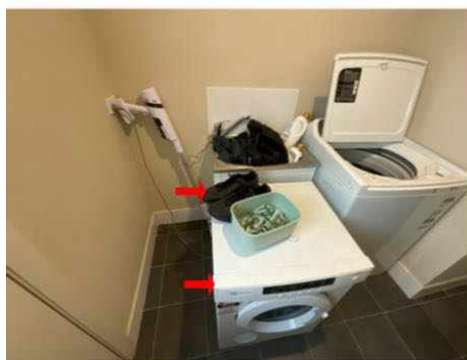
Building: Building 1  
Location: All Internal Areas  
Finding: Additional Photos - Obstructions and Limitations of INTERNAL AREAS  
Information: These photographs are an indication of the obstructions and limitations which impeded full inspection of Internal areas at the time of inspection. These obstructions can hide an array of defects and should be removed to allow full inspection to be carried out. A re-inspection is recommended once the areas are made accessible.

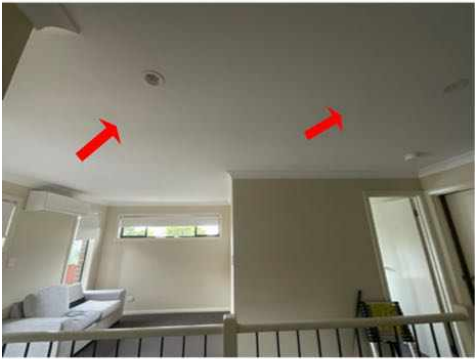
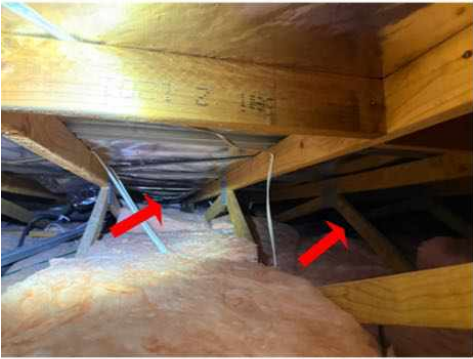
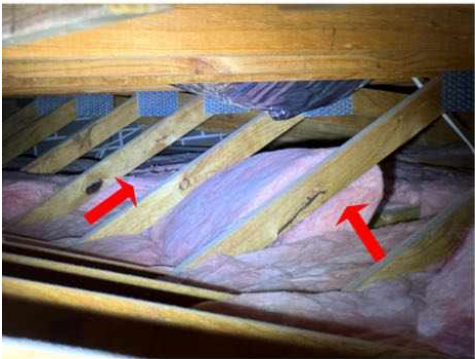
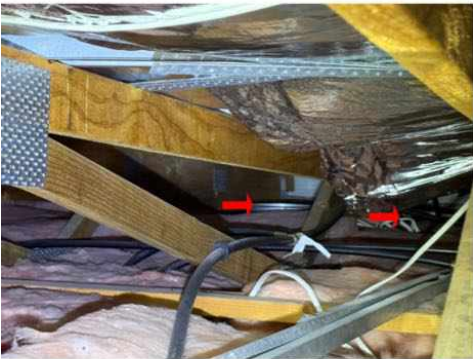
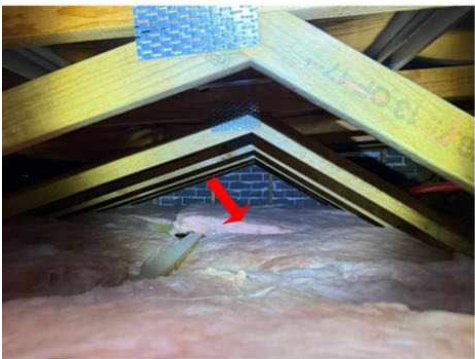
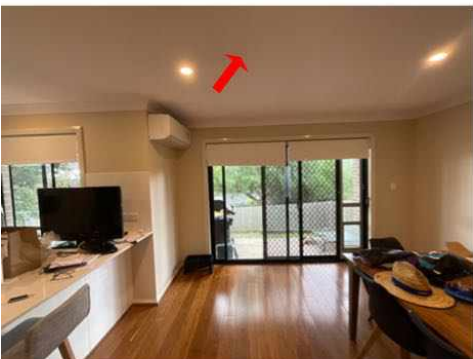
Building: Building 1  
 Location: All Roof cavity areas  
 Finding: Additional Photos - Obstructions and Limitations of the ROOF CAVITY  
 Information: These photographs are an indication of the obstructions and limitations which impeded full inspection of roof cavity areas at the time of inspection. These obstructions can hide an array of defects and should be removed to allow full inspection to be carried out if applicable. A re-inspection is recommended once the areas are made accessible.

The inspection was also limited to areas with an allowable crawl space of 600mm x 600mm, in particular towards the external walls where the roof line diminishes, these areas were not accessible.

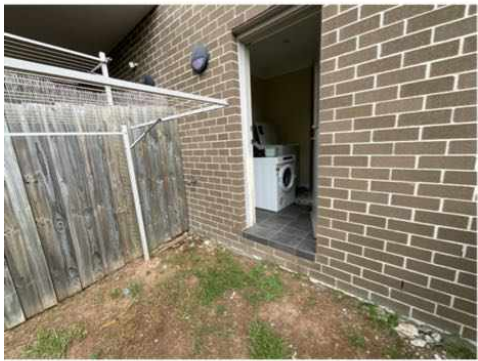
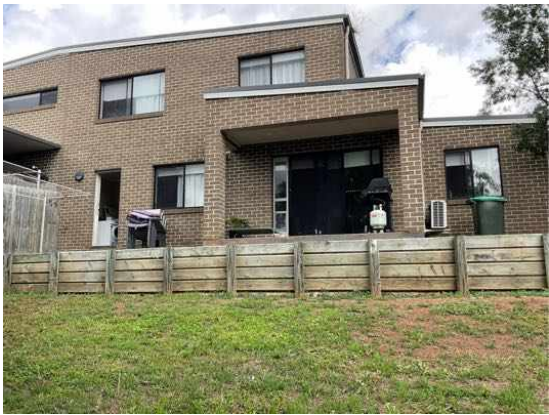
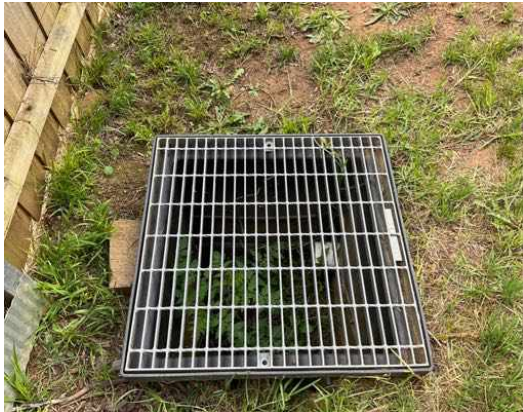
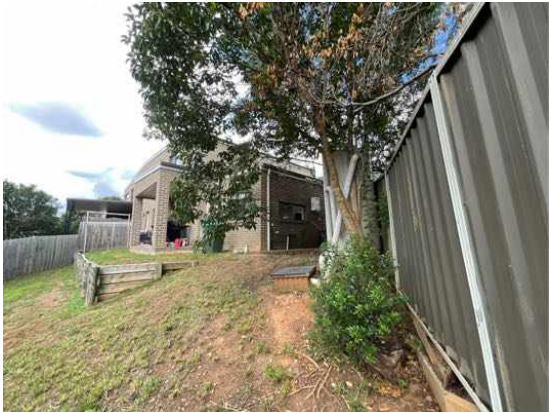
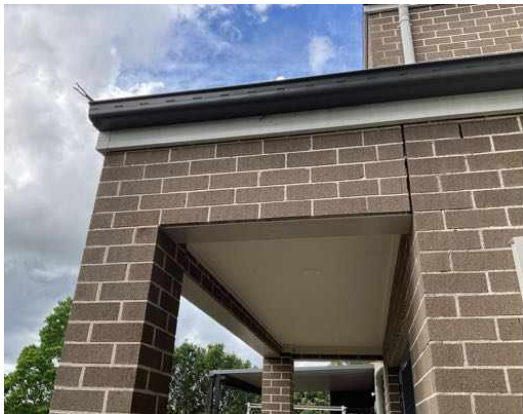
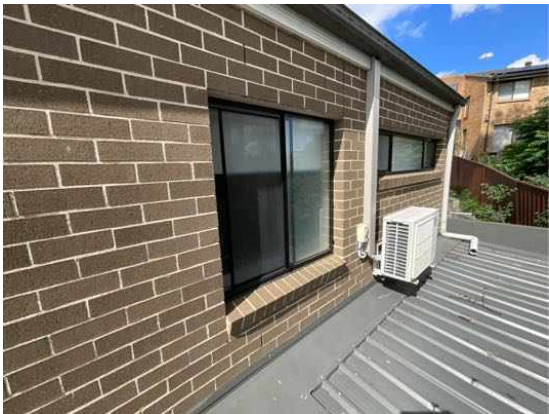
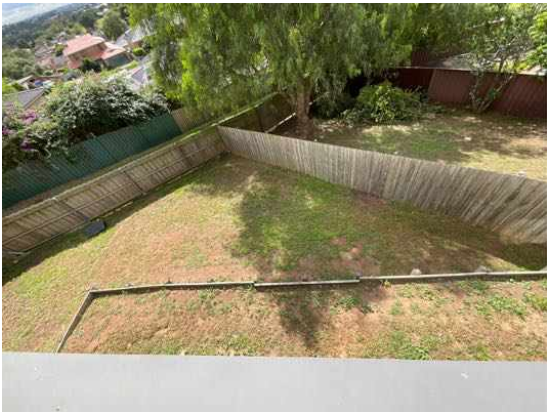
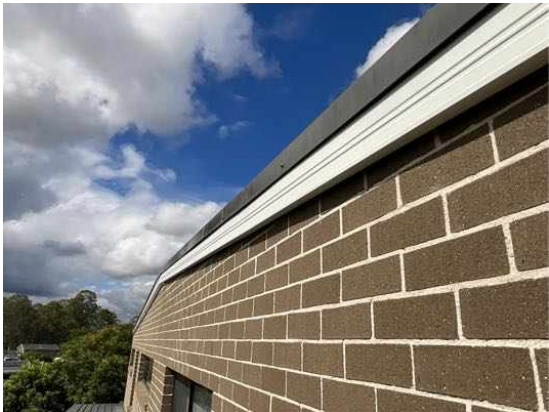
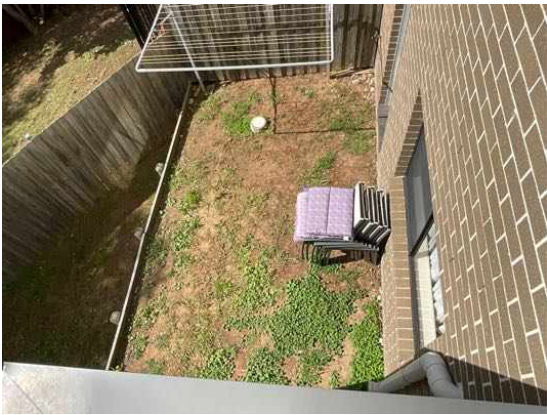
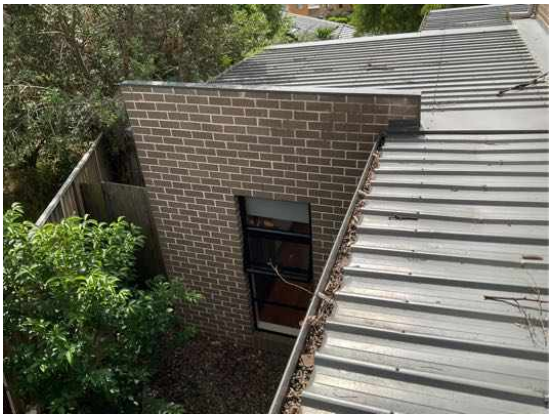
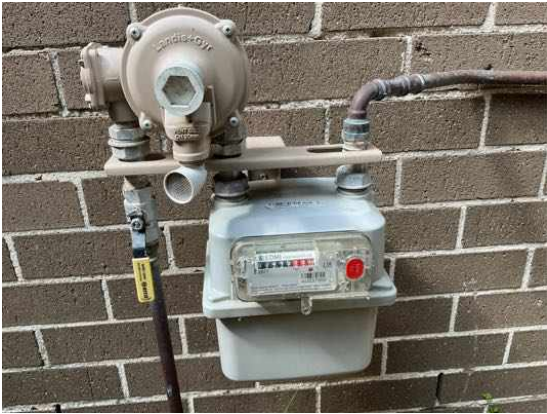
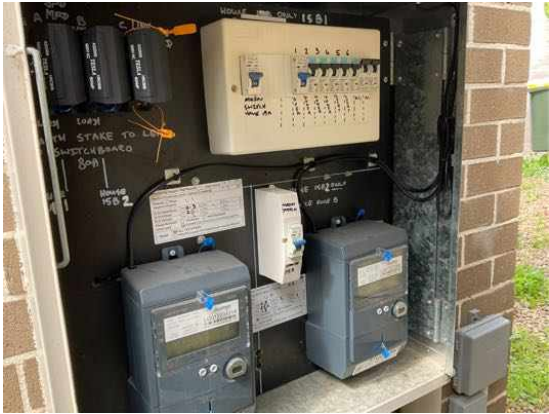
Building: Building 1  
Location: All External Areas  
Finding: Additional Photos  
Information: Additional photos are provided for your general reference

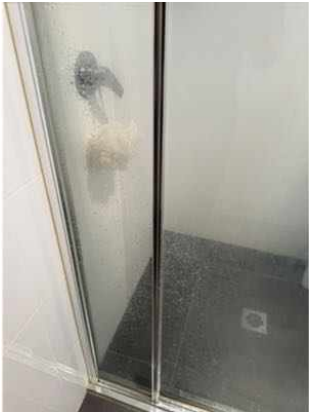
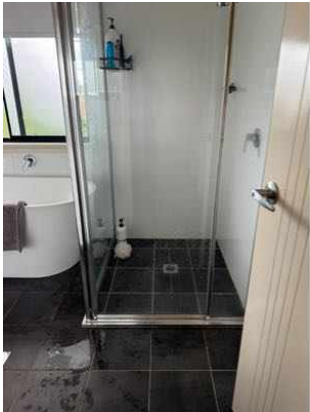
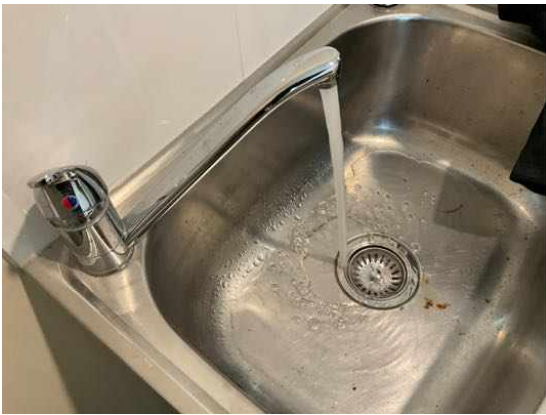
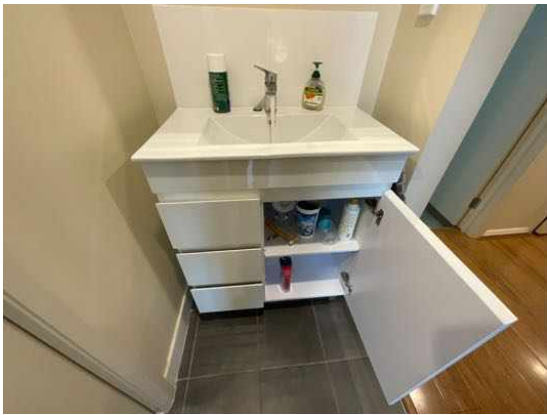
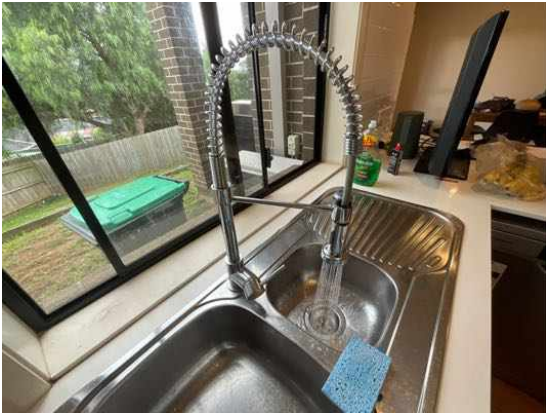
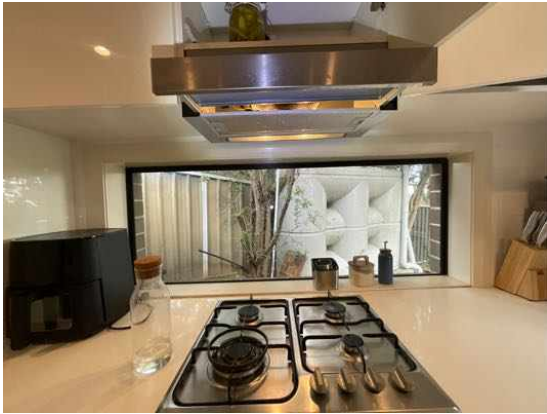
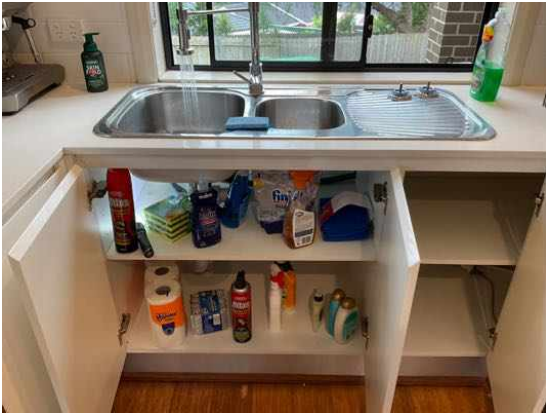
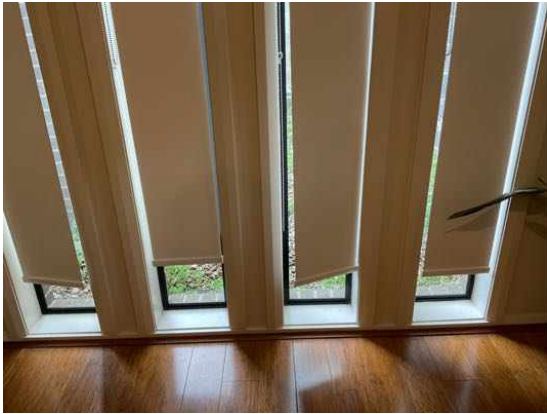
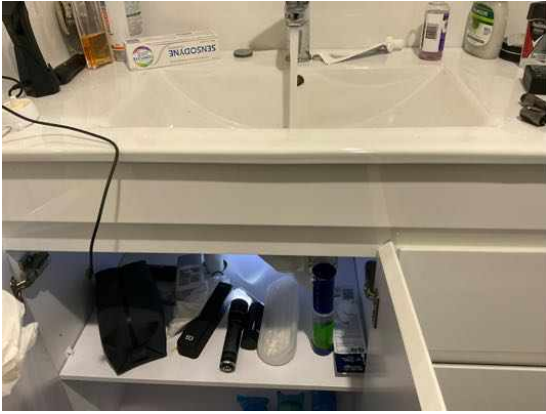
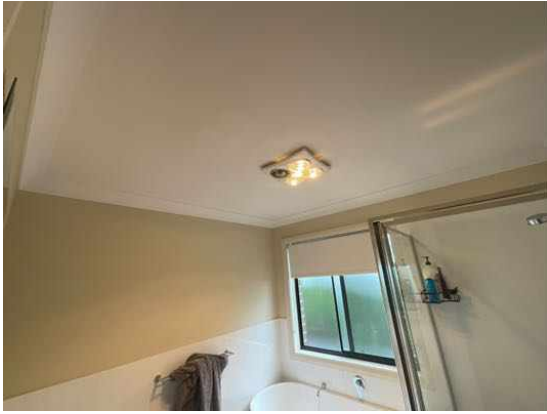
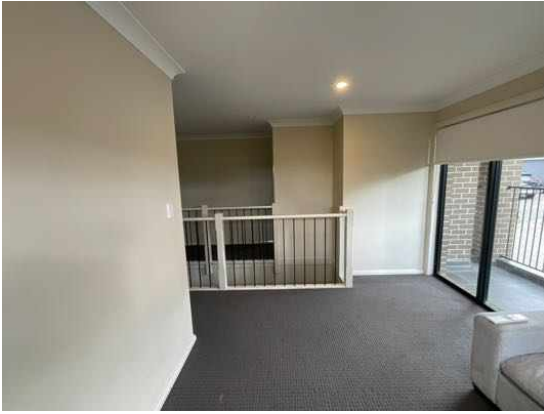
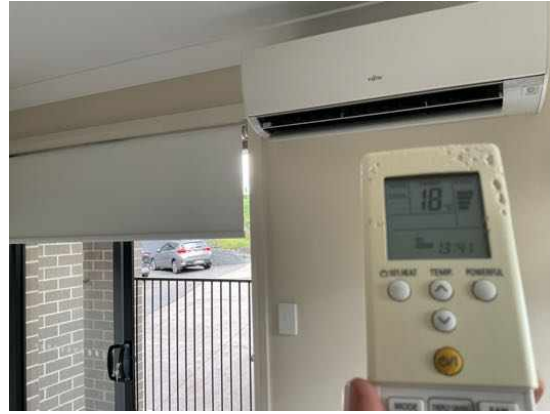
Building: Building 1  
Location: All Internal Areas  
Finding: Additional Photos  
Information: Additional photos are provided for your general reference

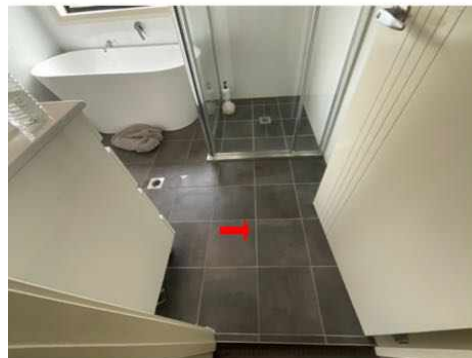
Building: Building 1  
 Location: Bathrooms and laundry  
 Finding: Waterproofing membranes - Information Only  
 Information: Internal Water Proofing Membranes, are crucial in preventing water ingress into the property is important to know that the Membrane System used is to Australian Standards and has been installed correctly.

With older property's where this information is unavailable all wet areas should be monitored. If any leaks, water staining, peeling or bubbling of the paint become evident to any adjacent walls or ceilings below a licensed builder or waterproofing specialist is recommended to investigate further.
