Building and Timber Pest Inspection Report

Inspection Date: Fri, 30 Jan 2026

Property Address: 23 Cayman Pl, Parrearra QLD 4575,
Australia

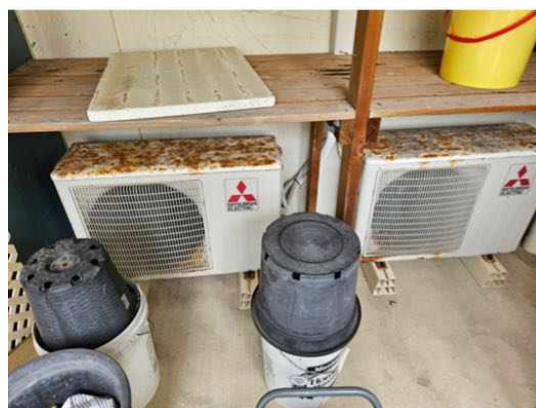
Finding 3.01

Building: Main Building
 Location: Rear elevation
 Finding: Air conditioner casing - rusted
 Information: The air conditioner casings of the two rear outdoor units are rusted. It does not appear to affect the operation of the system. It is possible that the metal may be able to be treated and repainted.

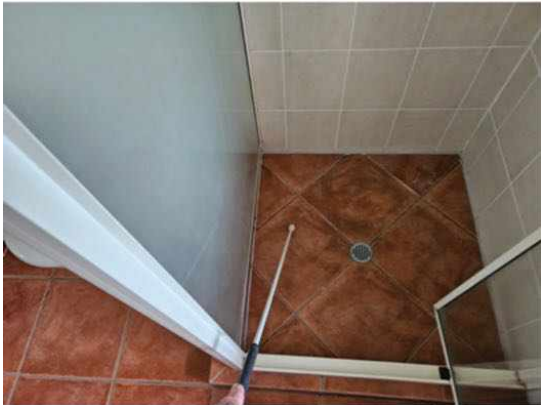
The term 'drummy' refers to tiles that have become detached from their fixing, despite otherwise being in relatively good condition. Such defects are generally caused by physical or moisture damage to the area. Drummy tiled areas may also be a direct result of poor workmanship during the construction process.

Tiled areas may swell and shrink with changes in air humidity if the area has sustained moisture damage. Any exposure to moisture is capable of causing tiled areas to become drummy and/or cracked over a prolonged period of time. Drummy tiled areas generally require removal and replacement of affected tiles.

Specialist trades are available for these types of services. A licensed builder may be required to undertake works if damage is extensive or if secondary building defects have resulted. Otherwise, it is advised that a tiling contractor or a tile adhesive injection service may be appointed to perform works as necessary.

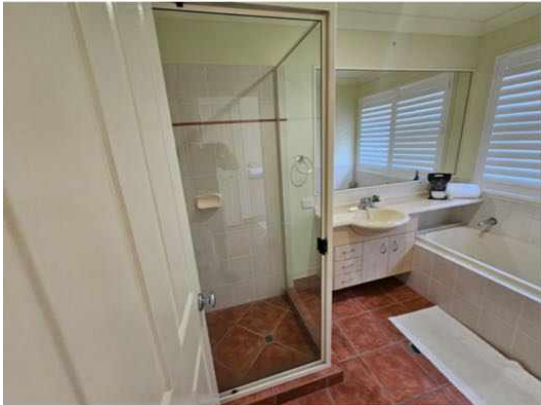
Finding 3.04

Building: Main Building
 Location: Ensuite, bathroom
 Finding: No moisture detected in bathroom / ensuite
 Information: On the day of inspection the showers in the bathroom/s and ensuite are measure for moisture using a "Tramex" moisture meter. During this inspection no moisture was detected in these areas and the tiled / sheeted surfaces appear to be in good order.

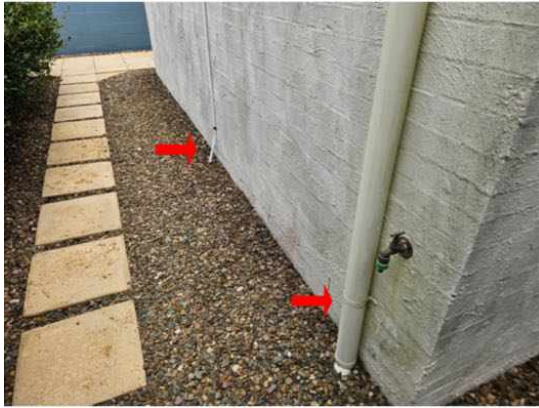
Finding 3.05

poorly fixed water pipes which can lead to fatigue cracks or friction holes developing.

alternative is to extend the overflow further into the garden away from the building perimeter.

These minor works should be carried out in the short term.

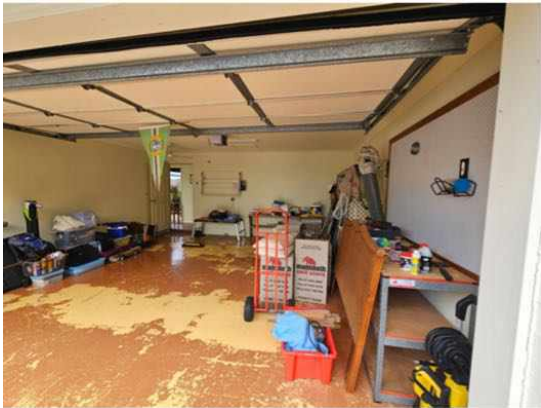
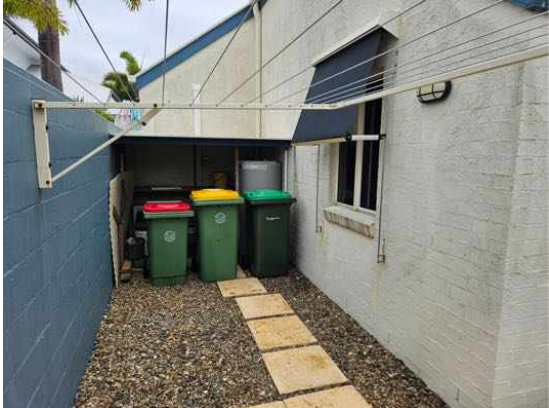
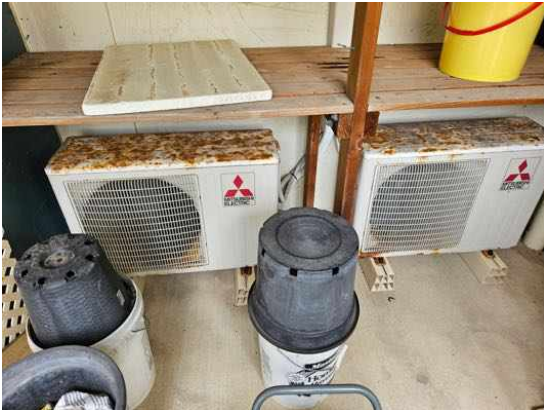
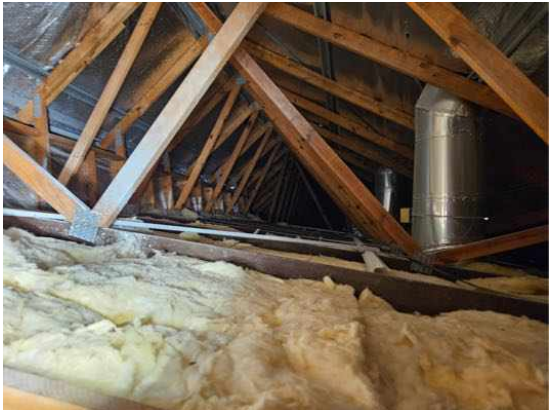
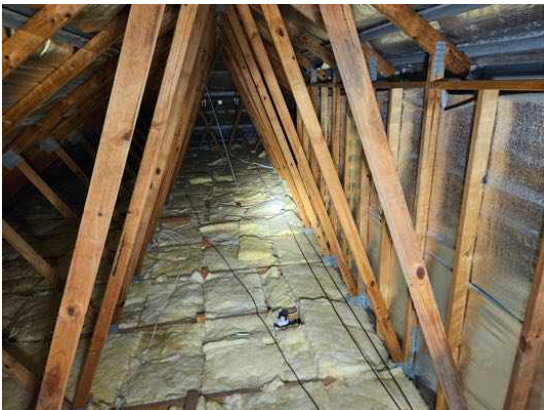
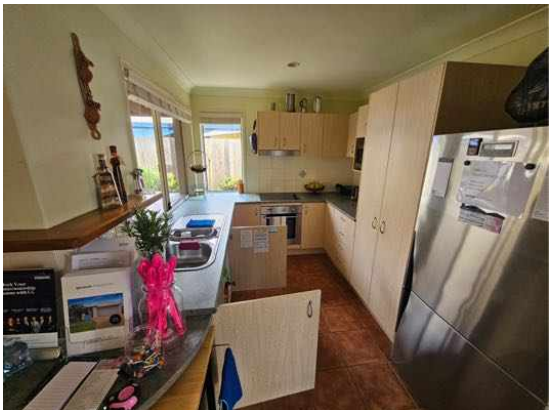
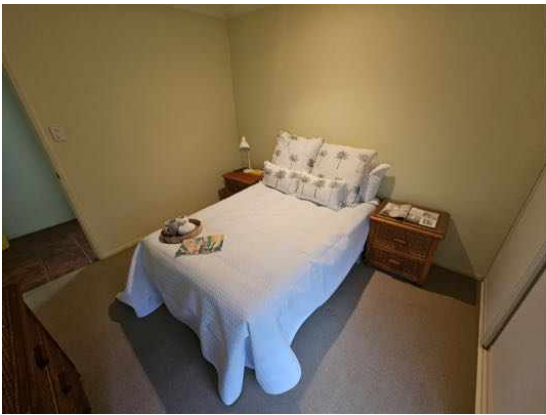
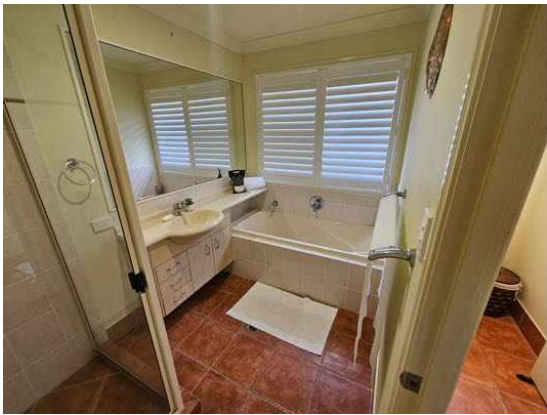
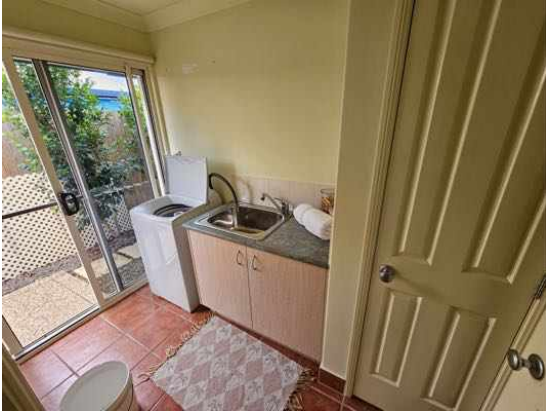
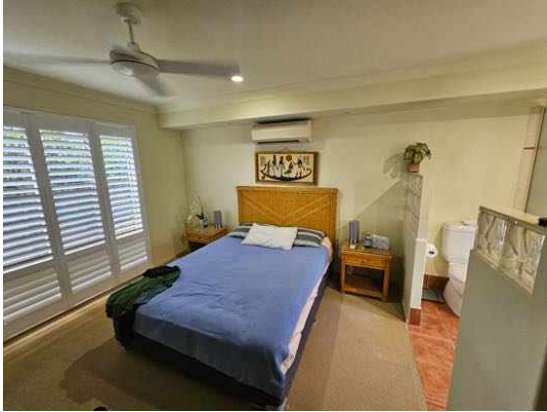
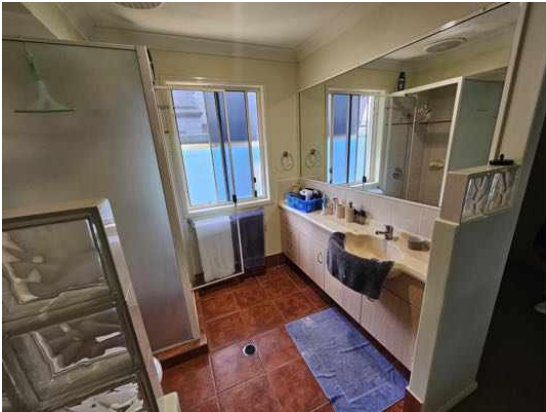
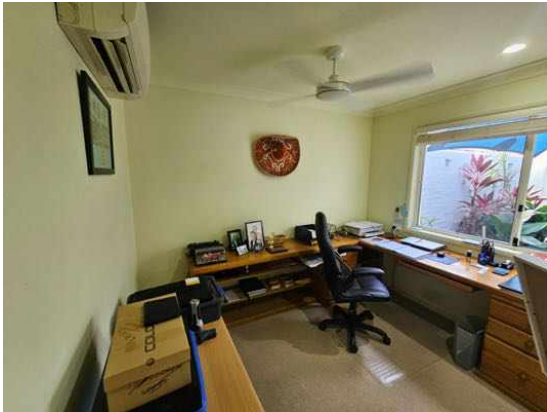
Noted Item

Building: Main Building
Location: All Areas
Finding: Additional Photos for client reference
Information: Additional photos are provided for your general reference.

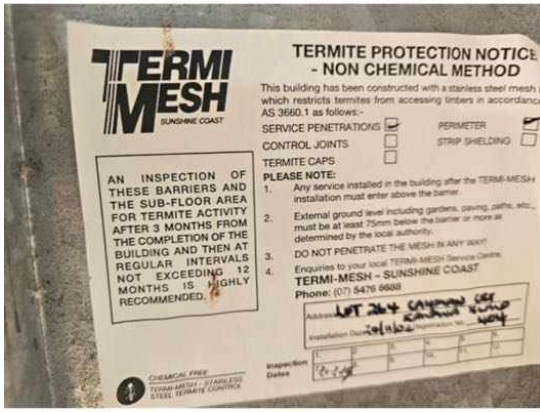
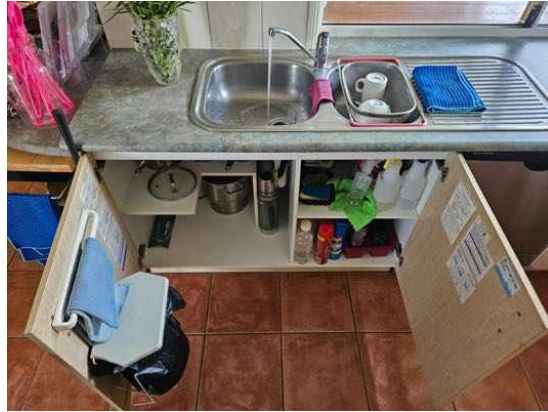
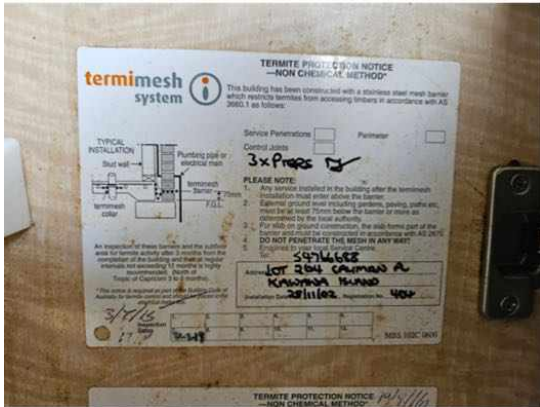
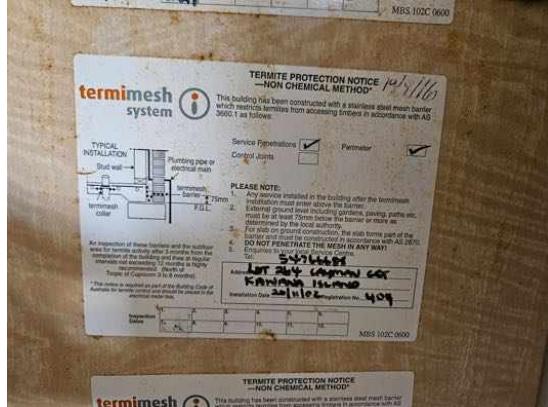
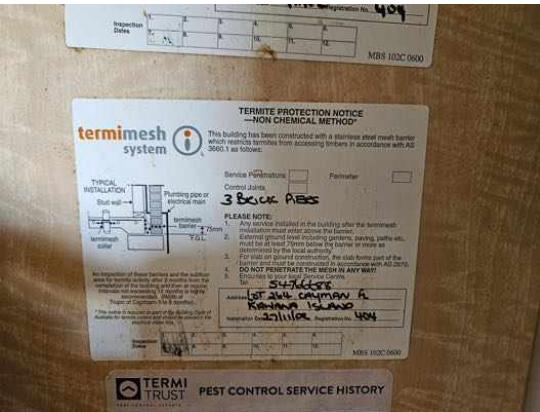
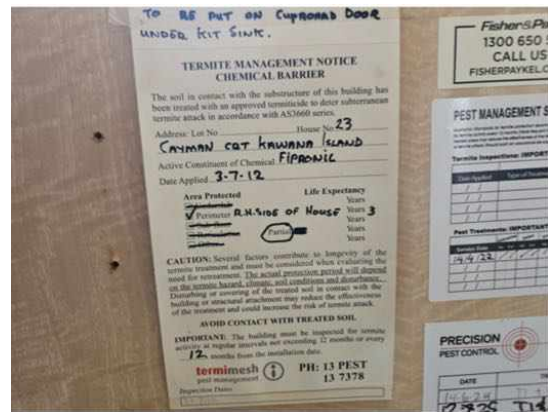
The building employs a physical barrier system to the perimeter and slab penetrations and has applied a chemical barrier in the past. In order for a barrier system to be effective, the property must have regular inspections at intervals of not greater than 12 months. Depending on the risk profile attributed to the property, these inspections may be recommended at lesser time periods.

Where a Termite Management System has been identified you should refer to the type of barrier, date of installation, warranty conditions and any documentation provided by a builder or past owner. Consult the company who installed the barrier to confirm whether the system is still under warranty.
