Building and Timber Pest Inspection Report

Inspection Date: Mon, 16 Mar 2026

Property Address: 44 Brooklyn Rd, Brooklyn NSW 2083,
Australia

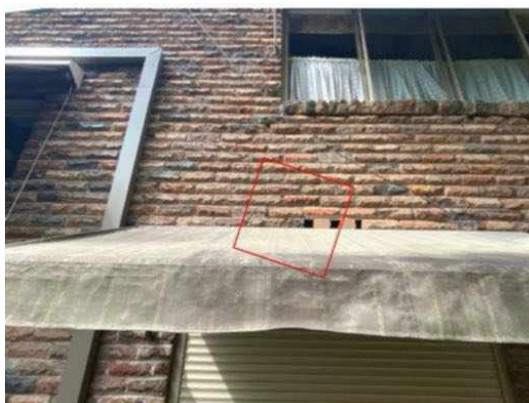
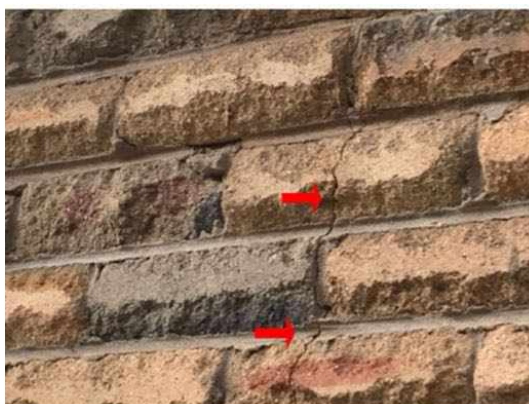
Building:	Main Building
Location:	Exterior walls - right side
Finding:	Brickwork - Step cracking
Information:	Step cracking was identified to the brickwork in this area at the time of inspection. Step cracking, which is similar to other forms of cracking, has a variety of possible causes. However, the most common is the subsidence of adjacent footings.

Step cracking is a relatively common defect, and is most likely to occur adjacent to windows, doors and other openings. Mortar failure in the gaps between affected bricks indicates the stresses and tensions affecting the wall.

Where step cracking is extensive or severe, the client is advised to consult a structural engineer. Minor step cracking can be used as a warning sign to address factors causing stress to the wall, which can include the effect of surrounding trees, water leaks, soil erosion, or even the presence of reactive soils in the surrounding area.

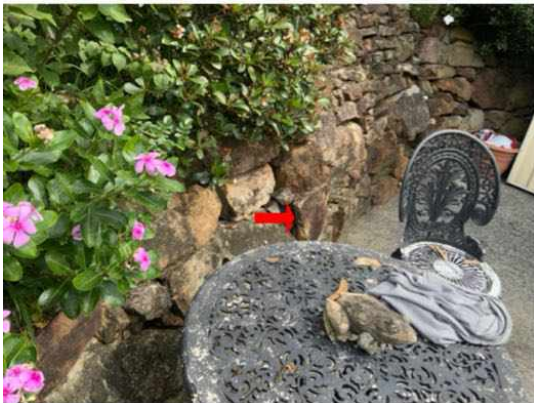
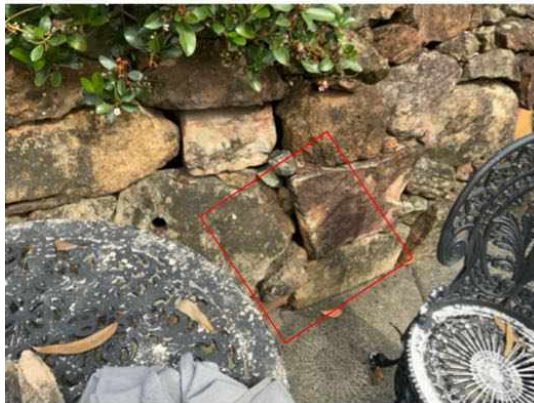
Finding 3.02

Building: Main Building
 Location: Exterior walls - rear
 Finding: Retaining wall - Defective

Information: The retaining wall in this area was found to be defective at the time of inspection. Generally, defective retaining walls are caused by poor original design or material use. However, deteriorated retaining walls may also be a result of substandard construction, poor site drainage or unmanaged stormwater flows.

If left unmanaged, the retaining wall may become a safety hazard if it continues to destabilise.

Significant repair and replacement should be expected. Where retaining walls are considered structural walls, a structural engineer / surveyor should be consulted regarding required remedial works. Otherwise, a landscaper or retaining wall installer may be appointed to repair or replace the wall, at the discretion of the client.

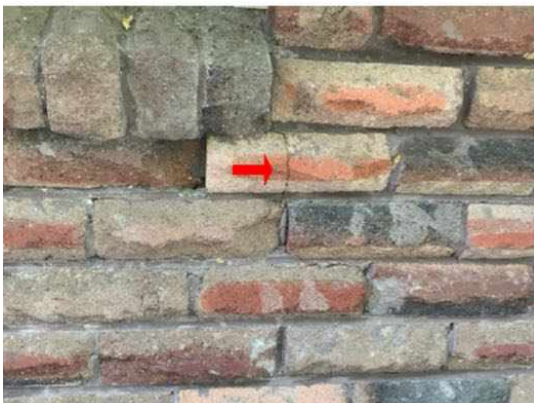
Finding 3.03

Building:	Main Building
Location:	Exterior walls - rear
Finding:	Brickwork - Cracking noticeable
Information:	There were several cracks and or crack repairs evident to external brickwork.

Noticeable cracks are a common occurrence in external brickwork and are a likely result of age expected building movement, general expansion, and/or contraction of building materials in different weather conditions. Noticeable cracks in brickwork may develop if left unattended, with potential for necessitating major remedial works or replacement of the brickwork.

It is highly advised that a qualified bricklayer be appointed to provide necessary works to cracked brickwork to prevent any further damage. Such works should be conducted as soon as possible.

Always monitor these cracks and contact a building inspector should cracks widen, lengthen, or become more numerous.

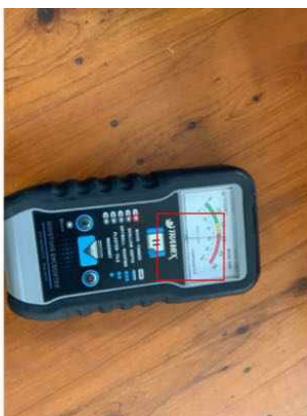
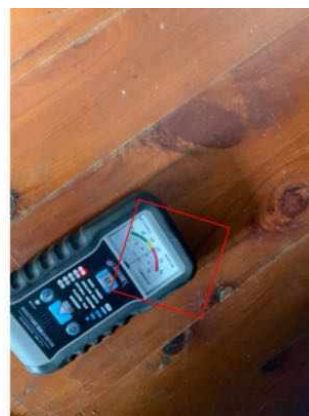
Finding 3.04

Building:	Main Building
Location:	Bedroom - Master
Finding:	Sub-floor excessive moisture
Information:	Excessive moisture can attract termites and produce conditions that promote termite attack fungal growth in wood decay.

Excessive moisture is generally caused by inadequate subfloor ventilation and poor site drainage.

There appear to be inadequate vents installed to the perimeter of the building and I would suggest that further solar powered fans or the like be installed to improve crossflow ventilation and aid in keeping the subfloor area relatively dry.

The installation of additional surface drainage to the front of the property would also be beneficial to keeping the subfloor dry.

It is highly recommended that subfloor ventilation and site drainage be improved and maintained regularly in order to prevent excessive moisture being present in the external/internal property.

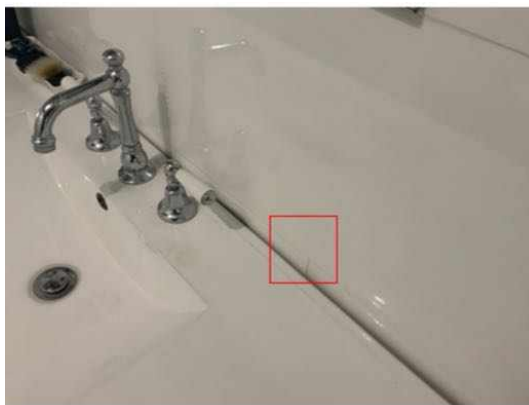
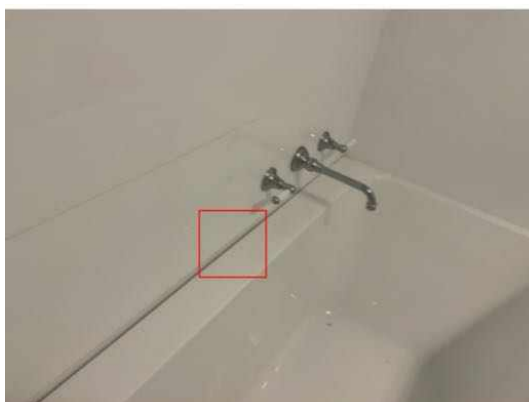
Finding 3.05

Building: Main Building
 Location: Bathroom
 Finding: Bathroom cabinetry - not sealed
 Information: Areas of bathroom cabinetry have not been fully sealed or have been sealed in a substandard manner. All junctions between bench tops and adjoining surfaces are defective if they are not sealed with an agreed or suitable flexible sealant or if leaks occur or where they are not installed to manufacturer's instructions.

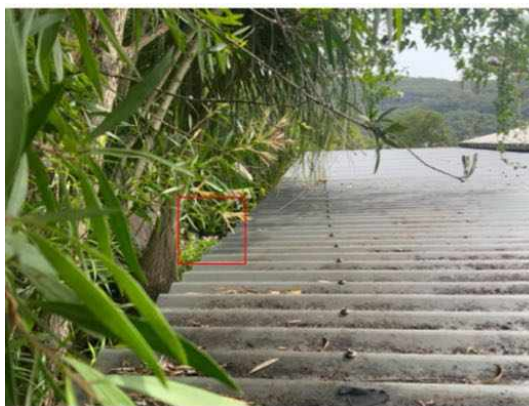
Building: Main Building
 Location: Exterior walls - rear
 Finding: Roof plumbing - Missing
 Information: Some sections of the roof are not adequately drained via gutters and downpipes. Gutters and downpipes that are not installed adequately are likely to result in excessively damp conditions against the exterior surfaces and around the base perimeter of the building.

Excessive moisture creates an environment which accelerates the deterioration of

building elements in the area, as well as being conducive to termite and pest infestation. Such an environment is likely to necessitate repair and/or replacement of building elements, which are prone to sustaining wood rot, rust or corrosion.

A roofing plumber should be appointed as soon as possible to install relevant roof plumbing materials. Depending on the extent of the damage, repair and/or replacement of damaged building elements may be required.

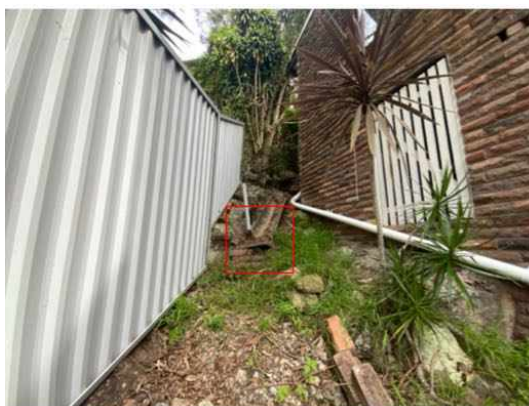
Finding 6.05

Building:	Main Building
Location:	Exterior walls - left side
Finding:	Site drainage - Inadequate
Information:	The site drainage in this area was found to be inadequate at the time of inspection, creating potential for subsequent water damage to associated building elements.

It is important that water does not lie against the base of walls; surrounding paths and ground levels should be sloped to drain water away from walls. Downpipes should not discharge stormwater onto lower walls or plinths. Stormwater should be carried away by large, regularly cleaned drains. Ground levels may need to be lowered to expose a buried DPC.

Where site drainage is inadequate, installation of an Agricultural (Aggie) Drain may be required. A qualified plumber should be appointed to further inspect the property and perform any remedial works as necessary. Water damage and secondary defects are likely to occur if left unmanaged.

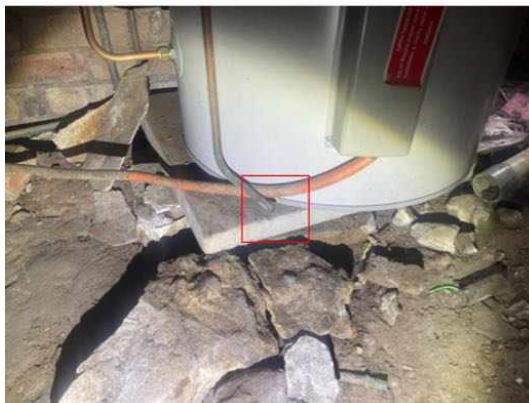
Finding 6.06

Building:	Main Building
Location:	Subfloor
Finding:	HWS Overflow - Not Connected
Information:	The Hot Water System (HWS) overflow was found to be disconnected from storm water drainage and is creating excessive moisture in the surrounding area.

These damp conditions can lead to secondary defects such as rot, rust or corrosion of associated building elements, the formation of fungal decay, or even the creation of potential slip hazards. When coupled with poor site drainage, pooling of water may also attract termite activity to this area.

It is highly recommended that a licensed plumber be appointed to connect the HWS overflow in order to prevent such an environment from being created. These minor works should be carried out as soon as possible.

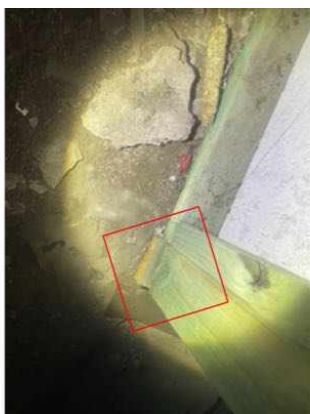
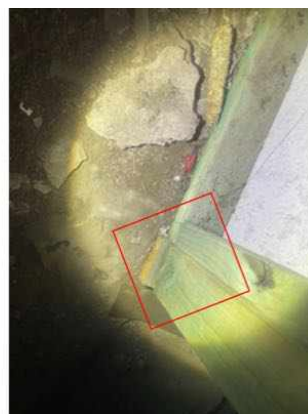
Finding 6.07

Building:	Main Building
Location:	Subfloor
Finding:	Untreated or non-durable timbers in a hazardous environment
Information:	To reduce the risk of timber pest attack it is essential that timber used in a hazardous environment (e.g. in direct contact with the ground or frequently exposed to damp conditions) is of sufficient durability and/or is adequately preservative treated.

Untreated timbers in direct contact with the ground are likely to develop severe wood rot and/or fungal decay if left unattended creating attraction for subterranean termites to infest the timbers from surrounding areas.

If untreated or non-durable timbers are found to be in a hazardous environment it is highly advised that replacement of these building elements be performed as soon as possible to aid the protection of the property against termite / timber pest attack.

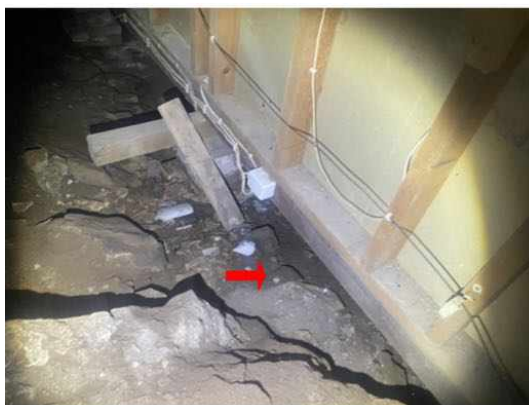
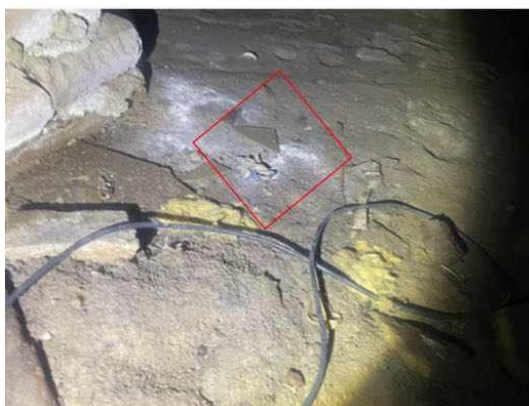
Finding 6.08

Building:	Main Building
Location:	Subfloor
Finding:	subfloor drainage poorly drained
Information:	Poor drainage leads to excessive moisture, entering the subfloor area and being retained in the soil, which overtime can destabilise the foundations and promote timber pest activity such as fungal decay and termite.

Generally, to ensure that water drains away from the footings, the profile of the ground adjacent to the building should slope away from the base of the exterior walls, and all stormwater drainage should be maintained in good condition and free from blockage.

If the ground level of the subfloor area is fully or partly below, the surrounding ground level, then well designed retaining walls with appropriate drainage are required to prevent water entering the subfloor area.

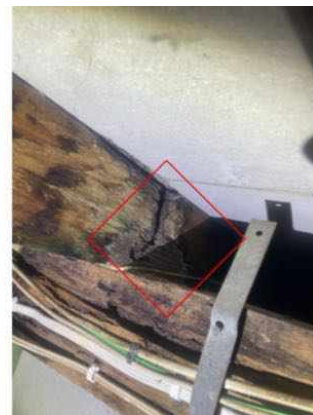
Finding 7.01

Damp conditions cause the timbers to fail, resulting in the subfloor structures failing to bear the load (or weight) of the building as originally intended. Without repairs and maintenance, including potential replacement of affected elements, it is likely that serious structural faults will result, as well as an array of minor defects.

Where wood rot is present to any structural timber, rectification or replacement of the affected timber building element is required. The adequate timeframe for such works are dependent on the severity of the rot. Where rot has developed to become widespread, replacement of sections of the subfloor structure may be required. Consultation with a structural engineer or registered builder specialising in re-stumping is highly advised as soon as possible.

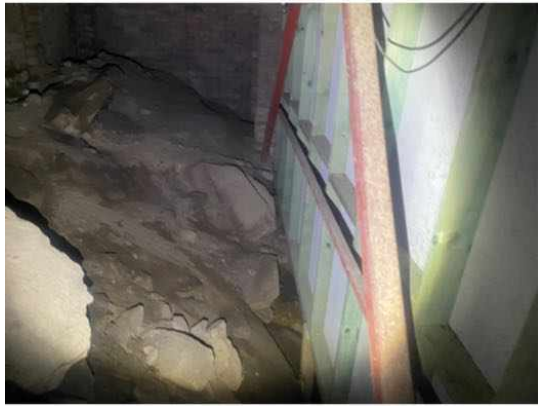
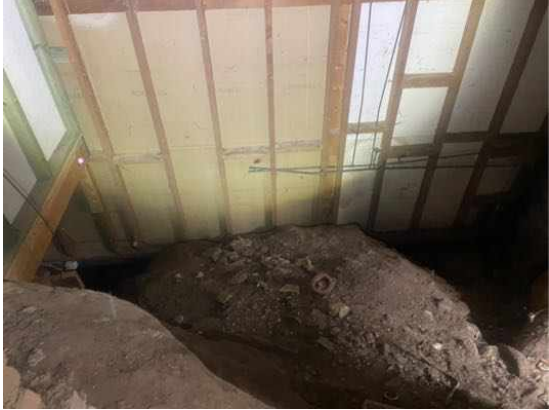
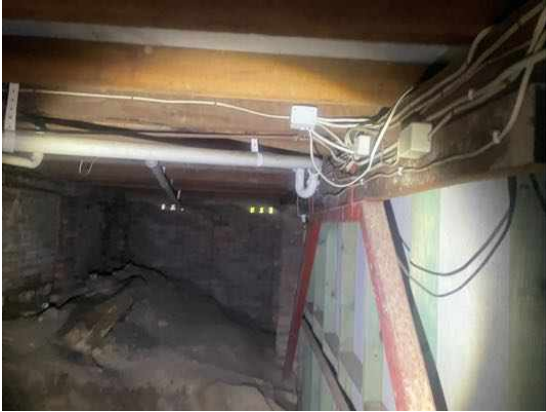
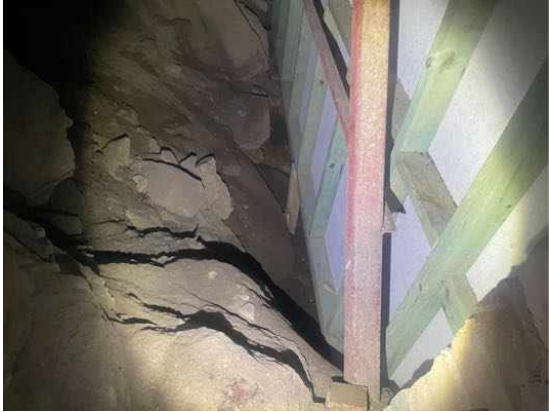
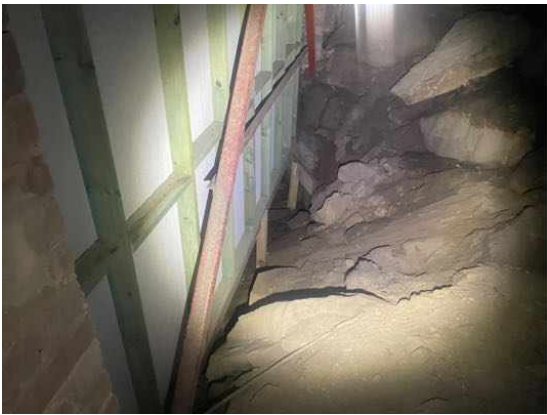
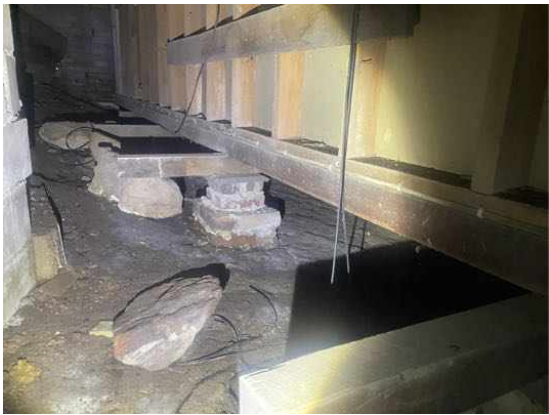
Building: Main Building
Location: All Areas
Finding: Additional Photos - Obstructions and Limitations
Information: These photographs are an indication of the obstructions and limitations which impeded full inspection of the property at the time of inspection. These obstructions can hide an array of defects and should be removed to allow full inspection to be carried out. A re-inspection is recommended once the areas are made accessible.

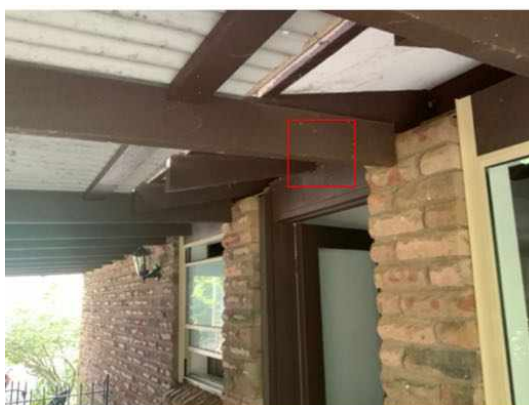
Building:	Main Building
Location:	Exterior walls - rear
Finding:	Structure - Old and non-compliant
Information:	This structure, whilst appearing to provide adequate structural support, does not comply with contemporary building practices and current Australian Standards.

Although this is not a requirement in older homes, the client should be aware of the age and non-compliance of the structure when planning any repairs or remodelling.

It is advised that this structure be inspected by a registered builder or structural engineer on a relatively frequent basis to ensure that the structural integrity does not falter over time.

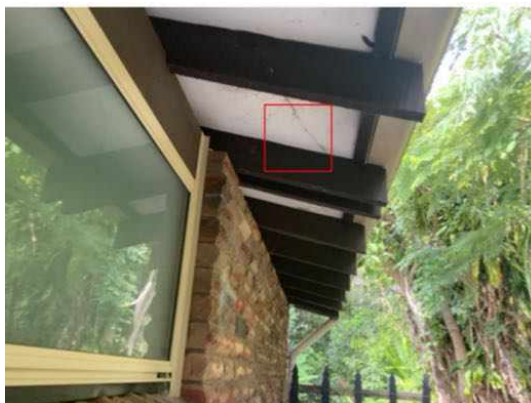
Building:	Main Building
Location:	Exterior walls - rear
Finding:	Asbestos - Suspected ACM Identified on Site
Information:	Reporting on Asbestos is outside the Scope of this Report. This suspected defect is highlighted as a caution only. We suspect, based on our experience in the building industry, that there is a higher risk of the identified building element containing asbestos.

As Asbestos Reporting is outside the scope of this report, we advise that you consider a separate Asbestos Inspection and Condition Audit, which can include the taking of samples for definitive confirmation of the presence of Asbestos.

In the interim, the client is advised to act with caution, especially when considering any damage to building materials general wear and tear renovations extensions demolition and general maintenance activities due to the suspected presence of Asbestos.

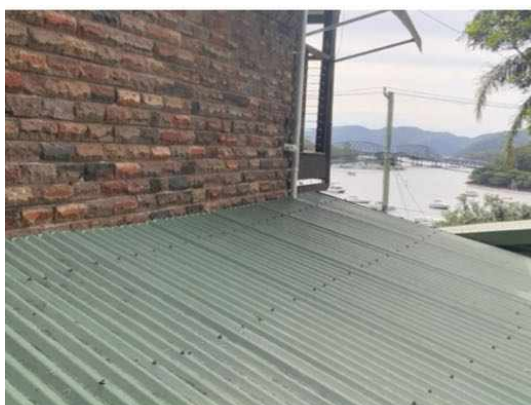
Building: Main Building
Location: Exterior walls - left side
Finding: Structure - Old and non-compliant
Information: This structure, whilst appearing to provide adequate structural support, does not comply with contemporary building practices and current Australian Standards.

Although this is not a requirement in older homes, the client should be aware of the age and non-compliance of the structure when planning any repairs or remodelling.

It is advised that this structure be inspected by a registered builder or structural engineer on a relatively frequent basis to ensure that the structural integrity does not falter over time.
