# Building and Timber Pest Inspection Report

Inspection Date: Thu, 5 Mar 2026

Property Address: 8 Chaplin Cres, Quakers Hill NSW 2763,  
Australia

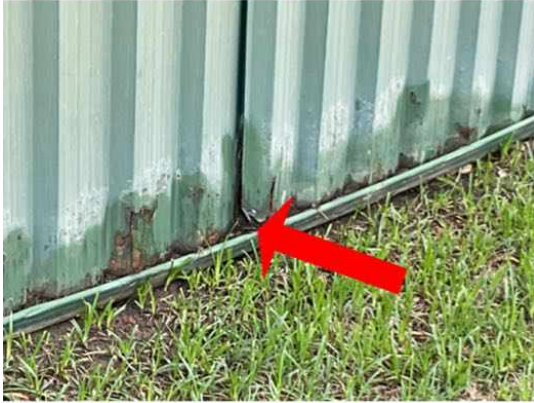
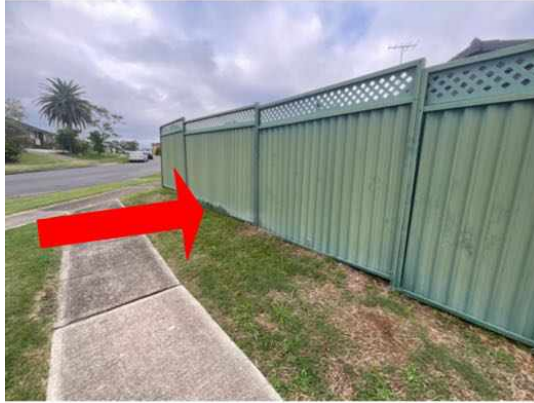
### Finding 3.02

Building:	Main Building
Location:	All External Areas
Finding:	Fencing - Deteriorated
Information:	It was noted at the time of inspection that sections of the fencing throughout the property have deteriorated. Typically fencing deteriorates due to age and or wear, rot and or rust which is generally expected for a structure of this age, due to prolonged exposure to weather conditions. Sometimes inadequate installation or maintenance can be to blame.

If left unattended, it is likely that further damage will occur. It is suspected that repair of several elements of the fencing may be required however replacement may be a

consideration of the client also.

A licensed fencing contractor should be appointed to provide further advice and perform rectification works as necessary.

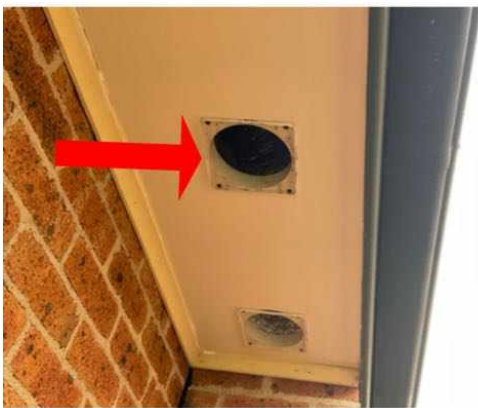
### Finding 3.03

Building:	Main Building
Location:	All External Areas
Finding:	External Vent Grille - missing
Information:	The external vent grille is missing / dislodged, leaving the vent opening exposed. This condition may allow vermin, insects, moisture, and debris to enter the building cavity.
	Supply and install a suitable external vent grille and ensure it is securely fixed and sealed.

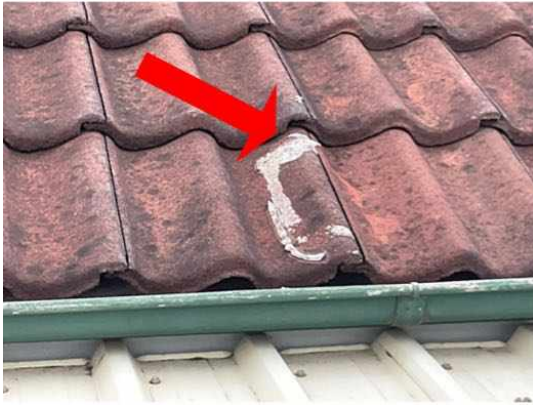
Building:	Main Building
Location:	Roof Exterior
Finding:	Roof tiles - Broken
Information:	Upon inspection of the exterior roof covering, broken roofing tiles were identified. Broken and friable roof tiles are generally the result of ageing and weathering of what is essentially a porous material.

If left to further deteriorate, broken and brittle roof tiles are likely to lead to water penetration via the roof into the ceiling space, causing secondary damage to ceiling linings, insulation and roof structures. Broken roof tiles are also likely to detract from the effectiveness of the roof drainage system, creating potential for secondary damage to the exterior roof covering and roof plumbing.

Replacement of broken tiles is required and should be performed by a roofing contractor as soon as possible.

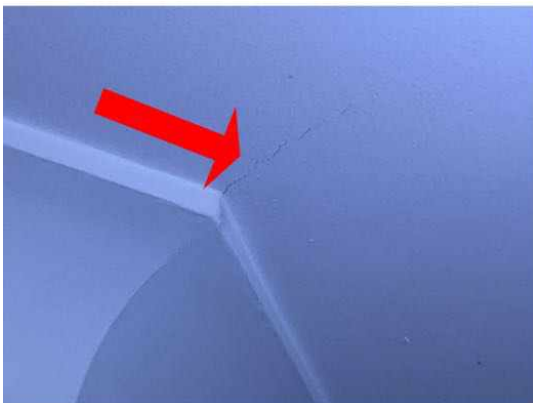
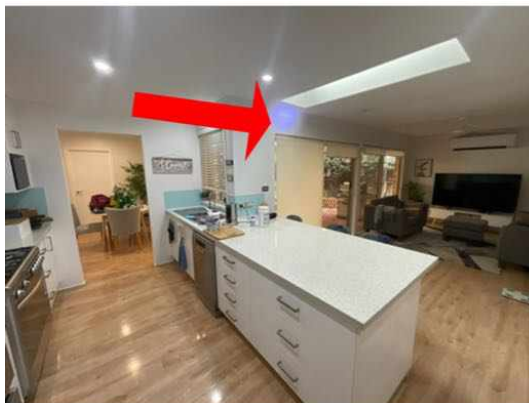
### Finding 3.06

Building:	Main Building
Location:	All Internal Areas
Finding:	Cracking - Damage Category 1 - Fine (up to 1mm)
Information:	Although fine cracks are quite noticeable, they are often only considered to be an appearance defect, and usually do not indicate any structural damage. Generally, the cause of a fine crack is indicative of a separation between building materials and finishes (e.g. paint, plaster, etc.) along joins.

Cracking of this nature can generally be repaired with minor sanding, filling and/or repainting. Such works should be performed by a qualified painter or a general handyman.

Monitoring of all cracking should be conducted frequently. Always contact a building inspector should cracks widen, lengthen, or become more numerous.

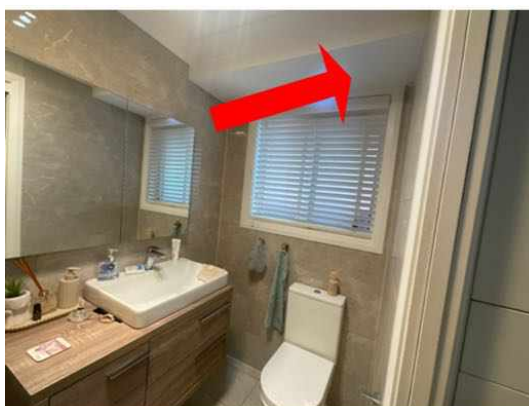
### Finding 3.07

Building:	Main Building
Location:	Ensuite
Finding:	Bathroom Ceiling - Mould Growth
Information:	Minor mould growth was observed to the bathroom ceiling along the joint line. This is likely due to condensation and elevated moisture levels within the bathroom environment.

While the mould appears localised and minor at the time of inspection, prolonged moisture exposure may lead to further deterioration of paint finishes and potential substrate damage.

Recommendation:

- Clean and treat affected areas with an appropriate mould removal solution.
- Repaint with mould-resistant paint if required.
- Improve ventilation (ensure exhaust fan is operational and ducted externally).
- Monitor for recurrence.

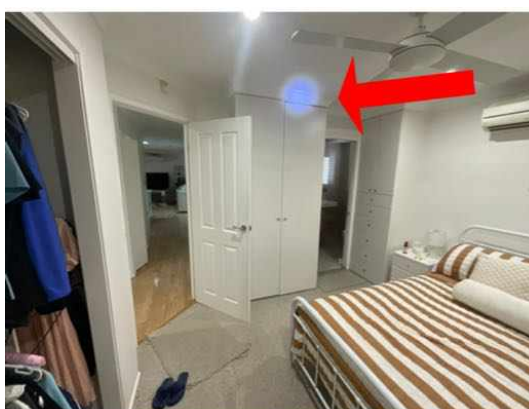
### Finding 3.08

Building:	Main Building
Location:	Bedroom - Master
Finding:	Cornices - Sagging
Information:	Sagging and uneven cornices generally indicate that the building materials have swollen, due to contact with water, or the movement of the ceiling joints or that fixings (e.g. nails or glue) have become loose and require reattachment. In some cases, sagging and uneven surfaces may also indicate that there are structural issues causing surfaces to warp, twist, or sag.

Where sagging appears to be major, appointment of a structural engineer is advised to further inspect the property. Otherwise, minor works such as re-gluing of wall/ceiling sheets may be required and should be performed by an aptly qualified plasterer or carpenter.

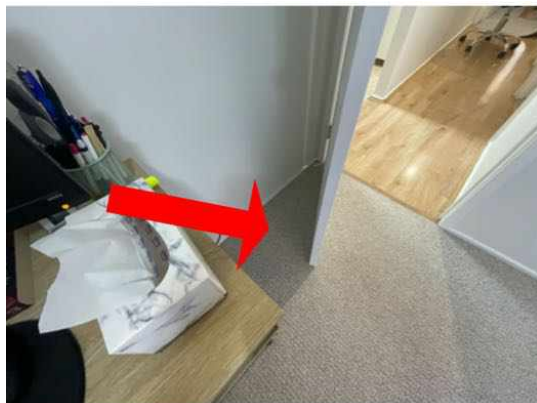
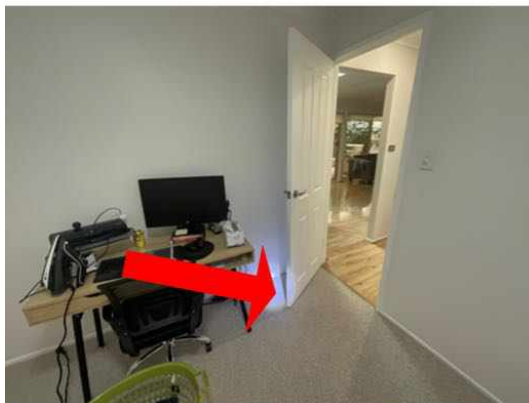
### Finding 3.09

Building:	Main Building
Location:	Bedroom 2
Finding:	Door stop - Missing
Information:	The door stop is missing or is inadequate to stop the door handle from damaging the wall. Although some building elements may seem irrelevant or unnecessary, all building elements play a key role in the operation and function of the overall structure and its performance.

Re-installation or replacement of the door stop is advised as soon as possible to prevent any subsequent damage to the door or associated structures. A general handyman may be appointed to perform these works at client discretion.

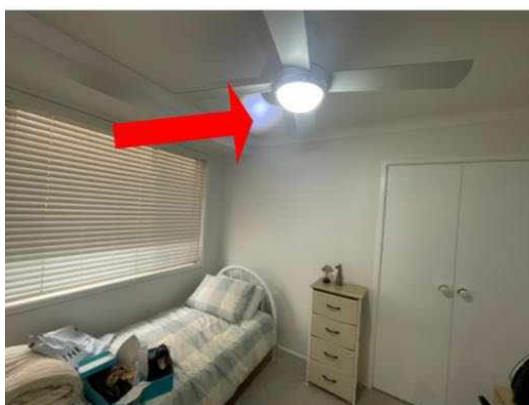
### Finding 3.10

Building:	Main Building
Location:	Bedroom 2
Finding:	Ceiling nails - Popping
Information:	Numerous popped nails were identified in the internal ceiling at the time of inspection. Nails and screws hold simply by the friction between them and the surface they are applied to. Over time, the nails and screws can back out, which is often a result of general ageing and deterioration of the building structure.

If left unmanaged, the ceiling sheets may become loose and unstable, increasing the rate of deterioration of the internal ceiling and creating potential for the development of secondary defects.

Re-fastening of popped nails will help to maintain the stability of the internal ceiling and associated building elements. Such minor works will also help to improve the appearance of the affected area and secure the ceiling sheets, so as to prevent the onset of ceiling sagging. These works should be performed by a qualified carpenter or plasterer at client discretion.

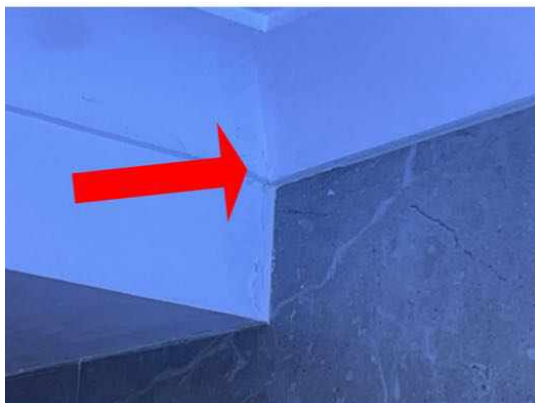
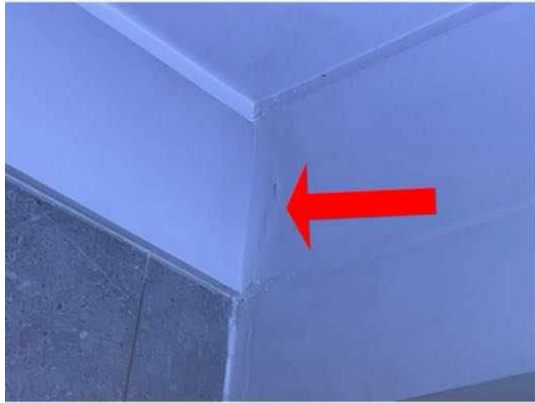
### Finding 3.11

Building:	Main Building
Location:	All Internal Areas
Finding:	Painted surface - Bubbling
Information:	Sections of paint in this area was found to have bubbled and deteriorated. Paint bubbling is generally an indication of excessive moisture in the area, that is currently hidden by the painted surface.

The presence of excessive moisture can have major implications on associated building elements if left unattended. While only seemingly minor at this stage, the damage cannot be determined due to the paint obstructing any further inspection of the damage.

It is highly advised that the affected paint be cleaned to allow a further, more invasive inspection by a licensed plumber. Failure to act on this defect may necessitate major works in the future.

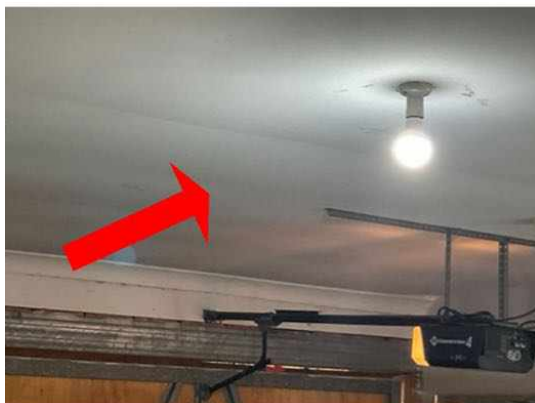
### Finding 3.12

Information: Sections of the ceiling were found to be sagging at the time of inspection. Sagging to the fixed ceiling structure generally indicates that the building materials have swollen, due to contact with water, or that fixings (e.g. nails or glue) have become loose and require reattachment.

Where minor sagging is evident, comparatively minor works, such as re-gluing of ceiling sheets, may be required. Such works may be performed by relevant tradespeople, such as carpenter and painters. Where excessive moisture has caused the roofing structure to swell and sag, the source of the water leak should primarily be identified prior to any remedial works being performed.

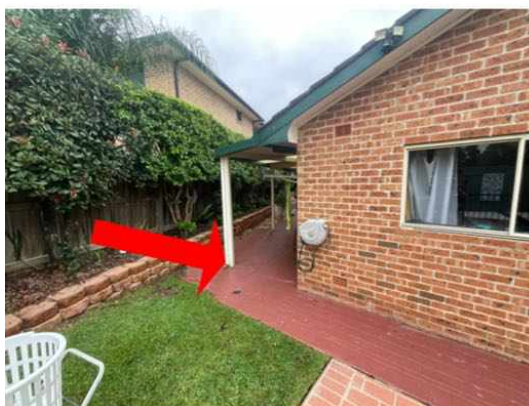
Building: Main Building  
Location: All Areas  
Finding: Overflow - Not plumbed for drainage  
Information: The overflow is not plumbed or connected to suitable drainage, which has resulted in the surrounding area becoming excessively damp. These damp conditions can lead to secondary defects such as rot, rust or corrosion of associated building elements, the formation of fungal decay, or even the creation of potential slip hazards. When coupled with poor site drainage, pooling of water may also attract termite activity to this area. It is highly recommended that a qualified plumber be appointed to install adequate drainage to the overflow. These works will ensure that the area remains dry and free of any secondary defects.

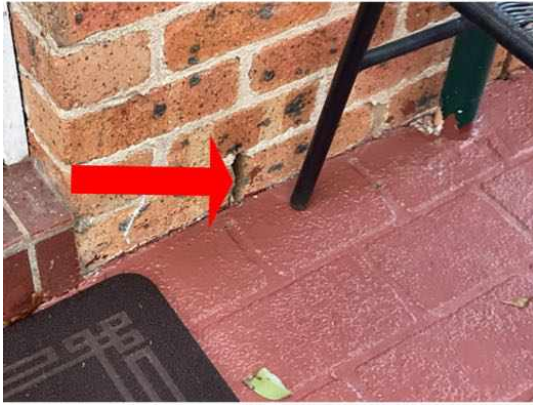
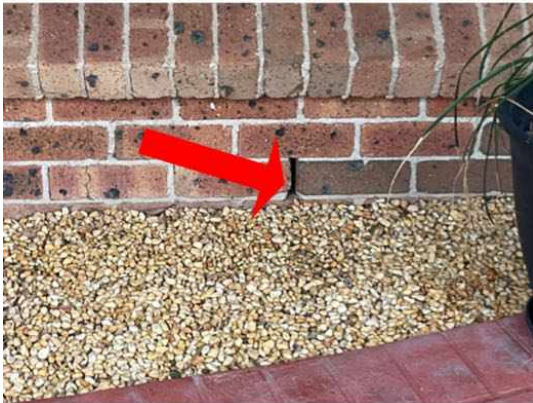
### Finding 6.03

Building:	Main Building
Location:	All Areas
Finding:	Bridging or breaching of termite barriers - weep holes
Information:	Bridging is the spanning of a termite barrier or inspection zone so that subterranean termites are provided with passage over or around that barrier.

Weep holes in the exterior brickwork of the property are designed to allow condensation that may build up between the brickwork and subsequent timber framework to drain from within the wall hence preventing any deterioration of the timber building elements.

Additionally build-up of moisture is likely to occur if weep holes are covered further attracting termite activity to these areas.

It is highly recommended that weep holes are left exposed in all areas throughout the external property. Therefore if any termite activity leading into weep holes becomes easily detectable during frequent pest inspections.

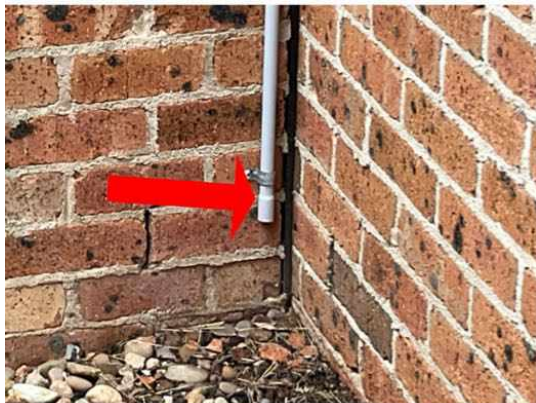
Building:	Main Building
Location:	All Areas
Finding:	Air conditioner - Disconnected overflow
Information:	The Air Conditioner (A/C) overflow was found to be disconnected from storm water drainage and is creating excessive moisture in the surrounding area.

Such leaking creates an environment which is conducive to an array of defects, including water damage to associated building elements and the attraction of termite or timber pest infestation.

It is highly recommended that a licensed plumber be appointed to connect the A/C overflow in order to prevent such an environment from being created. These minor works should be carried out as soon as possible.

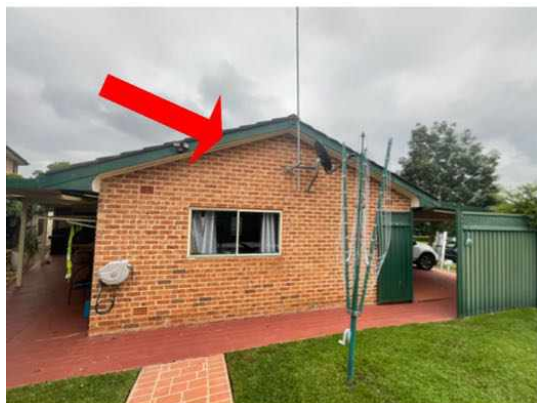
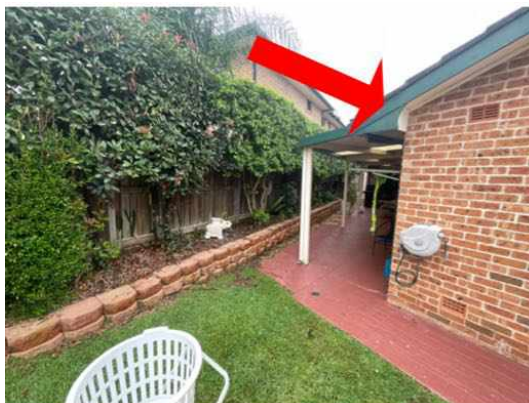
### Finding 6.06

Building:	Main Building
Location:	All Areas
Finding:	Timber - exposed to weather
Information:	External timbers that are frequently exposed to harsh weather conditions require adequate protection in order to maintain their condition. Where timbers have not been

painted or treated adequately, general deterioration is likely to occur at an accelerated rate.

If left unattended, replacement of these timbers is likely to be necessary in the short-term future. Adequate treatment of these timbers is required as soon as possible by a painting contractor or general handyman.

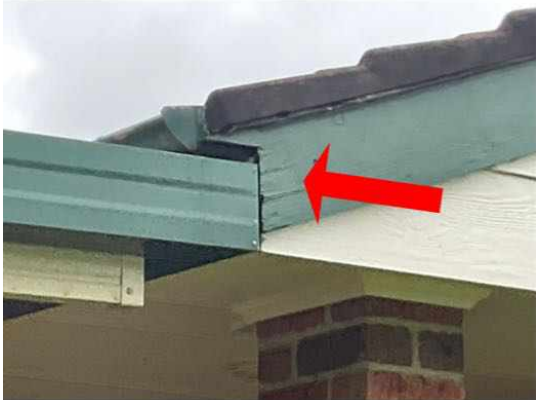
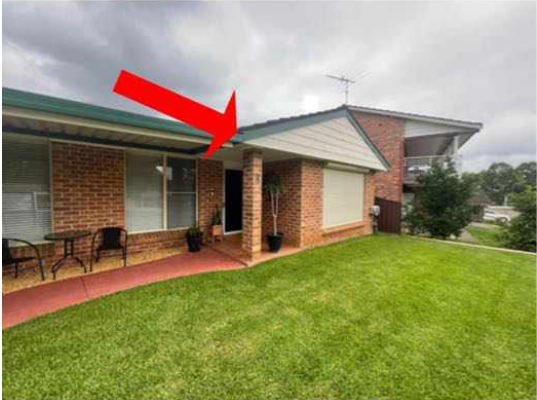
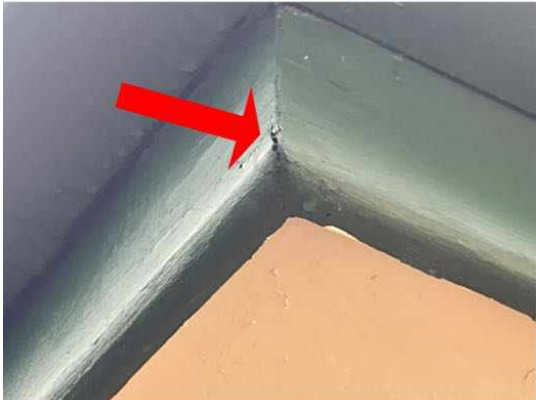
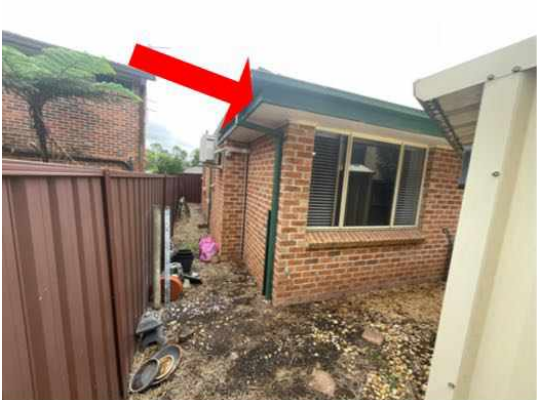
### Finding 7.01

Building:	Main Building
Location:	All Areas
Finding:	Wood rot
Information:	This building element shows evidence of wood rot. Wood rot, also known as Fungal Decay, occurs when timbers and other cellulose building materials are exposed to damp conditions on an ongoing basis. This could be the result of exposure to weathering over a prolonged period of time, or the attraction of excessive moisture from other abutting building materials. Contributing factors also include poor air ventilation in the area.

Wood rot is often associated with general damp problems and is evidenced by a 'musty' smell or mould and mildew occurring on surfaces. If left unmanaged, damp conditions can lead to further health problems and the decay of timbers will continue.

Early intervention and regular maintenance, particularly of exterior timbers, will prolong the useful life of these building elements. Prior to any works being performed, the cause of the moisture that has created the visible wood rot should be identified and addressed in a suitable manner. Replacement of affected timbers may then be a necessary step in protecting surrounding building elements from such deterioration.

A qualified plumber may be appointed to assess the cause of excessive moisture and to provide advice on any remedial works as required. A qualified carpenter or registered builder may also be required to replace affected building materials.

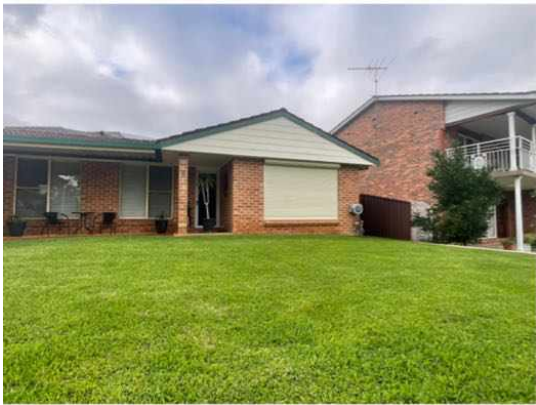
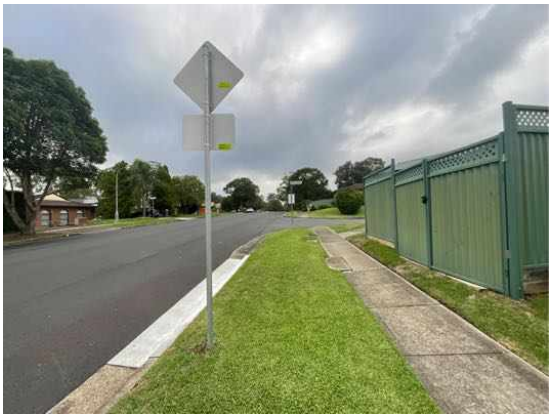
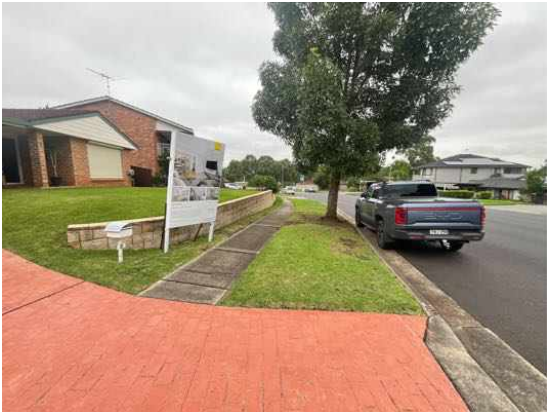
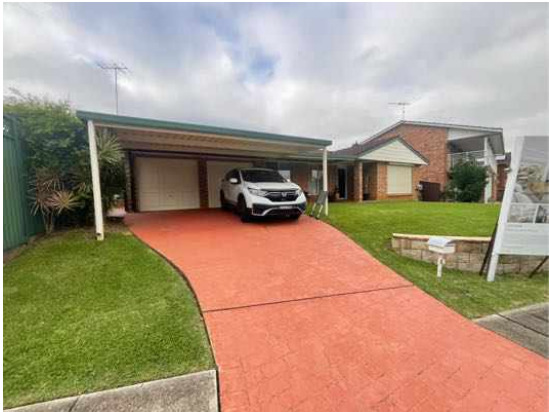
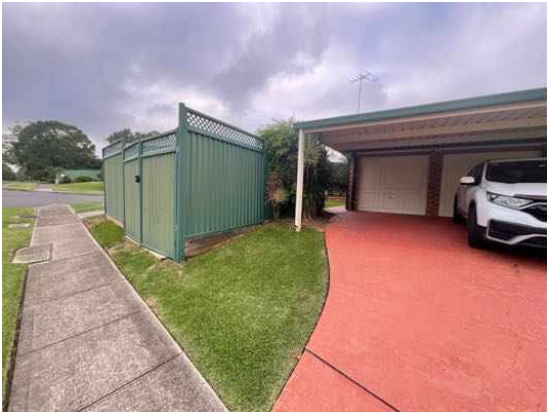
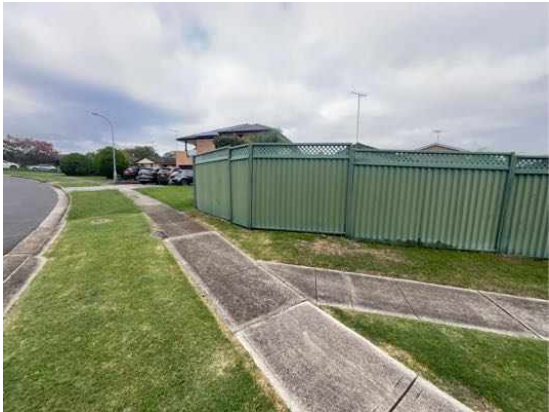
### Noted Item

Building: Main Building  
 Location: All Areas  
 Finding: Additional Photos - Obstructions and Limitations  
 Information: These photographs are an indication of the obstructions and limitations which impeded full inspection of the property at the time of inspection. These obstructions can hide an array of defects and should be removed to allow full inspection to be carried out. A re-inspection is recommended once the areas are made accessible.

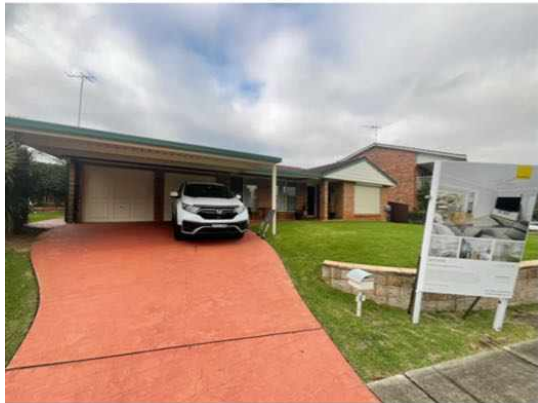
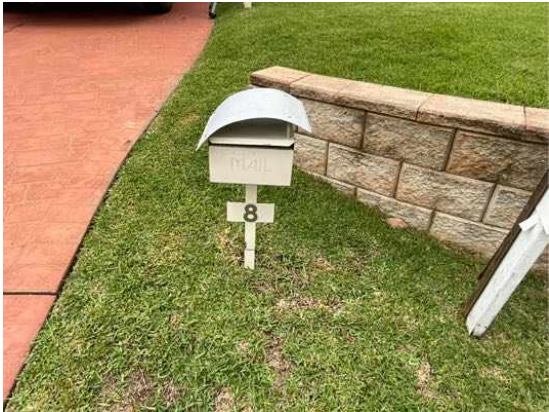
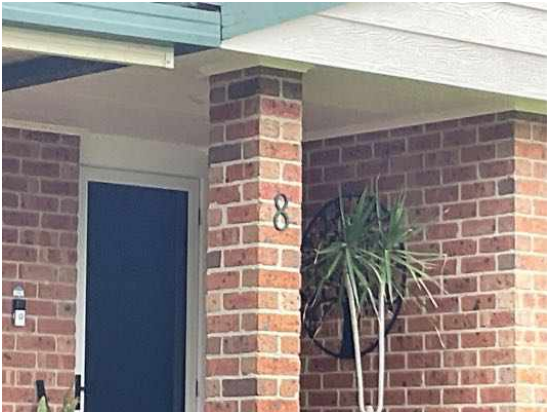
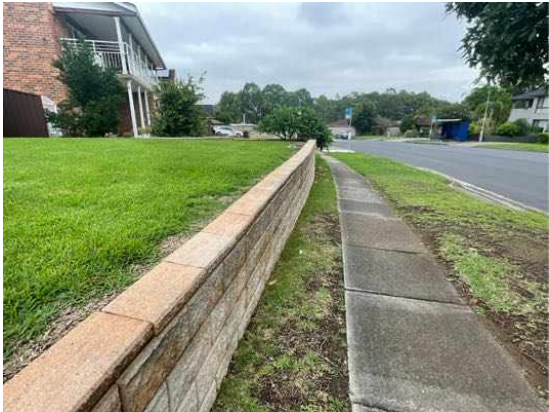
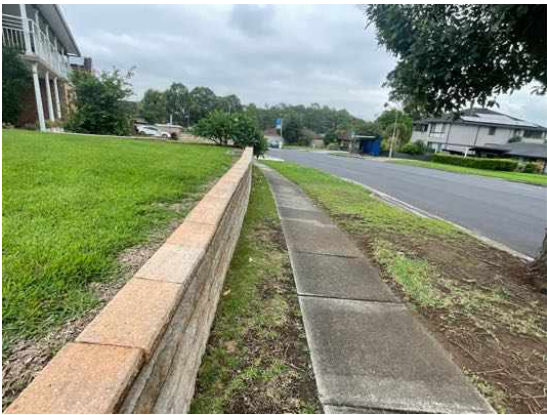
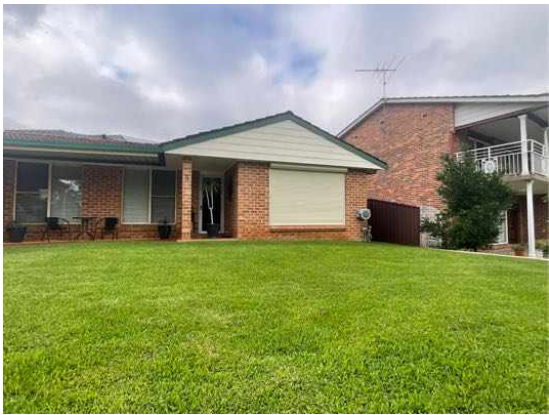
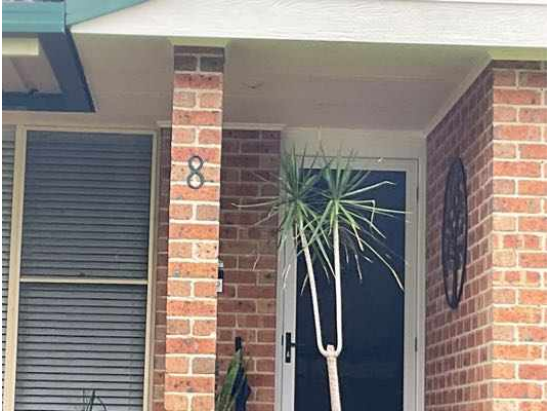
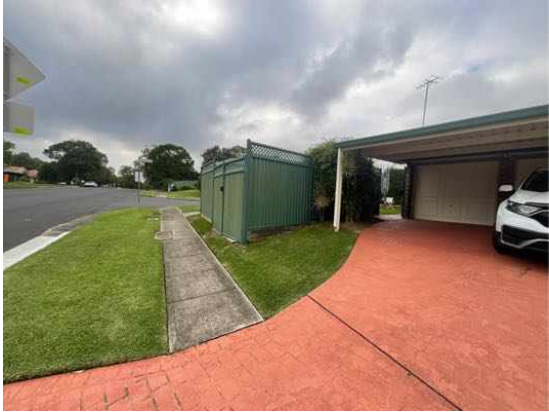
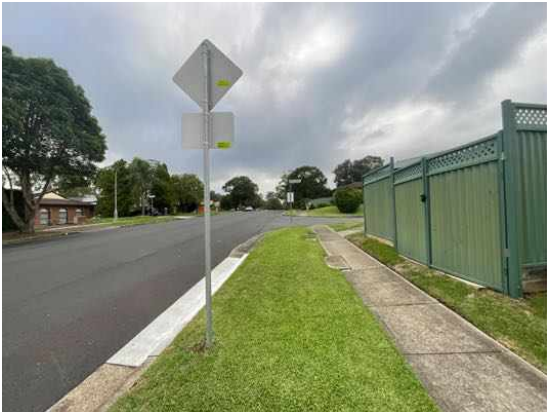
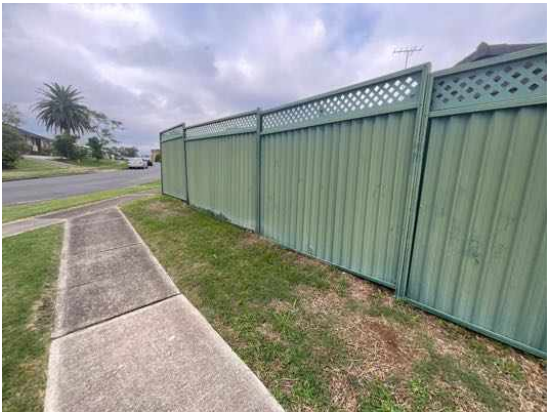
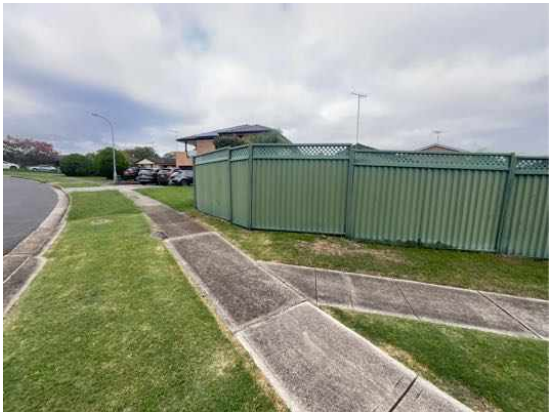
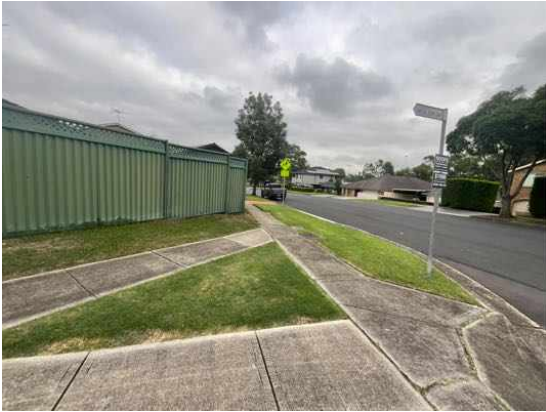
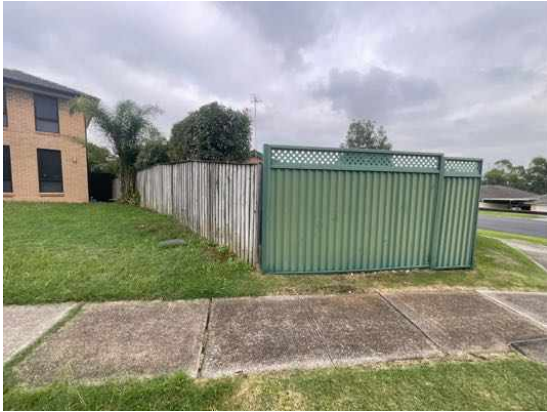
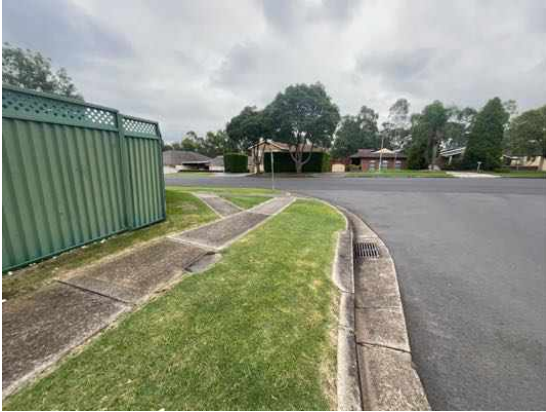
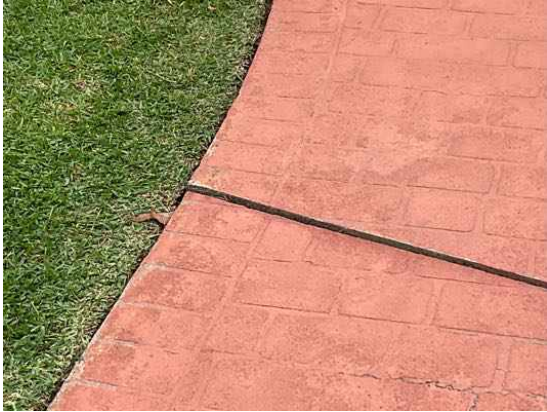
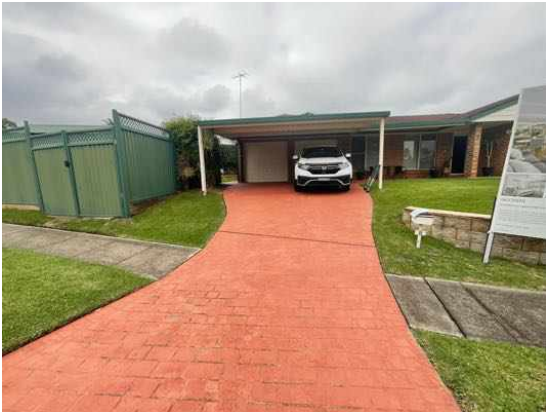
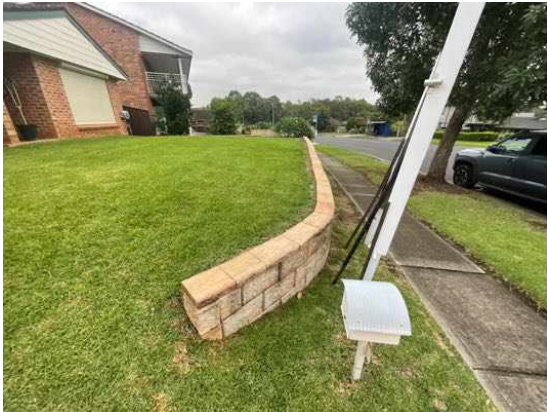
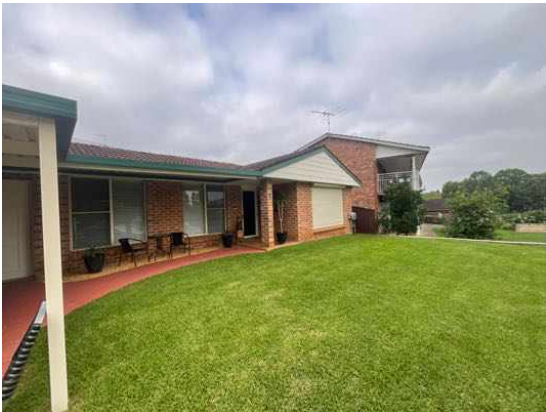
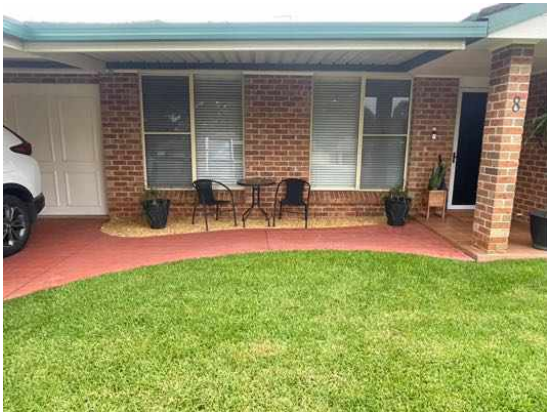
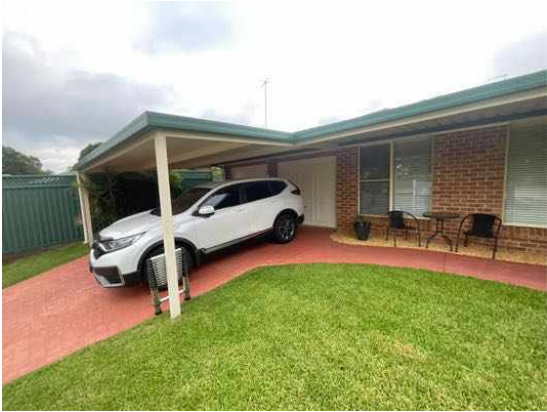
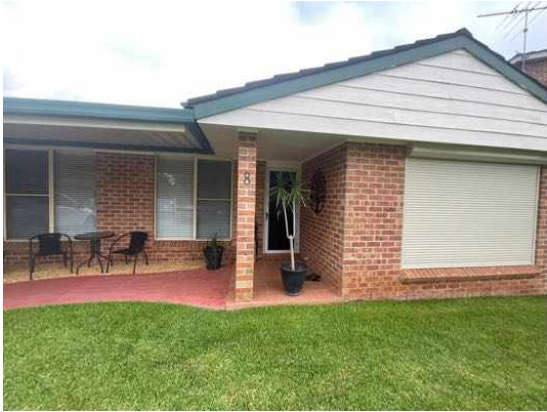
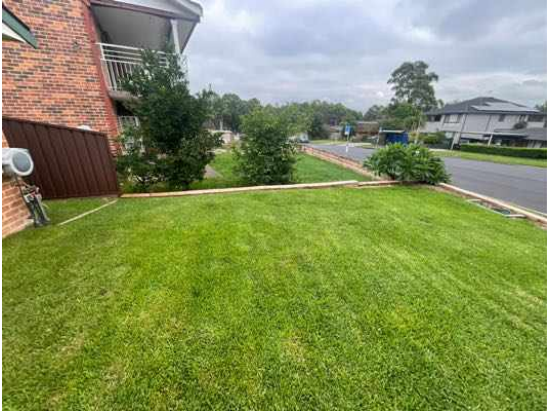
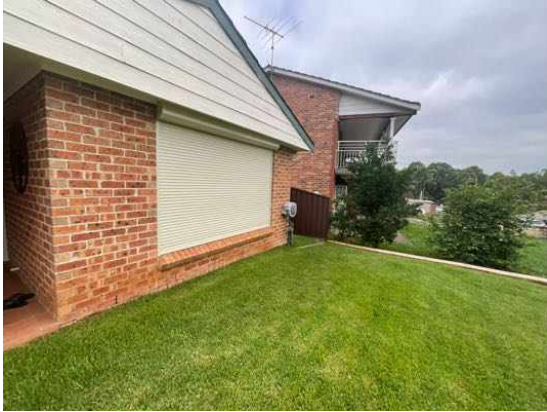
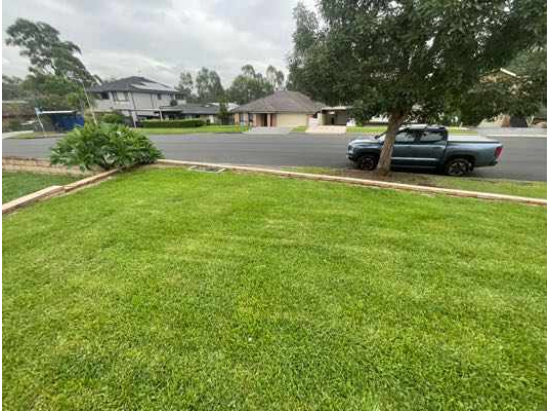
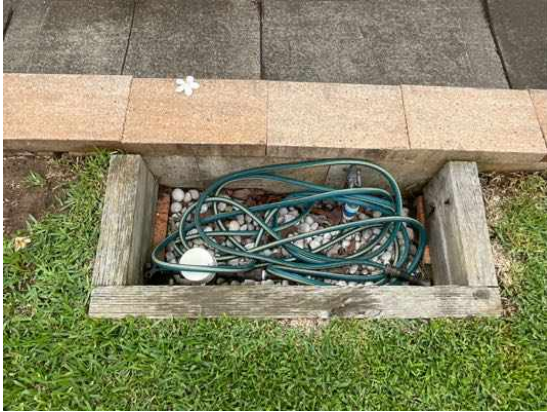
Building: Main Building  
 Location: All Areas  
 Finding: Additional Photos  
 Information: Additional photos are provided for your general reference
