# Building and Timber Pest Inspection Report

Inspection Date: Thu, 5 Mar 2026

Property Address: 8 Chaplin Cres, Quakers Hill NSW 2763,  
Australia

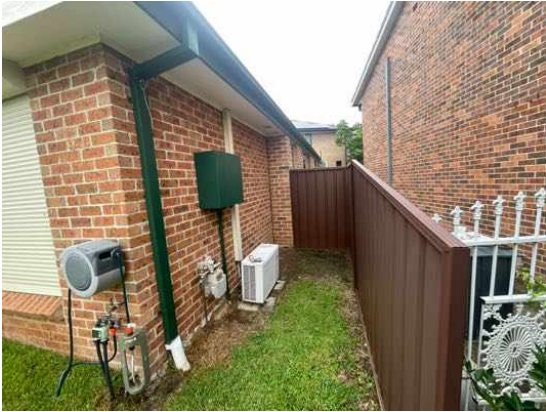
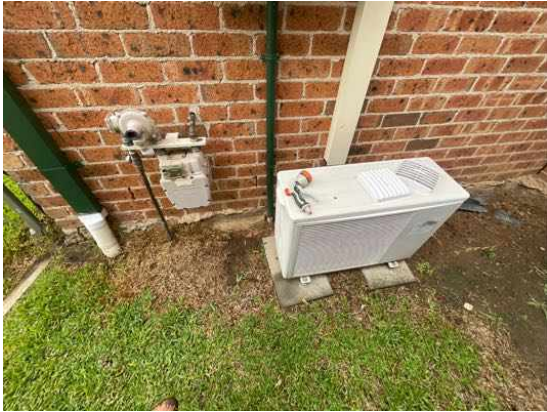
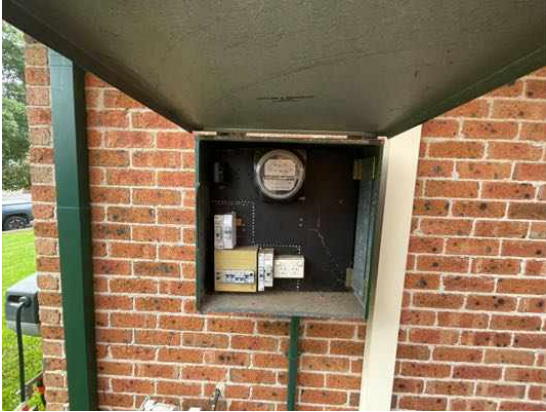
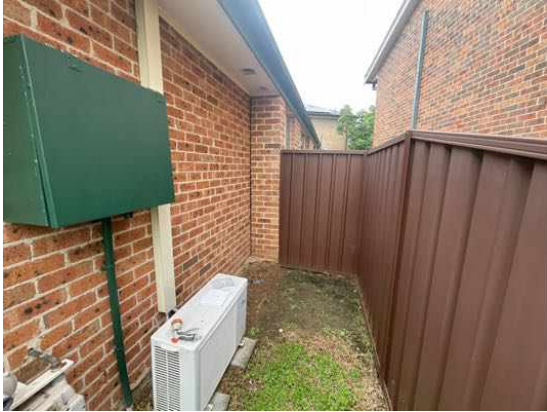
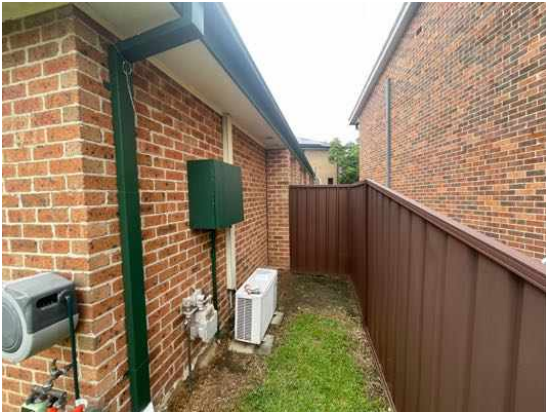
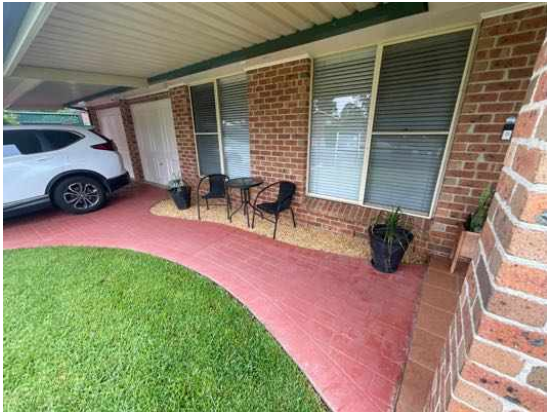
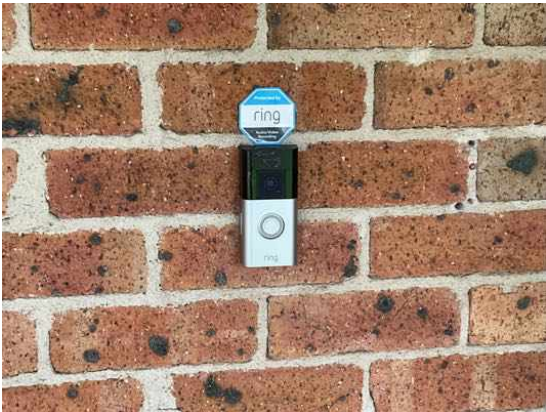
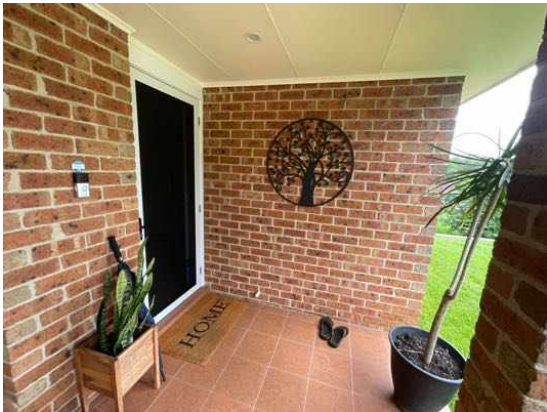
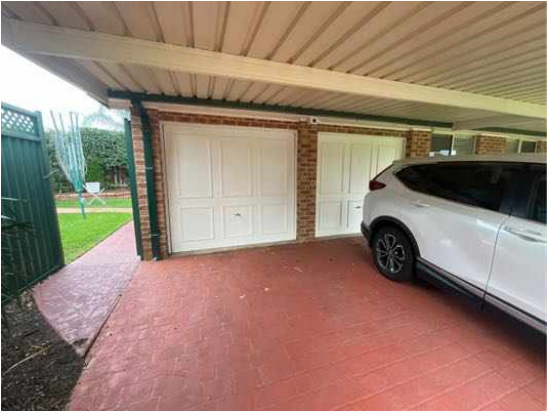
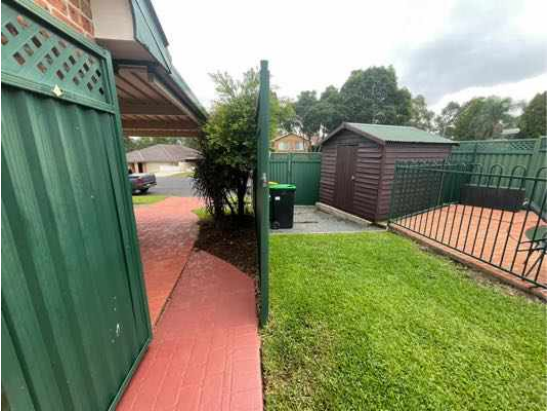
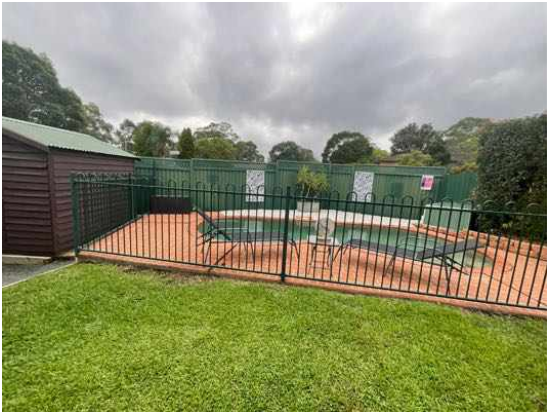
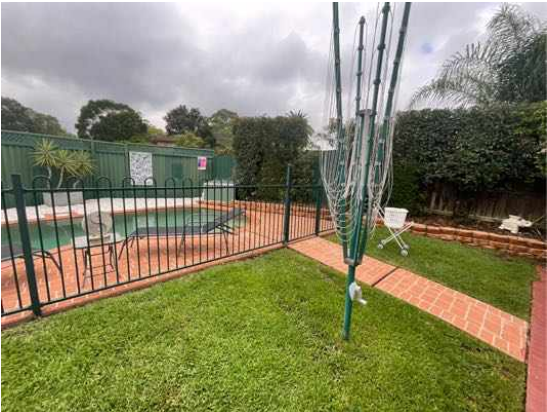
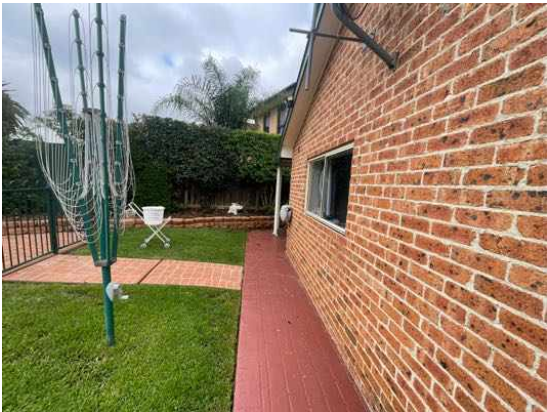
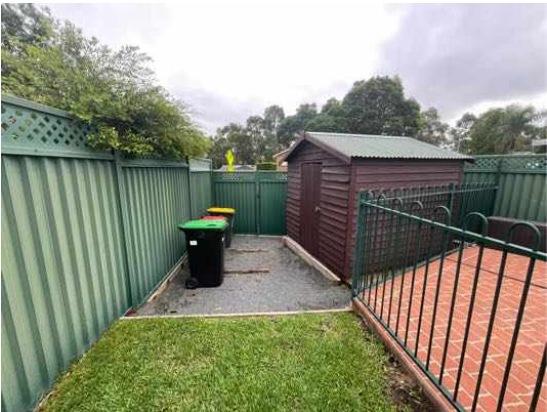
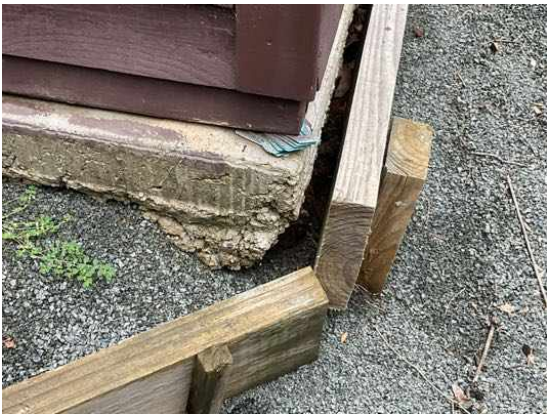
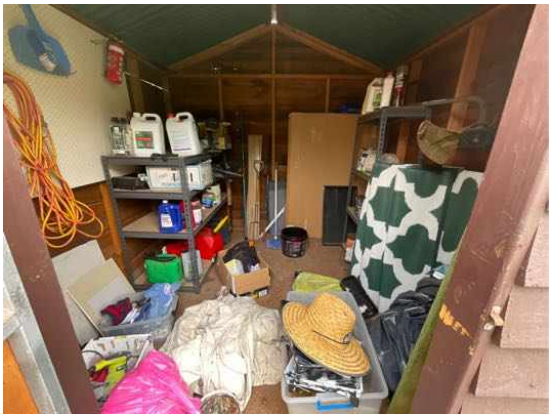
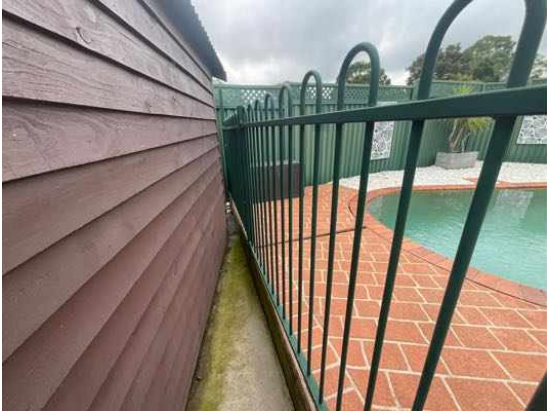
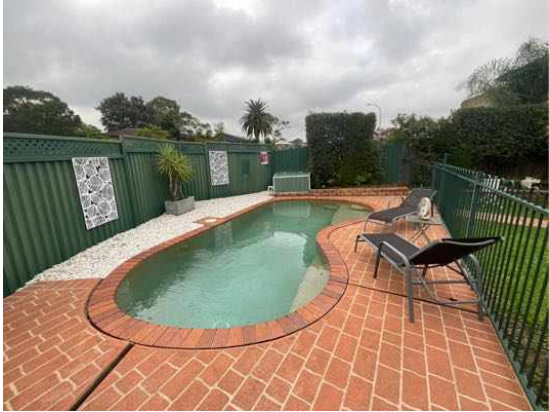
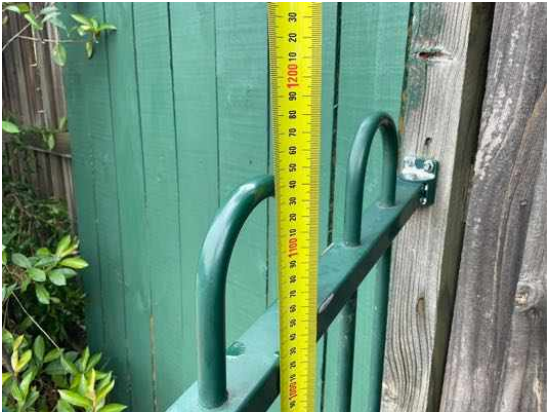
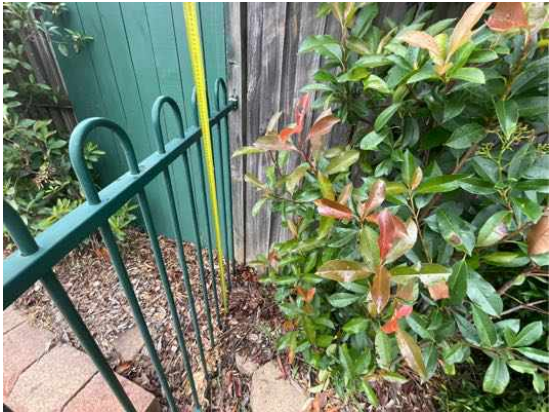
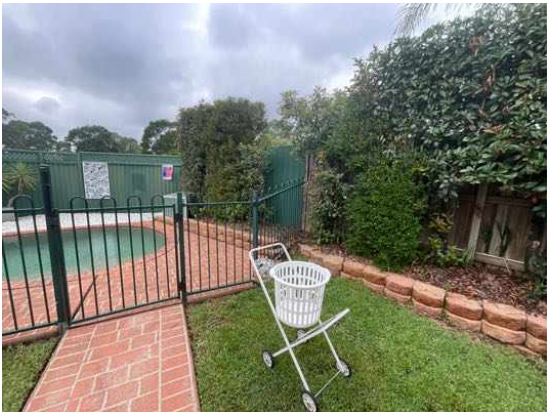
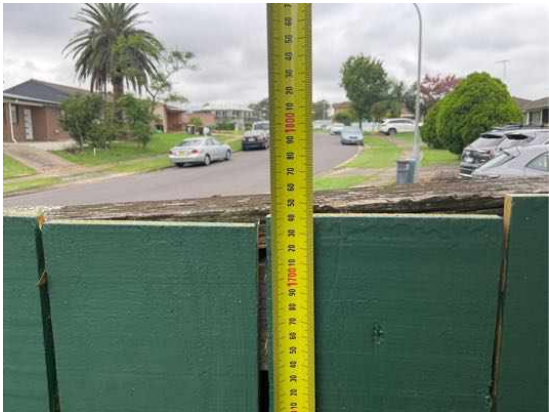
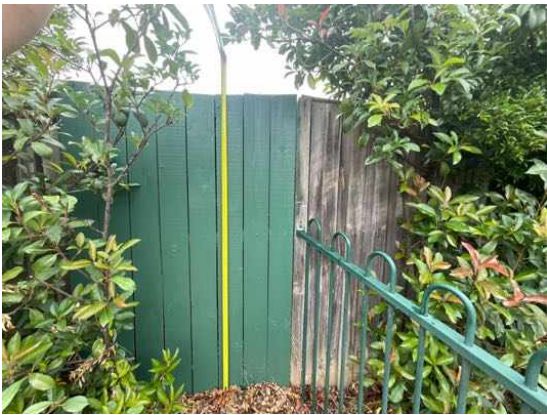
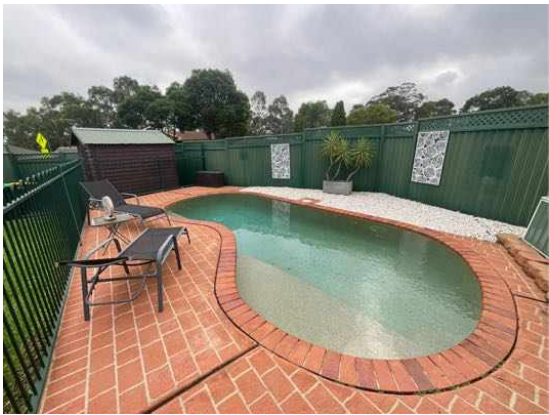
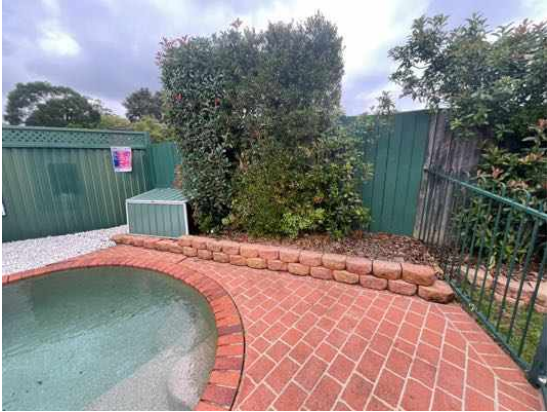
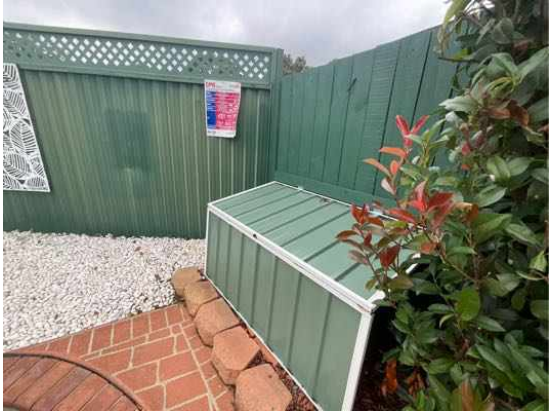
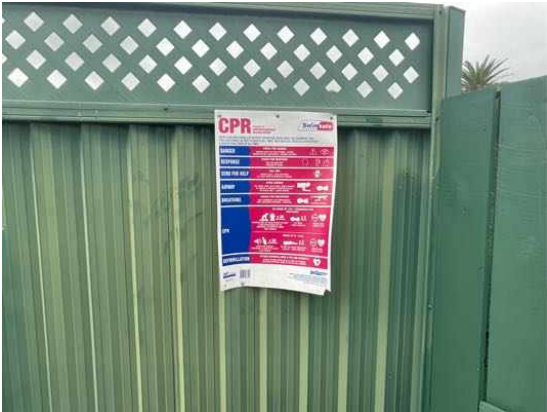
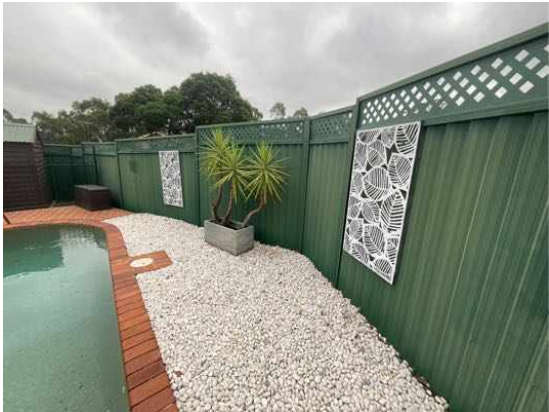
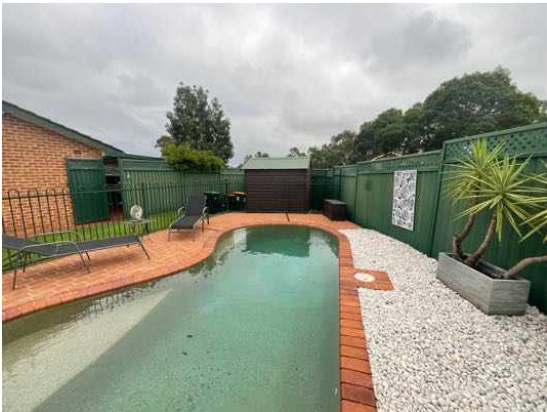
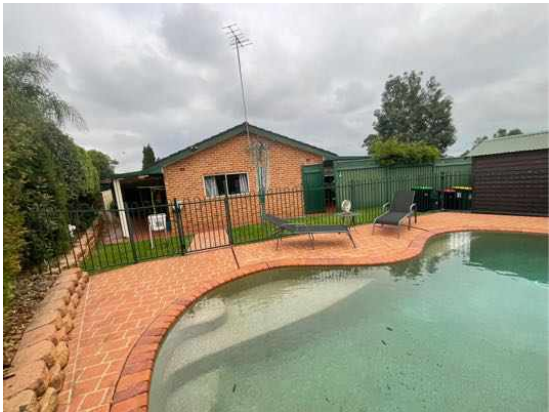
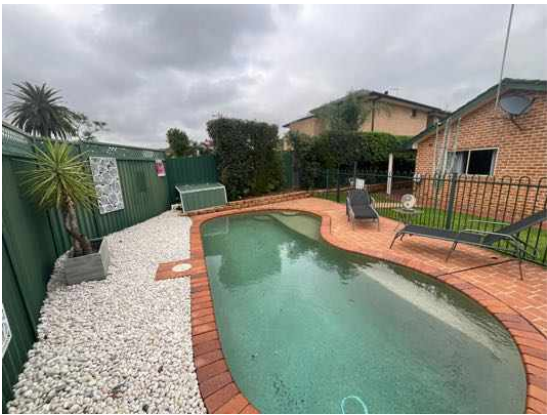
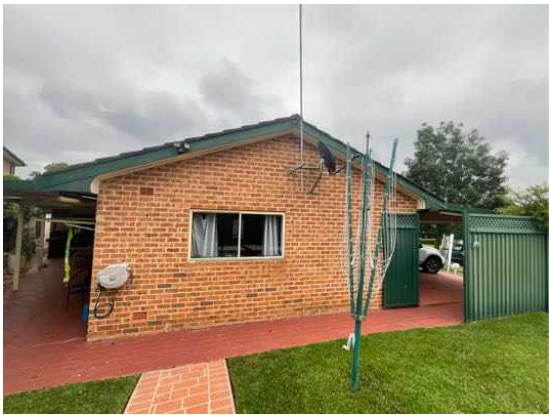
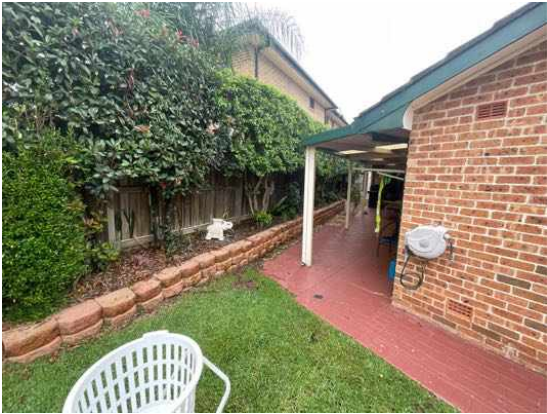
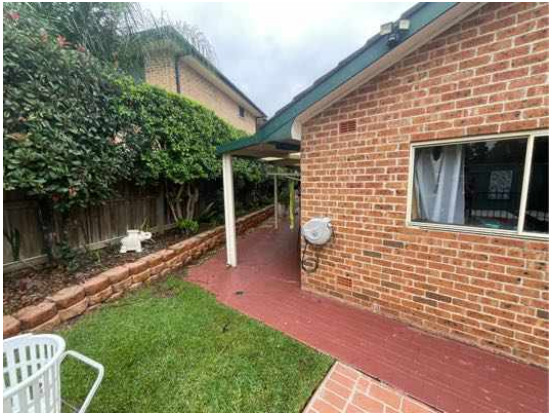
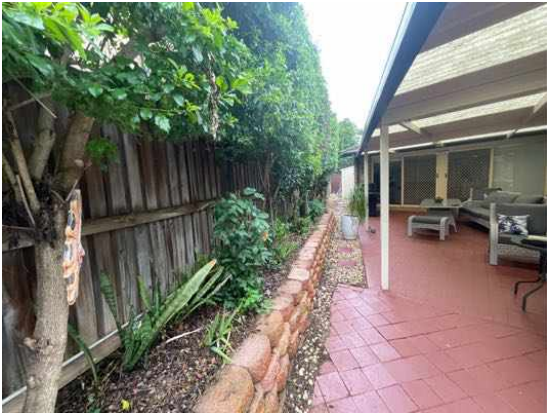
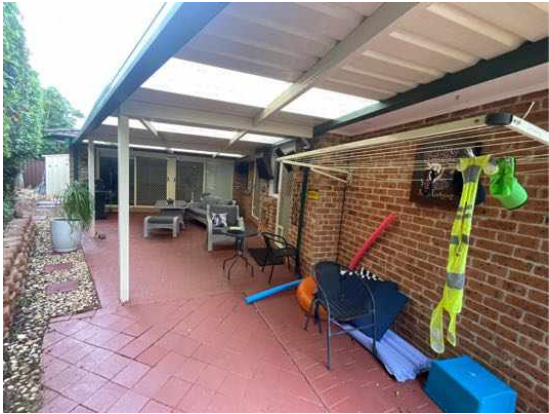
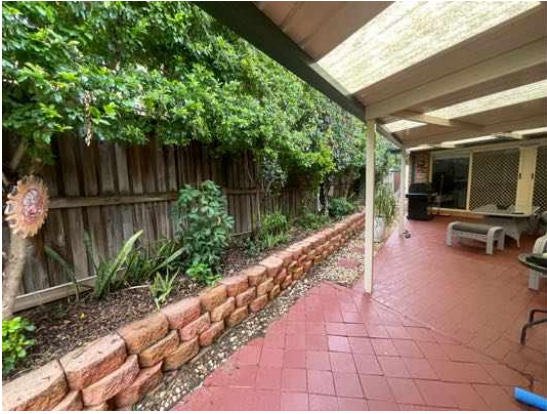
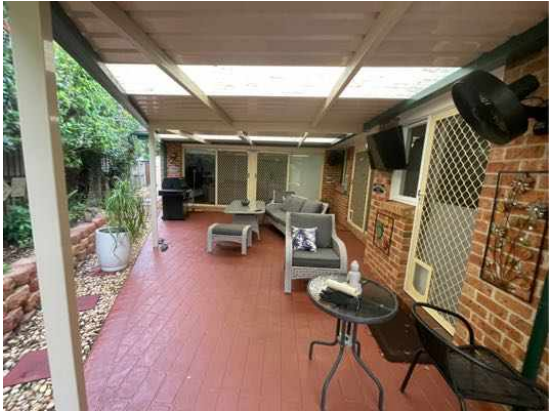
Building: Main Building  
 Location: All Areas  
 Finding: Additional Photos - Obstructions and Limitations  
 Information: These photographs are an indication of the obstructions and limitations which impeded full inspection of the property at the time of inspection. These obstructions can hide an array of defects and should be removed to allow full inspection to be carried out. A re-inspection is recommended once the areas are made accessible.
