Building Inspection Report

Inspection Date: Thu, 15 Jan 2026

Property Address: 52 Willoughby Rd, Crows Nest NSW 2065,
Australia

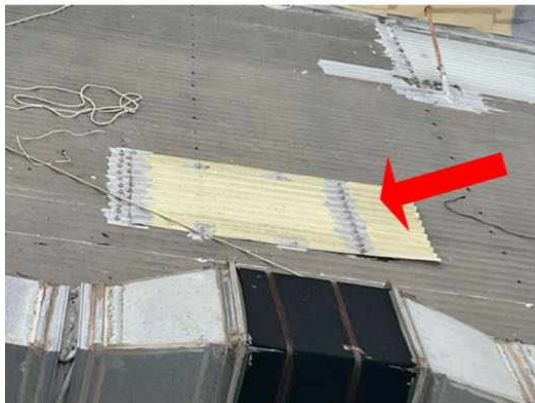
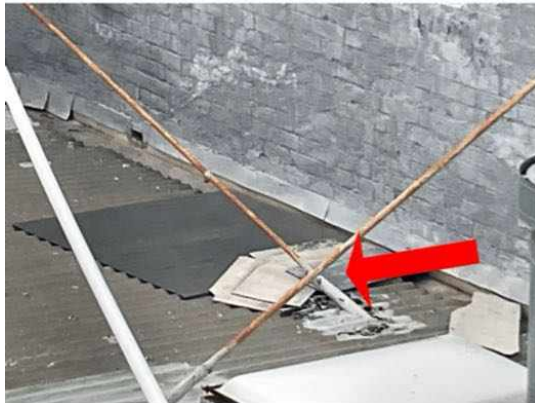
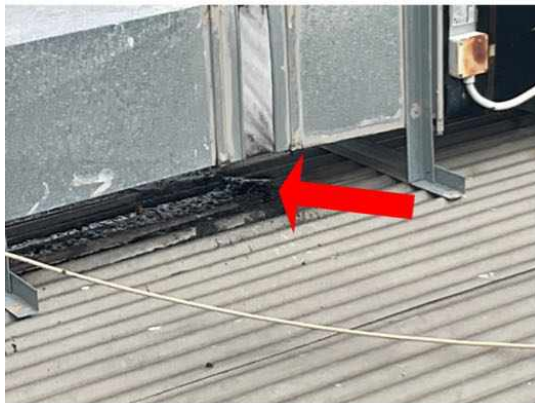
Defects 2.01

Building: Main Building
Location: Roof Exterior
Finding: Exterior roof - Leaking
Information: Active roof leaks were evident at the time of inspection. Roof leaks can have a number of causes, including damage to roof coverings, deterioration of roof fixtures and fittings, or loosely associated materials (fascias etc.).

Where water leaks are active, rain penetration is likely to cause water damage to associated structures and building elements in this area, which can have a range of implications. If left unmanaged, the development of major structural damage to the roofing and associated structures may occur.

A roof plumber should be appointed as soon as possible to primarily identify the cause of the leak, and to provide subsequent repair works as necessary. Depending on the extent of the damage, replacement of sections of the roof covering and/or roofing structures may be required, and may be performed by a registered builder or qualified carpenter.

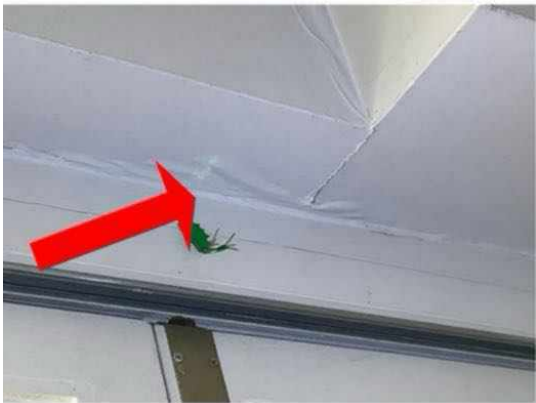
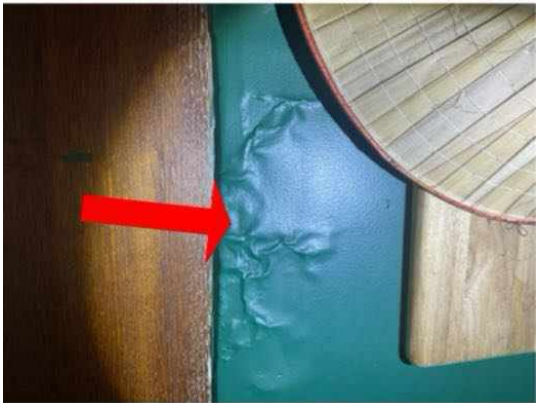
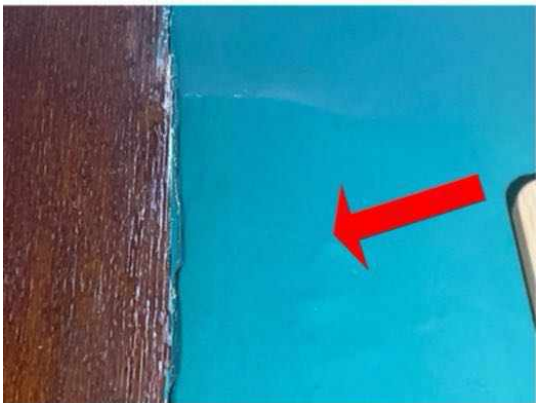
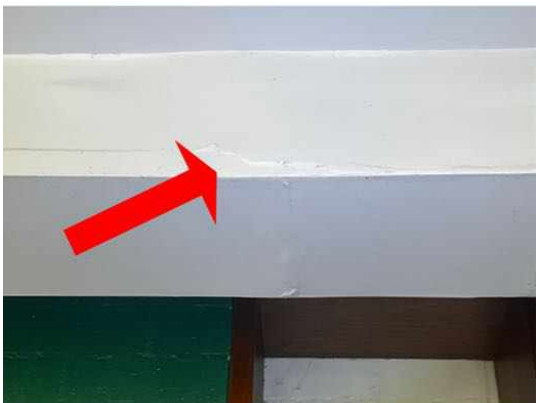
Defects 2.03

Building: Main Building
Location: All Internal Areas
Finding: Painted surface - Bubbling
Information: Sections of paint in this area was found to have bubbled and deteriorated. Paint bubbling is generally an indication of excessive moisture in the area, that is currently hidden by the painted surface.

The presence of excessive moisture can have major implications on associated building elements if left unattended. While only seemingly minor at this stage, the damage cannot be determined due to the paint obstructing any further inspection of the damage.

- Painted surfaces within internal areas were observed to be bubbling, which is consistent with underlying moisture issues. This condition suggests prolonged or recurring water exposure and may be linked to roof or drainage defects.

It is highly advised that the affected paint be cleaned to allow a further, more invasive inspection by a licensed plumber. Failure to act on this defect may necessitate major works in the future.

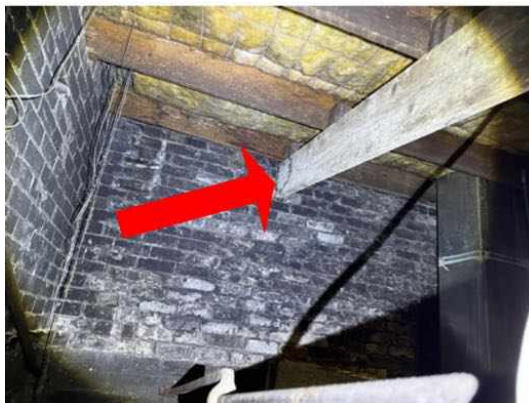
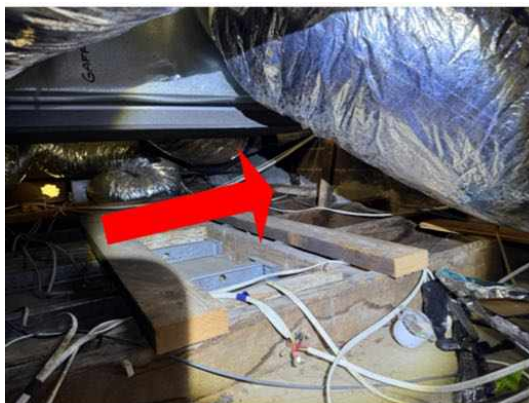
Defects 2.04

Building: Main Building
Location: Roof Void
Finding: Roof void - Water ingress
Information: Evidence of water ingress was observed within the roof void, including moisture staining, water marks, and discolouration to timber members and adjacent surfaces. Localised dampness and residue staining were noted on structural elements, indicating a history of moisture exposure. This condition is consistent with an active or previous roof leak.

Ongoing moisture exposure may lead to deterioration of timber elements, corrosion of fixings, reduced performance of insulation, and potential mould growth if not rectified.

A licensed roofing contractor should be engaged to investigate and identify the source of water ingress (e.g. roof covering, flashing, penetrations, or drainage components) and carry out necessary repairs. Affected materials should be allowed to dry and be assessed for damage, with repairs or replacement undertaken as required.

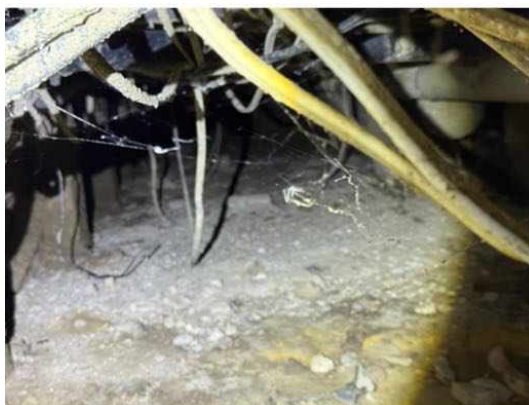
Defects 2.05

Building:	Main Building
Location:	Subfloor
Finding:	Subfloor - Excessive moisture and inadequate subfloor conditions
Information:	The subfloor shows deterioration typical of older homes, including damp brickwork, aged piers, and exposed cabling. While these issues are common in homes over 60 years old and not currently showing signs of failure, these conditions require attention to prevent further issues.

- Efflorescence and damp staining on internal brick walls, indicating rising damp or poor drainage.
- Damaged/makeshift brick piers and packing under bearers.
- Loose and unsupported electrical cabling.
- Signs of poor ventilation and moisture buildup.

We recommend further evaluation and maintenance to prolong the building's life and safety.

- Engage a builder to rectify subfloor supports and improve drainage.
- Consult a damp-proofing specialist for rising damp treatment.
- Improve subfloor ventilation.
- Have a licensed electrician secure and protect cabling.

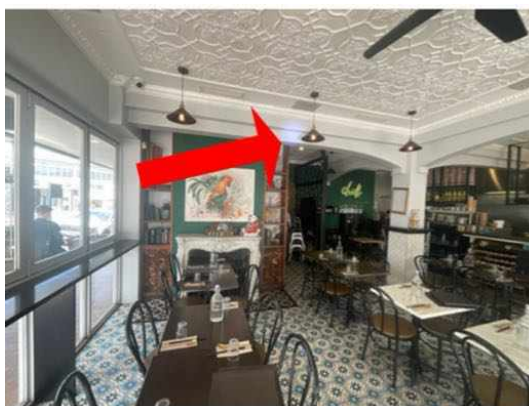
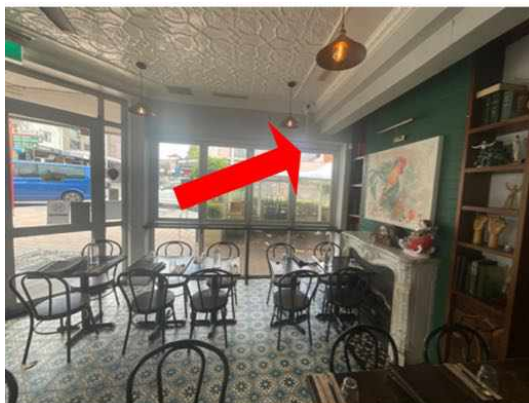
Defects 3.01

Building:	Main Building
Location:	All Internal Areas
Finding:	Cracking - Damage Category 1 - Fine (up to 1mm)
Information:	Although fine cracks are quite noticeable, they are often only considered to be an appearance defect, and usually do not indicate any structural damage. Generally, the cause of a fine crack is indicative of a separation between building materials and finishes (e.g. paint, plaster, etc.) along joints.

Cracking of this nature can generally be repaired with minor sanding, filling and/or repainting. Such works should be performed by a qualified painter or a general handyman.

Monitoring of all cracking should be conducted frequently. Always contact a building inspector should cracks widen, lengthen, or become more numerous.

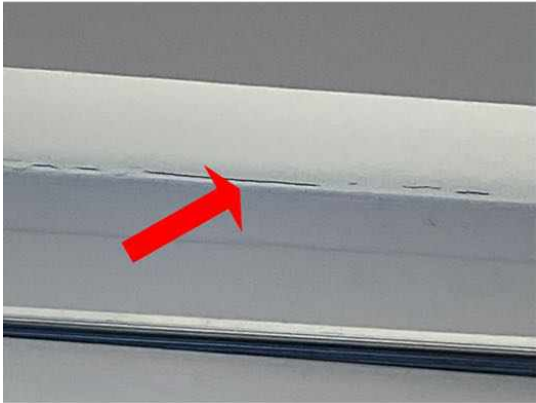
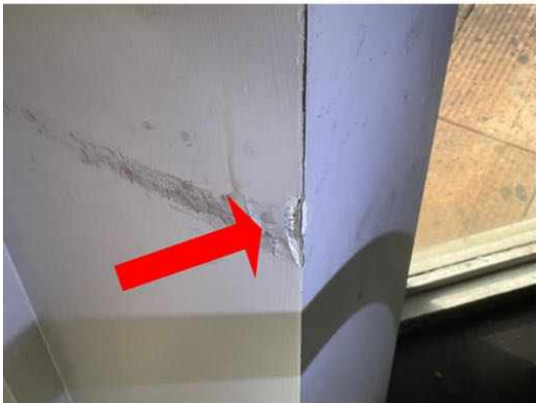
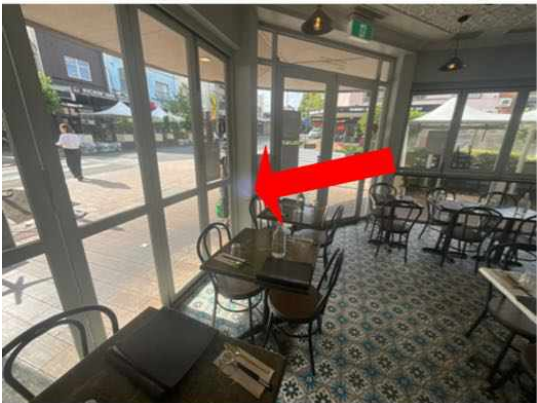
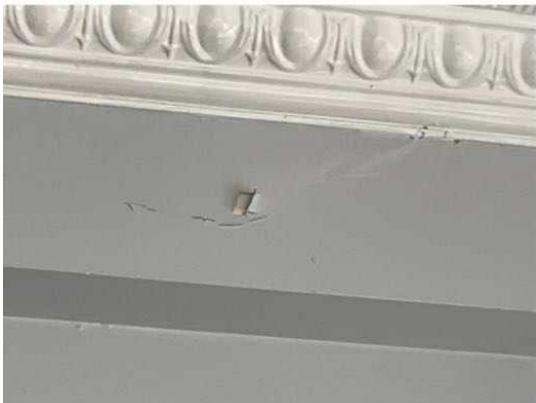
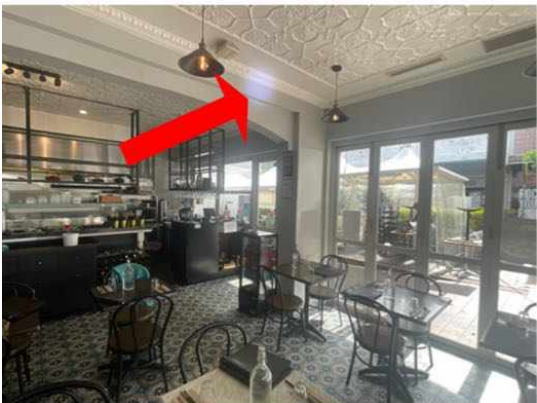
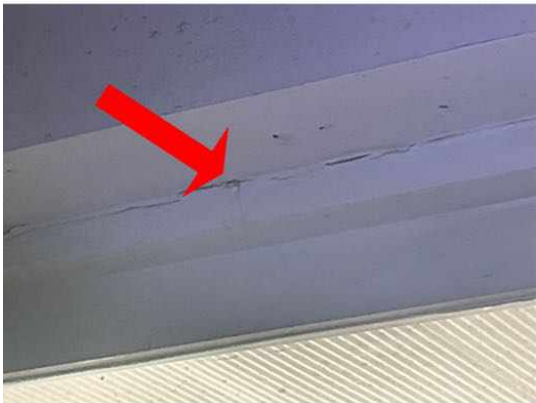
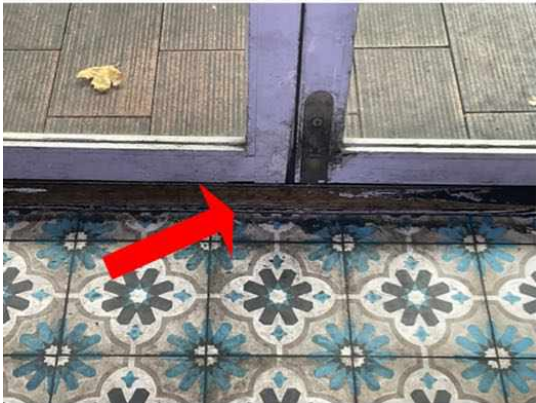
Defects 3.02

Building:	Main Building
Location:	All Internal Areas
Finding:	Internal painting deteriorated
Information:	Much of the internal paintwork including but not limited to windows, doors, walls, ceilings and other internal fittings have been neglected and require attention to prepare and re-paint.

Whilst incomplete or missing paint finish is generally an appearance defect, it can also lead to the development of secondary building defects over time. Incomplete areas of paint finish expose the area to moisture, potentially accelerating the deterioration of underlying building materials.

Degraded paint finishes should be sanded back, filled, leveled and painted, as applicable. Where inadequate or missing paint protection has led to the deterioration of the associated building element, repair and/or replacement of this building element may be required.

A painting contractor should be appointed as soon as possible to perform necessary works to aid the appearance of the affected area and to ensure the area is protected against further deterioration. Alternatively, the homeowner following manufacturer instructions may perform these works.

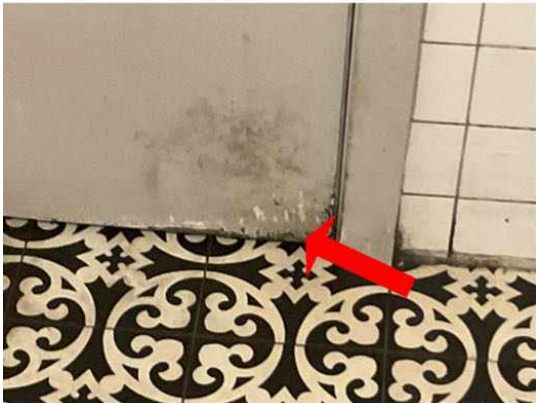
Defects 3.03

Building: Main Building
 Location: Toilet (WC)
 Finding: Door - swelling and damage at the bottom edge
 Information: Swollen and damaged door base in bathroom due to moisture exposure. Edges show fraying and surface degradation.

Replace or seal the affected door. Ensure door edges are properly sealed to prevent future water damage.

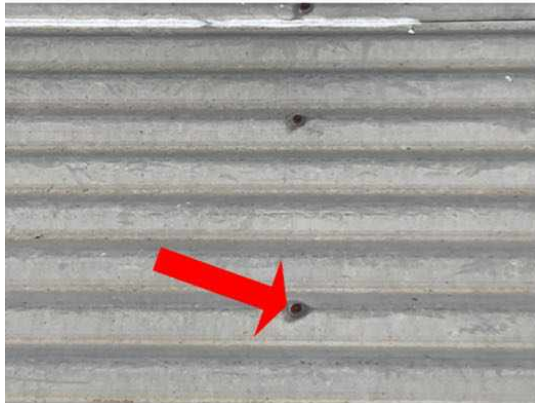
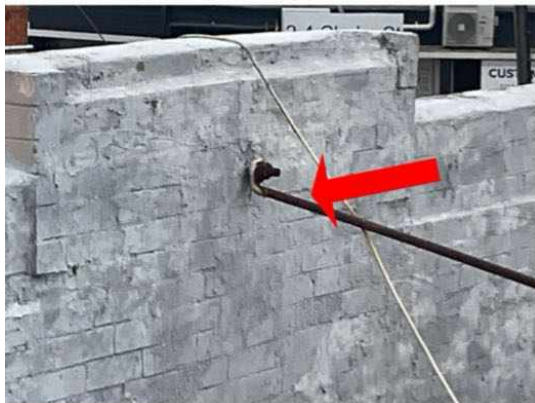
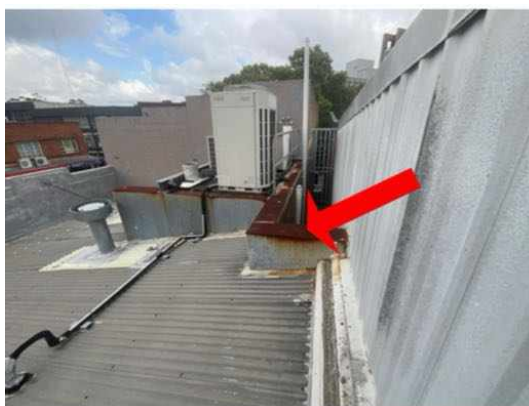
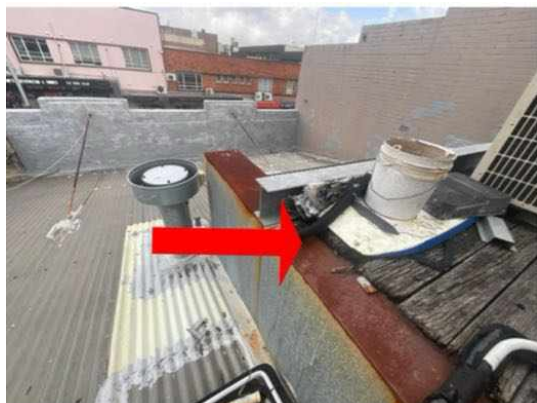
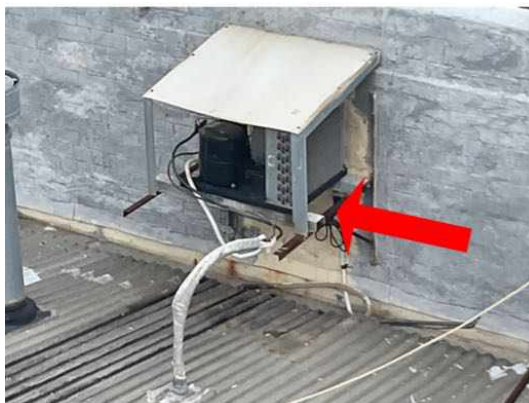
Defects 3.04

Building: Main Building
Location: Roof Exterior
Finding: Building element - Rusted or corroded
Information: This building element shows evidence of rusting and corrosion, which is likely to have developed as a result of excessive exposure to moisture and or inadequate coatings.

As surface rust provides no protection to the underlying iron, the deteriorating condition is likely to worsen if not addressed in the short-term future.

Where possible, the use of galvanized (treated) metals or aluminium coated metals aid in rust prevention, as does regular general maintenance. Rust formation can be controlled with coatings, such as paint, that isolate the iron from the environment.

Rusting and corrosion should be managed by ideally removing or limiting the affected surface from exposure to moisture. A registered builder may be appointed to replace any building elements that have been severely affected by rust or water damage.

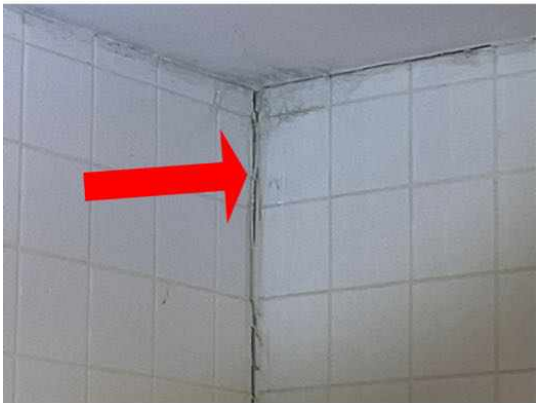
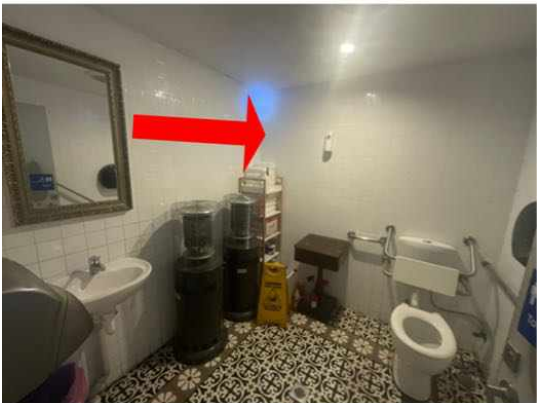
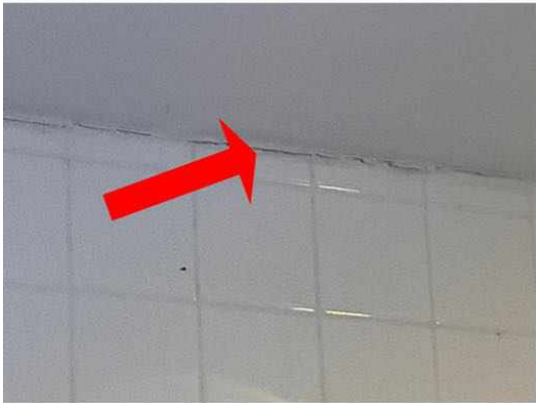
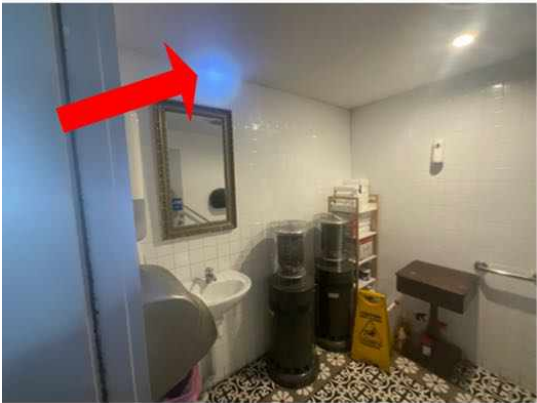
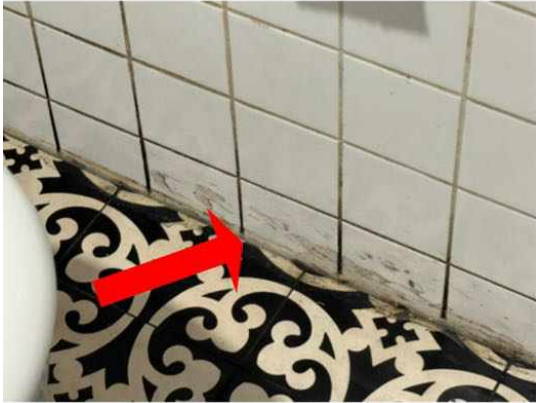
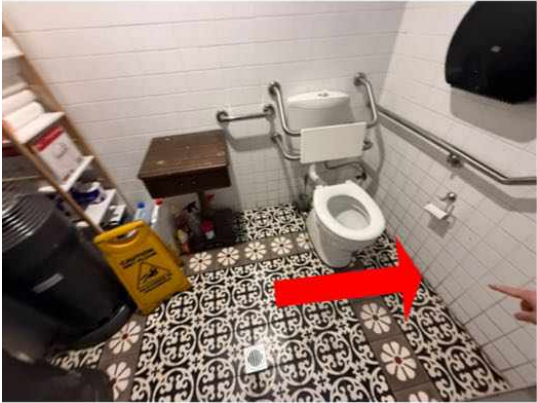
Defects 3.05

Building:	Main Building
Location:	Toilet (WC)
Finding:	Sealant and grouting - Missing or damaged
Information:	It was noted on inspection that sealant or grout is degraded to the tiled shower alcove and or other areas of the bathroom.

Different materials and floor areas move at different rates, generally causing cracking to grout or sealant at this point. A flexible sealant is required to allow for expected expansion and contraction, while keeping the joint water tight and protective of all associated building materials.

There appears to be excessive mould to the sealant and grout which will likely require scraping out and replacement.

Flexible and mould resistant materials should be applied to affected areas to prevent any subsequent water damage that is likely to occur. Regular maintenance and replacement of damage or missing or damaged sealant and grout is highly recommended to the wet areas, as this is a regular wear and tear defect. Sealant and grouting in areas that come into regular contact with water should be maintained for the long term care of your property.

A sealant specialist or tiling contractor should be appointed to complete these works

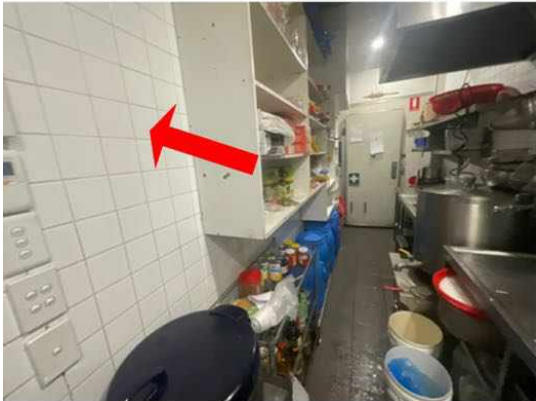
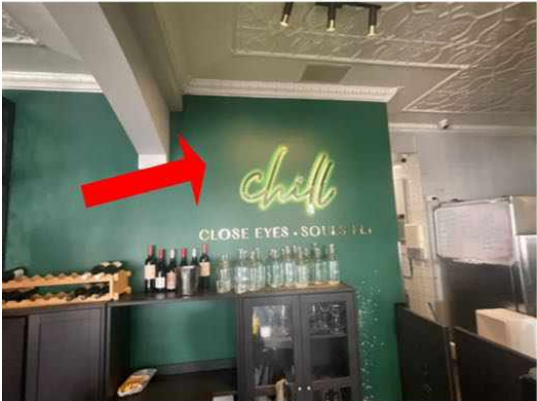
Defects 3.06

Building: Main Building
 Location: All Internal Areas
 Finding: Internal Wall – Lack of Rigidity / Stability
 Information: The internal wall was found to be loose and lacking adequate rigidity when light pressure was applied. This condition may indicate inadequate fixing, deterioration of wall framing, or previous moisture damage. The wall does not appear to provide adequate structural stability and may worsen over time if left unrectified.

A licensed builder should be engaged to further investigate the cause of the instability and carry out rectification works as required to restore adequate strength and rigidity.

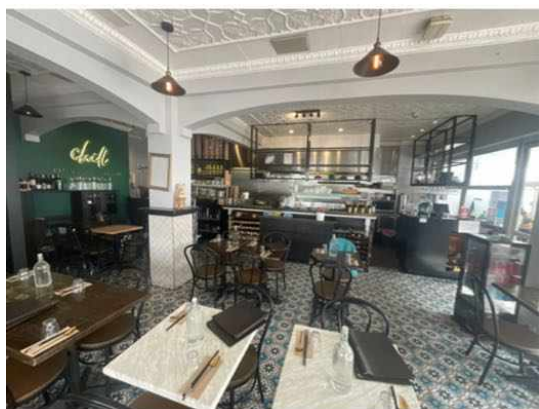
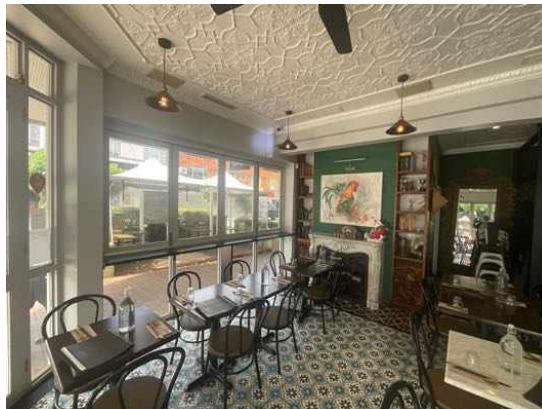
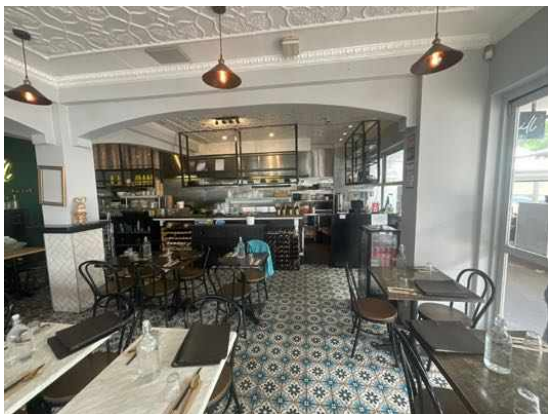
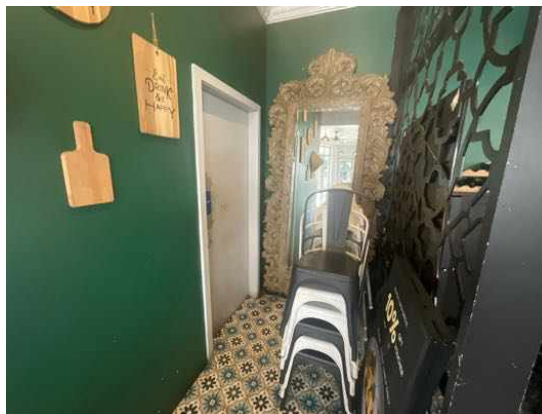
Noted Item

Building: Main Building
Location: All Areas
Finding: Additional Photos - Obstructions and Limitations
Information: These photographs are an indication of the obstructions and limitations which impeded full inspection of the property at the time of inspection. These obstructions can hide an array of defects and should be removed to allow full inspection to be carried out. A re-inspection is recommended once the areas are made accessible.
