Building and Timber Pest Inspection Report

Inspection Date: Sat, 28 Feb 2026

Property Address: 5/4 Forest Grove Dr, Kanahooka NSW
2530, Australia

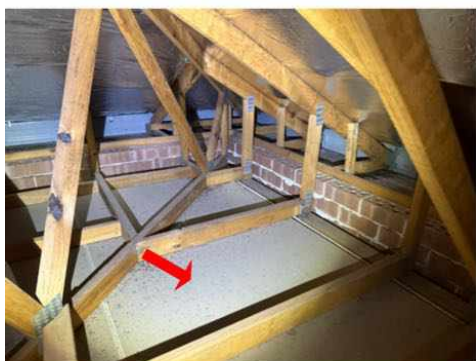
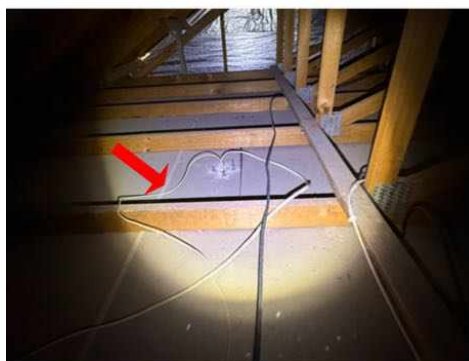
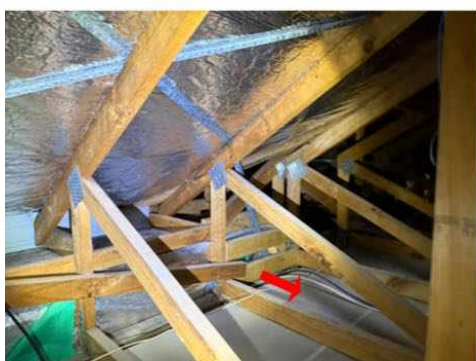
Building:	Building 1
Location:	Roof Void
Finding:	Insulation - Missing
Information:	Upon inspection of the roof void it was noted that insulation is not present (sarking

was found to be in good condition).

Insufficient insulation will result in a comparatively higher cost to heat and cool a property as there is a lack of Insulation (or uneven coverage of insulation) which works as a barrier to heat transfer. This helps to keep out unwanted heat in summer and preserves warmth inside your home in winter. It can also help soundproof your home from unwanted airborne noise transfer.

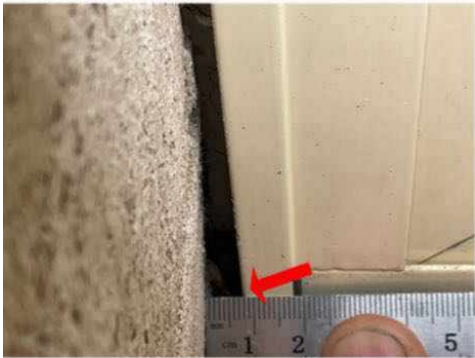
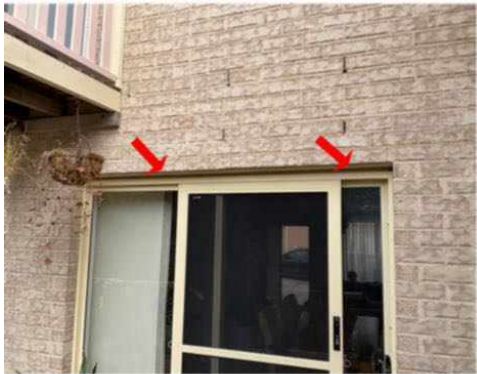
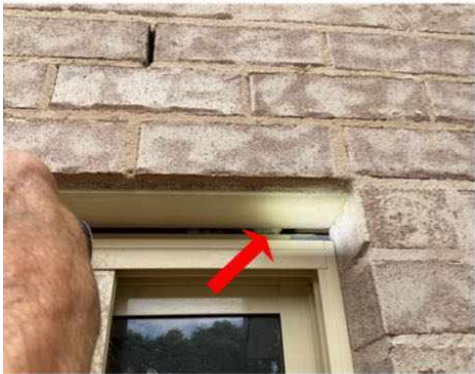
Finding 3.02

Building:	Building 1
Location:	Pictured Areas
Finding:	Sealant or flashing (external) - Missing.
Information:	It was noted on inspection that areas of external sealant or flashing was missing to small areas of some external windows.

Flexible sealants should be applied to these affected areas to prevent any subsequent water damage that is likely to occur.

A sealant specialist or carpenter should be appointed to complete these works.

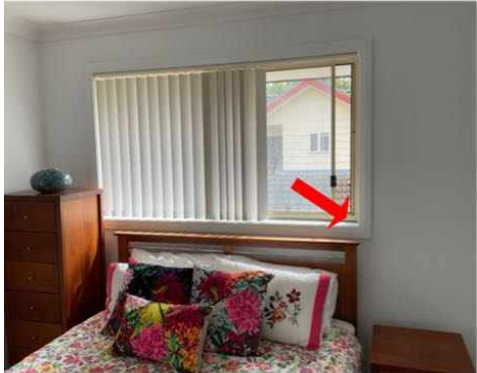
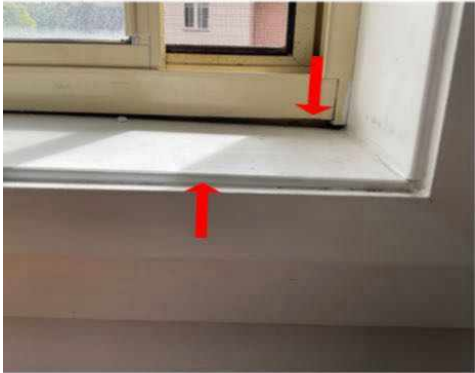
Finding 3.03

Building: Building 1
 Location: Bedroom
 Finding: Window installation substandard
 Information: The upstairs front bedroom window appears to be substandardly installed. This does not appear to have affected to operation of this window.

The window ledge is bowed with gaps evident. This should be monitored annually and is unlikely to worsen in the future.

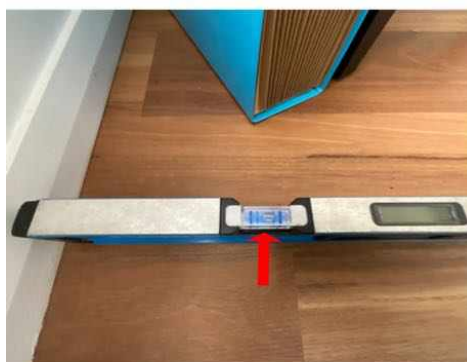
Finding 3.04

Building: Building 1
 Location: Front rooms
 Finding: Flooring - Uneven
 Information: The internal flooring in these areas is slightly out of level and uneven. Uneven flooring is likely to indicate minor defects such as expected movement of the foundations of the property, but may also indicate subsidence of the associated subfloor stumps.

It is thought the recent piercing works has rectified the previous movement that has occurred.

It is advised that the flooring be closely monitored to identify any further movement. Where flooring remains relatively unchanged for an extended period of time (i.e. several months), it is likely that this defect has been caused by expected movement of the foundations of the property.

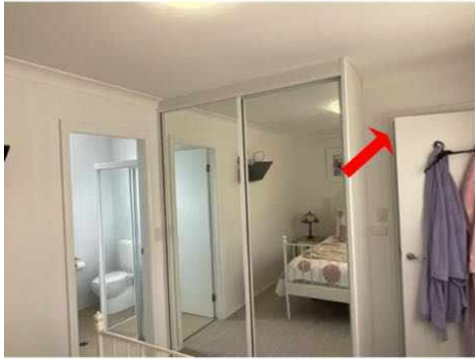
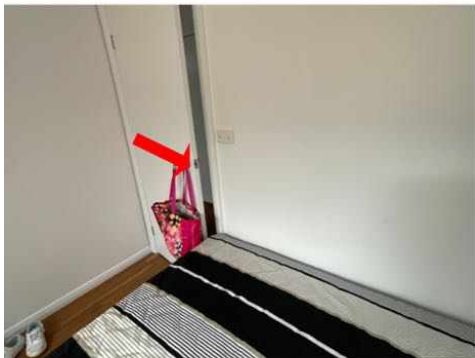
Finding 3.05

Building: Building 1
 Location: Bedroom - Master
 Finding: Doors - Binding/jamming/ not latching
 Information: Binding and/or jamming of the upstairs door and the lower bedroom door not latching was evident during standard operation. This defect inhibits the functionality of the affected doors.

A door that binds to flooring or to the associated door frame may have several causes, ranging from minor defects, such as poor installation of the door or deteriorated hinges, through to major structural issues, such as damage to subfloor structures.

For these minor causes, a qualified carpenter or general handyperson should be appointed to perform minor rectification works at client discretion.

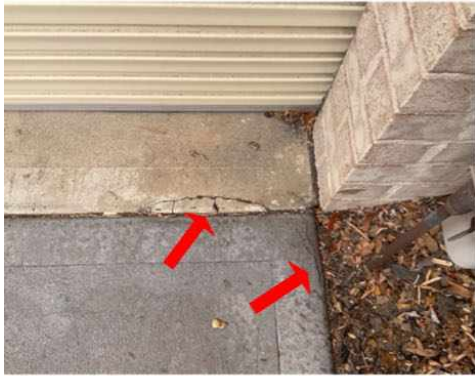
Finding 3.06

Building:	Building 1
Location:	Driveway
Finding:	Crack in concrete slabs - Category 1
Information:	Cracks coded as Category 1 was identified in these pictured slabs. A Category 1 crack is described as a fine but noticeable crack, with the slab at an otherwise reasonable level. To be considered Category 1, the approximate width of the crack is less than 1.0mm, or a less than 10mm change in offset when a 3m straight edge is placed over the defect.

Category 1 cracks should be monitored for a period of 12 months. At the end of the monitoring period, identified cracks that are rated greater than Category 2 are considered defects, and require rectification.

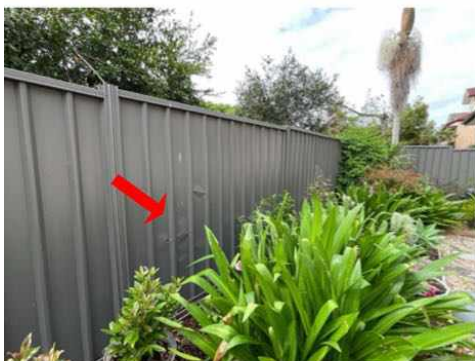
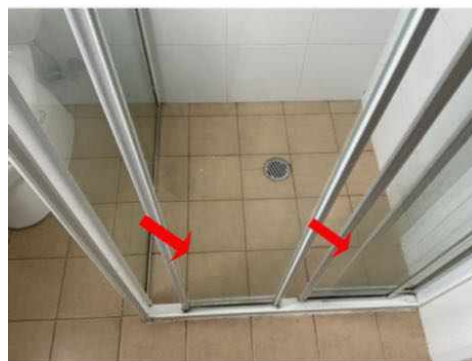
Finding 3.07

Building: Building 1
Location: Pictured external areas
Finding: Building elements - Damaged
Information: Evidence of minor missing or damaged areas was identified at the time of the inspection. These include -

1. The rear fence has minor impact damage.
2. The shower screen door is loose and requires repair.
3. The bathroom fan is noisy on start up and requires a service.

A carpenter would be the trade responsible for rectification of these areas when convenient.

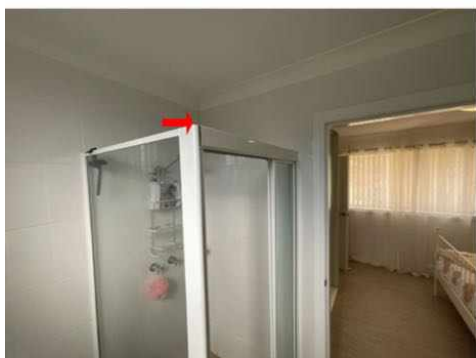
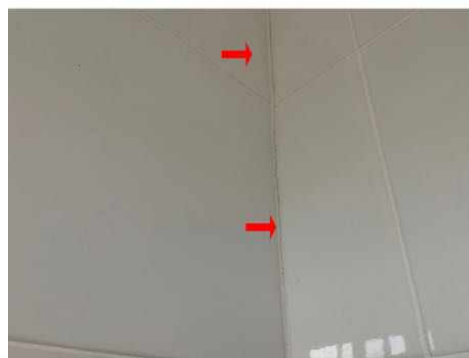
Finding 3.08

Building:	Building 1
Location:	Mostly in bathrooms
Finding:	Cracking - Damage Category 1 - Fine (up to 1mm)
Information:	Although fine cracks are quite noticeable, they are often only considered to be an appearance defect, and usually do not indicate any structural damage. Generally, the cause of a fine crack is indicative of a separation between building materials and finishes (e.g. paint, plaster, etc.) along joins.

Cracking of this nature can generally be repaired with minor sanding, filling and/or repainting. Such works should be performed by a qualified painter or a general handyman.

Monitoring of all cracking should be conducted frequently. Always contact a building inspector should cracks widen, lengthen, or become more numerous.

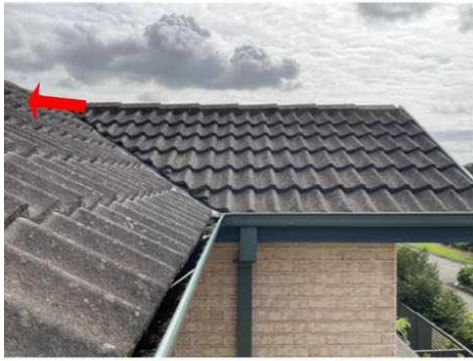
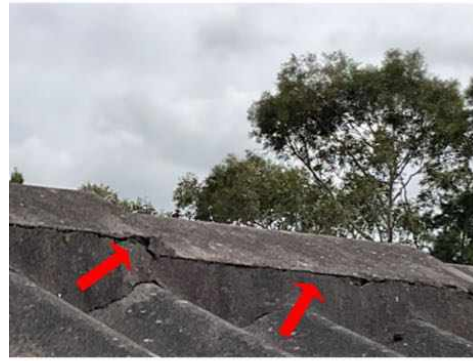
Finding 3.10

Finding: Tile cracked

Information: One crack tile was evident in these pictured areas at the time of inspection. It is suspected that this cracking has occurred as a result of minor settlement.

Cracked tiles throughout the household detract from the overall appearance of the affected areas. In wet areas of kitchens and bathrooms, it can lead to water damage of adjoining walls and floors.

Replacement of cracked tiles is recommended as soon as possible. A tiling contractor may be appointed to perform these works. Where cracks become more numerous, contact a licensed building inspector for further investigation.

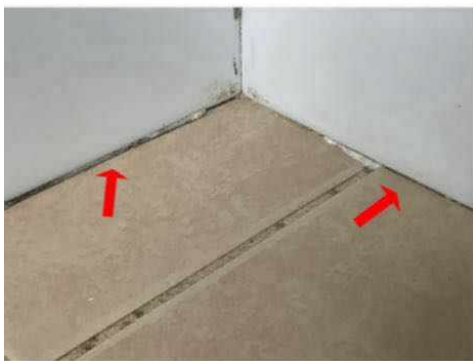
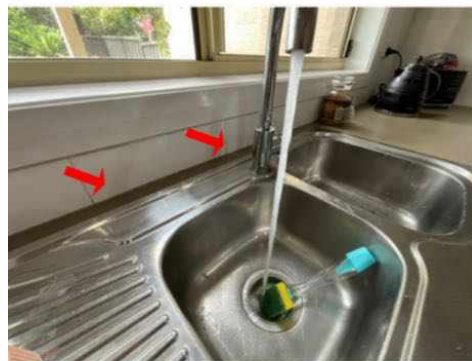
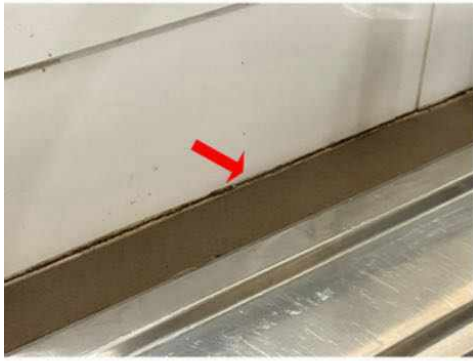
Finding: Sealant and grouting - Missing or damaged

Information: It was noted on inspection that sealant or grout is degraded to these pictured wet areas.

Different materials and floor areas move at different rates, generally causing cracking to grout or sealant at this point. A flexible sealant is required to allow for expected expansion and contraction, while keeping the joint water tight and protective of all associated building materials.

Flexible and mould resistant materials should be applied to affected areas to prevent any subsequent water damage that is likely to occur. Regular maintenance and replacement of damage or missing or damaged sealant and grout is highly recommended to the wet areas, as this is a regular wear and tear defect. Sealant and grouting in areas that come into regular contact with water should be maintained for the long term care of your property.

A sealant specialist or tiling contractor should be appointed to complete these works as soon as possible

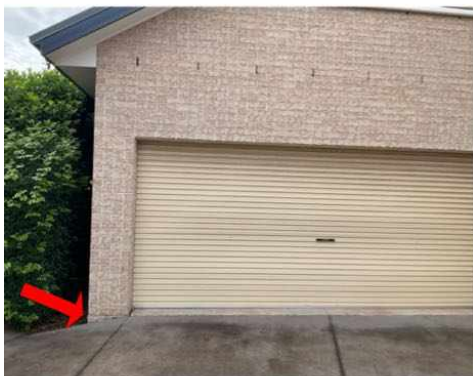
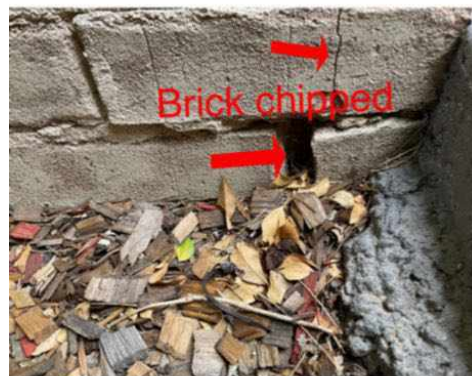
Finding 3.12

Building:	Building 1
Location:	Exterior wall
Finding:	Step cracking to brickwork (minor under 1mm)
Information:	Step cracking was identified to the brickwork in these two small areas at the time of inspection. Step cracking, which is similar to other forms of cracking, has a variety of possible causes. However, the most common is the subsidence of adjacent footings.

Step cracking is a relatively common defect, and is most likely to occur adjacent to windows, doors and other openings. Mortar failure in the gaps between affected bricks indicates the stresses and tensions affecting the wall.

Where step cracking is extensive or severe, the client is advised to consult a structural engineer. This minor step cracking can be used as a warning sign to address factors causing stress to the wall, which can include the effect of surrounding trees, water leaks, soil erosion, or even the presence of reactive soils in the surrounding area.

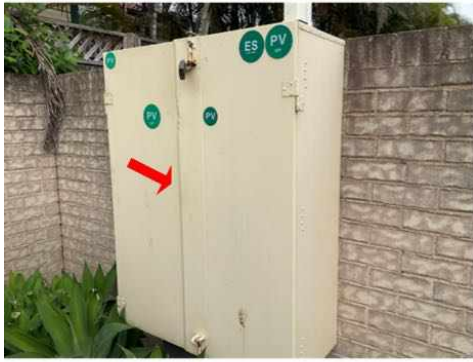
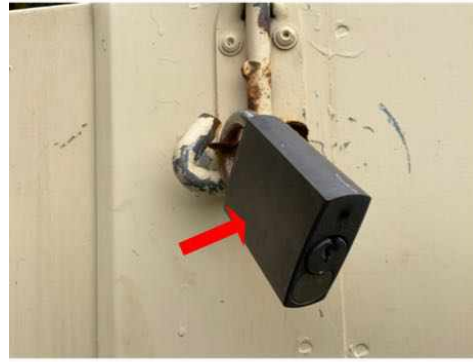
Building:	Building 1
Location:	Meter Box
Finding:	Termite Management System - no evidence of a chemical installation
Information:	The application of a post-construction chemical termite barrier is highly recommended for all properties. Such barriers are highly effective in preventing termite attack on any timber building elements throughout the property.

A durable notice should be placed in the switchboard unit to indicate current termite barriers. At the time of inspection, the electrical box was locked with no access.

The client may consider gaining further advice from the body corporate as to what measures are regularly taken and if a 'chemical' application is undertaken. It is recommended that obtaining such advice be a short-term priority.

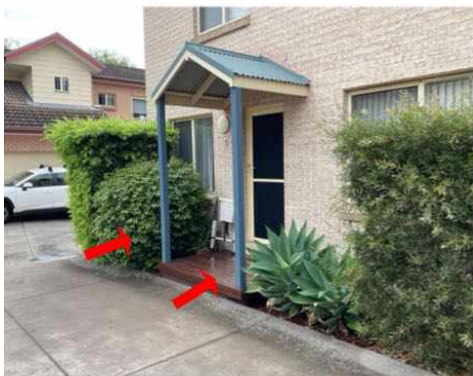
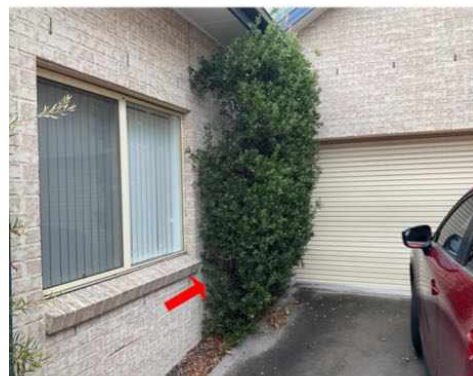
Finding 6.02

Building:	Building 1
Location:	Most walls
Finding:	Bridging - Vegetation and decking
Information:	Where vegetation and decking obstructs inspection of building elements, also known as bridging as it provides a bridging point for the access of termites, full inspection can not be achieved. Consequently moisture or dampness may be present and the areas becomes conducive to termite activity. Plants and decks against or very close to buildings provide cover, shade and can provide an environment that is attractive to termite infestation.

The removal and replanting of plant species that do not provide "cover" or cutting back of existing vegetation and leaving a small gap between decking and the building walls will assist greatly in preventing Bridging from occurring.

The removal of any such stored building or plant materials that may be conducive to termite activity should be carried out as soon as possible and arrange re inspection to minimize the risk of termite attack.

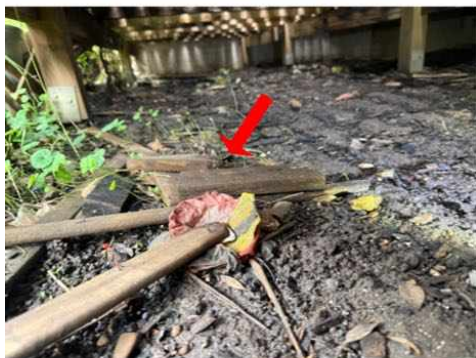
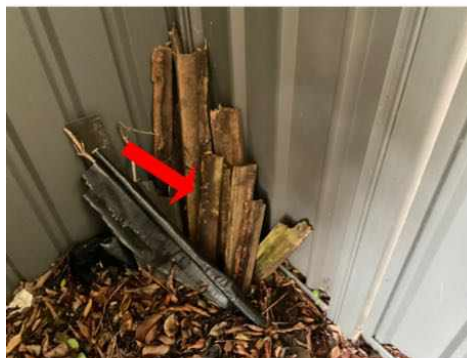
Finding 6.04

Building: Building 1
 Location: Yard - Back and left
 Finding: Timber in contact with the ground
 Information: Any timbers in direct ground contact provide opportunity for concealed termite entry and are likely to be subject to premature rot and decay as the soil retains moisture or damp conditions against the timbers.

Removal of all waste timber that is in direct contact with ground is highly advised. This timber is promoting mould and wood rot and is very attractive to termites.

Frequent pest inspections are advised to readily identify any termite activity in these areas.

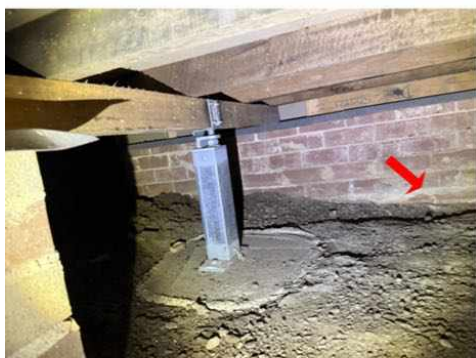
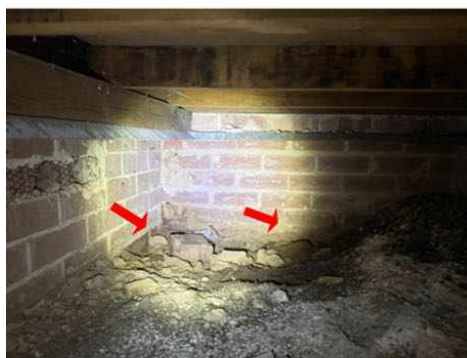
Building:	Building 1
Location:	Subfloor
Finding:	Damp - Rising (minor)
Information:	Rising damp was found in a few small subfloor areas. This is common in most subfloors. This describes the upward movement of water in low sections of building elements (e.g. walls) by capillary action - the movement of water through porous materials such as bricks, sandstone or mortar.

Rising damp is generally managed by the installation of a damp proof course during construction. A Damp Proof Course (DPC) is an impermeable barrier at the base of the wall above ground level. However, many 19th Century buildings have no damp course installed, or the materials have failed. The DPC may have been omitted as a consequence of poor workmanship, or it may have been bridged where materials built up against the side of the house allow moisture ingress above the DPC level.

The first step in addressing rising damp is to diagnose the cause. The identified cause should be addressed first before addressing the appearance and other defects which have resulted from the rising damp. A qualified plumber can provide advice on the rising damp.

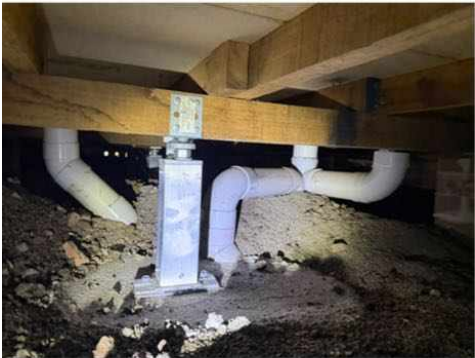
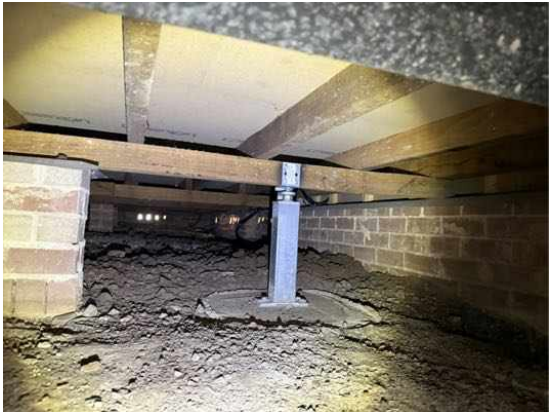
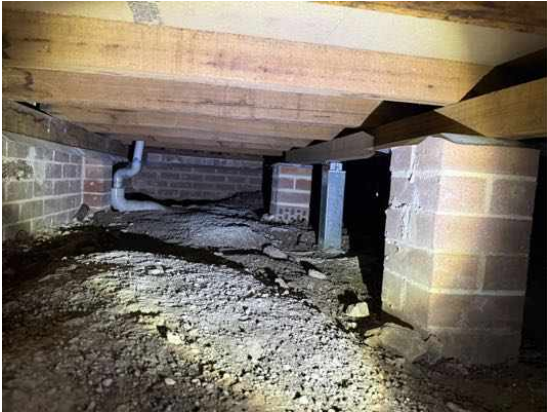
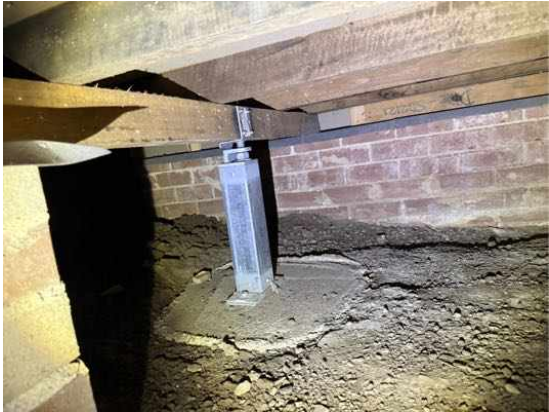
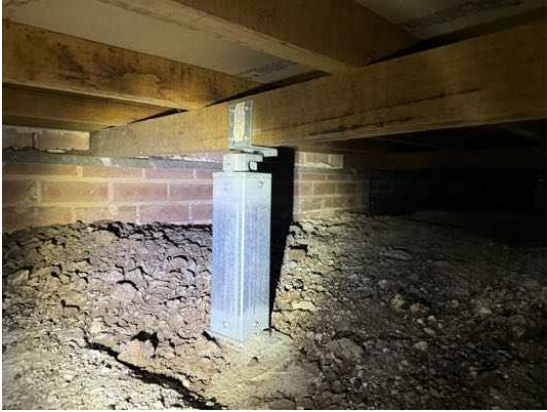
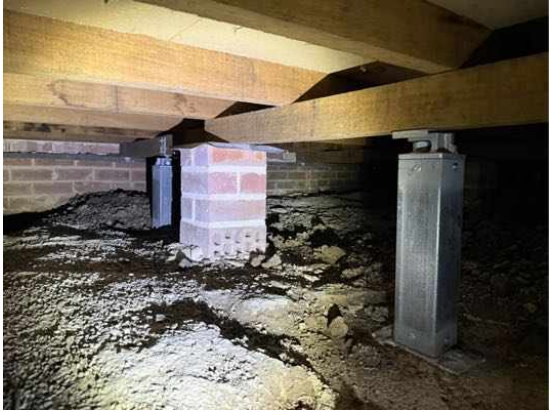
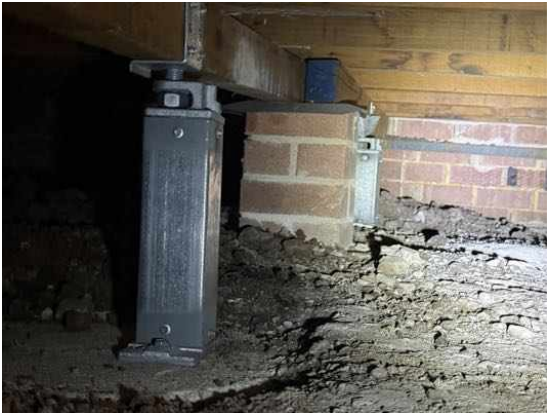
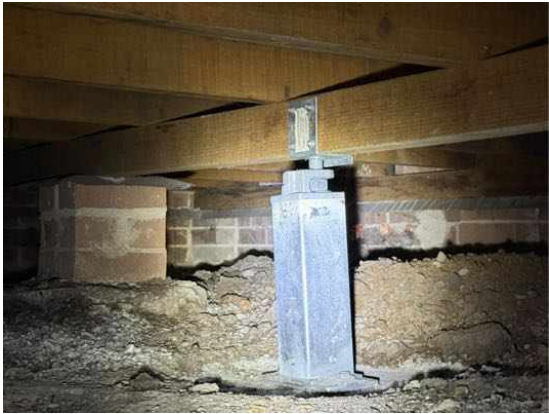
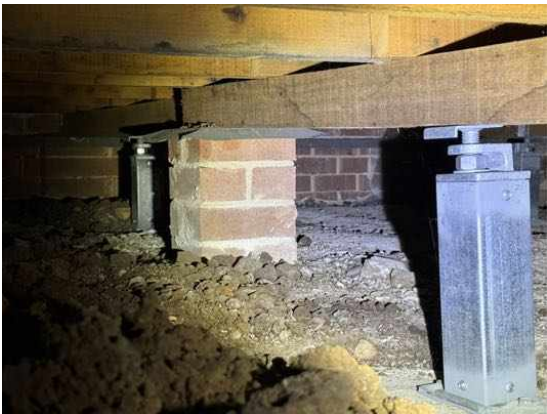
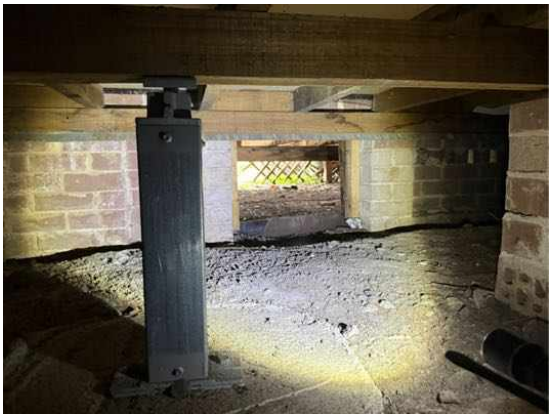
Building: Building 1
Location: Subfloor new piercing works
Finding: Additional Photos of piercing
Information: Additional photos are provided of the new subfloor works that appears to be completed to a high standard with no defects observed.

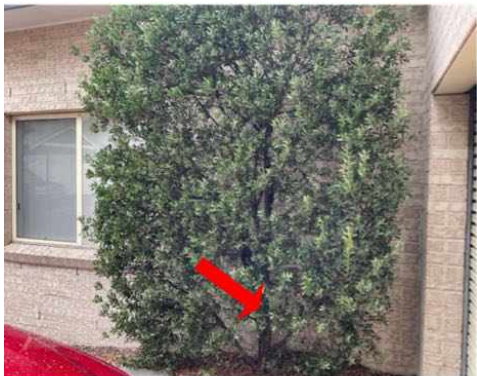
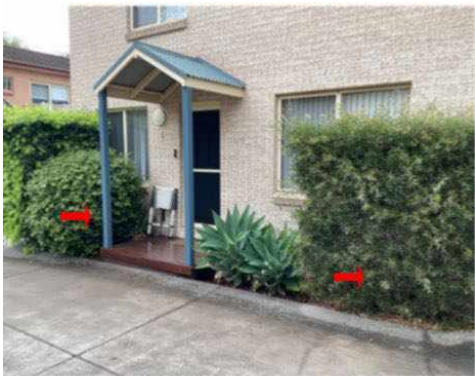
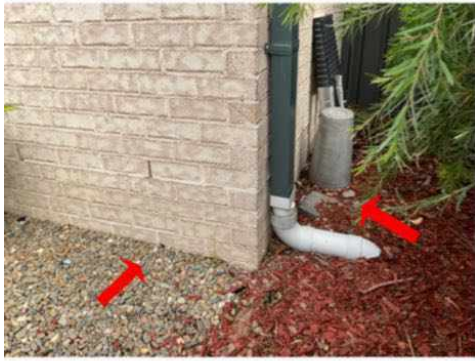
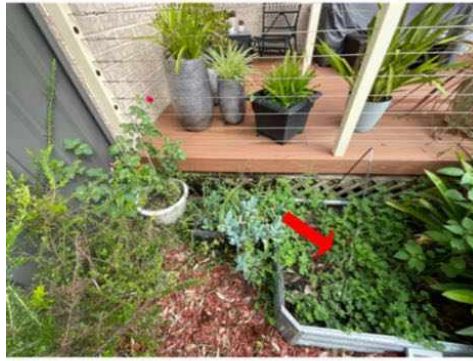
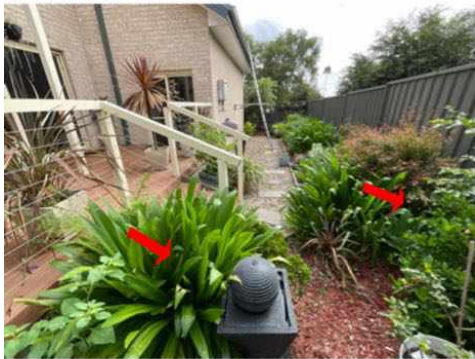
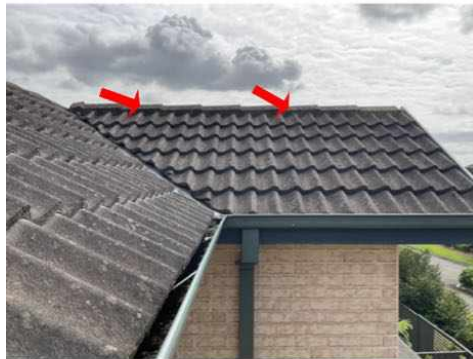
Building: Building 1
Location: All External Areas
Finding: Additional Photos - Obstructions and Limitations of EXTERNAL AREAS
Information: These photographs are an indication of the obstructions and limitations which impeded full inspection of external areas at the time of inspection. These obstructions can hide an array of defects and should be removed to allow full inspection to be carried out. A re-inspection is recommended once the areas are made accessible.

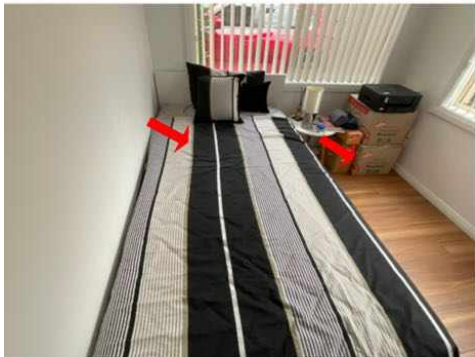
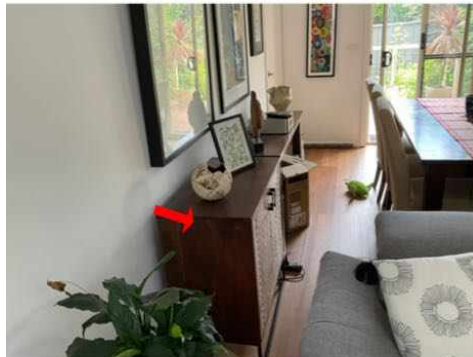
Building: Building 1
Location: All Internal Areas
Finding: Additional Photos - Obstructions and Limitations of INTERNAL AREAS
Information: These photographs are an indication of the obstructions and limitations which impeded full inspection of Internal areas at the time of inspection. These obstructions can hide an array of defects and should be removed to allow full inspection to be carried out. A re-inspection is recommended once the areas are made accessible.

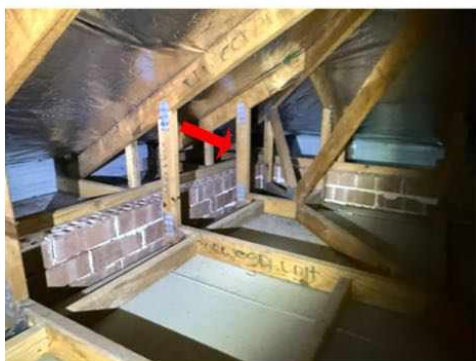
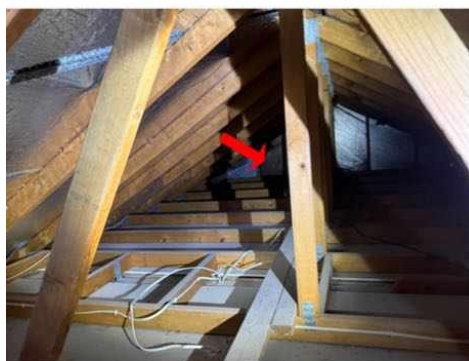
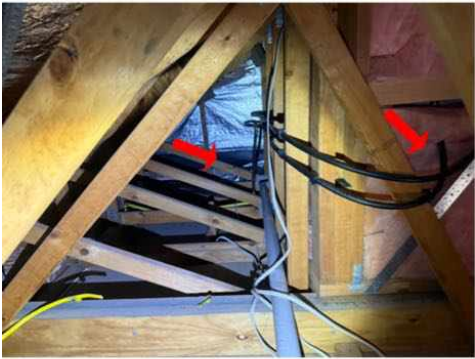
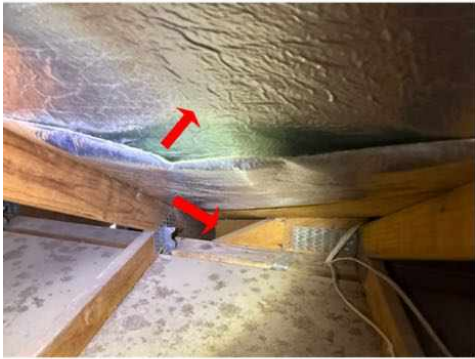
Building: Building 1
Location: All Roof cavity areas
Finding: Additional Photos - Obstructions and Limitations of the ROOF CAVITY
Information: These photographs are an indication of the obstructions and limitations which impeded full inspection of roof cavity areas at the time of inspection. These obstructions can hide an array of defects and should be removed to allow full inspection to be carried out if applicable. A re-inspection is recommended once the areas are made accessible.

The inspection was also limited to areas with an allowable crawl space of 600mm x 600mm, in particular towards the external walls where the roof line diminishes, these areas were not accessible.

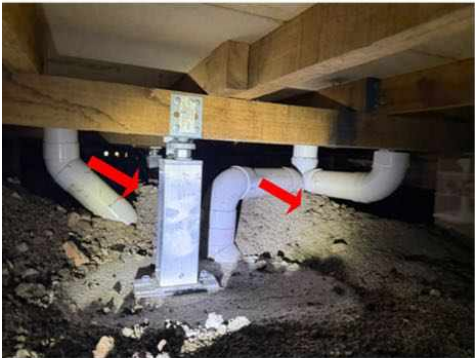
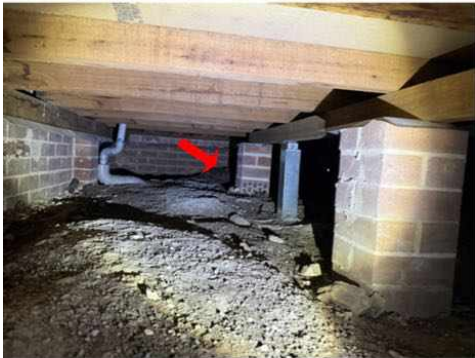
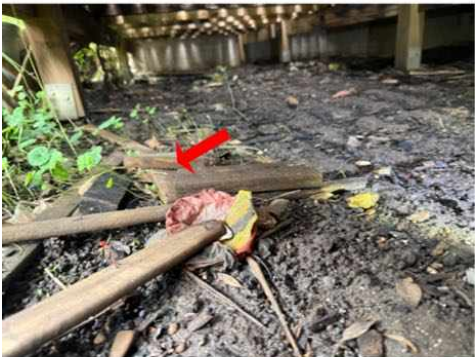
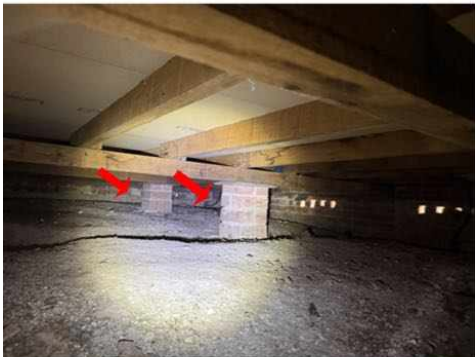
Building: Building 1
Location: All Subfloor Areas
Finding: Additional Photos - Obstructions and Limitations of SUBFLOOR AREAS
Information: These photographs are an indication of the obstructions and limitations which impeded full inspection of subfloor areas at the time of inspection. These obstructions can hide an array of defects and should be removed to allow full inspection to be carried out. A re-inspection is recommended once the areas are made accessible.

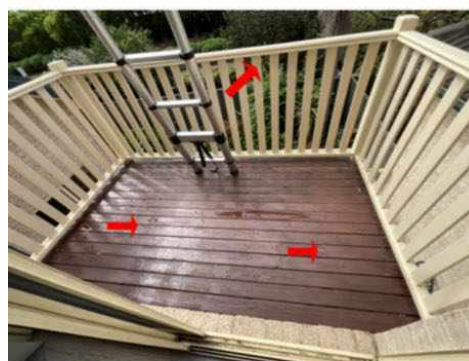
Building:	Building 1
Location:	Rear deck
Finding:	Elevated structure inspections
Information:	While this rear deck appears in good condition, where any elevated Structure (deck, balcony, verandah etc) is present, and this elevated structure is designed to accommodate people, you MUST have this structure checked by an engineer or other suitably qualified person.

You should also arrange annual inspections of the structure by an engineer or other suitably qualified person to ensure any maintenance, that may become necessary, is identified. Care must be taken not to overload the structure.

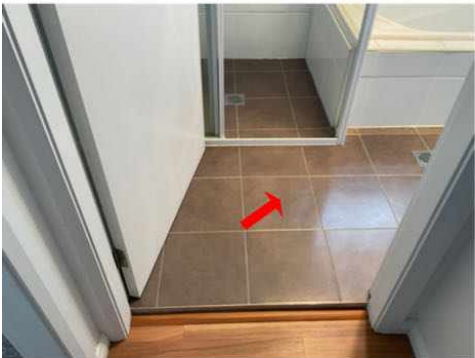
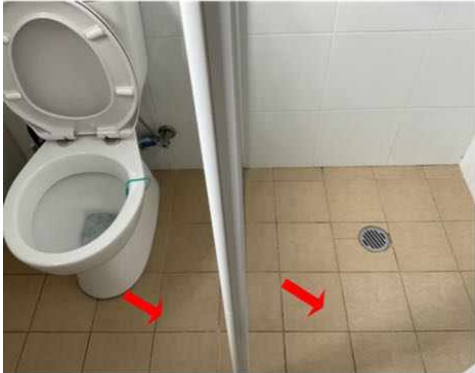
Building:	Building 1
Location:	Bathrooms and laundry
Finding:	Waterproofing membranes - Information Only
Information:	Internal Water Proofing Membranes, are crucial in preventing water ingress into the property is important to know that the Membrane System used is to Australian Standards and has been installed correctly.

With older property's where this information is unavailable all wet areas should be monitored. If any leaks, water staining, peeling or bubbling of the paint become evident to any adjacent walls or ceilings below a licensed builder or waterproofing

specialist is recommended to investigate further.
