Building and Timber Pest Inspection Report

Inspection Date: Tue, 17 Mar 2026

Property Address: 6/15 Ray Rd, Epping NSW 2121, Australia

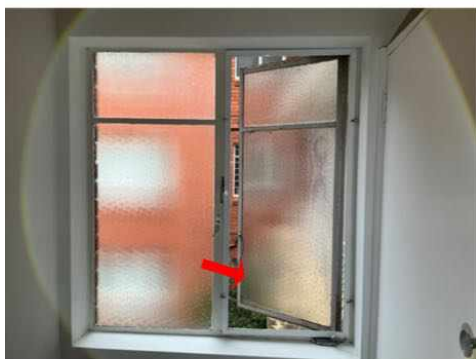
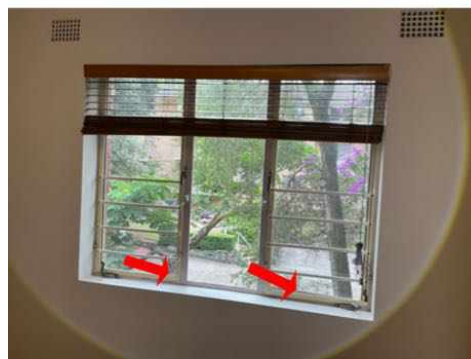
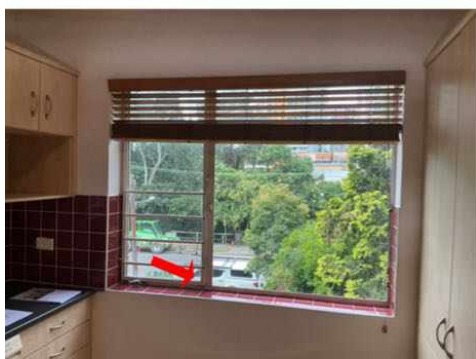
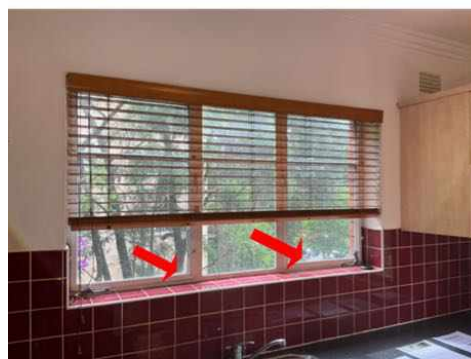
Building: Main Building
 Location: All Areas
 Finding: Window Restrictors - Recommended
 Information: Upstairs windows did not have window restrictors installed. Although not a requirement at the time of construction, it is advisable to install window opening restrictors on all second storey windows with sill heights below 1.7 meter and potential fall of 2 meters or more.

If you live in a strata scheme, window safety devices must be installed on all applicable windows by 13 March 2018. Residents with safety devices installed can still fully open their windows but it's recommended that devices be engaged whenever children are present, to prevent falls.

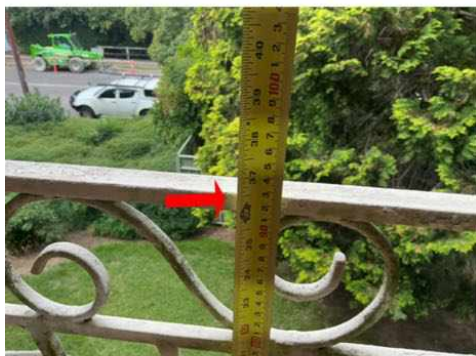
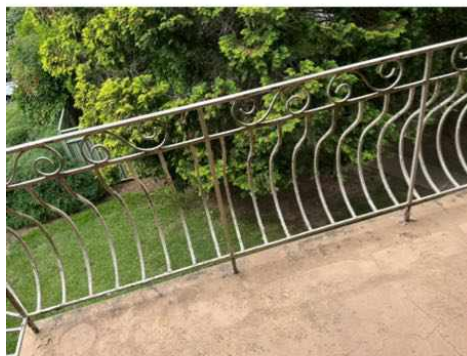
Finding 1.03

Building: Main Building
 Location: Balcony
 Finding: Balcony Balustrade Height - Less than 1 Meter
 Information: At the time of inspection, it was noted that the height of the balcony balustrade measured approximately 800 mm above the finished floor level. This is below the current minimum height requirement of 1000 mm for balcony barriers as generally expected for residential properties.

It is understood, however, that this building was constructed under older regulations, and the lower balustrade height may have complied with the standards applicable at the time of construction. Nonetheless, the reduced height presents a potential fall hazard, particularly for children or pets.

The client is advised to consult with the builder or strata management to increase the height to 1 meter.

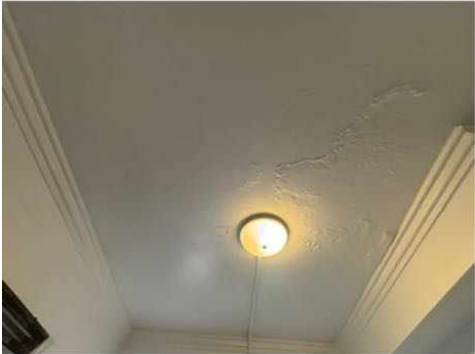
Finding 2.01

Building:	Main Building
Location:	Bathroom
Finding:	Elevated Moisture & Substandard Ceiling Repairs
Information:	At the time of inspection, evidence of previous water ingress was noted to the ceiling area, including visible patching and irregular finishes. The real estate agent advised that recent waterproofing works had been carried out by the current owner; however, moisture meter readings taken during the inspection recorded maximum levels (up to 100) in multiple areas, indicating the presence of significant retained moisture within the substrate.

While it is acknowledged that recently completed waterproofing works can result in elevated moisture readings for a period of time (often several weeks to months while the area dries out), the readings observed are considered high and warrant further attention. If the waterproofing works have not been carried out correctly or professionally, there is a risk of ongoing water ingress and further deterioration.

Additionally, the ceiling repairs appear to be of substandard workmanship, with poor

The client is advised to closely monitor the area over time for any signs of worsening conditions, including staining, bubbling, peeling paint, or mould growth.

It is strongly recommended that the client obtain all relevant documentation from the current owner, including:

patching and uneven finishes noted. The affected areas should be properly repaired and refinished by a qualified painter once the moisture issue has been confirmed as resolved and the substrate has adequately dried.

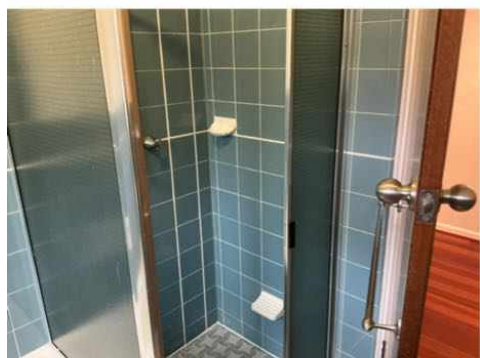
Building:	Main Building
Location:	Bathroom
Finding:	Excessive Moisture - Shower Damp
Information:	At the time of inspection, excessive moisture was noted within the shower area, which is a common issue in wet areas due to the continual exposure to water. This condition is typically caused by moisture seeping through grout lines and settling behind tiles, resulting in localised high-moisture zones. Provided there is no evidence of water

staining or elevated moisture readings on the opposite side of the wall, this is considered a minor defect.

However, persistently damp conditions may act as conducive conditions for termite activity, as termites are strongly attracted to moisture-rich environments. It is recommended that the client ensures regular use of the exhaust fan and maintains adequate ventilation after shower use to promote drying and reduce long-term moisture build-up, thereby also reducing the risk of attracting termites.

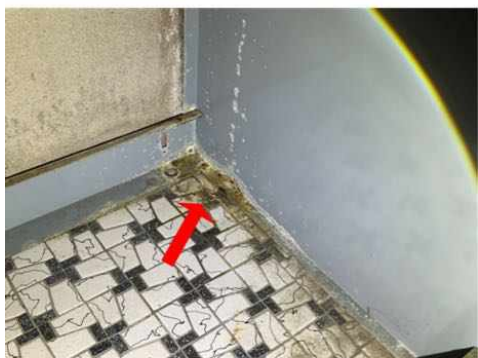
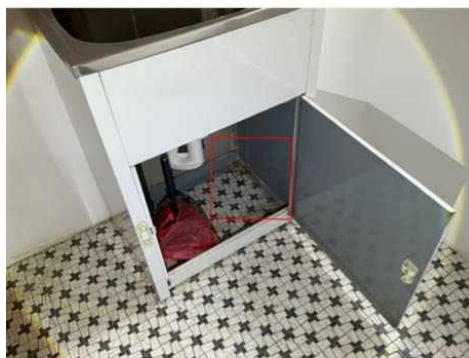
Finding 3.02

Building:	Main Building
Location:	Laundry
Finding:	Building element - Rusted or corroded
Information:	This building element shows evidence of rusting and corrosion, which is likely to have developed as a result of excessive exposure to moisture and or inadequate coatings.

As surface rust provides no protection to the underlying iron, the deteriorating condition is likely to worsen if not addressed in the short-term future.

Where possible, the use of galvanized (treated) metals or aluminium coated metals aid in rust prevention, as does regular general maintenance. Rust formation can be controlled with coatings, such as paint, that isolate the iron from the environment.

Rusting and corrosion should be managed by ideally removing or limiting the affected surface from exposure to moisture. A registered builder may be appointed to replace any building elements that have been severely affected by rust or water damage.

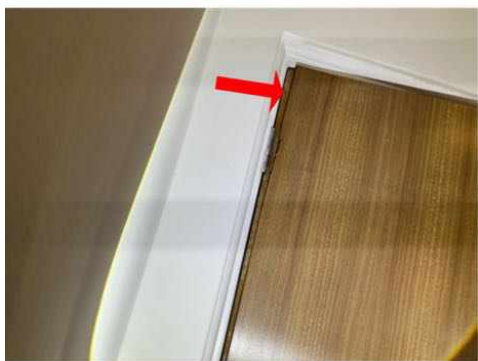
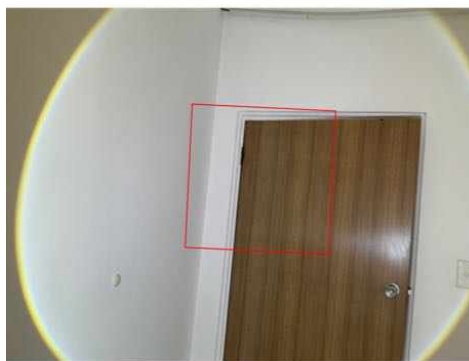
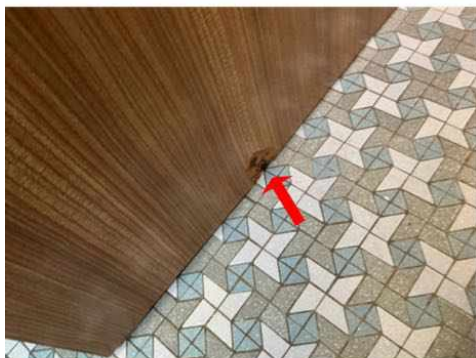
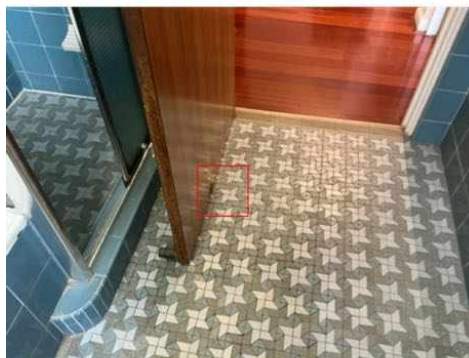
Finding 3.03

Finding: Door - Damaged and Wear & Tear (Internal)

Information: At the time of inspection, damage and wear & tear was noted to an internal door. The affected area may impact the door's appearance and functionality. Rectification by a handyman/carpenter or replacement is recommended at client's own discretion.

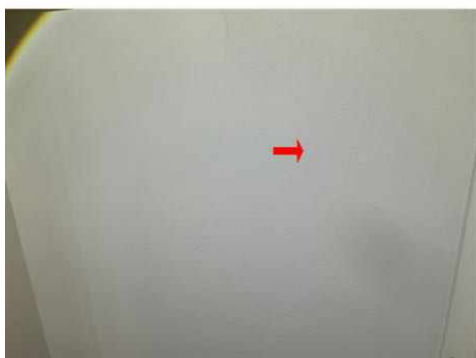
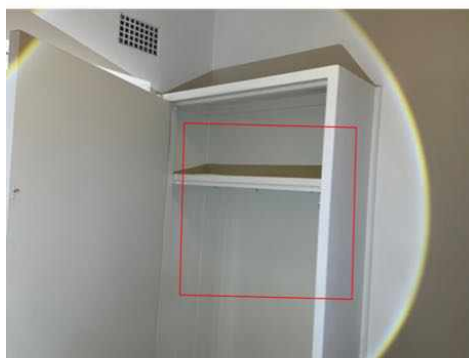
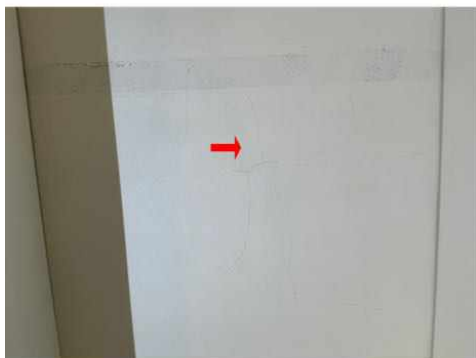
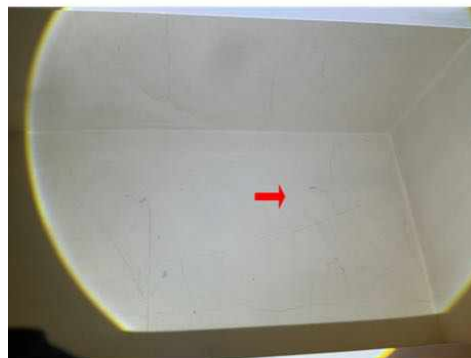
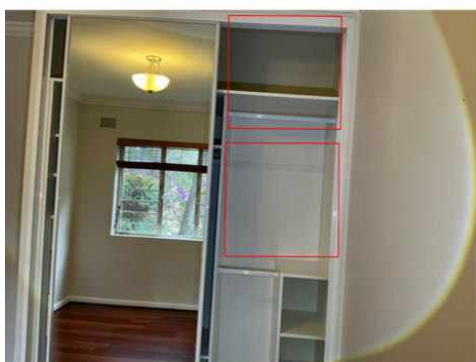
Finding 3.04

Building:	Main Building
Location:	Laundry, Both Bedrooms
Finding:	Cracking - Damage Category 1 - Fine (up to 1mm)
Information:	Although fine cracks are quite noticeable, they are often only considered to be an appearance defect, and usually do not indicate any structural damage. Generally, the cause of a fine crack is indicative of a separation between building materials and finishes (e.g. paint, plaster, etc.) along joins.

Cracking of this nature can generally be repaired with minor sanding, filling and/or repainting. Such works should be performed by a qualified painter or a general handyman.

Monitoring of all cracking should be conducted frequently. Always contact a building inspector should cracks widen, lengthen, or become more numerous.

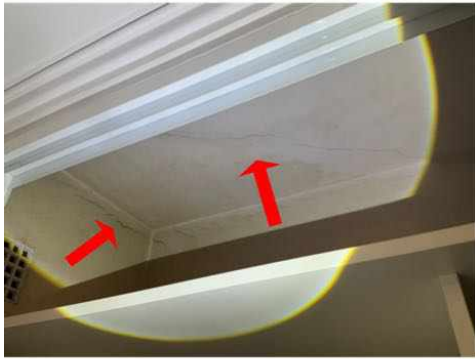
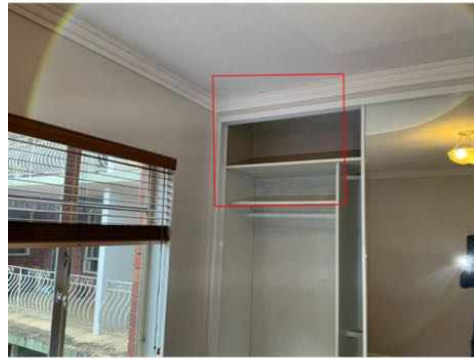
Finding 3.05

Finding: Cracking - Damage Category 2 - Noticeable (up to 5mm)

Information: Noticeable cracks are a common occurrence as a result of many primary defects. Such causes may include age, general wear and tear, expected building movement, general expansion/contraction of building materials in different weather conditions, and/or minor failings in the installation or application of building materials.

Monitoring of all cracking should be conducted frequently. Always contact a building inspector should cracks widen, lengthen, or become more numerous. Additionally, your building inspector should also be contacted if associated building elements such as doors and windows become more difficult to operate over time.

Relevant tradespeople, such as painters and plasterers, should be appointed to perform remedial works, as deemed necessary.

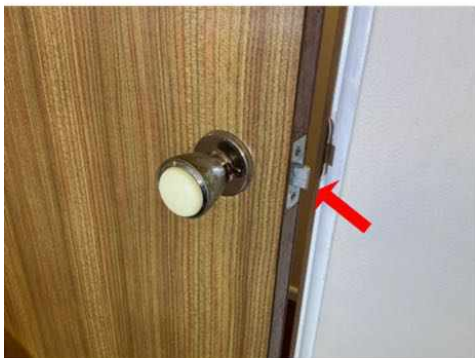
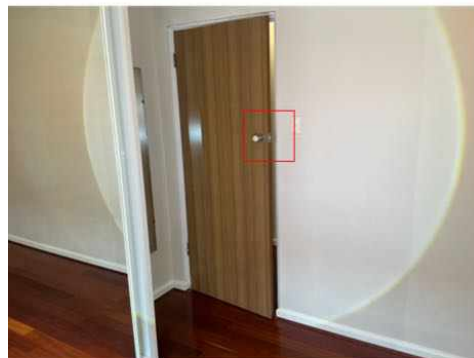
Finding 3.06

Building:	Main Building
Location:	Bedroom 2
Finding:	Door Handle - Not Latching
Information:	At the time of inspection, the door handle was found to be not latching properly, which may affect security and ease of use. This issue could be due to misalignment between the latch and strike plate or wear and tear of the handle mechanism. It is recommended that a handyman be engaged to assess and repair or realign the latch assembly to restore full functionality.

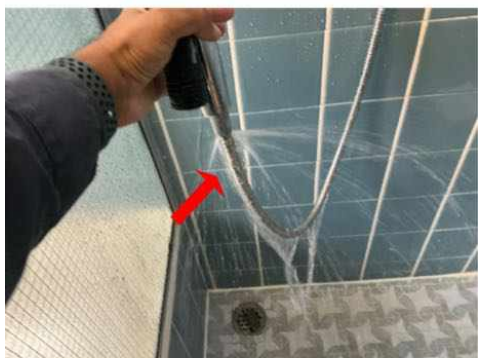
Finding 3.07

Building:	Main Building
Location:	Bathroom
Finding:	Shower Head - Leaking
Information:	Showerhead was found to be leaking at the time of inspection. This is a common defect.

A leaking shower head could be due to issues like a worn-out washer, a loose connection, a damaged O-ring, or mineral deposits blocking the flow. Inspecting and replacing any damaged components or tightening connections might help resolve the leakage.

A qualified plumber should be engaged to rectify the situation as soon as possible.

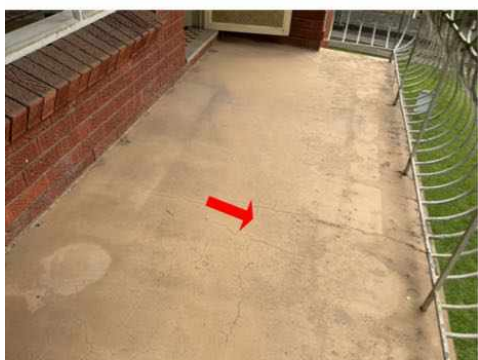
Finding 3.08

Finding: Crack in concrete slab - Category 1

Information: A crack coded as Category 1 was identified in the slab. A Category 1 crack is described as a fine but noticeable crack, with the slab at an otherwise reasonable level.

To be considered Category 1, the approximate width of the crack is less than 1.0mm, or a less than 10mm change in offset when a 3m straight edge is placed over the defect.

Category 1 cracks should be monitored for a period of 12 months. At the end of the monitoring period, identified cracks that are rated greater than Category 2 are considered defects, and require rectification.

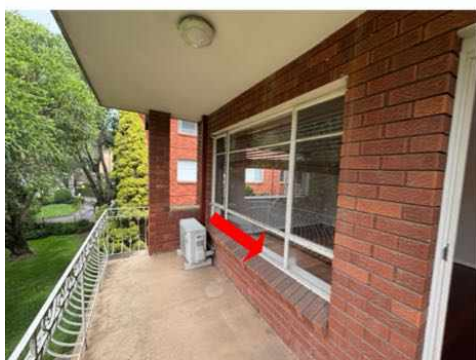
Finding 3.09

Finding: Peeling Paint
 Information: Peeling paint was observed in this area at the time of inspection.

This condition can result from various factors, including moisture ingress, poor surface preparation, use of low-quality or incompatible paint, excessive humidity (especially on timber), and natural ageing of paint. Painting under unfavourable conditions or over deteriorated surfaces can also lead to poor adhesion and peeling. Remedial work typically involves removing loose paint, repairing the affected surface, and repainting with appropriate preparation and materials.

Engaging a professional painter is recommended at the owner's discretion.

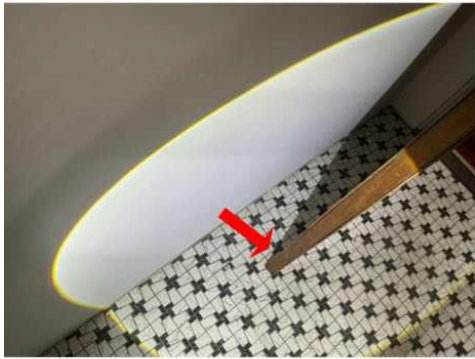
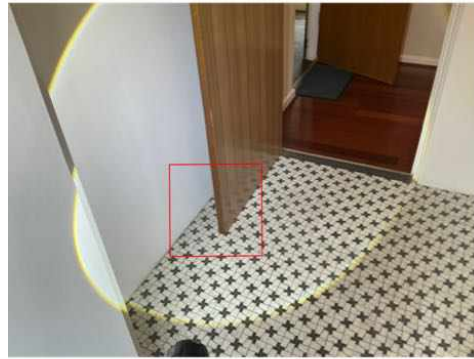
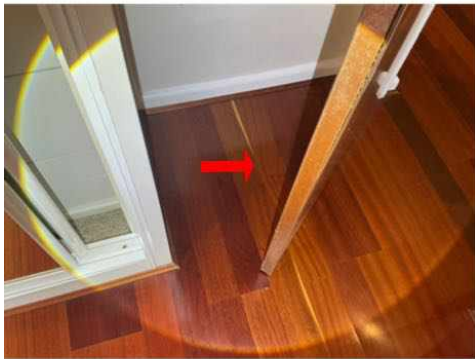
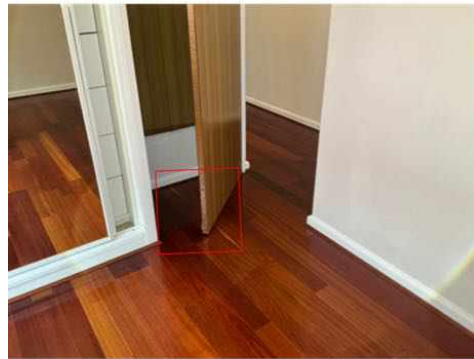
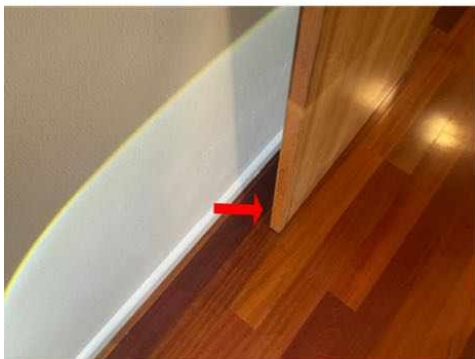
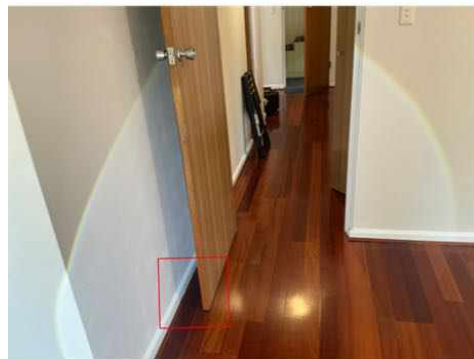
Finding 3.10

Building: Main Building
 Location: All Areas
 Finding: Door Stopper(s) - Missing
 Information: At the time of inspection, it was noted that a door stopper was missing in this area.

The absence of a door stopper can lead to potential damage to the door, wall, or surrounding finishes, as the door may swing open too far and impact the wall or adjacent objects. Over time, this can cause dents, scuffs, or even structural damage to the wall or door. It is recommended that a door stopper be installed to prevent further damage and ensure the protection of both the door and the surrounding area.

The client is advised to engage services of a handyman to install the door stopper.

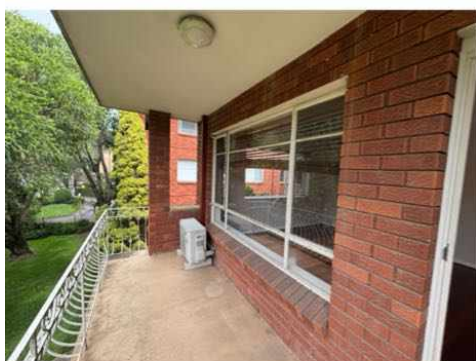
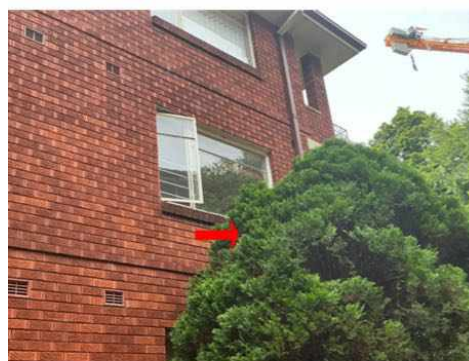
It is essential that these obstructions be cleared to allow for a comprehensive inspection of the external areas. Removing these barriers will enable a more accurate assessment of the property's condition and allow any hidden defects to be identified and addressed promptly. Failure to do so could result in undetected issues worsening over time, potentially leading to more costly repairs in the future.

Therefore, it is strongly recommended that the obstructions be removed and a re-inspection be scheduled once the affected areas are made fully accessible. This will ensure a complete evaluation of the property's exterior and provide the client with a clear understanding of any potential issues that may have been concealed during the initial inspection.

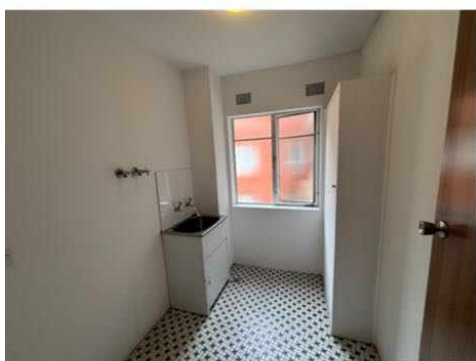
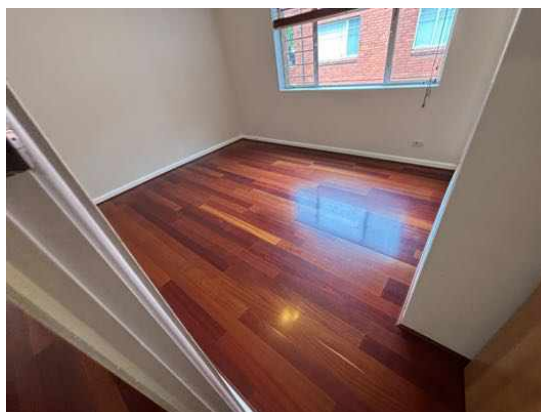
Noted Item

Building: Main Building
 Location: All Internal Areas

It is highly recommended that all obstructions be cleared to facilitate a complete and thorough inspection of the internal areas. Once the obstructions have been removed and full access is available, a re-inspection should be carried out to ensure that any previously concealed issues can be properly identified and rectified. This follow-up inspection will provide a more accurate assessment of the property's internal condition and help the client make informed decisions about any necessary repairs or maintenance.

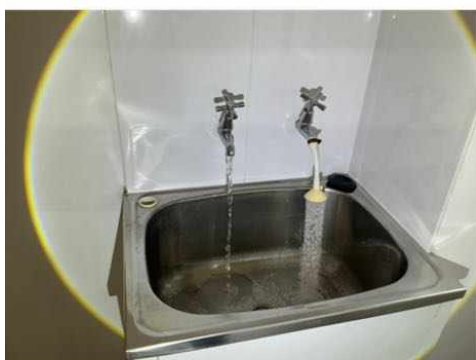
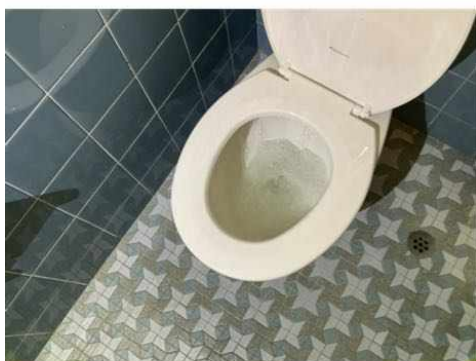
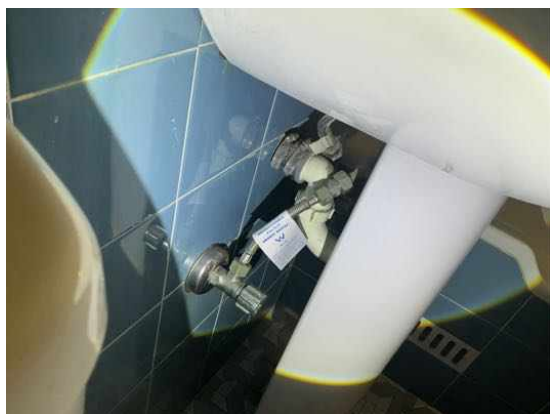
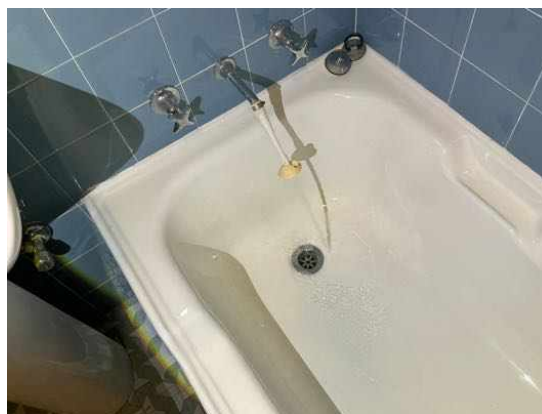
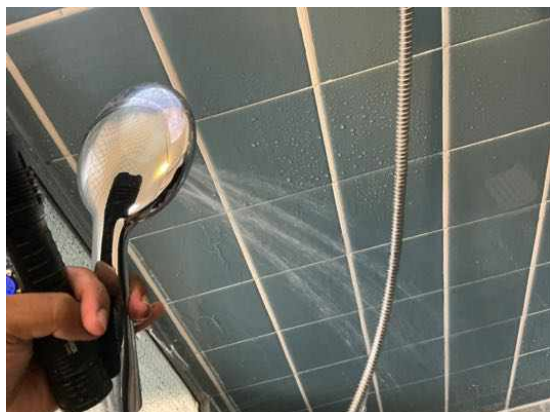
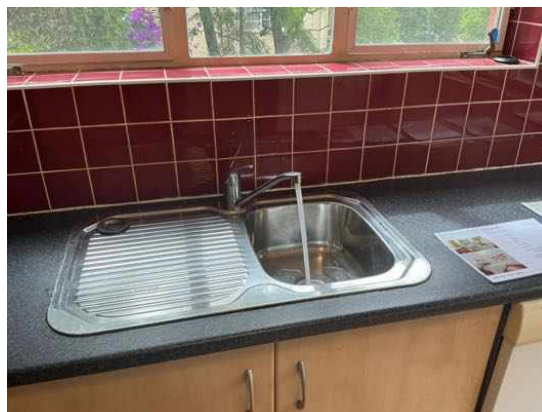
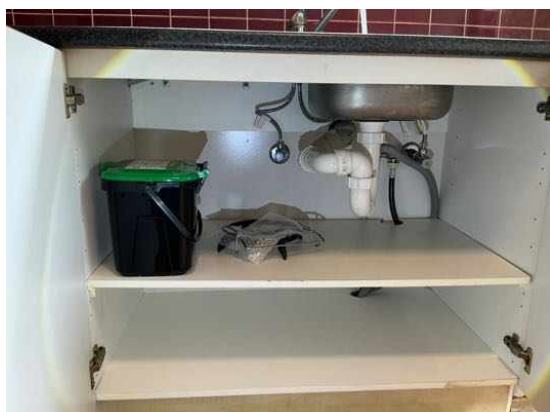
Building: Main Building
Location: All Areas
Finding: FYI - Taps, Drainage & Toilets Tested and Cabinetry Obstructions
Information: During the inspection, all accessible taps, drainage systems, and toilets were tested for water flow and drainage efficiency, and checked for any visible signs of leakage. At the time of the inspection, no issues were noted in these areas. Unless highlighted in a separate defect statement, no immediate remedial work appears necessary. Supporting images may be found in the additional photos section for reference.

It is important to note that while a visual inspection of cupboards and cabinetry beneath sinks and vanities was undertaken, stored personal items and fixtures presented obstructions that limited full visibility of the internal areas. As per standard inspection practices, inspectors are not permitted to move or disturb personal belongings during the inspection process. Therefore, only visible and accessible sections were inspected, and concealed water damage or plumbing defects may not have been detected.

Given this, a re-inspection is recommended after all obstructions have been cleared to allow for a comprehensive assessment of these areas. Regular maintenance and monitoring of plumbing and drainage systems is also advised to ensure ongoing functionality and early detection of potential issues.

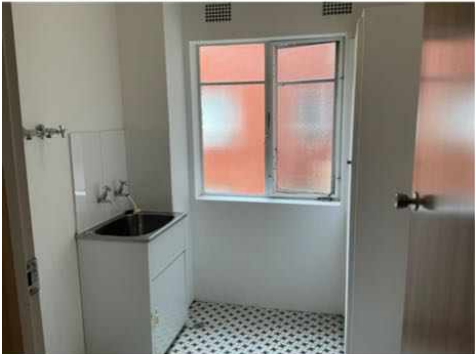
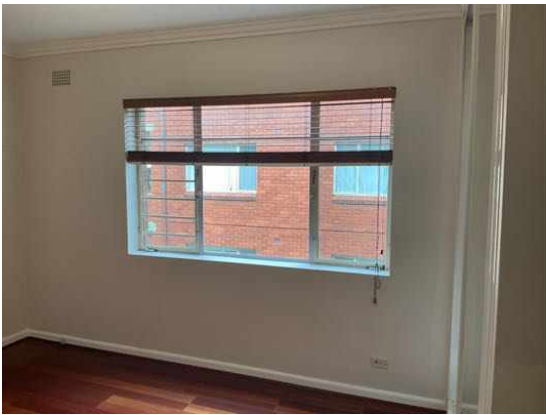
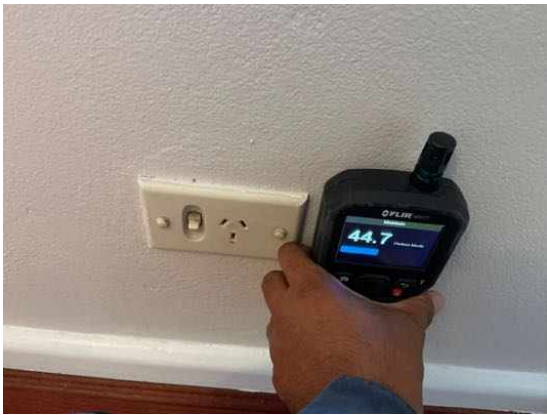
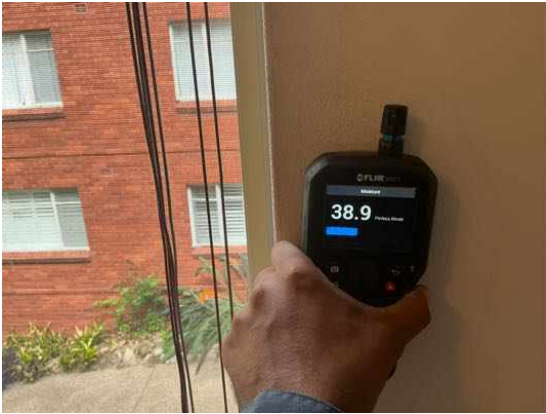
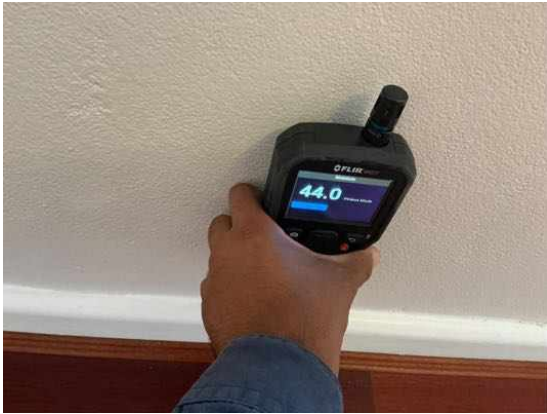
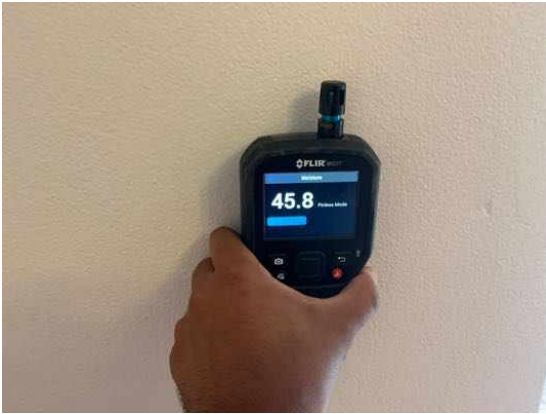
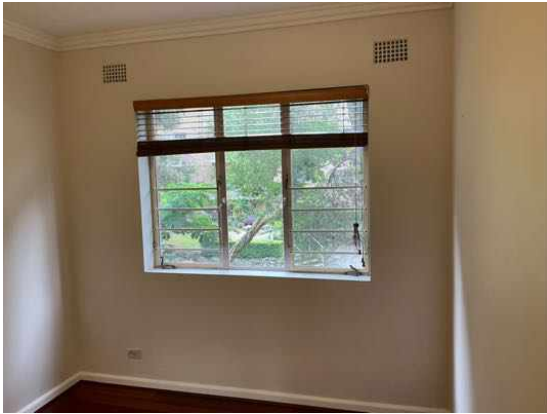
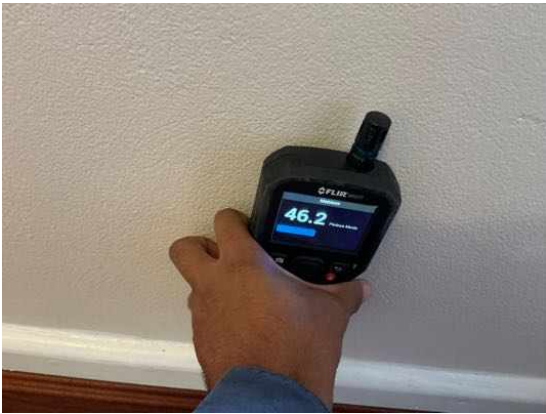
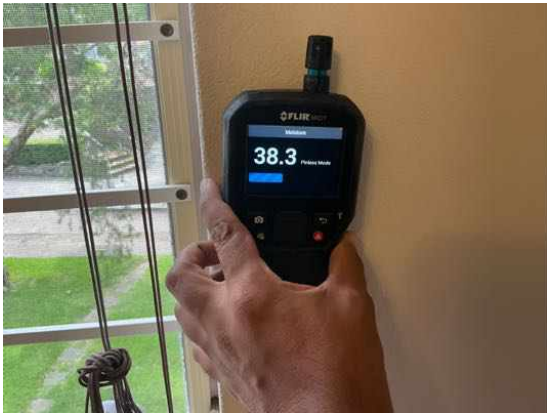
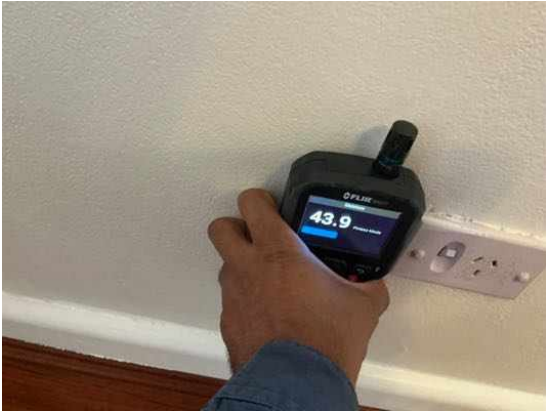
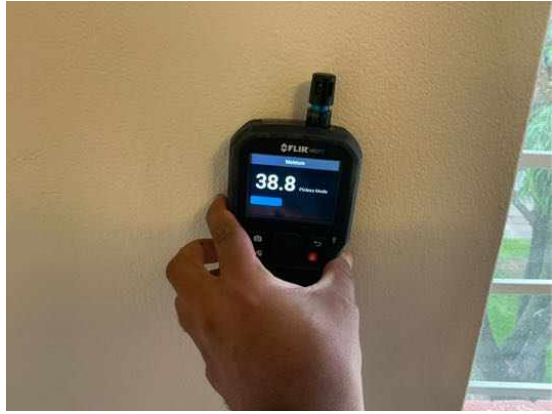
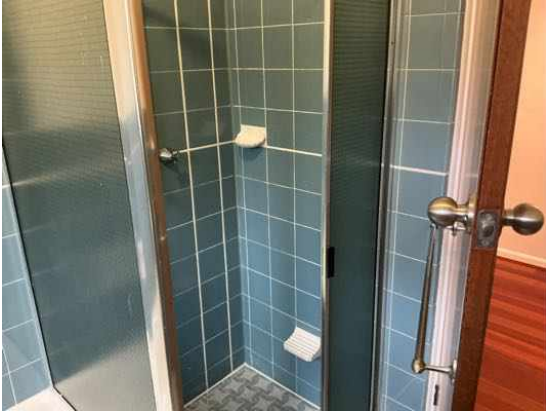
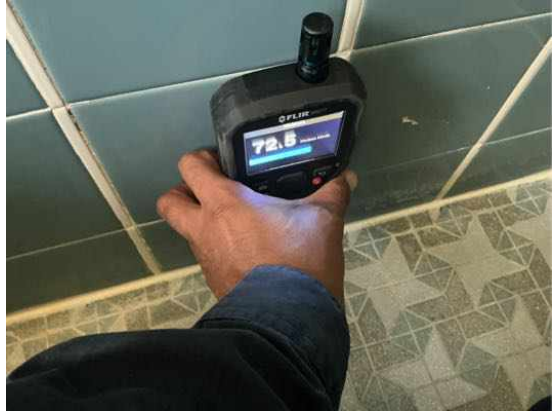
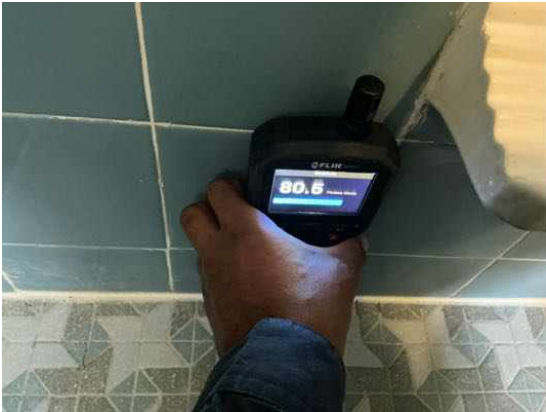
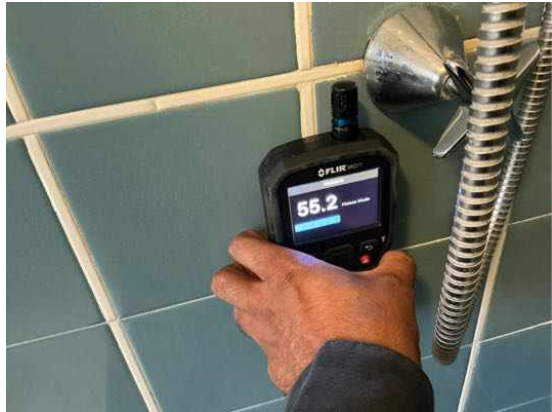
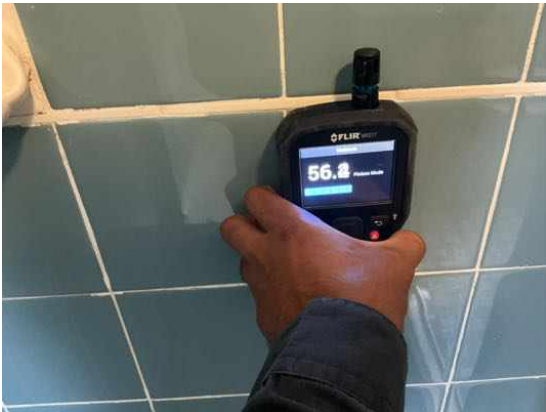
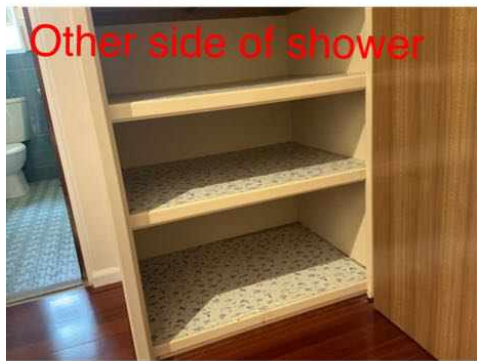
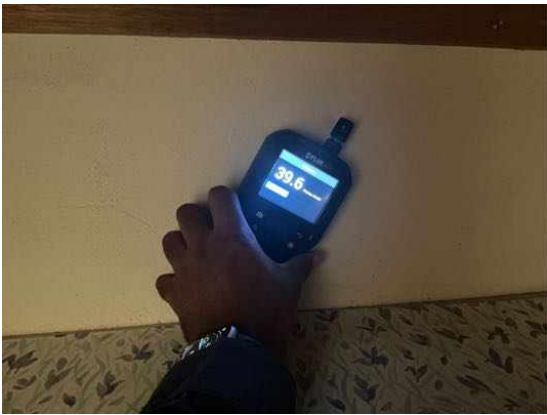
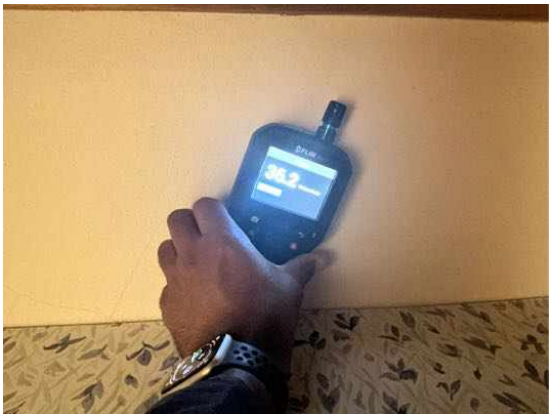
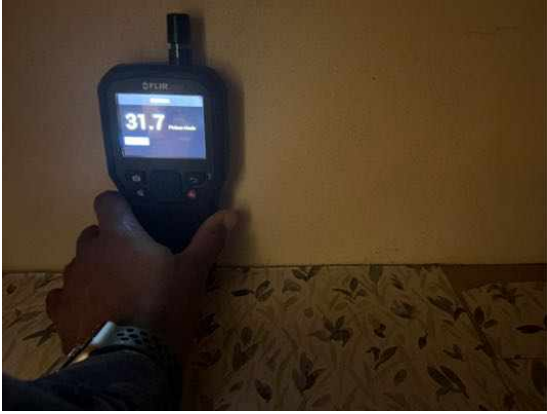
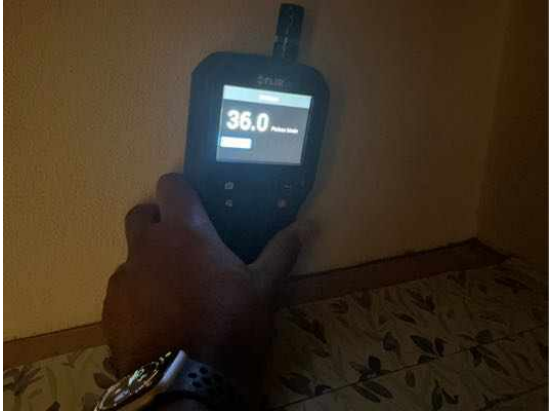
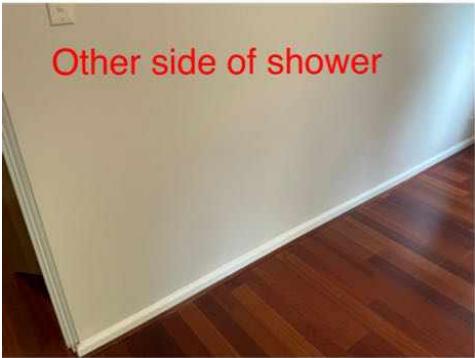
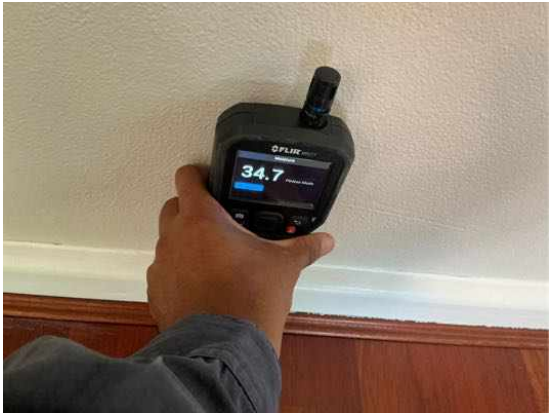
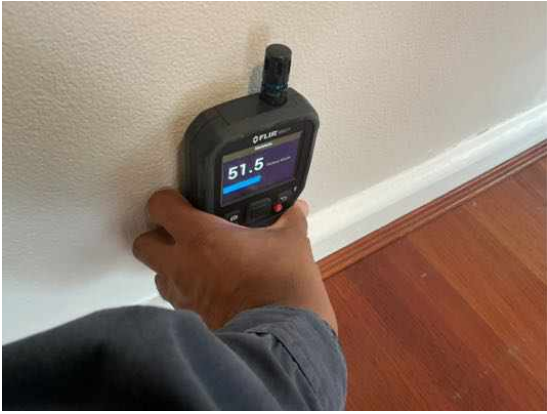
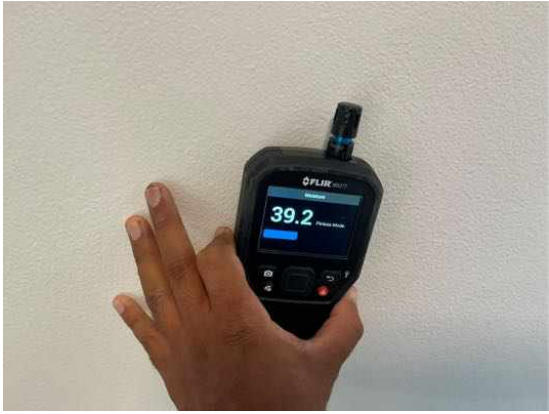
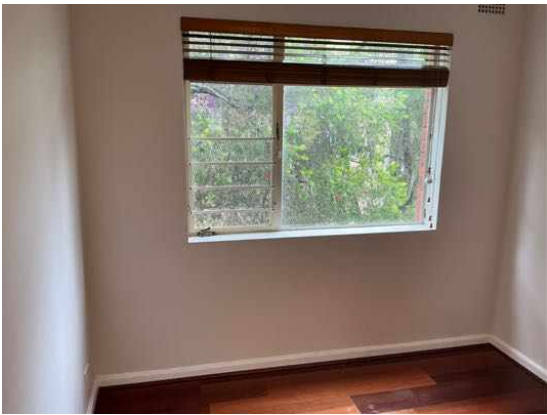
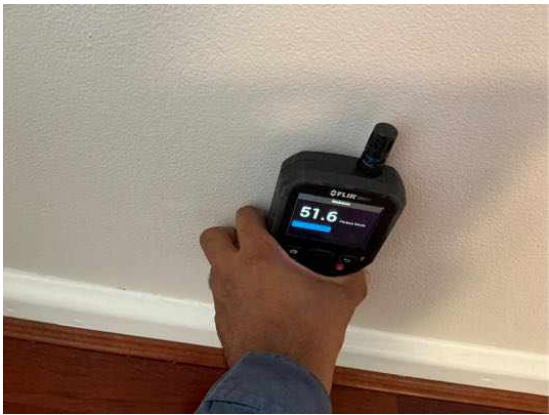
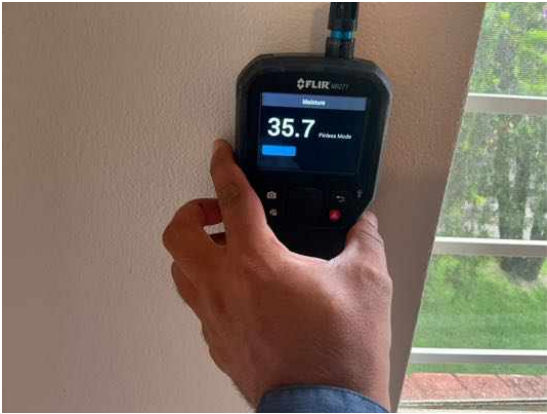
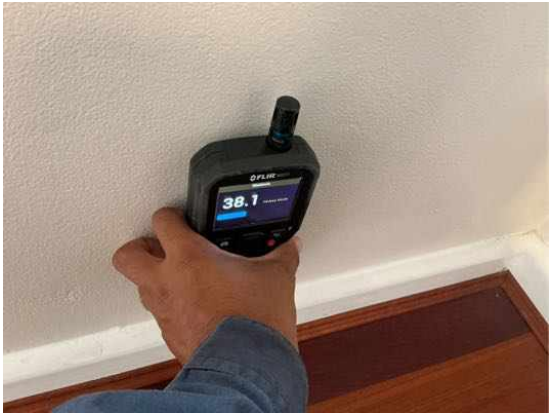
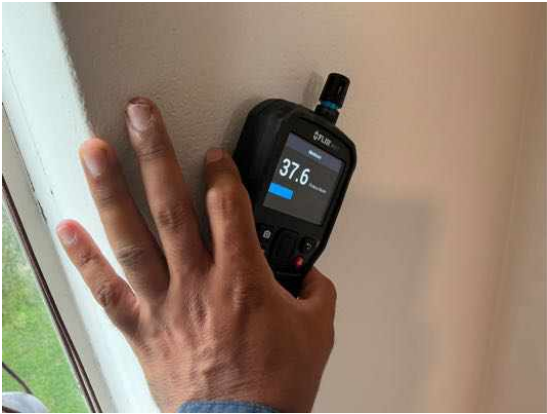
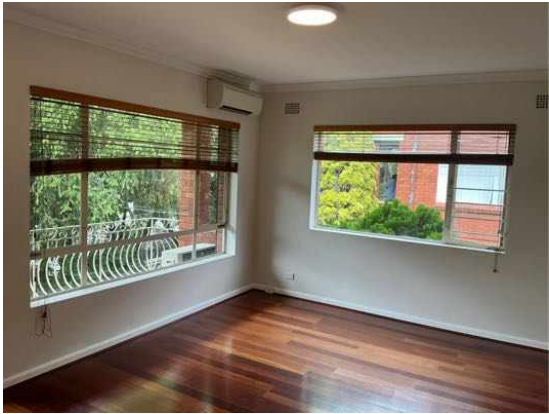
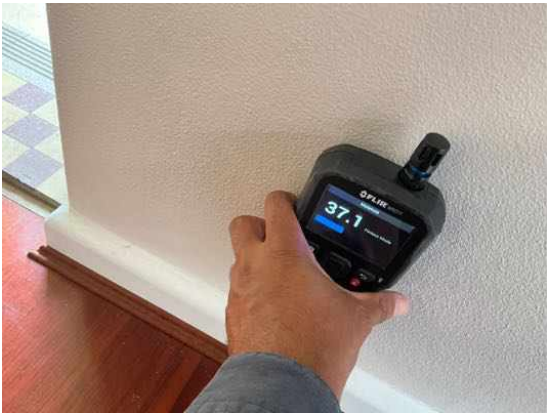
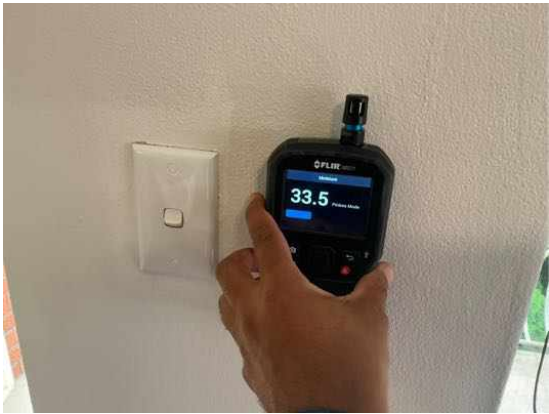
Building:	Main Building
Location:	All Areas
Finding:	Additional Photos - Moisture Meter Readings
Information:	<p>Additional moisture meter reading photos have been provided for the property to offer further clarity on areas tested during the inspection. These photos are intended to give a visual reference for the specific locations where moisture levels were measured.</p> <p>These readings were taken at the time of the inspection to assess any potential moisture-related issues within the property. Any defects related to moisture that were identified during the inspection have been separately mentioned in the defect statements within the report.</p>

For further clarification or additional information regarding the moisture readings, the client is encouraged to contact the building inspector directly. Regular monitoring of moisture-prone areas is recommended to ensure any emerging concerns are addressed promptly, particularly during wetter seasons or in high-humidity conditions.

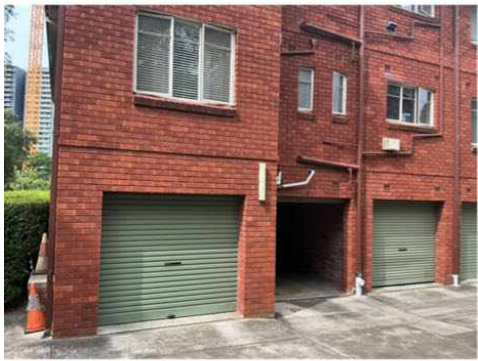
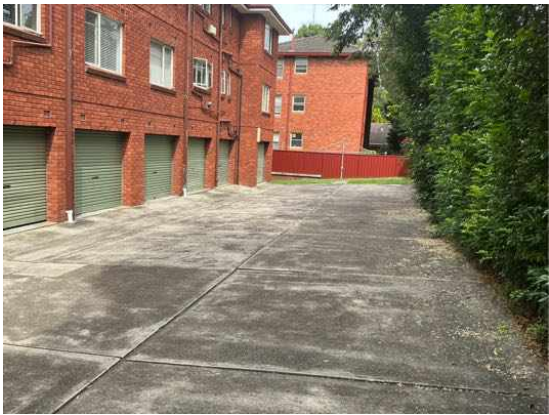
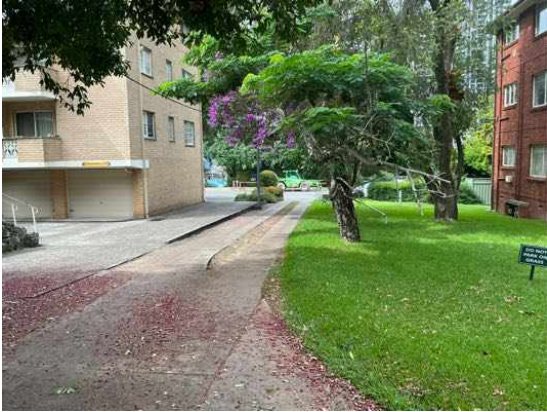
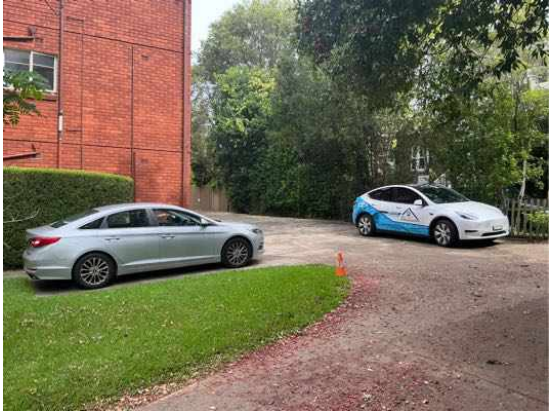
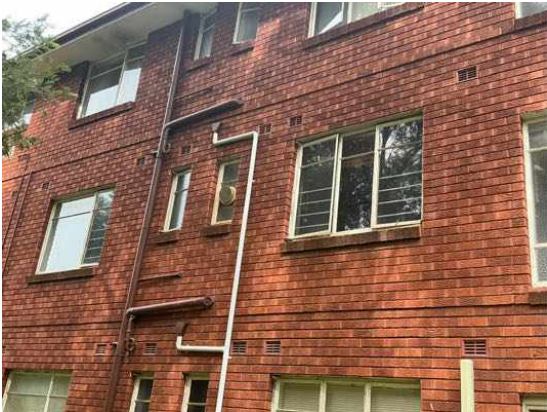
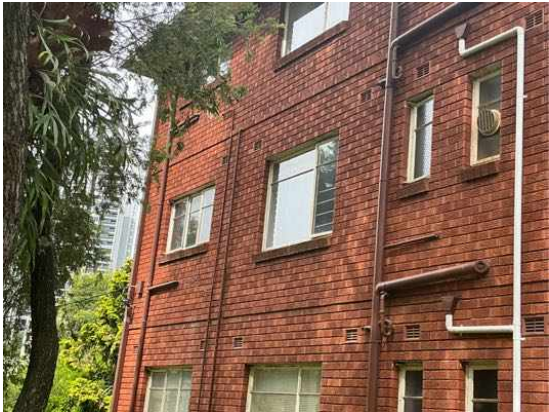
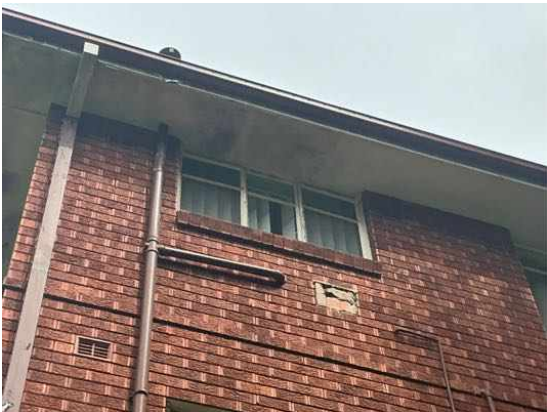
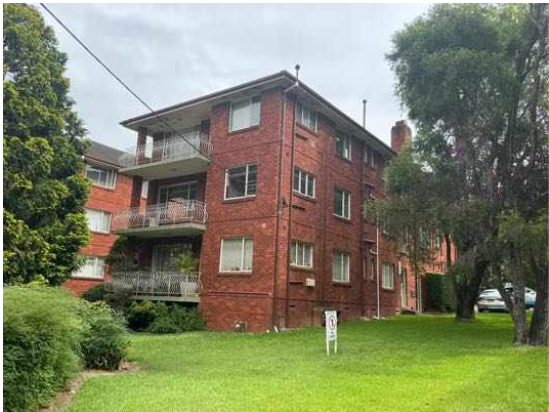
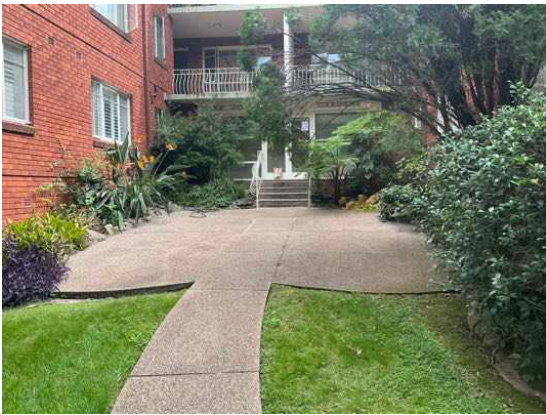
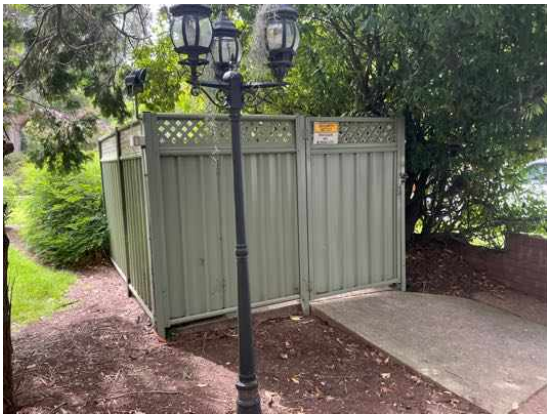
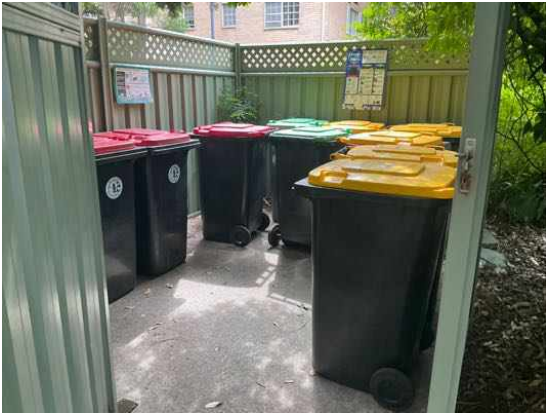
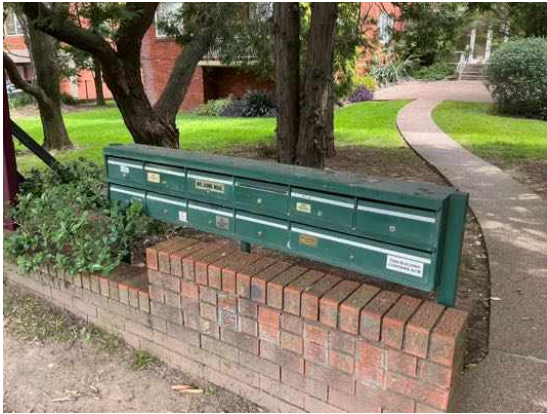
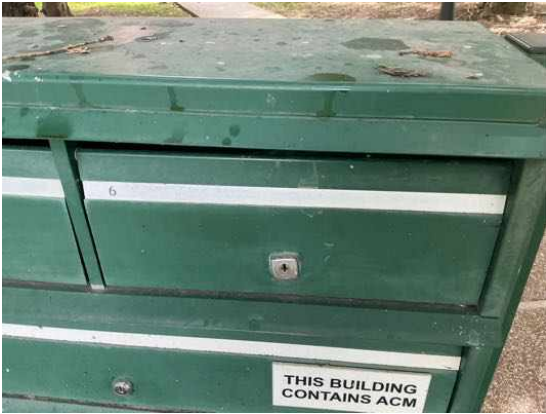
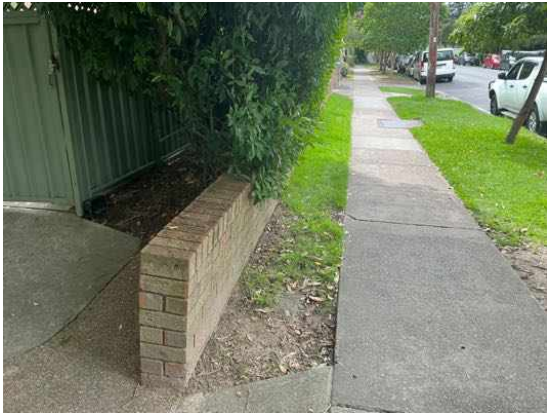
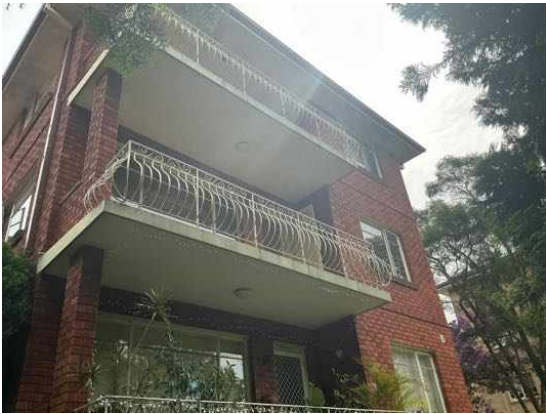
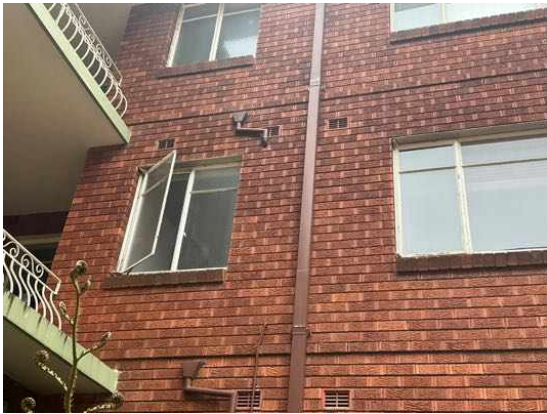
Building:	Main Building
Location:	All Areas
Finding:	Additional Photos of Common Areas
Information:	Additional photos have been provided for your general reference. These images serve as visual documentation of the current condition of the common areas within the building complex at the time of inspection. It is recommended that the client consult with strata management regarding any necessary repairs or maintenance required throughout the complex. These photographs are intended to illustrate the present state of the common areas and should be used as a basis for discussing and prioritizing any needed remedial works with the relevant parties.
