Building and Timber Pest Inspection Report

Inspection Date: Thu, 19 Mar 2026

Property Address: 33 John Batman Ave, Werrington County
NSW 2747, Australia

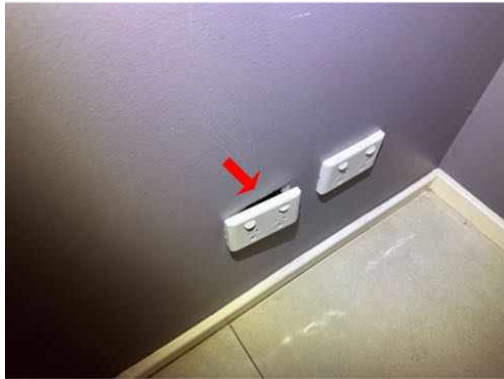
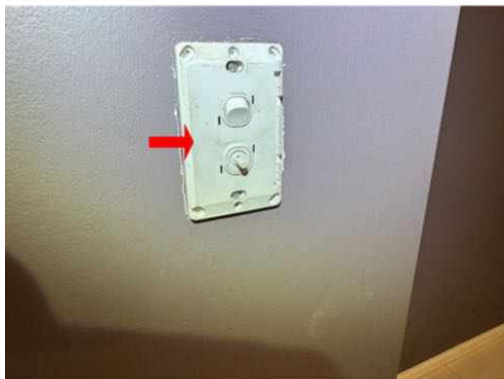
Building:	Main Building
Location:	Bedroom - Master > Rear Left
Finding:	Electrical fittings: Deteriorated damage.
Information:	The electrical fitting in this area was found to be showing signs of deterioration at the time of inspection.

Left unmanaged, the fitting is unlikely to cause further damage to surrounding building elements. However, the broken fitting may create a safety hazard if there is potential contact with persons in the area.

Repair and/or replacement of the broken fitting is advised. A Licensed electrician should be appointed to repair/replace the fitting immediately.

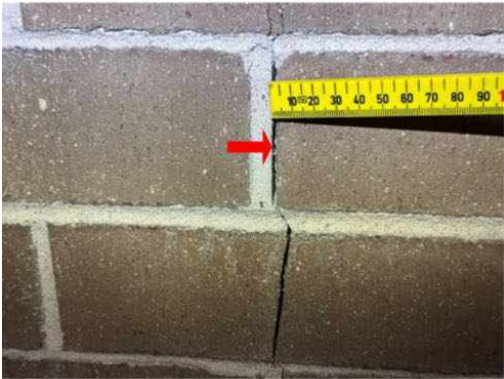
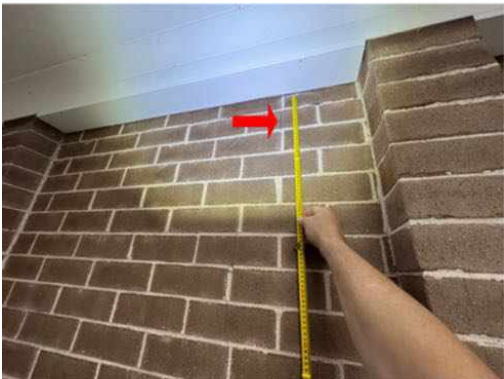
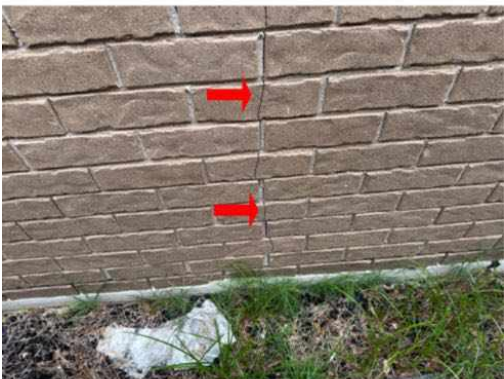
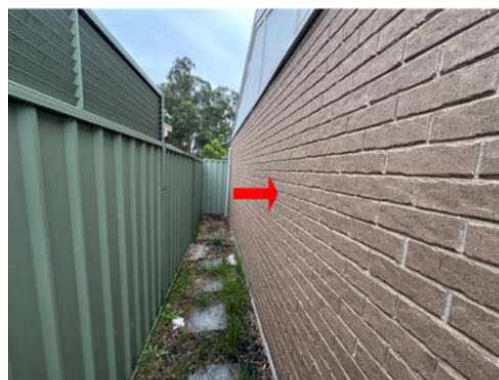
Finding 2.01

Building:	Main Building
Location:	Exterior walls - right side > Centre Right
Finding:	Brickwork - Cracking noticeable
Information:	There were several cracks and or crack repairs evident to external brickwork.

Noticeable cracks are a common occurrence in external brickwork and are a likely result of age expected building movement, general expansion, and/or contraction of building materials in different weather conditions. Noticeable cracks in brickwork may develop if left unattended, with potential for necessitating major remedial works or replacement of the brickwork.

It is highly advised that a qualified bricklayer be appointed to provide necessary works to cracked brickwork to prevent any further damage. Such works should be conducted as soon as possible.

Always monitor these cracks and contact a structural engineer should cracks widen, lengthen, or become more numerous.

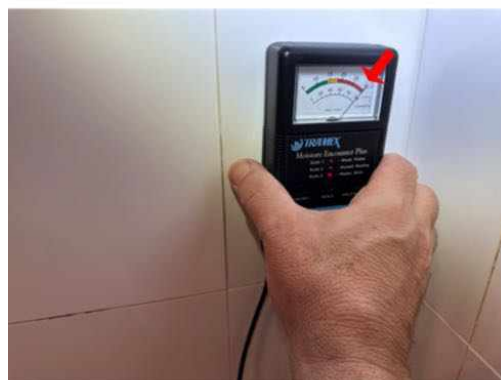
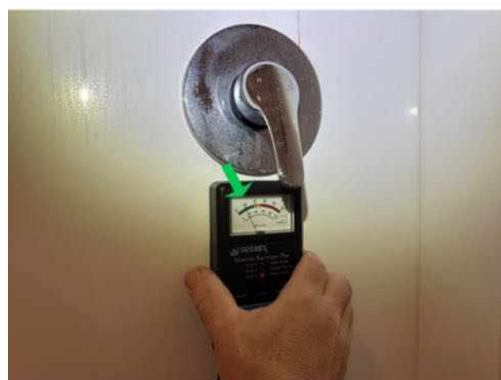
Finding 2.02

Building:	Main Building
Location:	Bathroom > Centre,Rear
Finding:	Moisture meter: used in Shower area.
Information:	A moisture meter was used during the inspection and isolated spots of excessive moisture was detected to accessible walls inside the property at the time of inspection.

It was noted on inspection that sealant or grout is in fair condition to most of the tiled shower alcove, with some areas requiring maintenance.

Different materials and floor areas move at different rates, generally causing cracking to grout or sealant at this point. A flexible sealant is required to allow for expected expansion and contraction, while keeping the joint water tight and protective of all associated building materials.

Flexible and mould resistant materials should be applied to affected areas to prevent any subsequent water damage that is likely to occur. Regular maintenance and replacement of damage or missing or damaged sealant and grout is highly recommended to the wet areas, as this is a regular wear and tear defect. Sealant and grouting in areas that come into regular contact with water should be maintained for the long term care of your property.

Monitoring the area is advised and if any visual signs of excessive moisture appear (peeling paint, mould) then consultation with a qualified plumber or bathroom specialist would be advised to identify the cause of damp and to perform remedial works as required.

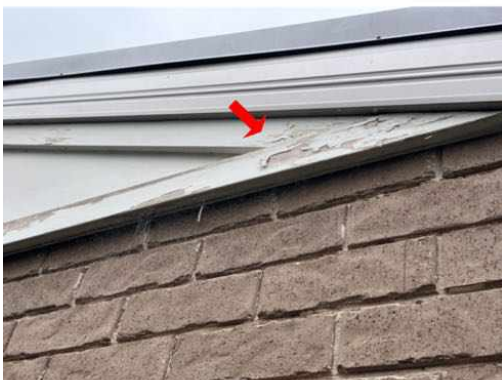
Building:	Main Building
Location:	Exterior walls - right side > Centre Right
Finding:	External painting deteriorated
Information:	Some of the external paintwork including external fitments have been neglected and require attention to prepare and re-paint.

Whilst incomplete or missing paint finish is generally an appearance defect, it can also lead to the development of secondary building defects over time. Incomplete areas of paint finish expose the area to moisture, potentially accelerating the deterioration of underlying building materials.

Degraded paint finishes should be sanded back, filled, leveled and painted, as applicable. Where inadequate or missing paint protection has led to the deterioration of the associated building element, repair and/or replacement of this building element may be required.

A painting contractor should be appointed as soon as possible to perform necessary works to aid the appearance of the affected area and to ensure the area is protected against further deterioration. Alternatively, the homeowner following manufacturer instructions may perform these works.

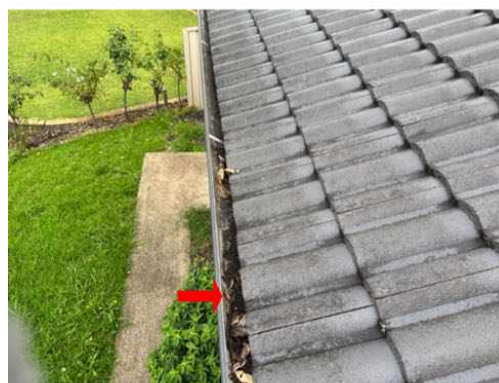
Finding 3.03

Building:	Main Building
Location:	Roof Exterior > Front
Finding:	Gutters - Blocked
Information:	Roof plumbing structures, such as guttering and downpipes, should be free of all debris to prevent blockages. Blockages of the guttering and downpipes will lead to pooling and accumulated water overflows, which is likely to subsequently flood eaves and exterior walls.

Blocked gutters are likely to lead to high levels of moisture in the affected areas. Such moisture will not only cause rust and decay of the associated building materials, but can also provide conditions that are conducive to termite and timber pest activity. Blockages in gutters should therefore be removed immediately to ensure dry conditions are maintained.

Consult a Licensed Plumber for further specific advice on remedial works that may be required. In the interim, it is highly advised that blocked gutters be removed by the homeowner or a general handyperson as a matter of urgency.

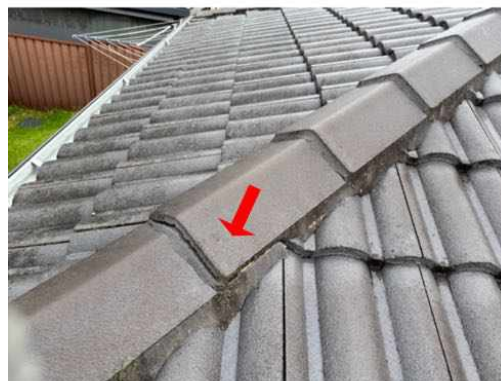
Finding 3.04

Building:	Main Building
Location:	Roof Exterior > All Areas
Finding:	Roof tiles - Weathered
Information:	Upon inspection of the exterior roofing, the majority of roof tiles were considered to be in a fair condition. While weathering of the tiles is consistent with the age of the property, maintenance works are required.

Isolated areas of mortar have come loose in the valleys and minor cracking is also present. Re-pointing and re-sealing the may be considered as an interim solution by

Where left unmanaged, deteriorating roof tiles are likely to lead to a number of secondary defects, including minor water leaks and weather exposure to internal roofing structures.

Consultation with a roofing contractor is highly advised to gain advice on cost of remedial works that may be required in the short to medium term. Remedial works are likely to increase the longevity of the exterior roofing structure.

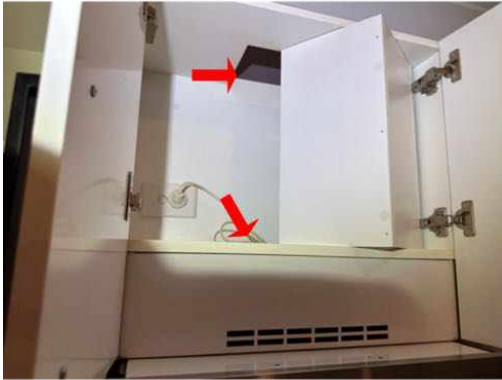
Finding 3.05

Building:	Main Building
Location:	Kitchen > Centre Right
Finding:	Rangehood - Flue disconnected
Information:	The range hood flue has not been connected and is allowing the emission of steam and evaporative moisture into the ceiling space above.

While this does not create high potential for secondary defects, development of grease is likely to occur in the surrounding area, necessitating regular cleaning and maintenance.

Consultation with a licensed electrician may be required to reconnect the flue and thus allow the emission of gases into the external environment. Works should be completed

at client discretion.

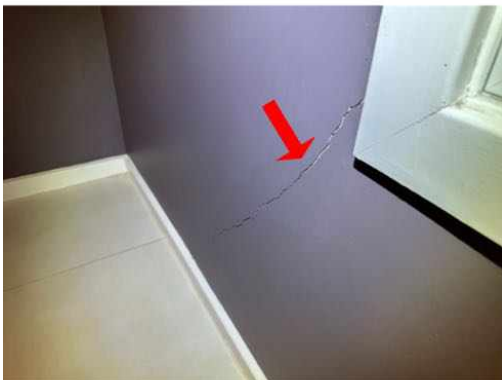
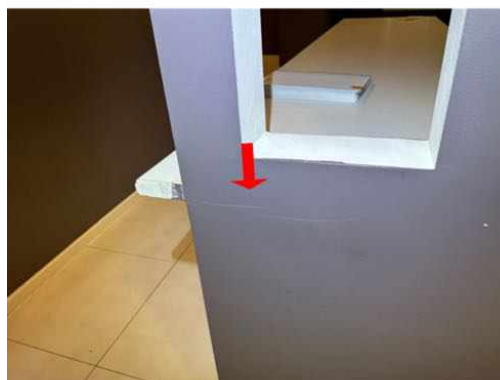
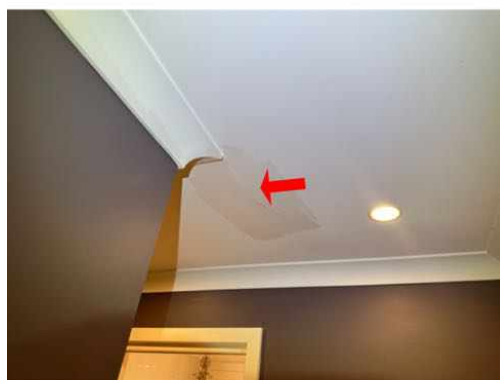
Finding 3.06

Building:	Main Building
Location:	All Areas > All Areas
Finding:	Cracking - Damage Category 1 - Fine (up to 1mm)
Information:	Although fine cracks are quite noticeable, they are often only considered to be an appearance defect, and usually do not indicate any structural damage. Generally, the cause of a fine crack is indicative of a separation between building materials and finishes (e.g. paint, plaster, etc.) along joins.

Cracking of this nature can generally be repaired with minor sanding, filling and/or repainting. Such works should be performed by a qualified painter or a general handyman.

Monitoring of all cracking should be conducted frequently. Always contact a building inspector should cracks widen, lengthen, or become more numerous.

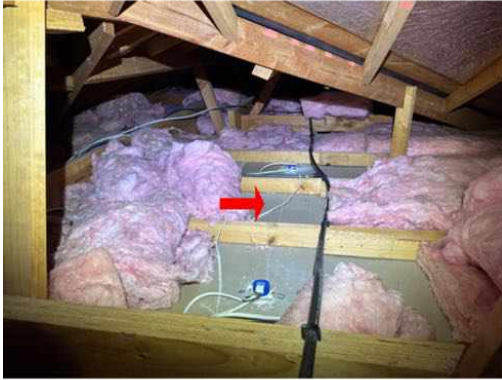
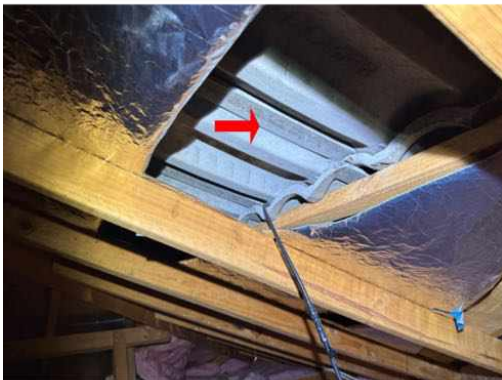
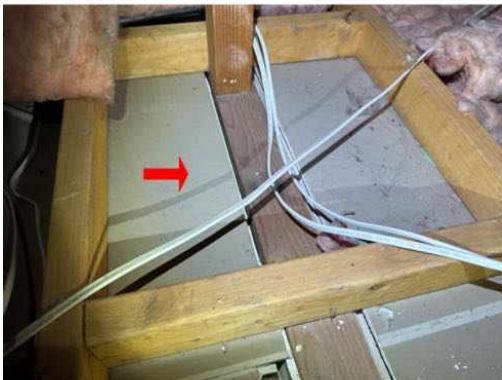
Finding 3.07

Building:	Main Building
Location:	Roof Void > All Areas
Finding:	Insulation - Inadequate
Information:	Upon inspection of the roof void it was noted that there is a lack of adequate insulation.

The level of insulation in the property does not meet current Australian Standards. Installation of adequate insulation is required and should be conducted as soon as possible.

Caution should be exercised when accessing the roof void. Do not attempt to stand on the framework to the underside of the trusses and be aware there is a potential for electric shock if contact is made with exposed or faulty electrical wiring.

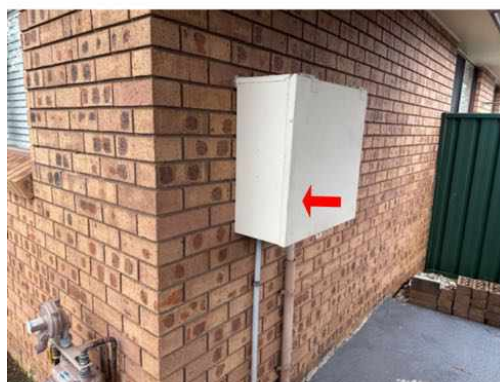
Building:	Main Building
Location:	Electrical Switchboard 11 Angel St > Front Right
Finding:	Termite Management System - no evidence of a chemical installation
Information:	The application of a post-construction chemical termite barrier is highly recommended for all properties, particularly if live termite activity has been found on the site previously. Such barriers are highly effective in preventing termite attack on any timber building elements throughout the property.

A durable notice should be placed in the switchboard unit to indicate current termite barriers. At the time of inspection, it appeared as though no termite management system has been installed, with no evidence to suggest preventative works taking place.

The client may consider gaining further advice from a pest controller as to the costs and procedures involved with this application. It is recommended that obtaining such advice be a short-term priority.

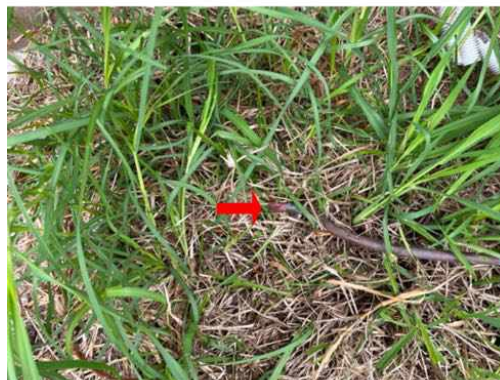
Building: Main Building
 Location: Exterior walls - rear > Centre
 Finding: HWS Overflow - Not Connected
 Information: The Hot Water System (HWS) overflow was found to be disconnected from storm water drainage and is creating excessive moisture in the surrounding area.

These damp conditions can lead to secondary defects such as rot, rust or corrosion of associated building elements, the formation of fungal decay, or even the creation of potential slip hazards. When coupled with poor site drainage, pooling of water may also attract termite activity to this area.

It is highly recommended that a licensed plumber be appointed to connect the HWS overflow in order to prevent such an environment from being created. These minor works should be carried out as soon as possible.

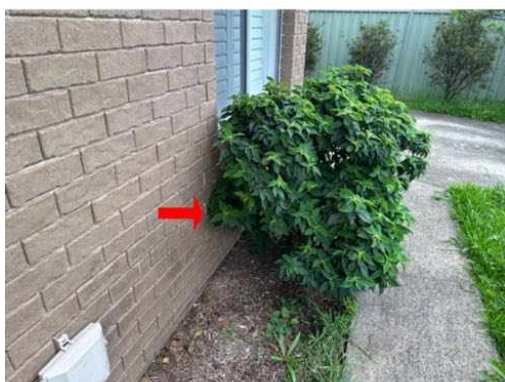
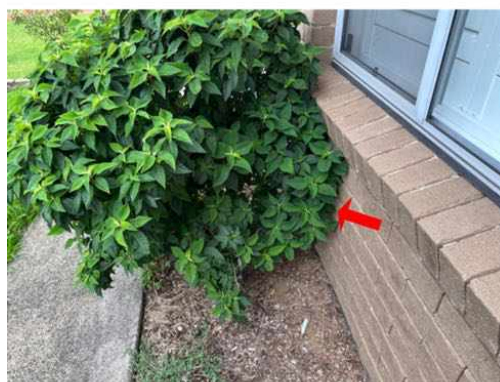
Finding 6.04

Building: Main Building
 Location: Exterior walls - front > Centre
 Finding: Bridging - Vegetation
 Information: Where vegetation obstructs inspection of building elements, also known as bridging as it provides a bridging point for the access of termites, full inspection can not be achieved. Consequently moisture or dampness may be present and the areas becomes conducive to termite activity. Plants against or very close to buildings provide cover, shade and can provide an environment that is attractive to termite infestation.

The removal and replanting of species that do not provide "cover" or cutting back of existing vegetation will assist greatly in preventing Bridging from occurring.

The removal of any such materials that may be conducive to termite activity should be carried out as soon as possible and arrange re inspection to minimize the risk of termite attack.

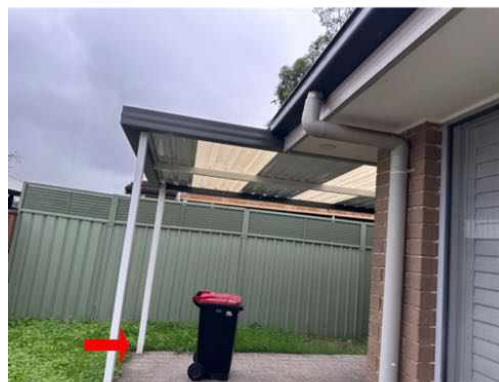
Finding 6.05

Building: Main Building
 Location: Alfresco > Rear Right

Finding: Awning down pipes - Disconnected overflow
Information: The awning down pipe overflow was found to be disconnected from storm water drainage and is creating excessive moisture in the surrounding area.

Such leaking creates an environment which is conducive to an array of defects, including water damage to associated building elements and the attraction of termite or timber pest infestation.

It is highly recommended that a licensed plumber be appointed to connect the awning down pipes overflow in order to prevent such an environment from being created. These minor works should be carried out as soon as possible.

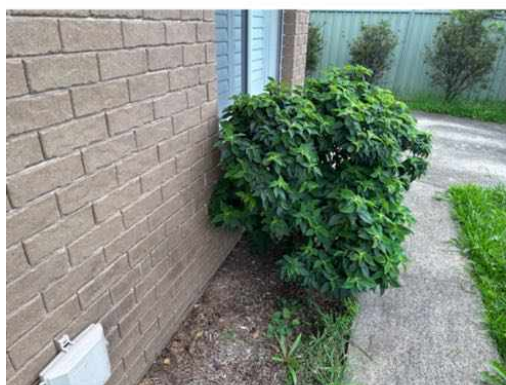
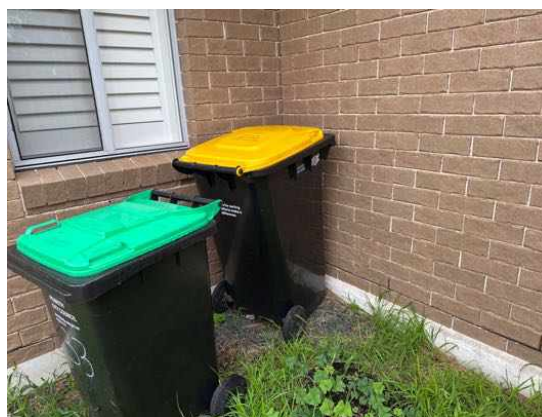
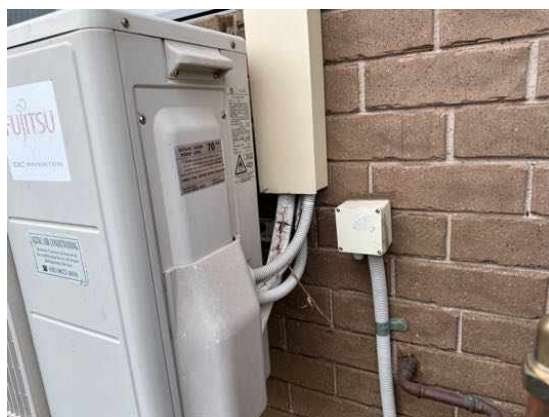
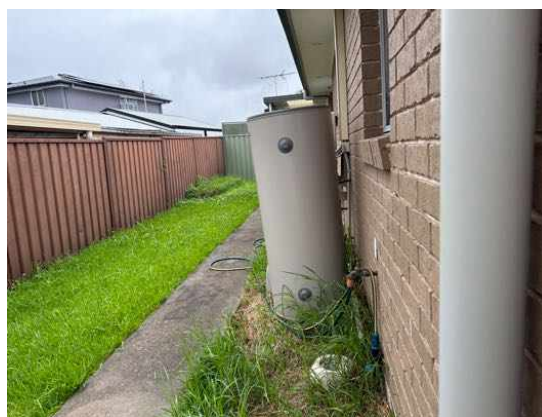
Building: Main Building
 Location: All Areas > All Areas
 Finding: Additional Photos - Obstructions and Limitations
 Information: These photographs are an indication of the obstructions and limitations which impeded full inspection of the property at the time of inspection. These obstructions can hide an array of defects and should be removed to allow full inspection to be carried out. A re-inspection is recommended once the areas are made accessible.

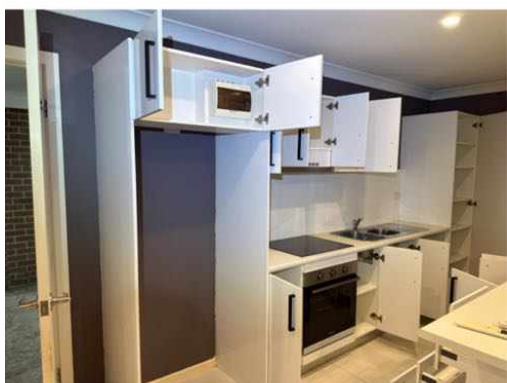
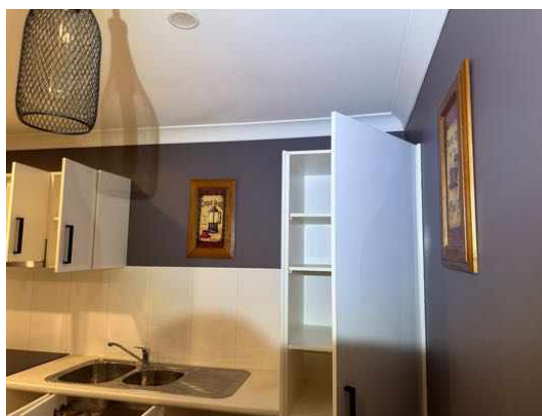
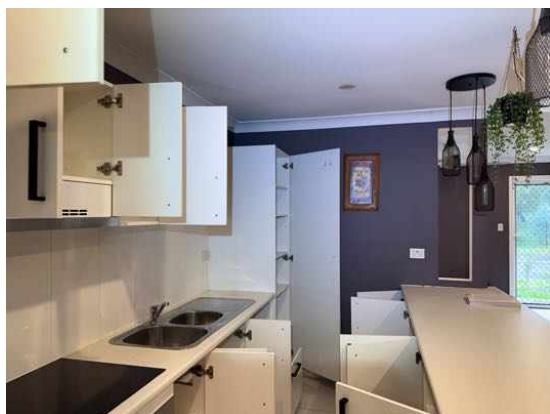
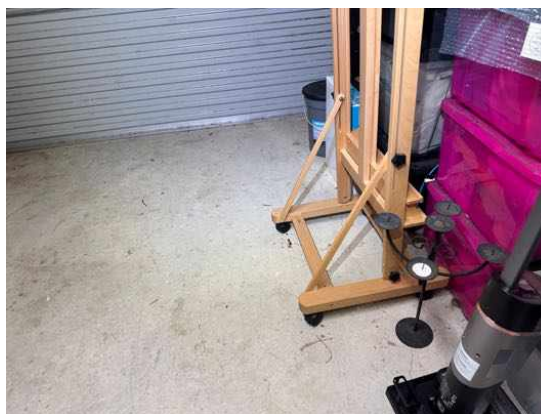
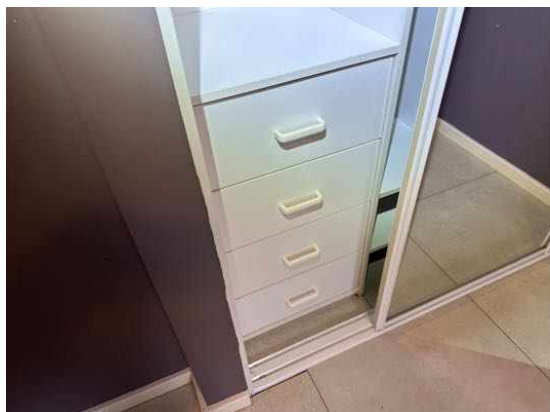
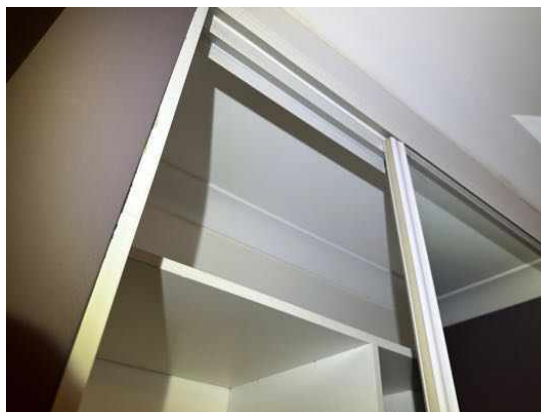
Building: Main Building
Location: All Areas > All Areas
Finding: Additional Photos - Obstructions and Limitations
Information: These photographs are an indication of the obstructions and limitations which impeded full inspection of the property at the time of inspection. These obstructions can hide an array of defects and should be removed to allow full inspection to be carried out. A re-inspection is recommended once the areas are made accessible.

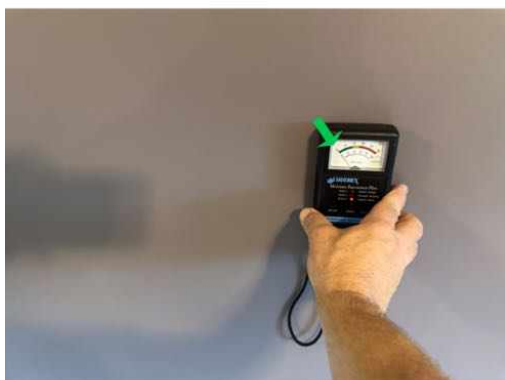
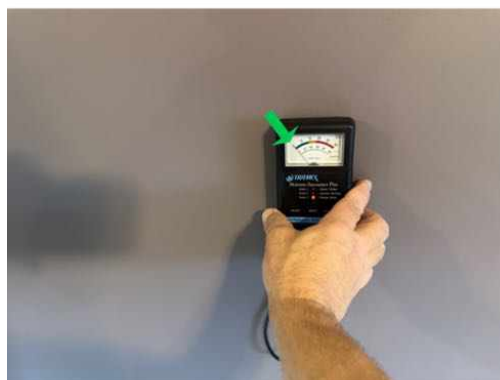
Building: Main Building
 Location: All Areas > All Areas
 Finding: Moisture Meter used: No Moisture Detected.
 Information: Moisture meter was used during the inspection and no excessive moisture was detected to accessible walls inside the property at the time of inspection.

Monitoring the area is advised and if any visual signs of excessive moisture appear (peeling paint, mould) then consultation with a qualified plumber, builder, or damp proof specialist would be advised to identify the cause of damp and to perform remedial works as required

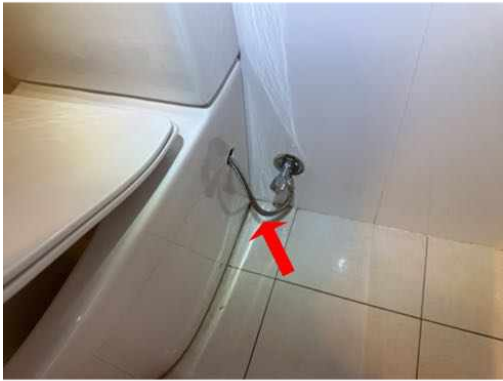
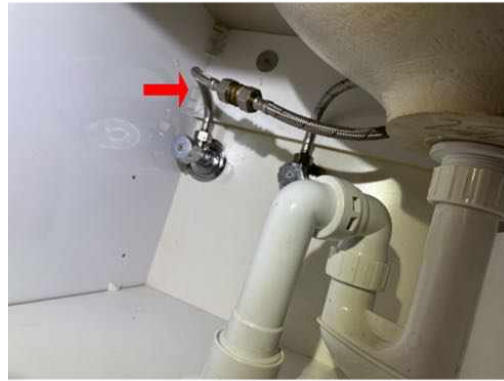
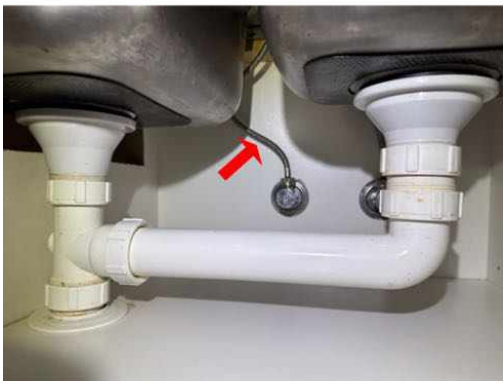
Building: Main Building
 Location: All Areas > All Areas
 Finding: Pipe: Flexible Braided pipes.
 Information: Braided Stainless Steel Flexi connector hose are popular in modern home fit outs because they can be bent into shape. They started to be installed in the early two thousands and their use is now extremely widespread in contemporary construction and renovations.

Flexible braided hoses accounted for more than one in five water damage claims lodged by Australian households according to research released by general insurer IAG.

It is recommended that the Flexi pipes to be replaced at the owners discretion to avoid an “escape water incident” which may lead to water damage to other building elements in the home.

This work can be undertaken by a licensed plumber, general handy person at the owners discretion.

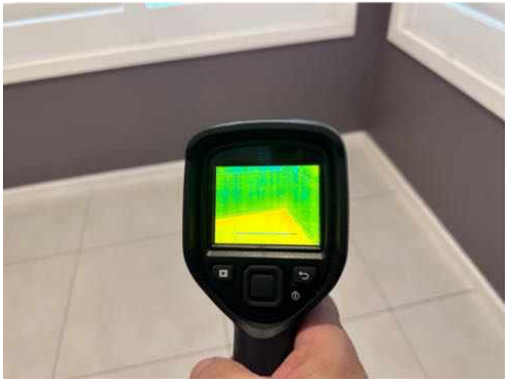
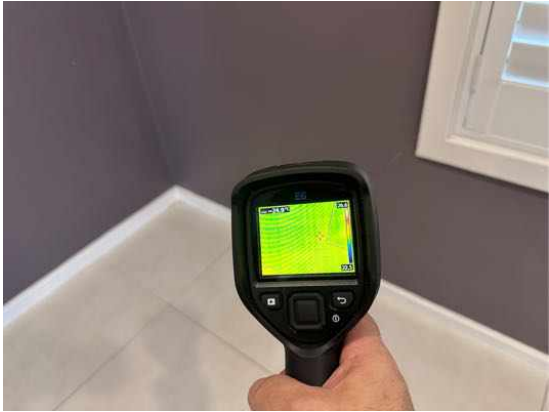
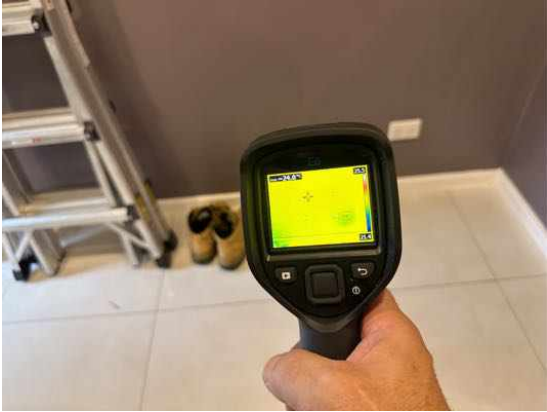
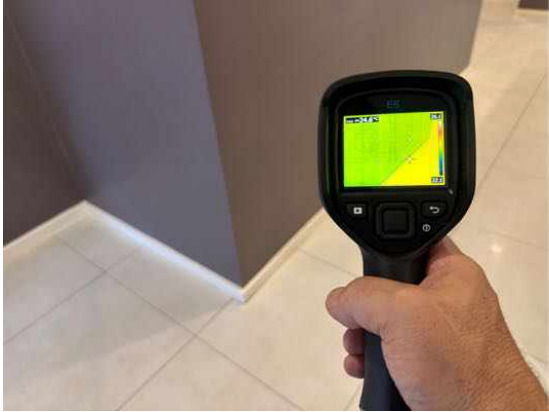
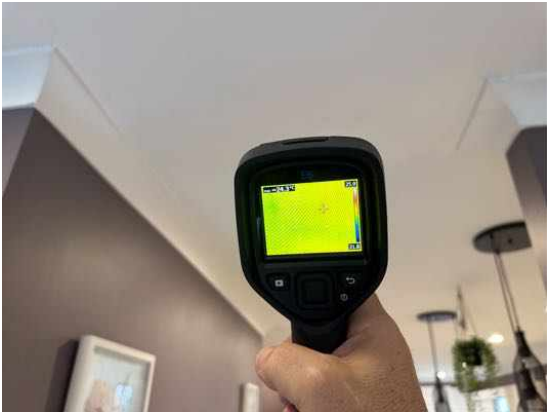
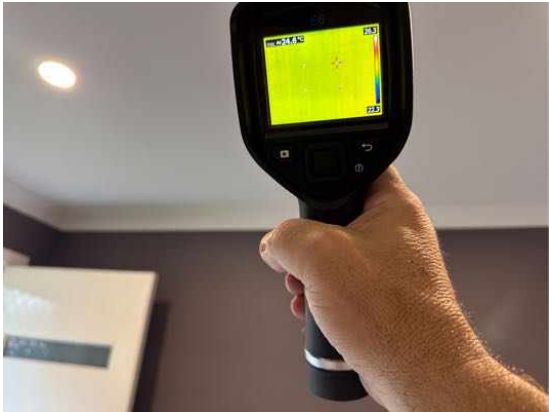
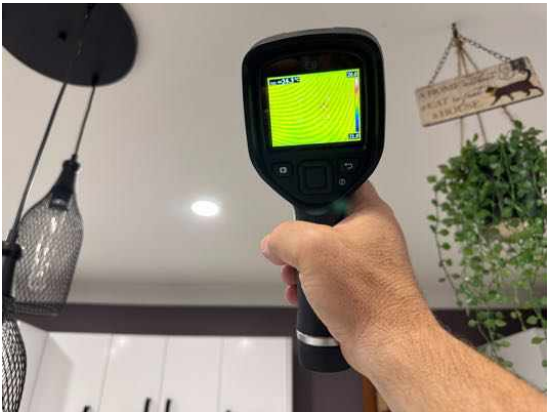
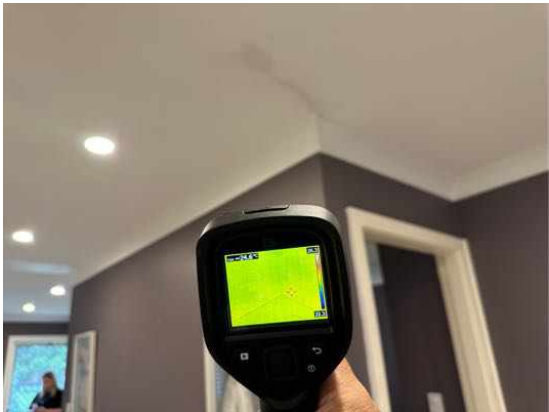
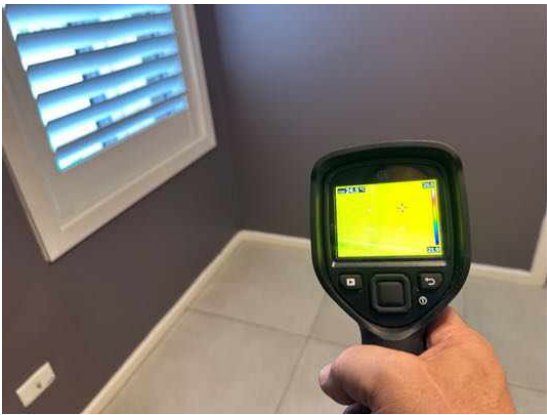
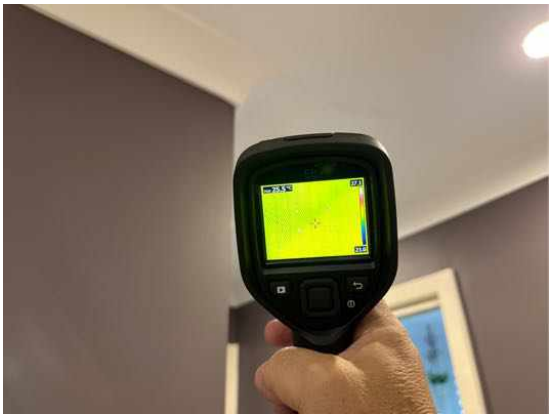
Building: Main Building
 Location: All Areas > All Areas
 Finding: Thermal imaging: No excessive moisture presentation.
 Information: At the time of inspection there appeared to be no excessive moisture presentation in this area.

NOTE: If the Property has been vacant for a period of time or wet areas not used, moisture levels or leaks may not be detectable at the time of the inspection because often only frequent use of water pipes (showers, taps etc) result in a leak being identifiable. We advise further testing on pipes and water susceptible areas (such as the bathroom and laundry) after more frequent use has occurred.

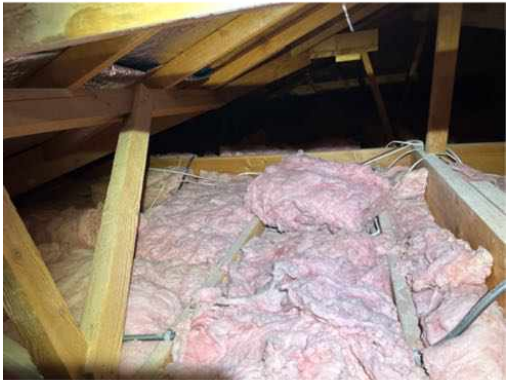
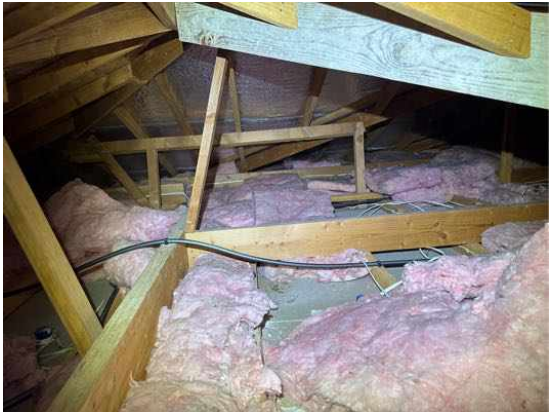
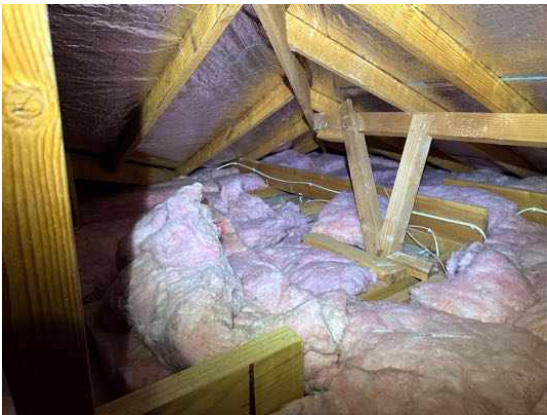
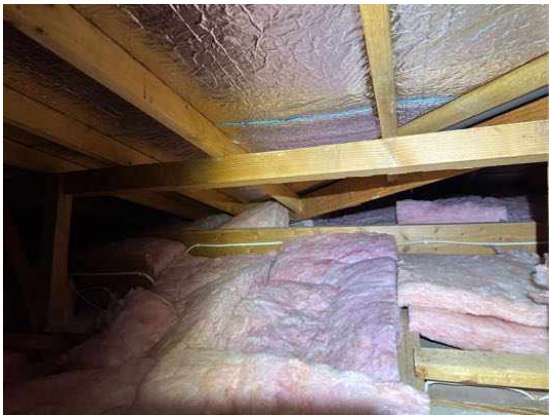
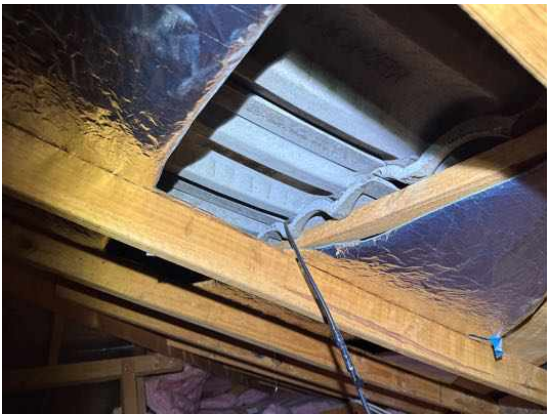
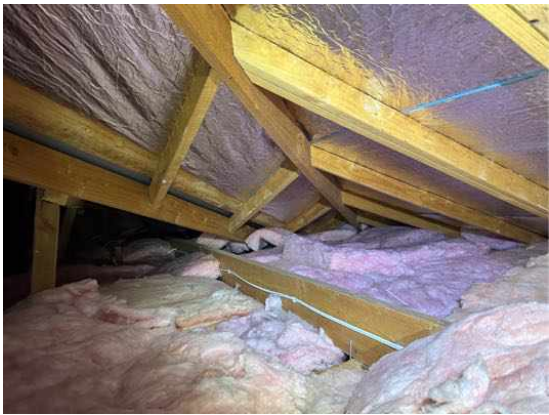
Building: Main Building
Location: Roof Void > All Areas
Finding: Roof void: limited access.
Information: Limited access to the roof void was present due to facts including but not limited to access hatch size or placement, insulation, low pitched roof area, for this reason inspection to the roof void was minimal and a range of defect's from minor to major may not be visible at the time of inspection.
