Building and Timber Pest Inspection Report

Inspection Date: Sat, 21 Mar 2026

Property Address: 88 Arthur St, Grafton NSW 2460, Australia

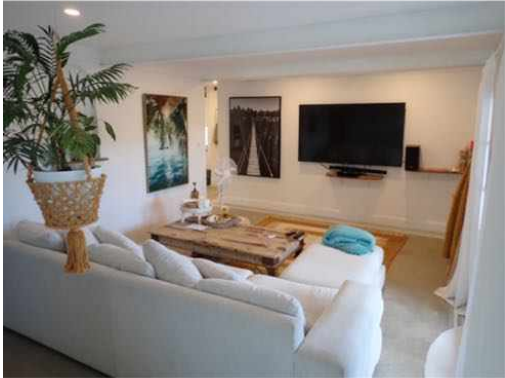
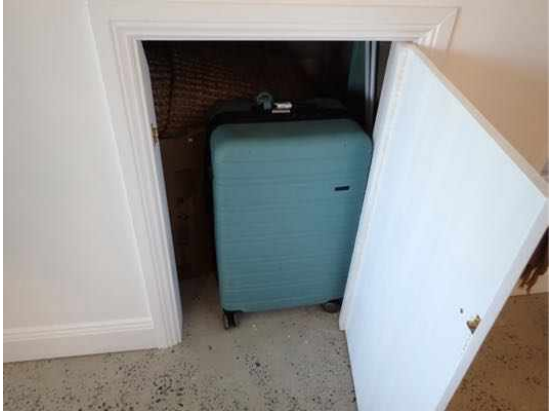
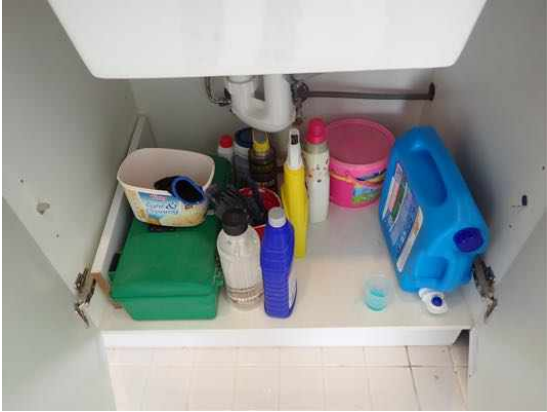
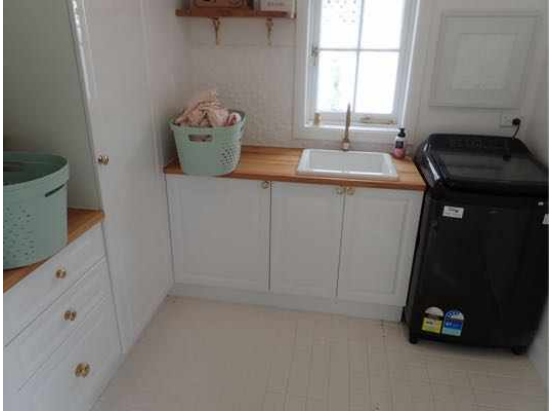
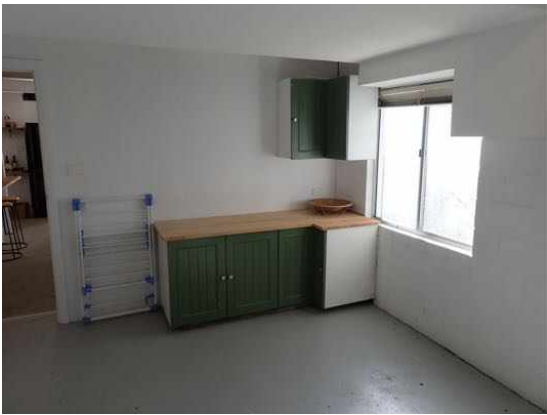
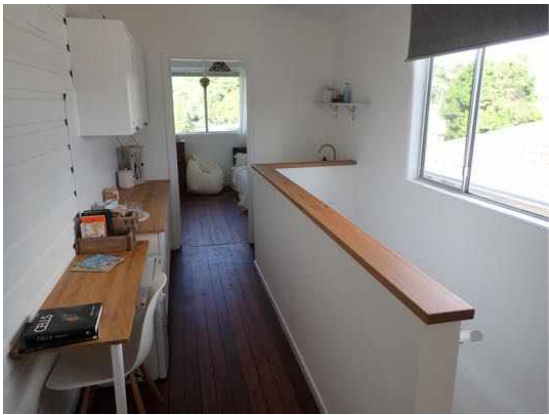
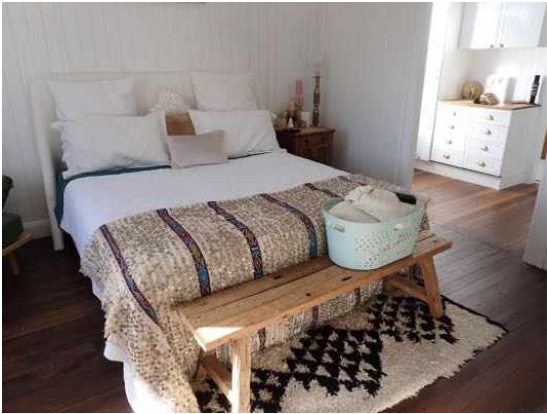
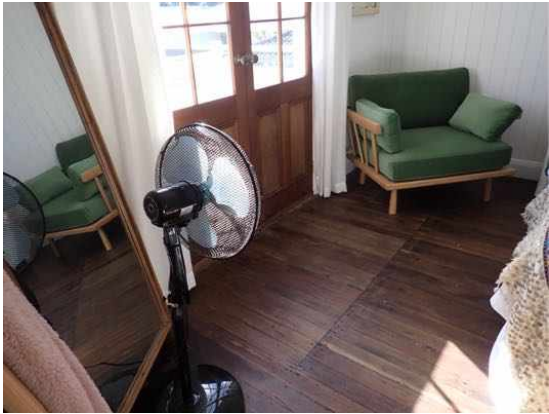
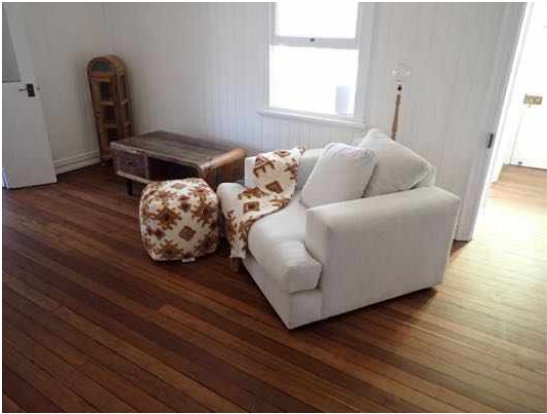
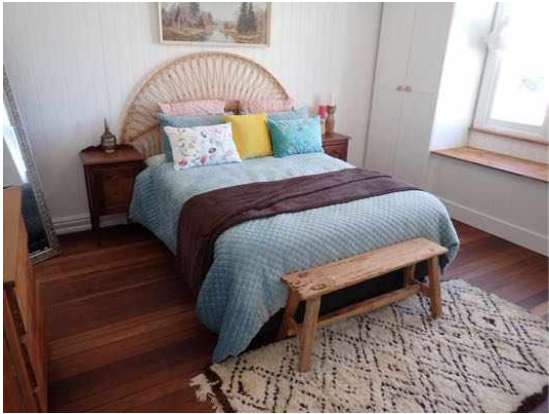
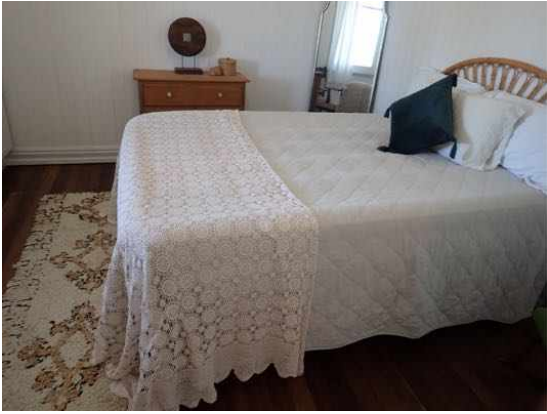
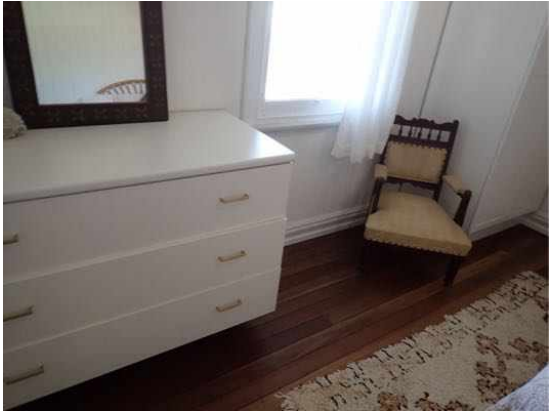
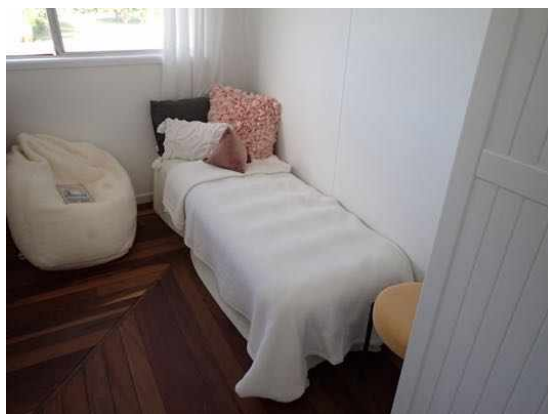
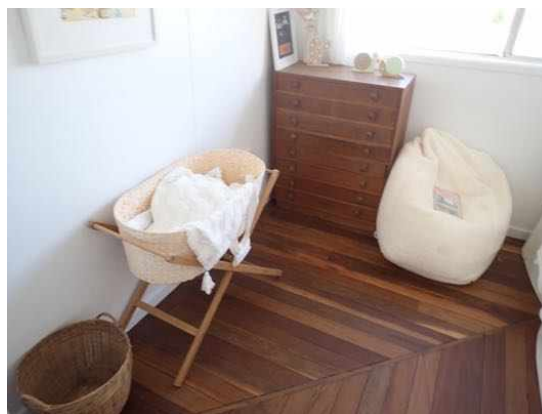
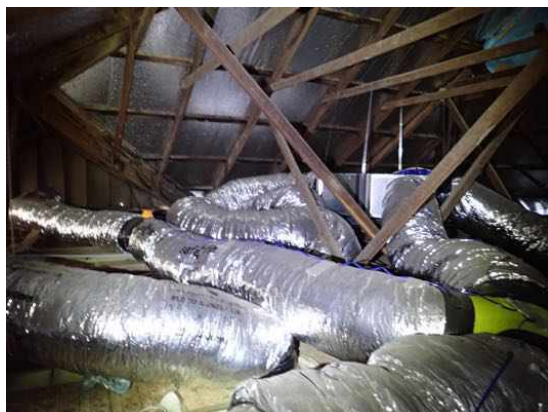
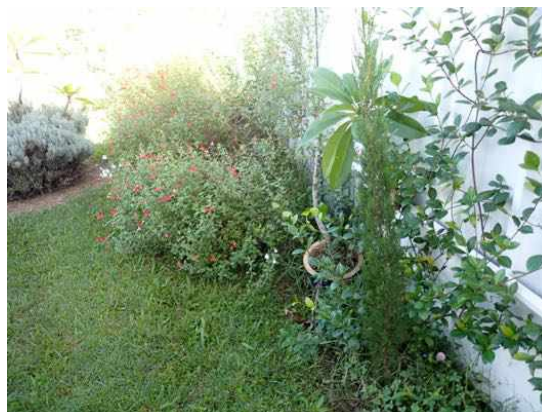
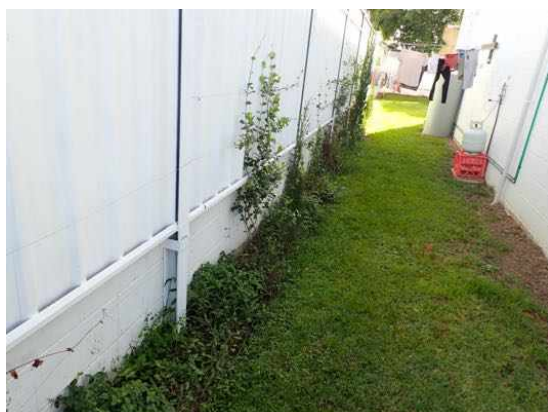
Building: Main Building
Location: All Areas
Finding: Additional Photos - Obstructions and Limitations
Information: These photographs are an indication of the obstructions and limitations which impeded full inspection of the area at the time of inspection. These obstructions can hide an array of defects and should be removed to allow full inspection to be carried out. A re-inspection is recommended once the areas are made accessible.
