Building and Timber Pest Inspection Report

Inspection Date: Mon, 2 Mar 2026

Property Address: 24 Corven Ave, Elderslie NSW 2570,
Australia

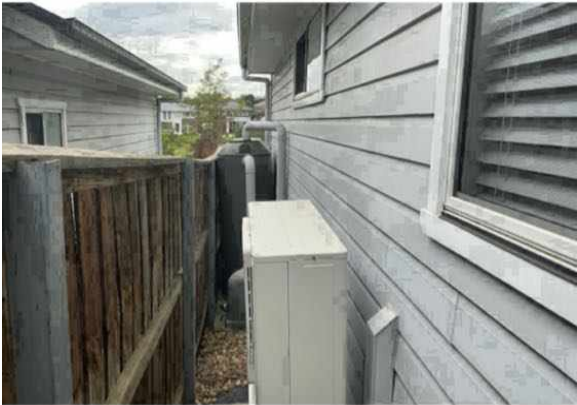
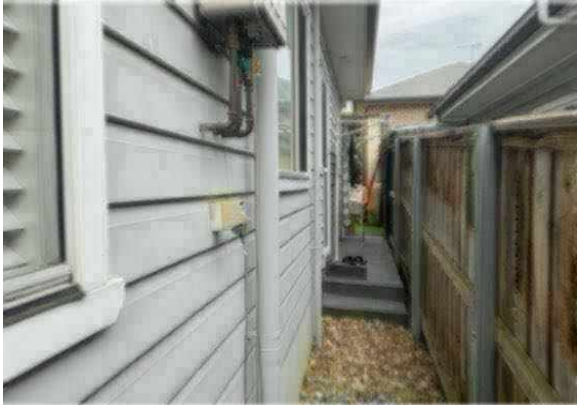
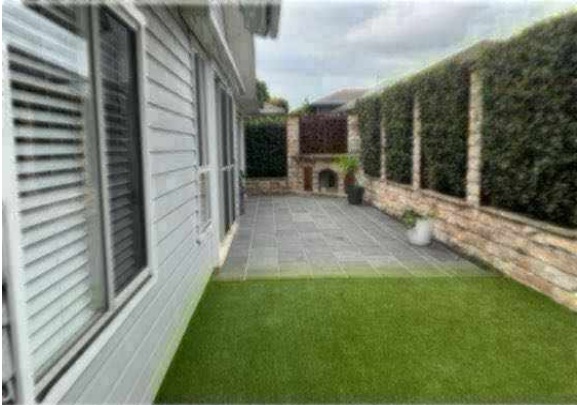
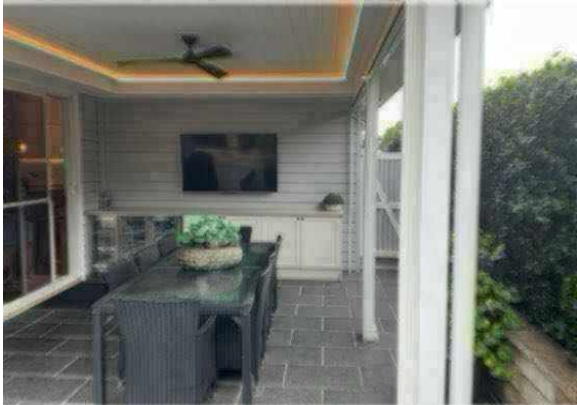
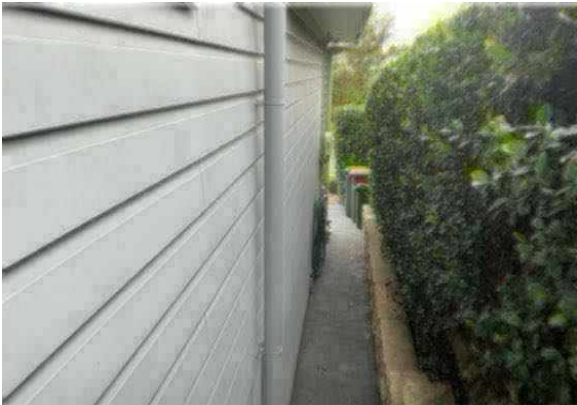
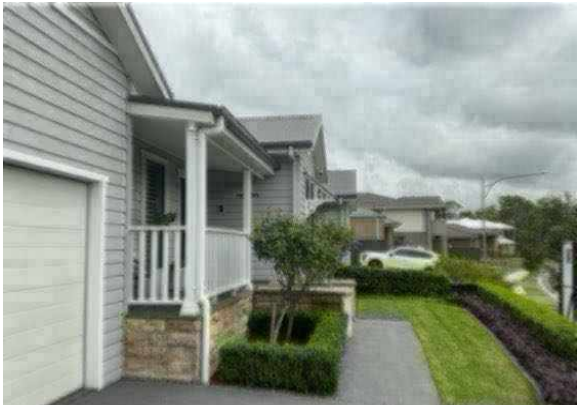
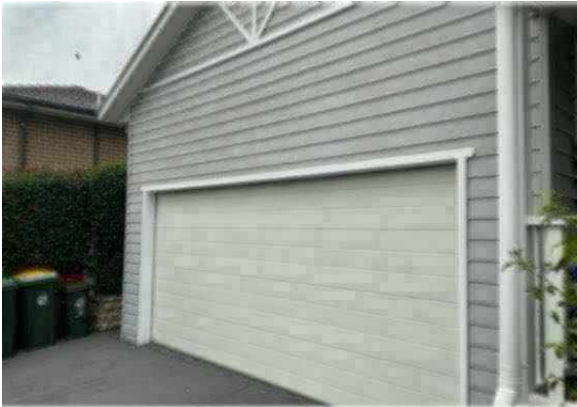
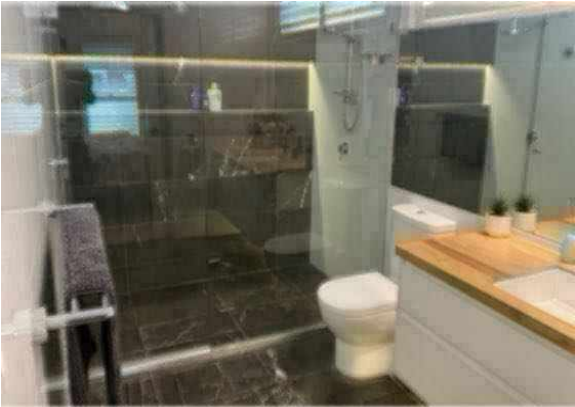
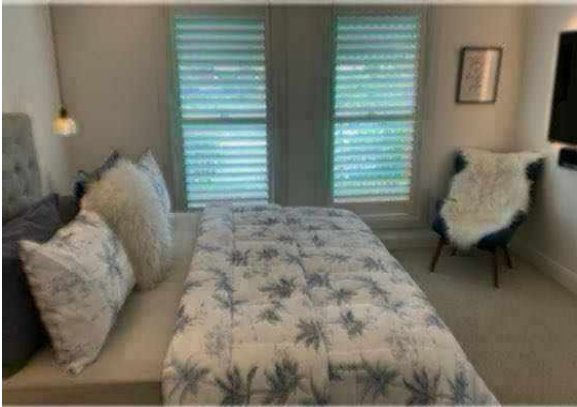
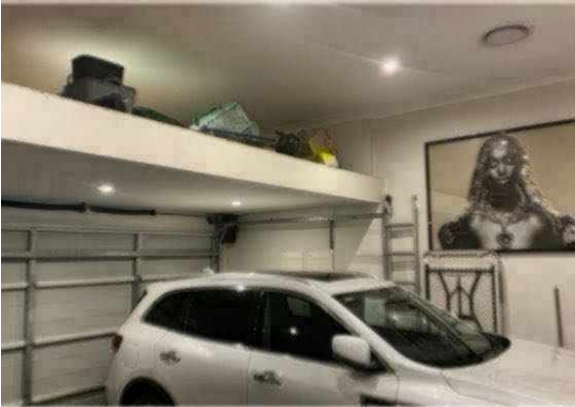
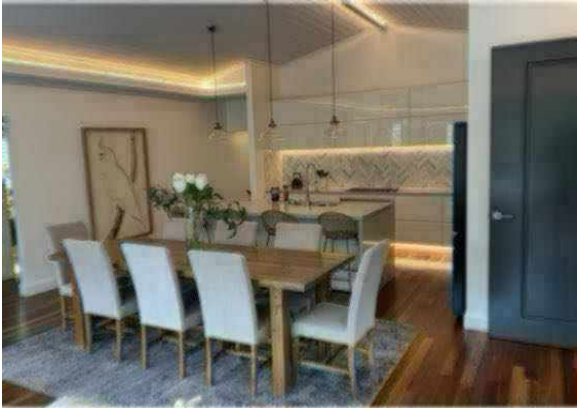
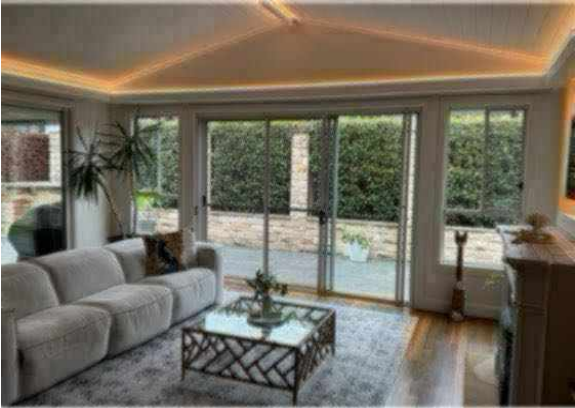
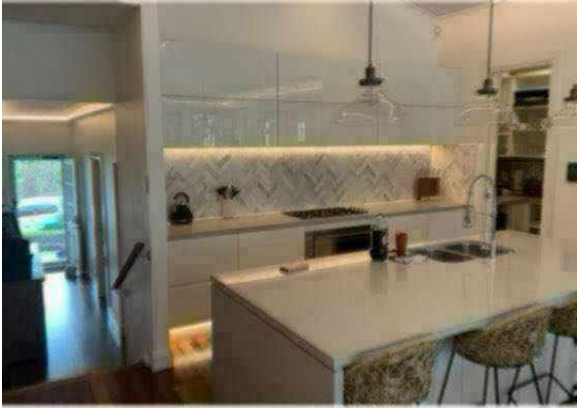
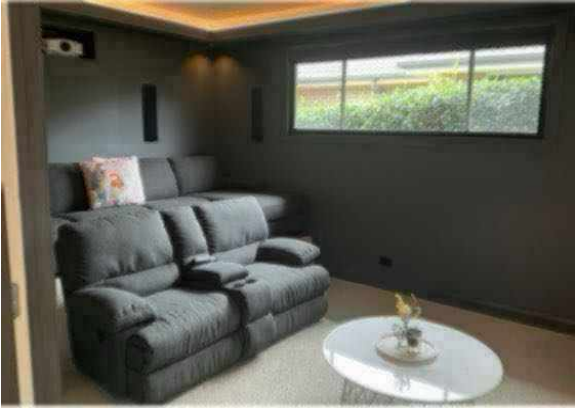
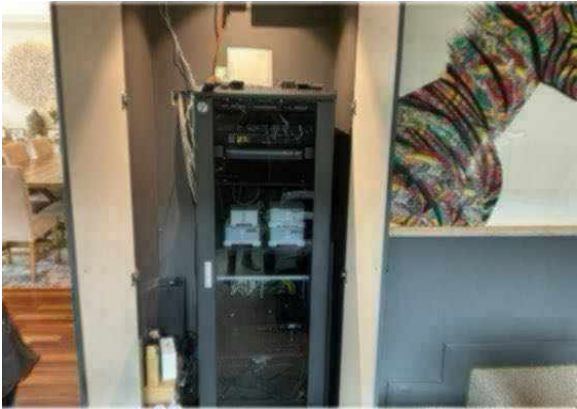
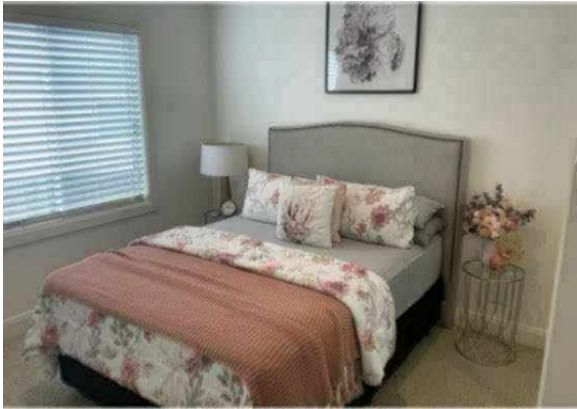
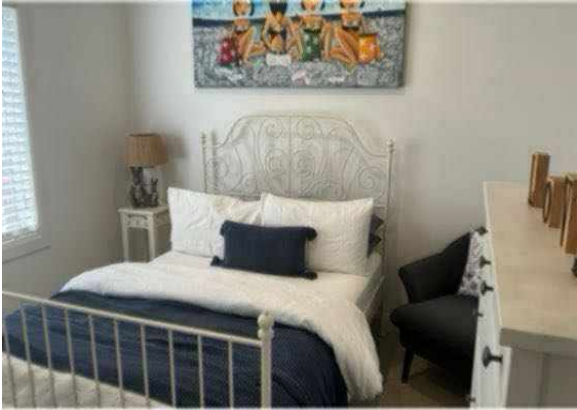
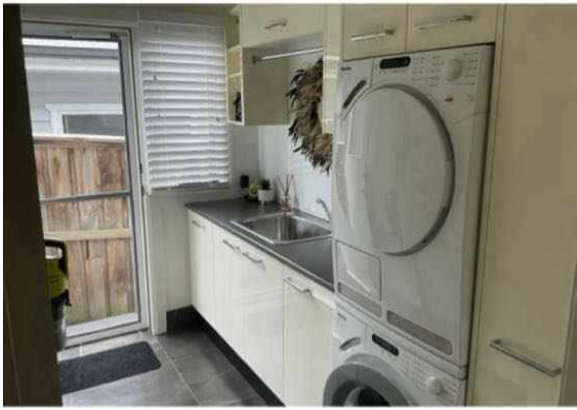
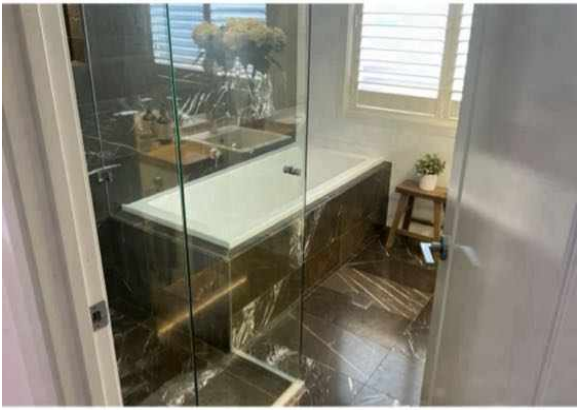
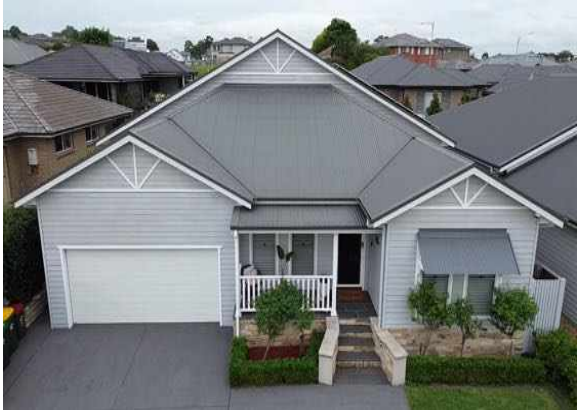
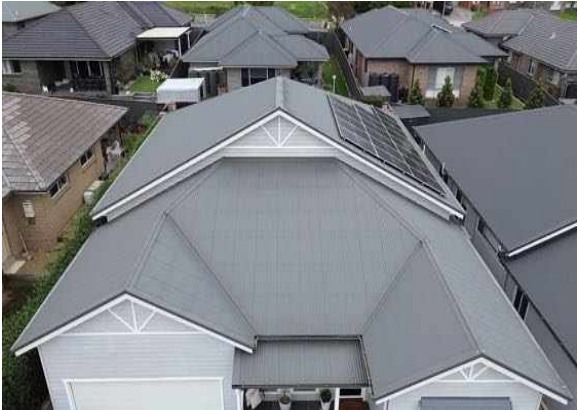
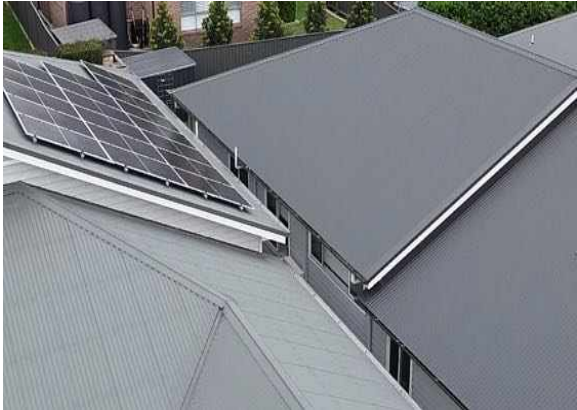
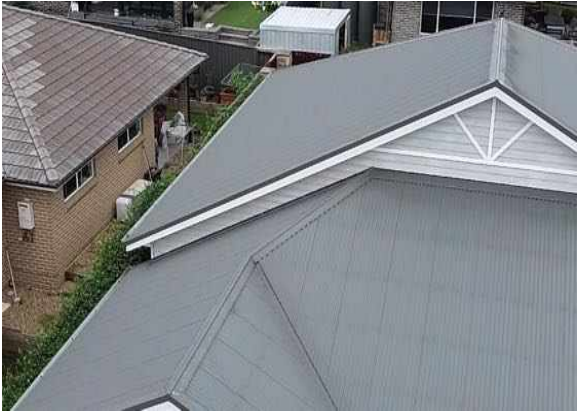
Building: Main Building
 Location: All Areas
 Finding: Inspection Photos (Obstructions and Limitations)

Information: Additional photos have been provided for your general reference, depicting the areas that were accessible during the inspection. Please note that this visual inspection was limited to readily accessible areas, as defined by the report's terms and conditions. The photos demonstrate the obstructions and limitations encountered, which may have impeded a comprehensive inspection and could potentially conceal various defects. For a more detailed and accurate assessment, a special-purpose inspection is recommended.
