# Building and Timber Pest Inspection Report

Inspection Date: Tue, 3 Mar 2026

Property Address: 9 Brown St, Willaston SA 5118, Australia

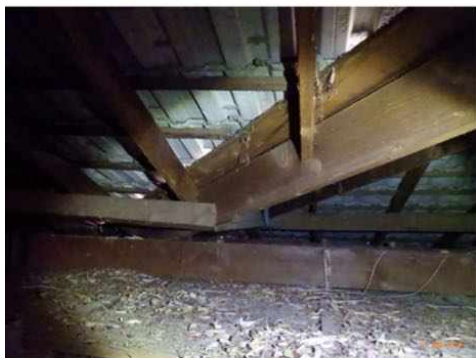
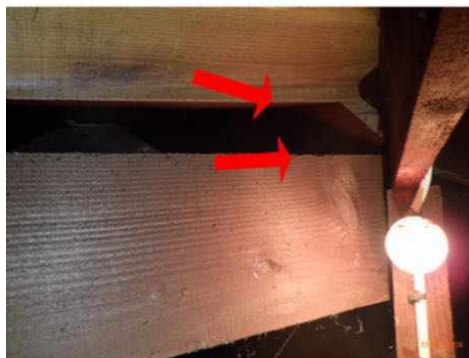
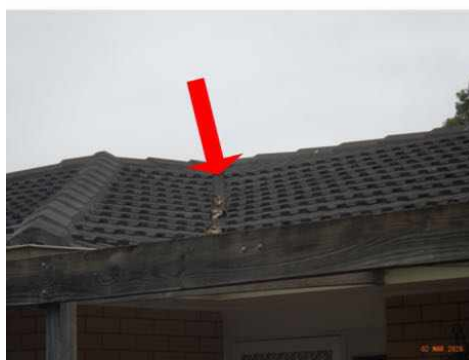
Building:	Building 1
Location:	Roof Void
Finding:	Sagging roof
Information:	The roofing structure was found to be sagging in several sections at the time of inspection.

Sagging roof structures are likely to create strain on associated building elements, creating potential for secondary damage including the deterioration of roof coverings. The roof is also unlikely to have sufficient support, which may lead to further sagging if left unmanaged.

It is advised that a licensed builder be appointed to reposition and fix the valley and install additional struts in accordance with advice from a structural engineer.

While it would appear that this defect has been present for a long period of time repair is recommended in the short term to ensure the longevity and structural integrity of the dwelling.

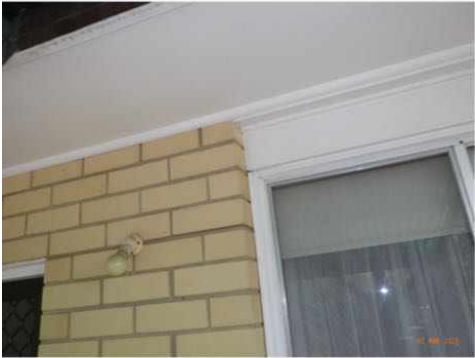
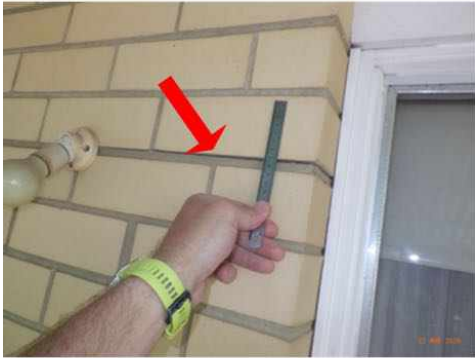
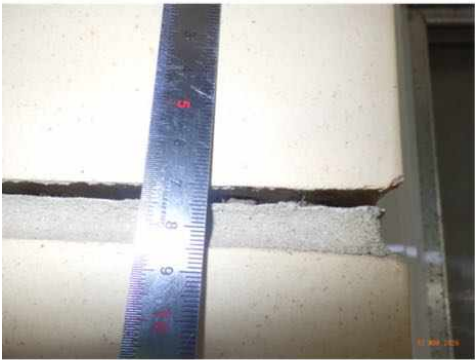
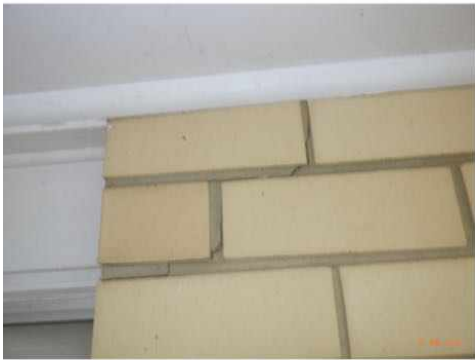
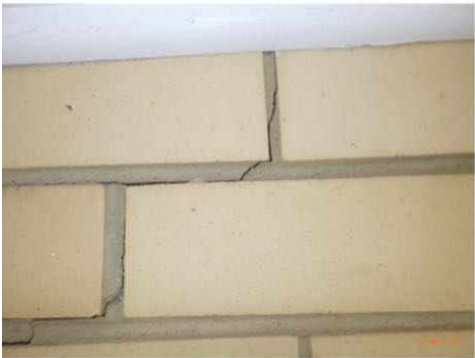
### Finding 3.01

Building: Building 1  
 Location: Exterior walls - right side  
 Finding: Brickwork - Cracking [Fine]  
 Information: There were fine cracks evident to the external brickwork at the time of inspection.

Although fine cracks are quite noticeable, they are often only considered to be an appearance defect and usually do not indicate any structural damage. Generally, the

cause of a fine crack is indicative of a separation between brickwork and mortar throughout the structure, but single bricks may also show cracks of this nature.

Cracking of this nature can generally be repaired with minor filling and should be conducted by a qualified bricklayer.

Always contact a building inspector should cracks widen lengthen or become more numerous.

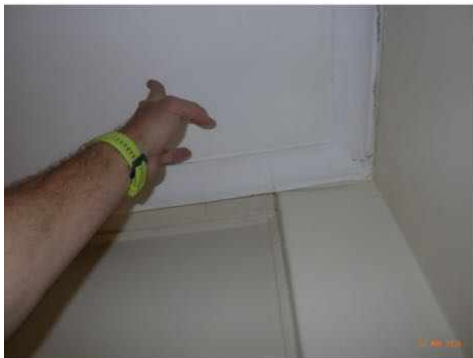
**Finding 3.02**

Building: Building 1  
Location: All Internal Areas

Information: Sections of the ceiling were found to be sagging at the time of inspection. Sagging to the fixed ceiling structure generally indicates that the building materials have swollen, due to contact with water, or that fixings (e.g. nails or glue) have become loose and require reattachment.

Where minor sagging is evident, comparatively minor works, such as re-gluing of ceiling sheets, may be required. Such works may be performed by relevant tradespeople, such as plasterers and painters. Where excessive moisture has caused the roofing structure to swell and sag, the source of the water leak should primarily be identified prior to any remedial works being performed.

In some cases, sagging ceiling linings may also indicate that there are structural issues, causing surfaces to warp, twist or sag. Where sagging appears to be major, appointment of a structural engineer is advised to further inspect the property and identify the source and rectification works required.

The appropriate action should be taken by the client as soon as possible to ensure that any potential further damage is limited.

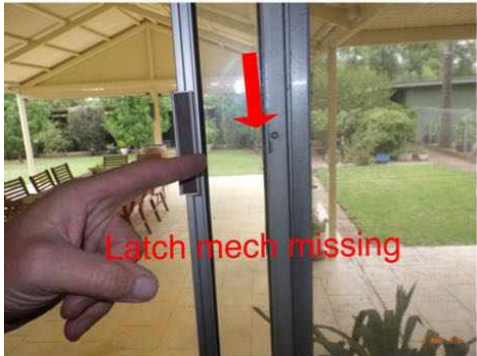
**Finding 3.03**

Building: Building 1  
 Location: Laundry  
 Finding: Window Lock - Not working  
 Information: The lock in this area was not operational at the time of inspection. Where locks have deteriorated to a point where they are no longer usable, the security of the property is immediately compromised.

Repair or replacement of the lock is highly recommended. Consultation with a locksmith or general handyman is required to gain further advice on any added security that may be available for the area.

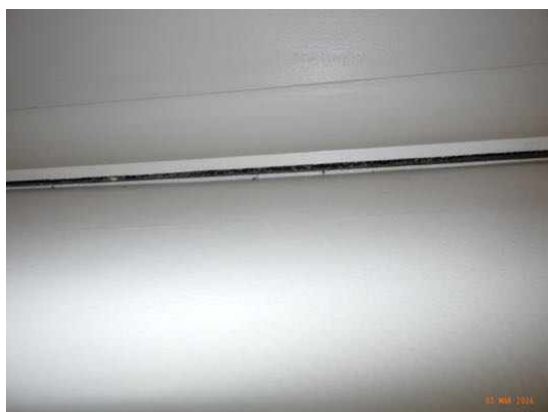
### Finding 3.04

Building:	Building 1
Location:	All Internal Areas
Finding:	Cracking - Damage Category 1 - Fine (up to 1mm)
Information:	There were fine cracks and or crack repairs evident to the walls and ceilings throughout the dwelling at the time of inspection.

Although fine cracks are quite noticeable, they are often only considered to be an appearance defect, and usually do not indicate any structural damage. Generally, the cause of a fine crack is indicative of a separation between building materials and finishes (e.g. paint, plaster, etc.) along joins.

Cracking of this nature can generally be repaired with minor sanding, filling and/or repainting. Such works should be performed by a qualified painter or a general handyman.

Monitoring of all cracking should be conducted frequently. Always contact a building inspector should cracks widen, lengthen, or become more numerous.

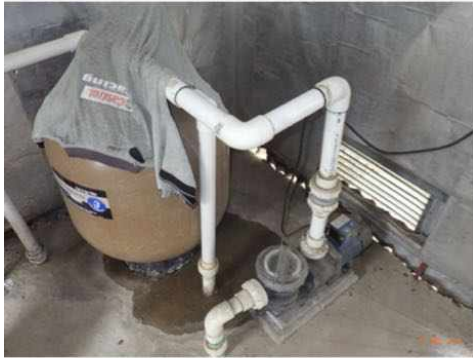
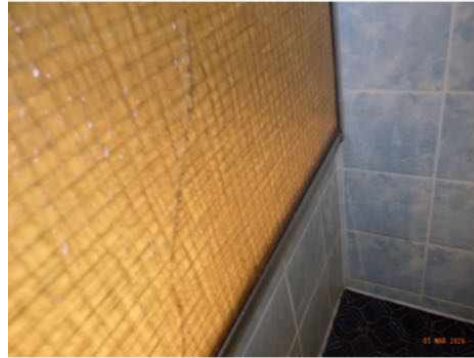
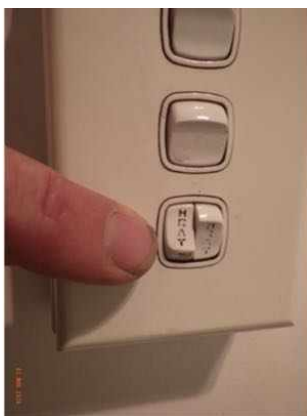
### Finding 3.05

Building:	Building 1
Location:	All Areas
Finding:	Minor defects present
Information:	<p>There were several age and maintenance related defects evident to the dwelling at the time of inspection. These defects include but are not limited to</p> <ul style="list-style-type: none"> <li>- small leak to pool equipment</li> <li>- Crack to shower screen</li> <li>- Heat lamp switch not staying on</li> </ul>

Appropriate licensed trades people could be appointed to make repairs at the discretion of the client.

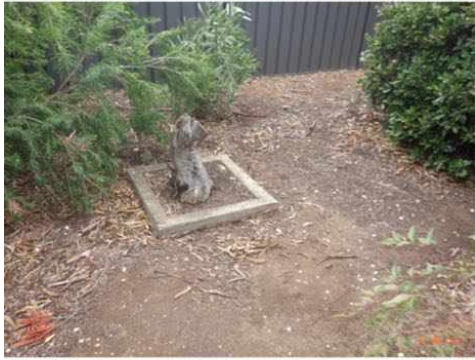
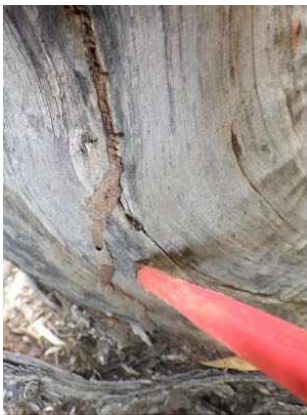
Building:	Building 1
Location:	All External Areas
Finding:	Evidence of termite damage - minor
Information:	Despite no live termite or timber pest activity being indicated, previous termite damage was found to have affected this area. This damage is considered to be inactive and is minor in nature.

It is advised that the area be visually inspected frequently to ensure that the condition of affected building materials does not worsen. At the time of inspection, damage is not structural and is only considered to be superficial.

A building contractor may be appointed to provide a further invasive inspection if further damage is evident.

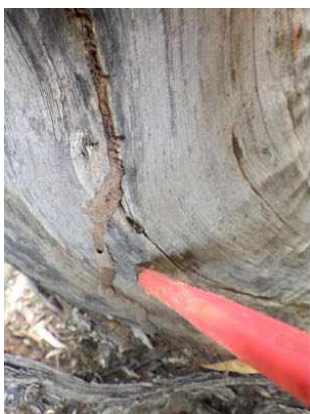
### Finding 6.01

Building:	Building 1
Location:	All External Areas
Finding:	Untreated or non-durable timbers in a hazardous environment
Information:	To reduce the risk of timber pest attack it is essential that timber used in a hazardous

environment (e.g. in direct contact with the ground or frequently exposed to damp conditions) is of sufficient durability and/or is adequately preservative treated. Additionally any timber lying around or timber stumps should be removed.

Untreated timbers in direct contact with the ground are likely to develop severe wood rot and/or fungal decay if left unattended creating attraction for subterranean termites to infest the timbers from surrounding areas.

If untreated or non-durable timbers are found to be in a hazardous environment it is highly advised that replacement of these building elements be performed as soon as possible to aid the protection of the property against termite / timber pest attack. Failing this close monitoring is recommended in an attempt to identify termite infestation at an early stage.

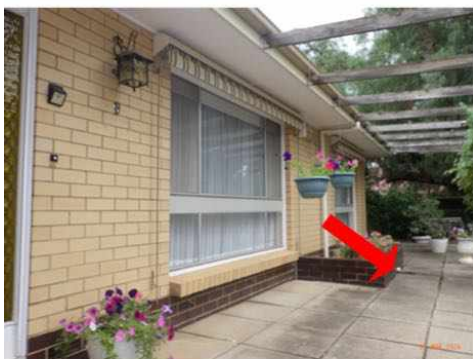
### Finding 6.04

Building:	Building 1
Location:	All External Areas
Finding:	Stormwater drain - Not connected
Information:	The roof plumbing is not adequately connected to stormwater drainage on the site. This disconnection negatively impacts the functional capacity of the roof plumbing.

Where roof plumbing doesn't drain adequately, the area at the base perimeter can become excessively damp, potentially creating an environment that is susceptible to rust and corrosion of surrounding building elements, as well as attracting termites and other pests.

It is highly recommended that a plumber be appointed to further inspect the area and to install adequate drainage equipment where necessary.

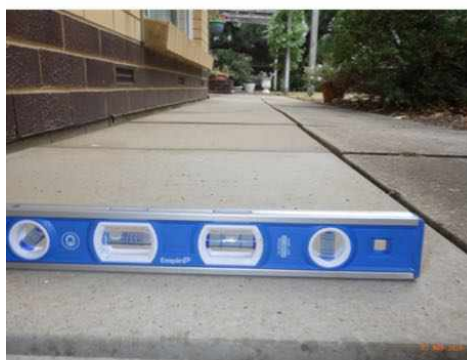
### Finding 6.05

This standard ensures that excessive moisture does not pool around the base of building structures, which creates potential for water and structural damage, as well as making the area susceptible to termite and timber pest activity.

Where paving or ground levels do not have adequate fall, a licensed paving contractor should be appointed to install or remove and re-level pavement.

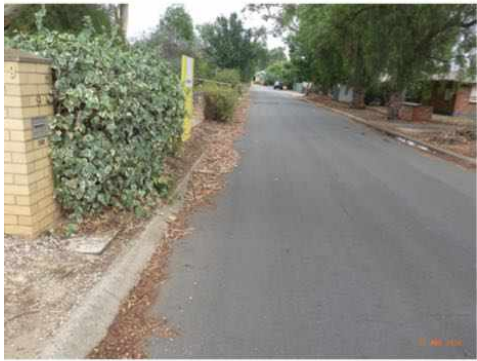
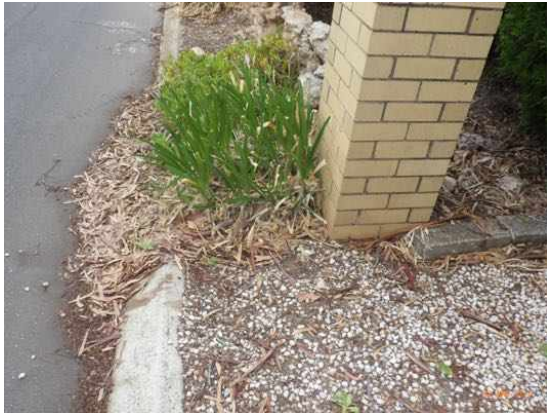
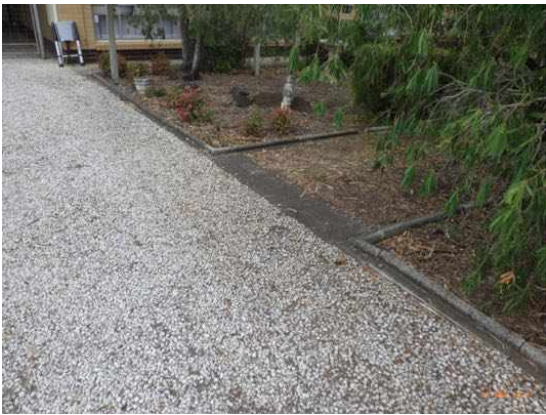
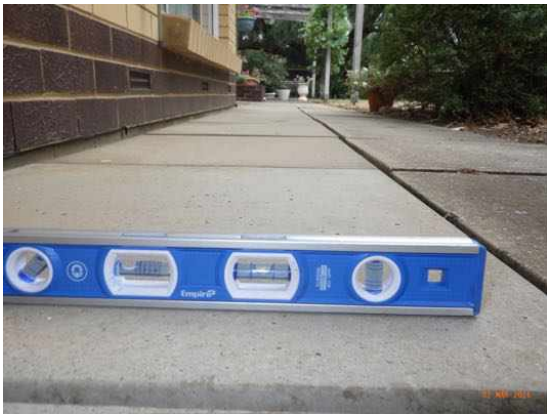
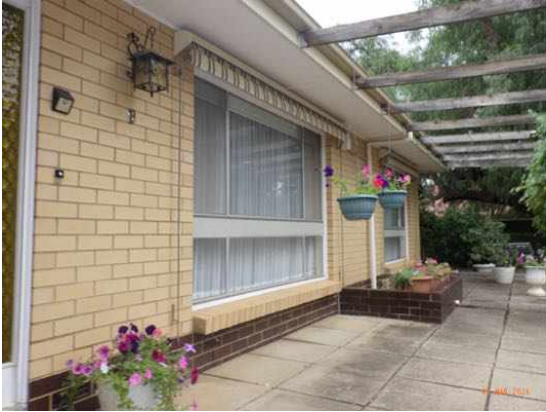
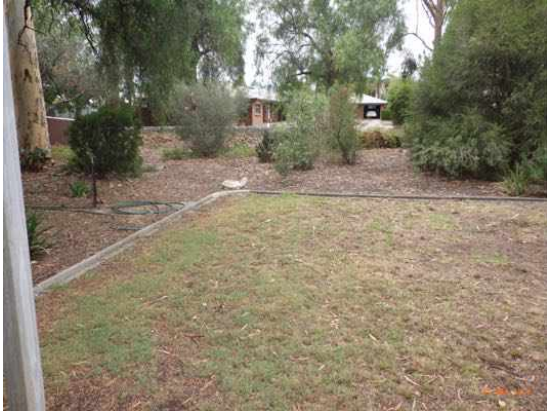
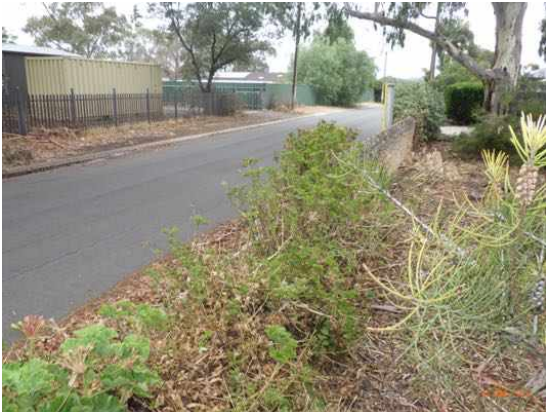
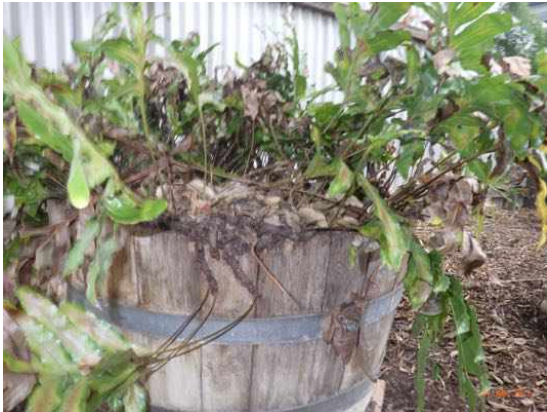
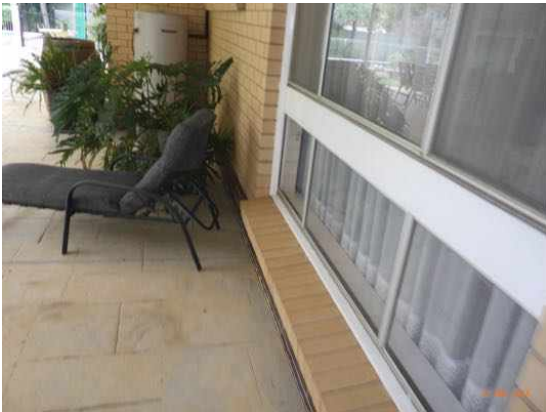
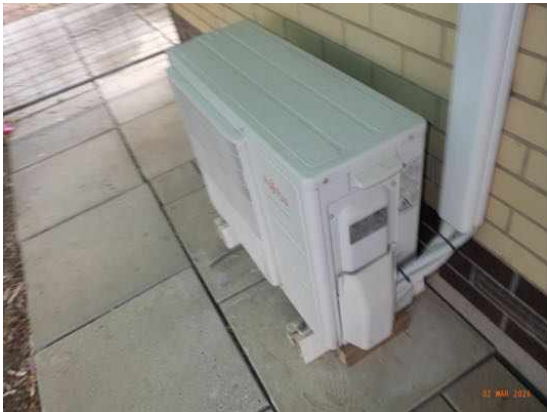
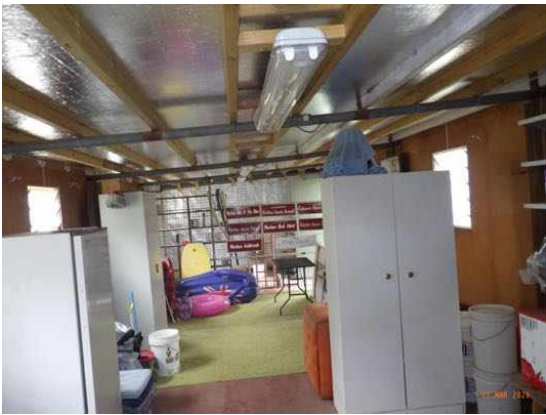
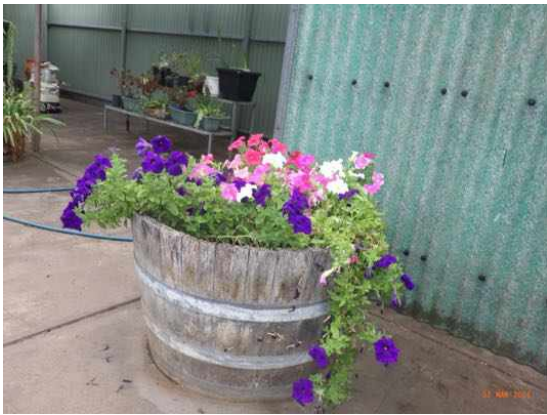
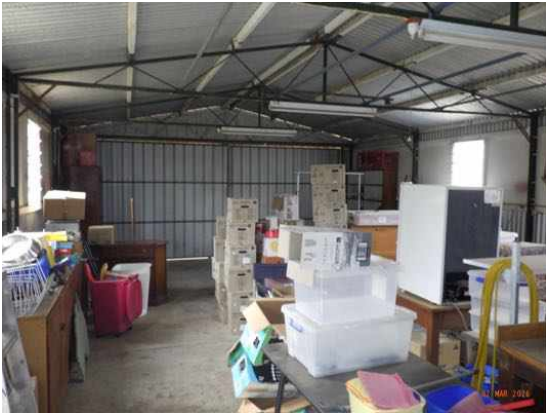
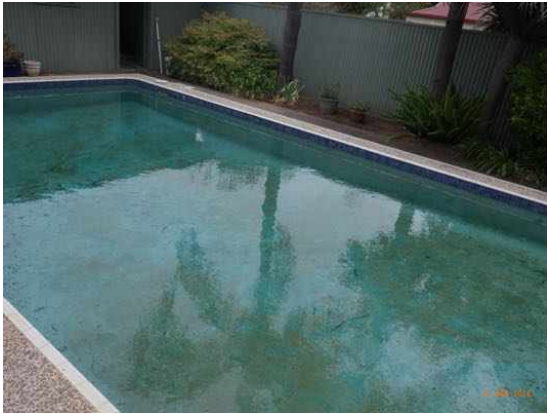
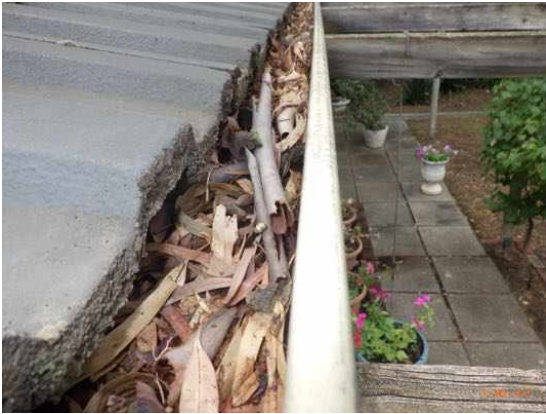
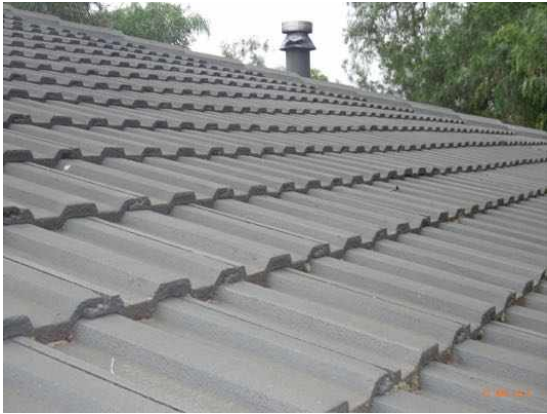
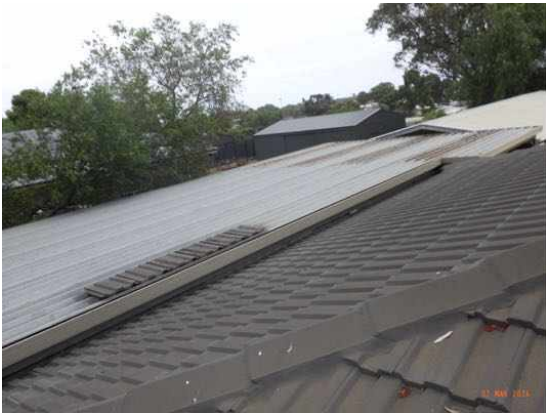
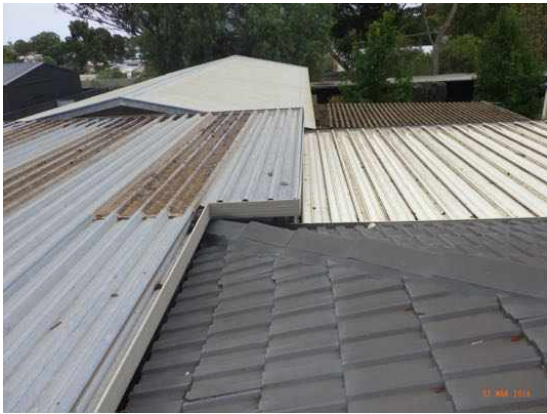
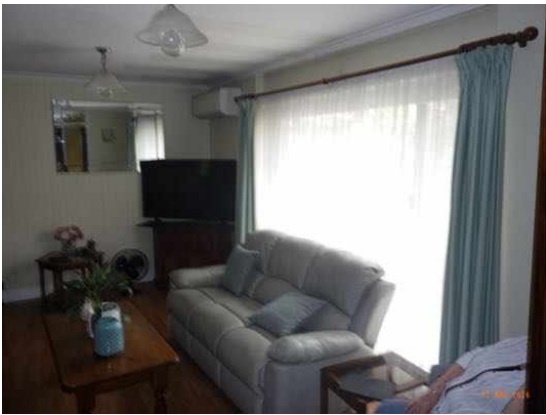
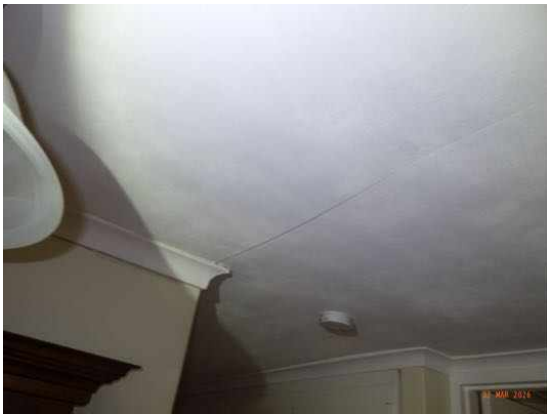
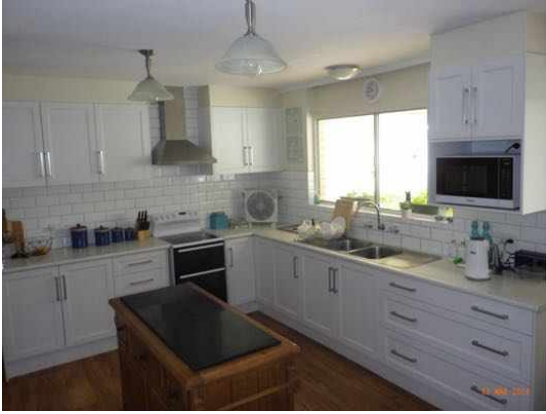
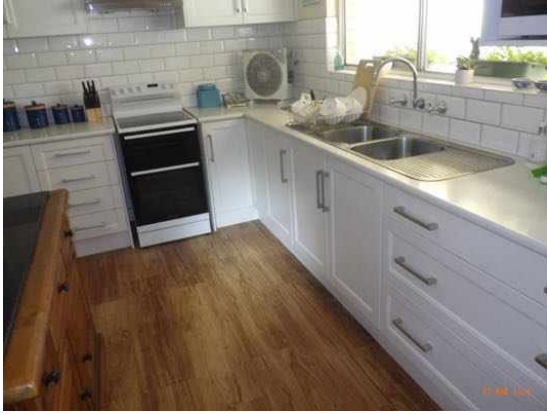
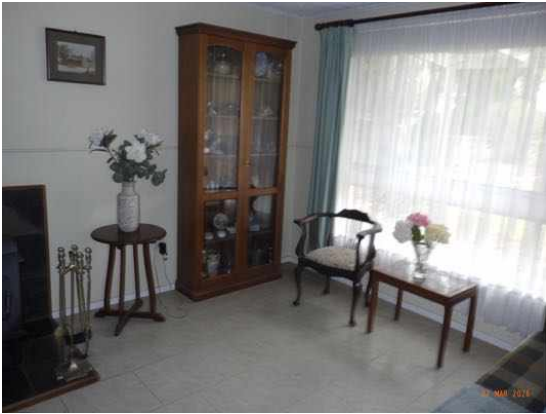
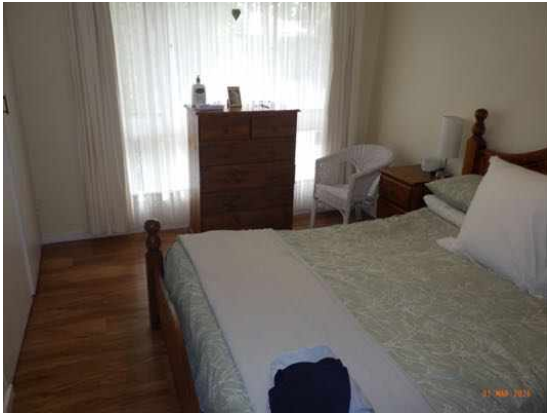
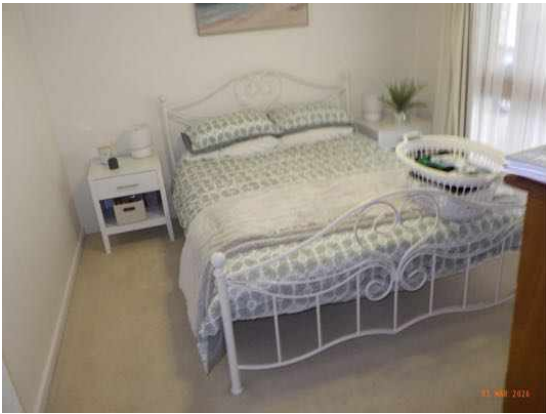
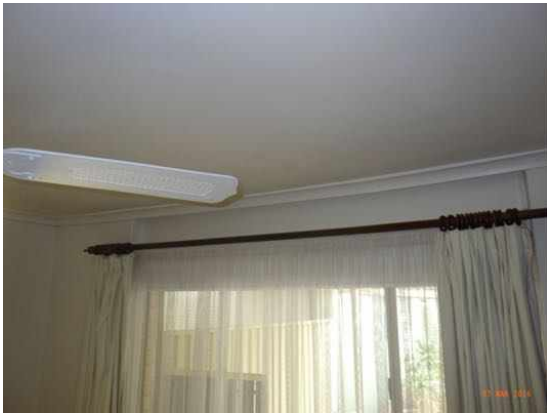
Building: Building 1  
Location: All Areas  
Finding: Additional Photos - Obstructions and Limitations  
Information:

These photographs are an indication of the obstructions and limitations which impeded full inspection of the property at the time of inspection. These obstructions can hide an array of defects and should be removed to allow full inspection to be carried out.
