# Building and Timber Pest Inspection Report

Inspection Date: Tue, 17 Mar 2026

Property Address: 8 Trixia Place, Leopold, Vic

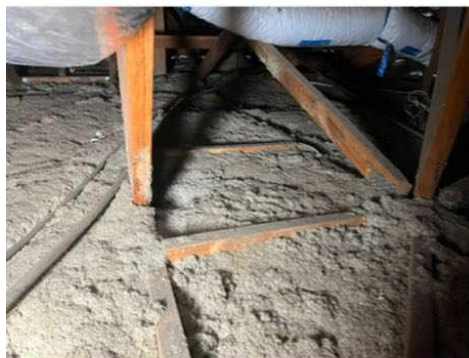
### Finding 3.02

Building:	Main Building
Location:	Roof Void
Finding:	Insulation - Reduced in volume
Information:	Insul-fluff is common in many older homes and is a loose form of insulation that is 'blown' into roof voids. While this type of insulation was considered effective at the time of installation, modern materials have surpassed it as the preferred insulator.

Note: insulation in the roof void also obstructs areas limiting the possibility of identifying termite activity or other timber pest damage.

It is highly advised that this insulation be removed and replaced with a more appropriate material.

This will ensure that the property is adequately insulated and will promote an increase in energy efficiency within the property. An insulation contractor should be appointed to provide further advice on replacement options and to perform works as necessary.

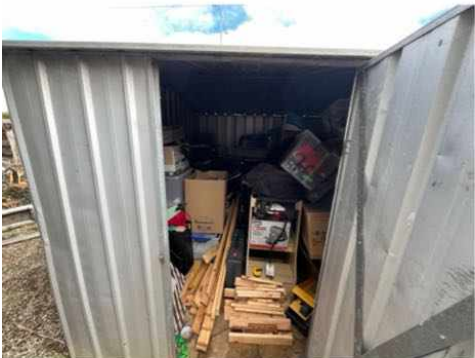
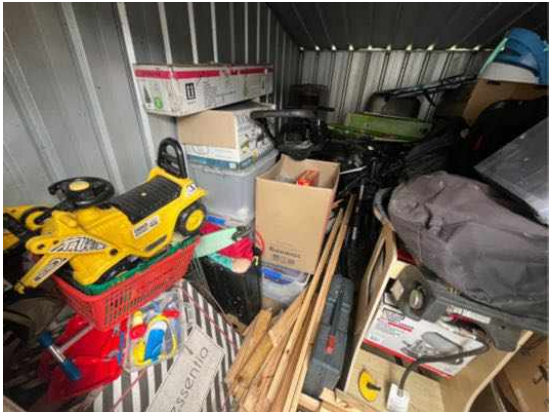
**Finding 6.06**

Building: Yard  
 Location: Shed  
 Finding: Additional Photos  
 Information: Additional photos are provided for your general reference

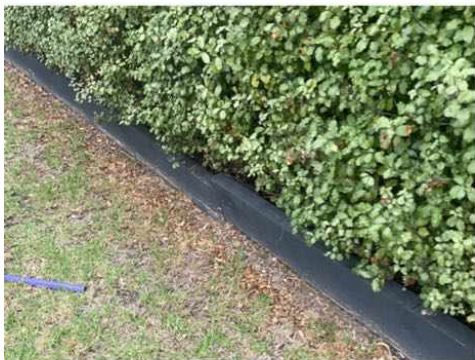
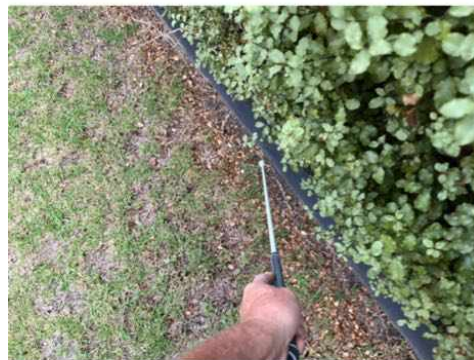
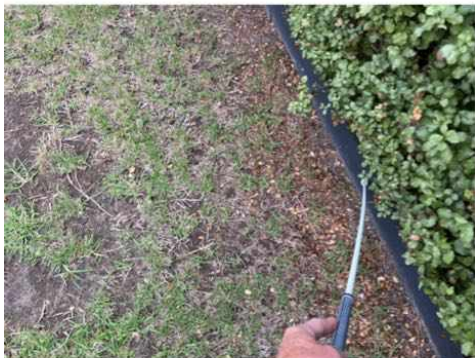
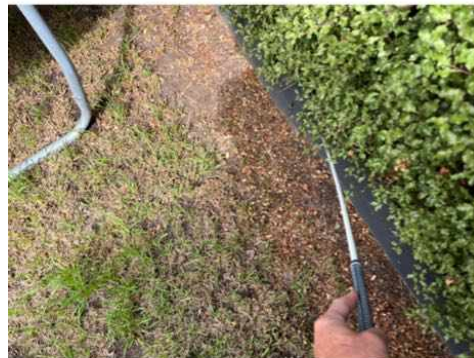
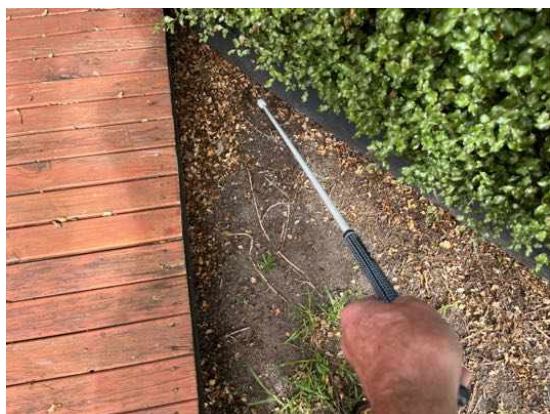
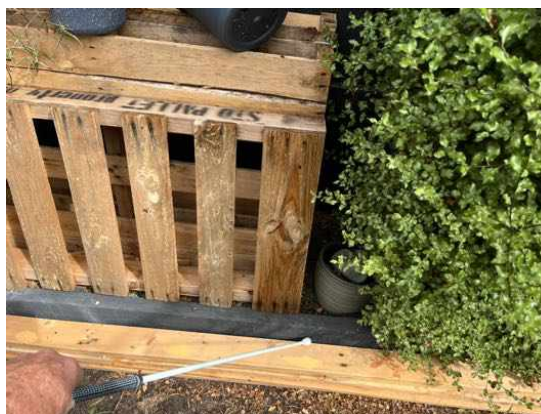
**Finding 6.07**

Building: Yard  
 Location: Garden  
 Finding: External - Termite Techniques

No termite or timber pest activity was dented at the time of the inspection.

Limitations do exist where access is blocked or restricted, therefore we strongly recommend a termite treatment.

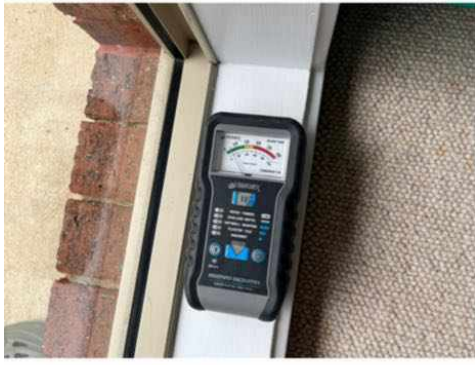
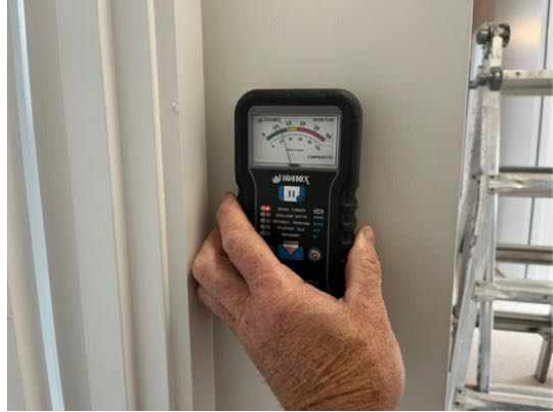
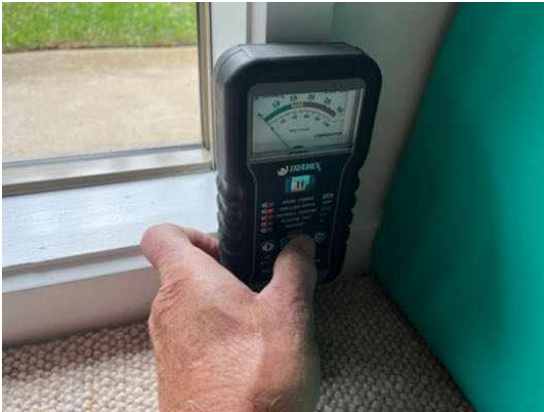
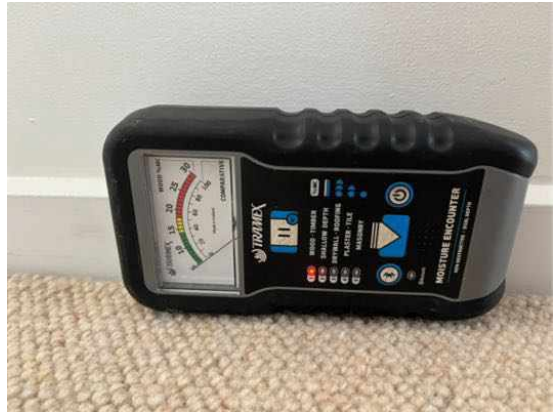
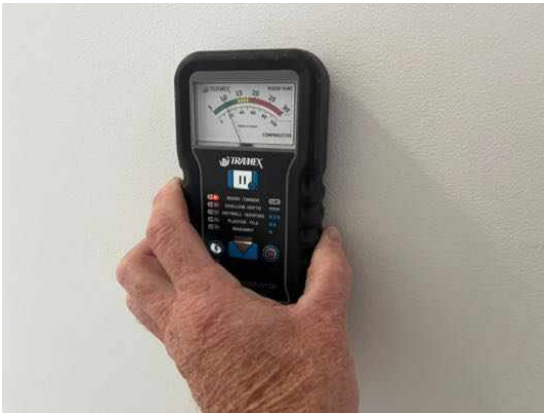
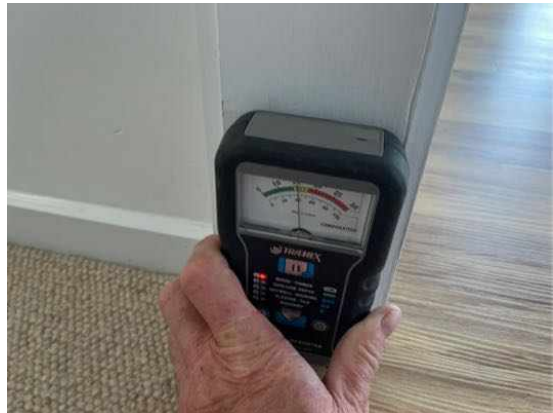
### Finding 6.08

Building:	Main Building
Location:	All Areas
Finding:	Termite Techniques
Information:	All areas of the dwelling are checked with particular attention paid to wet areas which were closely assessed to check for excessive levels of moisture and temperature anomalies.

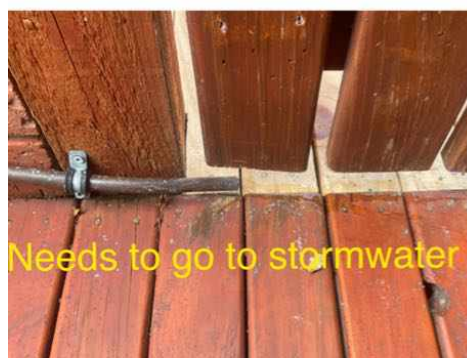
These damp conditions can lead to secondary defects such as rot, rust or corrosion of associated building elements, the formation of fungal decay, or even the creation of potential slip hazards. When coupled with poor site drainage, pooling of water may also attract termite activity to this area.

It is highly recommended that a licensed plumber be appointed to connect the HWS overflow in order to prevent such an environment from being created. These minor works should be carried out as soon as possible.

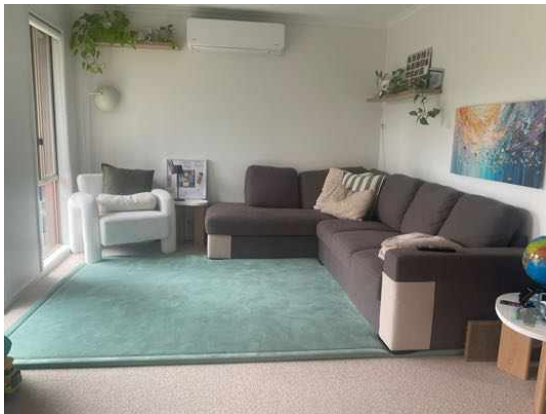
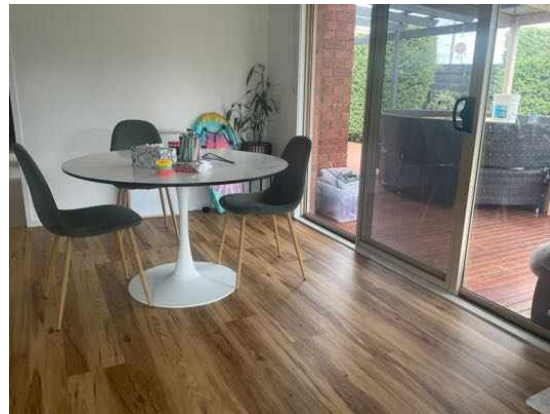
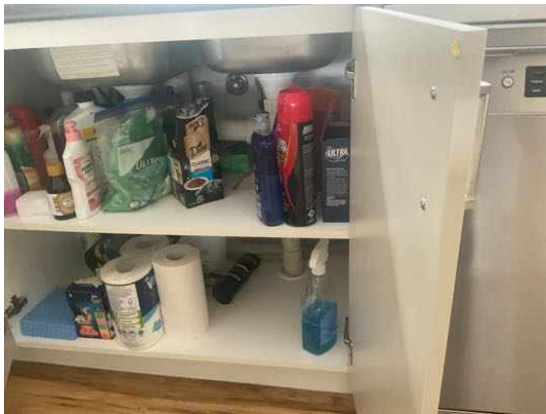
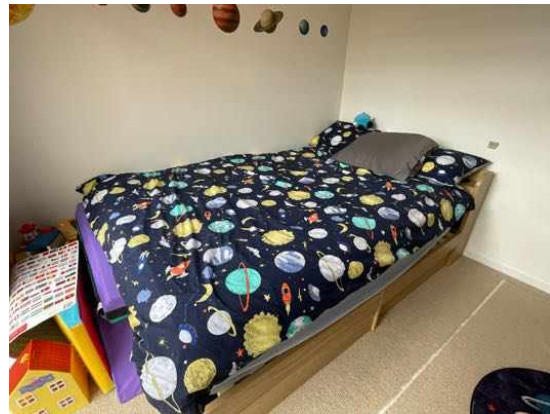
#### Noted Item

Building: Yard  
Location: All Areas  
Finding: Additional Photos - Obstructions and Limitations  
Information: These photographs are an indication of the obstructions and limitations which impeded full inspection of the property at the time of inspection. These obstructions can hide an array of defects and should be removed to allow full inspection to be carried out. A re-inspection is recommended once the areas are made accessible.
