# Building and Timber Pest Inspection Report

Inspection Date: Thu, 12 Feb 2026

Property Address: 13 Roebuck Cres, Willmot NSW 2770,  
Australia

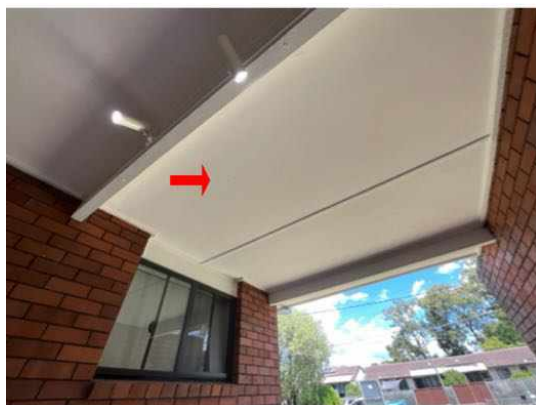
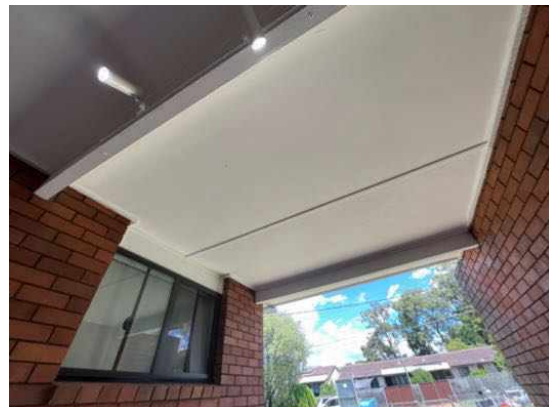
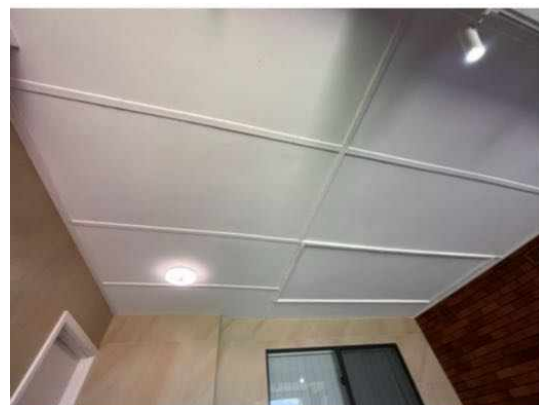
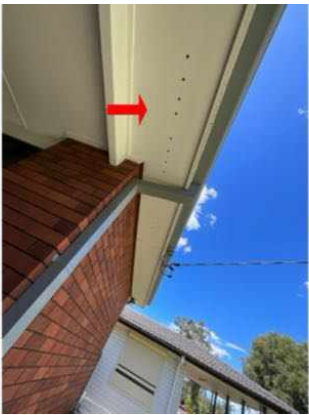
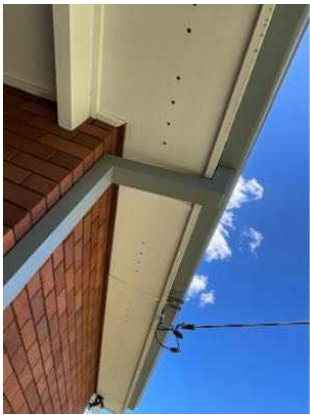
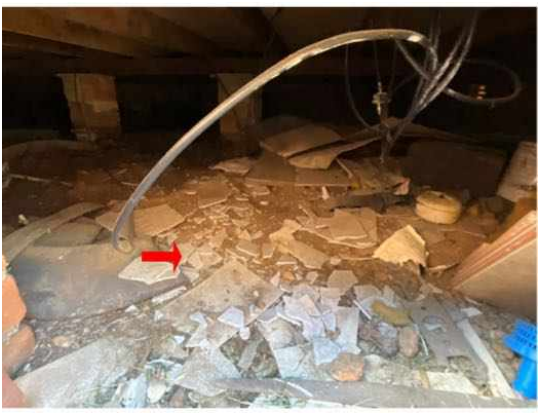
Building:	Main Building
Location:	All Areas
Finding:	Asbestos - Suspected ACM Identified on Site
Information:	Reporting on Asbestos is outside the Scope of this Report. This suspected defect is highlighted as a caution only. We suspect, based on our experience in the building industry, that there is a higher risk of the identified building element containing asbestos.

As Asbestos Reporting is outside the scope of this report, we advise that you consider a separate Asbestos Inspection and Condition Audit, which can include the taking of samples for definitive confirmation of the presence of Asbestos.

In the interim, the client is advised to act with caution, especially when considering any damage to building materials general wear and tear renovations extensions demolition and general maintenance activities due to the suspected presence of Asbestos.

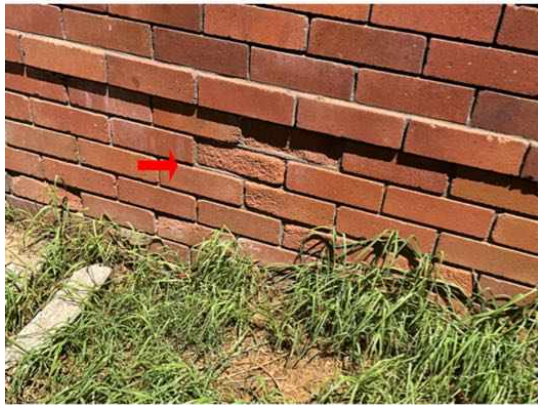
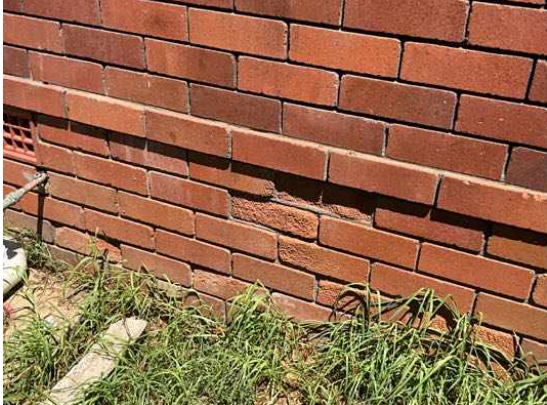
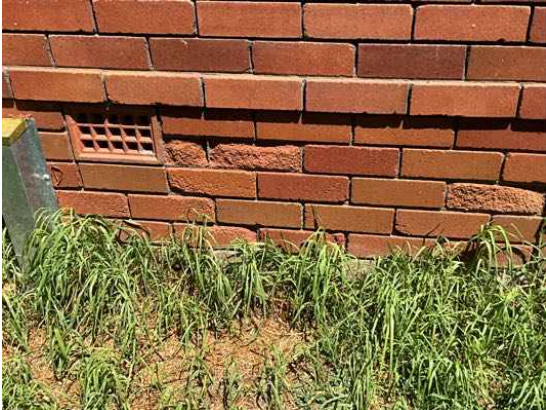
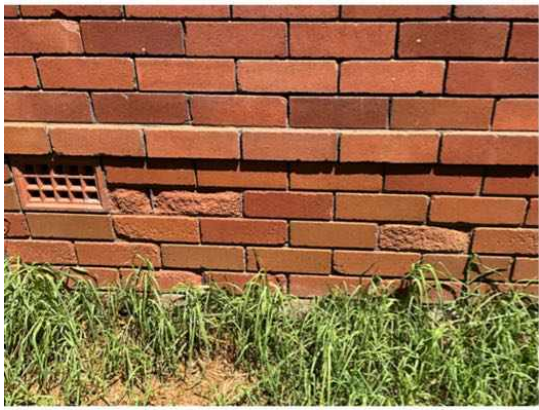
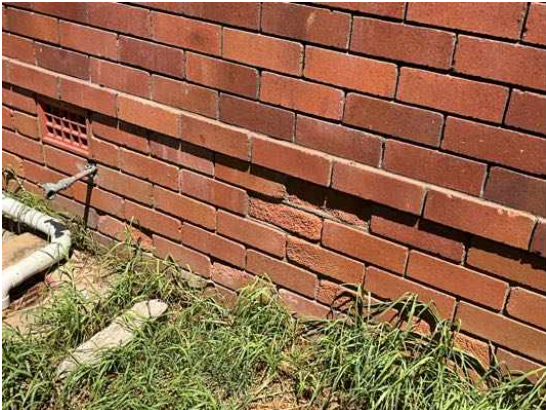
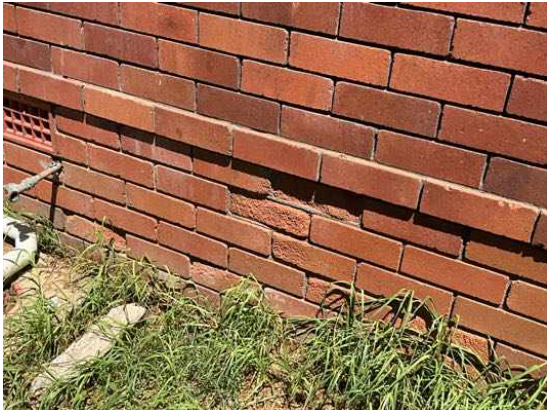
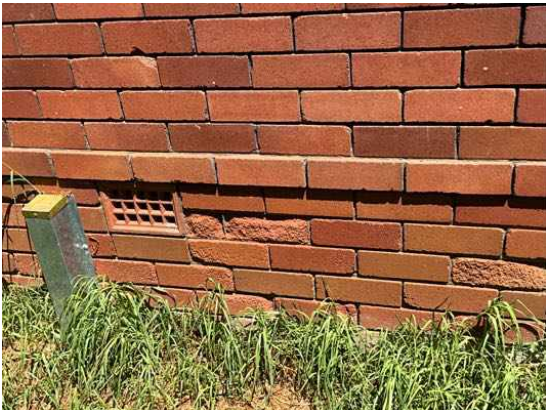
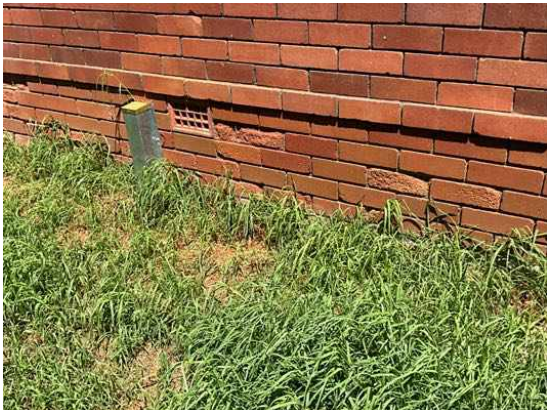
### Finding 3.02

Building: Main Building  
Location: All Areas  
Finding: Brickwork - suspected impact damage  
Information: The brickwork on the property shows signs of suspected impact damage.

**\*\*Risk:\*\*** Impact damage can weaken the structural integrity of the wall, leading to potential collapse, water infiltration, and increased vulnerability to further damage.

**\*\*Recommended Action:\*\*** A qualified mason or bricklayer should carry out the necessary repairs to ensure the structural safety of the property.

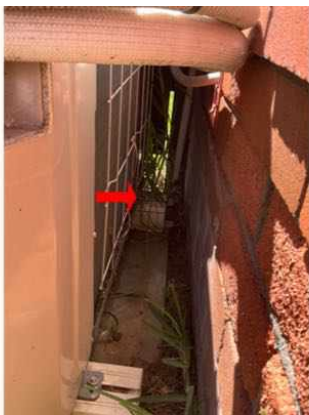
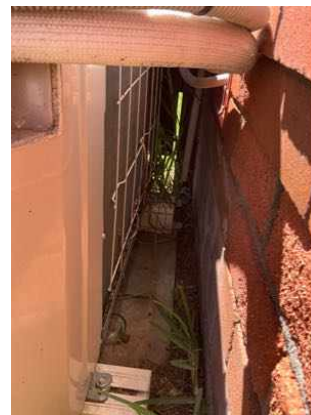
Finding 3.03

Building: Main Building  
 Location: Exterior walls - left side  
 Finding: Air conditioner - Disconnected overflow  
 Information: The Air Conditioner (A/C) overflow was found to be disconnected from storm water drainage and is creating excessive moisture in the surrounding area.

Such leaking creates an environment which is conducive to an array of defects, including water damage to associated building elements and the attraction of termite or timber pest infestation.

It is highly recommended that a licensed plumber be appointed to connect the A/C overflow in order to prevent such an environment from being created. These minor works should be carried out as soon as possible.

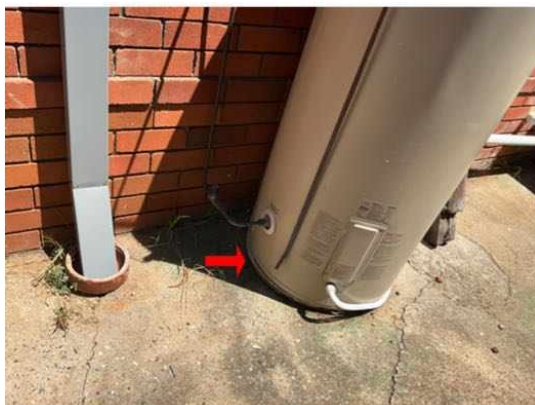
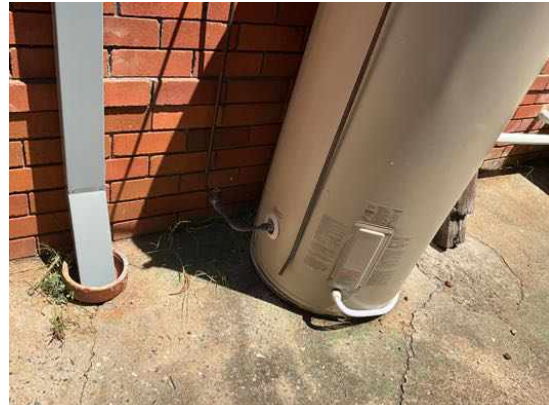
### Finding 3.04

Building: Main Building  
 Location: Exterior walls - rear  
 Finding: Hot Water System (HWS)  
 Information: The hot water system is connected in accordance with relevant plumbing standards, as confirmed by the plumber's email (screenshot attached).

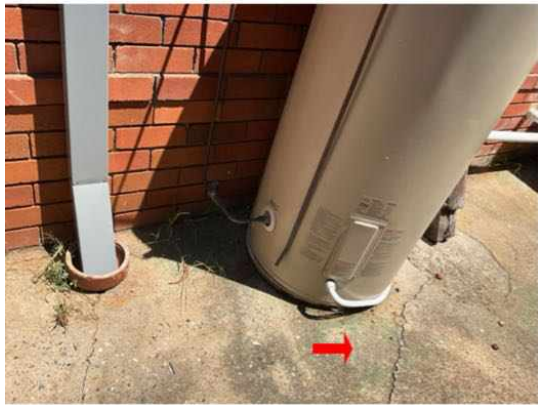
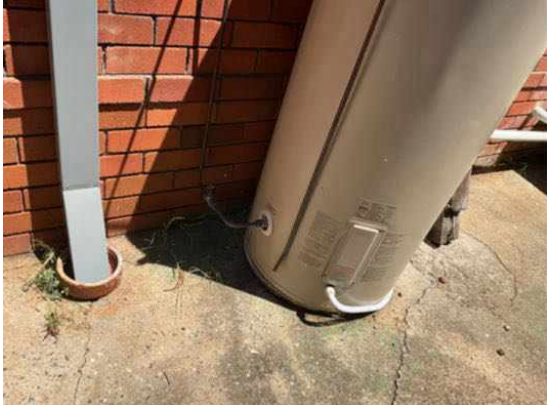
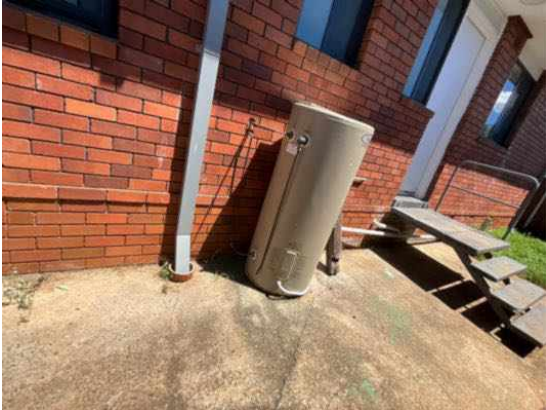
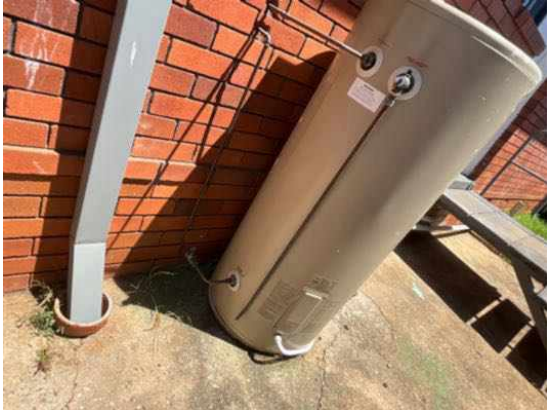
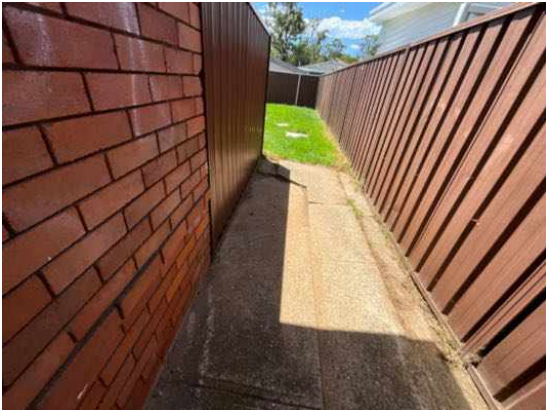
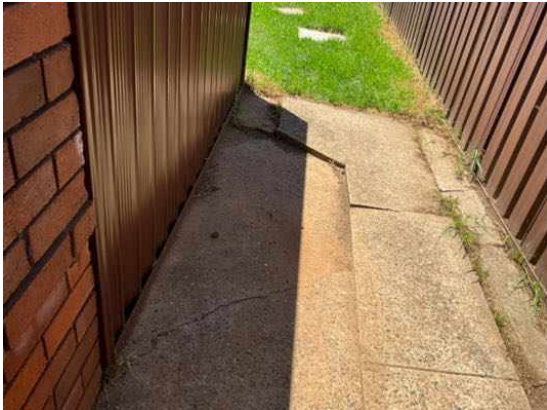
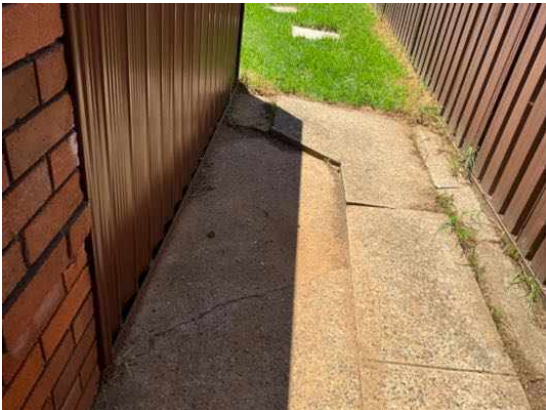
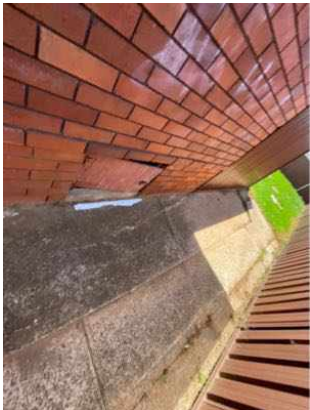
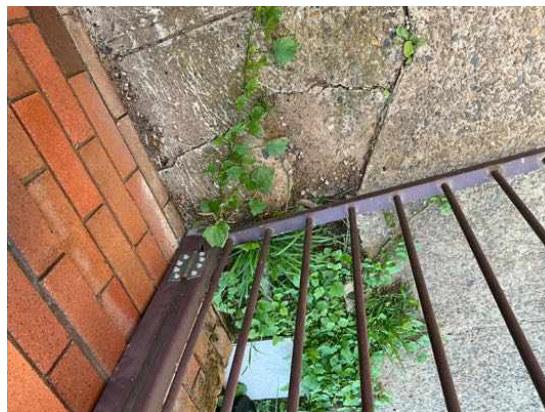
### Finding 3.05

Building: Main Building  
Location: All Areas  
Finding: Noticeable Cracking in Concrete Slab  
Information: Noticeable cracking has been observed in the concrete slab, failing to meet the required construction and quality standards.

- Cracks are visible on the surface and may extend through the depth of the slab.
- Evidence of improper curing or inadequate reinforcement leading to cracking.

- Compromised structural integrity of the slab, potentially leading to failure under load.
- Water ingress through cracks, causing corrosion of reinforcement and further weakening the structure.
- Potential trip hazards and aesthetic issues, reducing the overall value and safety of the property.
- Increased maintenance and repair costs due to ongoing deterioration.

- A structural engineer should be engaged to assess the extent of the cracking and recommend appropriate repair methods.
- A licensed contractor or concrete repair specialist should carry out the recommended repairs under the guidance of the structural engineer.

A detailed inspection should be conducted post-repair to confirm compliance with the required standards and to ensure that the structural integrity of the concrete slab has been restored.

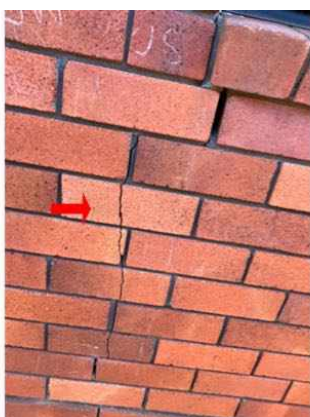
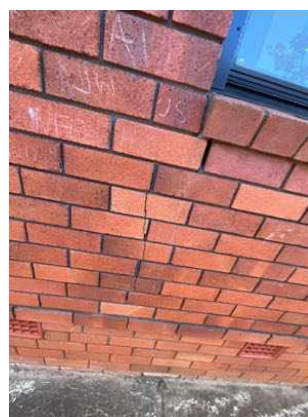
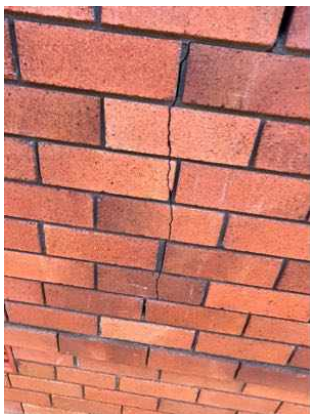
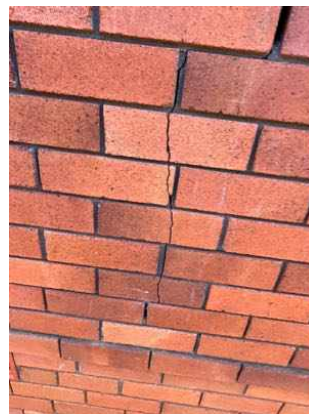
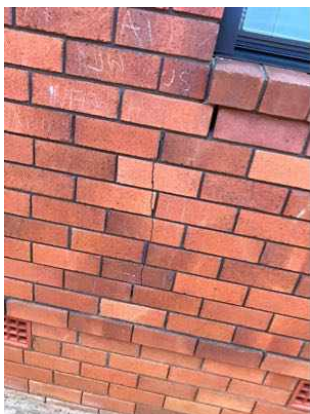
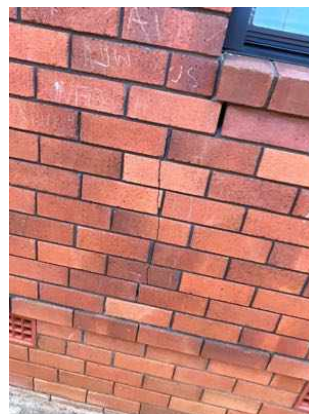
### Finding 3.06

Building:	Main Building
Location:	Exterior walls - right side
Finding:	Brickwork - Cracking noticeable
Information:	There were several cracks and or crack repairs evident to external brickwork.

Noticeable cracks are a common occurrence in external brickwork and are a likely result of age expected building movement, general expansion, and/or contraction of building materials in different weather conditions. Noticeable cracks in brickwork may develop if left unattended, with potential for necessitating major remedial works or replacement of the brickwork.

It is highly advised that a qualified bricklayer be appointed to provide necessary works to cracked brickwork to prevent any further damage. Such works should be conducted as soon as possible.

Always monitor these cracks and contact a building inspector should cracks widen, lengthen, or become more numerous.

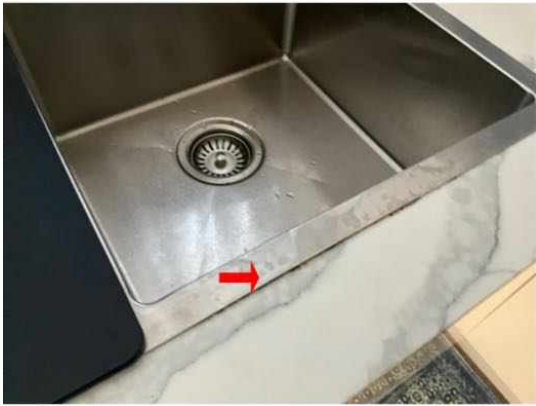
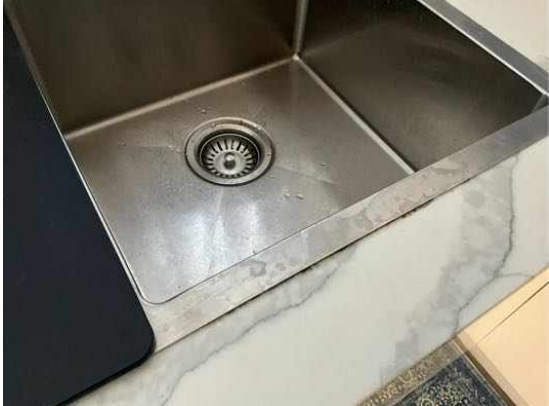
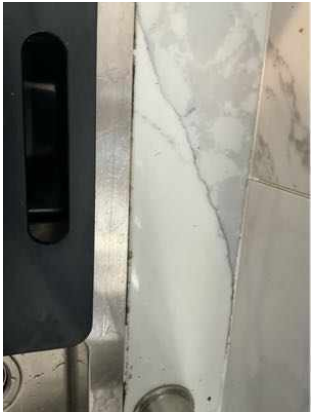
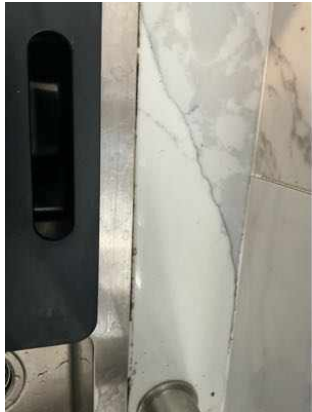
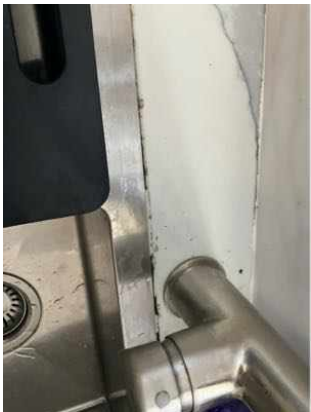
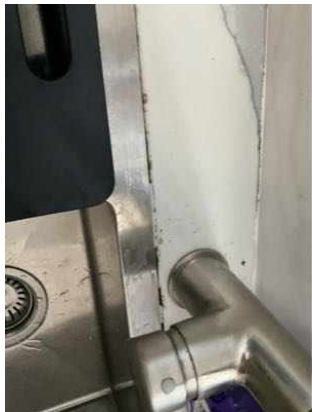
Building: Main Building  
Location: Kitchen  
Finding: Silicone Sealant - Detoriated Around Basin  
Information: The silicone seal around the basin has deteriorated, with visible gaps and discolouration noted along the edges.

Water penetration through the deteriorated seal may cause damage to surrounding surfaces, promote mould growth, and lead to deterioration of adjacent materials.

A licensed plumber or qualified handyman should remove the old sealant and reapply a sanitary-grade silicone to ensure watertight protection.

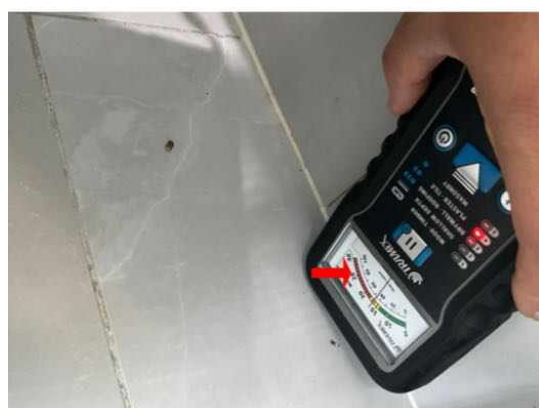
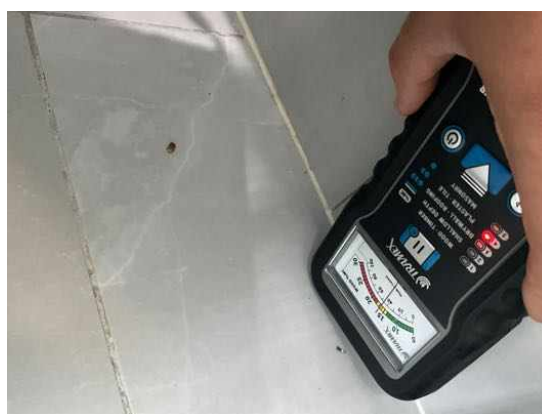
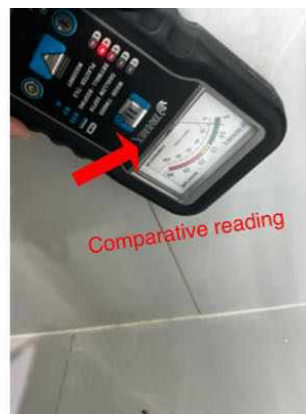
**Finding 3.09**

Building: Main Building  
Location: Bathroom

Finding: Shower - Damp  
Information: Damp is evident to the lower 300mm of wall to the shower alcove. This defect is quite common, and is suspected to have been caused by moisture permeating through the grouting in this area, which shows evidence of deterioration. Leaking pipes within the adjoining wall is also a possible cause.

Damp (or structural damp) refers to the presence of unwanted moisture in the structure of a building, either as the result of intrusion from outside, or condensation from within the structure. In the shower area, internal water leaks or other sources of excessive moisture are generally the cause of damp.

Unmanaged damp in the shower recess is likely to facilitate the formation and development of mould and fungi growth, decaying associated building materials and compromising their structural integrity. It is important to address damp conditions, as the World Health Organisation notes that excess moisture leads - on almost all indoor materials - to growth of microbes such as moulds, fungi and bacteria, which subsequently emit spores and other matter into the indoor air. Exposure to these contaminants is associated with a wide range of respiratory and other health-related problems.

Consultation with a qualified plumber or bathroom specialist is advised immediately to identify the cause of damp and to perform remedial works as required. Where excessive mould growth is present, further inspection by a specialist environmental health inspector should also be considered.

Always ensure that sealant and grout is in good condition to prevent any moisture issues occurring in the future.

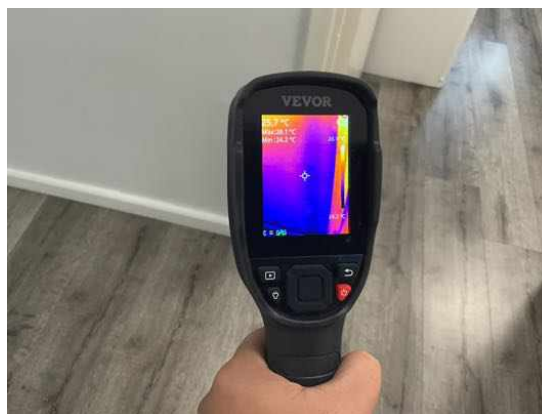
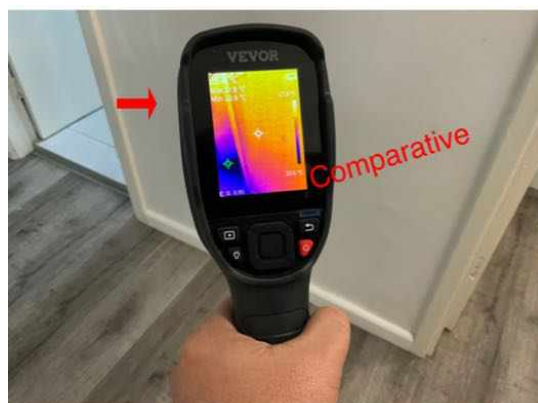
Building:	Main Building
Location:	Bedroom
Finding:	Evidence of excessive moisture - Drywall
Information:	Excessive moisture is present at the time of , indicating a potential water leakage issue within the wall.

The prolonged presence of moisture can lead to mold growth, deteriorate the structure, and create an environment conducive to health hazards. Additionally, it may compromise the adhesive holding the tiles, leading to their detachment.

A licensed plumber or a qualified contractor specializing in water damage remediation should investigate the source of the moisture, fix any leaks, and address the damage. Additionally, replacing affected tiles and ensuring proper waterproofing are crucial to preventing future issues.

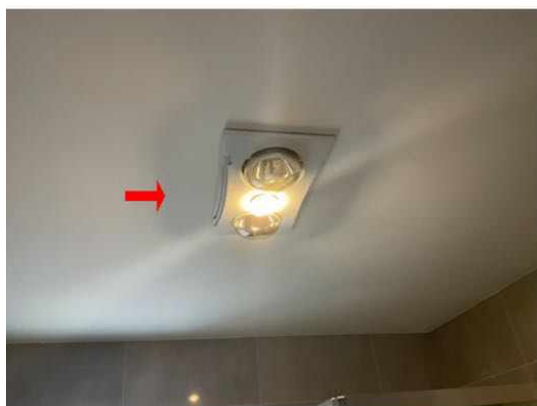
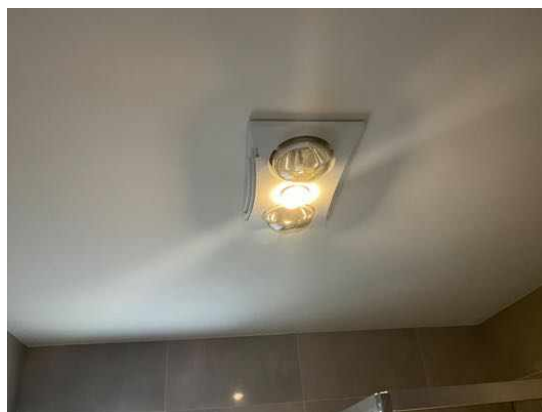
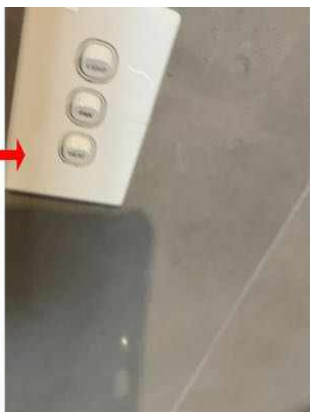
Building:	Main Building
Location:	Bathroom - Granny
Finding:	Heating light in exhaust fan not working / operating
Information:	"The heating light in the exhaust fan is not operating, failing to provide the intended heating function."

A qualified electrician or HVAC technician can fix the issue by inspecting the heating element, wiring, and controls to identify and repair any faults or damages.

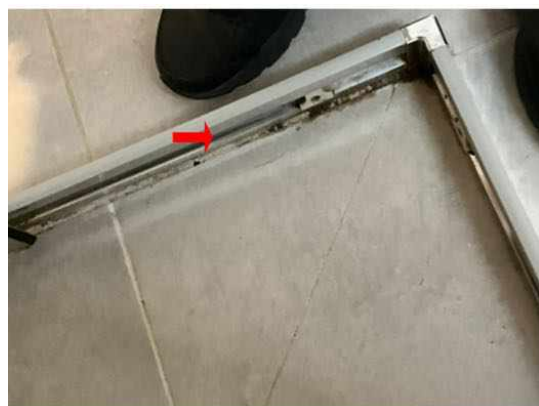
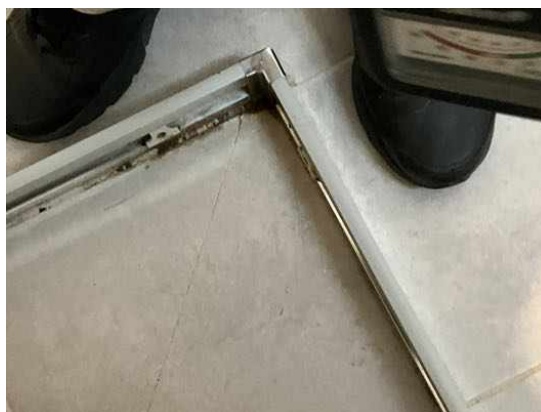
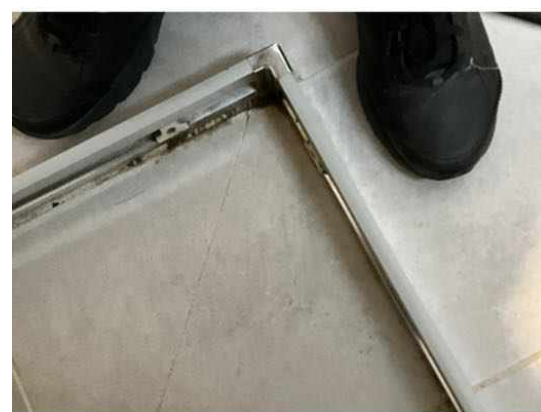
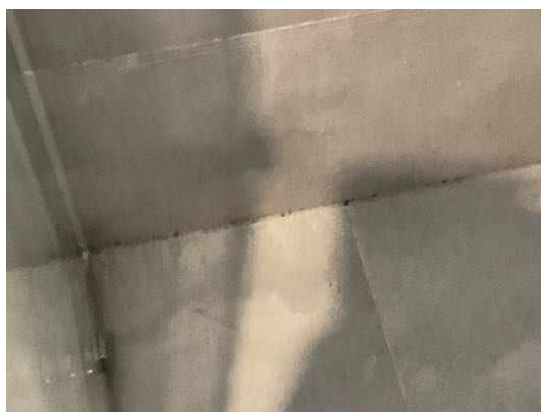
### Finding 3.15

Building:	Main Building
Location:	Bathroom - Granny
Finding:	Sealant and grouting - Missing or damaged
Information:	It was noted on inspection that sealant or grout is degraded to the tiled shower alcove and or other areas of the bathroom.

Different materials and floor areas move at different rates, generally causing cracking to grout or sealant at this point. A flexible sealant is required to allow for expected expansion and contraction, while keeping the joint water tight and protective of all associated building materials.

There appears to be excessive mould to the sealant and grout which will likely require scraping out and replacement.

Flexible and mould resistant materials should be applied to affected areas to prevent any subsequent water damage that is likely to occur. Regular maintenance and replacement of damage or missing or damaged sealant and grout is highly recommended to the wet areas, as this is a regular wear and tear defect. Sealant and grouting in areas that come into regular contact with water should be maintained for the long term care of your property.

A sealant specialist or tiling contractor should be appointed to complete these works as soon as possible

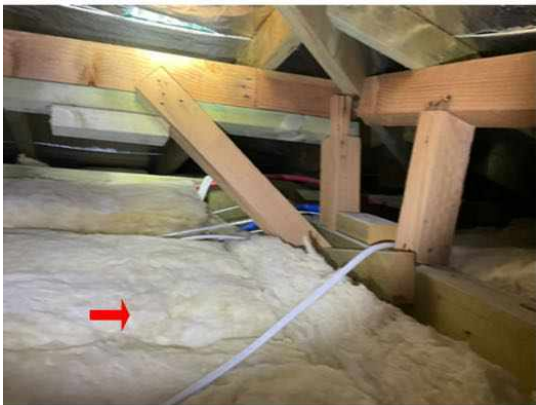
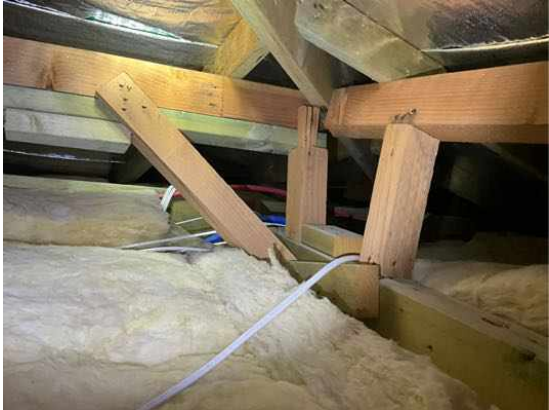
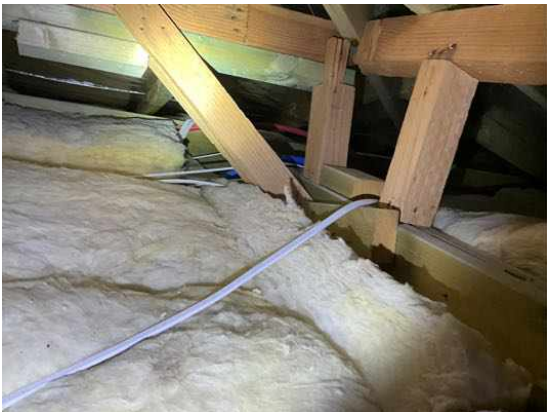
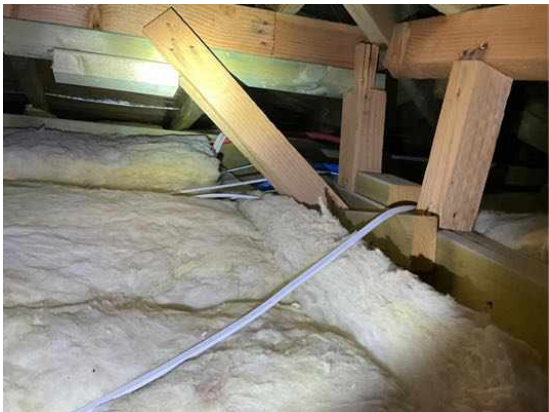
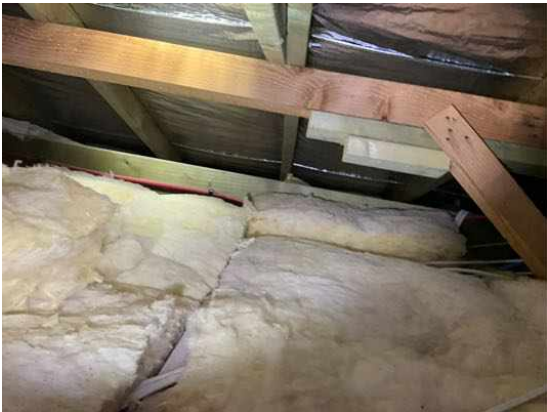
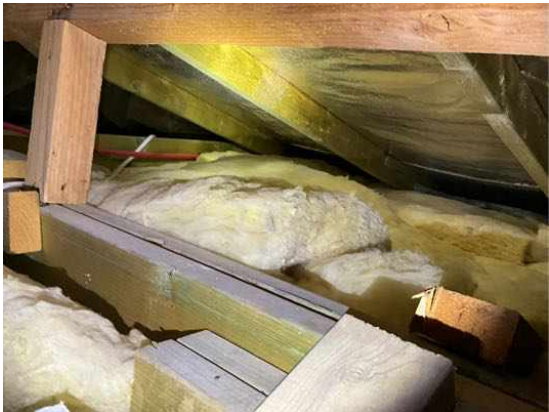
### Finding 3.16

Building:	Main Building
Location:	Roof Void - granny
Finding:	Insulation - Covering downlights
Information:	Sections of insulation in the roof void have been poorly installed or moved from their original position and are covering down light fittings. While the down lights have been fitted with appropriate protective covers, the presence of this insulation creates a potential fire hazard.

Any insulation within the vicinity of down light fixtures should be moved and re-applied to more appropriate sections of the roof void, thus ensuring the area is fire-safe. An insulation contractor should be appointed as soon as possible to perform any

necessary works as required.

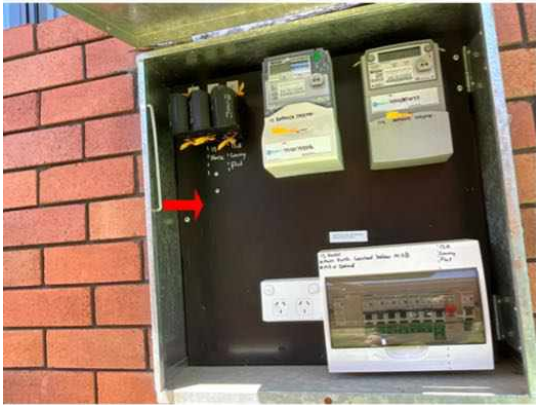
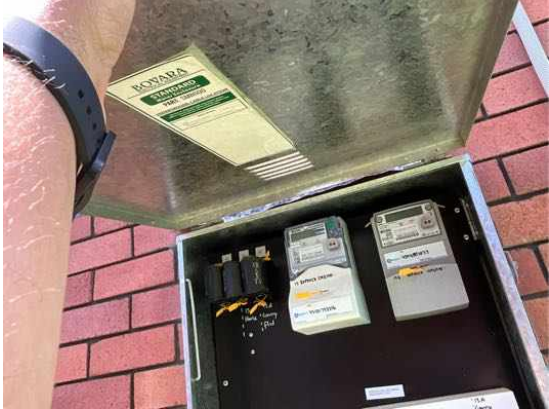
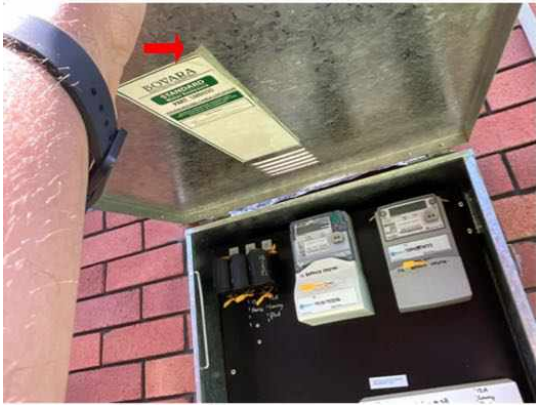
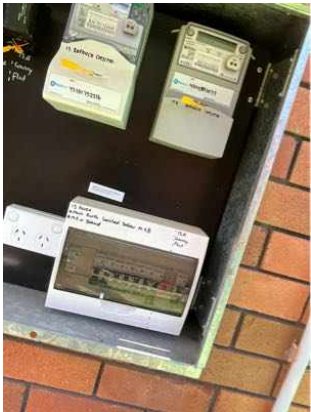
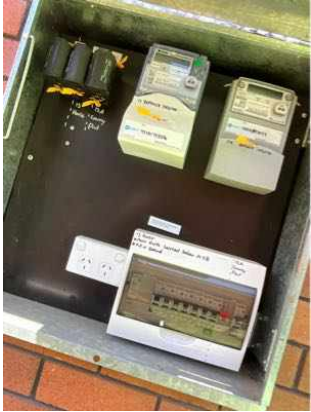
Building: Main Building  
 Location: Exterior walls - left side  
 Finding: No Evidence of Termite Management System - Durable notice / Legible Sticker  
 Information: The application of a pre & post-construction chemical termite barrier is highly recommended for all properties. Such barriers are highly effective in preventing termite attack on any timber building elements throughout the property.

Client must seek further information from the vendor or real estate agent if the

conditions of termite management systems were maintained.

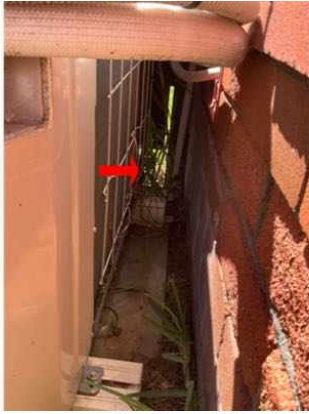
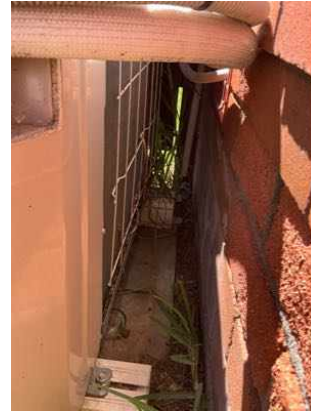
## Finding 6.02

Building: Main Building  
Location: Exterior walls - left side  
Finding: Aircon - Excessive moisture conducive condition near Air-conditioner  
Information: Excessive moisture near an air conditioner can indeed create conducive conditions for termites. Termites are attracted to damp and decaying wood, which can be found in areas with high moisture levels. To fix this issue:

1. Fix Leaks: Check for any leaks or condensation around your air conditioning unit. Repair any damaged pipes, drains, or insulation

2. Proper Drainage: Ensure that your air conditioner has proper drainage. Make sure the condensate drain line is clear and directed

3. Ventilation: Improve ventilation around the unit. Ensure that the area is well-ventilated to reduce humidity levels.

5. Please consult a HVAC Technician: HVAC (Heating, Ventilation, and Air Conditioning) technicians are trained to diagnose and

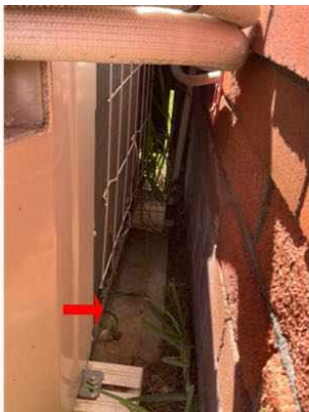
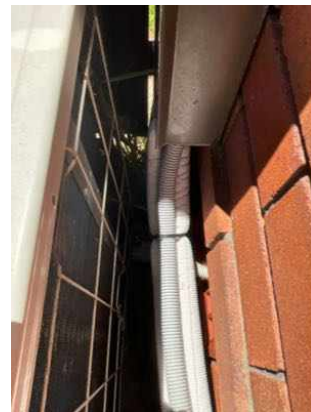
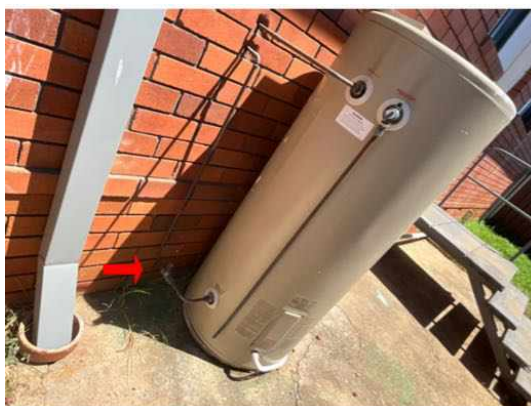
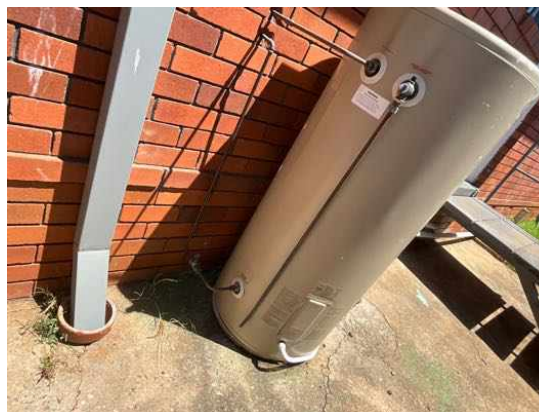
Where bridging has occurred full inspection is prevented and termites may enter a property in a concealed or undetected manner.

Recommended moving obstructions away from the external walls for further and future inspections.

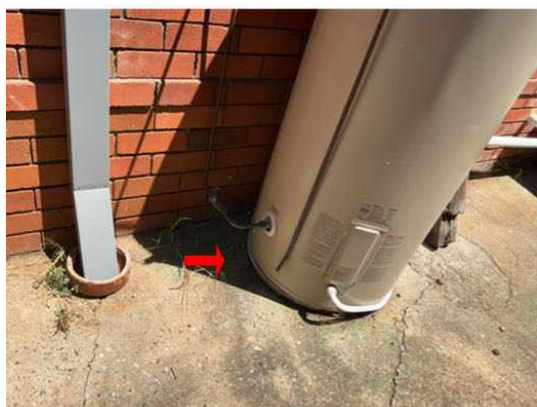
### Finding 6.04

Building:	Main Building
Location:	Exterior walls - rear
Finding:	HWS not connected - conducive conditions for timber pest attacks
Information:	The hot water system (HWS) is not connected, leaving exposed pipes and creating conducive conditions for timber pest attacks.

**Risk of Timber Pest Attack:** The risk of timber pest attack is heightened when the hot water system is not connected. Exposed pipes provide easy access points for timber pests like termites and ants to infiltrate the building structure. These pests are attracted to moisture, and the absence of flowing water through the system can lead to moisture buildup, creating an ideal environment for pests to thrive and cause damage to timber components within the building.

A licensed plumber or qualified plumbing technician should be engaged to reconnect the hot water system. They will assess the existing plumbing infrastructure, determine the appropriate connection points, and ensure proper installation and functionality of the HWS. Additionally, they may inspect for any signs of timber pest activity and recommend preventive measures, such as installing physical barriers or implementing moisture control measures, to deter pest infestations and protect the building from damage. Regular maintenance and inspections by homeowners or property managers are also essential to detect and address potential issues before they escalate.

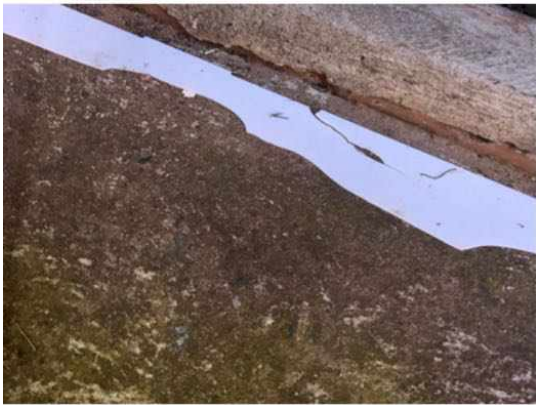
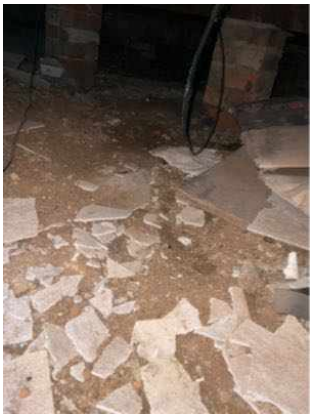
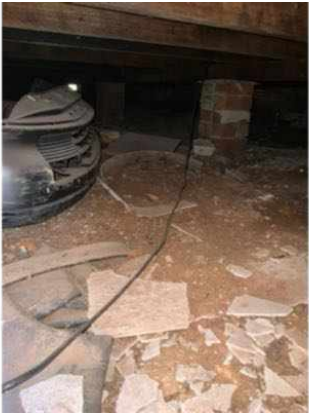
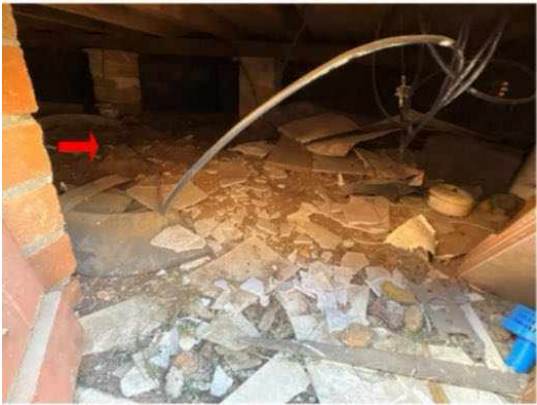
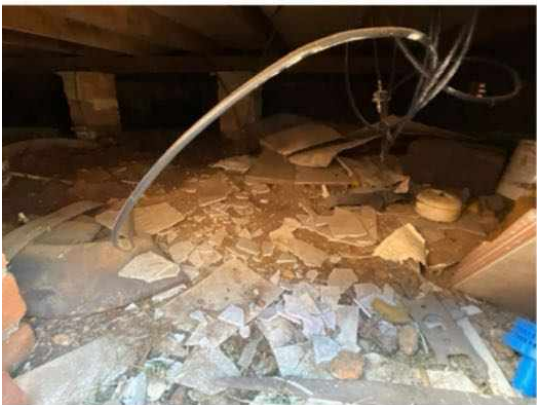
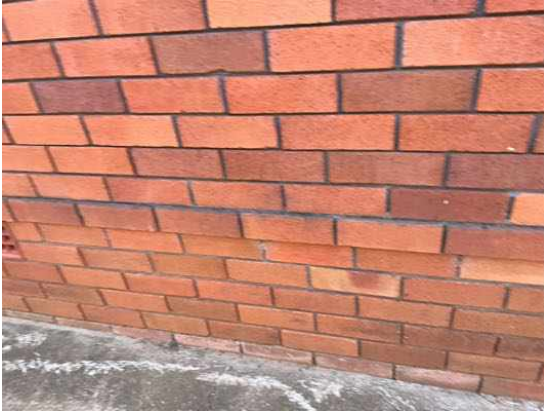
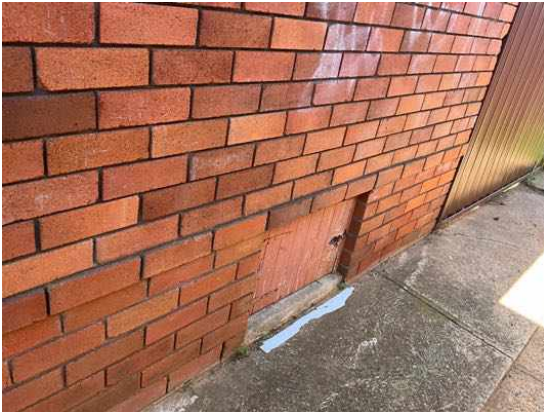
### Finding 6.05

Building:	Main Building
Location:	Subfloor
Finding:	Subfloor - poor ventilation, inadequate site drainage, water stains
Information:	The subfloor lacks adequate ventilation, suffers from inadequate site drainage, exhibits water stains, creating conducive conditions for timber pests such as termites.

Risk: The combination of poor ventilation, inadequate drainage, water stains significantly increases the risk of timber pest infestations. Termites are attracted to moist environments and can thrive in subfloors with high humidity levels and water damage. The lack of proper ventilation and drainage exacerbates moisture retention, providing an ideal habitat for timber pests to establish colonies and cause extensive damage to the subfloor structure. Additionally, water stains indicate previous or ongoing moisture issues, which further attract timber pests and contribute to the deterioration of timber materials.

A licensed pest control professional specializing in timber pest management should be consulted to assess the extent of the infestation and develop a comprehensive treatment plan. They can implement strategies to eliminate existing timber pests, such as termites and prevent future infestations by addressing underlying moisture issues. Additionally, a qualified plumber or builder may be needed to improve subfloor ventilation, enhance site drainage, repair water-damaged areas. Regular inspections and maintenance are essential to ensure ongoing protection against timber pests and maintain the structural integrity of the subfloor.

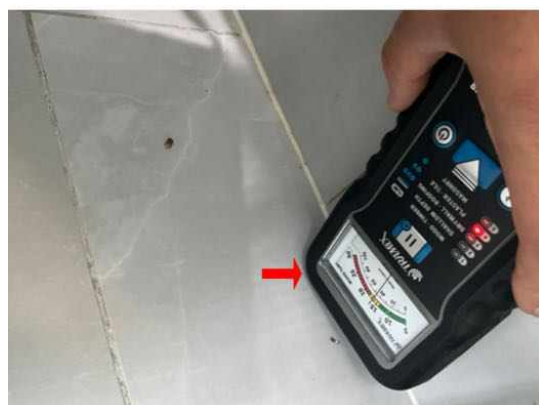
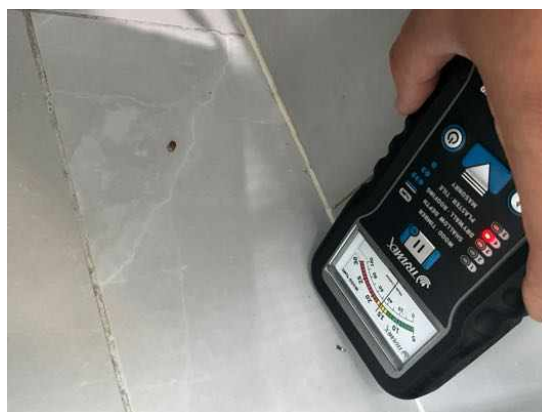
### Finding 6.06

Building:	Main Building
Location:	Bathroom
Finding:	Excessive moisture - Conducive to Timber pest
Information:	Excessive moisture can attract termites and produce conditions that promote fungal growth and wood decay.

Excessive moisture is generally caused by deteriorated inadequate or missing roof drainage leaking plumbing pipes or fixtures poorly plumbed HWS overflows or condenser units and poor site drainage.

Prior to any remedial works being performed a qualified plumber should be appointed to further inspect the property and to identify the cause of the excessive moisture. Works to remove affected building elements may then be necessary and should be performed by an appropriate tradesperson.

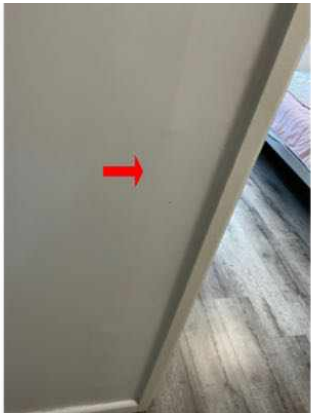
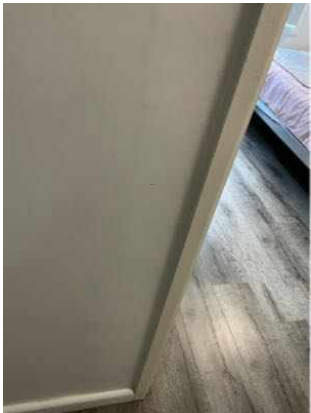
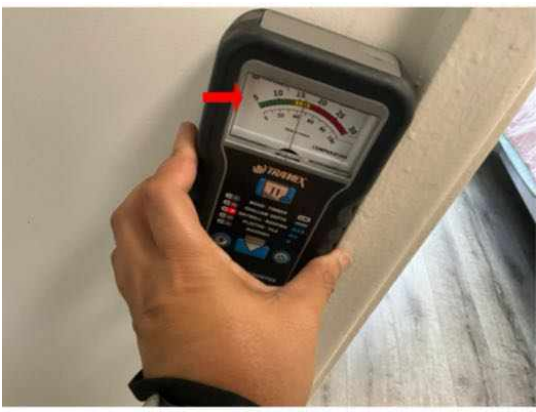
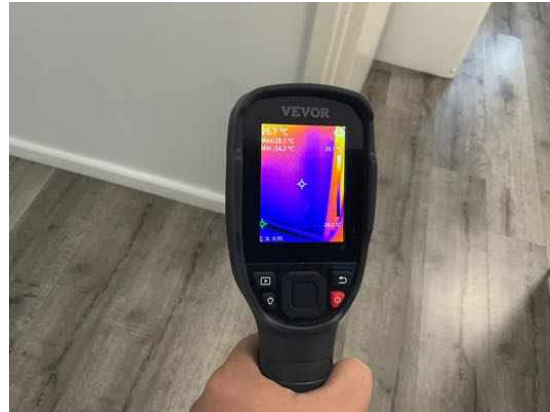
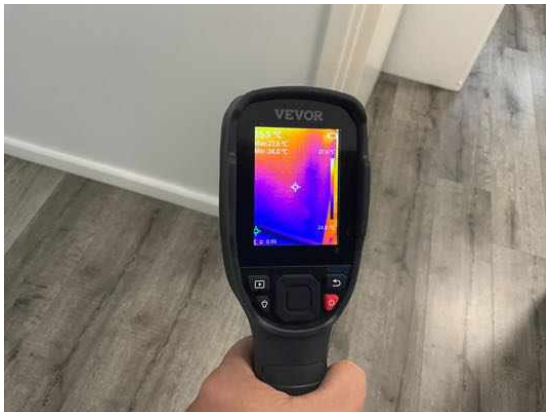
### Finding 6.07

Building:	Main Building
Location:	Bedroom
Finding:	Excessive moisture - Conducive to Timber pest
Information:	Excessive moisture can attract termites and produce conditions that promote fungal growth and wood decay.

Excessive moisture is generally caused by deteriorated inadequate or missing roof drainage leaking plumbing pipes or fixtures poorly plumbed HWS overflows or condenser units and poor site drainage.

Prior to any remedial works being performed a qualified plumber should be appointed to further inspect the property and to identify the cause of the excessive moisture. Works to remove affected building elements may then be necessary and should be performed by an appropriate tradesperson.

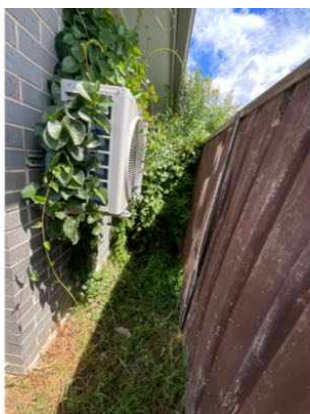
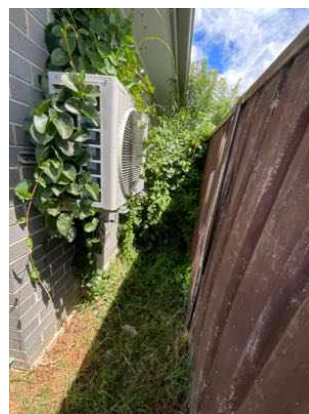
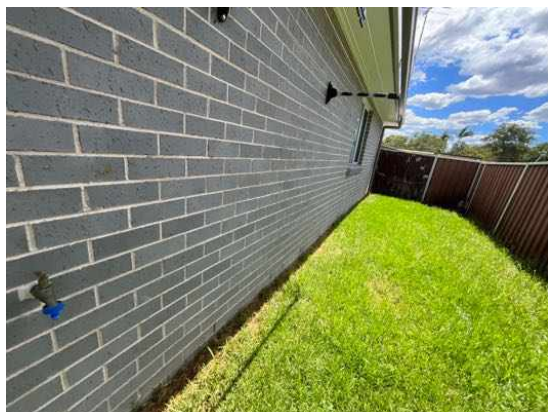
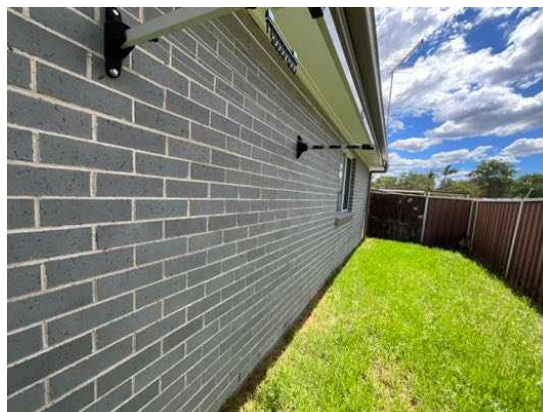
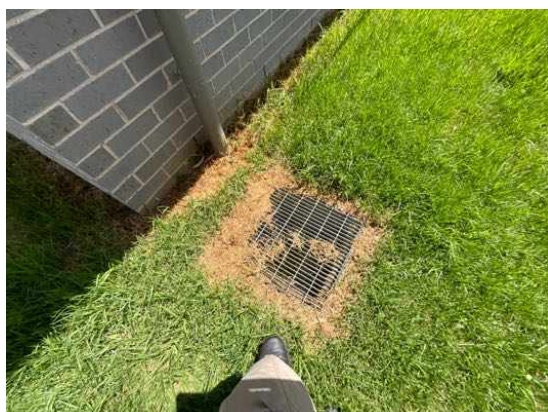
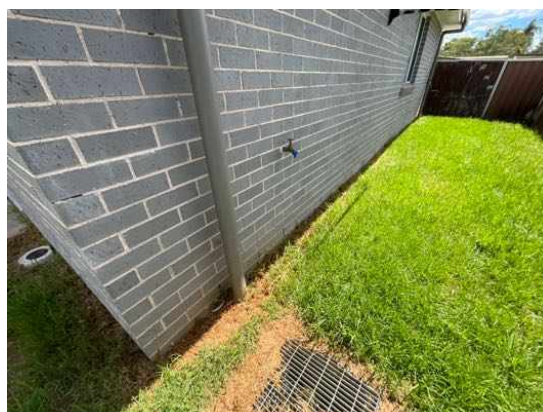
### Finding 6.08

Building:	Main Building
Location:	All Areas -
Finding:	Dense vegetation around a property can increase the risk of termite infestation
Information:	The presence of dense vegetation around a property can increase the risk of termite infestation, as it provides a conducive environment for them. To address this, consider maintaining a clear space between the vegetation and your home. If you suspect a termite issue, it's advisable to consult with a licensed pest control professional for inspection and treatment.
