# Building and Timber Pest Inspection Report

Inspection Date: Thu, 12 Feb 2026

Property Address: 13 Roebuck Cres, Willmot NSW 2770,  
Australia

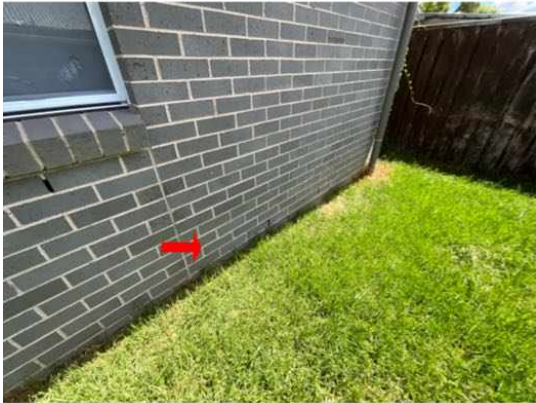
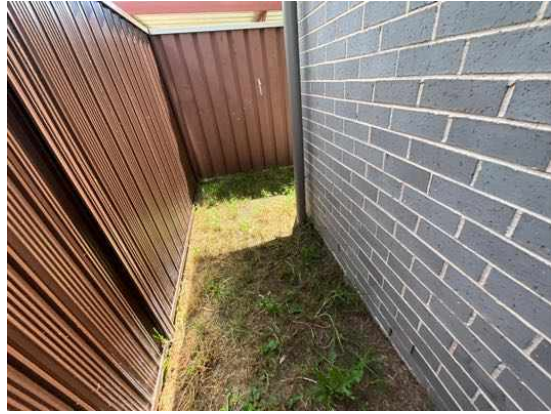
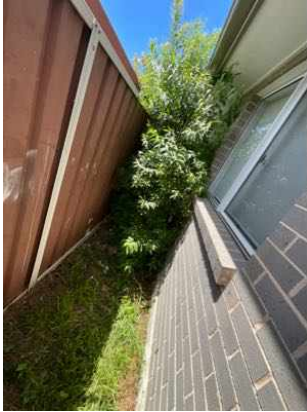
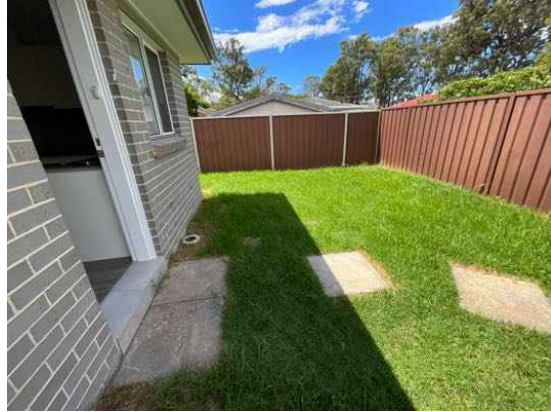
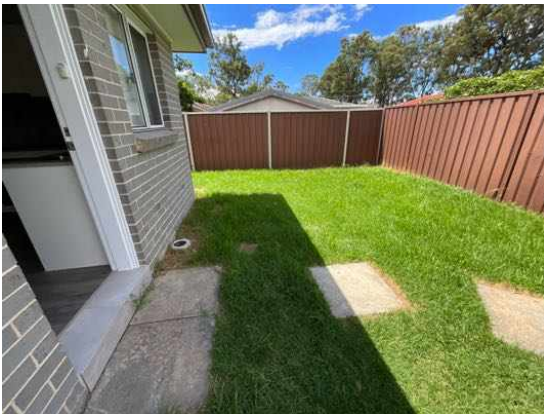
### Finding 6.09

Building:	Main Building
Location:	All Areas - Granny
Finding:	Slab Edge - Exposure
Information:	An inspection zone of at least 75mm in relation to the exposed slab edge, between the bottom brick and the perimeter pavement, is required. This inspection zone should be maintained in order to force termites into the open where they can be detected more readily during regular inspections. The slab edge should not be concealed by anything that may prevent inspection of the area, including render, landscaping, soil, turf, paving, concrete cladding or other structures.

Where the slab edge cannot be properly inspected, it is highly recommended that termite or timber pest inspections be carried out every 6-12 months to aid protection of the property against infestation.

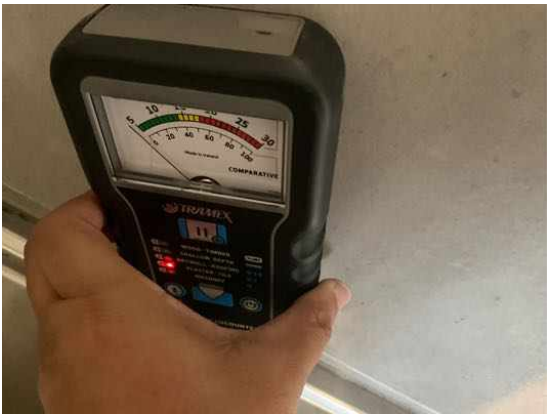
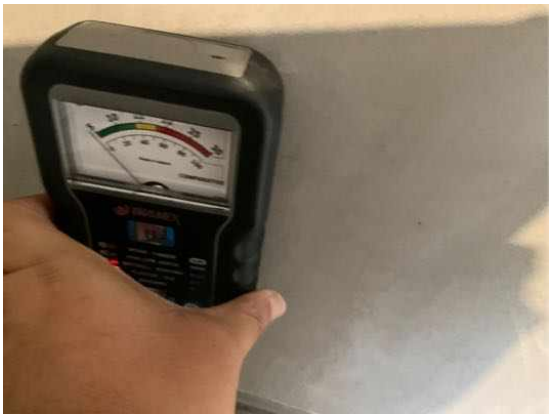
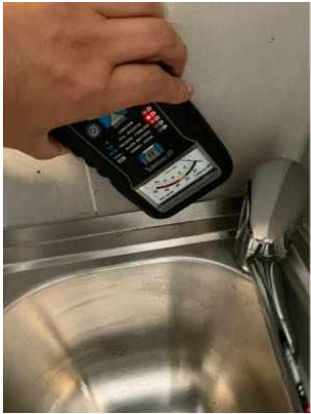
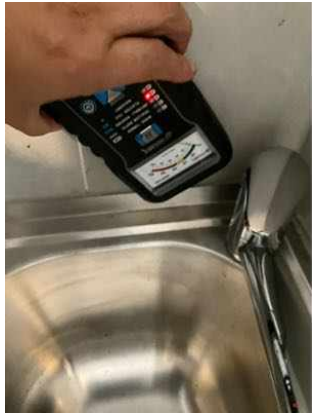
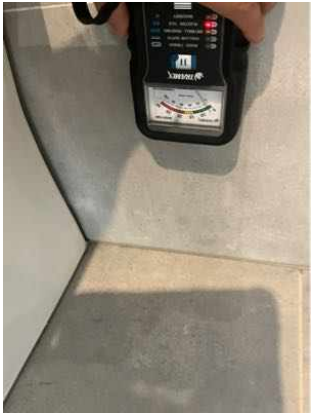
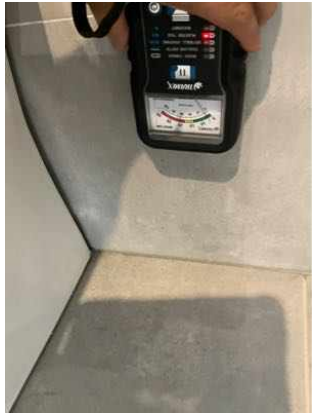
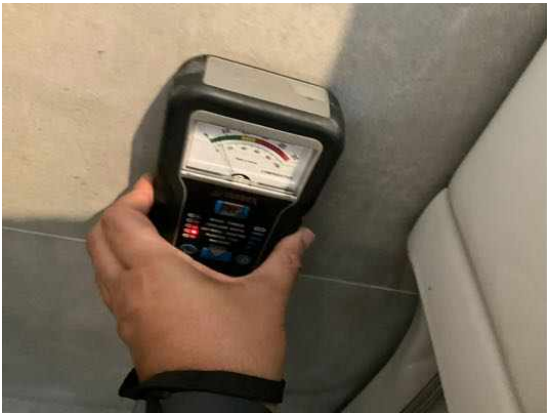
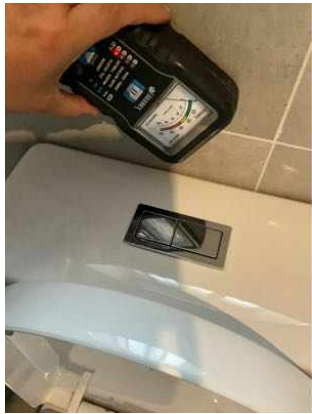
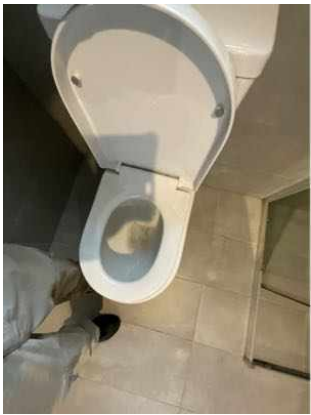
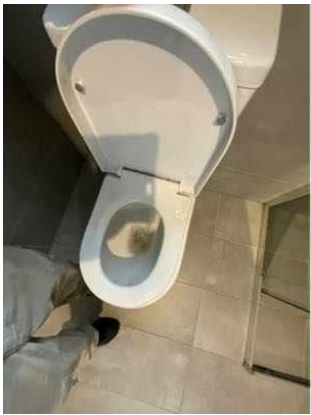
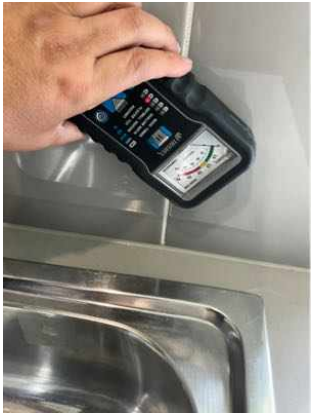
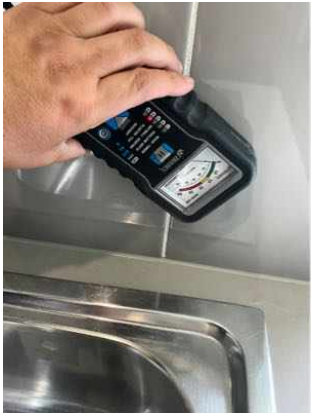
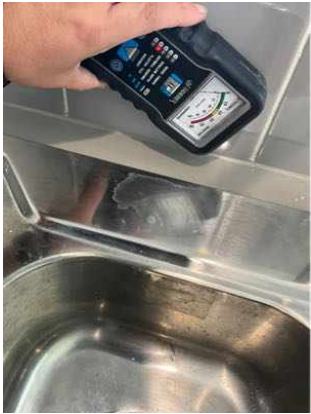
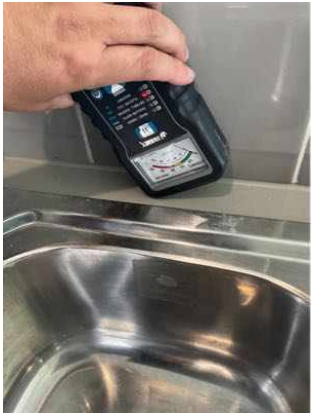
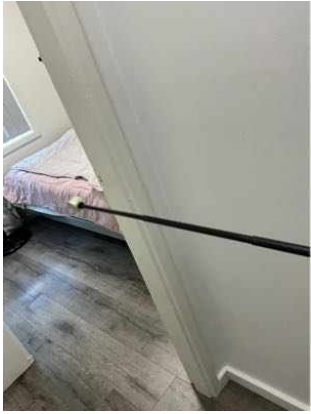
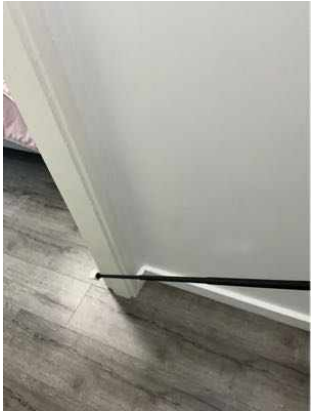
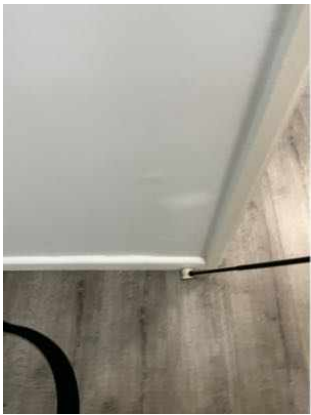
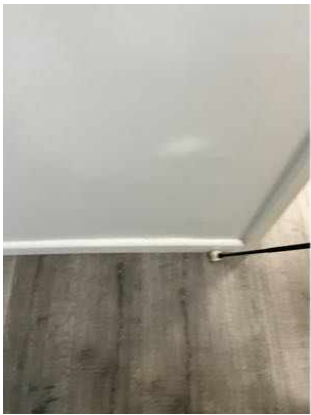
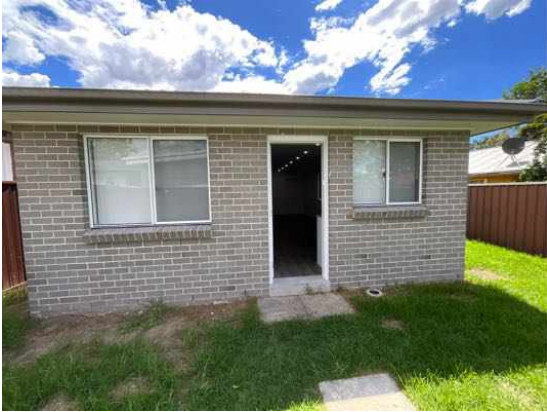
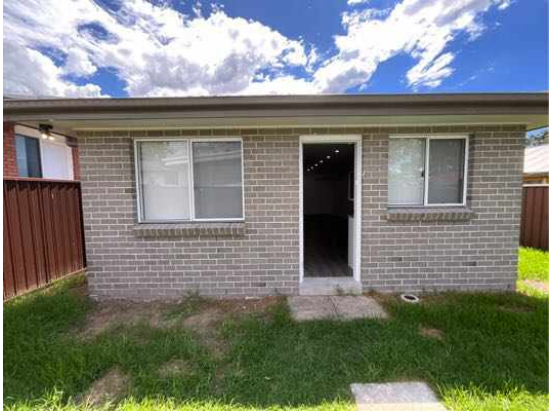
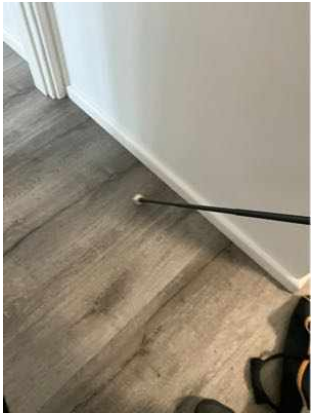
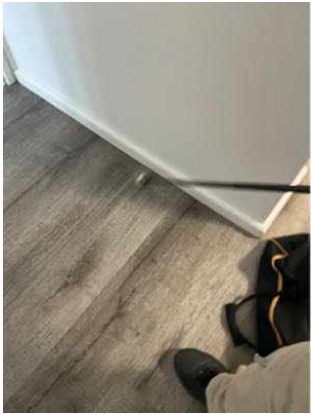
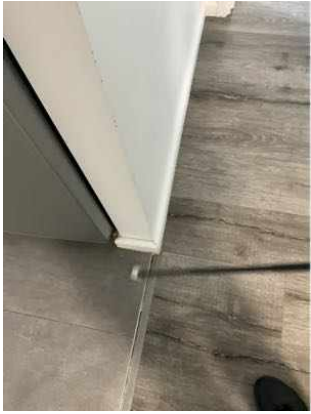
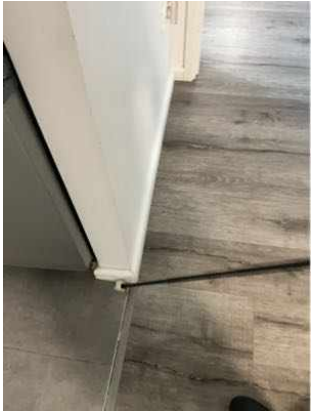
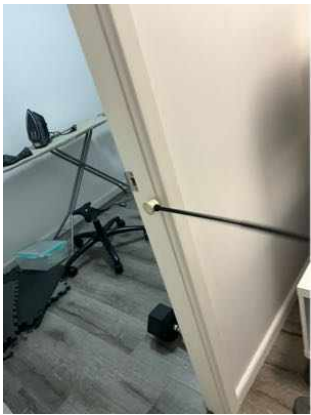
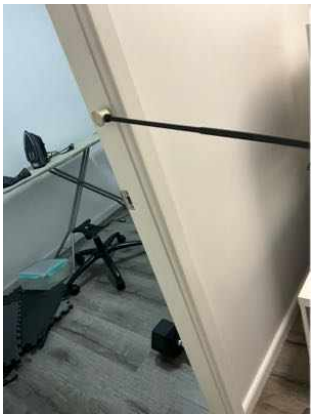
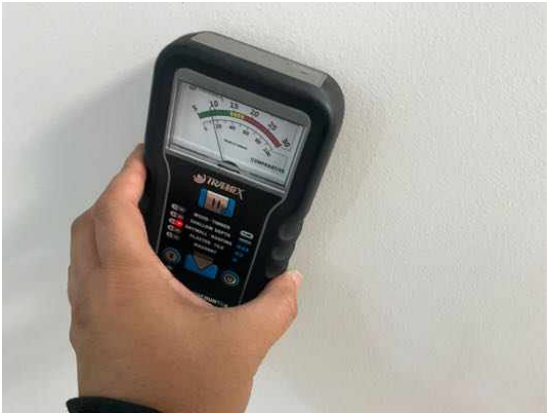
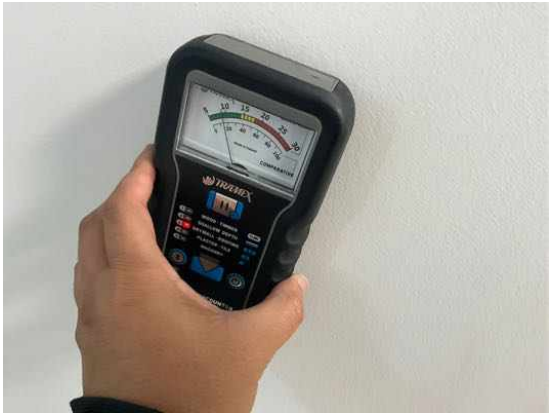
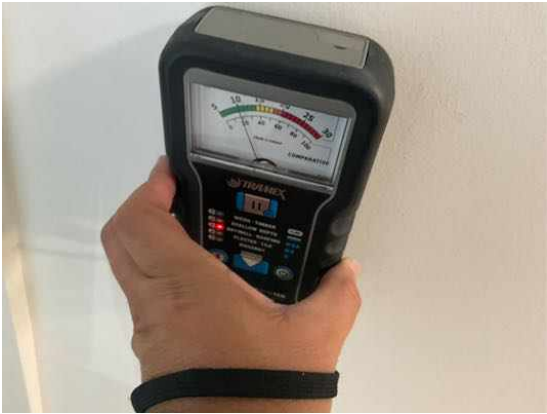
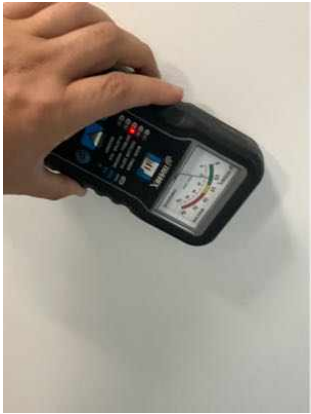
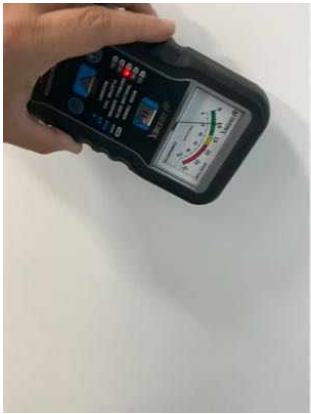
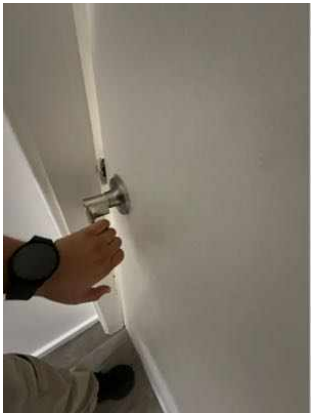
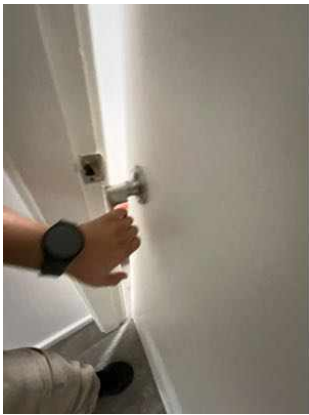
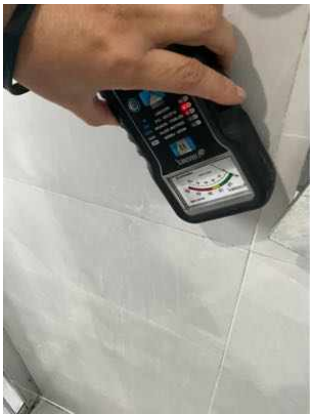
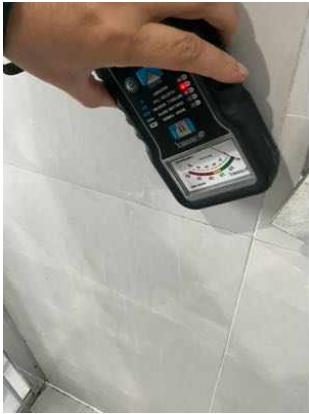
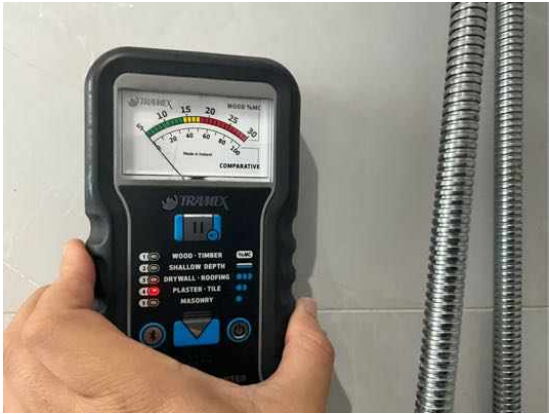
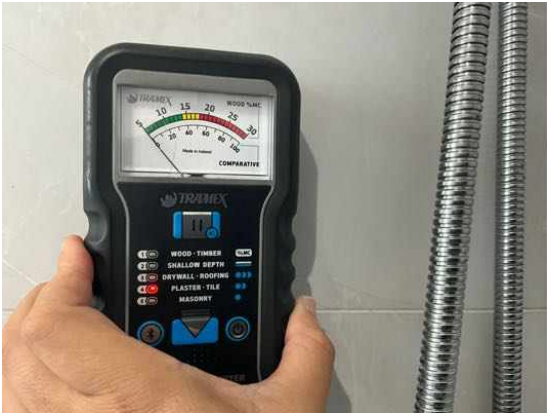
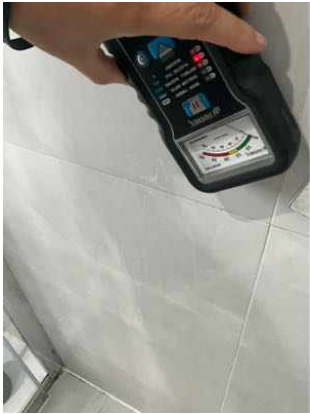
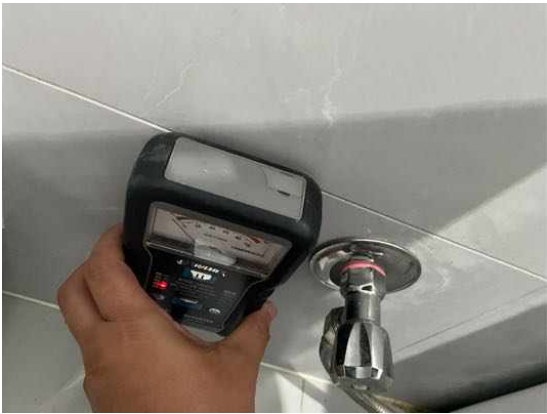
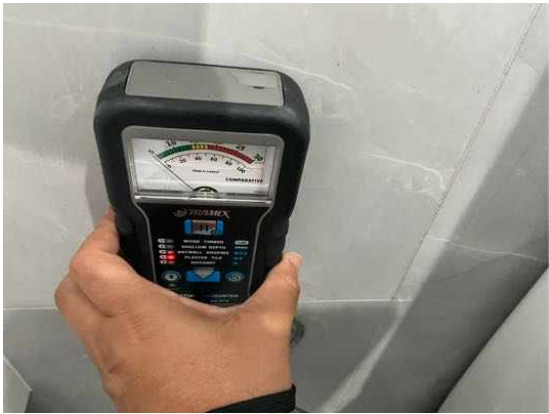
Building: Main Building  
Location: All Areas  
Finding: Additional Photos  
Information: Additional photos are provided for your general reference

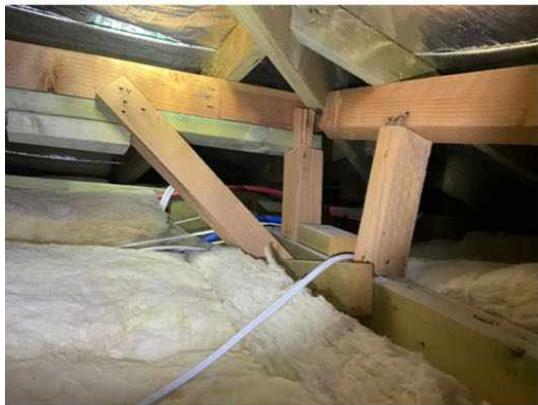
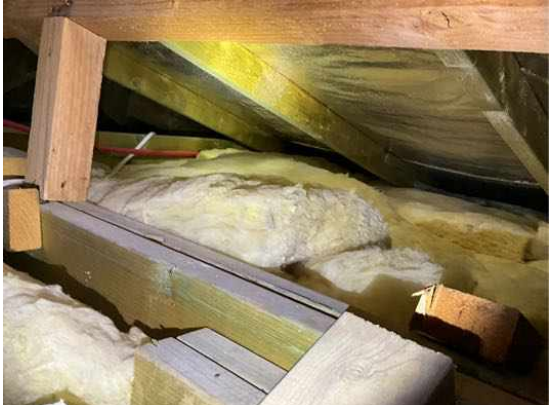
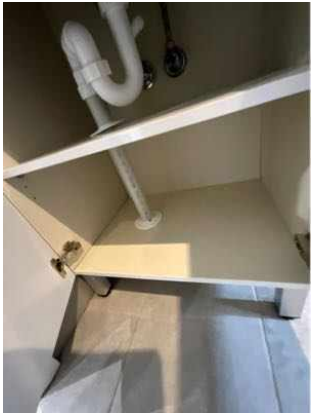
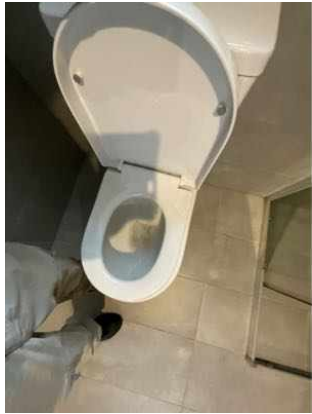
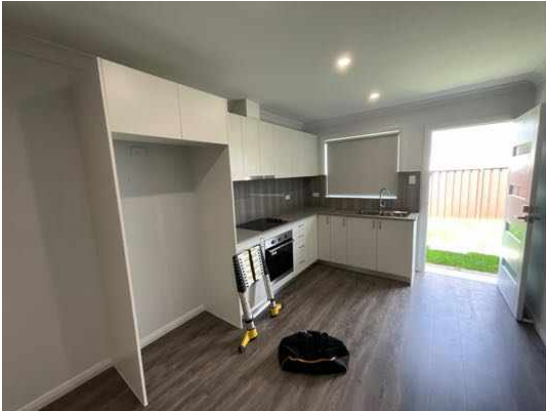
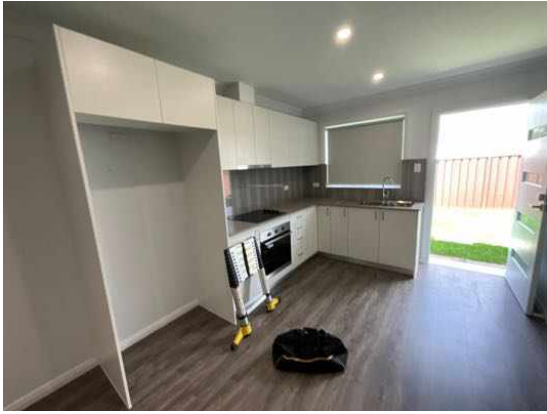
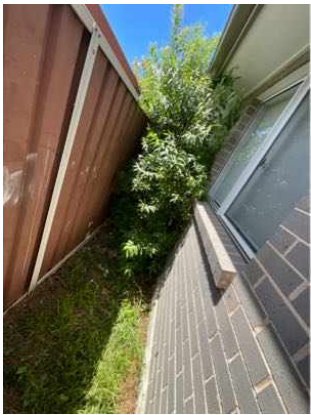
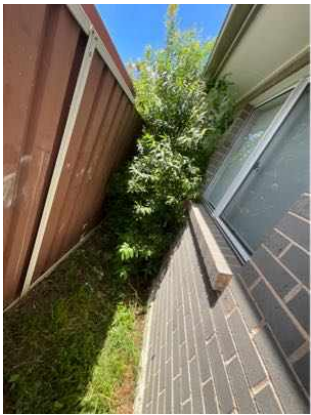
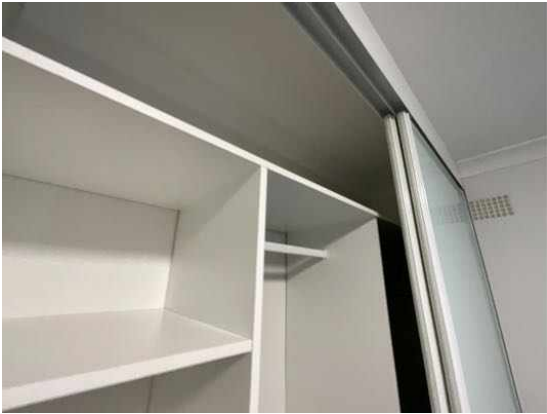
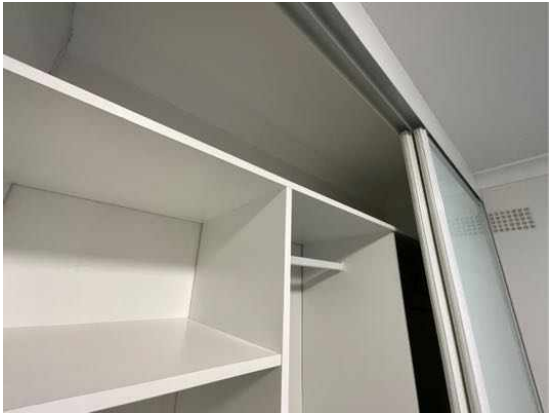
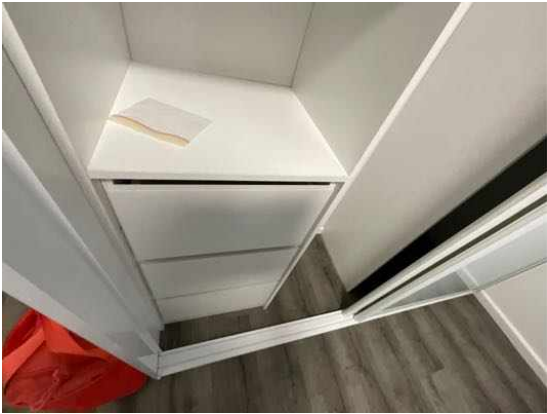
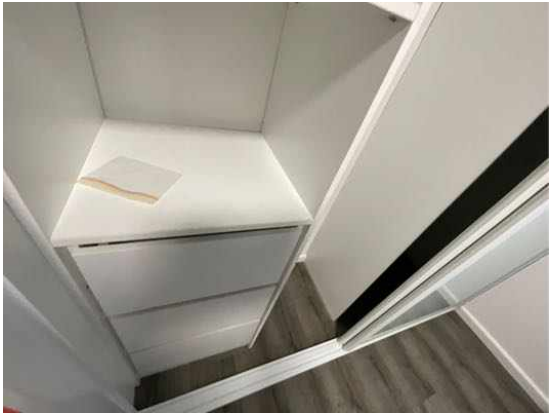
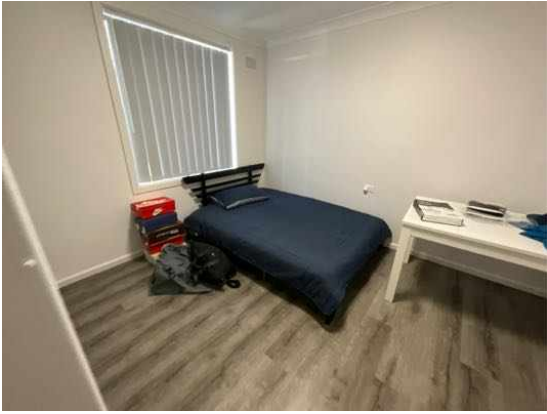
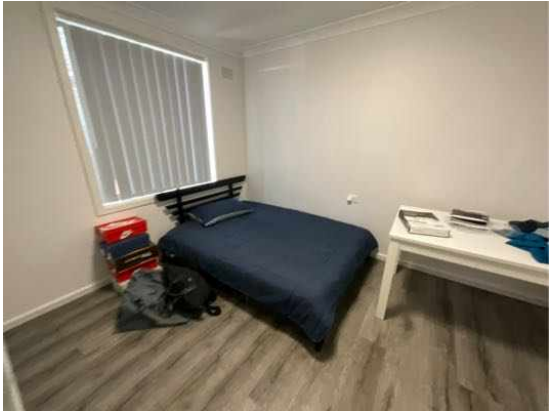
**Noted Item**

Building: Main Building  
Location: All Areas  
Finding: Additional Photos - Obstructions and Limitations  
Information: These photographs are an indication of the obstructions and limitations which impeded full inspection of the property at the time of inspection. These obstructions can hide an array of defects and should be removed to allow full inspection to be carried out. A re-inspection is recommended once the areas are made accessible.
