# Building and Timber Pest Inspection Report

Inspection Date: Wed, 4 Mar 2026

Property Address: 6 Hughes Ave, Penrith NSW 2750, Australia

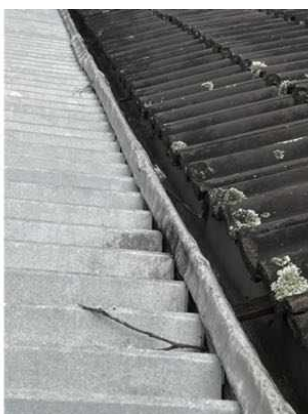
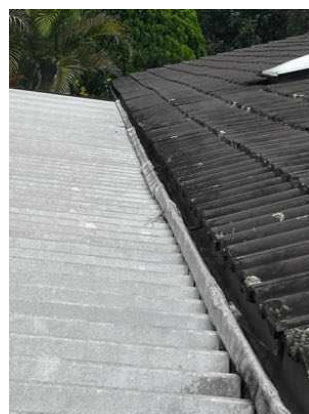
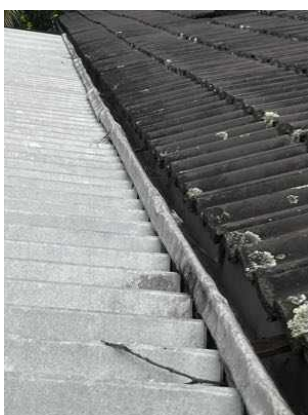
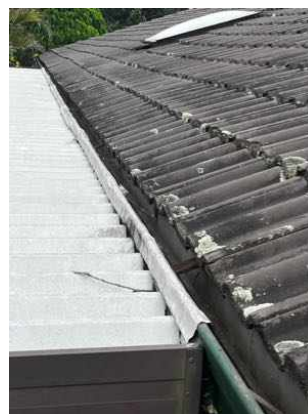
Building: Main Building  
Location: Alfresco roof  
Finding: Flashing defective -poor installation  
Information: Areas of flashing for for the colour bond roof or step flashings have been identified which are missing weathering folds anti-capillary breaks and sealing were identified.

Hence the water has penetrated into the timber sheet roof at the bottom of the alfresco.

Please consult a licensed roofer to inspect and remedy the situation.

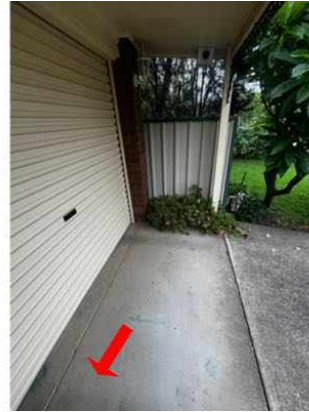
### Finding 3.01

Building: Main Building  
 Location: Driveway  
 Finding: Crack in concrete slab - Category 1  
 Information: A crack coded as Category 1 was identified in the slab. A Category 1 crack is described as a fine but noticeable crack, with the slab at an otherwise reasonable level.

To be considered Category 1, the approximate width of the crack is less than 1.0mm, or a less than 10mm change in offset when a 3m straight edge is placed over the defect.

Category 1 cracks should be monitored for a period of 12 months. At the end of the monitoring period, identified cracks that are rated greater than Category 2 are considered defects, and require rectification.

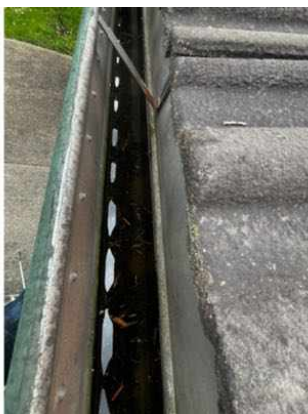
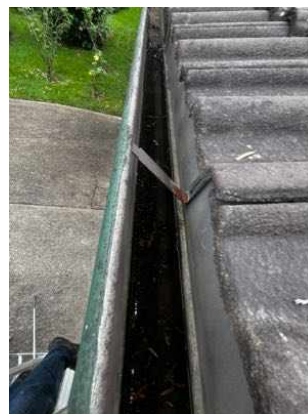
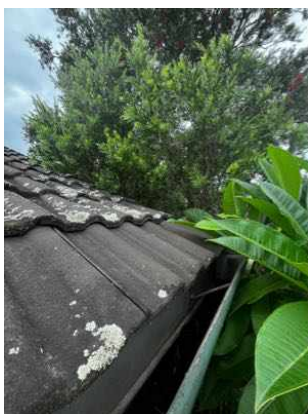
### Finding 3.02

Building:	Main Building
Location:	All External Areas
Finding:	Gutters - Water pooling
Information:	Water pooling happens in sections of the roof guttering and floor guttering too.. This is generally a secondary defect caused by blocked or partially blocked gutters. Such blockages and subsequent water pooling are likely to lead to rust and water damage to associated structures if left unattended.

The Gutter running at the back of the house roofline was not connected to a downpipe or a continues gutter from the colourbond roof. Hence water pouring from the gutter - show evidence.

Any areas of guttering that shows evidence of water pooling should be checked for partial or full blockages and any secondary damage that may have occurred as a result. Depending on the extent of the damage, building elements may require repair and/or replacement to ensure adequate roof drainage and function of exterior plumbing system.

A roofing plumber should be appointed as soon as possible to rectify this issue. It is highly advised that all gutters be maintained on a frequent basis to ensure the condition of roof plumbing.

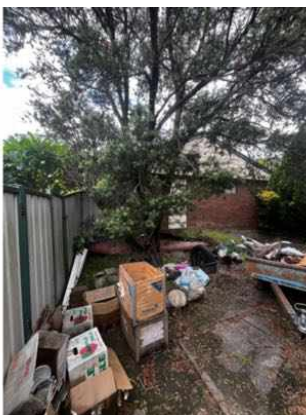
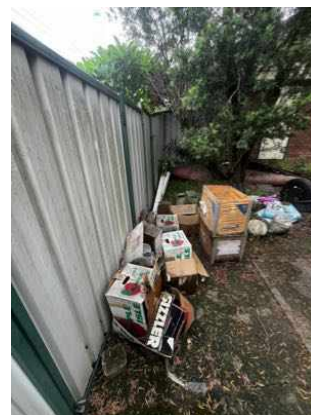
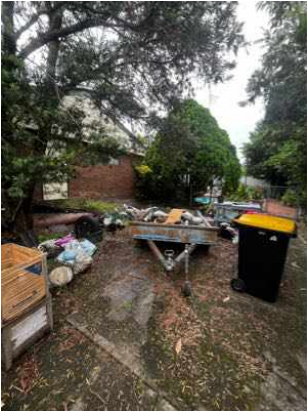
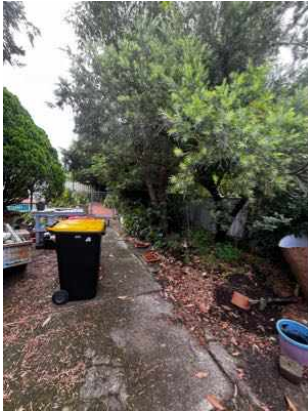
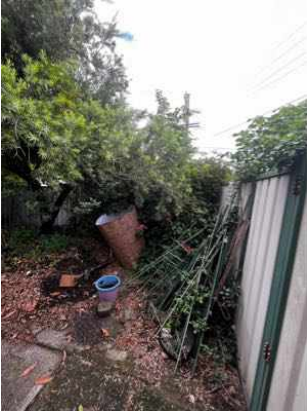
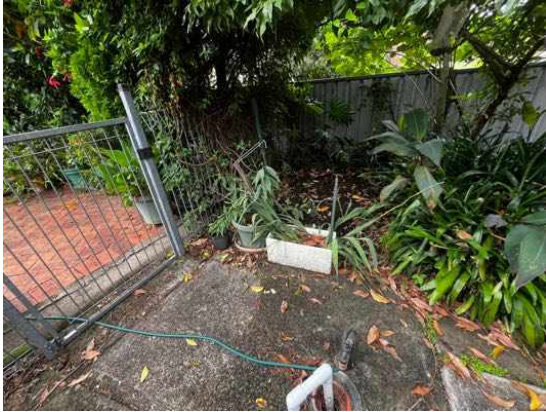
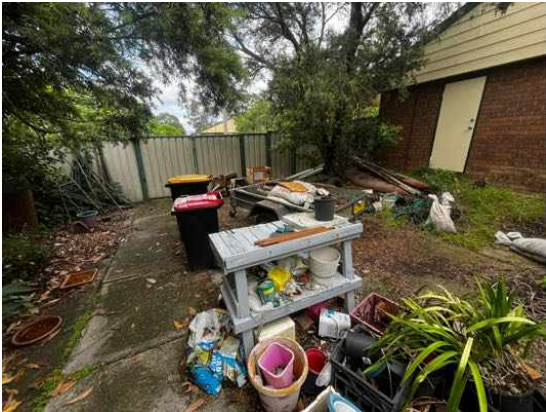
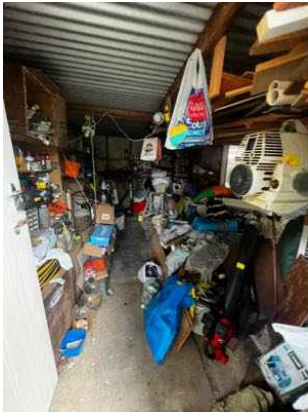
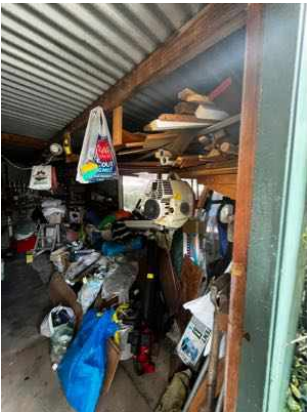
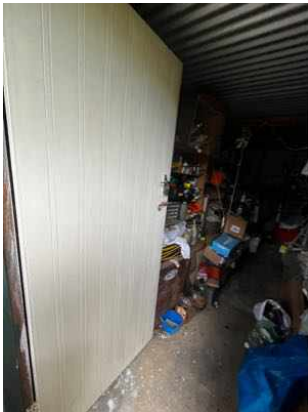
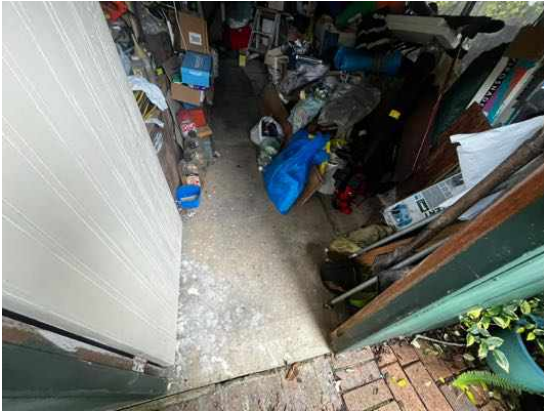
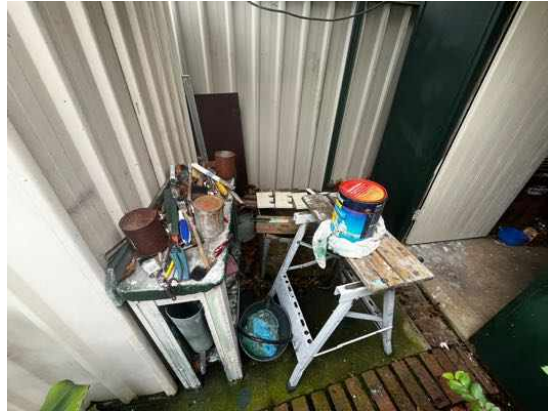
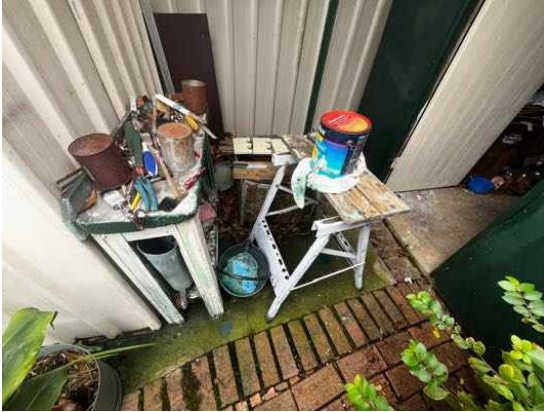
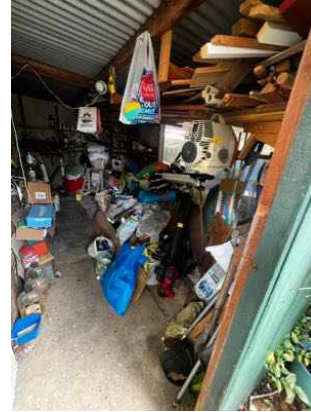
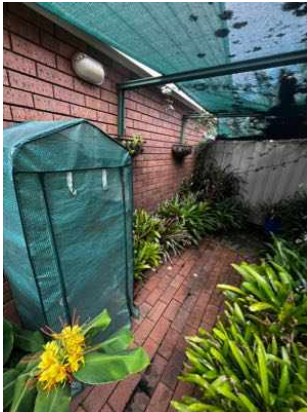
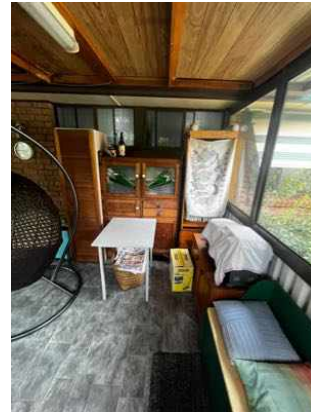
### Finding 6.02

Building: Main Building  
 Location: Studio/ storage  
 Finding: Stored items/ furniture - Limits Inspection  
 Information: There are stored items too close to the external walls and throughout cupboards and other items in the toilet/bathroom area and this limits the ability to inspect further

As at the time of inspection the photos are attached.

Request you to remove hindered items and clear the inspectable area as required. If needed another inspection may be scheduled.

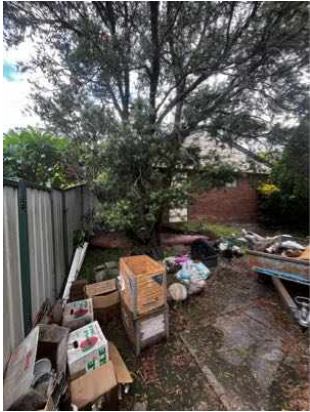
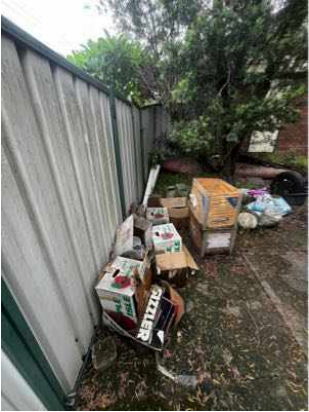
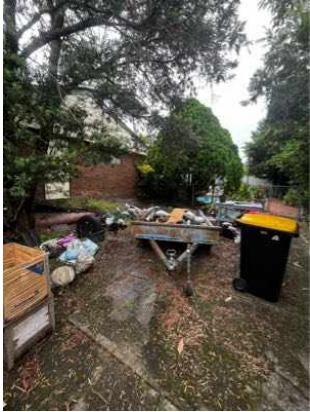
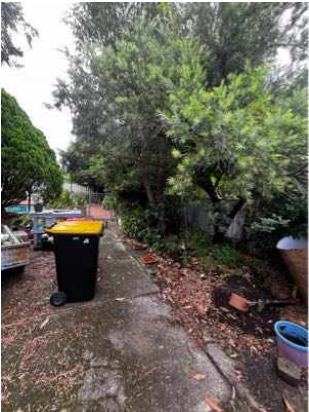
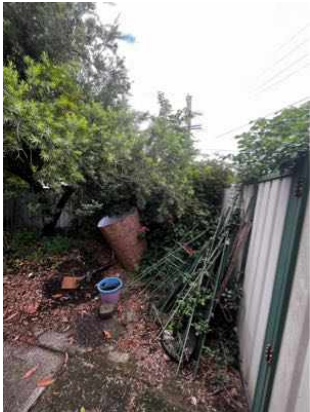
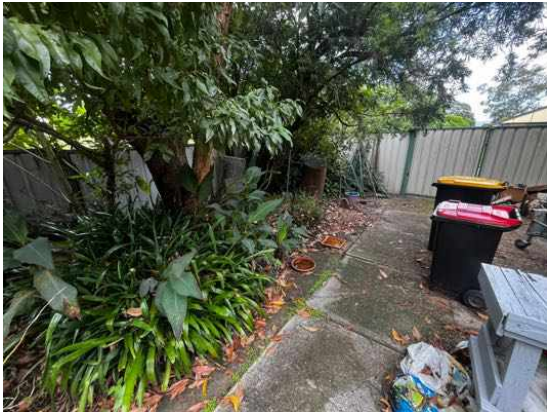
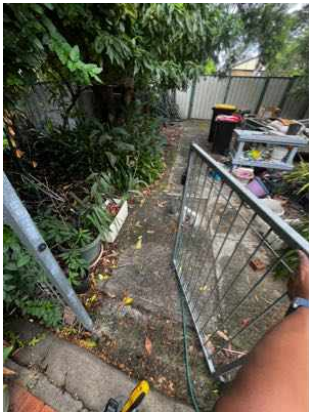
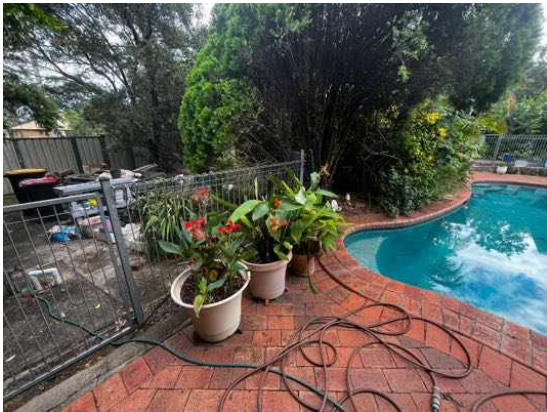
### Finding 6.03

Building: Main Building  
 Location: All External Areas  
 Finding: Limited Inspection Area - Alfresco area, Steps, Part Pool area, split level at the back of the property.  
 Information: There is limited to no access near the alfresco area, storage area and Pool area at the time of inspection and Part of the Left side of the house.

The risk of termite activity may be present. As they are likely to come into contact with weather conditions or excessive moisture wood rot is likely to develop on timbers that are not treated.

It is highly recommended that any stored timbers be immediately removed from areas in which they may attract any termite / timber pest attack. Minimisation of risk / prevention of termite attack is far more adequate than dealing with the presence of termite activity.

These obstructions can hide an array of defects and should be removed to allow full inspection to be carried out. A re-inspection is recommended once the areas are made accessible.

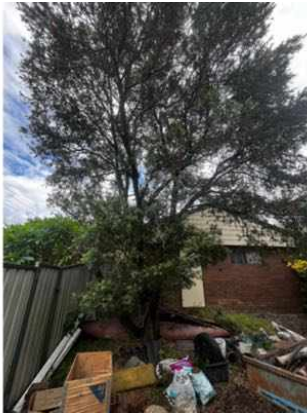
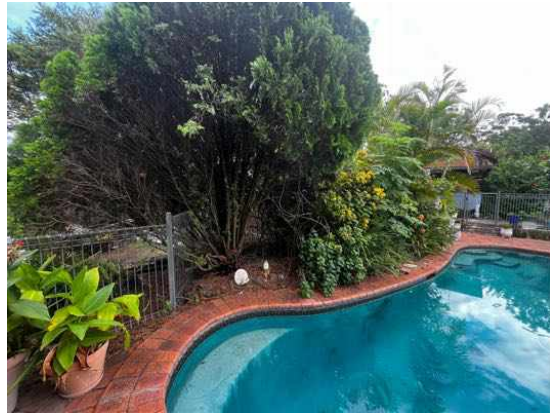
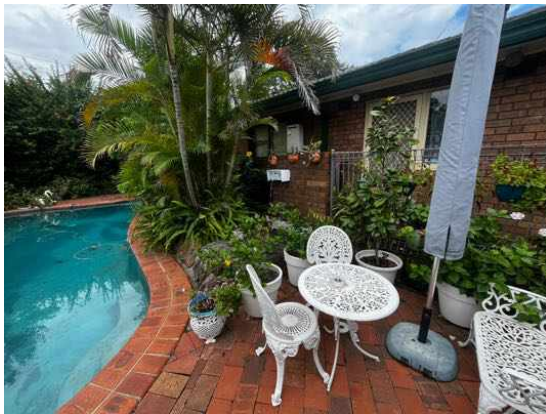
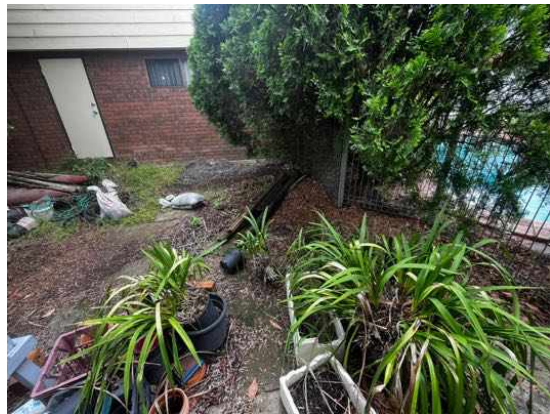
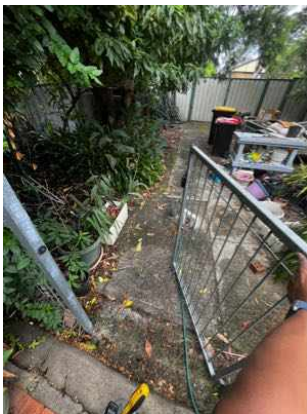
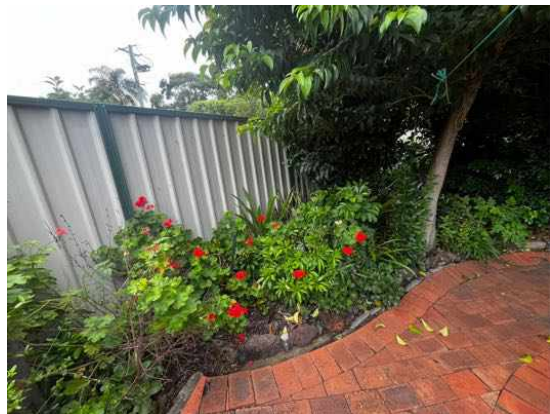
### Finding 6.04

Building: Main Building  
 Location: All External Areas  
 Finding: Large Trees/ Stumps within 30 meters of the house  
 Information: There are a number of large trees/ stumps within 30meters of the house which may contain natural termite activity. It is important to monitor these areas to ensure no natural activity is allowed to progress into the main house.

Regular inspections are recommended. Consider test drilling Trees.

A pest controller can be contacted to carry out such testing at owners discretion.

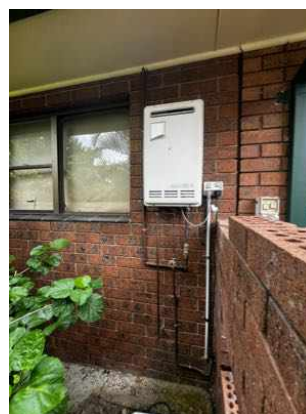
Building: Main Building  
 Location: Yard  
 Finding: Hot Water Unit  
 Information: The HWS appeared to be working in good condition during the inspection.

Water pressure appears to be normal, however, this is not an opinion of a licensed plumber.

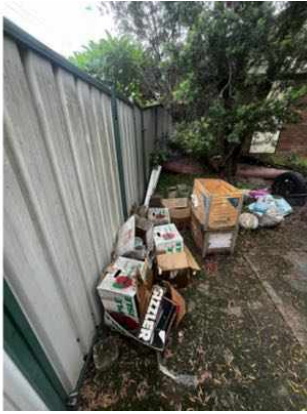
Building: Main Building  
 Location: Yard  
 Finding: Perimeter Fencing - Timber fence/ Colourbond Fence  
 Information: For your information photos taken at the time of inspection - During the inspection the Colourbond fence was inspected and found minor defects/ dents, deterioration but the fence at the back of the property Timber fence inspected.

Please appoint a fence installer to inspect and rectify the same at buyers convenience.

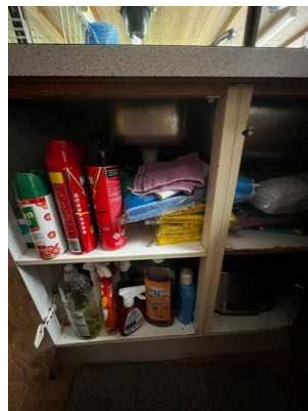
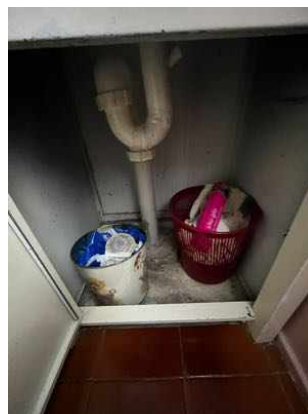
Building: Main Building  
 Location: All Areas  
 Finding: Cabinetry Plumbing - Kitchen/ Pantry cum Laundry  
 Information: Upon Inspection of the Kitchen and the Pantry/ Laundry and BBQ Kitchen all cupboards where sinks and basins with drainage plumbing were inspected and no evidence of leaks were present at the time of inspection.

For your information only no remedial works are required at the time of inspection.

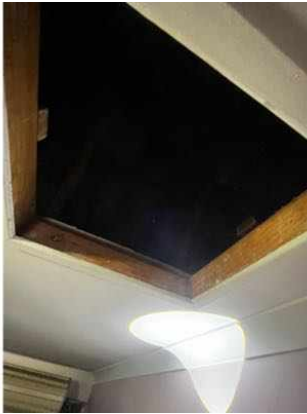
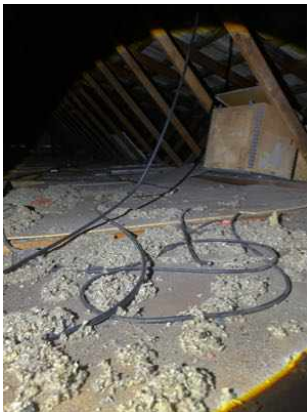
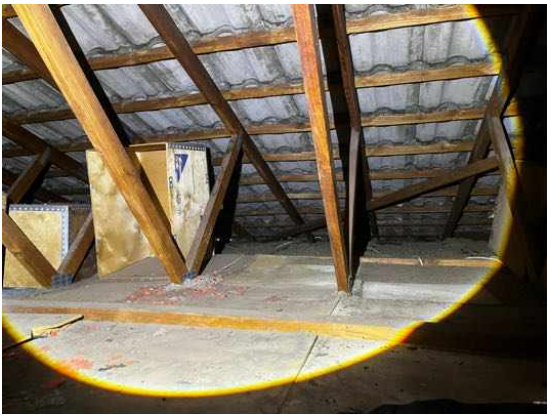
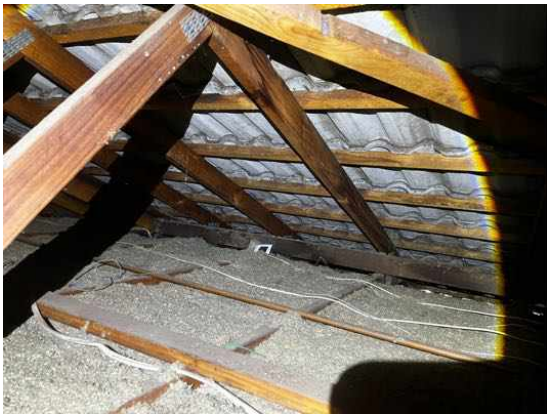
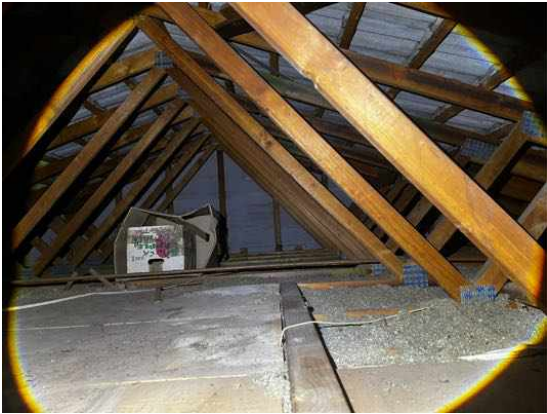
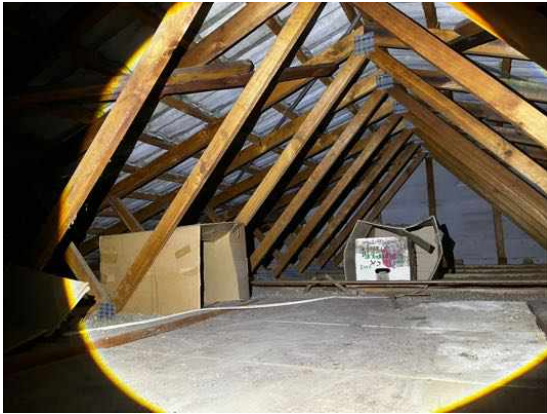
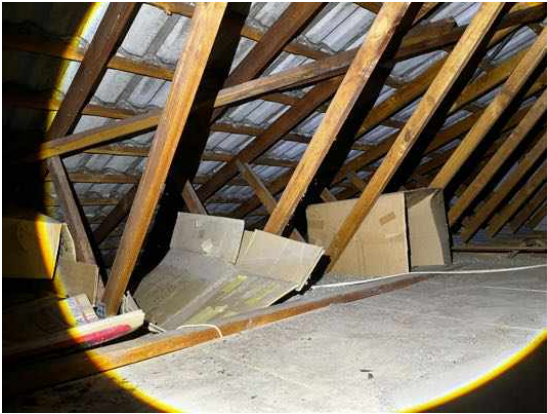
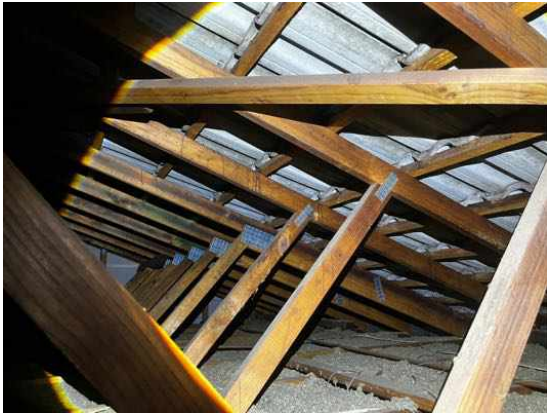
Signs or Rust in the roofing sheets are visible during inspection. For a longevity of the structure and the property the buyer can consider replacing the rusted sheets if preferred.

These obstructions can hide an array of defects and should be removed to allow full inspection to be carried out.

Photos are attached up to where access was possible.

A re-inspection is recommended once the areas are made accessible.

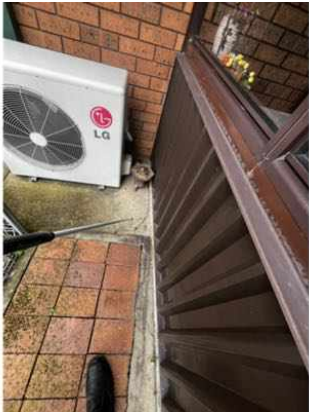
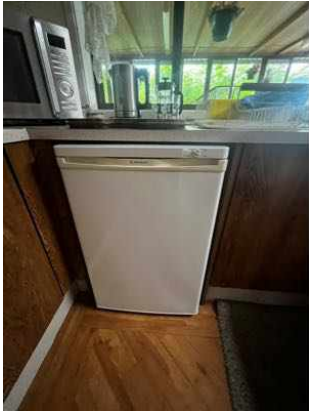
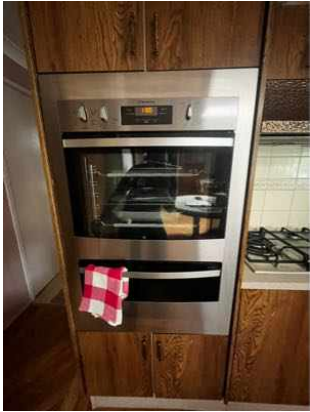
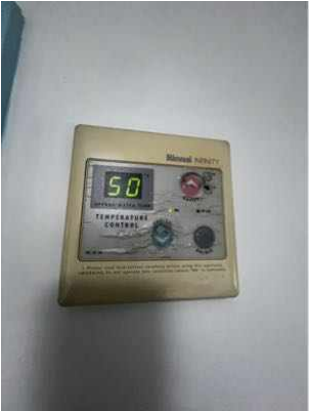
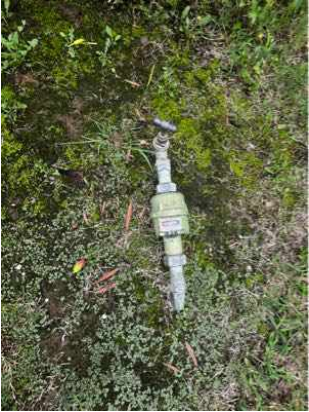
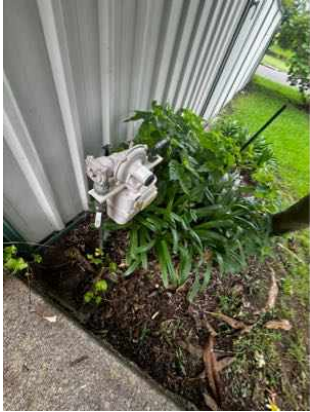
Whilst we note and comment of visually apparent defects that present during the

building inspection, legislation requires the checking and documenting of compliance for plumbing and electrical requirements be done by licensed electrician and plumbers respectively to ensure they are functioning correctly.

It is highly recommended that the client makes immediate arrangements to have the gas appliances checked by a licensed gas plumber to ensure that the appliances are working safely and efficiently.

We recommend all other installations be checked also.

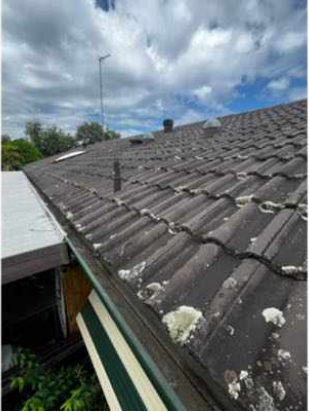
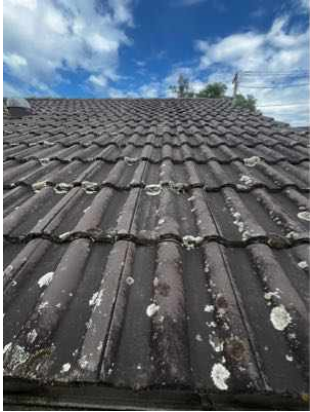
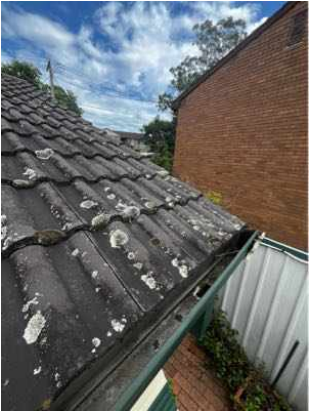
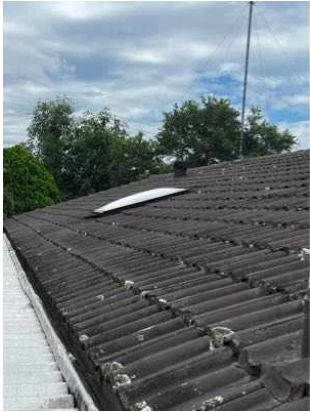
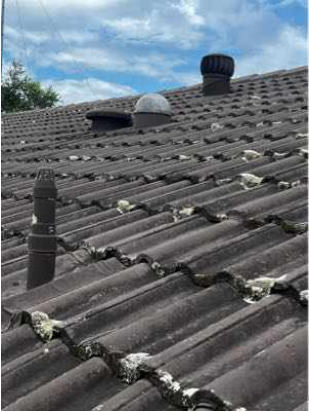
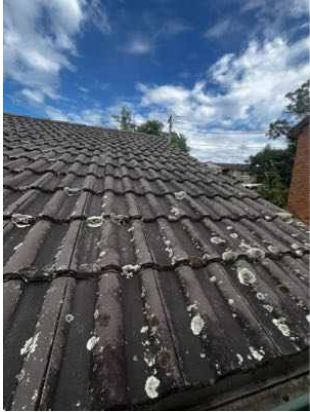
Building: Main Building  
Location: Roof Exterior  
Finding: Roof tiles - Weathered  
Information: Upon inspection of the exterior roofing, the majority of roof tiles were considered to be in a fair condition. While weathering of the tiles is consistent with the age of the property, maintenance works are required.

Consult a roofer if assistance required.

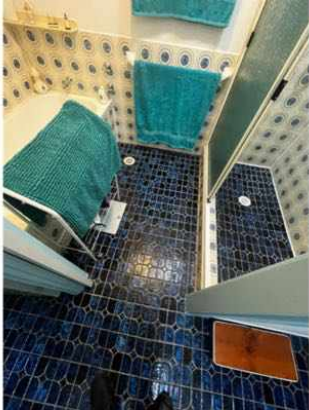
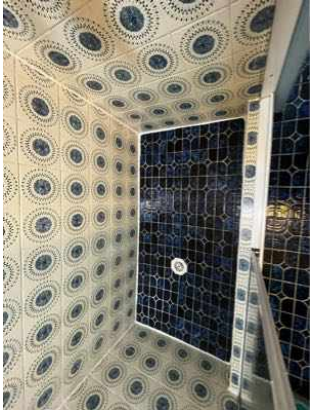
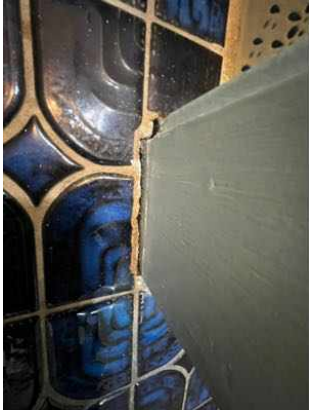
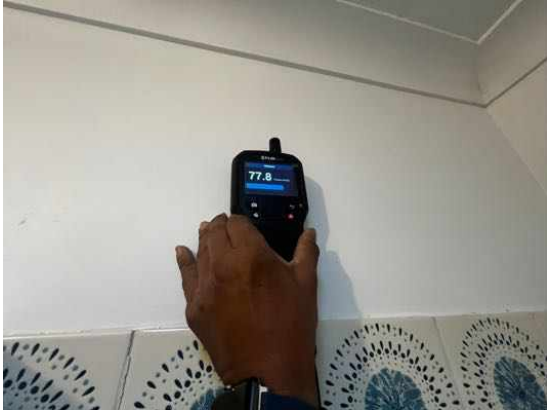
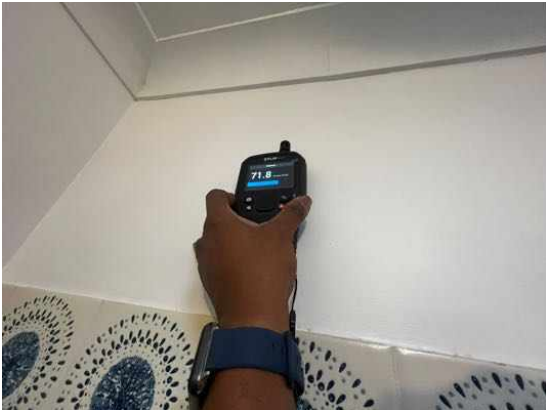
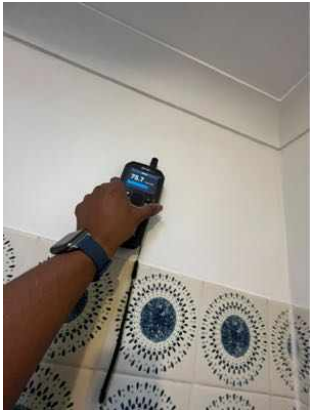
Building: Main Building  
Location: Bathroom  
Finding: For information only  
Information: A Cluster of Photos taken at the time of inspection.

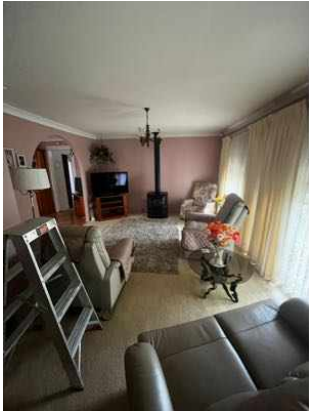
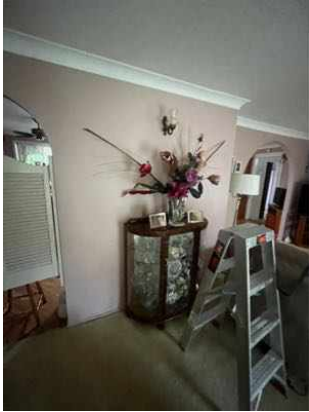
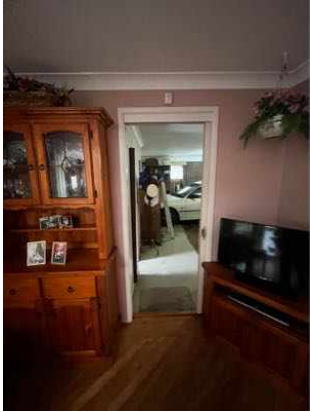
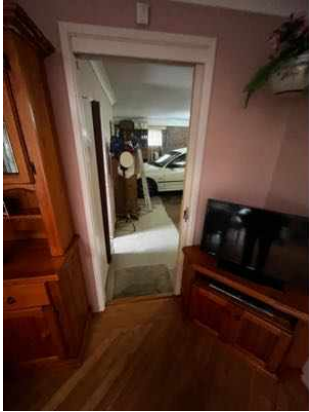
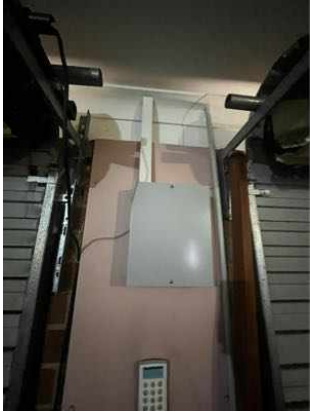
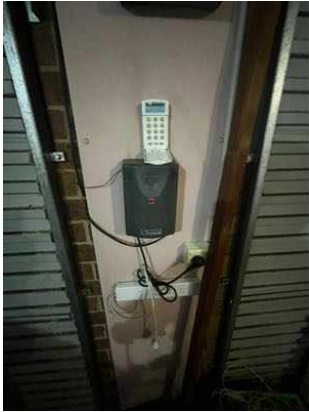
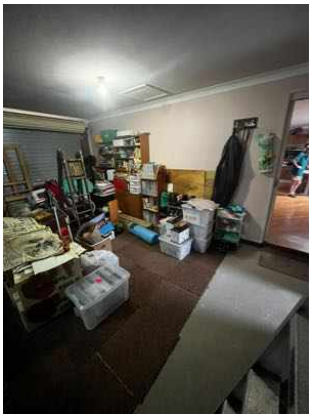
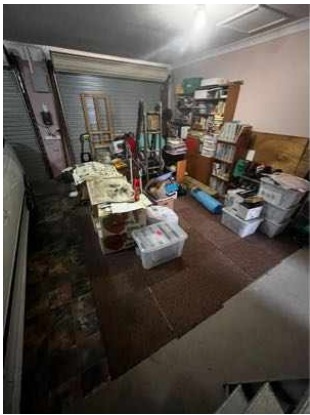
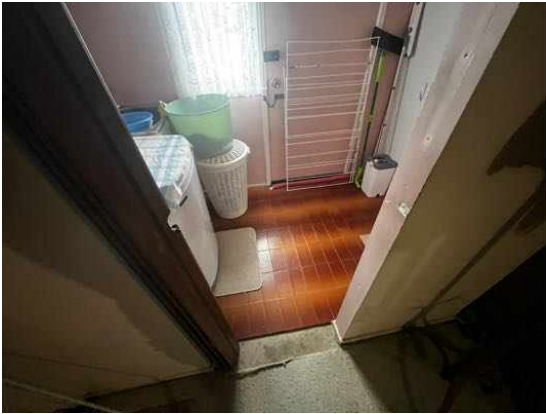
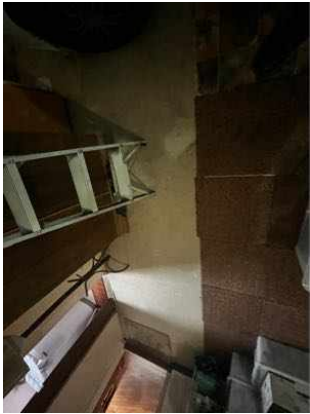
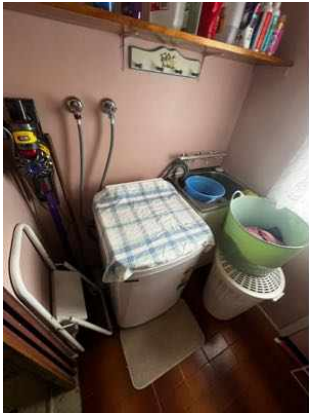
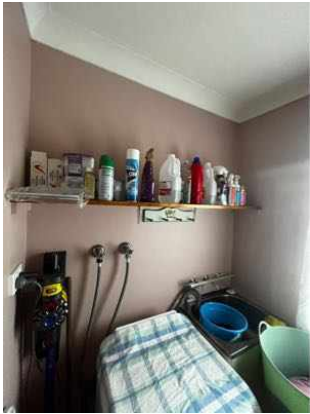
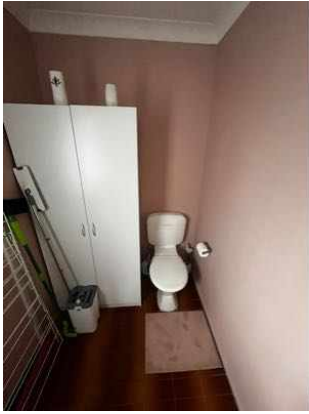
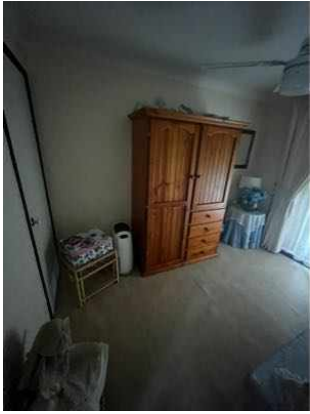
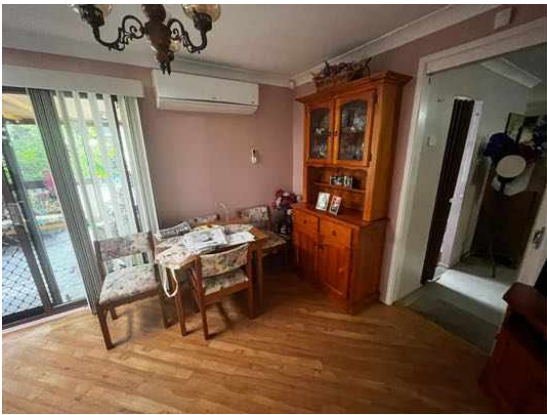
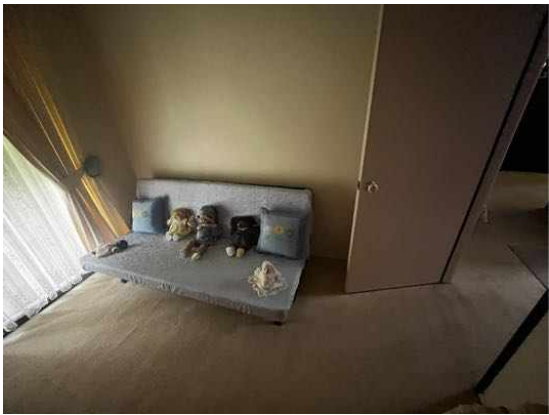
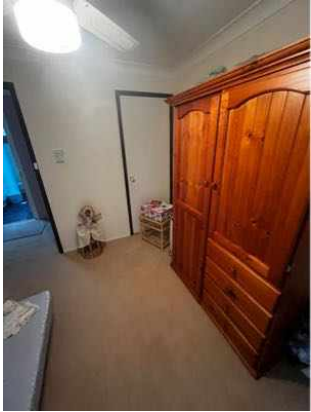
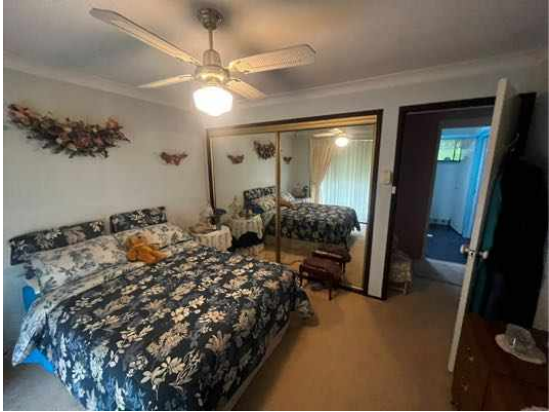
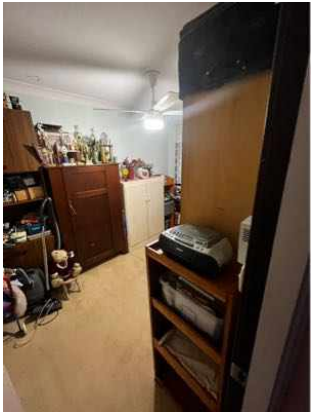
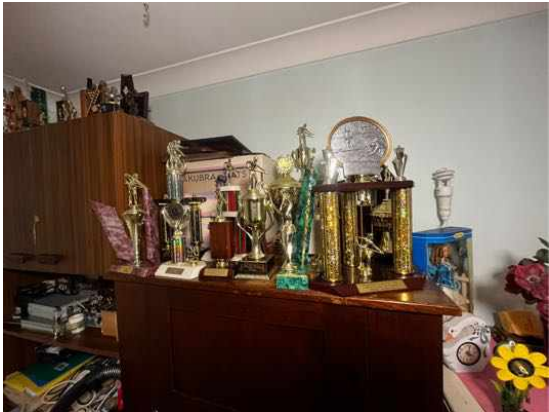
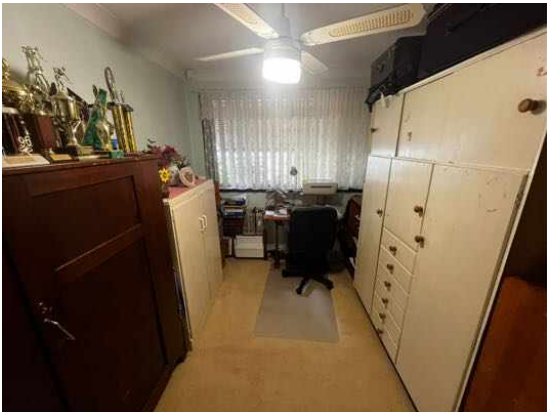
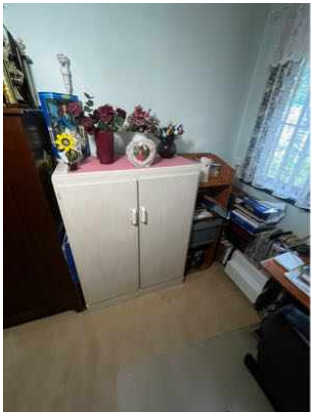
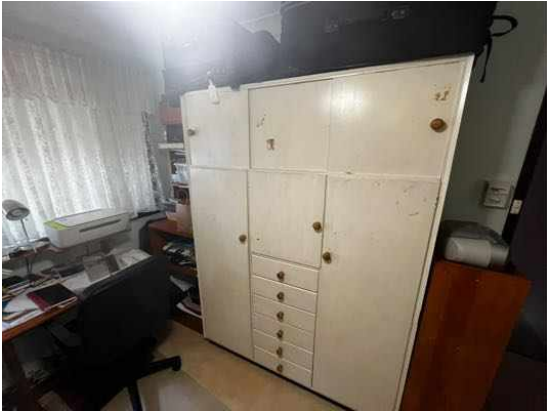
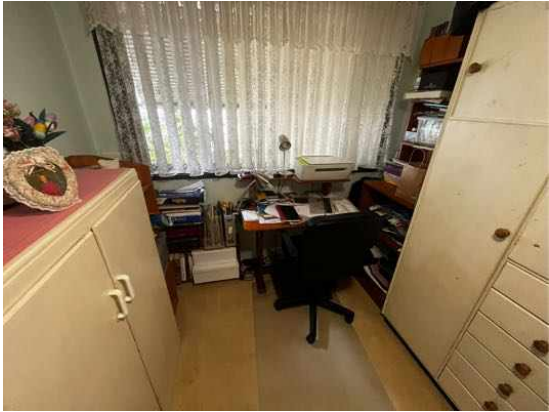
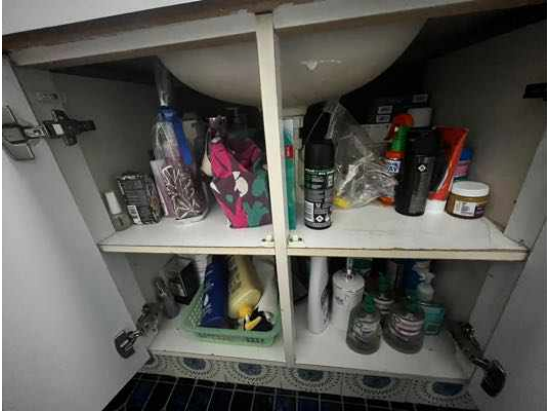
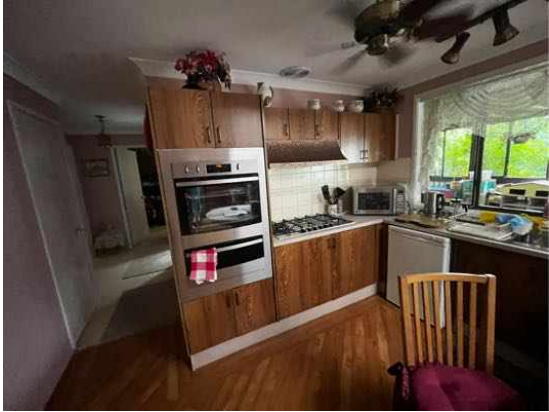
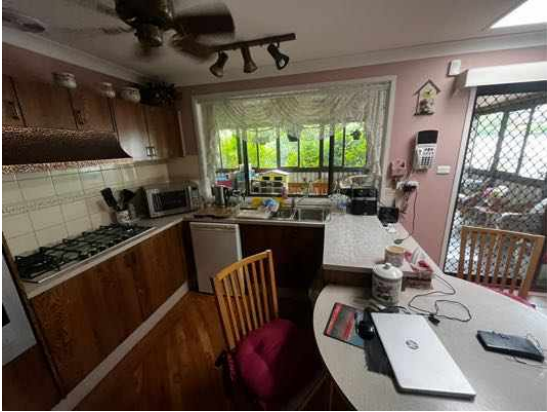
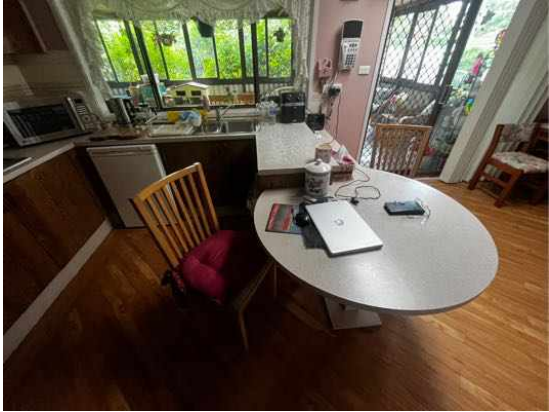
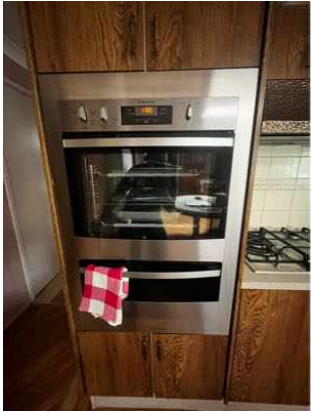
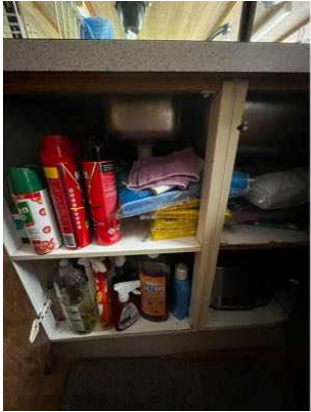
Building: Studio  
 Location: All Areas  
 Finding: Additional Photos - Obstructions and Limitations  
 Information: These photographs are an indication of the obstructions and limitations which impeded full inspection of the property at the time of inspection inside the studio.

These obstructions can hide an array of defects and should be removed to allow full inspection to be carried out. A re-inspection is recommended once the areas are made accessible.
