Building and Timber Pest Inspection Report

Inspection Date: Wed, 21 Jan 2026

Property Address: 39 Lachlan Cres, St Georges Basin NSW
2540, Australia

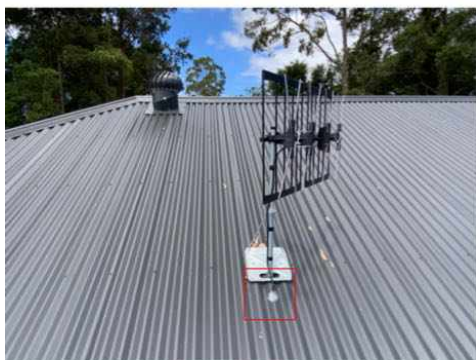
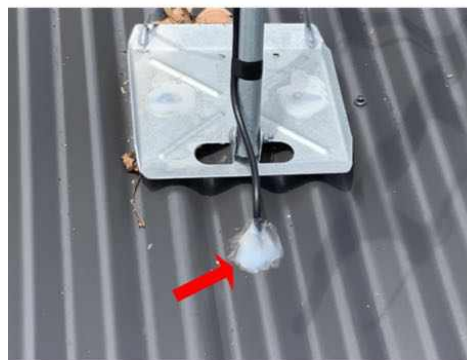
Finding 3.02

Building:	Main Building
Location:	Roof Exterior
Finding:	Roof Penetration - Flashing inadequate/ missing (Sealant will deteriorate short term - a suitable flashing is required)
Information:	Some sections of the roof are missing or have inadequate roof flashings. Flashings are metal and other materials which are applied to seals and intersections between roof coverings and building elements. They are designed to aid in weatherproofing of roof joins.

Flashings that are not installed adequately or are missing are likely to result in water penetration to the interior of the property, as well as creating excessively damp conditions against the exterior surfaces and around the base perimeter of the building.

Premature ageing and secondary building defects are imminent where roof plumbing is missing or inadequately installed. Additionally, water pooling also creates an environment that is susceptible to termite and pest infestation.

A roofing plumber should be appointed as soon as possible to install relevant roof plumbing materials, ensuring that no further damage is sustained.

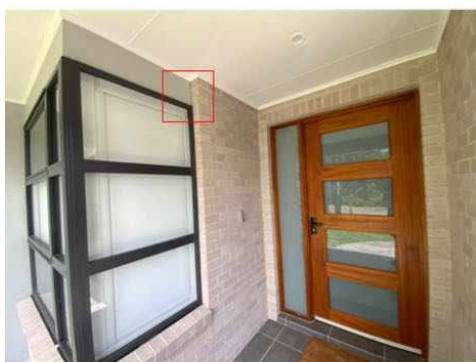
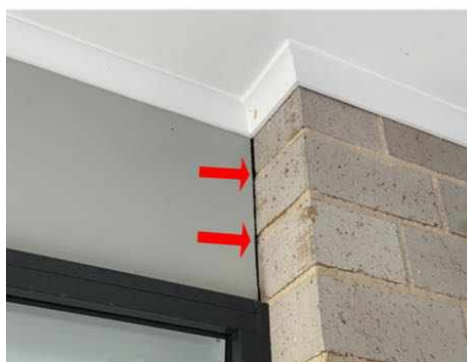
Finding 3.03

Building: Main Building
 Location: Entry
 Finding: Beads - Missing
 Information: Beading acts (like cornice or skirtings) to cover the intersection or joins of building materials. It was noted at the time of inspection that beading in this area is missing.

Beading is important in weatherproofing the surrounding building elements and preventing termite or pest ingress. Furthermore, beading works to protect the joins of building materials, which are more susceptible to deterioration and decay.

Replacement of the beading is advised to ensure the protection and longevity of any associated building elements. Such works may be performed by a general handyman or qualified carpenter.

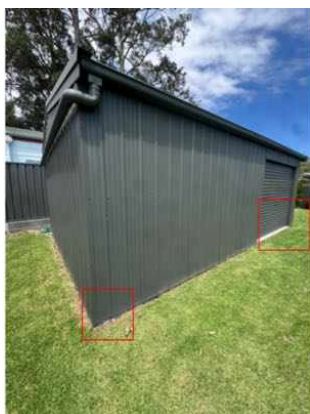
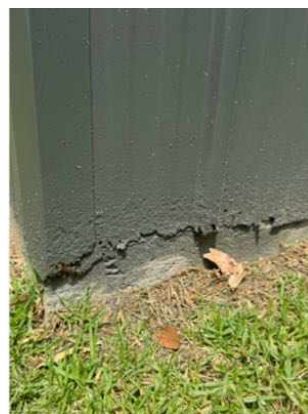
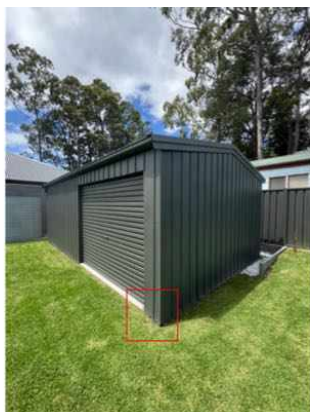
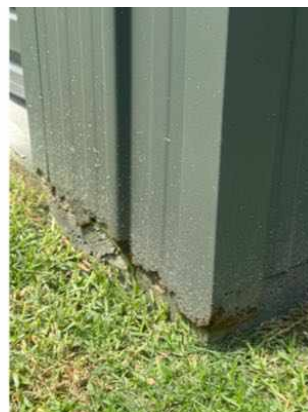
Finding 3.04

Building: Shed
 Location: All Areas
 Finding: Building element - Rusted or corroded (Bottom of wall sheeting to some areas)
 Information: This building element shows evidence of rusting and corrosion, which is likely to have developed as a result of excessive exposure to moisture and or inadequate coatings.

As surface rust provides no protection to the underlying iron, the deteriorating condition is likely to worsen if not addressed in the short-term future.

Where possible, the use of galvanized (treated) metals or aluminium coated metals aid in rust prevention, as does regular general maintenance. Rust formation can be controlled with coatings, such as paint, that isolate the iron from the environment.

Rusting and corrosion should be managed by ideally removing or limiting the affected surface from exposure to moisture. A registered builder may be appointed to replace any building elements that have been severely affected by rust or water damage.

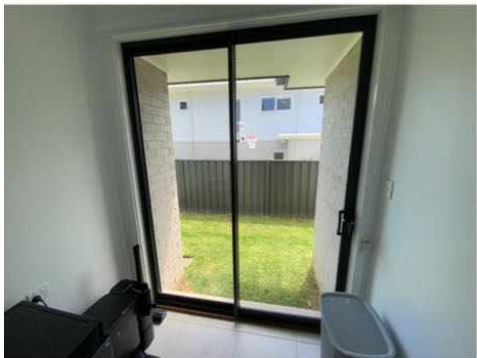
Finding 3.05

Building:	Main Building
Location:	All Areas
Finding:	Flyscreens - Missing to External Sliding Doors
Information:	Flyscreens were found to be missing to the windows in this area at the time of inspection. Whether the flyscreens have not been installed or have been removed post-installation, this missing building element detracts from the operational state of the window.

Where not replaced, missing flyscreens allow pest and insect ingress into the adjoining room/s. It is advised that all missing building elements be replaced in order to ensure the full function of all building structures.

A general handyperson may be appointed to replace flyscreens at the discretion of the client.

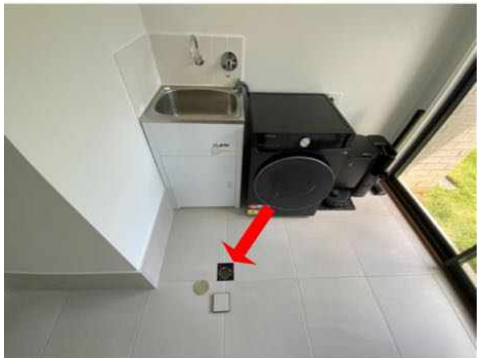
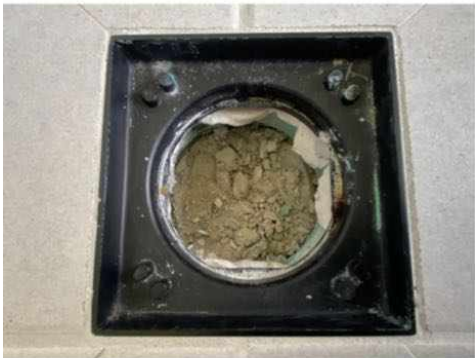
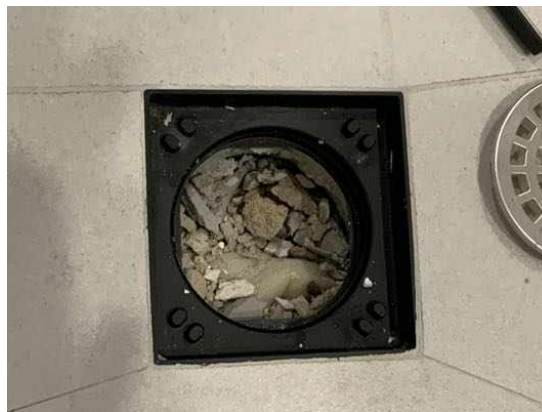
Finding 3.06

Building: Main Building
Location: Laundry & Bathroom
Finding: Installation - substandard or incomplete (Floor drain blocked)
Information: The installation of this building element appears to have been completed to a substandard level of workmanship or is incomplete. Generally substandard repairs or installation are related to poor workmanship, the use of inappropriate materials, or a failure to complete installation to a suitable standard.

Where installation is substandard and/or incomplete, the client should contact the responsible trade to undertake rectification. Unfinished and substandard building works are likely to degrade more quickly and may create potential for secondary defects to associated building elements.

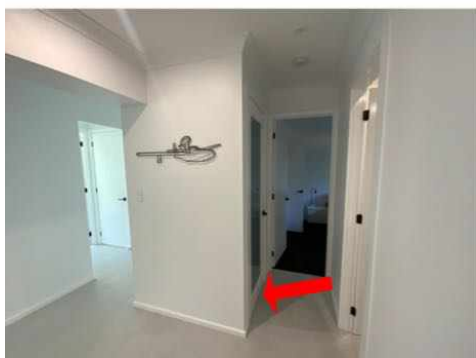
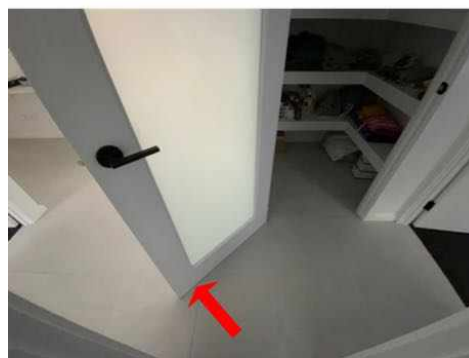
Finding 3.07

Building:	Main Building
Location:	Linen Cupboard
Finding:	Door - Binding/jamming
Information:	Binding and/or jamming of this door is evident during standard operation. This defect inhibits the functionality of the affected door as well as creating potential for secondary defects to associated building elements, such as damage to the floor covering.

A door that binds to flooring or to the associated door frame may have several causes, ranging from minor defects, such as poor installation of the door or deteriorated hinges, through to major structural issues, such as damage to subfloor structures.

Where door binding/jamming appears to indicate major structural issues, a registered builder specialising in re-stumping should be appointed to provide an estimate on the cost of rectification.

For minor causes, a qualified carpenter or general handyman should be appointed to perform minor rectification works at client discretion.

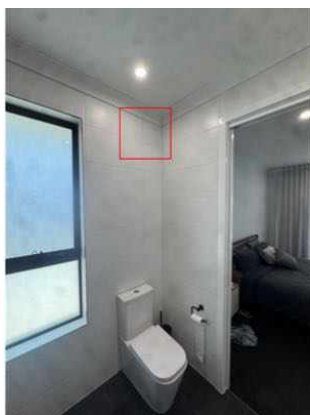
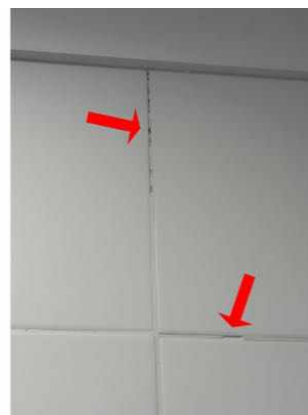
Finding 3.08

Building:	Main Building
-----------	---------------

Location:	Ensuite - Master
Finding:	Grout - Missing
Information:	Grout is missing in this area. Grout is used to protect gaps and crevices in building materials to ensure that they are water-tight and prevent water penetration to the associated structures.

Where grout is missing, a tiling contractor should be appointed immediately to apply grout and re-apply any silicone where necessary. Failure to do so is likely to lead to water damage to the surrounding area.

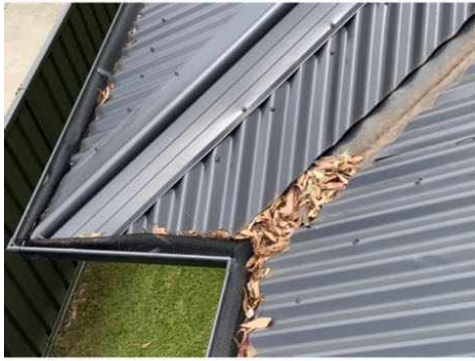
Finding 6.02

Building:	Main Building
Location:	Roof Exterior
Finding:	Gutters - Blocked
Information:	Roof plumbing structures, such as guttering and downpipes, should be free of all debris to prevent blockages. Blockages of the guttering and downpipes will lead to pooling and accumulated water overflows, which is likely to subsequently flood eaves and exterior walls.

Blocked gutters are likely to lead to high levels of moisture in the affected areas. Such moisture will not only cause rust and decay of the associated building materials, but can also provide conditions that are conducive to termite and timber pest activity. Blockages in gutters should therefore be removed immediately to ensure dry conditions are maintained.

Consult a Licensed Plumber for further specific advice on remedial works that may be required. In the interim, it is highly advised that blocked gutters be removed by the homeowner or a general handyperson as a matter of urgency.

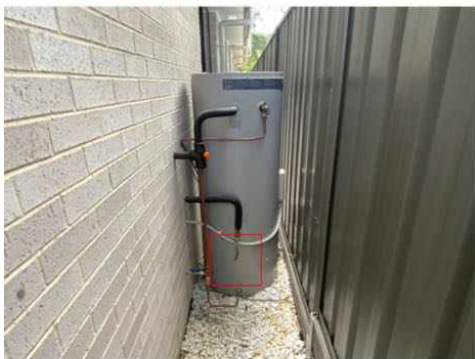
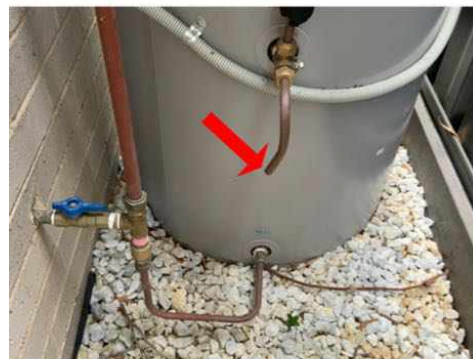
Finding 6.03

Building:	Main Building
Location:	All Areas
Finding:	HWS Overflow - Not Connected
Information:	The Hot Water System (HWS) overflow was found to be disconnected from storm water drainage and is creating excessive moisture in the surrounding area.

These damp conditions can lead to secondary defects such as rot, rust or corrosion of associated building elements, the formation of fungal decay, or even the creation of potential slip hazards. When coupled with poor site drainage, pooling of water may also attract termite activity to this area.

It is highly recommended that a licensed plumber be appointed to connect the HWS overflow in order to prevent such an environment from being created. These minor works should be carried out as soon as possible.

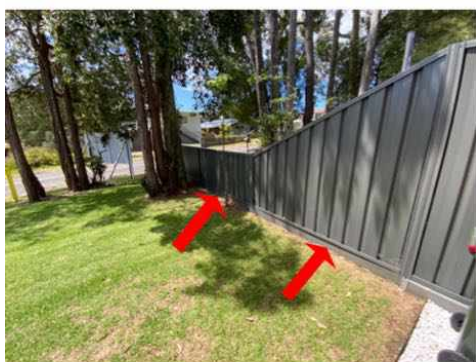
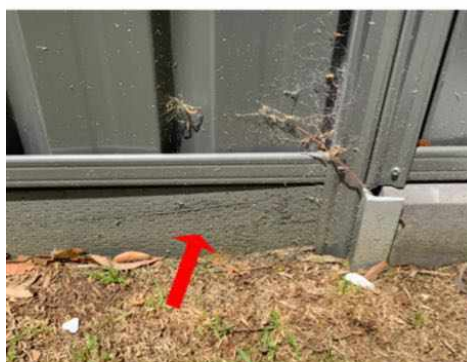
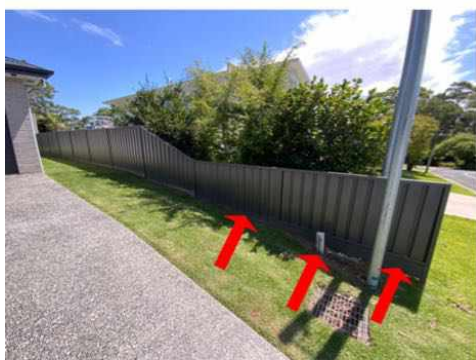
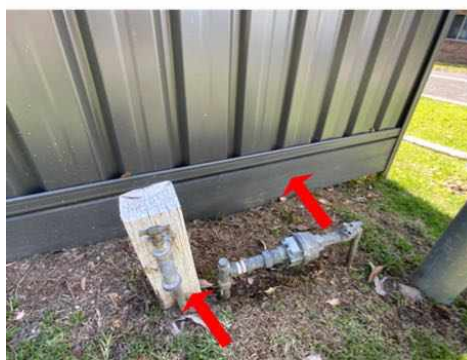
Finding 6.04

Building:	Main Building
Location:	All Areas
Finding:	Timber in ground contact
Information:	To reduce the risk of timber pest attack it is essential that timber used in a hazardous

environment (e.g. in direct contact with the ground or frequently exposed to damp conditions) is of sufficient durability and/or is adequately preservative treated.

Untreated timbers in direct contact with the ground are likely to develop severe wood rot and/or fungal decay if left unattended creating attraction for subterranean termites to infest the timbers from surrounding areas.

If untreated or non-durable timbers are found to be in a hazardous environment it is highly advised that replacement of these building elements be performed as soon as possible to aid the protection of the property against termite / timber pest attack.

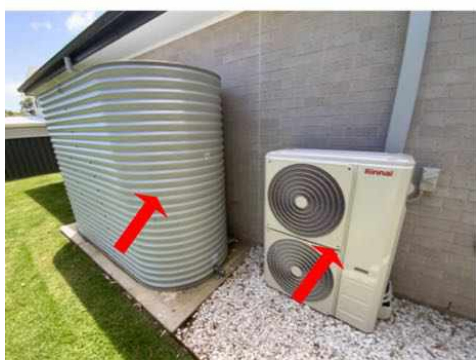
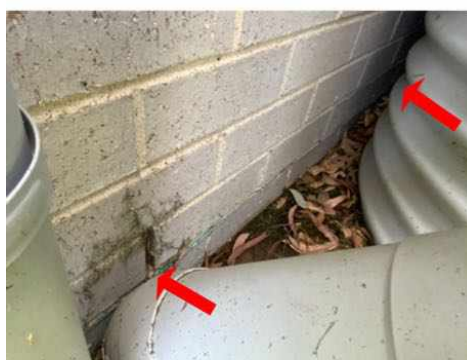
Finding 6.05

Building:	Main Building
Location:	Exterior walls
Finding:	Bridging or breaching of termite barriers - weep holes
Information:	Bridging is the spanning of a termite barrier or inspection zone so that subterranean termites are provided with passage over or around that barrier.

Additionally build-up of moisture is likely to occur if weep holes are covered further attracting termite activity to these areas.

It is highly recommended that weep holes are left exposed in all areas throughout the external property. Therefore if any termite activity leading into weep holes becomes easily detectable during frequent pest inspections.

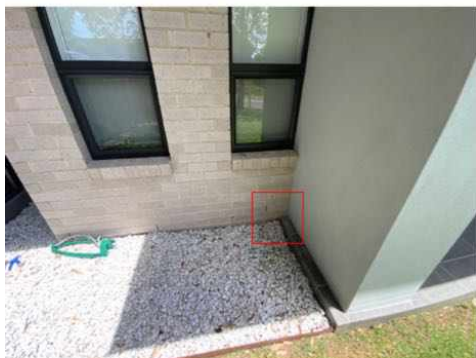
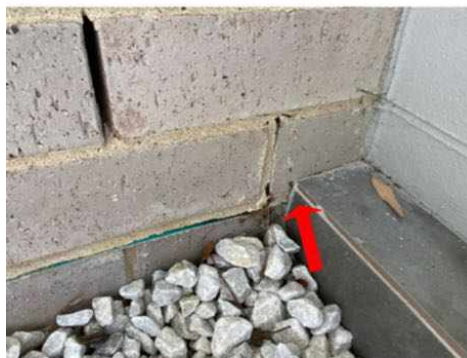
Finding 6.06

Building:	Main Building
Location:	Exterior walls
Finding:	Bridging or breaching of termite barriers - damp course level
Information:	Bridging is the spanning of a termite barrier or inspection zone so that subterranean termites are provided with passage over or around that barrier.

Damp proof course (DPC) is a barrier of impervious material built into a wall or pier to prevent moisture from moving to any part of the building. Where external ground levels are built up over this barrier ingress is provided for moisture from the exterior grounds into the base brickwork or other building material and allowed to rise.

Such conditions attract termites into these damp areas which is likely to lead to infestation if left untreated.

While retrospective fitting of DPC is considered to be impractical works are required in order to prevent the extraction of moisture from the external environment into exterior

brickwork or wall materials. Landscaping or re-paving of external grounds may be considered by the client. Regular annual inspections are strongly advised.

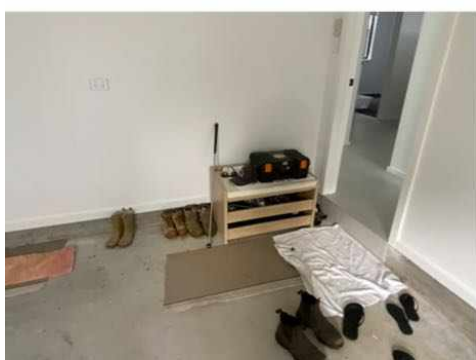
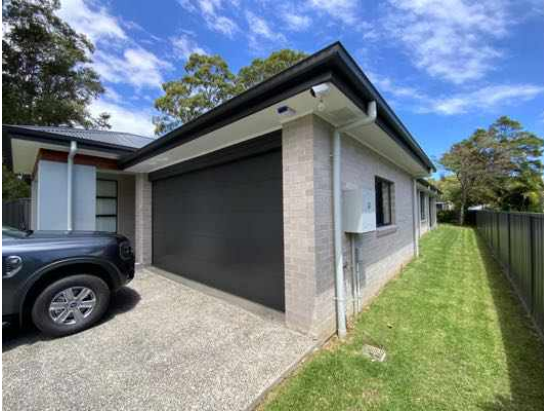
Finding 6.07

Building:	Main Building
Location:	Exterior walls
Finding:	Slab Edge - Exposure
Information:	An inspection zone of at least 75mm in relation to the exposed slab edge, between the bottom brick and the perimeter pavement, is required. This inspection zone should be maintained in order to force termites into the open where they can be detected more readily during regular inspections. The slab edge should not be concealed by anything that may prevent inspection of the area, including render, landscaping, soil, turf, paving, concrete cladding or other structures.

If the slab edge is not properly exposed there is a high risk of termite attack. Sometimes, in order to determine the type of slab, a suitably qualified person such as an architect or builder may be required to consult the construction plans.

Where the slab edge cannot be properly inspected, it is highly recommended that termite or timber pest inspections be carried out every 6-12 months to aid protection of the property against infestation.

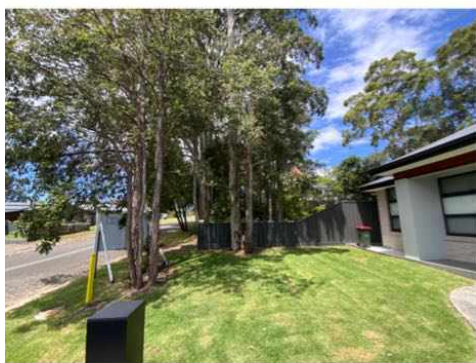
Finding 6.08

Building: Main Building
 Location: All Areas
 Finding: Trees within 50m of the property
 Information: Trees within 50m of the property can be conducive to termite activity. It is recommended an invasive inspection of all trees with 50m to the property be carried out by a qualified pest control expert.

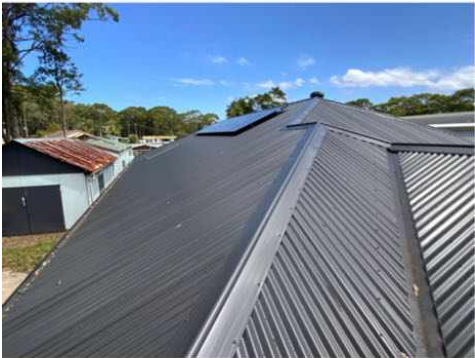
Noted Item

Building: Main Building
Location: Roof Exterior
Finding: Additional Photos - Obstructions and Limitations
Information: These photographs are an indication of the obstructions and limitations which impeded full inspection of the property at the time of inspection. These obstructions can hide an array of defects and should be removed to allow full inspection to be carried out. A re-inspection is recommended once the areas are made accessible.

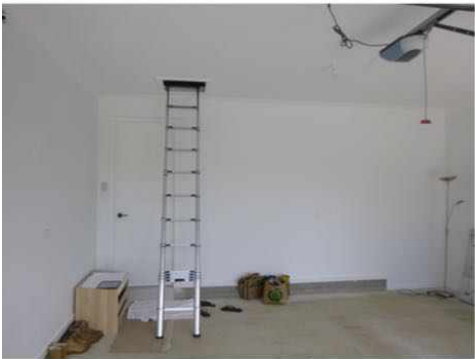
Noted Item

Building: Main Building
Location: Roof Void
Finding: Additional Photos - Obstructions and Limitations
Information: These photographs are an indication of the obstructions and limitations which impeded full inspection of the property at the time of inspection. These obstructions can hide an array of defects and should be removed to allow full inspection to be carried out. A re-inspection is recommended once the areas are made accessible.

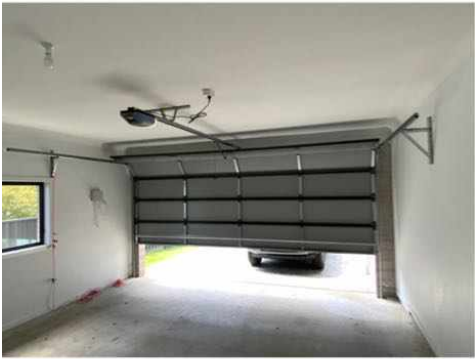
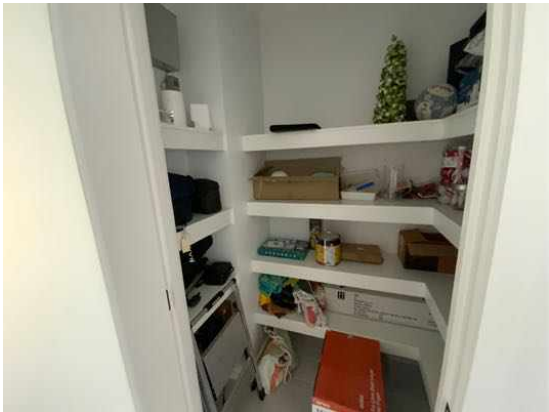
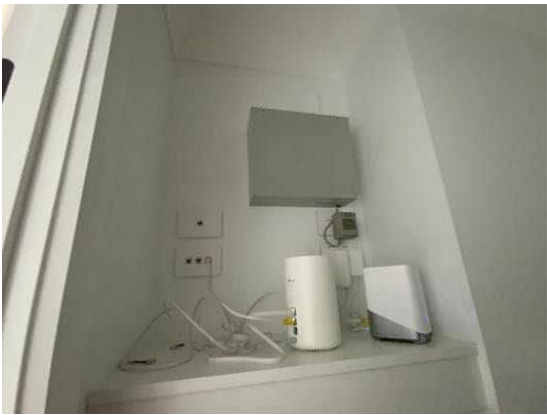
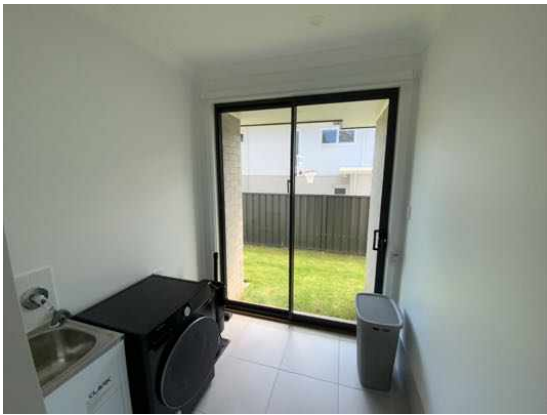
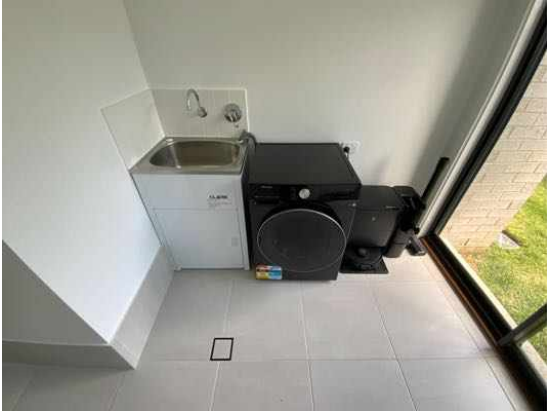
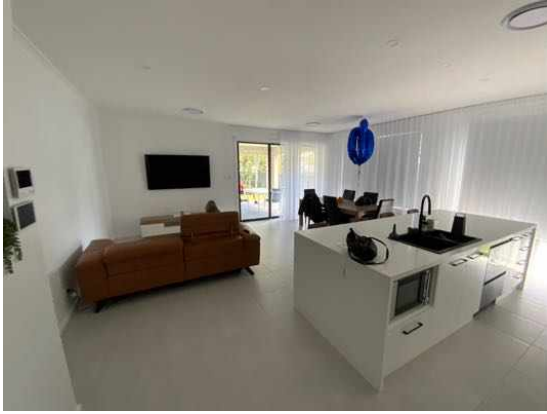
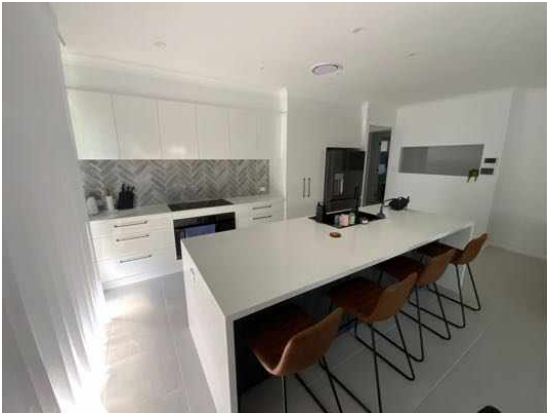
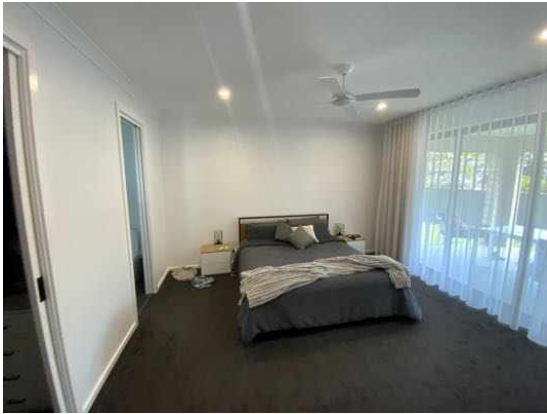
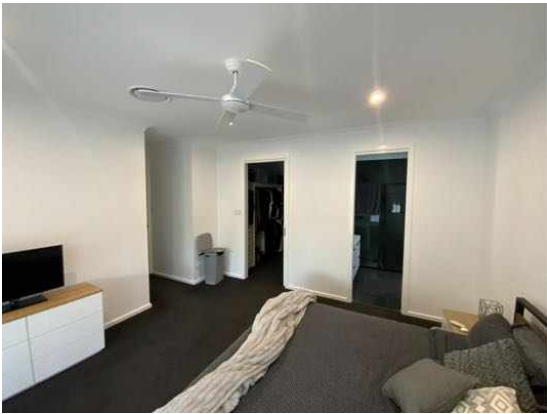
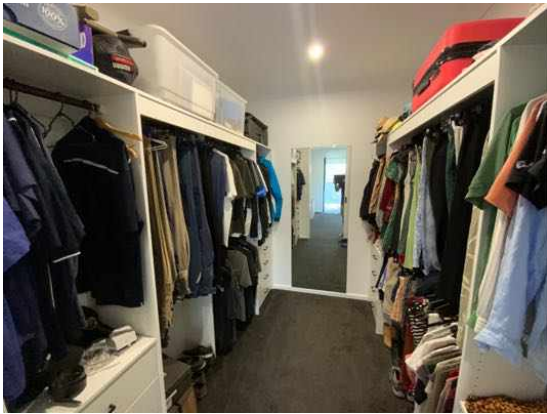
Building:	Main Building
Location:	All Areas
Finding:	Additional Photos - Obstructions and Limitations
Information:	These photographs are an indication of the obstructions and limitations which impeded full inspection of the property at the time of inspection. These obstructions can hide an array of defects and should be removed to allow full inspection to be carried out. A re-inspection is recommended once the areas are made accessible.

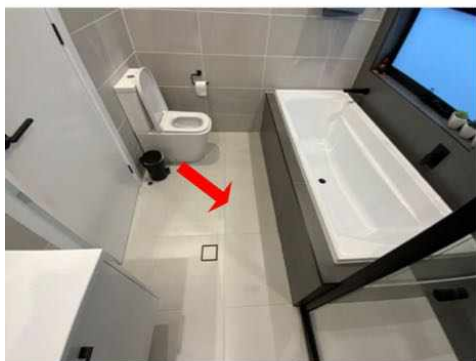
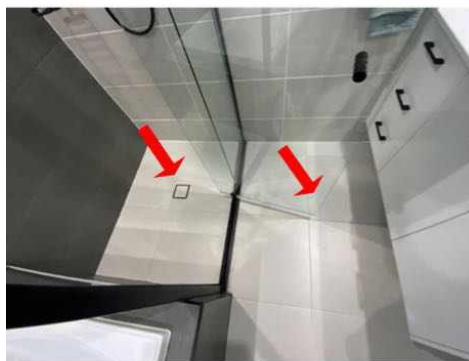
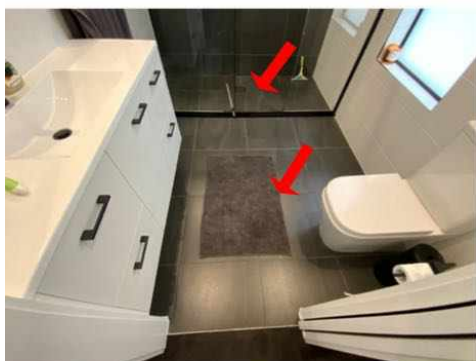
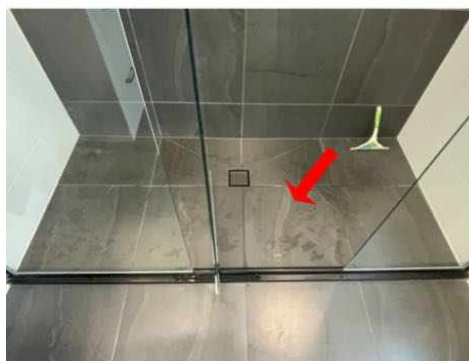
Building: Main Building
Location: All Wet Areas
Finding: Water Proofing Membranes - Information Only
Information: Internal Water Proofing Membranes, are crucial in preventing water ingress into the property is important to know that the Membrane System used is to Australian Standards and has been installed correctly.

With older property's where this information is unavailable all wet areas should be monitored. Generally waterproofing certificates are only valid for approximately 7-8yrs. If any leaks, water staining, peeling or bubbling of the paint become evident to any adjacent walls or ceilings below a licensed builder or waterproofing specialist is recommended to investigate further.

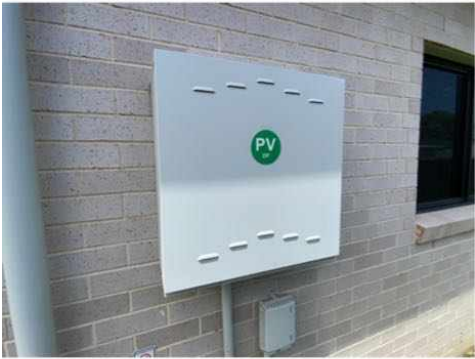
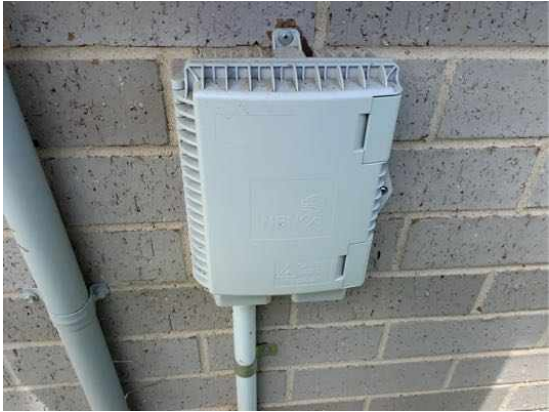
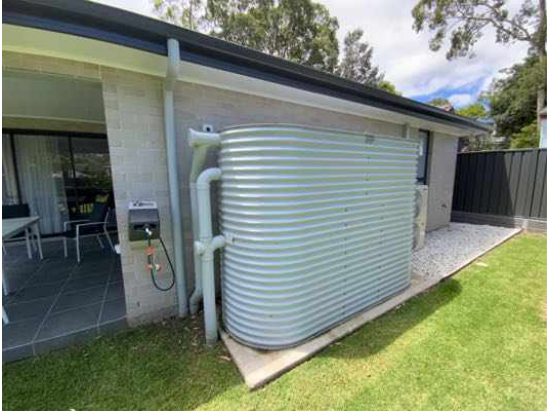
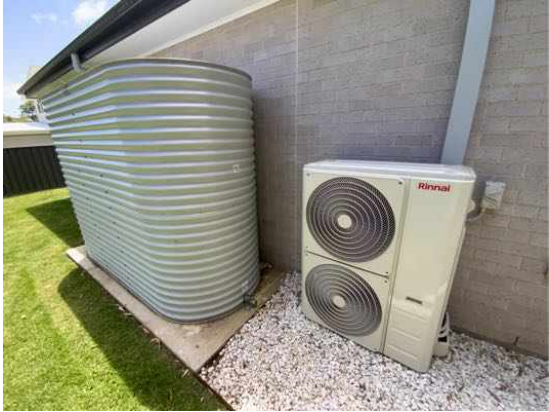
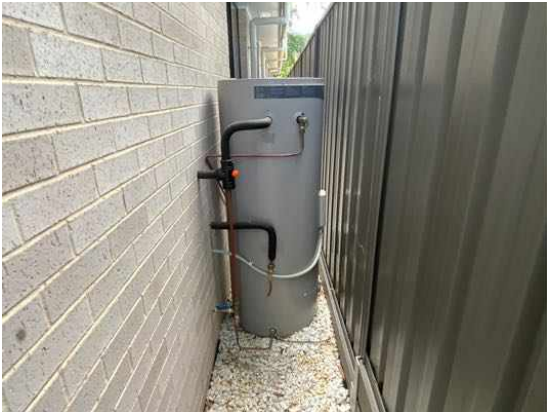
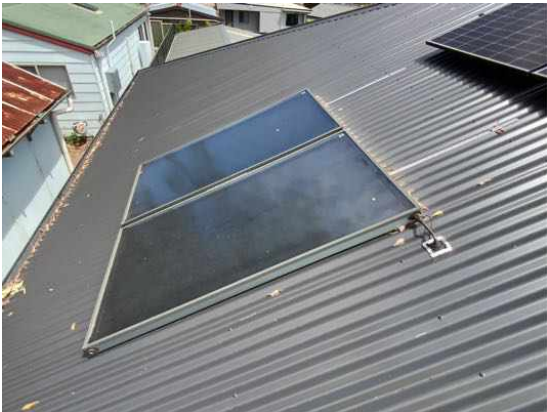
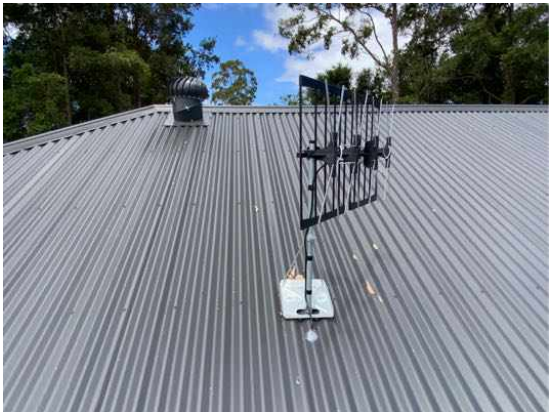
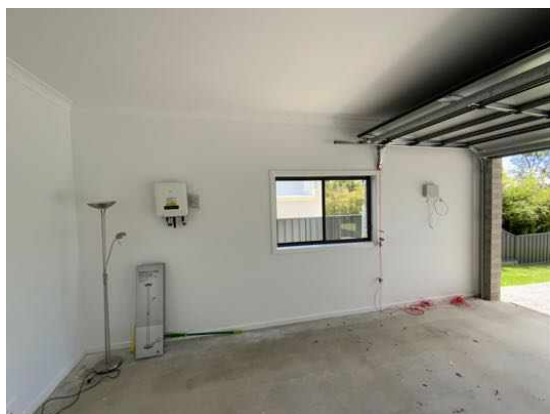
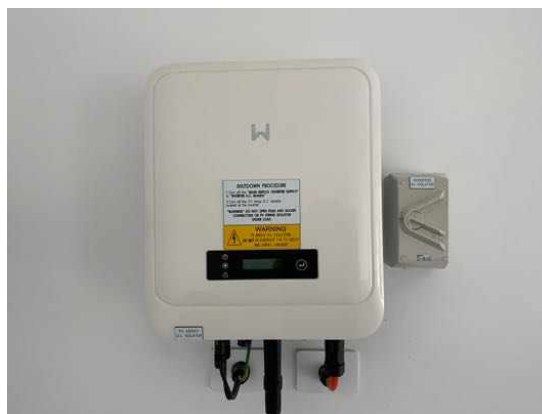
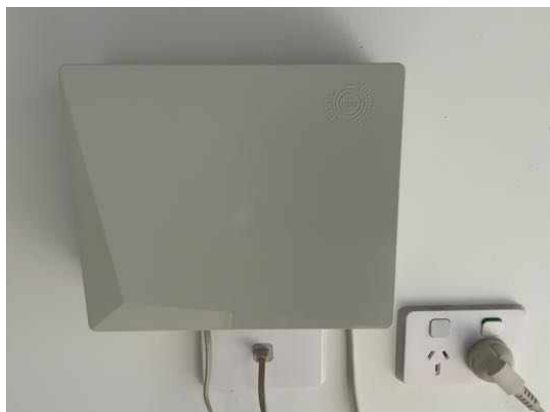
Building: Main Building
 Location: All Areas
 Finding: Additional Photos
 Information:

Additional photos are provided for your general reference. Arrows have been included to highlight areas of importance. Please discuss these photos with your building consultant for clarification.

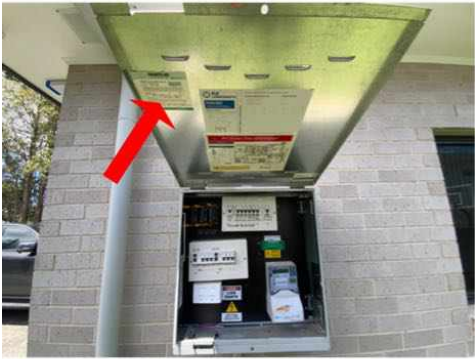
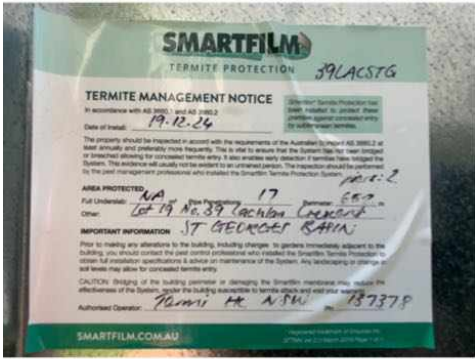
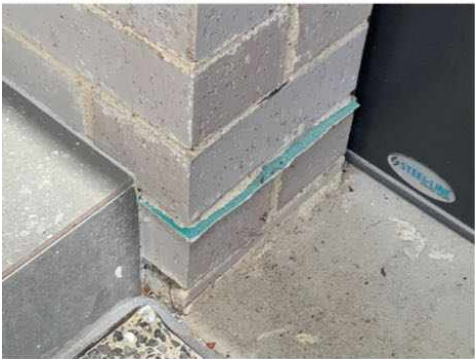
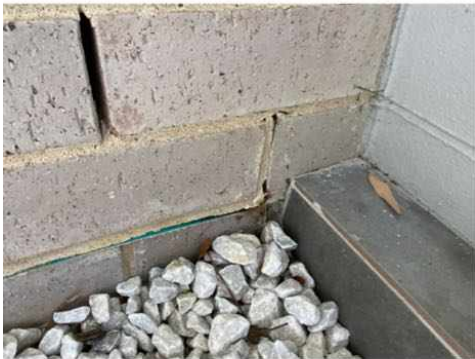
The following items were noted as - Evidence of a previous termite management program

Where a Termite Management System has been identified you should refer to the type of barrier date of installation warranty conditions and any documentation provided by a builder or past owner. Consult the company who installed the barrier to confirm whether the system is still under warranty.

Most chemical termite management systems expire and require replenishment and all physical systems are primarily designed to prevent concealed entry.
