Building and Timber Pest Inspection Report

Inspection Date: Tue, 31 Mar 2026

Property Address: 3/160 Cooper Rd, Yagoona NSW 2199,
Australia

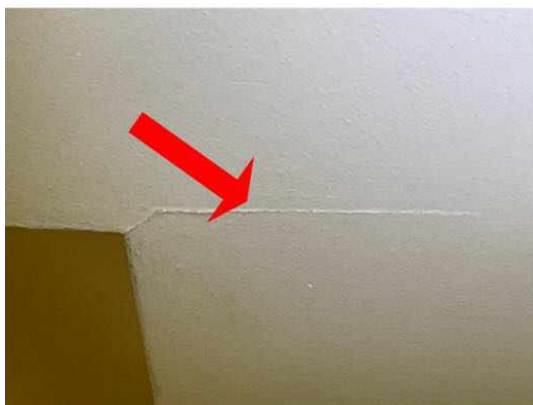
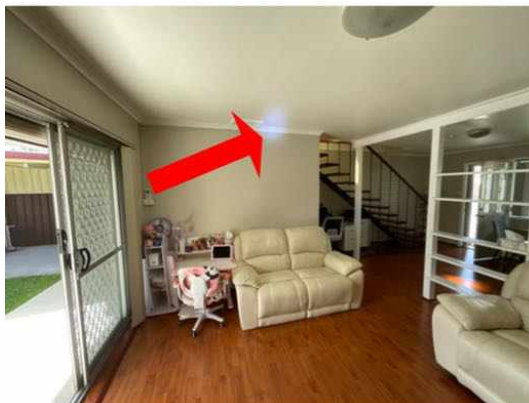
Building:	Main Building
Location:	All Internal Areas
Finding:	Cracking - Damage Category 1 - Fine (up to 1mm)
Information:	Although fine cracks are quite noticeable, they are often only considered to be an appearance defect, and usually do not indicate any structural damage. Generally, the cause of a fine crack is indicative of a separation between building materials and finishes (e.g. paint, plaster, etc.) along joins.

Cracking of this nature can generally be repaired with minor sanding, filling and/or repainting. Such works should be performed by a qualified painter or a general handyman.

Monitoring of all cracking should be conducted frequently. Always contact a building inspector should cracks widen, lengthen, or become more numerous.

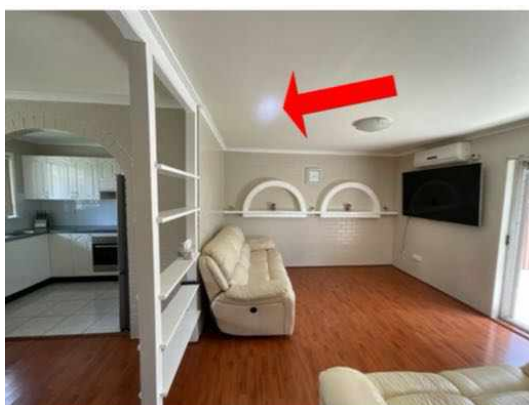
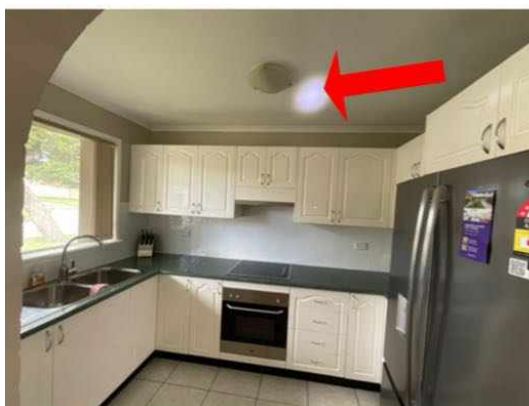
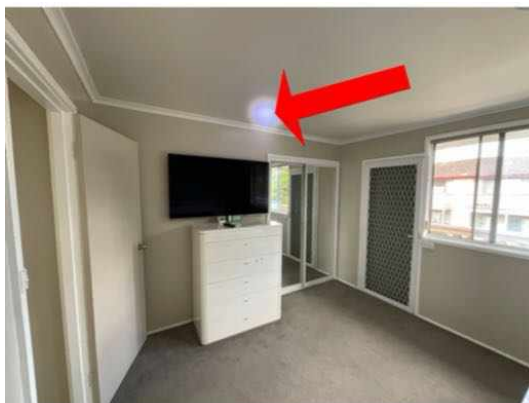
Finding 3.02

Building: Main Building
 Location: All Internal Areas
 Finding: Ceiling nails - Popping
 Information: Numerous popped nails were identified in the internal ceiling at the time of inspection. Nails and screws hold simply by the friction between them and the surface they are applied to. Over time, the nails and screws can back out, which is often a result of general ageing and deterioration of the building structure.

If left unmanaged, the ceiling sheets may become loose and unstable, increasing the rate of deterioration of the internal ceiling and creating potential for the development of secondary defects.

Re-fastening of popped nails will help to maintain the stability of the internal ceiling and associated building elements. Such minor works will also help to improve the appearance of the affected area and secure the ceiling sheets, so as to prevent the onset of ceiling sagging. These works should be performed by a qualified carpenter or plasterer at client discretion.

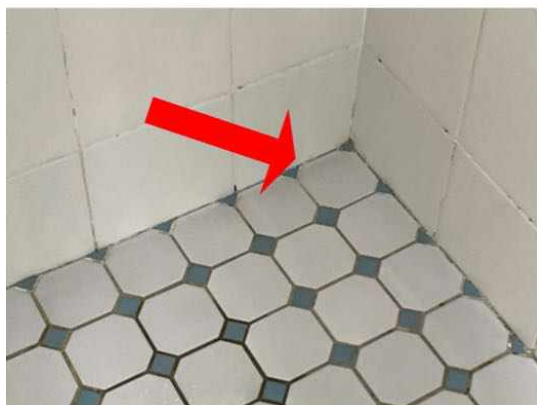
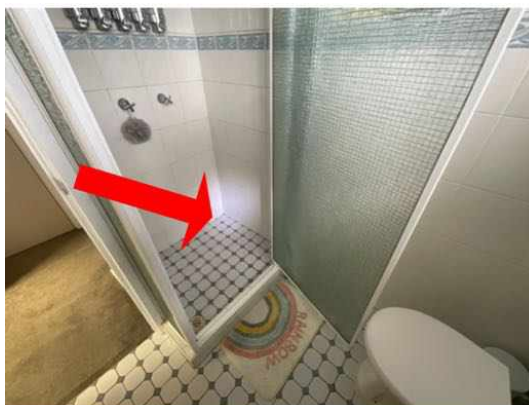
Finding 3.03

Building:	Main Building
Location:	Bathroom
Finding:	Sealant and grouting - Missing or damaged
Information:	It was noted on inspection that sealant or grout is degraded to the tiled shower alcove and or other areas of the bathroom.

Different materials and floor areas move at different rates, generally causing cracking to grout or sealant at this point. A flexible sealant is required to allow for expected expansion and contraction, while keeping the joint water tight and protective of all associated building materials.

There appears to be excessive mould to the sealant and grout which will likely require scraping out and replacement.

Flexible and mould resistant materials should be applied to affected areas to prevent any subsequent water damage that is likely to occur. Regular maintenance and replacement of damage or missing or damaged sealant and grout is highly recommended to the wet areas, as this is a regular wear and tear defect. Sealant and grouting in areas that come into regular contact with water should be maintained for the long term care of your property.

A sealant specialist or tiling contractor should be appointed to complete these works

as soon as possible

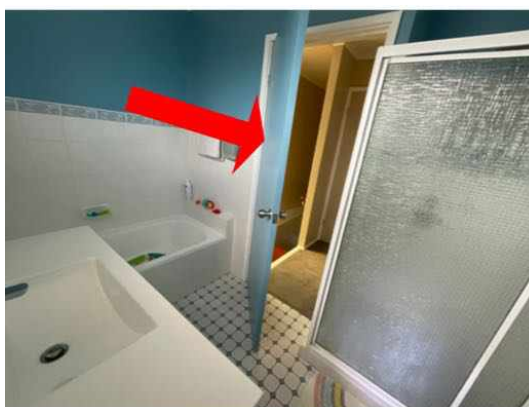
Finding 3.04

Building: Main Building
 Location: Bathroom
 Finding: Door frames - not square
 Information: It appears that one and / or more doors have been installed in a manner which is not consistent with acceptable standards of workmanship. The door frames are not square and or plumb and require rectification.

Deviation from the manufacturer's installation instructions is considered a defect with reference to Standards and Tolerances.

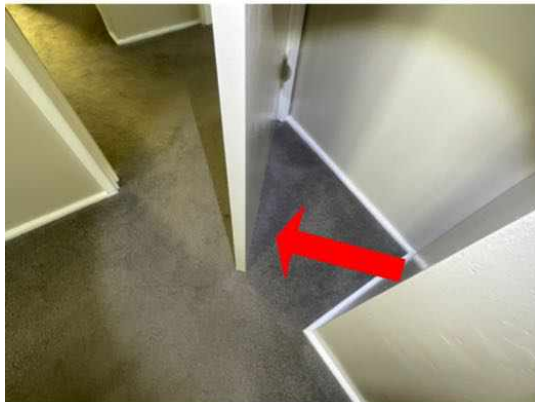
Finding 3.05

Building: Main Building
 Location: Bathroom
 Finding: Door stop - Missing
 Information: The door stop is missing or is inadequate to stop the door handle from damaging the wall. Although some building elements may seem irrelevant or unnecessary, all building elements play a key role in the operation and function of the overall structure and its performance.

Re-installation or replacement of the door stop is advised as soon as possible to prevent any subsequent damage to the door or associated structures. A general handyman may be appointed to perform these works at client discretion.

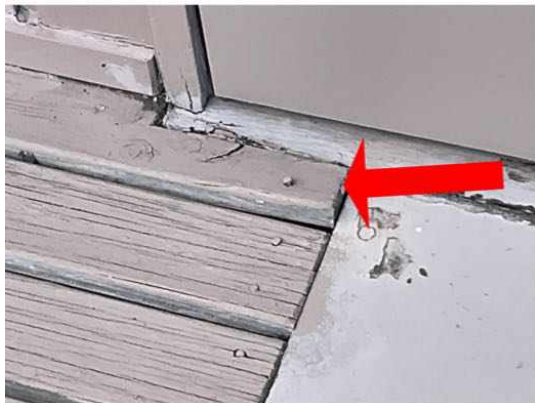
Finding 3.06

Building:	Main Building
Location:	Balcony
Finding:	Decking flooring - damaged
Information:	Damages to decking flooring were found during inspection. The decking timber flooring is typically resistant to water damage, but standing water and large amount of moisture as well as the weathers can eventually destroy the floor and delaminate the product.

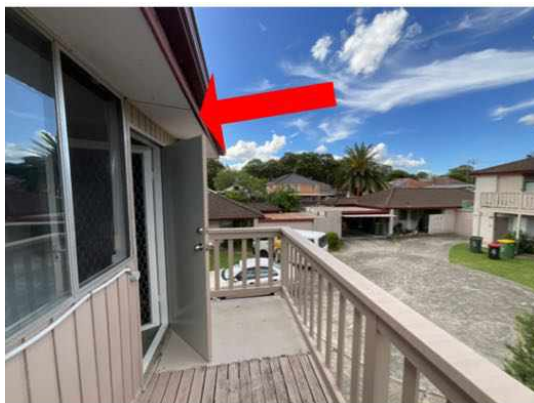
Finding 3.07

Finding: Eaves - Damaged

Information: The eaves around the external property were found to be in a visibly poor condition. The damage may have been sustained as a result of a number of possible causes, including poor roof drainage, leaking roof plumbing or minor impact damage.

The damage to the eave sheeting in this area detracts from the appearance of the structure, as well as potentially compromising the structural integrity of the roofing area.

Where eaves show moderate to severe damage, remedial works may be required. Where water damage is suspected as being the underlying cause, appointment of a licensed plumber is advised as a matter of urgency to identify the source of the water leak.

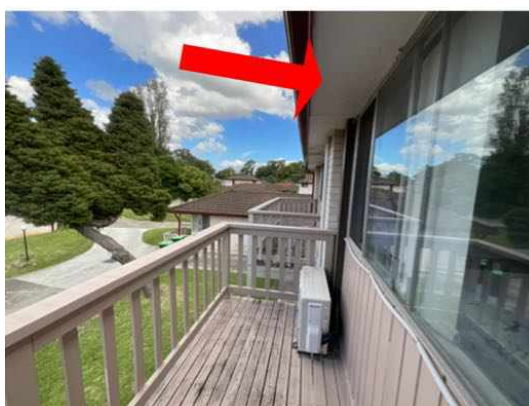
Finding 3.08

Information: Sections of paint in this area was found to have bubbled and deteriorated. Paint bubbling is generally an indication of excessive moisture in the area, that is currently hidden by the painted surface.

The presence of excessive moisture can have major implications on associated building elements if left unattended. While only seemingly minor at this stage, the damage cannot be determined due to the paint obstructing any further inspection of the damage.

It is highly advised that the affected paint be cleaned to allow a further, more invasive inspection by a licensed plumber. Failure to act on this defect may necessitate major works in the future.

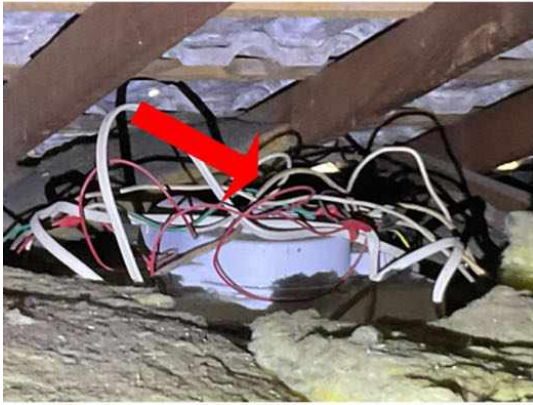
Finding 3.09

Finding: Extractor Fan - Vented into Roof Space

Information: The bathroom extractor flue was found to lead directly into the roof space, rather than venting to the exterior of the building. The positioning of this flue is likely to lead to a build-up of grease and grime in the surrounding area within the ceiling void, which can pose as a fire hazard in the roof void. The presence of insulation surrounding the flue adds to this fire safety risk. Without re-direction to the exterior of the building, the Rangehood is not considered fully operational and is deemed a minor safety hazard. It is therefore preferable that the flue be re-directed to vent into the external environment. A licensed plumber should be appointed as soon as possible to provide further consultation on the scope of these works and to provide quotations for any necessary works.

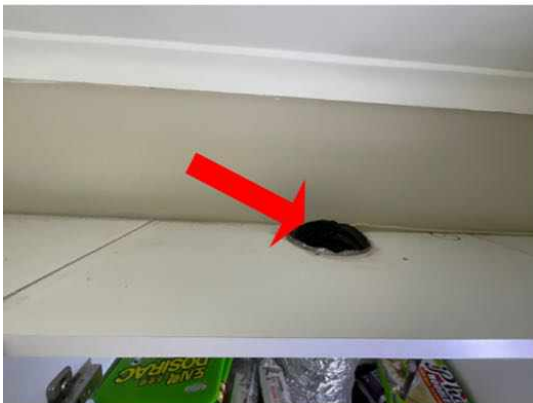
Finding 3.10

Building:	Main Building
Location:	Kitchen
Finding:	Rangehood - Flue disconnected
Information:	The range hood flue has become disconnected and is allowing the emission of steam and evaporative moisture into the ceiling space above.

While this does not create high potential for secondary defects, development of grease is likely to occur in the surrounding area, necessitating regular cleaning and maintenance.

Consultation with a licensed electrician may be required to reconnect the flue and thus allow the emission of gases into the external environment. Works should be completed at client discretion.

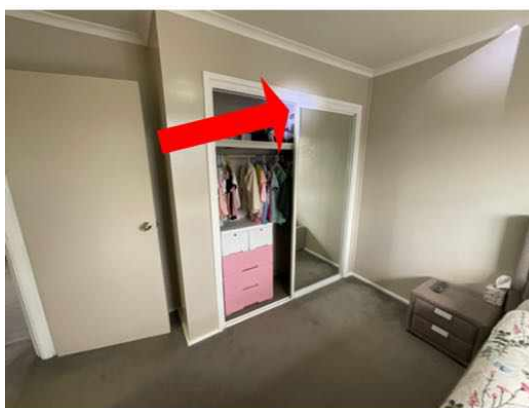
Finding 3.11

Building:	Main Building
Location:	All Internal Areas
Finding:	Paint finish - Substandard
Information:	The paint finish in this area was found to have been completed to a substandard level. Substandard painting is generally classified as an appearance defect. However, the substandard appearance may also be indicative of poor surface preparation and substandard workmanship.

If this applies, further areas of poor and incomplete finishes could develop over time. Furthermore, substandard paint finishes in areas exposed to moisture, e.g. external areas or wet areas, could lead to deterioration of underlying building materials.

Substandard paint finishes should be sanded back, filled, leveled and repainted, as applicable. Where inadequate paint protection has led to the deterioration of the associated building element, repair and/or replacement of this building element may be required.

A painting contractor should be appointed as soon as possible to perform necessary works to aid the appearance of the affected area and to ensure that the area is protected against further deterioration. Alternatively, the homeowner following manufacturer instructions may be able to provide this service.

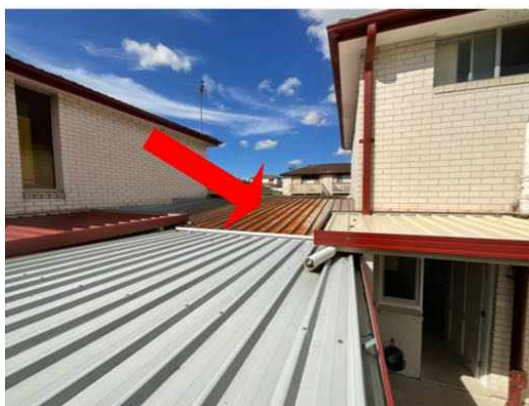
Finding 3.13

Building:	Main Building
Location:	Roof Exterior
Finding:	Roof sheets - Rusted
Information:	Metal roofs generally comprise numerous individual sheets, which join and overlap. These intersections are particularly prone to lift at the edge and consequently rust at these points.

Upon inspection of the exterior roofing structure, evidence of rust to these sections was identified. If left unmanaged, these degrading joins can allow water ingress to the internal roofing structures, potentially leading to secondary damage of building elements. Accelerated deterioration of the roofing sheets and any associated building elements is also likely to occur.

A roofing contractor should be appointed immediately to assess the damage to the roofing sheets and to perform remedial works as necessary. Works may include replacement of severely affected roofing sheets or minor works such as the application of rust-retardant surface protectors.

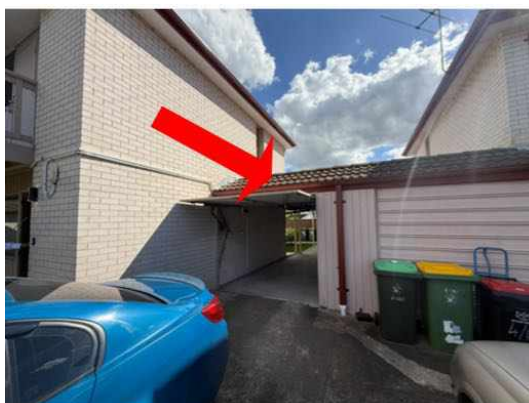
Finding 3.14

Building:	Main Building
Location:	Roof Exterior
Finding:	Roof tiles - Broken
Information:	Upon inspection of the exterior roof covering, broken roofing tiles were identified. Broken and friable roof tiles are generally the result of ageing and weathering of what is essentially a porous material.

If left to further deteriorate, broken and brittle roof tiles are likely to lead to water penetration via the roof into the ceiling space, causing secondary damage to ceiling linings, insulation and roof structures. Broken roof tiles are also likely to detract from the effectiveness of the roof drainage system, creating potential for secondary damage to the exterior roof covering and roof plumbing.

Replacement of broken tiles is required and should be performed by a roofing contractor as soon as possible.

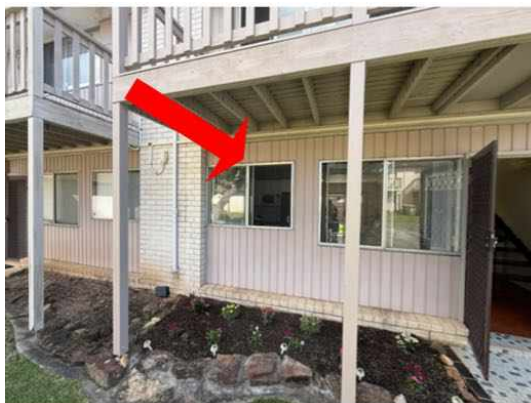
Finding 3.15

Building:	Main Building
Location:	All External Areas
Finding:	External Timber - Weather damaged

Information: Damaged external timber were found during the inspection. External timber structures are constantly exposed to weather elements and can deteriorate in an accelerated manner, ongoing assessments are required.

It is highly recommended that a Structural engineer further assess the external timber balcony/deck to inform the client of its load capacity. Regular maintenance inspections by competent practitioners is needed.

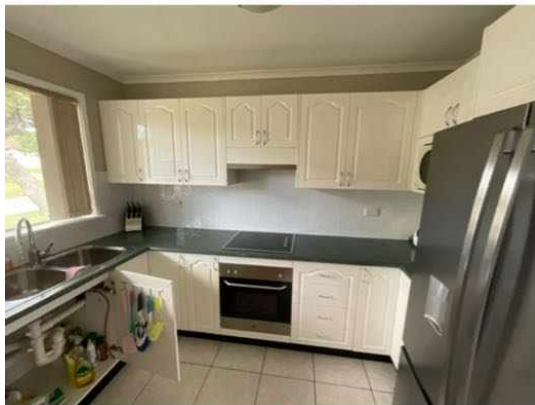
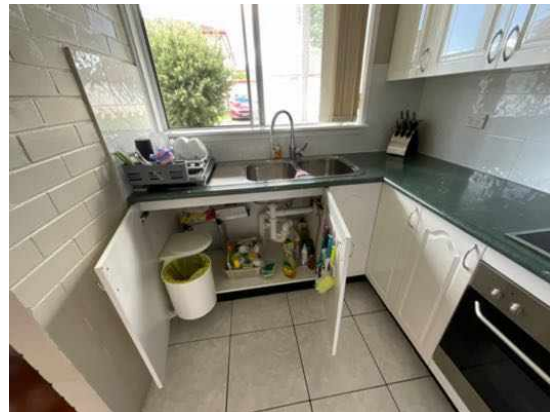
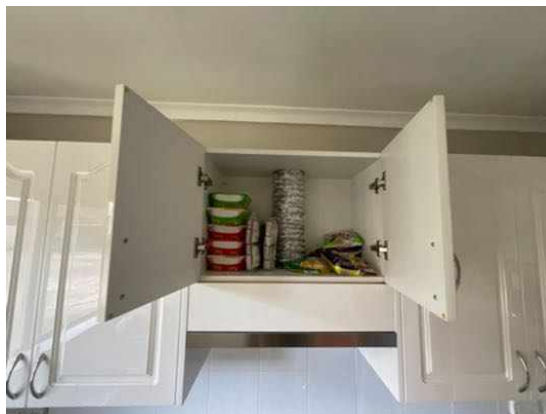
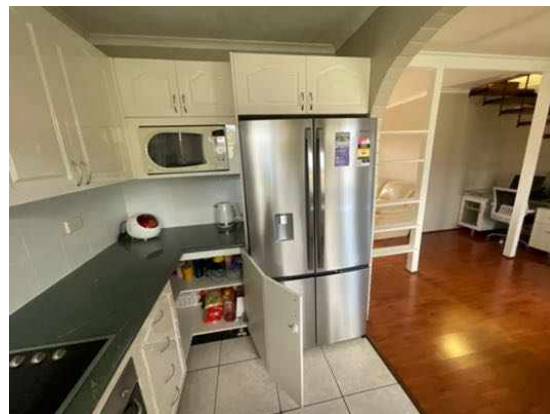
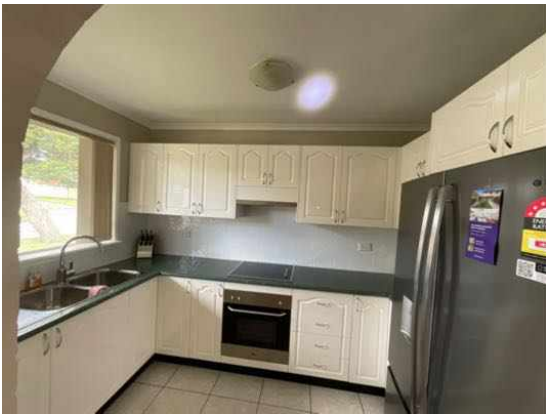
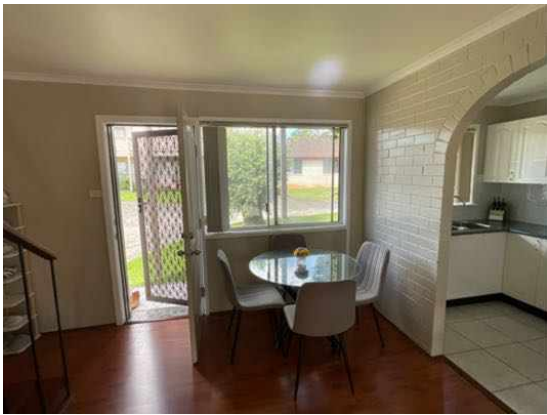
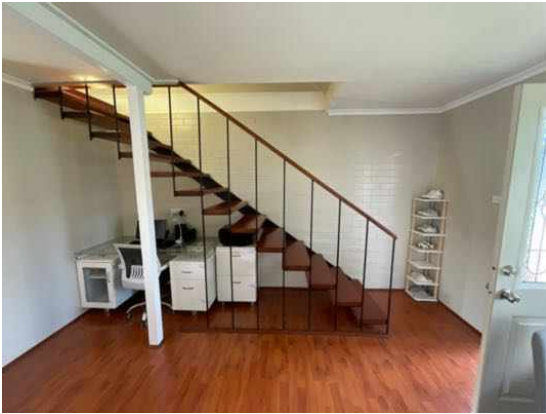
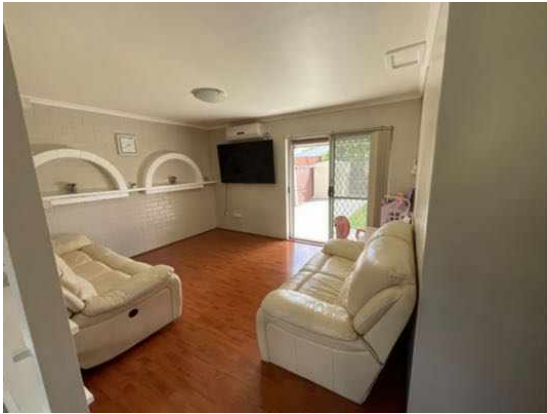
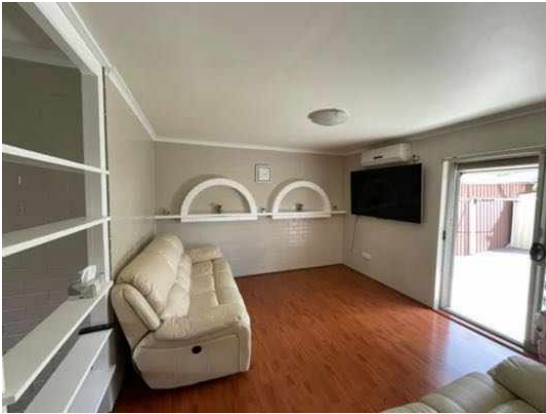
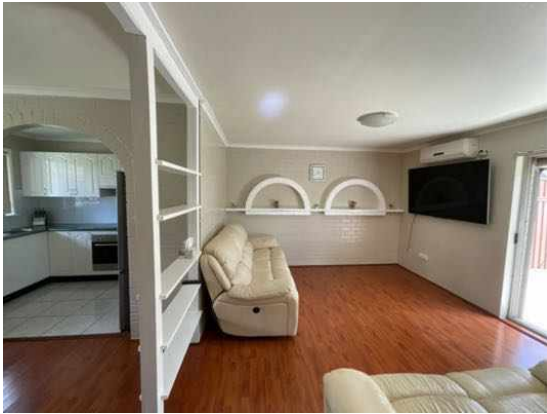
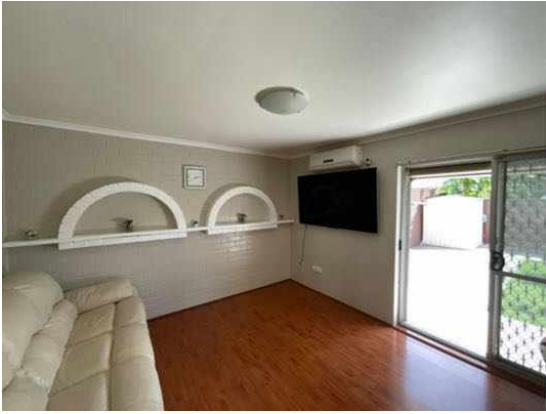
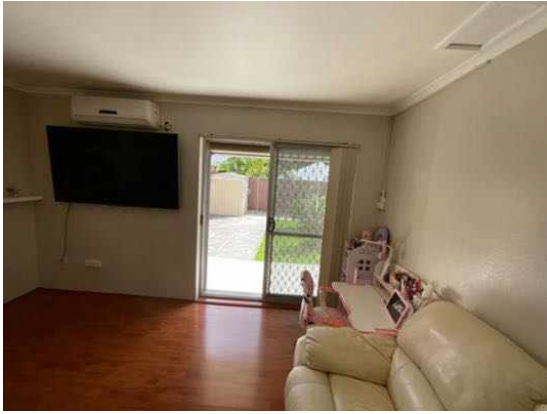
Noted Item

Building: Main Building
Location: All Areas
Finding: Additional Photos - Obstructions and Limitations
Information: These photographs are an indication of the obstructions and limitations which impeded full inspection of the property at the time of inspection. These obstructions can hide an array of defects and should be removed to allow full inspection to be carried out. A re-inspection is recommended once the areas are made accessible.

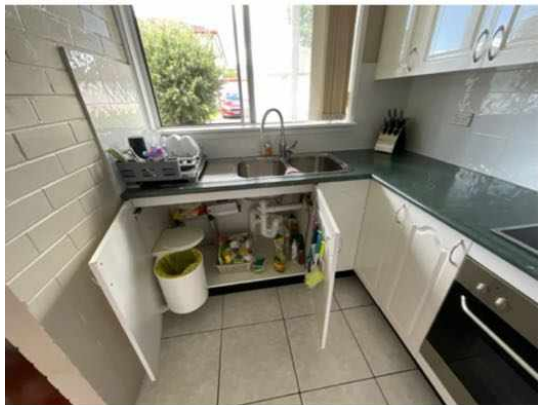
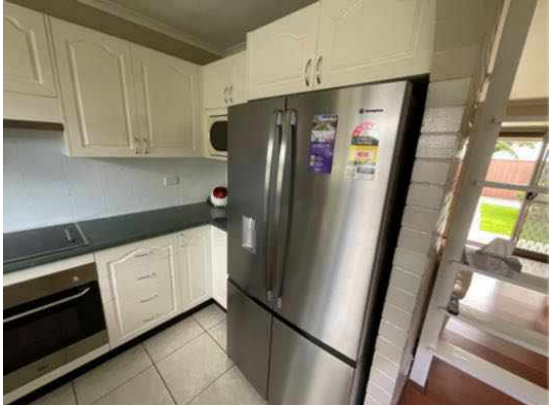
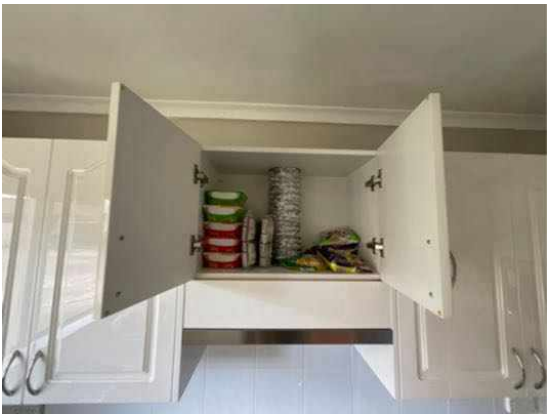
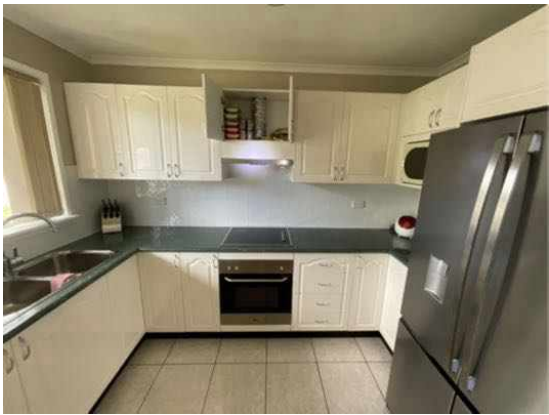
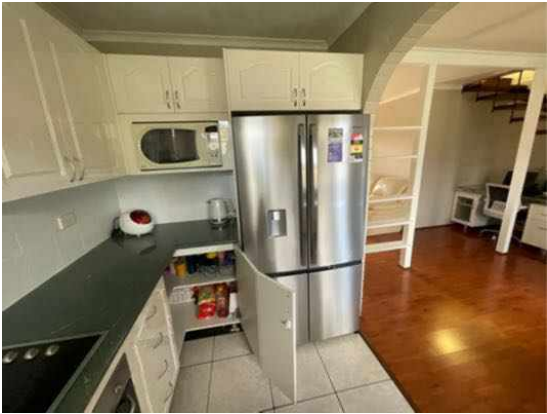
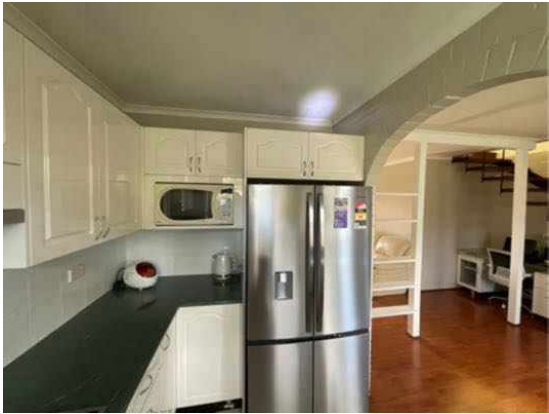
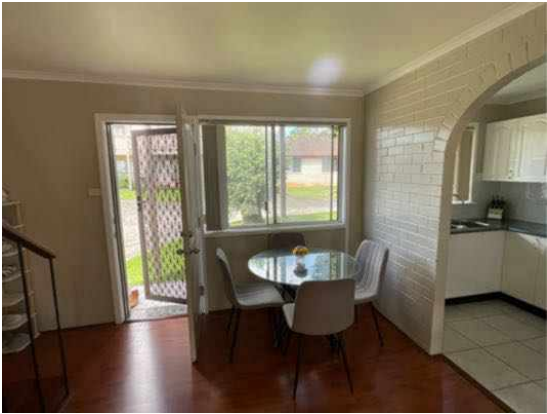
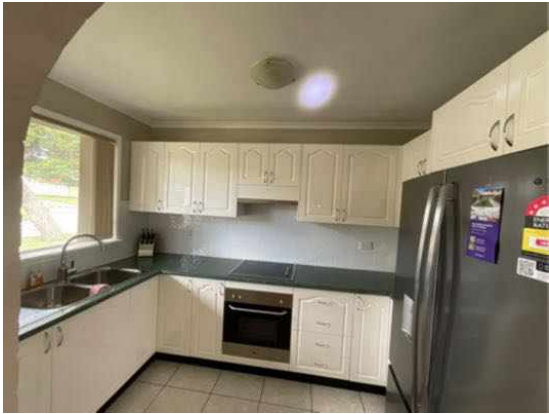
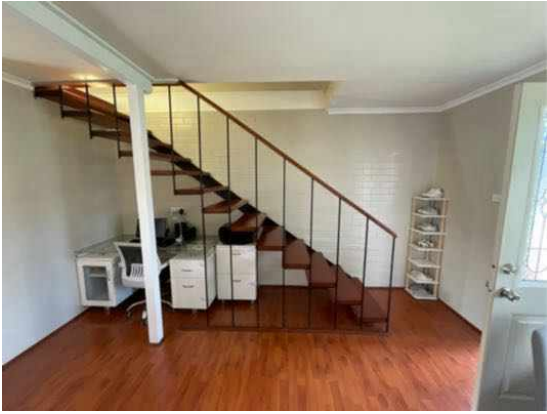
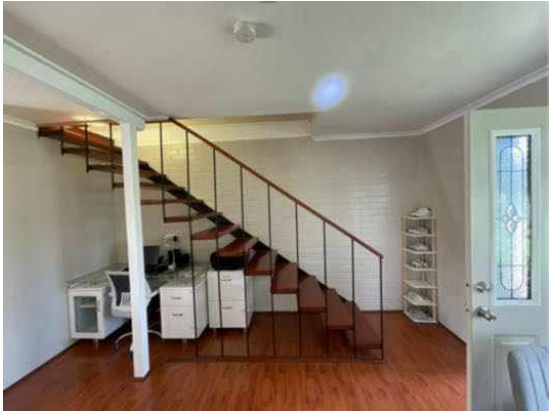
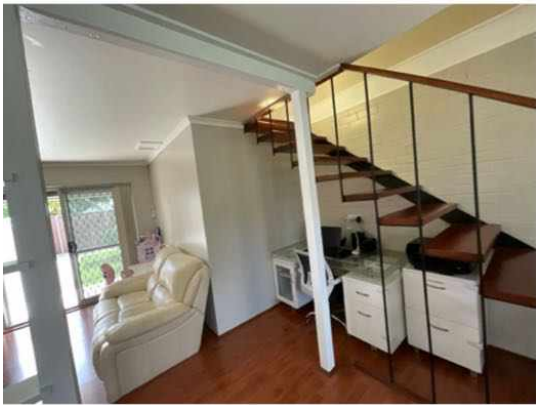
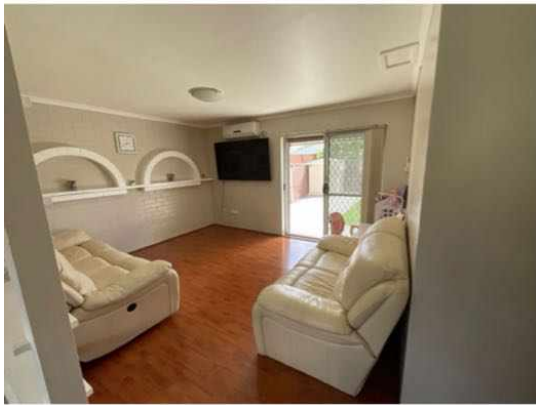
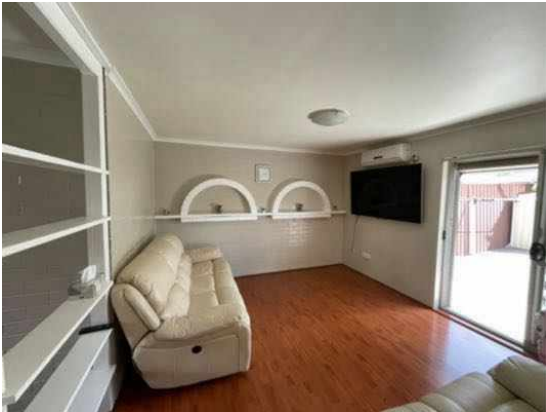
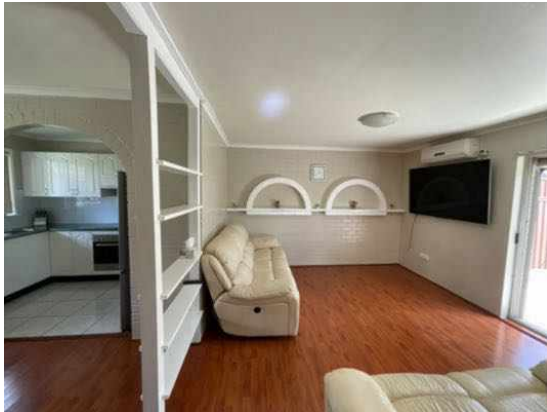
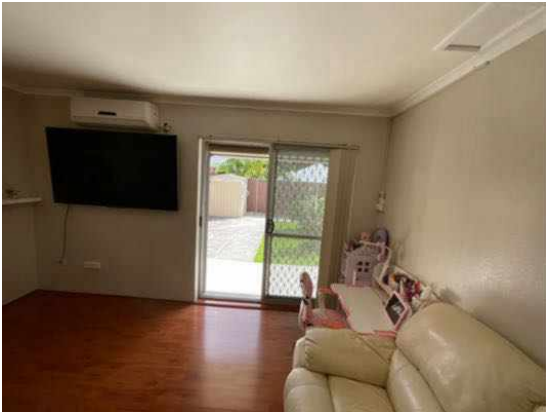
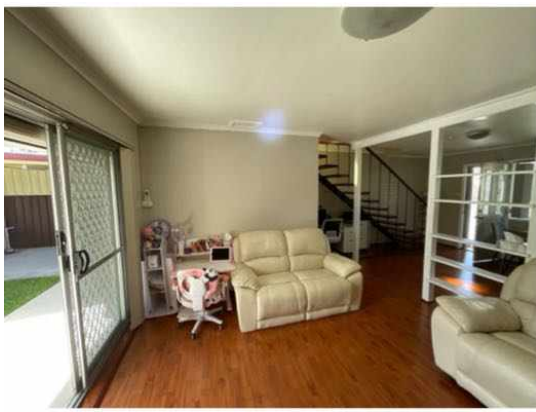
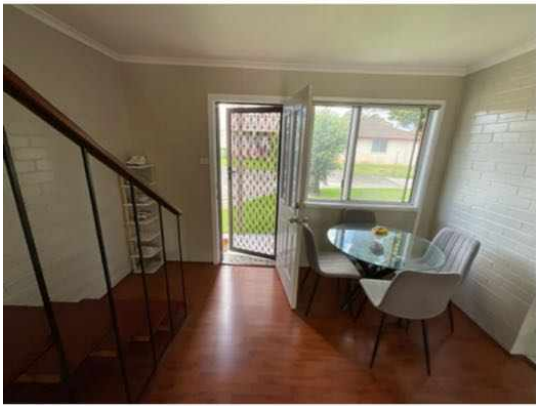
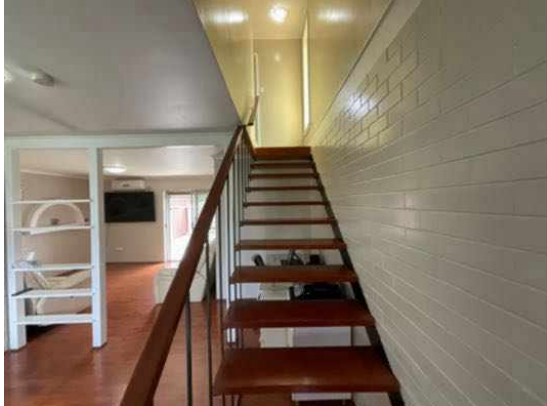
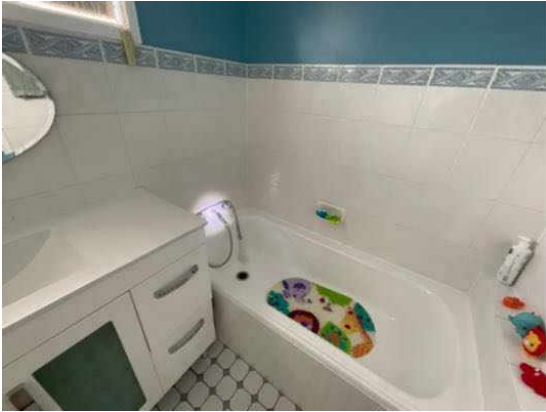
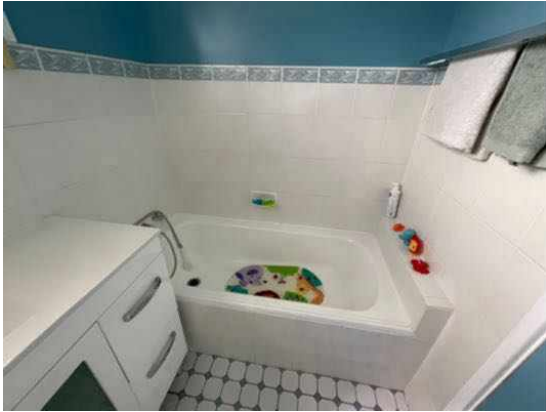
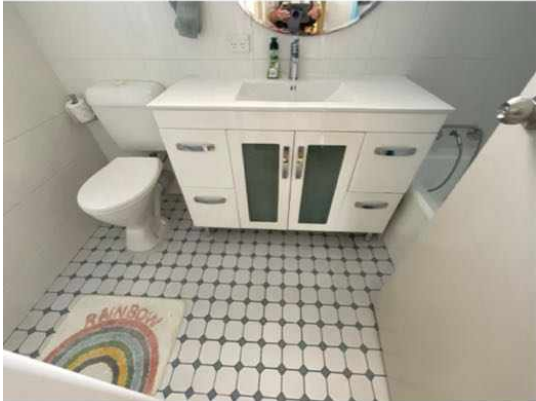
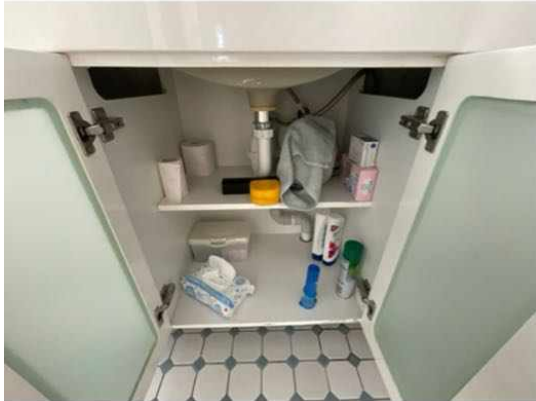
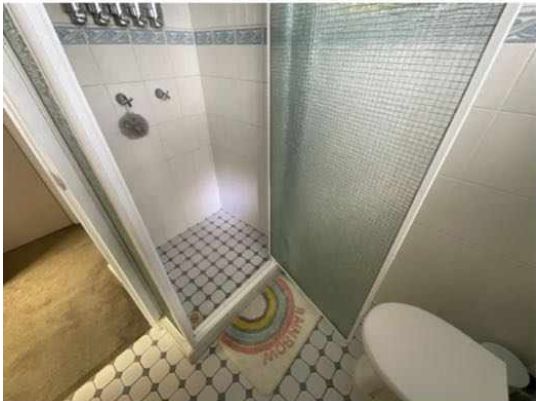
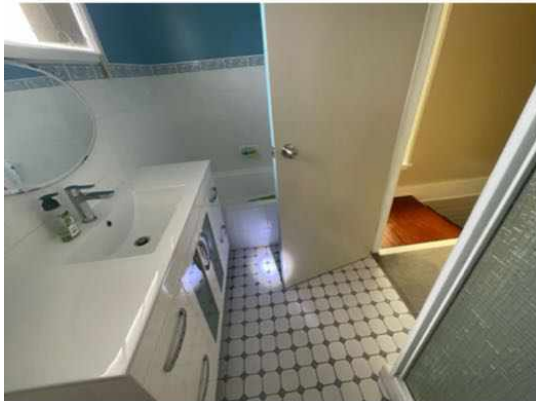
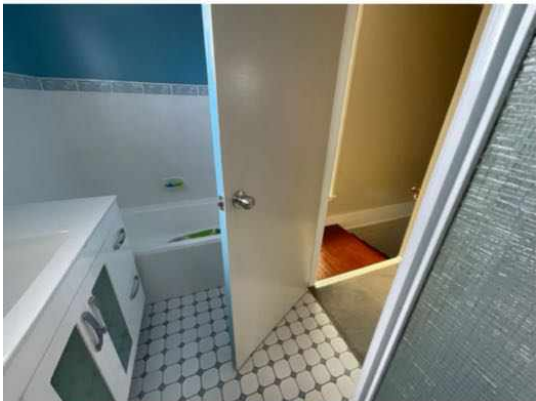
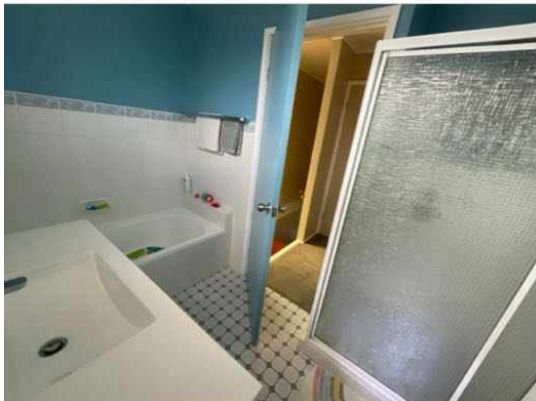
Building: Main Building
Location: All Areas
Finding: Additional Photos
Information: Additional photos are provided for your general reference
