Building and Timber Pest Inspection Report

Inspection Date: Tue, 31 Mar 2026

Property Address: 3/160 Cooper Rd, Yagoona NSW 2199,
Australia

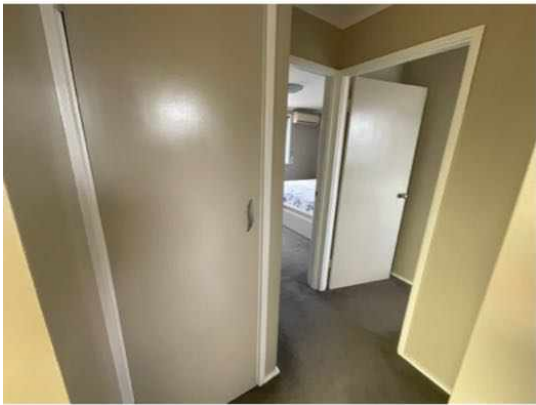
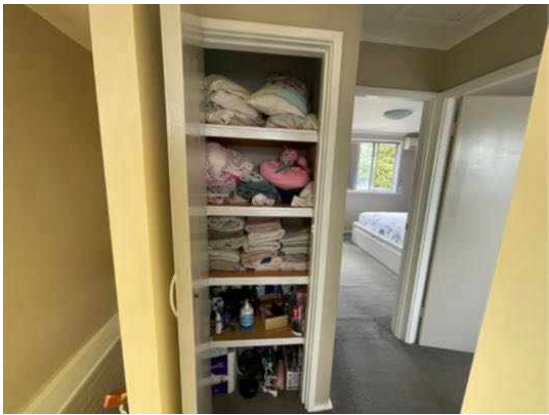
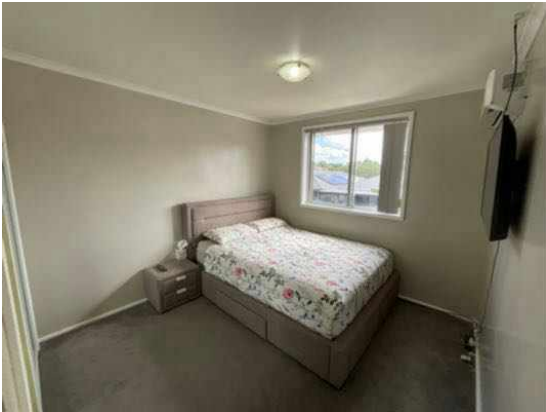
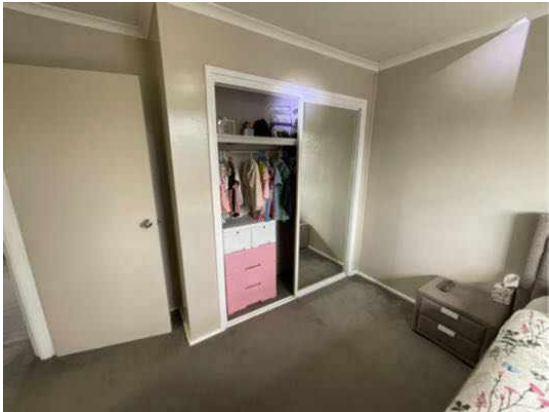
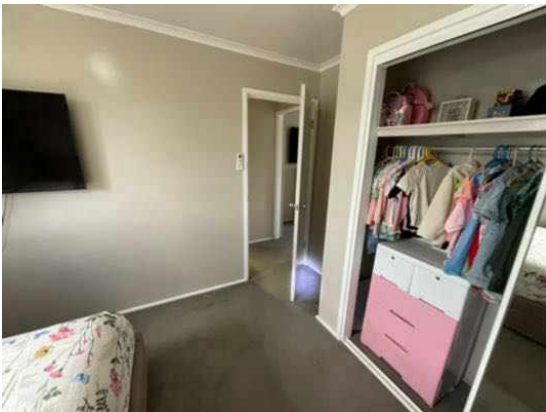
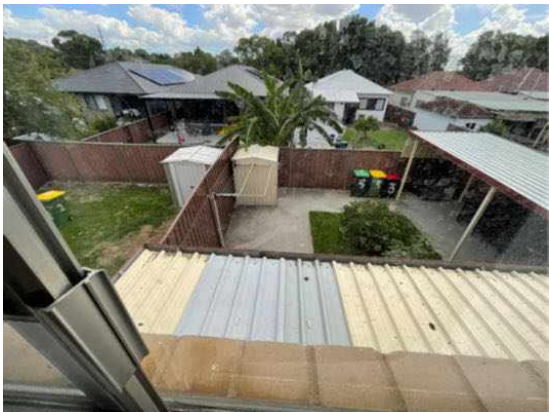
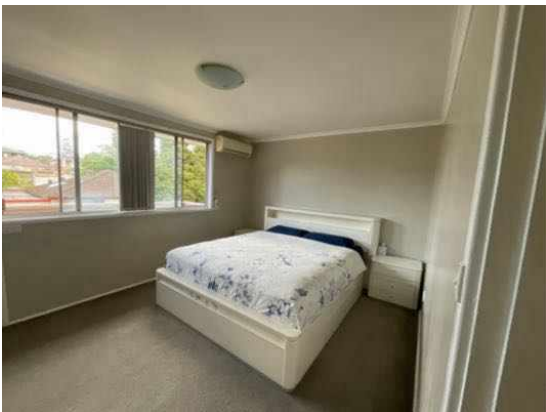
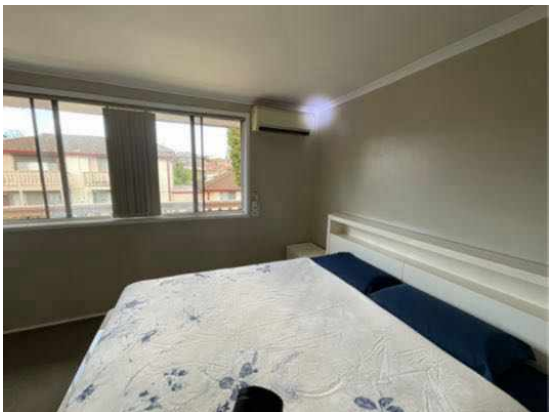
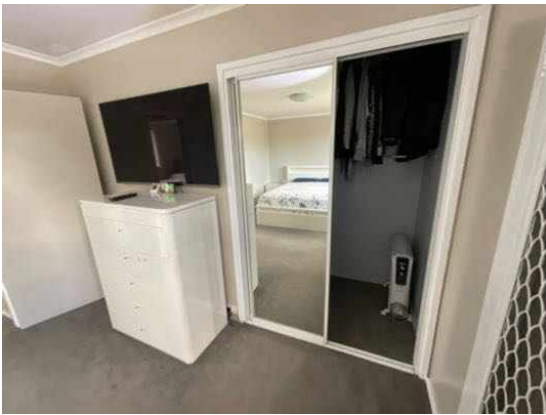
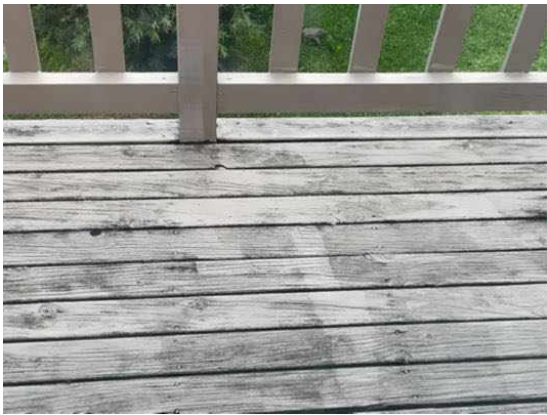
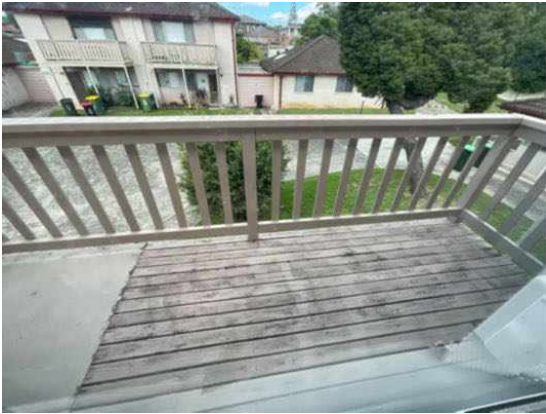
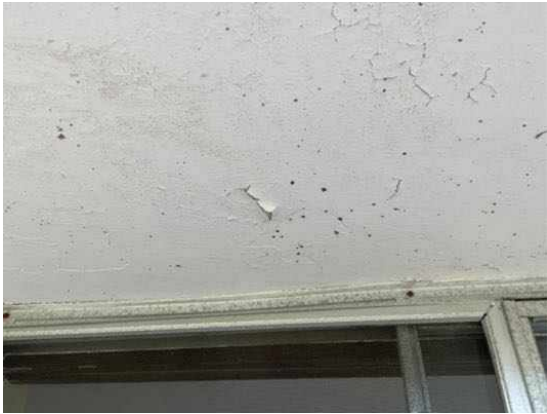
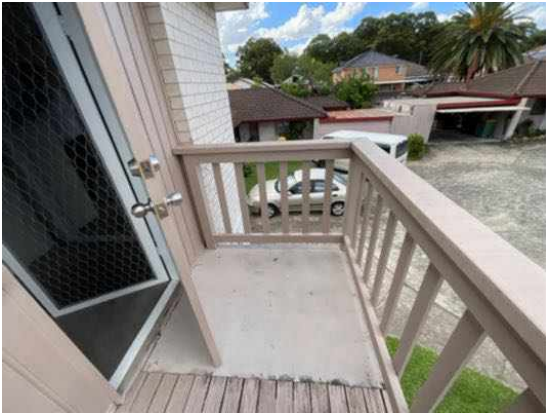
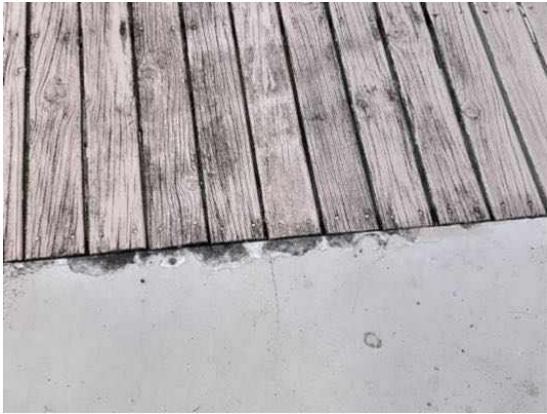
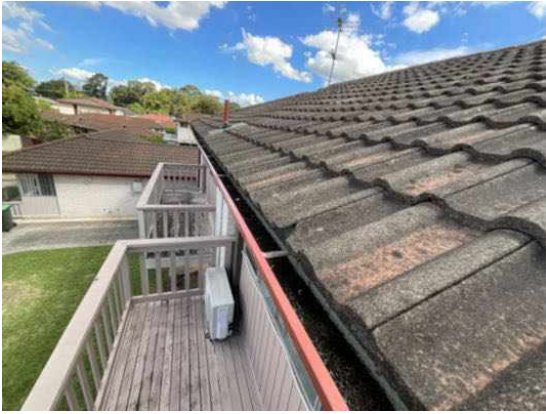
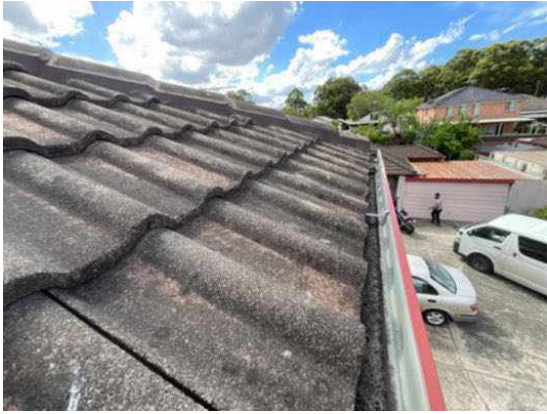
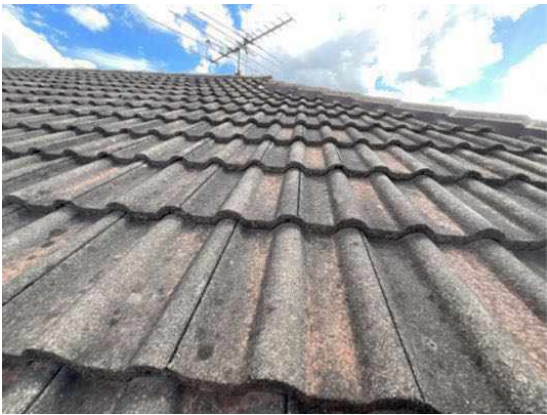
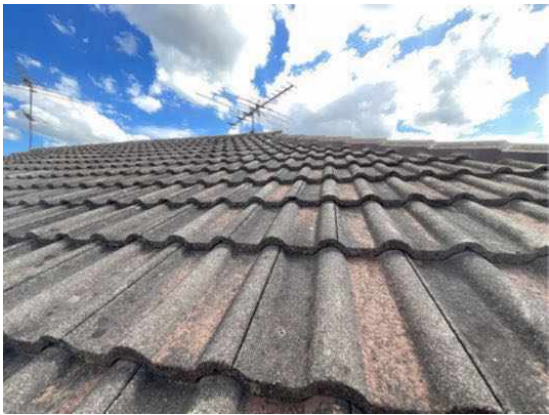
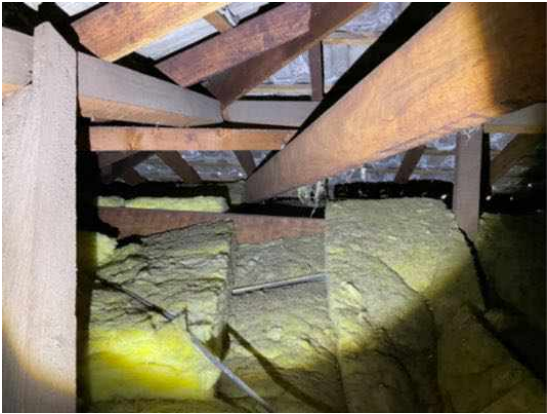
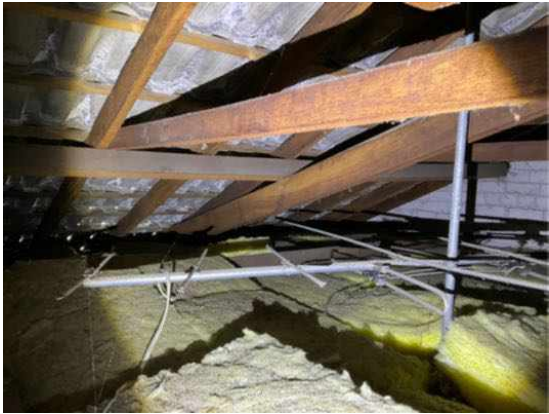
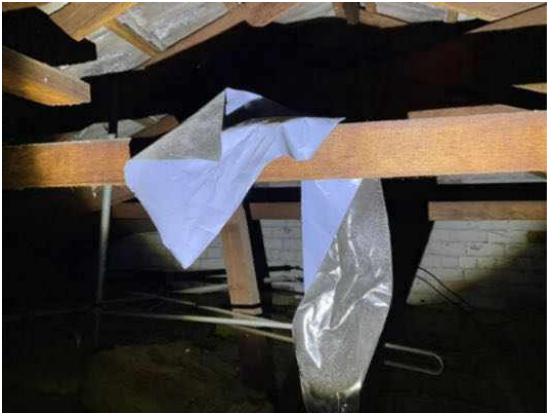
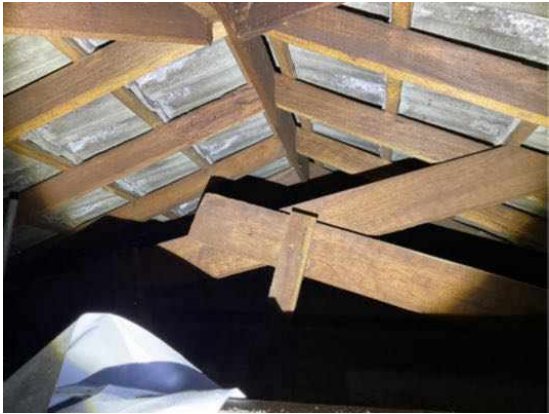
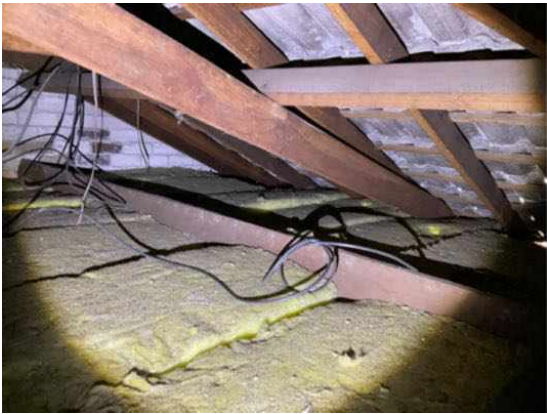
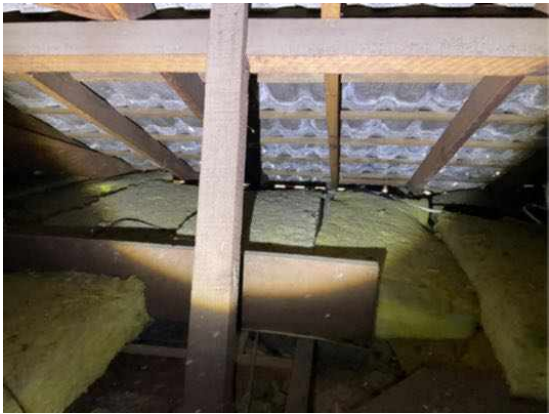
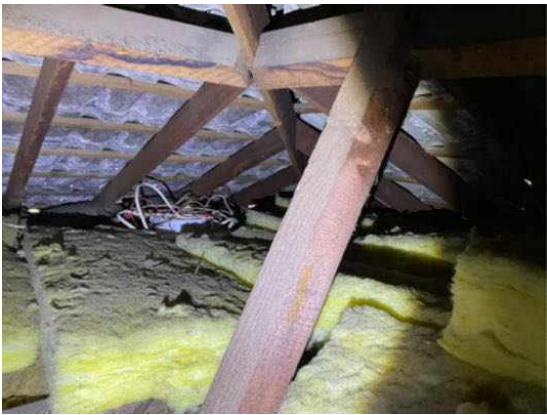
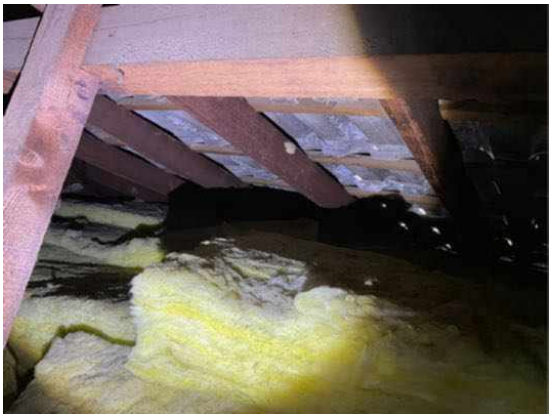
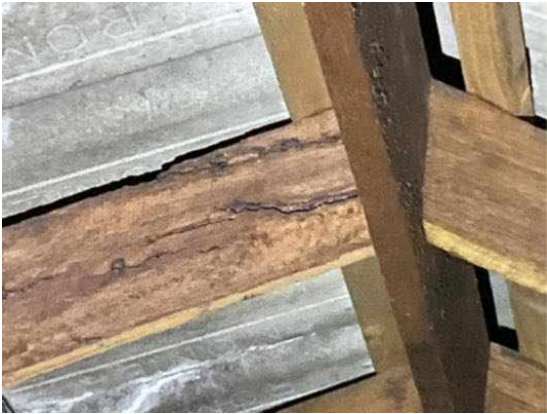
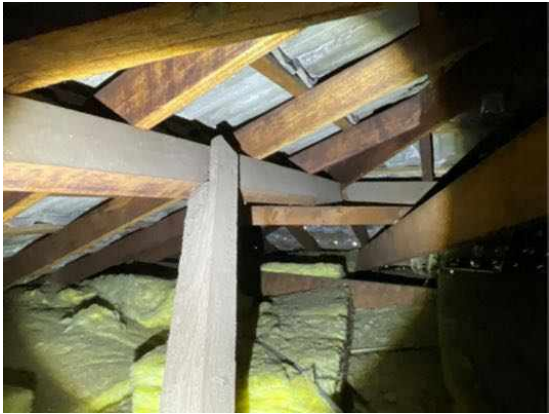
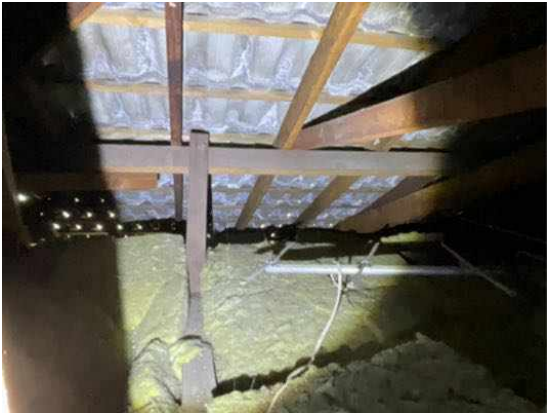
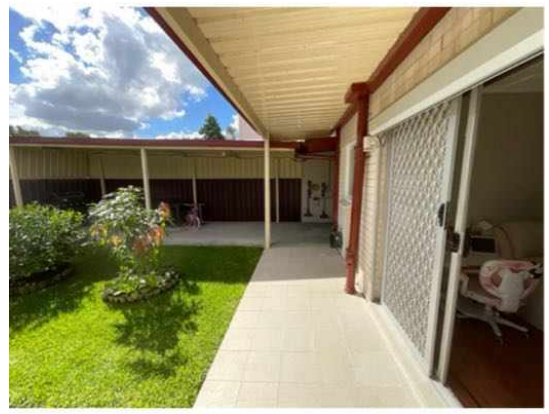
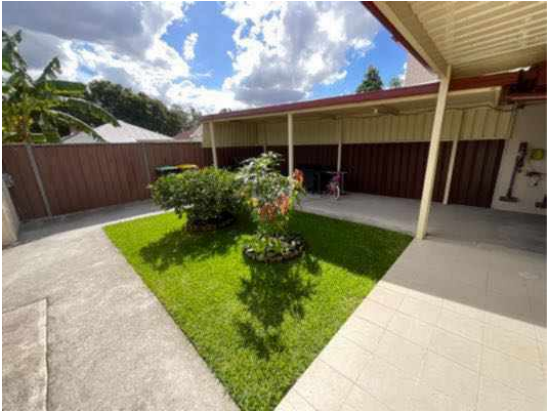
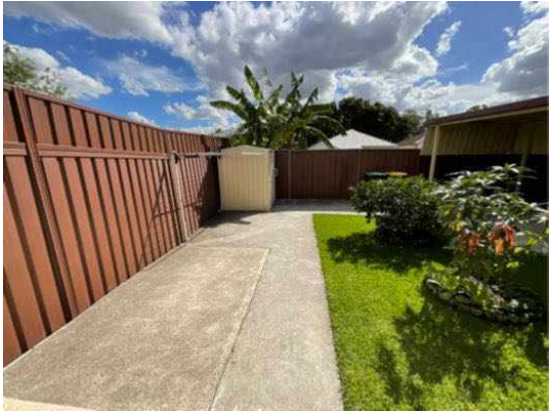
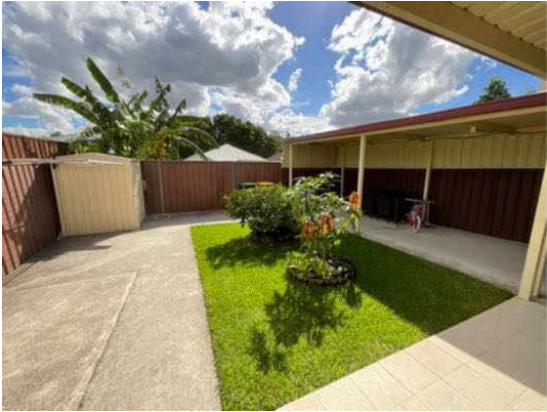
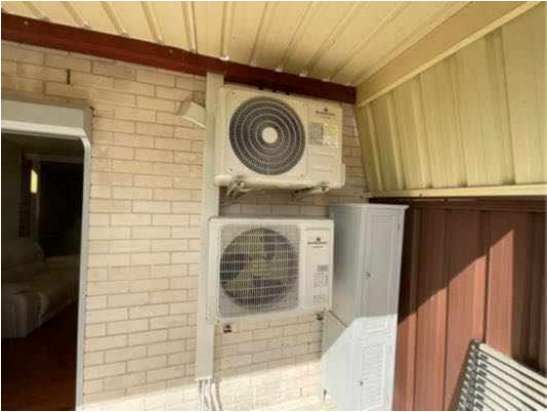
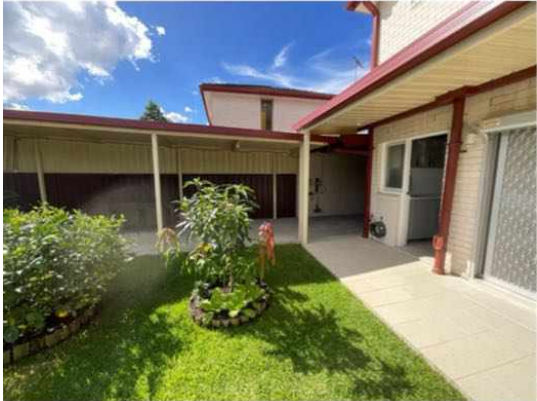
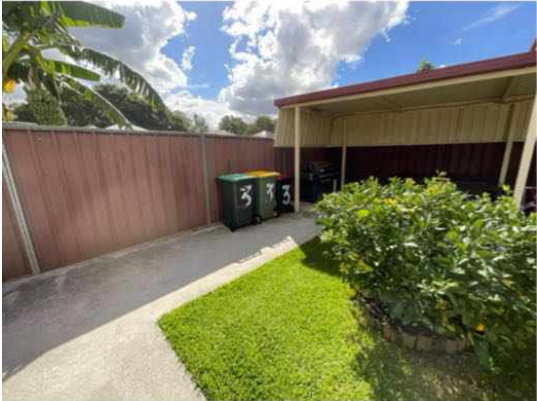
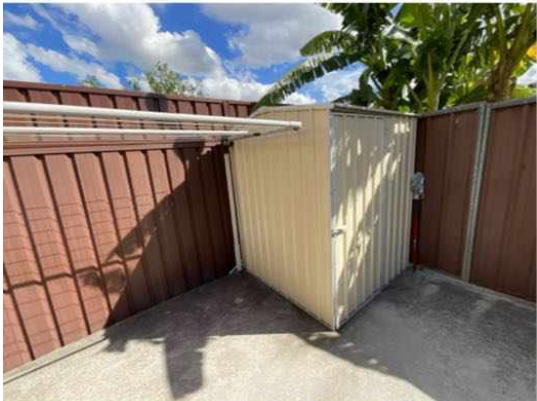
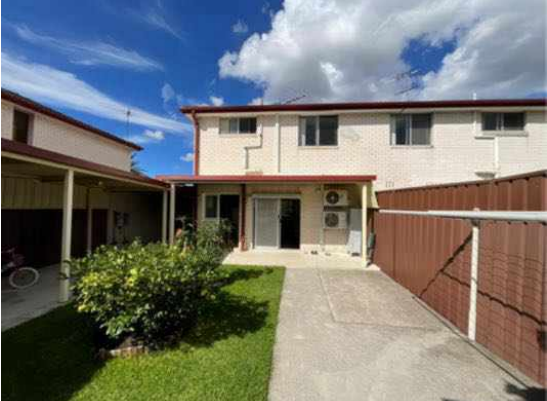
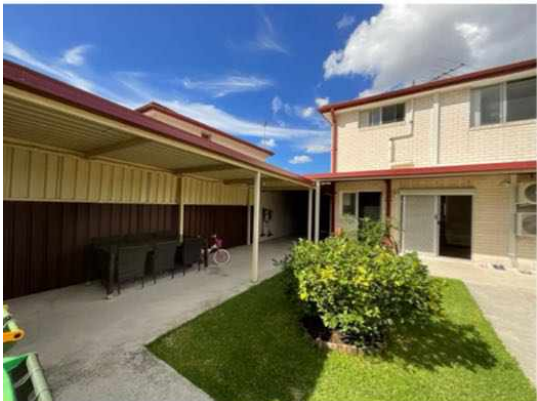
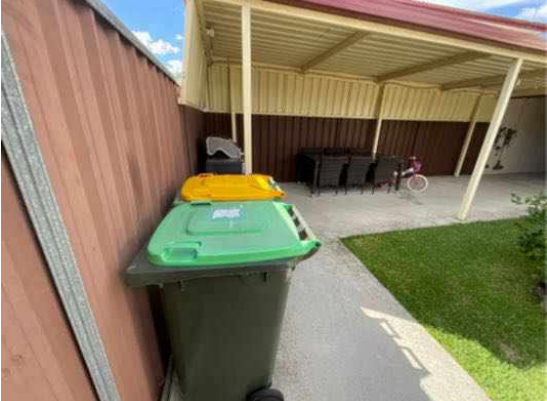
Building: Main Building
Location: All Areas
Finding: Additional Photos - Obstructions and Limitations
Information: These photographs are an indication of the obstructions and limitations which impeded full inspection of the property at the time of inspection. These obstructions can hide an array of defects and should be removed to allow full inspection to be carried out. A re-inspection is recommended once the areas are made accessible.

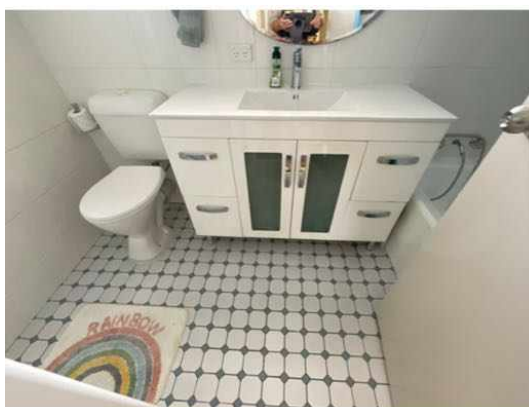
Building:	Main Building
Location:	All Areas
Finding:	Water Proofing Membranes - Information Only
Information:	Internal Water Proofing Membranes, are crucial in preventing water ingress into the property is important to know that the Membrane System used is to Australian Standards and has been installed correctly. Please refer to the original Building Documents or Maintenance Schedule for the relevant information including; - Membrane used and Manufacturers Specifications. - The Installer and Installation Certification. Especially with older property's where this information is unavailable, all wet areas should be monitored. Generally new waterproofing with a certificate may only have a guarantee of 8yrs. If any leaks, water staining, peeling or bubbling of the paint become evident to any adjacent walls or ceilings below a licensed builder or waterproofing specialist is recommended to investigate further.

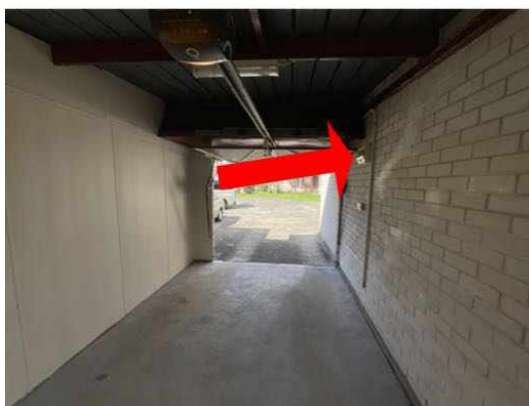
Building:	Main Building
Location:	All Areas
Finding:	Termite Management System - no evidence of a chemical installation
Information:	The application of a post-construction chemical termite barrier is highly recommended for all properties, particularly if live termite activity has been found on the site previously. Such barriers are highly effective in preventing termite attack on any timber building elements throughout the property.

A durable notice should be placed in the switchboard unit to indicate current termite barriers. At the time of inspection, it appeared as though no termite management system has been installed, with no evidence to suggest preventative works taking place.

The client may consider gaining further advice from a pest controller as to the costs and procedures involved with this application. It is recommended that obtaining such advice be a short-term priority.

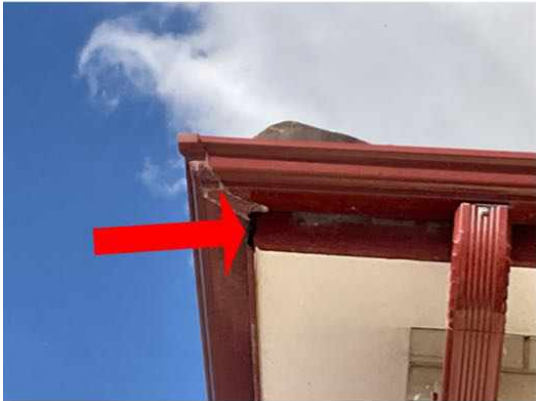
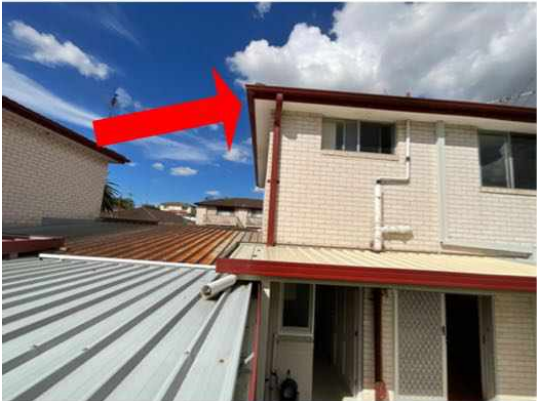
Building:	Main Building
Location:	Roof Exterior
Finding:	Fascias - Wood rot
Information:	Wood rot was found to be affecting fascias and barges in this area, evidenced by the presence of mould on the surface in some areas. Wood rot, also known as Fungal Decay, occurs when timbers and other cellulose building materials are exposed to damp conditions on an ongoing basis.

It is likely that this wood rot has developed as a result of faults in the roof plumbing, creating excessive moisture in this areas. Frequent exposure to rain and other weather conditions also make fascias and barges susceptible to accelerated deterioration.

Early intervention and regular maintenance will prolong the useful life of these building elements. Prior to any works being performed, the cause of the moisture that has created the visible wood rot should be identified and addressed in a suitable manner.

It is advised that a roof plumber be appointed to inspect all roof plumbing and subsequently identify the cause of the wood rot. Replacement of affected fascias and barges may then be a necessary step in protecting surrounding building elements from such deterioration.

A qualified plumber may be appointed to assess the cause of excessive moisture and to provide advice on any remedial works as required. A qualified carpenter or registered builder may also be required to replace affected building materials.
