Building and Timber Pest Inspection Report

Inspection Date: Tue, 17 Mar 2026

Property Address: 112 Reservoir St, Surry Hills NSW 2010,
Australia

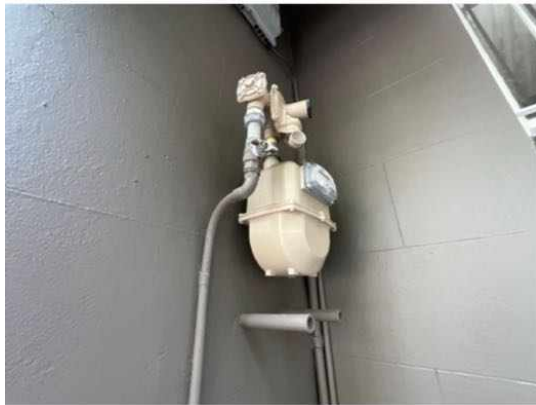
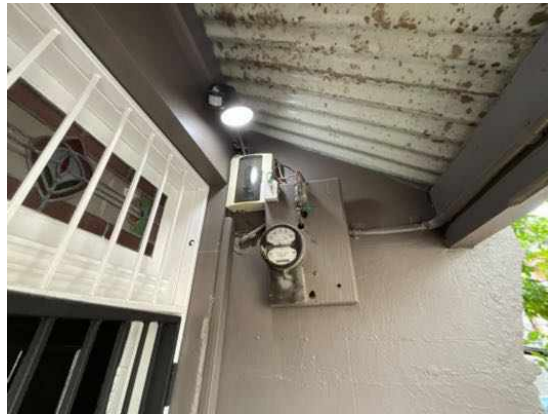
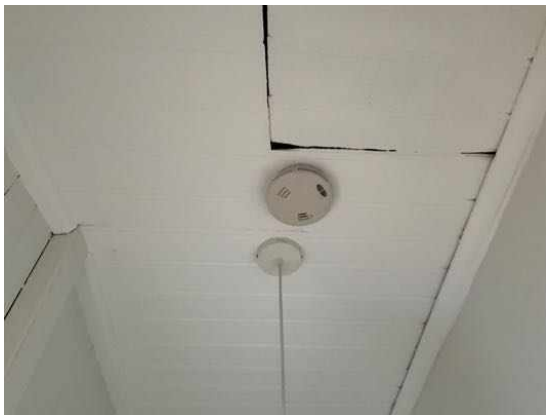
Building: Main Building
Location: All Areas
Finding: Photos Added
Information: Additional photos are provided for your general reference.

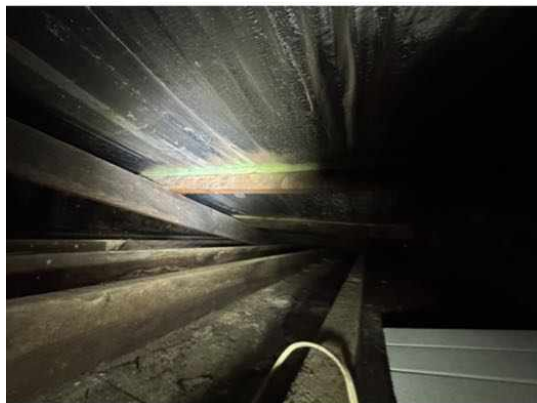
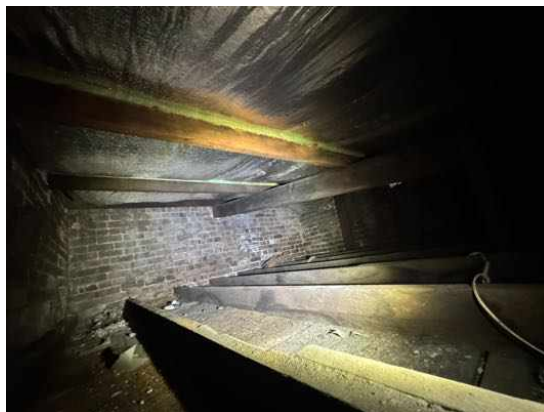
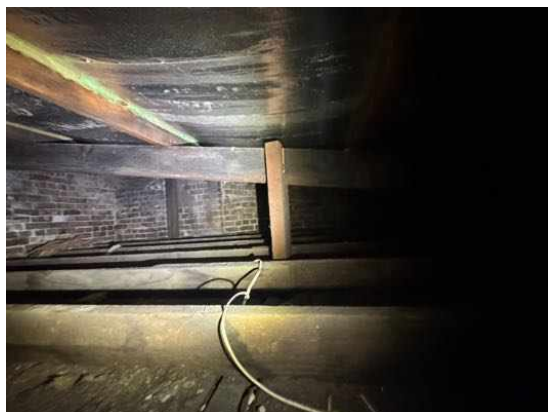
Building: Main Building
Location: Roof Void
Finding: Photos Added
Information: Additional photos are provided for your general reference.
