# Building and Timber Pest Inspection Report

Inspection Date: Sat, 14 Mar 2026

Property Address: 51 Galah St, Melonba NSW 2765, Australia

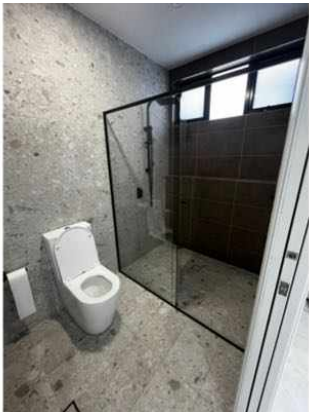
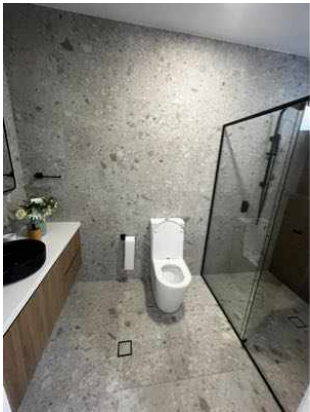
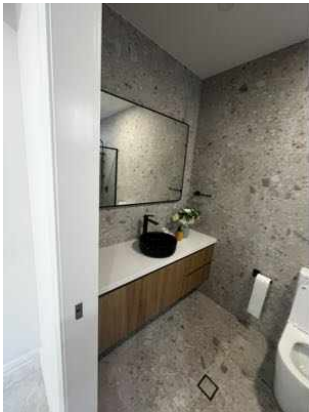
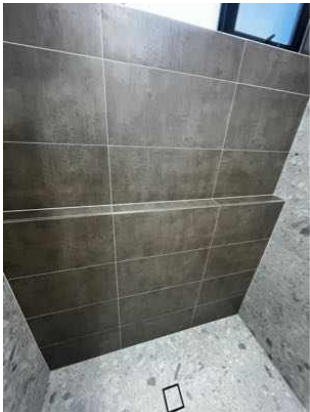
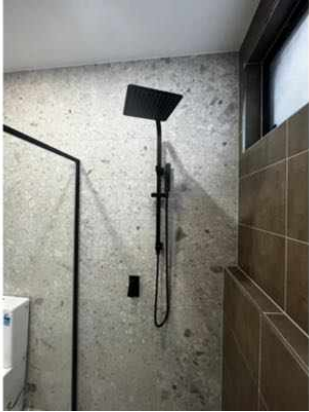
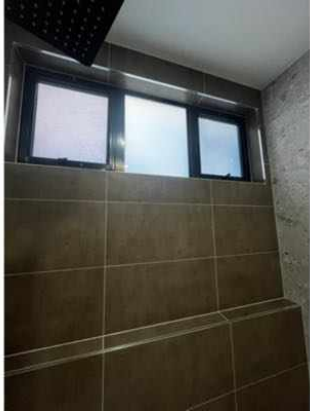
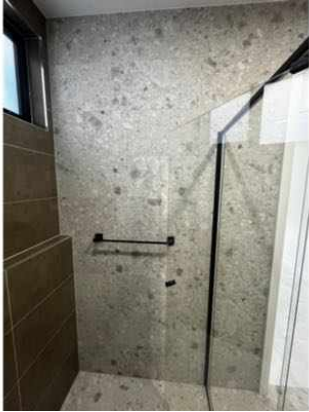
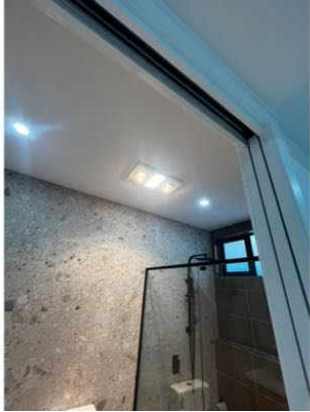
### Finding 3.01

Upon inspection do the ground floor bathroom there was a mark on the wall near the shower screen. Its happened while installation of the shower screen.

A suitable trade person may be consulted to repair and replenish the marked area.

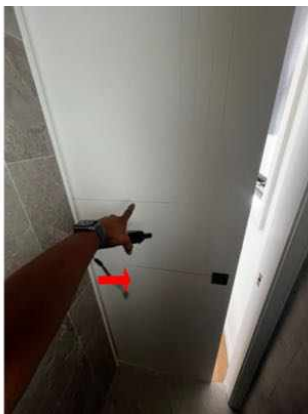
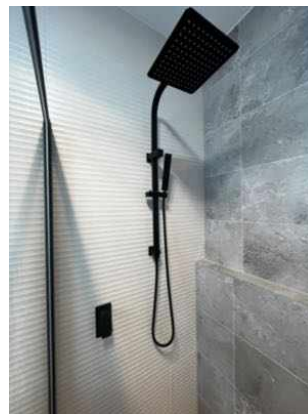
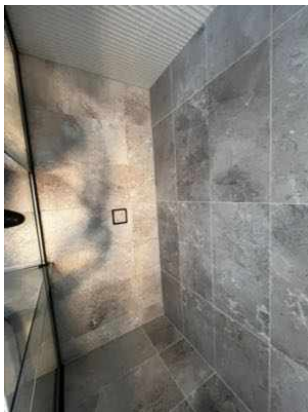
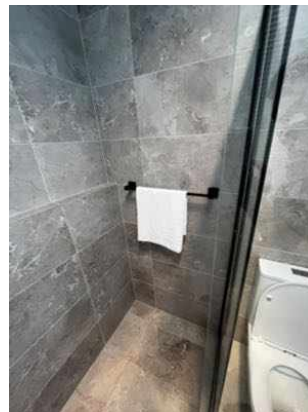
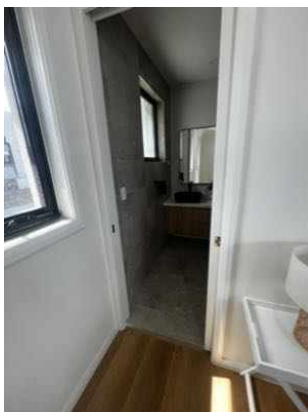
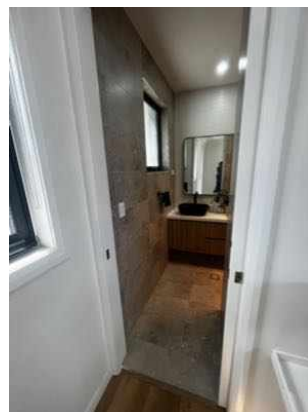
### Finding 3.04

Building:	Main Building
Location:	Ground floor bathroom
Finding:	Door stop - Missing Rubber edge
Information:	At the time of inspection The door stop was missing or was inadequate to stop the door handle from damaging the wall. Although some building elements may seem irrelevant or unnecessary, all building elements play a key role in the operation and function of the overall structure and its performance.

Re-installation or replacement of the door stop is advised as soon as possible to prevent any subsequent damage to the door or associated structures. A general handyman may be appointed to perform these works at client discretion.

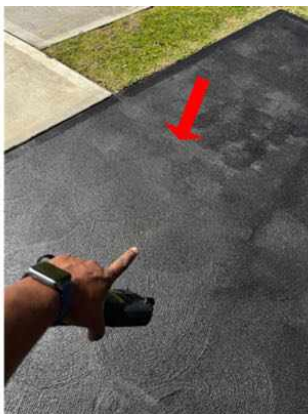
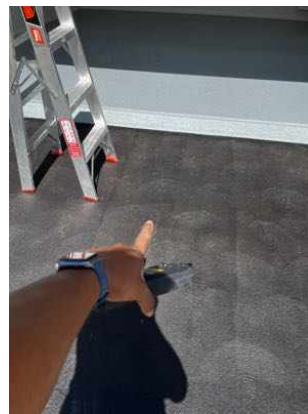
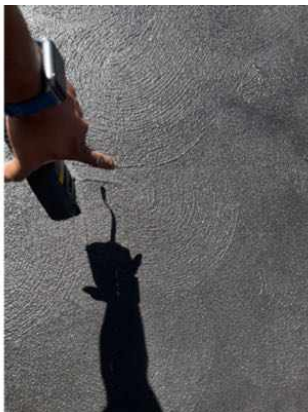
### Finding 3.06

Building:	Main Building
Location:	Roof PLumbing
Finding:	Roof plumbing - Loose flashing
Information:	Metal and other material flashings are applied to seals and intersections between roof coverings and building elements. They are designed to aid in weatherproofing of roof joins, and require regular inspection and maintenance as they are more subject to rust-related deterioration.

The flashing in this section of the exterior roofing appears to have come loose from its original fixing. It is suspected that this minor defect has occurred as a result of general deterioration over time.

Re-fixing and potential replacement of certain areas of flashing is advised to promote adequate roof drainage and protection from water penetration. Failure to perform these works may result in water damage and accelerated deterioration of associated building elements.

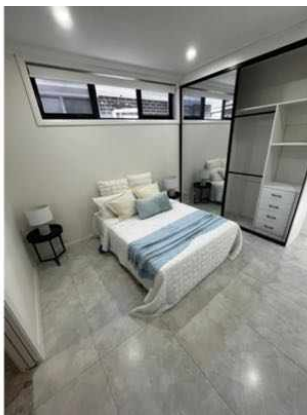
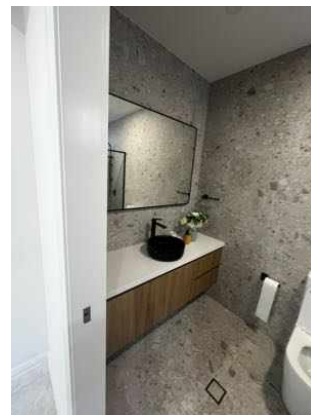
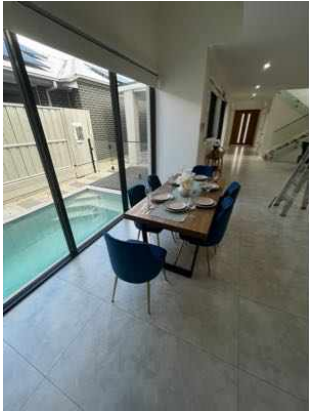
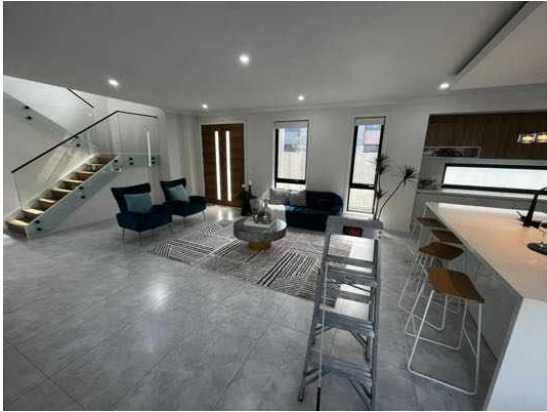
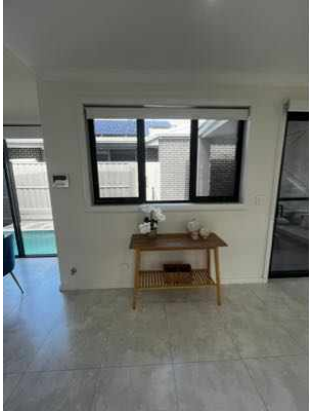
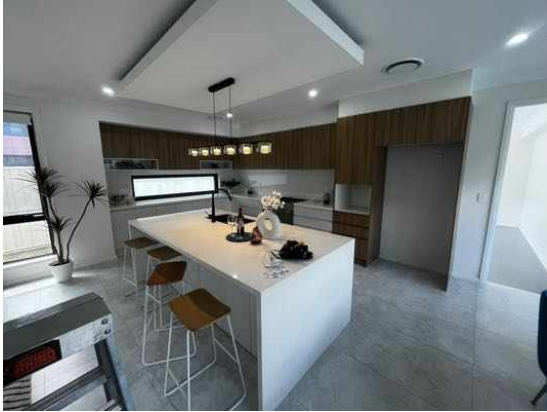
### Finding 6.01

Building: Main Building  
Location: All Areas  
Finding: Additional Photos - Obstructions and Limitations  
Information: These photographs are an indication of the obstructions and limitations which impeded full inspection of the property at the time of inspection. These obstructions can hide an array of defects and should be removed to allow full inspection to be carried out. A re-inspection is recommended once the areas are made accessible.

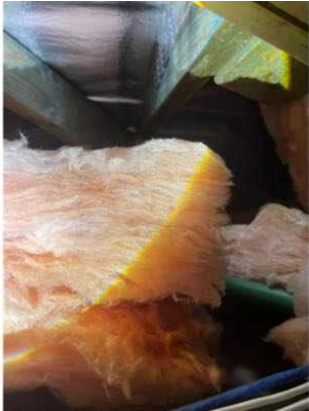
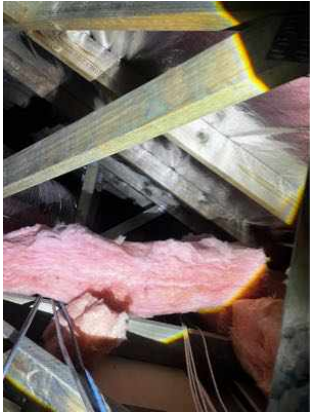
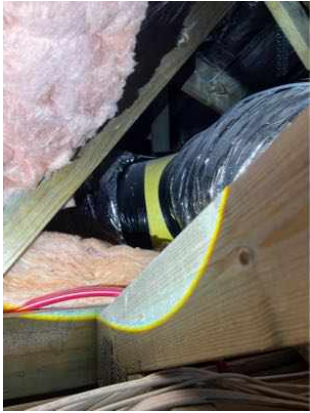
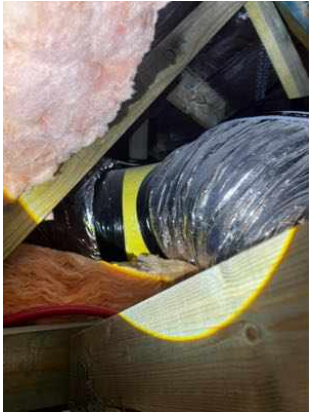
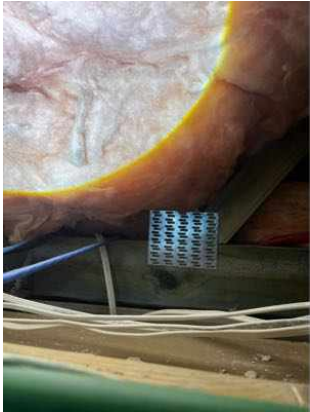
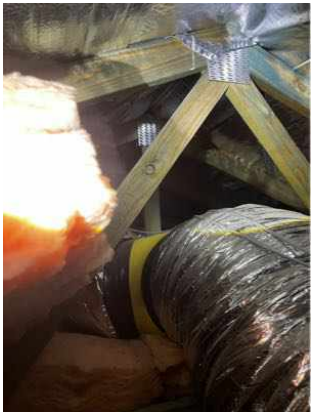
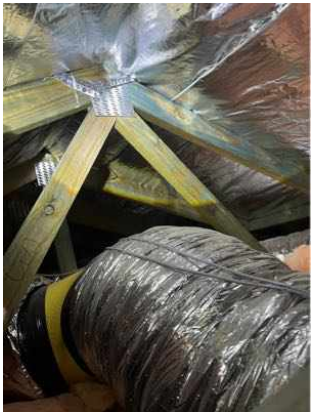
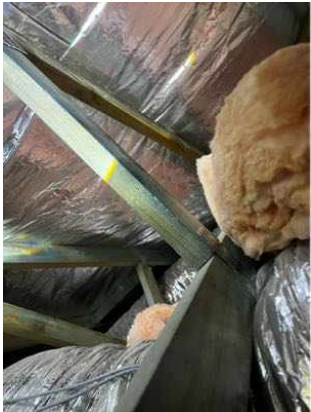
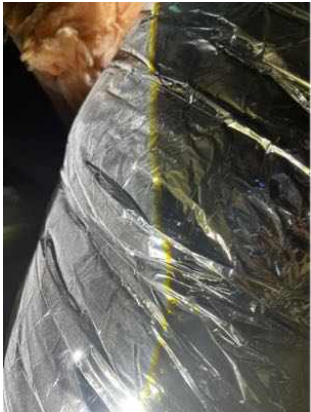
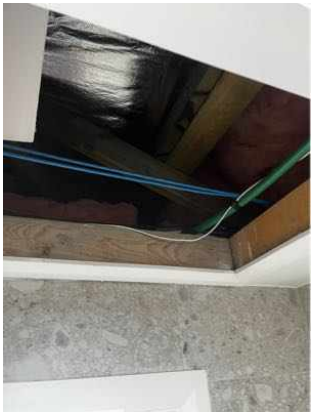
### Finding 6.02

Building: Main Building  
 Location: Roof Void  
 Finding: Obstructions and Limitations - Roof space  
 Information: Upon Inspection of the Roof void below mentioned photos have been attached as to the point been reachable to inspect the roof upon safe condition.

These photographs are an indication of the obstructions and limitations which impeded inspection of the Roof Space/Void at the time of inspection such as Stored items, Ducting, Aircon ducting, Skylight tubes, Electrical wires , insulation and cross beams, rafters, low clearance as of the pitch in the roof. These obstructions can hide an array of defects and should be removed to allow full inspection to be carried out.

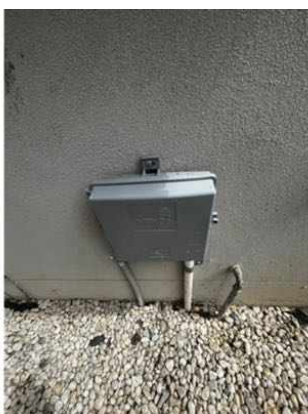
Finding 6.03

Building:	Main Building
Location:	All External Areas
Finding:	Slab Edge - Exposure
Information:	An inspection zone of at least 75mm in relation to the exposed slab edge, between the bottom brick and the perimeter pavement, is required. This inspection zone should be maintained in order to force termites into the open where they can be detected more readily during regular inspections. The slab edge should not be concealed by anything that may prevent inspection of the area, including render, landscaping, soil, turf, paving, concrete cladding or other structures.

If the slab edge is not properly exposed there is a high risk of termite attack. Sometimes, in order to determine the type of slab, a suitably qualified person such as an architect or builder may be required to consult the construction plans.

Where the slab edge cannot be properly inspected, it is highly recommended that termite or timber pest inspections be carried out every 6-12 months to aid protection of the property against infestation.

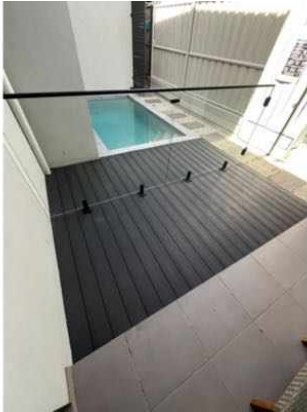
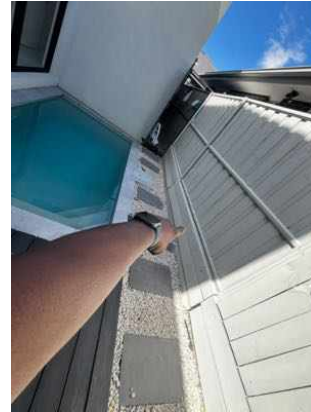
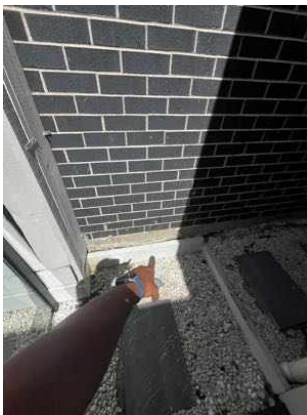
### Finding 6.04

Building:	Main Building
Location:	All External Areas
Finding:	Bridging - Attachments to Buildings
Information:	Upon Inspection, The retaining walls in the side of the building, Retaining walls of Garden beds towards the building , Timber around the perimeter area to the exterior wall of the House which can cause Bridging.

Where any part of an attachment to a building is not isolated and is not provided with a clear gap of not less than 25mm from the building occurs. Attachments to buildings such as hot water services, downpipes, verandahs, decks, steps, fences and service conduits provide the opportunity for concealed entry.

Building attachments of this nature need to be frequently inspected for termite activity by a qualified inspector.

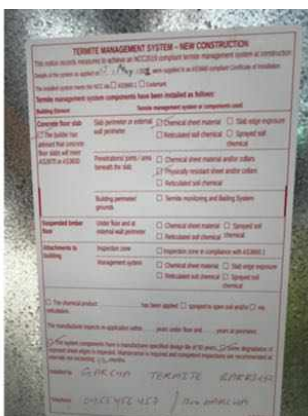
Noted Item

Building: Main Building  
 Location: Sink Cupboard/ Electrical Box  
 Finding: Evidence of a previous termite management system was identified  
 Information: Upon Inspection There was a Durable Notice of Termite treatment identified but the date and the information in the notice was not readable/ identifiable - So It is highly recommended to have a termite treatment organised and to follow a termite treatment proposal and keep note of the system every 12 months in duration.

Where a Termite Management System has been identified you should refer to the type of barrier date of installation warranty conditions and any documentation provided by a builder or past owner. Consult the company who installed the barrier to confirm whether the system is still under warranty.

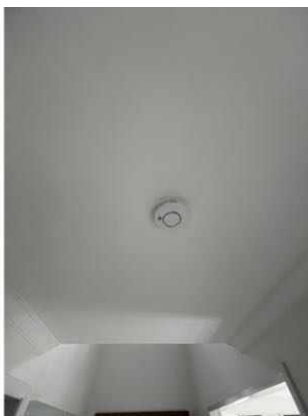
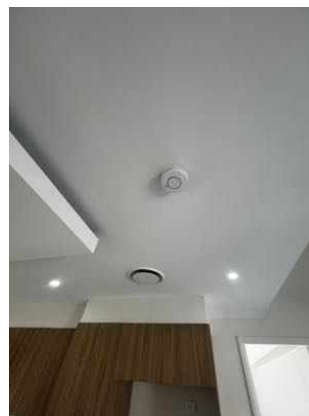
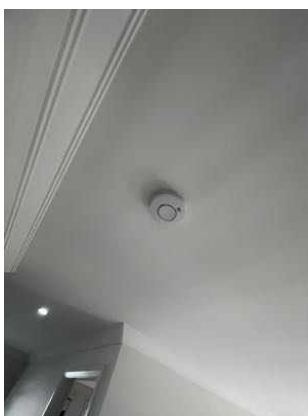
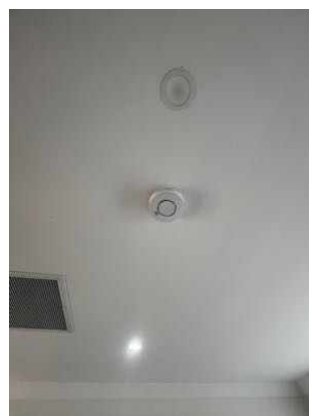
Additionally, it is advised that all smoke detectors be tested by the homeowner on a monthly basis.

Please refer to AS3786 and state based legislation, which may also apply.

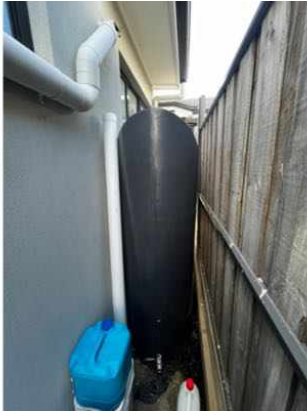
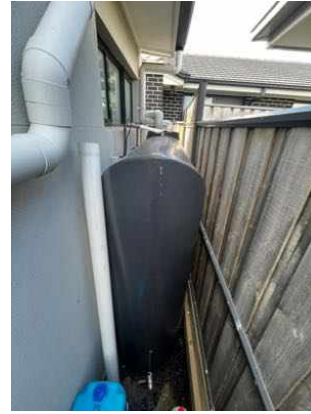
**Noted Item**

Building: Main Building  
Location: Yard - Side  
Finding: Storm Water Tank  
Information: Storm Water Tank photos taken at the time of inspection.

Please consult a licensed Plumber to check the Connections/ pressure/ pumps/ flow of water and functionality accordingly.

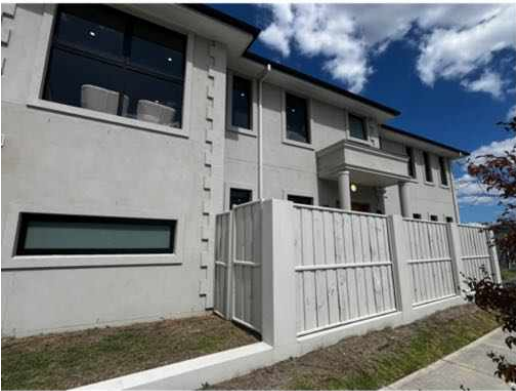
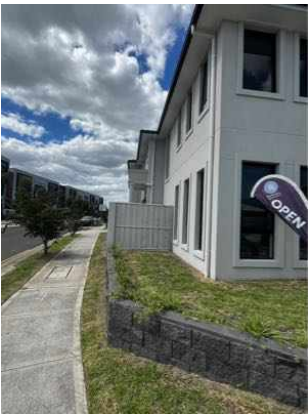
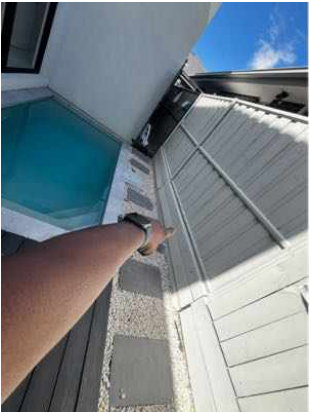
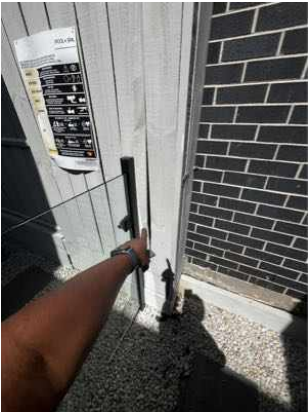
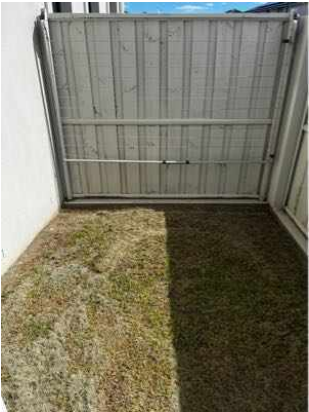
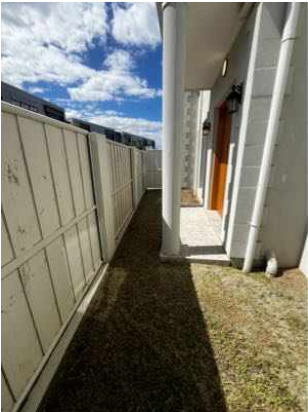
### Noted Item

Building: Main Building  
 Location: Yard  
 Finding: Perimeter Fencing -  
 Information: For your information photos taken at the time of inspection.

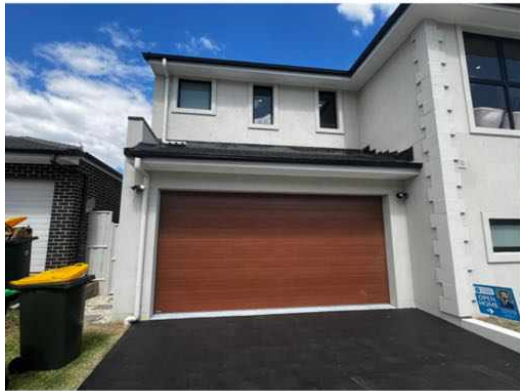
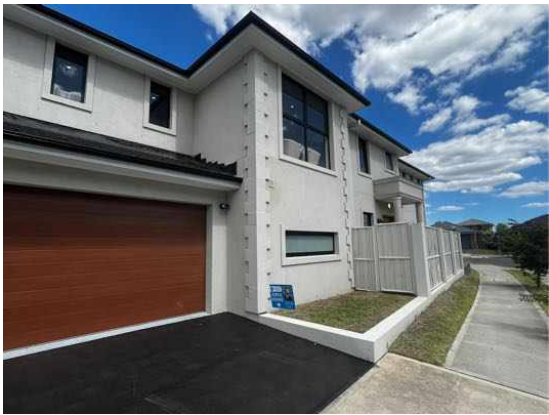
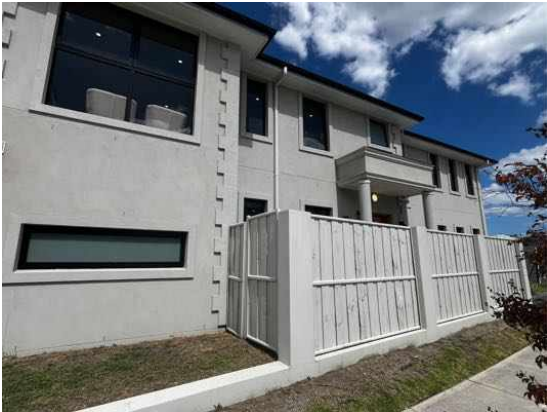
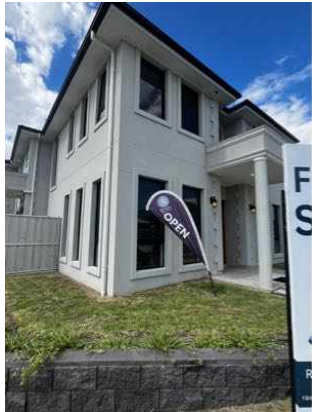
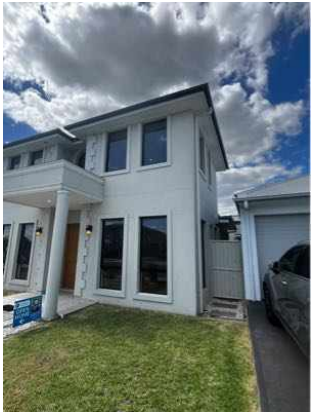
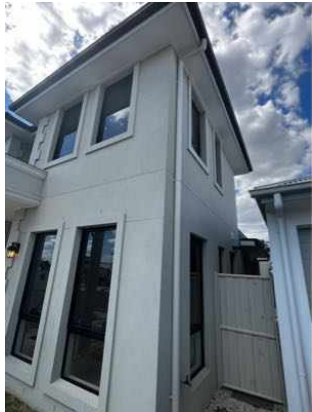
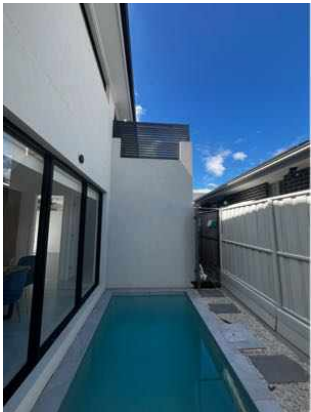
**Noted Item**

Building: Main Building  
Location: Exterior Walls  
Finding: Additional Photos  
Information: Additional photos are provided for your general reference

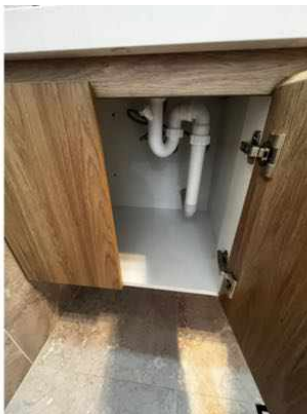
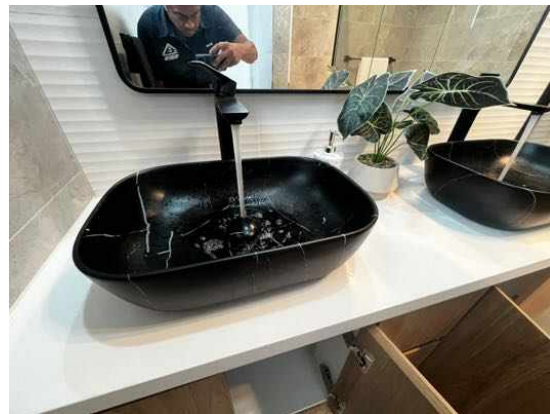
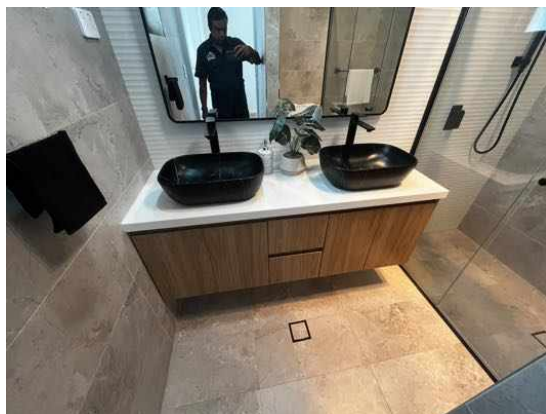
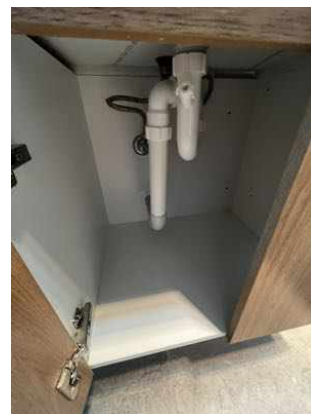
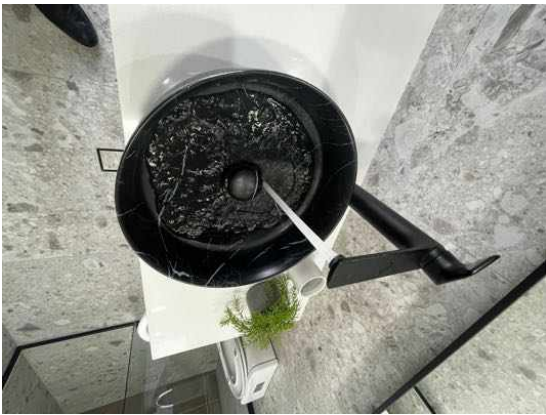
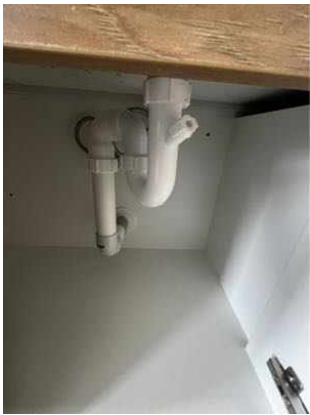
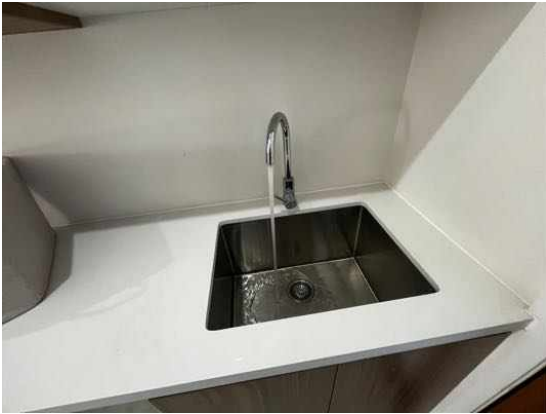
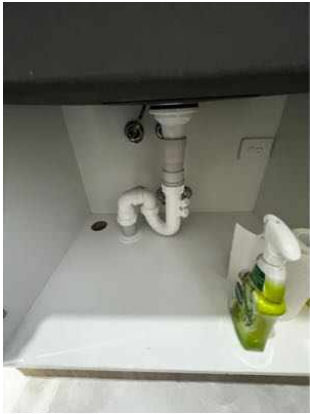
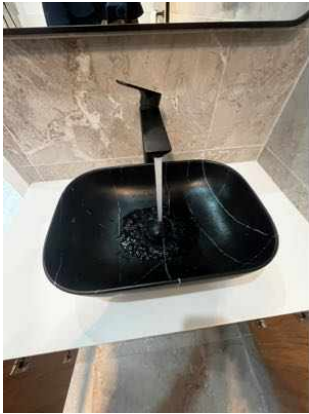
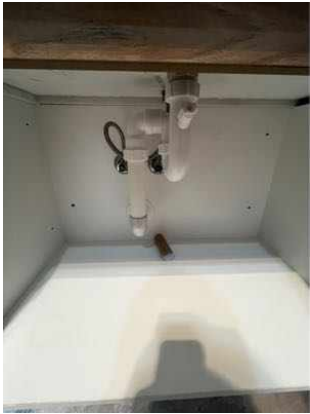
Noted Item

Building: Main Building  
Location: Kitchen/ Laundry/ Bathrooms  
Finding: Cabinetry Plumbing - Kitchen/ Laundry/ Bathrooms  
Information: Upon Inspection of the Kitchen and the Laundry and all bathroom cupboards where sinks and basins with drainage plumbing were inspected and no evidence of leaks were present at the time of inspection.

For your information only no remedial works are required at the time of inspection.

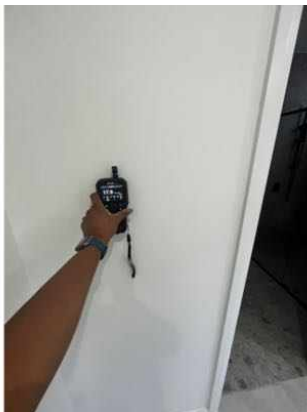
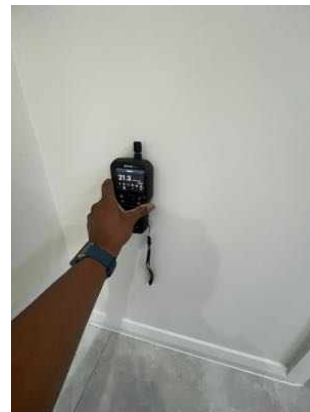
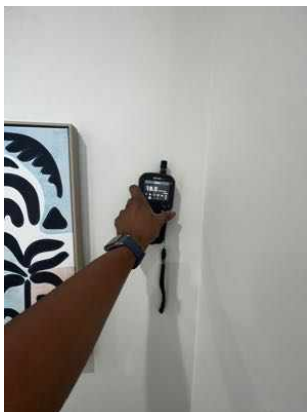
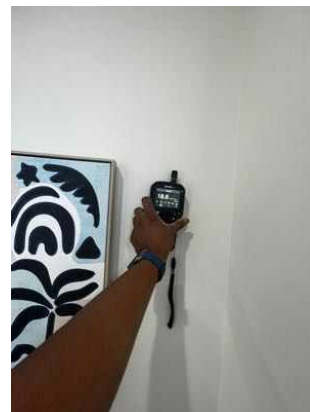
**Noted Item**

Building: Main Building  
Location: All Internal Areas  
Finding: Thermal Camera  
Information: All areas of the dwelling are checked with particular attention paid to wet areas which were closely assessed to check for excessive levels of moisture and temperature anomalies.

No evidence of termite activity was found inside the house at the time of the inspection.

NO readings for moisture was found at the time of inspection.

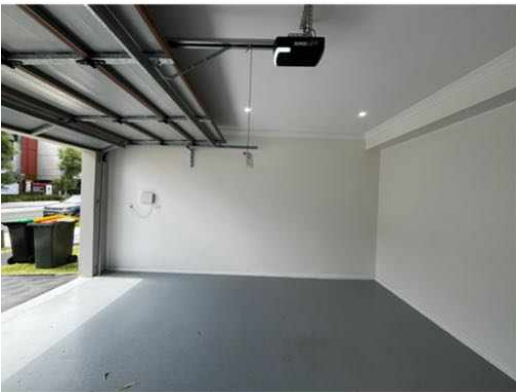
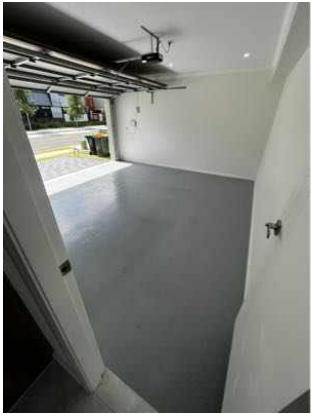
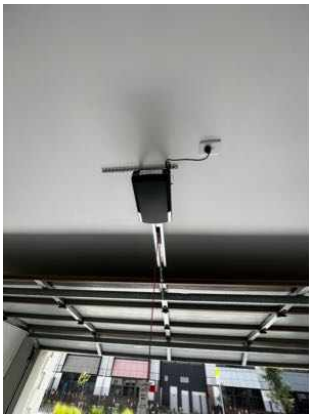
Building: Main Building  
Location: Garage  
Finding: For information only  
Information: A Cluster of Photos taken at the time of inspection.
